**Flood Control Project Maintenance
Levee Inspections**

Fall 2014 Levee Maintenance Deficiency Summary Report

Sacramento River Basin

Reclamation District No. 1000 Natomas

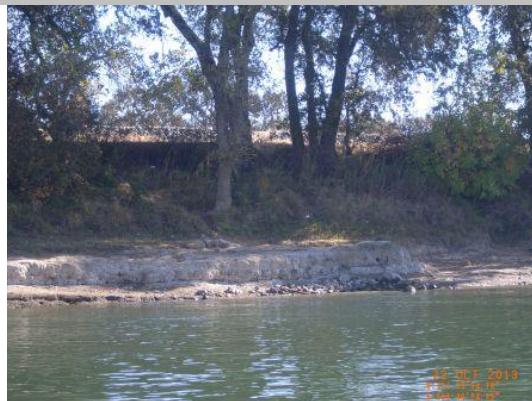
Photo 1 of 1 : FA_2014_RD1000_31_3_20141103_00001.jpg

USACE 2013 Photo #1

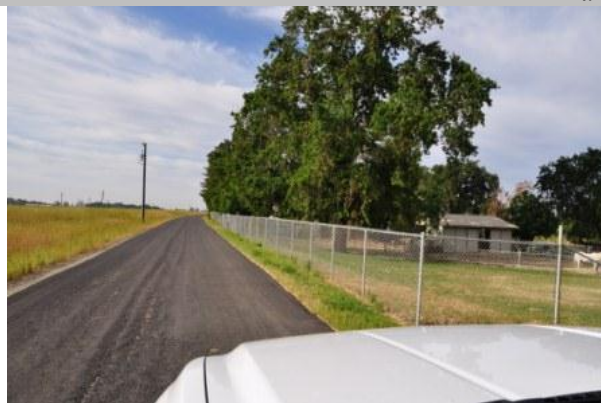
Photo 1 of 1 : FA_2014_RD1000_31_136_20141103_00005.jpg

Unauthorized encroachment, 'Fence'

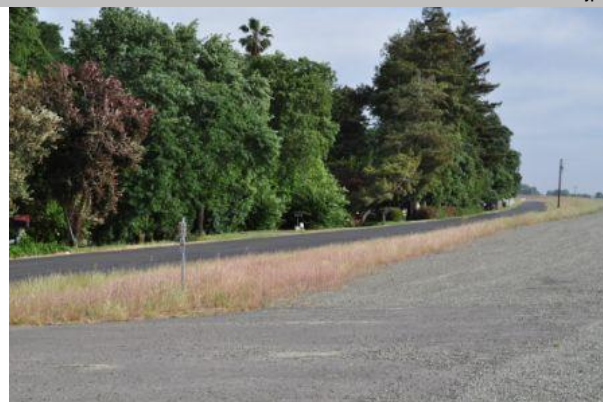
Photo 1 of 1 : FA_2014_RD1000_31_133_20141103_00004.jpg

Typical Garden Hwy 'Landscaping'

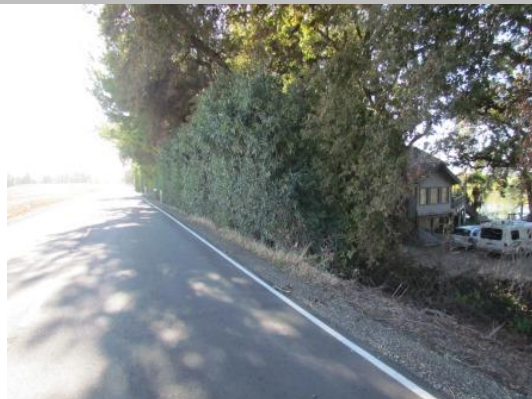
Photo 1 of 1 : FA_2014_RD1000_31_118_20141124_00007.jpg

This photo was taken from the crown facing downstream looking down the waterward levee slope at unacceptable landscaping. Fall 2014.

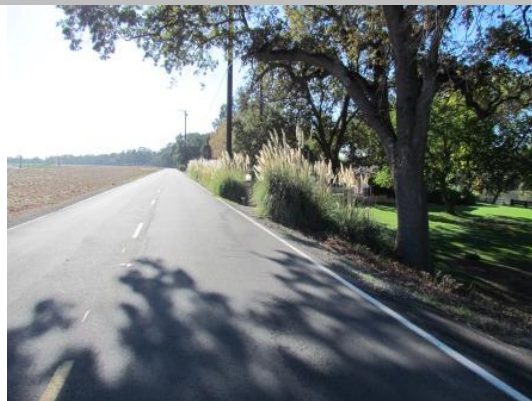
Photo 1 of 1 : FA_2014_RD1000_31_111_20141124_00008.jpg

This photo was taken from the crown facing downstream looking down the waterward levee slope at unacceptable landscaping. Fall 2014.

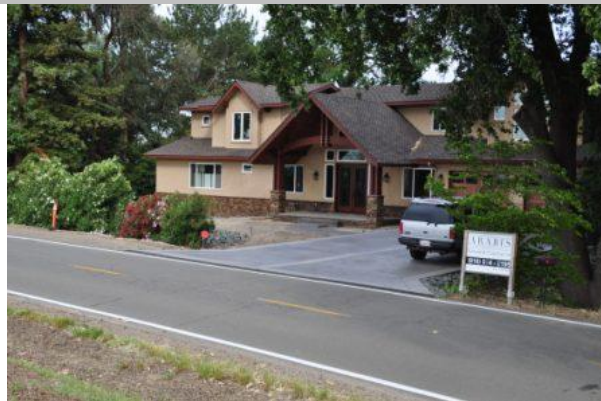
Photo 1 of 1 : FA_2014_RD1000_31_17_20141103_00002.jpg

Newly constructed home

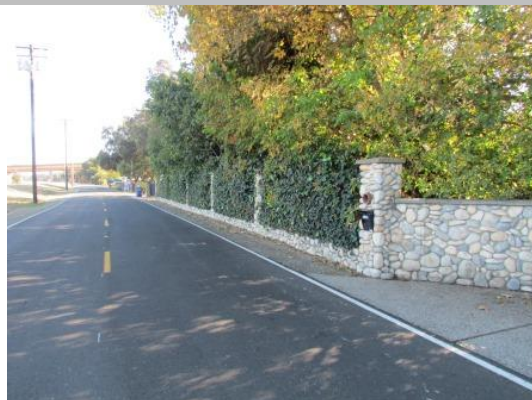
Photo 1 of 1 : FA_2014_RD1000_31_90_20141124_00009.jpg

This photo was taken from the crown facing downstream looking down the waterward levee slope at unacceptable landscaping. Fall 2014.

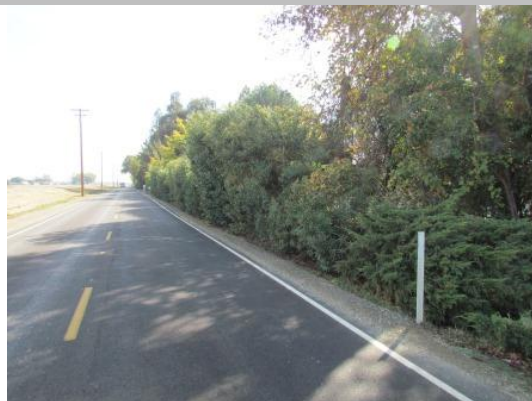
Photo 1 of 1 : FA_2014_RD1000_31_82_20141124_00010.jpg

This photo was taken from the crown facing downstream looking down the waterward levee slope at unacceptable landscaping. Fall 2014.

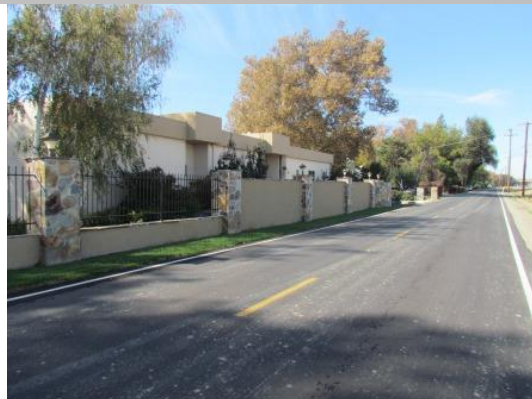
Photo 1 of 1 : FA_2014_RD1000_31_2_20141124_00011.jpg

This photo was taken from the crown facing upstream looking down the waterward levee slope at an unacceptable fence. Fall 2014.

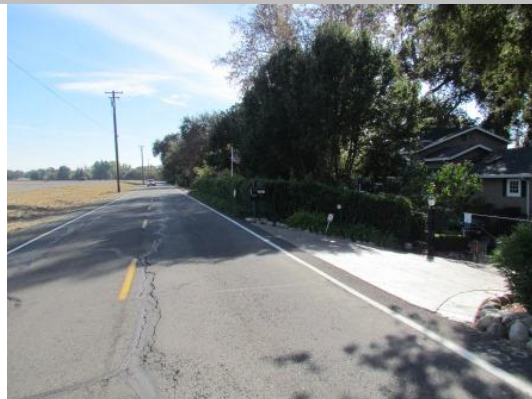
Photo 1 of 1 : FA_2014_RD1000_31_74_20141124_00012.jpg

This photo was taken from the crown facing downstream looking down the waterward levee slope at unacceptable landscaping. Fall 2014.

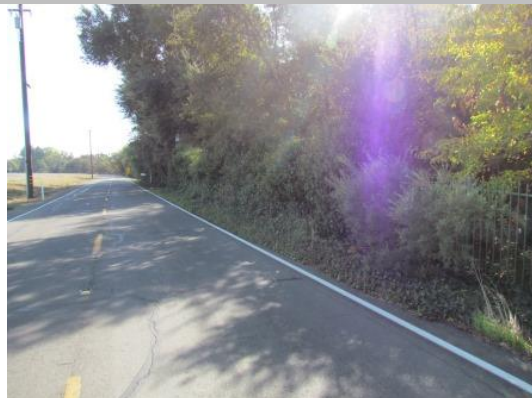
Photo 1 of 1 : FA_2014_RD1000_31_73_20141124_00013.jpg

This photo was taken from the crown facing downstream looking down the waterward levee slope at unacceptable landscaping. Fall 2014.

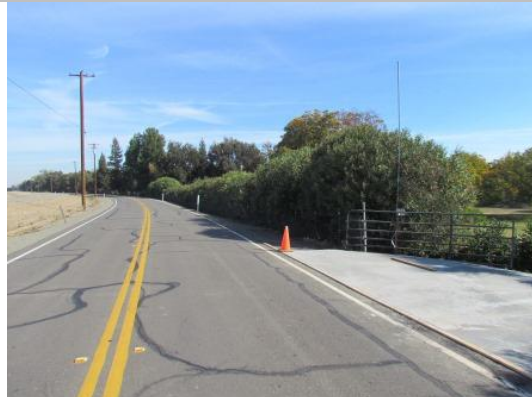
Photo 1 of 1 : FA_2014_RD1000_31_70_20141124_00014.jpg

This photo was taken from the crown facing downstream looking down the waterward levee slope at unacceptable landscaping. Fall 2014.

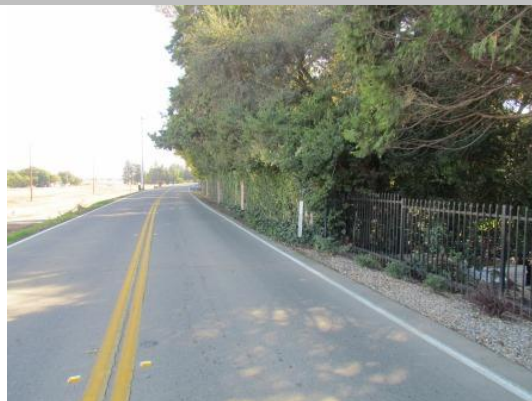
Photo 1 of 1 : FA_2014_RD1000_31_62_20141124_00015.jpg

This photo was taken from the crown facing downstream looking down the waterward levee slope at unacceptable landscaping. Fall 2014.

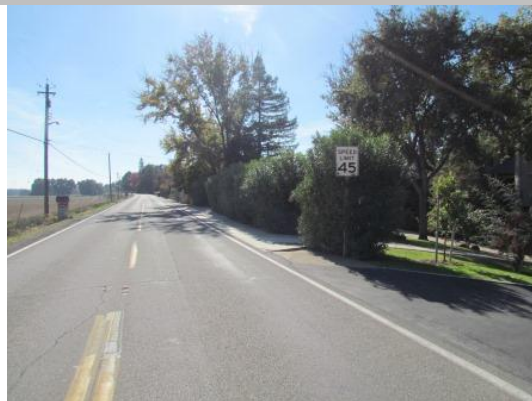
Photo 1 of 1 : FA_2014_RD1000_31_40_20141124_00020.jpg

This photo was taken from the crown facing downstream looking down the waterward levee slope at unacceptable landscaping. Fall 2014.

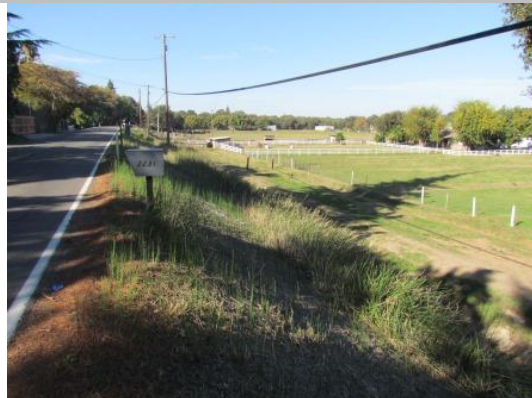
Photo 1 of 1 : FA_2014_RD1000_31_12_20141124_00006.jpg

This photo was taken from the crown facing upstream looking down the landward levee slope at a strip of joint grass the requires annual maintenance. Fall 2014.

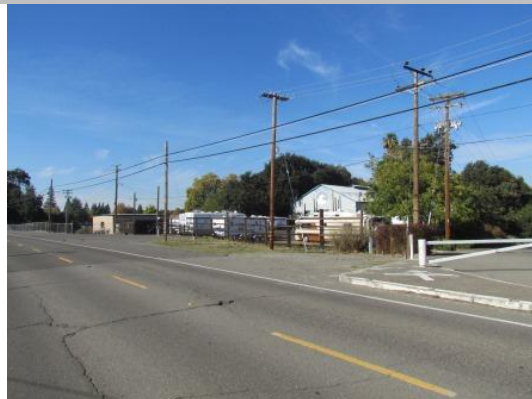
Photo 1 of 1 : FA_2014_RD1000_31_9_20141124_00026.jpg

This photo was taken from the crown facing upstream looking down the landward levee slope at an unacceptable building. Fall 2014.

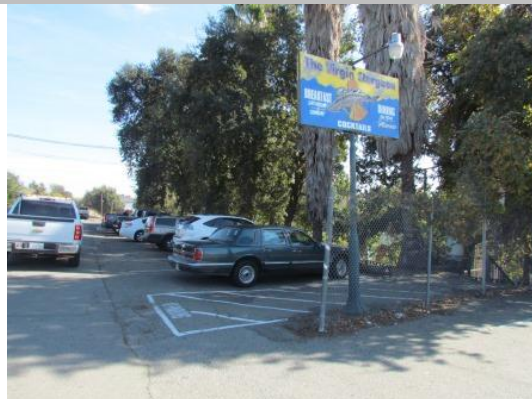
Photo 1 of 1 : FA_2014_RD1000_31_7_20141124_00027.jpg

This photo was taken from the crown facing downstream looking down the waterward levee slope at an unacceptable building. Fall 2014.

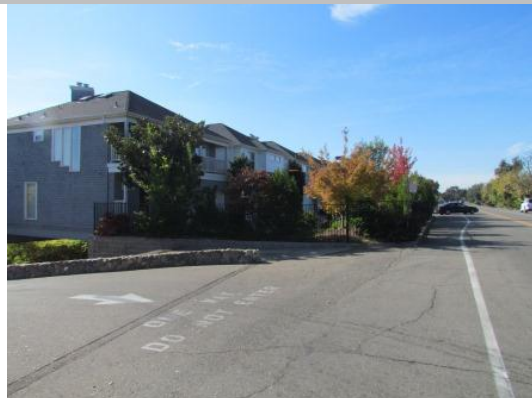
Photo 1 of 1 : FA_2014_RD1000_31_6_20141124_00028.jpg

This photo was taken from the crown facing upstream looking down the waterward levee slope at an unacceptable building. Fall 2014.

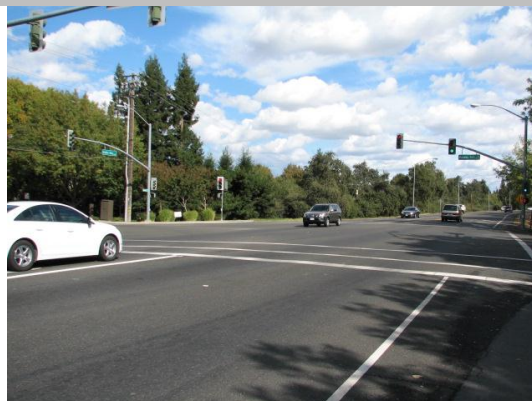
Photo 1 of 2 : FA_2014_RD1000_32_1_20141103_00001.jpg

Levee mile 0.56. This photo is looking upstream from the waterside levee shoulder to the landside shoulder.

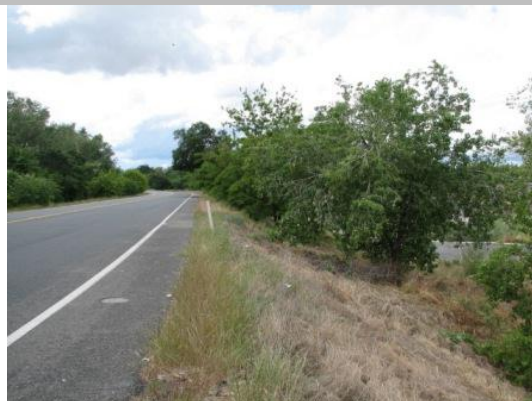
Photo 2 of 2 : FA_2014_RD1000_32_1_20141103_00002.jpg

Landside encroachment, landscaping, levee mile 1.68.

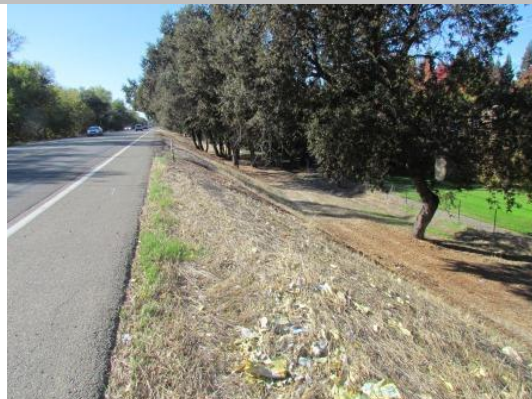
Photo 1 of 1 : FA_2014_RD1000_32_3_20141124_00004.jpg

This photo was taken from the crown facing west looking down the landward levee slope at acceptable vegetation maintenance. Fall 2014.

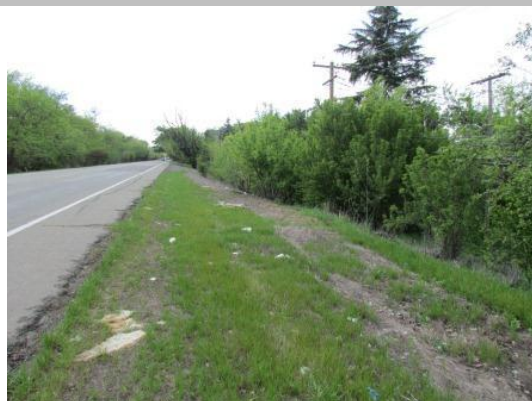
Photo 1 of 1 : FA_2014_RD1000_32_2_20141103_00003.jpg

This photo was taken from the crown facing west looking down the landward levee slope at trees requiring maintenance. Spring 2014.

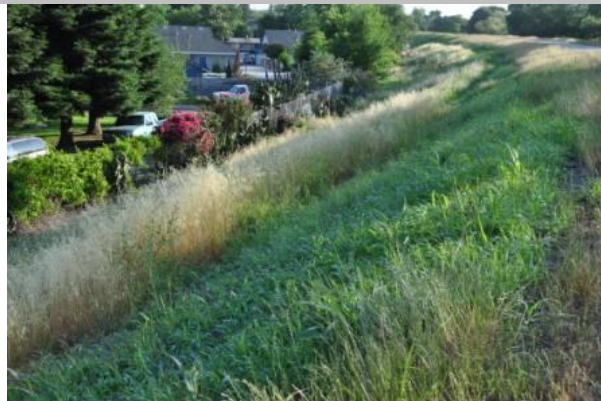
Photo 1 of 1 : FA_2014_RD1000_33_7_20141103_00004.jpg

Fence with vegetation at L/S toe.

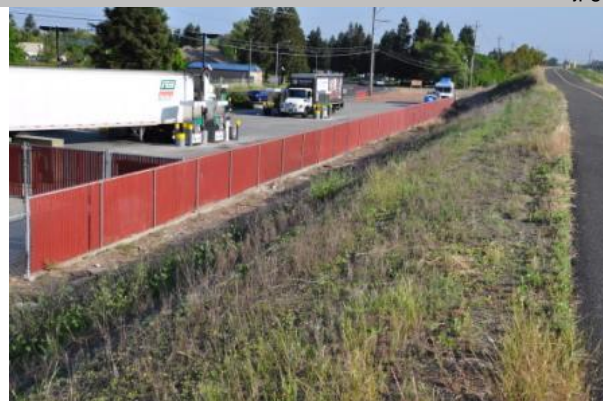
Photo 1 of 1 : FA_2014_RD1000_33_3_20141103_00003.jpg

Fence within 10' of L/S toe.

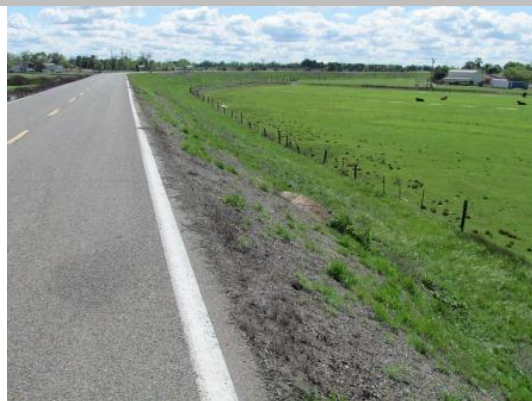
Photo 1 of 2 : FA_2014_RD1000_33_1_20141103_00001.jpg

This photo was taken from the crown facing south looking down the landward slope at a rodent hole requiring maintenance. Spring 2014.

LM Start	4.85	Rating **	A/W	Issue No.	1
LM End	4.96	Issue Type +	Ma	Location *	LS
Category	Earthen Levee			GPS Latitude/Longitude	
				Start	End
Item	Animal Control			38.672913 °	38.673685 °
				-121.481364 °	-121.483115 °
DWR ID	DWR_RD1000_03_f_2013_1				
Action/Comments					
Exterminate rodents and backfill and compact or grout burrows.

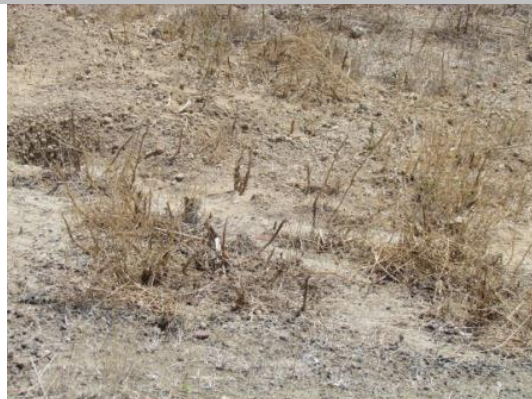
Photo 2 of 2 : FA_2014_RD1000_33_1_20141103_00002.jpg

This photo was taken from the levee crown looking down the landward slope at a squirrel poking its head out of a hole.

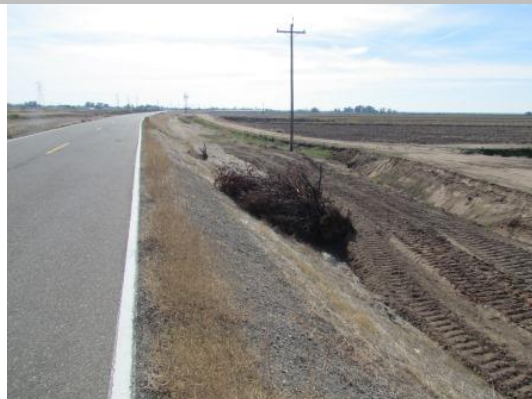
Photo 1 of 1 : FA_2014_RD1000_33_6_20141124_00009.jpg

This photo was taken from the crown facing south looking down the landward levee slope at a brush pile that should be removed. Fall 2014.

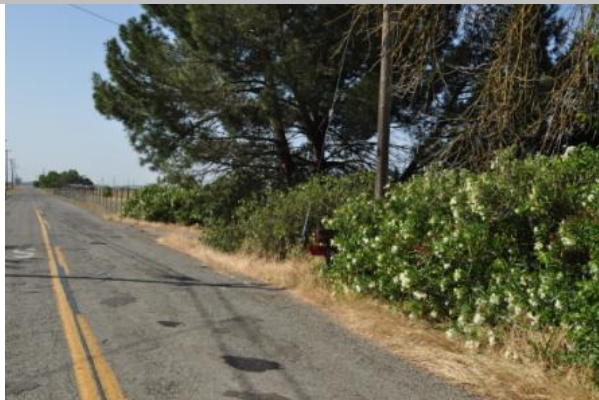
Photo 1 of 1 : FA_2014_RD1000_33_13_20141103_00007.jpg

L/S landscaping.

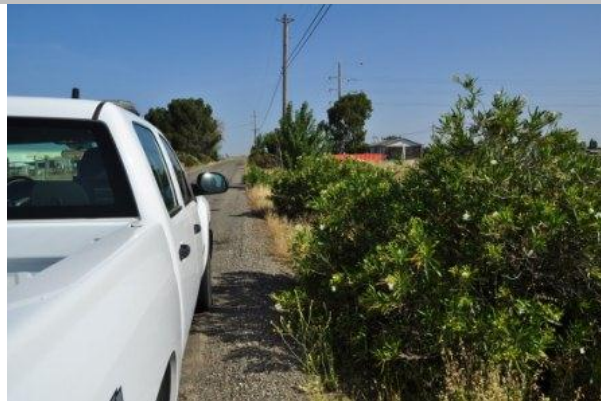
Photo 1 of 1 : FA_2014_RD1000_33_10_20141103_00006.jpg

W/S vegetation.

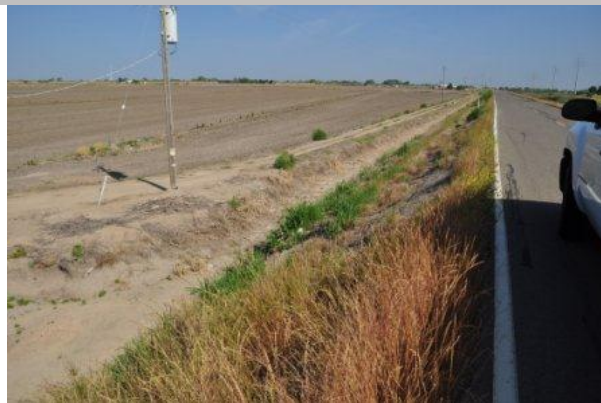
Photo 1 of 1 : FA_2014_RD1000_33_9_20141103_00005.jpg

L/S Ag ditch @ L/S toe.

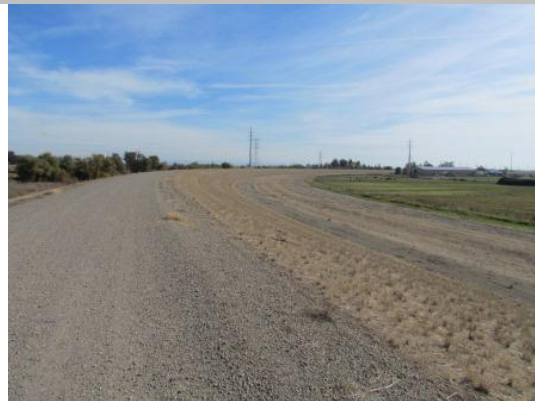
Photo 1 of 1 : FA_2014_RD1000_33_2_20141124_00008.jpg

This photo was taken from the crown facing east looking down the landward levee slope at acceptable vegetation maintenance. Fall 2014.

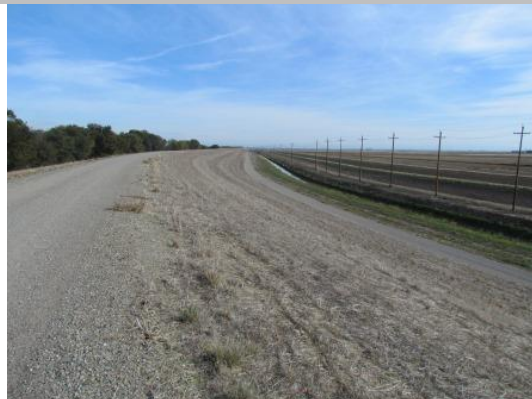
Photo 1 of 1 : FA_2014_RD1000_34_1_20141124_00001.jpg

This photo was taken from the crown facing east looking down the landward levee slope at acceptable vegetation maintenance. Fall 2014.
