**Flood Control Project Maintenance
Levee Inspections**

Fall 2015 Levee Maintenance Deficiency Summary Report

**Flood Control Project Maintenance
Levee Inspections**
LMA District Cover Sheet
Fall 2015 Levee Inspection Results

Reclamation District No. 1000 Natomas

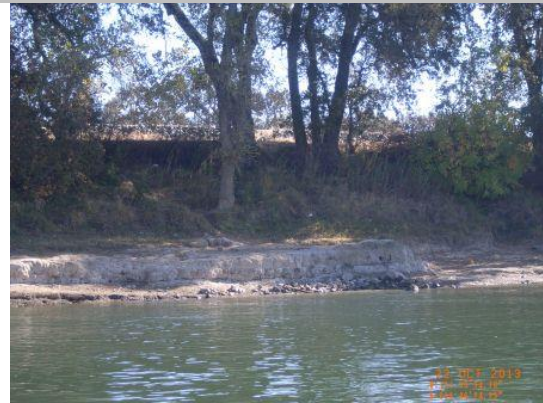
Photo 1 of 1 : USACE2013A_SAC_78-3_L_7.jpg

LM Start	0.48	Rating **	M	Issue No.	3
LM End	0.61	Issue Type +	Ma	Location *	WS
Category	Supplemental			GPS Latitude/Longitude	
				Start	End
Item	2015 USACE Erosion Survey, DRAFT			38.774507 °	38.772921 °
				-121.598865 °	-121.597788 °
DWR ID					
Action/Comments					
Inspector Comments: 1997 - Very cohesive toe. 2005 - Site was staked and rock was stockpiled along the top of the bank. 2010 - New adjacent levee under construction. 2011 - New animal burrow. 2015: No observed changes. [2015 Site ID: SAC_78-3_L]

USACE 2013 Photo #1

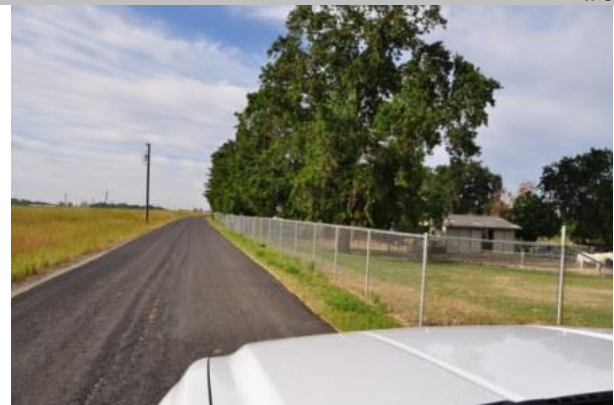
Photo 1 of 1 : FA_2015_RD1000_31_136_20151103_00032.jpg

LM Start	1.63	Rating **	M	Issue No.	136
LM End	1.63	Issue Type +	En	Location *	WS
Category	Earthen Levee			GPS Latitude/Longitude	
				Start	End
Item	Encroachments			38.759320 °	38.759320 °
				-121.591343 °	-121.591343 °
DWR ID	DWR_RD1000_01_s _ 2012_136				
Action/Comments					
Fence

Unauthorized encroachment, 'Fence'

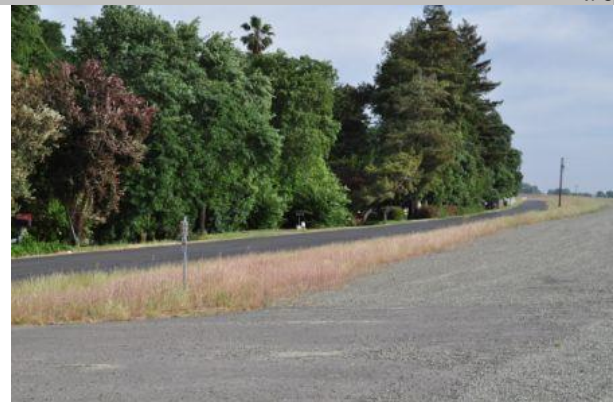
Photo 1 of 1 : FA_2015_RD1000_31_133_20151103_00031.jpg

Typical Garden Hwy 'Landscaping'

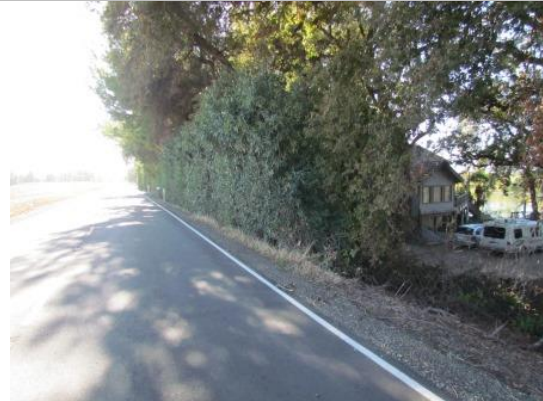
Photo 1 of 1 : FA_2015_RD1000_31_118_20151103_00030.jpg

This photo was taken from the crown facing downstream looking down the waterward levee slope at unacceptable landscaping. Fall 2014.

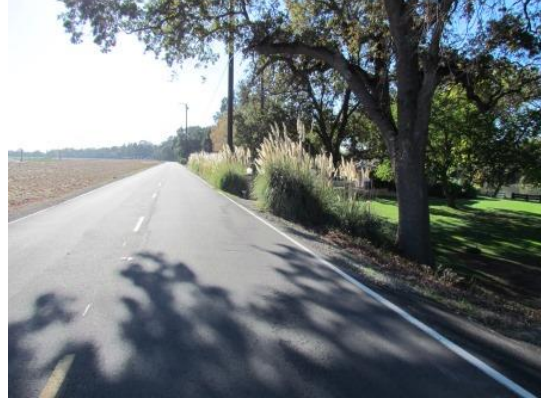
Photo 1 of 1 : FA_2015_RD1000_31_111_20151103_00029.jpg

This photo was taken from the crown facing downstream looking down the waterward levee slope at unacceptable landscaping. Fall 2014.

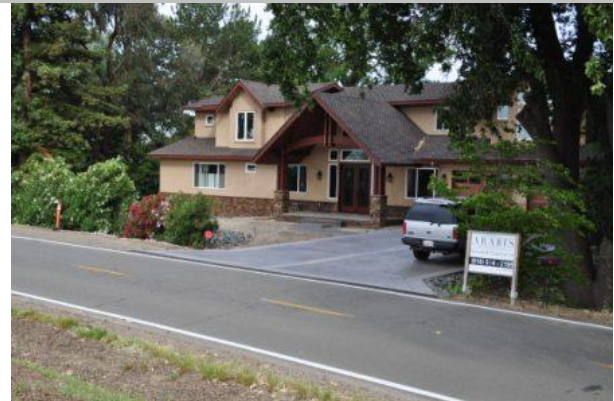
Photo 1 of 1 : FA_2015_RD1000_31_17_20151103_00011.jpg

Newly constructed home

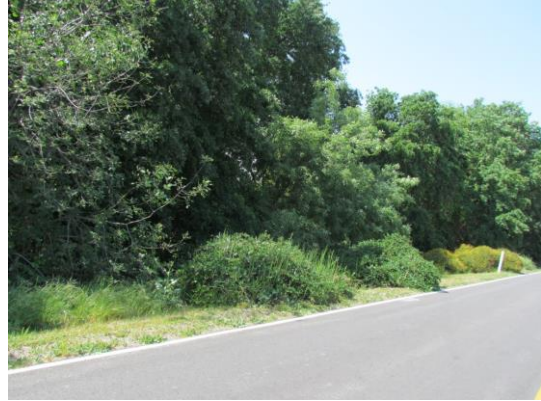
Photo 1 of 1 : FA_2015_RD1000_31_63_20151103_00022.jpg

This photo was taken facing the waterside of the levee looking upstream.

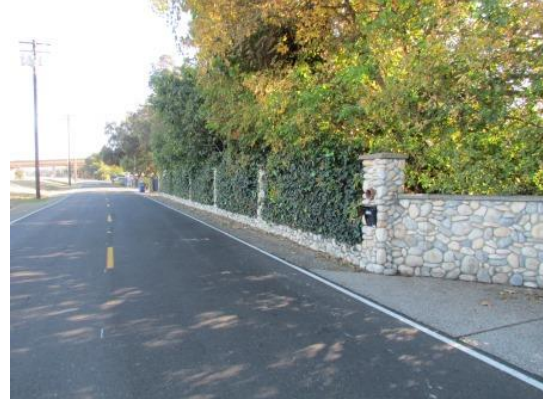
Photo 1 of 1 : FA_2015_RD1000_31_90_20151103_00028.jpg

This photo was taken from the crown facing downstream looking down the waterward levee slope at unacceptable landscaping. Fall 2014.

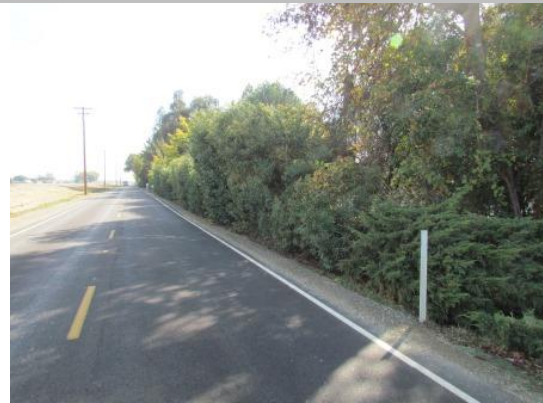
Photo 1 of 1 : FA_2015_RD1000_31_82_20151103_00027.jpg

This photo was taken from the crown facing downstream looking down the waterward levee slope at unacceptable landscaping. Fall 2014.

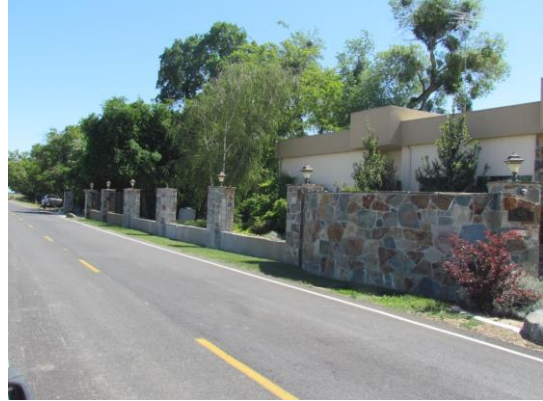
Photo 1 of 2 : FA_2015_RD1000_31_2_20151103_00001.jpg

Photo of a fence on the waterside of the levee facing upstream.

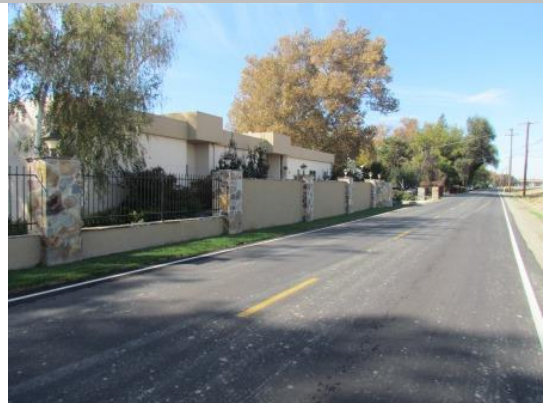
Photo 2 of 2 : FA_2015_RD1000_31_2_20151103_00002.jpg

This photo was taken from the crown facing upstream looking down the waterward levee slope at an unacceptable fence. Fall 2014.

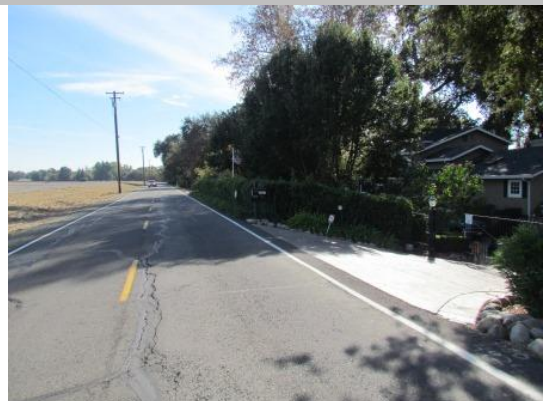
Photo 1 of 1 : FA_2015_RD1000_31_74_20151103_00025.jpg

LM Start	10.72	Rating **	U	Issue No.	74
LM End	10.76	Issue Type +	En	Location *	WS
Category	Earthen Levee			GPS Latitude/Longitude	
				Start	End
Item	Vegetation			38.648127 °	38.647663 °
				-121.595872 °	-121.595483 °
DWR ID	DWR_RD1000_01_s _ 2012_74				
Action/Comments					
Landscaping

This photo was taken from the crown facing downstream looking down the waterward levee slope at unacceptable landscaping. Fall 2014.

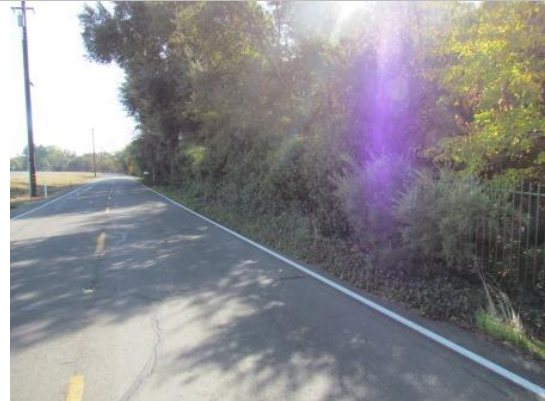
Photo 1 of 1 : FA_2015_RD1000_31_73_20151103_00024.jpg

This photo was taken from the crown facing downstream looking down the waterward levee slope at unacceptable landscaping. Fall 2014.

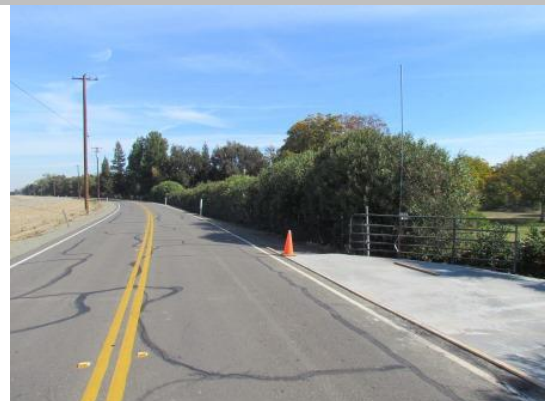
Photo 1 of 1 : FA_2015_RD1000_31_70_20151103_00023.jpg

This photo was taken from the crown facing downstream looking down the waterward levee slope at unacceptable landscaping. Fall 2014.

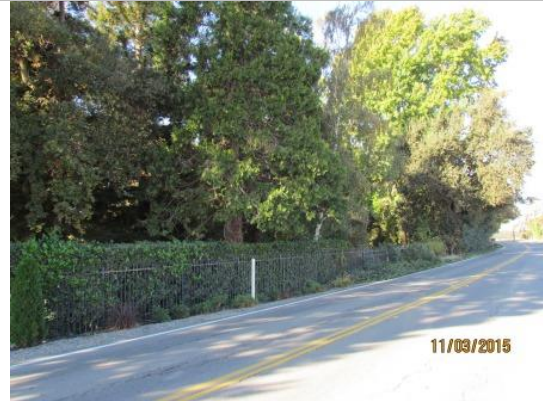
Photo 1 of 1 : FA_2015_RD1000_31_66_20151112_00035.jpg

View of the landscaping on the waterside levee slope.

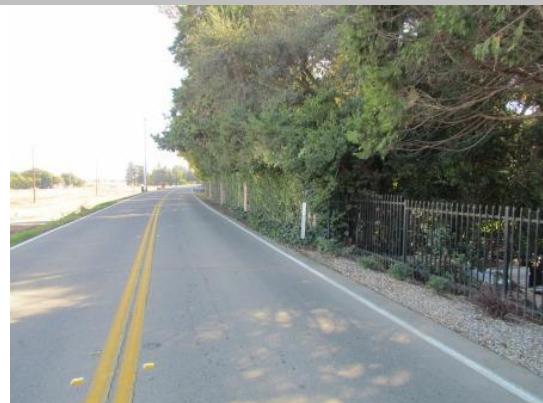
Photo 1 of 1 : FA_2015_RD1000_31_62_20151103_00021.jpg

This photo was taken from the crown facing downstream looking down the waterward levee slope at unacceptable landscaping. Fall 2014.

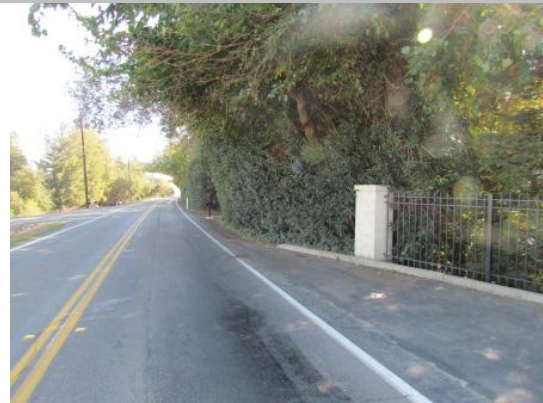
Photo 1 of 1 : FA_2015_RD1000_31_60_20151103_00020.jpg

This photo was taken from the crown facing downstream looking down the waterward levee slope at unacceptable landscaping. Fall 2014.

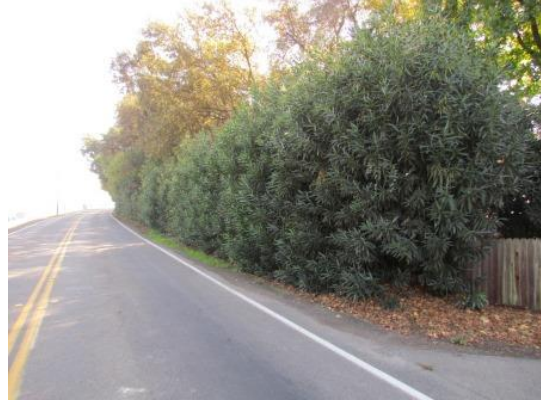
Photo 1 of 1 : FA_2015_RD1000_31_58_20151103_00019.jpg

This photo was taken from the crown facing downstream looking down the waterward levee slope at unacceptable landscaping. Fall 2014.

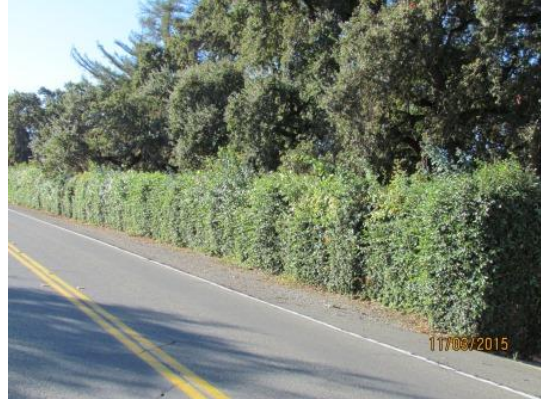
Photo 1 of 1 : FA_2015_RD1000_31_51_20151112_00034.jpg

View of the landscaping on the waterside levee slope.

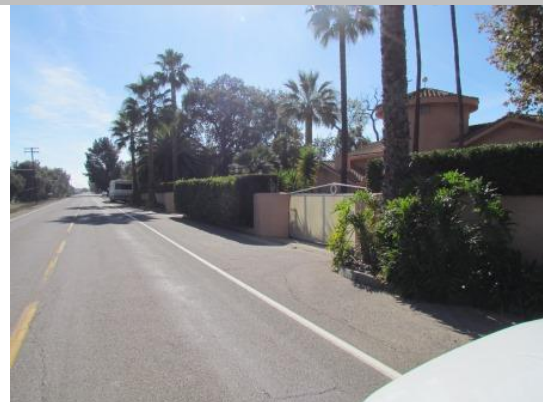
Photo 1 of 1 : FA_2015_RD1000_31_43_20151103_00017.jpg

This photo was taken from the crown facing downstream looking down the waterward levee slope at an unacceptable fence. Fall 2014.

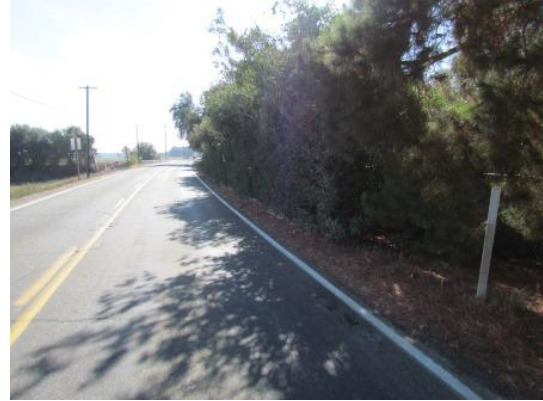
Photo 1 of 1 : FA_2015_RD1000_31_42_20151103_00016.jpg

This photo was taken from the crown facing downstream looking down the waterward levee slope at unacceptable landscaping. Fall 2014.

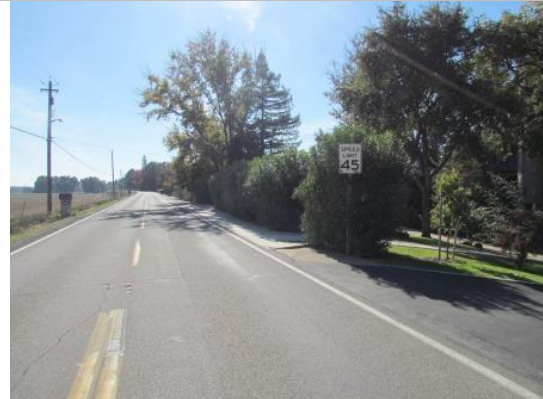
Photo 1 of 1 : FA_2015_RD1000_31_40_20151103_00015.jpg

This photo was taken from the crown facing downstream looking down the waterward levee slope at unacceptable landscaping. Fall 2014.

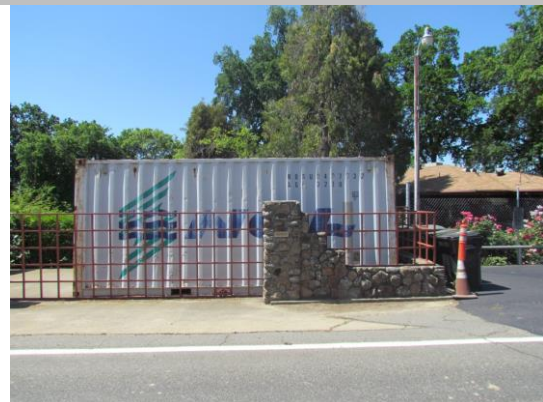
Photo 1 of 1 : FA_2015_RD1000_31_53_20151103_00018.jpg

View of storage container from the landside of the crown facing the waterside of the levee.

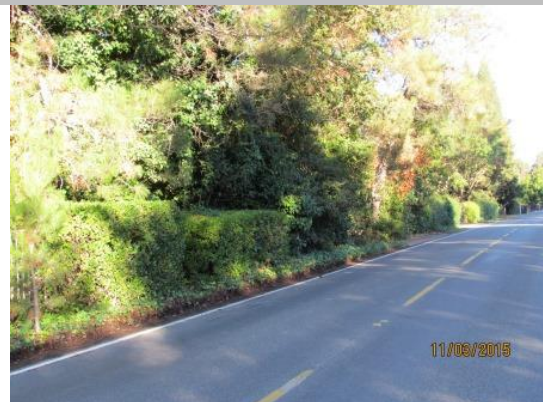
Photo 1 of 1 : FA_2015_RD1000_31_35_20151112_00033.jpg

View of the landscaping on the waterside levee slope.

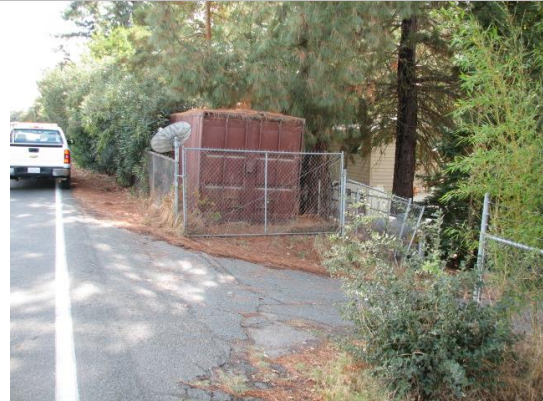
Photo 1 of 1 : FA_2015_RD1000_31_76_20151103_00026.jpg

Cargo container on levee shoulder, the property appears to be on fill material.

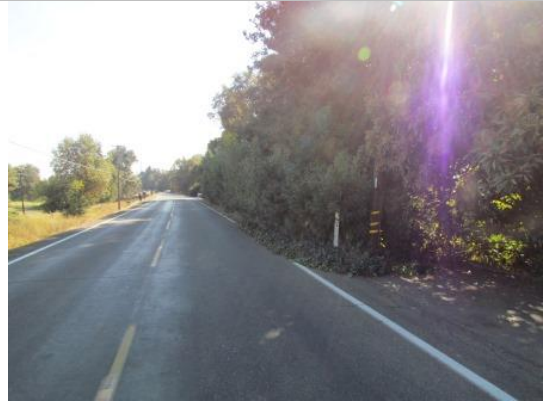
Photo 1 of 1 : FA_2015_RD1000_31_31_20151103_00014.jpg

This photo was taken from the crown facing downstream looking down the waterward levee slope at unacceptable landscaping. Fall 2014.

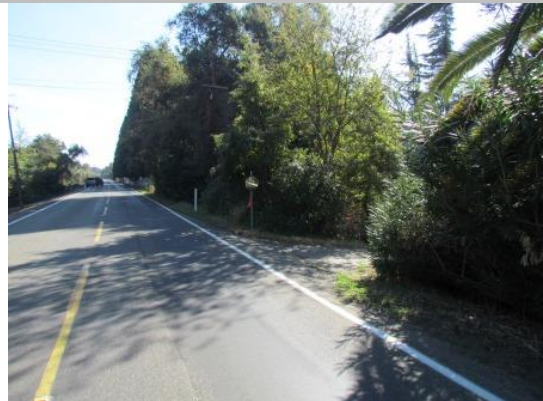
Photo 1 of 1 : FA_2015_RD1000_31_30_20151103_00013.jpg

This photo was taken from the crown facing down stream looking down the waterward levee slope at unacceptable landscaping. Fall 2014.

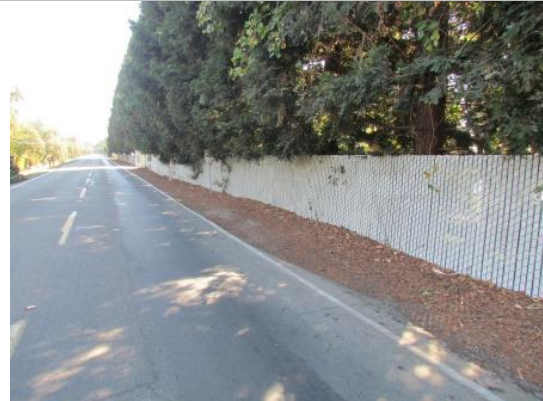
Photo 1 of 1 : FA_2015_RD1000_31_29_20151103_00012.jpg

This photo was taken from the crown facing downstream looking down the waterward levee slope at an unacceptable fence. Fall 2014.

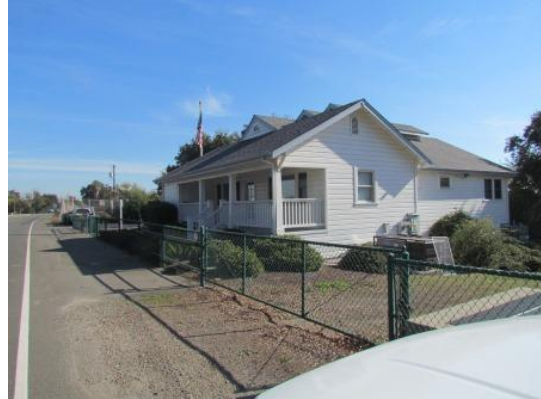
Photo 1 of 1 : FA_2015_RD1000_31_10_20151103_00010.jpg

This photo was taken from the crown facing downstream looking down the waterward levee slope at an unacceptable building. Fall 2014.

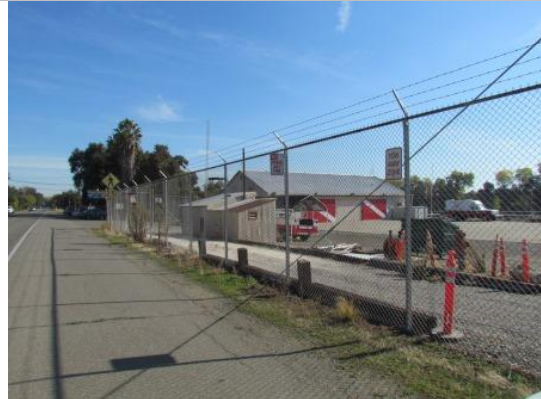
Photo 1 of 1 : FA_2015_RD1000_31_8_20151103_00008.jpg

This photo was taken from the crown facing downstream looking down the waterward levee slope at an unacceptable building. Fall 2014.

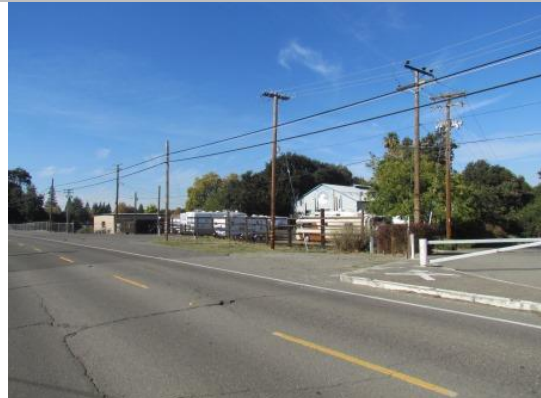
Photo 1 of 1 : FA_2015_RD1000_31_9_20151103_00009.jpg

This photo was taken from the crown facing upstream looking down the landward levee slope at an unacceptable building. Fall 2014.

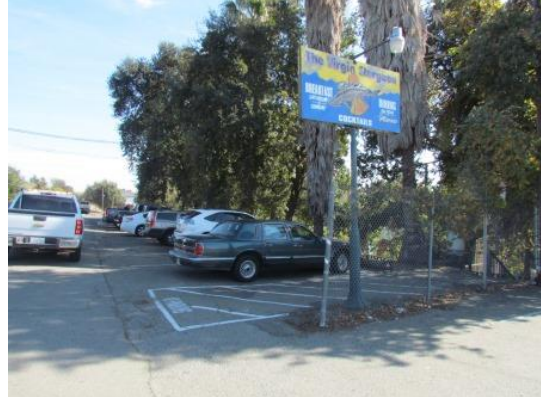
Photo 1 of 1 : FA_2015_RD1000_31_7_20151103_00007.jpg

This photo was taken from the crown facing downstream looking down the waterward levee slope at an unacceptable building. Fall 2014.

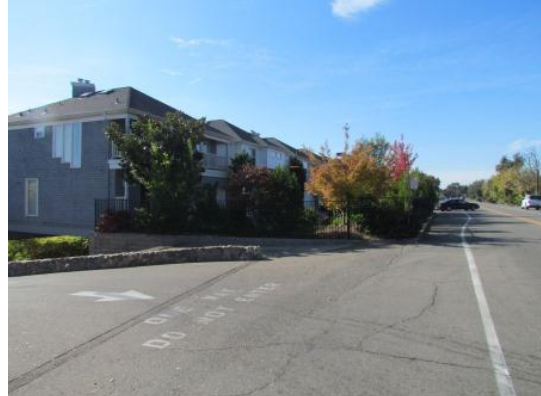
Photo 1 of 1 : FA_2015_RD1000_31_6_20151103_00006.jpg

This photo was taken from the crown facing upstream looking down the waterward levee slope at an unacceptable building. Fall 2014.

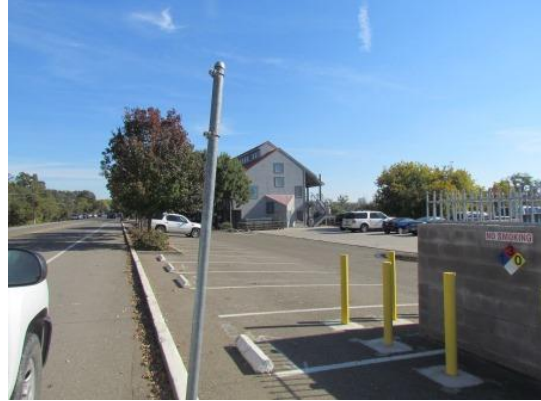
Photo 1 of 1 : FA_2015_RD1000_31_5_20151103_00005.jpg

This photo was taken from the crown facing downstream looking down the waterward levee slope at an unacceptable building. Fall 2014.

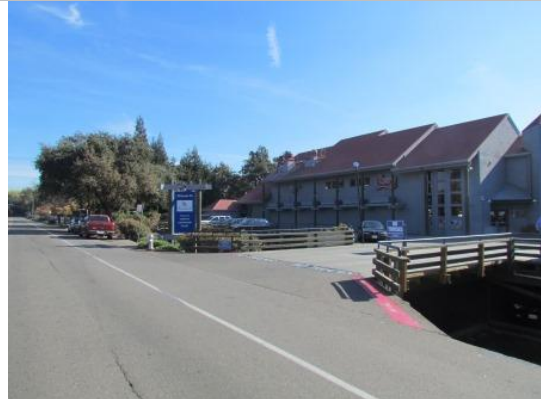
Photo 1 of 1 : FA_2015_RD1000_31_4_20151103_00004.jpg

This photo was taken from the crown facing downstream looking down the waterward levee slope at an unacceptable building. Fall 2014.

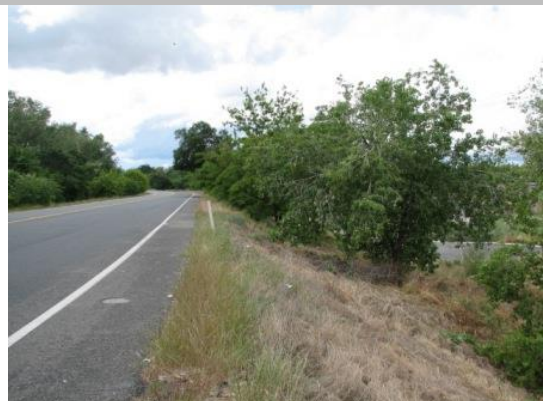
Photo 3 of 3 : FA_2015_RD1000_32_1_20151103_00003.jpg

Landside encroachment, landscaping, levee mile 1.68.

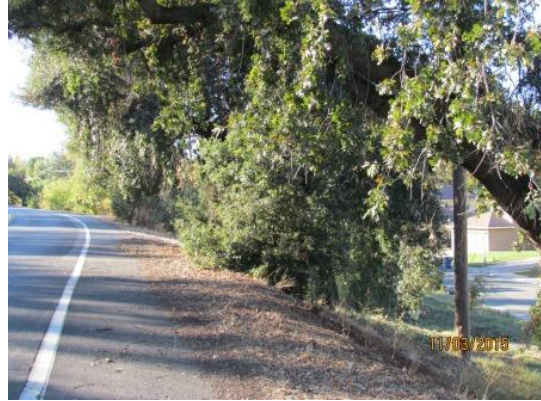
Photo 1 of 1 : FA_2015_RD1000_32_2_20151112_00005.jpg

View of the trees on the landside levee slope.

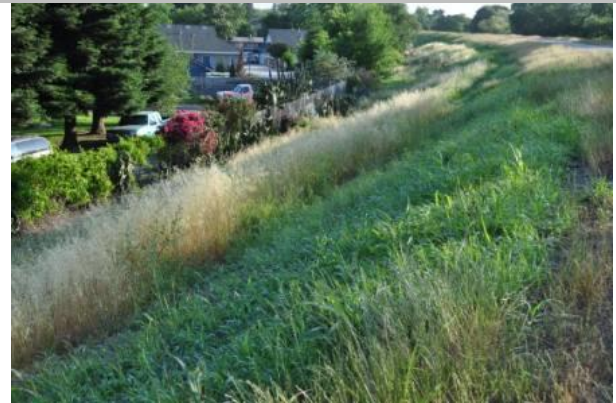
Photo 2 of 2 : FA_2015_RD1000_33_7_20151103_00006.jpg

Fence with vegetation at L/S toe.

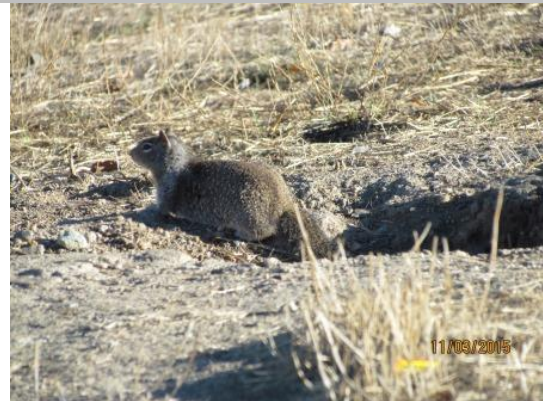
Photo 1 of 2 : FA_2015_RD1000_33_19_20151112_00014.jpg

View of the rodent on the waterside levee slope ready to retreat into the den, penetrating the levee prism.

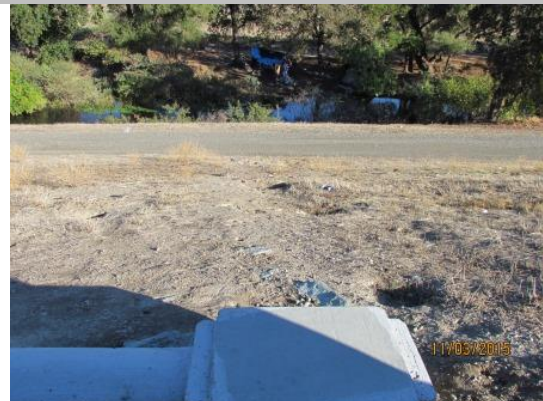
Photo 2 of 2 : FA_2015_RD1000_33_19_20151112_00015.jpg

View of the rodent holes on the waterside levee slope.

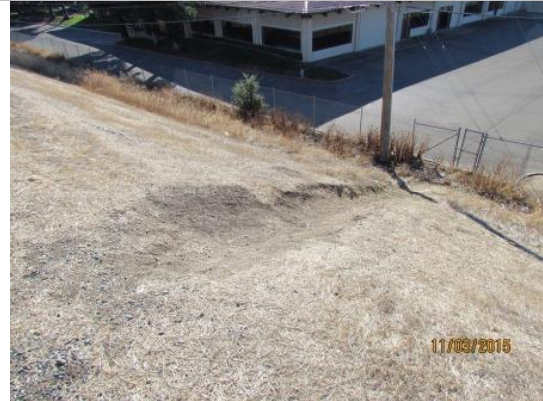
Photo 1 of 1 : FA_2015_RD1000_33_15_20151112_00013.jpg

View of the landside levee slope damaged by foot traffic.

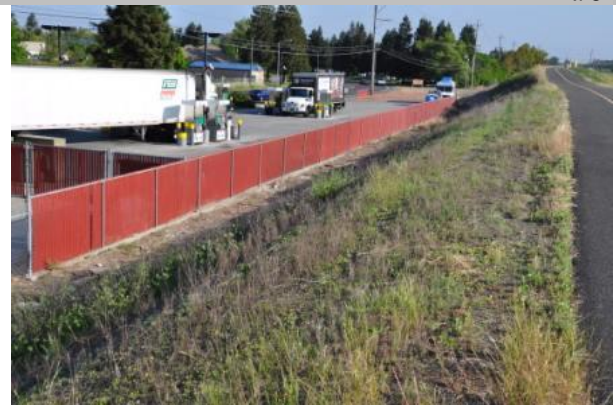
Photo 1 of 1 : FA_2015_RD1000_33_3_20151103_00004.jpg

Fence within 10' of L/S toe.

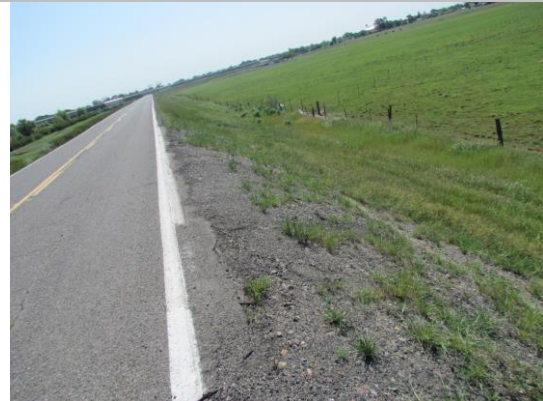
Photo 1 of 3 : FA_2015_RD1000_33_1_20151103_00001.jpg

Updated view taken facing the landside looking upstream. Rodent holes have been filled and no new activity was observed.

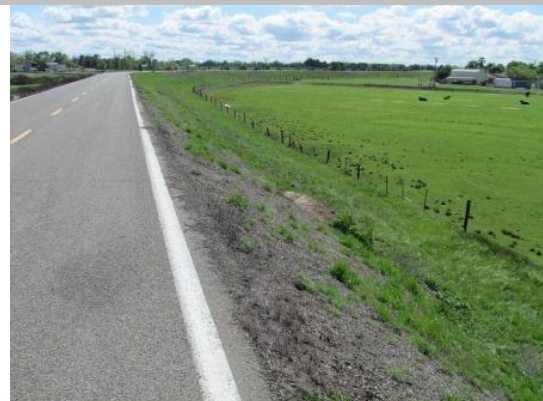
Photo 2 of 3 : FA_2015_RD1000_33_1_20151103_00002.jpg

This photo was taken from the crown facing south looking down the landward slope at a rodent hole requiring maintenance. Spring 2014.

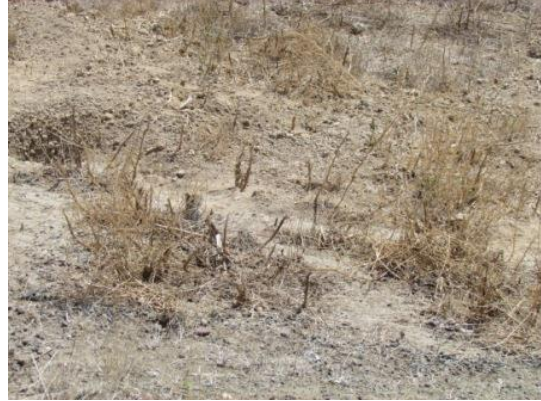
Photo 3 of 3 : FA_2015_RD1000_33_1_20151103_00003.jpg

This photo was taken from the levee crown looking down the landward slope at a squirrel poking its head out of a hole.

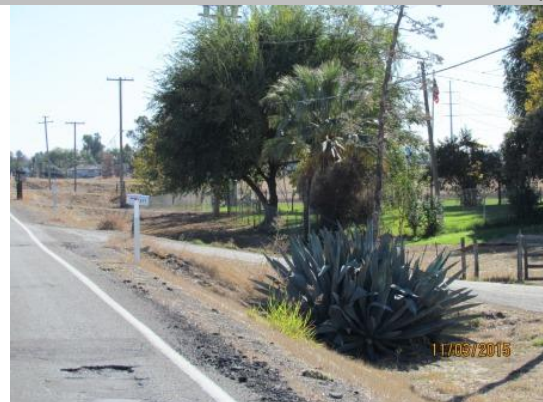
Photo 1 of 1 : FA_2015_RD1000_33_2_20151112_00012.jpg

View of the landscaping at the landside levee toe.

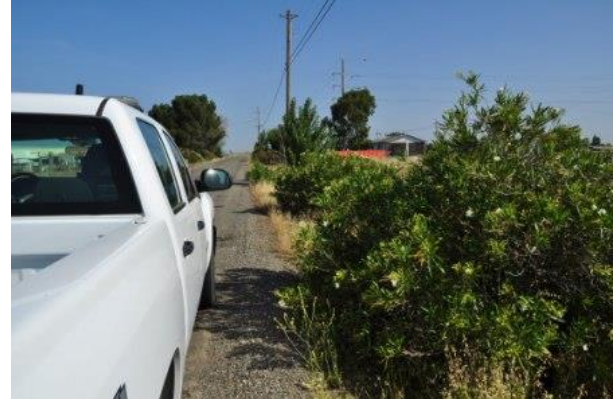
Photo 1 of 1 : FA_2015_RD1000_33_10_20151103_00008.jpg

WS vegetation.

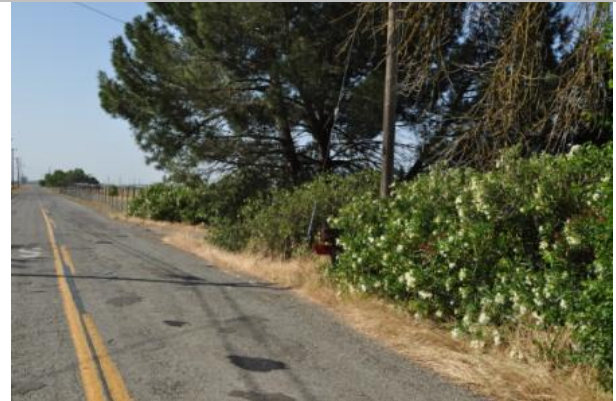
Photo 1 of 1 : FA_2015_RD1000_33_13_20151103_00011.jpg

LS landscaping.

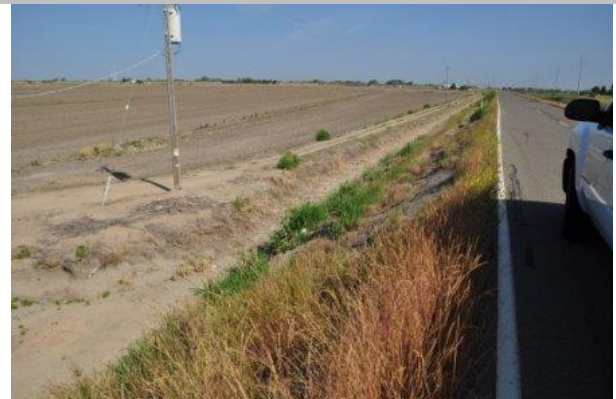
Photo 1 of 1 : FA_2015_RD1000_33_9_20151103_00007.jpg

LS Ag ditch at the LS toe.
