**Flood Control Project Maintenance  
Levee Inspections**

**Fall 2016 Levee Maintenance Deficiency Summary Report**

**Flood Control Project Maintenance  
Levee Inspections**  
**LMA District Cover Sheet**  
**Fall 2016 Levee Inspection Results**

**Reclamation District No. 1000 Natomas**

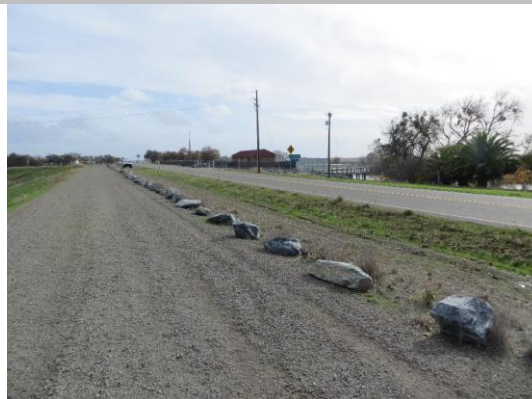
Photo 1 of 2 : UCIP\_FA\_2016\_46974\_74887.jpg

LM Start	0.00	Rating **	M	Issue No.	137
LM End	0.00	Issue Type +	En	Location *	WS
Category	Supplemental			GPS Latitude/Longitude	
				Start	End
Item	DWR UCIP Field Study			38.778010 °	38.778010 °
				-121.600766 °	-121.600766 °
DWR ID					
Comment Code					
Inspector Comment					
FS_ID:46974 DS_ID:25354 EP_NO: 16310 Repair Type: Non-Urgent Crossing Status: Found UCIP Comments: FIELD_STRUCT_DESC: 5 of 5. [Sankey Diversion Pumping Plant] 48-inch FS Date: 12/10/2015

Overview of levee crown near Sankey Pumping Station.

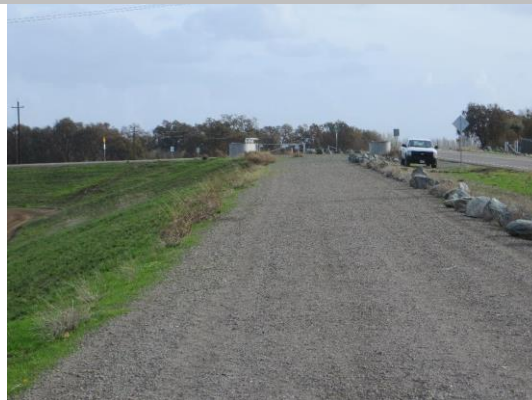
Photo 2 of 2 : UCIP\_FA\_2016\_46974\_74888.jpg

View of levee crown looking downstream.

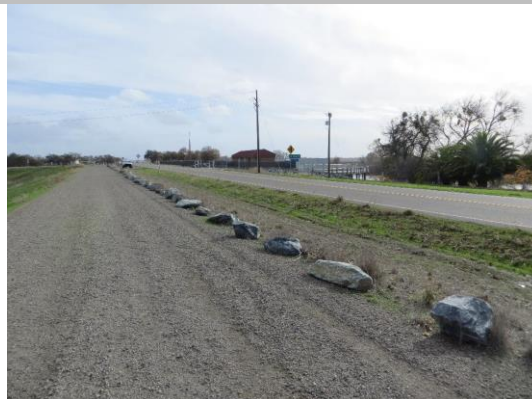
Photo 1 of 2 : UCIP\_FA\_2016\_46970\_74867.jpg

LM Start	0.00	Rating **	M	Issue No.	138
LM End	0.00	Issue Type +	En	Location *	WS
Category	Supplemental			GPS Latitude/Longitude	
				Start	End
Item	DWR UCIP Field Study			38.778052 °	38.778052 °
				-121.600805 °	-121.600805 °
DWR ID					
Comment Code					
Inspector Comment					
FS_ID:46970 DS_ID:25426 EP_NO: N/A Repair Type: Non-Urgent Crossing Status: Found UCIP Comments: Need additional as-builts for pump station. FIELD_STRUCT_DESC: 1 of 5. [Sankey Diversion Pumping Plant] 48-inch FS Date: 12/10/2015

Overview of levee crown near crossing.

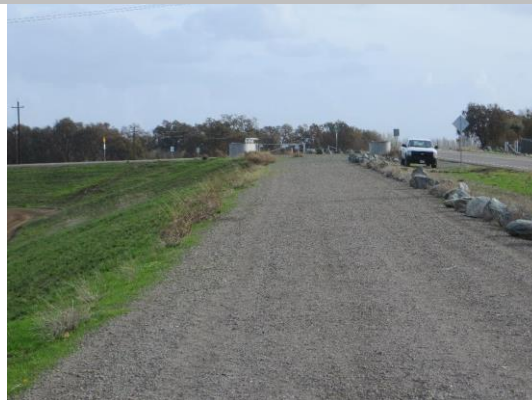
Photo 2 of 2 : UCIP\_FA\_2016\_46970\_74868.jpg

View of levee crown looking downstream.

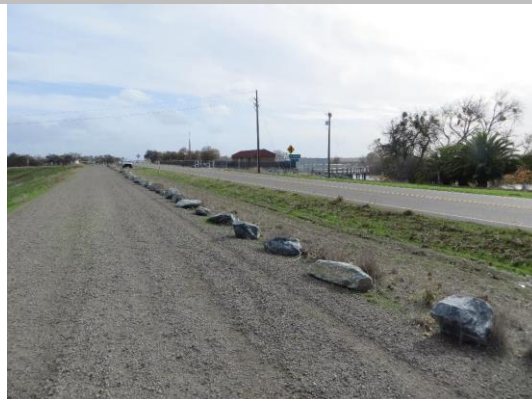
Photo 1 of 2 : UCIP\_FA\_2016\_46971\_74872.jpg

LM Start	0.00	Rating **	M	Issue No.	139
LM End	0.00	Issue Type +	En	Location *	WS
Category	Supplemental			GPS Latitude/Longitude	
				Start	End
Item	DWR UCIP Field Study			38.778052 °	38.778052 °
				-121.600805 °	-121.600805 °
DWR ID					
Comment Code					
Inspector Comment					
FS_ID:46971 DS_ID:25427 EP_NO: N/A Repair Type: Non-Urgent Crossing Status: Found UCIP Comments: FIELD_STRUCT_DESC: 2 of 5. [Sankey Diversion Pumping Plant] 48-inch FS Date: 12/10/2015

Overview of levee near Sankey Pumping Station.

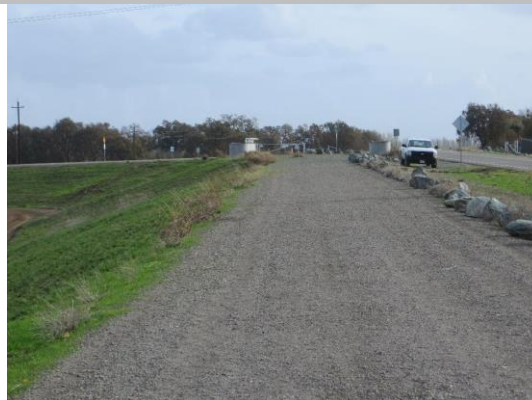
Photo 2 of 2 : UCIP\_FA\_2016\_46971\_74873.jpg

View of levee crown looking downstream.

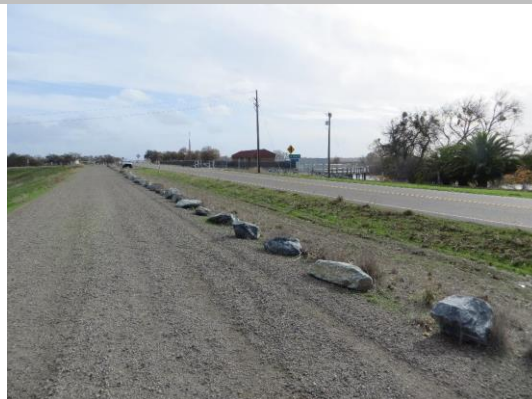
Photo 1 of 2 : UCIP\_FA\_2016\_46972\_74877.jpg

LM Start	0.00	Rating **	M	Issue No.	140
LM End	0.00	Issue Type +	En	Location *	WS
Category	Supplemental			GPS Latitude/Longitude	
				Start	End
Item	DWR UCIP Field Study			38.778038 °	38.778038 °
				-121.600790 °	-121.600790 °
DWR ID					
Comment Code					
Inspector Comment					
FS_ID:46972 DS_ID:25428 EP_NO: N/A Repair Type: Non-Urgent Crossing Status: Found UCIP Comments: FIELD_STRUCT_DESC: 3 of 5. [Sankey Diversion Pumping Plant] 48-inch FS Date: 12/10/2015

Overview of levee crown near Sankey Diversion Pumping Plant.

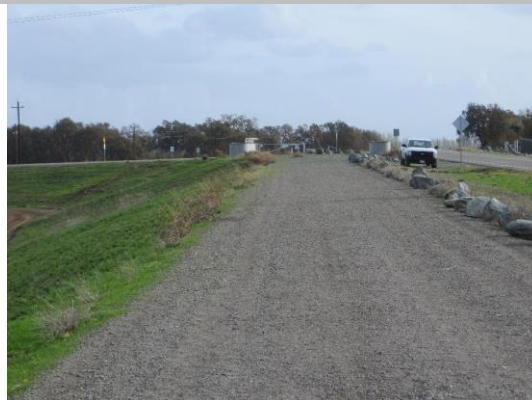
Photo 2 of 2 : UCIP\_FA\_2016\_46972\_74878.jpg

View of levee crown.

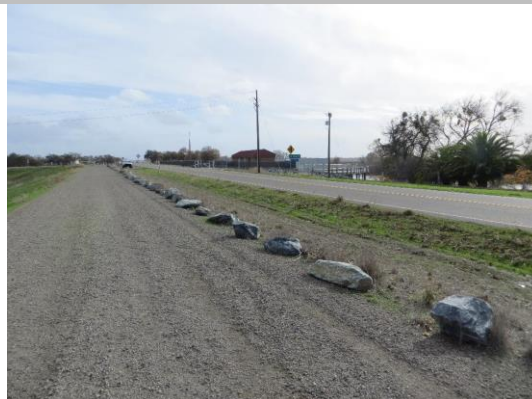
Photo 1 of 2 : UCIP\_FA\_2016\_46973\_74882.jpg

LM Start	0.00	Rating **	M	Issue No.	141
LM End	0.00	Issue Type +	En	Location *	WS
Category	Supplemental			GPS Latitude/Longitude	
				Start	End
Item	DWR UCIP Field Study			38.778022 °	38.778022 °
				-121.600777 °	-121.600777 °
DWR ID					
Comment Code					
Inspector Comment					
FS_ID:46973 DS_ID:25429 EP_NO: N/A Repair Type: Non-Urgent Crossing Status: Found UCIP Comments: FIELD_STRUCT_DESC: 4 of 5. [Sankey Diversion Pumping Plant] 48-inch FS Date: 12/10/2015

Overview of levee crown near Sankey Pumping Station.

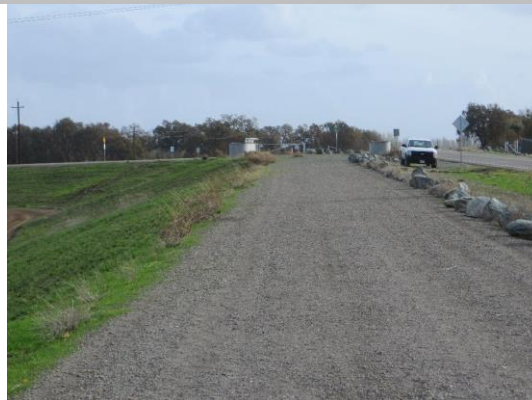
Photo 2 of 2 : UCIP\_FA\_2016\_46973\_74883.jpg

View of levee crown.

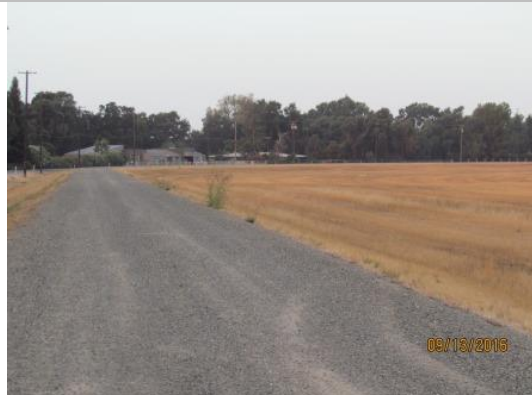
Photo 1 of 1 : FA\_2016\_RD1000\_31\_88\_20160919\_00051.jpg

View looking upstream landside of maintained annual grasses.

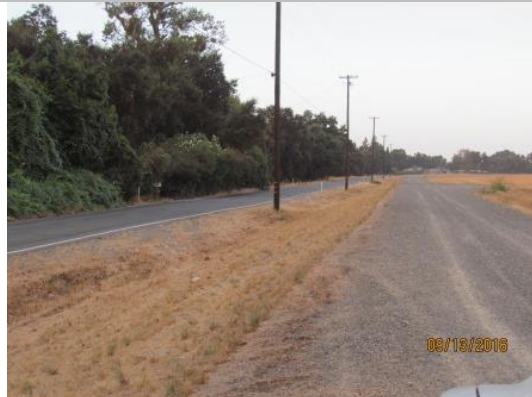
Photo 1 of 1 : FA\_2016\_RD1000\_31\_77\_20160919\_00050.jpg

LM Start	0.00	Rating **	A	Issue No.	77
LM End	12.30	Issue Type +	Ma	Location *	WS
Category	Earthen Levee			GPS Latitude/Longitude	
				Start	End
Item	Vegetation			38.780502 °	38.649896 °
				-121.603437 °	-121.571262 °
DWR ID	DWR_RD1000_01_f_2016_77				
Comment Code					
V1 : Control annual grass and weeds on the levee slopes and easements.					
Inspector Comment					
The Levee has no unwanted vegetation blocking visibility or access. The annual grasses are mowed making the slopes visible and accessible.

View looking upstream waterside of maintained annual grasses.

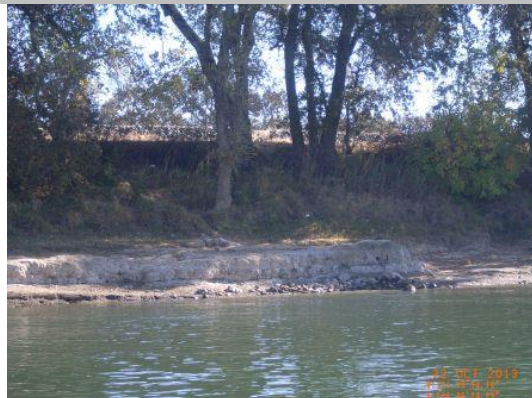
Photo 1 of 1 : FA\_2016\_RD1000\_31\_3\_20160906\_00003.jpg

LM Start	0.48	Rating **	M	Issue No.	3
LM End	0.61	Issue Type +	Ma	Location *	WS
Category	Supplemental			GPS Latitude/Longitude	
				Start	End
Item	2015 USACE Erosion Survey, DRAFT			38.774507 °	38.772921 °
				-121.598865 °	-121.597788 °
DWR ID	DWR_RD1000_01_s_2016_3				
Comment Code					
Inspector Comment					
1997 - Very cohesive toe. 2005 - Site was staked and rock was stockpiled along the top of the bank. 2010 - New adjacent levee under construction. 2011 - New animal burrow. 2015: No observed changes. [2015 Site ID: SAC_78-3_L]

USACE 2013 Photo #1

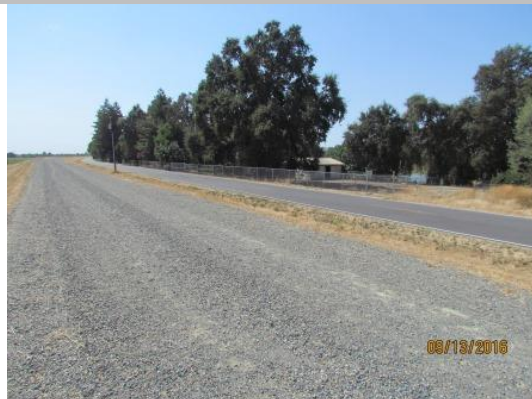
Photo 1 of 1 : FA\_2016\_RD1000\_31\_136\_20160919\_00053.jpg

View of an encroachment, 'Fence'. Fall 2016.

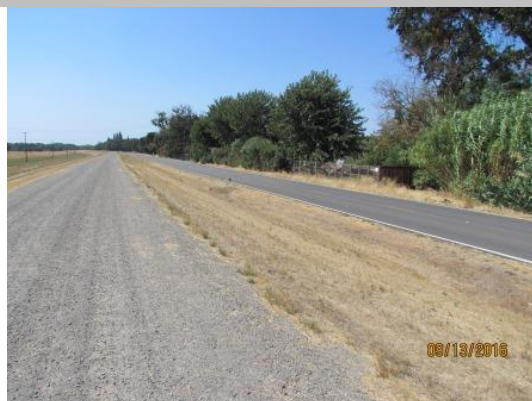
Photo 1 of 1 : FA\_2016\_RD1000\_31\_120\_20160919\_00055.jpg

Typical vegetation along the waterside in front of residences. Fall 2016.

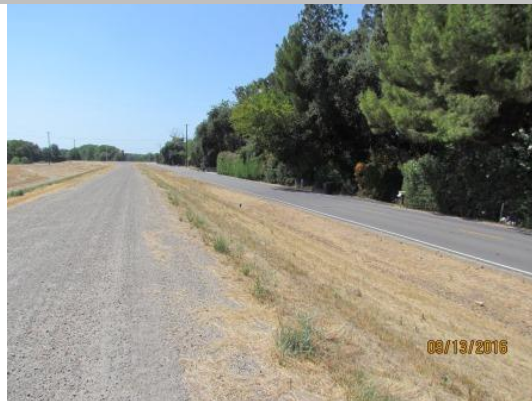
Photo 1 of 1 : FA\_2016\_RD1000\_31\_118\_20160919\_00056.jpg

This photo was taken from the crown facing downstream looking down the waterward levee slope at unacceptable landscaping. Fall 2016.

LM Start	5.97	Rating **	M	Issue No.	116
LM End	6.00	Issue Type +	En	Location *	WS
Category	Earthen Levee			GPS Latitude/Longitude	
				Start	End
Item	Vegetation			38.702742 °	38.702467 °
				-121.620557 °	-121.620947 °
DWR ID	DWR_RD1000_01_s_2012_116				
Comment Code					
V6 : Landscaping					
Inspector Comment

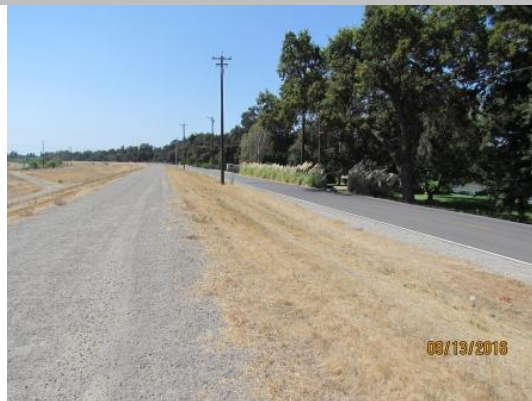
Photo 1 of 1 : FA\_2016\_RD1000\_31\_111\_20160919\_00057.jpg

This photo was taken from the crown facing downstream looking down the waterward levee slope at unacceptable landscaping. Fall 2016.

LM Start	6.36	Rating **	M	Issue No.	68
LM End	6.40	Issue Type +	En	Location *	WS
Category	Earthen Levee			GPS Latitude/Longitude	
				Start	End
Item	Vegetation			38.699313 °	38.698978 °
				-121.626281 °	-121.626777 °
DWR ID	DWR_RD1000_01_s_2015_68				
Comment Code					
V6 : Landscaping					
Inspector Comment

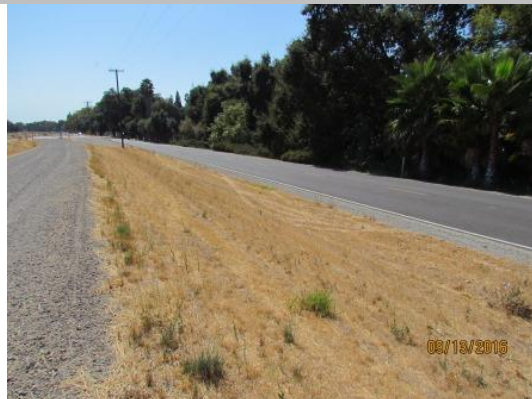
Photo 1 of 1 : FA\_2016\_RD1000\_31\_63\_20160919\_00059.jpg

This photo was taken facing the waterside of the levee looking downstream of typical vegetation in front of residence. Fall 2016.

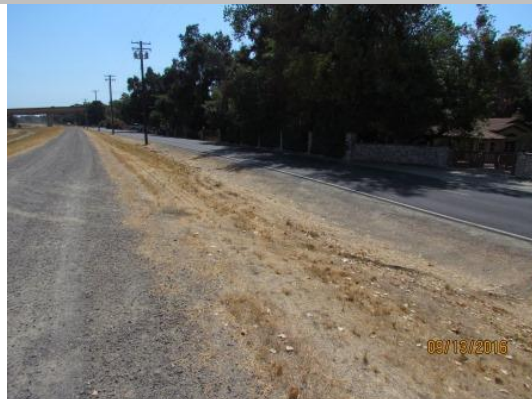
Photo 1 of 1 : FA\_2016\_RD1000\_31\_90\_20160919\_00060.jpg

This photo was taken from the crown facing downstream looking downstream. Landowner maintained vegetation completely block visibility of or access to the levee. Fall 2016.

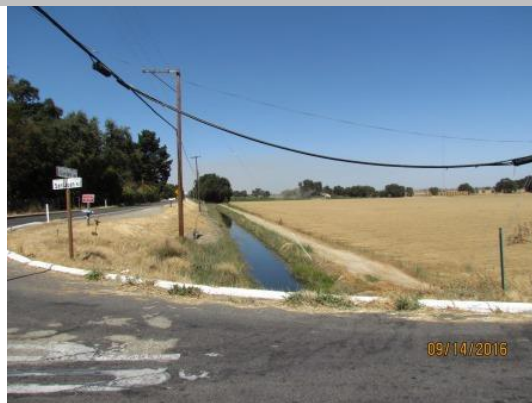
Photo 1 of 1 : FA\_2016\_RD1000\_31\_101\_20160919\_00067.jpg

View looking upstream at ditch on landside toe.

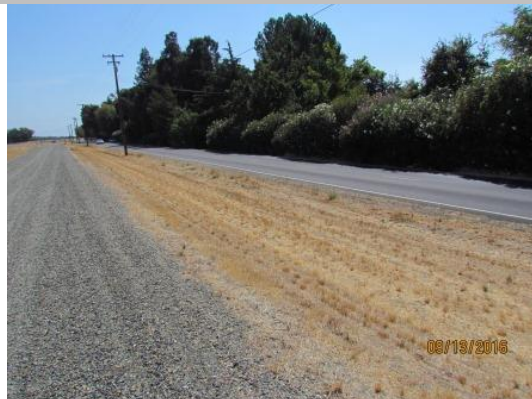
Photo 1 of 1 : FA\_2016\_RD1000\_31\_82\_20160919\_00061.jpg

This photo was taken from the crown facing downstream waterside levee slope at unacceptable landscaping. Fall 2016.

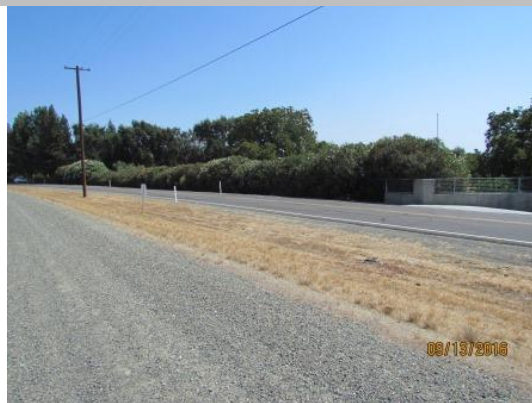
Photo 1 of 1 : FA\_2016\_RD1000\_31\_70\_20160919\_00065.jpg

This photo was taken from the crown facing downstream looking down the waterward levee slope at unacceptable landscaping. Fall 2016.

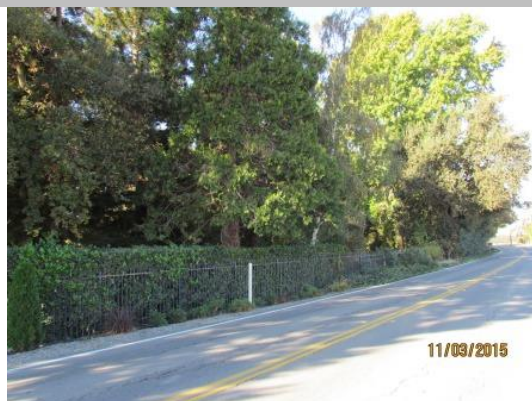
Photo 1 of 1 : FA\_2016\_RD1000\_31\_66\_20160906\_00024.jpg

View of the landscaping on the waterside levee slope.

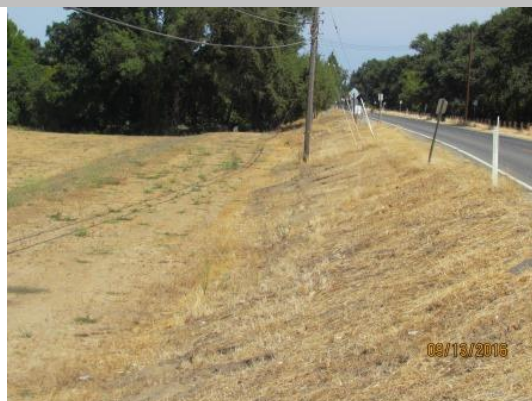
Photo 1 of 1 : FA\_2016\_RD1000\_31\_97\_20160919\_00066.jpg

View looking downstream landside of maintained annual grasses.

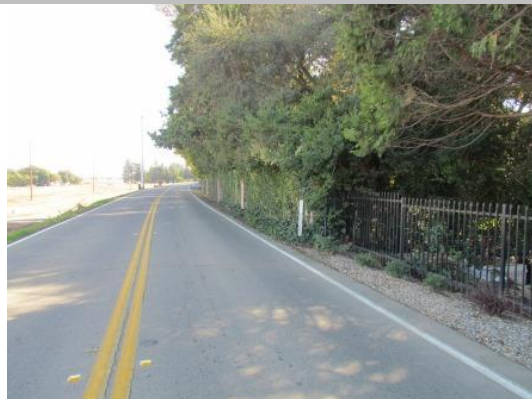
Photo 1 of 1 : FA\_2016\_RD1000\_31\_62\_20160906\_00022.jpg

This photo was taken from the crown facing downstream looking down the waterward levee slope at unacceptable landscaping. Fall 2014.

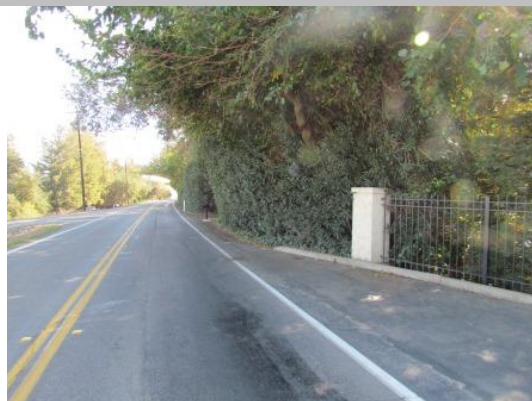
Photo 1 of 1 : FA\_2016\_RD1000\_31\_60\_20160906\_00021.jpg

This photo was taken from the crown facing downstream looking down the waterward levee slope at unacceptable landscaping. Fall 2014.

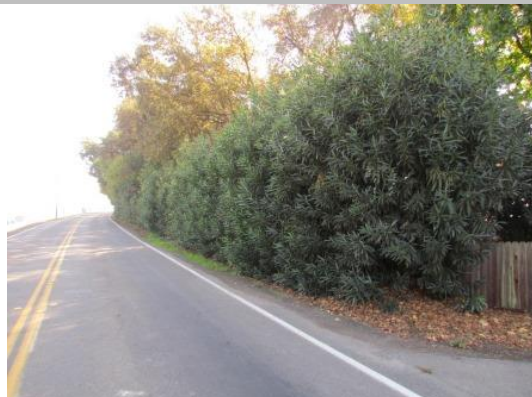
Photo 1 of 1 : FA\_2016\_RD1000\_31\_58\_20160906\_00020.jpg

This photo was taken from the crown facing downstream looking down the waterward levee slope at unacceptable landscaping. Fall 2014.

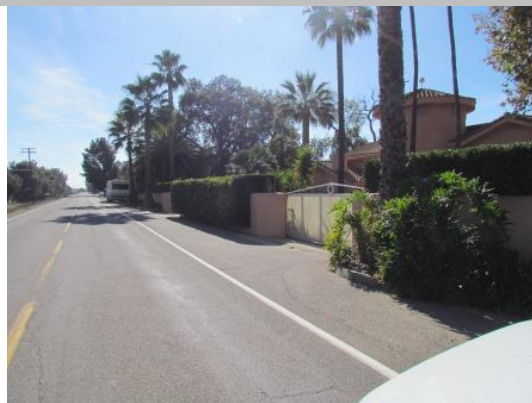
Photo 1 of 1 : FA\_2016\_RD1000\_31\_43\_20160906\_00017.jpg

This photo was taken from the crown facing downstream looking down the waterward levee slope at an unacceptable fence. Fall 2014.

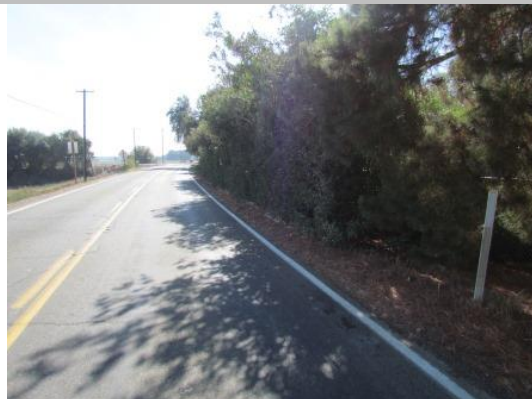
Photo 1 of 1 : FA\_2016\_RD1000\_31\_42\_20160906\_00016.jpg

This photo was taken from the crown facing downstream looking down the waterward levee slope at unacceptable landscaping. Fall 2014.

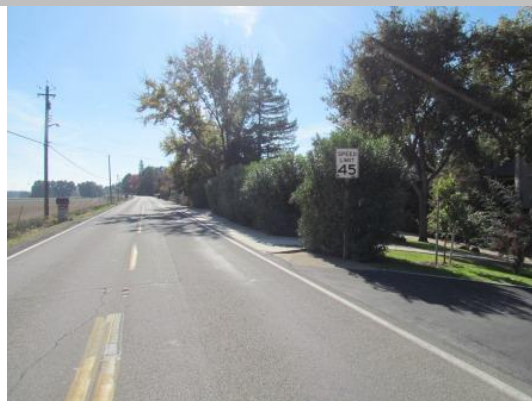
Photo 1 of 1 : FA\_2016\_RD1000\_31\_40\_20160906\_00015.jpg

This photo was taken from the crown facing downstream looking down the waterward levee slope at unacceptable landscaping. Fall 2014.

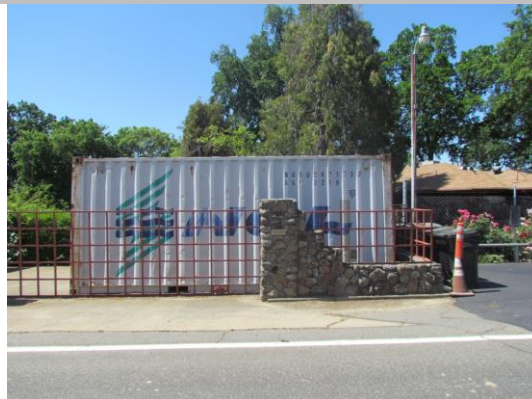
Photo 1 of 1 : FA\_2016\_RD1000\_31\_53\_20160906\_00019.jpg

View of storage container from the landside of the crown facing the waterside of the levee.

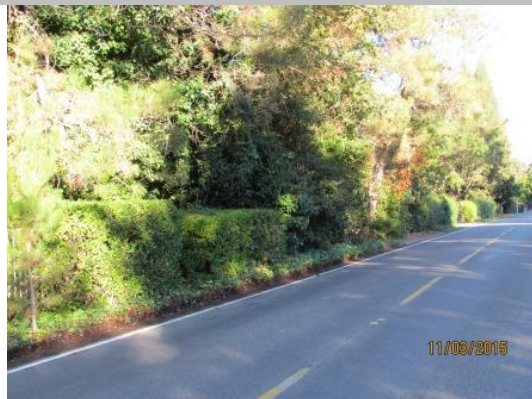
Photo 1 of 1 : FA\_2016\_RD1000\_31\_35\_20160906\_00014.jpg

View of the landscaping on the waterside levee slope.

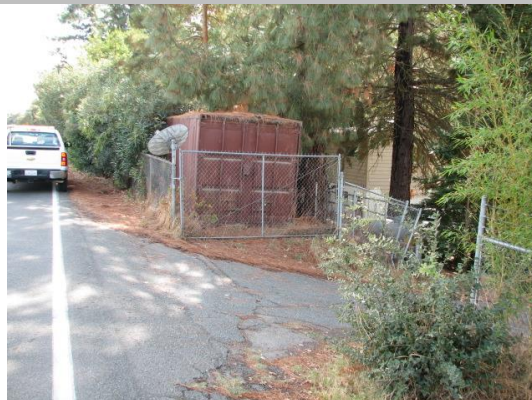
Photo 1 of 1 : FA\_2016\_RD1000\_31\_76\_20160906\_00028.jpg

Cargo container on levee shoulder, the property appears to be on fill material.

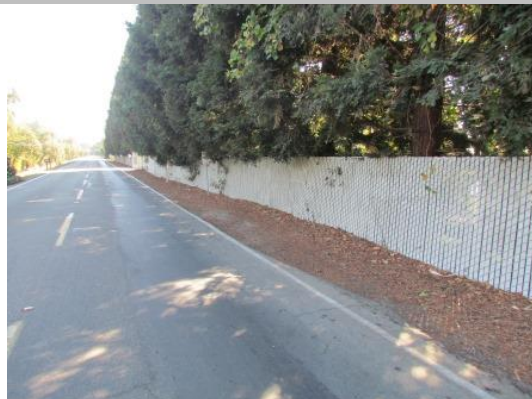
Photo 1 of 1 : FA\_2016\_RD1000\_31\_29\_20160906\_00011.jpg

This photo was taken from the crown facing downstream looking down the waterward levee slope at an unacceptable fence. Fall 2014.

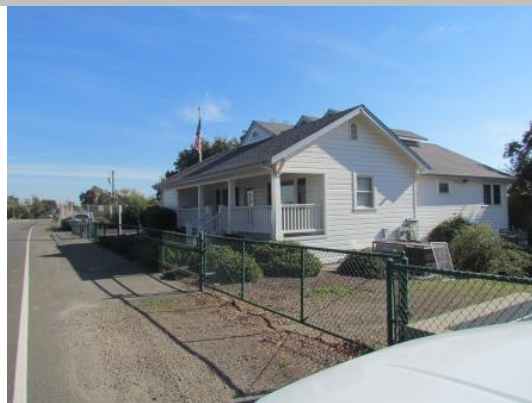
Photo 1 of 1 : FA\_2016\_RD1000\_31\_10\_20160906\_00010.jpg

This photo was taken from the crown facing downstream looking down the waterward levee slope. Fall 2014.

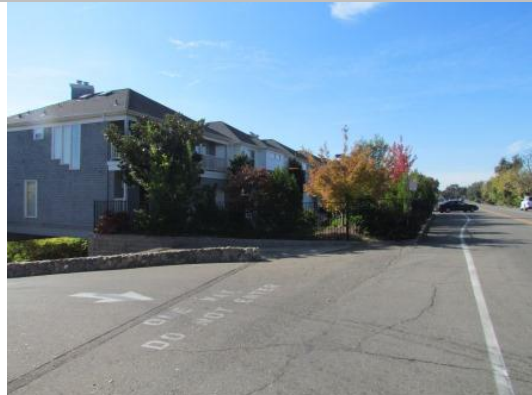
Photo 1 of 1 : FA\_2016\_RD1000\_31\_6\_20160906\_00006.jpg

This photo was taken from the crown facing upstream looking down the waterward levee slope. Fall 2014.

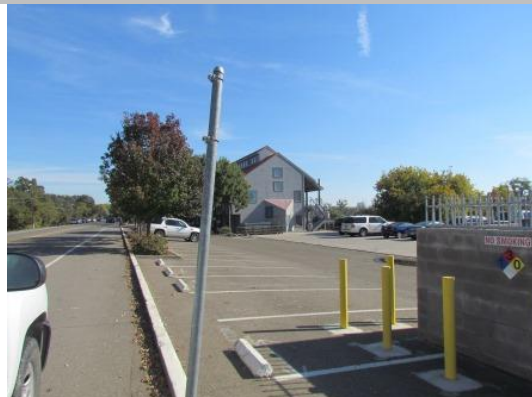
Photo 1 of 1 : FA\_2016\_RD1000\_31\_5\_20160906\_00005.jpg

This photo was taken from the crown facing downstream looking down the waterward levee slope at an unacceptable building. Fall 2014.

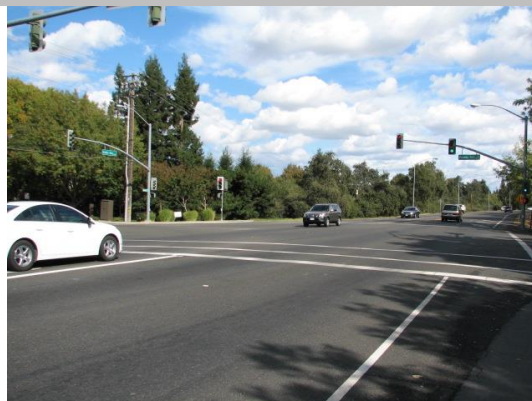
Photo 1 of 3 : FA\_2016\_RD1000\_32\_1\_20160906\_00001.jpg

Levee mile 0.56. This photo is looking upstream from the waterside levee shoulder to the landside shoulder.

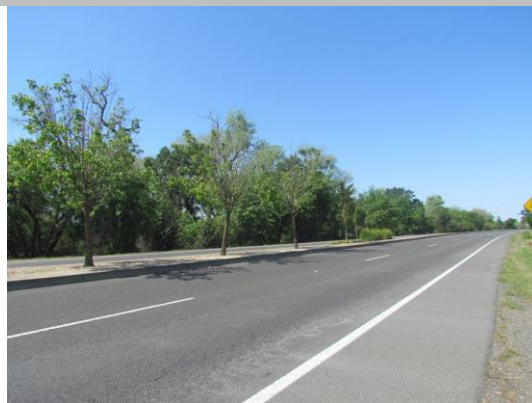
Photo 2 of 3 : FA\_2016\_RD1000\_32\_1\_20160906\_00002.jpg

Taken on the landside facing the waterside looking downstream.

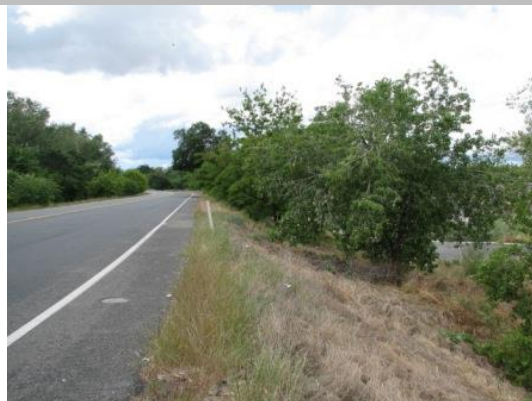
Photo 3 of 3 : FA\_2016\_RD1000\_32\_1\_20160906\_00003.jpg

Landside encroachment, landscaping, levee mile 1.68.

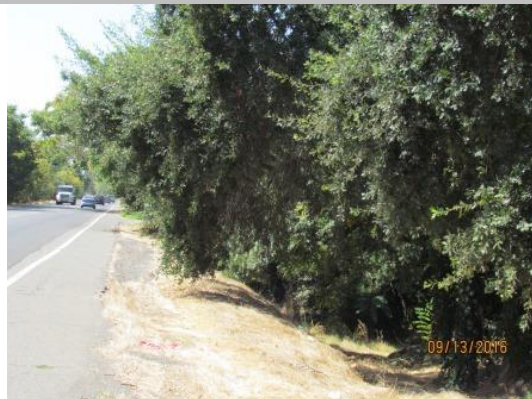
Photo 1 of 1 : FA\_2016\_RD1000\_32\_4\_20160919\_00006.jpg

View looking downstream landside of trees that need to be trimmed. Fall 2016.

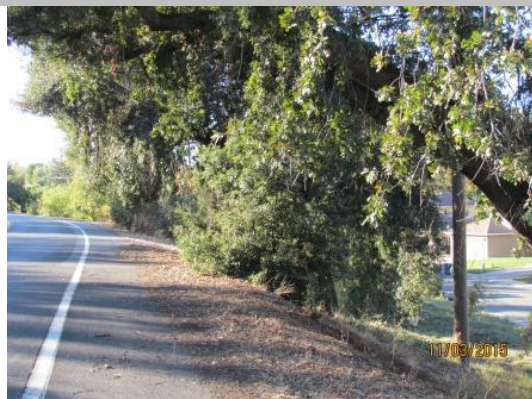
Photo 1 of 1 : FA\_2016\_RD1000\_32\_2\_20160906\_00004.jpg

View of the trees on the landside levee slope. Small trees 4" in diameter at chest height should be removed before they get to big.

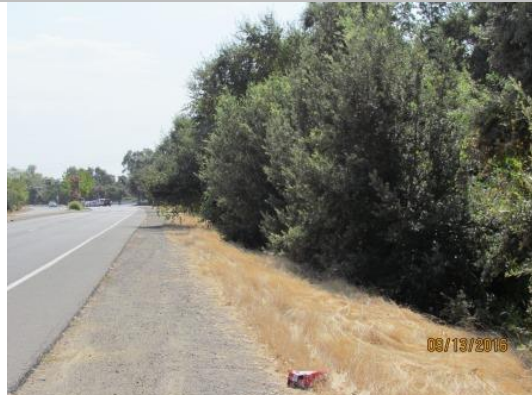
Photo 1 of 1 : FA\_2016\_RD1000\_32\_3\_20160919\_00005.jpg

View looking upstream waterside of trees that need to be trimmed. Fall 2016.

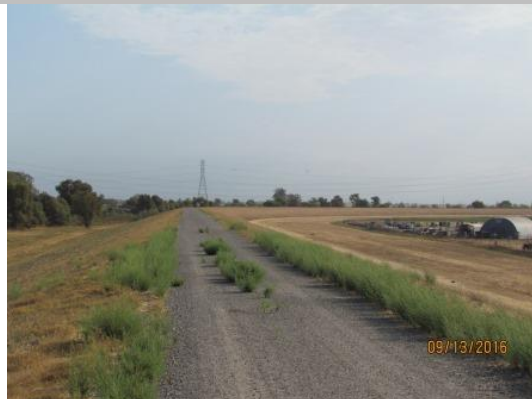
Photo 1 of 1 : FA\_2016\_RD1000\_33\_11\_20160915\_00023.jpg

View looking upstream landside of the mowed annual grass.

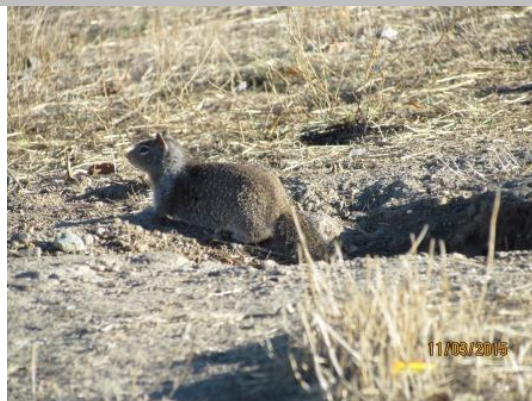
Photo 1 of 2 : FA\_2016\_RD1000\_33\_19\_20160906\_00013.jpg

View of the rodent on the waterside levee slope ready to retreat into the den, penetrating the levee prism.

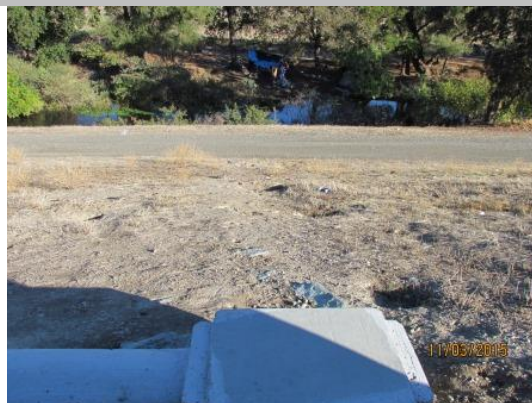
Photo 2 of 2 : FA\_2016\_RD1000\_33\_19\_20160906\_00014.jpg

View of the rodent holes on the waterside levee slope. Fall 2015. Bait injection into rodent hole for control, no sign of rodents Fall 2016.

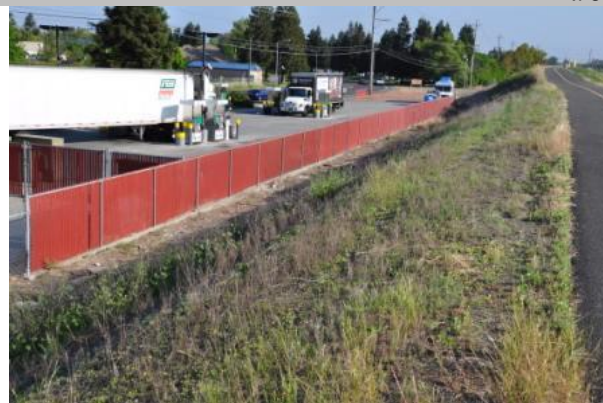
Photo 1 of 1 : FA\_2016\_RD1000\_33\_3\_20160906\_00005.jpg

Fence within 10' of L/S toe.

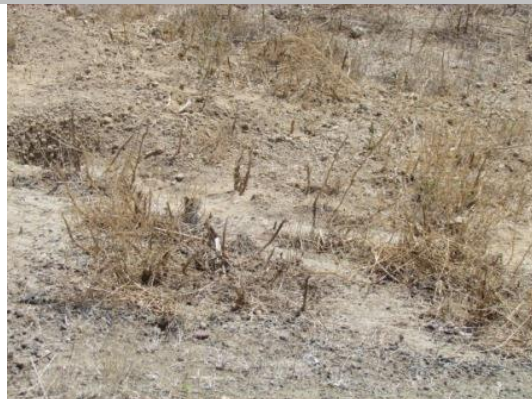
Photo 1 of 2 : FA\_2016\_RD1000\_33\_1\_20160906\_00003.jpg

This photo was taken from the levee crown looking down the landward slope at a squirrel poking its head out of a hole. Fall 2014.

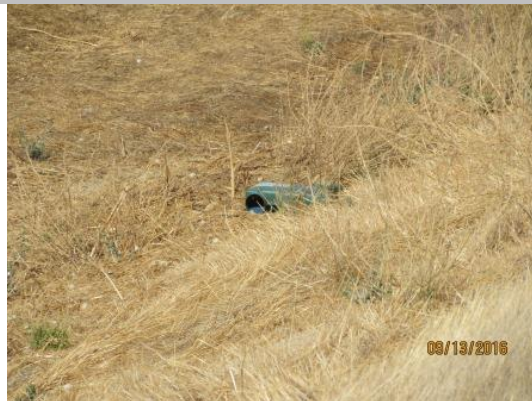
Photo 2 of 2 : FA\_2016\_RD1000\_33\_1\_20160914\_00020.jpg

Updated view taken facing the landside looking upstream at bait trap. Rodent holes have been filled and no new activity was observed. Several bait traps at landside levee toe. Fall 2016.

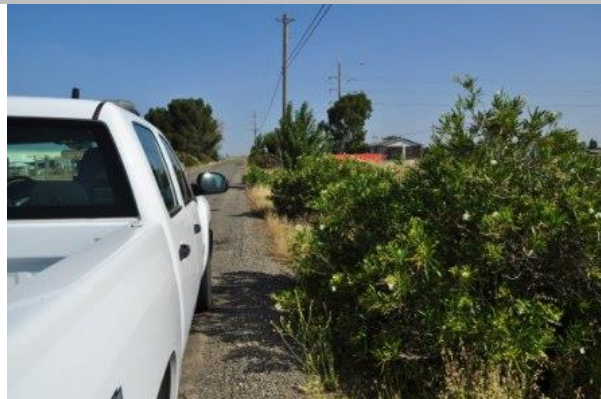
Photo 1 of 1 : FA\_2016\_RD1000\_33\_10\_20160906\_00009.jpg

WS vegetation.

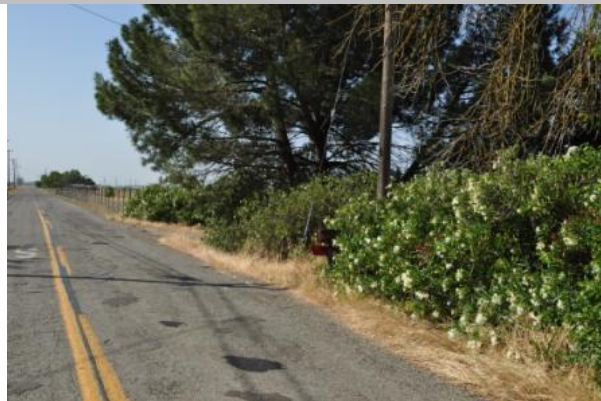
Photo 1 of 1 : FA\_2016\_RD1000\_33\_13\_20160906\_00011.jpg

LS landscaping.

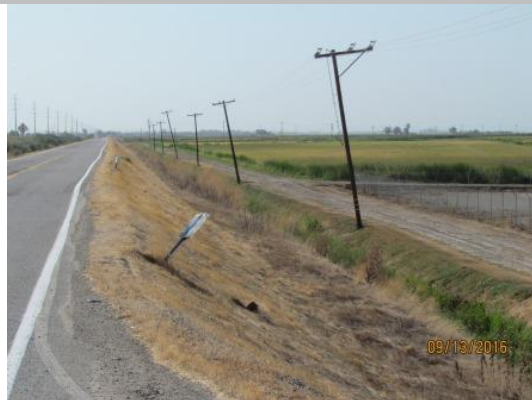
Photo 1 of 1 : FA\_2016\_RD1000\_33\_22\_20160914\_00018.jpg

View of landside ditch at toe of levee, looking downstream.

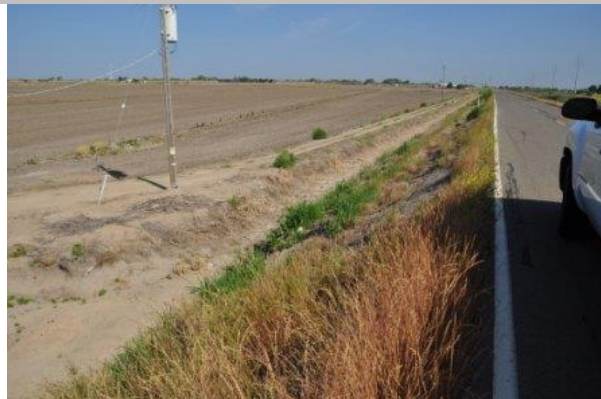
Photo 1 of 1 : FA\_2016\_RD1000\_33\_9\_20160906\_00008.jpg

LS Ag ditch at the LS toe.

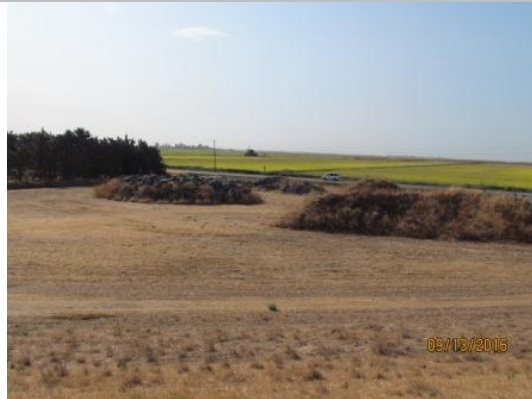
Photo 1 of 1 : FA\_2016\_RD1000\_33\_21\_20160914\_00017.jpg

View of stockpiled flood fight material on landside.
