**Flood Control Project Maintenance
Levee Inspections**

Fall 2017 Levee Maintenance Deficiency Summary Report

Sacramento River Basin

Reclamation District No. 1000 Natomas

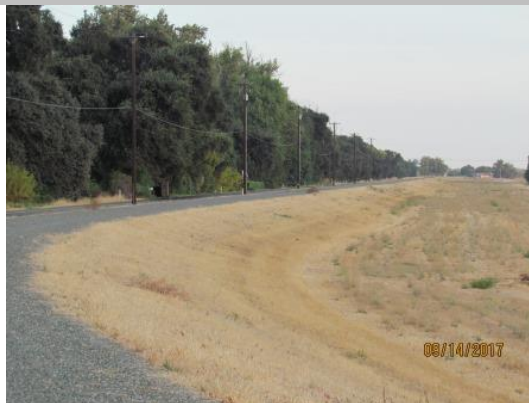
Photo 1 of 2 : FA_2017_RD1000_31_7_20170919_00037.jpg

View of the landside looking upstream of the well maintained annual vegetation, Fall 2017.

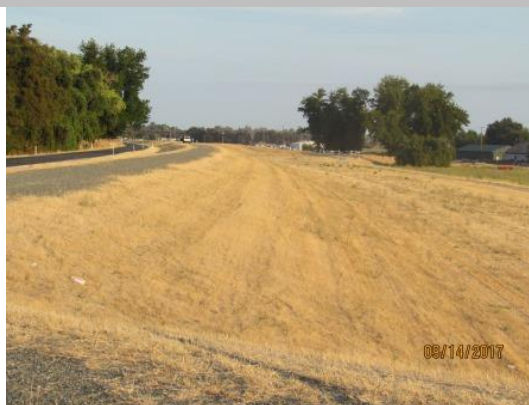
Photo 2 of 2 : FA_2017_RD1000_31_7_20170919_00038.jpg

Second view of the landside looking upstream of the well maintained annual vegetation, Fall 2017.

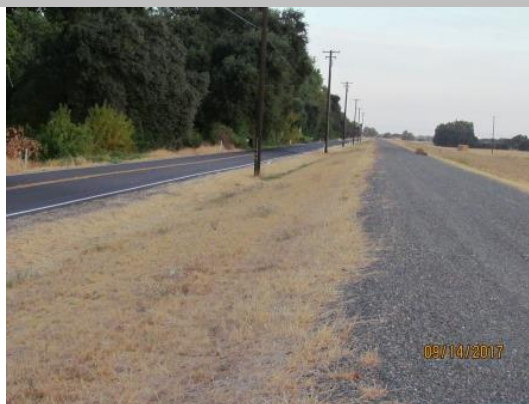
Photo 1 of 2 : FA_2017_RD1000_31_6_20170919_00039.jpg

View of the waterside looking upstream of the well maintained annual vegetation, Fall 2017.

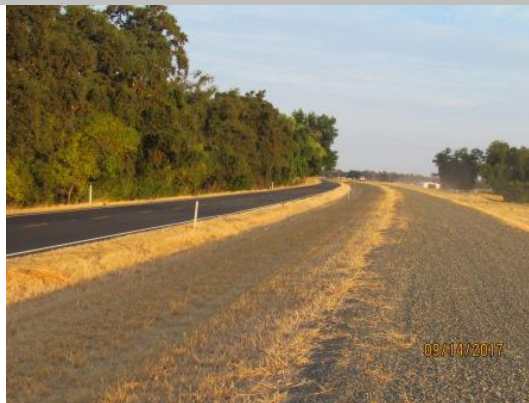
Photo 2 of 2 : FA_2017_RD1000_31_6_20170919_00040.jpg

Second view of the landside looking upstream of the well maintained annual vegetation, Fall 2017.

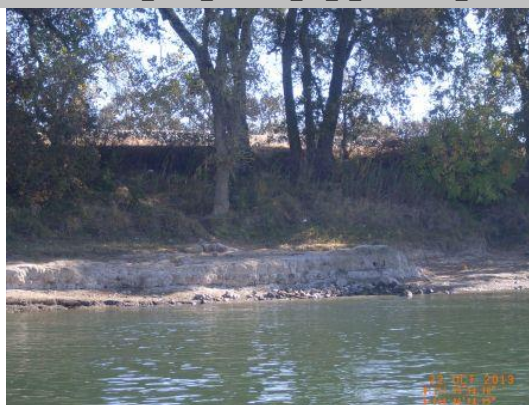
Photo 1 of 1 : FA_2017_RD1000_31_3_20170911_00002.jpg

LM Start	0.48	Rating **	M	Issue No.	3
LM End	0.61	Issue Type +	Ma	Location *	WS
Category	Supplemental			GPS Latitude/Longitude	
				Start	End
Item	2015 USACE Erosion Survey, DRAFT			38.774507 °	38.772921 °
				-121.598865 °	-121.597788 °
DWR ID	DWR_RD1000_01_s_2016_3				
Comment Code					
Inspector Comment					
1997 - Very cohesive toe. 2005 - Site was staked and rock was stockpiled along the top of the bank. 2010 - New adjacent levee under construction. 2011 - New animal burrow. 2015: No observed changes. [2015 Site ID: SAC_78-3_L]

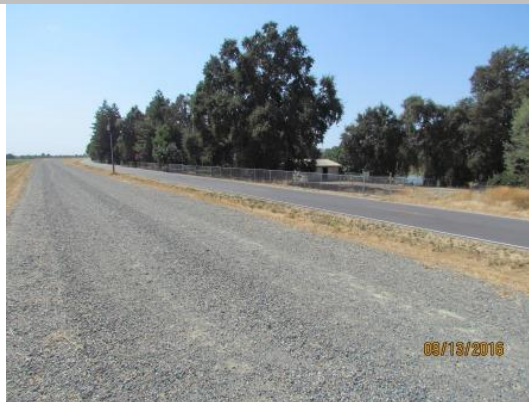
Photo 1 of 1 : FA_2017_RD1000_31_136_20170911_00033.jpg

View of an encroachment, 'Fence'. Fall 2016.

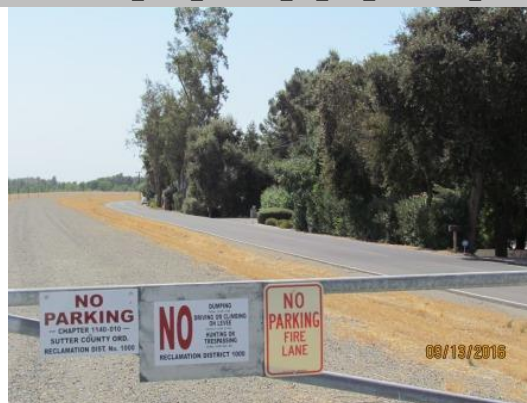
Photo 1 of 1 : FA_2017_RD1000_31_133_20170911_00032.jpg

Typical Garden Hwy 'Landscaping'. Fall 2016.

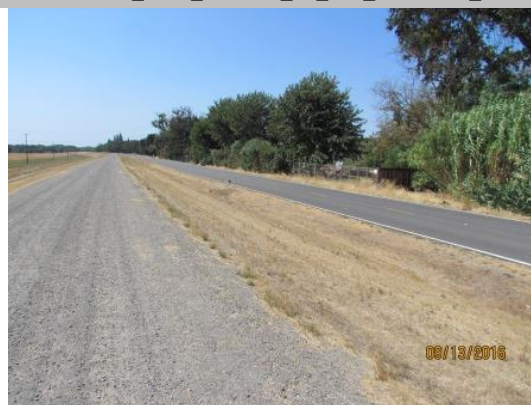
Photo 1 of 1 : FA_2017_RD1000_31_120_20170911_00031.jpg

Typical vegetation along the waterside in front of residences. Fall 2016.

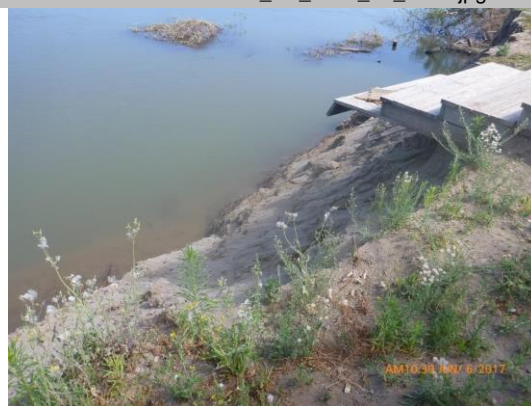
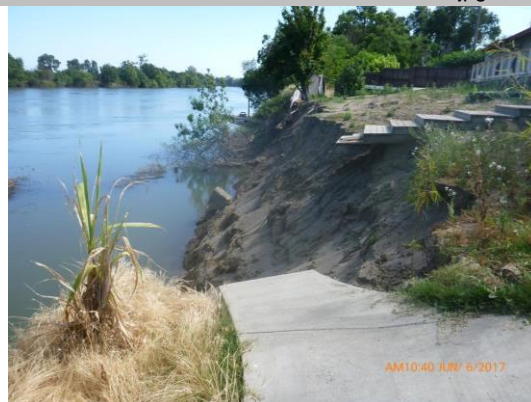
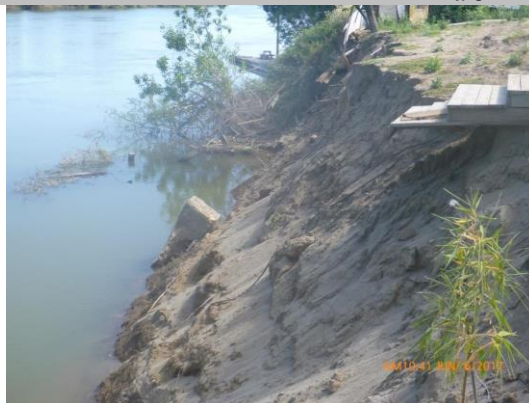
LM Start	5.21	Rating **	A/W	Issue No.	4	
LM End	5.21	Issue Type +	Ma	Location *		
Category	Supplemental			GPS Latitude/Longitude		
				Start	End	
Item	2017 Storm Damage			38.710830 °	38.710830 °	
				-121.611100 °	-121.611100 °	
DWR ID	DWR_RD1000_01_f_2017_4					
Comment Code						
Inspector Comment						
Levee Evaluation Comments						
Description:						
Site ID No:45						
Site Designation:LMA-12						
Repair Type: Erosion						
Rating:Area of Concern						
Field Date:6/6/2017						
Notes: private residence

LM Start	5.21	Rating **	A/W	Issue No.	4 (cont)							
LM End	5.21	Issue Type +	Ma	Location *								
Category	Supplemental		GPS Latitude/Longitude									
			Start	End								
Item	2017 Storm Damage		38.710830 °	38.710830 °								
			-121.611100 °	-121.611100 °								
DWR ID	DWR_RD1000_01_f_2017_4											
Comment Code												
Inspector Comment												
Levee Evaluation Comments Description: Site ID No:45 Site Designation:LMA-12 Repair Type: Erosion Rating:Area of Concern Field Date:6/6/2017 Notes: private residence

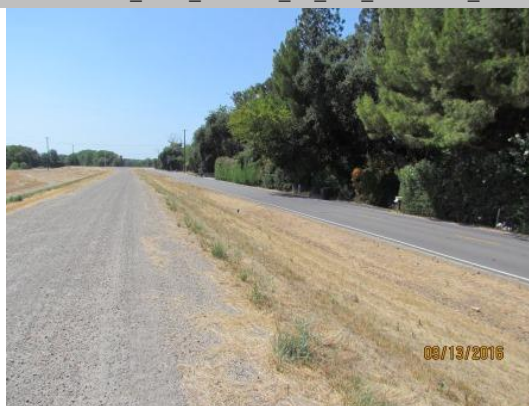
Photo 1 of 1 : FA_2017_RD1000_31_118_20170911_00030.jpg

This photo was taken from the crown facing downstream looking down the waterward levee slope at unacceptable landscaping. Fall 2016.

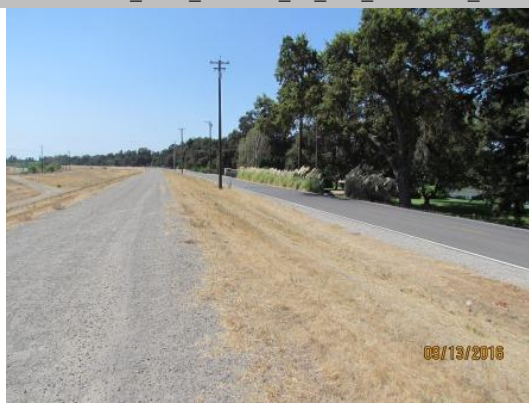
Photo 1 of 1 : FA_2017_RD1000_31_111_20170911_00029.jpg

This photo was taken from the crown facing downstream looking down the waterward levee slope at unacceptable landscaping. Fall 2016.

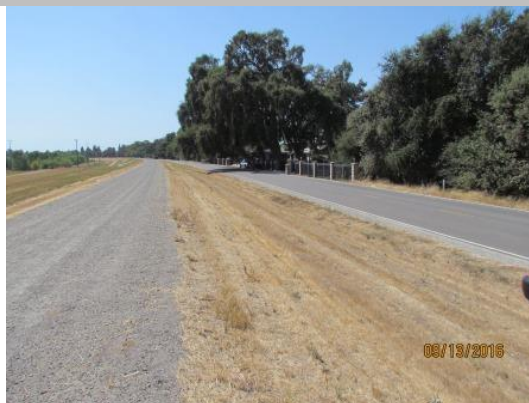
Photo 1 of 1 : FA_2017_RD1000_31_108_20170911_00028.jpg

View of an encroachment fence. Fall 2016.

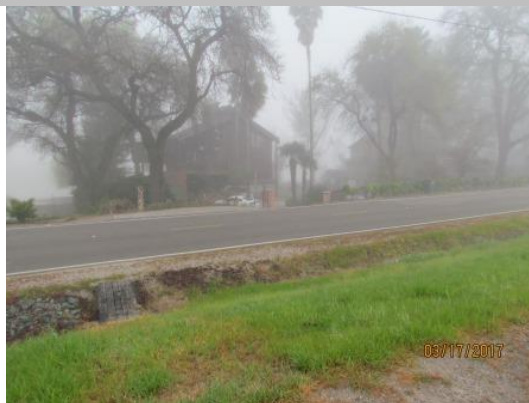
Photo 1 of 1 : FA_2017_RD1000_31_105_20170911_00027.jpg

View of vegetation that has been trimmed back by property owner and there is clear line of sight.

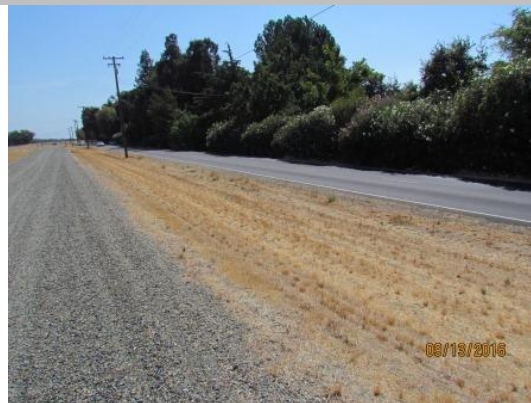
Photo 1 of 1 : FA_2017_RD1000_31_82_20170911_00024.jpg

This photo was taken from the crown facing downstream waterside levee slope at unacceptable landscaping. Fall 2016.

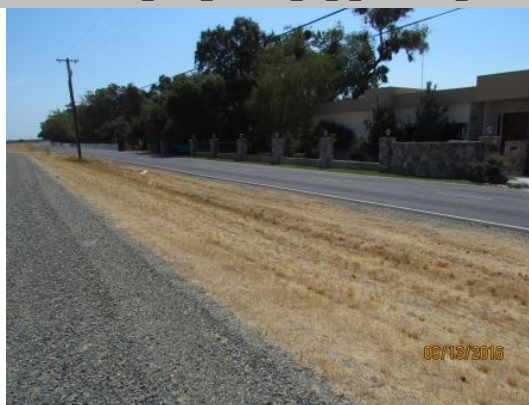
Photo 1 of 1 : FA_2017_RD1000_31_2_20170911_00001.jpg

This photo was taken during Fall 2015 from the crown facing downstream on the waterward levee slope at an enforcement issue with this fence, per the NOV all panels of the fence are to be removed. The owner has remove some of the panels between the post. Spring 2017.

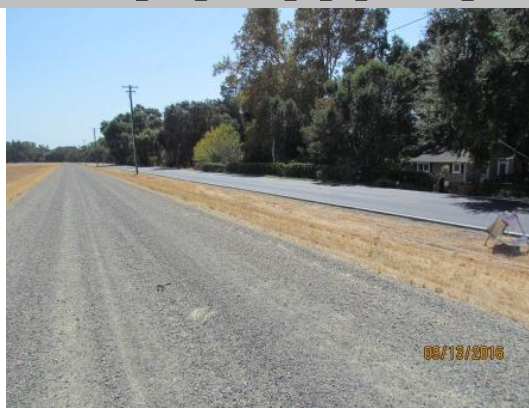
Photo 1 of 1 : FA_2017_RD1000_31_74_20170911_00022.jpg

This photo was taken from the crown facing downstream looking down the waterward levee slope at unacceptable landscaping. Fall 2016.

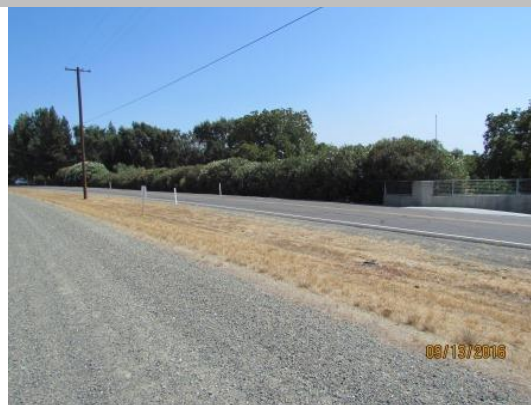
Photo 1 of 1 : FA_2017_RD1000_31_70_20170911_00020.jpg

This photo was taken from the crown facing downstream looking down the waterward levee slope at unacceptable landscaping. Fall 2016.

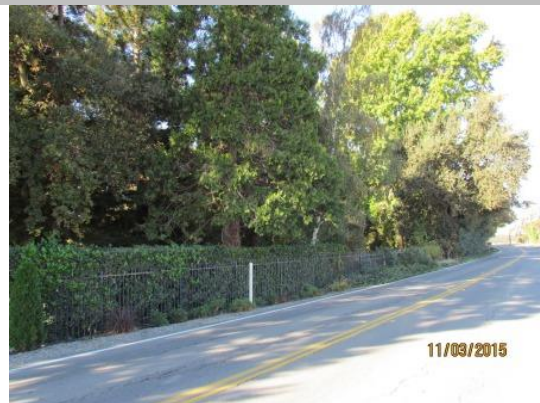
Photo 1 of 1 : FA_2017_RD1000_31_66_20170911_00019.jpg

View of the landscaping on the waterside levee slope.

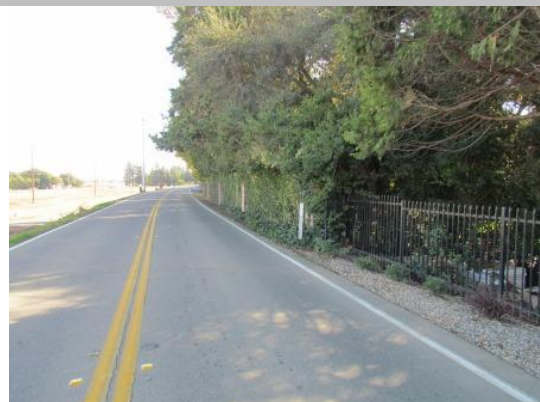
Photo 1 of 1 : FA_2017_RD1000_31_62_20170911_00017.jpg

This photo was taken from the crown facing downstream looking down the waterward levee slope at unacceptable landscaping. Fall 2014.

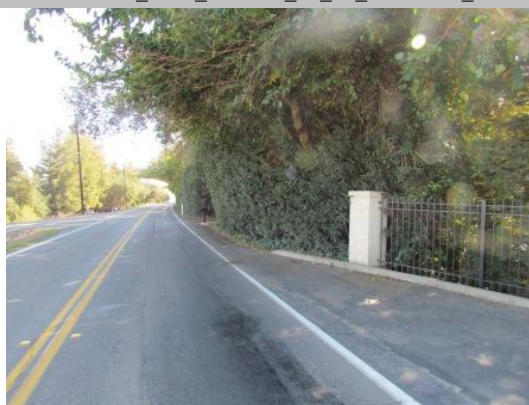
Photo 1 of 1 : FA_2017_RD1000_31_60_20170911_00016.jpg

This photo was taken from the crown facing downstream looking down the waterward levee slope at unacceptable landscaping. Fall 2014.

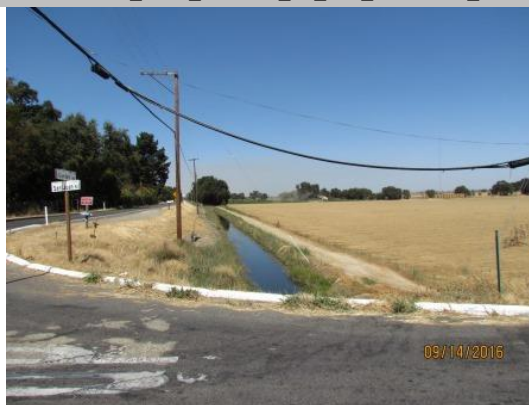
Photo 1 of 1 : FA_2017_RD1000_31_101_20170911_00026.jpg

View looking upstream at ditch on landside toe.

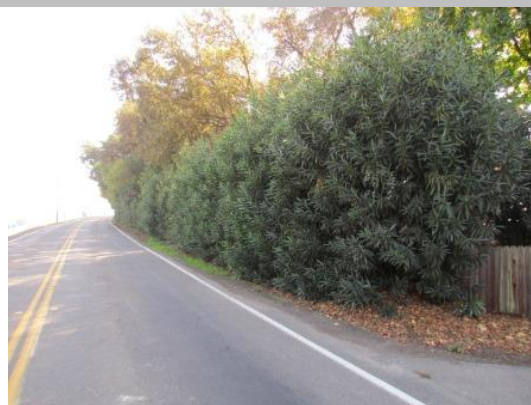
Photo 1 of 1 : FA_2017_RD1000_31_58_20170911_00015.jpg

This photo was taken from the crown facing downstream looking down the waterward levee slope at unacceptable landscaping. Fall 2014.

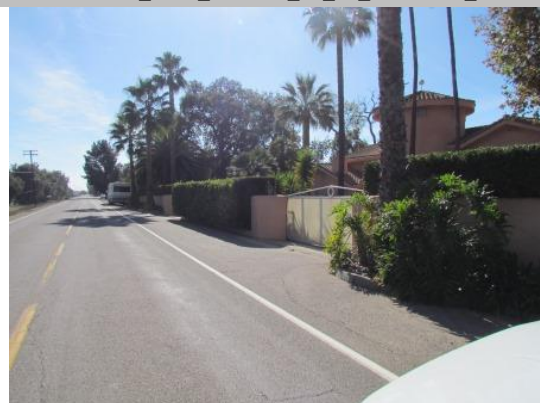
Photo 1 of 1 : FA_2017_RD1000_31_43_20170911_00012.jpg

This photo was taken from the crown facing downstream looking down the waterward levee slope at an unacceptable fence. Fall 2014.

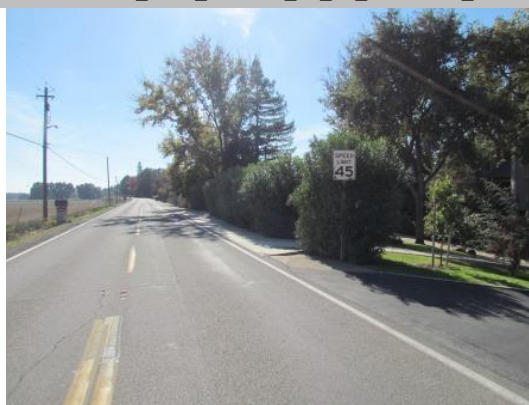
Photo 1 of 1 : FA_2017_RD1000_31_40_20170911_00010.jpg

This photo was taken from the crown facing downstream looking down the waterward levee slope at unacceptable landscaping. Fall 2014.

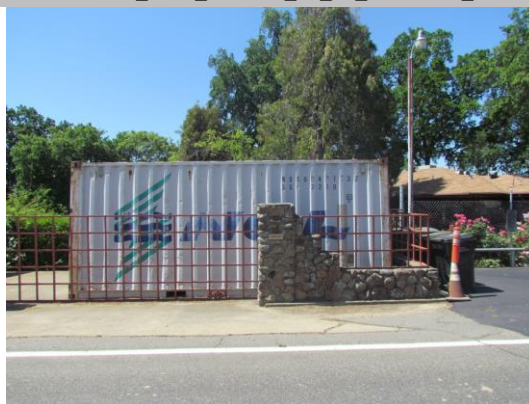
Photo 1 of 1 : FA_2017_RD1000_31_53_20170911_00014.jpg

View of storage container from the landside of the crown facing the waterside of the levee.

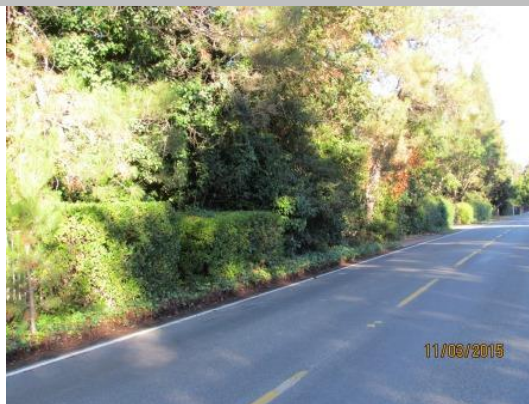
Photo 1 of 1 : FA_2017_RD1000_31_35_20170911_00009.jpg

View of the landscaping on the waterside levee slope.

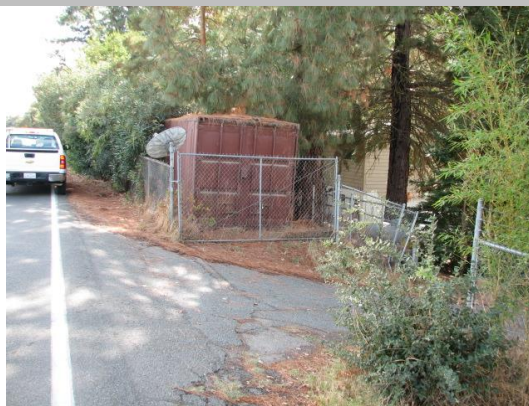
Photo 1 of 1 : FA_2017_RD1000_31_76_20170911_00023.jpg

Cargo container on levee shoulder, the property appears to be on fill material.

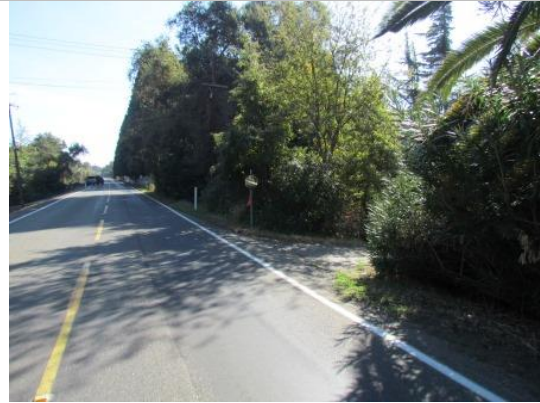
Photo 1 of 1 : FA_2017_RD1000_31_30_20170911_00007.jpg

This photo was taken from the crown facing down stream looking down the waterward levee slope at unacceptable landscaping. Fall 2014.

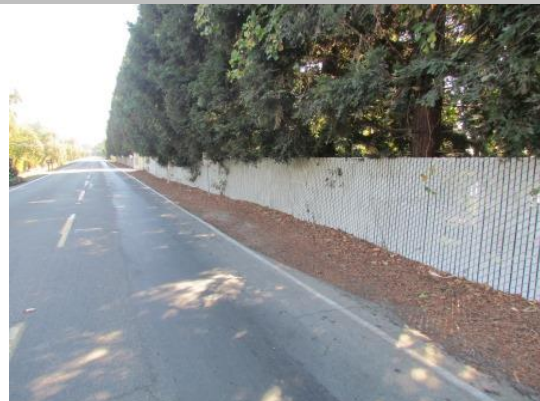
Photo 1 of 1 : FA_2017_RD1000_31_29_20170911_00006.jpg

This photo was taken from the crown facing downstream looking down the waterward levee slope at an unacceptable fence. Fall 2014.

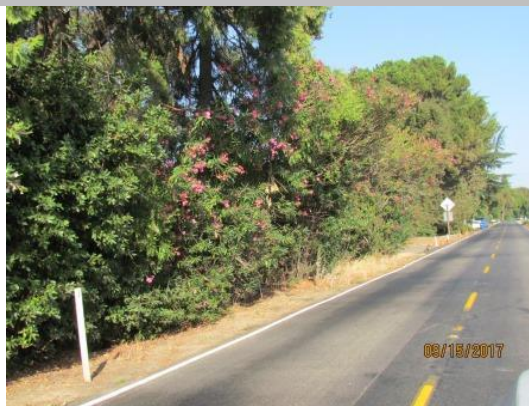
Photo 1 of 1 : FA_2017_RD1000_31_19_20170919_00051.jpg

View on waterside looking upstream of property covered by Oleander Bushes, Fall 2017.

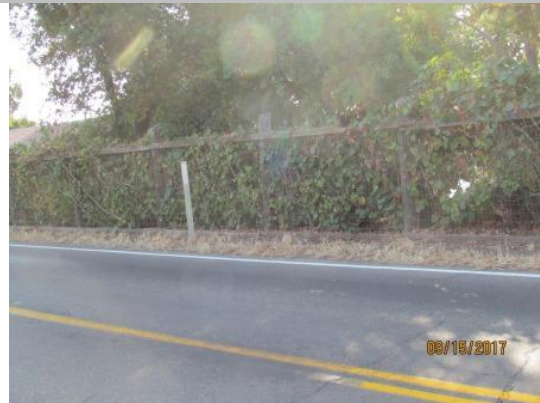
Photo 1 of 1 : FA_2017_RD1000_31_14_20170919_00052.jpg

View on waterside looking across at the fence covered by vegetation, Fall 2017.

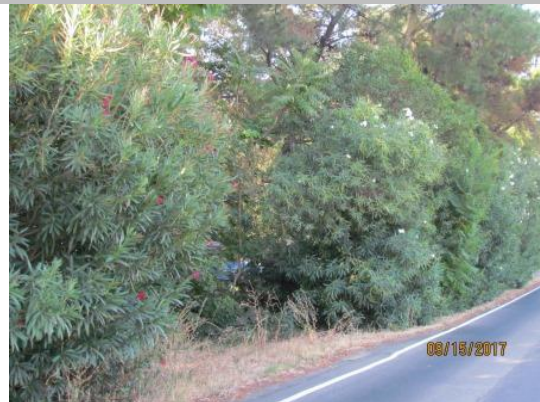
Photo 1 of 1 : FA_2017_RD1000_31_13_20170919_00053.jpg

View of fence covered by Oleander Bushes, Fall 2017.

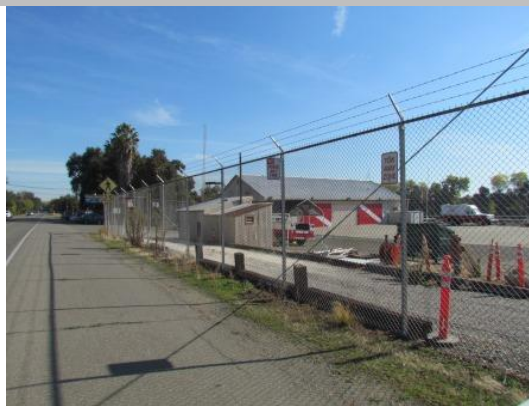
Photo 1 of 1 : FA_2017_RD1000_31_8_20170911_00004.jpg

This photo was taken from the crown facing downstream looking down the waterward levee slope at an unacceptable building. Fall 2014.

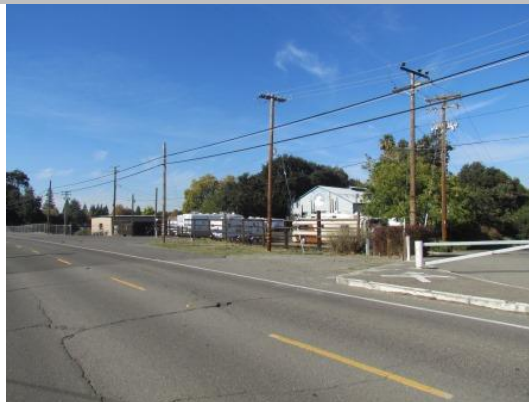
Photo 1 of 1 : FA_2017_RD1000_31_9_20170911_00005.jpg

This photo was taken from the crown facing upstream looking down the landward levee slope at an unacceptable building. Fall 2014.

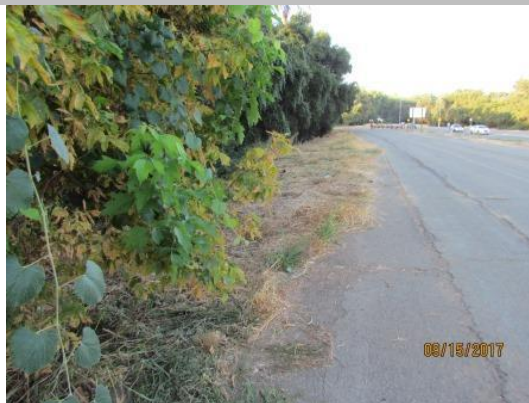
Photo 1 of 1 : FA_2017_RD1000_32_6_20170918_00008.jpg

View of waterside looking downstream of where annual vegetation has been mowed, Fall 2017.

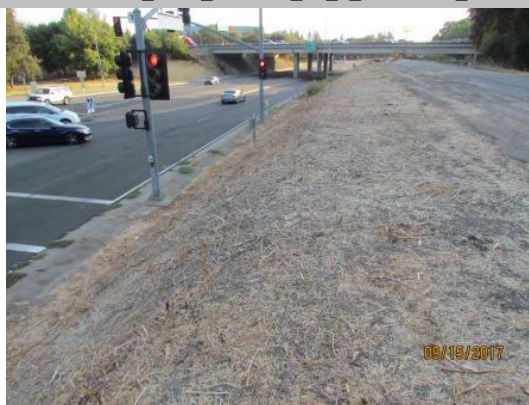
Photo 1 of 1 : FA_2017_RD1000_32_5_20170918_00007.jpg

View of landside looking upstream of well maintained vegetation, Fall 2017.

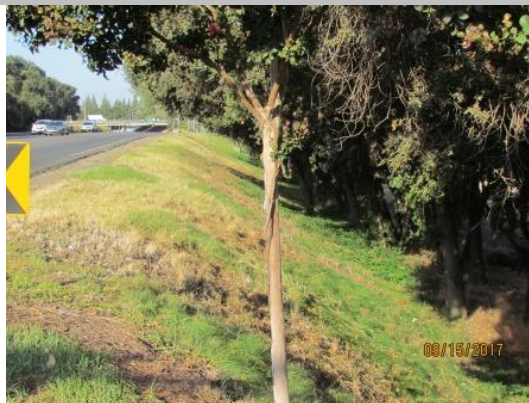
Photo 1 of 1 : FA_2017_RD1000_32_7_20170918_00010.jpg

View of landside looking downstream of well maintained vegetation, Fall 2017.

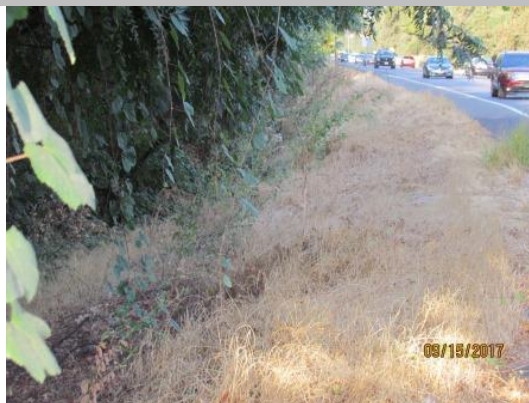
Photo 1 of 1 : FA_2017_RD1000_32_8_20170918_00009.jpg

View of waterside looking downstream at annual vegetation that needs to be mowed, Fall 2017.

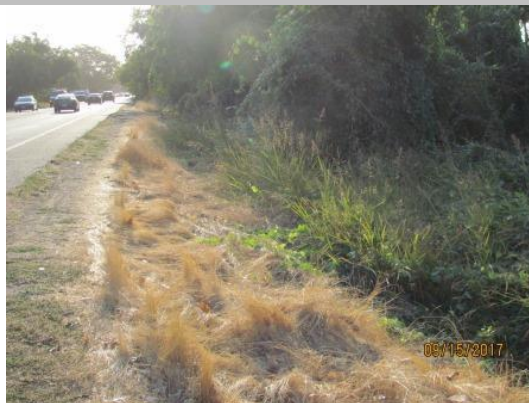
Photo 1 of 1 : FA_2017_RD1000_32_9_20170918_00011.jpg

View of waterside looking upstream of trees that need to be trimmed for visibility and access, Fall 2017.

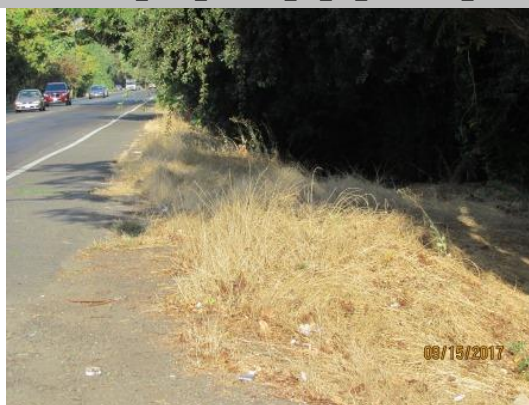
Photo 1 of 1 : FA_2017_RD1000_32_12_20170918_00012.jpg

View of landside looking downstream of trees that need to be trimmed for visibility and access, Fall 2017.

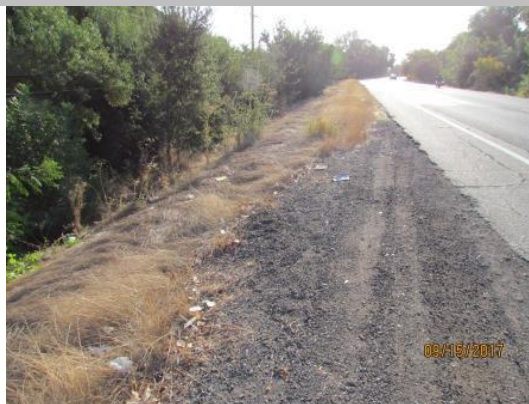
Photo 1 of 1 : FA_2017_RD1000_32_11_20170918_00013.jpg

View of landside looking upstream of vegetation, Fall 2017.

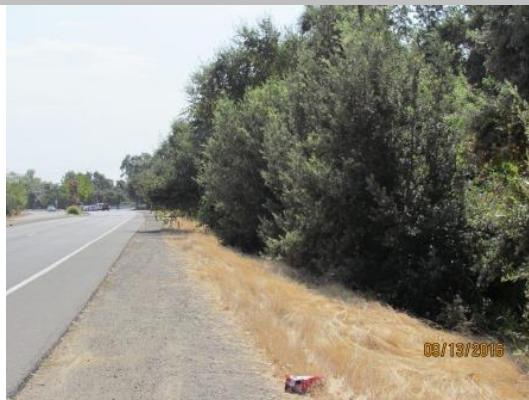
Photo 1 of 1 : FA_2017_RD1000_32_3_20170911_00005.jpg

View looking upstream waterside of trees that need to be trimmed. Fall 2016.

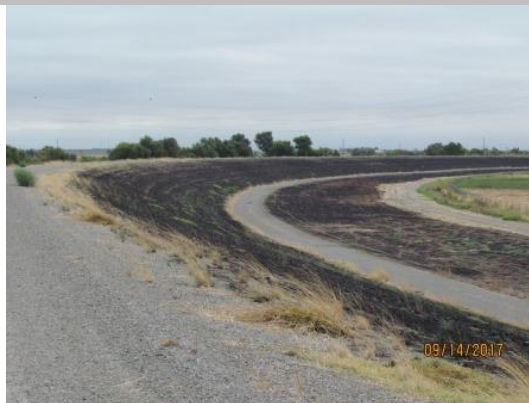
Photo 1 of 1 : FA_2017_RD1000_33_6_20170918_00017.jpg

View of landside looking upstream at the well maintained vegetation, Fall 2017.

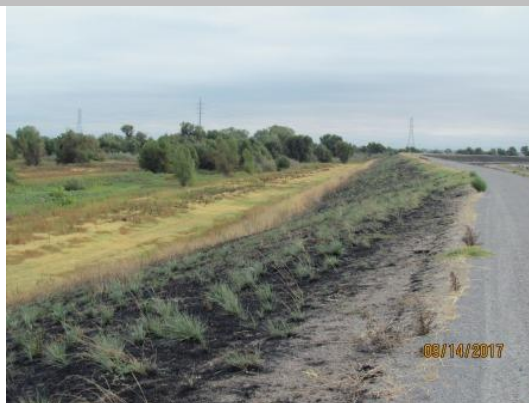
Photo 1 of 1 : FA_2017_RD1000_33_11_20170918_00016.jpg

View of waterside looking upstream at the well maintained vegetation, Fall 2017.

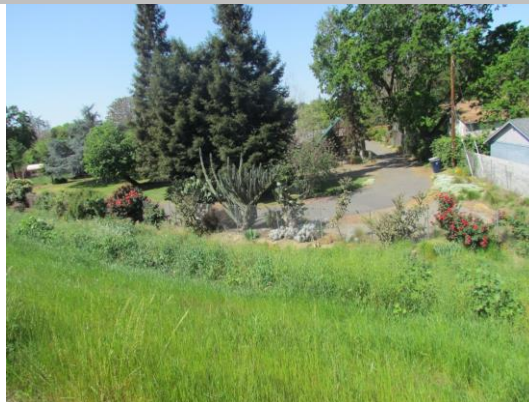
Photo 1 of 2 : FA_2017_RD1000_33_7_20170911_00005.jpg

Taken facing the landside looking downstream.

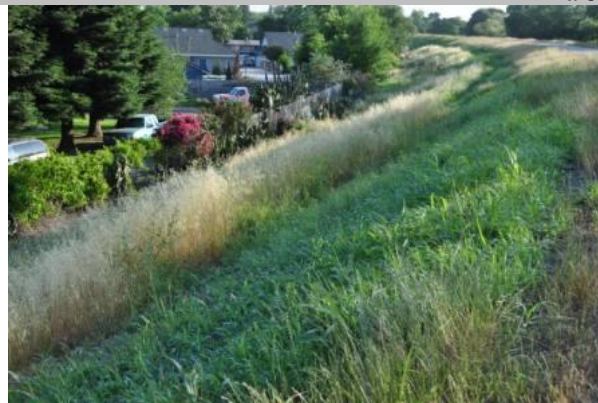
Photo 2 of 2 : FA_2017_RD1000_33_7_20170911_00006.jpg

Fence with vegetation at L/S toe.

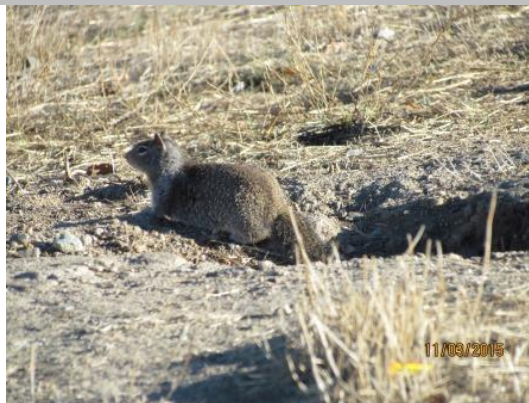
Photo 1 of 2 : FA_2017_RD1000_33_19_20170911_00013.jpg

View of the rodent on the waterside levee slope ready to retreat into the den, penetrating the levee prism.

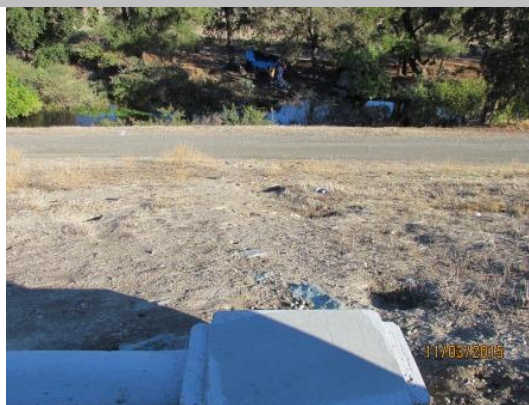
Photo 2 of 2 : FA_2017_RD1000_33_19_20170911_00014.jpg

View of the rodent holes on the waterside levee slope. Fall 2015. Bait injection into rodent hole for control, no sign of rodents Fall 2016.

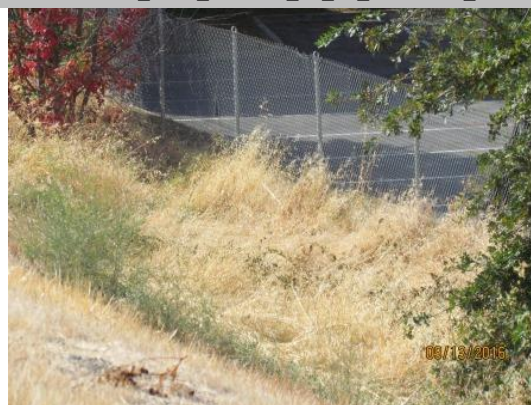
Photo 1 of 1 : FA_2017_RD1000_33_17_20170911_00012.jpg

View of fence at landside levee toe.

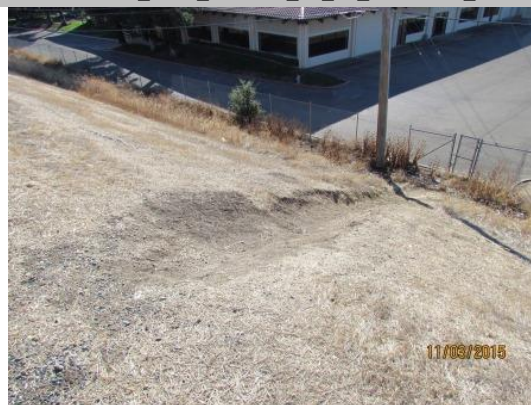
Photo 1 of 1 : FA_2017_RD1000_33_15_20170911_00011.jpg

View of the landside levee slope damaged by foot traffic.

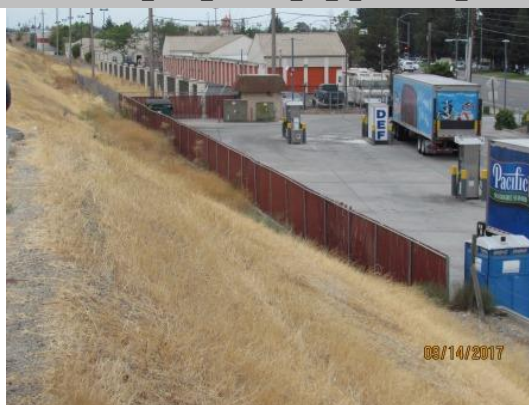
Photo 1 of 1 : FA_2017_RD1000_33_3_20170918_00020.jpg

View looking downstream landside of fence that encroaches at levee toe, Fall 2017.

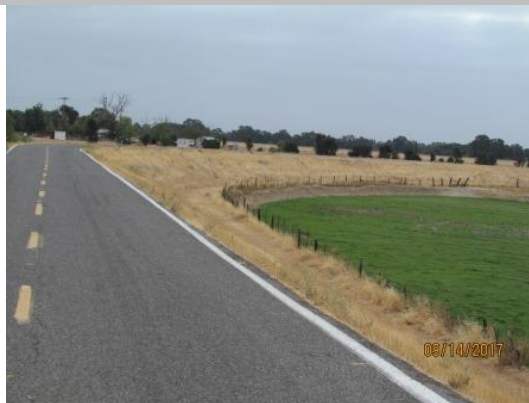
Photo 1 of 1 : FA_2017_RD1000_33_1_20170918_00019.jpg

View taken facing the landside looking downstream at location where there was rodent activity in past years. Rodent holes have been filled and no new activity was observed. Several bait traps at landside levee toe. Fall 2017.

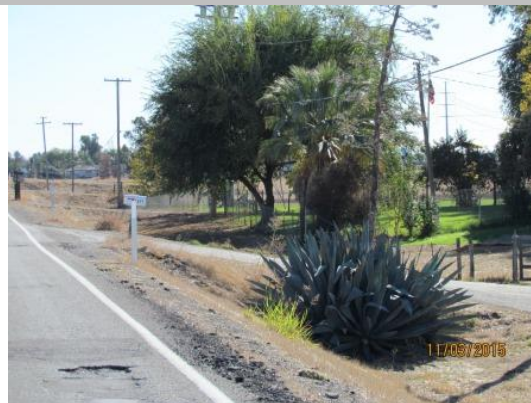
Photo 1 of 1 : FA_2017_RD1000_33_2_20170911_00003.jpg

View of the landscaping at the landside levee toe.

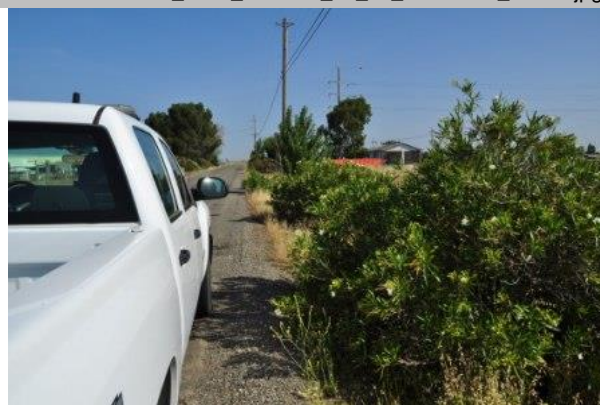
Photo 1 of 1 : FA_2017_RD1000_33_10_20170911_00009.jpg

WS vegetation.

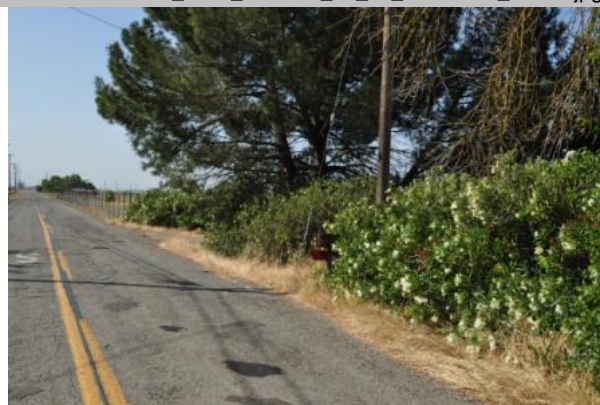
Photo 1 of 1 : FA_2017_RD1000_33_13_20170911_00010.jpg

LS landscaping.

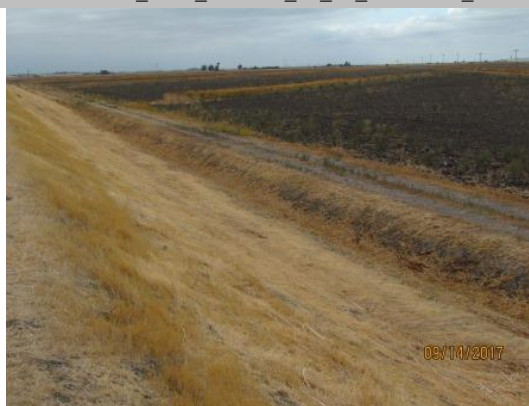
Photo 1 of 1 : FA_2017_RD1000_33_22_20170918_00018.jpg

View of landside ditch at toe of levee, looking downstream, Fall 2017.

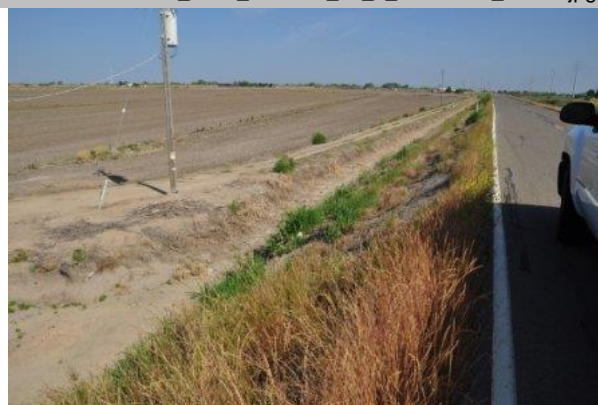
Photo 1 of 1 : FA_2017_RD1000_33_9_20170911_00008.jpg

LS Ag ditch at the LS toe.

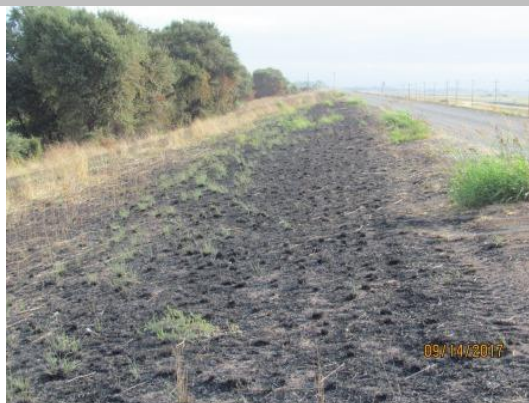
Photo 1 of 1 : FA_2017_RD1000_34_14_20170918_00001.jpg

View looking upstream on the waterside at the well maintained vegetation, Fall 2017.
