**Flood Control Project Maintenance
Levee Inspections**

Fall 2018 Levee Maintenance Deficiency Summary Report

Sacramento River Basin

**Flood Control Project Maintenance
Levee Inspections****LMA District Cover Sheet
Fall 2018 Levee Inspection Results****Reclamation District No. 1000 Natomas**

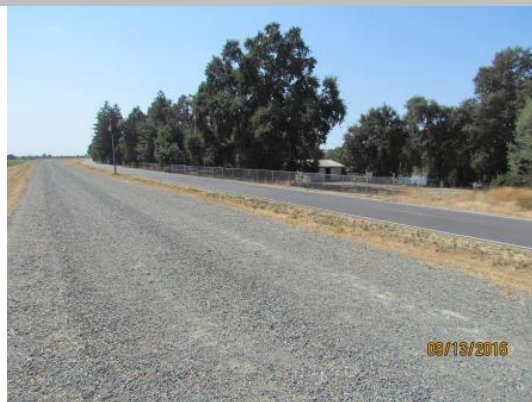
Photo 1 of 1 : FA_2018_RD1000_31_136_20180918_00046.jpg

LM Start	1.63	Rating **	M	Issue No.	136
LM End	1.69	Issue Type +	En	Location *	WS
Category	Earthen Levee			GPS Latitude/Longitude	
				Start	End
Item	Encroachments			38.759320 °	38.758415 °
				-121.591343 °	-121.591348 °
DWR ID	DWR_RD1000_01_s_2012_136				
Comment Code					
FE : Fence					
Inspector Comment

View of an encroachment, 'Fence'.

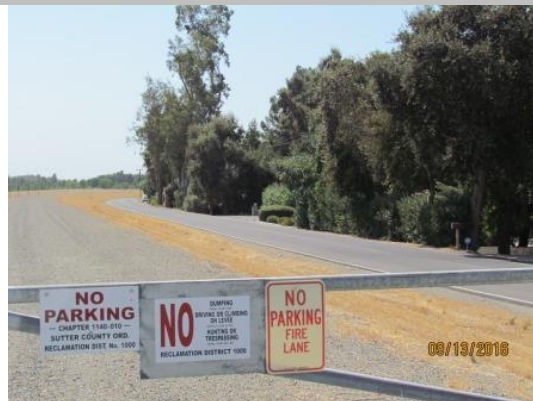
Photo 1 of 1 : FA_2018_RD1000_31_133_20180918_00045.jpg

Typical Garden Hwy 'Landscaping'.

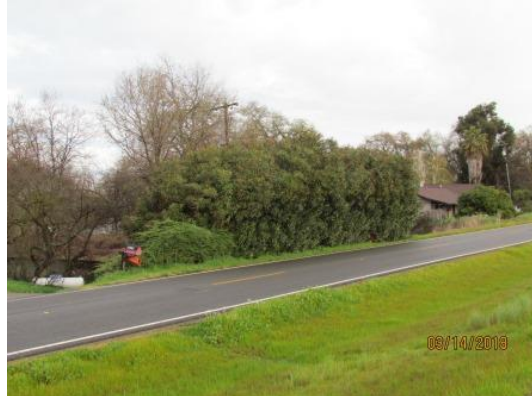
Photo 1 of 1 : FA_2018_RD1000_31_129_20180918_00044.jpg

View looking upstream waterside of landscape vegetation that is blocking access and visibility to the levee.

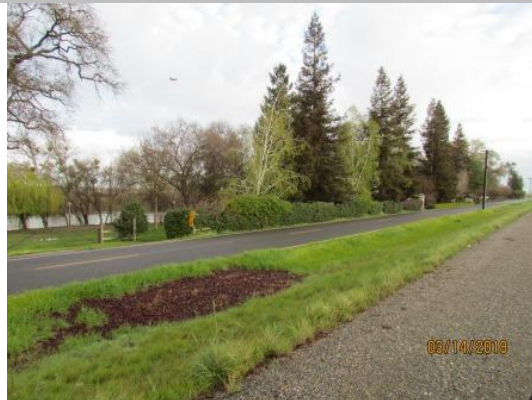
Photo 1 of 1 : FA_2018_RD1000_31_122_20180918_00043.jpg

View looking upstream waterside of landscape vegetation that is blocking access and visibility to the levee.

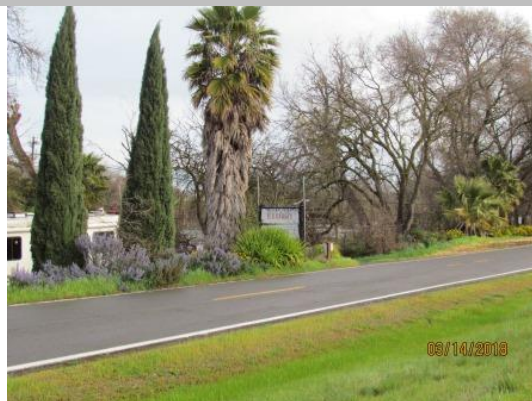
Photo 1 of 1 : FA_2018_RD1000_31_121_20180918_00042.jpg

View looking upstream waterside of landscape vegetation that is blocking access and visibility to the levee.

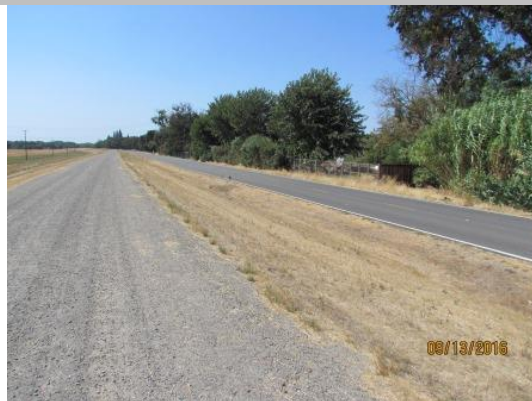
Photo 1 of 1 : FA_2018_RD1000_31_120_20180918_00041.jpg

LM Start	5.17	Rating **	M	Issue No.	120
LM End	5.21	Issue Type +	En	Location *	WS
Category	Earthen Levee			GPS Latitude/Longitude	
				Start	End
Item	Vegetation			38.711248°	38.710806°
				-121.610500°	-121.611110°
DWR ID	DWR_RD1000_01_s_2012_120				
Comment Code					
V6 : Landscaping					
Inspector Comment

Typical landscape vegetation along the waterside in front of residences.

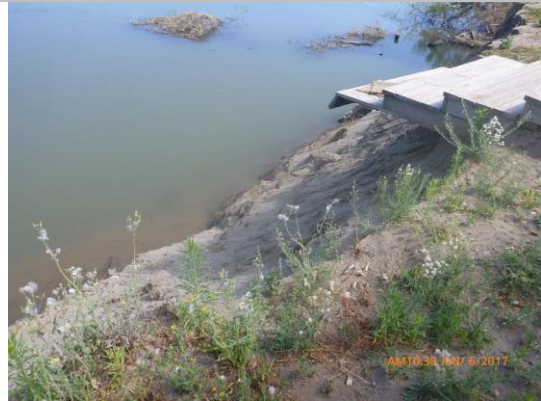
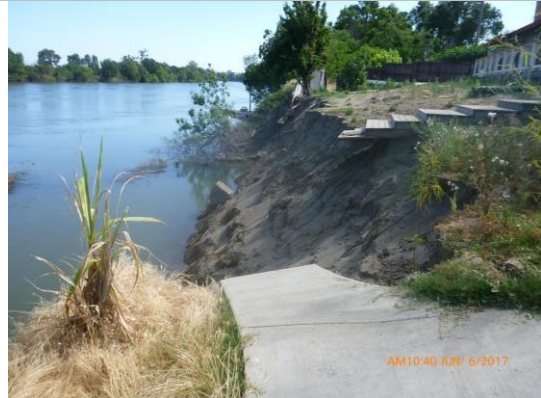
LM Start	5.21	Rating **	A/W	Issue No.	4	
LM End	5.21	Issue Type +	Ma	Location *		
Category	Supplemental			GPS Latitude/Longitude		
				Start	End	
Item	2017 Storm Damage			38.710830°	38.710830°	
				-121.611100°	-121.611100°	
DWR ID	DWR_RD1000_01_f_2017_4					
Comment Code						
Inspector Comment						
Levee Evaluation Comments						
Description:						
Site ID No:45						
Site Designation:LMA-12						
Repair Type: Erosion						
Rating:Area of Concern						
Field Date:6/6/2017						
Notes: private residence

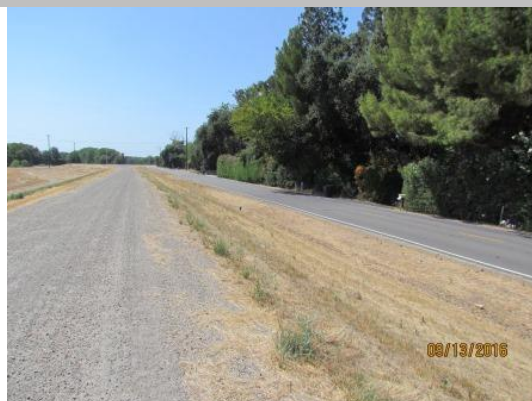
Photo 1 of 1 : FA_2018_RD1000_31_118_20180918_00040.jpg

This photo was taken from the crown facing downstream looking down the waterward levee slope at unacceptable landscaping.

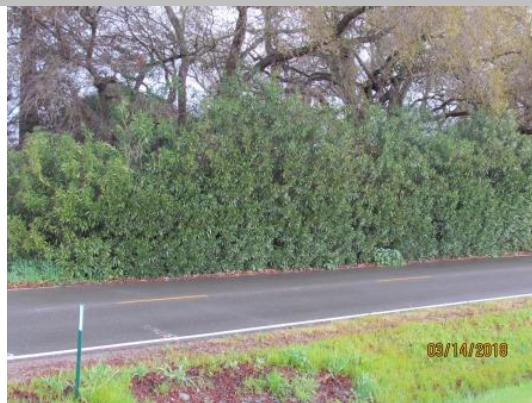
Photo 1 of 1 : FA_2018_RD1000_31_116_20180918_00039.jpg

LM Start	5.97	Rating **	M	Issue No.	116
LM End	6.00	Issue Type +	En	Location *	WS
Category	Earthen Levee			GPS Latitude/Longitude	
				Start	End
Item	Vegetation			38.702742 °	38.702467 °
				-121.620557 °	-121.620947 °
DWR ID	DWR_RD1000_01_s_2012_116				
Comment Code					
V6 : Landscaping					
Inspector Comment					
Landscape vegetation is blocking access and visibility to the levee.

View looking at waterside landscape vegetation that is blocking access and visibility to the levee.

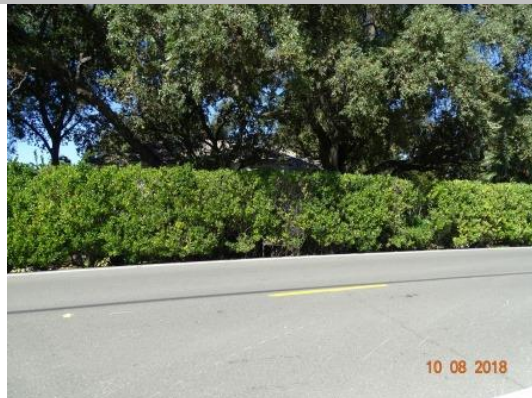
Photo 1 of 1 : FA_2018_RD1000_31_68_20181113_00051.jpg

View at landscape vegetation that is blocking visibility and access, Fall 2018.

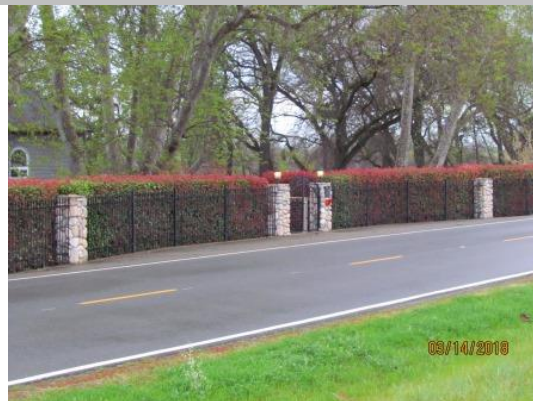
Photo 1 of 1 : FA_2018_RD1000_31_95_20180918_00035.jpg

View looking at waterside landscape vegetation that is blocking access and visibility to the levee.

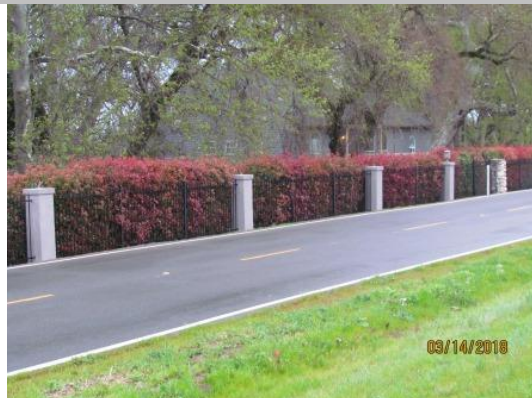
Photo 1 of 1 : FA_2018_RD1000_31_94_20180918_00034.jpg

View looking at waterside landscape vegetation that is blocking access and visibility to the levee.

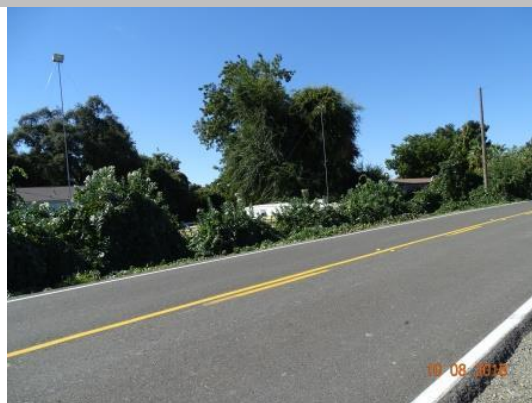
Photo 1 of 1 : FA_2018_RD1000_31_87_20181113_00054.jpg

View of landscape vegetation that is blocking visibility and access, Fall 2108.

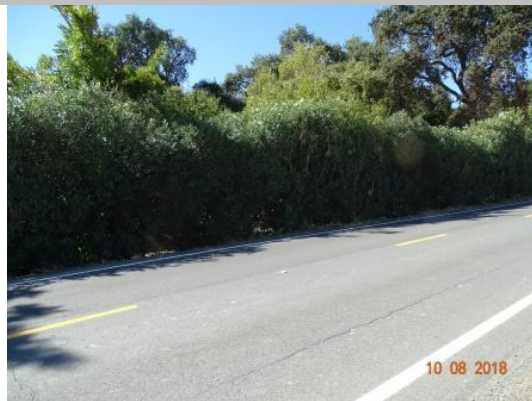
Photo 1 of 1 : FA_2018_RD1000_31_82_20181113_00056.jpg

This photo was taken from the crown facing downstream waterside levee slope at unacceptable landscaping. Fall 2018.

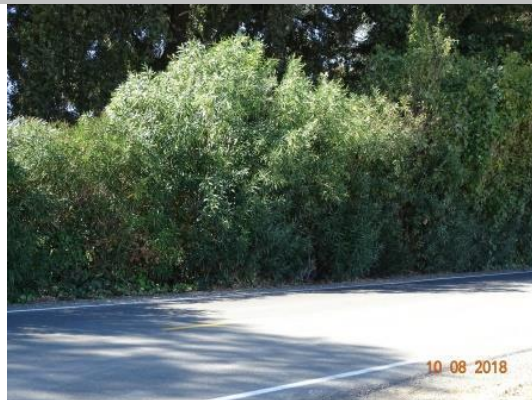
Photo 1 of 1 : FA_2018_RD1000_31_81_20181113_00057.jpg

View of landscape vegetation that blocks visibility and access, Fall 2018.

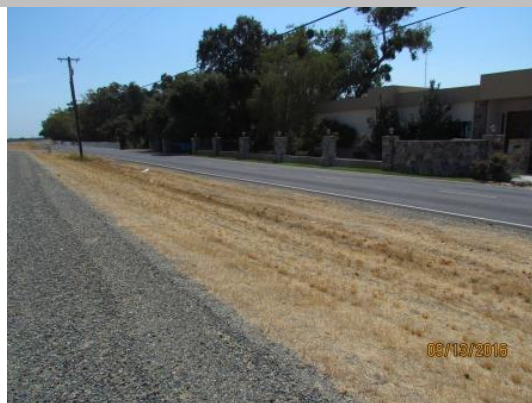
Photo 1 of 1 : FA_2018_RD1000_31_2_20180918_00001.jpg

This photo was taken during Fall 2015 from the crown facing downstream on the waterward levee slope at an enforcement issue with this fence, per the NOV all panels of the fence are to be removed. The owner has remove some of the panels between the post.

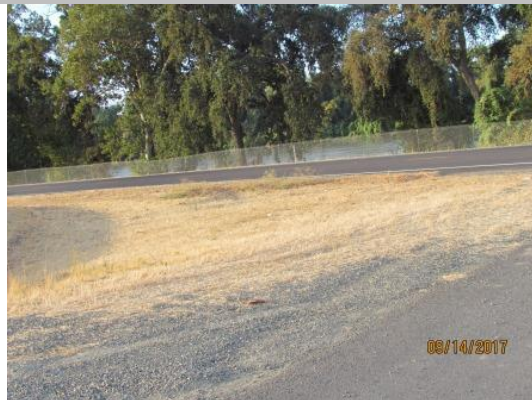
Photo 1 of 1 : FA_2018_RD1000_31_10_20180918_00008.jpg

View on waterside of a non-permitted fence.

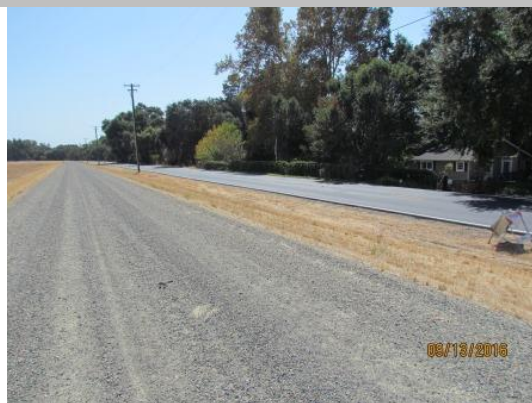
Photo 1 of 1 : FA_2018_RD1000_31_74_20180918_00030.jpg

This photo was taken from the crown facing downstream looking down the waterward levee slope at unacceptable landscaping.

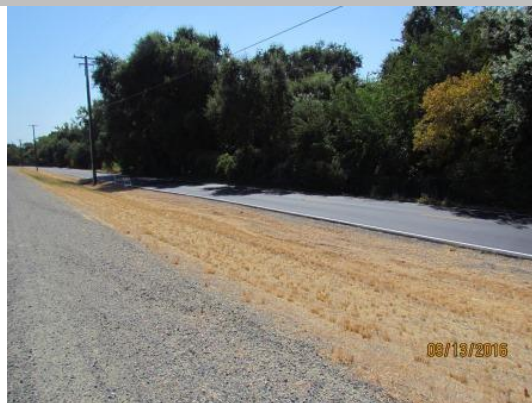
Photo 1 of 1 : FA_2018_RD1000_31_73_20180918_00029.jpg

This photo was taken from the crown facing downstream looking down the waterward levee slope at unacceptable landscaping.

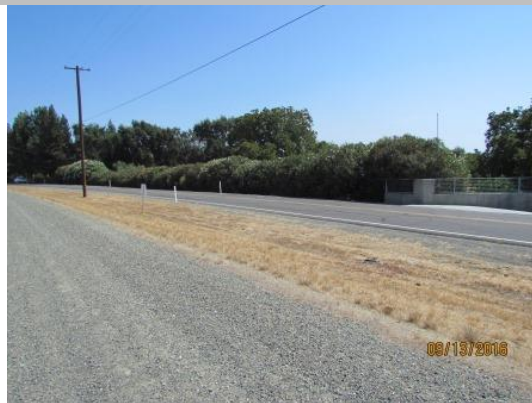
Photo 1 of 1 : FA_2018_RD1000_31_70_20180918_00028.jpg

This photo was taken from the crown facing downstream looking down the waterward levee slope at unacceptable landscaping.

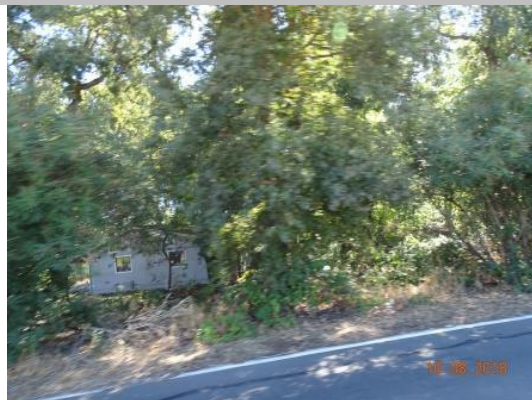
Photo 1 of 1 : FA_2018_RD1000_31_69_20181113_00058.jpg

View of landscape vegetation that blocks access and visibility, Fall 2018.

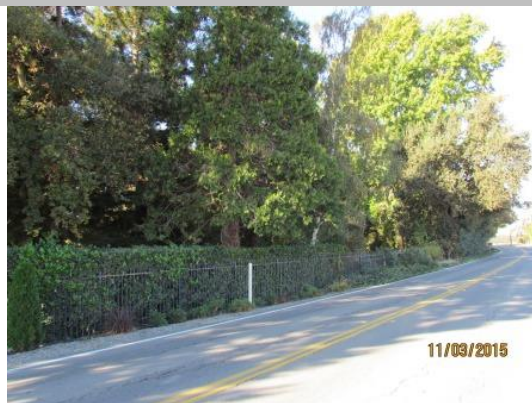
Photo 1 of 1 : FA_2018_RD1000_31_66_20180918_00027.jpg

View of the landscaping on the waterside levee slope.

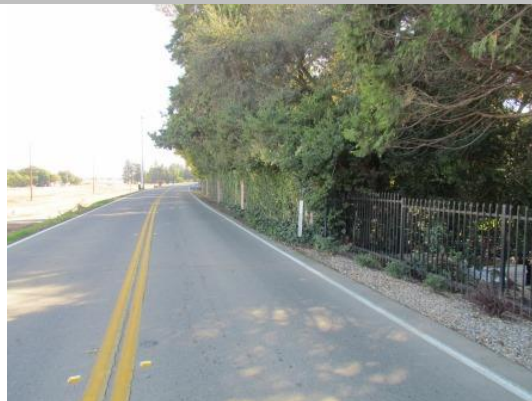
Photo 1 of 1 : FA_2018_RD1000_31_62_20180918_00025.jpg

This photo was taken from the crown facing downstream looking down the waterward levee slope at unacceptable landscaping.

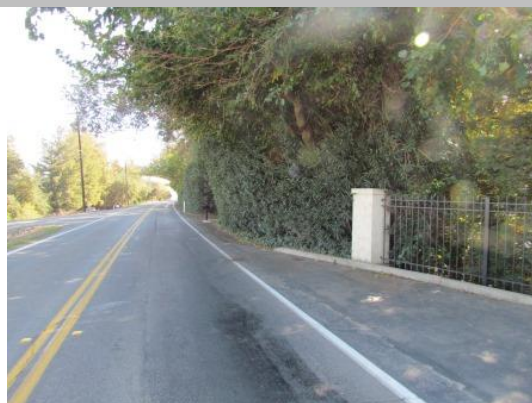
Photo 1 of 1 : FA_2018_RD1000_31_60_20180918_00024.jpg

This photo was taken from the crown facing downstream looking down the waterward levee slope at unacceptable landscaping.

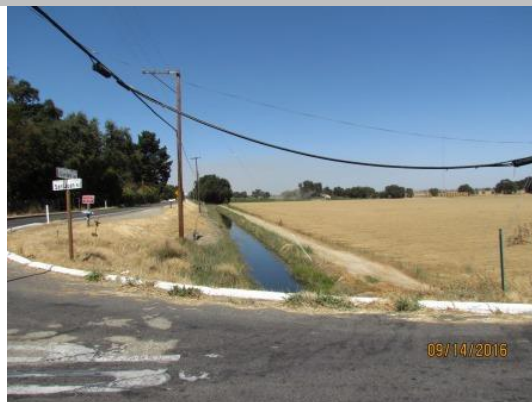
Photo 1 of 1 : FA_2018_RD1000_31_101_20180918_00036.jpg

View looking upstream at ditch on landside toe.

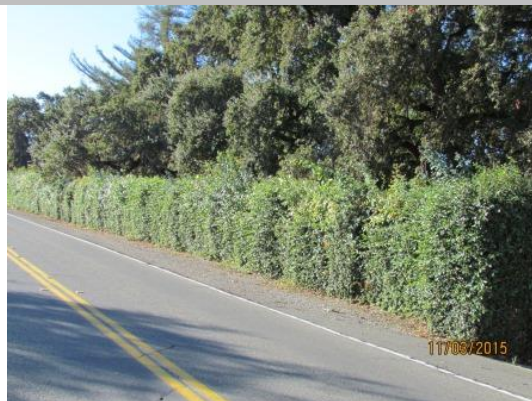
Photo 1 of 1 : FA_2018_RD1000_31_51_20180918_00021.jpg

View of the landscaping on the waterside levee slope.

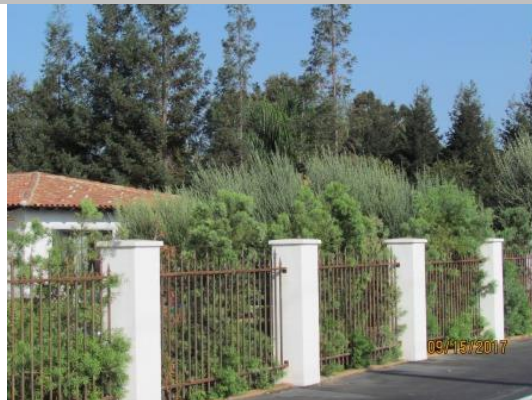
Photo 1 of 1 : FA_2018_RD1000_31_46_20180918_00020.jpg

View on waterside looking upstream of where the vegetation covers the front of the fence,

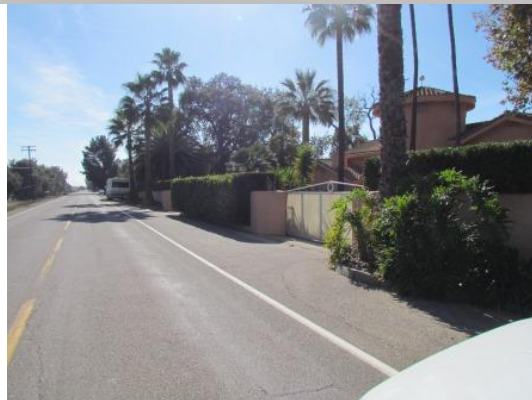
Photo 1 of 1 : FA_2018_RD1000_31_43_20180918_00019.jpg

This photo was taken from the crown facing downstream looking down the waterward levee slope at an unacceptable fence.

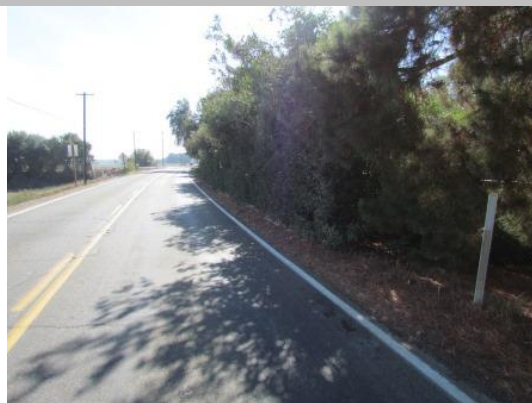
Photo 1 of 1 : FA_2018_RD1000_31_42_20180918_00018.jpg

This photo was taken from the crown facing downstream looking down the waterward levee slope at unacceptable landscaping.

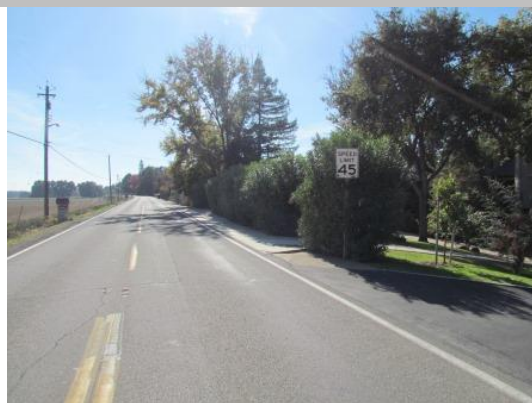
Photo 1 of 1 : FA_2018_RD1000_31_40_20180918_00017.jpg

This photo was taken from the crown facing downstream looking down the waterward levee slope at unacceptable landscaping.

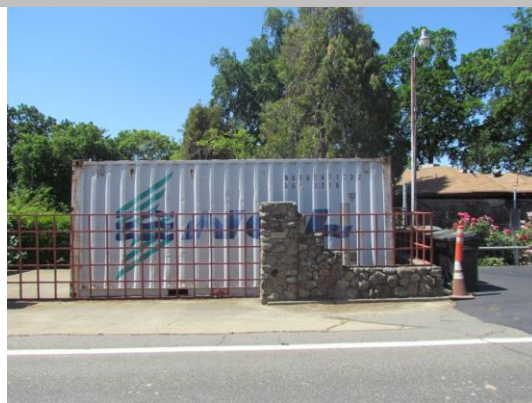
Photo 1 of 1 : FA_2018_RD1000_31_53_20180918_00022.jpg

View of storage container from the landside of the crown facing the waterside of the levee.

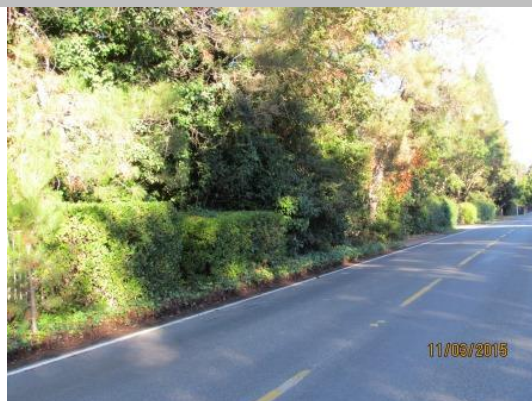
Photo 1 of 1 : FA_2018_RD1000_31_35_20180918_00016.jpg

View of the landscaping on the waterside levee slope.

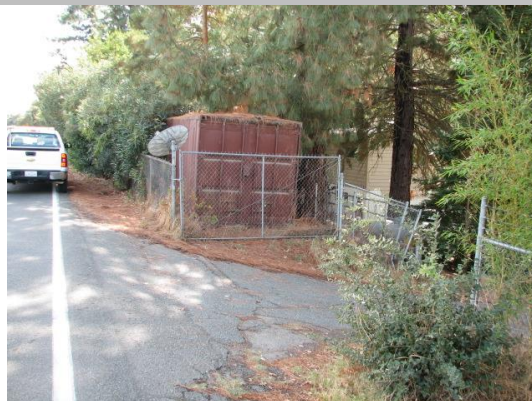
Photo 1 of 1 : FA_2018_RD1000_31_76_20180918_00031.jpg

Cargo container on levee shoulder, the property appears to be on fill material.

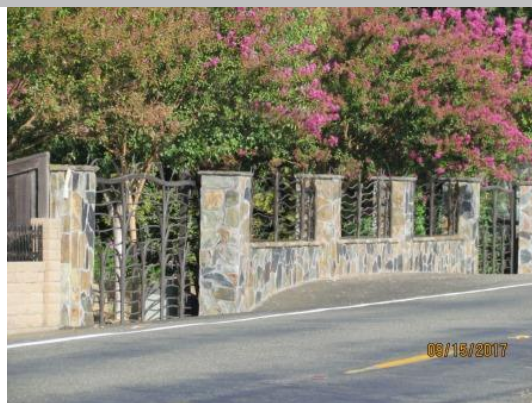
Photo 1 of 1 : FA_2018_RD1000_31_32_20180918_00015.jpg

View on waterside looking upstream of a rock and wrought iron fence that partially blocks visibility and access.

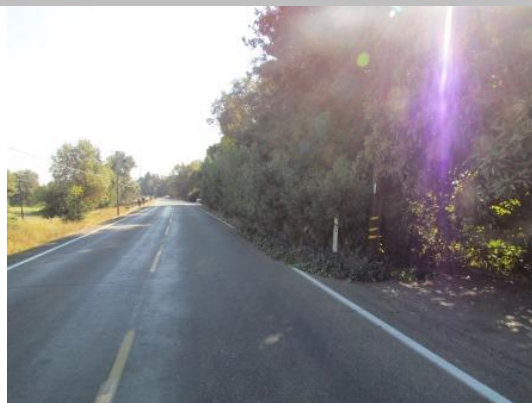
Photo 1 of 1 : FA_2018_RD1000_31_31_20180918_00014.jpg

This photo was taken from the crown facing downstream looking down the waterward levee slope at unacceptable landscaping.

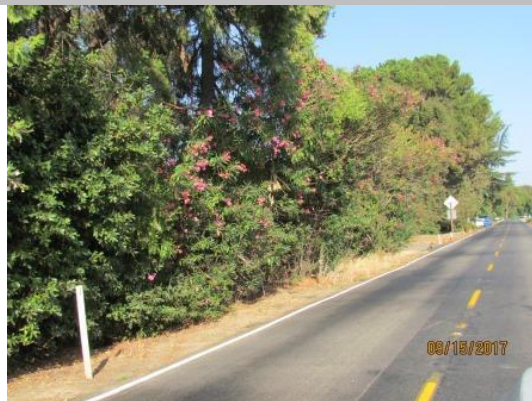
Photo 1 of 1 : FA_2018_RD1000_31_19_20180918_00011.jpg

View on waterside looking upstream of property covered by Oleander Bushes.

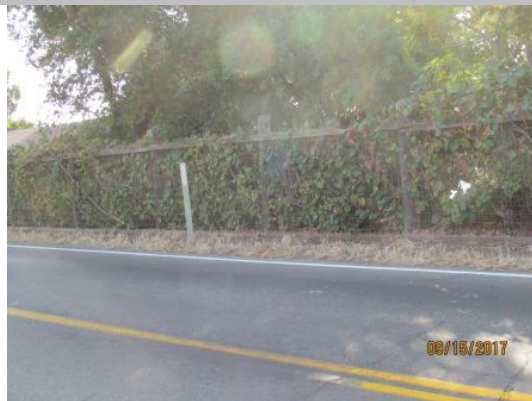
Photo 1 of 1 : FA_2018_RD1000_31_14_20180918_00010.jpg

View on waterside looking across at the fence covered by vegetation.

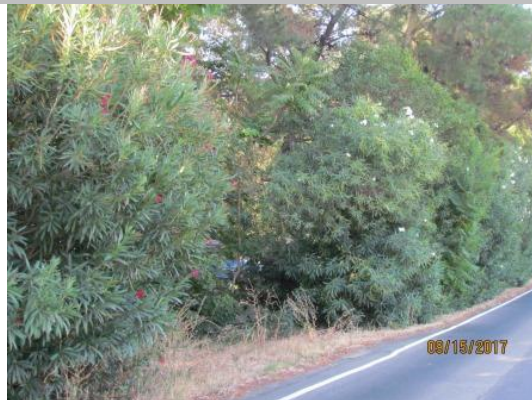
Photo 1 of 1 : FA_2018_RD1000_31_13_20180918_00009.jpg

View of fence covered by Oleander Bushes.

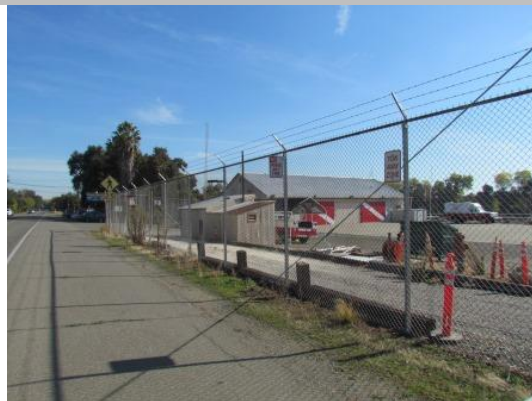
Photo 1 of 1 : FA_2018_RD1000_31_8_20180918_00006.jpg

This photo was taken from the crown facing downstream looking down the waterward levee slope at an unacceptable building.

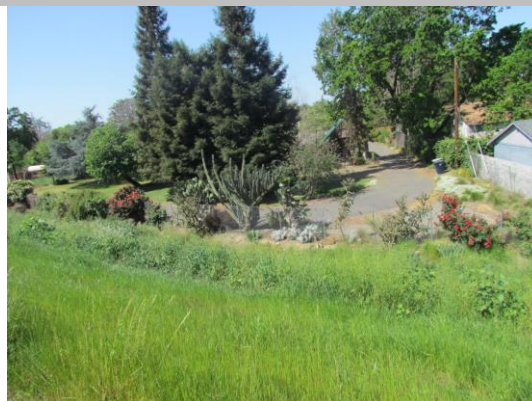
Photo 1 of 2 : FA_2018_RD1000_33_7_20180918_00005.jpg

Taken facing the landside looking downstream.

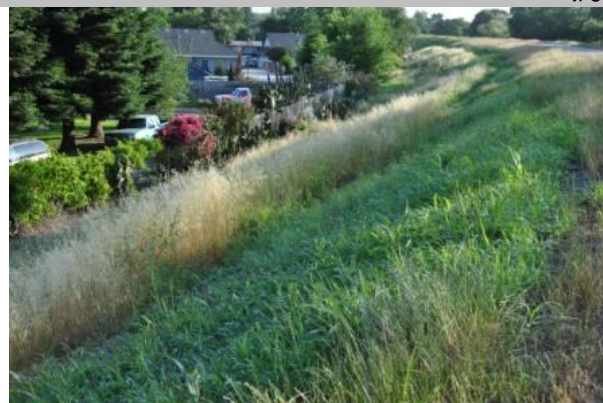
Photo 2 of 2 : FA_2018_RD1000_33_7_20180918_00006.jpg

Fence with vegetation at LS toe.

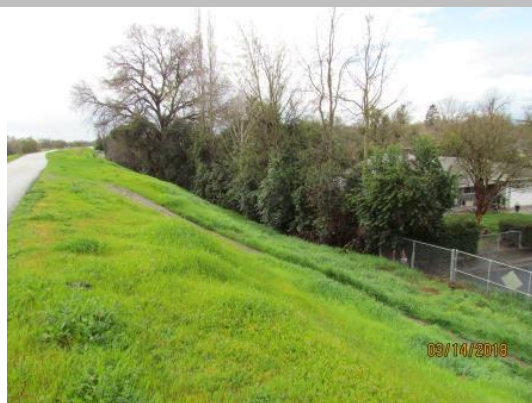
Photo 1 of 1 : FA_2018_RD1000_33_4_20180918_00004.jpg

View looking downstream landside of fence at levee toe, Spring 2018.

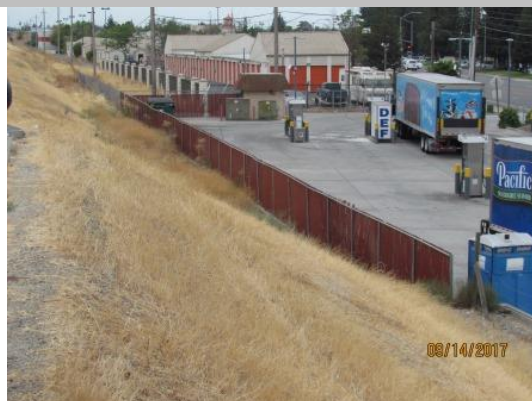
Photo 1 of 1 : FA_2018_RD1000_33_3_20180918_00003.jpg

View looking downstream landside of fence that encroaches at levee toe, Fall 2017.

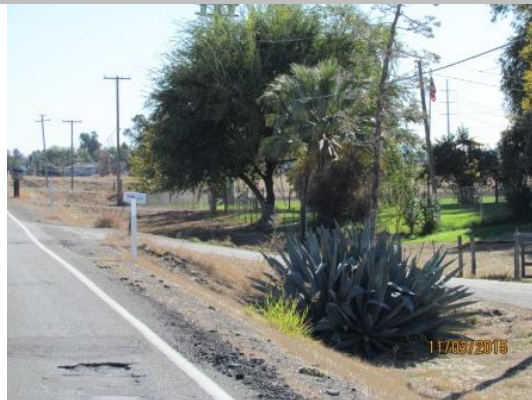
Photo 1 of 1 : FA_2018_RD1000_33_2_20180918_00002.jpg

View of the landscaping at the landside levee toe.

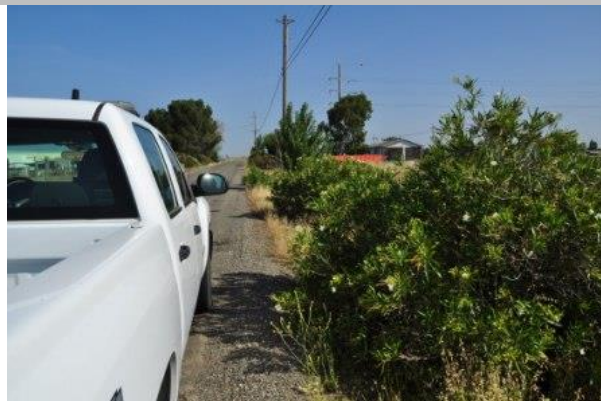
Photo 1 of 1 : FA_2018_RD1000_33_10_20180918_00009.jpg

WS vegetation.

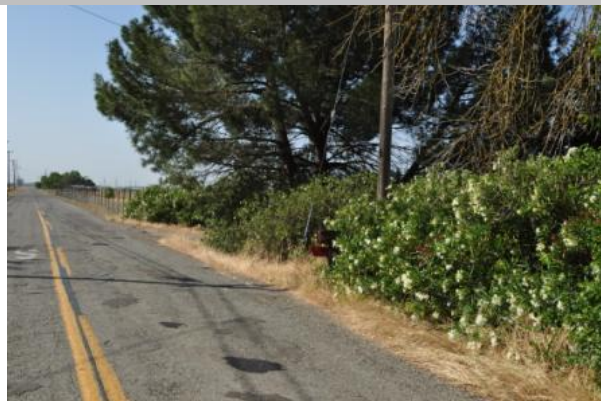
Photo 1 of 1 : FA_2018_RD1000_33_13_20180918_00010.jpg

LS landscaping.
