**Flood Control Project Maintenance
Levee Inspections**

Fall 2019 Levee Maintenance Deficiency Summary Report

Sacramento River Basin

**Flood Control Project Maintenance
Levee Inspections****LMA District Cover Sheet****Fall 2019 Levee Inspection Results****Reclamation District No. 1000 Natomas**

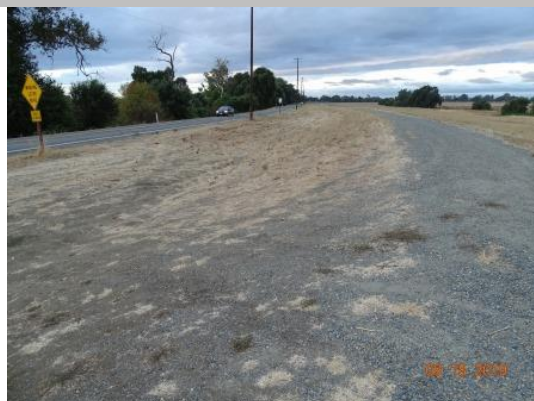
Photo 1 of 1 : FA_2019_RD1000_31_6_20190930_00054.jpg

View looking upstream waterside of the well maintained annual vegetation, Fall 2019.

LM Start	0.01	Rating **	A	Issue No.	3
LM End	11.97	Issue Type +	Ma	Location *	LS
Category	Earthen Levee			GPS Latitude/Longitude	
				Start	End
Item	Vegetation			38.780408 °	38.650068 °
				-121.603300 °	-121.577248 °
DWR ID	DWR_RD1000_01_f_2019_3				
Comment Code					
V1 : Control annual grass and weeds on the levee slopes and easements.					
Inspector Comment					
The annual vegetation is well maintained, Fall 2019.

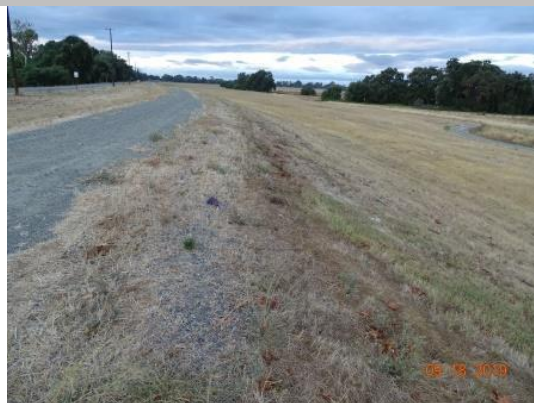
Photo 1 of 1 : FA_2019_RD1000_31_3_20190930_00055.jpg

View looking upstream landside of the well maintained annual vegetation, Fall 2019.

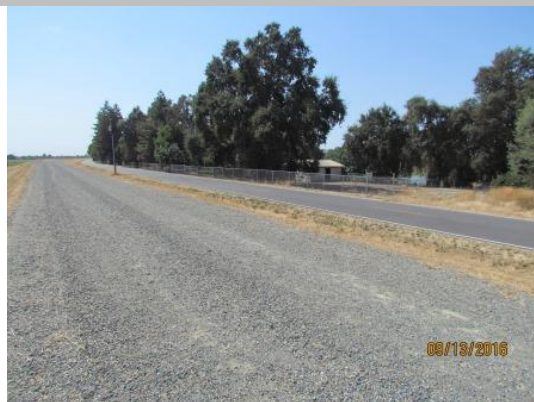
Photo 1 of 1 : FA_2019_RD1000_31_136_20190904_00050.jpg

LM Start	1.63	Rating **	M	Issue No.	136
LM End	1.69	Issue Type +	En	Location *	WS
Category	Earthen Levee			GPS Latitude/Longitude	
				Start	End
Item	Encroachments			38.759320 °	38.758415 °
				-121.591343 °	-121.591348 °
DWR ID	DWR_RD1000_01_s_2012_136				
Comment Code					
FE : Fence					
Inspector Comment

View of an encroachment, 'Fence'.

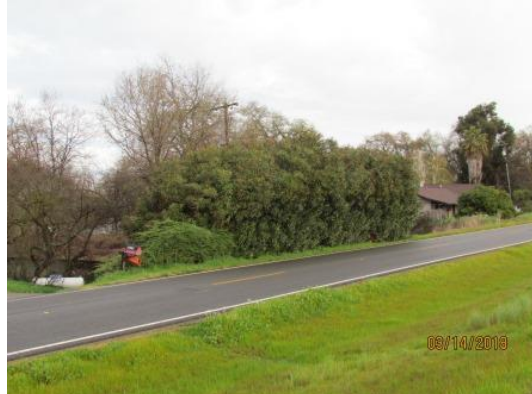
Photo 1 of 1 : FA_2019_RD1000_31_129_20190904_00048.jpg

View looking upstream waterside of landscape vegetation that is blocking access and visibility to the levee.

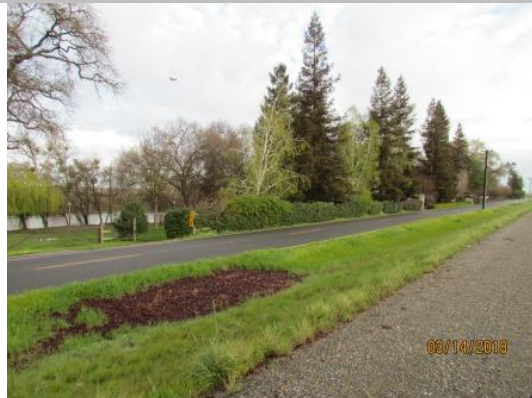
Photo 1 of 1 : FA_2019_RD1000_31_122_20190904_00047.jpg

LM Start	2.10	Rating **	M	Issue No.	122
LM End	2.16	Issue Type +	En	Location *	WS
Category	Earthen Levee			GPS Latitude/Longitude	
				Start	End
Item	Vegetation			38.752540 °	38.751822 °
				-121.592563 °	-121.592857 °
DWR ID	DWR_RD1000_01_s _ 2012_122				
Comment Code					
V6 : Landscaping					
Inspector Comment					
Landscape vegetation is blocking access and visibility to the levee.

View looking upstream waterside of landscape vegetation that is blocking access and visibility to the levee.

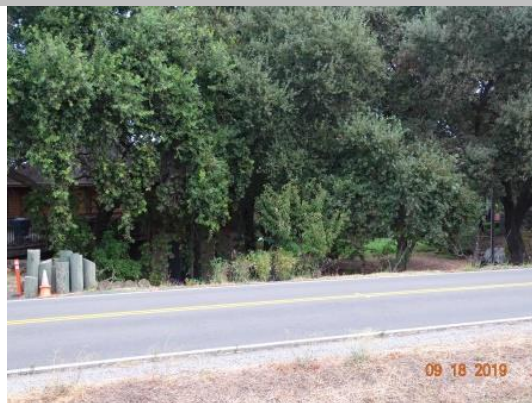
Photo 1 of 1 : FA_2019_RD1000_31_7_20190930_00051.jpg

LM Start	5.92	Rating **	M	Issue No.	7
LM End	5.92	Issue Type +	En	Location *	WS
Category	Earthen Levee			GPS Latitude/Longitude	
				Start	End
Item	Encroachments			38.703201 °	38.703201 °
				-121.619718 °	-121.619718 °
DWR ID	DWR_RD1000_01_f_2019_7				
Comment Code					
TR : Tree or limb					
Inspector Comment					
Remove fruit trees and vegetation that has been planted on the levee slope.

View of waterside levee where the landowner has planted fruit trees and other landscape vegetation.

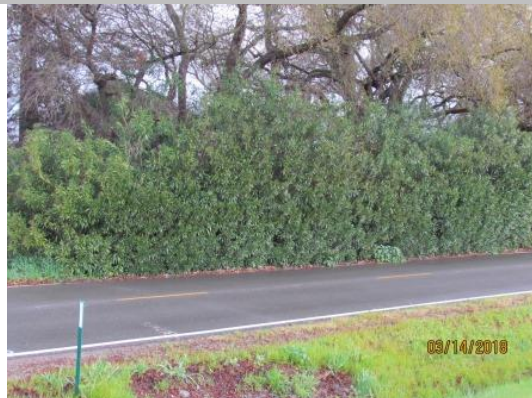
Photo 1 of 1 : FA_2019_RD1000_31_116_20190904_00043.jpg

View looking at waterside landscape vegetation that is blocking access and visibility to the levee.

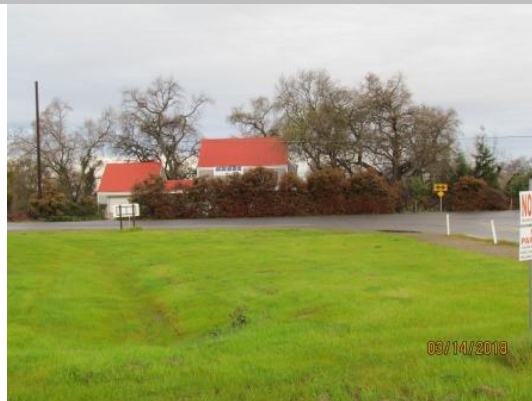
Photo 1 of 1 : FA_2019_RD1000_31_113_20190904_00042.jpg

LM Start	6.12	Rating **	M	Issue No.	113
LM End	6.17	Issue Type +	En	Location *	WS
Category	Earthen Levee			GPS Latitude/Longitude	
				Start	End
Item	Vegetation			38.701422°	38.700987°
				-121.622755°	-121.623564°
DWR ID	DWR_RD1000_01_s_2012_113				
Comment Code					
V6 : Landscaping					
Inspector Comment					
Landscape vegetation is blocking access and visibility to the levee.

View looking at waterside landscape vegetation that is blocking access and visibility to the levee.

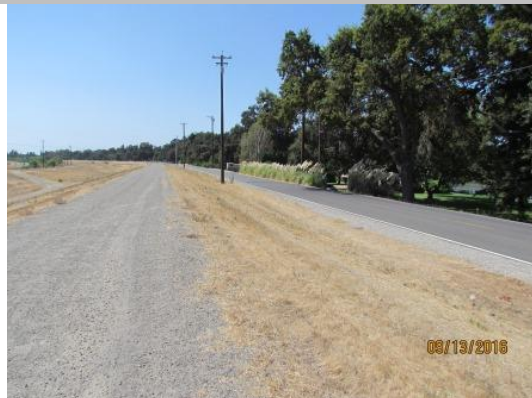
Photo 1 of 1 : FA_2019_RD1000_31_111_20190904_00041.jpg

This photo was taken from the crown facing downstream looking down the waterward levee slope at unacceptable landscaping.

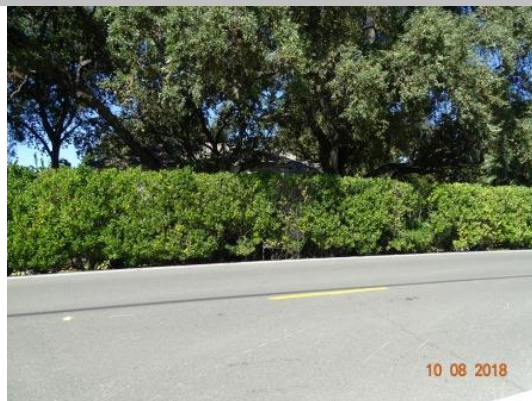
Photo 1 of 1 : FA_2019_RD1000_31_68_20190904_00027.jpg

LM Start	6.36	Rating **	M	Issue No.	68
LM End	6.40	Issue Type +	En	Location *	WS
Category	Earthen Levee			GPS Latitude/Longitude	
				Start	End
Item	Vegetation			38.699313 °	38.698978 °
				-121.626281 °	-121.626777 °
DWR ID	DWR_RD1000_01_s_2015_68				
Comment Code					
V6 : Landscaping					
Inspector Comment					
Vegetation is blocking visibility and access.

View at landscape vegetation that is blocking visibility and access.

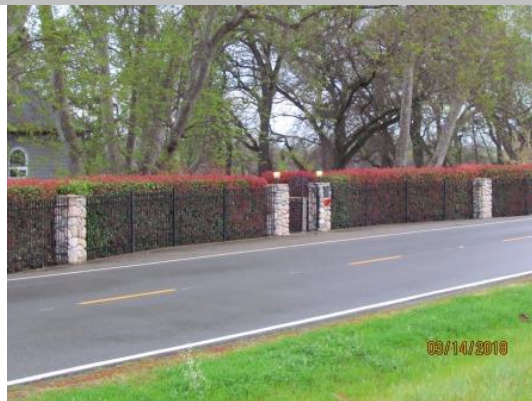
Photo 1 of 1 : FA_2019_RD1000_31_95_20190904_00039.jpg

View looking at waterside landscape vegetation that is blocking access and visibility to the levee.

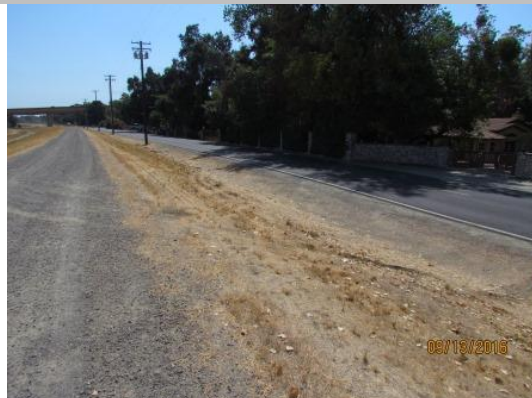
Photo 1 of 1 : FA_2019_RD1000_31_90_20190904_00037.jpg

This photo was taken from the crown facing downstream looking downstream. Landowner maintained vegetation completely blocks visibility of or access to the levee.

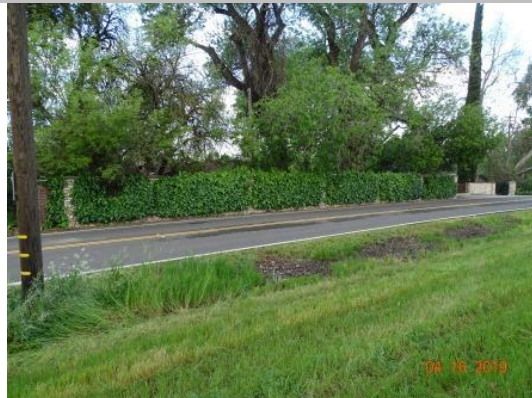
Photo 1 of 1 : FA_2019_RD1000_31_89_20190904_00036.jpg

View of landscape vegetation that is blocking visibility and access.

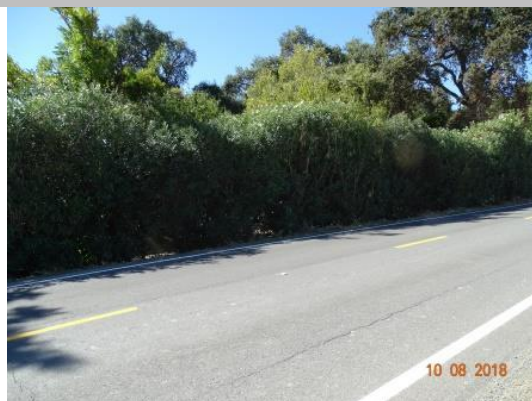
Photo 1 of 1 : FA_2019_RD1000_31_82_20190904_00034.jpg

This photo was taken from the crown facing downstream waterside levee slope at unacceptable landscaping.

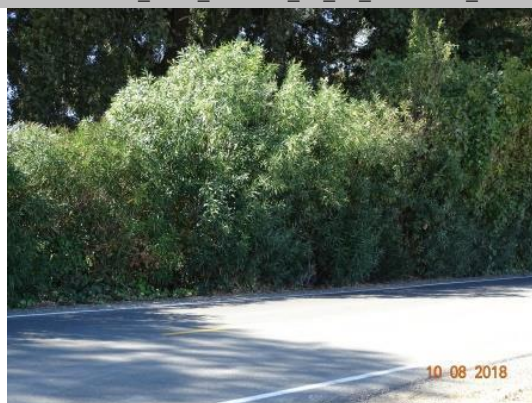
Photo 1 of 1 : FA_2019_RD1000_31_81_20190904_00033.jpg

View of landscape vegetation that blocks visibility and access.

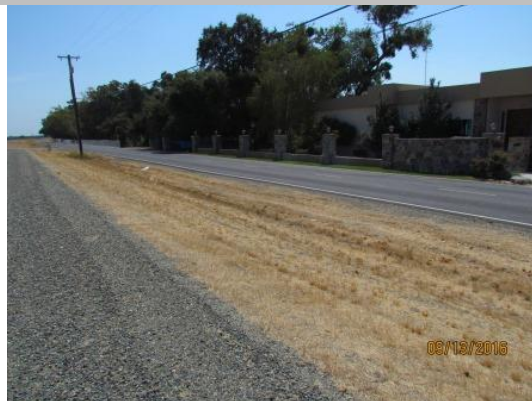
Photo 1 of 1 : FA_2019_RD1000_31_2_20190904_00001.jpg

This photo was taken during Fall 2015 from the crown facing downstream on the waterward levee slope at a fence enforcement issue.

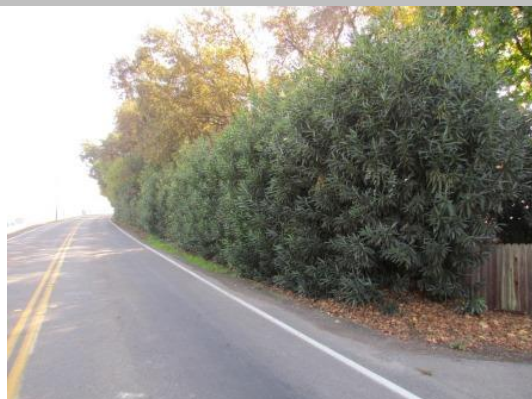
Photo 1 of 1 : FA_2019_RD1000_31_58_20190904_00023.jpg

This photo was taken from the crown facing downstream looking down the waterward levee slope at unacceptable landscaping.

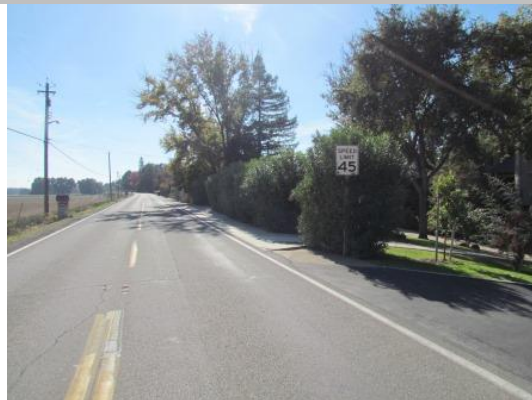
Photo 1 of 1 : FA_2019_RD1000_31_40_20190904_00017.jpg

This photo was taken from the crown facing downstream looking down the waterward levee slope at unacceptable landscaping.

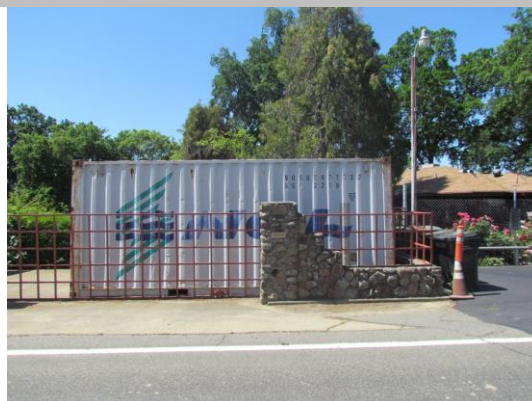
Photo 1 of 1 : FA_2019_RD1000_31_53_20190904_00022.jpg

View of storage container from the landside of the crown facing the waterside of the levee.

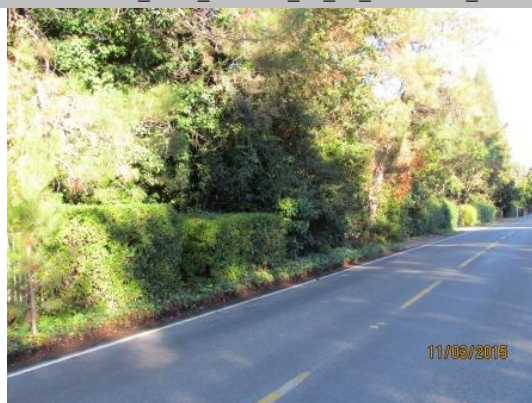
Photo 1 of 1 : FA_2019_RD1000_31_35_20190904_00016.jpg

View of the landscaping on the waterside levee slope.

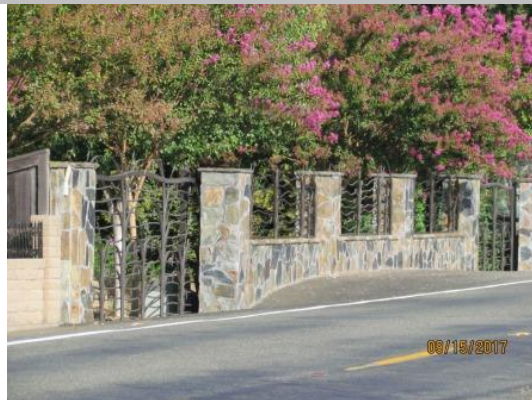
Photo 1 of 1 : FA_2019_RD1000_31_32_20190904_00015.jpg

View on waterside looking upstream of a rock and wrought iron fence that partially blocks visibility and access.

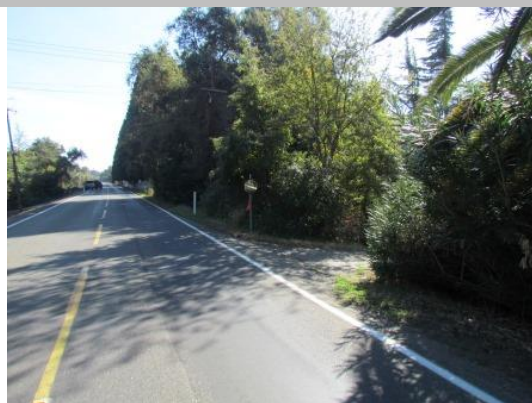
Photo 1 of 1 : FA_2019_RD1000_31_30_20190904_00013.jpg

This photo was taken from the crown facing downstream looking down the waterward levee slope at unacceptable landscaping.

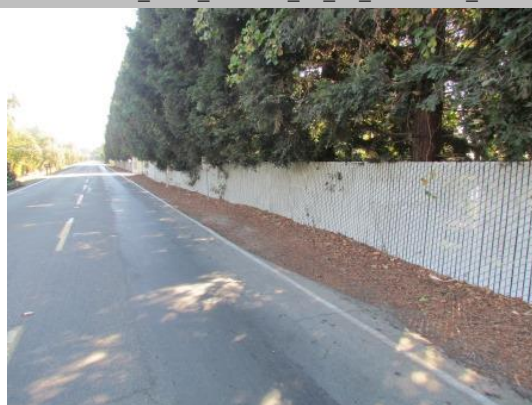
Photo 1 of 1 : FA_2019_RD1000_31_29_20190904_00012.jpg

This photo was taken from the crown facing downstream looking down the waterward levee slope at an unacceptable fence.

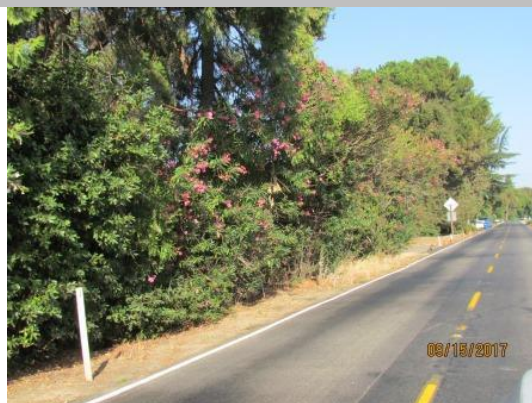
Photo 1 of 1 : FA_2019_RD1000_31_19_20190904_00011.jpg

View on waterside looking upstream of property covered by Oleander Bushes.

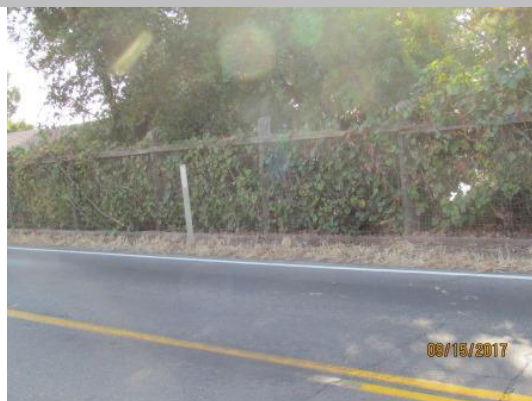
Photo 1 of 1 : FA_2019_RD1000_31_14_20190904_00010.jpg

View on waterside looking across at the fence covered by vegetation.

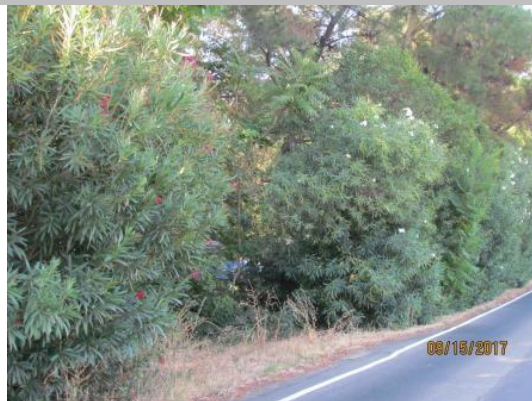
Photo 1 of 1 : FA_2019_RD1000_31_13_20190904_00009.jpg

View of fence covered by Oleander Bushes.

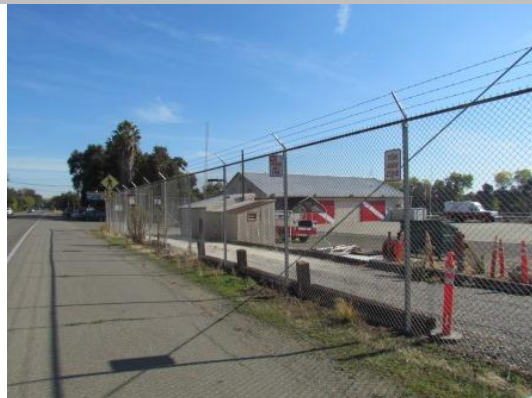
Photo 1 of 1 : FA_2019_RD1000_31_8_20190904_00006.jpg

This photo was taken from the crown facing downstream looking down the waterward levee slope at an unpermitted building.

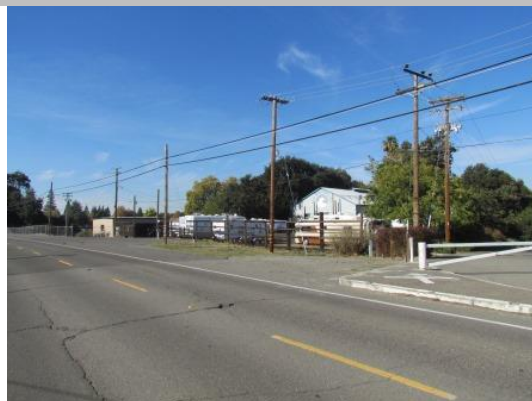
Photo 1 of 1 : FA_2019_RD1000_31_9_20190904_00007.jpg

This photo was taken from the crown facing upstream looking down the landward levee slope at an unpermitted building.

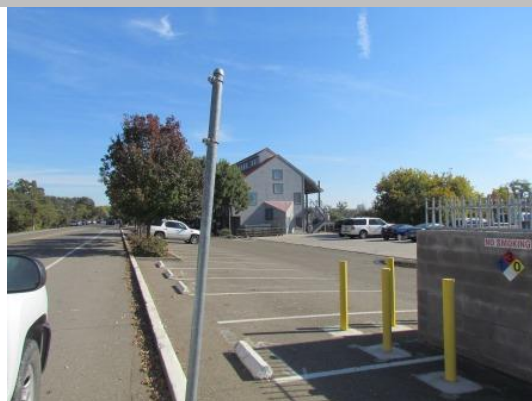
Photo 1 of 1 : FA_2019_RD1000_31_5_20190904_00005.jpg

This photo was taken from the crown facing downstream looking down the waterward levee slope at an unpermitted building.

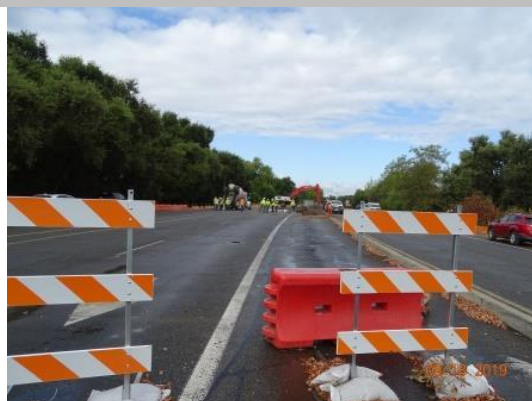
Photo 1 of 2 : FA_2019_RD1000_32_1_20190930_00001.jpg

View looking downstream, this unit is under construction with Reach H & I CORP's Project, Fall 2019.

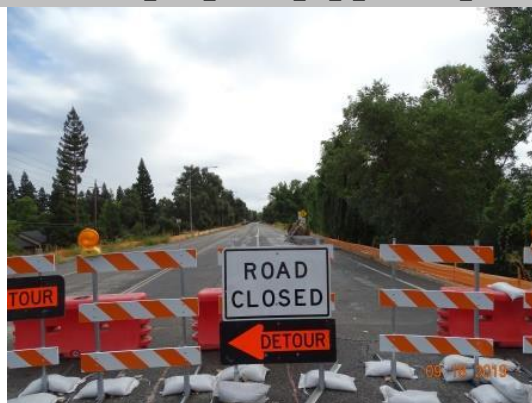
Photo 2 of 2 : FA_2019_RD1000_32_1_20190930_00002.jpg

View looking upstream, this unit is under construction with Reach H & I CORP's Project, Fall 2019.

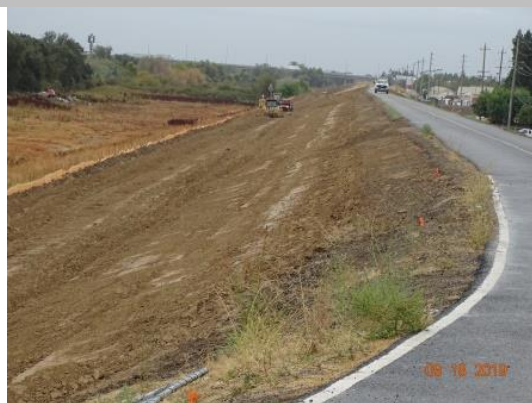
Photo 1 of 2 : FA_2019_RD1000_33_11_20190930_00014.jpg

View looking downstream waterside of the levee under construction, Reach H-Army Corp Project, Fall 2019.

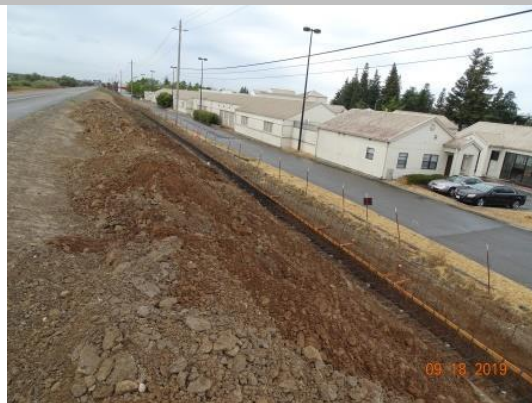
Photo 2 of 2 : FA_2019_RD1000_33_11_20190930_00015.jpg

View looking downstream landside of the levee under construction, Reach H-Army Corp Project, Fall 2019.

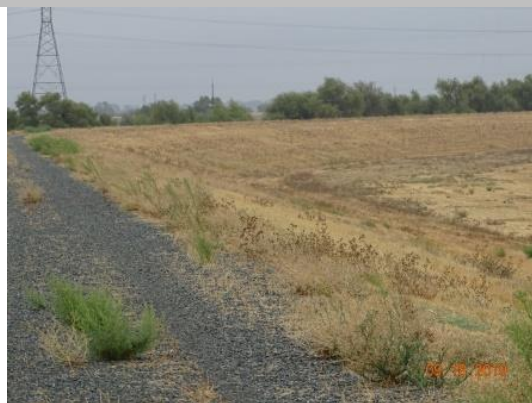
Photo 1 of 1 : FA_2019_RD1000_33_1_20190930_00016.jpg

View looking downstream landside at the well maintained annual vegetation, Fall 2019.

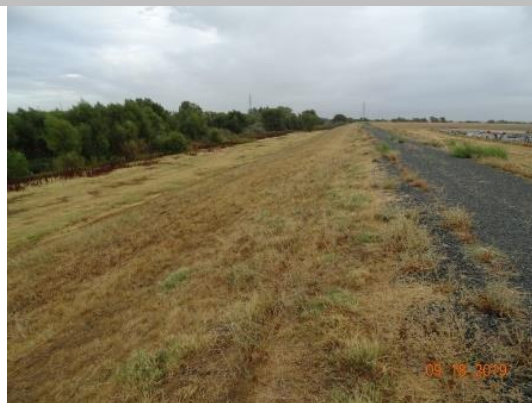
Photo 1 of 1 : FA_2019_RD1000_33_6_20190930_00017.jpg

View looking downstream waterside at the well maintained annual vegetation, Fall 2019.

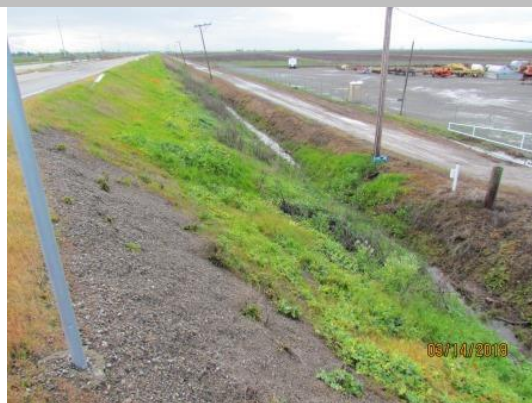
Photo 1 of 1 : FA_2019_RD1000_33_22_20190904_00013.jpg

View of landside ditch at toe of levee, looking downstream.

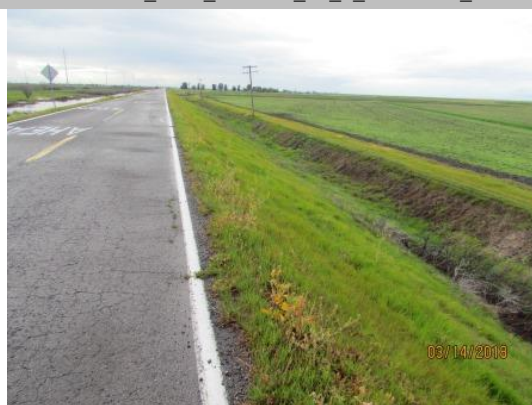
Photo 1 of 1 : FA_2019_RD1000_33_9_20190904_00007.jpg

View looking downstream landside at a ditch at the toe.

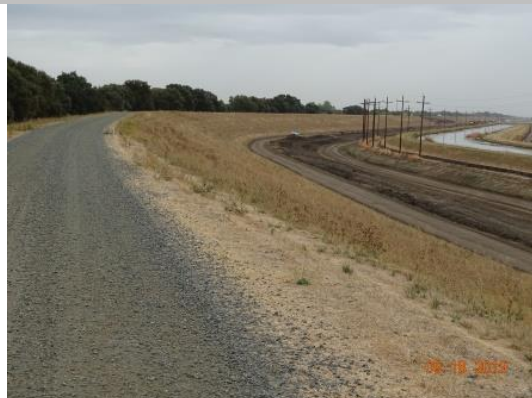
Photo 1 of 1 : FA_2019_RD1000_34_13_20190930_00001.jpg

View looking upstream landside of the well maintained annual vegetation, Fall 2019.

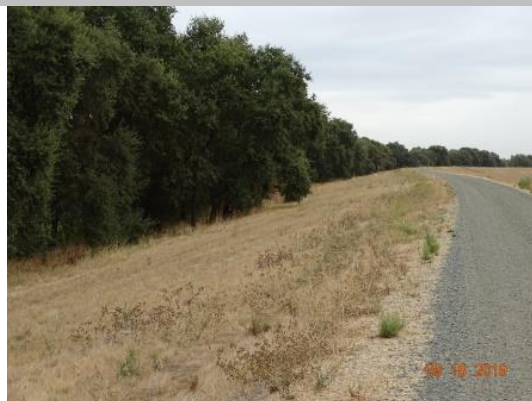
Photo 1 of 1 : FA_2019_RD1000_34_14_20190930_00002.jpg

View looking upstream waterside of the well maintained annual vegetation, Fall 2019.

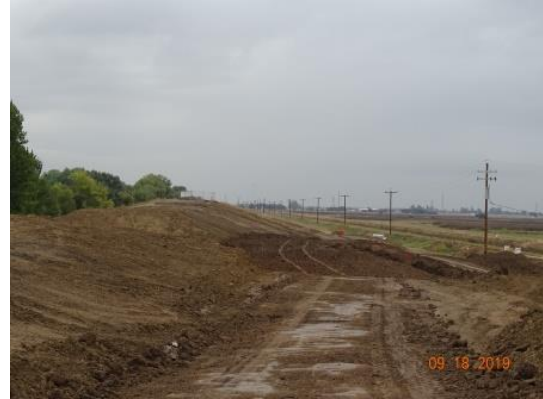
Photo 1 of 1 : FA_2019_RD1000_34_16_20190930_00005.jpg

View of the construction area where the new pipes for the new pumping plant have been placed, Fall 2019.

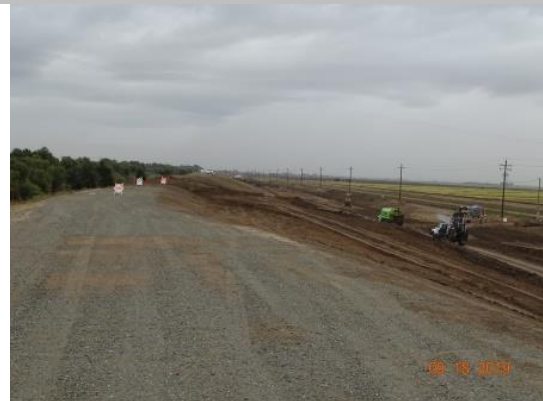
Photo 1 of 1 : FA_2019_RD1000_34_15_20190930_00004.jpg

View of the construction area where the old pipes to the old pumping plant have been removed, Fall 2019.
