## Flood Control Project Maintenance Levee Inspections

### Fall 2020 Levee Maintenance Deficiency Summary Report

#### Sacramento River Basin

**Reclamation District No. 1000 Natomas**

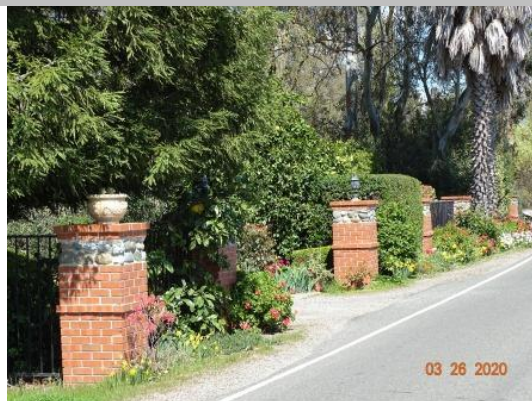
Photo 1 of 1 : FA\_2020\_RD1000\_31\_132\_20201022\_00057.jpg

LM Start	1.94	Rating **	M	Issue No.	132
LM End	1.96	Issue Type +	En	Location *	WS
Category	Earthen Levee			GPS Latitude/Longitude	
				Start	End
Item	Vegetation			38.754848 °	38.754562 °
				-121.591742 °	-121.591795 °
DWR ID	DWR_RD1000_01_s_2012_132				
Comment Code					
V6 : Landscaping					
Inspector Comment					
The landscape vegetation prevents the ability to see waterside slope and will make it difficult to access for flood fight, Fall 2020.

View taken from the crown facing upstream looking at the waterward levee slope at the landscaping, Spring 2020.

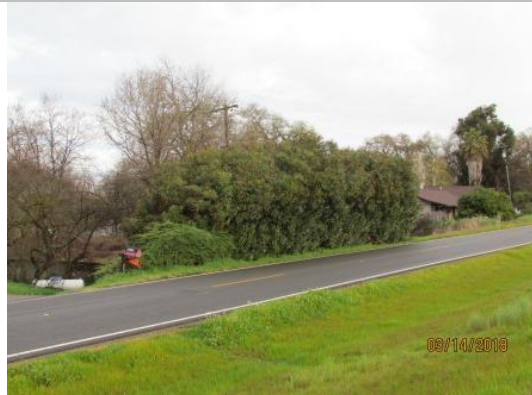
Photo 1 of 1 : FA\_2020\_RD1000\_31\_129\_20201022\_00056.jpg

View looking upstream waterside of landscape vegetation that is blocking access and visibility to the levee.

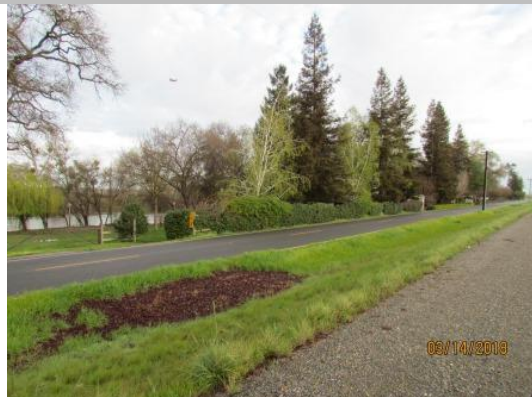
Photo 1 of 1 : FA\_2020\_RD1000\_31\_122\_20201022\_00054.jpg

LM Start	2.10	Rating **	M	Issue No.	122
LM End	2.16	Issue Type +	En	Location *	WS
Category	Earthen Levee			GPS Latitude/Longitude	
				Start	End
Item	Vegetation			38.752540 °	38.751822 °
				-121.592563 °	-121.592857 °
DWR ID	DWR_RD1000_01_s_2012_122				
Comment Code					
V6 : Landscaping					
Inspector Comment					
Landscape vegetation is blocking access and visibility to the levee.

View looking upstream waterside of landscape vegetation that is blocking access and visibility to the levee.

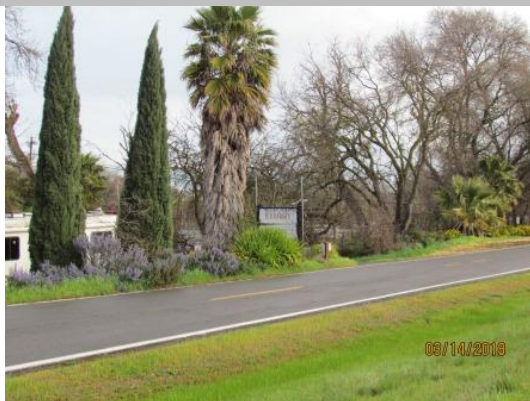
Photo 1 of 1 : FA\_2020\_RD1000\_31\_121\_20201022\_00053.jpg

View looking upstream waterside of landscape vegetation that is blocking access and visibility to the levee.

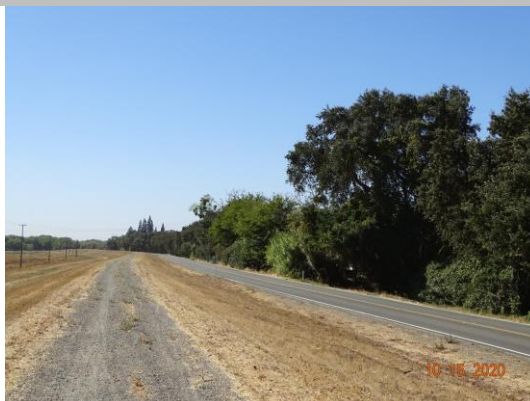
Photo 1 of 1 : FA\_2020\_RD1000\_31\_120\_20201022\_00062.jpg

LM Start	5.17	Rating **	M	Issue No.	120
LM End	5.21	Issue Type +	En	Location *	WS
Category	Earthen Levee			GPS Latitude/Longitude	
				Start	End
Item	Vegetation			38.711248 °	38.710806 °
				-121.610500 °	-121.611110 °
DWR ID	DWR_RD1000_01_s_2012_120				
Comment Code					
V6 : Landscaping					
Inspector Comment

Typical landscape vegetation along the waterside in front of residences.

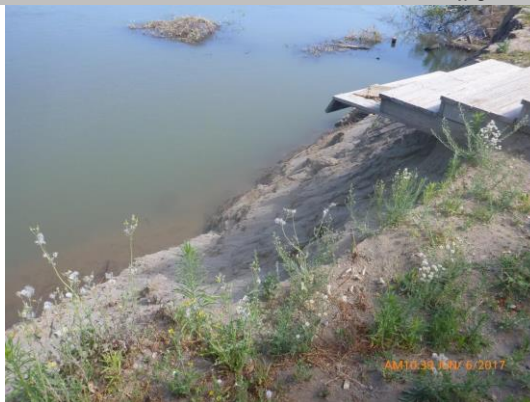
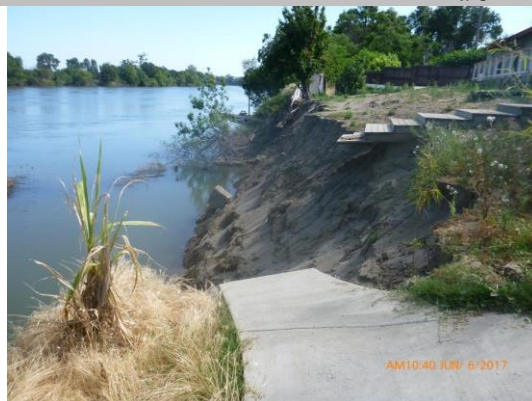
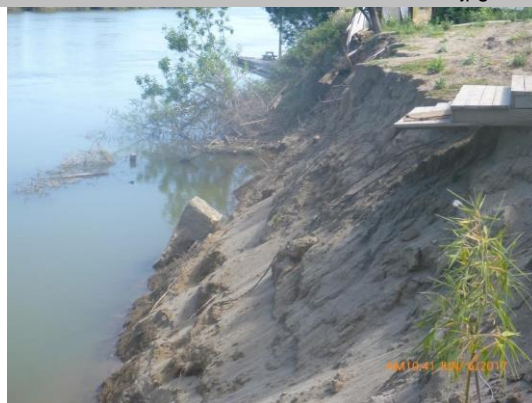
LM Start	5.21	Rating **	A/W	Issue No.	4
LM End	5.21	Issue Type +	Ma	Location *	WS
Category	Earthen Levee			GPS Latitude/Longitude	
				Start	End
Item	Erosion / Bank Caving			38.710830 °	38.710830 °
				-121.611100 °	-121.611100 °
DWR ID	LMA-12				
Comment Code					
E1 : Note and monitor erosion site.					
Inspector Comment					
Erosion site is at a private residence.					
Site ID No:45					
Site Designation:LMA-12

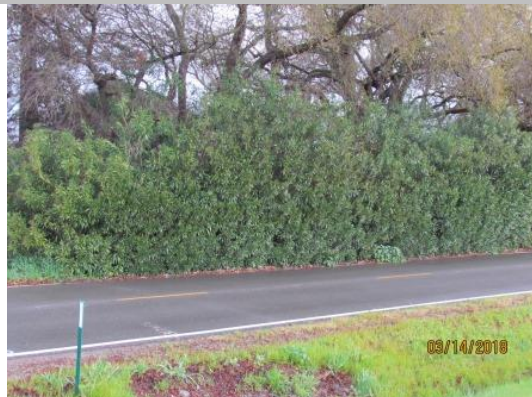
Photo 1 of 1 : FA\_2020\_RD1000\_31\_116\_20201022\_00050.jpg

View looking at waterside landscape vegetation that is blocking access and visibility to the levee.

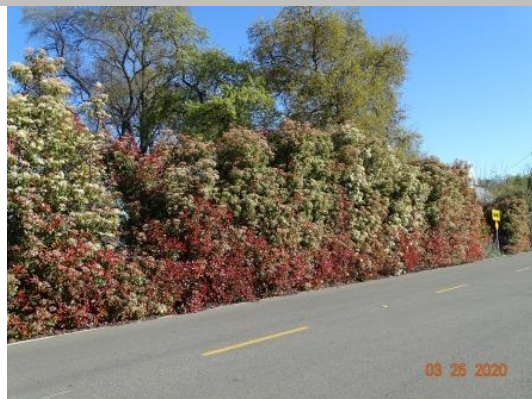
Photo 1 of 1 : FA\_2020\_RD1000\_31\_113\_20201022\_00049.jpg

View taken from the crown facing upstream looking at the waterward levee slope at the landscaping, Spring 2020.

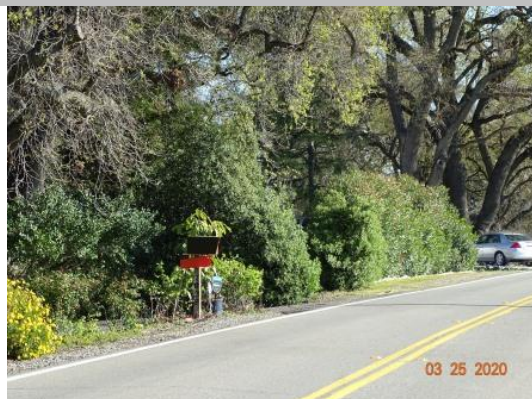
Photo 1 of 1 : FA\_2020\_RD1000\_31\_125\_20201022\_00055.jpg

View taken from the crown facing upstream looking at the waterward levee slope at the landscaping, Spring 2020.

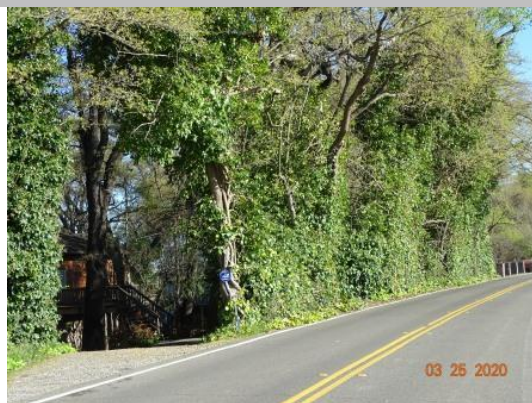
Photo 1 of 1 : FA\_2020\_RD1000\_31\_102\_20201022\_00047.jpg

View taken from the crown facing upstream looking at the waterward levee slope at the landscaping, Spring 2020.

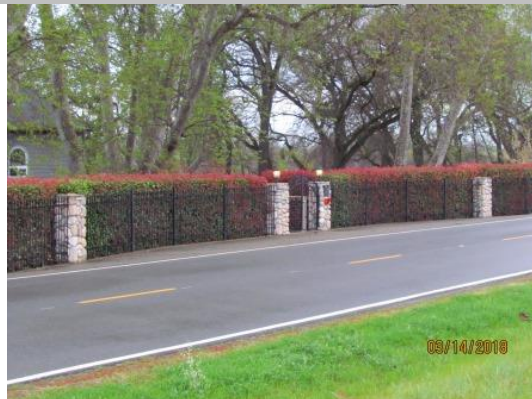
Photo 1 of 1 : FA\_2020\_RD1000\_31\_95\_20201022\_00045.jpg

View looking at waterside landscape vegetation that is blocking access and visibility to the levee.

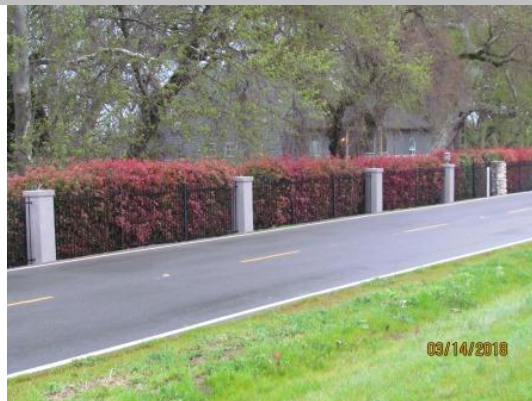
Photo 1 of 1 : FA\_2020\_RD1000\_31\_94\_20201022\_00044.jpg

View looking at waterside landscape vegetation that is blocking access and visibility to the levee.

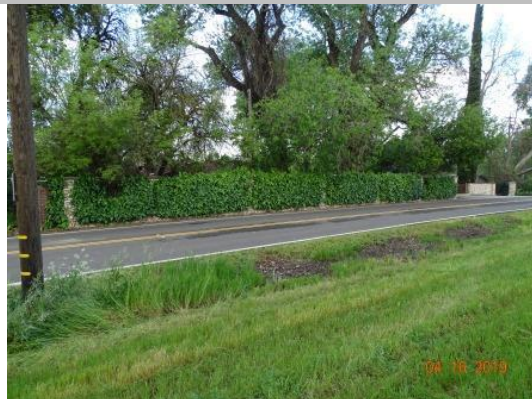
Photo 1 of 1 : FA\_2020\_RD1000\_31\_89\_20201022\_00042.jpg

View of landscape vegetation that is blocking visibility and access.

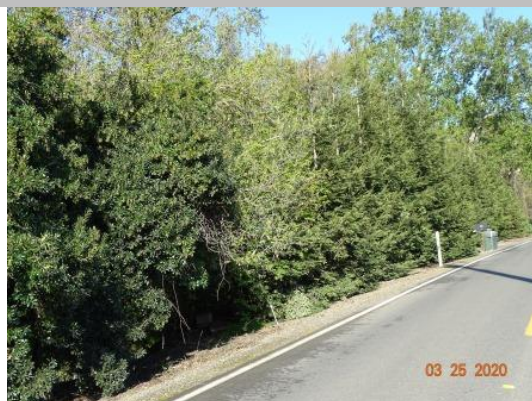
Photo 1 of 1 : FA\_2020\_RD1000\_31\_6\_20201022\_00007.jpg

View taken from the crown facing upstream looking at the waterward levee slope at the landscaping, Spring 2020.

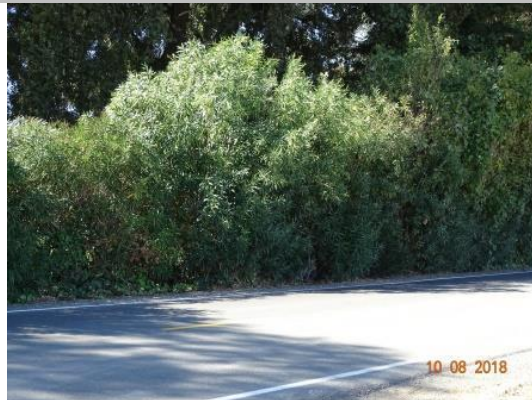
Photo 1 of 1 : FA\_2020\_RD1000\_31\_81\_20201022\_00040.jpg

View of landscape vegetation that blocks visibility and access.

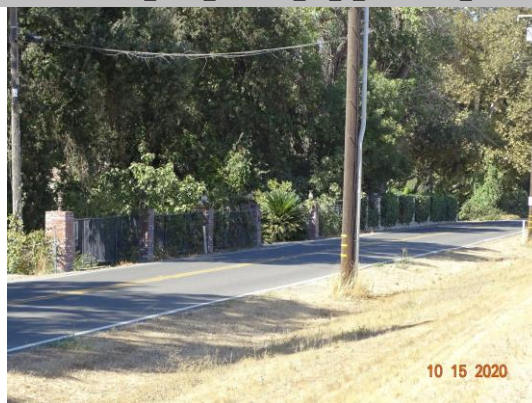
Photo 1 of 1 : FA\_2020\_RD1000\_31\_2\_20201022\_00066.jpg

This photo was taken during Fall 2020 from the crown facing upstream on the waterward levee slope at a fence enforcement issue.

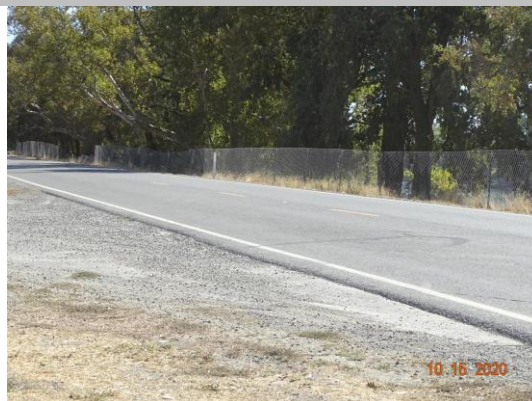
Photo 1 of 1 : FA\_2020\_RD1000\_31\_10\_20201022\_00067.jpg

View on waterside of a non-permitted fence.

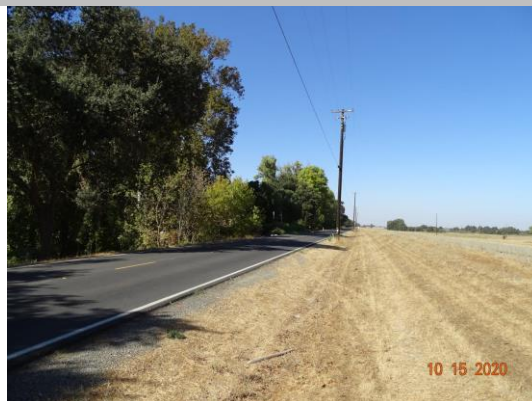
Photo 1 of 1 : FA\_2020\_RD1000\_31\_74\_20201022\_00068.jpg

This photo was taken from the crown facing downstream looking down the waterward levee slope at unacceptable landscaping

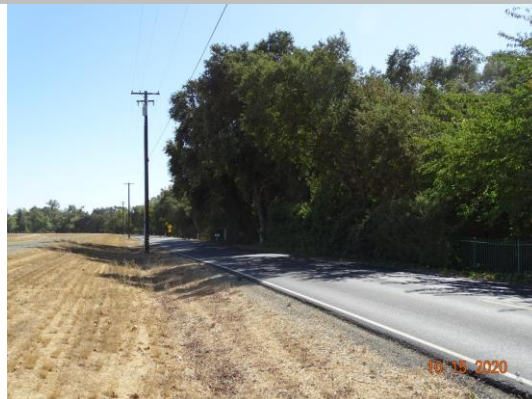
Photo 1 of 1 : FA\_2020\_RD1000\_31\_73\_20201022\_00069.jpg

This photo was taken from the crown facing downstream looking down the waterward levee slope at the landscaping.

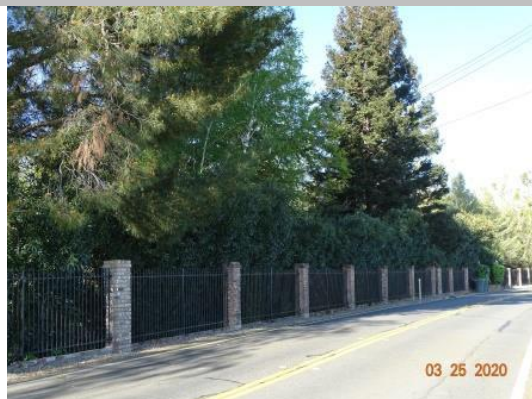
Photo 1 of 1 : FA\_2020\_RD1000\_31\_72\_20201022\_00036.jpg

View taken from the crown facing upstream looking at the waterward levee slope at the landscaping, Spring 2020.

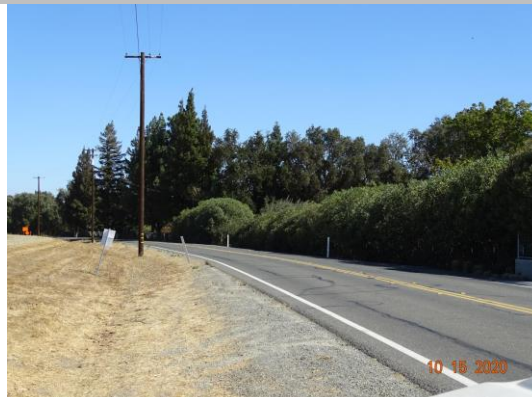
Photo 1 of 1 : FA\_2020\_RD1000\_31\_70\_20201022\_00070.jpg

This photo was taken from the crown facing downstream looking down the waterward levee slope at the landscaping.

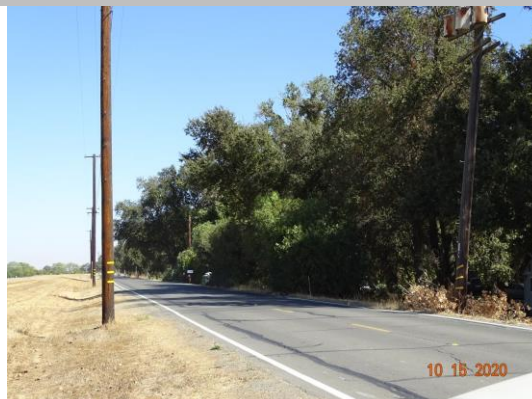
Photo 1 of 1 : FA\_2020\_RD1000\_31\_69\_20201022\_00071.jpg

View of landscape vegetation that blocks access and visibility.

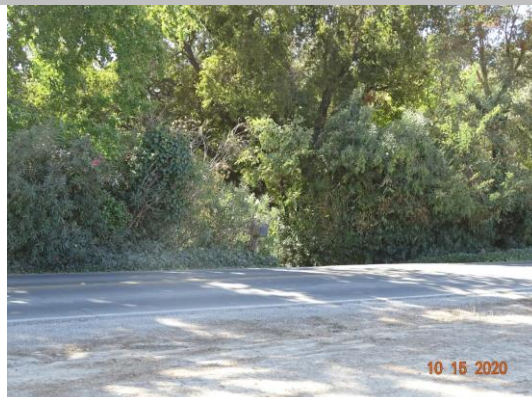
Photo 1 of 1 : FA\_2020\_RD1000\_31\_66\_20201022\_00072.jpg

View of the landscaping on the waterside levee slope.

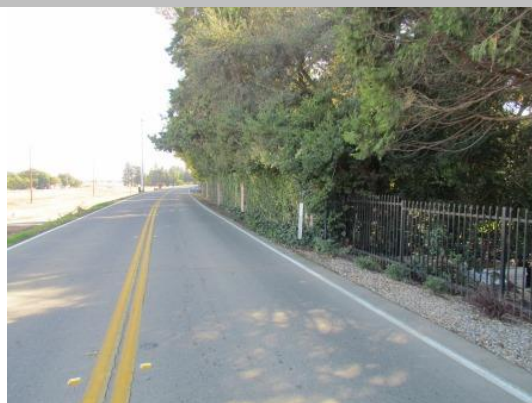
Photo 1 of 1 : FA\_2020\_RD1000\_31\_62\_20201022\_00031.jpg

This photo was taken from the crown facing downstream looking down the waterward levee slope at the landscaping.

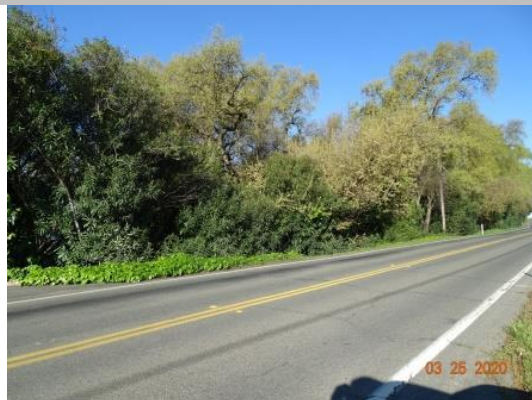
Photo 1 of 1 : FA\_2020\_RD1000\_31\_5\_20201022\_00006.jpg

View taken from the crown facing upstream looking at the waterward levee slope at unacceptable landscaping, Spring 2020.

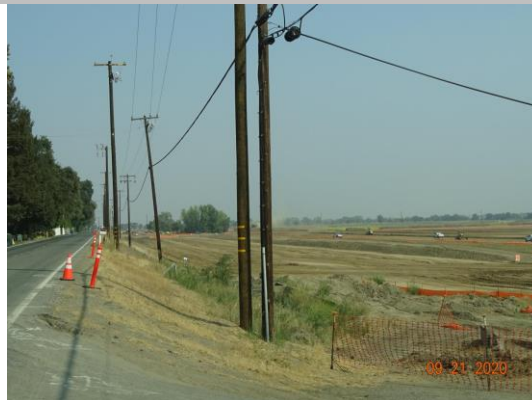
Photo 1 of 1 : FA\_2020\_RD1000\_31\_11\_20201022\_00073.jpg

View of construction in Reach B looking upstream, Fall 2020.

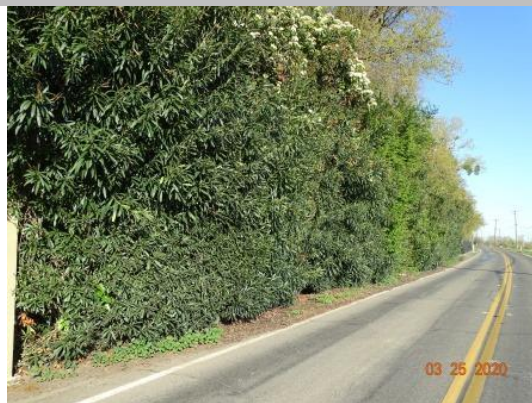
Photo 1 of 1 : FA\_2020\_RD1000\_31\_58\_20201022\_00030.jpg

View taken from the crown facing upstream looking at the waterward levee slope at unacceptable landscaping, Spring 2020.

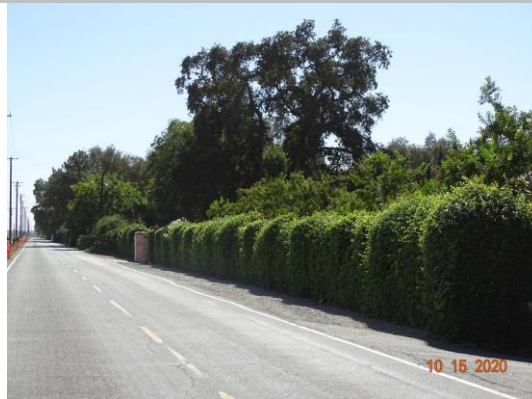
Photo 1 of 1 : FA\_2020\_RD1000\_31\_51\_20201022\_00074.jpg

View of the landscaping on the waterside levee slope.

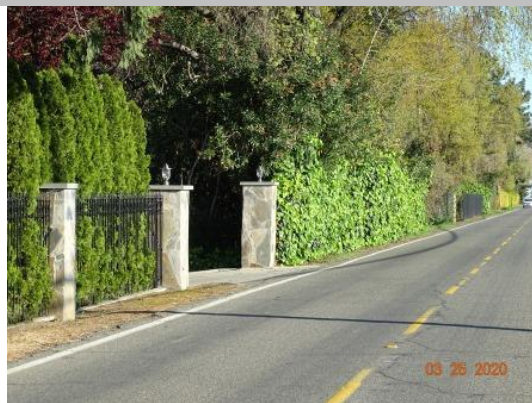
Photo 1 of 1 : FA\_2020\_RD1000\_31\_48\_20201022\_00027.jpg

View taken from the crown facing upstream looking at the waterward levee slope at the landscaping, Spring 2020.

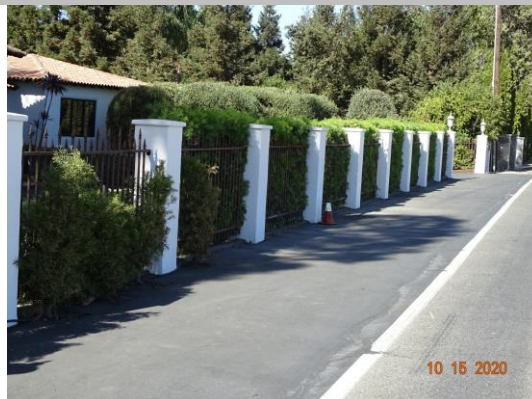
Photo 1 of 1 : FA\_2020\_RD1000\_31\_46\_20201022\_00075.jpg

View on waterside looking upstream of where the vegetation covers the front of the fence.

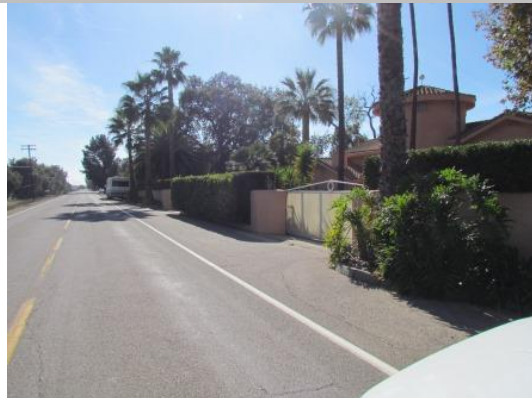
Photo 1 of 1 : FA\_2020\_RD1000\_31\_43\_20201022\_00025.jpg

This photo was taken from the crown facing downstream looking down the waterward levee slope at an unacceptable fence.

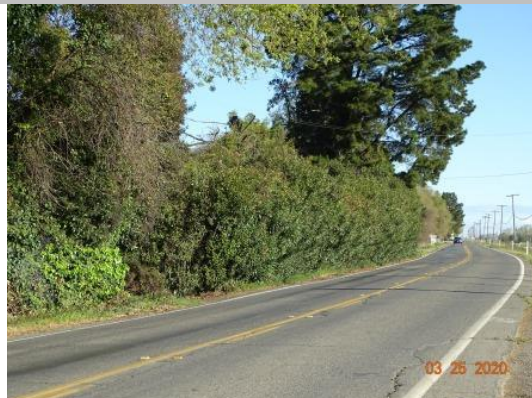
Photo 1 of 1 : FA\_2020\_RD1000\_31\_42\_20201022\_00024.jpg

View taken from the crown facing upstream looking at the waterward levee slope at unacceptable landscaping, Spring 2020.

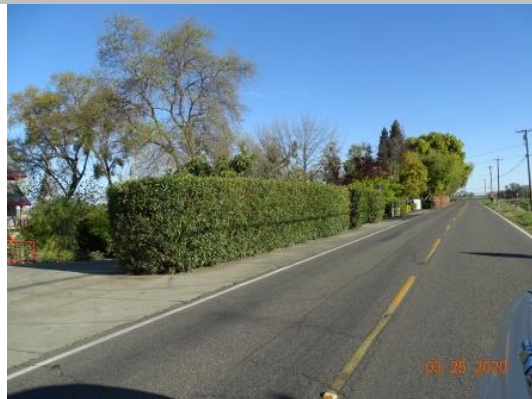
Photo 1 of 1 : FA\_2020\_RD1000\_31\_40\_20201022\_00023.jpg

View taken from the crown facing upstream looking at the waterward levee slope at unacceptable landscaping, Spring 2020.

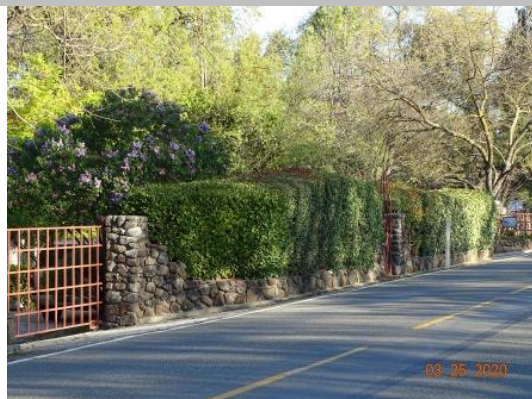
Photo 1 of 1 : FA\_2020\_RD1000\_31\_37\_20201022\_00022.jpg

View taken from the crown facing upstream looking at the waterward levee slope at landscaping, Spring 2020.

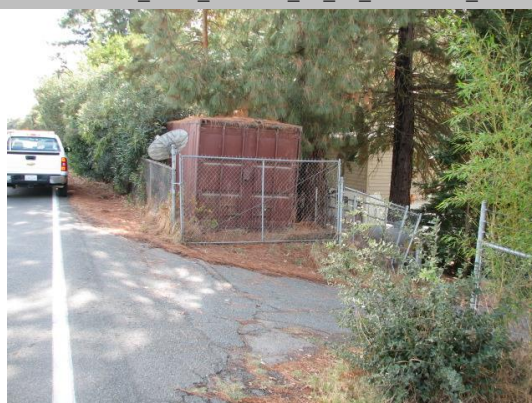
Photo 1 of 1 : FA\_2020\_RD1000\_31\_76\_20201022\_00039.jpg

Cargo container on levee shoulder, the property appears to be on fill material.

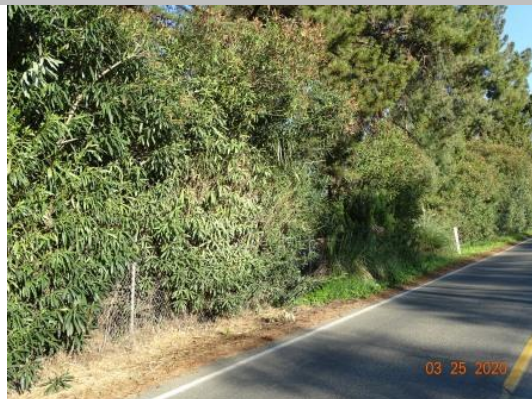
Photo 1 of 1 : FA\_2020\_RD1000\_31\_3\_20201022\_00002.jpg

View taken from the crown facing upstream looking at the waterward levee slope at unacceptable landscaping, Spring 2020.

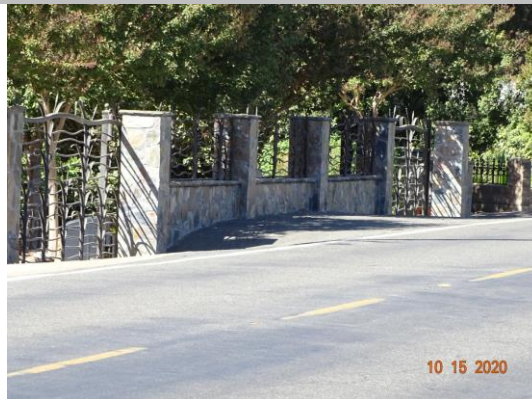
Photo 1 of 1 : FA\_2020\_RD1000\_31\_32\_20201022\_00077.jpg

View on waterside looking upstream of a rock and wrought iron fence that partially blocks visibility and access.

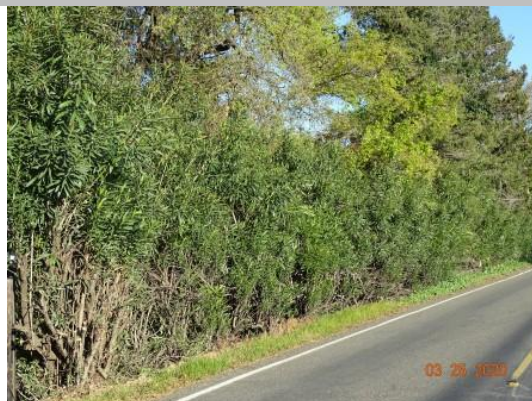
Photo 1 of 1 : FA\_2020\_RD1000\_31\_31\_20201022\_00019.jpg

View taken from the crown facing upstream looking at the waterward levee slope at unacceptable landscaping, Spring 2020.

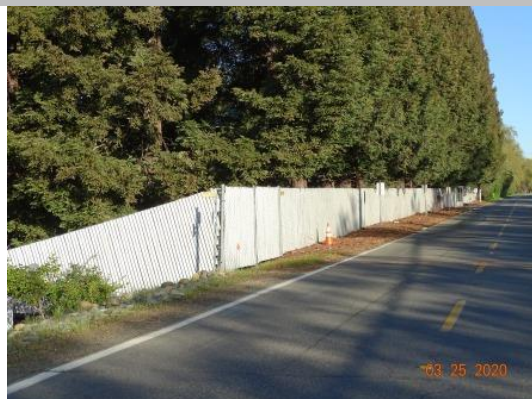
Photo 1 of 1 : FA\_2020\_RD1000\_31\_29\_20201022\_00017.jpg

View taken from the crown facing upstream looking at the waterward levee slope at an unacceptable fence, Spring 2020.

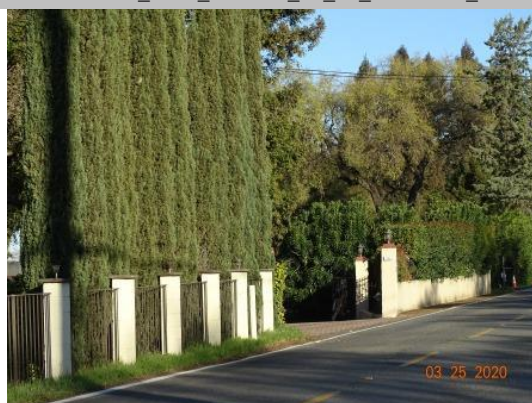
Photo 1 of 1 : FA\_2020\_RD1000\_31\_26\_20201022\_00016.jpg

View looking upstream at landscape vegetation blocking visibility and access, Spring 2020.

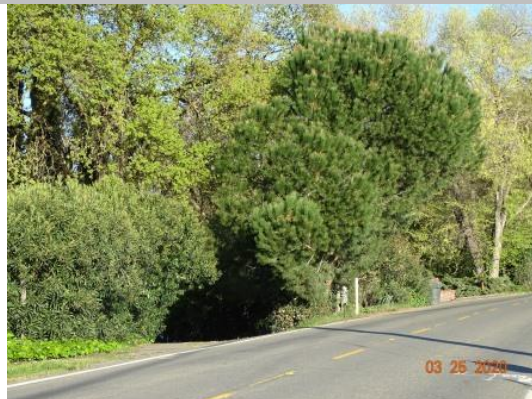
Photo 1 of 1 : FA\_2020\_RD1000\_31\_21\_20201022\_00015.jpg

View looking upstream at landscape vegetation blocking visibility and access, Spring 2020.

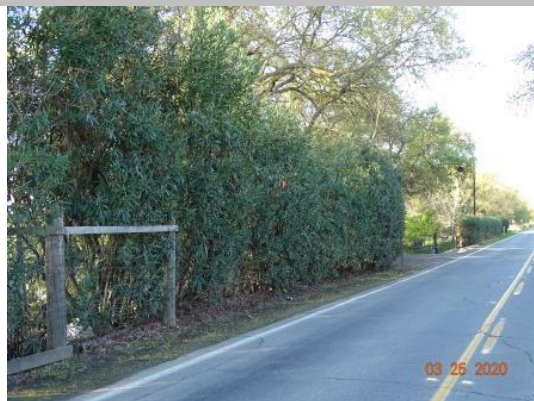
Photo 1 of 1 : FA\_2020\_RD1000\_31\_15\_20201022\_00013.jpg

View looking upstream waterside at landscaping that needs to be removed, Spring 2020.

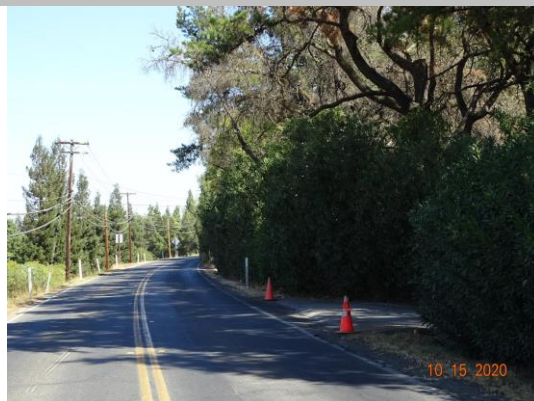
Photo 1 of 1 : FA\_2020\_RD1000\_31\_14\_20201022\_00079.jpg

View on waterside looking across at the fence covered by vegetation.

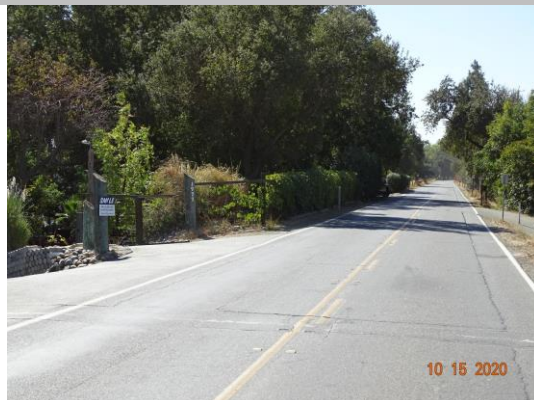
Photo 1 of 1 : FA\_2020\_RD1000\_31\_13\_20201022\_00080.jpg

View of fence covered by Oleander Bushes.

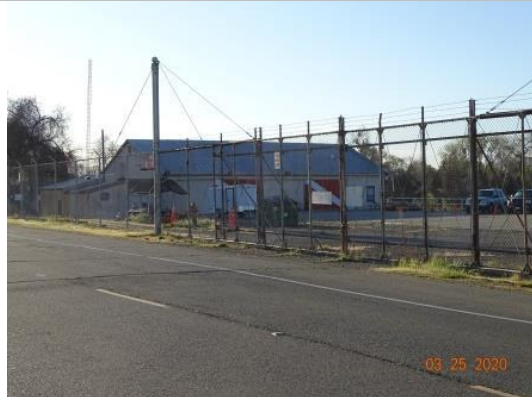
Photo 1 of 1 : FA\_2020\_RD1000\_31\_8\_20201022\_00009.jpg

This photo was taken from the crown facing downstream looking down the waterward levee slope at an unpermitted building.

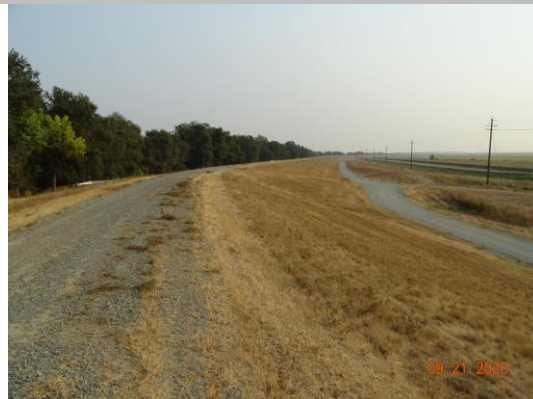
Photo 1 of 1 : FA\_2020\_RD1000\_34\_13\_20201029\_00003.jpg

View of annual vegetation on landside slope, Fall 2020.

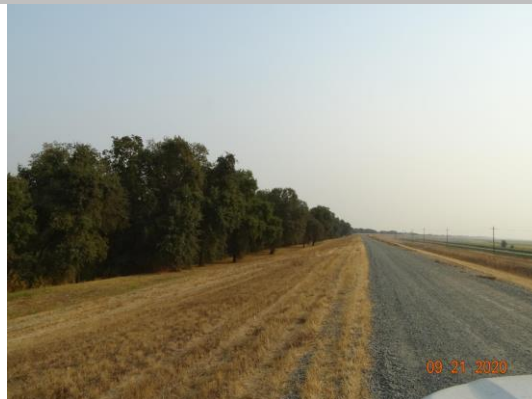
Photo 1 of 1 : FA\_2020\_RD1000\_34\_14\_20201029\_00004.jpg

View of annual vegetation on waterside slope, Fall 2020.

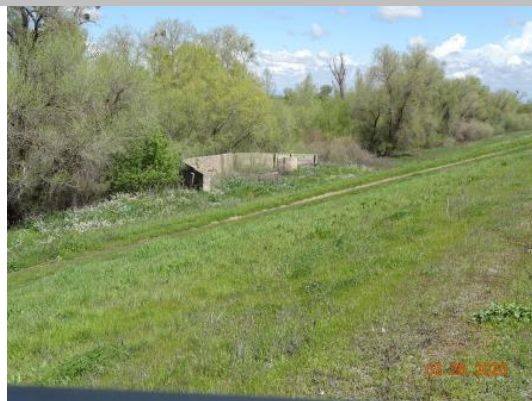
Photo 1 of 1 : FA\_2020\_RD1000\_34\_18\_20201022\_00002.jpg

View looking upstream waterside at an old existing wall, Spring 2020.

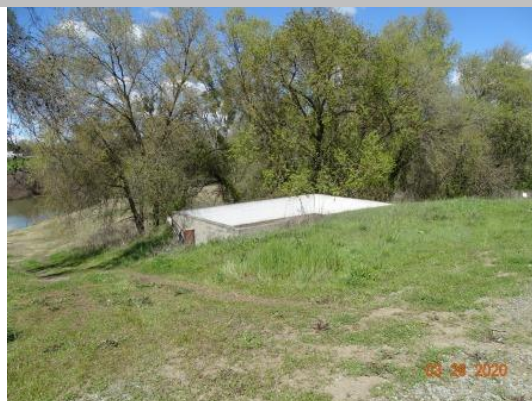
Photo 1 of 1 : FA\_2020\_RD1000\_34\_17\_20201022\_00001.jpg

View of an existing concrete basin on the waterside slope, Spring 2020.
