Flood Control Project Maintenance Levee Inspections

Fall 2021 Levee Maintenance Deficiency Summary Report

Sacramento River Basin

Reclamation District No. 1000 Natomas

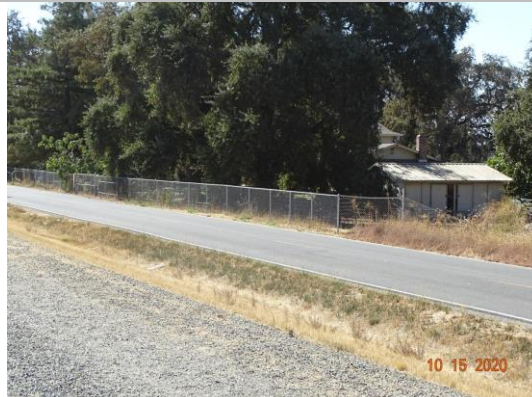
Photo 1 of 1 : FA_2021_RD1000_31_136_20210901_00060.jpg

View of the fence encroachment.

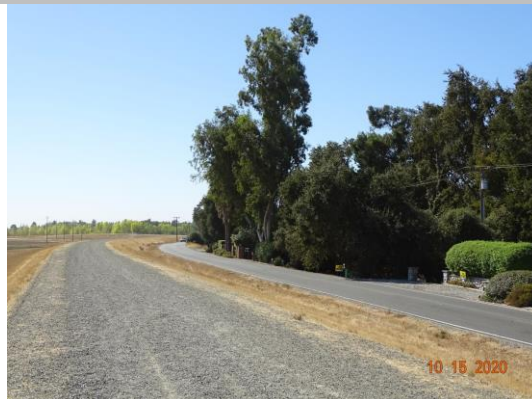
Photo 1 of 1 : FA_2021_RD1000_31_133_20210901_00059.jpg

Typical Garden Hwy 'Landscaping'.

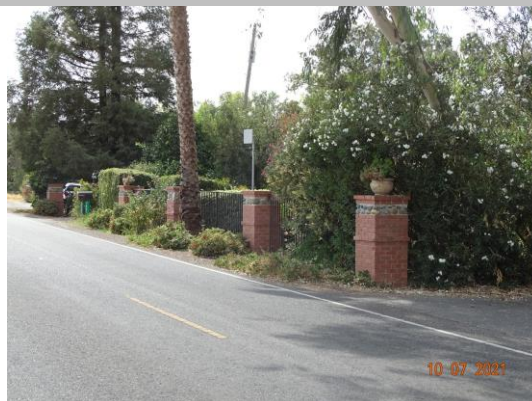
Photo 1 of 1 : FA_2021_RD1000_31_132_20211019_00061.jpg

View taken from the crown facing downstream looking at the waterward levee slope at the landscaping, Fall 2021.

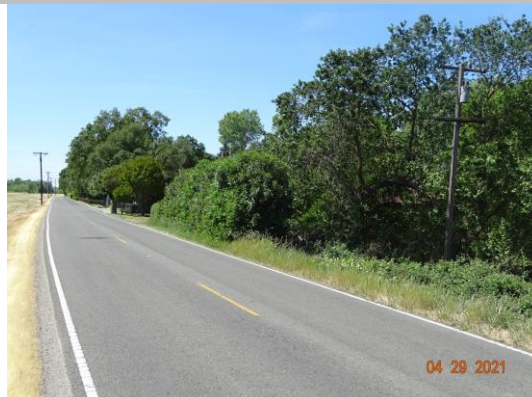
Photo 1 of 1 : FA_2021_RD1000_31_129_20210901_00057.jpg

View looking upstream waterside of landscape vegetation that is blocking access and visibility to the levee, Spring 2021.

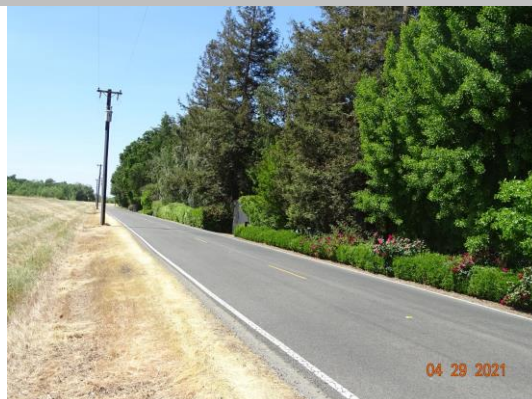
Photo 1 of 1 : FA_2021_RD1000_31_122_20210901_00055.jpg

View looking upstream waterside of landscape vegetation that is blocking access and visibility to the levee, Spring 2021.

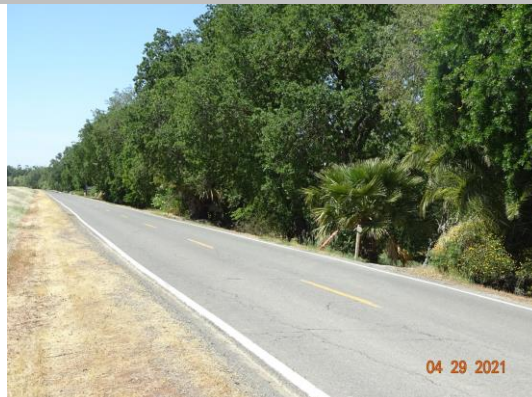
Photo 1 of 1 : FA_2021_RD1000_31_121_20210901_00054.jpg

View looking upstream waterside of landscape vegetation that is blocking access and visibility to the levee, Spring 2021

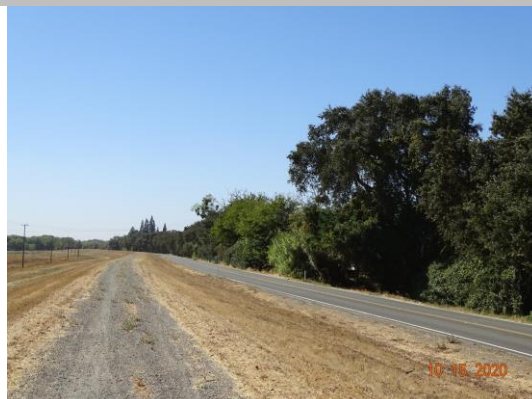
Photo 1 of 1 : FA_2021_RD1000_31_120_20210901_00053.jpg

Typical landscape vegetation along the waterside in front of residences.

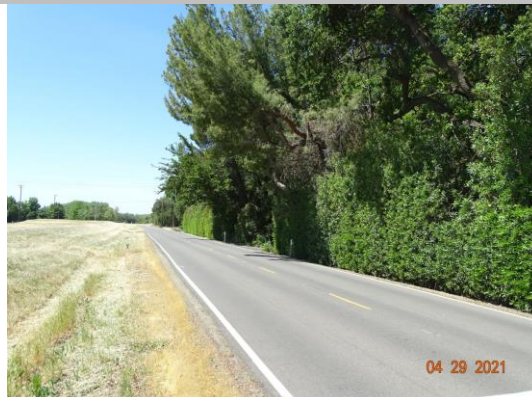
Photo 1 of 1 : FA_2021_RD1000_31_118_20210901_00052.jpg

This photo was taken from the crown facing downstream looking down the waterward levee slope at the landscaping, Spring 2021.

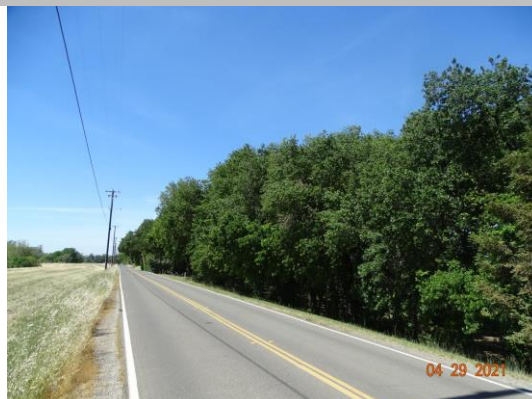
Photo 1 of 1 : FA_2021_RD1000_31_7_20210901_00008.jpg

View of waterside levee where the landowner has planted fruit trees and other landscape vegetation, Spring 2021.

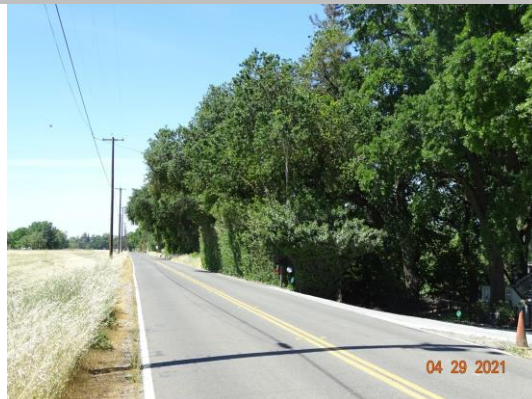
Photo 1 of 1 : FA_2021_RD1000_31_116_20210901_00051.jpg

View looking at waterside landscape vegetation that is blocking access and visibility to the levee, Spring 2021.

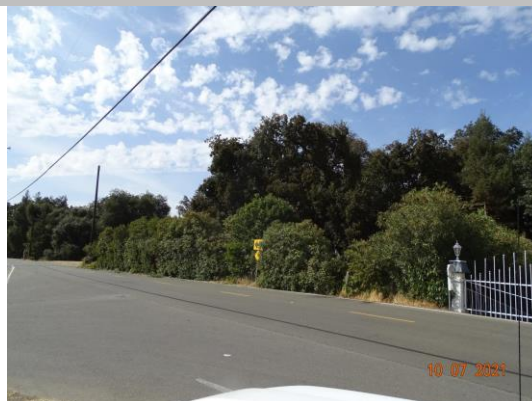
Photo 1 of 1 : FA_2021_RD1000_31_113_20211019_00062.jpg

View taken from the crown facing downstream looking at the waterward levee slope at the landscaping, Fall 2021.

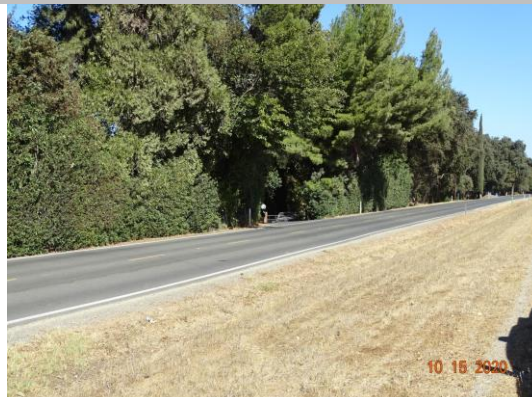
Photo 1 of 1 : FA_2021_RD1000_31_111_20210901_00049.jpg

This photo was taken from the crown facing downstream looking down the waterward levee slope at the landscaping.

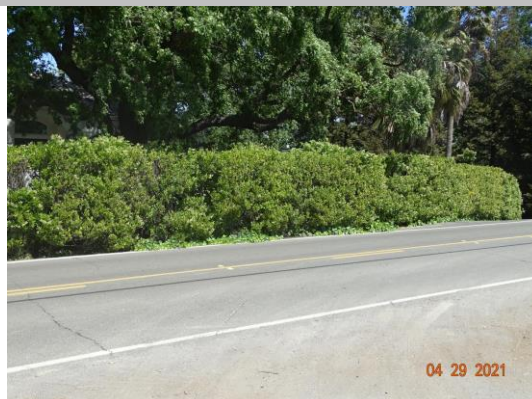
Photo 1 of 1 : FA_2021_RD1000_31_68_20210901_00035.jpg

View at landscape vegetation that is blocking visibility and access, Spring 2021.

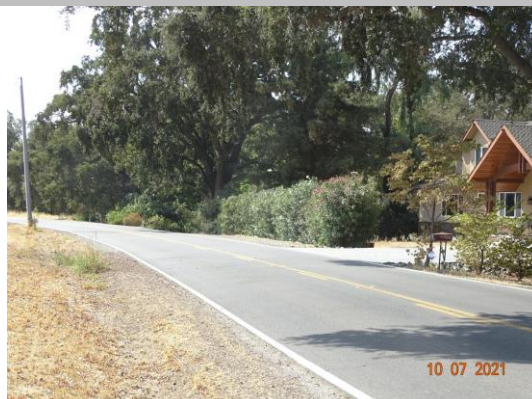
Photo 1 of 1 : FA_2021_RD1000_31_125_20211019_00063.jpg

View taken from the crown facing downstream looking at the waterward levee slope at the landscaping, Fall 2021.

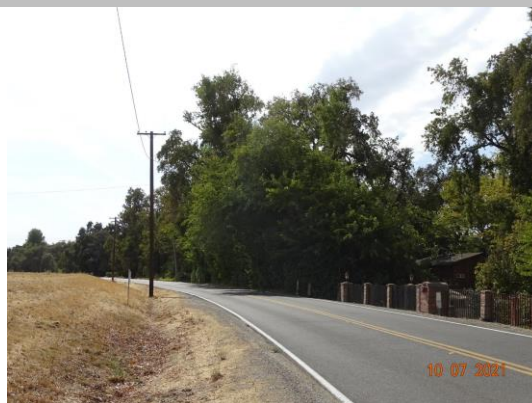
Photo 1 of 1 : FA_2021_RD1000_31_102_20211019_00064.jpg

View taken from the crown facing downstream looking at the waterward levee slope at the landscaping, Fall 2021.

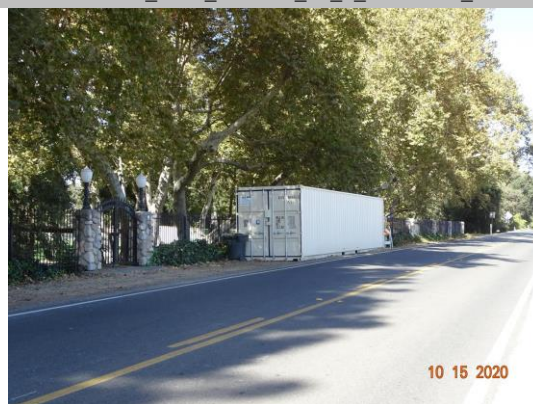
Photo 1 of 1 : FA_2021_RD1000_31_9_20210901_00010.jpg

View of shipping container on water side.

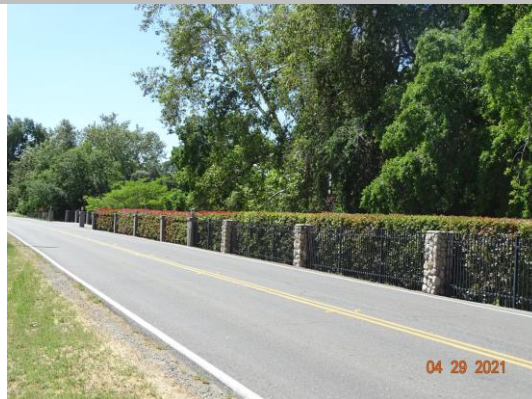
Photo 1 of 1 : FA_2021_RD1000_31_95_20210901_00047.jpg

View looking at waterside landscape vegetation that is blocking access and visibility to the levee, Spring 2021.

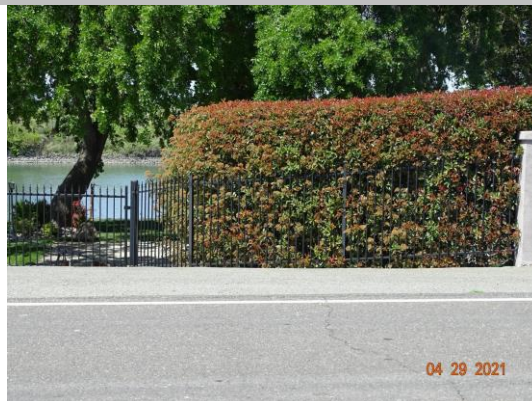
Photo 1 of 1 : FA_2021_RD1000_31_94_20210901_00046.jpg

View looking at waterside landscape vegetation that is blocking access and visibility to the levee, Spring 2021.

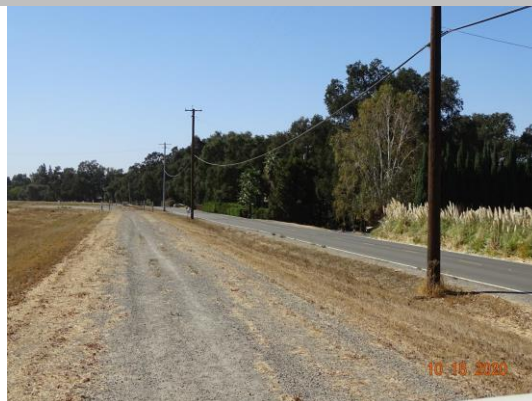
Photo 1 of 1 : FA_2021_RD1000_31_90_20210901_00045.jpg

This photo was taken from the crown facing downstream looking downstream. Landowner maintained vegetation completely blocks visibility of or access to the levee.

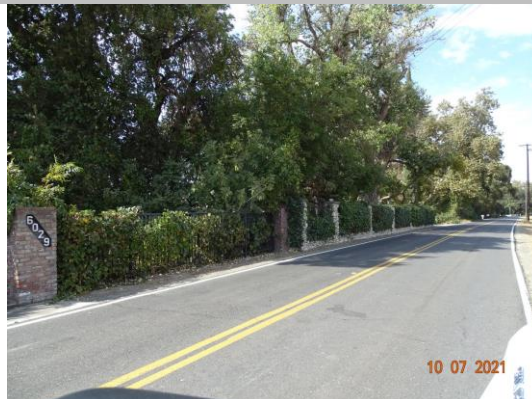
Photo 1 of 1 : FA_2021_RD1000_31_89_20211019_00065.jpg

View of landscape vegetation that is blocking visibility and access, Fall 2021.

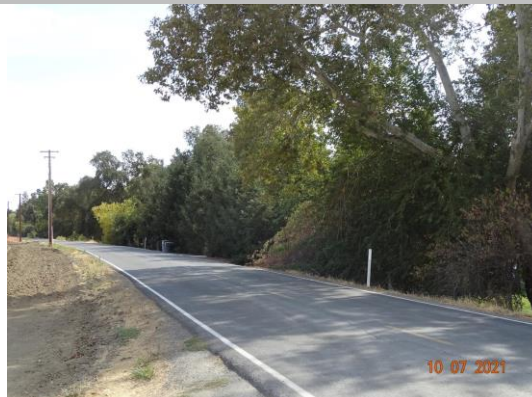
Photo 1 of 1 : FA_2021_RD1000_31_6_20211019_00066.jpg

View taken from the crown facing downstream looking at the waterward levee slope at the landscaping, Fall 2021.

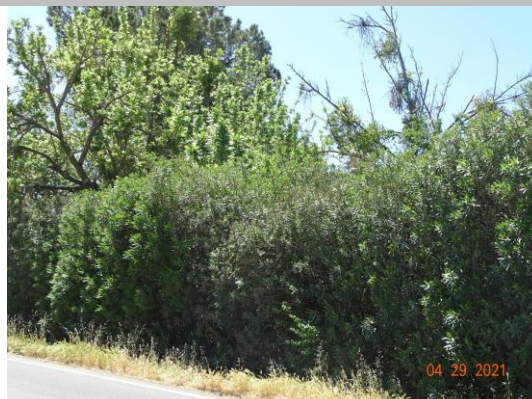
Photo 1 of 1 : FA_2021_RD1000_31_82_20210901_00043.jpg

This photo was taken from the crown facing downstream waterside levee slope at the landscaping, Spring 2021.

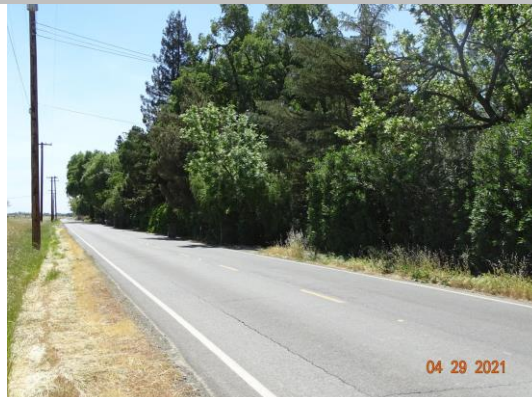
Photo 1 of 1 : FA_2021_RD1000_31_81_20210901_00042.jpg

View of landscape vegetation that blocks visibility and access, Spring 2021.

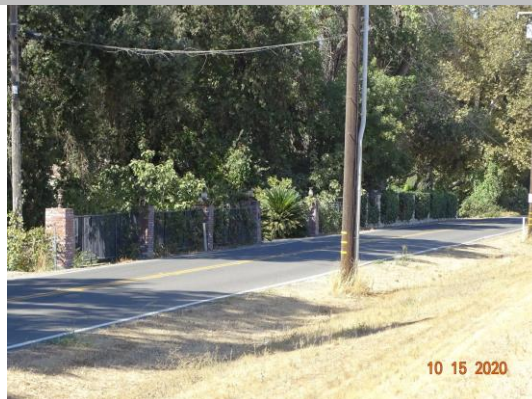
Photo 1 of 1 : FA_2021_RD1000_31_2_20210901_00001.jpg

This photo was taken during Fall 2020 from the crown facing upstream on the waterward levee slope at a fence enforcement issue.

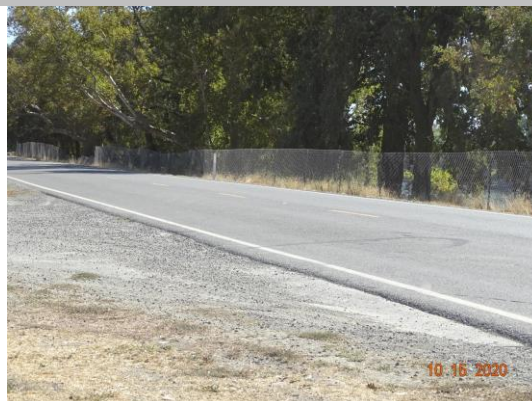
Photo 1 of 1 : FA_2021_RD1000_31_10_20210901_00011.jpg

View on waterside of a non-permitted fence.

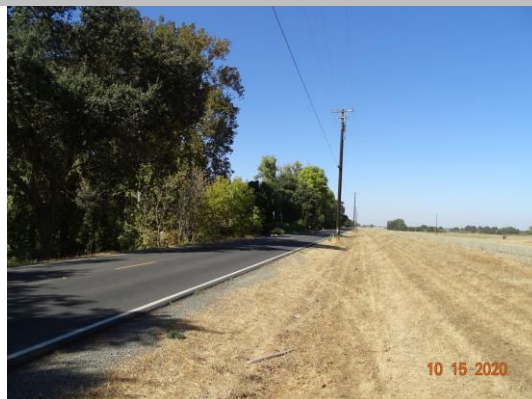
Photo 1 of 1 : FA_2021_RD1000_31_74_20210901_00040.jpg

This photo was taken from the crown facing downstream looking down the waterward levee slope at unacceptable landscaping.

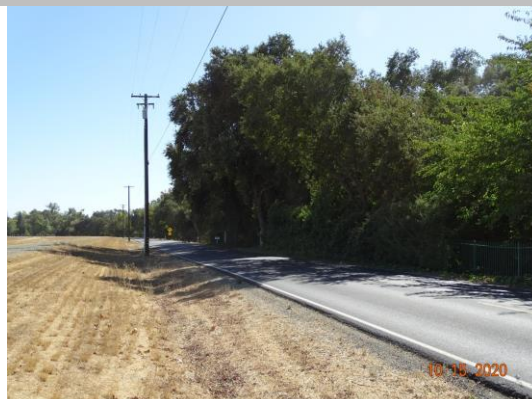
Photo 1 of 1 : FA_2021_RD1000_31_73_20210901_00039.jpg

This photo was taken from the crown facing downstream looking down the waterward levee slope at the landscaping.

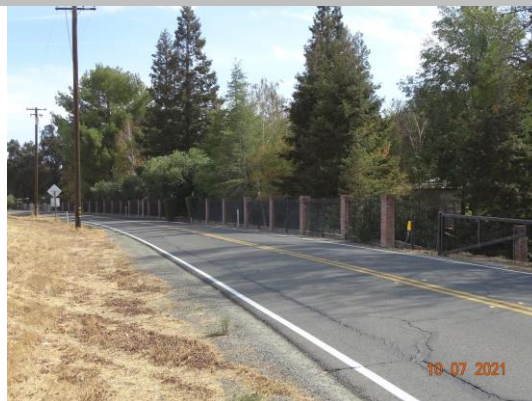
Photo 1 of 1 : FA_2021_RD1000_31_72_20211019_00067.jpg

View taken from the crown facing downstream looking at the waterward levee slope at the landscaping, Fall 2021.

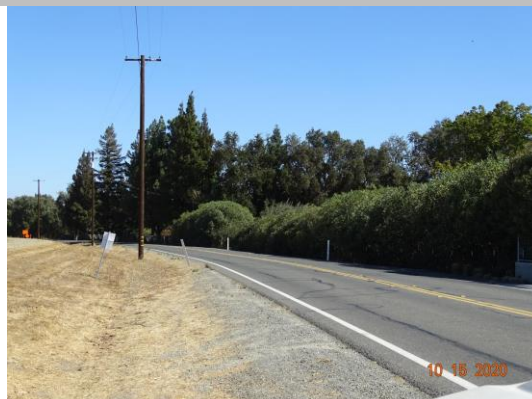
Photo 1 of 1 : FA_2021_RD1000_31_70_20210901_00037.jpg

This photo was taken from the crown facing downstream looking down the waterward levee slope at the landscaping.

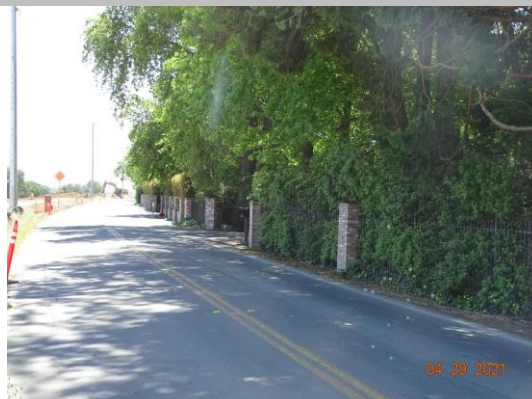
Photo 1 of 1 : FA_2021_RD1000_31_62_20210901_00033.jpg

This photo was taken from the crown facing downstream looking down the waterward levee slope at the landscaping.

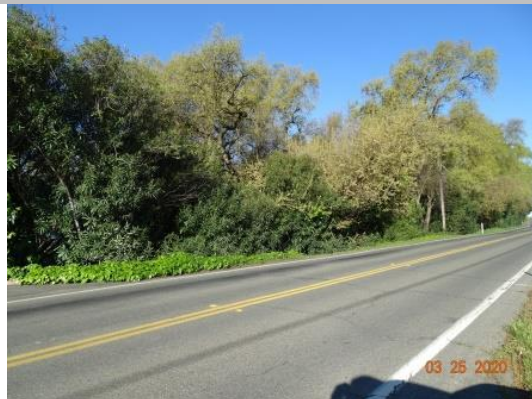
Photo 1 of 1 : FA_2021_RD1000_31_5_20210901_00006.jpg

View taken from the crown facing upstream looking at the waterward levee slope at unacceptable landscaping, Spring 2020.

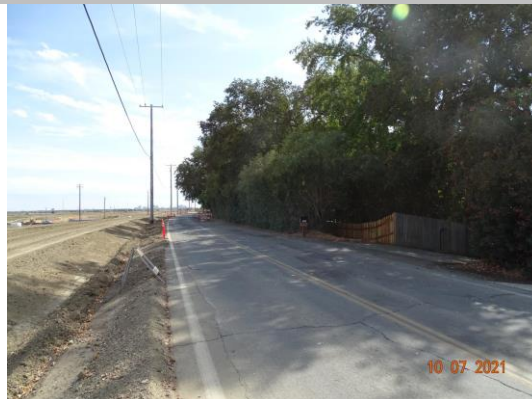
Photo 1 of 1 : FA_2021_RD1000_31_58_20211019_00068.jpg

View taken from the crown facing downstream looking at the waterward levee slope at unacceptable landscaping, Fall 2021.

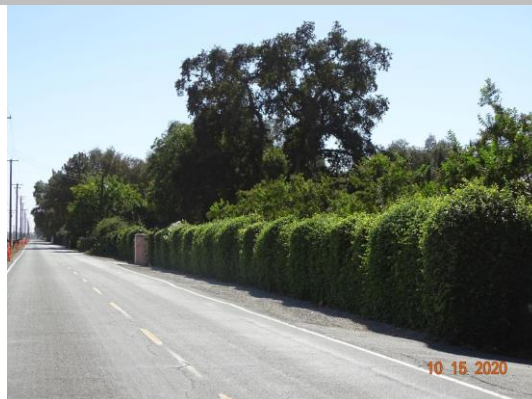
Photo 1 of 1 : FA_2021_RD1000_31_51_20210901_00030.jpg

View of the landscaping on the waterside levee slope.

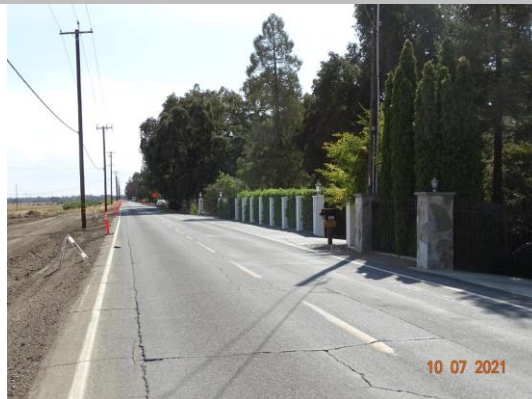
Photo 1 of 1 : FA_2021_RD1000_31_46_20211019_00070.jpg

View on waterside looking downstream of where the vegetation covers the front of the fence, Fall 2021

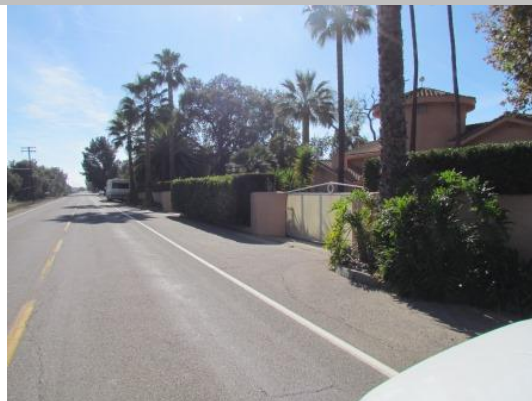
Photo 1 of 1 : FA_2021_RD1000_31_43_20210901_00027.jpg

This photo was taken from the crown facing downstream looking down the waterward levee slope at an unacceptable fence.

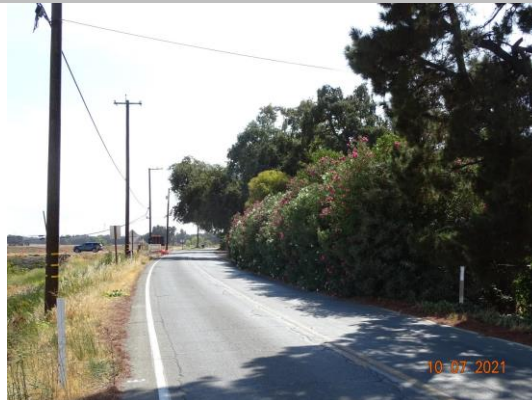
Photo 1 of 1 : FA_2021_RD1000_31_42_20211019_00071.jpg

View on waterside looking downstream of where the vegetation covers the front of the fence, Fall 2021.

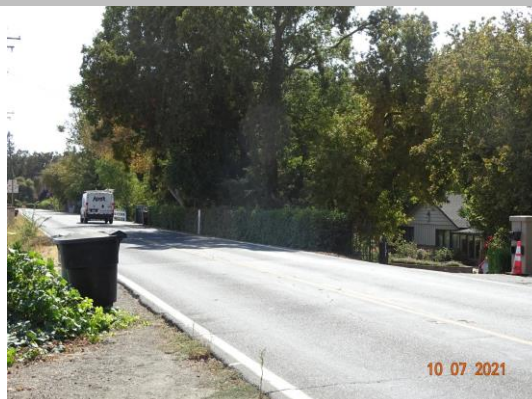
Photo 1 of 1 : FA_2021_RD1000_31_40_20211019_00072.jpg

View taken from the crown facing downstream looking at the waterward levee slope at unacceptable landscaping, Fall 2021.

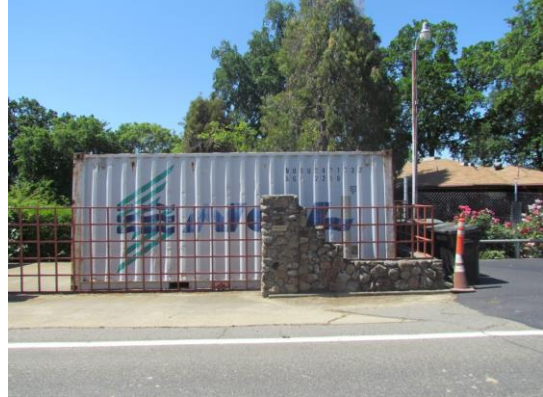
Photo 1 of 1 : FA_2021_RD1000_31_53_20210901_00031.jpg

View of storage container from the landside of the crown facing the waterside of the levee.

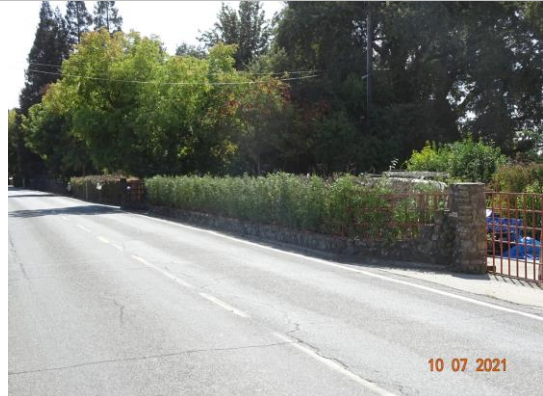
Photo 1 of 1 : FA_2021_RD1000_31_37_20211019_00073.jpg

View taken from the crown facing downstream looking at the waterward levee slope at landscaping, Fall 2021.

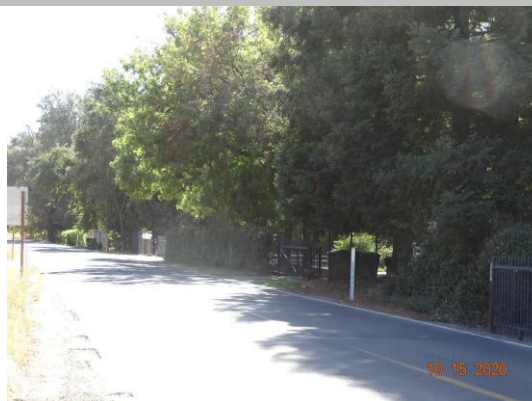
Photo 1 of 1 : FA_2021_RD1000_31_35_20210901_00023.jpg

View of the landscaping on the waterside levee slope.

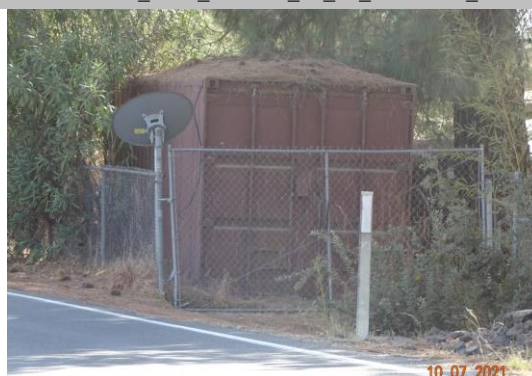
Photo 1 of 1 : FA_2021_RD1000_31_76_20211019_00074.jpg

Cargo container on levee shoulder, the property appears to be on fill material, Fall 2021.

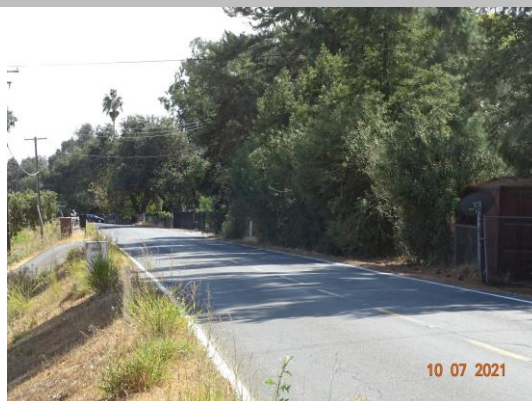
Photo 1 of 1 : FA_2021_RD1000_31_3_20211019_00075.jpg

View taken from the crown facing downstream looking at the waterward levee slope at unacceptable landscaping, Fall 2021.

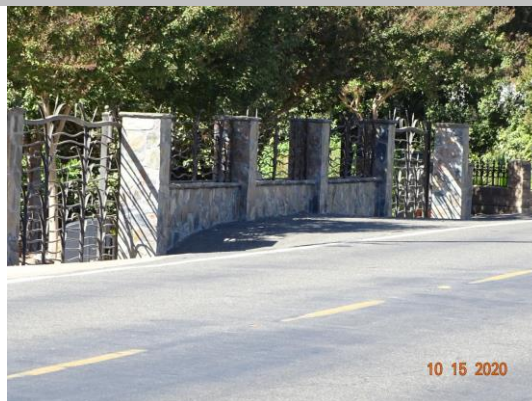
Photo 1 of 1 : FA_2021_RD1000_31_32_20210901_00022.jpg

View on waterside looking upstream of a rock and wrought iron fence that partially blocks visibility and access.

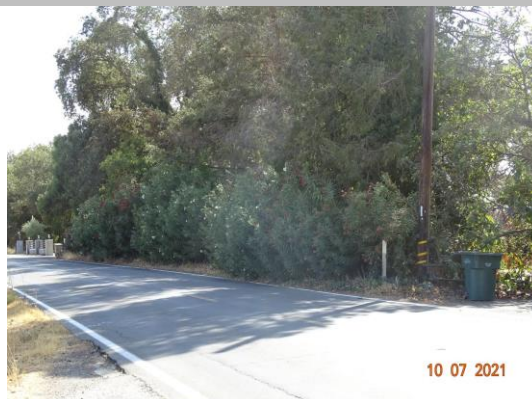
Photo 1 of 1 : FA_2021_RD1000_31_31_20211019_00076.jpg

View taken from the crown facing downstream looking at the waterward levee slope at unacceptable landscaping, Fall 2021.

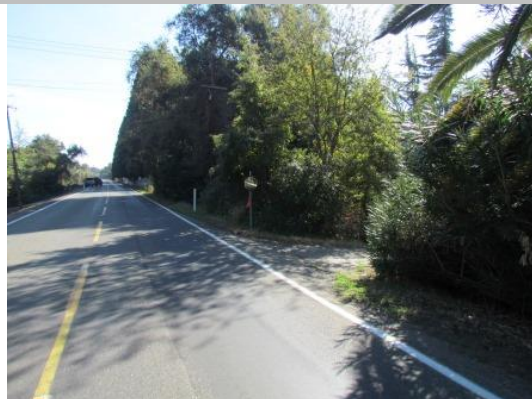
Photo 1 of 1 : FA_2021_RD1000_31_30_20210901_00020.jpg

This photo was taken from the crown facing downstream looking down the waterward levee slope at unacceptable landscaping.

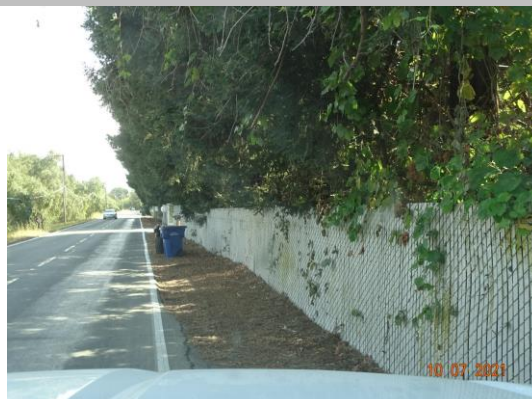
Photo 1 of 1 : FA_2021_RD1000_31_29_20211019_00077.jpg

View taken from the crown facing downstream looking at the waterward levee slope at an unacceptable fence, Fall 2021.

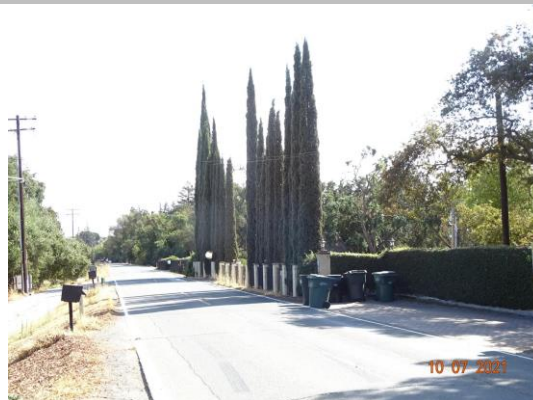
Photo 1 of 1 : FA_2021_RD1000_31_26_20211019_00078.jpg

View looking upstream at landscape vegetation blocking visibility and access, Fall 2021.

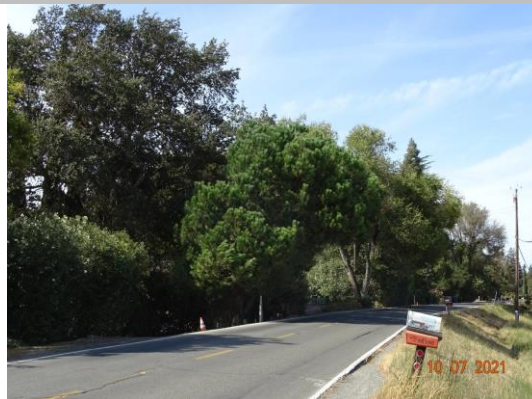
Photo 1 of 1 : FA_2021_RD1000_31_21_20211019_00079.jpg

View looking upstream at landscape vegetation blocking visibility and access, Fall 2021.

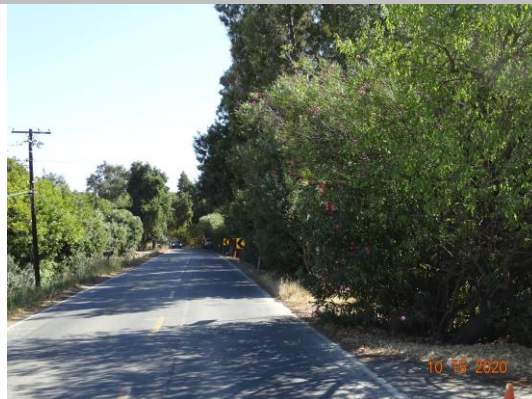
Photo 1 of 1 : FA_2021_RD1000_31_19_20210901_00016.jpg

View on waterside looking downstream of property covered by Oleander Bushes.

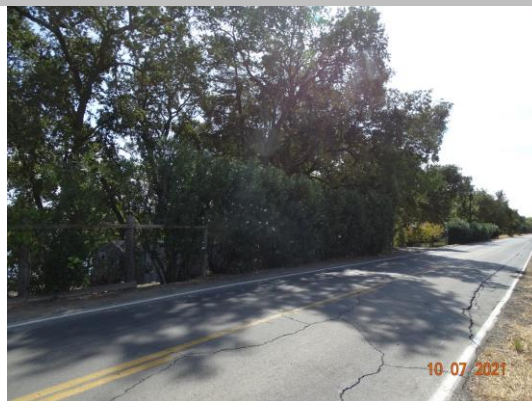
Photo 1 of 1 : FA_2021_RD1000_31_15_20211019_00080.jpg

View looking upstream waterside at landscaping that needs to be removed, Fall 2021.

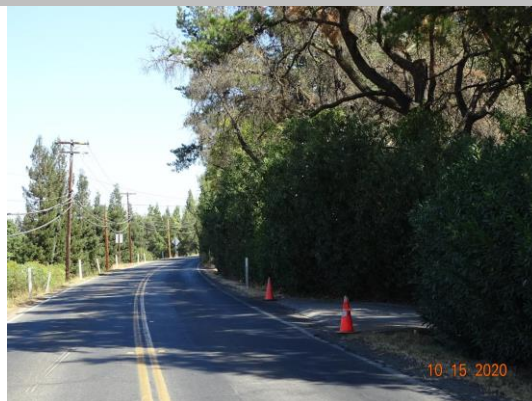
Photo 1 of 1 : FA_2021_RD1000_31_14_20210901_00014.jpg

View on waterside looking across at the fence covered by vegetation.

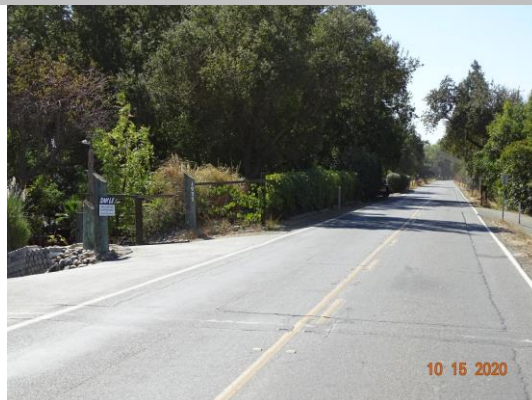
Photo 1 of 1 : FA_2021_RD1000_31_13_20210901_00013.jpg

View of fence covered by Oleander Bushes.

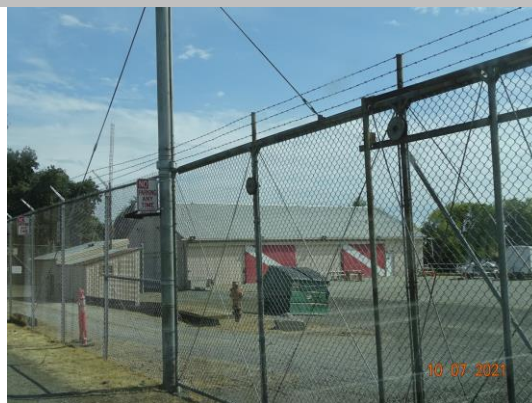
Photo 1 of 1 : FA_2021_RD1000_31_8_20211019_00081.jpg

This photo was taken from the crown facing downstream looking down the waterward levee slope at an unpermitted building, Fall 2021.

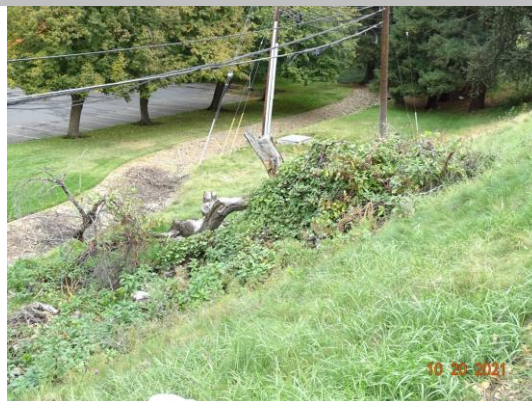
Photo 1 of 1 : FA_2021_RD1000_32_4_20211020_00006.jpg

View of downed tree on landside slope, Fall 2021.

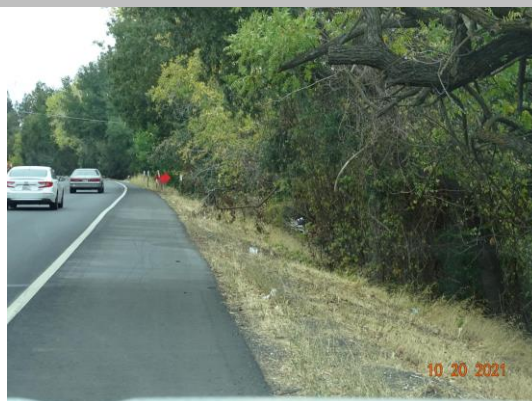
Photo 1 of 1 : FA_2021_RD1000_32_2_20211020_00007.jpg

View of low hanging trees on the landside slope, Fall 2021.

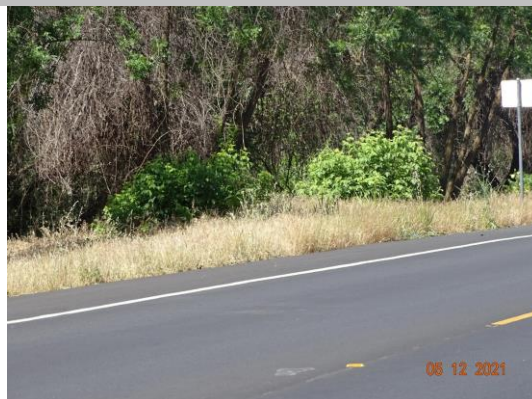
Photo 1 of 1 : FA_2021_RD1000_32_3_20210901_00002.jpg

View of starter trees on the waterside slope, Spring 2021.

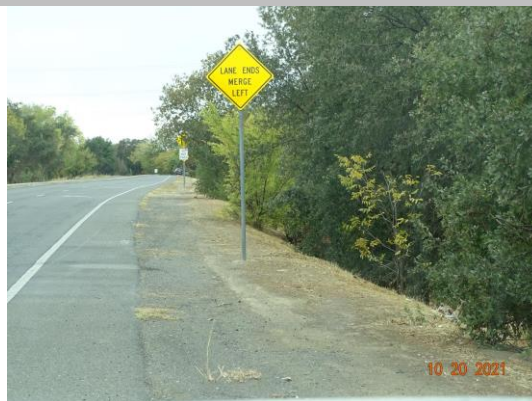
Photo 1 of 1 : FA_2021_RD1000_32_1_20211020_00008.jpg

View of low hanging trees on the landside slope, Fall 2021.

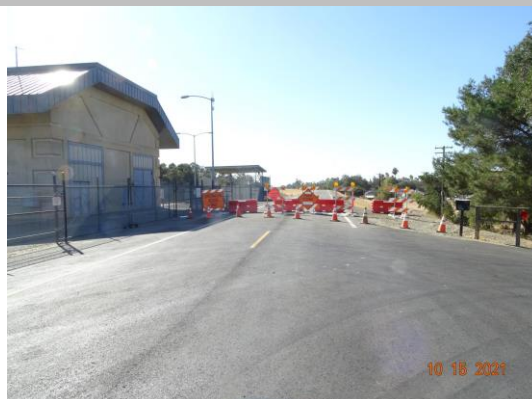
Photo 1 of 1 : FA_2021_RD1000_33_11_20211019_00010.jpg

LM Start	0.05	Rating **	A/W	Issue No.	11
LM End	4.20	Issue Type +	Ob	Location *	CR
Category	Earthen Levee			GPS Latitude/Longitude	
				Start	End
Item	Slope Stability			38.606454 °	38.665724 °
				-121.469943 °	-121.477500 °
DWR ID	DWR_RD1000_03_f_2020_11				
Comment Code					
S1 : Repair slope instability.					
Inspector Comment					
Still under construction, Reach H- USACE Project, Fall 2021.

View of the levee under construction, Reach H-USACE Project, Spring 2021.

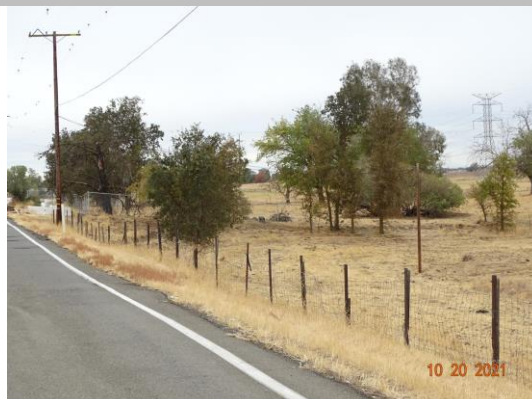
Photo 1 of 1 : FA_2021_RD1000_33_8_20211020_00011.jpg

View of fence on landside levee slope, looking downstream, Fall 2021.

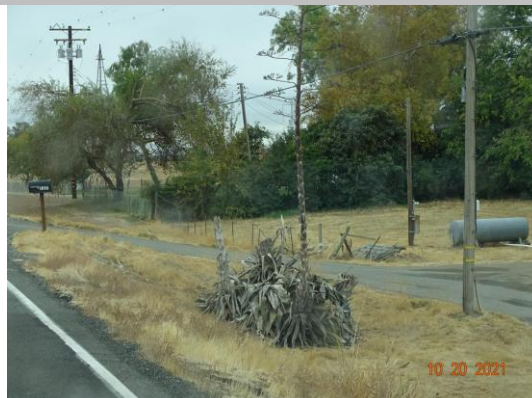
Photo 1 of 1 : FA_2021_RD1000_33_2_20211020_00012.jpg

View of the landscaping at the landside levee toe, Fall 2021.

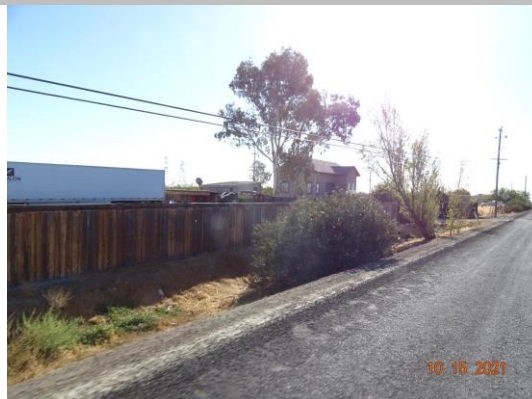
Photo 1 of 1 : FA_2021_RD1000_33_10_20211019_00009.jpg

View of landscaping on the waterside levee slope, Fall 2021.

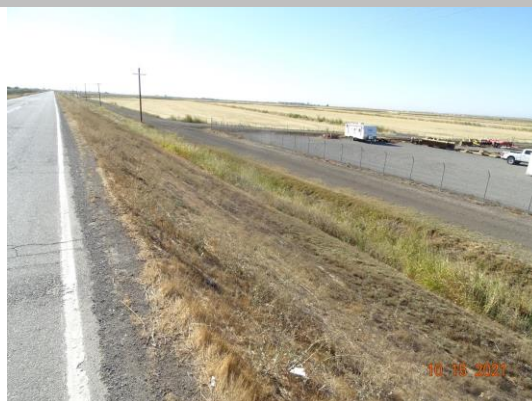
Photo 1 of 1 : FA_2021_RD1000_33_22_20211019_00008.jpg

View of landside ditch at toe of levee, looking downstream, Fall 2021.

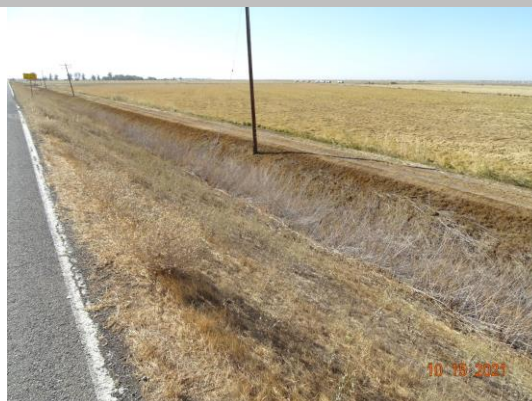
Photo 1 of 1 : FA_2021_RD1000_33_9_20211019_00007.jpg

View looking downstream landside at a ditch at the toe, Fall 2021.
