**Flood Control Project Maintenance
Levee Inspections
Fall 2022 Levee Maintenance Deficiency Summary Report**

Sacramento River Basin

**Flood Control Project Maintenance
Levee Inspections
LMA District Cover Sheet**

Reclamation District No. 1000 Natomas

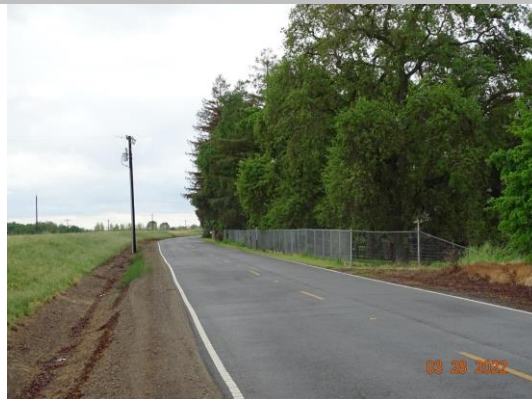
Photo 1 of 1 : FA_2022_RD1000_31_136_20220927_00060.jpg

View of the fence encroachment, Spring 2022.

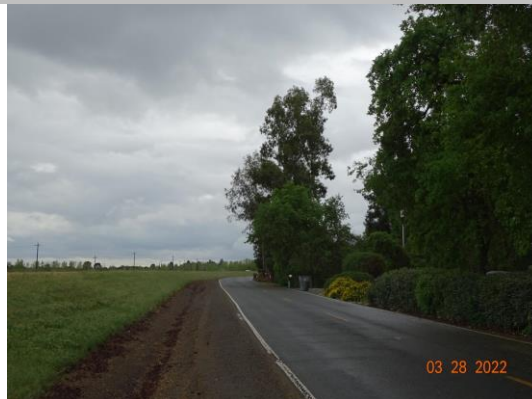
Photo 1 of 1 : FA_2022_RD1000_31_133_20220927_00059.jpg

Typical Garden Hwy 'Landscaping'.

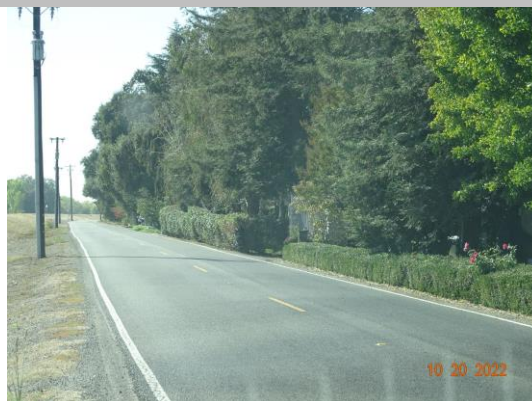
Photo 1 of 1 : FA_2022_RD1000_31_122_20221031_00061.jpg

View looking upstream waterside of landscape vegetation that is blocking access and visibility to the levee, Fall 2021.

LM Start	2.52	Rating **	M	Issue No.	121
LM End	2.67	Issue Type +	En	Location *	WS
Category	Earthen Levee			GPS Latitude/Longitude	
				Start	End
Item	Vegetation			38.747087 °	38.745127 °
				-121.595582 °	-121.596793 °
DWR ID	DWR_RD1000_01_s_2012_121				
Comment Code					
V6 : Landscaping					
Inspector Comment					
Landscape vegetation is blocking access and visibility to the levee, Fall 2022.

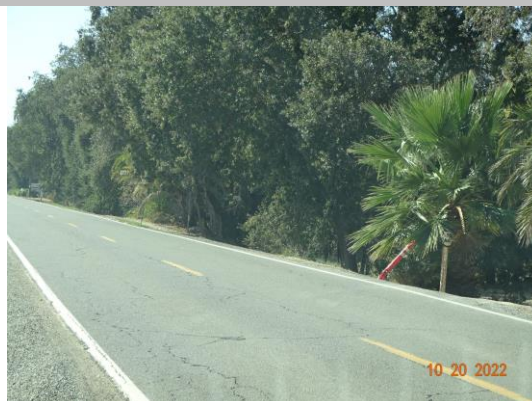
Photo 1 of 1 : FA_2022_RD1000_31_121_20221031_00062.jpg

View looking upstream waterside of landscape vegetation that is blocking access and visibility to the levee, Fall 2022.

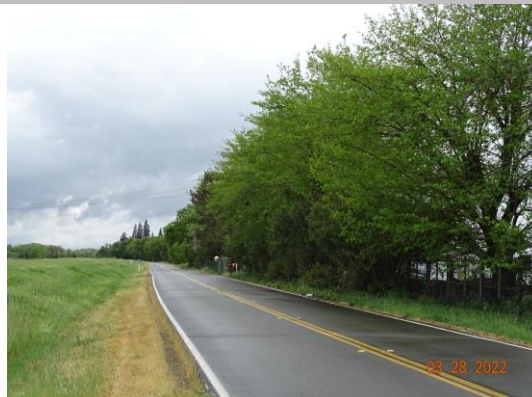
Photo 1 of 1 : FA_2022_RD1000_31_120_20220927_00053.jpg

Typical landscape vegetation along the waterside in front of residences.

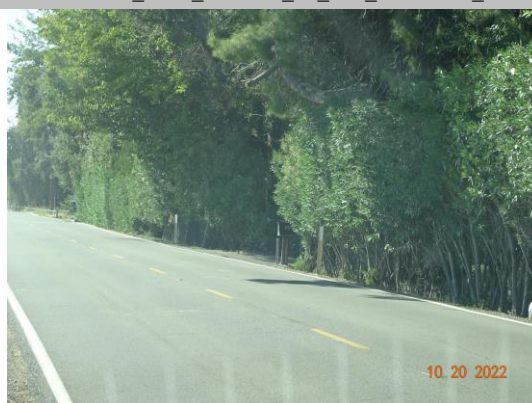
Photo 1 of 1 : FA_2022_RD1000_31_118_20221031_00063.jpg

This photo was taken from the crown facing downstream looking down the waterward levee slope at the landscaping, Fall 2022.

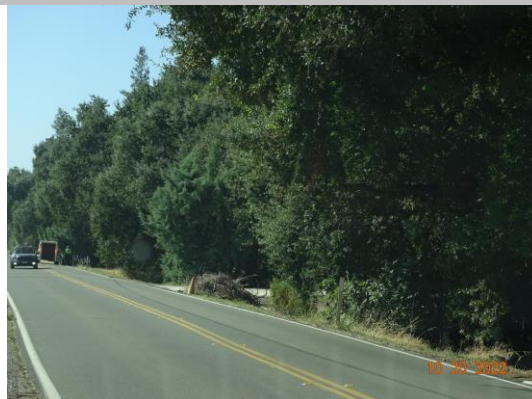
Photo 1 of 1 : FA_2022_RD1000_31_7_20221031_00064.jpg

View of waterside levee where the landowner has planted fruit trees and other landscape vegetation, Fall 2022.

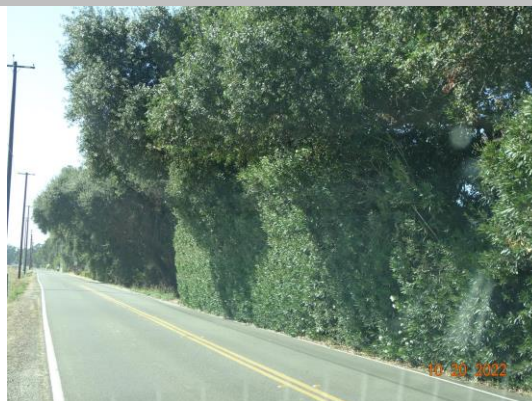
Photo 1 of 1 : FA_2022_RD1000_31_116_20221031_00065.jpg

View looking at waterside landscape vegetation that is blocking access and visibility to the levee, Fall 2022.

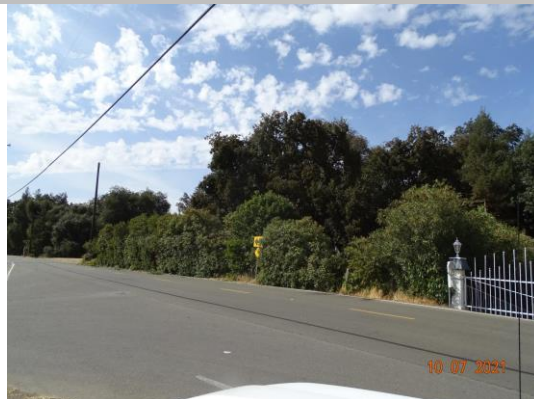
Photo 1 of 1 : FA_2022_RD1000_31_113_20220927_00050.jpg

View taken from the crown facing downstream looking at the waterward levee slope at the landscaping, Fall 2021.

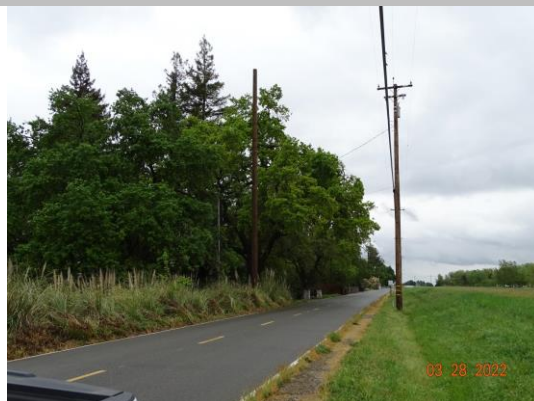
Photo 1 of 1 : FA_2022_RD1000_31_111_20220927_00049.jpg

This photo was taken from the crown facing downstream looking down the waterward levee slope at the landscaping.

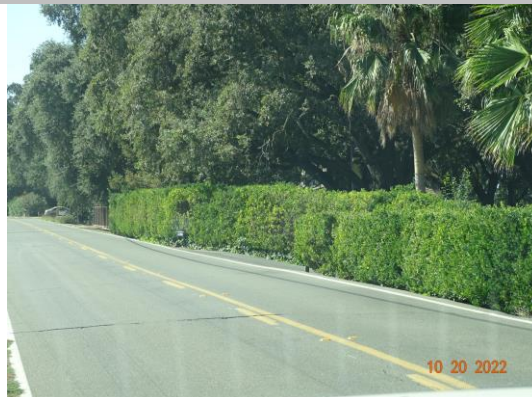
Photo 1 of 1 : FA_2022_RD1000_31_68_20221031_00066.jpg

View at landscape vegetation that is blocking visibility and access, Fall 2022.

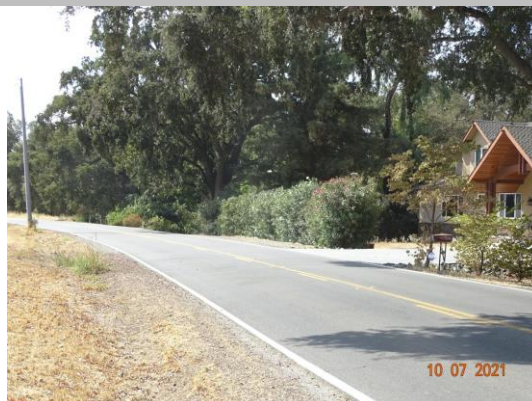
Photo 1 of 1 : FA_2022_RD1000_31_125_20220927_00056.jpg

View taken from the crown facing downstream looking at the waterward levee slope at the landscaping, Fall 2021.

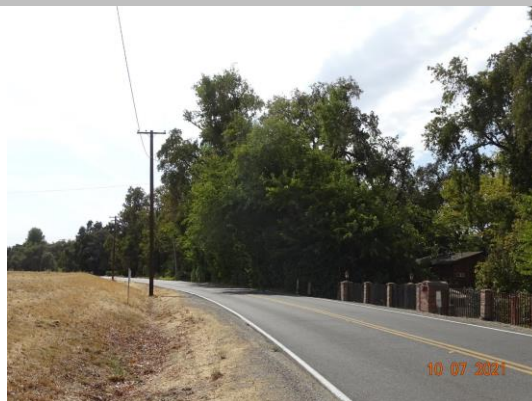
Photo 1 of 1 : FA_2022_RD1000_31_102_20220927_00048.jpg

View taken from the crown facing downstream looking at the waterward levee slope at the landscaping, Fall 2021.

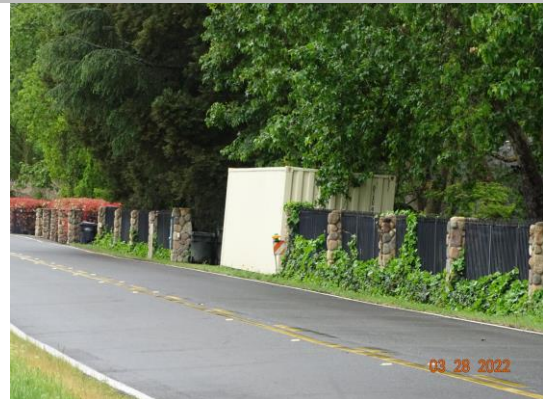
Photo 1 of 1 : FA_2022_RD1000_31_9_20220927_00010.jpg

View of shipping container on waterside.

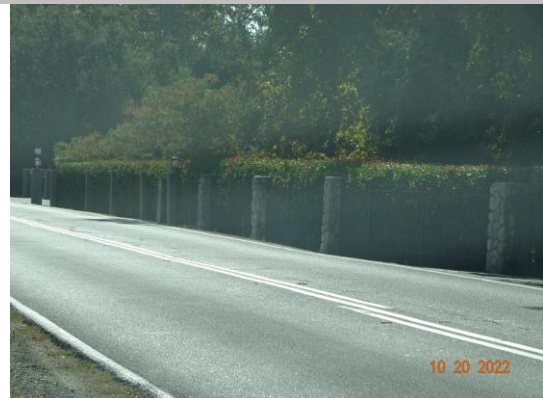
Photo 1 of 1 : FA_2022_RD1000_31_95_20221031_00067.jpg

View looking at waterside landscape vegetation that is blocking access and visibility to the levee, Fall 2022.

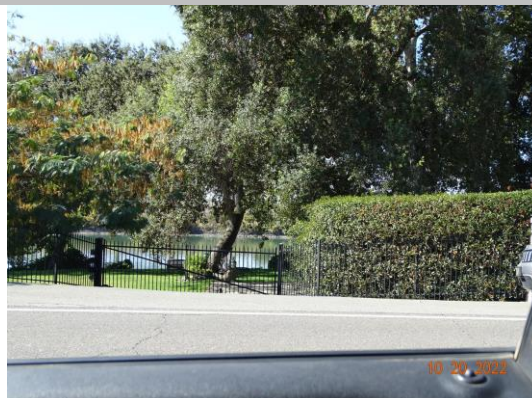
Photo 1 of 1 : FA_2022_RD1000_31_94_20221031_00068.jpg

View looking at waterside landscape vegetation that is blocking access and visibility to the levee, Fall 2022.

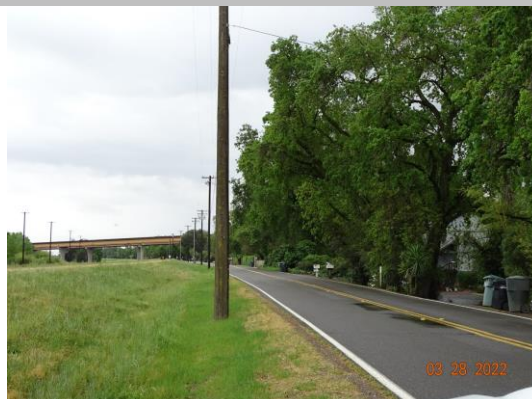
Photo 1 of 1 : FA_2022_RD1000_31_90_20220927_00045.jpg

This photo was taken from the crown facing downstream looking downstream. Landowner maintained vegetation completely blocks visibility of or access to the levee.

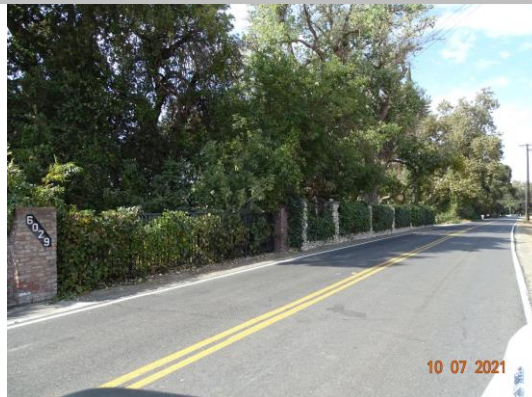
Photo 1 of 1 : FA_2022_RD1000_31_89_20220927_00044.jpg

View of landscape vegetation that is blocking visibility and access, Fall 2021.

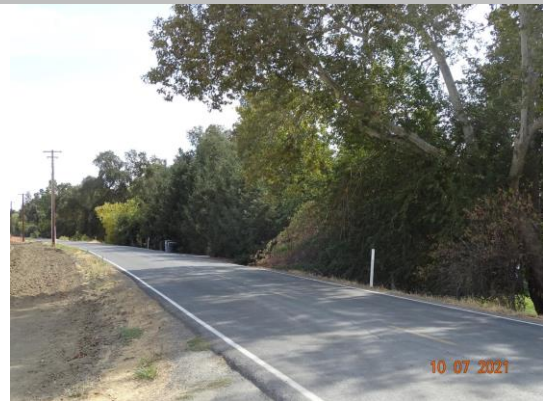
Photo 1 of 1 : FA_2022_RD1000_31_6_20220927_00007.jpg

View taken from the crown facing downstream looking at the waterward levee slope at the landscaping, Fall 2021.

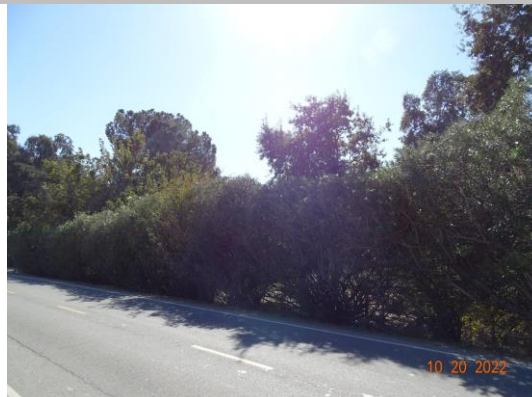
Photo 1 of 1 : FA_2022_RD1000_31_82_20221031_00069.jpg

This photo was taken from the crown facing downstream waterside levee slope at the landscaping, Fall 2022.

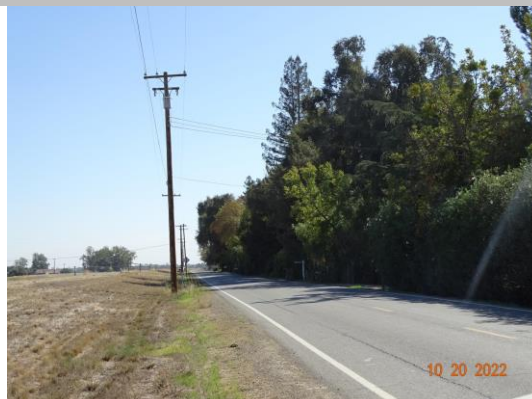
Photo 1 of 1 : FA_2022_RD1000_31_81_20221031_00070.jpg

View of landscape vegetation that blocks visibility and access, Fall 2022.

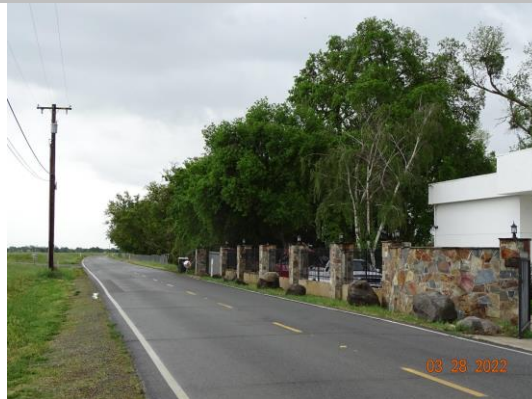
Photo 1 of 1 : FA_2022_RD1000_31_2_20220927_00001.jpg

This photo was taken during Fall 2020 from the crown facing downstream on the waterward levee slope at a fence enforcement issue.

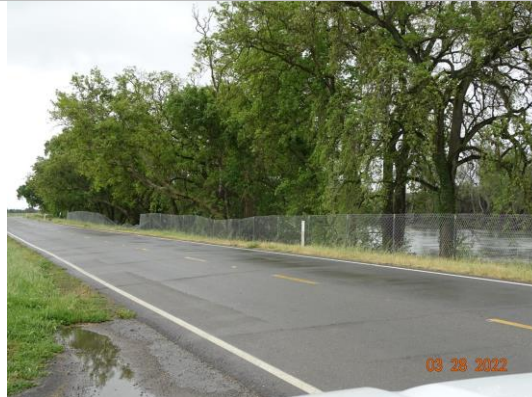
Photo 1 of 1 : FA_2022_RD1000_31_10_20220927_00011.jpg

View on waterside of a non-permitted fence.

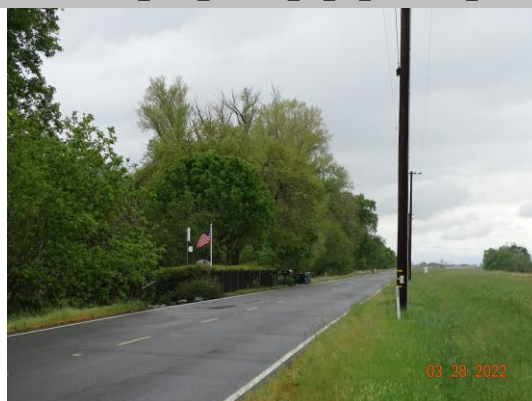
Photo 1 of 1 : FA_2022_RD1000_31_74_20220927_00040.jpg

This photo was taken from the crown facing downstream looking down the waterward levee slope at unacceptable landscaping.

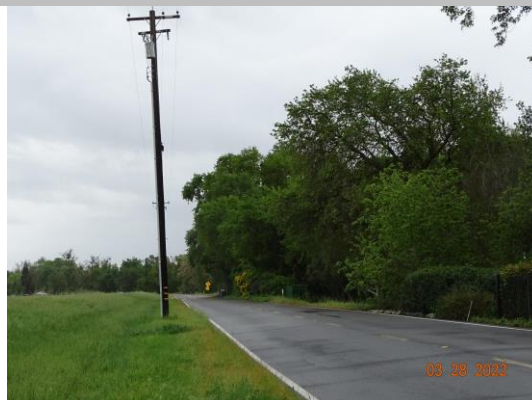
Photo 1 of 1 : FA_2022_RD1000_31_73_20220927_00039.jpg

This photo was taken from the crown facing downstream looking down the waterward levee slope at the landscaping.

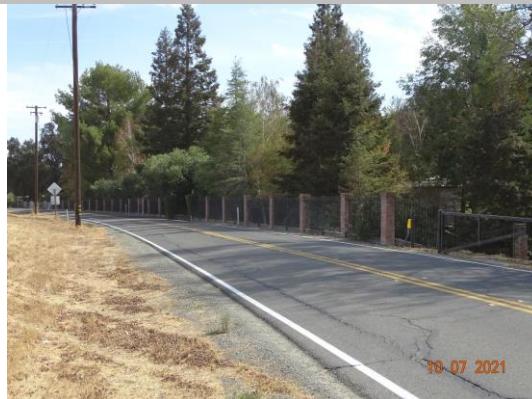
Photo 1 of 1 : FA_2022_RD1000_31_72_20220927_00038.jpg

View taken from the crown facing downstream looking at the waterward levee slope at the landscaping, Fall 2021.

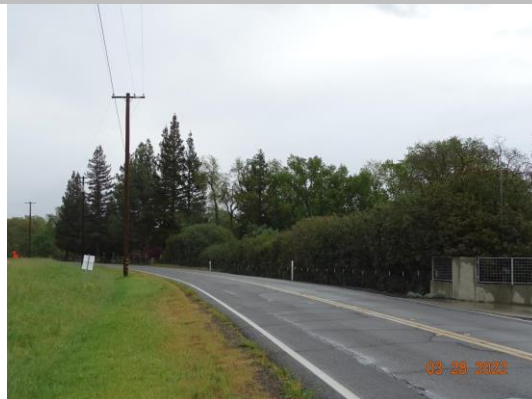
Photo 1 of 1 : FA_2022_RD1000_31_70_20220927_00037.jpg

This photo was taken from the crown facing downstream looking down the waterward levee slope at the landscaping.

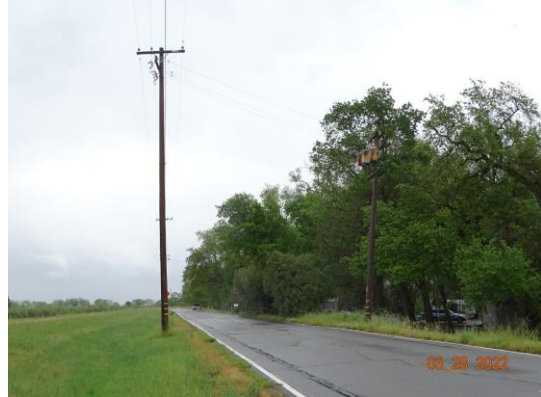
Photo 1 of 1 : FA_2022_RD1000_31_69_20220927_00036.jpg

View of landscape vegetation that blocks access and visibility.

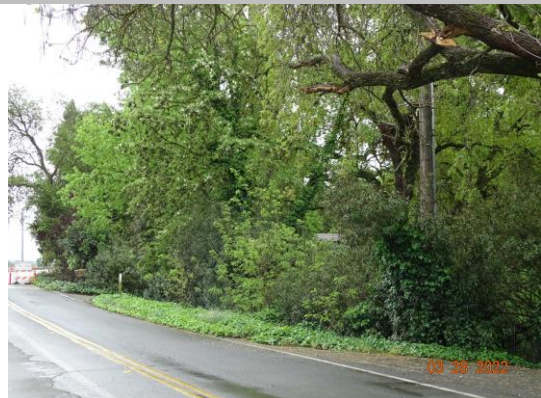
Photo 1 of 1 : FA_2022_RD1000_31_66_20220927_00034.jpg

View of the landscaping on the waterside levee slope.

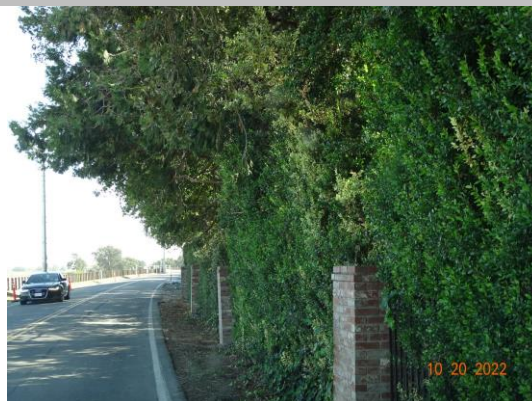
Photo 1 of 1 : FA_2022_RD1000_31_62_20221031_00071.jpg

This photo was taken from the crown facing downstream looking down the waterward levee slope at the landscaping, Fall 2022.

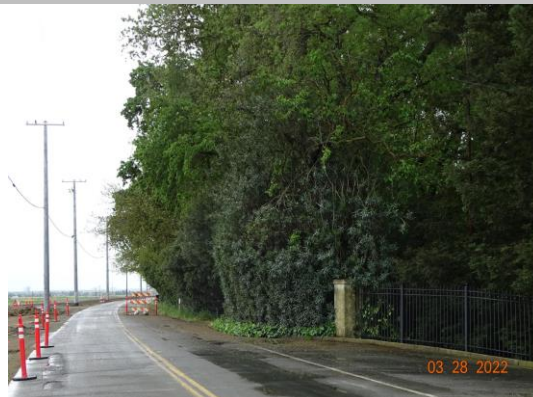
Photo 1 of 1 : FA_2022_RD1000_31_5_20220927_00006.jpg

View taken from the crown facing downstream looking at the waterward levee slope at unacceptable landscaping, Spring 2020.

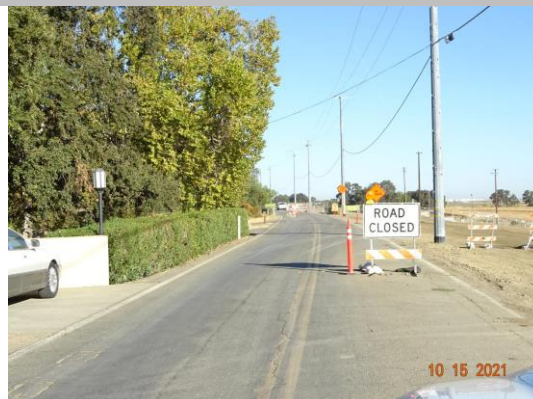
Photo 1 of 1 : FA_2022_RD1000_31_11_20220927_00012.jpg

View of construction in Reach B looking upstream, Fall 2021.

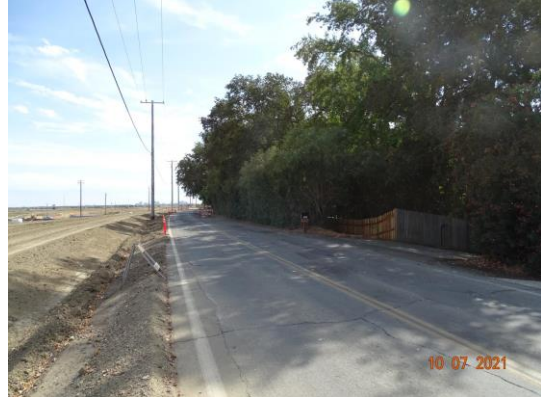
Photo 1 of 1 : FA_2022_RD1000_31_58_20220927_00032.jpg

View taken from the crown facing downstream looking at the waterward levee slope at unacceptable landscaping, Fall 2021.

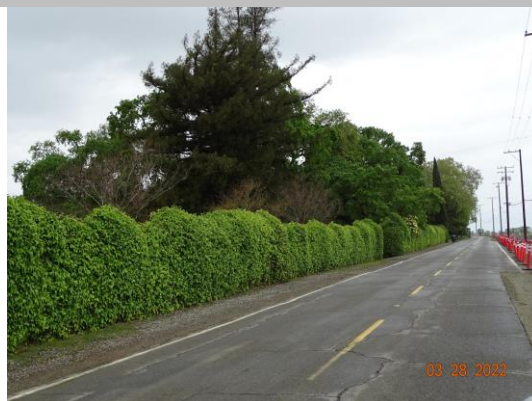
Photo 1 of 1 : FA_2022_RD1000_31_51_20220927_00030.jpg

View of the landscaping on the waterside levee slope.

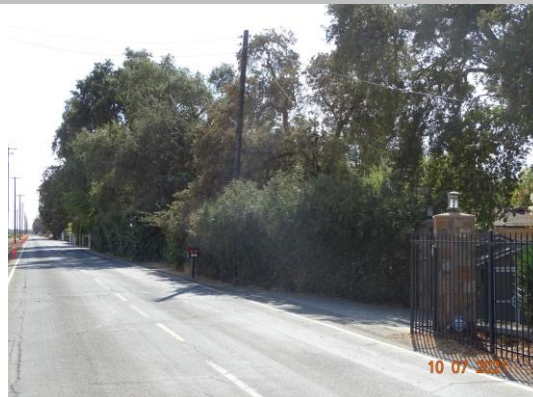
Photo 1 of 1 : FA_2022_RD1000_31_48_20220927_00029.jpg

View taken from the crown facing downstream looking at the waterward levee slope at the landscaping, Fall 2021.

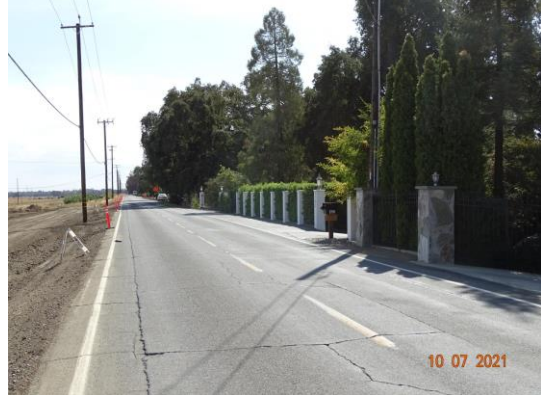
Photo 1 of 1 : FA_2022_RD1000_31_46_20220927_00028.jpg

View on waterside looking downstream of where the vegetation covers the front of the fence, Fall 2021

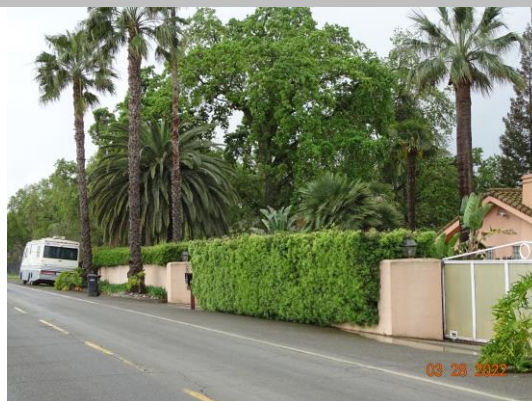
Photo 1 of 1 : FA_2022_RD1000_31_43_20220927_00027.jpg

This photo was taken from the crown facing downstream looking down the waterward levee slope at an unacceptable fence.

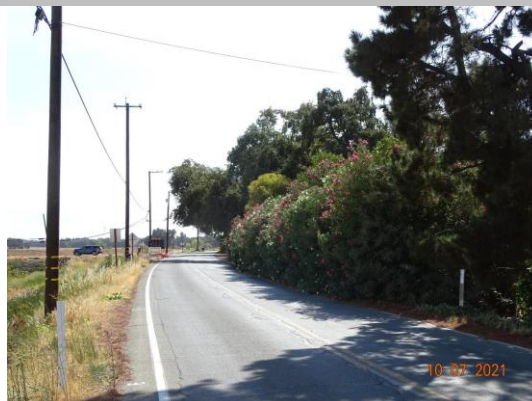
Photo 1 of 1 : FA_2022_RD1000_31_42_20220927_00026.jpg

View on waterside looking downstream of where the vegetation covers the front of the fence, Fall 2021.

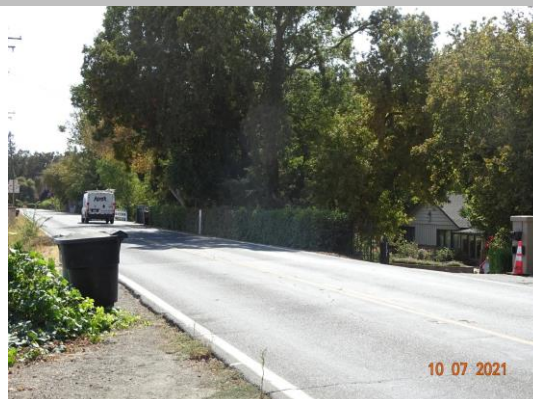
Photo 1 of 1 : FA_2022_RD1000_31_40_20220927_00025.jpg

View taken from the crown facing downstream looking at the waterward levee slope at unacceptable landscaping, Fall 2021.

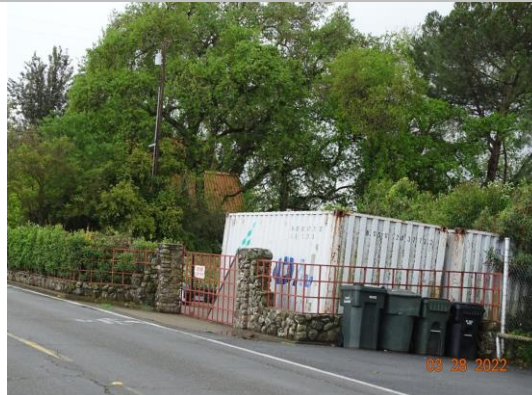
Photo 1 of 1 : FA_2022_RD1000_31_53_20220927_00031.jpg

View of storage container from the landside of the crown facing the waterside of the levee.

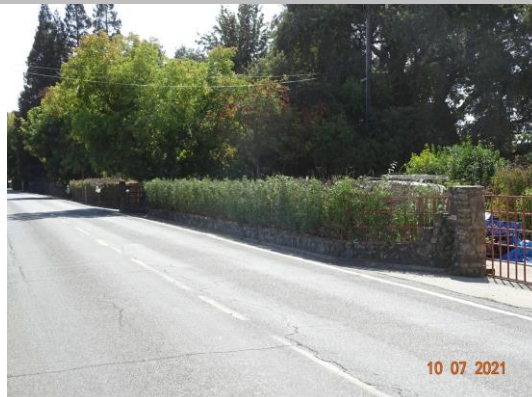
Photo 1 of 1 : FA_2022_RD1000_31_37_20220927_00024.jpg

View taken from the crown facing downstream looking at the waterward levee slope at landscaping, Fall 2021.

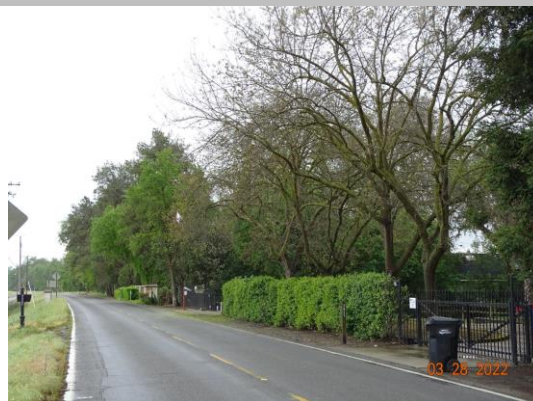
Photo 1 of 1 : FA_2022_RD1000_31_35_20220927_00023.jpg

View of the landscaping on the waterside levee slope.

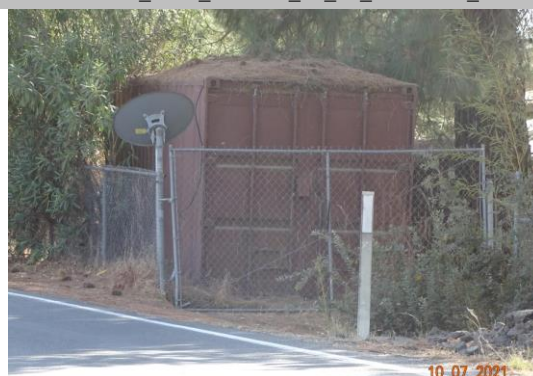
Photo 1 of 1 : FA_2022_RD1000_31_76_20220927_00041.jpg

Cargo container on levee shoulder, the property appears to be on fill material, Fall 2021.

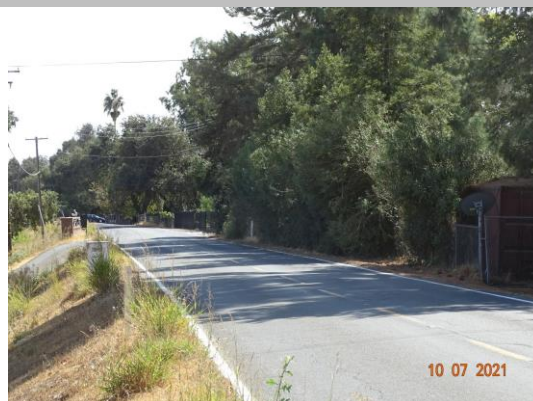
Photo 1 of 1 : FA_2022_RD1000_31_3_20220927_00002.jpg

View taken from the crown facing downstream looking at the waterward levee slope at unacceptable landscaping, Fall 2021.

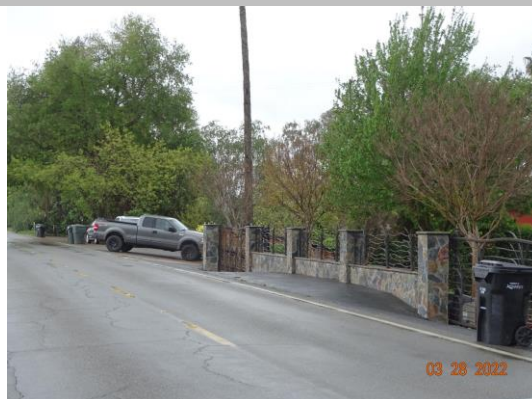
Photo 1 of 1 : FA_2022_RD1000_31_32_20220927_00022.jpg

View on waterside looking downstream of a rock and wrought iron fence that partially blocks visibility and access.

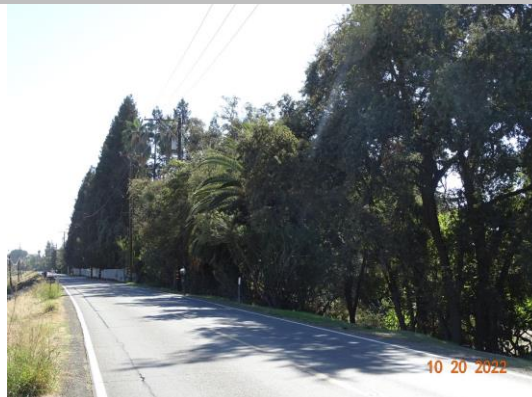
Photo 1 of 1 : FA_2022_RD1000_31_30_20221031_00072.jpg

This photo was taken from the crown facing downstream looking down the waterward levee slope at unacceptable landscaping, Fall 2022.

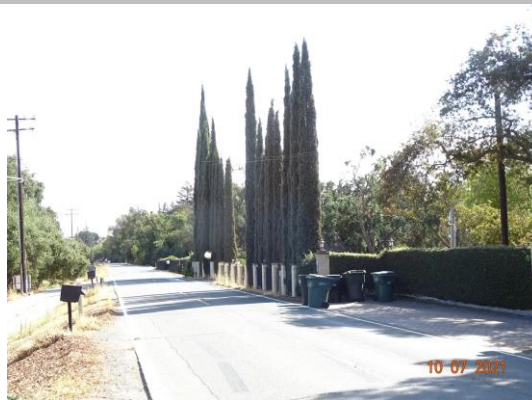
Photo 1 of 1 : FA_2022_RD1000_31_26_20220927_00018.jpg

View looking upstream at landscape vegetation blocking visibility and access, Fall 2021.

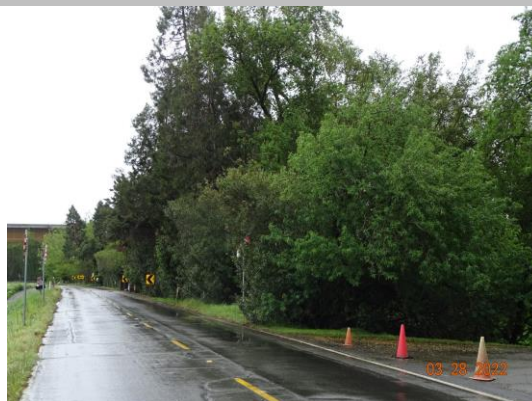
Photo 1 of 1 : FA_2022_RD1000_31_19_20220927_00016.jpg

View on waterside looking downstream of property covered by Oleander Bushes.

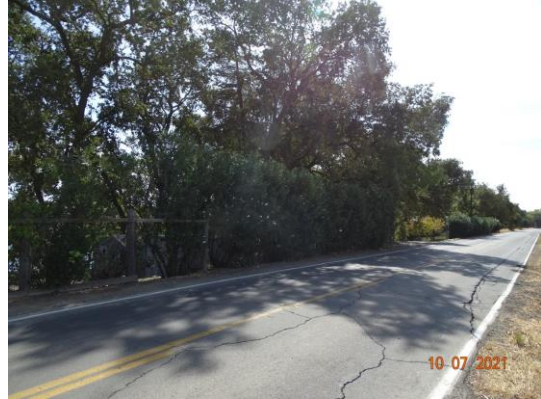
Photo 1 of 1 : FA_2022_RD1000_31_15_20220927_00015.jpg

View looking upstream waterside at landscaping that needs to be removed, Fall 2021.

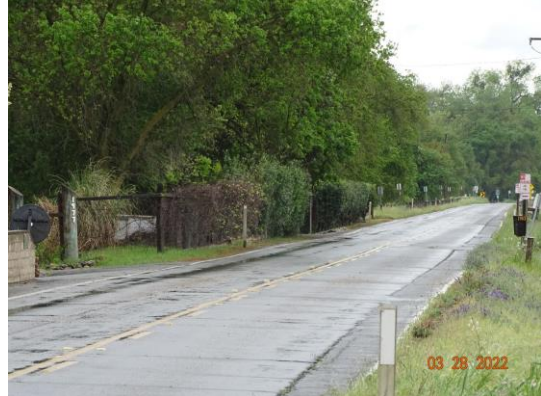
Photo 1 of 1 : FA_2022_RD1000_31_14_20220927_00014.jpg

View on waterside looking across at the fence covered by vegetation.

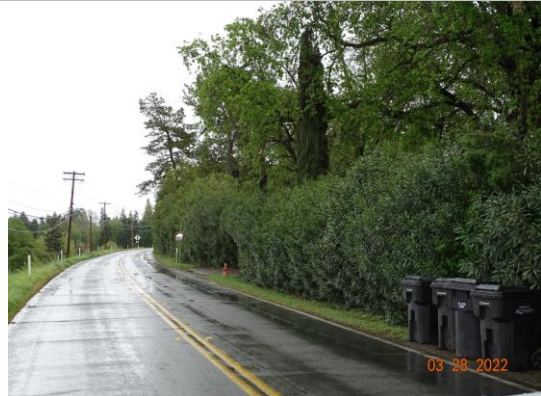
Photo 1 of 1 : FA_2022_RD1000_31_13_20220927_00013.jpg

View of fence covered by Oleander Bushes.

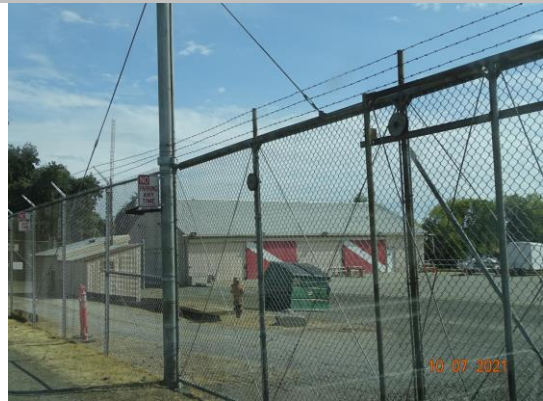
Photo 1 of 1 : FA_2022_RD1000_31_8_20220927_00009.jpg

This photo was taken from the crown facing downstream looking down the waterward levee slope at an unpermitted building, Fall 2021.

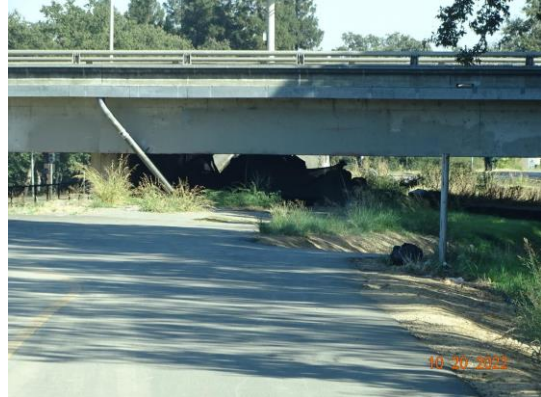
Photo 1 of 1 : FA_2022_RD1000_32_5_20221031_00004.jpg

View of debris and tents from campers on the levee crown, Fall 2022.

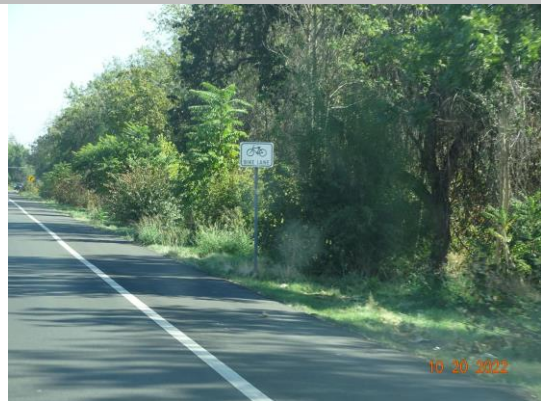
Photo 1 of 1 : FA_2022_RD1000_32_3_20221031_00005.jpg

View of starter trees on the waterside slope, Fall 2022.

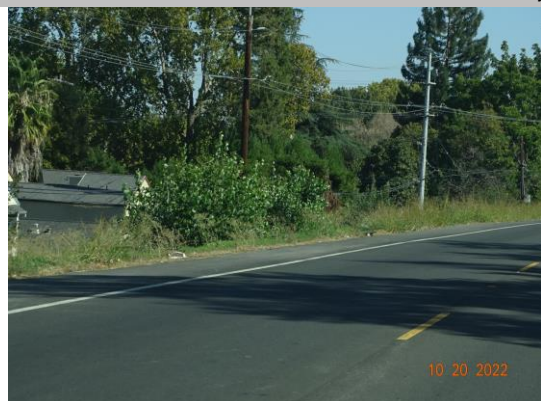
Photo 1 of 1 : FA_2022_RD1000_32_1_20221031_00006.jpg

View of starter trees on the landside slope, Fall 2022.

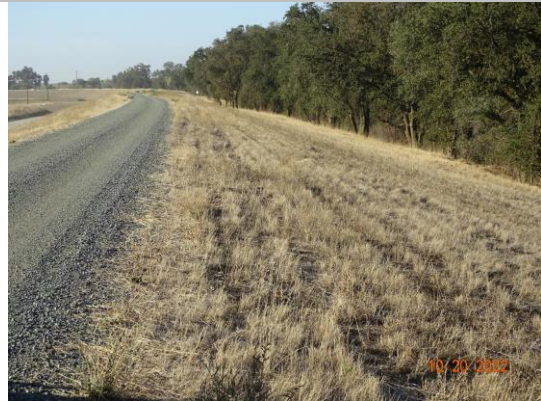
Photo 1 of 1 : FA_2022_RD1000_34_14_20221031_00001.jpg

View of annual vegetation on the waterside slope, Fall 2022.

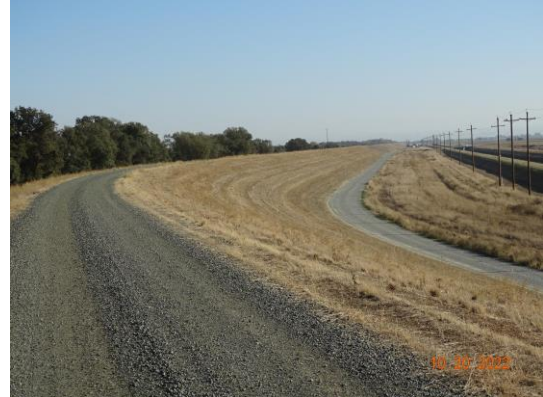
Photo 1 of 1 : FA_2022_RD1000_34_13_20221031_00002.jpg

View of annual vegetation on the landside slope, Fall 2022.
