## Flood Control Project Maintenance Levee Inspections

### Fall 2023 Levee Maintenance Deficiency Summary Report

#### Sacramento River Basin

**Reclamation District No. 1000 Natomas**

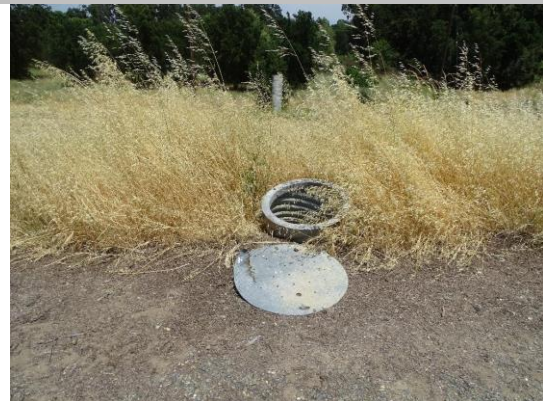
Photo 1 of 3 : UCIP\_FA\_2023\_81189\_116409.jpg

Comment Code					
Inspector Comment					
DS_ID:25177 FS_ID:81189 EP_NO: 4722 Repair Type: Non-Urgent EVAL Issue: Crossing Status: Found UCIP Comments: 06/08/2023 Record updated to Non-Urgent. A minor (less than 1/2-foot) surface erosion located waterward of Garden Highway. Lid was not closed on landside riser creating a safety hazard. Coordinates have been updated from 38.773867, -121.597746 to 38.773700, -121.597690. (M. Thao - DWR UCIP) FIELD_STRUCT_DESC: 10-inch pipe through the levee, 4.0 feet below the crown. Slant pump connected to intake pipe on waterside (WS). 24-inch corrugated metal risers at each of WS and landside (LS) shoulders. (10-inch pipe removed and replaced under Permit No. 4722, 1966 - E.L. Kearns). [Additional Reference(s): DWR Levee Log, 2002 (HLM 0.56). USACE Sacramento O&M Manual, Unit No. 124, June1953, Revised 25 February 2022, River Mile 78.27, listed as 10-inch pipe]. FS Date: 6/8/2023

LS view: CMP riser on shoulder; lid laying next to riser.

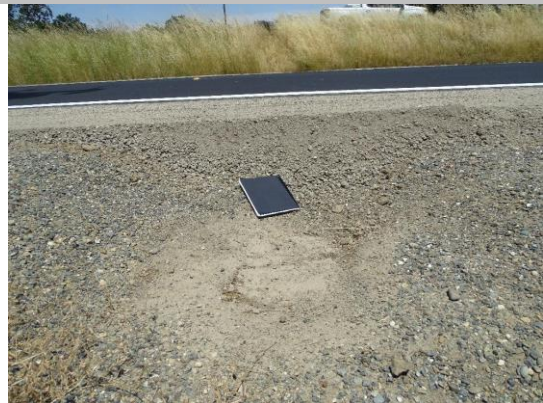
Photo 3 of 3 : UCIP\_FA\_2023\_81189\_116413.jpg

WS view: Minor (less than 1/2 foot) surface erosion along alignment of pipe; looking at a different angle toward levee.

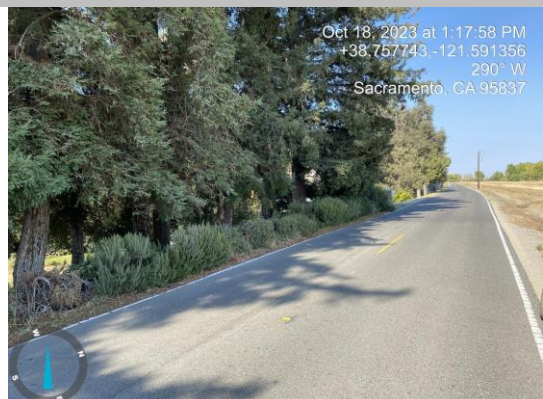
Photo 1 of 1 : FA\_2023\_RD1000\_31\_135\_20231023\_00281.jpg

View taken from the crown facing upstream looking at the waterward levee slope at the landscaping (Fall 2023).

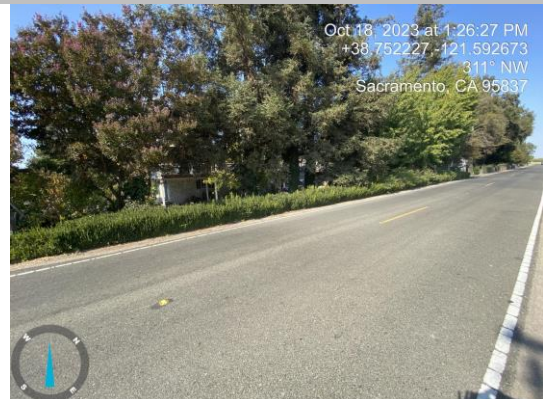
Photo 1 of 1 : FA\_2023\_RD1000\_31\_122\_20231023\_00283.jpg

View taken from the crown facing upstream looking at the waterward levee slope at the landscaping (Fall 2023).

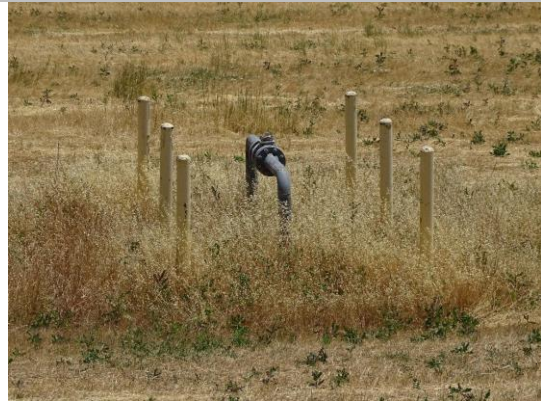
Photo 3 of 3 : UCIP\_FA\_2023\_80954\_116497.jpg

LS view: Close-up view of shut-off valve approximately 40 feet off toe.

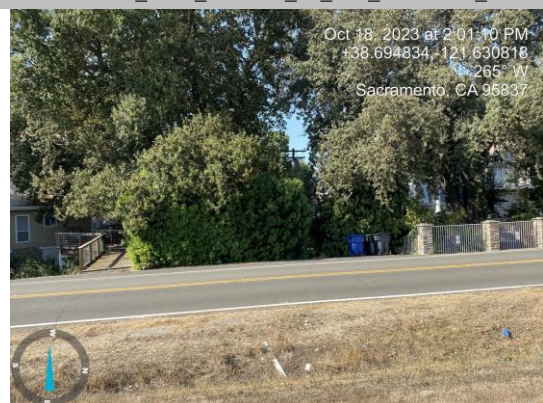
Photo 1 of 1 : FA\_2023\_RD1000\_31\_216\_20231025\_00286.jpg

View of landscaping on the waterside slope (Fall 2023).

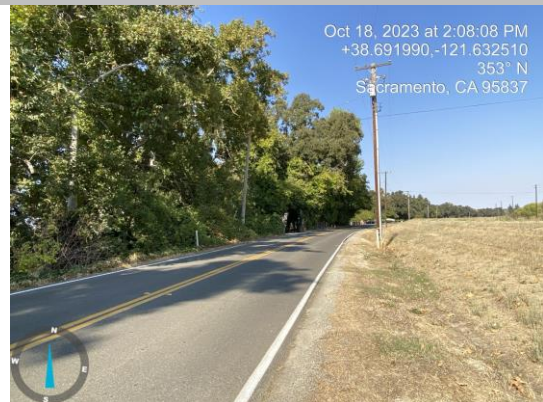
Photo 1 of 1 : FA\_2023\_RD1000\_31\_102\_20231025\_00288.jpg

View taken from the crown facing upstream looking at the waterward levee slope at the landscaping (Fall 2023).

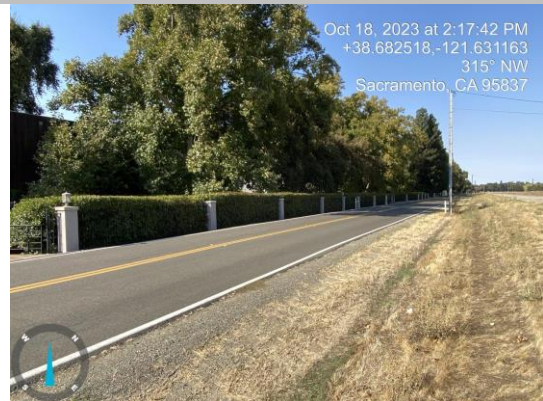
Photo 1 of 1 : FA\_2023\_RD1000\_31\_95\_20231025\_00290.jpg

View looking at waterside landscape vegetation that is blocking access and visibility to the levee (Fall 2023).

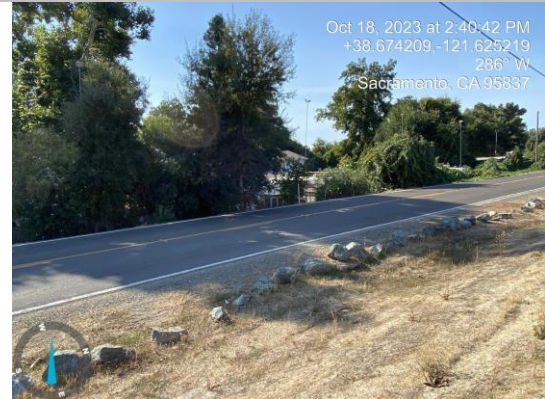
Photo 1 of 1 : FA\_2023\_RD1000\_31\_219\_20231025\_00291.jpg

View of landscaping on the waterside slope (Fall 2023).

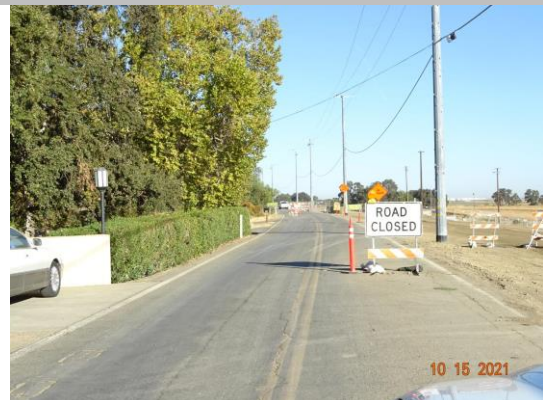
Photo 1 of 1 : FA\_2023\_RD1000\_31\_11\_20231016\_00011.jpg

View of construction in Reach B looking upstream, Fall 2021.

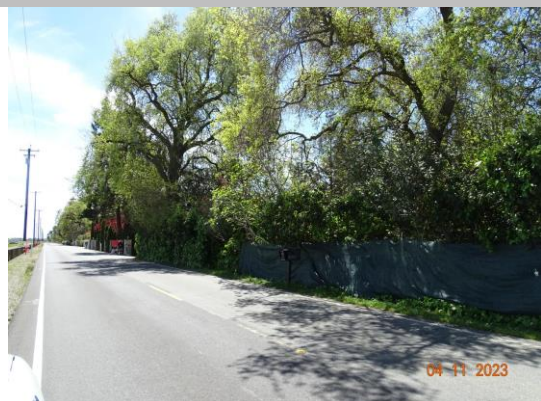
Photo 1 of 1 : FA\_2023\_RD1000\_31\_48\_20231016\_00026.jpg

View taken from the crown facing downstream looking at the waterward levee slope at the landscaping (Spring 2023).

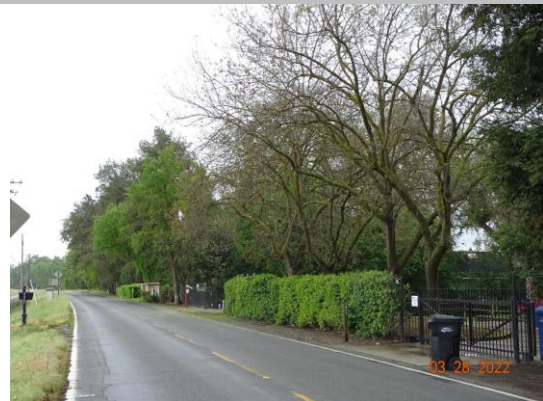
Photo 1 of 1 : FA\_2023\_RD1000\_31\_35\_20231016\_00020.jpg

View of the landscaping on the waterside levee slope.

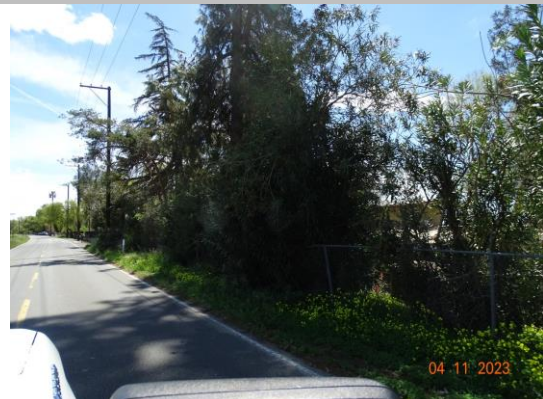
Photo 1 of 1 : FA\_2023\_RD1000\_31\_3\_20231016\_00002.jpg

View taken from the crown facing downstream looking at the waterward levee slope at landscaping (Spring 2023).

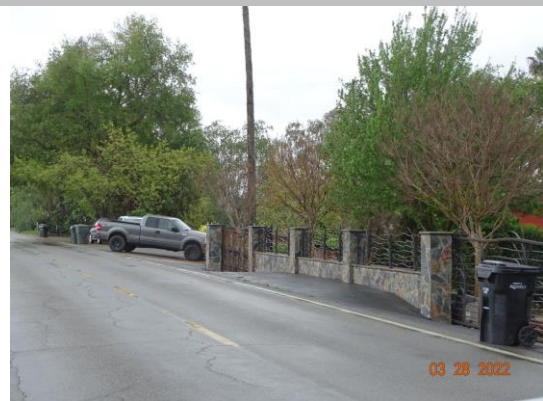
Photo 1 of 1 : FA\_2023\_RD1000\_31\_32\_20231016\_00019.jpg

View on waterside looking downstream of a rock and wrought iron fence that partially blocks visibility and access.

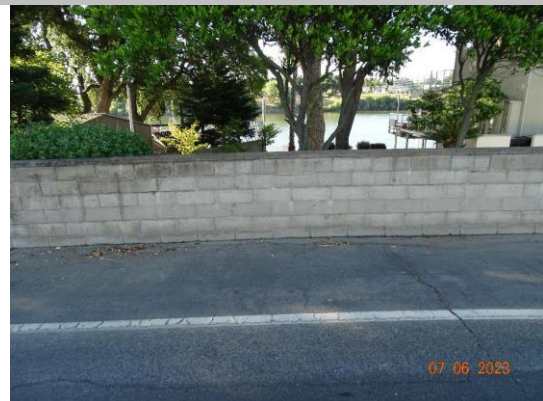
Photo 3 of 3 : UCIP\_FA\_2023\_80993\_117039.jpg

WS view: Brick and mortar wall on the shoulder looking from crown.

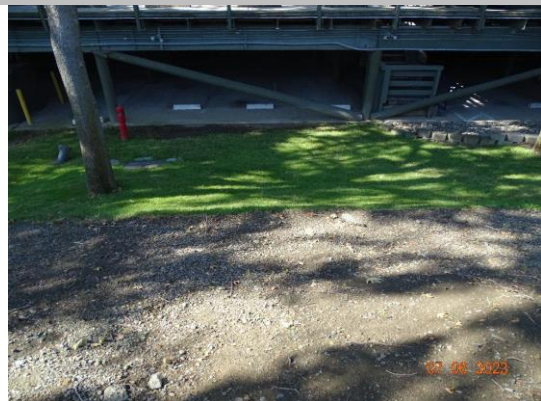
Photo 3 of 3 : UCIP\_FA\_2023\_81328\_117313.jpg

WS view: General overview looking from crown; unsure if standpipes located 10 feet off toe (left) is related to crossing.

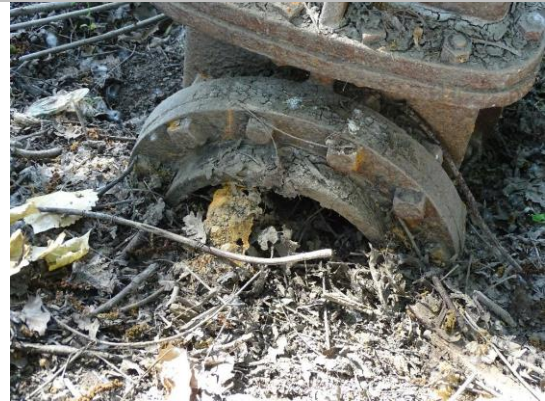
Photo 2 of 3 : UCIP\_FA\_2023\_80395\_116054.jpg

WS view: Close-up view of missing pipe section.

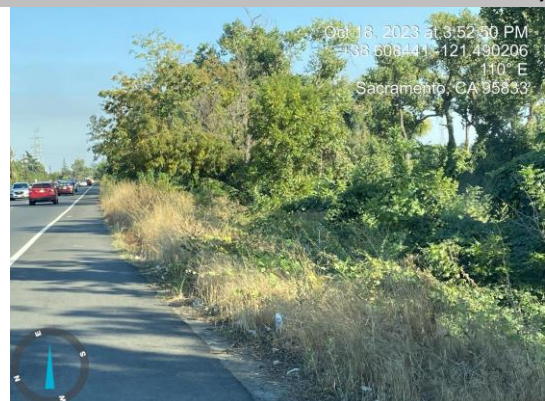
Photo 1 of 1 : FA\_2023\_RD1000\_32\_4\_20231025\_00007.jpg

View of vegetation on the waterside slope (Fall 2023).

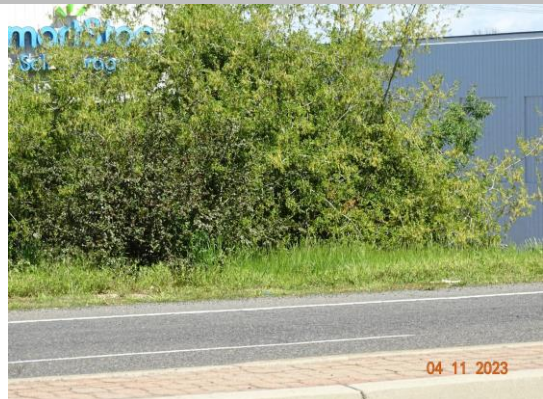
Photo 1 of 1 : FA\_2023\_RD1000\_32\_1\_20231016\_00001.jpg

View of starter trees on the landside slope, Spring 2023.

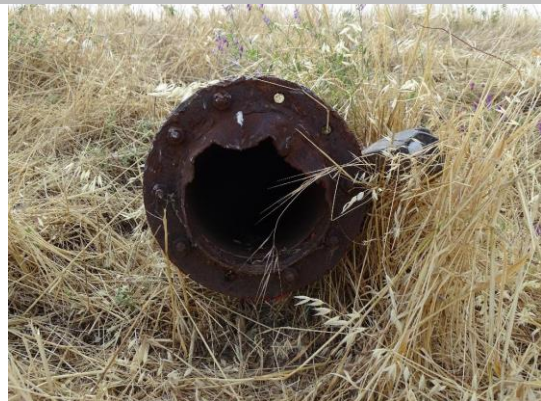
Photo 1 of 2 : UCIP\_FA\_2023\_80532\_116187.jpg

LS view: Pipe daylights on slope and is opened.

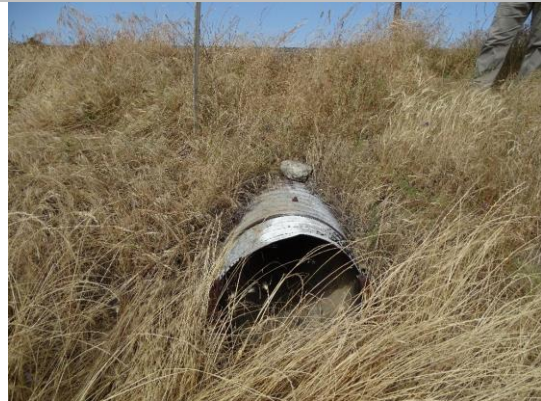
Photo 1 of 1 : UCIP\_FA\_2023\_80456\_116229.jpg

WS view: Pipe outlet at toe looking toward levee; missing flap gate.

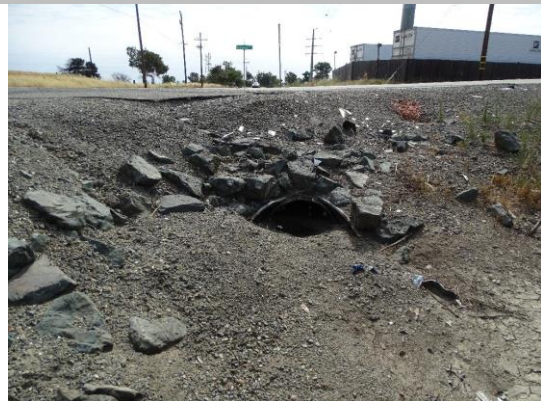
Photo 1 of 2 : UCIP\_FA\_2023\_80535\_116233.jpg

LS view: Pipe inlet at toe approximately 60% filled with sediment; looking toward levee.

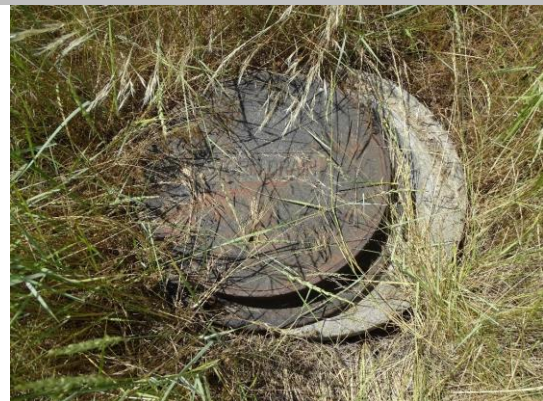
Photo 1 of 1 : UCIP\_FA\_2023\_80472\_116267.jpg

LS view: 36-inch outside diameter manhole present at toe.
