Flood Control Project Maintenance Levee Inspections

Fall 2024 Levee Maintenance Deficiency Summary Report

Sacramento River Basin

Reclamation District No. 1000 Natomas

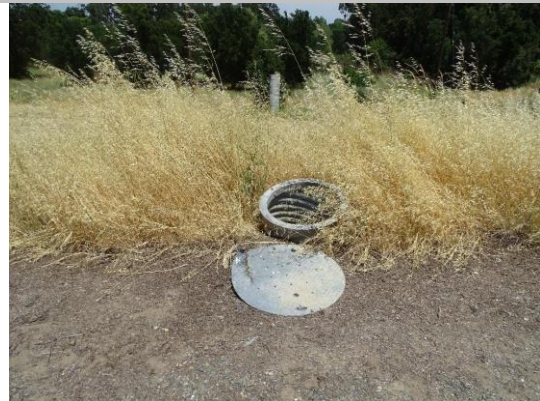
Photo 1 of 3 : UCIP_FA_2024_81707_118466.jpg

DS_ID:25820
FS_ID:81707
EP_NO: 4722
Repair Type: Non-Urgent
EVAL Issue: 4b, Safety Issue
Crossing Status: Found
UCIP Comments: 06/08/2023 Record updated to Non-Urgent. A minor (less than 1/2-foot) surface erosion located waterward of Garden Highway. Lid was not closed on landside riser creating a safety hazard. (M. Thao - DWR UCIP)
FIELD_STRUCT_DESC: [Cummings River Pump Crossing] 10-inch steel irrigation pipe through the levee, 2.0 feet below the crown. Slant pump on a steel pile structure on the river bank. Wooden power pole with 3-inch electrical conduit located on the waterside (WS) shoulder of the Garden Highway. (10-inch pipe authorized under Permit No. 4722, 1966 - E.L. Kearns).
FS Date: 6/8/2023

LS view: 24-inch CMP riser with missing lid on the shoulder.

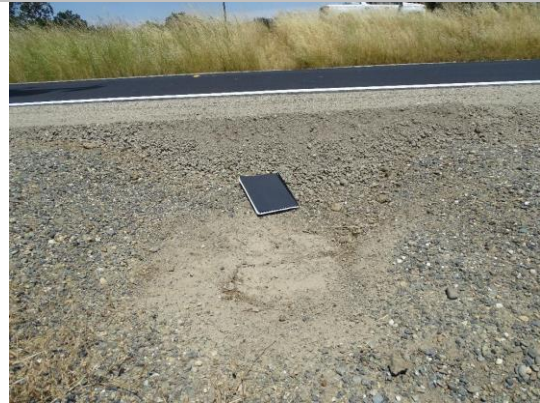
Photo 3 of 3 : UCIP_FA_2024_81707_118470.jpg

WS view: Different angle of the minor (less than 1/2 foot) surface erosion on waterward shoulder of the Garden Highway.

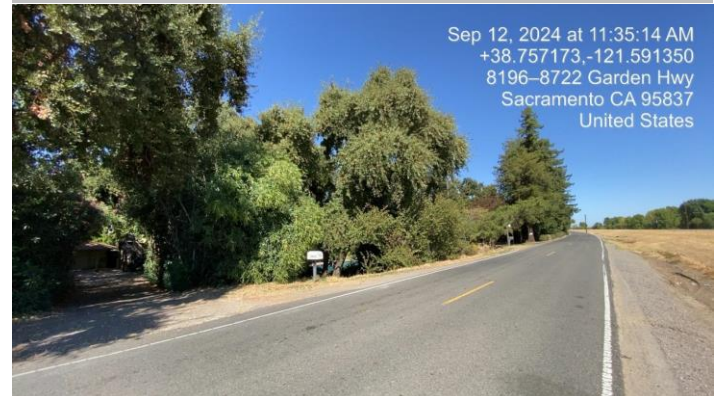
Photo 1 of 1 : FA_2024_RD1000_31_134_20240916_00463.jpg

View of landscape vegetation on the waterside slope (Fall 2024).

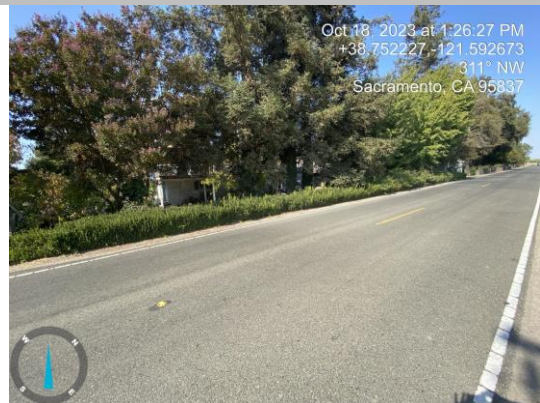
Photo 1 of 1 : FA_2024_RD1000_31_122_20240911_00060.jpg

View taken from the crown facing upstream looking at the waterward levee slope at the landscaping (Fall 2023).

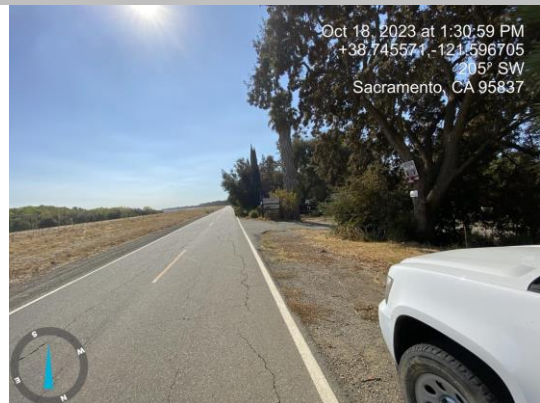
Photo 1 of 1 : FA_2024_RD1000_31_211_20240911_00071.jpg

View of vegetation (bushes) along the waterward slope and looking downstream (Fall 2023).

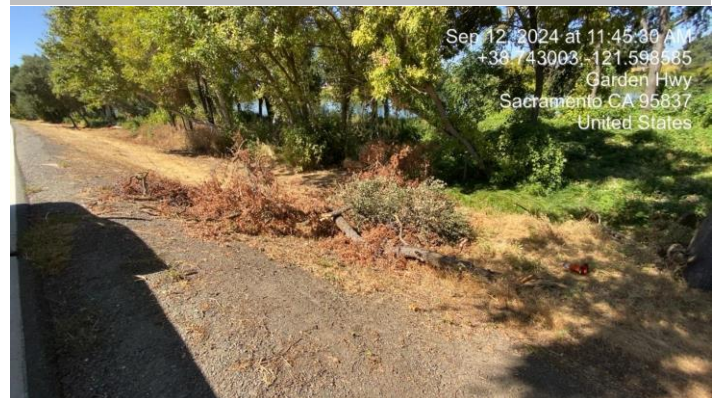
Photo 1 of 1 : FA_2024_RD1000_31_200_20240916_00464.jpg

View tree limbs and branches on the waterside slope (Fall 2024).

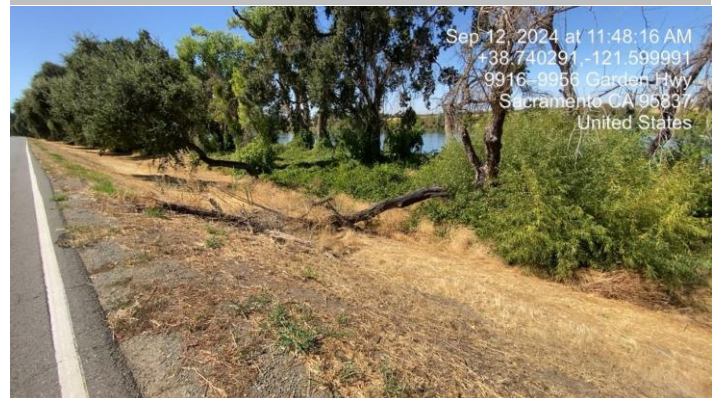
Photo 1 of 1 : FA_2024_RD1000_31_201_20240916_00465.jpg

View of tree limb on the waterside slope (Fall 2024).

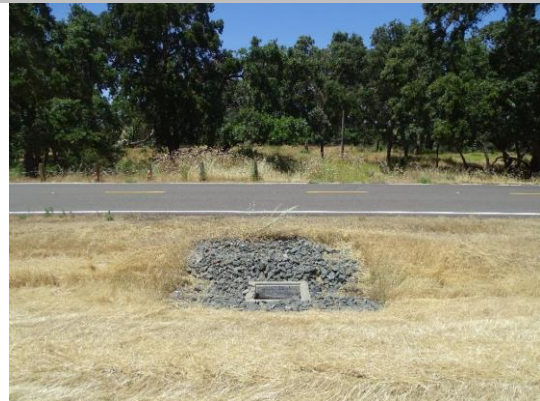
Photo 1 of 2 : UCIP_FA_2024_81713_118483.jpg

WS view: Drainage inlet without a cover located between the setback levee and Garden Highway; looking from crown.

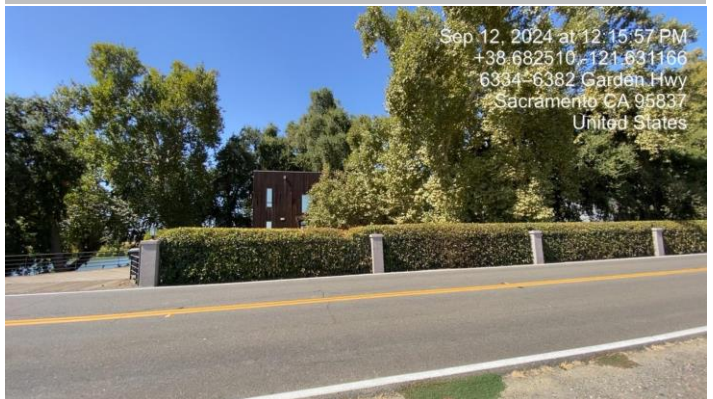
Photo 1 of 1 : FA_2024_RD1000_31_94_20240916_00467.jpg

View looking at waterside landscape vegetation that is blocking access and visibility to the levee (Fall 2024).

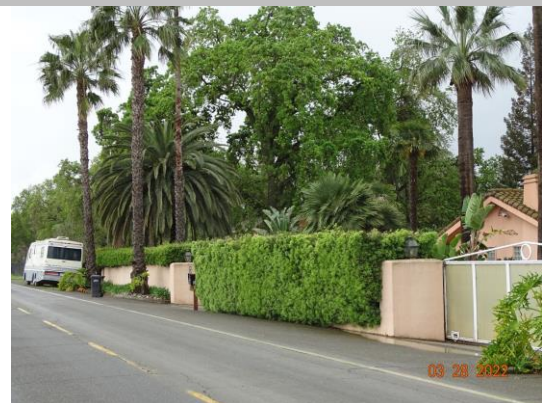
Photo 1 of 1 : FA_2024_RD1000_31_43_20240911_00026.jpg

This photo was taken from the crown facing downstream looking down the waterward levee slope at an unacceptable fence (Spring 2022).

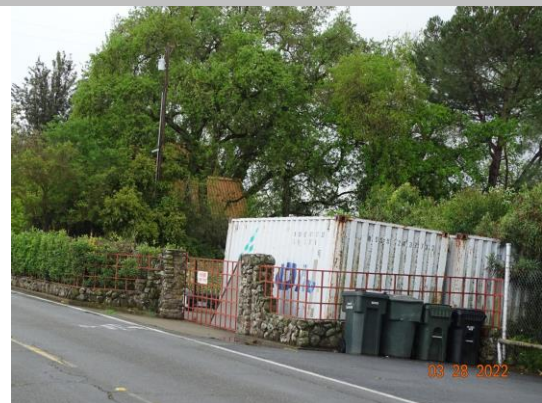
Photo 1 of 1 : FA_2024_RD1000_31_53_20240911_00032.jpg

View of storage container from the landside of the crown facing the waterside of the levee (Spring 2022).

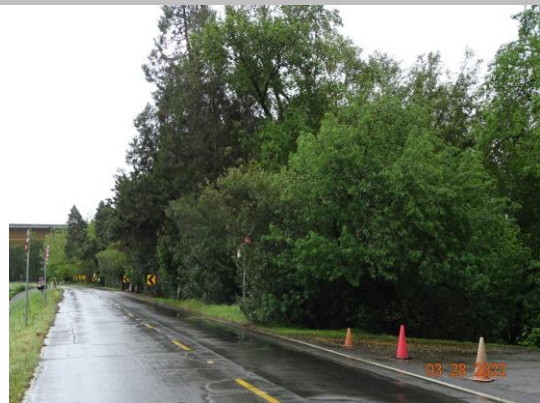
Photo 1 of 1 : FA_2024_RD1000_31_19_20240911_00013.jpg

View on waterside looking downstream of property covered by Oleander Bushes (Spring 2022).

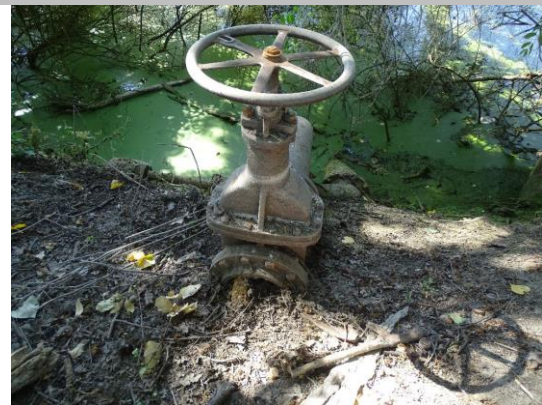
Photo 1 of 3 : UCIP_FA_2024_80395_116053.jpg

WS view: Gate valve with missing pipe section.

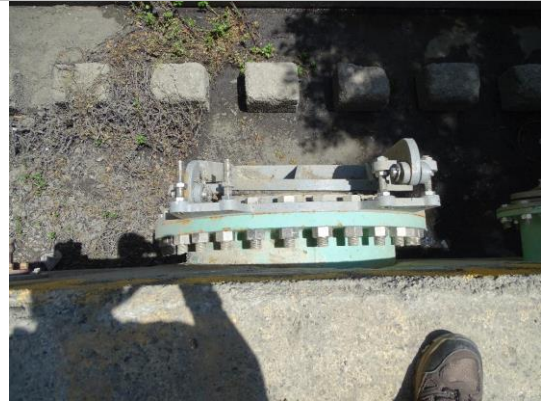
Photo 2 of 2 : UCIP_FA_2024_80527_116154.jpg

WS view: Looking down at the 36-inch pipe flap gate hanging loose and being held on by only one hinge.

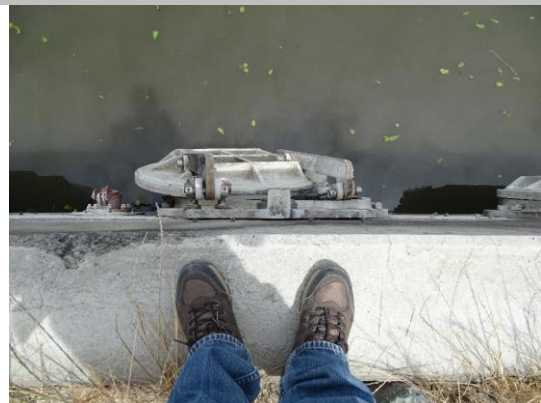
Photo 1 of 2 : UCIP_FA_2024_80483_116292.jpg

WS view: Loose flap gate being held by hinge.

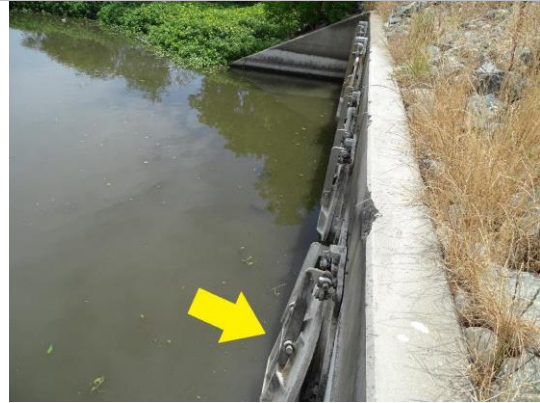
Photo 2 of 2 : UCIP_FA_2024_80483_116293.jpg

WS view: Concrete headwall and loose flap gate on toe; yellow arrow is pointing to crossing associated with this record.

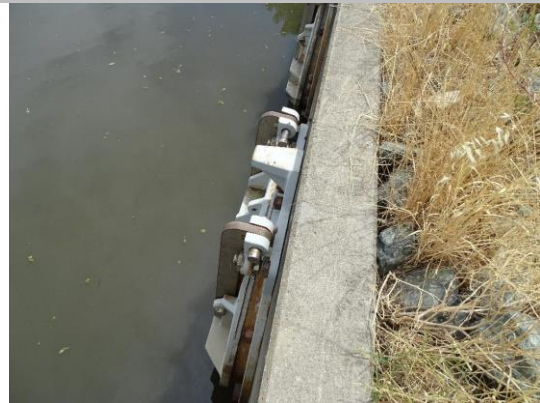
Photo 1 of 2 : UCIP_FA_2024_80485_116298.jpg

WS view: Flap gate with loose hinge pin.

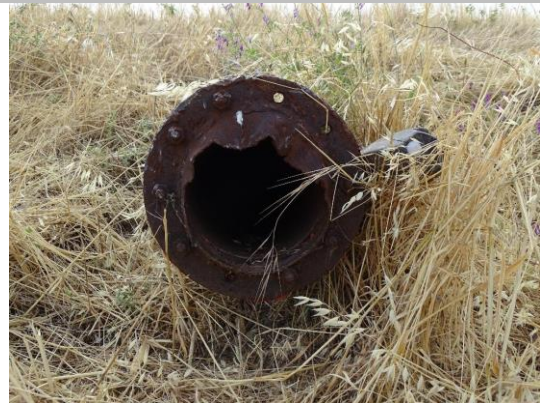
Photo 1 of 2 : UCIP_FA_2024_80532_116187.jpg

LS view: Pipe daylights on slope and is opened.

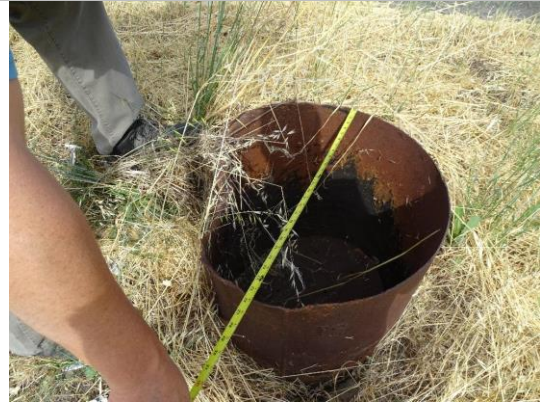
Photo 1 of 1 : UCIP_FA_2024_80533_116194.jpg

WS view: Close-up view of the 24-inch steel riser with no cover on waterside shoulder.

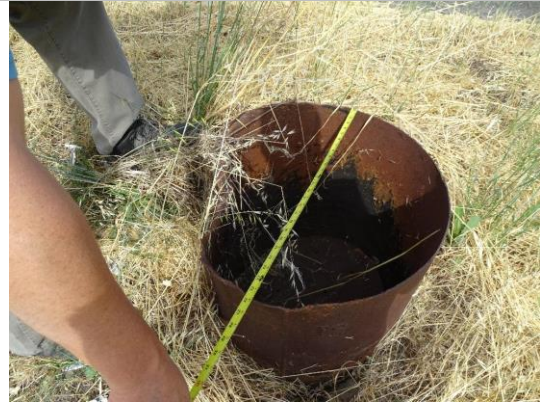
Photo 1 of 1 : UCIP_FA_2024_84543_124879.jpg

WS view: Close-up view of the 24-inch steel riser with no cover on waterside shoulder.

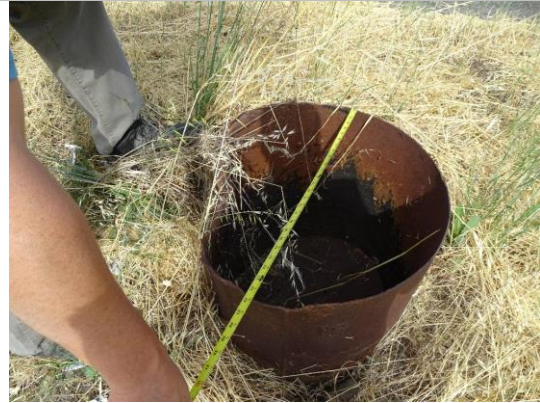
Photo 1 of 1 : UCIP_FA_2024_84544_124887.jpg

WS view: Close-up view of the 24-inch steel riser with no cover on waterside shoulder.

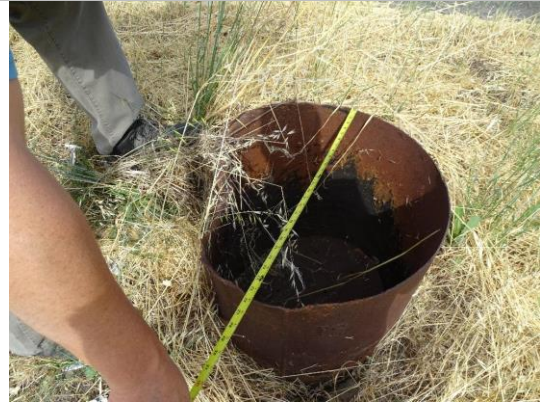
Photo 1 of 1 : UCIP_FA_2024_84545_124895.jpg

WS view: Close-up view of the 24-inch steel riser with no cover on waterside shoulder.

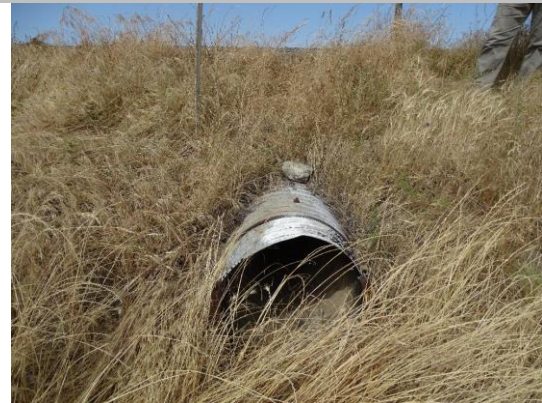
Photo 1 of 1 : UCIP_FA_2024_84437_116229.jpg

WS view: Pipe outlet at toe looking toward levee; missing flap gate.

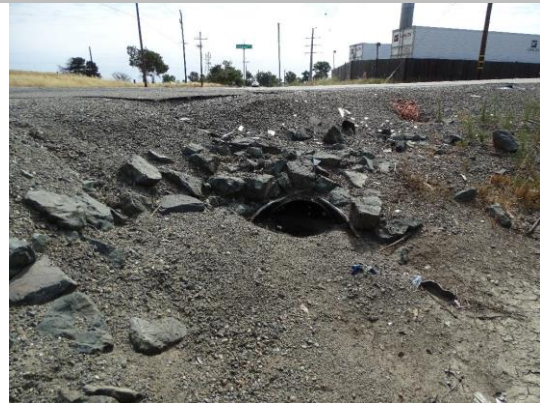
Photo 1 of 2 : UCIP_FA_2024_80535_116233.jpg

LS view: Pipe inlet at toe approximately 60% filled with sediment; looking toward levee.
