**Flood Control Project Maintenance
Levee Inspections**

Maintenance Issue Types Only, Levee Inspection Report By Mile - Fall 2014

Reclamation District No. 1000 Natomas

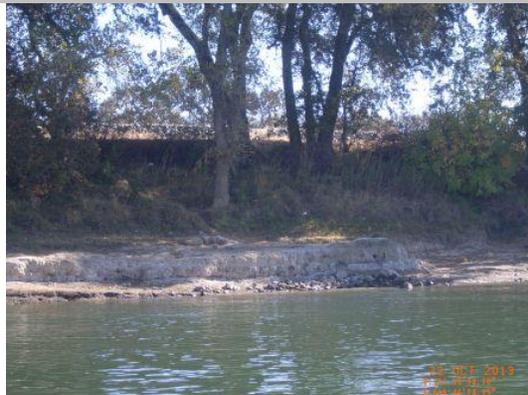
Photo 1 of 1 : FA_2014_RD1000_31_3_20141103_00001.jpg

| Inspector Comments: 1997 - Very cohesive toe. 2005 - Site was staked and rock was stockpiled along the top of the bank. 2010 - New adjacent levee under construction. 2011 - New animal burrow. 2013: No observed changes. [2013 Site ID: SAC_78-3_L] | | | | | |

USACE 2013 Photo #1

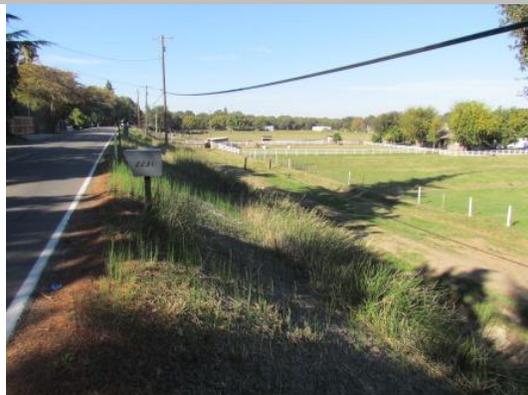
Photo 1 of 1 : FA_2014_RD1000_31_12_20141124_00006.jpg

This photo was taken from the crown facing upstream looking down the landward levee slope at a strip of joint grass the requires annual maintenance. Fall 2014.

| Control annual grass and weeds on the levee slopes and easements. | | | | | |

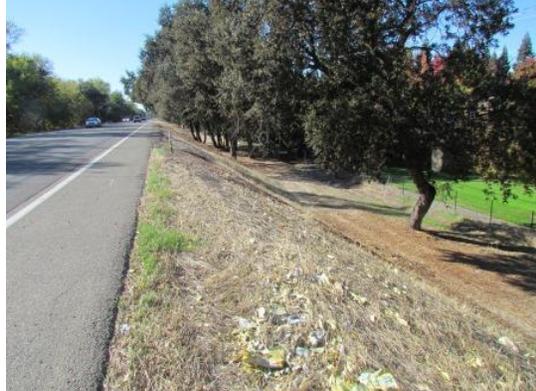
Photo 1 of 1 : FA_2014_RD1000_32_3_20141124_00004.jpg

This photo was taken from the crown facing west looking down the landward levee slope at acceptable vegetation maintenance. Fall 2014.

| Control annual grass and weeds on the levee slopes and easements. | | | | | |

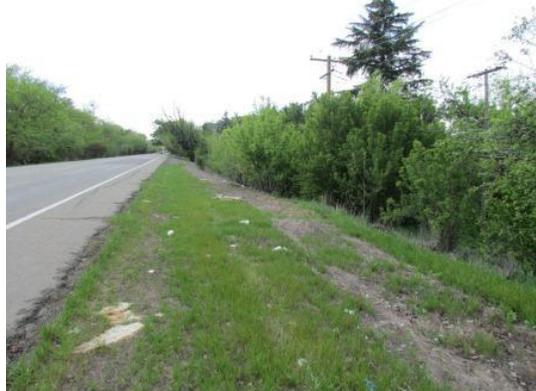
Photo 1 of 1 : FA_2014_RD1000_32_2_20141103_00003.jpg

This photo was taken from the crown facing west looking down the landward levee slope at trees requiring maintenance. Spring 2014.

| Thin trees to allow visibility of the ground and room to flood fight. | | | | | |

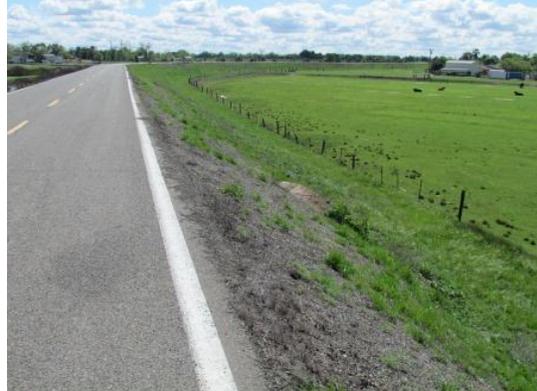
Photo 1 of 2 : FA_2014_RD1000_33_1_20141103_00001.jpg

This photo was taken from the crown facing south looking down the landward slope at a rodent hole requiring maintenance. Spring 2014.

| Exterminate rodents and backfill and compact or grout burrows. | | | | | |

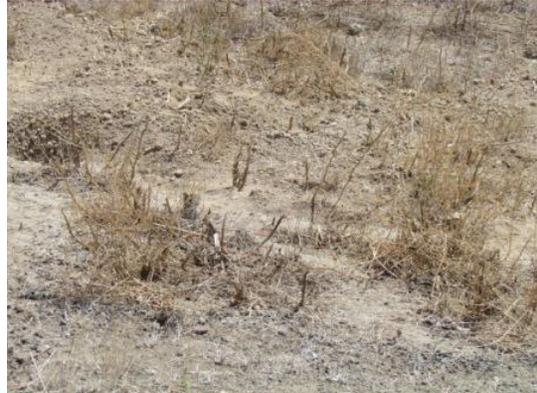
Photo 2 of 2 : FA_2014_RD1000_33_1_20141103_00002.jpg

This photo was taken from the levee crown looking down the landward slope at a squirrel poking its head out of a hole.

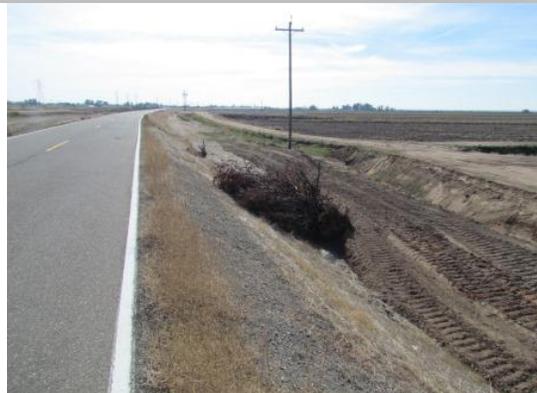
Photo 1 of 1 : FA_2014_RD1000_33_6_20141124_00009.jpg

| Tree or limb | | | | | |

This photo was taken from the crown facing south looking down the landward levee slope at a brush pile that should be removed. Fall 2014.
