**Flood Control Project Maintenance
Levee Inspections**

Maintenance Issue Types Only, Levee Inspection Report By Mile - Fall 2015

Reclamation District No. 1000 Natomas

Waterway	Bank	Unit Miles	Inspection Start/End	Inspector
Unit No. 01 Sacramento River	Left	18.28	11/03/2015 11/03/2015	Maksim Khashchuk

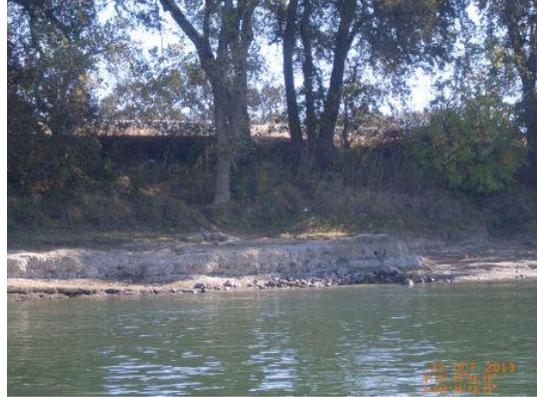
USACE 2013 Photo #1

LM Start	0.48	Rating **	M	Issue No.	3
LM End	0.61	Issue Type +	Ma	Location *	WS
Category	Supplemental			GPS Latitude/Longitude	
				Start	End
Item	2015 USACE Erosion Survey, DRAFT			38.774507 °	38.772921 °
				-121.598865 °	-121.597788 °
DWR ID					
Action/Comments					
Inspector Comments: 1997 - Very cohesive toe. 2005 - Site was staked and rock was stockpiled along the top of the bank. 2010 - New adjacent levee under construction. 2011 - New animal burrow. 2015: No observed changes. [2015 Site ID: SAC_78-3_L]

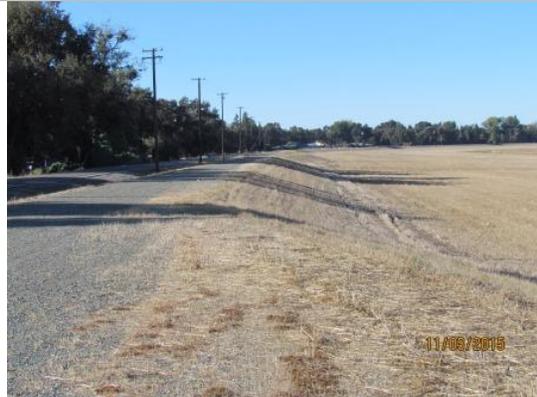
Photo 1 of 1 : FA_2015_RD1000_31_12_20151112_00036.jpg

View of the acceptable vegetation control on the landside levee slope.

LM Start	11.81	Rating **	A	Issue No.	12
LM End	11.81	Issue Type +	Ma	Location *	LS
Category	Earthen Levee			GPS Latitude/Longitude	
				Start	End
Item	Vegetation			38.648797 °	38.648797 °
				-121.579782 °	-121.579782 °
DWR ID	DWR_RD1000_01_f_2015_12				
Action/Comments					
Control annual grass and weeds on the levee slopes and easements.

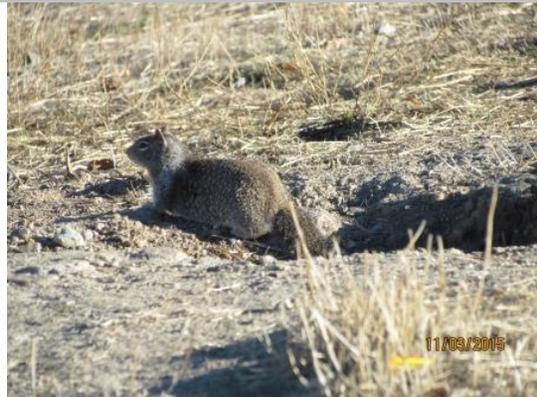
Photo 1 of 2 : FA_2015_RD1000_33_19_20151112_00014.jpg

View of the rodent on the waterside levee slope ready to retreat into the den, penetrating the levee prism.

LM Start	0.38	Rating **	M	Issue No.	19
LM End	0.38	Issue Type +	Ma	Location *	WS
Category	Earthen Levee			GPS Latitude/Longitude	
				Start	End
Item	Animal Control			38.610854 °	38.610854 °
				-121.467961 °	-121.467961 °
DWR ID	DWR_RD1000_03_f_2015_19				
Action/Comments					
Exterminate rodents and backfill and compact or grout burrows.

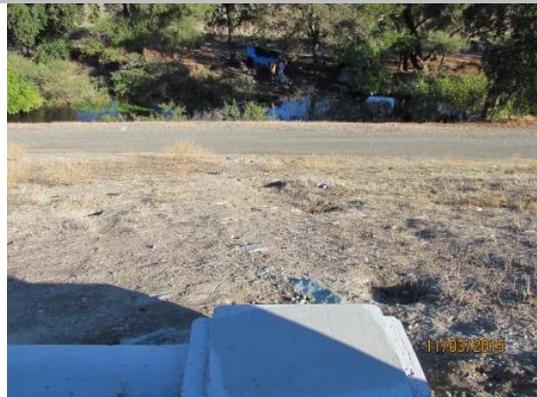
Photo 2 of 2 : FA_2015_RD1000_33_19_20151112_00015.jpg

View of the rodent holes on the waterside levee slope.

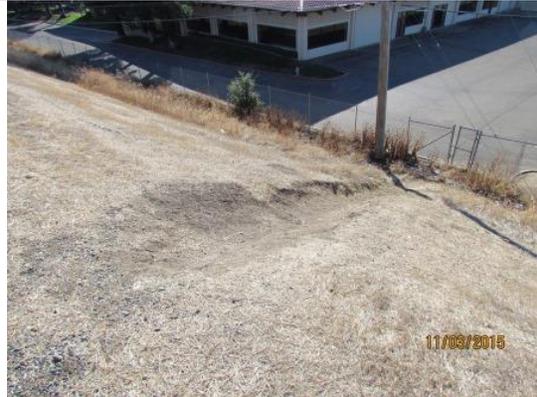
Photo 1 of 1 : FA_2015_RD1000_33_15_20151112_00013.jpg

View of the landside levee slope damaged by foot traffic.

LM Start	2.36	Rating **	M	Issue No.	15
LM End	2.36	Issue Type +	Ma	Location *	LS
Category	Earthen Levee		GPS Latitude/Longitude		
			Start	End	
Item	Slope Stability		38.639326 °	38.639326 °	
			-121.473107 °	-121.473107 °	
DWR ID	DWR_RD1000_03_f_2015_15				
Action/Comments					
Repair the levee slope damaged by foot traffic and prevent access where possible.

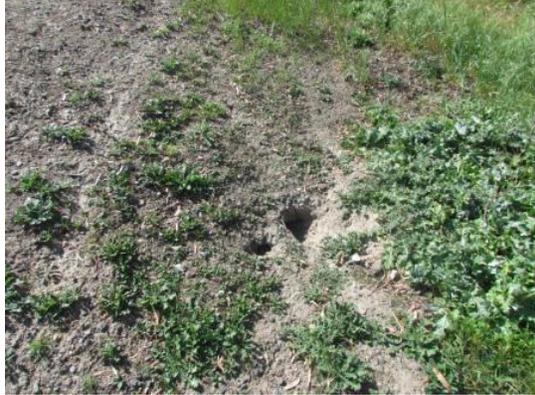
Photo 1 of 1 : FA_2015_RD1000_33_12_20151103_00010.jpg

LM Start	3.29	Rating **	A/W	Issue No.	12
LM End	3.29	Issue Type +	Ma	Location *	LS
Category	Earthen Levee		GPS Latitude/Longitude		
			Start	End	
Item	Animal Control		38.652670 °	38.652670 °	
			-121.475588 °	-121.475588 °	
DWR ID	DWR_RD1000_03_s_2015_12				
Action/Comments					
No rodents visible, but rodent burrows visible; need to backfill and compact or grout burrows.

This photo was taken looking at the landside facing downstream.

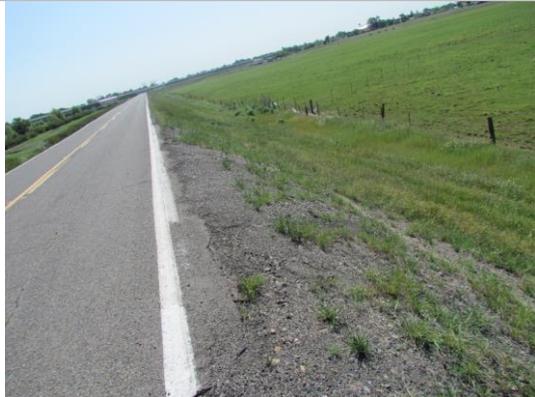
Photo 1 of 3 : FA_2015_RD1000_33_1_20151103_00001.jpg

Updated view taken facing the landside looking upstream. Rodent holes have been filled and no new activity was observed.

LM Start	4.78	Rating **	A/W	Issue No.	1
LM End	4.89	Issue Type +	Ma	Location *	LS
Category	Earthen Levee		GPS Latitude/Longitude		
			Start	End	
Item	Animal Control		38.672913 °	38.673685 °	
			-121.481364 °	-121.483115 °	
DWR ID	DWR_RD1000_03_f_2013_1				
Action/Comments					
Exterminate rodents and backfill and compact or grout burrows.

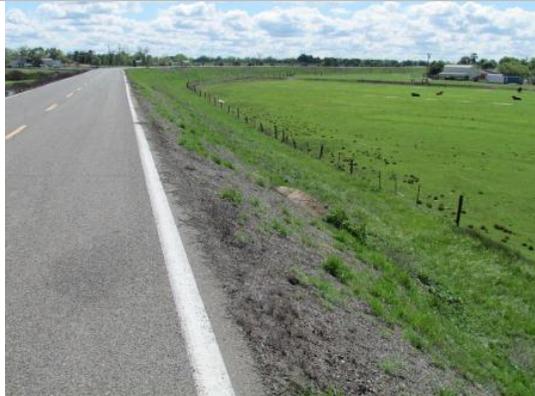
Photo 2 of 3 : FA_2015_RD1000_33_1_20151103_00002.jpg

This photo was taken from the crown facing south looking down the landward slope at a rodent hole requiring maintenance. Spring 2014.

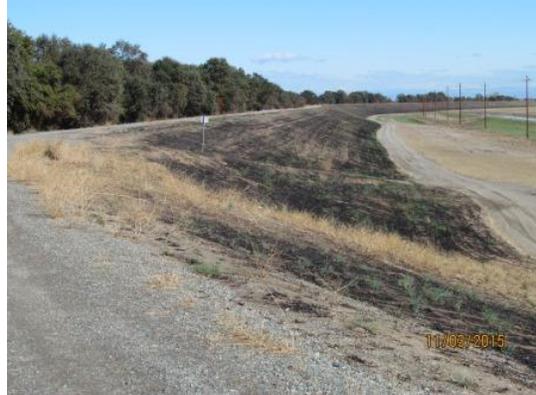
Photo 1 of 1 : FA_2015_RD1000_34_1_20151112_00001.jpg

View of the acceptable vegetation control on the landside levee slope.

LM Start	0.19	Rating **	A	Issue No.	1
LM End	4.25	Issue Type +	Ma	Location *	LS
Category	Earthen Levee		GPS Latitude/Longitude		
			Start	End	
Item	Vegetation		38.818972 °	38.781306 °	
			-121.546581 °	-121.603435 °	
DWR ID	DWR_RD1000_04_f_2015_1				
Action/Comments					
Control annual grass and weeds on the levee slopes and easements.
