**Flood Control Project Maintenance
Levee Inspections**

Maintenance Issue Types Only, Levee Inspection Report By Mile - Spring 2015

Reclamation District No. 1000 Natomas

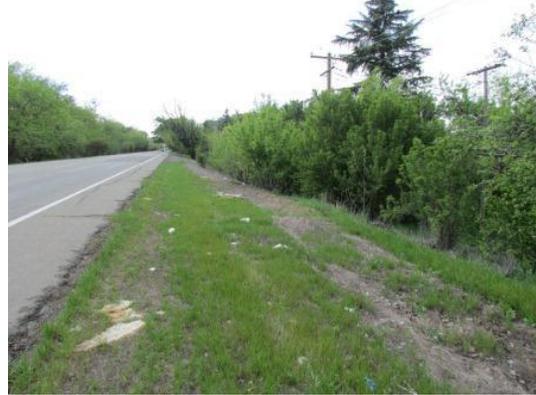
Photo 1 of 1 : SP_2015_RD1000_32_2_20150330_00003.jpg

| Item | Trim / Thin Trees | | | 38.607978 ° | 38.607978 ° |

This photo was taken from the crown facing west looking down the landward levee slope at trees requiring maintenance. Spring 2014.

| Thin trees to allow visibility of the ground and room to flood fight. | | | | | |

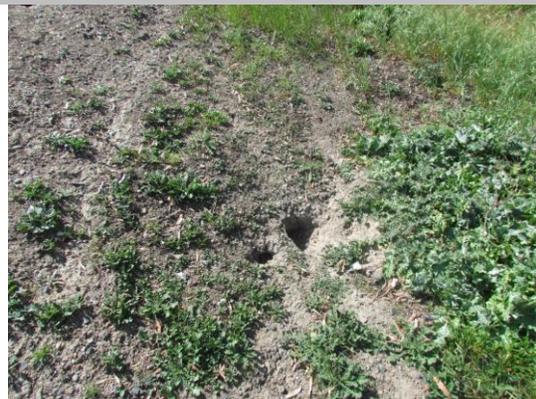
Photo 1 of 1 : SP_2015_RD1000_33_12_20150407_00010.jpg

| Item | Animal Control | | 38.652670 ° | 38.652670 ° | |

This photo was taken looking at the landside facing downstream.

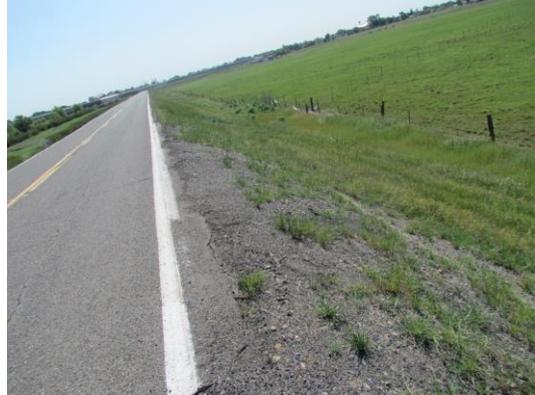
Photo 1 of 3 : SP_2015_RD1000_33_1_20150407_00011.jpg

| Item | Animal Control | | | 38.672913 ° | 38.673685 ° |

Updated view taken facing the landside looking upstream. Rodent holes have been filled and no new activity was observed.

| Exterminate rodents and backfill and compact or grout burrows. | | | | | |

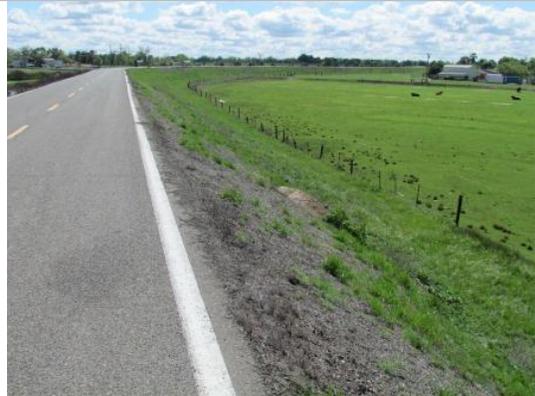
Photo 2 of 3 : SP_2015_RD1000_33_1_20150330_00001.jpg

This photo was taken from the crown facing south looking down the landward slope at a rodent hole requiring maintenance. Spring 2014.

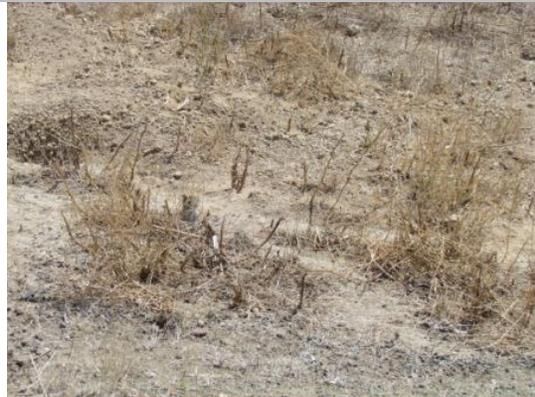
Photo 3 of 3 : SP_2015_RD1000_33_1_20150330_00002.jpg

This photo was taken from the levee crown looking down the landward slope at a squirrel poking its head out of a hole.

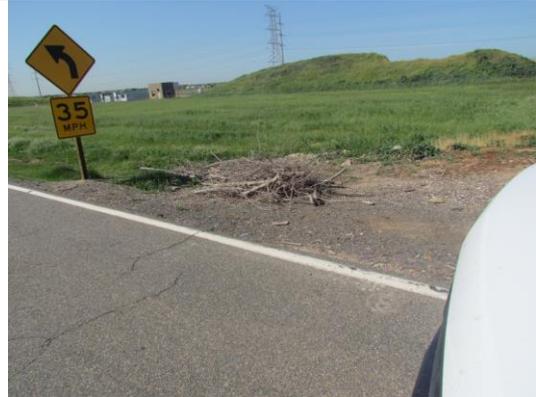
Photo 1 of 1 : SP_2015_RD1000_33_11_20150407_00012.jpg

| Item | Encroachments | | 38.677913 ° | 38.677913 ° | |
| Tree or limb | | | | | |

Taken on the landside facing upstream.

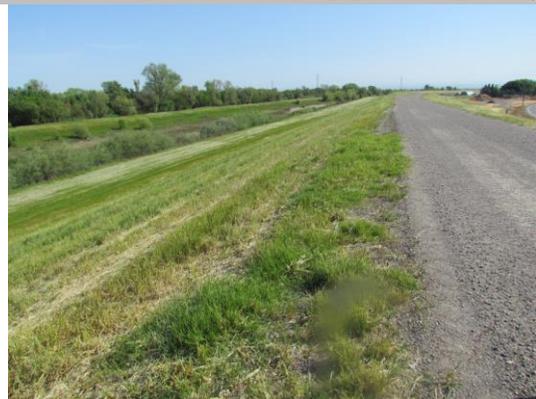
Photo 1 of 1 : SP_2015_RD1000_33_2_20150407_00013.jpg

| Item | Vegetation | | 38.822638 ° | 38.822638 ° | |

Taken on the waterside facing upstream.

| Control annual grass and weeds on the levee slopes and easements. | | | | | |

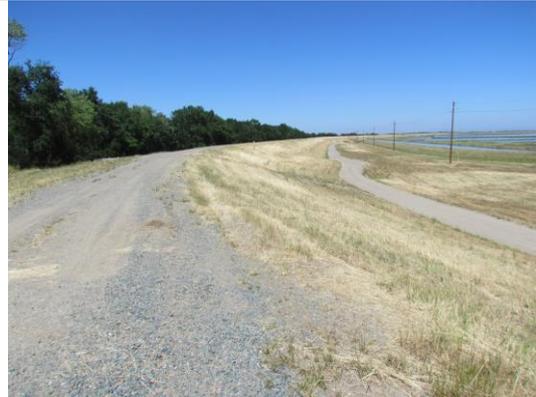
Photo 1 of 1 : SP_2015_RD1000_34_2_20150505_00001.jpg

| Item | Vegetation | | 38.820460 ° | 38.780695 ° | |

This view of the vegetation was taken on the landside facing downstream.

| Control annual grass and weeds on the levee slopes and easements. | | | | | |
