**Flood Control Project Maintenance
Levee Inspections
LMA District Cover Sheet
Spring 2011 Levee Inspection Results**

Reclamation District No. 1000 Natomas

Levee Inspection Report By Mile - Spring 2011

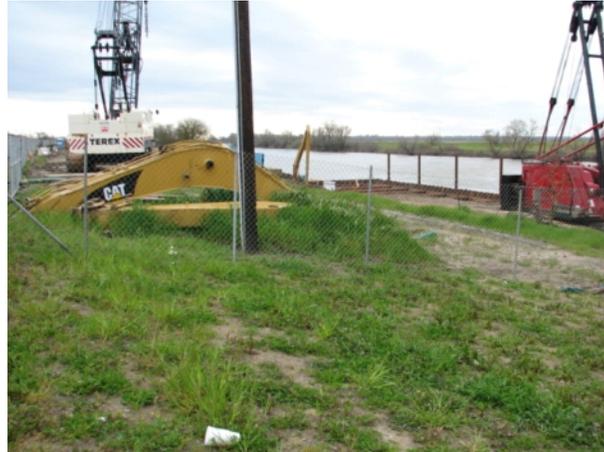
Levee Mile Report Line	3
Start Levee Mile	0.18
End Levee Mile	0.18
Location	Water Side
Category	Earthen Levee
Item	Vegetation
Levee mile 0.18, vegetation and construction on the waterside slope.	
cathom_s_20110404_115.jpg

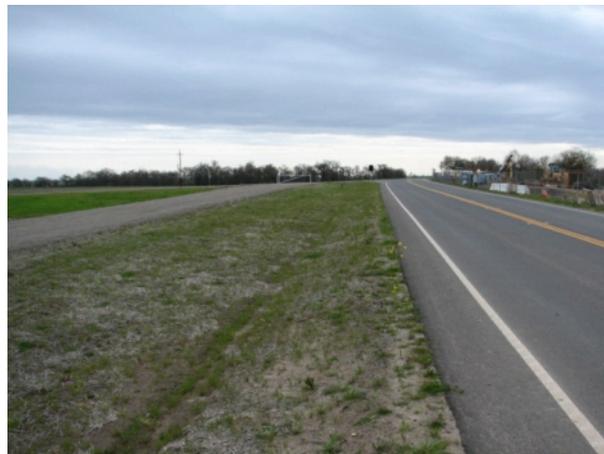
Levee Mile Report Line	4
Start Levee Mile	0.18
End Levee Mile	0.18
Location	Land Side
Category	Earthen Levee
Item	Vegetation
Levee mile 0.18, vegetation on the landside of the levee, also the new levee on the landside slope.	
cathom_s_20110404_116.jpg

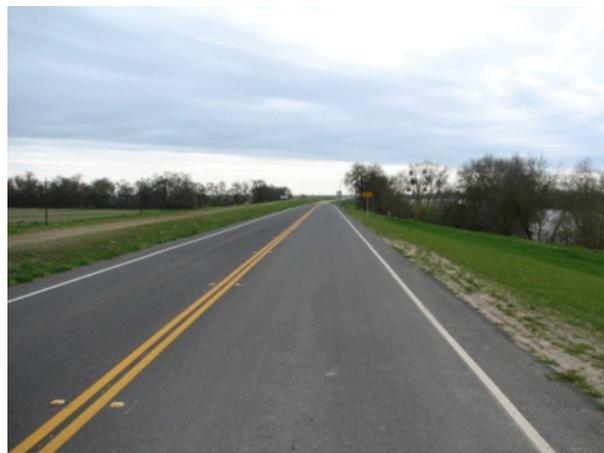
Levee Mile Report Line	5
Start Levee Mile	0.29
End Levee Mile	0.29
Location	Crown
Category	Earthen Levee
Item	Vegetation
Levee mile 0.29, this photo shows the new levee on the landside and the waterside vegetation.	
cathom_s_20110404_117.jpg

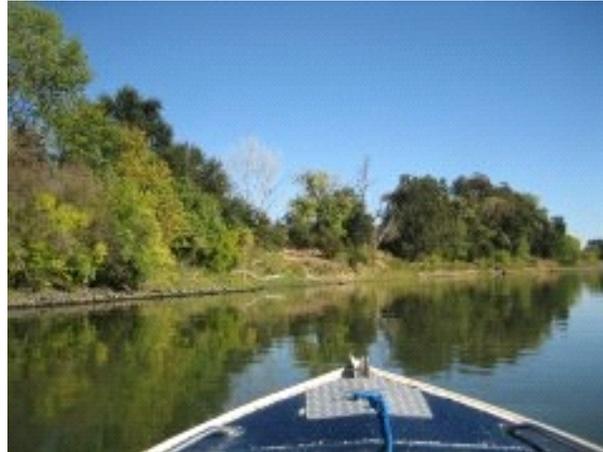
Levee Mile Report Line	6
Start Levee Mile	0.48
End Levee Mile	0.61
Location	Water Side
Category	Supplemental
Item	USACE Erosion Survey
2009: 15 ft berm, 2.5:1 slope, seepage, clays and silts, 4.89 ft/s [2009 SiteID:SAC_78-3_L]	
cathom_s_20110228_011.JPG

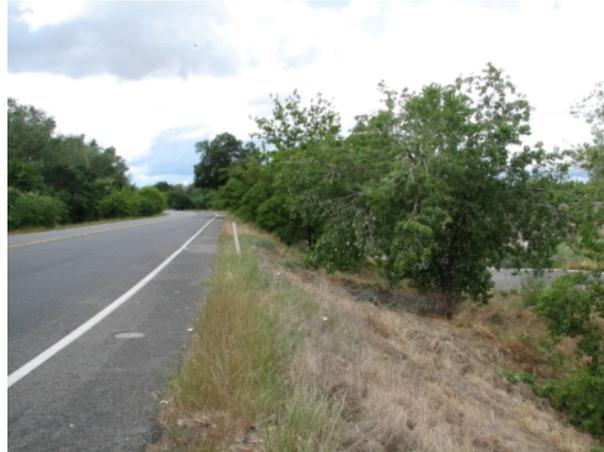
Levee Mile Report Line	1
Start Levee Mile	0.00
End Levee Mile	2.33
Location	Land Side
Category	Earthen Levee
Item	Encroachments
Land side encroachment, landscaping, levee mile 1.68.	
cathom_s_20110228_012.jpg

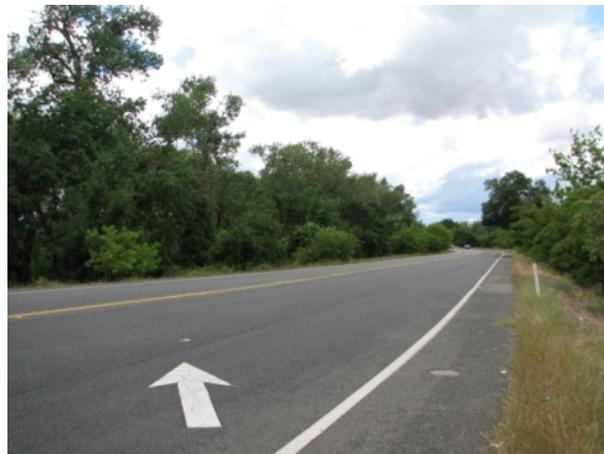
Levee Mile Report Line	2
Start Levee Mile	0.00
End Levee Mile	2.33
Location	Water Side
Category	Earthen Levee
Item	Encroachments
Water side encroachment, landscaping, levee mile 1.68.	
cathom_s_20110228_013.jpg

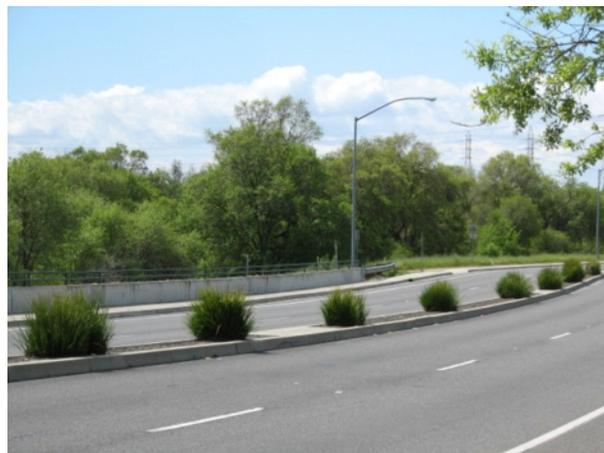
Levee Mile Report Line	3
Start Levee Mile	2.33
End Levee Mile	2.33
Location	Water Side
Category	Earthen Levee
Item	Vegetation
Levee mile 2.33, looking downstream at the vegetation on the waterside.	
cathom_s_20110411_132.jpg

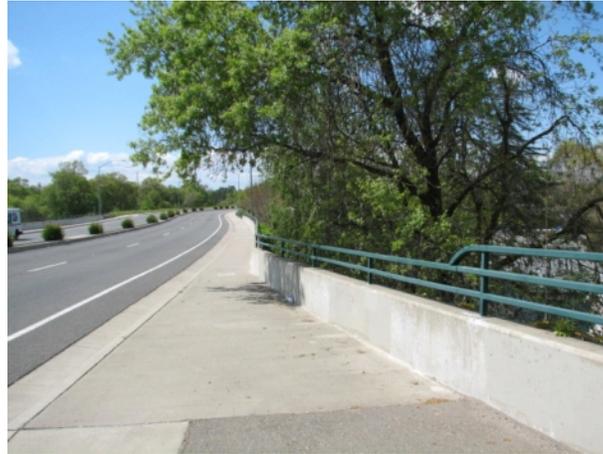
Levee Mile Report Line	4
Start Levee Mile	2.33
End Levee Mile	2.33
Location	Land Side
Category	Earthen Levee
Item	Vegetation
Levee mile 2.33, looking downstream at the vegetation on the landside.	
cathom_s_20110411_131.jpg

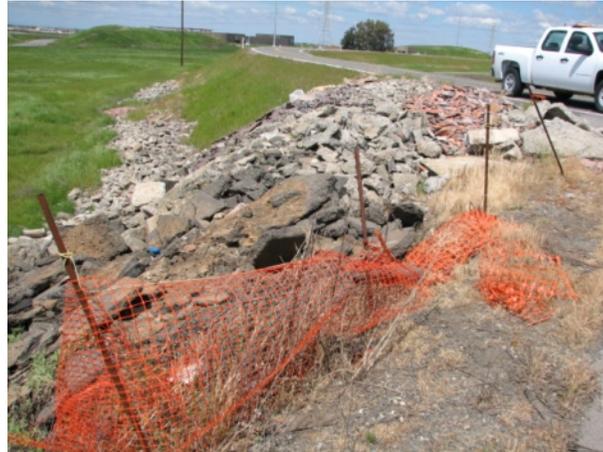
Levee Mile Report Line	7
Start Levee Mile	5.03
End Levee Mile	5.03
Location	Land Side
Category	Earthen Levee
Item	Encroachments
Levee mile 5.03, this is the landside shoulder and slope.	
cathom_s_20110411_130.jpg

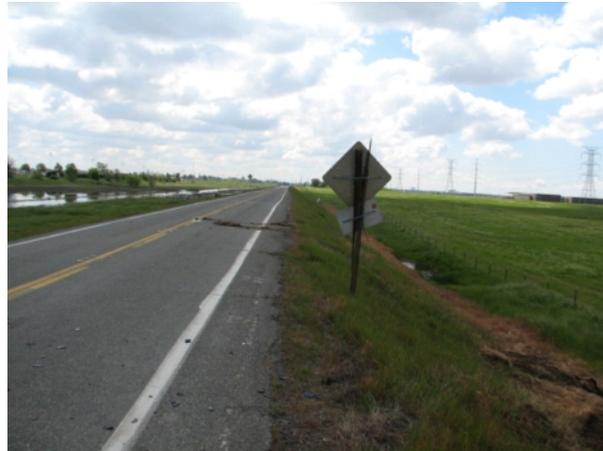
Levee Mile Report Line	8
Start Levee Mile	5.80
End Levee Mile	5.80
Location	Land Side
Category	Earthen Levee
Item	Vegetation
Levee mile 5.80, looking downstream at the vegetation on the landside slope.	
cathom_s_20110411_128.jpg

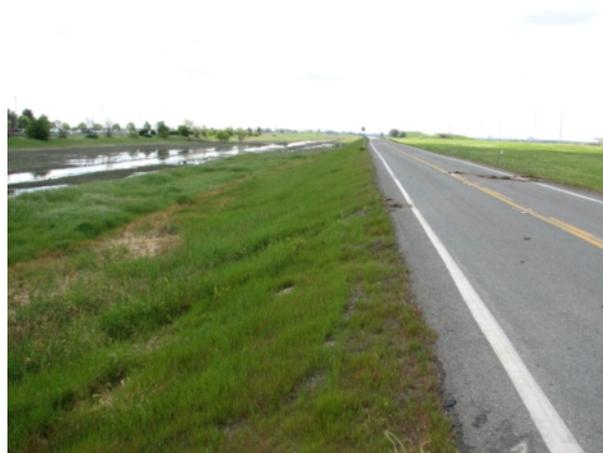
Levee Mile Report Line	9
Start Levee Mile	5.80
End Levee Mile	5.80
Location	Water Side
Category	Earthen Levee
Item	Vegetation
Levee mile 5.80, looking downstream at the waterside vegetation.	
cathom_s_20110411_129.jpg

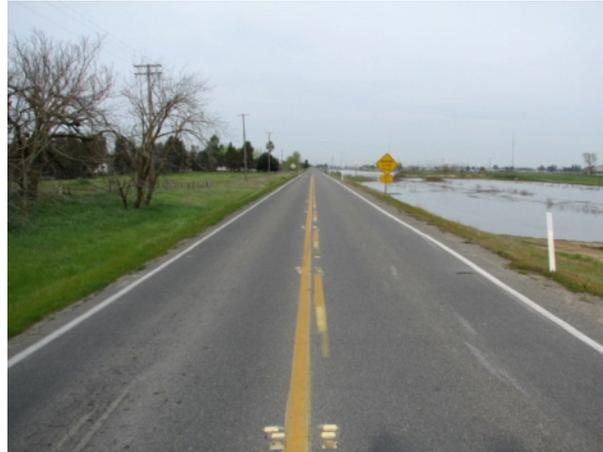
Levee Mile Report Line	1
Start Levee Mile	0.08
End Levee Mile	0.08
Location	Crown
Category	Earthen Levee
Item	Vegetation
Levee mile 0.08, looking upstream at vegetation on the levee.	
cathom_s_20110404_110.jpg
