**Flood Control Project Maintenance
Levee Inspections**
LMA District Cover Sheet
Spring 2011 Levee Inspection Results

Reclamation District No. 1001 Nicolaus

Levee Inspection Report By Mile - Spring 2011

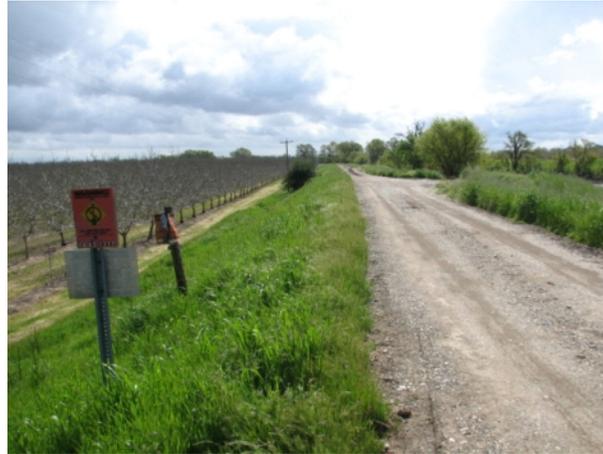
cathom_s_20110418_137.jpg

Levee Mile Report Line	5
Start Levee Mile	2.76
End Levee Mile	3.87
Location	Land Side
Category	Earthen Levee
Item	Vegetation

Levee mile 3.87, this photo is looking upstream at the vegetation on the landside slope.

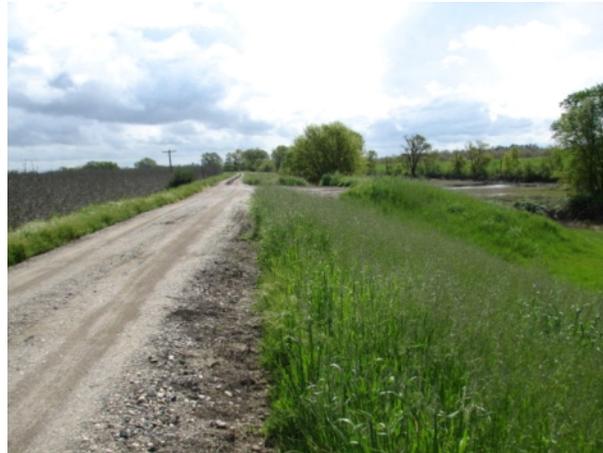
cathom_s_20110418_138.jpg

Levee Mile Report Line	6
Start Levee Mile	2.76
End Levee Mile	4.12
Location	Water Side
Category	Earthen Levee
Item	Vegetation

Levee mile 3.87, this photo is looking upstream at the vegetation on the waterside slope.

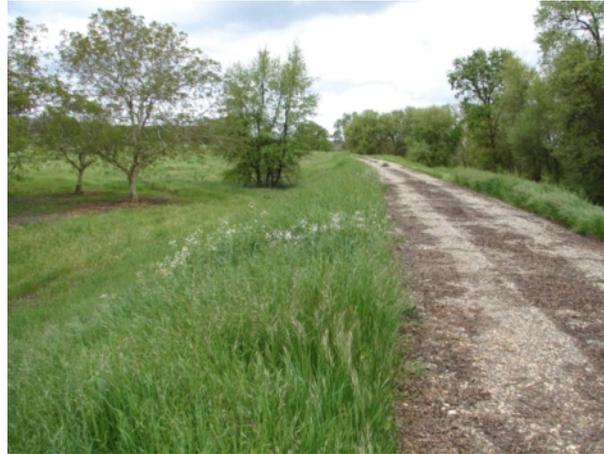
Levee Mile Report Line	1
Start Levee Mile	0.04
End Levee Mile	3.65
Location	Land Side
Category	Earthen Levee
Item	Vegetation
<p>Levee mile 0.04, this photo is looking downstream at the vegetation on the landside slope.</p>	
<p>cathom_s_20110418_139.jpg</p>

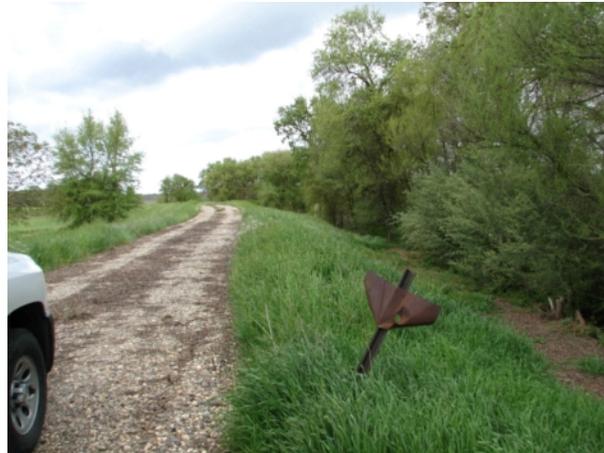
Levee Mile Report Line	2
Start Levee Mile	0.04
End Levee Mile	3.65
Location	Water Side
Category	Earthen Levee
Item	Vegetation
<p>Levee mile 0.04, this photo is looking downstream at the vegetation on the waterside slope.</p>	
<p>cathom_s_20110418_140.jpg</p>

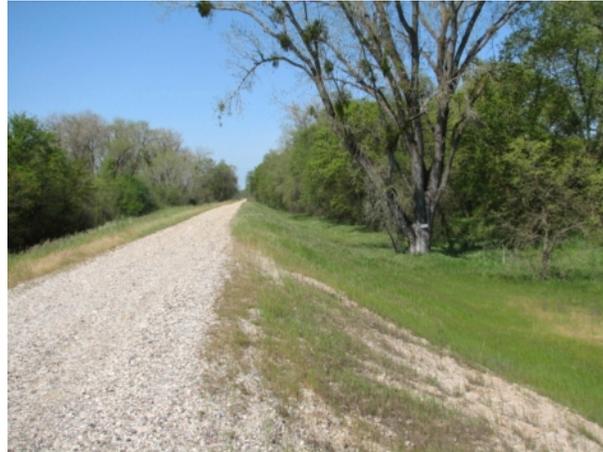
cathom_s_20110418_133.jpg

Levee mile 0.14, this photo is looking downstream at the vegetation on the waterside slope.

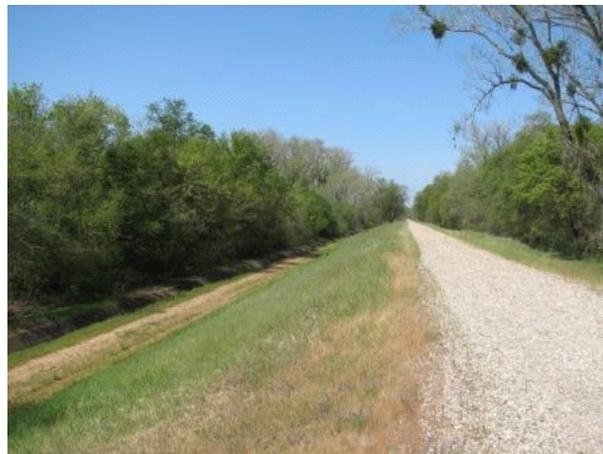
cathom_s_20110418_134.jpg

Levee Mile Report Line	2
Start Levee Mile	0.14
End Levee Mile	9.43
Location	Land Side
Category	Earthen Levee
Item	Vegetation

Levee mile 0.14, this photo is looking downstream at the vegetation on the landside slope.

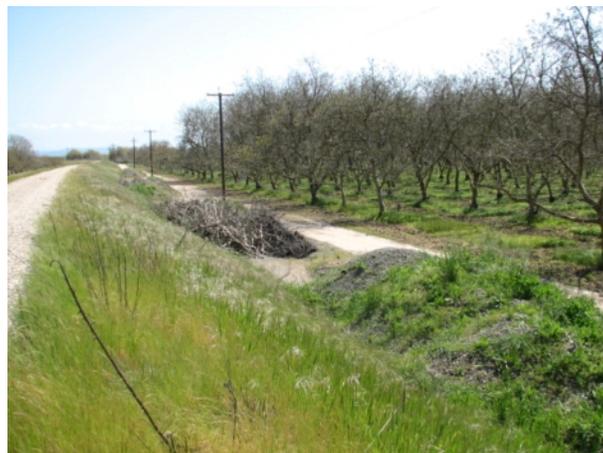
cathom_s_20110418_135.jpg

Levee Mile Report Line	8
Start Levee Mile	3.80
End Levee Mile	3.96
Location	Land Side
Category	Earthen Levee
Item	Encroachments

Levee mile 3.80, this photo is looking at the debris on the landside slope and toe.

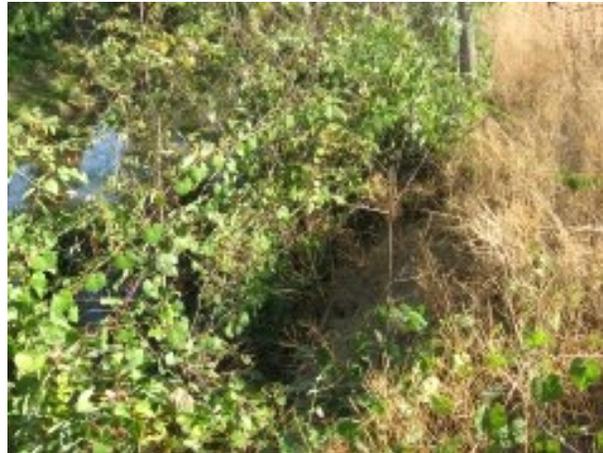
cathom_s_20110228_014.JPG

Levee Mile Report Line	22
Start Levee Mile	12.16
End Levee Mile	12.22
Location	Water Side
Category	Supplemental
Item	USACE Erosion Survey

2009: 15 ft berm, 1:1 slope, tree hazards, holes, slumping, and seepage, clays and silts, 2.84 ft/s [2009 SiteID:BER_0-8_L]

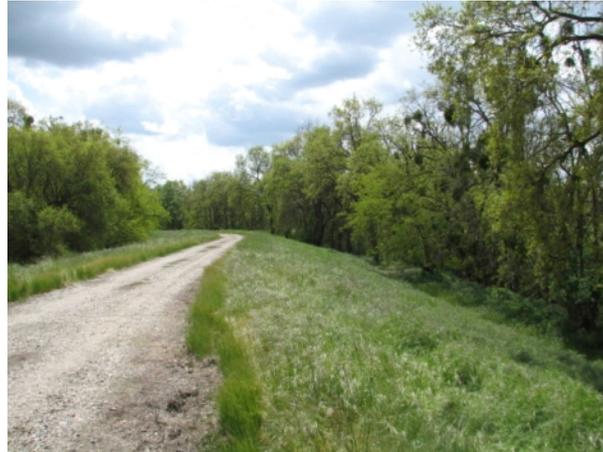
Levee Mile Report Line	1
Start Levee Mile	0.01
End Levee Mile	5.21
Location	Water Side
Category	Earthen Levee
Item	Vegetation
<p>Levee mile 0.01, this photo is looking downstream at the vegetation on the waterside slope.</p>	
<p>cathom_s_20110418_141.jpg</p>

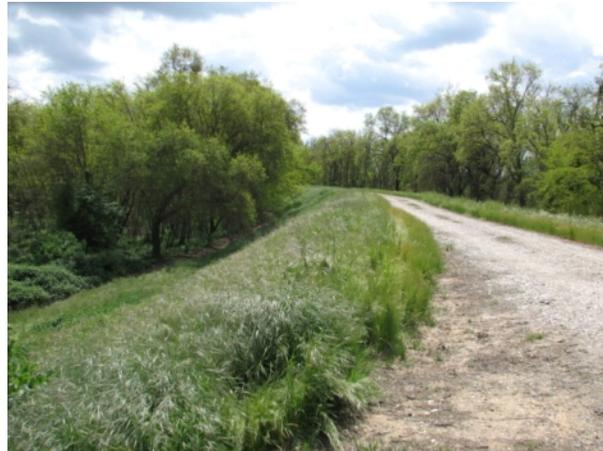
Levee Mile Report Line	2
Start Levee Mile	0.01
End Levee Mile	5.21
Location	Land Side
Category	Earthen Levee
Item	Vegetation
<p>Levee mile 0.01, this photo is looking downstream at the vegetation on the landside slope.</p>	
<p>cathom_s_20110418_142.jpg</p>

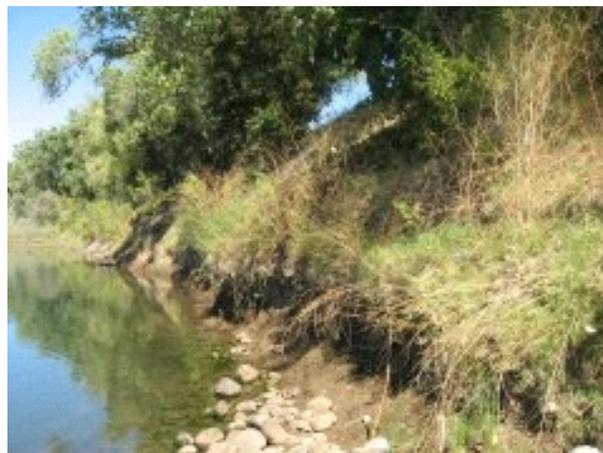
Levee Mile Report Line	9
Start Levee Mile	5.42
End Levee Mile	5.51
Location	Water Side
Category	Supplemental
Item	USACE Erosion Survey
<p>2009: 5 ft berm, 2.5:1 slope, tree hazards, seepage, and slumping, sands and silts, 9.97 ft/s [2009 SiteID:FHR_7-0_L]</p>	
<p>cathom_s_20110228_015.JPG</p>

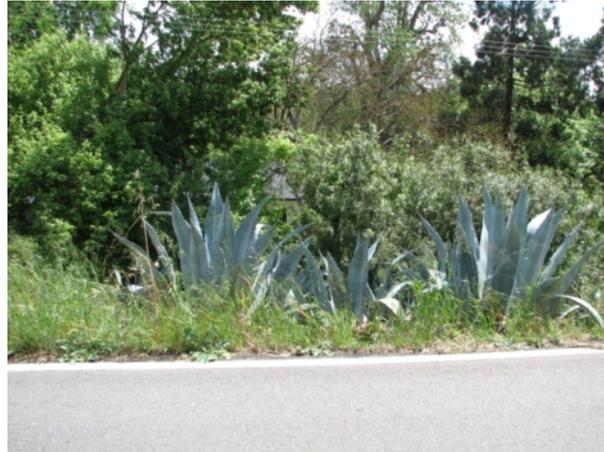
Levee Mile Report Line	10
Start Levee Mile	6.48
End Levee Mile	6.48
Location	Land Side
Category	Earthen Levee
Item	Encroachments
Landscaping on the land side shoulder and slope levee mile 6.48.	
cathom_s_20110228_018.jpg

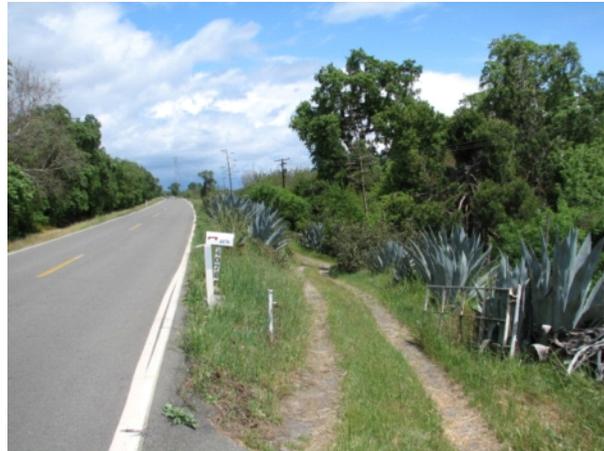
Levee Mile Report Line	10
Start Levee Mile	6.48
End Levee Mile	6.48
Location	Land Side
Category	Earthen Levee
Item	Encroachments
Landscaping levee mile 6.48.	
cathom_s_20110228_019.jpg

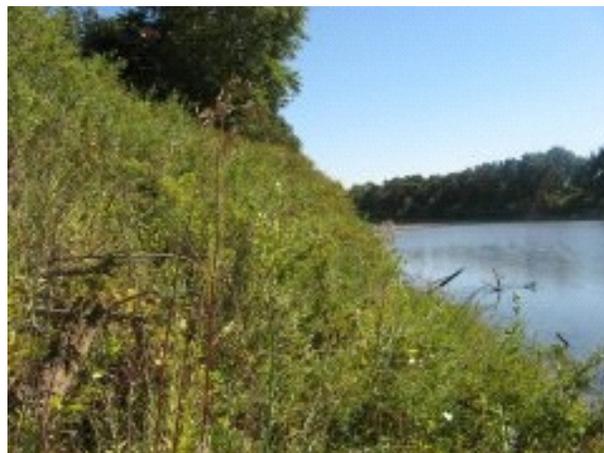
Levee Mile Report Line	15
Start Levee Mile	11.26
End Levee Mile	11.45
Location	Water Side
Category	Supplemental
Item	USACE Erosion Survey
2009: 15 ft berm, 1:1 slope, tree hazards and seepage, sands and silts, 5.46 ft/s [2009 SiteID:FHR_1-0_L]	
cathom_s_20110228_016.JPG

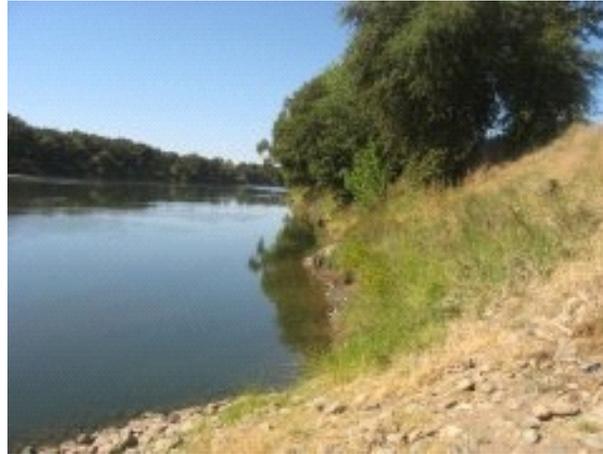
Levee Mile Report Line	17
Start Levee Mile	11.80
End Levee Mile	11.83
Location	Water Side
Category	Supplemental
Item	USACE Erosion Survey
2009: 15 ft berm, 2.5:1 slope, tree hazards, seepage, and slumping, sands and cobbles, 4.8 ft/s [2009 SiteID:FHR_0-6_L]	
cathom_s_20110228_017.JPG

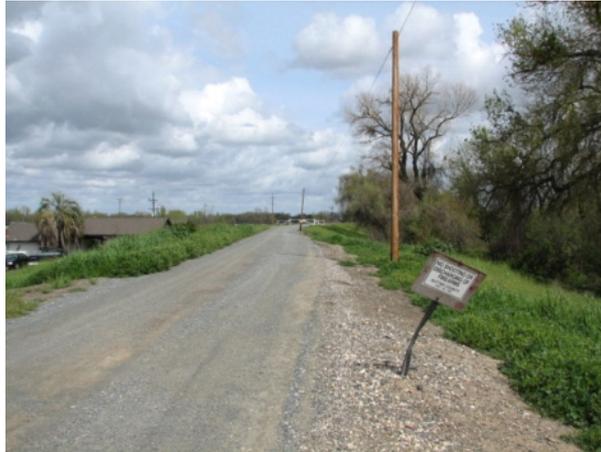
Levee Mile Report Line	1
Start Levee Mile	0.00
End Levee Mile	0.75
Location	Water Side
Category	Earthen Levee
Item	Encroachments
Poles on the water side shoulder levee mile 0.00 - 0.75	
cathom_s_20110228_020.jpg

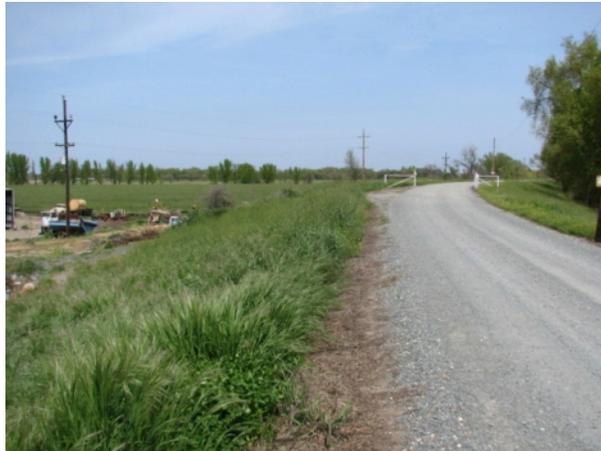
Levee Mile Report Line	2
Start Levee Mile	0.07
End Levee Mile	5.43
Location	Land Side
Category	Earthen Levee
Item	Vegetation
Levee mile 0.06, this photo is looking upstream at the vegetation on the landside slope.	
cathom_s_20110418_143.jpg

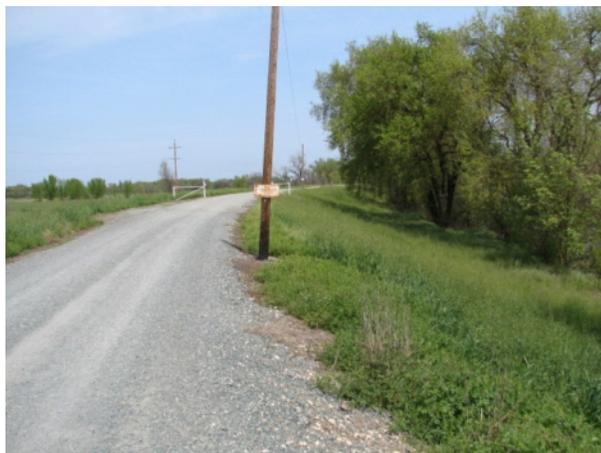
Levee Mile Report Line	3
Start Levee Mile	0.07
End Levee Mile	5.43
Location	Water Side
Category	Earthen Levee
Item	Vegetation
Levee mile 0.06, this photo is looking upstream at the vegetation on the waterside slope.	
cathom_s_20110418_144.jpg

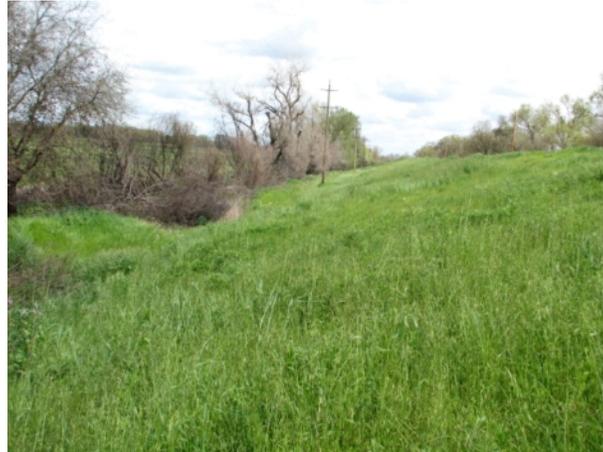
Levee Mile Report Line	4
Start Levee Mile	0.19
End Levee Mile	0.86
Location	Land Side
Category	Earthen Levee
Item	Encroachments
Poles at the land side toe levee mile 0.19 - 0.86.	
cathom_s_20110228_023.jpg

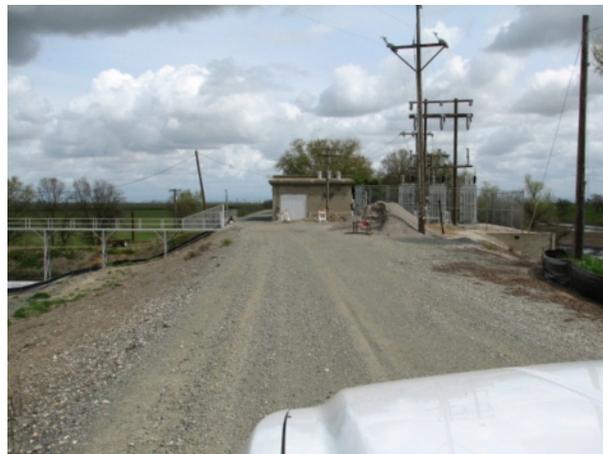
Levee Mile Report Line	5
Start Levee Mile	0.83
End Levee Mile	0.83
Location	Water Side
Category	Earthen Levee
Item	Encroachments
Pump house on the water side levee mile 0.83.	
cathom_s_20110228_021.jpg

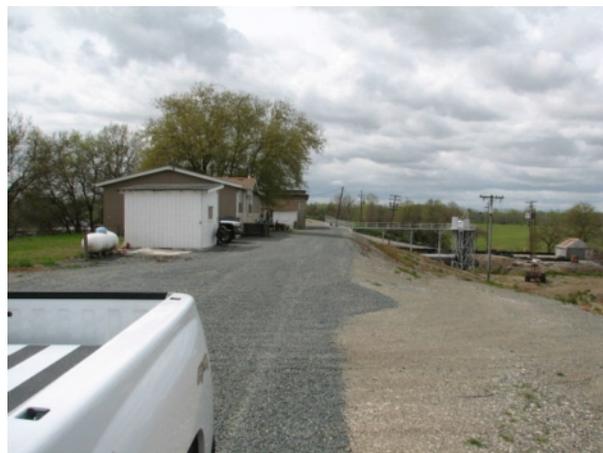
Levee Mile Report Line	5
Start Levee Mile	0.83
End Levee Mile	0.83
Location	Water Side
Category	Earthen Levee
Item	Encroachments
Pump house and Caretakers home levee mile 0.83	
cathom_s_20110228_022.jpg

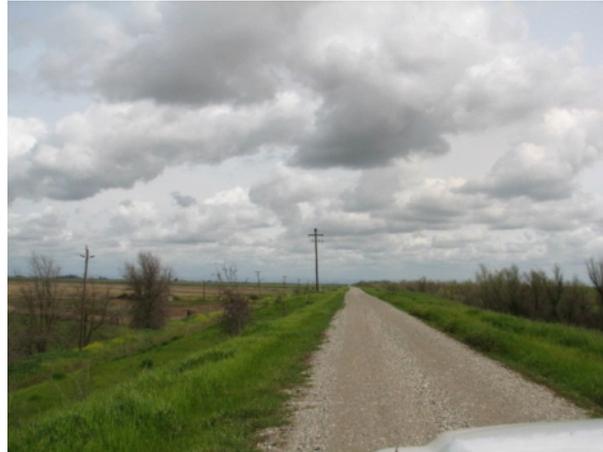
Levee Mile Report Line	6
Start Levee Mile	1.15
End Levee Mile	1.15
Location	Land Side
Category	Earthen Levee
Item	Encroachments
Pole on land side shoulder levee mile 1.15.	
cathom_s_20110228_024.jpg

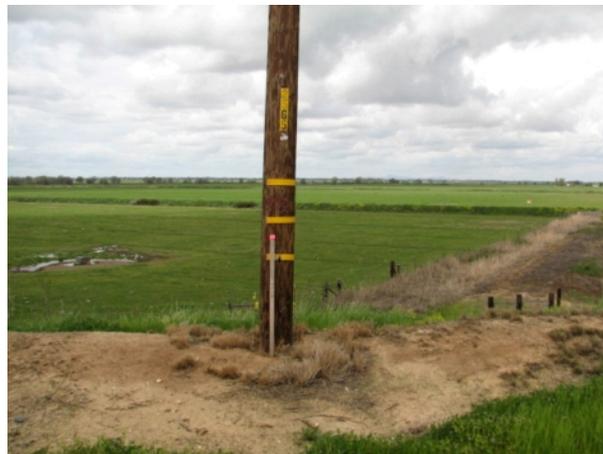
Levee Mile Report Line	6
Start Levee Mile	1.15
End Levee Mile	1.15
Location	Land Side
Category	Earthen Levee
Item	Encroachments
Pole on land side shoulder.	
cathom_s_20110228_025.jpg

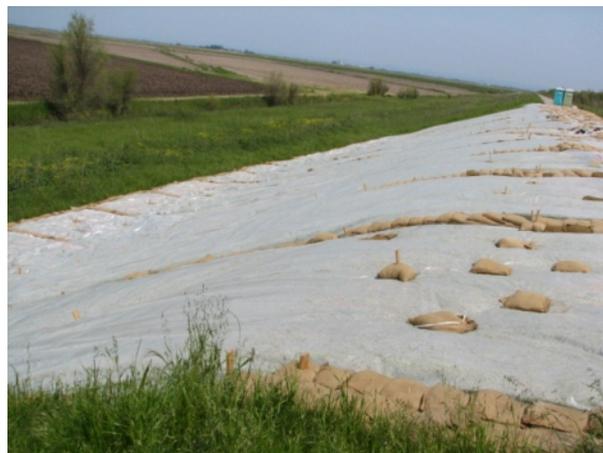
Levee Mile Report Line	7
Start Levee Mile	1.52
End Levee Mile	1.59
Location	Land Side
Category	Earthen Levee
Item	Slope Stability
Levee mile 1.52, this photo shows the site to be repaired, the temporary plastic sheets are still in place.	
cathom_s_20110420_145.jpg

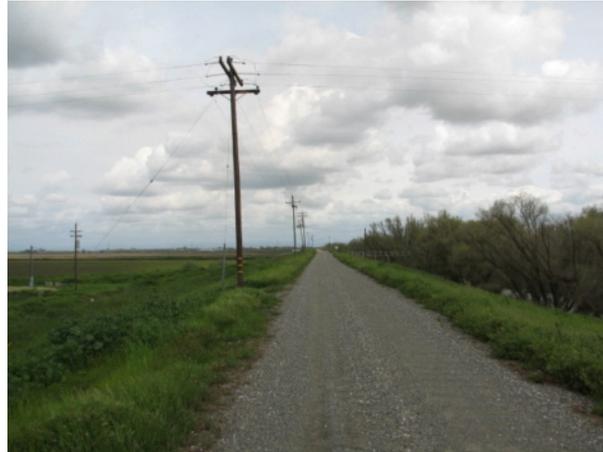
Levee Mile Report Line	8
Start Levee Mile	3.59
End Levee Mile	3.85
Location	Land Side
Category	Earthen Levee
Item	Encroachments
Poles on the land side shoulder levee mile 3.59 - 3.85.	
cathom_s_20110228_026.jpg

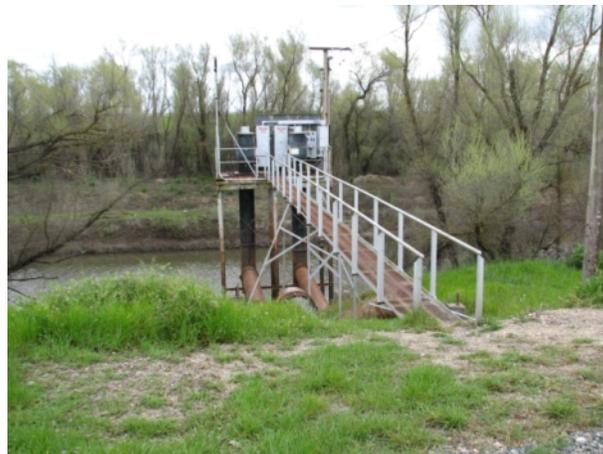
Levee Mile Report Line	9
Start Levee Mile	3.69
End Levee Mile	3.69
Location	Water Side
Category	Earthen Levee
Item	Encroachments
Pump water side levee mile 3.69.	
cathom_s_20110228_027.jpg

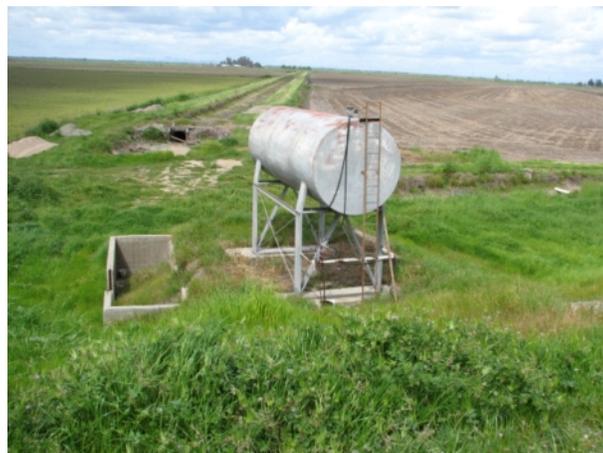
Levee Mile Report Line	12
Start Levee Mile	3.85
End Levee Mile	3.85
Location	Land Side
Category	Earthen Levee
Item	Encroachments
Storage tank on land side slope levee mile 3.85.	
cathom_s_20110228_028.jpg

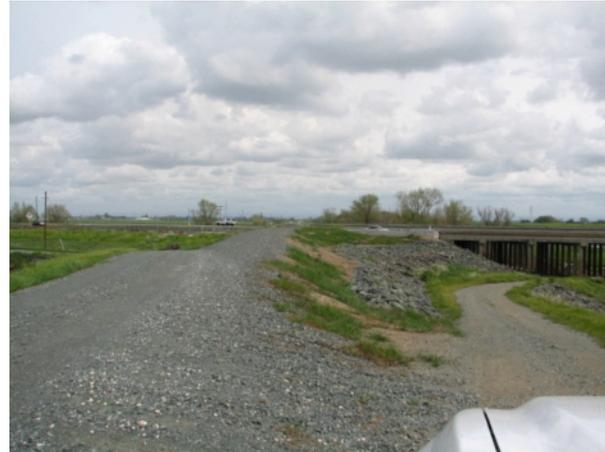
Levee Mile Report Line	13
Start Levee Mile	4.44
End Levee Mile	4.44
Location	Crown
Category	Earthen Levee
Item	Encroachments
Levee stops at hwy 70 and starts again on the other side of hwy 70.	
cathom_s_20110228_029.jpg

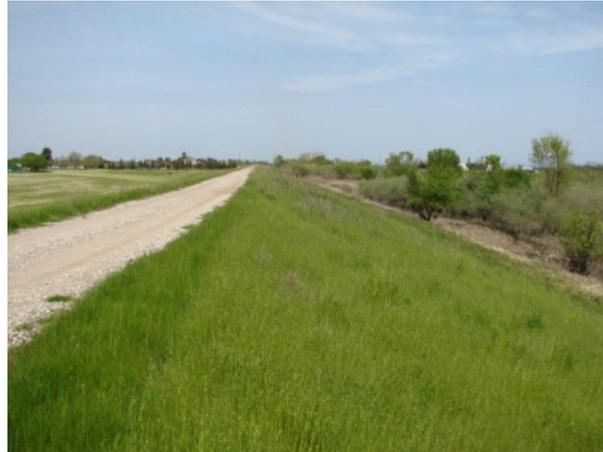
Levee Mile Report Line	1
Start Levee Mile	0.06
End Levee Mile	4.74
Location	Water Side
Category	Earthen Levee
Item	Vegetation
Levee mile 0.06, this photo is looking upstream at the vegetation on the waterside slope.	
cathom_s_20110427_146.jpg

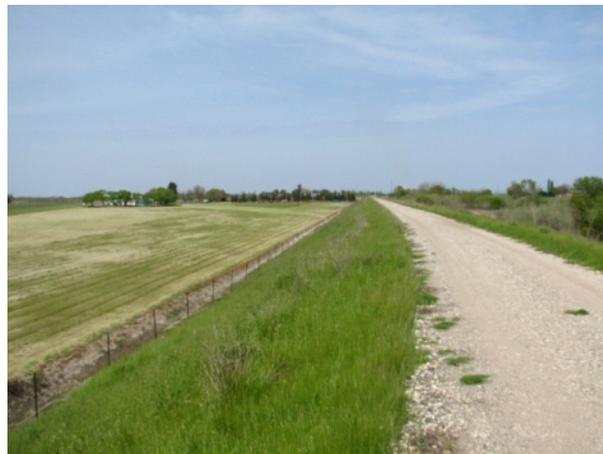
Levee Mile Report Line	2
Start Levee Mile	0.06
End Levee Mile	4.74
Location	Land Side
Category	Earthen Levee
Item	Vegetation
Levee mile 0.06, this photo is looking upstream at the vegetation on the landside slope.	
cathom_s_20110427_147.jpg

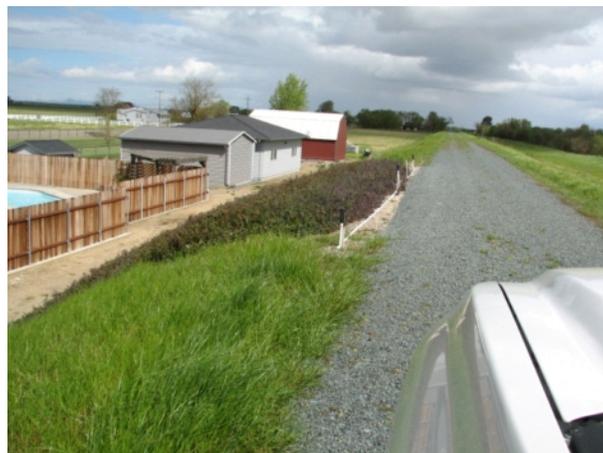
Levee Mile Report Line	3
Start Levee Mile	1.06
End Levee Mile	1.06
Location	Land Side
Category	Earthen Levee
Item	Encroachments
Landscaping on the land side slope L/M 1.06.	
cathom_s_20110228_031.jpg

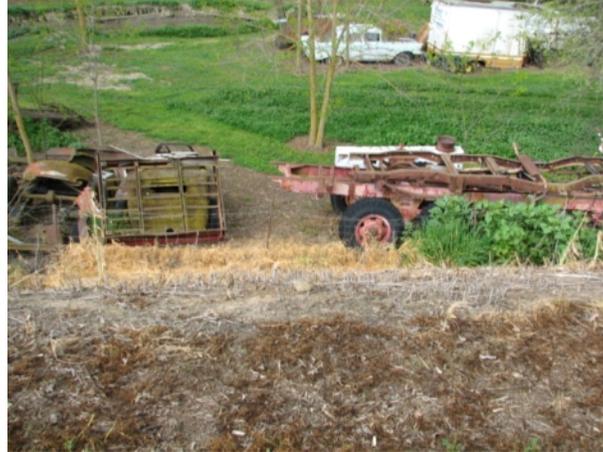
Levee Mile Report Line	4
Start Levee Mile	1.37
End Levee Mile	1.37
Location	Land Side
Category	Earthen Levee
Item	Encroachments
Equipment at the land side toe L/M 1.37.	
cathom_s_20110228_032.jpg

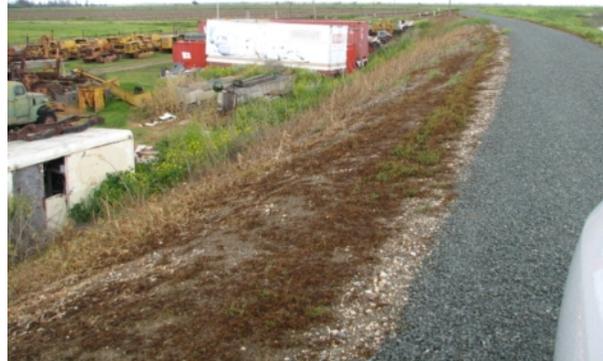
Levee Mile Report Line	5
Start Levee Mile	1.45
End Levee Mile	1.45
Location	Land Side
Category	Earthen Levee
Item	Encroachments
Equipment at the land side toe L/M 1.45.	
cathom_s_20110228_030.jpg
