**Flood Control Project Maintenance  
Levee Inspections**  
**LMA District Cover Sheet**  
**Spring 2014 Levee Inspection Results**

**Reclamation District No. 1001 Nicolaus**

**Spring 2014 Levee Inspection Results**

| Unit No. 01 Yankee Slough | | Right | 4.17 |

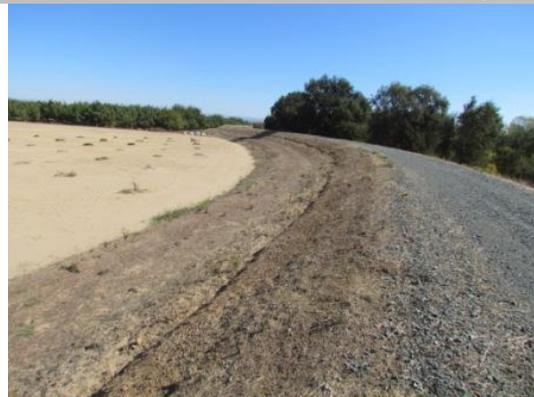
Photo 1 of 1 : mhoffman\_s\_20140401\_294.jpg

The vegetation has been mowed needs to be controlled. Spring 2013

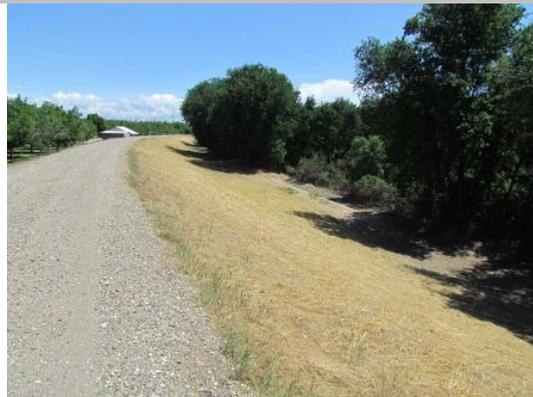
Photo 1 of 1 : mhoffman\_s\_20140512\_505.jpg

This photo was taken from the crown facing east looking down the waterward levee slope at acceptable vegetation control. Spring 2014.

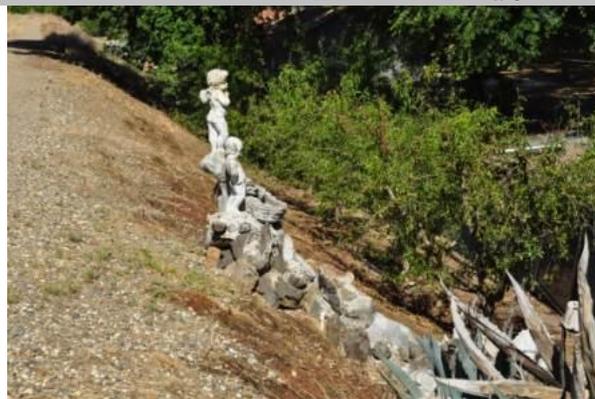
Photo 2 of 2 : mhoffman\_s\_20140512\_507.jpg

Unit 1 Landscaping on levee slope. L/S

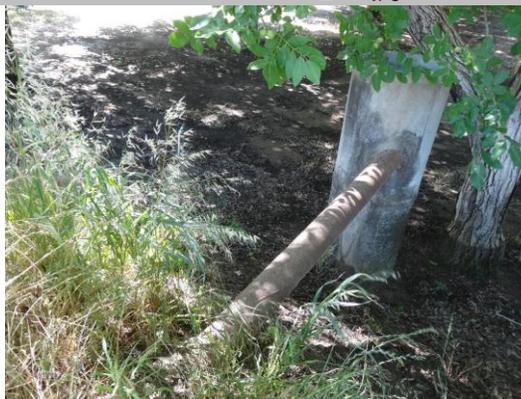
Photo 1 of 1 : UCIP\_924.jpg

| Inspector Comments: FS_ID:13847<br>EP_NO: 2281<br>Repair Type:<br>Crossing Status:<br>UCIP Comments: - leaky pipe end and erosion on WS cracked dirt mound on LS seems not been used for some time.<br>FIELD_STRUCT_DESC: 8-inch steel pipe through the levee, 1.9 feet below the crown, portable pump mounted on the bank during the summer months, control valve on the waterward side, steel plate bolted on the waterward end during the winter months, the pipe discharges into a 30-inch concrete standpipe at the landward toe (Permit No. 2281, 1956)<br>FS Date: 5/23/2013 | | | | | |

LS- steel pipe and concrete standpipe.

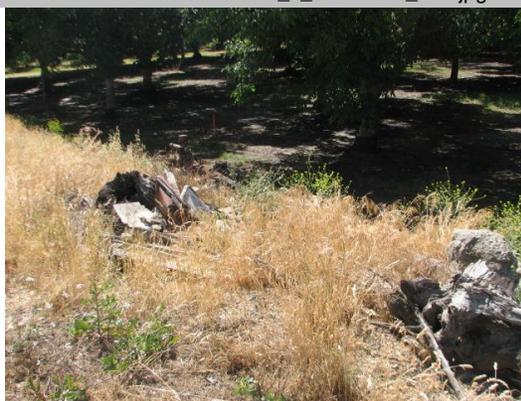
Photo 1 of 1 : mhoffman\_s\_20140401\_548.jpg

Debris on the levee slope and at the toe of the levee. Spring 2013

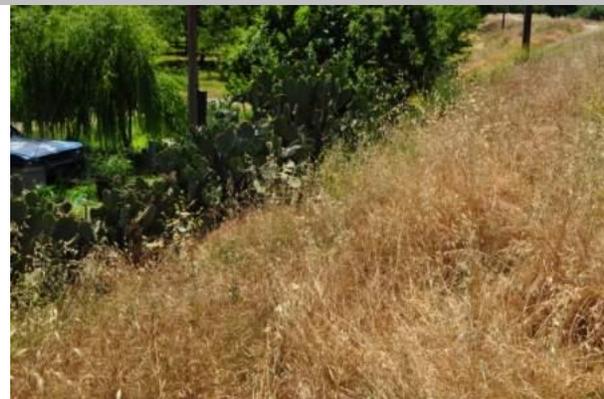
Photo 1 of 1 : mhoffman\_s\_20140401\_553.jpg

RD 1001 Unit 2 - L/S -Landscaping - Cactus and fruit trees

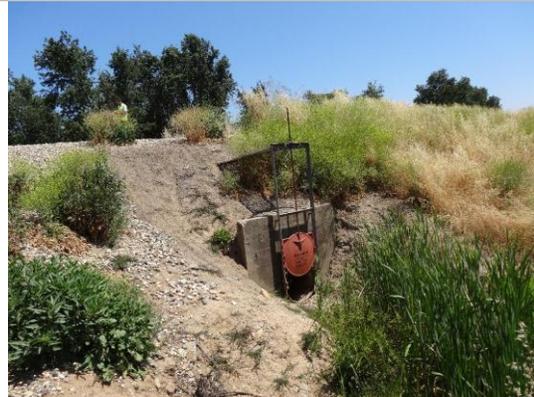
Photo 1 of 1 : UCIP\_949.jpg

| Inspector Comments: FS_ID:14008<br>EP_NO: N/A<br>Repair Type:<br>Crossing Status:<br>UCIP Comments: - slide gate in inlet pipe on landside pits on pipe due to corrosion<br>FIELD_STRUCT_DESC: 36-inch corrugated-metal drainage pipe through the levee, 15.0 feet below the crown, concrete-U headwall and flap gate at outfall on the waterward end and slide gate on landside inlet (R.D. No. 1001). O&M Manual Sac 141, August 1955.<br>FS Date: 5/23/2013 | | | | | |

LS- slide gate in inlet pipe structure

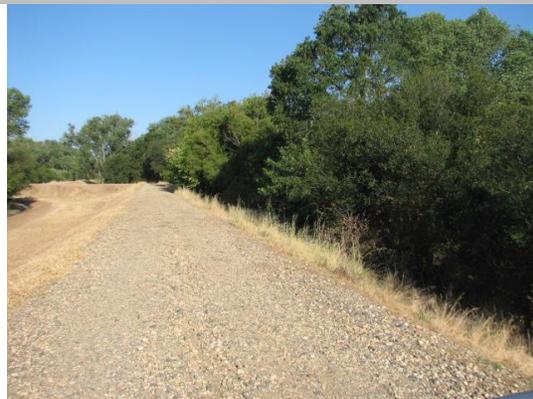
Photo 1 of 1 : mhoffman\_s\_20140401\_865.jpg

Trees partially obstruct visibility. Spring 2013

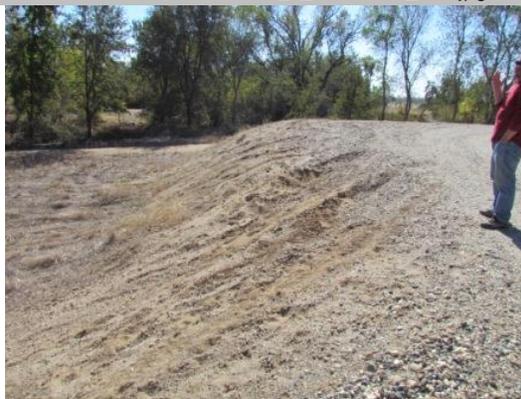
Photo 1 of 1 : mhoffman\_s\_20140401\_837.jpg

This photo was taken from the crown of the levee facing west looking down the slope at rutting caused by vehicles driving up the landward levee slope.

| Repair the levee slope damaged by vehicle traffic and prevent access where possible.<br>Inspector Comments: Rutting caused by vehicles driving up the landward levee slope. | | | | | |

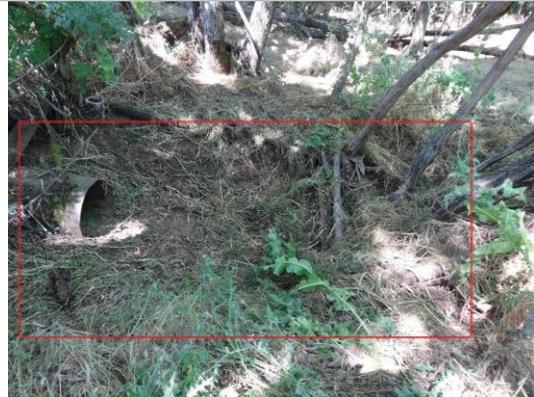
Photo 1 of 1 : UCIP\_955.jpg

| Inspector Comments: FS_ID:14128<br>EP_NO: 958<br>Repair Type:<br>Crossing Status:<br>UCIP Comments: - slide gate on WS not foundneeds abandoned properly.<br>FIELD_STRUCT_DESC: Abandoned 24-inch irrigation pipe through the levee.(Permit No. 958, 1944)<br>FS Date: 5/21/2013 | | | | | |

WS- abandoned CMP and depression around it.

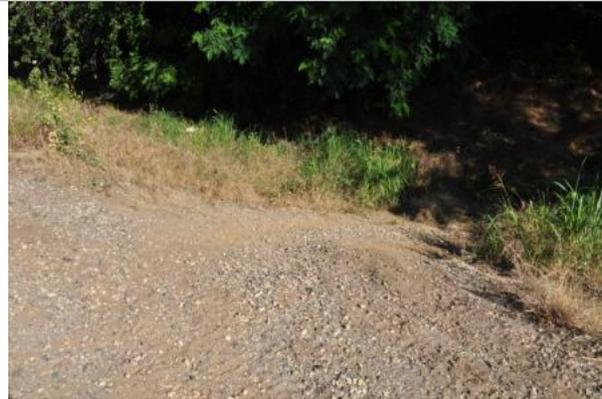
Photo 1 of 1 : mhoffman\_s\_20140401\_839.jpg

RD 1001 Unit 3 - Slope damage

| Repair the levee slope damaged by vehicle traffic and prevent access where possible. | | | | | |

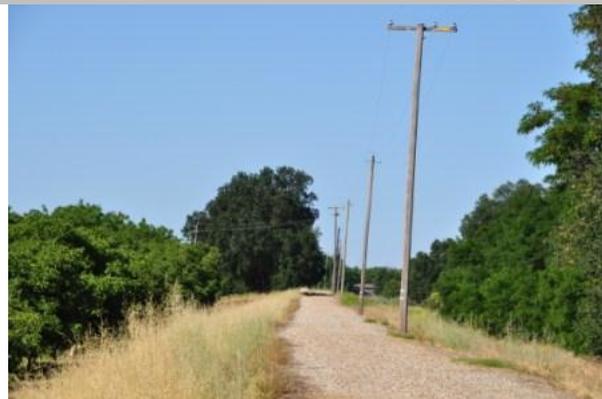
Photo 1 of 1 : mhoffman\_s\_20140401\_838.jpg

RD 1001 Unit 3 - Power Poles along W/S shoulder.

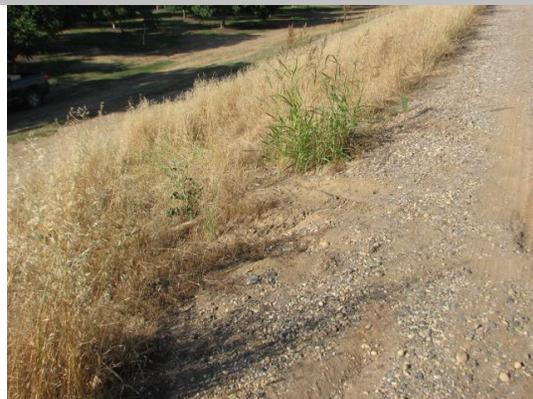
Photo 1 of 2 : mhoffman\_s\_20140401\_869.jpg

Damage caused by vehicles. Spring 2013

| Repair the levee slope damaged by vehicle traffic and prevent access | | | | | |

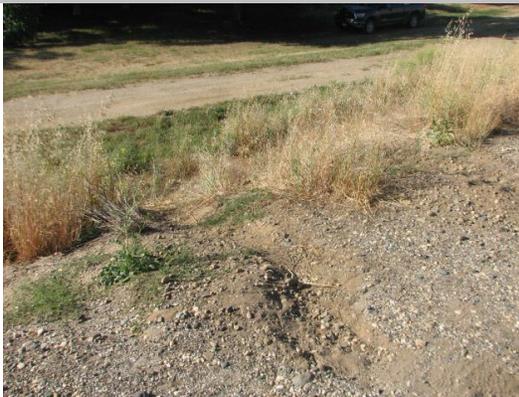
Photo 2 of 2 : mhoffman\_s\_20140401\_870.jpg

Damage caused by vehicles going around the gate. Spring 2013

| Repair the levee slope damaged by vehicle traffic and prevent access where possible. | | | | | |

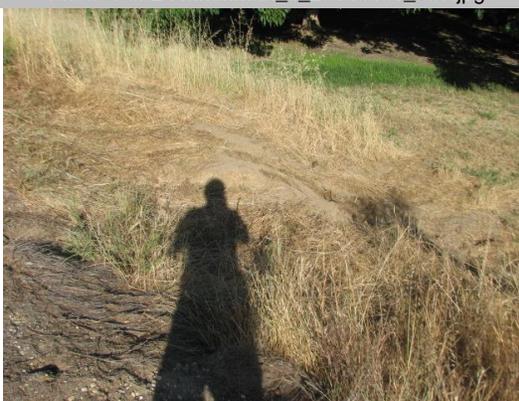
Photo 1 of 2 : mhoffman\_s\_20140401\_867.jpg

Damage caused by vehicles. Spring 2013

| Repair the levee slope damaged by vehicle traffic and prevent access where possible. | | | | | |

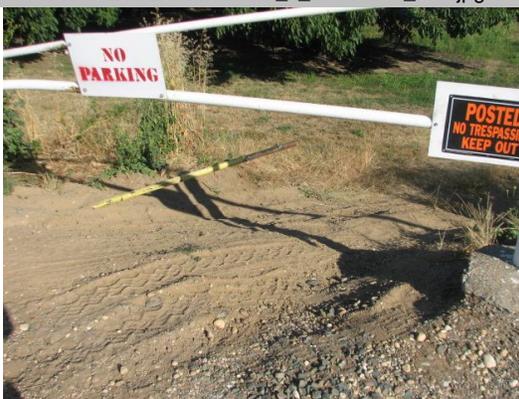
Photo 2 of 2 : mhoffman\_s\_20140401\_868.jpg

Damage caused by vehicles Spring 2013

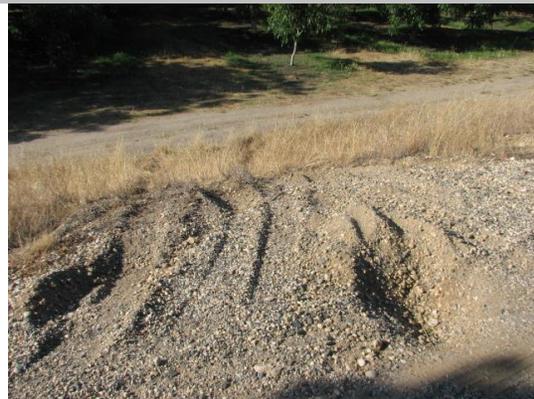
Photo 1 of 1 : mhoffman\_s\_20140401\_871.jpg

Damage caused by vehicles. Spring 2013

| Repair the levee slope damaged by vehicle traffic and prevent access where possible. | | | | | |

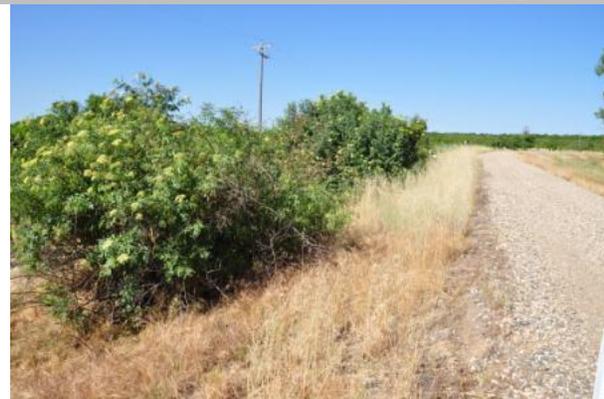
Photo 1 of 1 : mhoffman\_s\_20140401\_885.jpg

RD 1001 Unit 3 - L/S slope -Elderberries

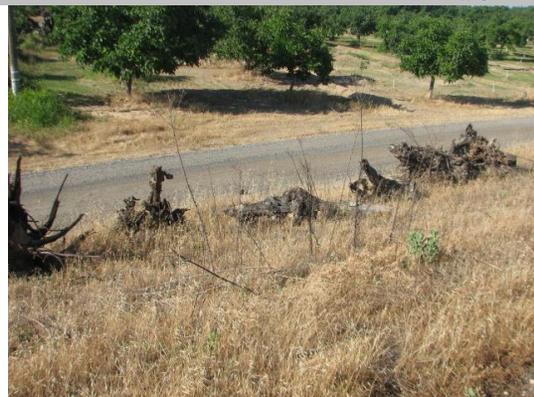
Photo 1 of 1 : mhoffman\_s\_20140401\_874.jpg

Walnut root balls at the levee toe. Spring 2013

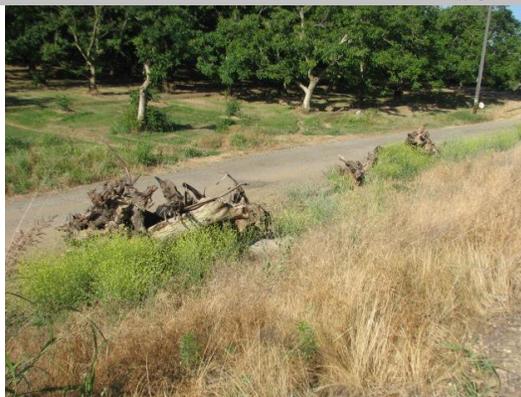
Photo 1 of 1 : mhoffman\_s\_20140401\_840.jpg

Walnut stumps at the levee toe. Spring 2013

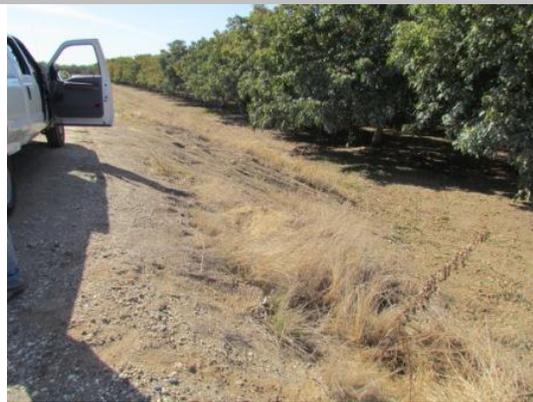
Photo 1 of 1 : mhoffman\_s\_20140401\_881.jpg

This photo was taken from the crown of the levee facing west looking down the slope at rutting caused by vehicles driving up the waterward levee slope.

| Repair the levee slope damaged by vehicle traffic and prevent access where possible.<br>Inspector Comments: Rutting caused by vehicles driving up the waterward levee slope. | | | | | |

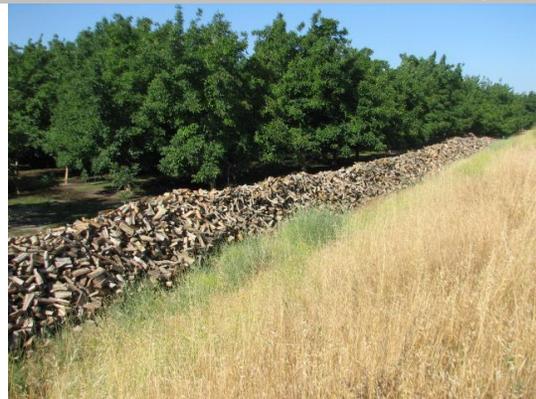
Photo 1 of 1 : mhoffman\_s\_20140401\_878.jpg

A very neat stack of firewood within the easement of the levee. Spring 2013

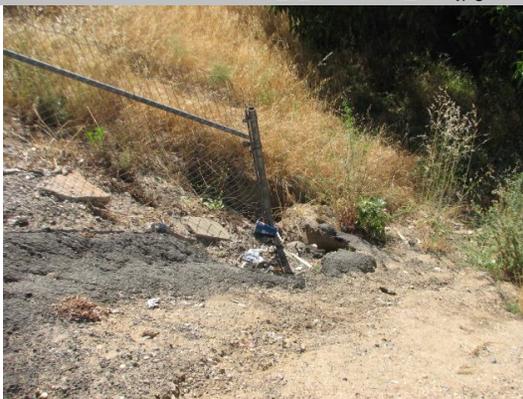
Photo 1 of 1 : mhoffman\_s\_20140401\_879.jpg

Erosion caused by run off from the roadway. Spring 2013

| Schedule repair of erosion site prior to the next inspection. | | | | | |

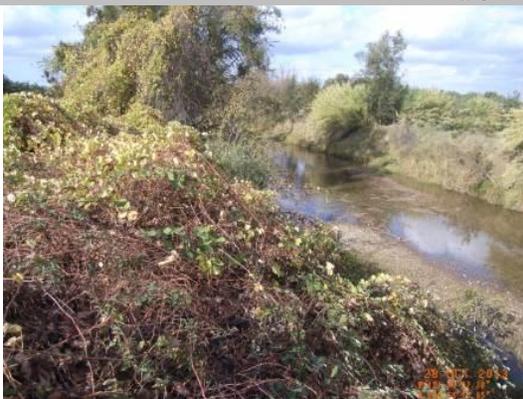
USACE 2013 Photo #1

| Inspector Comments: 2008 - Sandy/silty banks with rotational slab failures creating near vertical bank with pop-outs due to tree failures. Narrow berm. 2013: No observed changes. [2013 Site ID: BER_5-7_L] | | | | | |

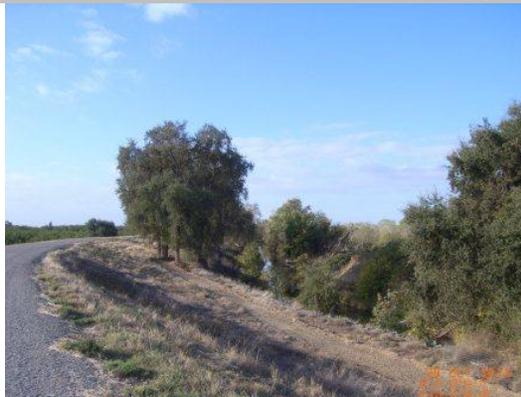
USACE 2013 Photo #1

| Inspector Comments: 2011 - Large slumped sections of bank. 2012 - Slopes slightly steeper. 2013: No observed changes. [2013 Site ID: BER_1-9_L] | | | | | |

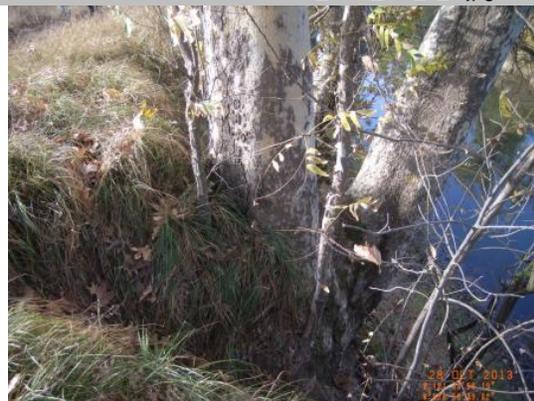
USACE 2013 Photo #1

| Inspector Comments: 2006 - Multiple rotational failures in the berm. Erosion is into the levee toe and lower slope. Tension cracks extensive at top of bank. Cohesive toe creates a bench on which failures occur. 2007 - Still steep bank with some berm with pistol-butted reeds. 2012 - Site extended upstream due to additional slumping. Slopes slightly steeper. 2013: No observed changes. [2013 Site ID: BER_0-8_L] | | | | | |

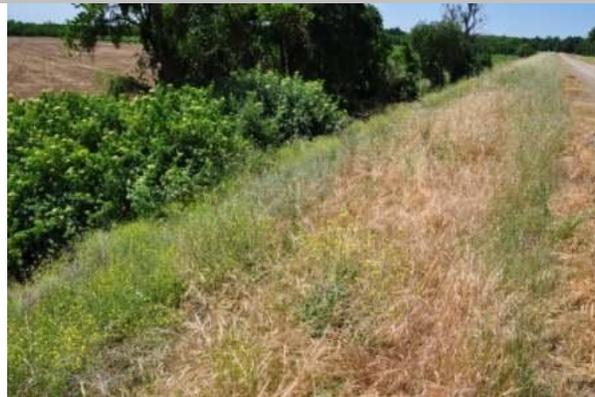
Photo 1 of 1 : mhoffman\_s\_20140401\_866.jpg

RD 1001 Unit 3 - L/S slope -Elderberries @ toe.

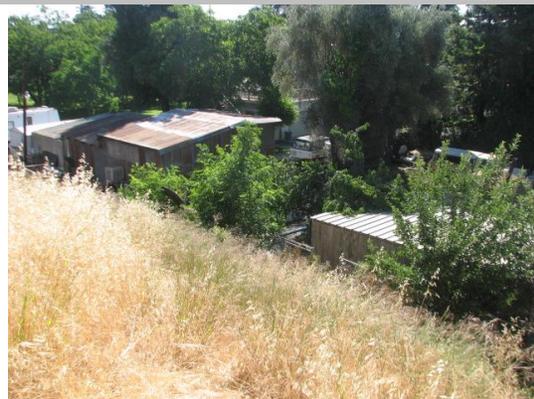
Photo 1 of 1 : mhoffman\_s\_20140401\_682.jpg

Buildings along the toe within the easement of the levee. Spring 2013

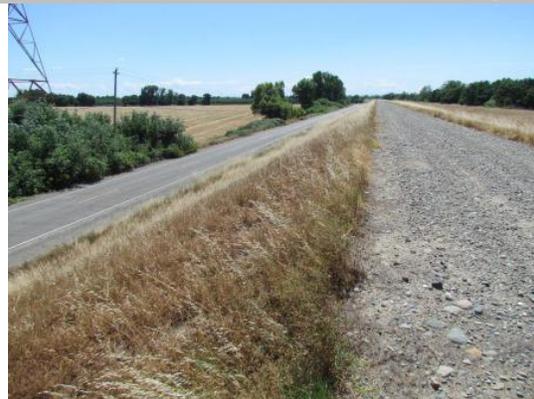
Photo 1 of 1 : mhoffman\_s\_20140513\_00999.jpg

This photo was taken from the crown facing west looking down the landward levee slope at vegetation requiring maintenance. Spring 2014.

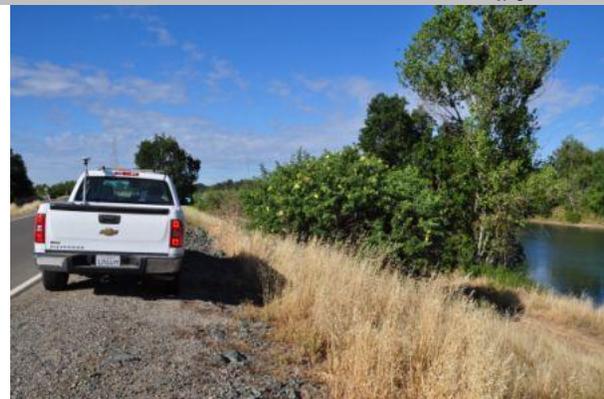
Photo 1 of 1 : mhoffman\_s\_20140401\_696.jpg

RD 1001 Unit 4 - W/S slope - Elderberries

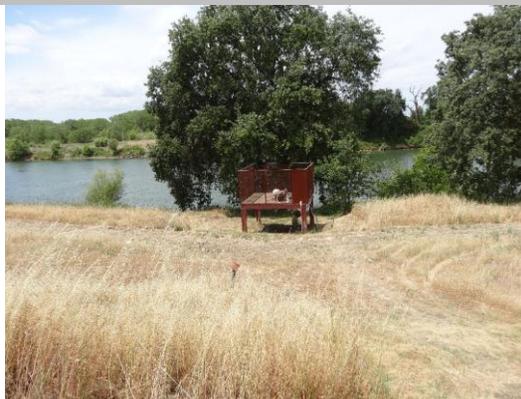
Photo 1 of 1 : UCIP\_1077.jpg

| Inspector Comments: FS_ID:14604<br>EP_NO: 10389<br>Repair Type:<br>Crossing Status:<br>UCIP Comments: - water leakage causes erosion on LS slope may be pressure breaker valve not closed properly on LS a 36-inch concrete standpipe at the landward toe not found.<br>FIELD_STRUCT_DESC: 12-inch irrigation pipe through the levee, 10.0 feet below the crown, slant pump on the bank, siphon breaker in a 24-inch corrugated metal pipe riser on the landward slope, pipe discharges into a 36-inch concrete standpipe at the landward toe, pipe installed by the U.S.C.E. in 1963, switch panel and service pole at the landward toe (Permit No. 10389, 1974)<br>FS Date: 5/16/2013 | | | | | |

WS- slanted pump station on steel platform on levee berm.

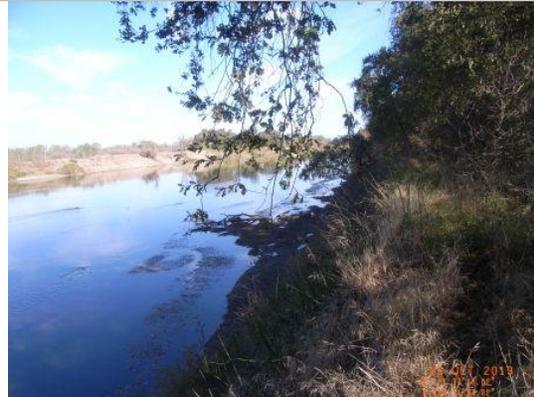
USACE 2013 Photo #1

| Inspector Comments: 2011 - Tall slumping sections. Scour around trees has exposed most of the roots. 2013: No observed changes. [2013 Site ID: FHR_6-0_L] | | | | | |

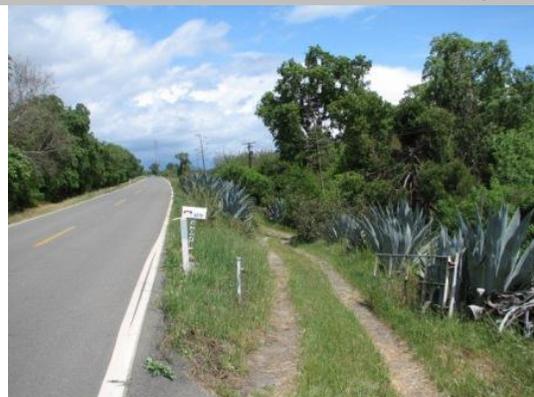
Photo 2 of 2 : mhoffman\_s\_20140401\_680.jpg

Landscaping levee mile 6.48.

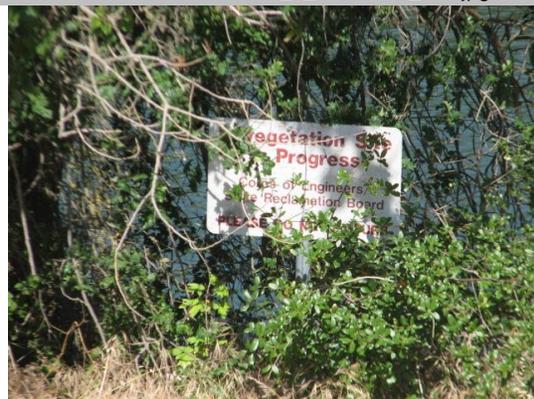
Photo 1 of 1 : mhoffman\_s\_20140401\_691.jpg

Revegetation site. Spring 2013

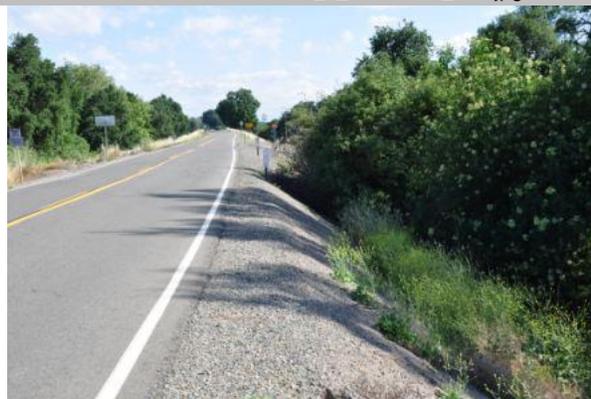
Photo 1 of 1 : mhoffman\_s\_20140401\_677.jpg

RD 1001 Unit 4 - W/S slope - Elderberries

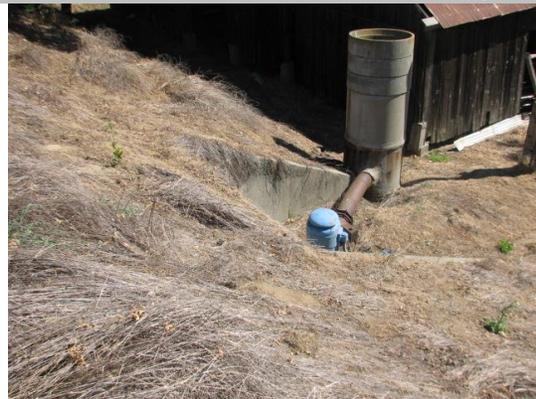
Photo 1 of 1 : mhoffman\_s\_20140401\_693.jpg

A retaining wall is within the profile of the slope. Spring 2013

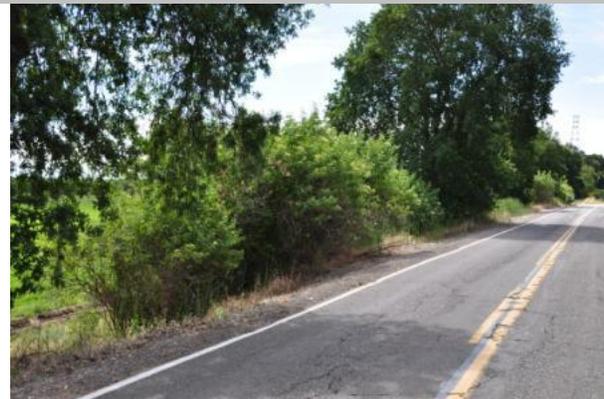
Photo 1 of 1 : mhoffman\_s\_20140401\_686.jpg

RD 1001 Unit 4 - L/S slope - Elderberries

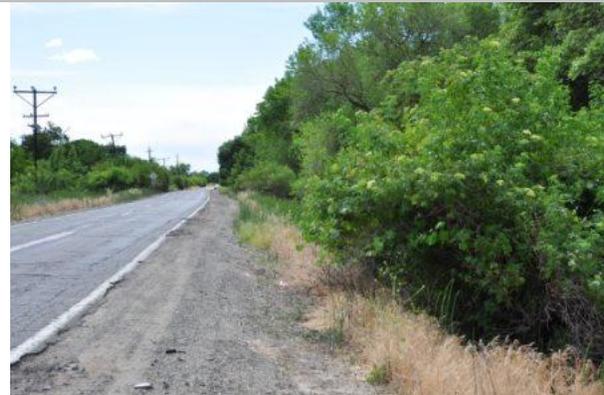
Photo 1 of 1 : mhoffman\_s\_20140401\_689.jpg

RD 1001 Unit 4 - W/S slope - Elderberries

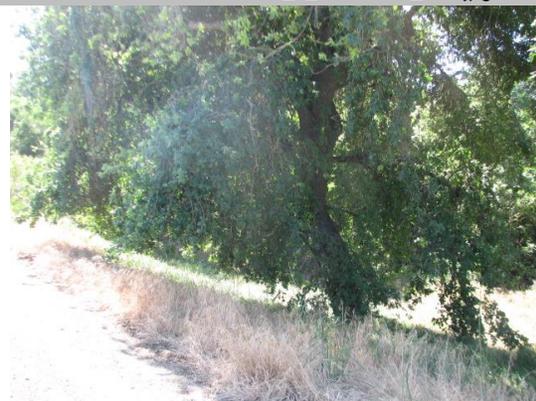
Photo 1 of 1 : mhoffman\_s\_20140401\_697.jpg

Trees need to be trimmed up at least 5 feet. Spring 2013

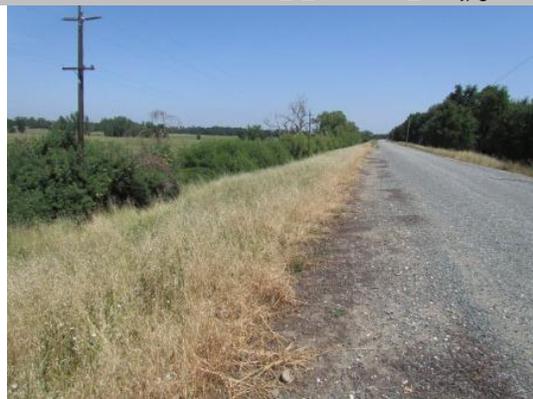
Photo 1 of 1 : mhoffman\_s\_20140512\_508.jpg

This photo was taken from the crown facing east looking down the landward levee slope at vegetation requiring maintenance. Spring 2014.

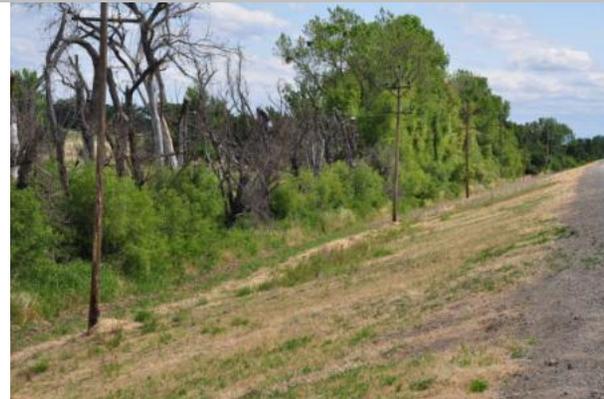
Photo 2 of 2 : mhoffman\_s\_20140401\_782.jpg

RD 1001 Unit 5 - L/S Levee Toe - Poles

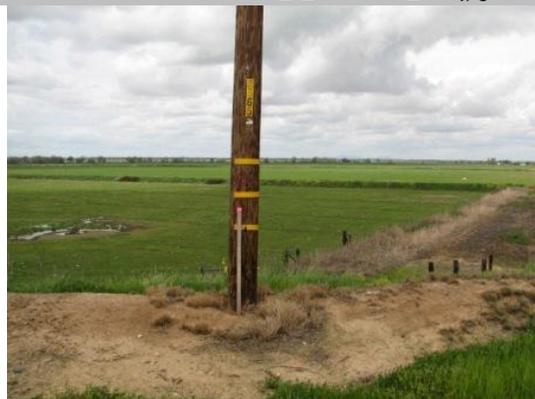
Photo 2 of 2 : mhoffman\_s\_20140401\_784.jpg

Pole on land side shoulder.

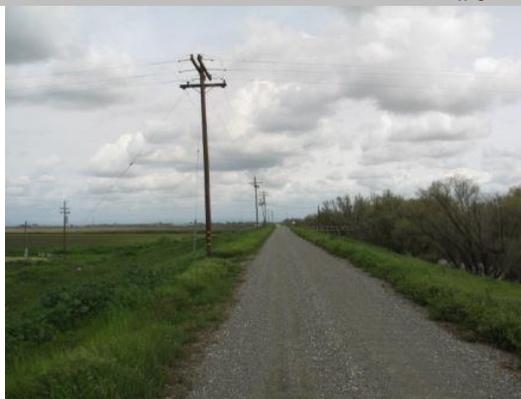
Photo 1 of 1 : mhoffman\_s\_20140401\_785.jpg

Poles on the land side shoulder levee mile 3.59 - 3.85.

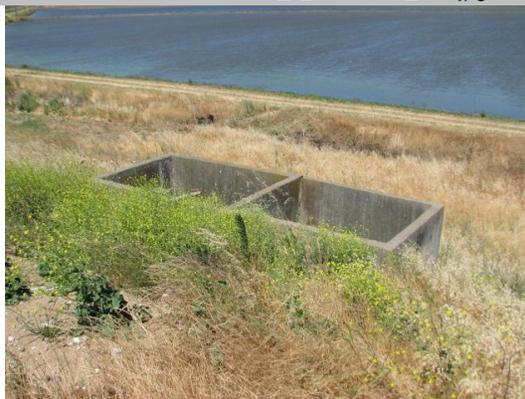
Photo 2 of 2 : mhoffman\_s\_20140401\_788.jpg

Concrete distribution box on the landside levee slope. Spring 2013

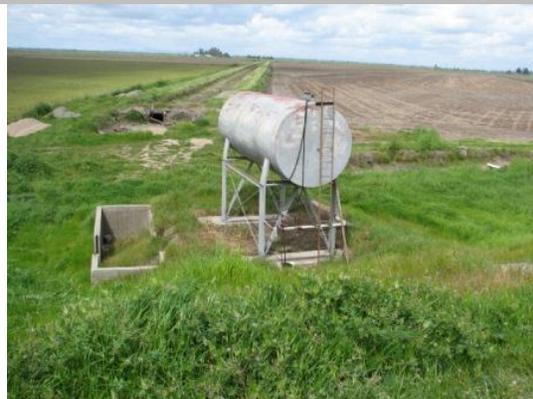
Photo 1 of 1 : mhoffman\_s\_20140401\_789.jpg

Storage tank on land side slope levee mile 3.85.

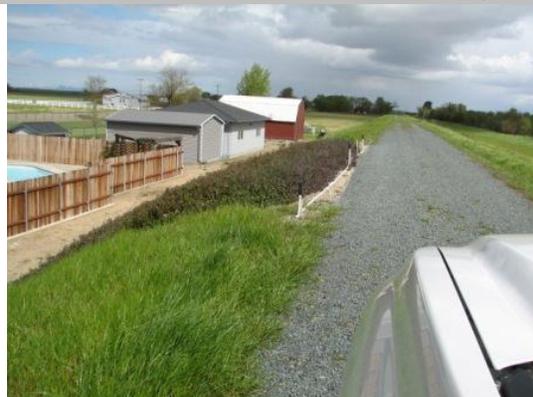
Photo 1 of 1 : mhoffman\_s\_20140401\_045.jpg

Landscaping on the landside slope LM 1.06.

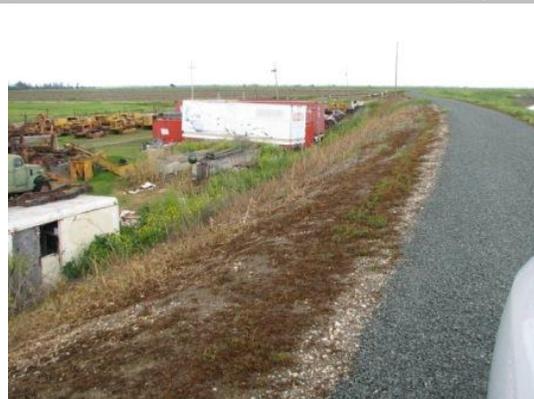
Photo 1 of 1 : mhoffman\_s\_20140401\_044.jpg

Equipment at the landside toe LM 1.45.

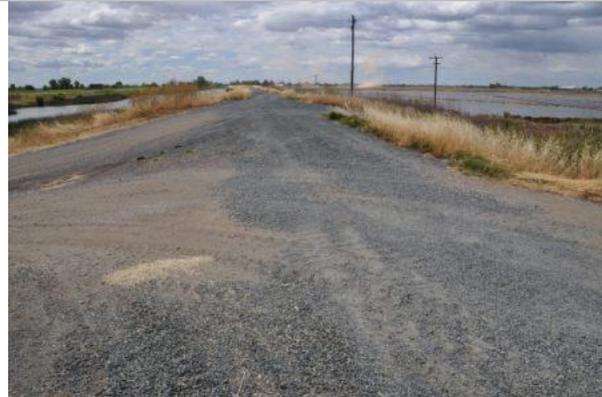
Photo 1 of 1 : mhoffman\_s\_20140401\_048.jpg

RD 1001 Unit 6 - Levee Crown - Subsidence due to vehicle traffic.

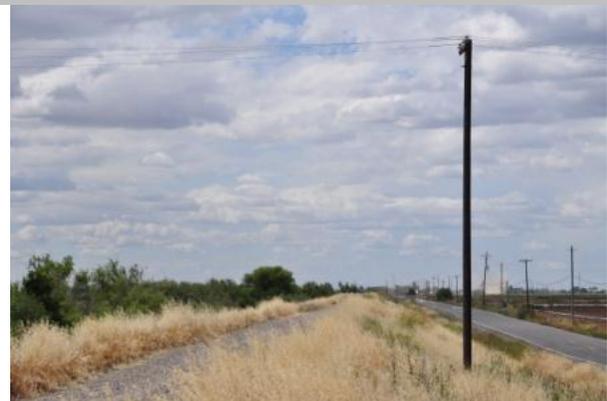
Photo 1 of 1 : mhoffman\_s\_20140401\_051.jpg

RD 1001 Unit 6 - L/S Slope - Pole

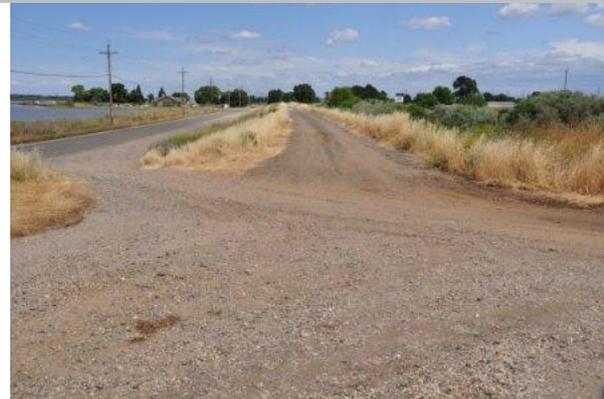
Photo 1 of 1 : mhoffman\_s\_20140401\_047.jpg

RD 1001 Unit 6 - Levee Crown - Subsidence due to vehicle traffic.

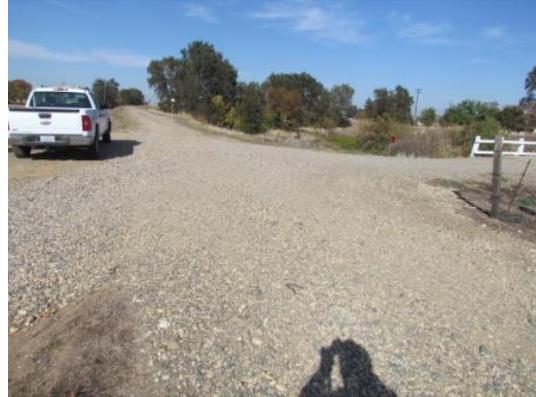
Photo 1 of 1 : mhoffman\_s\_20140401\_049.jpg

This photo was taken from the levee crown facing north looking at subsidence due to vehicle traffic across crown. Fall 2013.
