**Flood Control Project Maintenance
Levee Inspections**

Maintenance Issue Types Only, Levee Inspection Report By Mile - Fall 2015

Reclamation District No. 1001 Nicolaus

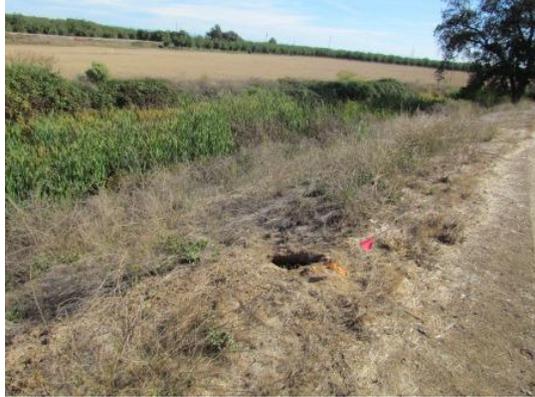
Photo 1 of 2 : FA_2015_RD1001_35_4_20151103_00001.jpg

LM Start	0.27	Rating **	M	Issue No.	4
LM End	0.27	Issue Type +	Ma	Location *	WS
Category	Earthen Levee		GPS Latitude/Longitude		
			Start	End	
Item	Animal Control		38.974323 °	38.974323 °	
			-121.476442 °	-121.476442 °	
DWR ID	DWR_RD1001_02_f_2014_4				
Action/Comments					
No rodents visible, but rodent burrows visible; need to backfill and compact or grout burrows. Inspector Comments: Animal hole on waterward levee slope near the crown. Hole is approximately 1' in diameter and 8" deep.

This photo was taken from the levee crown facing east looking down the waterward slope at an animal burrow. Fall 2014.

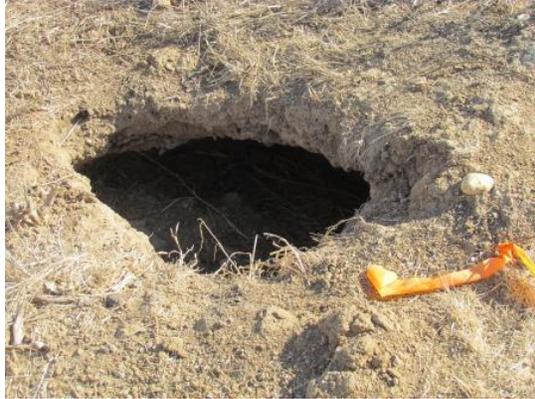
Photo 2 of 2 : FA_2015_RD1001_35_4_20151103_00002.jpg

Another picture of the animal burrow. Fall 2014.

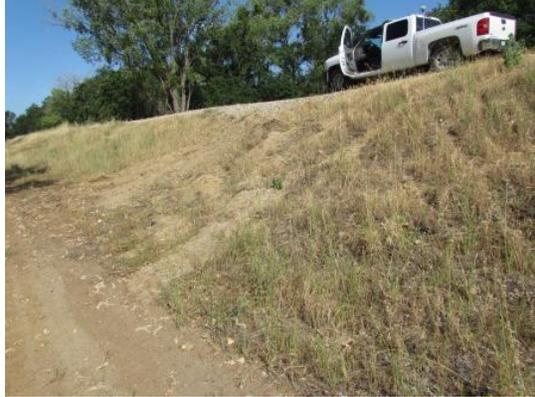
Photo 1 of 1 : FA_2015_RD1001_37_23_20151103_00014.jpg

LM Start	0.14	Rating **	M	Issue No.	23
LM End	0.14	Issue Type +	Ma	Location *	LS
Category	Earthen Levee		GPS Latitude/Longitude		
			Start	End	
Item	Slope Stability		39.006351 °	39.006351 °	
			-121.377313 °	-121.377313 °	
DWR ID	DWR_RD1001_03_s_2015_23				
Action/Comments					
Repair the levee slope damaged by vehicle traffic and prevent access where possible.

View of the rutting on the landside of the levee from the toe facing downstream.

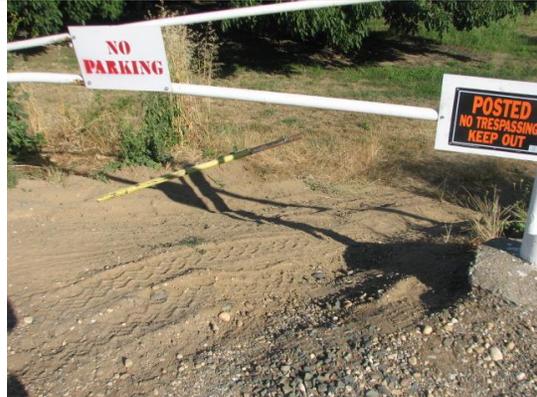
Photo 1 of 2 : FA_2015_RD1001_37_28_20151103_00018.jpg

LM Start	1.87	Rating **	A/W	Issue No.	28
LM End	1.87	Issue Type +	Ma	Location *	WS
Category	Earthen Levee		GPS Latitude/Longitude		
			Start	End	
Item	Slope Stability		38.998608 °	38.998608 °	
			-121.405570 °	-121.405570 °	
DWR ID	DWR_RD1001_03_s_2013_28				
Action/Comments					
Repair the levee slope damaged by vehicle traffic and prevent access where possible.

Damage caused by vehicles Spring 2013

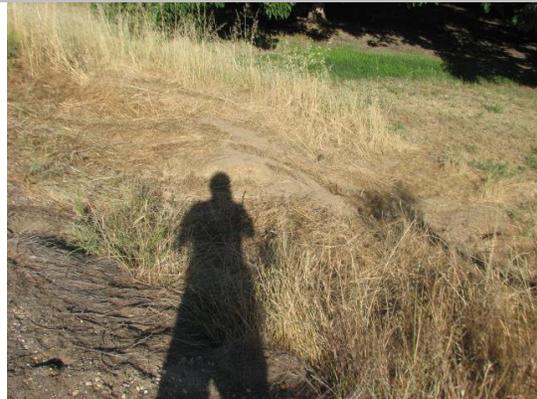
Photo 2 of 2 : FA_2015_RD1001_37_28_20151103_00019.jpg

Damage caused by vehicles. Spring 2013

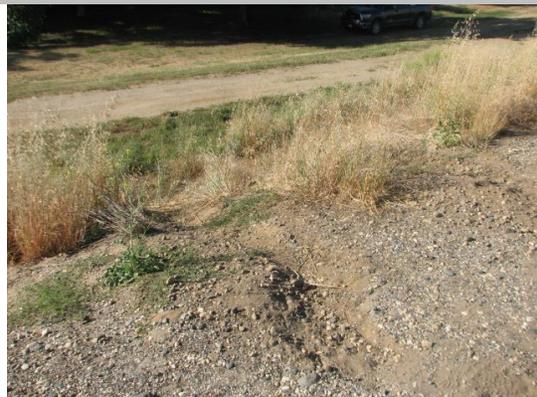
Photo 1 of 2 : FA_2015_RD1001_37_29_20151103_00020.jpg

LM Start	1.87	Rating **	A/W	Issue No.	29
LM End	1.87	Issue Type +	Ma	Location *	LS
Category	Earthen Levee		GPS Latitude/Longitude		
			Start	End	
Item	Slope Stability		38.998608 °	38.998608 °	
			-121.405570 °	-121.405570 °	
DWR ID	DWR_RD1001_03_s_2013_29				
Action/Comments					
Repair the levee slope damaged by vehicle traffic and prevent access where possible.

Damage caused by vehicles going around the gate. Spring 2013

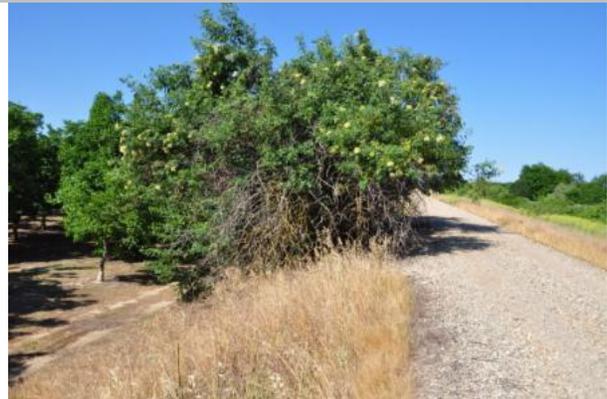
Photo 1 of 1 : FA_2015_RD1001_37_910_20151103_00030.jpg

LM Start	4.82	Rating **	M	Issue No.	910
LM End	4.82	Issue Type +	Ma	Location *	LS
Category	Earthen Levee		GPS Latitude/Longitude		
			Start	End	
Item	Vegetation		38.990773 °	38.990773 °	
			-121.458203 °	-121.458203 °	
DWR ID	DWR_RD1001_03_s_2012_910				
Action/Comments					
Elderberries are blocking visibility and flood fight capability.

RD 1001 Unit 3 - L/S slope -Elderberries

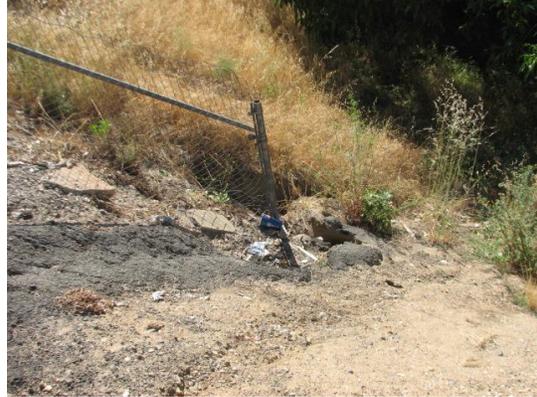
Photo 1 of 1 : FA_2015_RD1001_37_38_20151103_00024.jpg

LM Start	6.47	Rating **	M	Issue No.	38
LM End	6.51	Issue Type +	Ma	Location *	LS
Category	Earthen Levee		GPS Latitude/Longitude		
			Start	End	
Item	Erosion / Bank Caving		38.984010 °	38.983955 °	
			-121.487420 °	-121.488083 °	
DWR ID	DWR_RD1001_03_s_2013_38				
Action/Comments					
Schedule repair of erosion site prior to the next inspection.

Erosion caused by run off from the roadway. Spring 2013

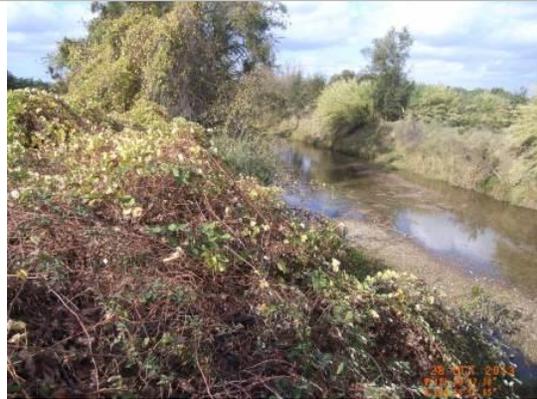
Photo 1 of 1 : USACE2013A_BER_5-7_L_2.jpg

LM Start	7.22	Rating **	M	Issue No.	17
LM End	7.31	Issue Type +	Ma	Location *	WS
Category	Supplemental		GPS Latitude/Longitude		
			Start	End	
Item	2015 USACE Erosion Survey, DRAFT		38.982737 °	38.982572 °	
			-121.501144 °	-121.502797 °	
DWR ID					
Action/Comments					
Inspector Comments: 2008 - Sandy/silty banks with rotational slab failures creating near vertical bank with pop-outs due to tree failures. Narrow berm. 2015: Last observed in 2013. [2015 Site ID: BER_5-7_L]

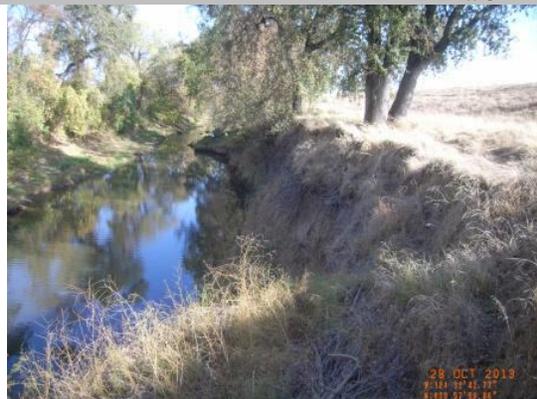
Photo 1 of 1 : USACE2013A_BER_2-5_L_2.jpg

LM Start	10.36	Rating **	M	Issue No.	10
LM End	10.40	Issue Type +	Ma	Location *	WS
Category	Supplemental		GPS Latitude/Longitude		
			Start	End	
Item	2015 USACE Erosion Survey, DRAFT		38.964583 °	38.964010 °	
			-121.544967 °	-121.545228 °	
DWR ID					
Action/Comments					
Inspector Comments: 2011 - Large section of bank has slumped off. RD has flagged and appears to be watching. 2012 - Slopes slightly steeper. 2013 - Minor new erosion observed. 2015: Last observed in 2013. [2015 Site ID: BER_2-5_L]

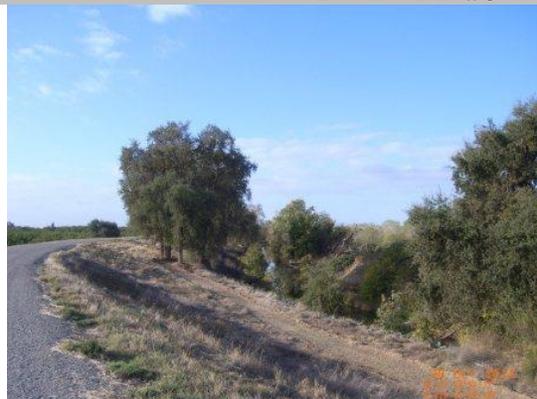
Photo 1 of 1 : USACE2013A_BER_1-9_L_2.jpg

LM Start	11.08	Rating **	M	Issue No.	1
LM End	11.16	Issue Type +	Ma	Location *	WS
Category	Supplemental		GPS Latitude/Longitude		
			Start	End	
Item	2015 USACE Erosion Survey, DRAFT		38.955070 °	38.954227 °	
			-121.549528 °	-121.550592 °	
DWR ID					
Action/Comments					
Inspector Comments: 2011 - Large slumped sections of bank. 2012 - Slopes slightly steeper. 2015: Last observed in 2013. [2015 Site ID: BER_1-9_L]

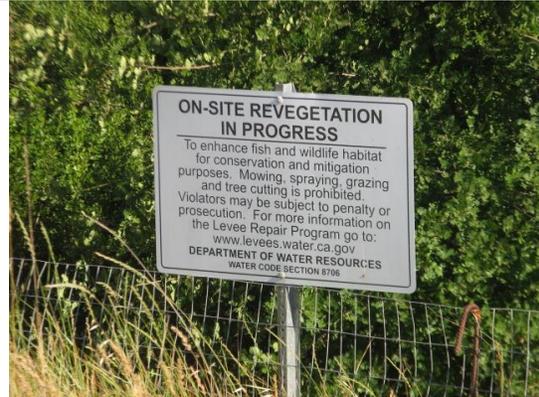
Photo 1 of 1 : FA_2015_RD1001_37_25_20151103_00015.jpg

LM Start	11.59	Rating **	A/W	Issue No.	25
LM End	11.80	Issue Type +	Ma	Location *	WS
Category	Earthen Levee		GPS Latitude/Longitude		
			Start	End	
Item	Vegetation		38.951302 °	38.950960 °	
			-121.556872 °	-121.560717 °	
DWR ID	DWR_RD1001_03_s_2013_25				
Action/Comments					
Environmental Requirements.

Revegetation site in progress. Spring 2013

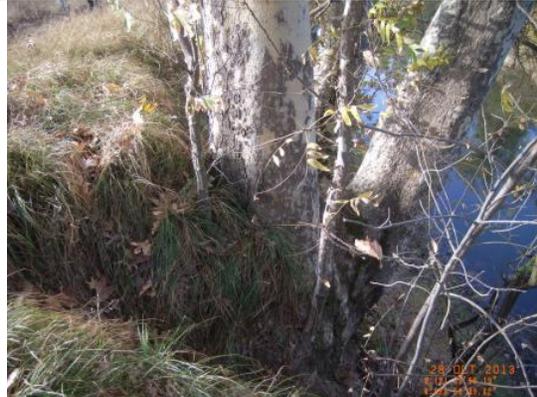
Photo 1 of 1 : USACE2013A_BER_0-8_L_5.jpg

LM Start	12.07	Rating **	M	Issue No.	4
LM End	12.16	Issue Type +	Ma	Location *	WS
Category	Supplemental			GPS Latitude/Longitude	
				Start	End
Item	2015 USACE Erosion Survey, DRAFT			38.947591 °	38.946477 °
				-121.563390 °	-121.564094 °
DWR ID					
Action/Comments					
Inspector Comments: 2006 - Multiple rotational failures in the berm. Erosion is into the levee toe and lower slope. Tension cracks extensive at top of bank. Cohesive toe creates a bench on which failures occur. 2007 - Still steep bank with some berm with pistol-butted reeds. 2012 - Site extended upstream due to additional slumping. Slopes slightly steeper. 2015: Last observed in 2013. [2015 Site ID: BER_0-8_L]

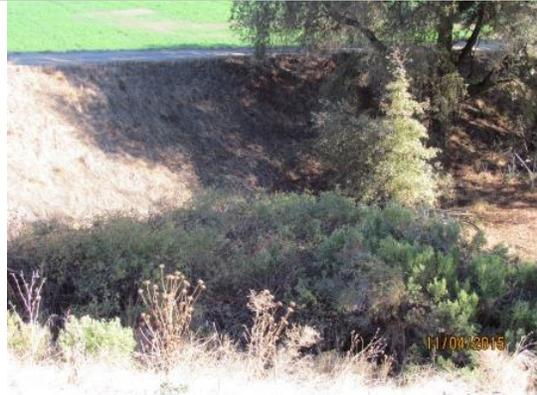
Photo 1 of 1 : FA_2015_RD1001_38_31_20151112_00030.jpg

LM Start	0.78	Rating **	M	Issue No.	31
LM End	0.78	Issue Type +	Ma	Location *	LS
Category	Earthen Levee		GPS Latitude/Longitude		
			Start	End	
Item	Vegetation		38.930026 °	38.930026 °	
			-121.567918 °	-121.567918 °	
DWR ID	DWR_RD1001_04_f_2015_31				
Action/Comments					
Remove the wild growth other than native grasses from the levee slopes.

View of the tall vegetation at the landside levee toe.

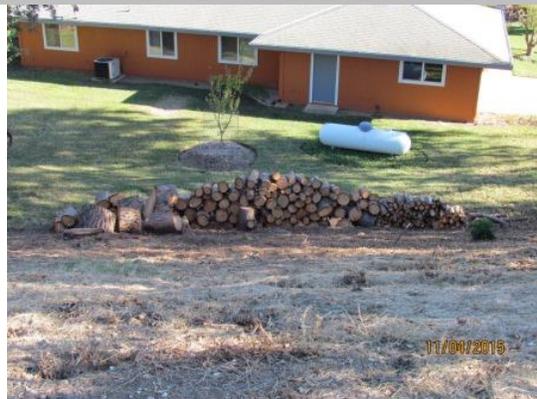
Photo 1 of 1 : FA_2015_RD1001_38_35_20151112_00031.jpg

View of the firewood at the landside levee toe.

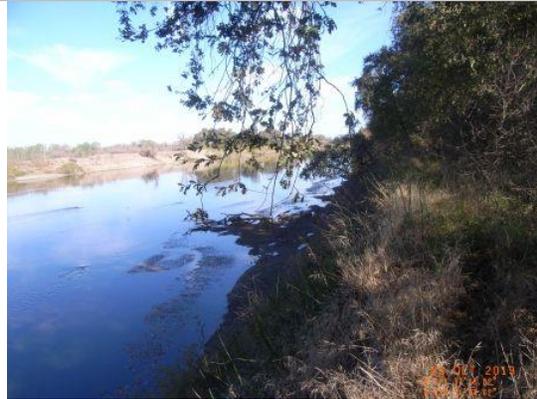
Photo 1 of 1 : USACE2013A_FHR_6-0_L_3.jpg

LM Start	6.42	Rating **	M	Issue No.	5
LM End	6.51	Issue Type +	Ma	Location *	WS
Category	Supplemental			GPS Latitude/Longitude	
				Start	End
Item	2015 USACE Erosion Survey, DRAFT			38.865875 °	38.864706 °
DWR ID				-121.619983 °	-121.620813 °
Action/Comments					
Inspector Comments: 2011 - Tall slumping sections. Scour around trees has exposed most of the roots. 2015: Recent large slope failure observed. [2015 Site ID: FHR_6-0_L]

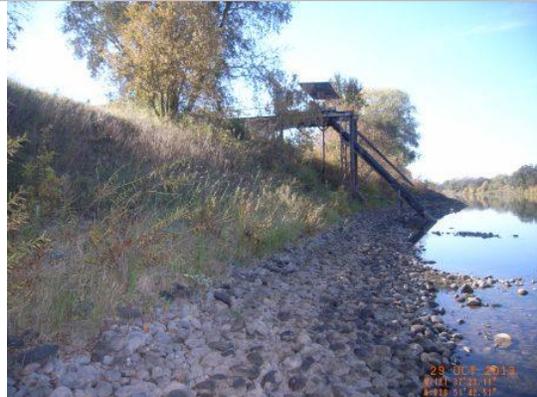
Photo 1 of 1 : USACE2013A_FHR_5-8_L_1.jpg

LM Start	6.57	Rating **	M	Issue No.	4
LM End	6.77	Issue Type +	Ma	Location *	WS
Category	Supplemental			GPS Latitude/Longitude	
				Start	End
Item	2015 USACE Erosion Survey, DRAFT			38.863946 °	38.861558 °
DWR ID				-121.621388 °	-121.623316 °
Action/Comments					
Inspector Comments: 2011 - Large slumped sections on the lower bank. 2012 - New cracks observed. 2015: No observed changes. [2015 Site ID: FHR_5-8_L]

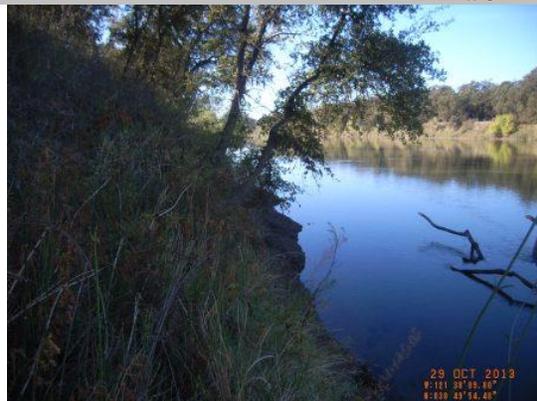
Photo 1 of 1 : USACE2013A_FHR_3-8_L_2.jpg

LM Start	8.57	Rating **	M	Issue No.	7
LM End	8.97	Issue Type +	Ma	Location *	WS
Category	Supplemental		GPS Latitude/Longitude		
			Start	End	
Item	2015 USACE Erosion Survey, DRAFT		38.836966 °	38.831498 °	
			-121.634128 °	-121.636371 °	
DWR ID					
Action/Comments					
Inspector Comments: 2006 - Sandy, silty bank with intermittent pockets of erosion. Rotational failure and tree pop outs are most of the problem. Some upper slope fluvial erosion. 2010 - Site extended upstream. The lower Feather may benefit from a regional repair. 2011 - Site combined with 3.6. Minimal new erosion. 2013 - New erosion observed at bank toe. Trees on site now have exposed roots. 2015: No observed changes. [2015 Site ID: FHR_3-8_L]

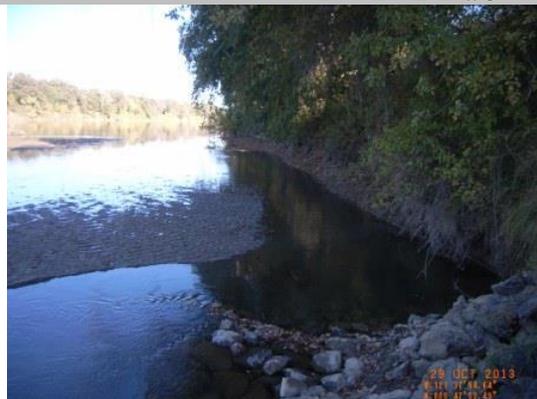
Photo 1 of 1 : USACE2013A_FHR_1-0_L_2.jpg

LM Start	11.18	Rating **	M	Issue No.	6
LM End	11.37	Issue Type +	Ma	Location *	WS
Category	Supplemental		GPS Latitude/Longitude		
			Start	End	
Item	2015 USACE Erosion Survey, DRAFT		38.800920 °	38.798165 °	
			-121.633050 °	-121.631939 °	
DWR ID					
Action/Comments					
Inspector Comments: 2000 - Site is relatively stable except for some toe erosion at the upstream end, recommend monitoring the upstream end. 2004 - Some new block failures (10ft deep) at the toe of the upstream end. 2007 - Some minor new slumping at the waterline. 2013 - Minor new erosion along the bank toe. 2015: No observed changes. [2015 Site ID: FHR_1-0_L]

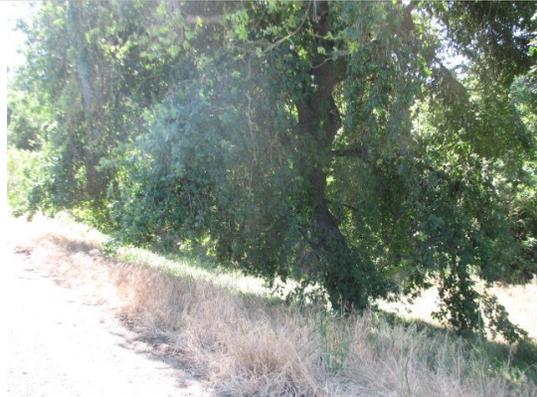
Photo 1 of 1 : FA_2015_RD1001_38_151_20151103_00024.jpg

Trees need to be trimmed up at least 5 feet. Spring 2013

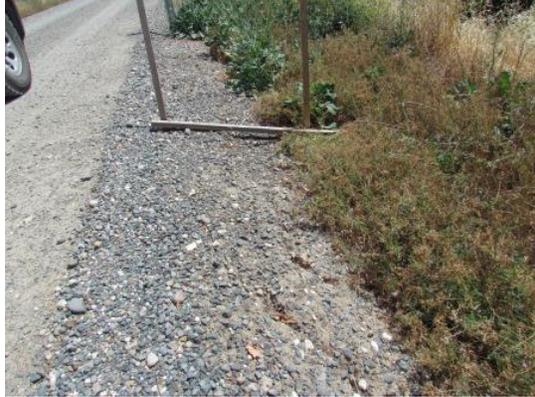
Photo 1 of 1 : FA_2015_RD1001_39_18_20151103_00015.jpg

View of the cracks from erosion on the waterside of the levee facing upstream.

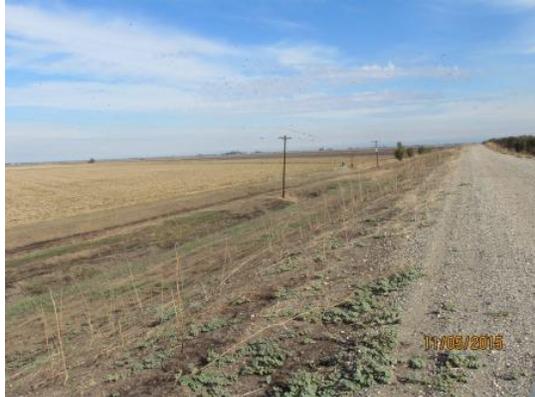
Photo 1 of 1 : FA_2015_RD1001_39_17_20151112_00019.jpg

LM Start	1.33	Rating **	A	Issue No.	17
LM End	1.33	Issue Type +	Ma	Location *	LS
Category	Earthen Levee		GPS Latitude/Longitude		
			Start	End	
Item	Vegetation		38.795275 °	38.795275 °	
			-121.589482 °	-121.589482 °	
DWR ID	DWR_RD1001_05_f_2015_17				
Action/Comments					
Control annual grass and weeds on the levee slopes and easements.

View of the acceptable vegetation control on the landside levee slope.

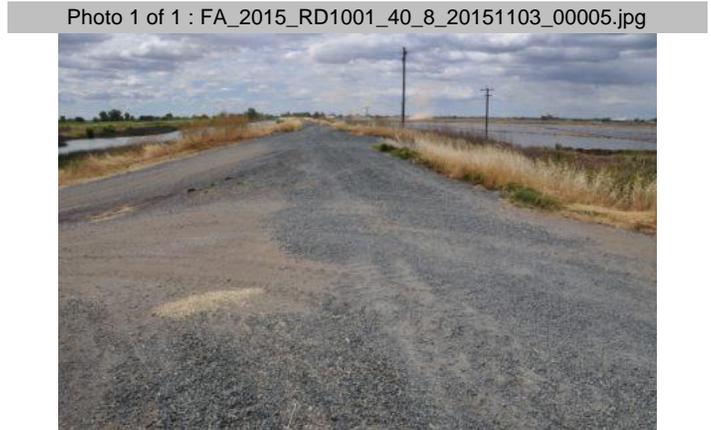
LM Start	2.05	Rating **	M	Issue No.	8
LM End	2.05	Issue Type +	Ma	Location *	CR
Category	Earthen Levee		GPS Latitude/Longitude		
			Start	End	
Item	Slope Stability		38.860002 °	38.860002 °	
			-121.524873 °	-121.524873 °	
DWR ID	DWR_RD1001_06_s_2012_8				
Action/Comments					
Repair the levee slope damaged by vehicle traffic and prevent access where possible. Inspector Comments: Subsidence due to traffic across levee crown.

RD 1001 Unit 6 - Levee Crown - Subsidence due to vehicle traffic.

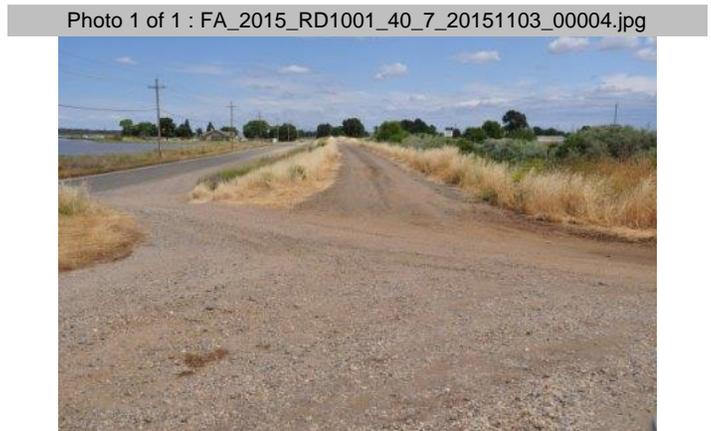
LM Start	4.04	Rating **	M	Issue No.	7
LM End	4.04	Issue Type +	Ma	Location *	CR
Category	Earthen Levee		GPS Latitude/Longitude		
			Start	End	
Item	Slope Stability		38.888821 °	38.888821 °	
			-121.524733 °	-121.524733 °	
DWR ID	DWR_RD1001_06_s_2012_7				
Action/Comments					
Repair the levee slope damaged by vehicle traffic and prevent access where possible. Inspector Comments: Levee crown subsided due to vehicle traffic across crown.

RD 1001 Unit 6 - Levee Crown - Subsidence due to vehicle traffic.

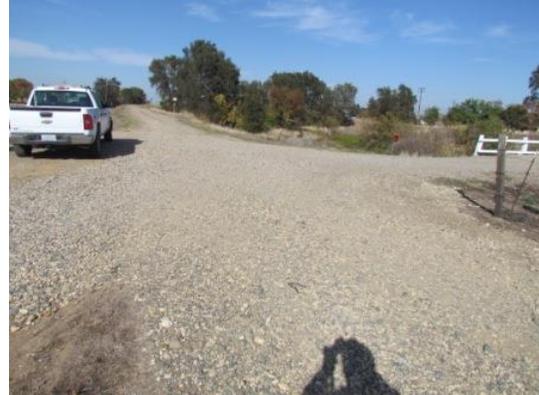
Photo 1 of 1 : FA_2015_RD1001_40_19_20151103_00006.jpg

This photo was taken from the levee crown facing north looking at subsidence due to vehicle traffic across crown. Fall 2013.
