**Flood Control Project Maintenance  
Levee Inspections**

**Fall 2010 Levee Maintenance Deficiency Summary Report**

**Reclamation District No. 1500 Sutter Basin**

**Levee Inspection Report By Mile - Fall 2010**

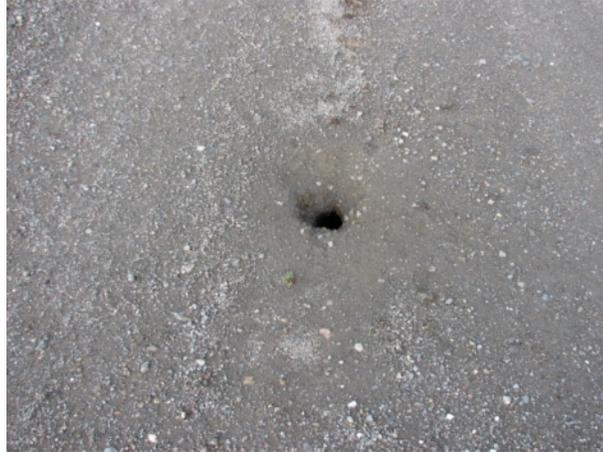
Levee Mile Report Line	2
Start Levee Mile	0.03
End Levee Mile	0.03
Location	Crown
Category	Earthen Levee
Item	Animal Control
hole in crown	
johngw_f_20101012_156.jpg

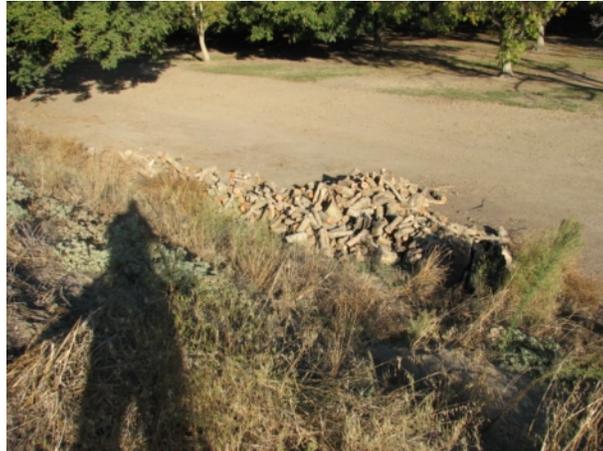
Levee Mile Report Line	3
Start Levee Mile	0.03
End Levee Mile	0.03
Location	Land Side
Category	Earthen Levee
Item	Encroachments
Fresh pile of firewood from this years prunings.	
johngw_f_20101018_242.jpg

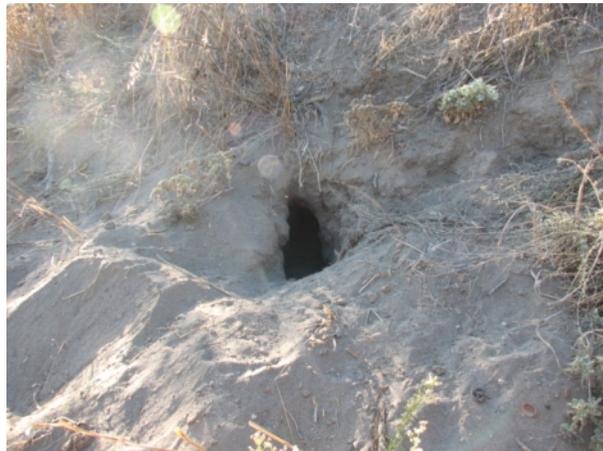
Levee Mile Report Line	4
Start Levee Mile	0.03
End Levee Mile	0.03
Location	Land Side
Category	Earthen Levee
Item	Animal Control
This is one of serval rodent holes in the area.	
johngw_f_20101018_243.jpg

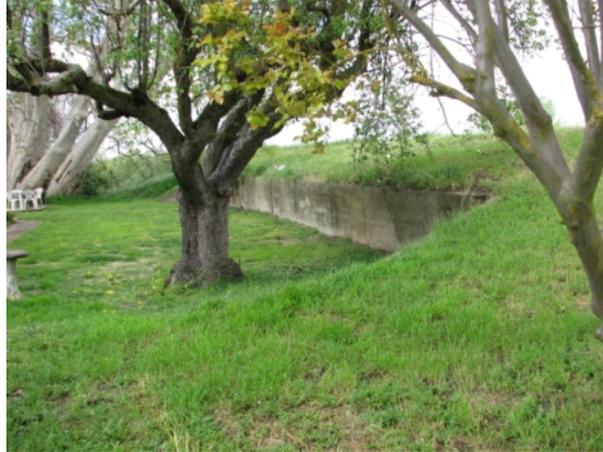
Levee Mile Report Line	12
Start Levee Mile	1.34
End Levee Mile	1.34
Location	Land Side
Category	Earthen Levee
Item	Encroachments
landscape and retaining wall, This photo is from spring 2010.	
johngw_f_20101012_137.jpg

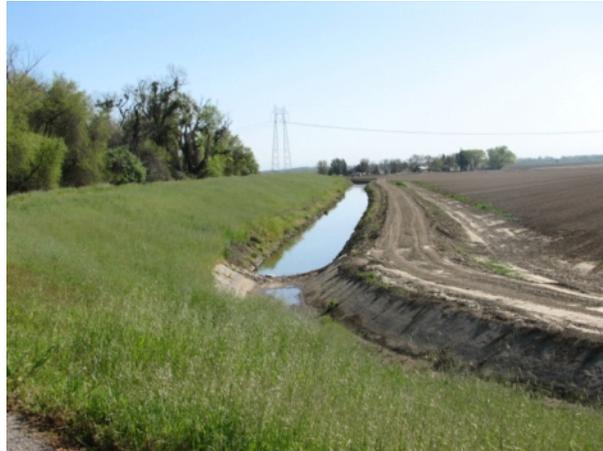
Levee Mile Report Line	14
Start Levee Mile	2.57
End Levee Mile	3.83
Location	Land Side
Category	Earthen Levee
Item	Encroachments
ag. ditch, Photo was taken in spring 2010.	
johngw_f_20101012_157.jpg

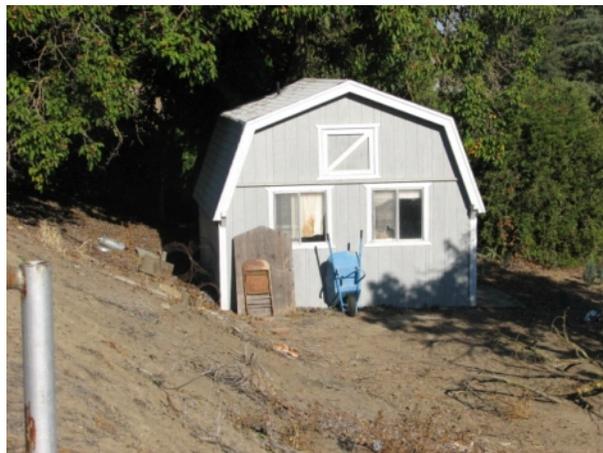
Levee Mile Report Line	19
Start Levee Mile	4.03
End Levee Mile	4.03
Location	Water Side
Category	Earthen Levee
Item	Encroachments
Garden shed located at the landside levee toe.	
johngw_f_20101018_244.jpg

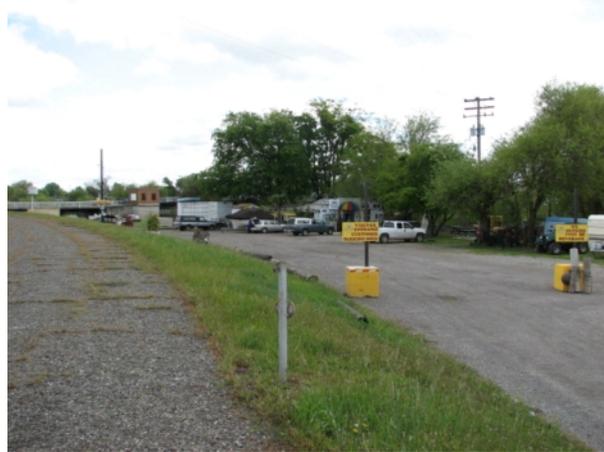
Levee Mile Report Line	25
Start Levee Mile	5.67
End Levee Mile	5.75
Location	Water Side
Category	Earthen Levee
Item	Encroachments
Sting Rays Marina RV park, Photo was taken in spring 2010.	
johngw_f_20101012_155.jpg

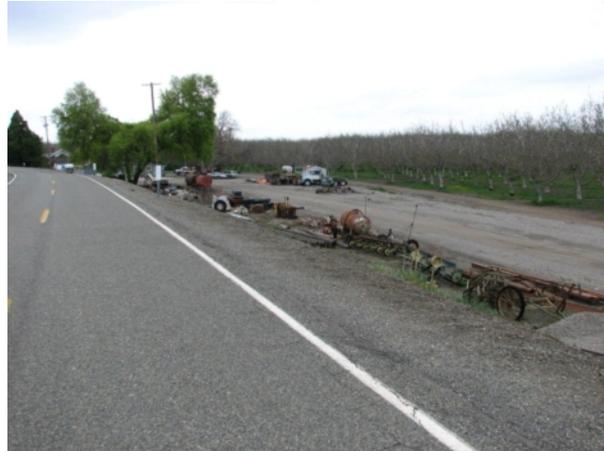
Levee Mile Report Line	27
Start Levee Mile	7.57
End Levee Mile	7.57
Location	Land Side
Category	Earthen Levee
Item	Encroachments
along landside toe, Photo was taken in spring 2010.	
johngw_f_20101012_140.jpg

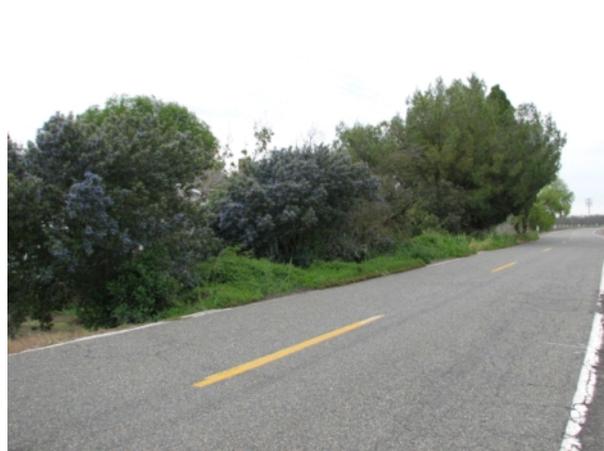
Levee Mile Report Line	28
Start Levee Mile	7.66
End Levee Mile	7.66
Location	Land Side
Category	Earthen Levee
Item	Encroachments
landscape shrubs, Photo was taken in spring 2010.	
johngw_f_20101012_141.jpg

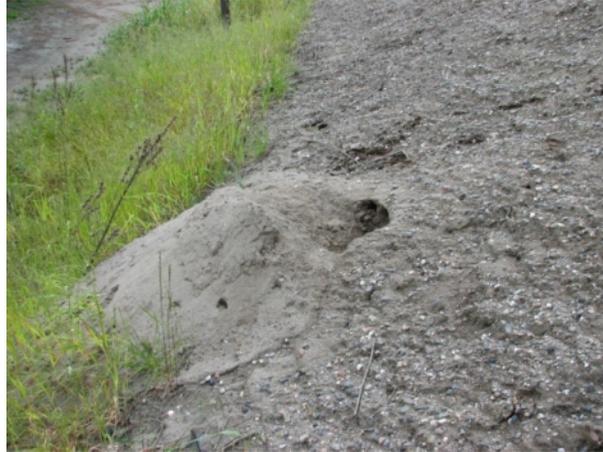
Levee Mile Report Line	29
Start Levee Mile	7.71
End Levee Mile	7.71
Location	Land Side
Category	Earthen Levee
Item	Animal Control
<p>large amount of spoils landside Photo was taken in spring 2010.</p> <p>johngw_f_20101012_139.jpg</p>

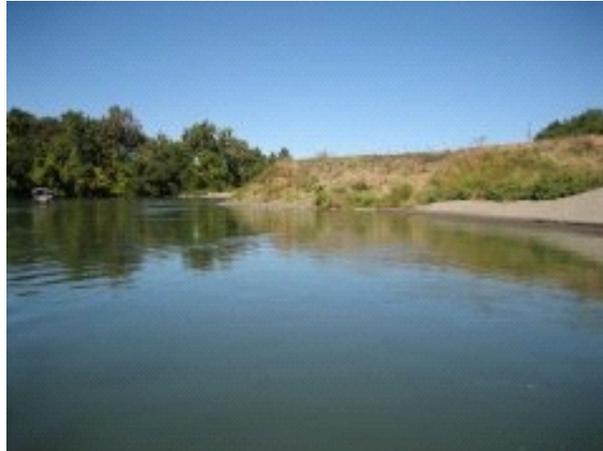
Levee Mile Report Line	30
Start Levee Mile	8.33
End Levee Mile	8.54
Location	Water Side
Category	Supplemental
Item	USACE Erosion Survey
<p>2009: no berm, 2:1 slope, slumping, sands and silts, 3.32 ft/s [2009 SiteID:SAC_92-8_L]</p> <p>johngw_f_20101012_149.JPG</p>

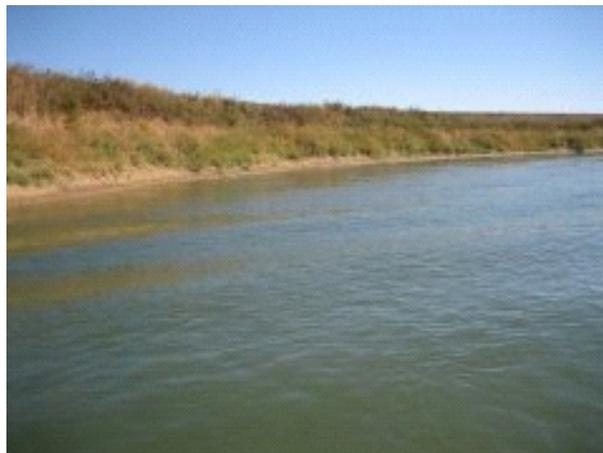
Levee Mile Report Line	32
Start Levee Mile	9.44
End Levee Mile	9.65
Location	Water Side
Category	Supplemental
Item	USACE Erosion Survey
<p>2009: 15 ft berm, 1.5:1 slope, no stability issues, clays and silts, 3.37 ft/s [2009 SiteID:SAC_93-7_L]</p> <p>johngw_f_20101012_150.JPG</p>

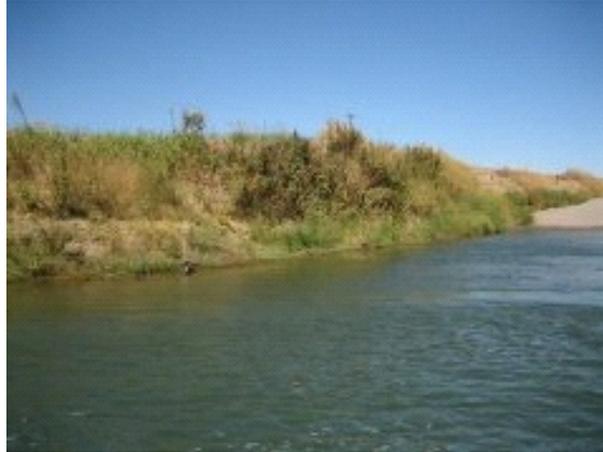
Levee Mile Report Line	35
Start Levee Mile	12.10
End Levee Mile	12.38
Location	Water Side
Category	Supplemental
Item	USACE Erosion Survey
2009: 15 ft berm, 1.5:1 slope, holes and slumping, clays and silts, 3.22 ft/s [2009 SiteID:SAC_96-2_L]	
johngw_f_20101012_152.JPG

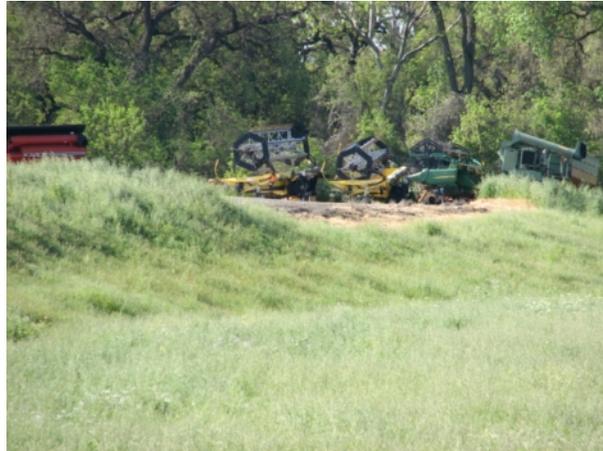
Levee Mile Report Line	43
Start Levee Mile	14.13
End Levee Mile	14.13
Location	Water Side
Category	Earthen Levee
Item	Encroachments
shot of equipment, Photo was taken in spring 2010.	
johngw_f_20101012_144.jpg

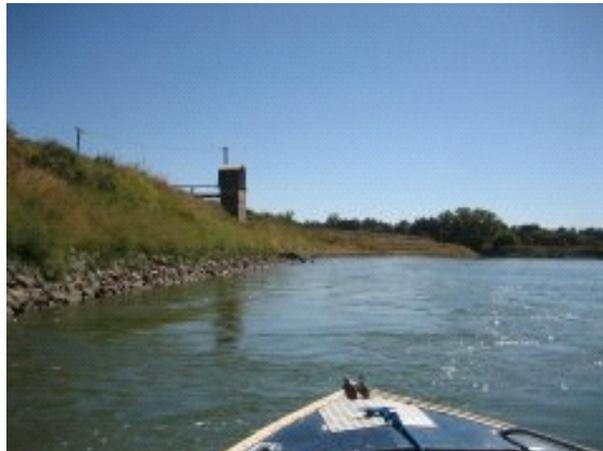
Levee Mile Report Line	44
Start Levee Mile	14.13
End Levee Mile	14.43
Location	Water Side
Category	Supplemental
Item	USACE Erosion Survey
2009: 10 ft berm, 1:1 slope, slumping, sands and silts, 2.72 ft/s [2009 SiteID:SAC_99-0_L]	
johngw_f_20101012_153.JPG

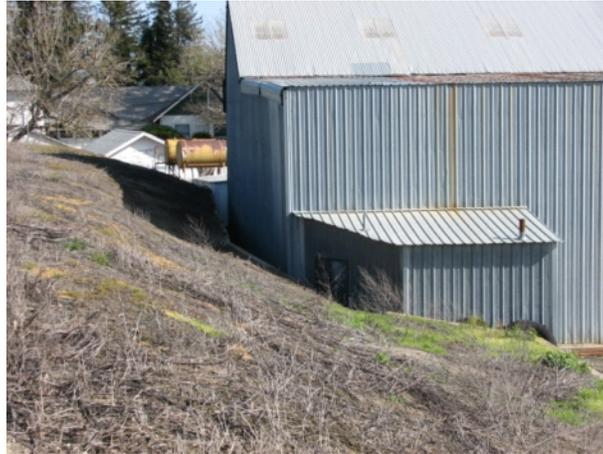
Levee Mile Report Line	45
Start Levee Mile	14.35
End Levee Mile	14.35
Location	Land Side
Category	Earthen Levee
Item	Encroachments
building and wall into levee, Photo was taken in spring 2010.	
johngw_f_20101012_145.jpg

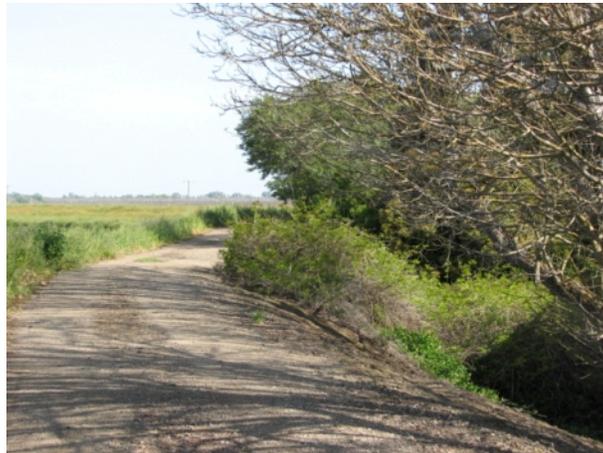
Levee Mile Report Line	46
Start Levee Mile	14.39
End Levee Mile	14.39
Location	Land Side
Category	Earthen Levee
Item	Encroachments
landscape shrubs on shoulder, Photo was taken in spring 2010.	
johngw_f_20101012_146.jpg

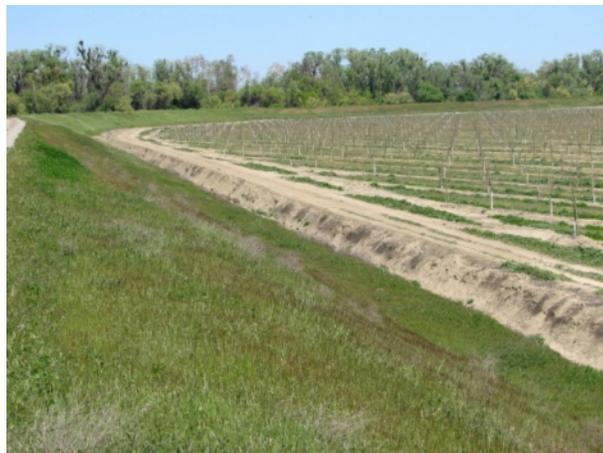
Levee Mile Report Line	47
Start Levee Mile	14.86
End Levee Mile	15.93
Location	Land Side
Category	Earthen Levee
Item	Encroachments
ag. ditch, Photo was taken in spring 2010.	
johngw_f_20101012_158.jpg

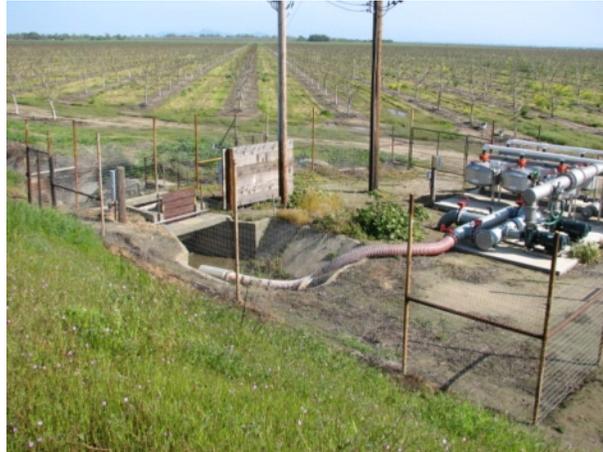
Levee Mile Report Line	48
Start Levee Mile	15.27
End Levee Mile	15.27
Location	Land Side
Category	Earthen Levee
Item	Encroachments
fence into levee toe, Photo was taken in spring 2010.	
johngw_f_20101012_143.jpg

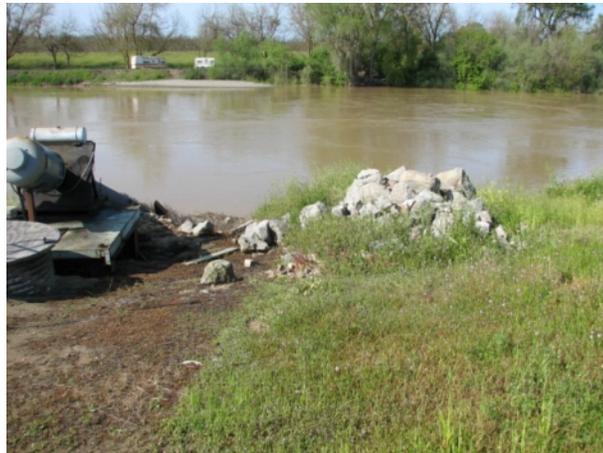
Levee Mile Report Line	49
Start Levee Mile	15.27
End Levee Mile	15.27
Location	Water Side
Category	Earthen Levee
Item	Encroachments
rip rap and concrete debris, Photo was taken in spring 2010.	
johngw_f_20101012_142.jpg

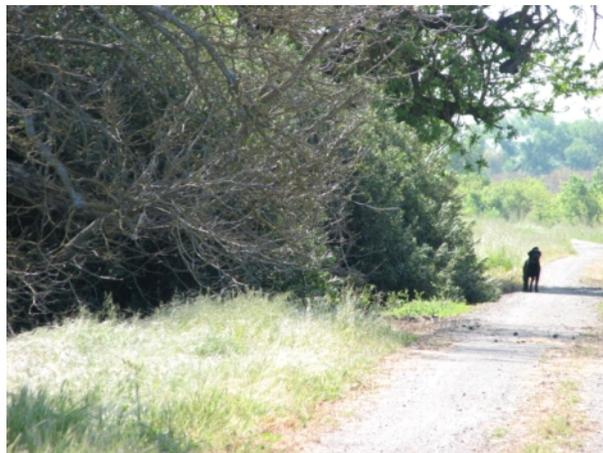
Levee Mile Report Line	51
Start Levee Mile	16.48
End Levee Mile	16.48
Location	Land Side
Category	Earthen Levee
Item	Encroachments
landscape shrubs, Photo was taken in spring 2010.	
johngw_f_20101012_147.jpg

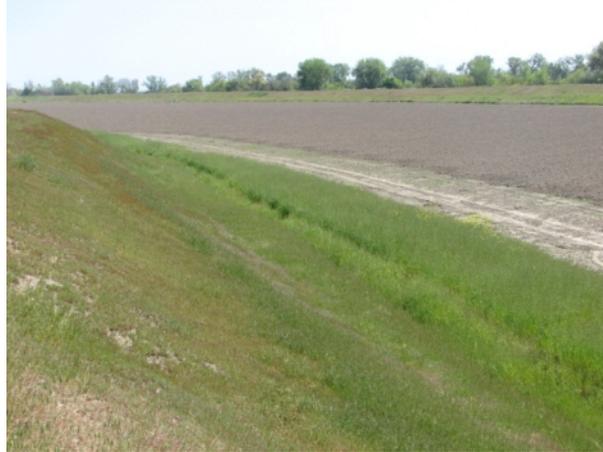
Levee Mile Report Line	52
Start Levee Mile	16.86
End Levee Mile	17.45
Location	Land Side
Category	Earthen Levee
Item	Encroachments
ag. ditch, Photo was taken in spring 2010.	
johngw_f_20101012_159.jpg

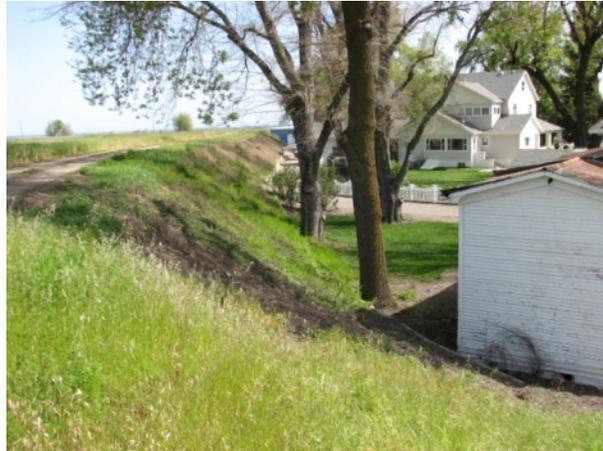
Levee Mile Report Line	55
Start Levee Mile	19.19
End Levee Mile	19.19
Location	Land Side
Category	Earthen Levee
Item	Encroachments
building and wall into levee with landscape, Photo was taken in spring 2010.	
johngw_f_20101012_148.jpg

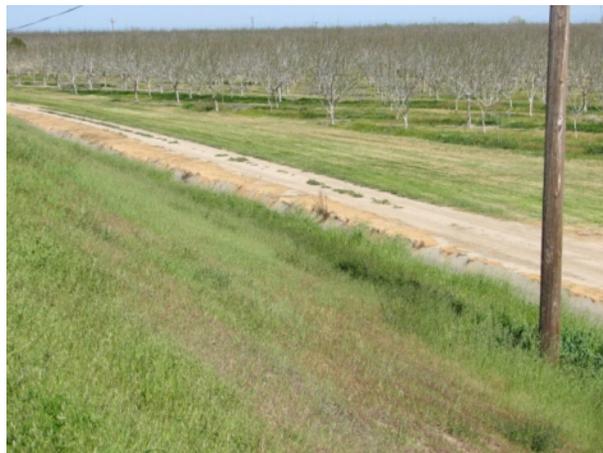
Levee Mile Report Line	59
Start Levee Mile	20.86
End Levee Mile	21.40
Location	Land Side
Category	Earthen Levee
Item	Encroachments
ag. ditch, Photo was taken in spring 2010.	
johngw_f_20101012_160.jpg

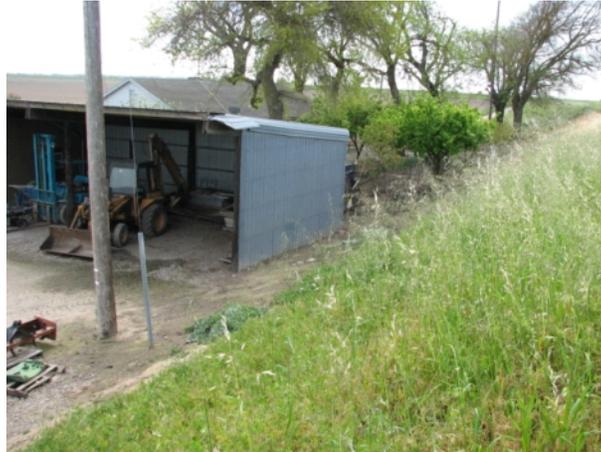
Levee Mile Report Line	63
Start Levee Mile	24.04
End Levee Mile	24.04
Location	Land Side
Category	Earthen Levee
Item	Encroachments
pole barn and some equipment, Photo was taken in spring 2010.	
johngw_f_20101012_151.jpg

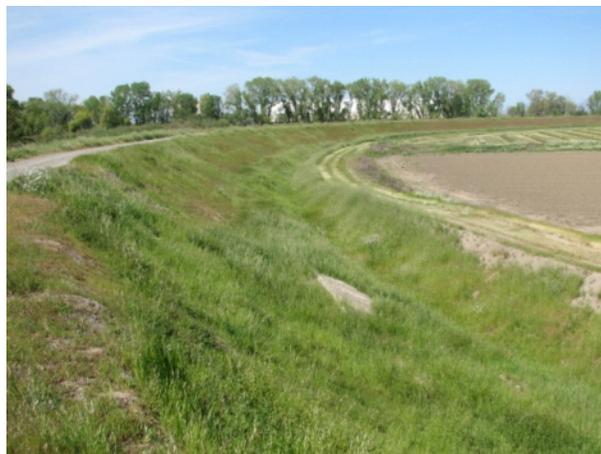
Levee Mile Report Line	64
Start Levee Mile	24.44
End Levee Mile	24.78
Location	Land Side
Category	Earthen Levee
Item	Encroachments
ag. ditch, Photo was taken in spring 2010.	
johngw_f_20101012_161.jpg

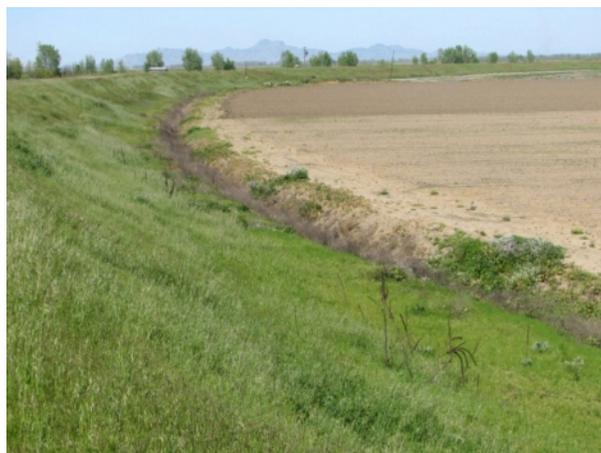
Levee Mile Report Line	67
Start Levee Mile	25.76
End Levee Mile	26.54
Location	Land Side
Category	Earthen Levee
Item	Encroachments
ag. ditch, Photo was taken in spring 2010.	
johngw_f_20101012_162.jpg

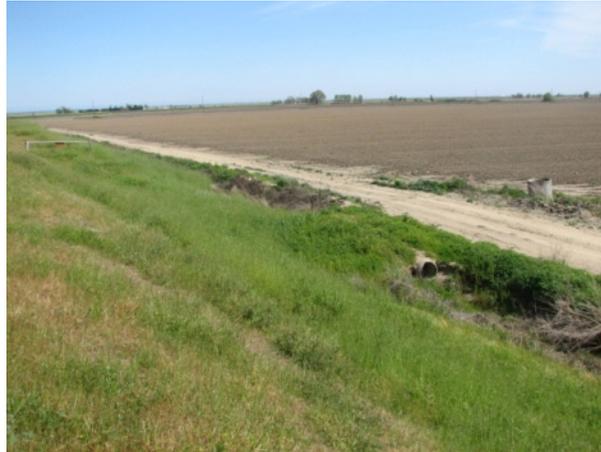
Levee Mile Report Line	69
Start Levee Mile	26.84
End Levee Mile	27.07
Location	Land Side
Category	Earthen Levee
Item	Encroachments
ag. ditch, Photo was taken in spring 2010.	
johngw_f_20101012_163.jpg

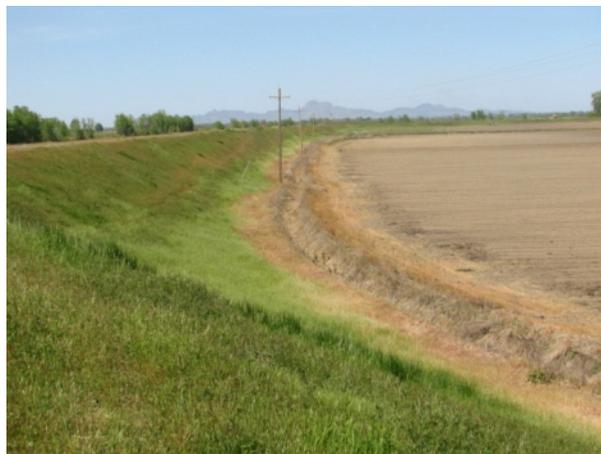
Levee Mile Report Line	70
Start Levee Mile	27.63
End Levee Mile	27.78
Location	Land Side
Category	Earthen Levee
Item	Encroachments
ag. ditch, Photo was taken in spring 2010.	
johngw_f_20101012_164.jpg

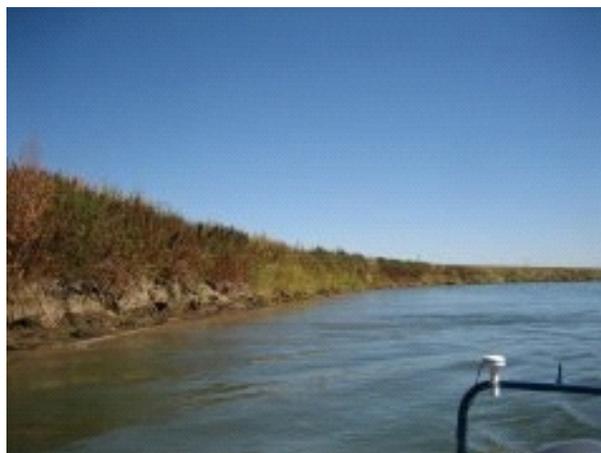
Levee Mile Report Line	73
Start Levee Mile	31.34
End Levee Mile	31.98
Location	Water Side
Category	Supplemental
Item	USACE Erosion Survey
2009: 10 ft berm, 1.5:1 slope, holes and slumping, clays and silts, 4 ft/s [2009 SiteID:SAC_116-5_L]	
johngw_f_20101012_154.JPG

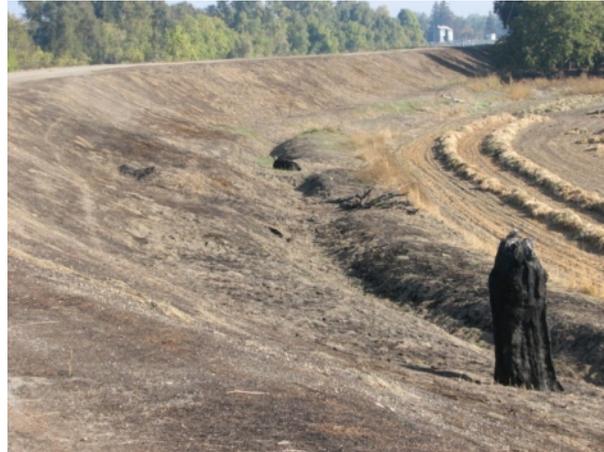
Levee Mile Report Line	74
Start Levee Mile	32.71
End Levee Mile	33.00
Location	Land Side
Category	Earthen Levee
Item	Encroachments
older unused ag ditch stump of tree needs to be removed	
johngw_f_20101025_245.jpg

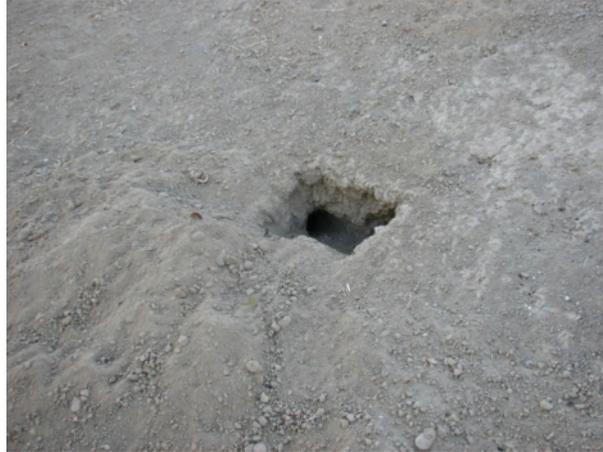
Levee Mile Report Line	3
Start Levee Mile	0.17
End Levee Mile	0.17
Location	Land Side
Category	Earthen Levee
Item	Animal Control
This a rodent hole on the slope of the ramp.	
johngw_f_20101018_237.jpg

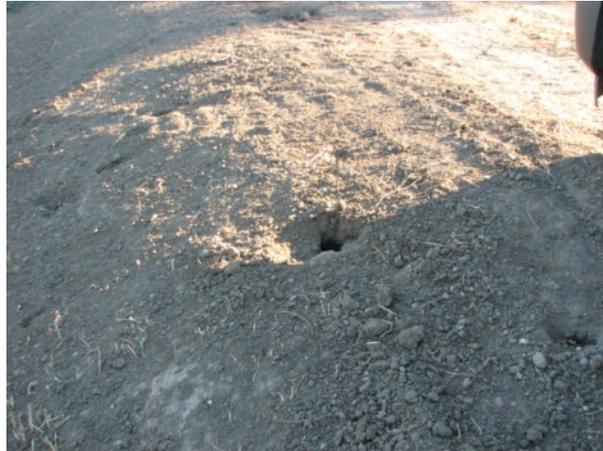
Levee Mile Report Line	3
Start Levee Mile	0.17
End Levee Mile	0.17
Location	Land Side
Category	Earthen Levee
Item	Animal Control
A small rodent hole at the shoulder.	
johngw_f_20101018_238.jpg

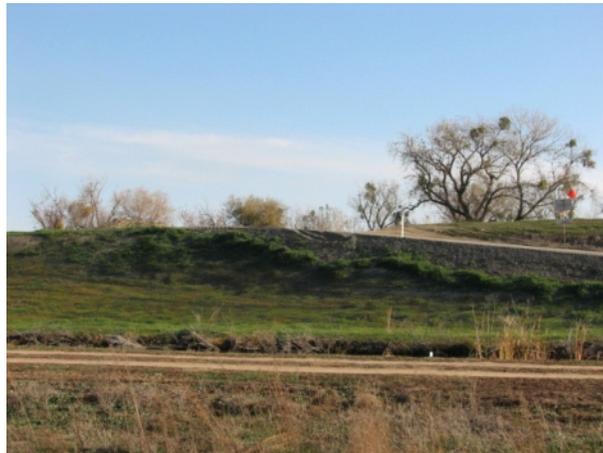
Levee Mile Report Line	6
Start Levee Mile	11.03
End Levee Mile	11.03
Location	Crown
Category	Earthen Levee
Item	Crown Surface / Depressions / Rutting
cross view of levee crown	
johngw_f_20101012_169.jpg

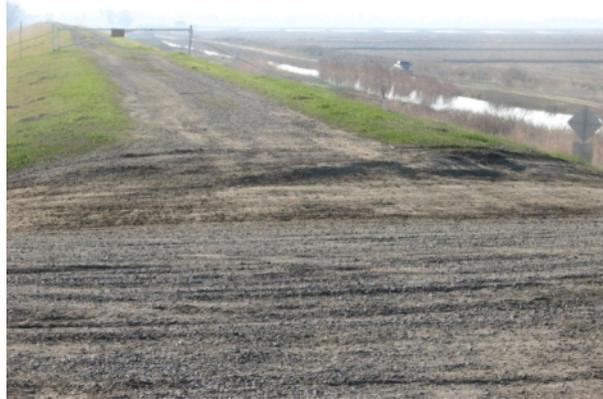
Levee Mile Report Line	6
Start Levee Mile	11.03
End Levee Mile	11.03
Location	Crown
Category	Earthen Levee
Item	Crown Surface / Depressions / Rutting
dip coming off the crown of levee	
johngw_f_20101012_170.jpg

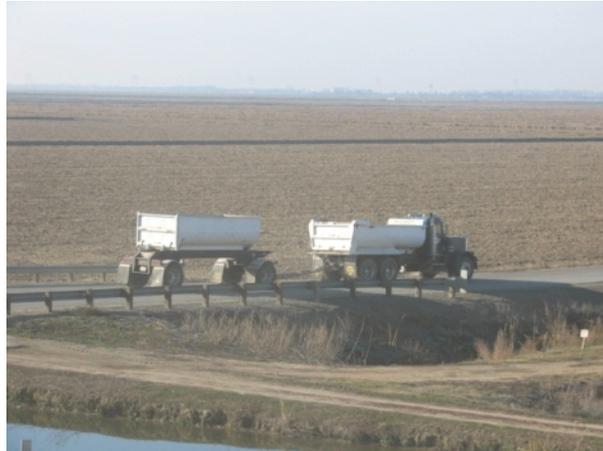
Levee Mile Report Line	6
Start Levee Mile	11.03
End Levee Mile	11.03
Location	Crown
Category	Earthen Levee
Item	Crown Surface / Depressions / Rutting
typical truck that crosses the levee	
johngw_f_20101012_171.jpg

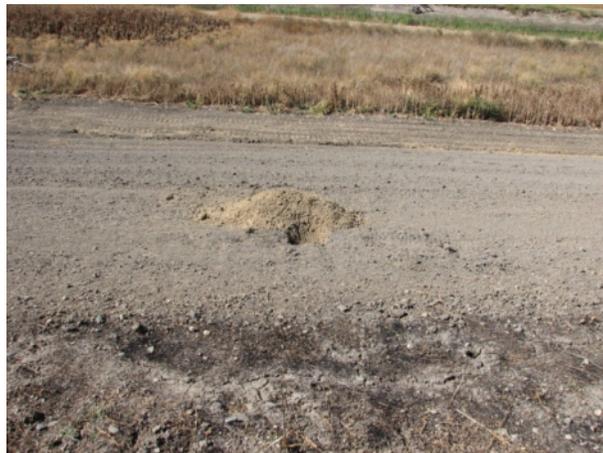
Levee Mile Report Line	7
Start Levee Mile	19.58
End Levee Mile	19.58
Location	Land Side
Category	Earthen Levee
Item	Animal Control
Another rodent hole in unit 2.	
johngw_f_20101018_241.jpg
