**Flood Control Project Maintenance
Levee Inspections**

Fall 2014 Levee Maintenance Deficiency Summary Report

Reclamation District No. 1500 Sutter Basin

Fall 2014 Levee Inspection Results

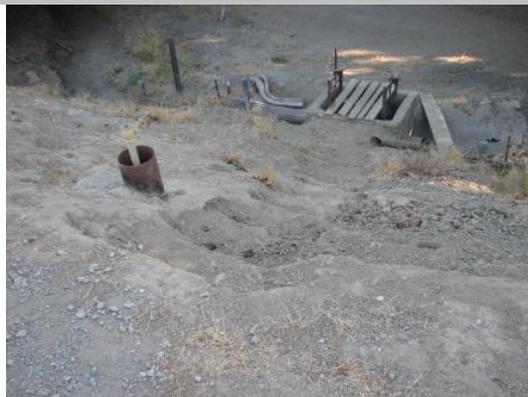
Photo 1 of 1 : FA_2014_RD1500_189_53_20141014_00049.jpg

Steps carved into the levee slope at a pipe crossing. Photo fall 2012.

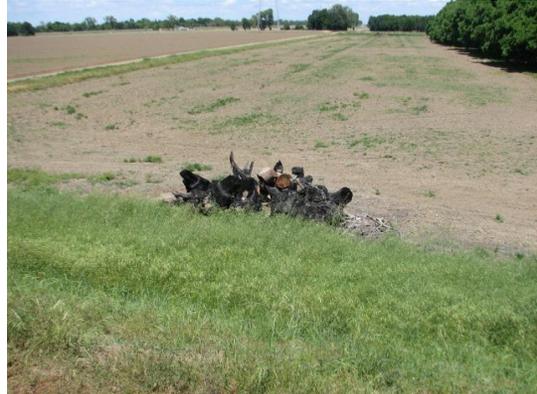
Photo 1 of 1 : FA_2014_RD1500_189_1336_20141014_00094.jpg

Large stumps piled up at the toe of the levee. Spring 2014

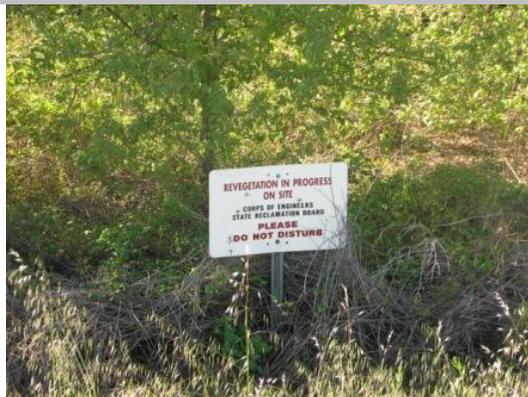
Photo 2 of 2 : FA_2014_RD1500_189_72_20141014_00060.jpg

A revegetation site waterside toe, photo taken spring 2012.

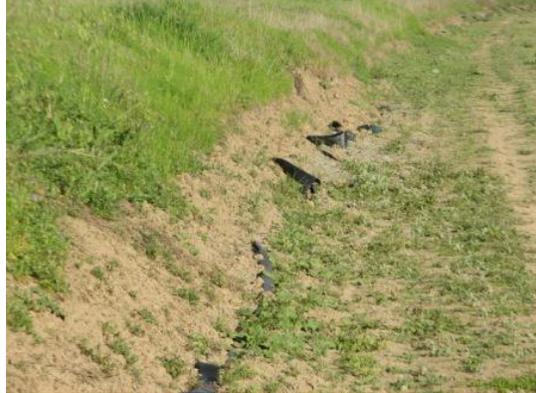
Photo 1 of 2 : FA_2014_RD1500_189_76_20141014_00063.jpg

LM Start	0.64	Rating **	A/W	Issue No.	76
LM End	1.06	Issue Type +	Ma	Location *	LS
Category	Earthen Levee			GPS Latitude/Longitude	
				Start	End
Item	Slope Stability			38.764305 °	38.766827 °
				-121.684396 °	-121.690884 °
DWR ID	DWR_RD1500_01_s_2013_76				
Action/Comments					
Repair slope instability. Inspector Comments: Seepage berm was damaged last fall in prep for the agricultural field and needs to be restored by the land owner. A field investigation report was made. The seepage berm is scheduled to be repaired before next flood season.

Damage to the seepage berm during the flood season needs to be repaired, Spring 2013

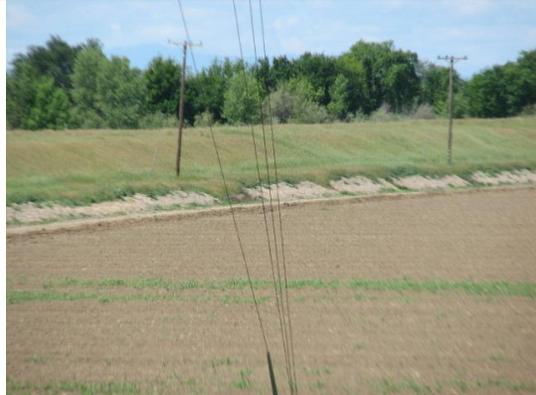
Photo 2 of 2 : FA_2014_RD1500_189_76_20141014_00064.jpg

The damage to the seepage berm has been repaired and needs to be monitored. Spring 2014

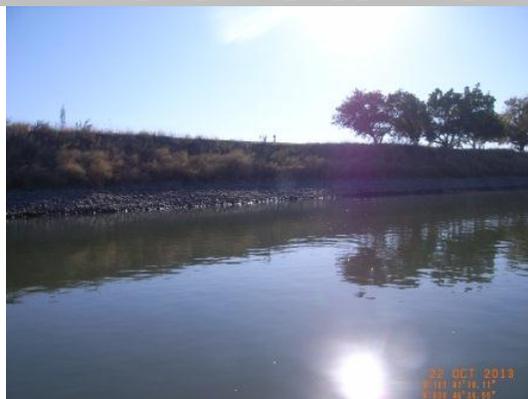
Photo 1 of 1 : FA_2014_RD1500_189_1_20141014_00001.jpg

LM Start	1.32	Rating **	M	Issue No.	1
LM End	1.32	Issue Type +	Ma	Location *	WS
Category	Supplemental			GPS Latitude/Longitude	
				Start	End
Item	USACE Erosion Survey			38.770390 °	38.777282 °
				-121.690553 °	-121.685841 °
DWR ID	DWR_RD1500_01_f_2014_1				
Action/Comments					
Inspector Comments: 2006 - New erosion upstream, new bank failures near levee but still fairly wide berm in most places. 2008 - Large berm, questionable as to if it should remain in the inventory. 2010 - Minor new erosion, old cobble starting to fail. 2011 - Cobble continues to unravel and additional slumping. 2014 - Minor new erosion at bank mid point. 2013: Minor new erosion. [2013 Site ID: SAC_86-3_L]

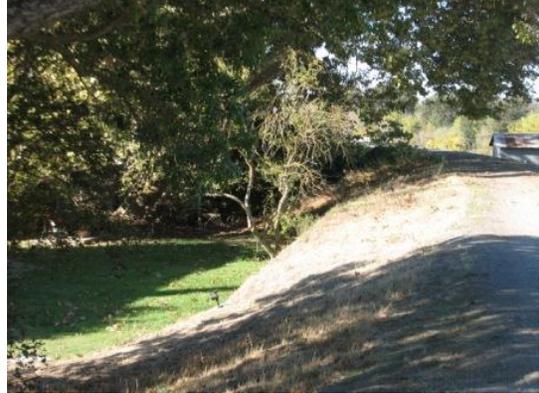
Photo 1 of 1 : FA_2014_RD1500_189_4_20141014_00004.jpg

Landscape with retaining wall that is in the USACE as-builts Fall 2013

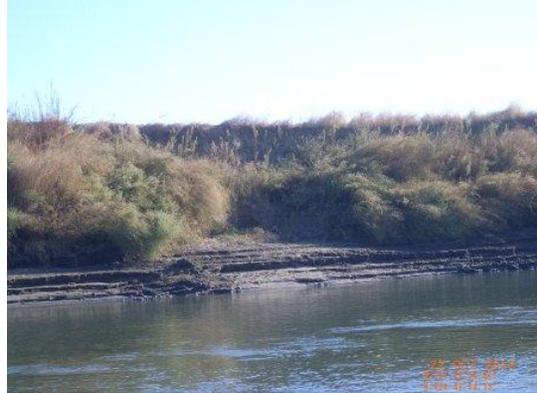
Photo 1 of 1 : FA_2014_RD1500_189_2_20141014_00002.jpg

LM Start	2.34	Rating **	M	Issue No.	2
LM End	2.34	Issue Type +	Ma	Location *	WS
Category	Supplemental			GPS Latitude/Longitude	
				Start	End
Item	USACE Erosion Survey			38.781962 °	38.784936 °
				-121.688033 °	-121.690033 °
DWR ID	DWR_RD1500_01_f_2014_2				
Action/Comments					
Inspector Comments: 2010 - The upstream end of the repair site at 87.0. Repair did not extend far enough upstream. 2011 - New erosion pockets. 2012 - Minor new erosion at toe. 2013: Minor new erosion. [2013 Site ID: SAC_87-1_L]

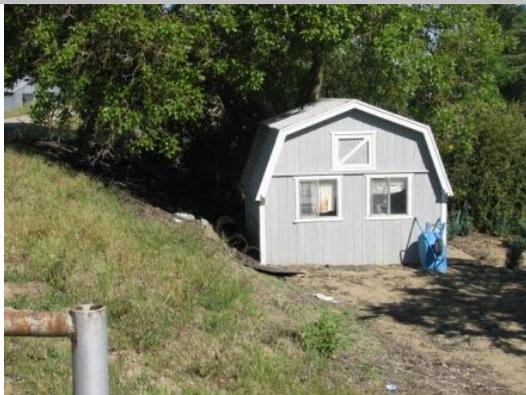
Photo 1 of 2 : FA_2014_RD1500_189_7_20141014_00006.jpg

A small building is encroaching into the landside levee toe.

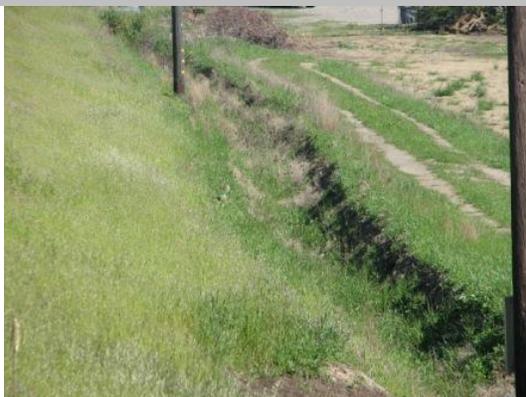
Photo 1 of 1 : FA_2014_RD1500_189_54_20141014_00050.jpg

An agricultural ditch runs along the toe of the levee, photo taken spring 2012.

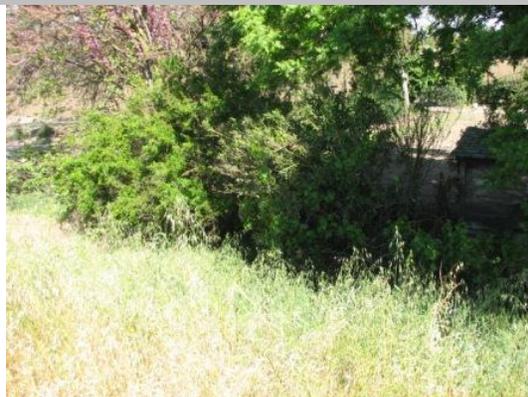
Photo 1 of 1 : FA_2014_RD1500_189_12_20141014_00011.jpg

The landscape is planted within the encroachment area of 15'.

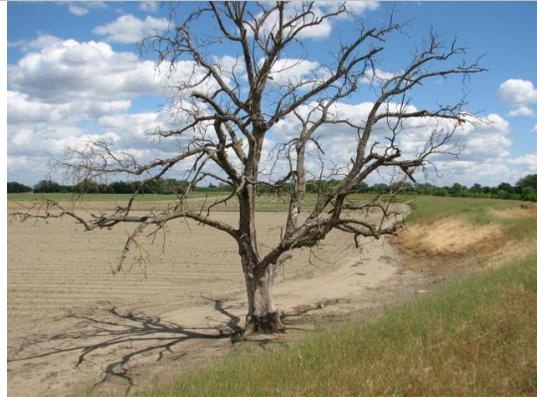
Photo 1 of 1 : FA_2014_RD1500_189_1340_20141014_00098.jpg

Monitor tree that may pose a future threat to the integrity of the levee. Spring 2014

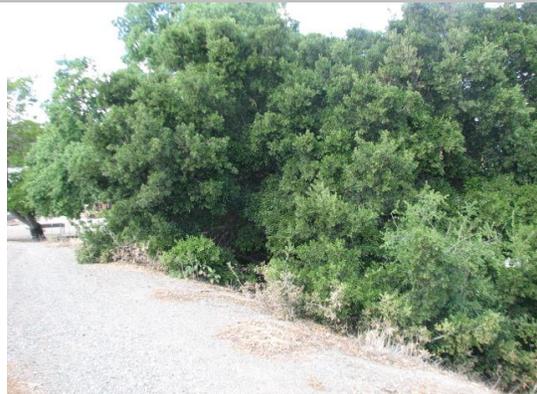
Photo 1 of 1 : FA_2014_RD1500_189_1341_20141014_00099.jpg

Trees need to be trimmed up to at least 5' they are blocking the visibility. Spring 2014

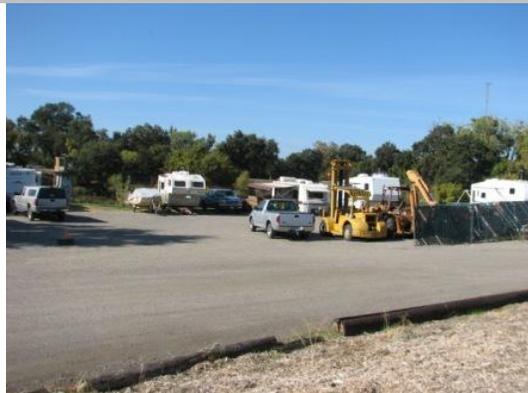
Photo 1 of 2 : FA_2014_RD1500_189_52_20141014_00047.jpg

String Rayz RV park, Fall 2013

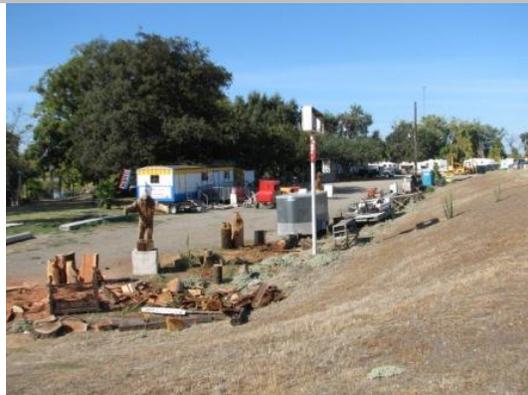
Photo 2 of 2 : FA_2014_RD1500_189_52_20141014_00048.jpg

String Rayzs, Fall 2013

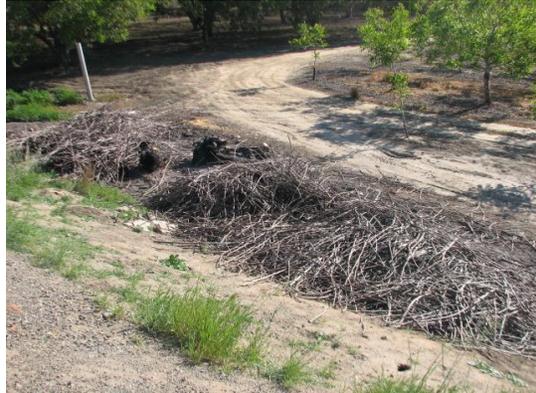
Photo 2 of 2 : FA_2014_RD1500_189_216_20141014_00077.jpg

The pruning pile has reduced in size by burning it. A new pile is started. Spring 2014

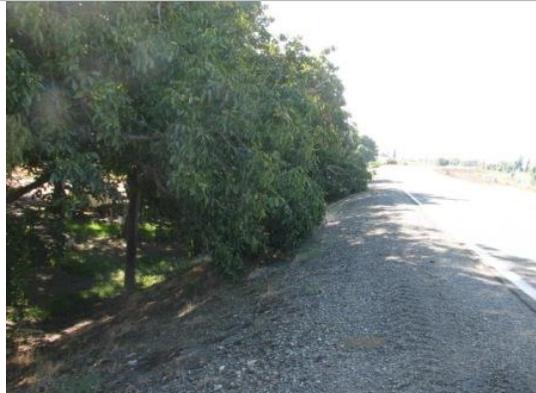
Photo 1 of 1 : FA_2014_RD1500_189_217_20141014_00078.jpg

Trees need to be trimmed to the height of 5 feet to see the slope.

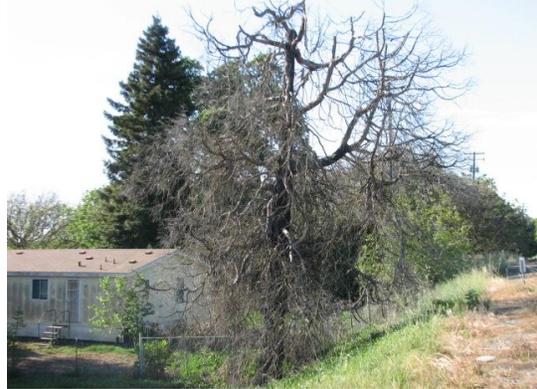
Photo 1 of 1 : FA_2014_RD1500_189_1343_20141014_00101.jpg

Monitor tree that may pose a future threat to the integrity of the levee. Spring 2014

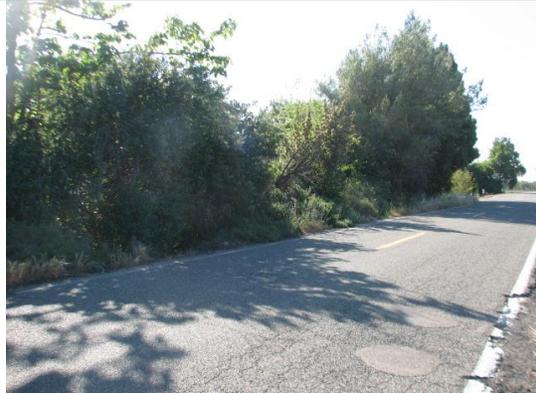
Photo 2 of 2 : FA_2014_RD1500_189_17_20141014_00016.jpg

A current view of the landscape on the levee slope. Spring 2014

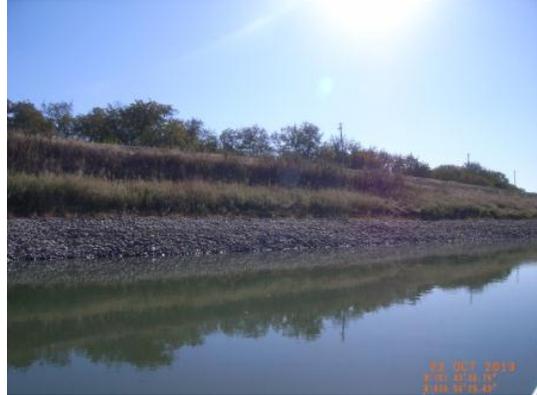
Photo 1 of 1 : FA_2014_RD1500_189_3_20141014_00003.jpg

USACE 2013 Photo #1

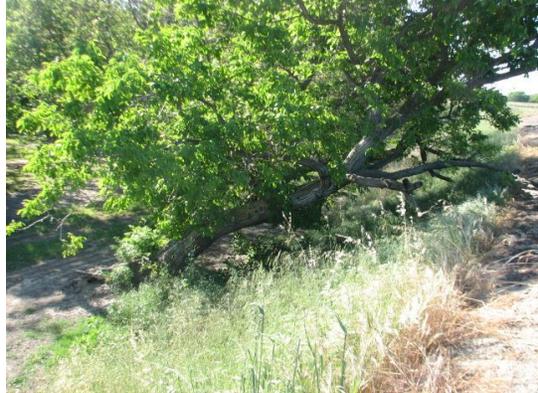
Photo 1 of 1 : FA_2014_RD1500_189_1344_20141014_00102.jpg

The walnut tree at the toe has fallen. The roots are exposed and the branches are holding it up. Spring 2014

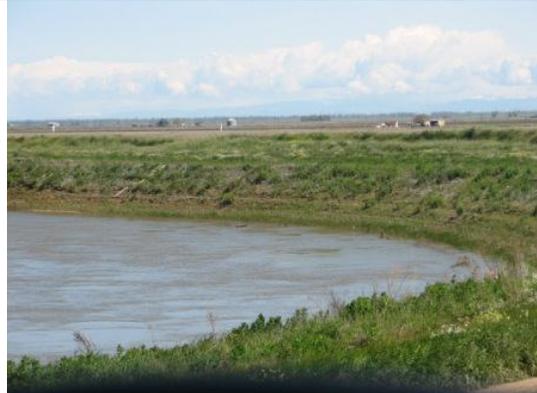
Photo 1 of 2 : FA_2014_RD1500_189_74_20141014_00061.jpg

A revegetation site on the waterside bank with sprinklers installed.

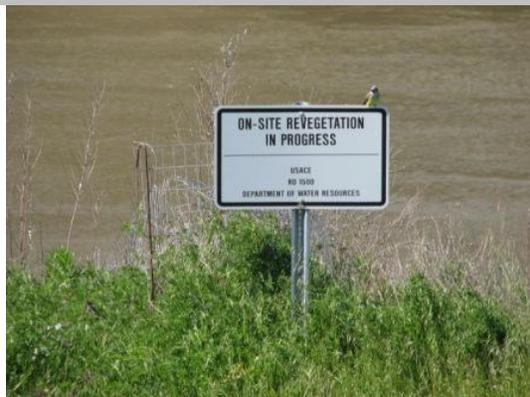
Photo 2 of 2 : FA_2014_RD1500_189_74_20141014_00062.jpg

Another revegetation site photo taken spring 2012.

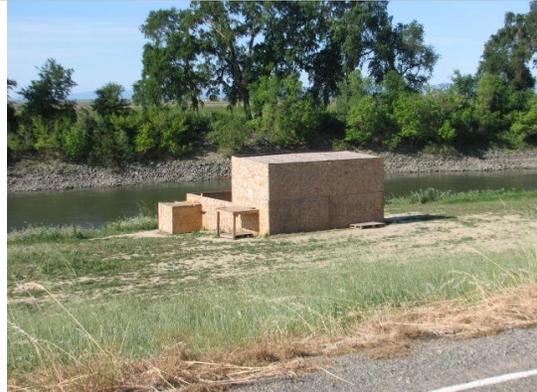
Photo 1 of 1 : FA_2014_RD1500_189_1345_20141014_00103.jpg

A temporary building (fishing shack) is on the waterside berm. Spring 2014

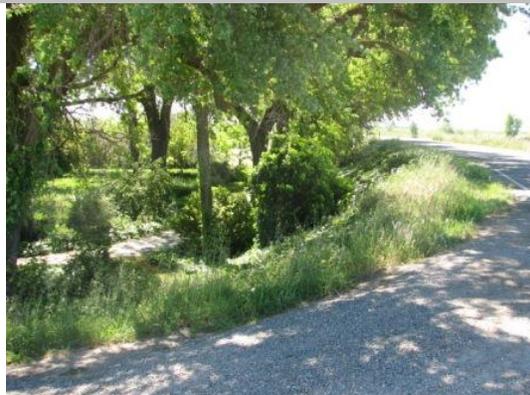
Photo 1 of 1 : FA_2014_RD1500_189_20_20141014_00018.jpg

The homeowner has landscaped the levee slope.

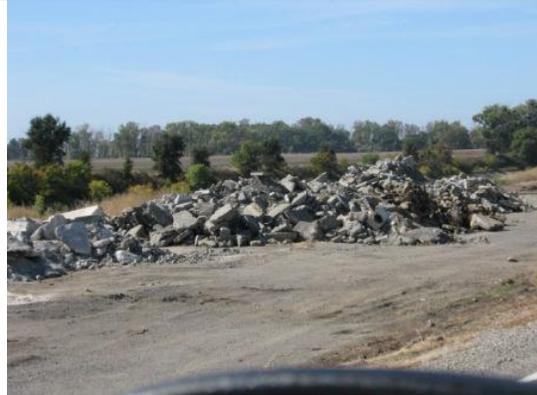
Photo 1 of 2 : FA_2014_RD1500_189_219_20141014_00079.jpg

Concret debris stockpiled on the waterside. Fall 2013

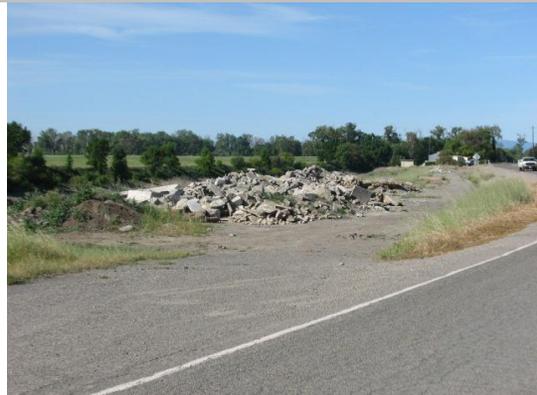
Photo 2 of 2 : FA_2014_RD1500_189_219_20141014_00080.jpg

Concrete debris is along the berm area. Spring 2014

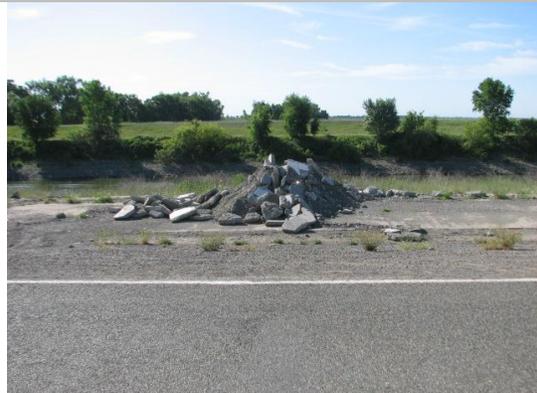
Photo 1 of 1 : FA_2014_RD1500_189_1346_20141014_00104.jpg

A concrete debris pile is on the berm area. Spring 2014

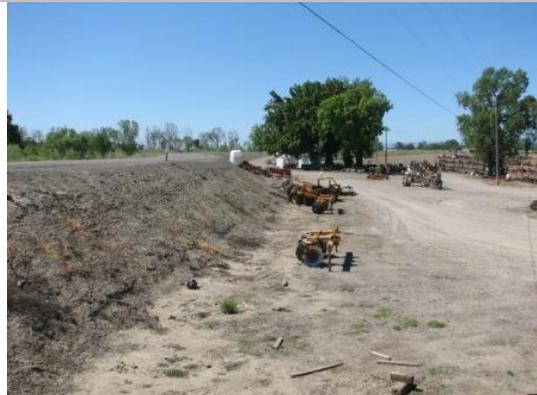
Photo 1 of 2 : FA_2014_RD1500_189_24_20141014_00022.jpg

There is equipment parked along the toe of the levee.

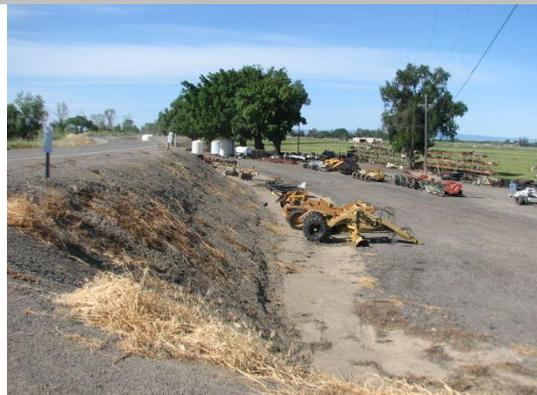
Photo 2 of 2 : FA_2014_RD1500_189_24_20141014_00023.jpg

A current view of the equipment parked along the levee toe Spring 2014

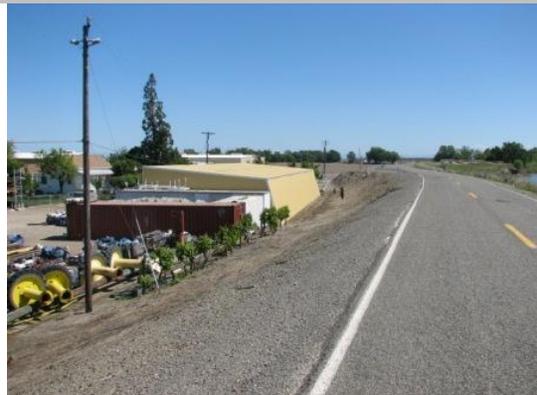
Photo 1 of 1 : FA_2014_RD1500_189_26_20141014_00025.jpg

The buildings backside was built into the toe of the levee.

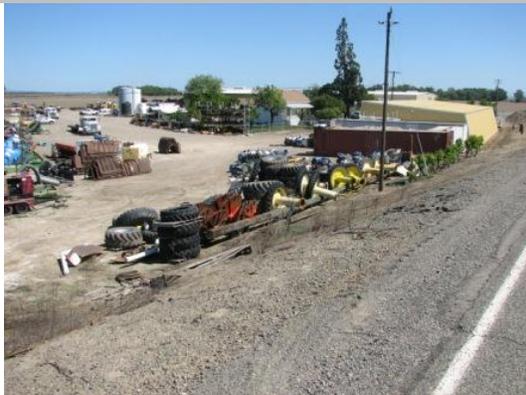
Photo 1 of 1 : FA_2014_RD1500_189_992_20141014_00091.jpg

Next to the building there are tires and axles stored at the toe.

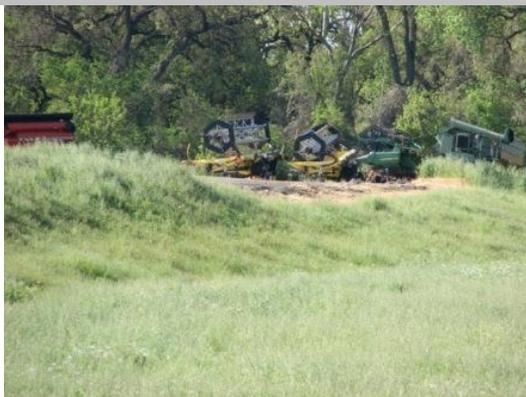
Photo 1 of 1 : FA_2014_RD1500_189_28_20141014_00026.jpg

View of equipment. Photo was taken in spring 2010.

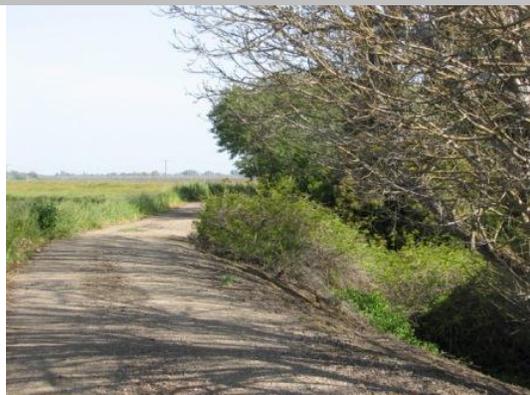
Photo 1 of 1 : FA_2014_RD1500_189_31_20141014_00029.jpg

Landscape shrubs on shoulder. Photo was taken in spring 2010.

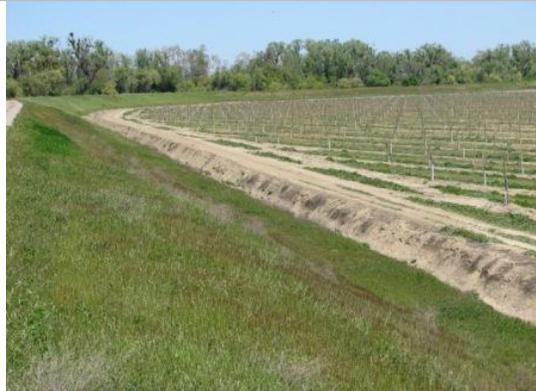
Photo 1 of 1 : FA_2014_RD1500_189_969_20141014_00082.jpg

Agricultural ditch, photo taken in spring 2010.

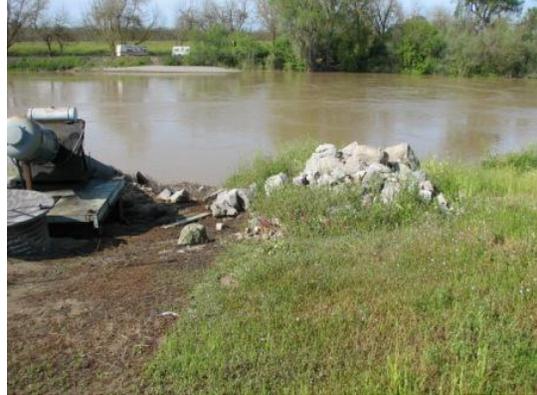
Photo 1 of 1 : FA_2014_RD1500_189_21_20141014_00019.jpg

Rip rap and concrete debris, photo taken in spring 2010.

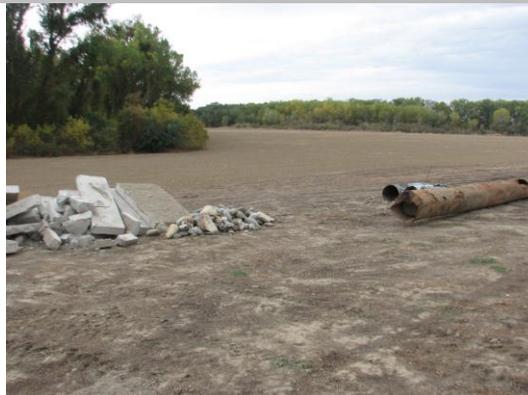
Photo 1 of 1 : FA_2014_RD1500_189_110_20141030_00154.jpg

Broken concrete and a pipe.

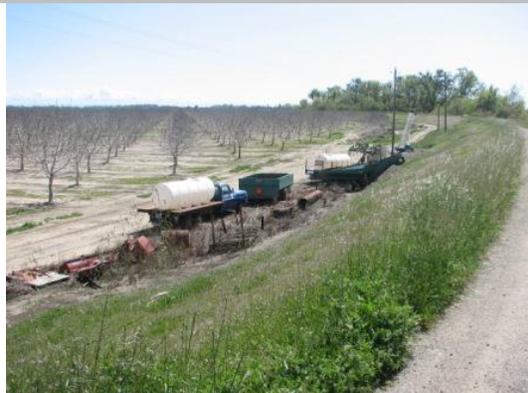
Photo 1 of 2 : FA_2014_RD1500_189_78_20141014_00067.jpg

The equipment is parked along the toe of the levee, photo taken spring 2012.

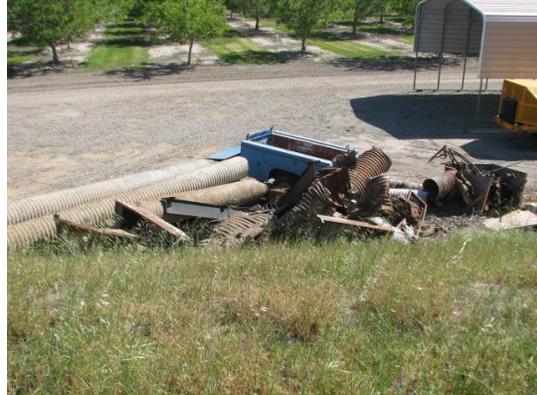
Photo 1 of 1 : FA_2014_RD1500_189_1347_20141014_00105.jpg

Pipe and debris is placed along the levee toe. Spring 2014

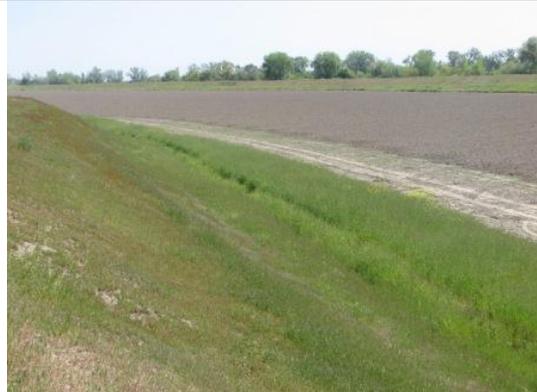
Photo 1 of 2 : FA_2014_RD1500_189_972_20141014_00083.jpg

Agricultural ditch, photo taken in spring 2010.

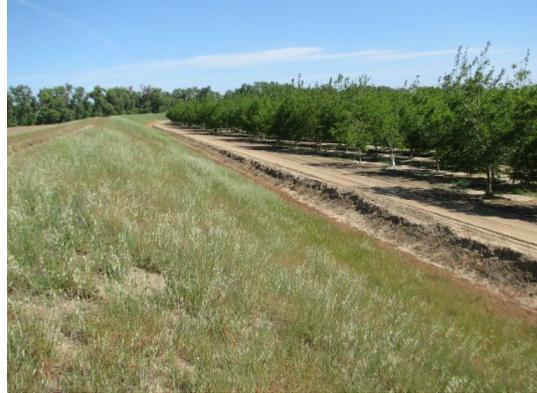
Photo 2 of 2 : FA_2014_RD1500_189_972_20141014_00084.jpg

Agricultural ditch runs along the toe of the levee. Spring 2014

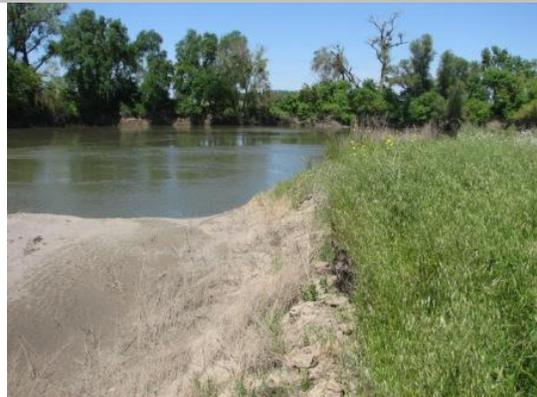
Photo 1 of 2 : FA_2014_RD1500_189_51_20141014_00045.jpg

This is an upstream view of the same erosion.

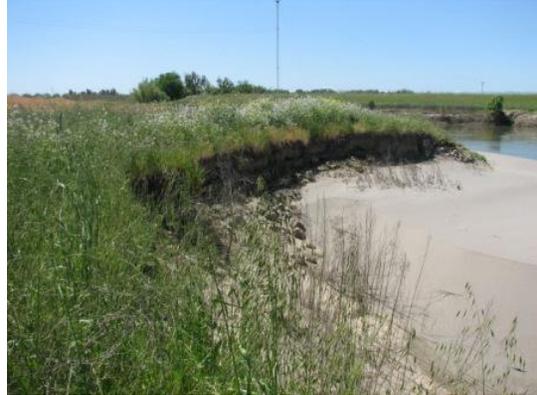
Photo 2 of 2 : FA_2014_RD1500_189_51_20141014_00046.jpg

This is an inside curve in the river and erosion has occurred.

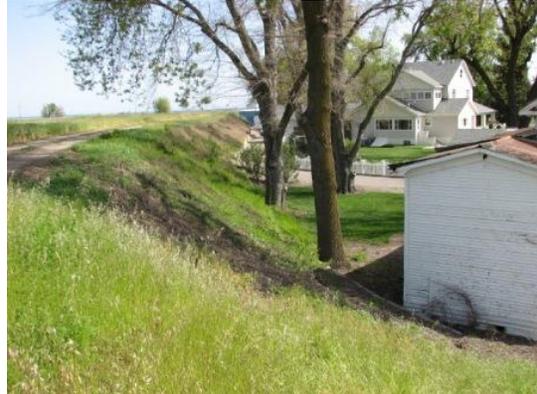
Photo 1 of 1 : FA_2014_RD1500_189_36_20141014_00035.jpg

Building and wall into levee with landscape, photo taken in spring 2010.

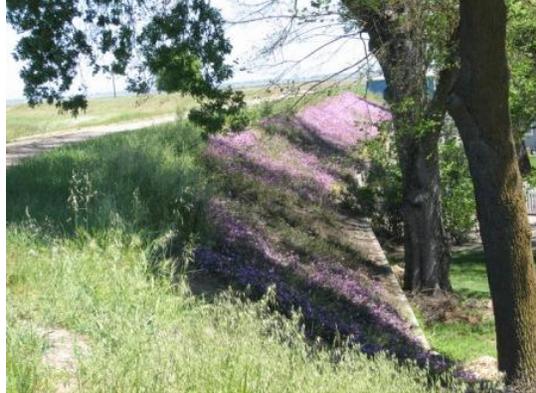
Photo 1 of 1 : FA_2014_RD1500_189_37_20141014_00036.jpg

The groundcover is on the levee slope above the concrete retaining wall. The groundcover is irrigated.

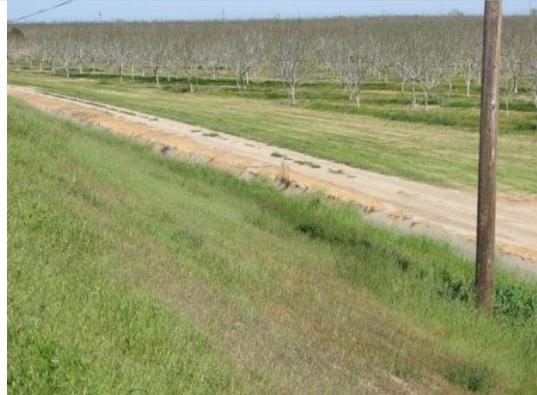
Photo 1 of 1 : FA_2014_RD1500_189_975_20141014_00085.jpg

Agricultural ditch, photo taken in spring 2010.

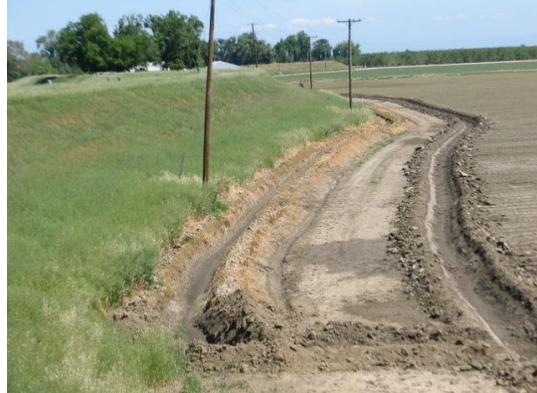
Photo 1 of 1 : FA_2014_RD1500_189_1349_20141014_00107.jpg

Agricultural ditch runs along the toe of the levee. Spring 2014

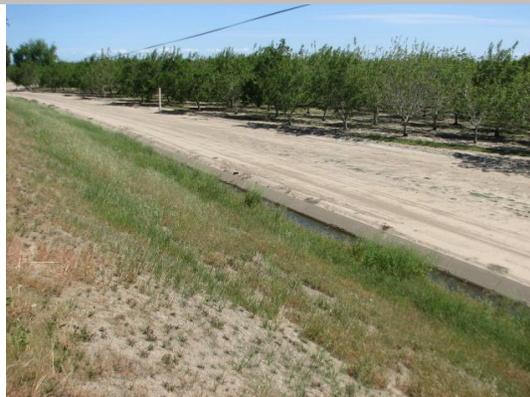
Photo 2 of 2 : FA_2014_RD1500_189_979_20141014_00087.jpg

Agricultural ditch runs along the toe of the levee. Spring 2014

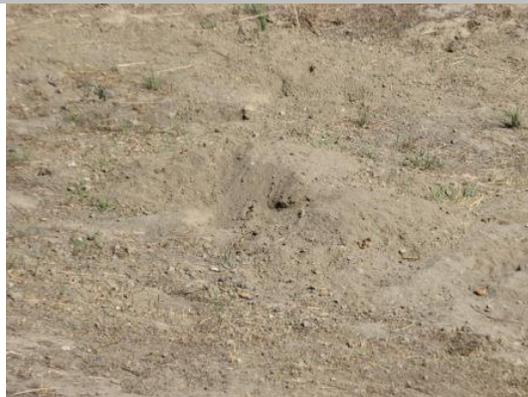
Photo 2 of 2 : FA_2014_RD1500_189_69_20141014_00058.jpg

A rodent burrow on the landside Fall 2013

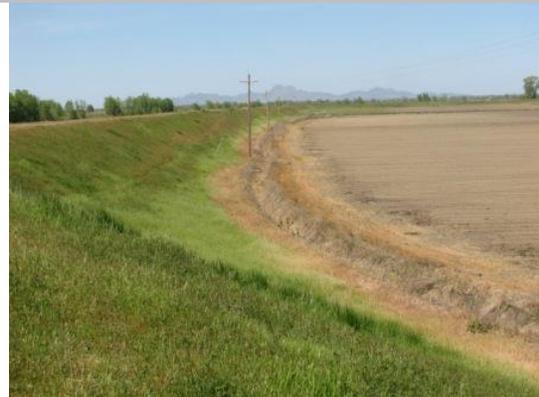
Photo 1 of 2 : FA_2014_RD1500_189_983_20141014_00089.jpg

Agricultural ditch, photo taken in spring 2010.

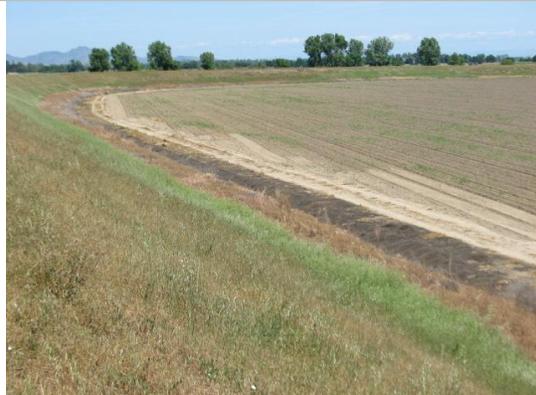
Photo 2 of 2 : FA_2014_RD1500_189_38_20141014_00038.jpg

A current view of the agricultural ditch along the toe. Spring 2014

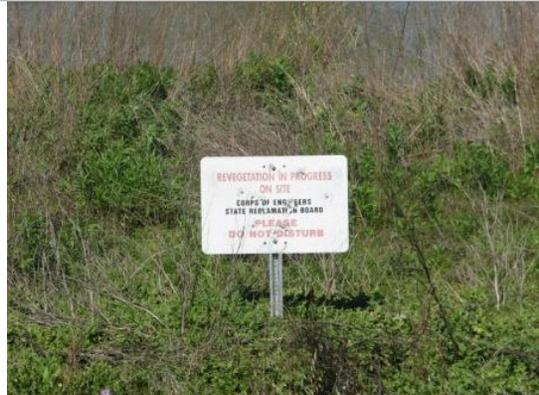
Photo 2 of 2 : FA_2014_RD1500_189_84_20141014_00070.jpg

Another revegetation site on the waterside berm, photo taken spring 2012.

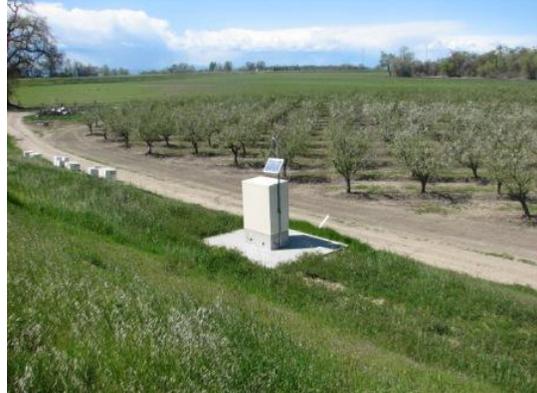
Photo 1 of 1 : FA_2014_RD1500_189_86_20141014_00071.jpg

The control unit for pizometers installed in 2012, photo taken spring 2012.

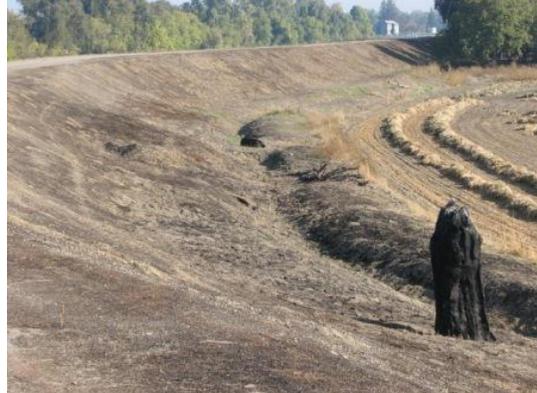
Photo 1 of 1 : FA_2014_RD1500_189_60_20141014_00052.jpg

Older, unused agricultural ditch. Tree stump needs to be removed.

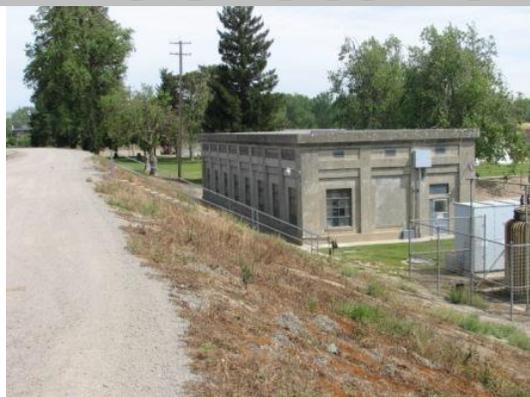
Photo 1 of 1 : FA_2014_RD1500_189_47_20141014_00042.jpg

The building is the pumping plant for Sutter Municipal.

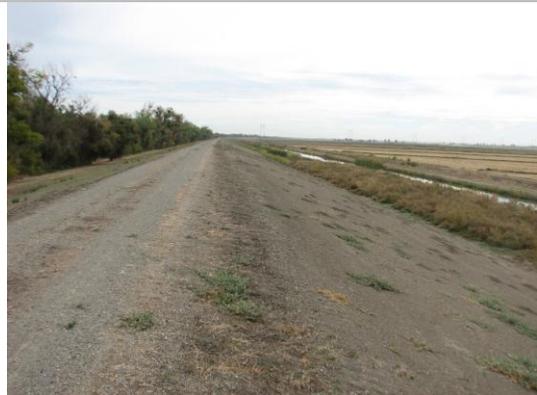
Photo 1 of 1 : FA_2014_RD1500_190_3_20141030_00021.jpg

Levee mile 16.71, vegetation on the land side slope. Fall 2014.

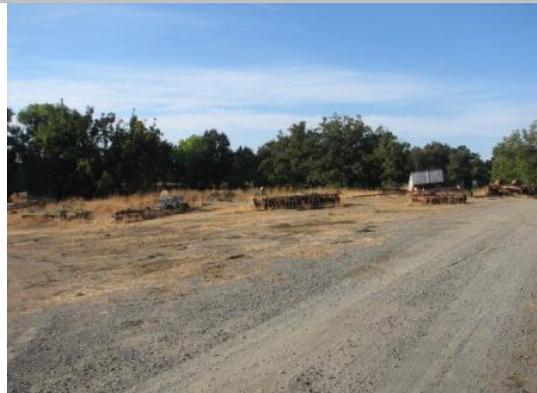
Photo 1 of 2 : FA_2014_RD1500_190_12_20141014_00008.jpg

Farm equipment is parked on the levee slope. Photo fall 2012.

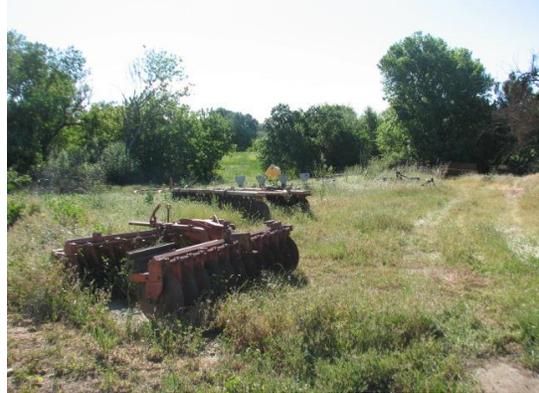
Photo 2 of 2 : FA_2014_RD1500_190_12_20141014_00009.jpg

Farm equipment is on the levee crown. Spring 2014

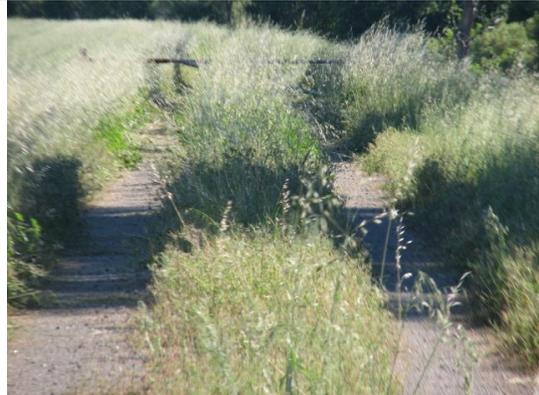
Photo 1 of 1 : FA_2014_RD1500_190_302_20141014_00016.jpg

Maintain unwanted vegetation on the levee crown Spring 2014

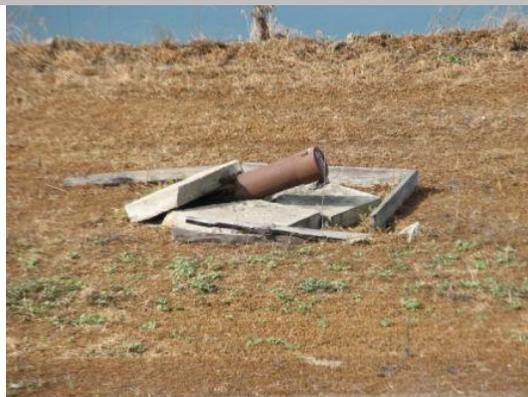
Photo 2 of 2 : FA_2014_RD1500_190_10_20141014_00006.jpg

The seepage well and pad needs to be repaired, Spring 2013

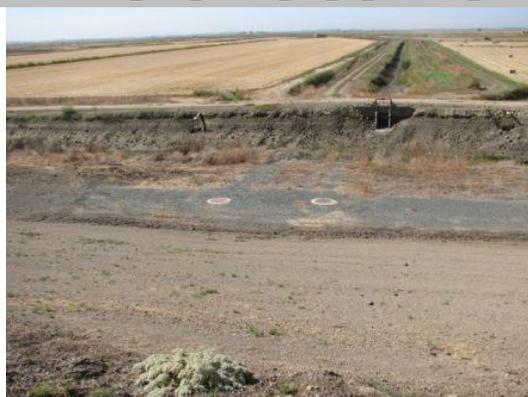
Photo 1 of 2 : FA_2014_RD1500_190_13_20141014_00010.jpg

Two of five drains on the landside berm. Photo fall 2012.

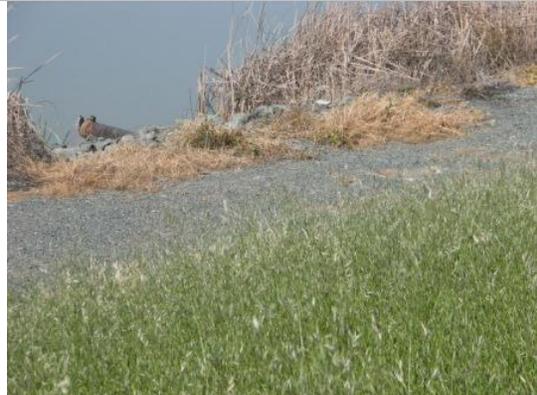
Photo 1 of 2 : FA_2014_RD1500_190_15_20141014_00012.jpg

Another toe drainage system close by, photo taken spring 2012.

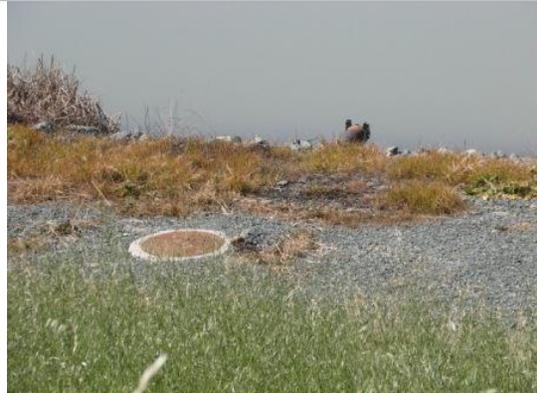
Photo 2 of 2 : FA_2014_RD1500_190_15_20141014_00013.jpg

A toe drainage system at the toe berm, photo taken spring 2012.
