**Flood Control Project Maintenance
Levee Inspections**

Fall 2015 Levee Maintenance Deficiency Summary Report

Sacramento River Basin

Reclamation District No. 1500 Sutter Basin

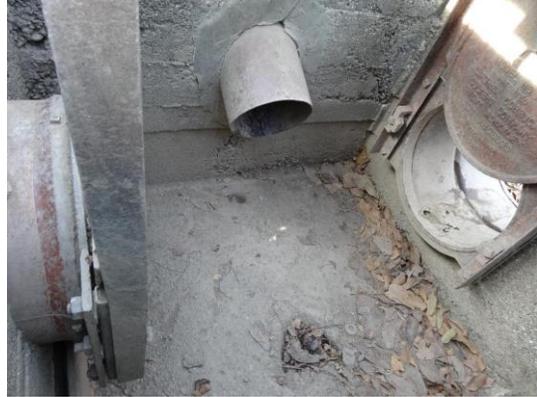
Photo 1 of 3 : UCIP_FA_2015_2967.jpg

LM Start	0.31	Rating **	M	Issue No.	2551
LM End	0.31	Issue Type +	En	Location *	CR
Category	Supplemental			GPS Latitude/Longitude	
				Start	End
Item	DWR UCIP Field Study			38.763210 °	38.763210 °
				-121.679017 °	-121.679017 °
DWR ID					
Action/Comments					
Inspector Comments: FS_ID:28183 DS_ID:20032 EP_NO: 1566A FS_HLM: 0.32 Repair Type: Non-Urgent Crossing Status: Found UCIP Comments: - soil erosion around headwall on waterside.- pump was removed.- overhead powerline. FIELD_STRUCT_DESC: 10-inch steel irrigation pipe through levee, 5.0 feet below crown. Pump and switch panel on waterside berm. Service pole on waterward shoulder. Siphon breaker on landward slope. A 3-foot by 4-foot concrete distribution box at landward toe (App. No. 1566A White) O&M Manual Sac 128, March 1960. FS Date: 01/09/2014

LS view: open steel pipe in concrete distribution box on levee toe.

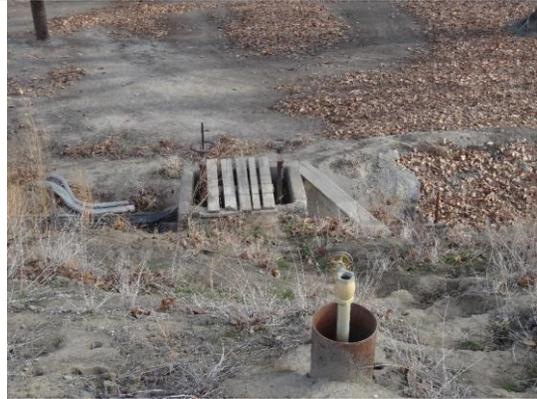
Photo 2 of 3 : UCIP_FA_2015_2968.jpg

LS view: pressure breaker (bottom) in steel pipe riser and concrete distribution box on levee toe.

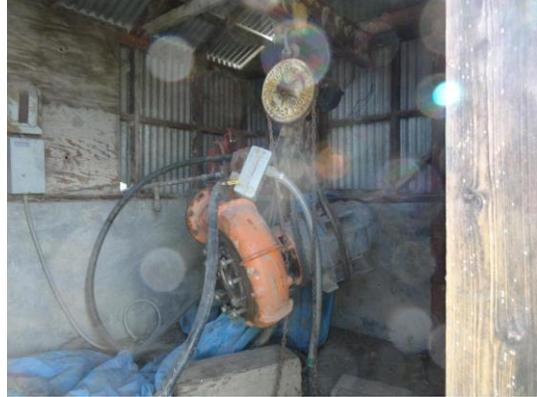
Photo 1 of 3 : UCIP_FA_2015_3270.jpg

LM Start	1.29	Rating **	M	Issue No.	2552
LM End	1.29	Issue Type +	En	Location *	LS
Category	Supplemental			GPS Latitude/Longitude	
				Start	End
Item	DWR UCIP Field Study			38.769697 °	38.769697 °
				-121.691024 °	-121.691024 °
DWR ID					
Action/Comments					
Inspector Comments: FS_ID:28903 DS_ID:20094 EP_NO: 10080 FS_HLM: 1.305 Repair Type: Non-Urgent Crossing Status: Found UCIP Comments: Pump removed from concrete pad and kept inside pump house (may be for storage purpose) on waterside. A 8-inch steel pipe inside 14-inch pipe. FIELD_STRUCT_DESC: 14-inch steel irrigation pipe through levee, 5.2 feet below crown. Pump on river bank. Butterfly valve on waterward side. Concrete stairway on waterward slope. 1-3/4-inch galvanized iron waterline with tap exposed on landward slope 3.4 feet below crown. 4 foot by 5.1 foot concrete distribution box at landward toe. 1-1/4-inch conduit through levee, 2.0 feet below crown. (ABO No. 10080 - Yturralde) FS Date: 01/09/2014

WS view: pump removed from pipe and stored in pump house.

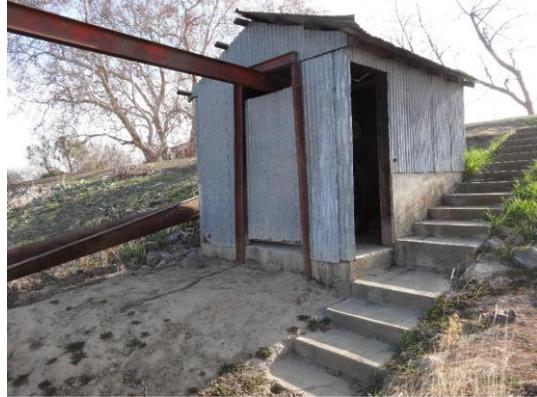
Photo 3 of 3 : UCIP_FA_2015_3272.jpg

WS view: pipe (left), pump house/store, and concrete steps.

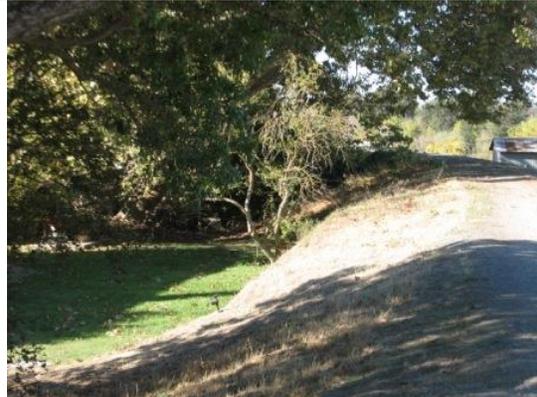
Photo 1 of 1 : FA_2015_RD1500_189_4_20150914_00004.jpg

Landscape with retaining wall that is in the USACE as-builts Fall 2013

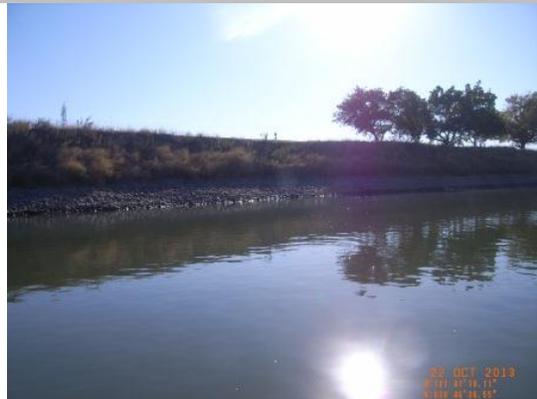
Photo 1 of 1 : USACE2013A_SAC_86-3_L_2.jpg

LM Start	1.34	Rating **	M	Issue No.	6
LM End	1.95	Issue Type +	Ma	Location *	WS
Category	Supplemental		GPS Latitude/Longitude		
			Start	End	
Item	2015 USACE Erosion Survey, DRAFT		38.770390 °	38.777282 °	
			-121.690553 °	-121.685841 °	
DWR ID					
Action/Comments					
Inspector Comments: 2006 - New erosion upstream, new bank failures near levee but still fairly wide berm in most places. 2008 - Large berm, questionable as to if it should remain in the inventory. 2010 - Minor new erosion, old cobble starting to fail. 2011 - Cobble continues to unravel and additional slumping. 2012 - Minor new erosion at bank mid point. 2013 - Minor new erosion. 2015: No observed changes. [2015 Site ID: SAC_86-3_L]

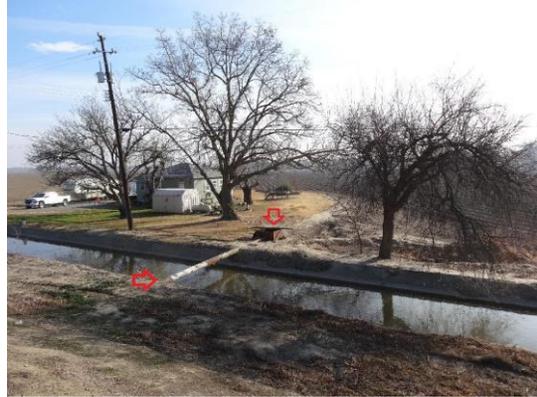
Photo 1 of 3 : UCIP_FA_2015_2990.jpg

LM Start	1.63	Rating **	M	Issue No.	2554
LM End	1.63	Issue Type +	En	Location *	WS
Category	Supplemental			GPS Latitude/Longitude	
				Start	End
Item	DWR UCIP Field Study			38.772862 °	38.772862 °
				-121.686453 °	-121.686453 °
DWR ID					
Action/Comments					
Inspector Comments: FS_ID:28204 DS_ID:20033 EP_NO: N/A FS_HLM: 1.64 Repair Type: Non-Urgent Crossing Status: Found UCIP Comments: - pump removed- erosion around pump station.- overhead electrical line. FIELD_STRUCT_DESC: 10-inch diameter steel irrigation pipeline through levee, 10.0 feet below crown. Pump and gate valve on bank. Service pole and switch panel on waterward shoulder. Pipe crosses irrigation ditch and discharges into steel distribution box on the field. FS Date: 01/09/2014

LS view: pipe crosses irrigation ditch. Steel distribution box across irrigation ditch.

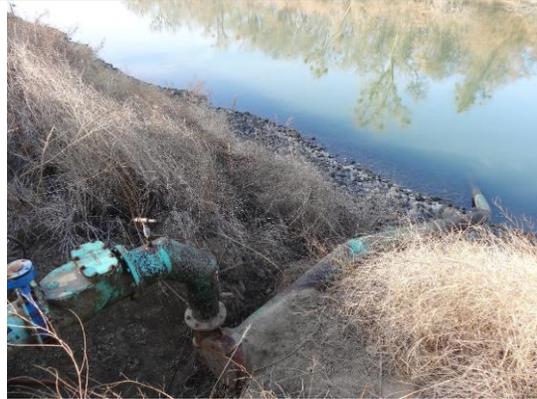
Photo 2 of 3 : UCIP_FA_2015_2991.jpg

WS view: pump (removed) and inlet pipe on river bank.

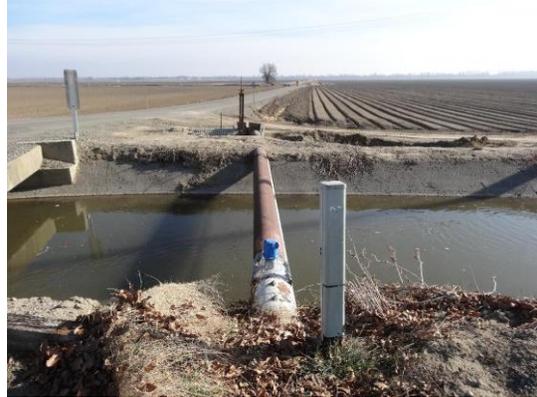
Photo 1 of 3 : UCIP_FA_2015_3052.jpg

LM Start	1.96	Rating **	M	Issue No.	2555
LM End	1.96	Issue Type +	En	Location *	WS
Category	Supplemental			GPS Latitude/Longitude	
				Start	End
Item	DWR UCIP Field Study			38.777433 °	38.777433 °
				-121.685348 °	-121.685348 °
DWR ID					
Action/Comments					
Inspector Comments: FS_ID:28263 DS_ID:20034 EP_NO: 16146 FS_HLM: 1.973 Repair Type: Non-Urgent Crossing Status: Found UCIP Comments: - pump removed- overhead powerline- pile structure abandoned- levee slope erosion due to leaky siphon breaker on landside. FIELD_STRUCT_DESC: 12-inch diameter steel pipe through levee, 12.0 feet below crown. Pump mounted on river bank, butterfly valve on waterward side. Power pole with one anchor on waterside slope. Pump discharges into 5 foot by 5 foot concrete distribution box (damaged) across the irrigation ditch on the landside. (Cat. I Furlan) (App. No. 16146) O&M Manual Sac 128, March 1960. FS Date: 01/09/2014

LS view: discharge pipe crossing irrigation ditch.

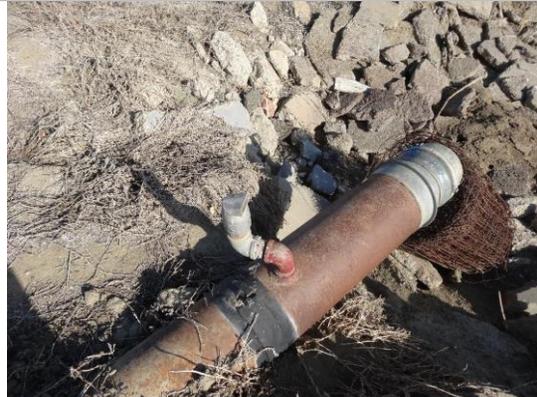
Photo 1 of 3 : UCIP_FA_2015_3055.jpg

LM Start	2.38	Rating **	M	Issue No.	2556
LM End	2.38	Issue Type +	En	Location *	WS
Category	Supplemental			GPS Latitude/Longitude	
				Start	End
Item	DWR UCIP Field Study			38.783184 °	38.783184 °
				-121.688136 °	-121.688136 °
DWR ID					
Action/Comments					
Inspector Comments: FS_ID:28264 DS_ID:20035 EP_NO: 10029 FS_HLM: 2.402 Repair Type: Non-Urgent Crossing Status: Found UCIP Comments: - pump removed- outlet plugged- looks abandoned. Found abandoned pipe parts on levee slope and berm.- overhead powerline FIELD_STRUCT_DESC: Abandoned 12-inch steel irrigation pipe through levee, 11.0-feet below crown. Two metal cutoff walls installed. Pump on bank during irrigation season. Gate valve at waterward toe. Discharges into 2.5x2.5 foot concrete distribution box on landward side of irrigation ditch. (ABO No. 10029 - Anderson). O&M Manual Sac 128, March 1960. FS Date: 01/09/2014

LS view: plugged discharge pipe with air vent across irrigation ditch on landside.

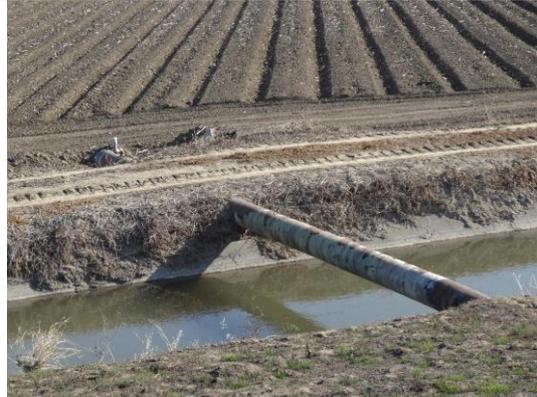
Photo 2 of 3 : UCIP_FA_2015_3056.jpg

LS view: discharge pipe crossing irrigation ditch on landside.

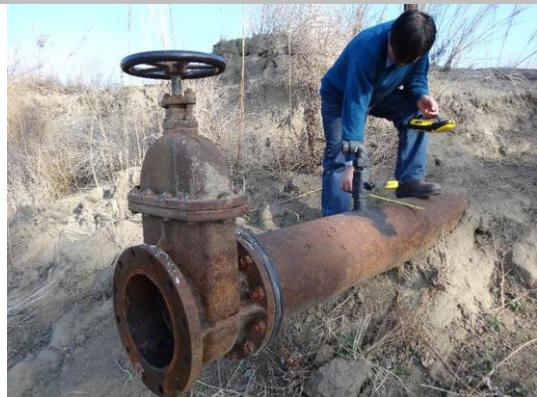
Photo 3 of 3 : UCIP_FA_2015_3057.jpg

WS view: steel pipe, gate valve, and pump (removed) on river bank. Looks abandoned.

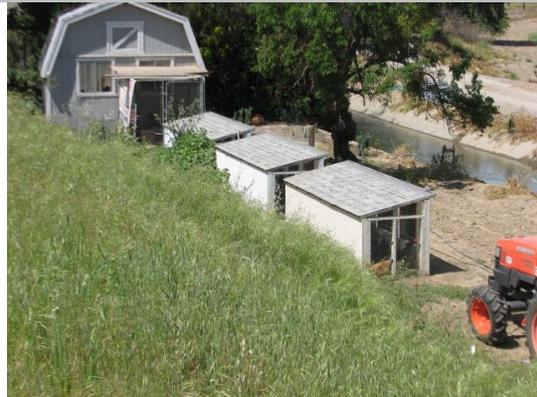
Photo 2 of 2 : FA_2015_RD1500_189_7_20150914_00006.jpg

Chicken coupes have been added along the toe of the levee. Spring 2014

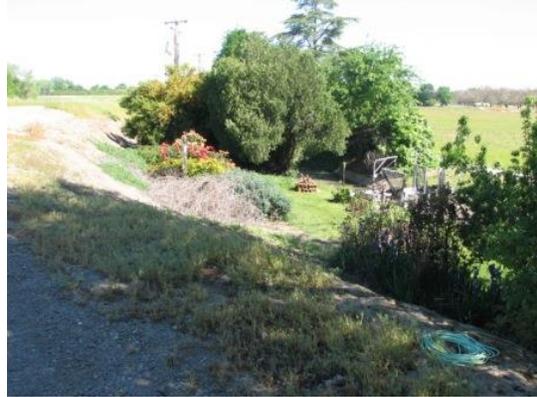
Photo 1 of 1 : FA_2015_RD1500_189_8_20150914_00007.jpg

The landscape is planted into the encroachment zone within 15' of the toe.

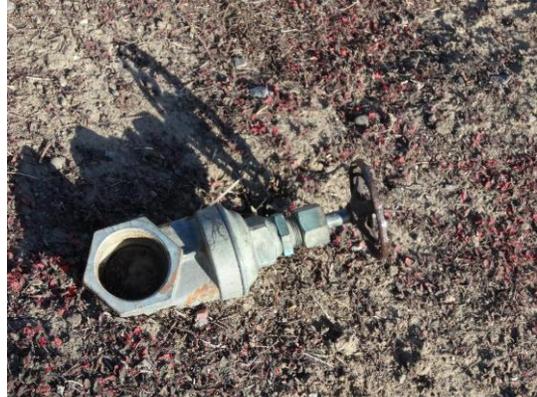
Photo 1 of 3 : UCIP_FA_2015_3240.jpg

LM Start	4.01	Rating **	M	Issue No.	2557
LM End	4.01	Issue Type +	En	Location *	LS
Category	Supplemental		GPS Latitude/Longitude		
			Start	End	
Item	DWR UCIP Field Study		38.798436 °	38.798436 °	
			-121.696280 °	-121.696280 °	
DWR ID					
Action/Comments					
Inspector Comments: FS_ID:28272 DS_ID:20037 EP_NO: 3638 FS_HLM: 4.04 Repair Type: Non-Urgent Crossing Status: Found UCIP Comments: - No protection for pressure breaker. FIELD_STRUCT_DESC: 12-inch steel irrigation pipe through levee, 2.4 feet below crown. Slant pump on berm. Pressure breaker on landward slope. Service pole at landward toe. Discharges into 36-inch diameter concrete standpipe on landside. (App. No. 3638 - J. Waters) FS Date: 01/09/2014

LS view: pressure breaker without protection on levee slope.

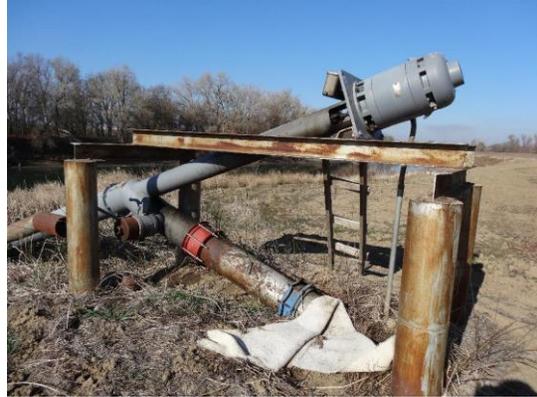
Photo 2 of 3 : UCIP_FA_2015_3241.jpg

WS view: slant pump on steel frame on levee berm.

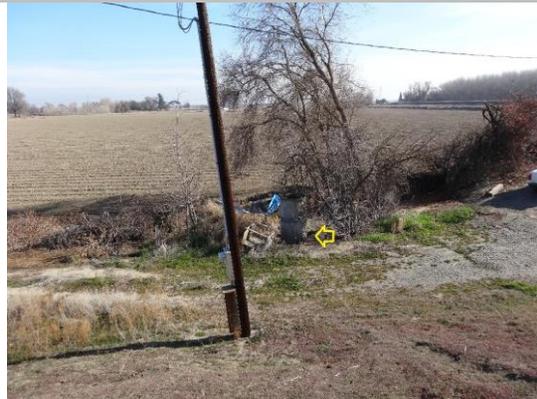
Photo 3 of 3 : UCIP_FA_2015_3242.jpg

LS view: power pole and concrete standpipe on levee toe.

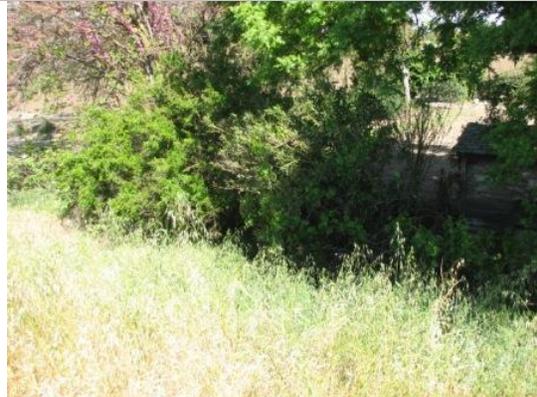
Photo 1 of 1 : FA_2015_RD1500_189_12_20150914_00010.jpg

The landscape is planted within the encroachment area of 15'.

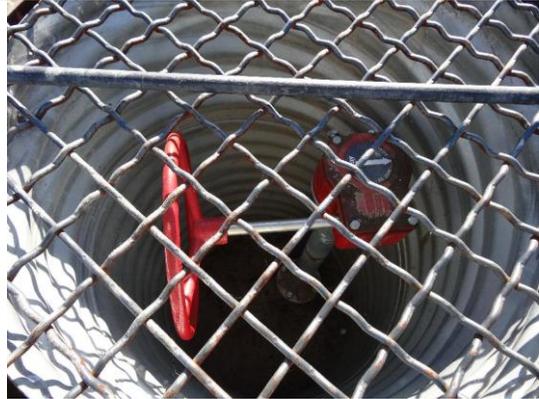
Photo 1 of 3 : UCIP_FA_2015_0609.jpg

Inspector Comments: FS_ID:28912
 DS_ID:20040
 EP_NO: 5031
 FS_HLM: 4.713
 Repair Type: Non-Urgent
 Crossing Status: Found
 UCIP Comments: New butterfly valve in CMP riser on waterside slope. New pipe and pump. Needs cleaning and clearing of siphon breaker in CMP on landside. An abandoned 5x5 foot concrete distribution box on landside. Abandoned pipe found on both sides of the levee.
 FIELD_STRUCT_DESC: 12-inch diameter steel irrigation pipe through levee at slight angle, 4.2 feet below crown. A 2-inch diameter conduit through levee, 2.0 feet below crown. Slant pump on steel platform on berm. (App. No. 5031-Knox.) Discharges into irrigation ditch and an abandoned 5x5 foot concrete distribution box on landside. Pipe originally installed in 1950 under App. No. 1466 By Estate of Caroline L. Knox reinstalled by USCE, in 1958; O&M Manual Sac 128, March 1960. FS Date: 01/09/2014

WS view: new butterfly valve in CMP on levee shoulder.

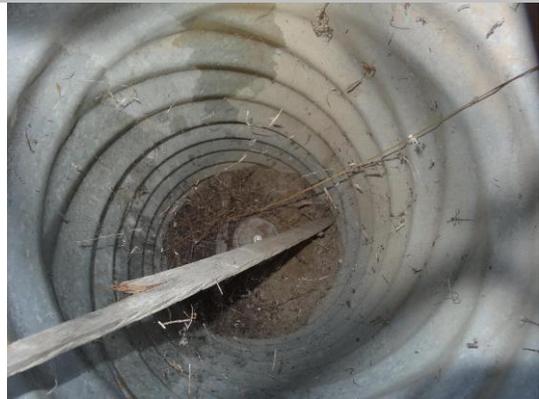
Photo 2 of 3 : UCIP_FA_2015_0610.jpg

LS view: obstructed siphon breaker in CMP riser.

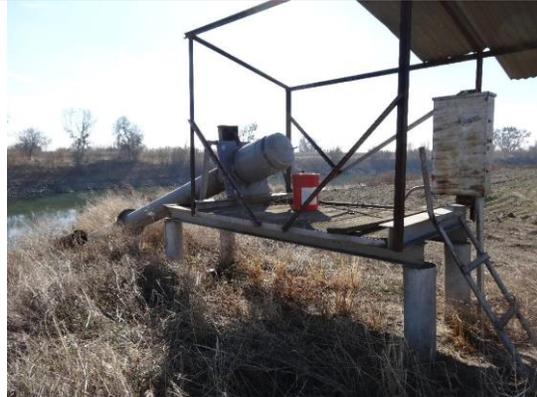
Photo 3 of 3 : UCIP_FA_2015_0611.jpg

WS view: slant pump and switch panel in shed on levee berm.

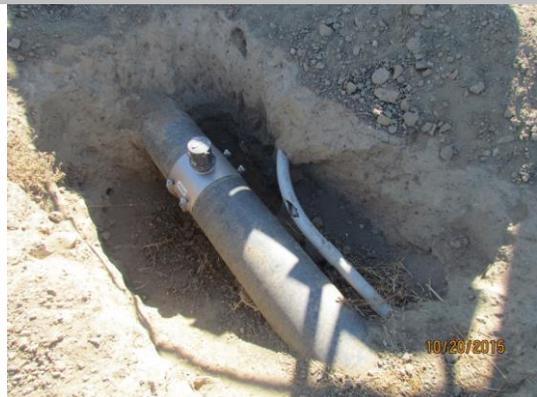
Photo 2 of 3 : FA_2015_RD1500_189_107_20151026_00140.jpg

A close-up view of the exposed pipe. Fall 2015.

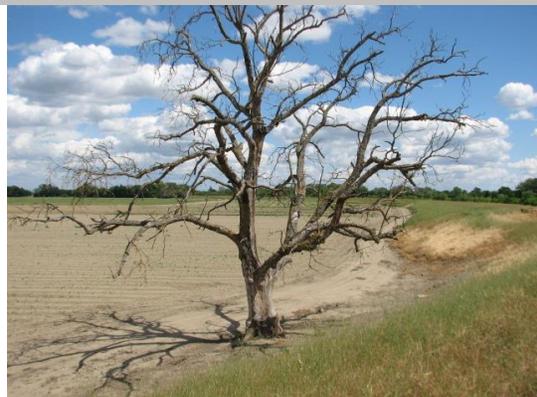
Photo 1 of 1 : FA_2015_RD1500_189_1340_20150914_00076.jpg

Monitor tree that may pose a future threat to the integrity of the levee. Spring 2014

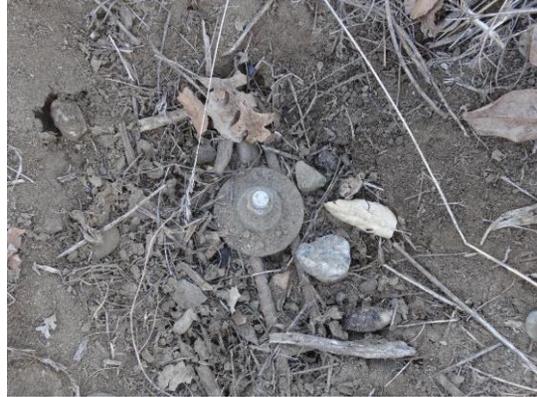
Photo 1 of 3 : UCIP_FA_2015_0612.jpg

LS view: leaky and obstructed siphon breaker. Depression around siphon breaker due to leakage.

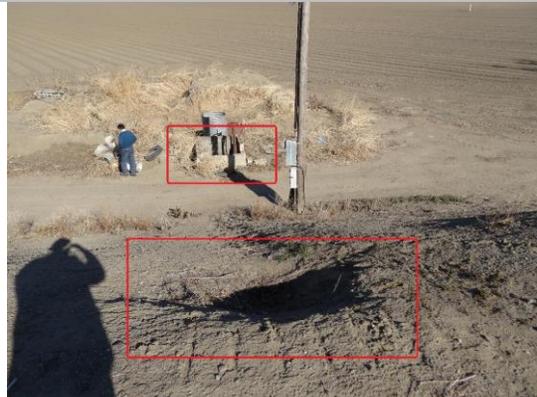
Photo 2 of 3 : UCIP_FA_2015_0613.jpg

LS view: depression on landside levee slope around siphon breaker due to leakage. Concrete distribution box (top) on levee toe.

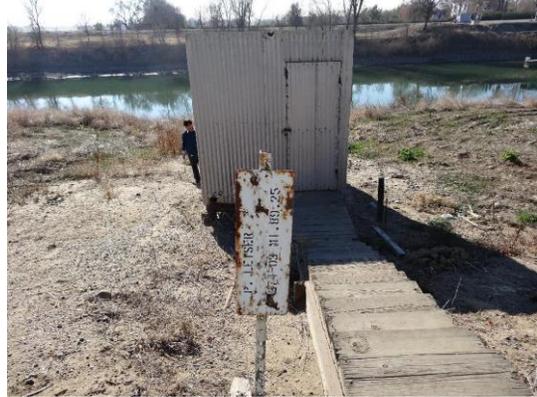
Photo 3 of 3 : UCIP_FA_2015_0614.jpg

WS view: wooden steps to pump house on levee berm.

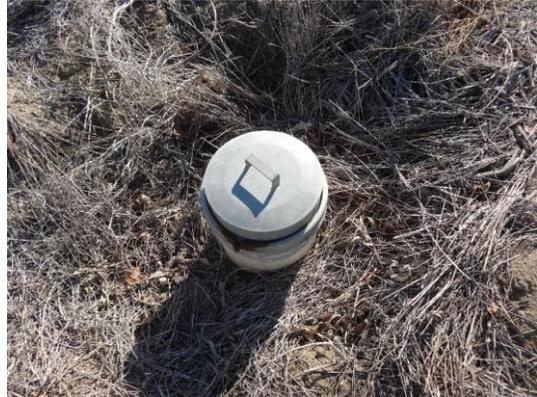
Photo 1 of 2 : UCIP_FA_2015_3383.jpg

LS view: a capped pipe on levee toe. It is not clear whether this pipe is connected to the CMP riser on waterside.

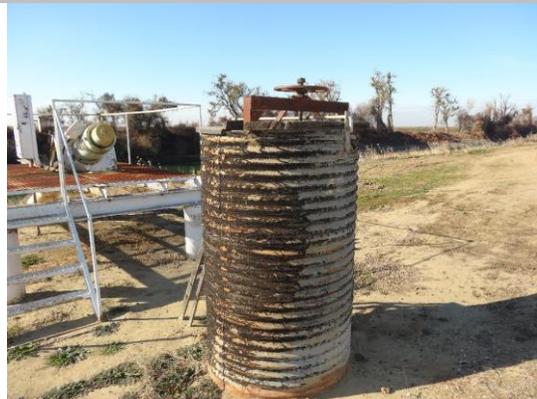
Photo 2 of 2 : UCIP_FA_2015_3384.jpg

WS view: CMP riser with slide gate and slant pump on steel platform on levee berm.

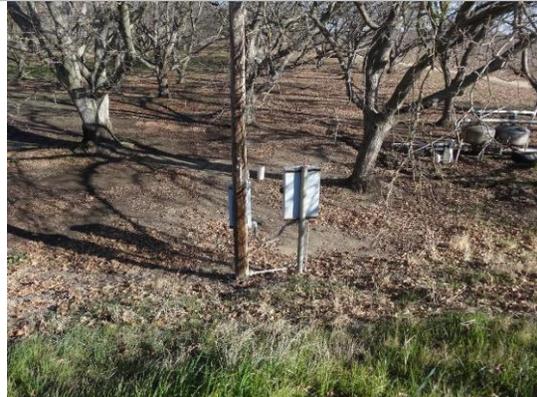
Photo 1 of 3 : UCIP_FA_2015_0615.jpg

LS view: service pole and switch board on levee toe. No other apurtenances found on landside.

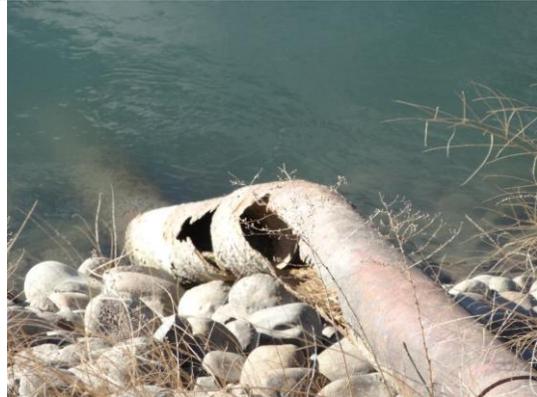
Photo 2 of 3 : UCIP_FA_2015_0616.jpg

WS view: deteorated and abandoned steel pipe on river bank.

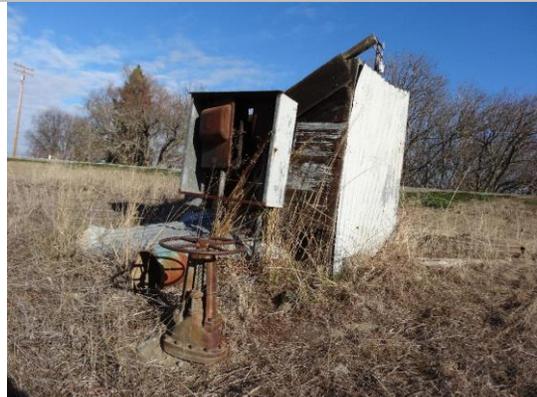
Photo 3 of 3 : UCIP_FA_2015_0617.jpg

WS view: dilapidated and abandoned CM pump house on berm. Pipe and gate valve also on berm.

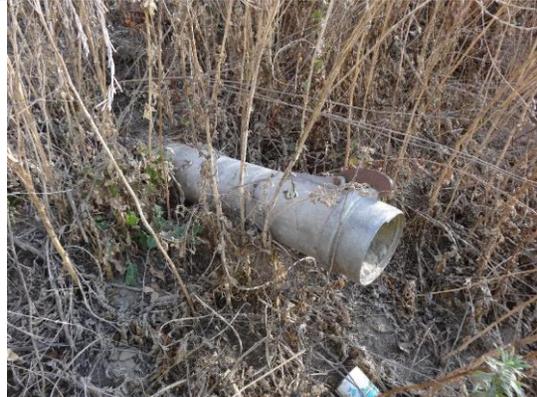
Photo 2 of 3 : UCIP_FA_2015_3084.jpg

WS view: abandoned steel pipe exposed on river bank.

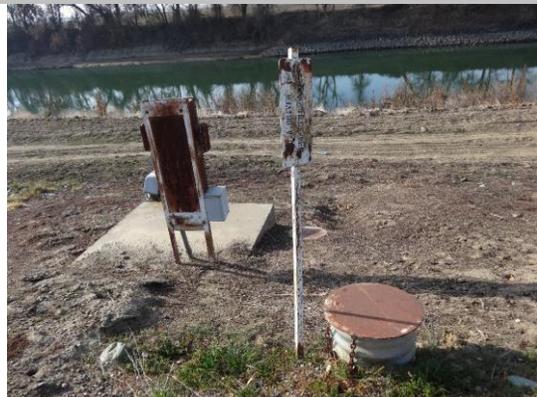
Photo 3 of 3 : UCIP_FA_2015_3085.jpg

WS view: CMP with air vent (right), concrete pad (left), and switch panel (left) on levee slope.

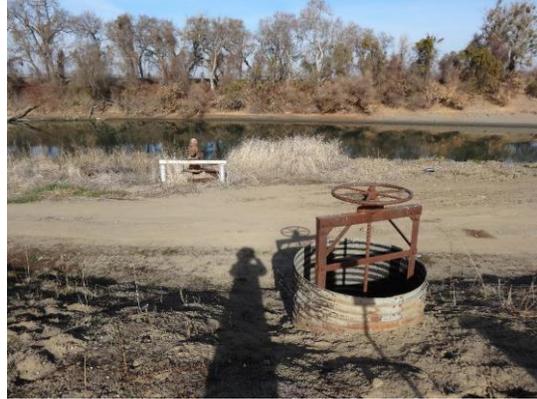
Photo 3 of 3 : UCIP_FA_2015_3088.jpg

WS view: slide gate in CMP riser on levee slope. Looks abandoned.

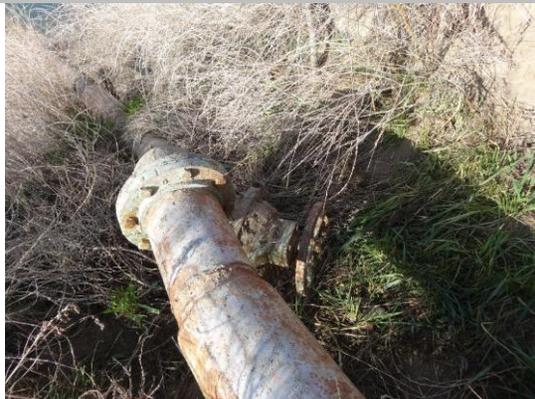
Photo 2 of 3 : UCIP_FA_2015_3262.jpg

WS view: inlet steel pipe with gate valve on river bank.

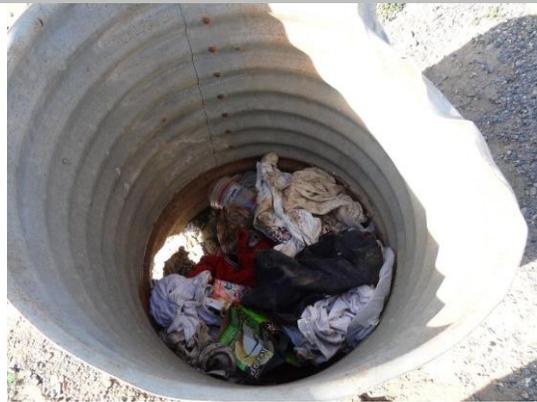
Photo 2 of 3 : UCIP_FA_2015_1223.jpg

WS view: siphon breaker obstructed by dumped-trash in CMP riser.

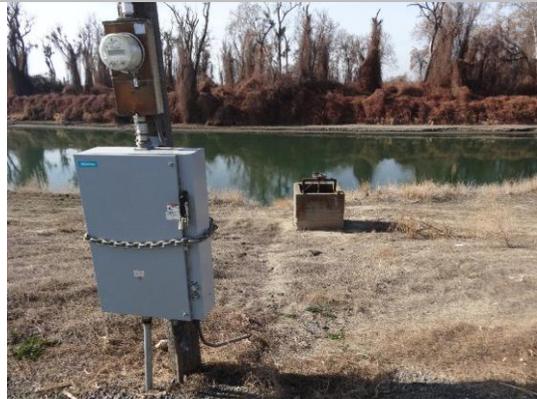
Photo 3 of 3 : UCIP_FA_2015_3335.jpg

WS view: service pole and concrete surge box with slide gate on berm.

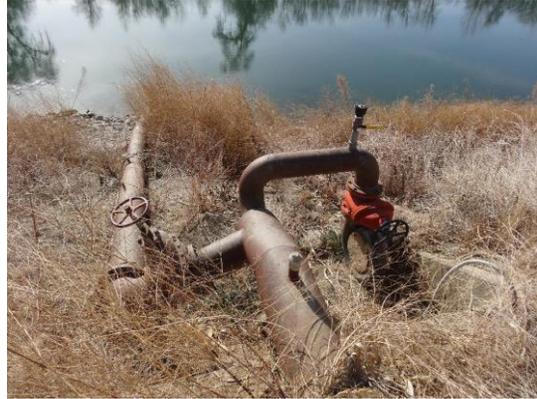
Photo 3 of 3 : UCIP_FA_2015_2935.jpg

WS view: pipe, pump (removed and plugged with plywood), headwall, and appurtenances on river bank.

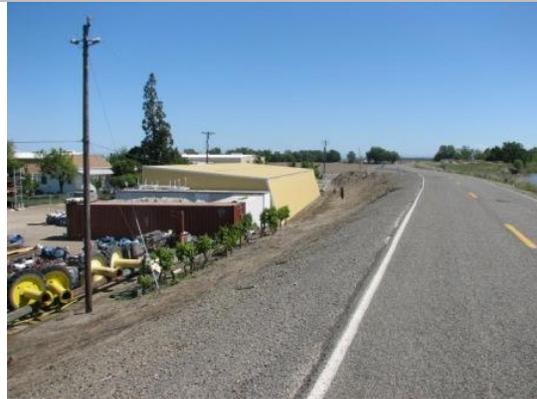
Photo 1 of 1 : FA_2015_RD1500_189_26_20150914_00024.jpg

The building's backside was built into the toe of the levee.

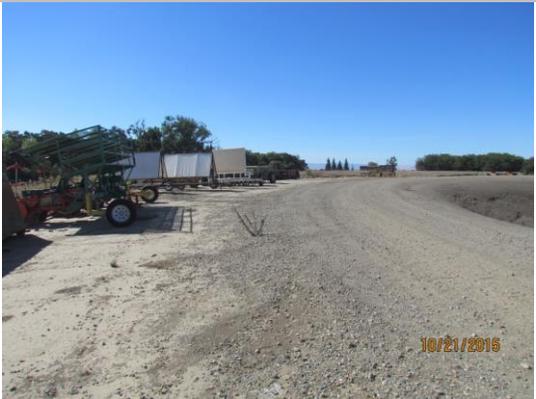
Photo 1 of 1 : FA_2015_RD1500_189_28_20151026_00168.jpg

View of the equipment on the waterward side of the levee looking upstream. Fall 2015.

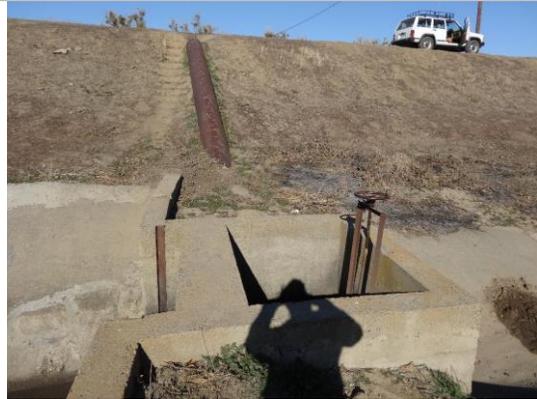
Photo 1 of 3 : UCIP_FA_2015_3093.jpg

LS view: exposed pipe on levee slope, and concrete distribution box on levee toe.

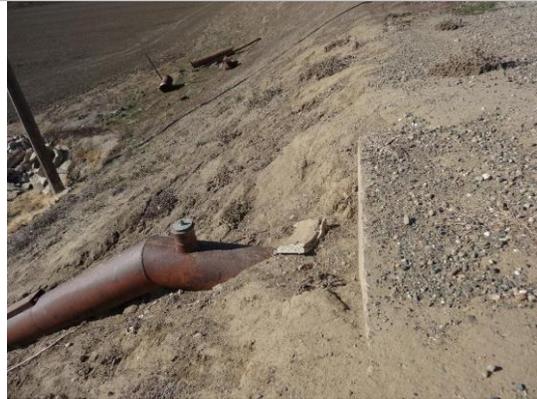
Photo 1 of 3 : UCIP_FA_2015_1226.jpg

LS view: siphon breaker (left) on exposed steel pipe on levee slope. Concrete pad (right) on levee shoulder.

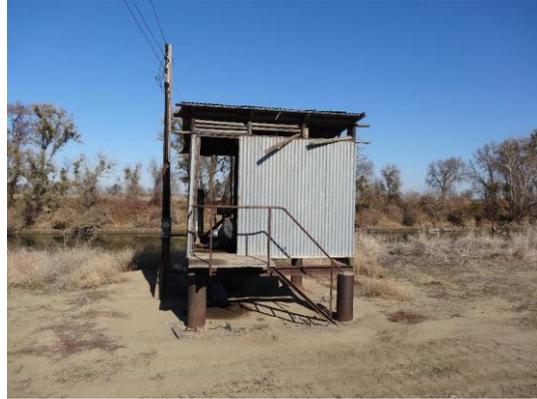
Photo 3 of 3 : UCIP_FA_2015_1228.jpg

WS view: slant pump in CM shed on levee berm. Oil leaks from the pump.

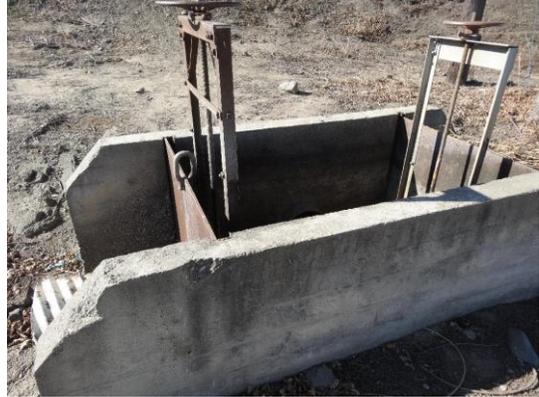
Photo 1 of 3 : UCIP_FA_2015_1229.jpg

LS view: concrete distribution box on levee toe.

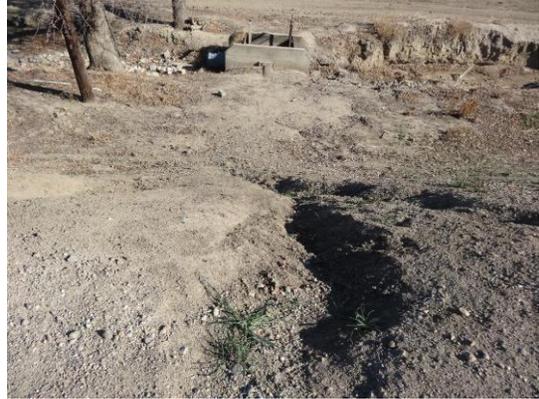
Photo 2 of 3 : UCIP_FA_2015_1230.jpg

LS view: surface erosion on landside levee slope.

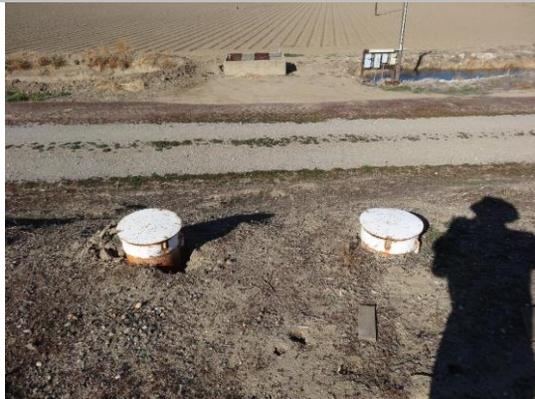
Photo 2 of 3 : UCIP_FA_2015_2937.jpg

LS view: siphon breakers in steel pipe risers (bottom) on levee slope and concrete distribution (top) box on levee toe.

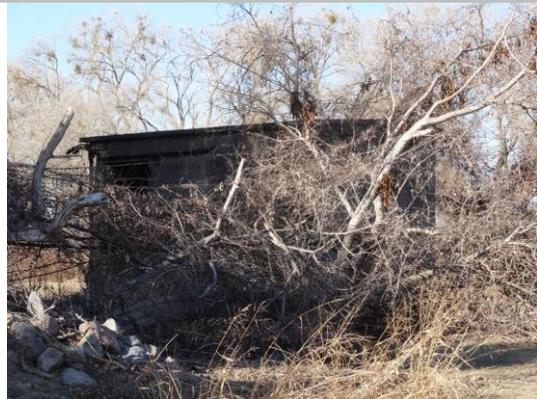
Photo 2 of 3 : UCIP_FA_2015_3347.jpg

WS view: abandoned pump house on river bank at the bend of the river (ab 250 ft from the levee).

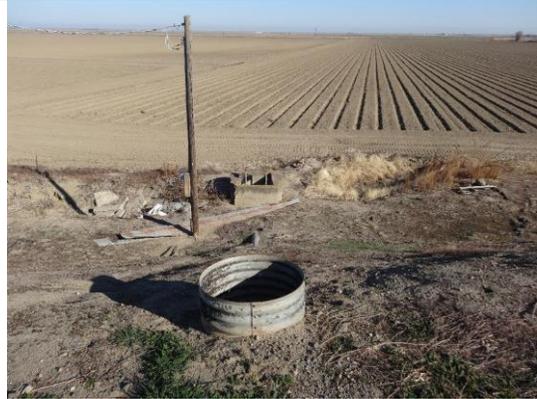
Photo 2 of 3 : UCIP_FA_2015_2917.jpg

LS view: siphon breaker in CMP riser on levee slope (bottom) and concrete distribution box (top) on levee toe.

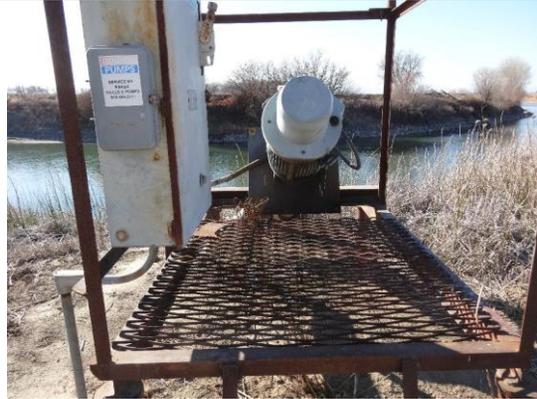
Photo 3 of 3 : UCIP_FA_2015_2918.jpg

WS view: slant pump on steel platform on levee berm.

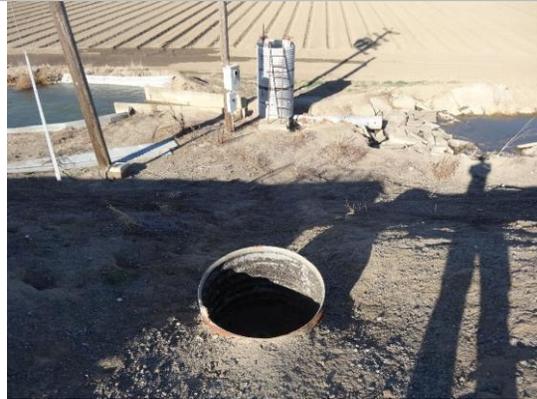
Photo 1 of 3 : UCIP_FA_2015_2919.jpg

LS view: siphon breaker in CMP riser on levee slope (bottom) and CMP stand pipe (top) on levee toe.

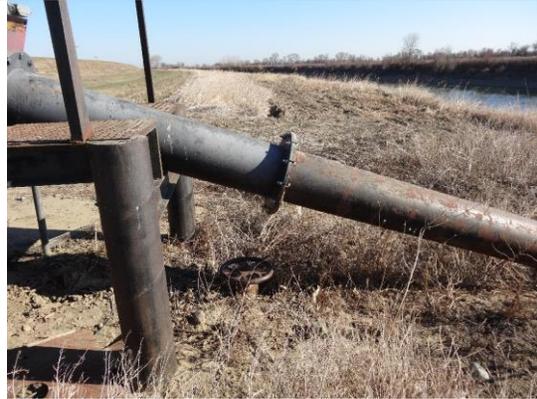
Photo 2 of 3 : UCIP_FA_2015_2995.jpg

WS view: slant pipe and gate valve at the end of levee berm.

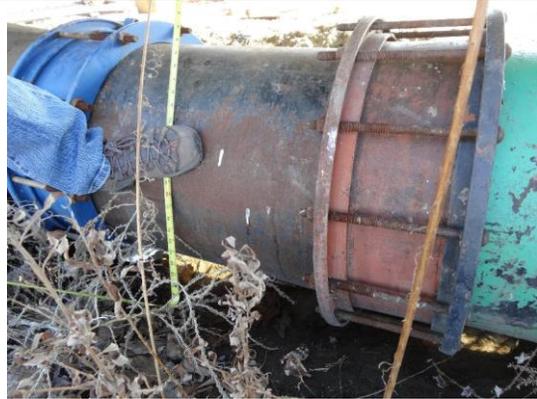
Photo 2 of 3 : UCIP_FA_2015_3102.jpg

WS view: leaky pipe near pump platform. Pipe leaks from the joint.

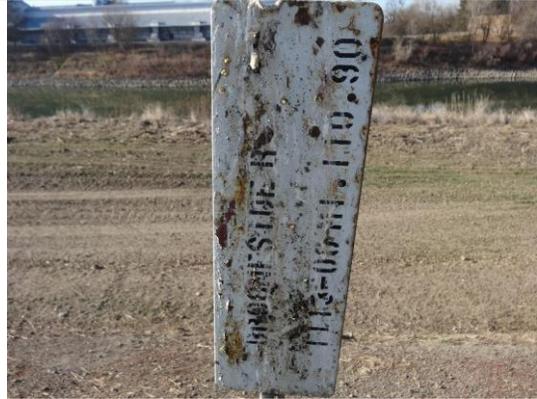
Photo 2 of 2 : UCIP_FA_2015_3105.jpg

WS view: utility tag plate on waterside shoulder. No pipe found.

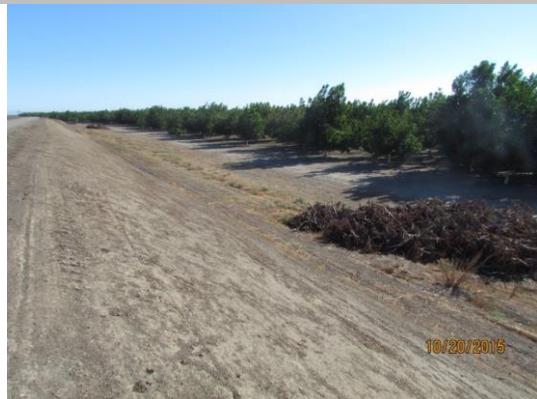
Photo 1 of 1 : FA_2015_RD1500_189_103_20151026_00135.jpg

View of the prunings on the landward toe of the levee looking upstream. Fall 2015.

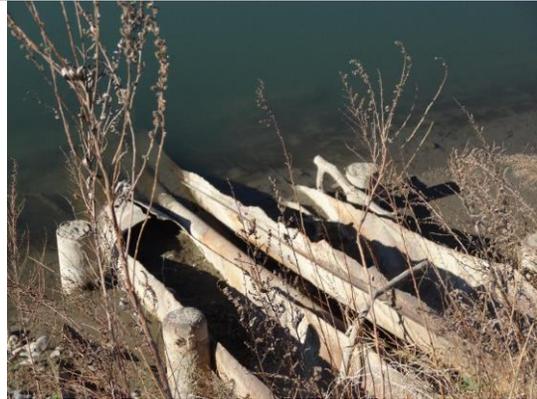
Photo 2 of 2 : UCIP_FA_2015_3268.jpg

WS view: abandoned 24" and 30" steel pipe on river bank.

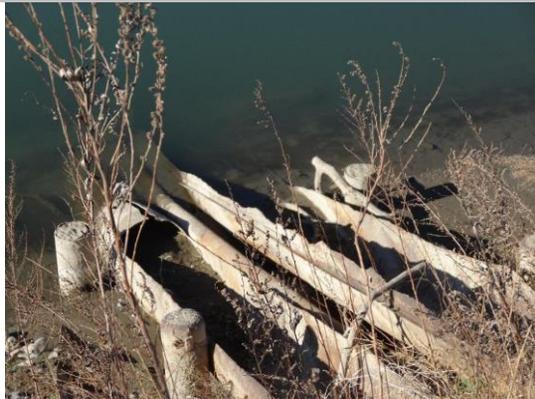
Photo 2 of 2 : UCIP_FA_2015_3266.jpg

WS view: abandoned 24" and 30" steel pipe on river bank.

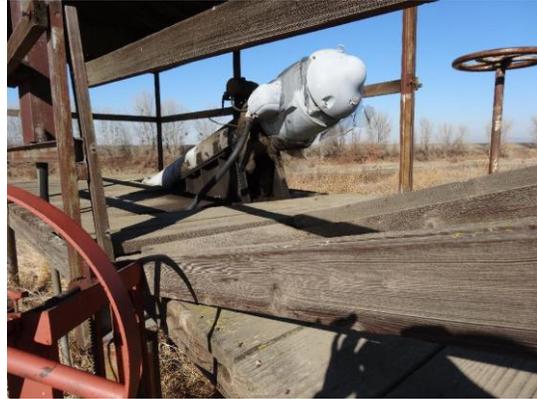
Photo 2 of 3 : UCIP_FA_2015_3350.jpg

WS view: slant pump and gate valves on wooden platform at levee berm. Wooden walkway to the pump.

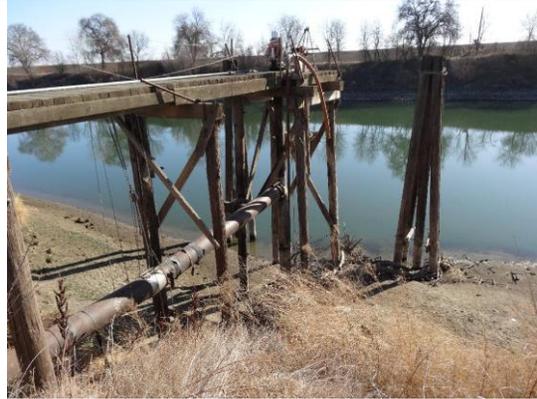
Photo 2 of 3 : UCIP_FA_2015_3298.jpg

WS view: abandoned walkway, pipe, and pump on river bank.

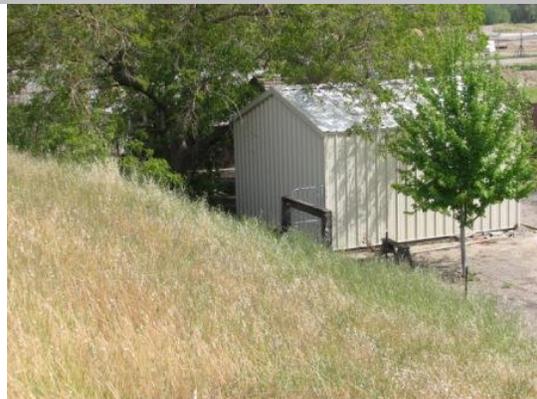
Photo 1 of 1 : FA_2015_RD1500_189_46_20150914_00038.jpg

The building is within the easement of the levee toe.

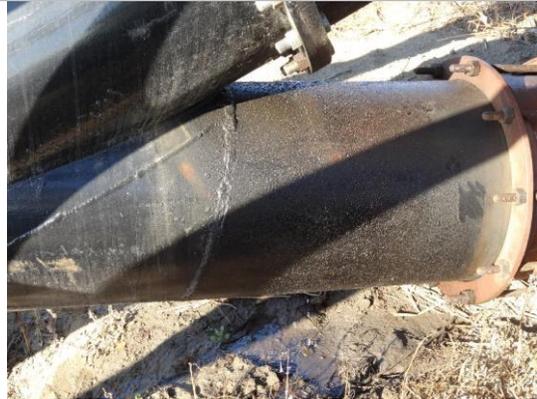
Photo 1 of 3 : UCIP_FA_2015_3461.jpg

WS view: oil and water leakage from pipe near pump.

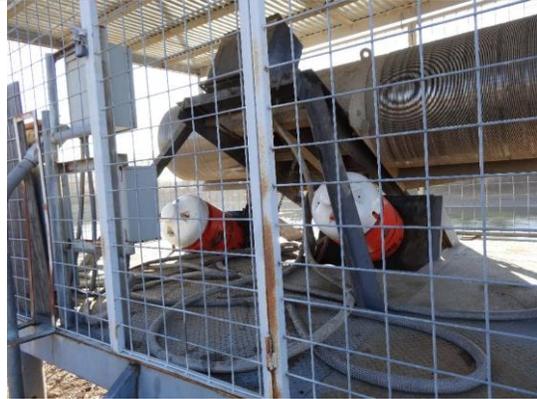
Photo 2 of 3 : UCIP_FA_2015_3462.jpg

WS view: two slant pumps on steel platform at waterside berm.
