**Flood Control Project Maintenance
Levee Inspections**
LMA District Cover Sheet
Spring 2014 Levee Inspection Results

Reclamation District No. 1500 Sutter Basin

Spring 2014 Levee Inspection Results

Waterway		Bank	Unit Miles
Unit No. 01 Sacramento River		Left	33.58

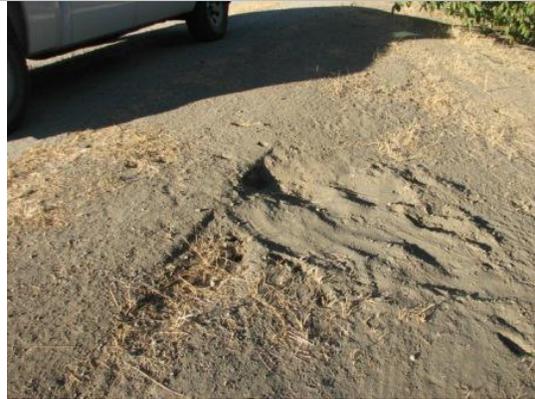
Photo 1 of 2 : johngw_s_20140414_281.jpg

Rodent holes along the levee shoulder. Photo fall 2012.

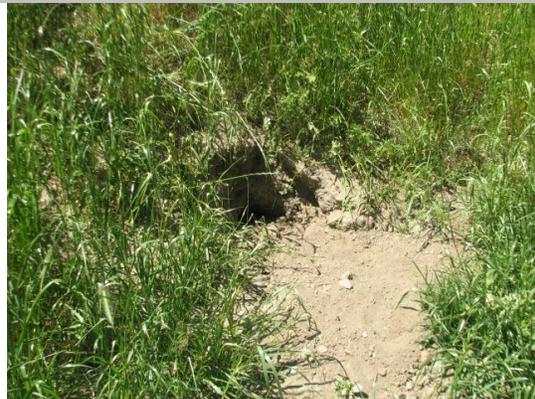
Photo 1 of 1 : johngw_s_20140428_880.jpg

Rodent hole on the landside levee slope needs to be filled in. Spring 2014

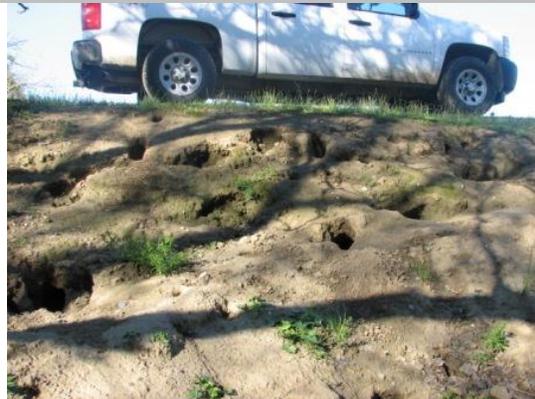
Photo 1 of 3 : johngw_s_20140414_263.jpg

More than five hole in a 25' area, photo taken spring 2012.

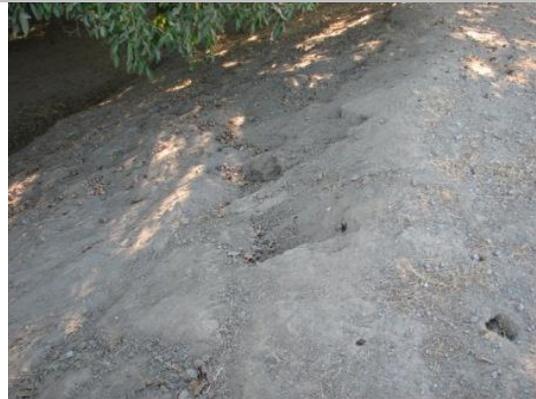
Photo 3 of 3 : johngw_s_20140414_265.jpg

LM Start	0.30	Rating **	U	Issue No.	68 (cont)
LM End	0.30	Issue Type +	Ma	Location *	LS

Rodent hole and damage from the on the levee slope. Photo fall 2012.

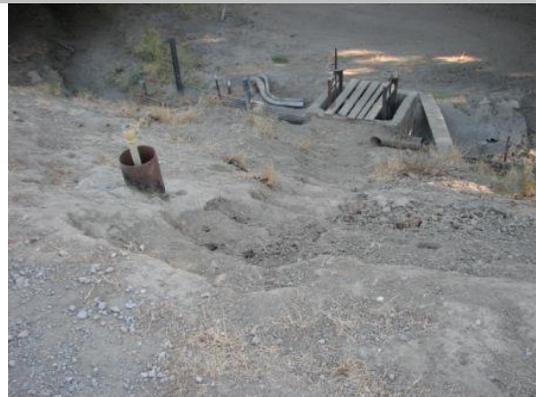
Photo 1 of 1 : johngw_s_20140414_252.jpg

LM Start	0.32	Rating **	M	Issue No.	53
LM End	0.32	Issue Type +	Ma	Location *	LS
Category	Earthen Levee		GPS Latitude/Longitude		
			Start	End	
Item	Encroachments		38.763219 °	38.763219 °	
			-121.679036 °	-121.679036 °	
DWR ID	DWR_RD1500_01_f_2012_53				
Action/Comments					
Stairway

Steps carved into the levee slope at a pipe crossing. Photo fall 2012.

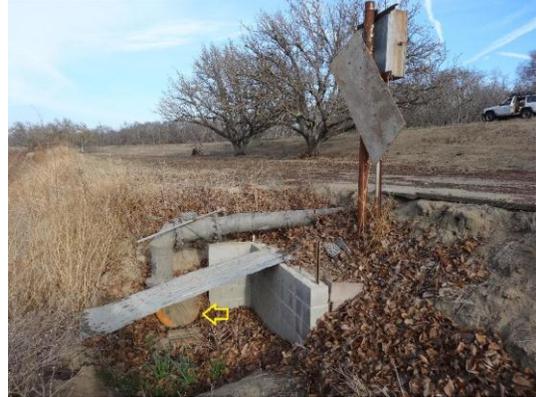
Photo 1 of 1 : UCIP_5581.jpg

LM Start	0.32	Rating **	M	Issue No.	1285
LM End	0.32	Issue Type +	En	Location *	LS
Category	Supplemental			GPS Latitude/Longitude	
				Start	End
Item	DWR UCIP Field Study			38.763210 °	38.763210 °
				-121.679017 °	-121.679017 °
DWR ID	DWR_RD1500_01_s_2014_1285				
Action/Comments					
Inspector Comments: FS_ID:28183 EP_NO: 1566A Repair Type: Crossing Status: UCIP Comments: - soil erosion around headwall on waterside.pump was removed.overhead powerline. FIELD_STRUCT_DESC: 10-inch steel irrigation pipe through levee, 5.0 feet below crown. Pump and switch panel on waterside berm. Service pole on waterward shoulder. Siphon breaker on landward slope. A 3-foot by 4-foot concrete distribution box at landward toe (App. No. 1566A White) O&M Manual Sac 128, March 1960. FS Date: 1/9/2014

WS view: concrete blocks headwall and pump on river bank. Pump has been removed (marked). Surface erosion around headwall.

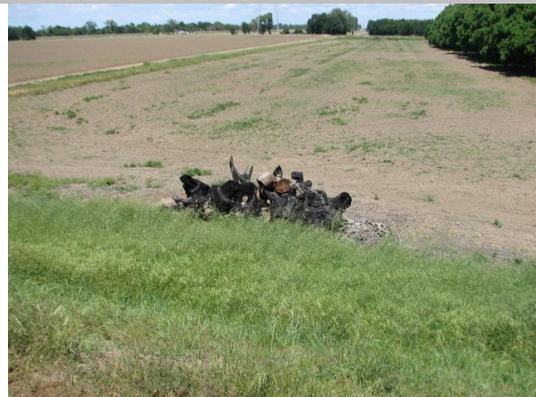
Photo 1 of 1 : johngw_s_20140428_882.jpg

LM Start	0.49	Rating **	M	Issue No.	1336
LM End	0.49	Issue Type +	En	Location *	LS
Category	Earthen Levee			GPS Latitude/Longitude	
				Start	End
Item	Encroachments			38.764497 °	38.764497 °
				-121.681925 °	-121.681925 °
DWR ID	DWR_RD1500_01_s_2014_1336				
Action/Comments					
Prunings

Large stumps piled up at the toe of the levee. Spring 2014

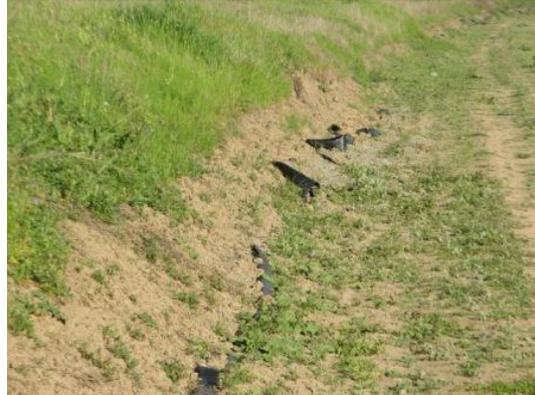
Photo 1 of 2 : johngw_s_20140414_272.jpg

LM Start	0.64	Rating **	A/W	Issue No.	76
LM End	1.06	Issue Type +	Ma	Location *	LS
Category	Earthen Levee			GPS Latitude/Longitude	
				Start	End
Item	Slope Stability			38.764305 °	38.766827 °
				-121.684396 °	-121.690884 °
DWR ID	DWR_RD1500_01_s_2013_76				
Action/Comments					
Repair slope instability.

Damage to the seepage berm during the flood season needs to be repaired, Spring 2013

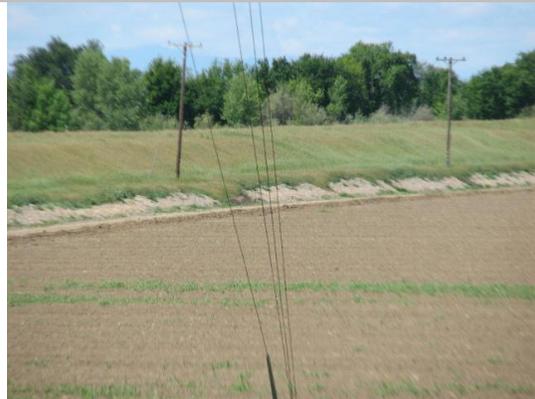
Photo 2 of 2 : johngw_s_20140428_884.jpg

LM Start	0.64	Rating **	A/W	Issue No.	76 (cont)
LM End	1.06	Issue Type +	Ma	Location *	LS

The damage to the seepage berm has been repaired and needs to be monitor. Spring 2014

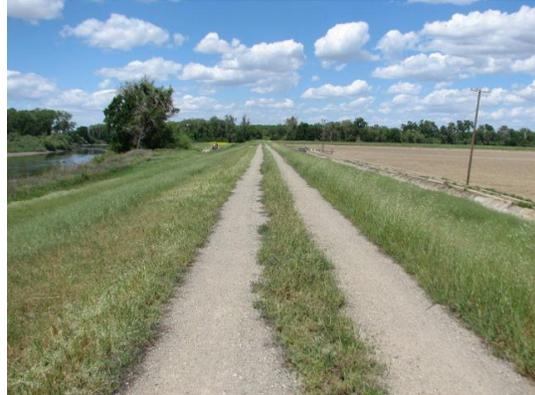
Photo 1 of 1 : johngw_s_20140428_886.jpg

Unwanted vegetation on the crown needs to be maintained. Spring 2014

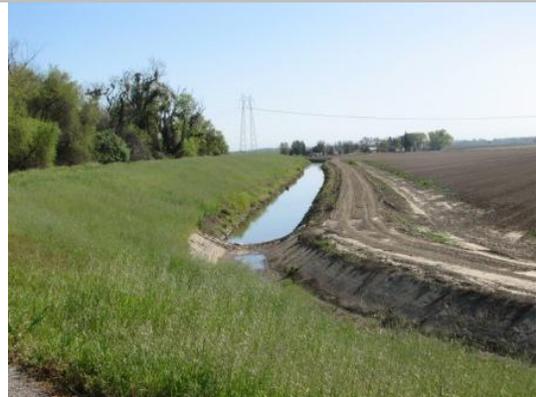
Photo 1 of 1 : johngw_s_20140414_285.jpg

LM Start	2.57	Rating **	M	Issue No.	963
LM End	3.83	Issue Type +	En	Location *	LS
Category	Earthen Levee			GPS Latitude/Longitude	
				Start	End
Item	Encroachments			38.785351 °	38.797174 °
				-121.689075 °	-121.693045 °
DWR ID	DWR_RD1500_01_s_2012_963				
Action/Comments					
Ditch

Agricultural ditch, photo was taken in spring 2010.

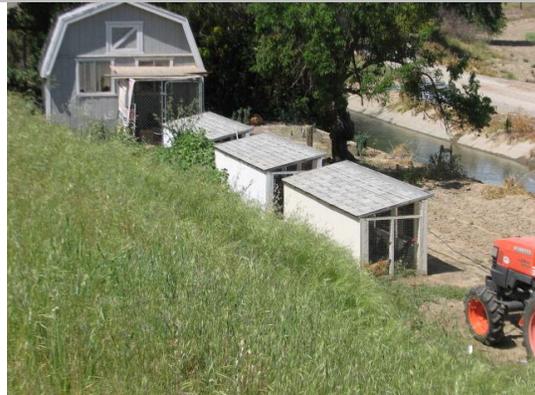
Photo 2 of 2 : johngw_s_20140428_888.jpg

Chicken coupes have been added along the toe of the levee. Spring 2014

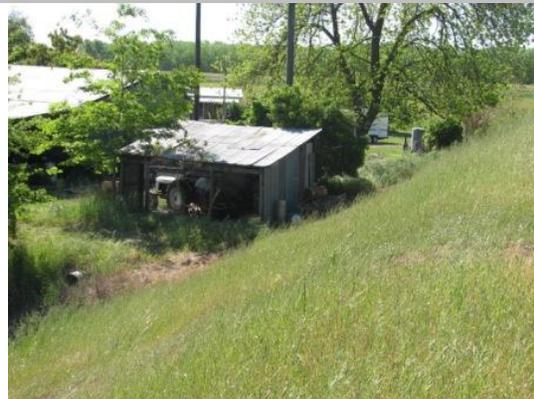
Photo 1 of 1 : johngw_s_20140414_189.jpg

The equipment shed encroaches into the toe of the levee.

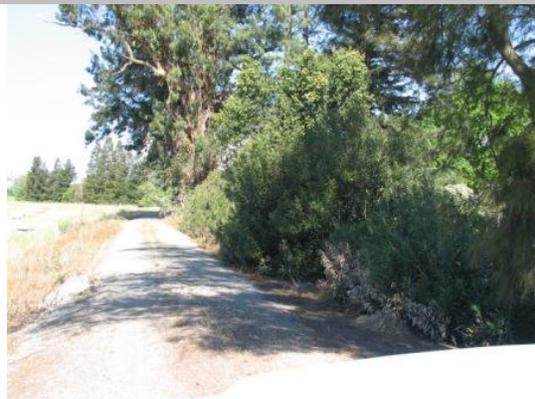
Photo 1 of 1 : johngw_s_20140414_192.jpg

The landscape completely blocks the landside slope and toe.

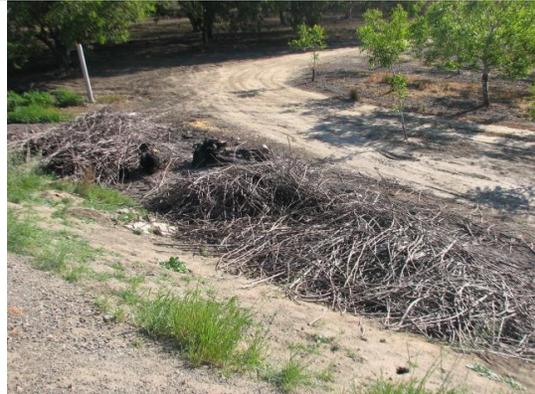
Photo 2 of 2 : johngw_s_20140428_899.jpg

The pruning pile has reduced in size by burning it. A new pile is started. Spring 2014

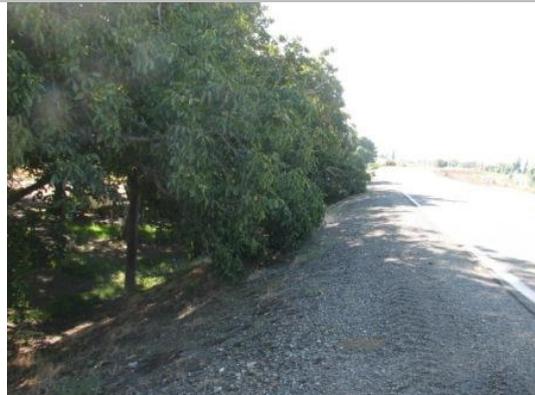
Photo 1 of 1 : johngw_s_20140414_283.jpg

Trees need to be trimmed to the height of 5 feet to see the slope.

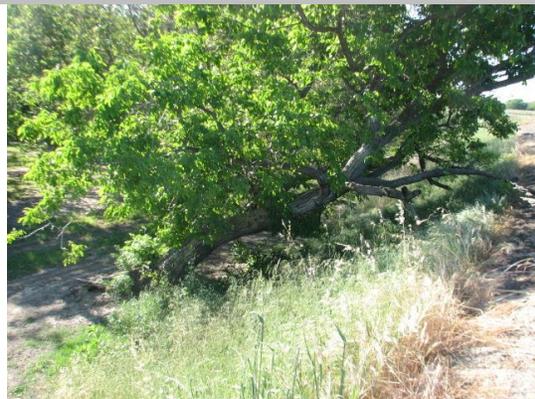
Photo 1 of 1 : johngw_s_20140428_902.jpg

The walnut tree at the toe has fallen. The roots are exposed and the branches are holding it up. Spring 2014

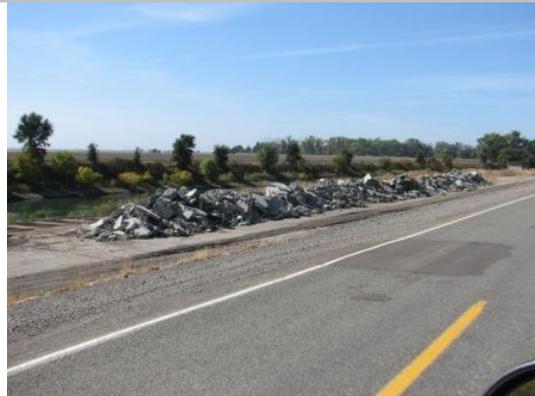
Photo 1 of 1 : johngw_s_20140414_254.jpg

Another pile of concrete debris on the waterside. Fall 2013

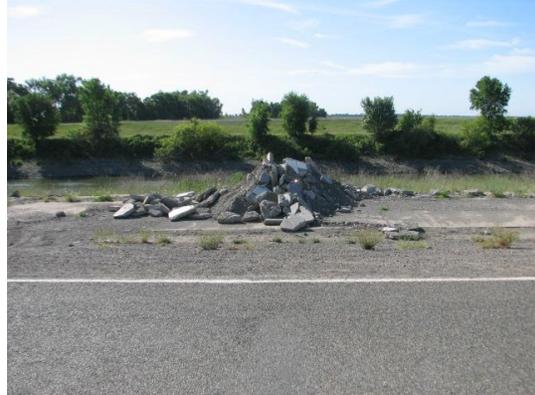
Photo 1 of 1 : johngw_s_20140428_905.jpg

A concrete debris pile is on the berm area. Spring 2014

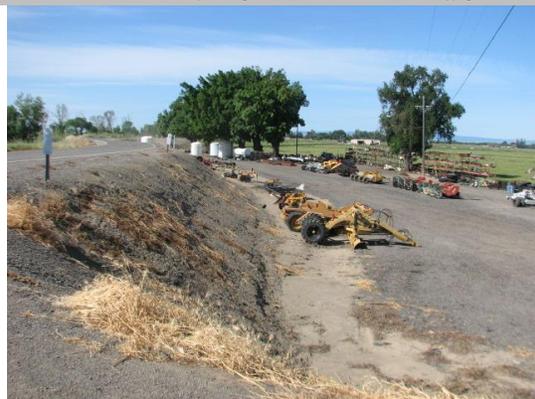
Photo 2 of 2 : johngw_s_20140428_906.jpg

A current view of the equipment parked along the levee toe Spring 2014

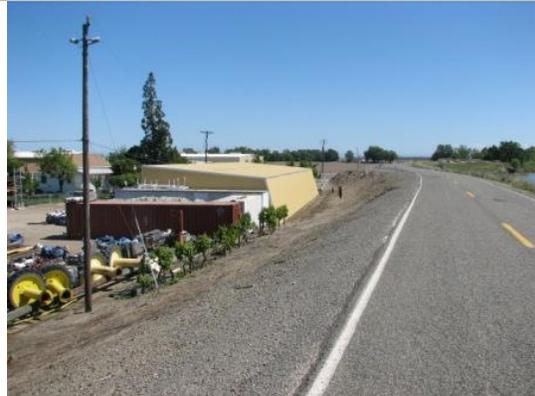
Photo 1 of 1 : johngw_s_20140414_203.jpg

The buildings backside was built into the toe of the levee.

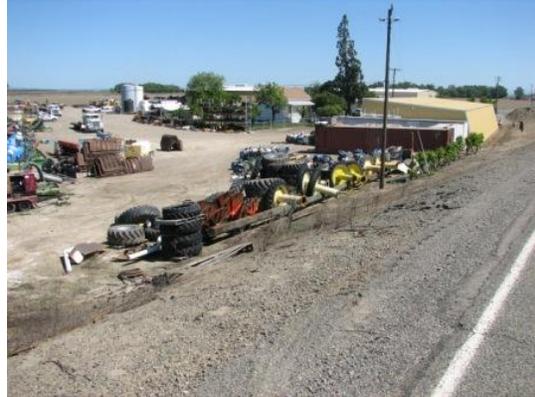
Photo 1 of 1 : johngw_s_20140414_292.jpg

Next to the building there are tires and axles stored at the toe.

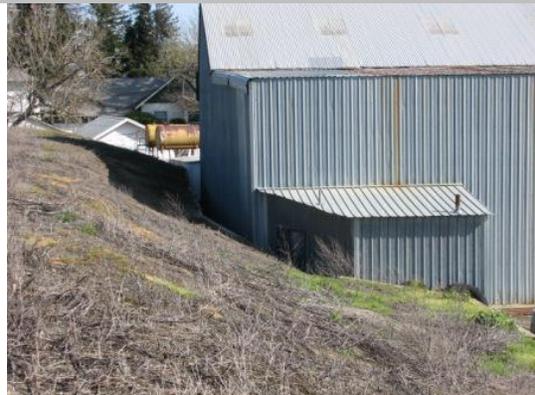
Photo 1 of 1 : johngw_s_20140414_210.jpg

Building and wall into levee. Photo was taken in spring 2010.

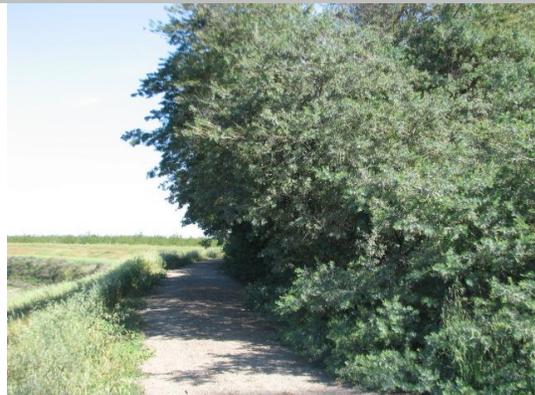
Photo 2 of 2 : johngw_s_20140428_907.jpg

The trees on the levee slope completely blocks visibility. Spring 2014

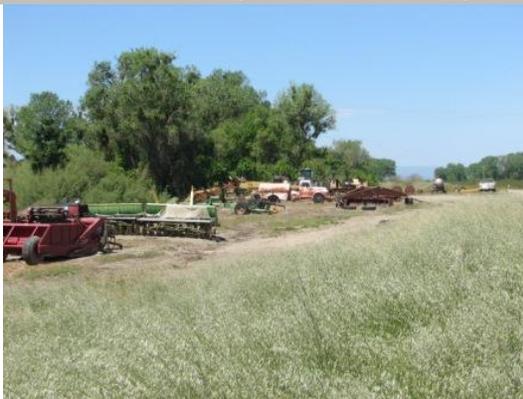
Photo 1 of 1 : johngw_s_20140414_212.jpg

Farm equipment has been parked on the waterside berm.

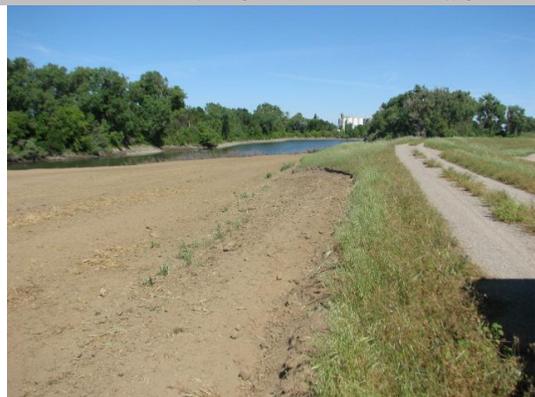
Photo 1 of 1 : johngw_s_20140428_911.jpg

Agricultural tilling has encroached into the levee slope. Spring 2014

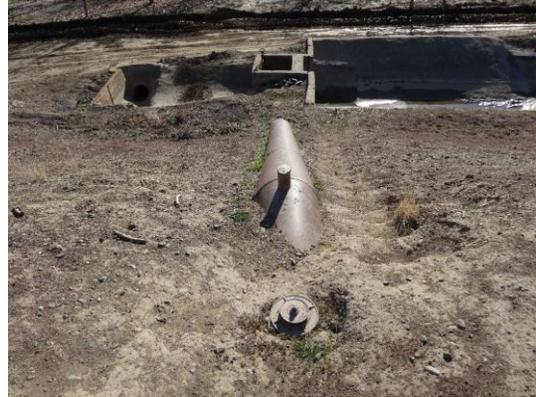
Photo 1 of 1 : UCIP_5663.jpg

LS view: siphon breaker (bottom) without protection, exposed pipe on levee slope, and distribution box on levee toe.

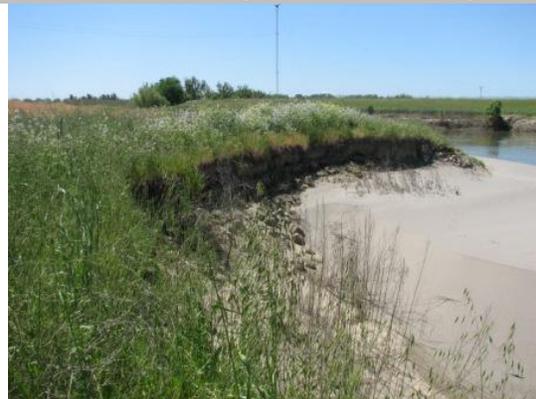
Photo 1 of 2 : johngw_s_20140414_248.jpg

This is an inside curve in the river and erosion has occurred.

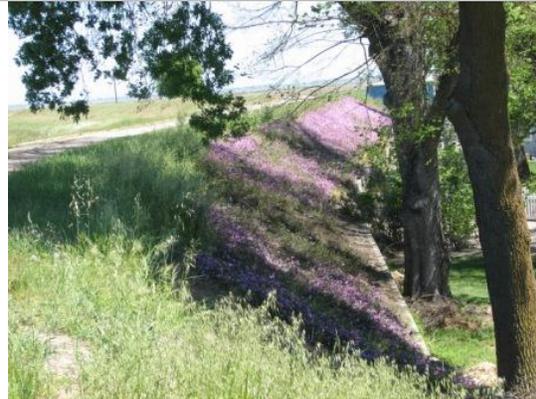
Photo 1 of 1 : johngw_s_20140414_221.jpg

The groundcover is on the levee slope above the concrete retaining wall. The groundcover is irrigated.

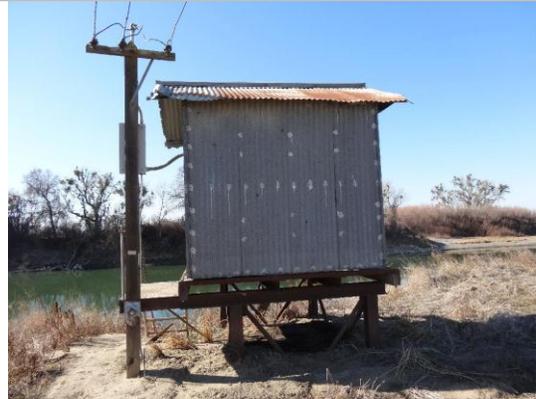
Photo 1 of 1 : UCIP_5670.jpg

WS view: slant pump in CM shed on levee berm. Oil leaks from the pump.

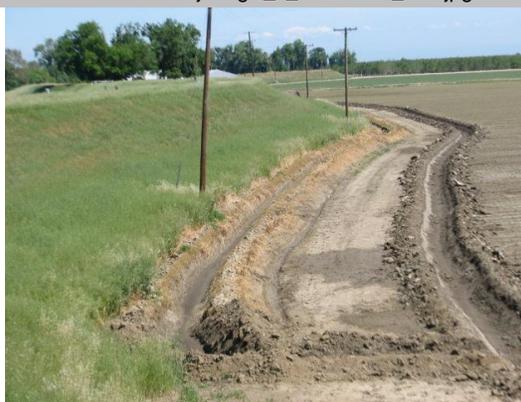
Photo 1 of 1 : johngw_s_20140428_913.jpg

Agricultural ditch runs along the toe of the levee. Spring 2014

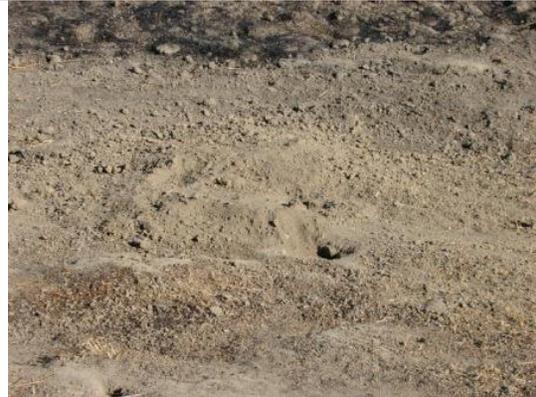
Photo 1 of 1 : johngw_s_20140414_279.jpg

Many rodent holes on the levee slope. Photo fall 2012.

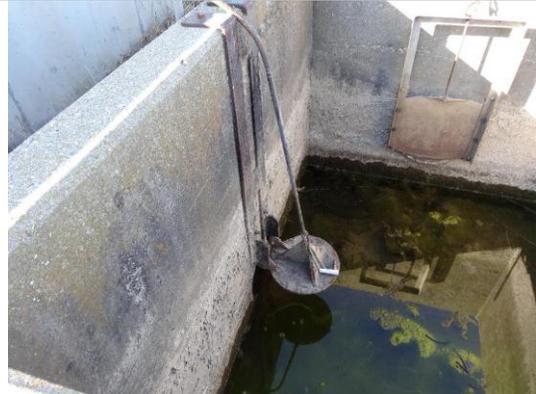
Photo 1 of 1 : UCIP_5571.jpg

LS view: corroded flap gate in concrete distribution box.

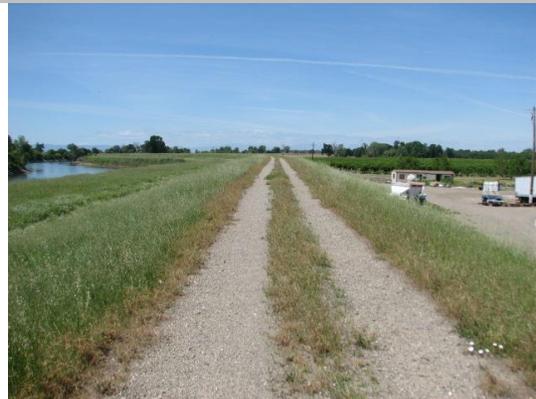
Photo 1 of 1 : johngw_s_20140428_918.jpg

Maintain the vegetation on the levee crown. Spring 2014

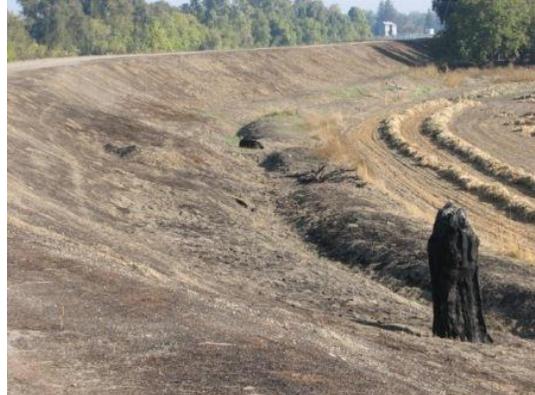
Photo 1 of 1 : johngw_s_20140414_255.jpg

Older, unused agricultural ditch. Tree stump needs to be removed.

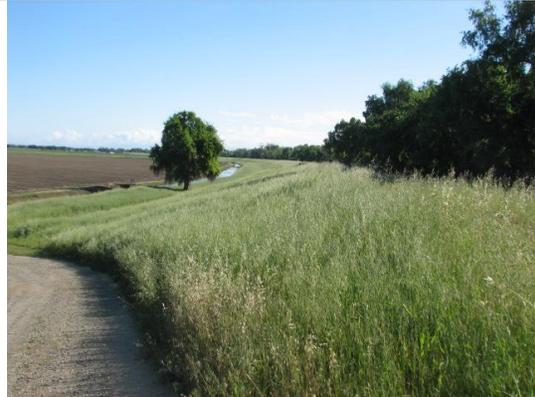
Photo 1 of 1 : johngw_s_20140428_893.jpg

Tall grasses partially blocks visibility. Spring 2014

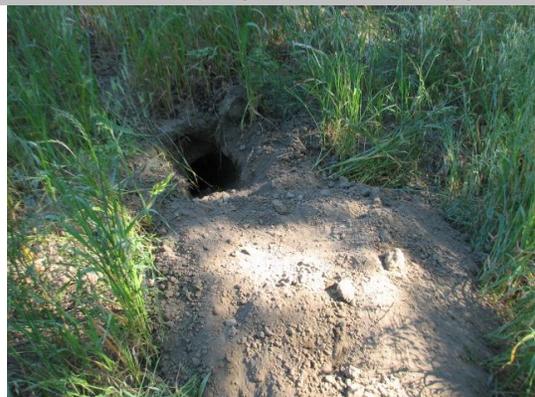
Photo 1 of 1 : johngw_s_20140428_896.jpg

A large rodent hole is on the waterside levee slope. Spring 2014

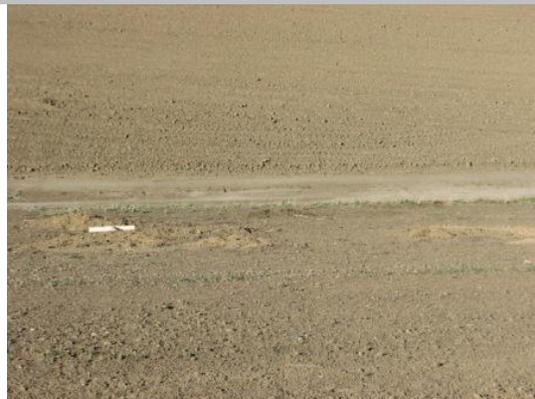
Photo 1 of 1 : johngw_s_20140414_485.jpg

Rodent hole on the landside toe. A bait station is close by. Fall 2013

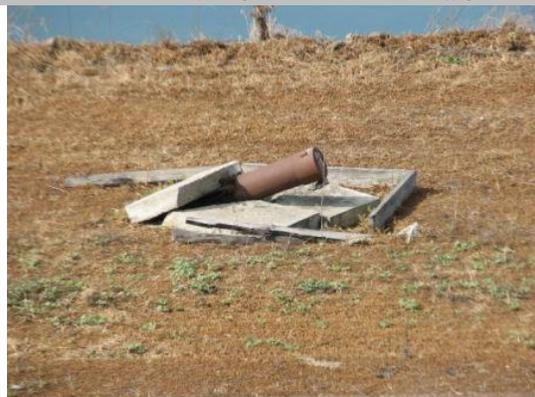
Photo 1 of 2 : johngw_s_20140414_487.jpg

The seepage well and pad needs to be repaired, Spring 2013

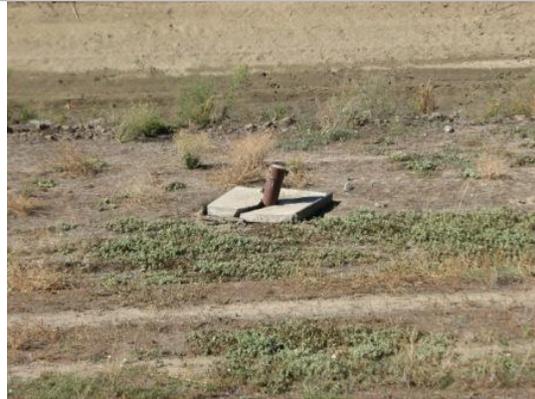
Photo 2 of 2 : johngw_s_20140414_488.jpg

The pieces of the puzzle have been placed back. Unsure if repaired. Fall 2013
