**Flood Control Project Maintenance
Levee Inspections**

Maintenance Issue Types Only, Levee Inspection Report By Mile - Fall 2014

Reclamation District No. 1500 Sutter Basin

Waterway	Bank	Unit Miles	Inspection Start/End	Inspector
Unit No. 01 Sacramento River	Left	33.15	10/23/2014 10/23/2014	Clay Thomas

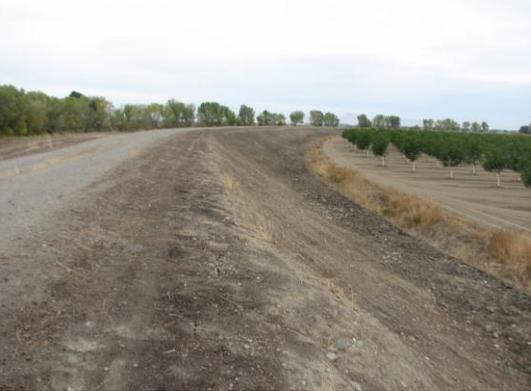
Photo 1 of 1 : FA_2014_RD1500_189_39_20141030_00153.jpg

LM Start	0.00	Rating **	A	Issue No.	39
LM End	33.58	Issue Type +	Ma	Location *	LS
Category	Earthen Levee		GPS Latitude/Longitude		
			Start	End	
Item	Vegetation			°	°
				°	°
DWR ID	DWR_RD1500_01_s_2012_39				
Action/Comments					
Control annual grass and weeds on the levee slopes and easements.

Levee mile 26.84, vegetation on the land side levee slope. Fall 2014.

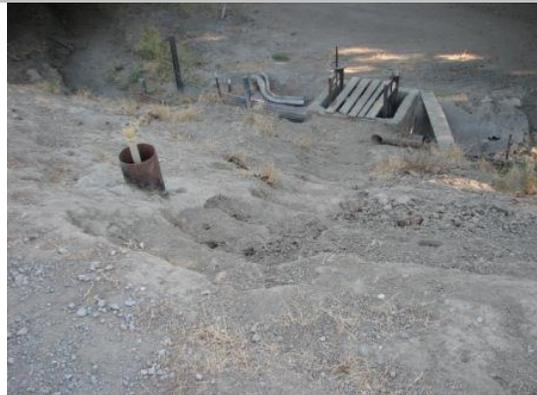
Photo 1 of 1 : FA_2014_RD1500_189_53_20141014_00049.jpg

Steps carved into the levee slope at a pipe crossing. Photo fall 2012.

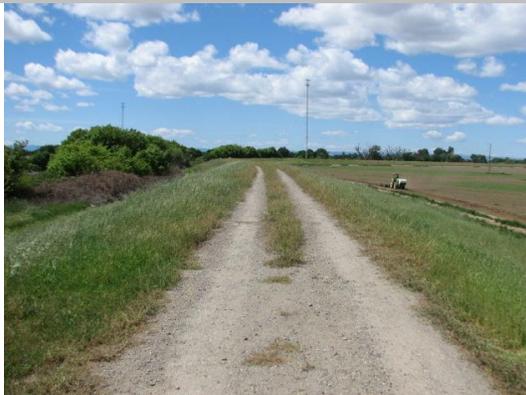
Photo 1 of 1 : FA_2014_RD1500_189_1337_20141014_00095.jpg

Control unwanted vegetation on the levee crown. Spring 2014

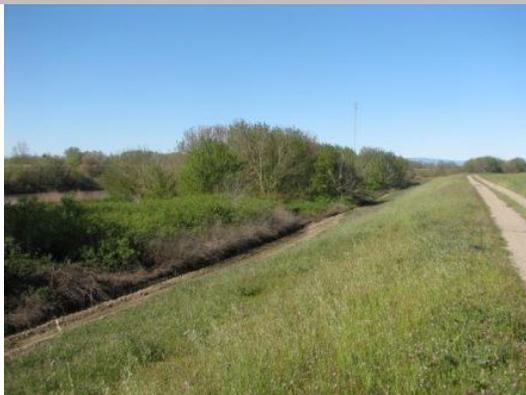
Photo 1 of 2 : FA_2014_RD1500_189_72_20141014_00059.jpg

LM Start	0.57	Rating **	A/W	Issue No.	72
LM End	0.83	Issue Type +	Ma	Location *	WS
Category	Earthen Levee		GPS Latitude/Longitude		
			Start	End	
Item	Vegetation		38.764462 °	38.764638 °	
			-121.683167 °	-121.687690 °	
DWR ID	DWR_RD1500_01_s_2012_72				
Action/Comments					
Environmental Requirements.

A view of the revegetation site.

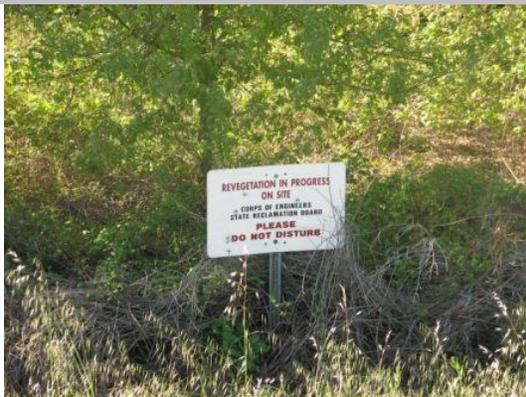
Photo 2 of 2 : FA_2014_RD1500_189_72_20141014_00060.jpg

A revegetation site waterside toe, photo taken spring 2012.

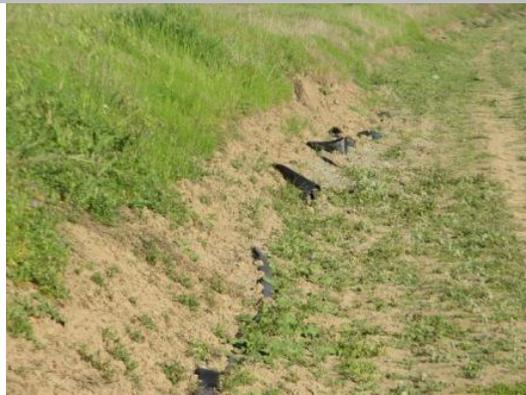
Photo 1 of 2 : FA_2014_RD1500_189_76_20141014_00063.jpg

LM Start	0.64	Rating **	A/W	Issue No.	76
LM End	1.06	Issue Type +	Ma	Location *	LS
Category	Earthen Levee		GPS Latitude/Longitude		
			Start	End	
Item	Slope Stability		38.764305 °	38.766827 °	
			-121.684396 °	-121.690884 °	
DWR ID	DWR_RD1500_01_s_2013_76				
Action/Comments					
Repair slope instability. Inspector Comments: Seepage berm was damaged last fall in prep for the agricultural field and needs to be restored by the land owner. A field investigation report was made. The seepage berm is scheduled to be repaired before next flood season.

Damage to the seepage berm during the flood season needs to be repaired, Spring 2013

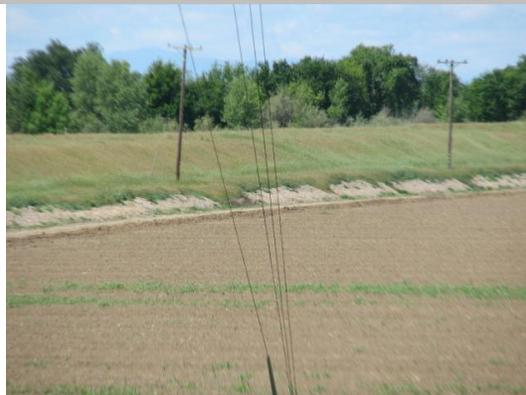
Photo 2 of 2 : FA_2014_RD1500_189_76_20141014_00064.jpg

The damage to the seepage berm has been repaired and needs to be monitored. Spring 2014

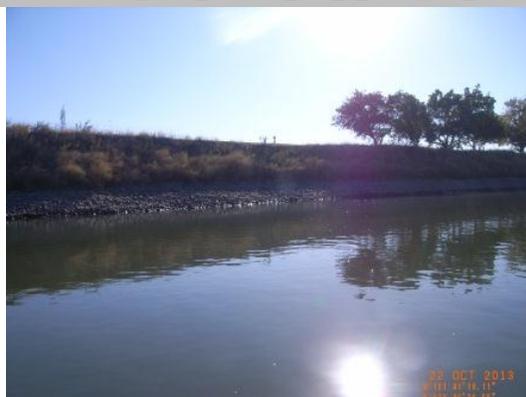
Photo 1 of 1 : FA_2014_RD1500_189_1_20141014_00001.jpg

LM Start	1.32	Rating **	M	Issue No.	1
LM End	1.32	Issue Type +	Ma	Location *	WS
Category	Supplemental		GPS Latitude/Longitude		
			Start	End	
Item	USACE Erosion Survey		38.770390 °	38.777282 °	
			-121.690553 °	-121.685841 °	
DWR ID	DWR_RD1500_01_f_2014_1				
Action/Comments					
Inspector Comments: 2006 - New erosion upstream, new bank failures near levee but still fairly wide berm in most places. 2008 - Large berm, questionable as to if it should remain in the inventory. 2010 - Minor new erosion, old cobble starting to fail. 2011 - Cobble continues to unravel and additional slumping. 2014 - Minor new erosion at bank mid point. 2013: Minor new erosion. [2013 Site ID: SAC_86-3_L]

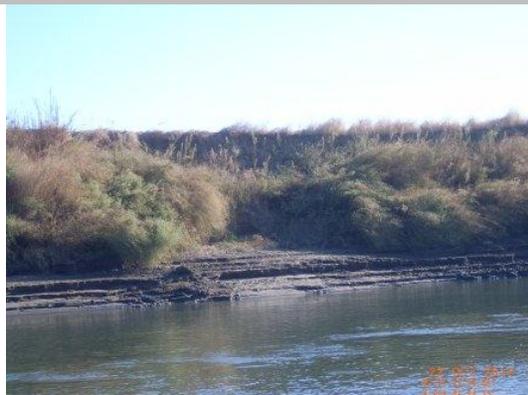
Photo 1 of 1 : FA_2014_RD1500_189_2_20141014_00002.jpg

LM Start	2.34	Rating **	M	Issue No.	2
LM End	2.34	Issue Type +	Ma	Location *	WS
Category	Supplemental		GPS Latitude/Longitude		
			Start	End	
Item	USACE Erosion Survey		38.781962 °	38.784936 °	
			-121.688033 °	-121.690033 °	
DWR ID	DWR_RD1500_01_f_2014_2				
Action/Comments					
Inspector Comments: 2010 - The upstream end of the repair site at 87.0. Repair did not extend far enough upstream. 2011 - New erosion pockets. 2012 - Minor new erosion at toe. 2013: Minor new erosion. [2013 Site ID: SAC_87-1_L]

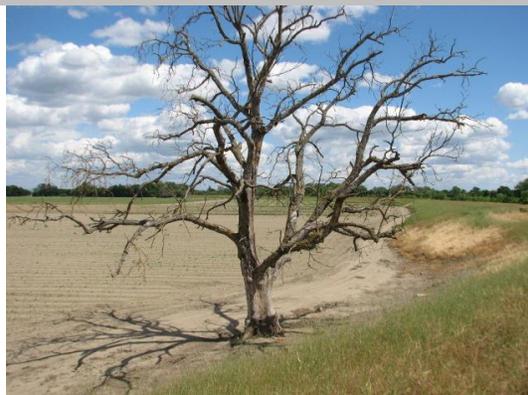
Photo 1 of 1 : FA_2014_RD1500_189_1340_20141014_00098.jpg

LM Start	5.20	Rating **	A/W	Issue No.	1340
LM End	5.20	Issue Type +	Ma	Location *	LS
Category	Earthen Levee		GPS Latitude/Longitude		
			Start	End	
Item	Vegetation		38.802164 °	38.802164 °	
			-121.712560 °	-121.712560 °	
DWR ID	DWR_RD1500_01_s_2014_1340				
Action/Comments					
Trees / Woody Vegetation

Monitor tree that may pose a future threat to the integrity of the levee. Spring 2014

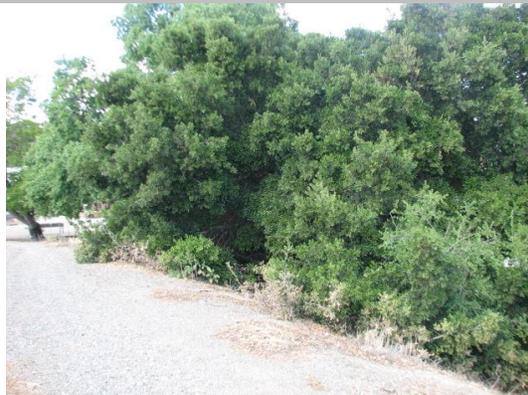
Photo 1 of 1 : FA_2014_RD1500_189_1341_20141014_00099.jpg

Trees need to be trimmed up to at least 5' they are blocking the visibility. Spring 2014

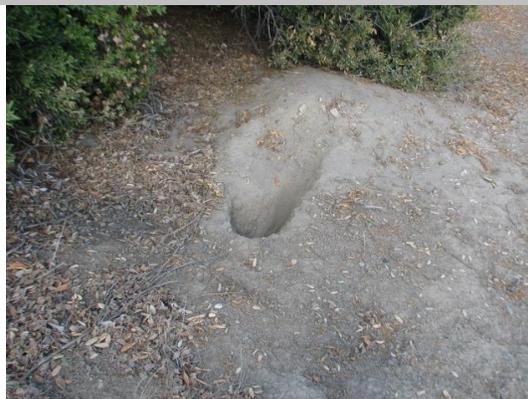
Photo 1 of 1 : FA_2014_RD1500_189_1342_20141014_00100.jpg

LM Start	5.30	Rating **	M	Issue No.	1342
LM End	5.30	Issue Type +	Ma	Location *	LS
Category	Earthen Levee		GPS Latitude/Longitude		
			Start	End	
Item	Animal Control		38.802826 °	38.802826 °	
			-121.714044 °	-121.714044 °	
DWR ID	DWR_RD1500_01_s_2014_1342				
Action/Comments					
Exterminate rodents and backfill and compact or grout burrows.

A rodent hole on the landside levee slope. Spring 2014

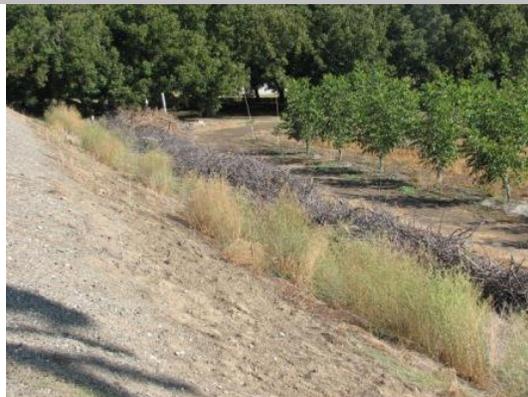
Photo 1 of 2 : FA_2014_RD1500_189_216_20141014_00076.jpg

LM Start	7.18	Rating **	M	Issue No.	216
LM End	7.18	Issue Type +	Ma	Location *	LS
Category	Earthen Levee		GPS Latitude/Longitude		
			Start	End	
Item	Encroachments		38.823781 °	38.823781 °	
			-121.722752 °	-121.722752 °	
DWR ID	DWR_RD1500_01_s_2012_216				
Action/Comments					
Prunings

The landowner has piled prunings along the levee toe.

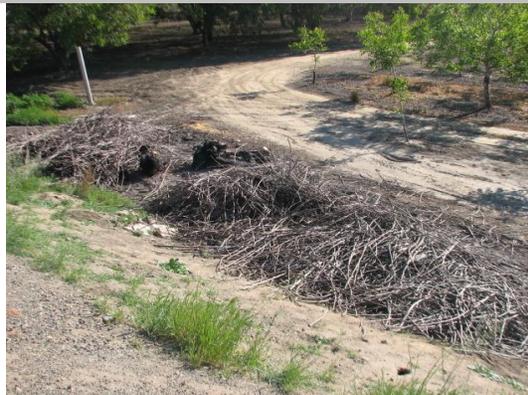
Photo 2 of 2 : FA_2014_RD1500_189_216_20141014_00077.jpg

The pruning pile has reduced in size by burning it. A new pile is started. Spring 2014

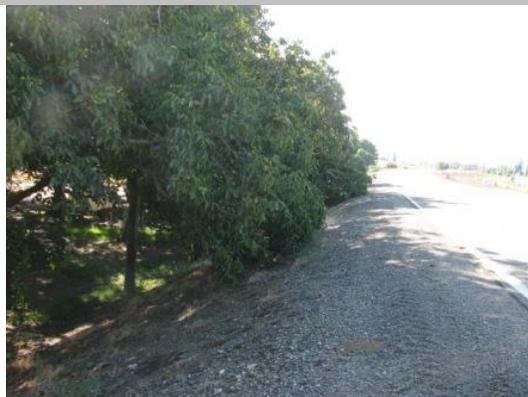
Photo 1 of 1 : FA_2014_RD1500_189_217_20141014_00078.jpg

LM Start	7.21	Rating **	M	Issue No.	217
LM End	7.21	Issue Type +	Ma	Location *	LS
Category	Earthen Levee		GPS Latitude/Longitude		
			Start	End	
Item	Trim / Thin Trees		38.824119 °	38.824119 °	
			-121.722776 °	-121.722776 °	
DWR ID	DWR_RD1500_01_s_2012_217				
Action/Comments					
Trim trees to at least five feet above ground level.

Trees need to be trimmed to the height of 5 feet to see the slope.

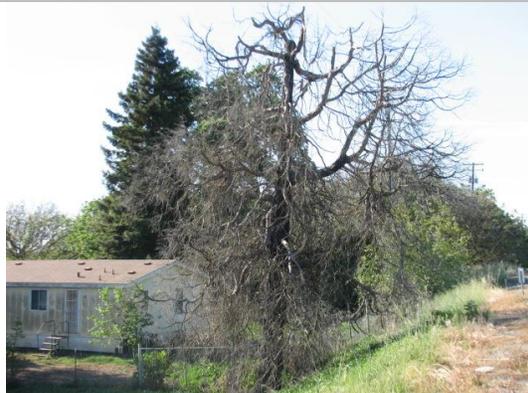
Photo 1 of 1 : FA_2014_RD1500_189_1343_20141014_00101.jpg

LM Start	7.26	Rating **	A/W	Issue No.	1343
LM End	7.26	Issue Type +	Ma	Location *	LS
Category	Earthen Levee		GPS Latitude/Longitude		
			Start	End	
Item	Vegetation		38.824900 °	38.824900 °	
			-121.722851 °	-121.722851 °	
DWR ID	DWR_RD1500_01_s_2014_1343				
Action/Comments					
Trees / Woody Vegetation

Monitor tree that may pose a future threat to the integrity of the levee. Spring 2014

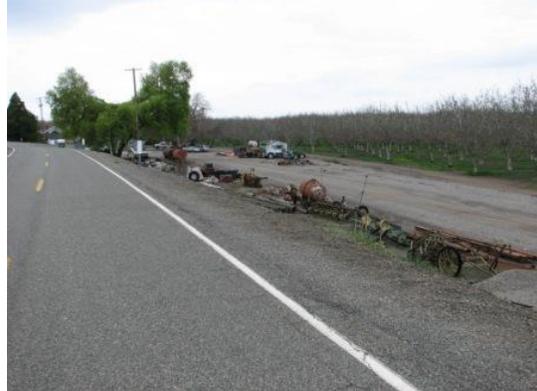
Photo 1 of 1 : FA_2014_RD1500_189_16_20141014_00014.jpg

Equipment along landside toe. Photo was taken in spring 2010.

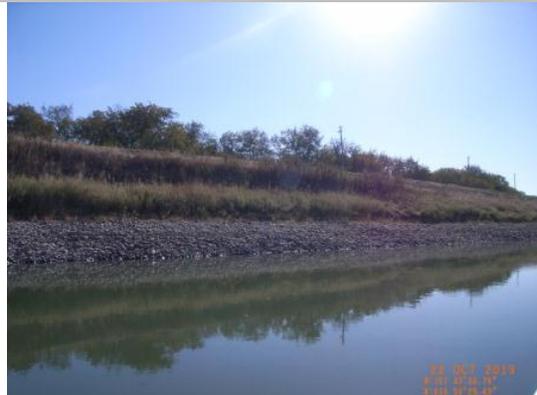
Photo 1 of 1 : FA_2014_RD1500_189_3_20141014_00003.jpg

LM Start	8.30	Rating **	M	Issue No.	3
LM End	8.30	Issue Type +	Ma	Location *	WS
Category	Supplemental		GPS Latitude/Longitude		
			Start	End	
Item	USACE Erosion Survey		38.838464 °	38.840347 °	
			-121.730205 °	-121.726857 °	
DWR ID	DWR_RD1500_01_f_2014_3				
Action/Comments					
Inspector Comments: 1997 - Damage to cobble revetment on top left bank and toe damage. 2004 - Site is pretty minor. 2010 - Cobbles continue to deteriorate. 2011 - Minor new erosion at the toe. 2013: Might be able to shorten due to deposition. [2013 Site ID: SAC_92-8_L]

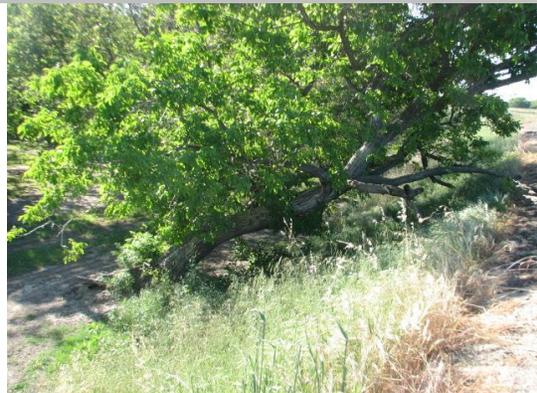
Photo 1 of 1 : FA_2014_RD1500_189_1344_20141014_00102.jpg

LM Start	8.99	Rating **	A/W	Issue No.	1344
LM End	8.99	Issue Type +	Ma	Location *	LS
Category	Earthen Levee		GPS Latitude/Longitude		
			Start	End	
Item	Vegetation		38.845076 °	38.845076 °	
			-121.728301 °	-121.728301 °	
DWR ID	DWR_RD1500_01_s_2014_1344				
Action/Comments					
Trees / Woody Vegetation

The walnut tree at the toe has fallen. The roots are exposed and the branches are holding it up. Spring 2014

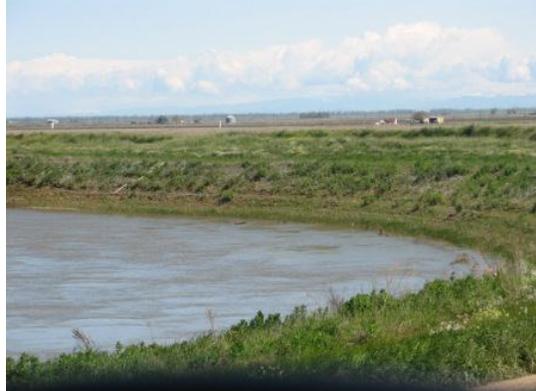
Photo 1 of 2 : FA_2014_RD1500_189_74_20141014_00061.jpg

A revegetation site on the waterside bank with sprinklers installed.

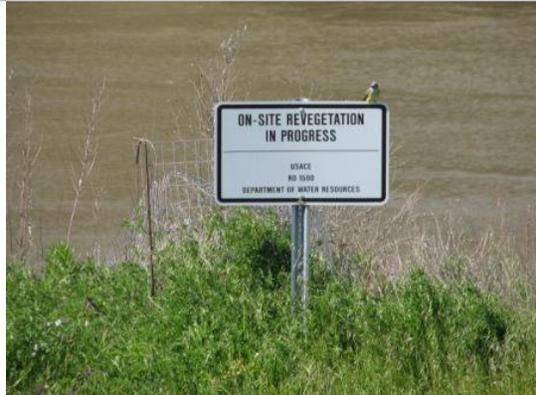
Photo 2 of 2 : FA_2014_RD1500_189_74_20141014_00062.jpg

Another revegetation site photo taken spring 2012.

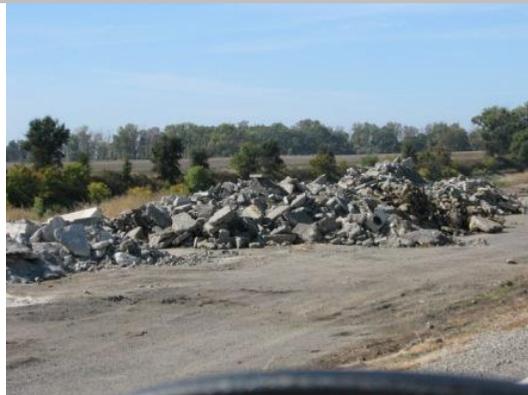
Photo 1 of 2 : FA_2014_RD1500_189_219_20141014_00079.jpg

Concret debris stockpiled on the waterside. Fall 2013

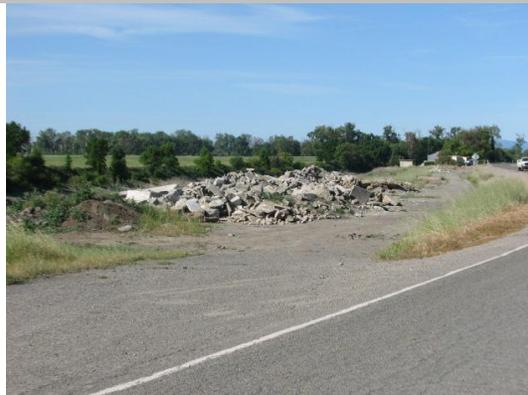
Photo 2 of 2 : FA_2014_RD1500_189_219_20141014_00080.jpg

Concrete debris is along the berm area. Spring 2014

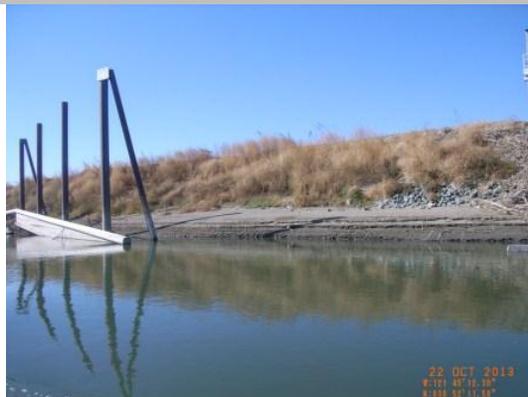
Photo 1 of 1 : FA_2014_RD1500_189_10_20141014_00009.jpg

LM Start	12.14	Rating **	M	Issue No.	10
LM End	12.14	Issue Type +	Ma	Location *	WS
Category	Supplemental		GPS Latitude/Longitude		
			Start	End	
Item	USACE Erosion Survey		38.870474 °	38.869139 °	
			-121.752237 °	-121.757108 °	
DWR ID	DWR_RD1500_01_f_2014_10				
Action/Comments					
Inspector Comments: 2000 - Vertical Modesto Formation bank with mass failure. 2003 - Upstream end has some new bank retreat. 2004 - Upstream end is worse. 2006 - Some new erosion, mainly on the steep slope and scarps. (Pumping station is not part of the erosion site.) 2010 - Some new erosion and deposition at upstream end, definite encroachments. 2011 - Minor new erosion at the toe. 2013: No

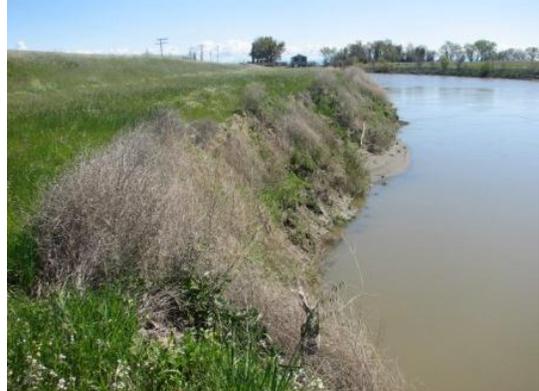
Photo 1 of 1 : FA_2014_RD1500_189_50_20141014_00044.jpg

An erosion site along the embankment, photo taken spring 2012.

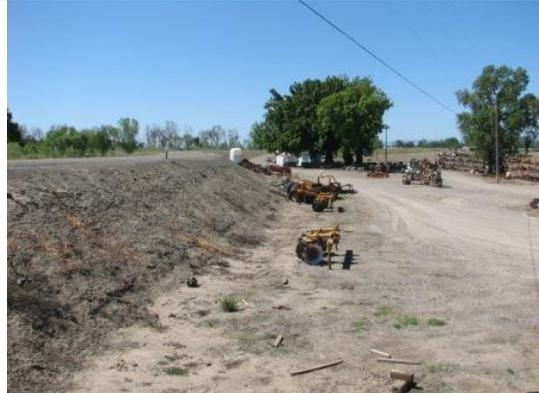
Photo 1 of 2 : FA_2014_RD1500_189_24_20141014_00022.jpg

There is equipment parked along the toe of the levee.

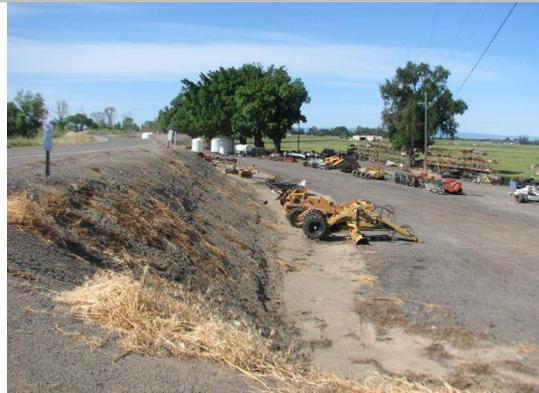
Photo 2 of 2 : FA_2014_RD1500_189_24_20141014_00023.jpg

A current view of the equipment parked along the levee toe Spring 2014

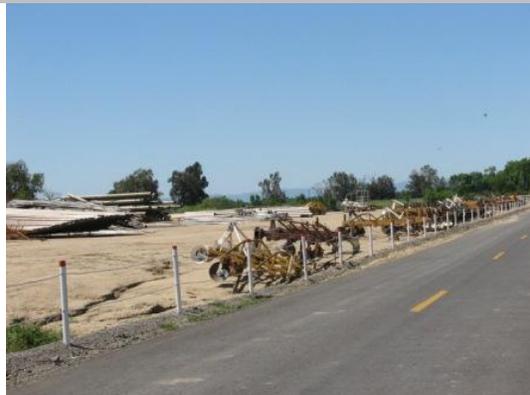
Photo 1 of 1 : FA_2014_RD1500_189_25_20141014_00024.jpg

On top of the crown is farm equipment and irrigation pipe.

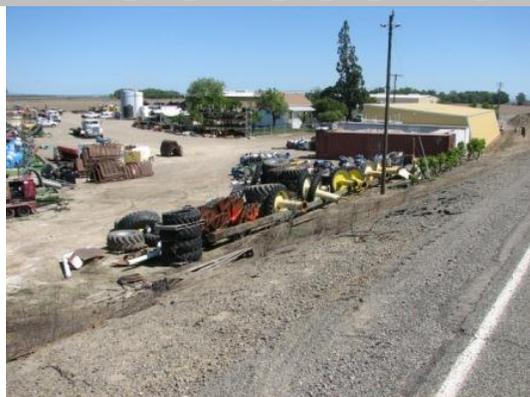
Photo 1 of 1 : FA_2014_RD1500_189_992_20141014_00091.jpg

Next to the building there are tires and axles stored at the toe.

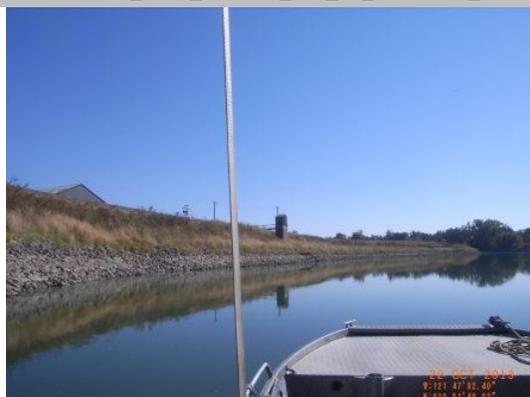
Photo 1 of 1 : FA_2014_RD1500_189_15_20141014_00013.jpg

LM Start	13.98	Rating **	M	Issue No.	15
LM End	13.98	Issue Type +	Ma	Location *	WS
Category	Supplemental		GPS Latitude/Longitude		
			Start	End	
Item	USACE Erosion Survey		38.857239 °	38.861899 °	
			-121.783771 °	-121.784057 °	
DWR ID	DWR_RD1500_01_f_2014_15				
Action/Comments					
Inspector Comments: 1997 - Intermittent toe failure of the hand placed riprap; failure of toe materials. 2013: No observed changes. [2013 Site ID: SAC_99-0_L]

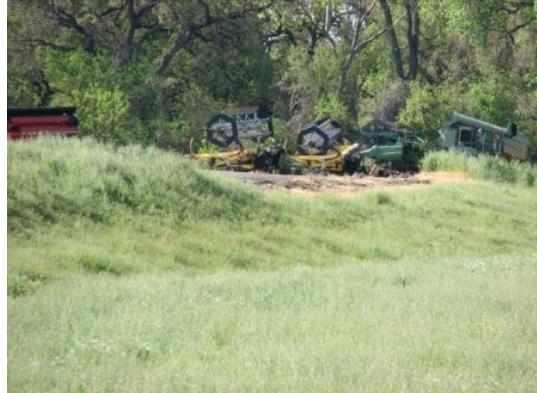
Photo 1 of 1 : FA_2014_RD1500_189_28_20141014_00026.jpg

View of equipment. Photo was taken in spring 2010.

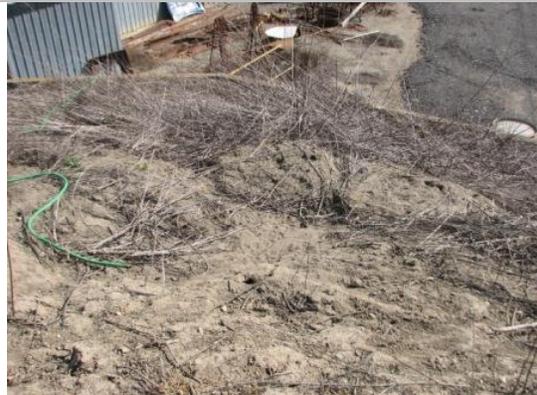
Photo 1 of 1 : FA_2014_RD1500_189_89_20141014_00072.jpg

Rodent hole in the levee slope above the retaining wall, Spring 2013

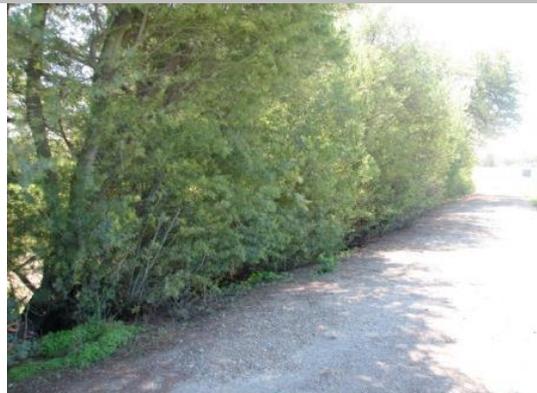
Photo 1 of 2 : FA_2014_RD1500_189_77_20141014_00065.jpg

The trees on the landside slope blocks the view of the slope, photo taken spring 2012.

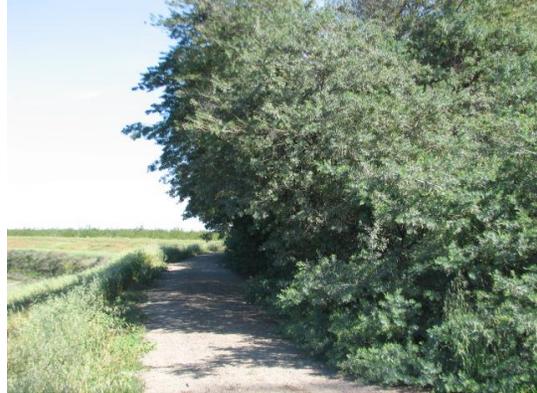
Photo 2 of 2 : FA_2014_RD1500_189_77_20141014_00066.jpg

The trees on the levee slope completely blocks visibility. Spring 2014

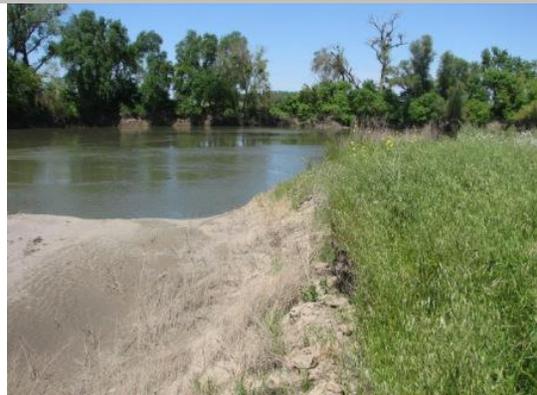
Photo 1 of 2 : FA_2014_RD1500_189_51_20141014_00045.jpg

This is an upstream view of the same erosion.

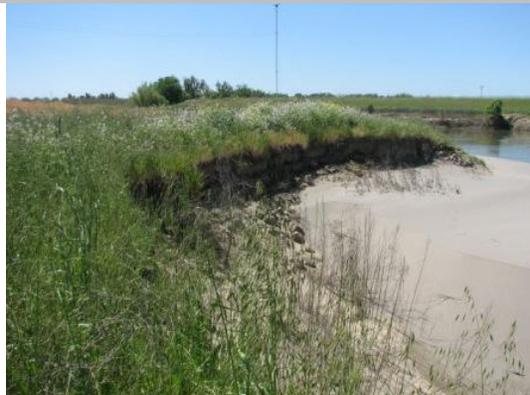
Photo 2 of 2 : FA_2014_RD1500_189_51_20141014_00046.jpg

This is an inside curve in the river and erosion has occurred.

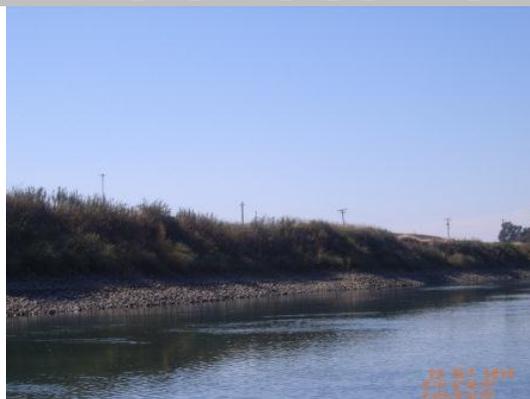
Photo 1 of 1 : FA_2014_RD1500_189_22_20141014_00020.jpg

LM Start	18.51	Rating **	M	Issue No.	22
LM End	18.51	Issue Type +	Ma	Location *	WS
Category	Supplemental			GPS Latitude/Longitude	
				Start	End
Item	USACE Erosion Survey			38.901337 °	38.902721 °
				-121.801175 °	-121.790677 °
DWR ID	DWR_RD1500_01_f_2014_22				
Action/Comments					
Inspector Comments: 1997 - Pocket failures of cobble revetment toe; scallops of rock loss along the bank; irregular bankline developing. 2001 - Small scallops in the toe of the berm. 2005 - Still multiple erosion pockets in the toe. 2006 - Two new small slumps. 2011 - Old cobble continue to fail causing minor slumping. 2012 - Portions of site appears to be stabilizing. 2013: No observed changes. [2013 Site ID: SAC_104-0_L]

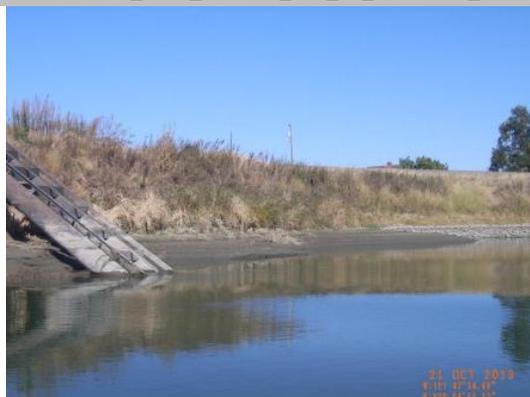
Photo 1 of 1 : FA_2014_RD1500_189_23_20141014_00021.jpg

LM Start	19.24	Rating **	M	Issue No.	23
LM End	19.24	Issue Type +	Ma	Location *	WS
Category	Supplemental			GPS Latitude/Longitude	
				Start	End
Item	USACE Erosion Survey			38.904041 °	38.906697 °
				-121.790298 °	-121.792796 °
DWR ID	DWR_RD1500_01_f_2014_23				
Action/Comments					
Inspector Comments: 1997 - Cobbles eroded off the clay materials; not much evidence of erosion on the toe; cobble loss on the toe. 2011 - Some minor new erosion. 2013: No observed changes. [2013 Site ID: SAC_104-5_L]

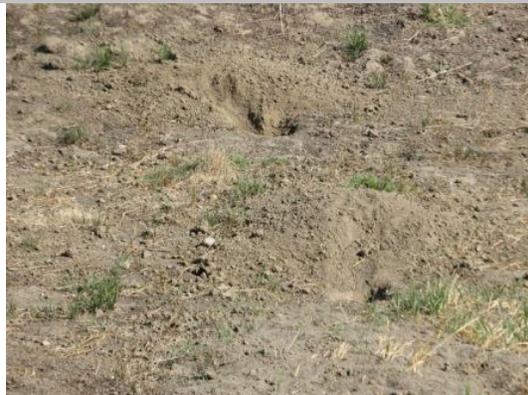
Photo 1 of 2 : FA_2014_RD1500_189_69_20141014_00057.jpg

Multiple rodent burrows on landside slope. Fall 2013

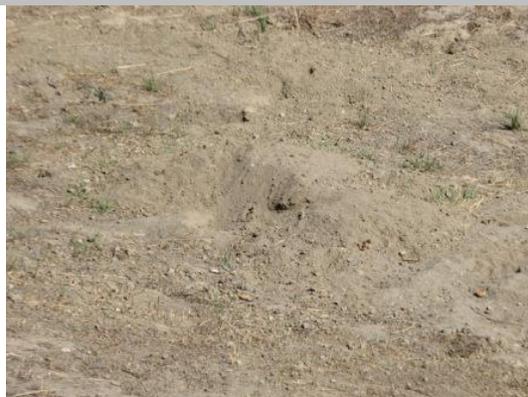
Photo 2 of 2 : FA_2014_RD1500_189_69_20141014_00058.jpg

A rodent burrow on the landside Fall 2013

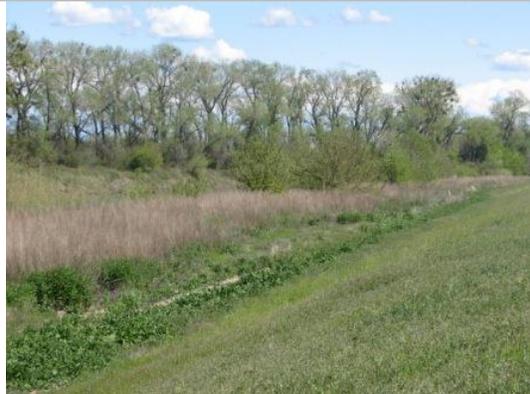
Photo 1 of 2 : FA_2014_RD1500_189_84_20141014_00069.jpg

A photo of the revegetation site.

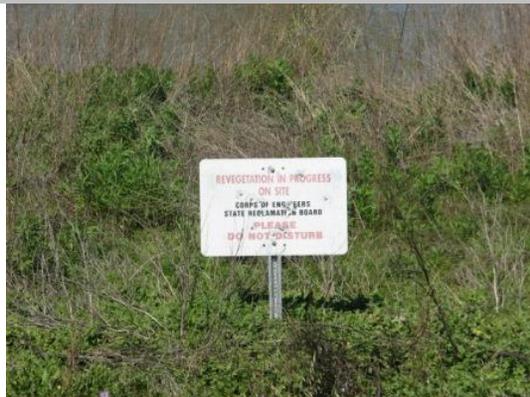
Photo 2 of 2 : FA_2014_RD1500_189_84_20141014_00070.jpg

Another revegetation site on the waterside berm, photo taken spring 2012.

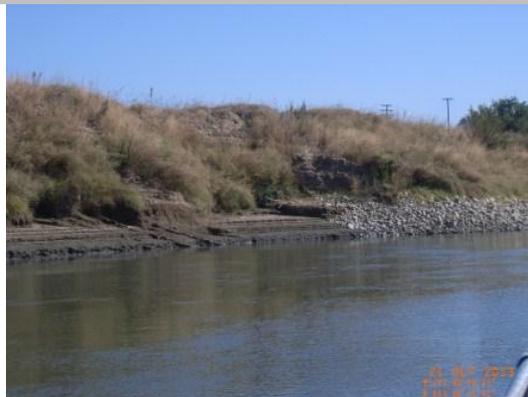
Photo 1 of 1 : FA_2014_RD1500_189_34_20141014_00032.jpg

LM Start	31.38	Rating **	M	Issue No.	34
LM End	31.38	Issue Type +	Ma	Location *	WS
Category	Supplemental			GPS Latitude/Longitude	
				Start	End
Item	USACE Erosion Survey			39.003301 °	39.006072 °
				-121.805024 °	-121.815926 °
DWR ID	DWR_RD1500_01_f_2014_34				
Action/Comments					
Inspector Comments: 2003 - New sedimentation and some new small toe scallops at the upstream end; downstream end has some new erosion. 2004 - Some new erosion at the toe and upper bank and some small new rotational failures (mainly minor, except at the downstream end). 2007 - Some new slumps. 2009 - Some new scallops and site was extended upstream. 2010 - New deposition along upstream end of site, however there is also new erosion throughout the site. Site seems to be worsening, and eroding fast. Large habitat for bank swallows. 2011 - Some new minor erosion. 2012 - Minor new erosion. 2013: No observed changes. [2013 Site ID: SAC_116-5_L]

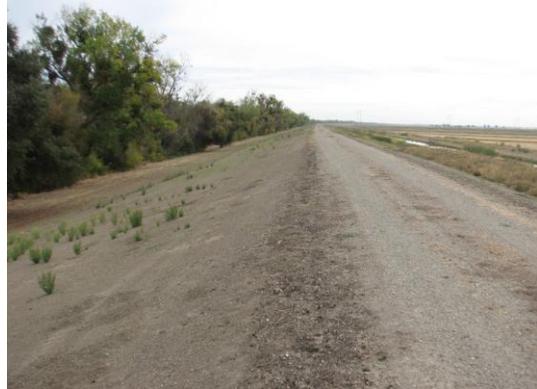
Photo 1 of 1 : FA_2014_RD1500_190_2_20141030_00020.jpg

Levee mile 16.71, vegetation on the water side slope. Fall 2014

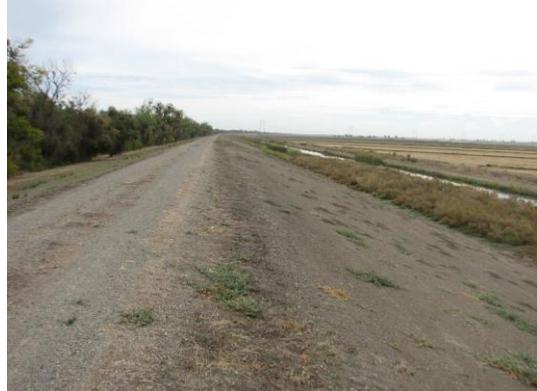
Photo 1 of 1 : FA_2014_RD1500_190_3_20141030_00021.jpg

Levee mile 16.71, vegetation on the land side slope. Fall 2014.

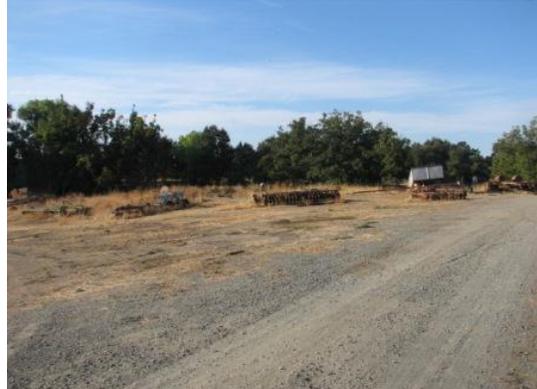
Photo 1 of 2 : FA_2014_RD1500_190_12_20141014_00008.jpg

Farm equipment is parked on the levee slope. Photo fall 2012.

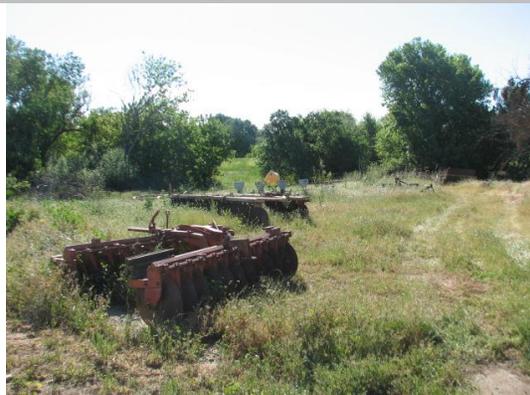
Photo 2 of 2 : FA_2014_RD1500_190_12_20141014_00009.jpg

Farm equipment is on the levee crown. Spring 2014

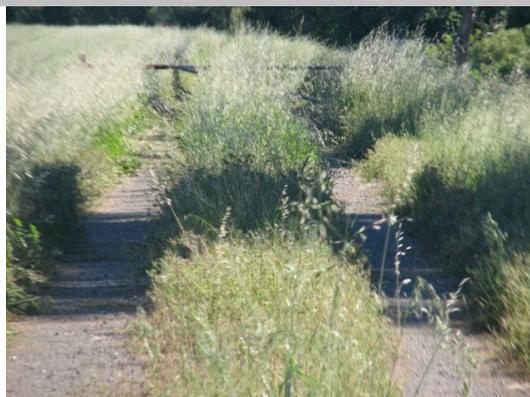
Photo 1 of 1 : FA_2014_RD1500_190_302_20141014_00016.jpg

Maintain unwanted vegetation on the levee crown Spring 2014

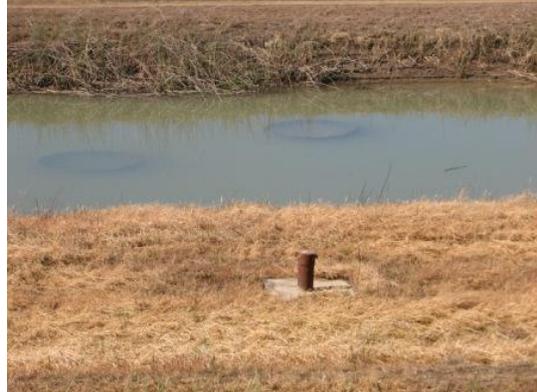
Photo 1 of 1 : FA_2014_RD1500_190_4_20141014_00002.jpg

The relief well at boil 12, photo taken spring 2012.

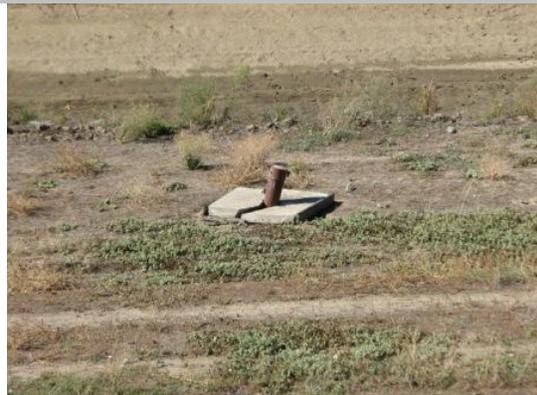
Photo 1 of 2 : FA_2014_RD1500_190_10_20141014_00005.jpg

The pieces of the puzzle have been placed back. Unsure if repaired. Fall 2013

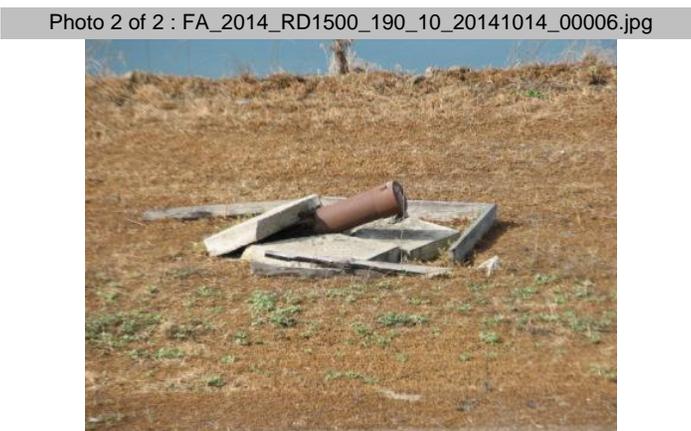
LM Start	14.40	Rating **	U	Issue No.	10 (cont)
LM End	14.40	Issue Type +	Ma	Location *	LS
Category	Earthen Levee			GPS Latitude/Longitude	
				Start	End
Item	Underseepage Relief Wells			38.949640 °	38.949640 °
				-121.671947 °	-121.671947 °
DWR ID	DWR_RD1500_02_s_2012_10				
Action/Comments					
Inspector Comments: Fall 2013, work has been done on the seepage well. Unsure if it operates properly. Spring 2014 unable to find may have been removed.

The seepage well and pad needs to be repaired, Spring 2013

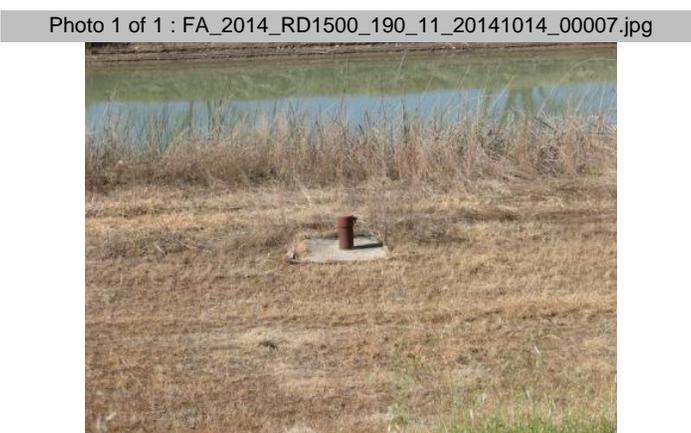
LM Start	14.56	Rating **	A/W	Issue No.	11
LM End	14.56	Issue Type +	Ma	Location *	LS
Category	Earthen Levee			GPS Latitude/Longitude	
				Start	End
Item	Underseepage Relief Wells			38.951398 °	38.951398 °
				-121.673827 °	-121.673827 °
DWR ID	DWR_RD1500_02_s_2012_11				
Action/Comments

A relief well at boil 16, photo taken spring 2012.

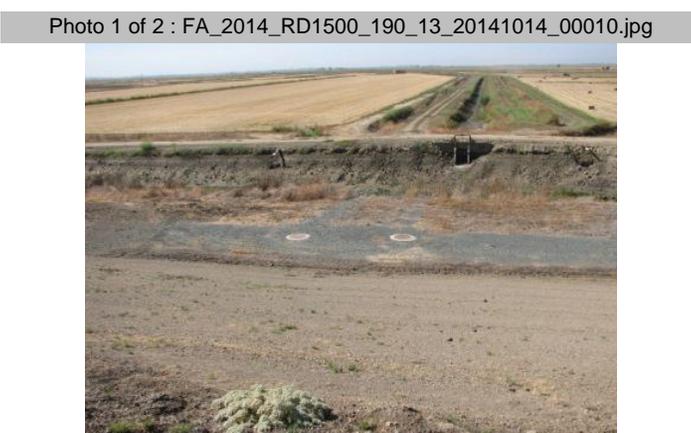
LM Start	18.24	Rating **	A/W	Issue No.	13
LM End	18.24	Issue Type +	Ma	Location *	LS
Category	Earthen Levee			GPS Latitude/Longitude	
				Start	End
Item	Underseepage Relief Wells			38.987092 °	38.987092 °
				-121.725097 °	-121.725097 °
DWR ID	DWR_RD1500_02_s_2012_13				
Action/Comments

Two of five drains on the landside berm. Photo fall 2012.
