**Flood Control Project Maintenance
Levee Inspections**

Maintenance Issue Types Only, Levee Inspection Report By Mile - Fall 2015

Reclamation District No. 1500 Sutter Basin

Waterway	Bank	Unit Miles	Inspection Start/End	Inspector
Unit No. 01 Sacramento River	Left	33.15	10/20/2015 10/21/2015	Jai Lor

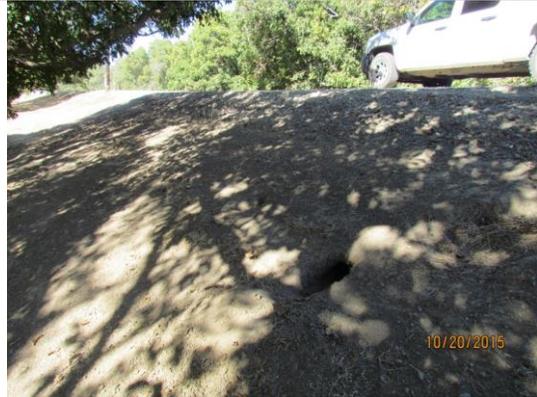
Photo 1 of 1 : FA_2015_RD1500_189_105_20151026_00137.jpg

LM Start	0.29	Rating **	M	Issue No.	105
LM End	0.29	Issue Type +	Ma	Location *	WS
Category	Earthen Levee			GPS Latitude/Longitude	
				Start	End
Item	Animal Control			38.762946 °	38.762946 °
				-121.678817 °	-121.678817 °
DWR ID	DWR_RD1500_01_f_2015_105				
Action/Comments					
No rodents visible, but rodent burrows visible; need to backfill and compact or grout burrows.

View of the rodent hole on the waterward side of the levee looking upstream. Fall 2015.

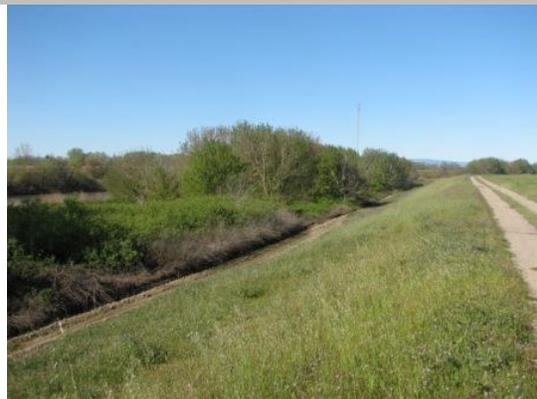
Photo 1 of 2 : FA_2015_RD1500_189_72_20150914_00049.jpg

A view of the revegetation site.

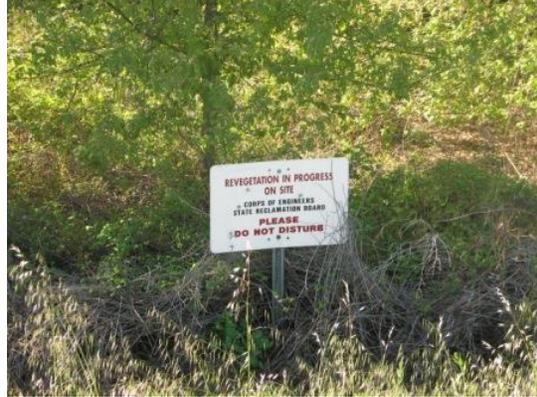
Photo 2 of 2 : FA_2015_RD1500_189_72_20150914_00050.jpg

A revegetation site waterside toe, photo taken spring 2012.

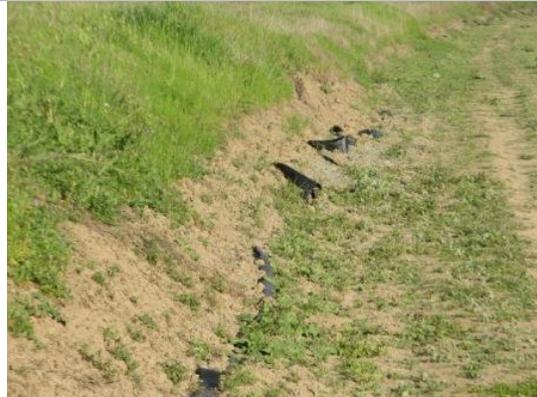
Photo 1 of 2 : FA_2015_RD1500_189_76_20150914_00053.jpg

LM Start	0.63	Rating **	A/W	Issue No.	76
LM End	1.05	Issue Type +	Ma	Location *	LS
Category	Earthen Levee		GPS Latitude/Longitude		
			Start	End	
Item	Slope Stability		38.764305 °	38.766827 °	
			-121.684396 °	-121.690884 °	
DWR ID	DWR_RD1500_01_s_2013_76				
Action/Comments					
Repair slope instability. Inspector Comments: Seepage berm was damaged last fall in prep for the agricultural field and needs to be restored by the land owner. A field investigation report was made. The seepage berm is scheduled to be repaired before next flood season.

Damage to the seepage berm during the flood season needs to be repaired, Spring 2013

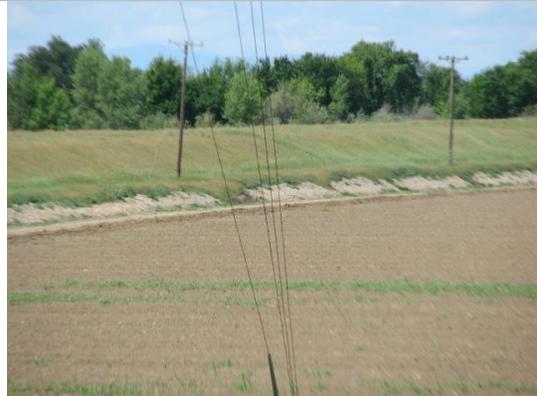
Photo 2 of 2 : FA_2015_RD1500_189_76_20150914_00054.jpg

The damage to the seepage berm has been repaired and needs to be monitored. Spring 2014

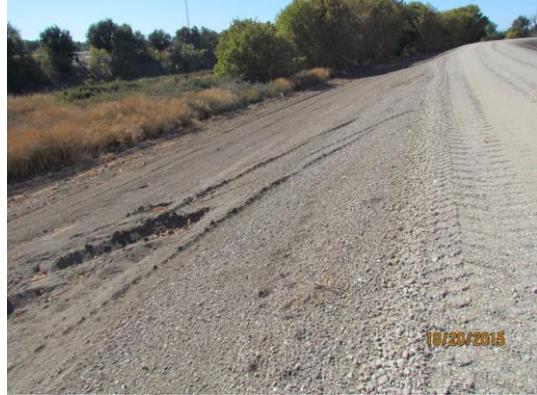
Photo 1 of 1 : FA_2015_RD1500_189_106_20151026_00138.jpg

LM Start	0.71	Rating **	M	Issue No.	106
LM End	0.71	Issue Type +	Ma	Location *	WS
Category	Earthen Levee			GPS Latitude/Longitude	
				Start	End
Item	Slope Stability			38.764155 °	38.764155 °
				-121.685888 °	-121.685888 °
DWR ID	DWR_RD1500_01_f_2015_106				
Action/Comments					
Repair the levee slope damaged by vehicle traffic and prevent access where possible.

View of the damaged slope on the waterward side of the levee looking upstream. Fall 2015.

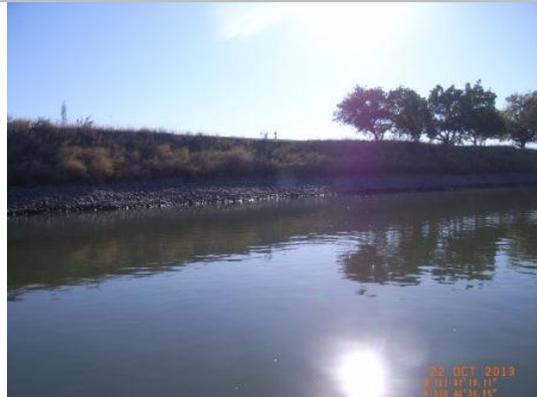
Photo 1 of 1 : USACE2013A_SAC_86-3_L_2.jpg

LM Start	1.34	Rating **	M	Issue No.	6
LM End	1.95	Issue Type +	Ma	Location *	WS
Category	Supplemental			GPS Latitude/Longitude	
				Start	End
Item	2015 USACE Erosion Survey, DRAFT			38.770390 °	38.777282 °
				-121.690553 °	-121.685841 °
DWR ID					
Action/Comments					
Inspector Comments: 2006 - New erosion upstream, new bank failures near levee but still fairly wide berm in most places. 2008 - Large berm, questionable as to if it should remain in the inventory. 2010 - Minor new erosion, old cobble starting to fail. 2011 - Cobble continues to unravel and additional slumping. 2012 - Minor new erosion at bank mid point. 2013 - Minor new erosion. 2015: No observed changes. [2015 Site ID: SAC_86-3_L]

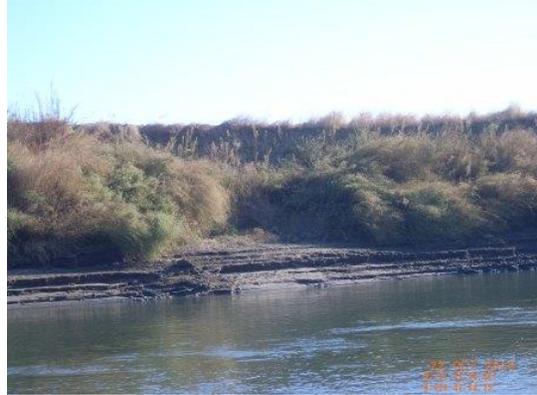
Photo 1 of 1 : USACE2013A_SAC_87-1_L_3.jpg

LM Start	2.30	Rating **	M	Issue No.	2
LM End	2.52	Issue Type +	Ma	Location *	WS
Category	Supplemental			GPS Latitude/Longitude	
				Start	End
Item	2015 USACE Erosion Survey, DRAFT			38.781962 °	38.784936 °
				-121.688033 °	-121.690033 °
DWR ID					
Action/Comments					
Inspector Comments: 2010 - The upstream end of the repair site at 87.0. Repair did not extend far enough upstream. 2011 - New erosion pockets. 2012 - Minor new erosion at toe. 2013 - Minor new erosion. 2015: Significant new toe erosion. [2015 Site ID: SAC_87-1_L]

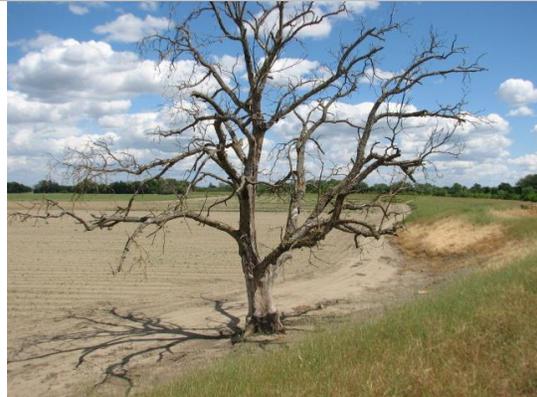
Photo 1 of 1 : FA_2015_RD1500_189_1340_20150914_00076.jpg

LM Start	5.17	Rating **	A/W	Issue No.	1340
LM End	5.17	Issue Type +	Ma	Location *	LS
Category	Earthen Levee			GPS Latitude/Longitude	
				Start	End
Item	Vegetation			38.802164 °	38.802164 °
				-121.712560 °	-121.712560 °
DWR ID	DWR_RD1500_01_s_2014_1340				
Action/Comments					
Trees / Woody Vegetation

Monitor tree that may pose a future threat to the integrity of the levee. Spring 2014

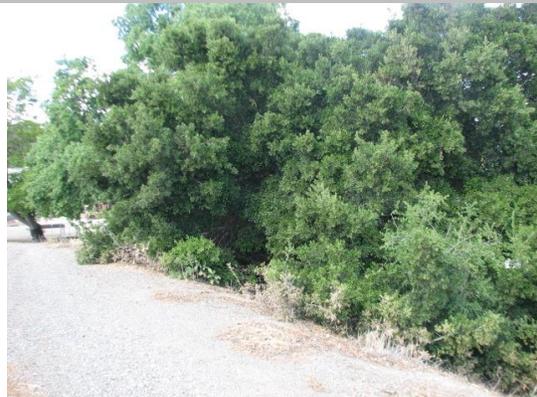
Photo 1 of 1 : FA_2015_RD1500_189_1341_20150914_00077.jpg

LM Start	5.26	Rating **	M	Issue No.	1341
LM End	5.26	Issue Type +	Ma	Location *	LS
Category	Earthen Levee			GPS Latitude/Longitude	
				Start	End
Item	Trim / Thin Trees			38.802827 °	38.802827 °
				-121.714043 °	-121.714043 °
DWR ID	DWR_RD1500_01_s_2014_1341				
Action/Comments					
Trim trees to at least five feet above ground level.

Trees need to be trimmed up to at least 5' they are blocking the visibility. Spring 2014

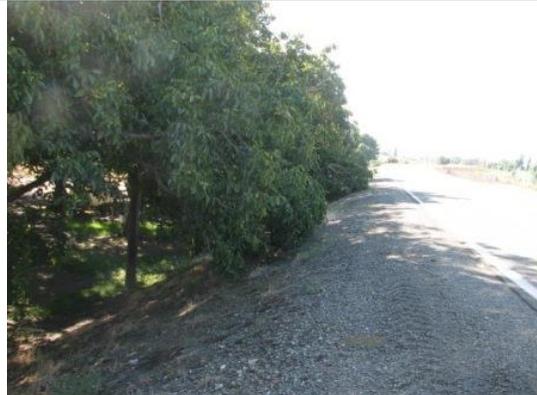
Photo 1 of 1 : FA_2015_RD1500_189_217_20150914_00064.jpg

Trees need to be trimmed to the height of 5 feet to see the slope.

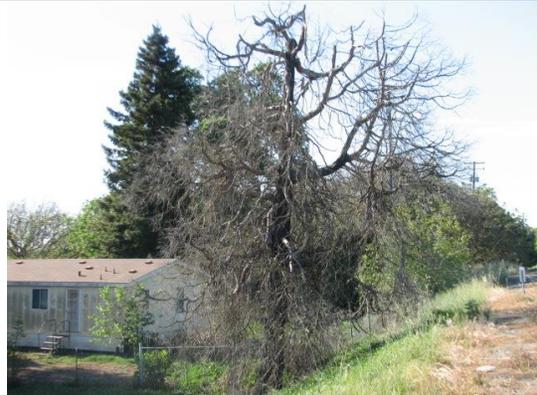
Photo 1 of 1 : FA_2015_RD1500_189_1343_20150914_00079.jpg

LM Start	7.20	Rating **	A/W	Issue No.	1343
LM End	7.20	Issue Type +	Ma	Location *	LS
Category	Earthen Levee		GPS Latitude/Longitude		
			Start	End	
Item	Vegetation		38.824900 °	38.824900 °	
			-121.722851 °	-121.722851 °	
DWR ID	DWR_RD1500_01_s_2014_1343				
Action/Comments					
Trees / Woody Vegetation

Monitor tree that may pose a future threat to the integrity of the levee.
Spring 2014

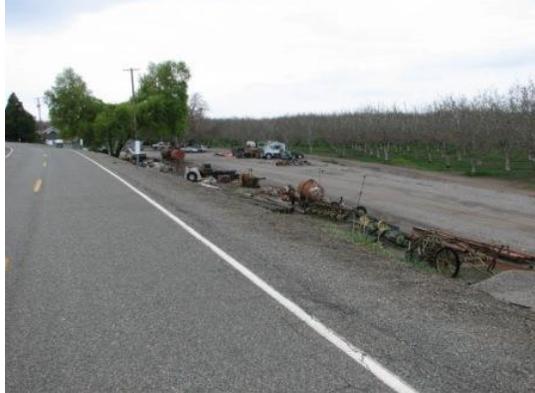
Photo 1 of 1 : FA_2015_RD1500_189_16_20150914_00013.jpg

Equipment along landside toe. Photo was taken in spring 2010.

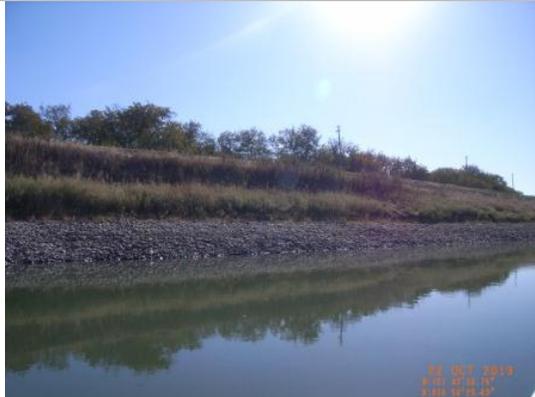
Photo 1 of 1 : USACE2013A_SAC_92-8_L_2.jpg

LM Start	8.33	Rating **	M	Issue No.	3
LM End	8.47	Issue Type +	Ma	Location *	WS
Category	Supplemental		GPS Latitude/Longitude		
			Start	End	
Item	2015 USACE Erosion Survey, DRAFT		38.839546 °	38.840347 °	
			-121.729591 °	-121.726857 °	
DWR ID					
Action/Comments					
Inspector Comments: 1997 - Damage to cobble revetment on top left bank and toe damage. 2004 - Site is pretty minor. 2010 - Cobbles continue to deteriorate. 2011 - Minor new erosion at the toe. 2013 - Might be able to shorten due to deposition. 2015: Site shortened, downstream end has plenty of berm and deposited material, well vegetated. [2015 Site ID: SAC_92-8_L]

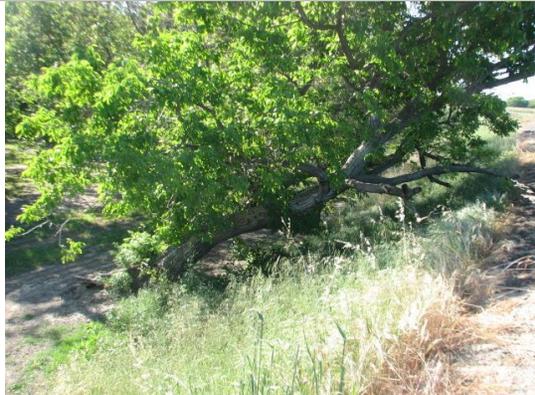
Photo 1 of 3 : FA_2015_RD1500_189_1344_20150914_00080.jpg

LM Start	8.92	Rating **	A/W	Issue No.	1344
LM End	8.92	Issue Type +	Ma	Location *	LS
Category	Earthen Levee		GPS Latitude/Longitude		
			Start	End	
Item	Vegetation		38.845076 °	38.845076 °	
			-121.728301 °	-121.728301 °	
DWR ID	DWR_RD1500_01_s_2014_1344				
Action/Comments					
Trees / Woody Vegetation

The walnut tree at the toe has fallen. The roots are exposed and the branches are holding it up. Spring 2014

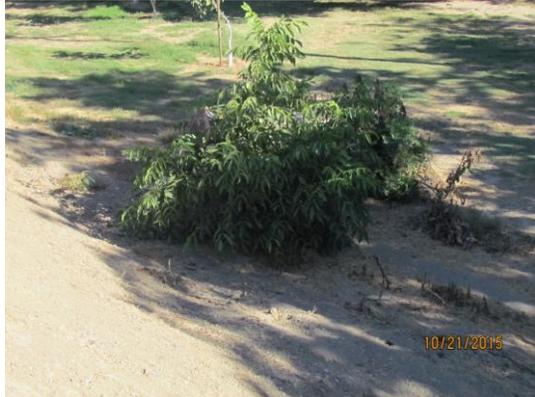
Photo 2 of 3 : FA_2015_RD1500_189_1344_20151026_00145.jpg

The walnut tree has been trimmed but still remains at the landward toe of the levee. Fall 2015.

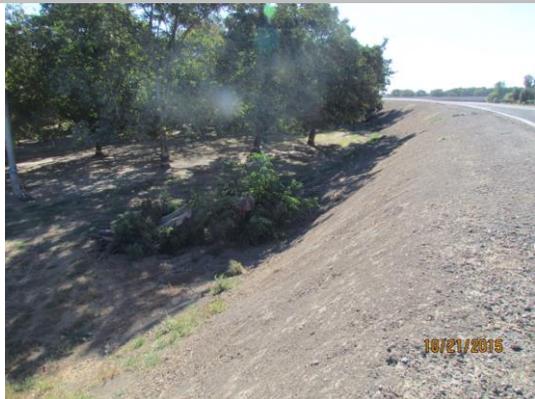
Photo 3 of 3 : FA_2015_RD1500_189_1344_20151026_00146.jpg

Perspective view of the walnut tree on the landward side of the levee looking downstream. Fall 2015.

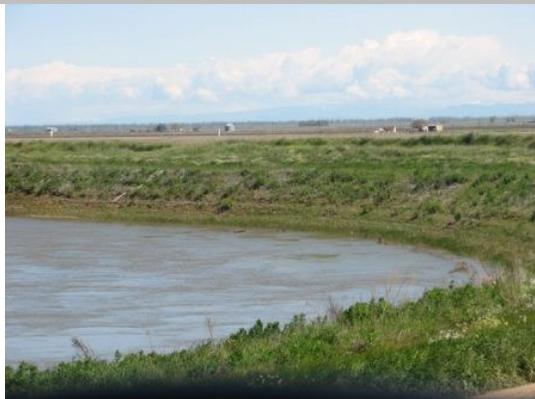
Photo 1 of 2 : FA_2015_RD1500_189_74_20150914_00051.jpg

LM Start	9.40	Rating **	A/W	Issue No.	74
LM End	9.63	Issue Type +	Ma	Location *	WS
Category	Earthen Levee			GPS Latitude/Longitude	
				Start	End
Item	Vegetation			38.850267 °	38.853222 °
				-121.723275 °	-121.724062 °
DWR ID	DWR_RD1500_01_s_2012_74				
Action/Comments					
Environmental Requirements.

A revegetation site on the waterside bank with sprinklers installed.

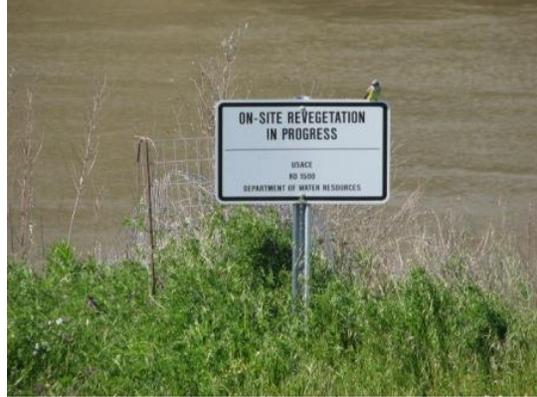
Photo 2 of 2 : FA_2015_RD1500_189_74_20150914_00052.jpg

Another revegetation site photo taken spring 2012.

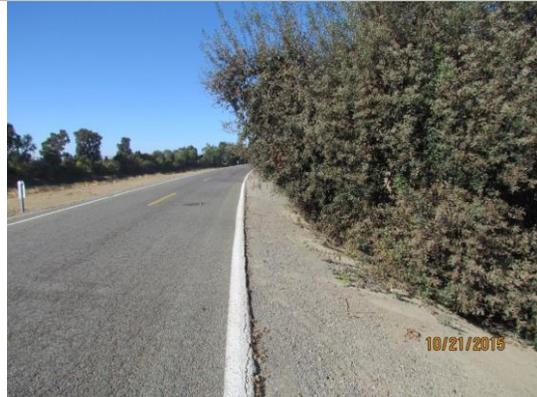
Photo 1 of 1 : FA_2015_RD1500_189_112_20151026_00148.jpg

LM Start	10.54	Rating **	M	Issue No.	112
LM End	10.54	Issue Type +	Ma	Location *	LS
Category	Earthen Levee			GPS Latitude/Longitude	
				Start	End
Item	Trim / Thin Trees			38.861027 °	38.861027 °
				-121.734094 °	-121.734094 °
DWR ID	DWR_RD1500_01_f_2015_112				
Action/Comments					
Trim trees to at least five feet above ground level.

View of the trees on the landward side of the levee looking upstream. Fall 2015.

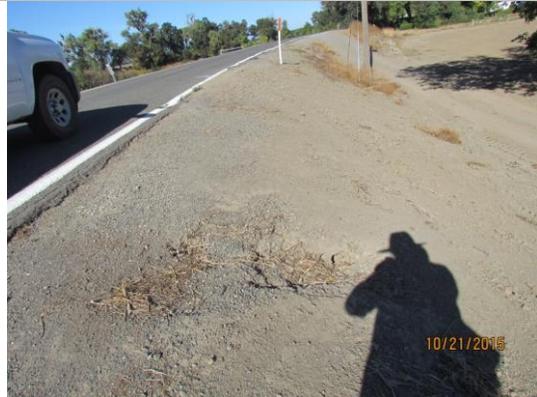
Photo 1 of 1 : FA_2015_RD1500_189_113_20151026_00149.jpg

LM Start	11.23	Rating **	M	Issue No.	113
LM End	11.23	Issue Type +	Ma	Location *	LS
Category	Earthen Levee			GPS Latitude/Longitude	
				Start	End
Item	Erosion / Bank Caving			38.865598 °	38.865598 °
				-121.745196 °	-121.745196 °
DWR ID	DWR_RD1500_01_f_2015_113				
Action/Comments					
Schedule repair of erosion site prior to the next inspection.

View of the erosion on the landward side of the levee looking upstream. Fall 2015.

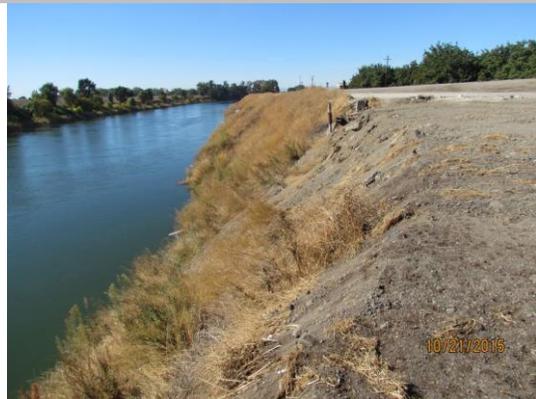
Photo 1 of 2 : FA_2015_RD1500_189_115_20151026_00157.jpg

View of the erosion at the edge of the waterward berm looking upstream. Fall 2015.

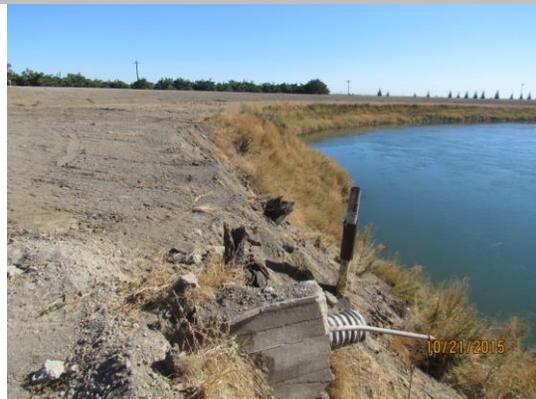
Photo 2 of 2 : FA_2015_RD1500_189_115_20151026_00158.jpg

View of the erosion at the edge of the river looking downstream. Fall 2015.

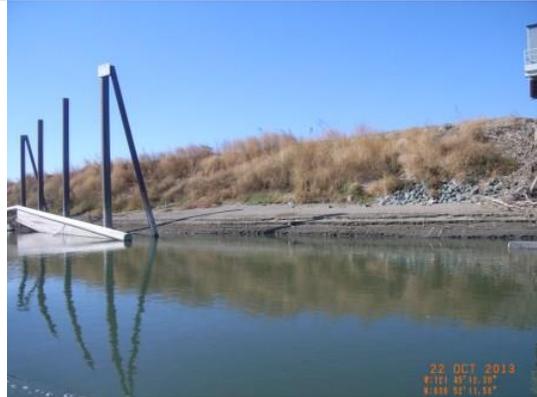
Photo 1 of 1 : USACE2013A_SAC_96-2_L_11.jpg

LM Start	11.99	Rating **	A/W	Issue No.	1
LM End	12.26	Issue Type +	Ma	Location *	WS
Category	Supplemental			GPS Latitude/Longitude	
				Start	End
Item	2015 USACE Erosion Survey, DRAFT			38.870474 °	38.869139 °
				-121.752237 °	-121.757108 °
DWR ID					
Action/Comments					
Inspector Comments: 2000 - Vertical Modesto Formation bank with mass failure. 2003 - Upstream end has some new bank retreat. 2004 - Upstream end is worse. 2006 - Some new erosion, mainly on the steep slope and scarps. (Pumping station is not part of the erosion site.) 2010 - Some new erosion and deposition at upstream end, definite encroachments. 2011 - Minor new erosion at the toe. 2015: Site

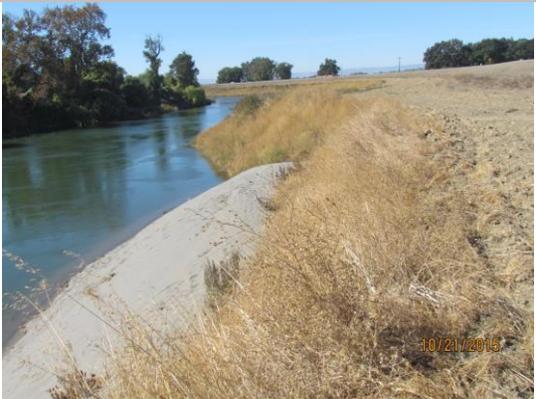
Photo 2 of 2 : FA_2015_RD1500_189_50_20151026_00160.jpg

View of the erosion site along the embankment looking downstream. Fall 2015.

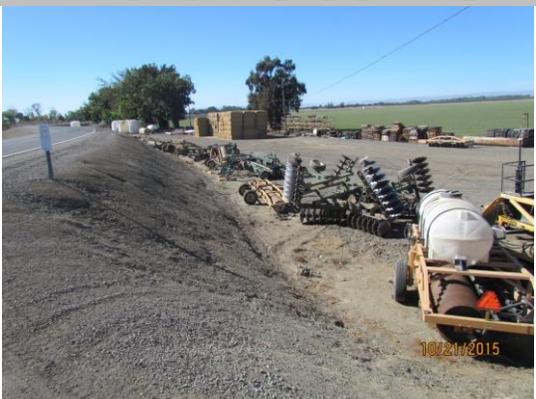
Photo 1 of 1 : FA_2015_RD1500_189_24_20151026_00162.jpg

View of the equipment on the landward side of the levee looking upstream. Fall 2015.

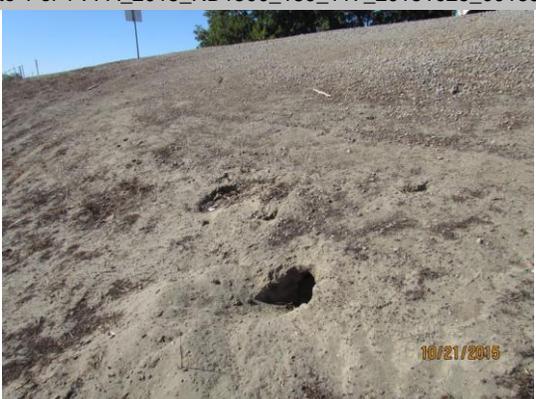
Photo 1 of 1 : FA_2015_RD1500_189_117_20151026_00163.jpg

View of the rodent hole on the waterward side of the levee looking upstream. Fall 2015.

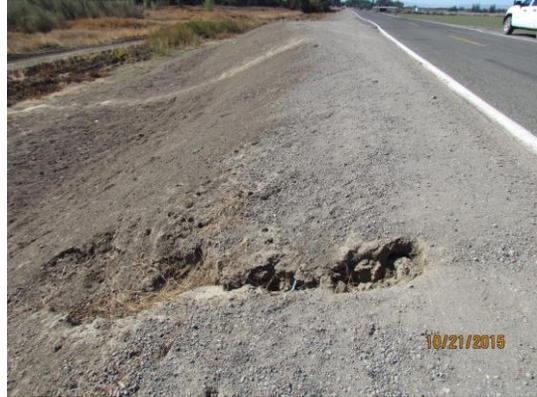
Photo 1 of 1 : FA_2015_RD1500_189_118_20151026_00164.jpg

LM Start	12.57	Rating **	M	Issue No.	118
LM End	12.57	Issue Type +	Ma	Location *	WS
Category	Earthen Levee			GPS Latitude/Longitude	
				Start	End
Item	Erosion / Bank Caving			38.867108 °	38.867108 °
				-121.761498 °	-121.761498 °
DWR ID	DWR_RD1500_01_f_2015_118				
Action/Comments					
Schedule repair of erosion site prior to the next inspection.

View of the erosion on the waterward side of the levee looking upstream. Fall 2015.

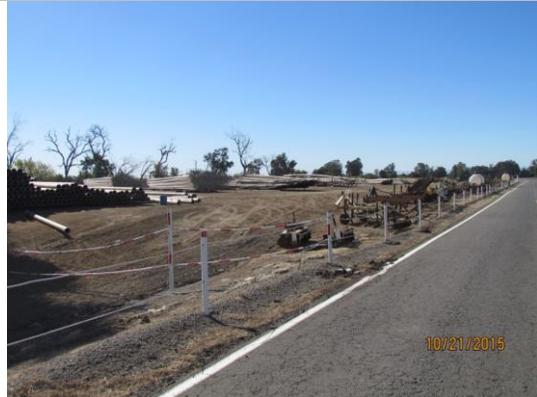
Photo 1 of 1 : FA_2015_RD1500_189_25_20151026_00165.jpg

View of the equipment on the crown of the levee looking upstream. Fall 2015.

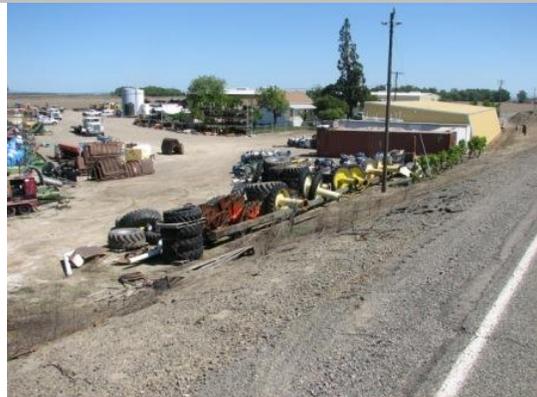
Photo 1 of 1 : FA_2015_RD1500_189_992_20150914_00074.jpg

Next to the building there are tires and axles stored at the toe.

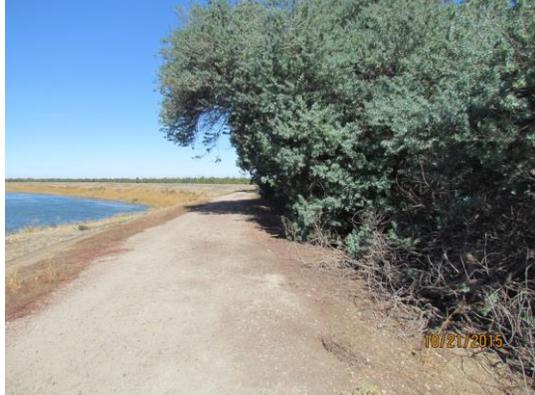
Photo 1 of 1 : FA_2015_RD1500_189_77_20151026_00171.jpg

View of the trees on the landward side of the levee looking upstream. Blocking visibility. Fall 2015.

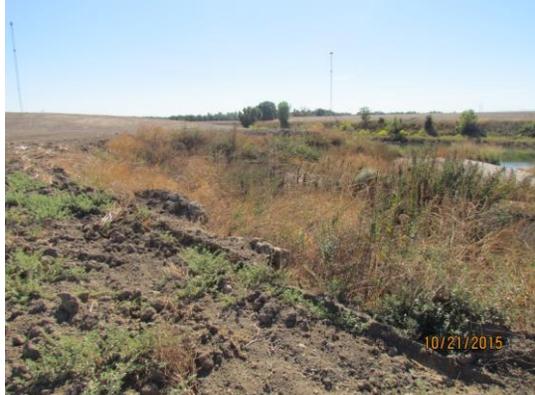
Photo 1 of 2 : FA_2015_RD1500_189_51_20151026_00182.jpg

Looking downstream at the embankment erosion. Fall 2015.

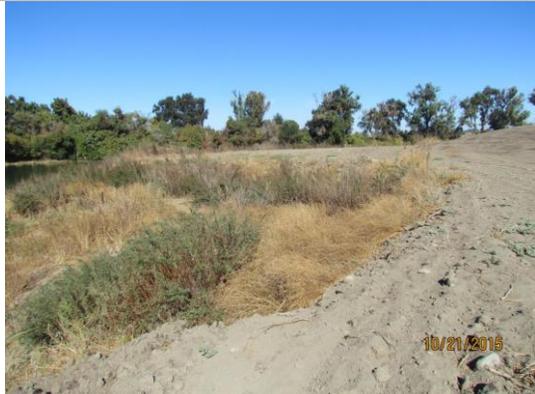
Photo 2 of 2 : FA_2015_RD1500_189_51_20151026_00181.jpg

Looking upstream at the same embankment erosion. Fall 2015.

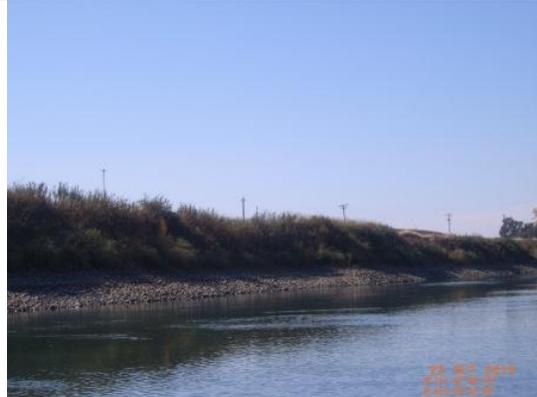
Photo 1 of 1 : USACE2013A_SAC_104-0_L_11.jpg

LM Start	18.38	Rating **	M	Issue No.	13
LM End	19.06	Issue Type +	Ma	Location *	WS
Category	Supplemental			GPS Latitude/Longitude	
				Start	End
Item	2015 USACE Erosion Survey, DRAFT			38.901337 °	38.902721 °
				-121.801175 °	-121.790677 °
DWR ID					
Action/Comments					
Inspector Comments: 1997 - Pocket failures of cobble revetment toe; scallops of rock loss along the bank; irregular bankline developing. 2001 - Small scallops in the toe of the berm. 2005 - Still multiple erosion pockets in the toe. 2006 - Two new small slumps. 2011 - Old cobble continue to fail causing minor slumping. 2012 - Portions of site appears to be stabilizing. 2015: No observed changes. [2015 Site ID:

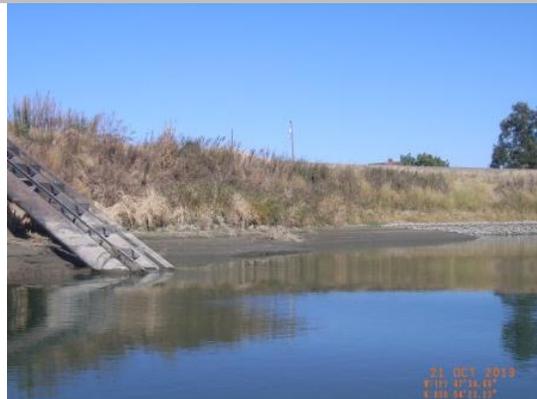
Photo 1 of 1 : USACE2013A_SAC_104-5_L_3.jpg

LM Start	19.16	Rating **	M	Issue No.	5
LM End	19.47	Issue Type +	Ma	Location *	WS
Category	Supplemental			GPS Latitude/Longitude	
				Start	End
Item	2015 USACE Erosion Survey, DRAFT			38.904041 °	38.906697 °
				-121.790298 °	-121.792796 °
DWR ID					
Action/Comments					
Inspector Comments: 1997 - Cobbles eroded off the clay materials; not much evidence of erosion on the toe; cobble loss on the toe. 2011 - Some minor new erosion. 2015: No observed changes. [2015 Site ID: SAC_104-5_L]

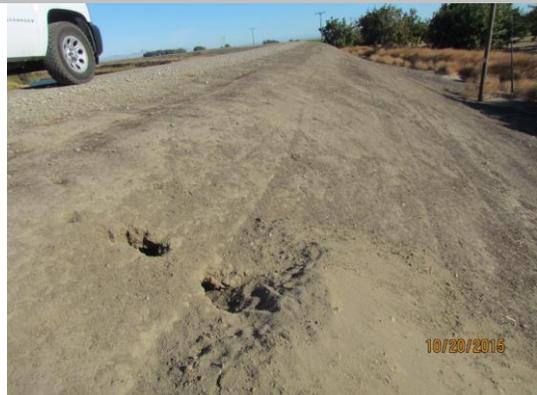
Photo 1 of 1 : FA_2015_RD1500_189_101_20151026_00133.jpg

View of the rodent hole on the landward side of the levee looking upstream. Fall 2015.

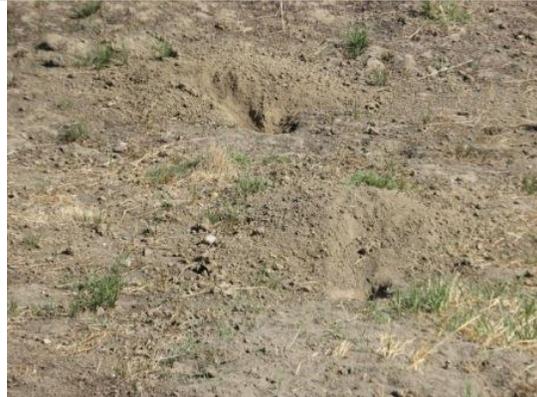
Photo 1 of 2 : FA_2015_RD1500_189_69_20150914_00047.jpg

Multiple rodent burrows on landside slope. Fall 2013

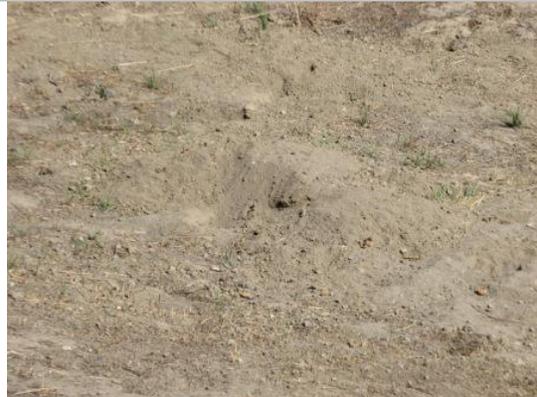
Photo 2 of 2 : FA_2015_RD1500_189_69_20150914_00048.jpg

A rodent burrow on the landside Fall 2013

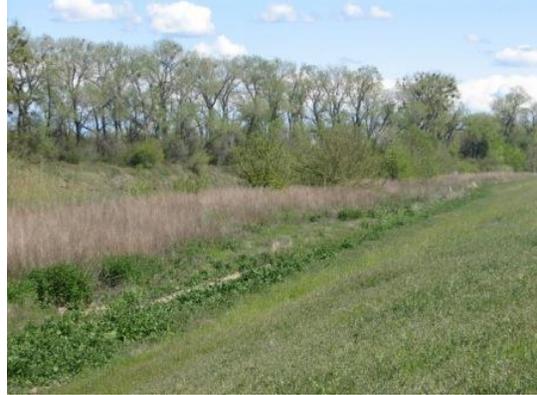
Photo 1 of 2 : FA_2015_RD1500_189_84_20150914_00059.jpg

A photo of the revegetation site.

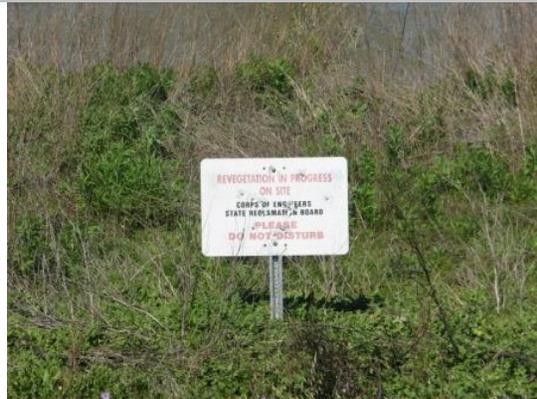
Photo 2 of 2 : FA_2015_RD1500_189_84_20150914_00060.jpg

Another revegetation site on the waterside berm, photo taken spring 2012.

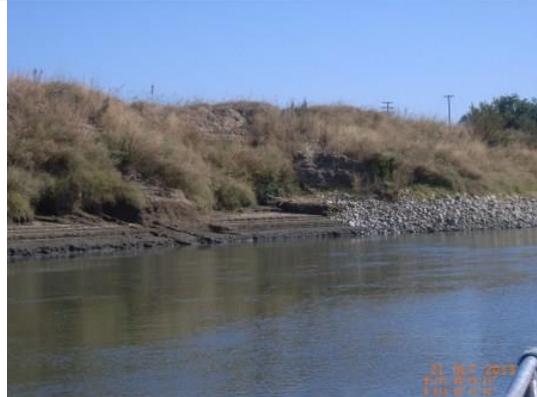
Photo 1 of 1 : USACE2013A_SAC_116-5_L_10.jpg

LM Start	30.94	Rating **	M	Issue No.	15
LM End	31.60	Issue Type +	Ma	Location *	WS
Category	Supplemental			GPS Latitude/Longitude	
				Start	End
Item	2015 USACE Erosion Survey, DRAFT			39.003301 °	39.006072 °
				-121.805024 °	-121.815926 °
DWR ID					
Action/Comments					
Inspector Comments: 2003 - New sedimentation and some new small toe scallops at the upstream end; downstream end has some new erosion. 2004 - Some new erosion at the toe and upper bank and some small new rotational failures (mainly minor, except at the downstream end). 2007 - Some new slumps. 2009 - Some new scallops and site was extended upstream. 2010 - New deposition along upstream end of site, however there is also new erosion throughout the site. Site seems to be worsening, and eroding fast. Large habitat for bank swallows. 2011 - Some new minor erosion. 2012 - Minor new erosion. 2015: No observed changes. [2015 Site ID: SAC_116-5_L]

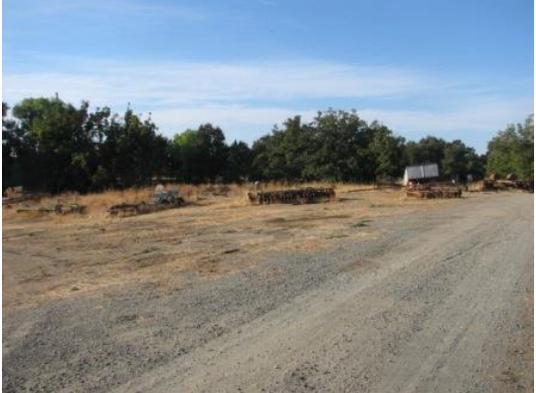
Photo 1 of 2 : FA_2015_RD1500_190_12_20150914_00005.jpg

Farm equipment is parked on the levee slope. Photo fall 2012.

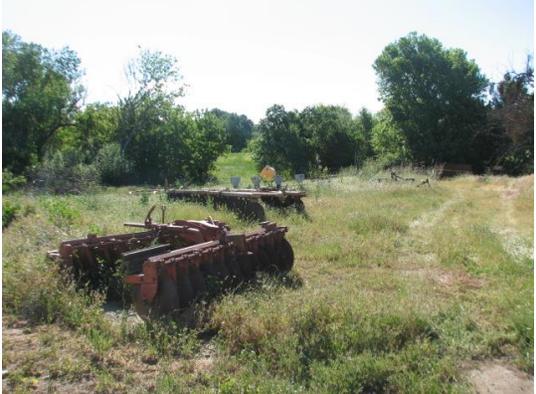
Photo 2 of 2 : FA_2015_RD1500_190_12_20150914_00006.jpg

Farm equipment is on the levee crown. Spring 2014

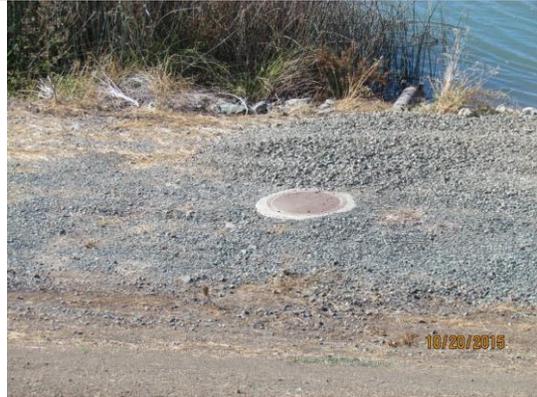
Photo 1 of 1 : FA_2015_RD1500_190_15_20151026_00014.jpg

View of the toe drainage at the landward toe berm. Fall 2015.

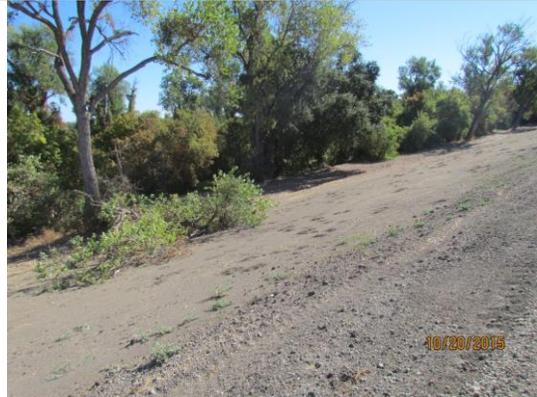
Photo 1 of 1 : FA_2015_RD1500_190_1_20151026_00013.jpg

View of the fallen tree on the waterward side of the levee looking downstream. Fall 2015.
