**Flood Control Project Maintenance  
Levee Inspections**

**Maintenance Issue Types Only, Levee Inspection Report By Mile - Spring 2015**

**Reclamation District No. 1500 Sutter Basin**

Waterway	Bank	Unit Miles	Inspection Start/End	Inspector
Unit No. 01 Sacramento River	Left	33.15	05/13/2015 05/14/2015	Jai Lor

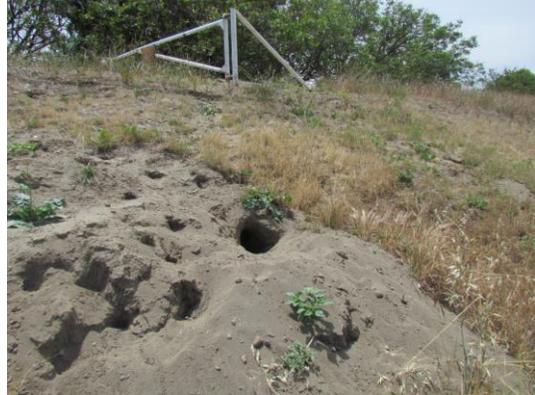
Photo 1 of 1 : SP\_2015\_RD1500\_189\_1681\_20150514\_03098.jpg

LM Start	<b>0.02</b>	Rating **	U	Issue No.	<b>1681</b>
LM End	<b>0.02</b>	Issue Type +	Ma	Location *	N/A
Category	Earthen Levee		GPS Latitude/Longitude		
			Start	End	
Item	Animal Control		38.761057 °	38.761057 °	
			-121.675021 °	-121.675021 °	
DWR ID	DWR_RD1500_01_s_2015_1681				
Action/Comments					
Exterminate rodents and backfill and compact or grout burrows.

View of the animal burrow on the landward side of the levee looking upstream. The hole seems to be freshly dug. Spring 2015.

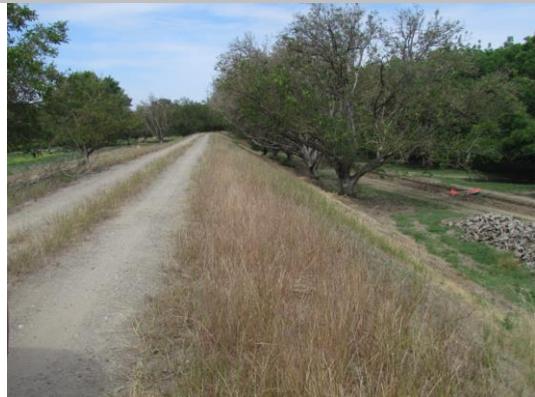
Photo 1 of 1 : SP\_2015\_RD1500\_189\_2533\_20150514\_03090.jpg

LM Start	<b>0.03</b>	Rating **	M	Issue No.	<b>2533</b>
LM End	<b>4.71</b>	Issue Type +	Ma	Location *	LS
Category	Earthen Levee		GPS Latitude/Longitude		
			Start	End	
Item	Vegetation		38.761054 °	38.802750 °	
			-121.675166 °	-121.704561 °	
DWR ID	DWR_RD1500_01_s_2015_2533				
Action/Comments					
Control annual grass and weeds on the levee slopes and easements.

View of the vegetation on the landward side of the levee looking upstream. Spring 2015.

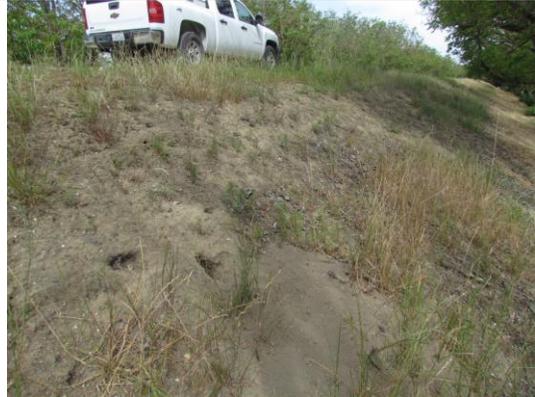
Photo 1 of 1 : SP\_2015\_RD1500\_189\_2535\_20150514\_03091.jpg

LM Start	<b>0.20</b>	Rating **	M	Issue No.	<b>2535</b>
LM End	<b>0.20</b>	Issue Type +	Ma	Location *	LS
Category	Earthen Levee		GPS Latitude/Longitude		
			Start	End	
Item	Animal Control		38.761728 °	38.761728 °	
			-121.677991 °	-121.677991 °	
DWR ID	DWR_RD1500_01_s_2015_2535				
Action/Comments					
No rodents visible, but rodent burrows visible; need to backfill and compact or grout burrows.

View of the animal burrow on the landward side of the levee looking upstream. Spring 2015.

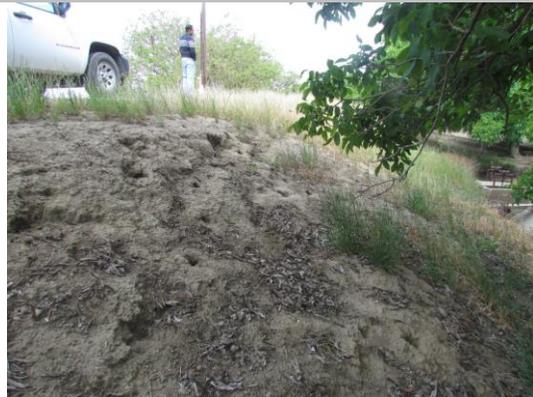
Photo 1 of 1 : SP\_2015\_RD1500\_189\_2538\_20150514\_03092.jpg

View of the animal burrows on the landward side of the levee looking upstream. Spring 2015.

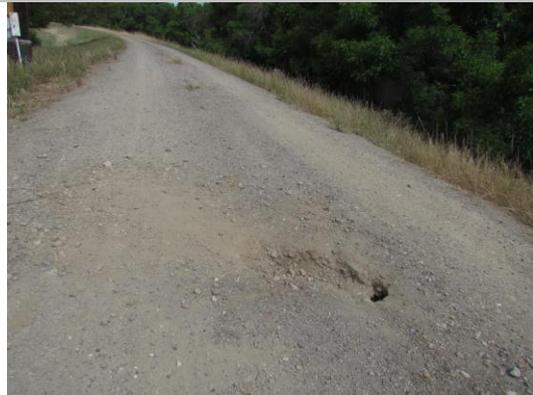
Photo 1 of 1 : SP\_2015\_RD1500\_189\_2540\_20150514\_03093.jpg

LM Start	<b>0.31</b>	Rating **	M	Issue No.	<b>2540</b>
LM End	<b>0.31</b>	Issue Type +	Ma	Location *	CR
Category	Earthen Levee			GPS Latitude/Longitude	
				Start	End
Item	Animal Control			38.763154 °	38.763154 °
				-121.678967 °	-121.678967 °
DWR ID	DWR_RD1500_01_s_2015_2540				
Action/Comments					
Exterminate rodents and backfill and compact or grout burrows.

Perspective view of the animal burrow on the crown of the levee looking upstream. Spring 2015.

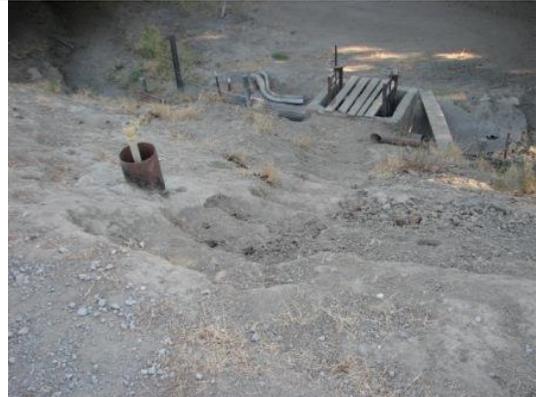
Photo 1 of 1 : SP\_2015\_RD1500\_189\_53\_20150401\_00044.jpg

Steps carved into the levee slope at a pipe crossing. Photo fall 2012.

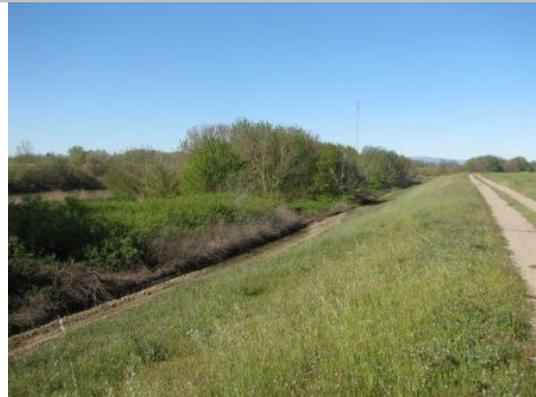
Photo 1 of 2 : SP\_2015\_RD1500\_189\_72\_20150401\_00050.jpg

A view of the revegetation site.

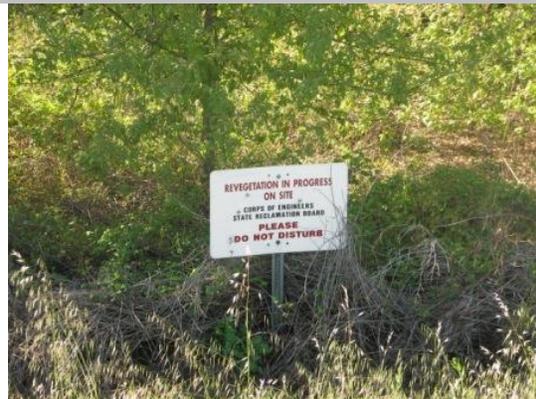
Photo 2 of 2 : SP\_2015\_RD1500\_189\_72\_20150401\_00051.jpg

A revegetation site waterside toe, photo taken spring 2012.

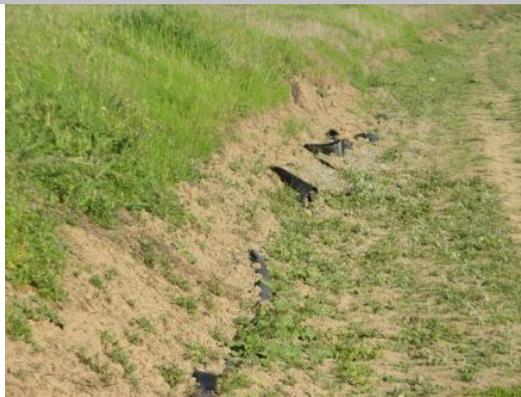
Photo 1 of 2 : SP\_2015\_RD1500\_189\_76\_20150401\_00054.jpg

LM Start	<b>0.63</b>	Rating **	A/W	Issue No.	<b>76</b>
LM End	<b>1.05</b>	Issue Type +	Ma	Location *	LS
Category	Earthen Levee			GPS Latitude/Longitude	
				Start	End
Item	Slope Stability			38.764305 °	38.766827 °
				-121.684396 °	-121.690884 °
DWR ID	DWR_RD1500_01_s_2013_76				
Action/Comments					
Repair slope instability. Inspector Comments: Seepage berm was damaged last fall in prep for the agricultural field and needs to be restored by the land owner. A field investigation report was made. The seepage berm is scheduled to be repaired before next flood season.

Damage to the seepage berm during the flood season needs to be repaired, Spring 2013

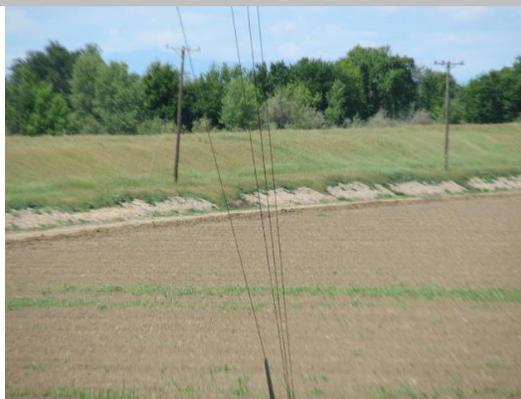
Photo 2 of 2 : SP\_2015\_RD1500\_189\_76\_20150401\_00055.jpg

The damage to the seepage berm has been repaired and needs to be monitored. Spring 2014

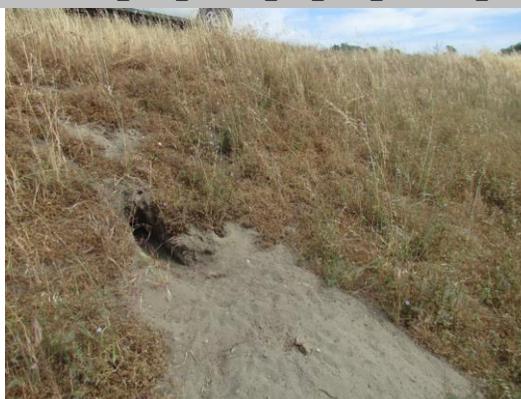
Photo 1 of 1 : SP\_2015\_RD1500\_189\_2543\_20150514\_03094.jpg

LM Start	<b>1.24</b>	Rating **	M	Issue No.	<b>2543</b>
LM End	<b>1.24</b>	Issue Type +	Ma	Location *	LS
Category	Earthen Levee			GPS Latitude/Longitude	
				Start	End
Item	Animal Control			38.769175 °	38.769175 °
				-121.691849 °	-121.691849 °
DWR ID	DWR_RD1500_01_s_2015_2543				
Action/Comments					
No rodents visible, but rodent burrows visible; need to backfill and compact or grout burrows.

View of the animal burrow on the landward side of the levee looking upstream. Spring 2015.

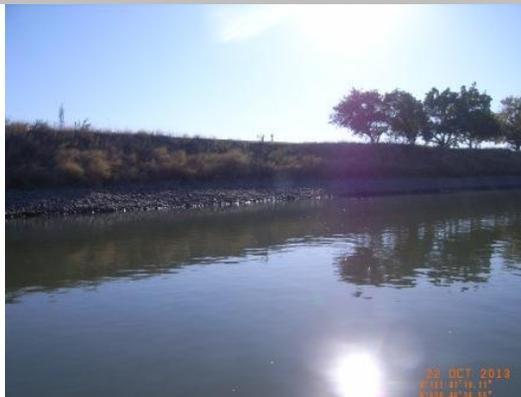
Photo 1 of 1 : SP\_2015\_RD1500\_189\_1\_20150401\_00001.jpg

LM Start	<b>1.34</b>	Rating **	M	Issue No.	<b>1</b>
LM End	<b>1.95</b>	Issue Type +	Ma	Location *	WS
Category	Supplemental		GPS Latitude/Longitude		
			Start	End	
Item	USACE Erosion Survey		38.770390 °	38.777282 °	
			-121.690553 °	-121.685841 °	
DWR ID	DWR_RD1500_01_f_2014_1				
Action/Comments					
Inspector Comments: 2006 - New erosion upstream, new bank failures near levee but still fairly wide berm in most places. 2008 - Large berm, questionable as to if it should remain in the inventory. 2010 - Minor new erosion, old cobble starting to fail. 2011 - Cobble continues to unravel and additional slumping. 2014 - Minor new erosion at bank mid point. 2013: Minor new erosion. [2013 Site ID: SAC_86-3_L]

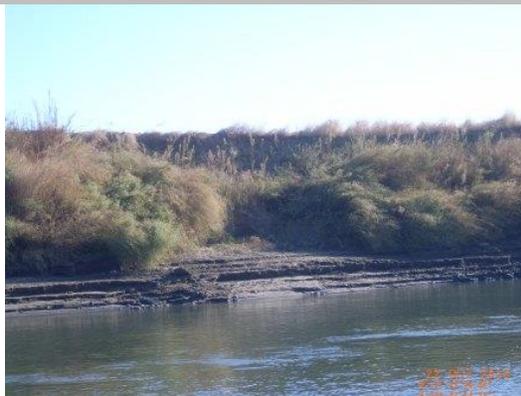
Photo 1 of 1 : SP\_2015\_RD1500\_189\_2\_20150401\_00002.jpg

LM Start	<b>2.30</b>	Rating **	M	Issue No.	<b>2</b>
LM End	<b>2.34</b>	Issue Type +	Ma	Location *	WS
Category	Supplemental		GPS Latitude/Longitude		
			Start	End	
Item	USACE Erosion Survey		38.781962 °	38.784936 °	
			-121.688033 °	-121.690033 °	
DWR ID	DWR_RD1500_01_f_2014_2				
Action/Comments					
Inspector Comments: 2010 - The upstream end of the repair site at 87.0. Repair did not extend far enough upstream. 2011 - New erosion pockets. 2012 - Minor new erosion at toe. 2013: Minor new erosion. [2013 Site ID: SAC_87-1_L]

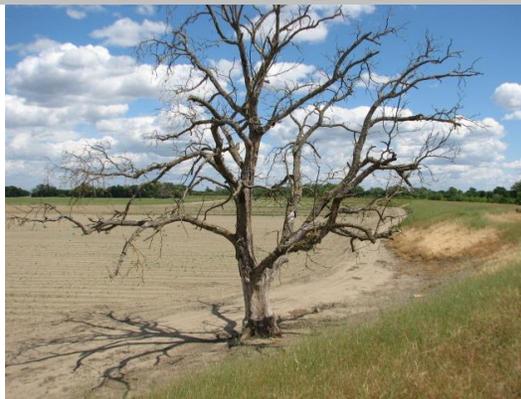
Photo 1 of 1 : SP\_2015\_RD1500\_189\_1340\_20150401\_00083.jpg

Monitor tree that may pose a future threat to the integrity of the levee. Spring 2014

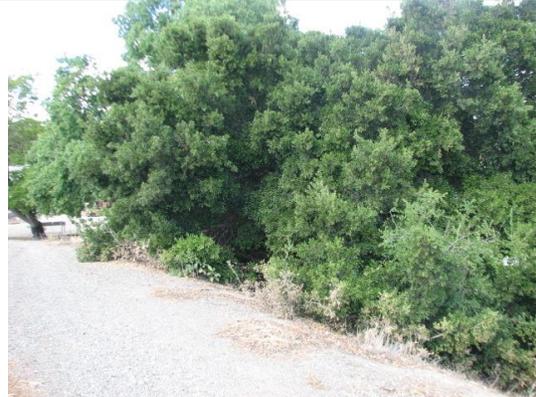
Photo 1 of 1 : SP\_2015\_RD1500\_189\_1341\_20150401\_00084.jpg

Trees need to be trimmed up to at least 5' they are blocking the visibility. Spring 2014

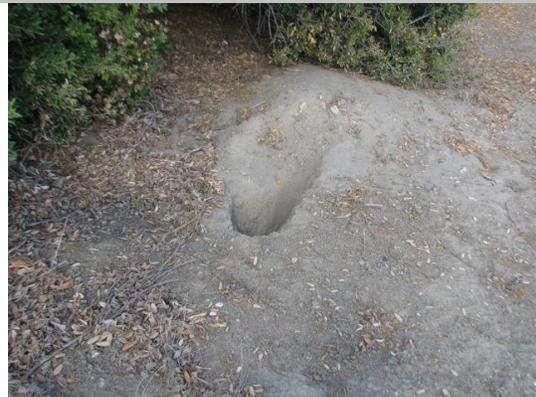
Photo 1 of 1 : SP\_2015\_RD1500\_189\_1342\_20150401\_00085.jpg

LM Start	<b>5.26</b>	Rating **	M	Issue No.	<b>1342</b>
LM End	<b>5.26</b>	Issue Type +	Ma	Location *	LS
Category	Earthen Levee			GPS Latitude/Longitude	
				Start	End
Item	Animal Control			38.802826 °	38.802826 °
				-121.714044 °	-121.714044 °
DWR ID	DWR_RD1500_01_s_2014_1342				
Action/Comments					
Exterminate rodents and backfill and compact or grout burrows.

A rodent hole on the landside levee slope. Spring 2014

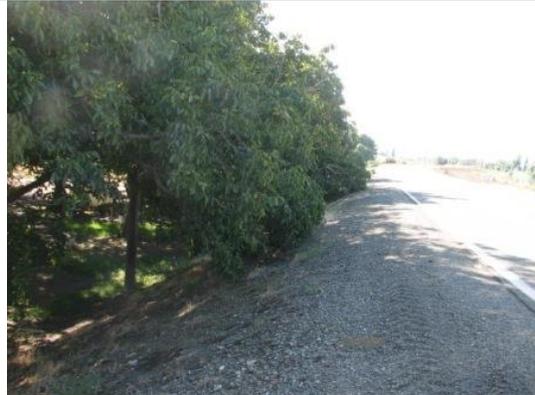
Photo 1 of 1 : SP\_2015\_RD1500\_189\_217\_20150401\_00067.jpg

Trees need to be trimmed to the height of 5 feet to see the slope.

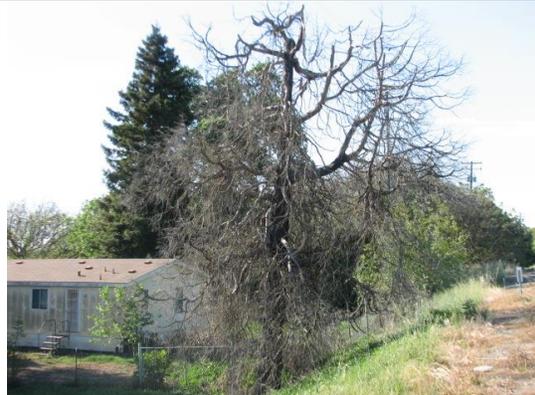
Photo 1 of 1 : SP\_2015\_RD1500\_189\_1343\_20150401\_00086.jpg

LM Start	<b>7.20</b>	Rating **	A/W	Issue No.	<b>1343</b>
LM End	<b>7.20</b>	Issue Type +	Ma	Location *	LS
Category	Earthen Levee		GPS Latitude/Longitude		
			Start	End	
Item	Vegetation		38.824900 °	38.824900 °	
			-121.722851 °	-121.722851 °	
DWR ID	DWR_RD1500_01_s_2014_1343				
Action/Comments					
Trees / Woody Vegetation

Monitor tree that may poise a future threat to the integrity of the levee.  
Spring 2014

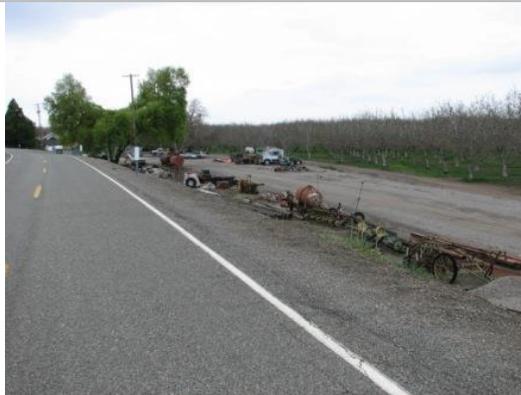
Photo 1 of 1 : SP\_2015\_RD1500\_189\_16\_20150401\_00013.jpg

Equipment along landside toe. Photo was taken in spring 2010.

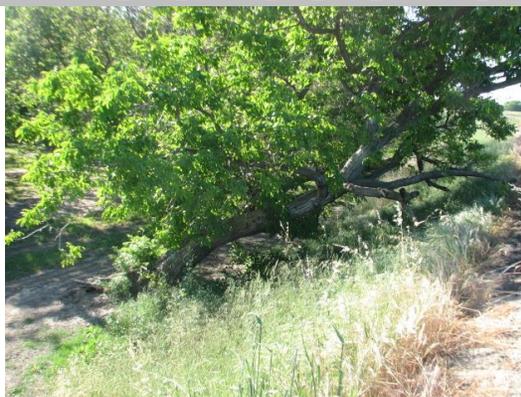
Photo 1 of 1 : SP\_2015\_RD1500\_189\_1344\_20150401\_00087.jpg

The walnut tree at the toe has fallen. The roots are exposed and the branches are holding it up. Spring 2014

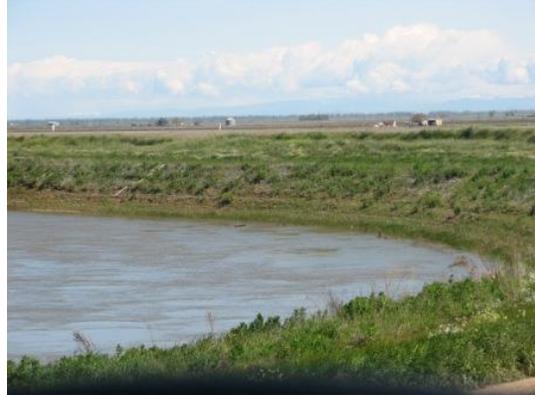
Photo 1 of 2 : SP\_2015\_RD1500\_189\_74\_20150401\_00052.jpg

A revegetation site on the waterside bank with sprinklers installed.

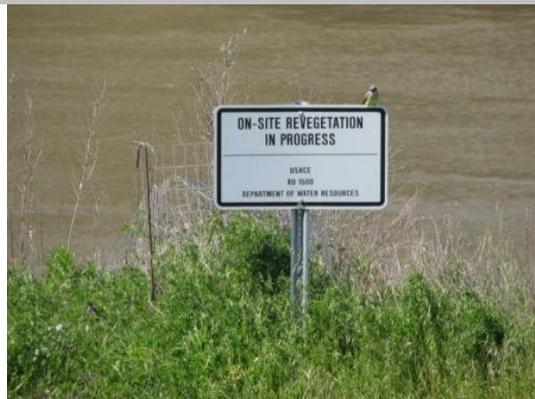
Photo 2 of 2 : SP\_2015\_RD1500\_189\_74\_20150401\_00053.jpg

Another revegetation site photo taken spring 2012.

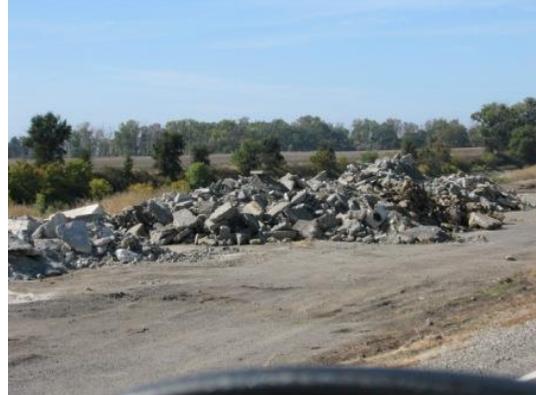
Photo 1 of 2 : SP\_2015\_RD1500\_189\_219\_20150401\_00068.jpg

Concrete debris stockpiled on the waterside. Fall 2013

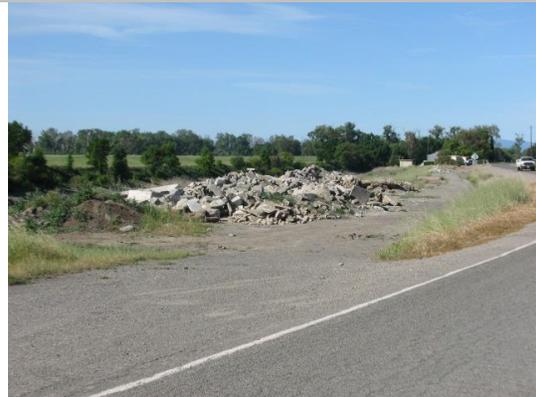
Photo 2 of 2 : SP\_2015\_RD1500\_189\_219\_20150401\_00069.jpg

Concrete debris is along the berm area. Spring 2014

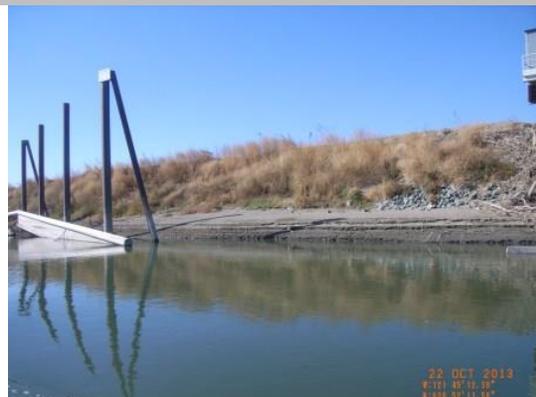
Photo 1 of 1 : SP\_2015\_RD1500\_189\_10\_20150401\_00008.jpg

LM Start	<b>12.14</b>	Rating **	M	Issue No.	<b>10</b>
LM End	<b>12.14</b>	Issue Type +	Ma	Location *	WS
Category	Supplemental		GPS Latitude/Longitude		
			Start	End	
Item	USACE Erosion Survey		38.870474 °	38.869139 °	
			-121.752237 °	-121.757108 °	
DWR ID	DWR_RD1500_01_f_2014_10				
Action/Comments					
Inspector Comments: 2000 - Vertical Modesto Formation bank with mass failure. 2003 - Upstream end has some new bank retreat. 2004 - Upstream end is worse. 2006 - Some new erosion, mainly on the steep slope and scarps. (Pumping station is not part of the erosion site.) 2010 - Some new erosion and deposition at upstream end, definite encroachments. 2011 - Minor new erosion at the toe. 2013: No

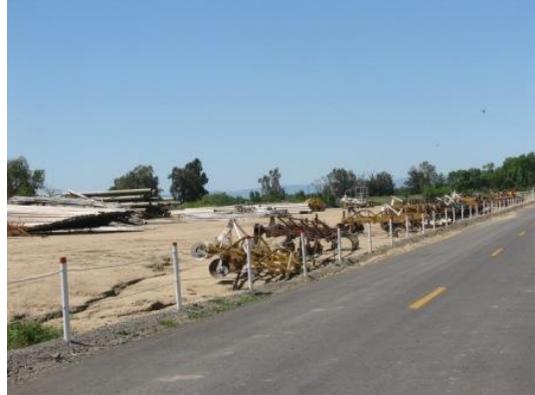
Photo 1 of 1 : SP\_2015\_RD1500\_189\_25\_20150401\_00023.jpg

On top of the crown is farm equipment and irrigation pipe.

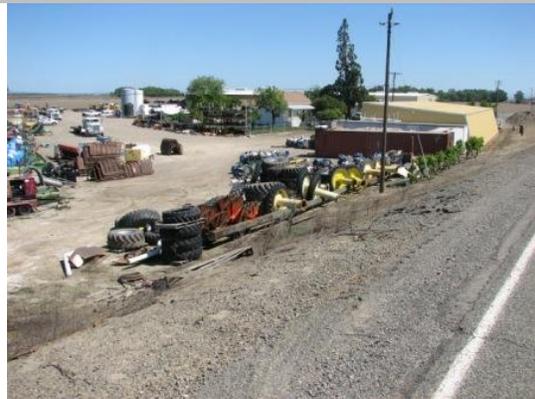
Photo 1 of 1 : SP\_2015\_RD1500\_189\_992\_20150401\_00079.jpg

Next to the building there are tires and axles stored at the toe.

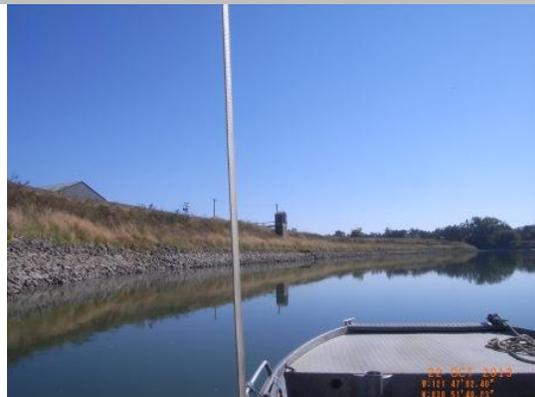
Photo 1 of 1 : SP\_2015\_RD1500\_189\_15\_20150401\_00012.jpg

LM Start	<b>13.98</b>	Rating **	M	Issue No.	<b>15</b>
LM End	<b>14.28</b>	Issue Type +	Ma	Location *	WS
Category	Supplemental		GPS Latitude/Longitude		
			Start	End	
Item	USACE Erosion Survey		38.857239 °	38.861899 °	
			-121.783771 °	-121.784057 °	
DWR ID	DWR_RD1500_01_f_2014_15				
Action/Comments					
Inspector Comments: 1997 - Intermittent toe failure of the hand placed riprap; failure of toe materials. 2013: No observed changes. [2013 Site ID: SAC_99-0_L]

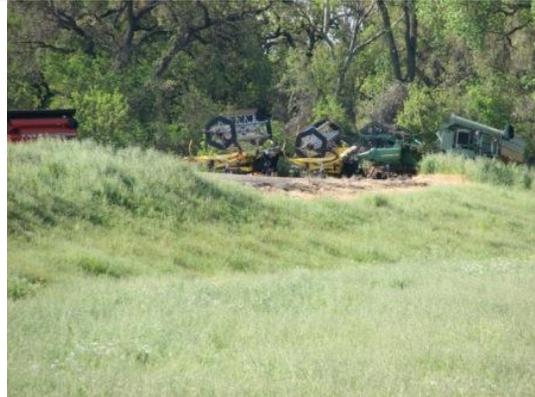
Photo 1 of 1 : SP\_2015\_RD1500\_189\_28\_20150401\_00025.jpg

View of equipment. Photo was taken in spring 2010.

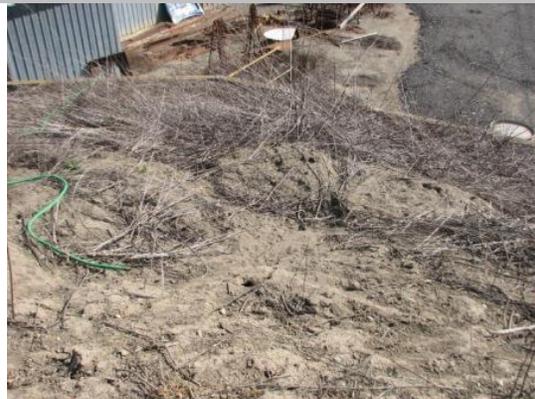
Photo 1 of 1 : SP\_2015\_RD1500\_189\_89\_20150401\_00063.jpg

Rodent hole in the levee slope above the retaining wall, Spring 2013

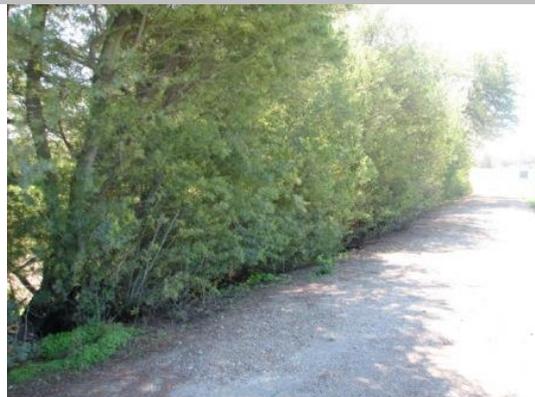
Photo 1 of 2 : SP\_2015\_RD1500\_189\_77\_20150401\_00056.jpg

The trees on the landside slope blocks the view of the slope, photo taken spring 2012.

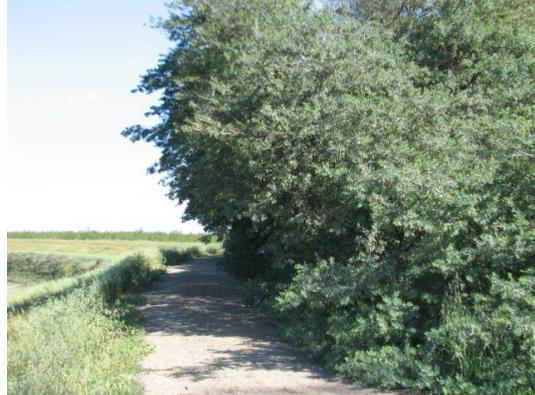
Photo 2 of 2 : SP\_2015\_RD1500\_189\_77\_20150401\_00057.jpg

The trees on the levee slope completely blocks visibility. Spring 2014

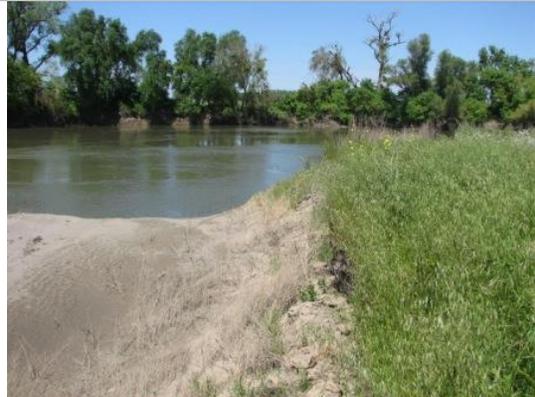
Photo 1 of 2 : SP\_2015\_RD1500\_189\_51\_20150401\_00040.jpg

This is an upstream view of the same erosion.

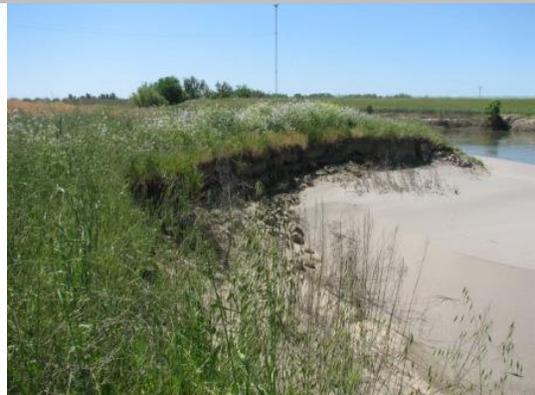
Photo 2 of 2 : SP\_2015\_RD1500\_189\_51\_20150401\_00041.jpg

This is an inside curve in the river and erosion has occurred.

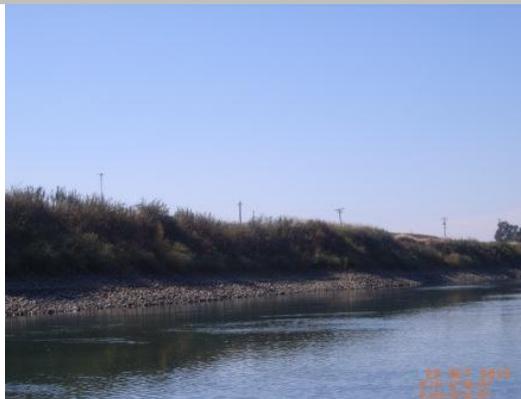
Photo 1 of 1 : SP\_2015\_RD1500\_189\_22\_20150401\_00019.jpg

LM Start	<b>18.38</b>	Rating **	M	Issue No.	<b>22</b>
LM End	<b>19.06</b>	Issue Type +	Ma	Location *	WS
Category	Supplemental		GPS Latitude/Longitude		
			Start	End	
Item	USACE Erosion Survey		38.901337 °	38.902721 °	
			-121.801175 °	-121.790677 °	
DWR ID	DWR_RD1500_01_f_2014_22				
Action/Comments					
Inspector Comments: 1997 - Pocket failures of cobble revetment toe; scallops of rock loss along the bank; irregular bankline developing. 2001 - Small scallops in the toe of the berm. 2005 - Still multiple erosion pockets in the toe. 2006 - Two new small slumps. 2011 - Old cobble continue to fail causing minor slumping. 2012 - Portions of site appears to be stabilizing. 2013: No observed changes. [2013 Site ID:

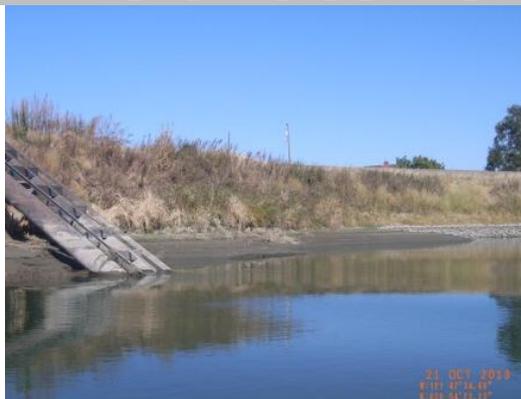
Photo 1 of 1 : SP\_2015\_RD1500\_189\_23\_20150401\_00020.jpg

LM Start	<b>19.16</b>	Rating **	M	Issue No.	<b>23</b>
LM End	<b>19.47</b>	Issue Type +	Ma	Location *	WS
Category	Supplemental		GPS Latitude/Longitude		
			Start	End	
Item	USACE Erosion Survey		38.904041 °	38.906697 °	
			-121.790298 °	-121.792796 °	
DWR ID	DWR_RD1500_01_s_2015_23				
Action/Comments					
Inspector Comments: 1997 - Cobbles eroded off the clay materials; not much evidence of erosion on the toe; cobble loss on the toe. 2011 - Some minor new erosion. 2013: No observed changes. [2013 Site ID: SAC_104-5_L]

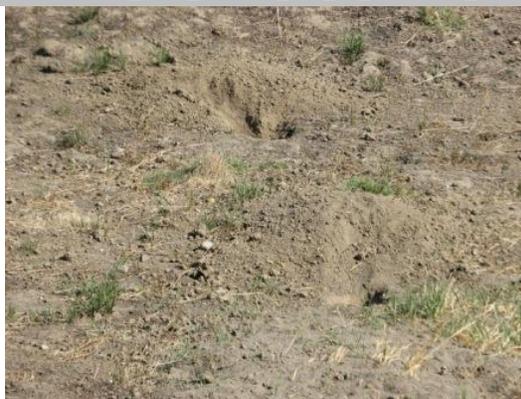
Photo 1 of 2 : SP\_2015\_RD1500\_189\_69\_20150401\_00048.jpg

Multiple rodent burrows on landside slope. Fall 2013

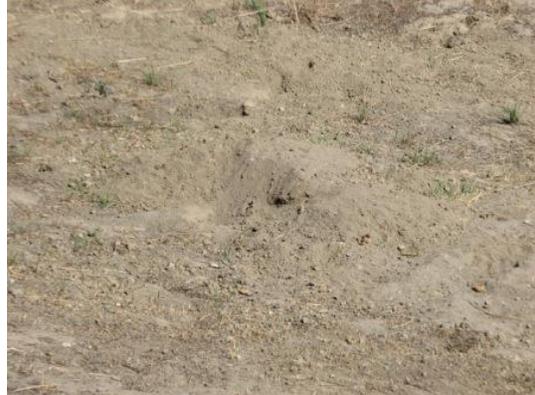
Photo 2 of 2 : SP\_2015\_RD1500\_189\_69\_20150401\_00049.jpg

A rodent burrow on the landside Fall 2013

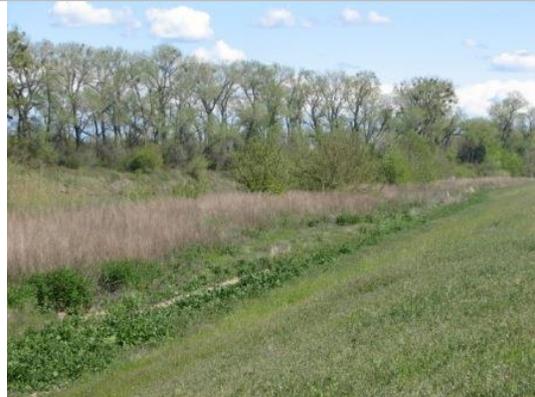
Photo 1 of 2 : SP\_2015\_RD1500\_189\_84\_20150401\_00060.jpg

A photo of the revegetation site.

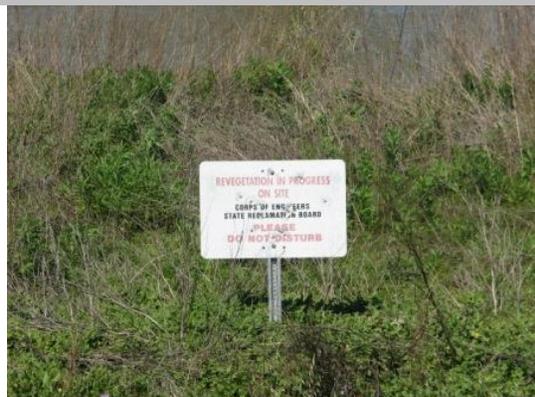
Photo 2 of 2 : SP\_2015\_RD1500\_189\_84\_20150401\_00061.jpg

Another revegetation site on the waterside berm, photo taken spring 2012.

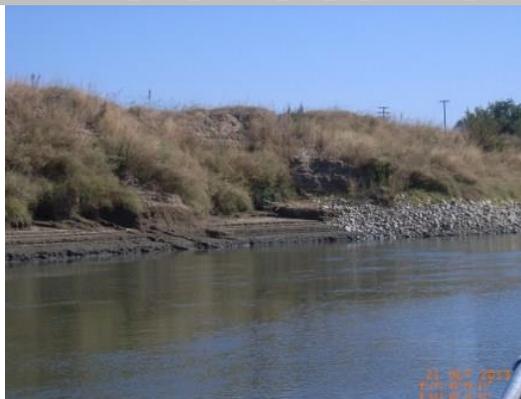
Photo 1 of 1 : SP\_2015\_RD1500\_189\_34\_20150401\_00031.jpg

Item	USACE Erosion Survey			39.003301 °	39.006072 °
				-121.805024 °	-121.815926 °
DWR ID	DWR_RD1500_01_s_2015_34				
Action/Comments					
Inspector Comments: 2003 - New sedimentation and some new small toe scallops at the upstream end; downstream end has some new erosion. 2004 - Some new erosion at the toe and upper bank and some small new rotational failures (mainly minor, except at the downstream end). 2007 - Some new slumps. 2009 - Some new scallops and site was extended upstream. 2010 - New deposition along upstream end of site, however there is also new erosion throughout the site. Site seems to be worsening, and eroding fast. Large habitat for bank swallows. 2011 - Some new minor erosion. 2012 - Minor new erosion. 2013: No observed changes. [2013 Site ID: SAC_116-5_L]

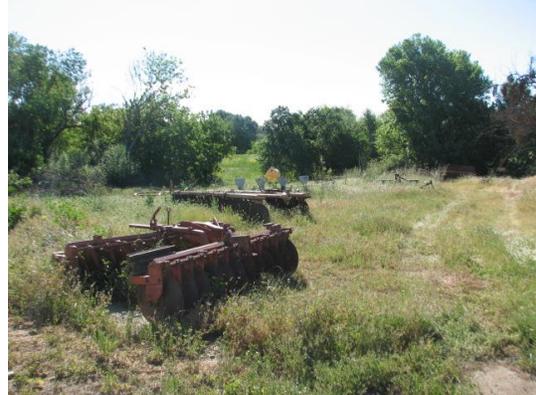
Photo 2 of 2 : SP\_2015\_RD1500\_190\_12\_20150401\_00006.jpg

Farm equipment is on the levee crown. Spring 2014

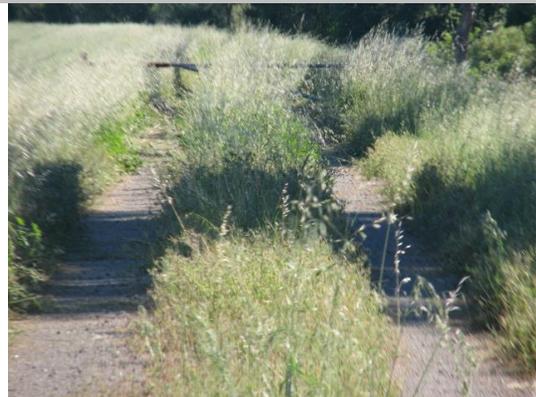
Photo 1 of 1 : SP\_2015\_RD1500\_190\_302\_20150401\_00011.jpg

Control unwanted vegetation on the levee crown Spring 2014

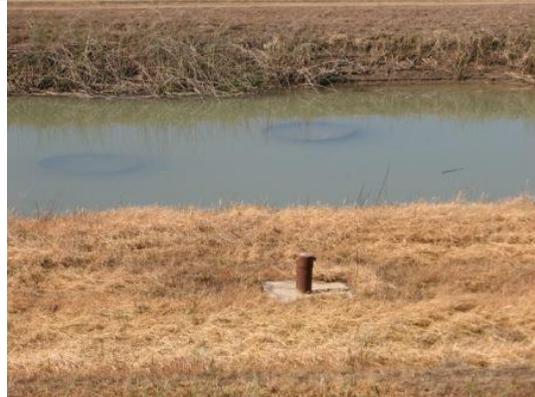
Photo 1 of 1 : SP\_2015\_RD1500\_190\_4\_20150401\_00001.jpg

The relief well at boil 12, photo taken spring 2012.

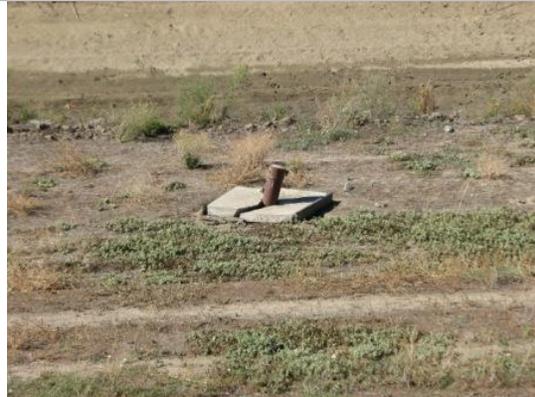
Photo 1 of 2 : SP\_2015\_RD1500\_190\_10\_20150401\_00002.jpg

The pieces of the puzzle have been placed back. Unsure if repaired. Fall 2013

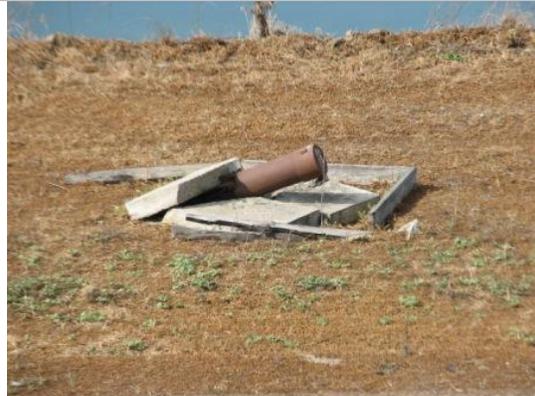
Photo 2 of 2 : SP\_2015\_RD1500\_190\_10\_20150401\_00003.jpg

The seepage well and pad needs to be repaired, Spring 2013

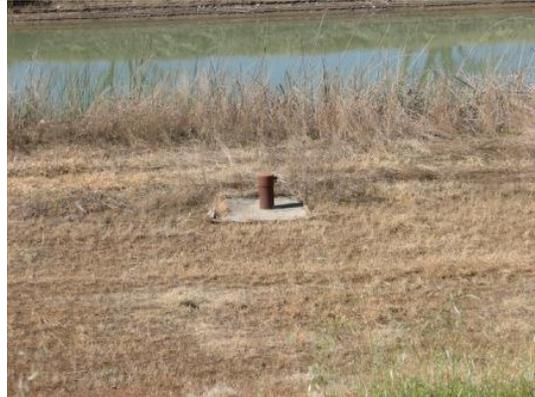
Photo 1 of 1 : SP\_2015\_RD1500\_190\_11\_20150401\_00004.jpg

A relief well at boil 16, photo taken spring 2012.

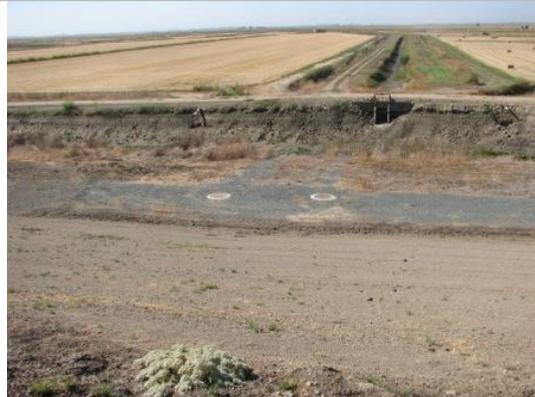
Photo 1 of 2 : SP\_2015\_RD1500\_190\_13\_20150401\_00007.jpg

Two of five drains on the landside berm. Photo fall 2012.

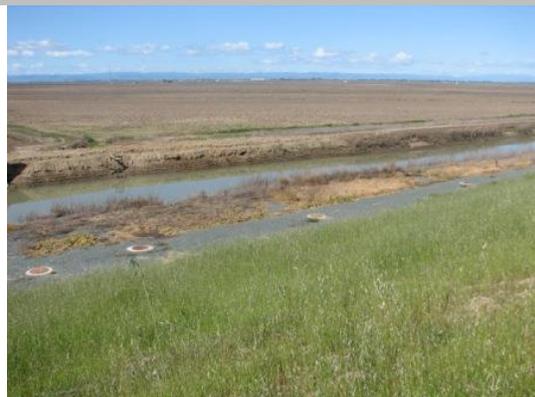
Photo 2 of 2 : SP\_2015\_RD1500\_190\_13\_20150401\_00008.jpg

Toe drainage systems along the toe berm four total, photo taken spring 2012.

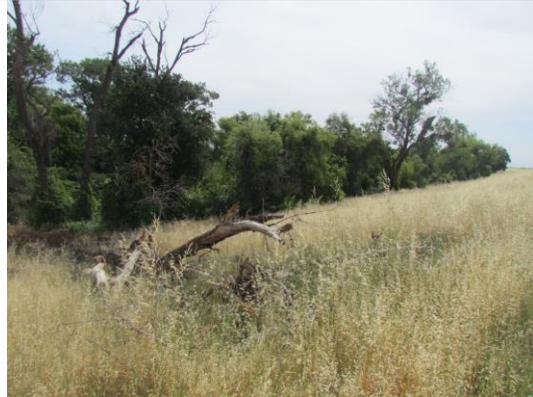
Photo 1 of 1 : SP\_2015\_RD1500\_190\_584\_20150514\_00814.jpg

View of the fallen tree on the waterward side of the levee looking downstream. Spring 2015.

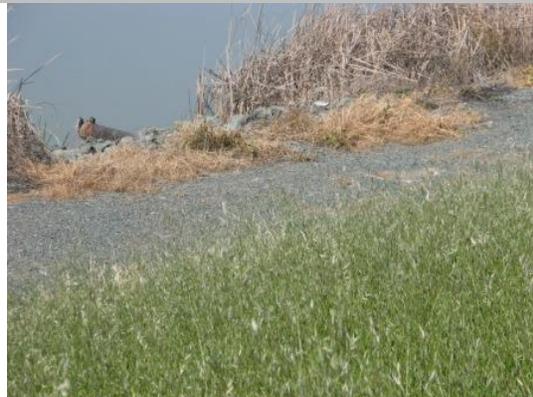
Photo 1 of 2 : SP\_2015\_RD1500\_190\_15\_20150401\_00009.jpg

Another toe drainage system close by, photo taken spring 2012.

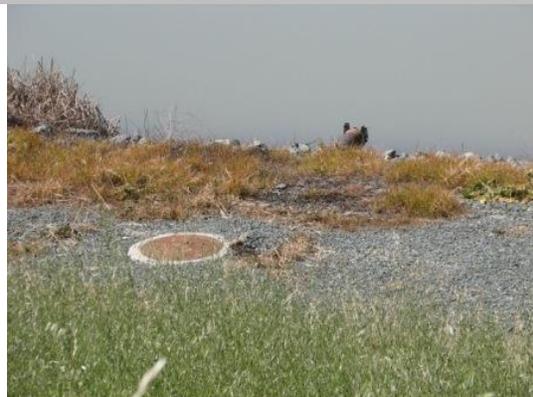
Photo 2 of 2 : SP\_2015\_RD1500\_190\_15\_20150401\_00010.jpg

A toe drainage system at the toe berm, photo taken spring 2012.
