**Flood Control Project Maintenance
Levee Inspections**
LMA District Cover Sheet
Spring 2009 Levee Inspection Results

Reclamation District No. 1500

**Flood Control Project Maintenance
Levee Inspections
Unit Cover Sheet
Spring 2009 Levee Inspection Results
Reclamation District No. 1500**

Waterway		Bank	Unit Miles
Unit No. 01 Sacramento River		Left	33.60

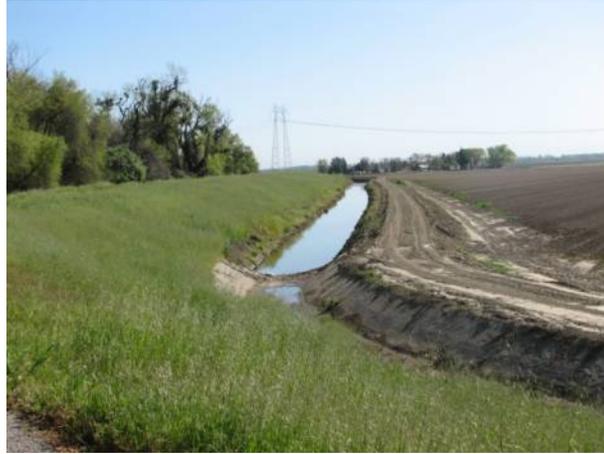
7	2.57	3.83	Earthen Levee	Encroachments	LS	PO	Agricultural Ditch	38.785351 ° -121.689075 °	38.797174 ° -121.693045 °	Y	963
8	2.60	3.63	Earthen Levee	Crown Surface / Depressions / Rutting	CR	M	Keep the crown roadway free of vegetation.	38.785684 ° -121.688634 °	38.796300 ° -121.689733 °		964
9	2.63	3.85	Earthen Levee	Vegetation	LS	M	Control annual grass and weeds on the levee slopes and easements.	38.785835 ° -121.688198 °	38.797185 ° -121.693460 °		965
10	3.73	3.73	Earthen Levee	Encroachments	WS	PO	Buildings	38.797139 ° -121.691137 °	38.797139 ° -121.691137 °		6
11	3.99	3.99	Earthen Levee	Encroachments	LS	PO	Buildings	38.797597 ° -121.695775 °	38.797597 ° -121.695775 °		7
12	4.01	4.01	Earthen Levee	Encroachments	LS	PO	Landscaping	38.797827 ° -121.695985 °	38.797827 ° -121.695985 °		8
13	4.03	4.03	Earthen Levee	Encroachments	WS	PO	Buildings Inspector Comments: pump house concrete building	38.798048 ° -121.696148 °	38.798048 ° -121.696148 °		9

Levee Mile Report Line	7
Start Levee Mile	2.57
End Levee Mile	3.83
Location	Land Side
Category	Earthen Levee
Item	Encroachments
ag. ditch

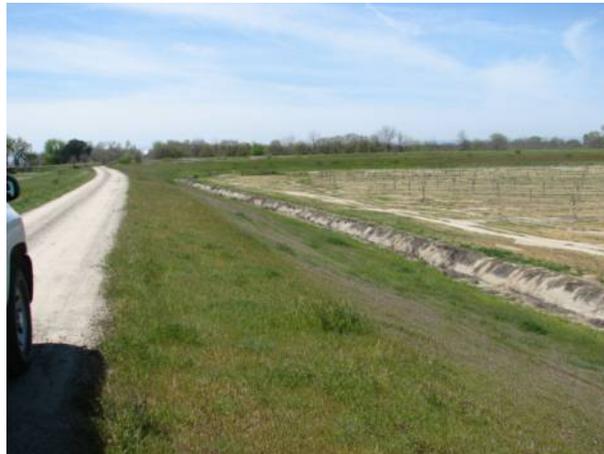
14	4.03	4.03	Earthen Levee	Encroachments	LS	PO	Buildings	38.798048 ° -121.696150 °	38.798048 ° -121.696150 °		10
15	4.07	4.17	Earthen Levee	Encroachments	LS	PO	Agricultural Ditch	38.798641 ° -121.696344 °	38.800108 ° -121.696635 °	Y	966
16	4.20	4.20	Earthen Levee	Encroachments	LS	PO	Buildings	38.800550 ° -121.696752 °	38.800550 ° -121.696752 °		11
17	4.65	4.65	Earthen Levee	Encroachments	LS	PO	Landscaping	38.803632 ° -121.702770 °	38.803632 ° -121.702770 °		12

Levee Mile Report Line	15
Start Levee Mile	4.07
End Levee Mile	4.17
Location	Land Side
Category	Earthen Levee
Item	Encroachments
ag. ditch

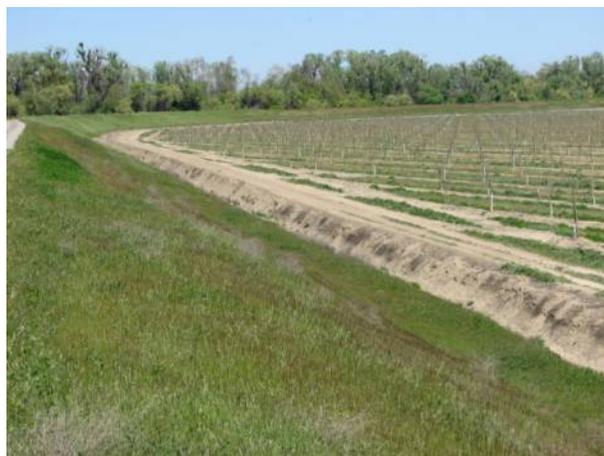
Levee Mile Report Line	39
Start Levee Mile	14.86
End Levee Mile	15.93
Location	Land Side
Category	Earthen Levee
Item	Encroachments
ag. ditch

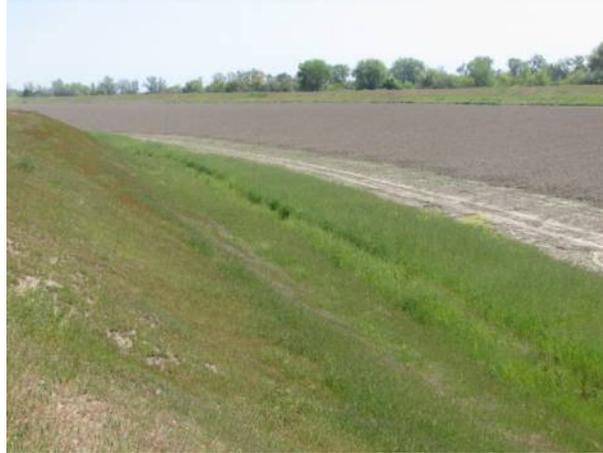
Levee Mile Report Line	45
Start Levee Mile	16.86
End Levee Mile	17.45
Location	Land Side
Category	Earthen Levee
Item	Encroachments
ag. ditch

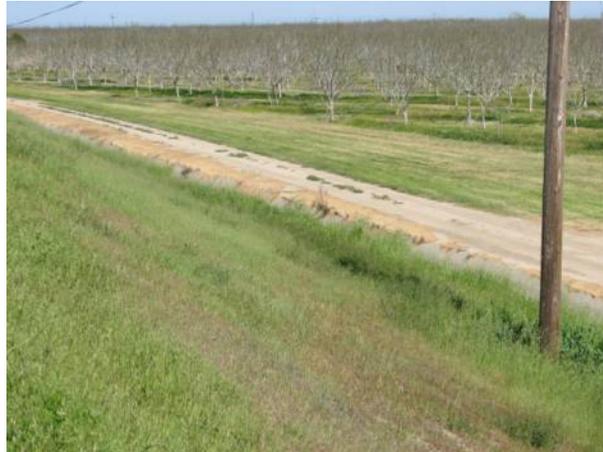
LMR Line	Levee Mile		Category	Item	Location	Rating	Action/Comment	GPS Latitude/Longitude		Photo	Issue
	Start	End						Start	End		
52	20.86	21.40	Earthen Levee	Encroachments	LS	PO	Agricultural Ditch	38.910177 ° -121.810352 °	38.913267 ° -121.803142 °		Y 975
53	23.69	25.29	Earthen Levee	Vegetation	LS	M	Control annual grass and weeds on the levee slopes and easements.	38.927240 ° -121.836932 °	38.946028 ° -121.835795 °		976
54	23.70	25.29	Earthen Levee	Vegetation	WS	M	Control annual grass and weeds on the levee slopes and easements.	38.927325 ° -121.836907 °	38.946028 ° -121.835797 °		977
55	23.94	24.78	Earthen Levee	Crown Surface / Depressions / Rutting	CR	M	Keep the crown roadway free of vegetation.	38.930435 ° -121.834778 °	38.940718 ° -121.830637 °		978
56	24.04	24.04	Earthen Levee	Encroachments	LS	PO	Buildings	38.931838 ° -121.834437 °	38.931838 ° -121.834437 °		42
57	24.44	24.78	Earthen Levee	Encroachments	LS	PO	Agricultural Ditch	38.936282 ° -121.830192 °	38.940712 ° -121.830650 °		Y 979

Levee Mile Report Line	52
Start Levee Mile	20.86
End Levee Mile	21.40
Location	Land Side
Category	Earthen Levee
Item	Encroachments
ag. ditch

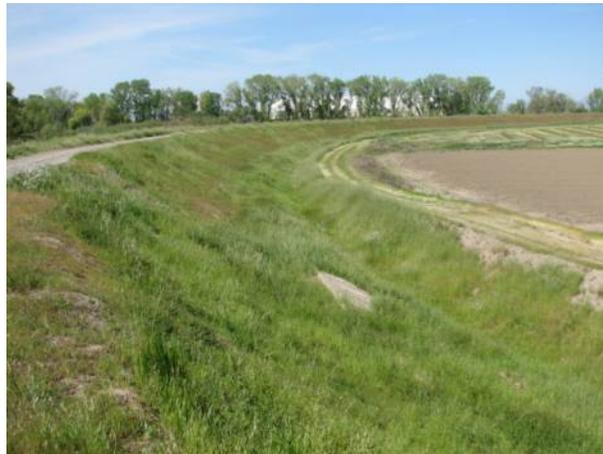
Levee Mile Report Line	57
Start Levee Mile	24.44
End Levee Mile	24.78
Location	Land Side
Category	Earthen Levee
Item	Encroachments
ag. ditch

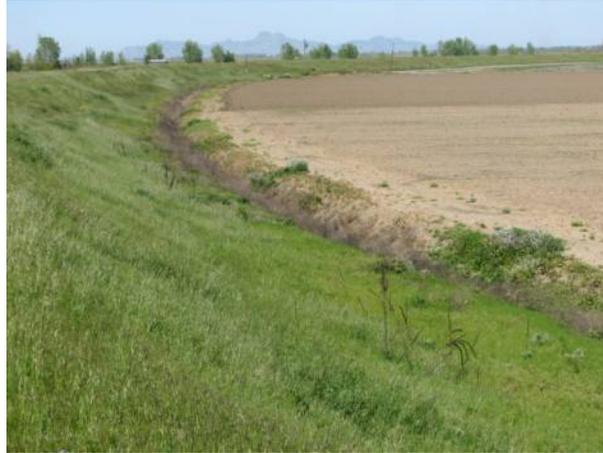
58	24.64	24.64	Earthen Levee	Encroachments	LS	M	Prunings	38.938957 ° -121.829282 °	38.938957 ° -121.829282 °		980
59	25.76	26.54	Earthen Levee	Encroachments	LS	PO	Agricultural Ditch	38.952500 ° -121.837247 °	38.961135 ° -121.830902 °		Y 981
60	26.84	27.07	Earthen Levee	Encroachments	LS	PO	Agricultural Ditch	38.964850 ° -121.833595 °	38.968083 ° -121.833593 °		Y 982
61	26.93	26.93	Earthen Levee	Animal Control	LS	C	No rodents visible, but rodent burrows visible; need to backfill and compact or grout borrows.	38.966175 ° -121.833909 °	38.966175 ° -121.833909 °		54
62	27.63	27.78	Earthen Levee	Encroachments	LS	PO	Agricultural Ditch	38.972440 ° -121.825892 °	38.972848 ° -121.823098 °		Y 983
63	28.12	29.60	Earthen Levee	Encroachments	LS	PO	Agricultural Ditch	38.976513 ° -121.819652 °	38.988433 ° -121.806403 °		984
64	30.60	30.60	Earthen Levee	Encroachments	LS	PO	Landscaping	38.996980 ° -121.794723 °	38.996980 ° -121.794723 °		45

Levee Mile Report Line	59
Start Levee Mile	25.76
End Levee Mile	26.54
Location	Land Side
Category	Earthen Levee
Item	Encroachments
ag. ditch

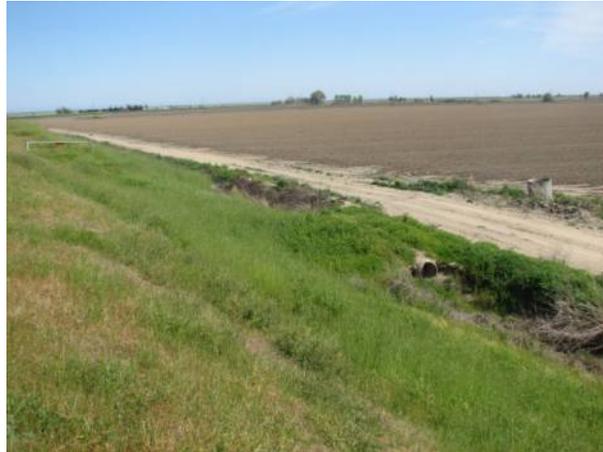
Levee Mile Report Line	60
Start Levee Mile	26.84
End Levee Mile	27.07
Location	Land Side
Category	Earthen Levee
Item	Encroachments
ag. ditch

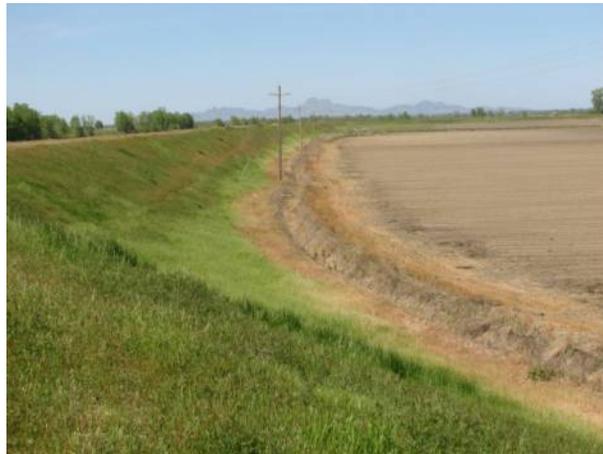
Levee Mile Report Line	62
Start Levee Mile	27.63
End Levee Mile	27.78
Location	Land Side
Category	Earthen Levee
Item	Encroachments
ag. ditch
