**Flood Control Project Maintenance  
Levee Inspections**

**Fall 2010 Levee Maintenance Deficiency Summary Report**

**Sacramento River Basin**

**Reclamation District No. 1600 Mull**

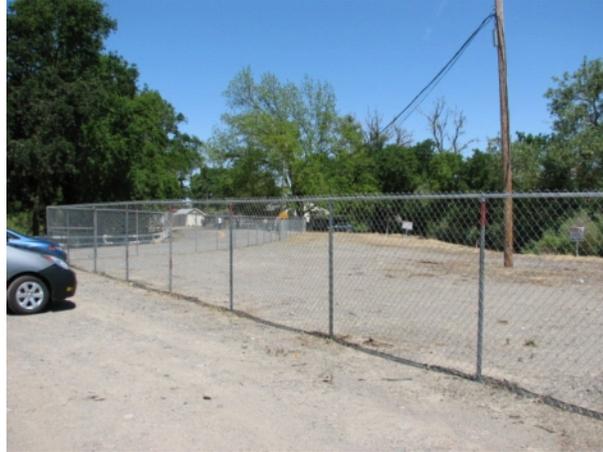
Levee Mile Report Line	1
Start Levee Mile	0.01
End Levee Mile	0.09
Location	Water Side
Category	Earthen Levee
Item	Encroachments
Chain link fence no permit. The building and pumping plant in background is an issue.	
johngw_f_20101012_173.jpg

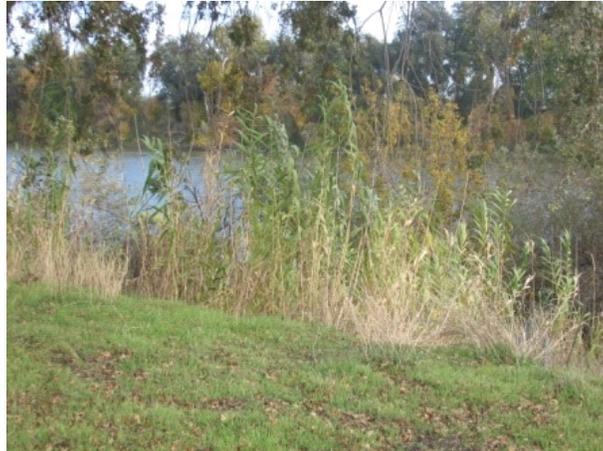
Levee Mile Report Line	3
Start Levee Mile	0.21
End Levee Mile	0.21
Location	Water Side
Category	Earthen Levee
Item	Vegetation
The Arundo is close to the repair area but spreads upstream.	
johngw_f_20101122_373.jpg

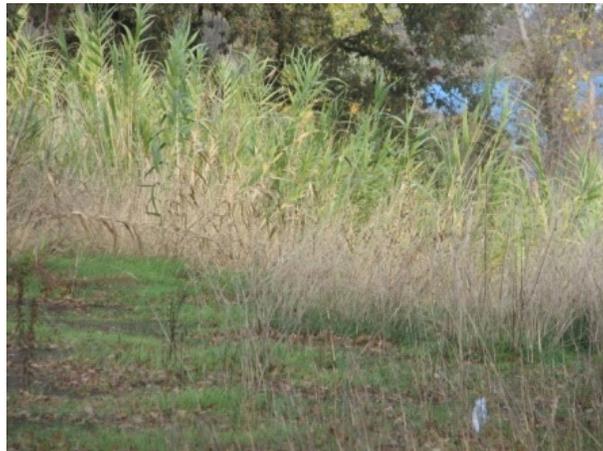
Levee Mile Report Line	3
Start Levee Mile	0.21
End Levee Mile	0.21
Location	Water Side
Category	Earthen Levee
Item	Vegetation
The Arundo has spread upstream and most is below the 20' line on the waterside..	
johngw_f_20101122_374.jpg

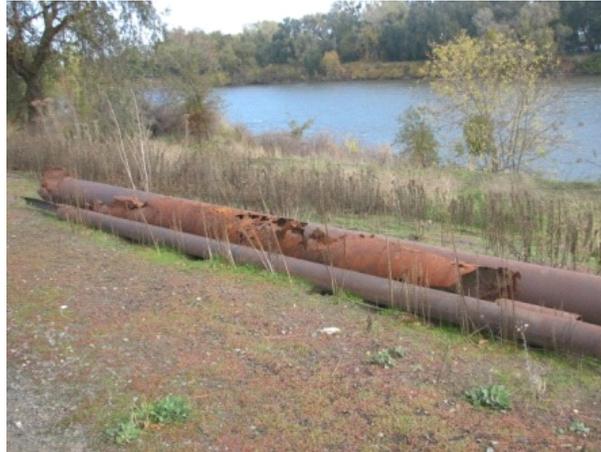
Levee Mile Report Line	5
Start Levee Mile	0.54
End Levee Mile	0.54
Location	Water Side
Category	Earthen Levee
Item	Encroachments
<p>The rusty pipe is still laying on the shoulder to be pick-up.</p>	
<p>johngw_f_20101122_375.jpg</p>

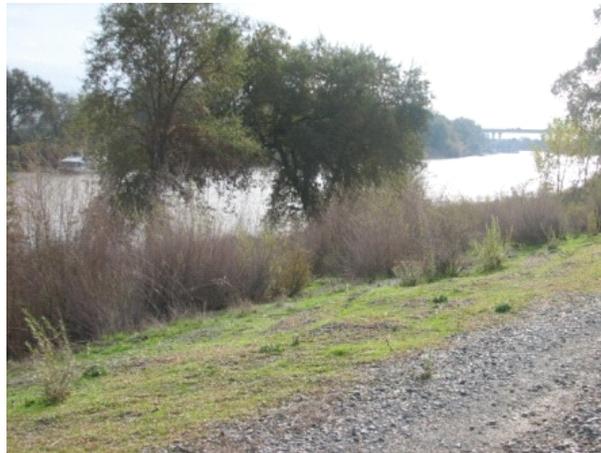
Levee Mile Report Line	6
Start Levee Mile	0.62
End Levee Mile	0.62
Location	Water Side
Category	Earthen Levee
Item	Vegetation
<p>The sandbar willows are creeping up the levee slope.</p>	
<p>johngw_f_20101122_376.jpg</p>

6	0.62	0.62	Earthen Levee	Vegetation	WS	M	Remove the wild growth other than native grasses from the levee slopes. Inspector Comments: willows need to be controled	38.683323 ° -121.634422 °	38.683323 ° -121.634422 °	4 Y
7	1.24	1.40	Earthen Levee	Crown Surface / Depressions / Rutting	CR	C	Keep the crown roadway free of vegetation. Inspector Comments: tall weeds in center of crown	38.692139 ° -121.635438 °	38.694396 ° -121.634348 °	8
8	1.54	1.59	Earthen Levee	Vegetation	WS	M	Remove the wild growth other than native grasses from the levee slopes.	38.696379 ° -121.633414 °	38.696937 ° -121.633046 °	5 Y
9	1.71	1.71	Earthen Levee	Encroachments	WS	M	Material Inspector Comments: old metal ramp from unused dock, ramp is on levee shoulder	38.698364 ° -121.631926 °	38.698364 ° -121.631926 °	9 Y
10	2.00	5.89	Earthen Levee	Crown Surface / Depressions / Rutting	CR	C	Keep the crown roadway free of vegetation. Inspector Comments: weeds cover crown	38.701435 ° -121.628240 °	38.749309 ° -121.597185 °	10

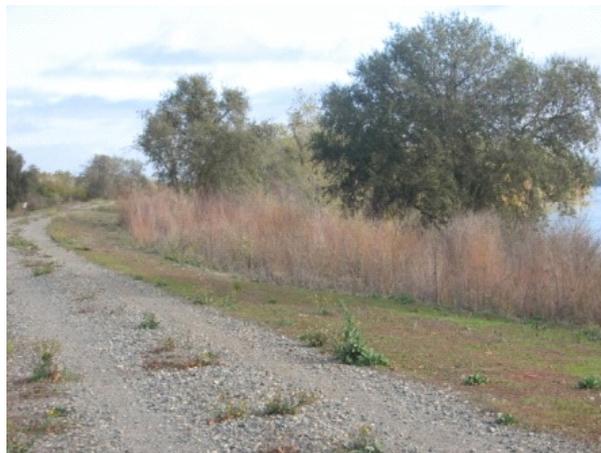
Levee Mile Report Line	8
Start Levee Mile	1.54
End Levee Mile	1.59
Location	Water Side
Category	Earthen Levee
Item	Vegetation
<p>Sandbar willows are too far up the slope and too thick to see through.</p>	
<p>johngw_f_20101122_377.jpg</p>

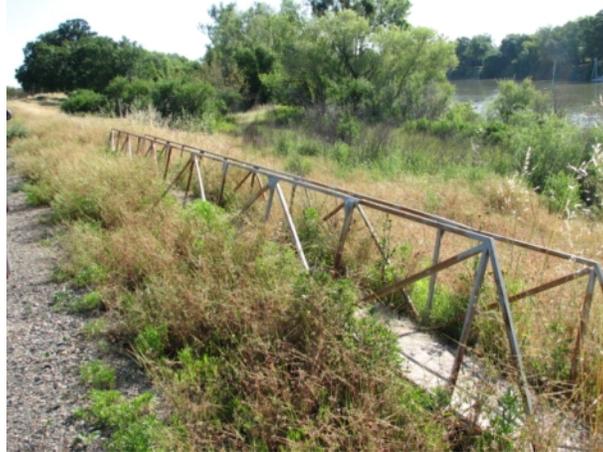
Levee Mile Report Line	9
Start Levee Mile	1.71
End Levee Mile	1.71
Location	Water Side
Category	Earthen Levee
Item	Encroachments
ramp for dock not being used	
johngw_f_20101012_176.jpg

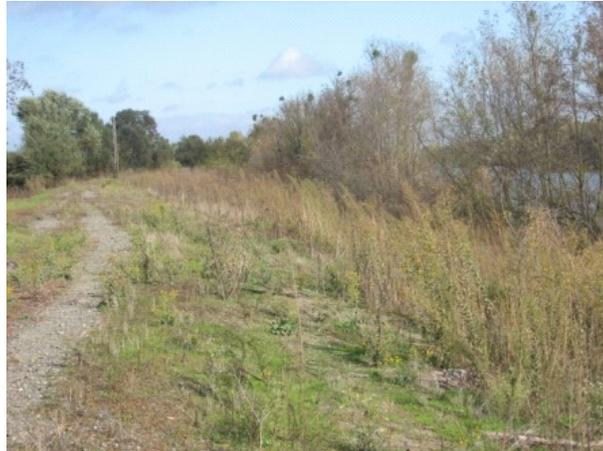
Levee Mile Report Line	12
Start Levee Mile	4.81
End Levee Mile	5.19
Location	Water Side
Category	Earthen Levee
Item	Vegetation
The vegetation is taller than 12" and a large quantity of Mares tail	
johngw_f_20101122_378.jpg

11	2.74	2.74	Earthen Levee	Trim / Thin Trees	CR	C	Trim trees over roadway to at least 12 feet above ground level.	38.708532 ° -121.617962 °	38.708532 ° -121.617962 °	16
12	4.81	5.19	Earthen Levee	Vegetation	WS	M	Remove the wild growth other than native grasses from the levee slopes. Inspector Comments: mares tail has taken over	38.735065 ° -121.604953 °	38.740265 ° -121.603097 °	24 Y
13	5.43	5.43	Earthen Levee	Vegetation	LS	W	Elderberries are blocking visibility and flood fight capability.	38.743632 ° -121.601173 °	38.743632 ° -121.601173 °	13
14	5.48	5.81	Earthen Levee	Erosion / Bank Caving	WS	M	Note and monitor erosion site.	38.744118 ° -121.601104 °	38.748210 ° -121.598025 °	19
15	5.88	5.88	Earthen Levee	Trim / Thin Trees	LS	U	Trim trees to at least five feet above ground level.	38.749162 ° -121.597271 °	38.749162 ° -121.597271 °	12 Y

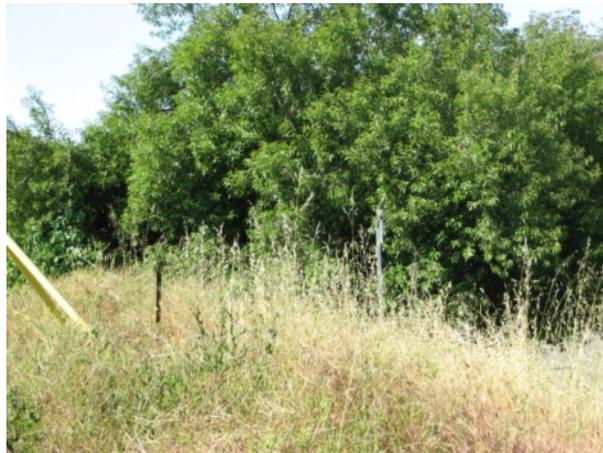
Levee Mile Report Line	15
Start Levee Mile	5.88
End Levee Mile	5.88
Location	Land Side
Category	Earthen Levee
Item	Trim / Thin Trees
Almond tree blocking levee slope view.	
johngw_f_20101012_177.jpg

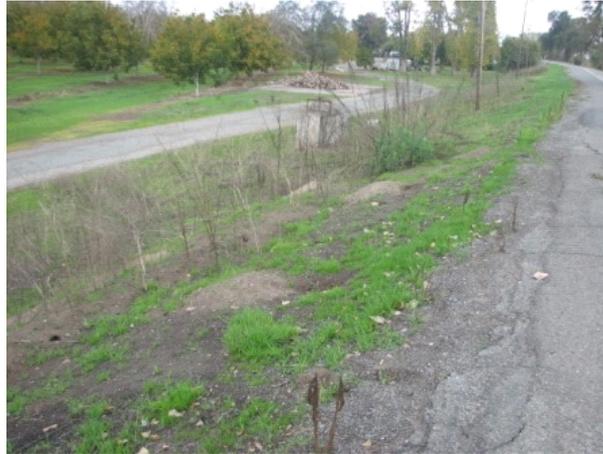
Levee Mile Report Line	16
Start Levee Mile	6.22
End Levee Mile	6.22
Location	Land Side
Category	Earthen Levee
Item	Animal Control
There is a cluster of rodent holes on the landside.	
johngw_f_20101122_379.jpg

LMR No.	Levee Mile		Category	Item	* Location	** Rating	Action/Comment	GPS Latitude/Longitude		Issue No. Photo
	Start	End						Start	End	
16	6.22	6.22	Earthen Levee	Animal Control	LS	M	No rodents visible, but rodent burrows visible; need to backfill and compact or grout borrows.	38.753658 ° -121.595082 °	38.753658 ° -121.595082 °	25 Y
17	6.33	6.33	Earthen Levee	Trim / Thin Trees	LS	M	Trim trees to at least five feet above ground level. Inspector Comments: fig tree needs to be trimmed or removed cactus at levee toe	38.755242 ° -121.594620 °	38.755242 ° -121.594620 °	15 Y
18	6.61	6.73	Earthen Levee	Vegetation	LS	M	Remove the wild growth other than native grasses from the levee slopes.	38.759289 ° -121.594104 °	38.761042 ° -121.594256 °	26 Y
19	6.62	6.68	Earthen Levee	Trim / Thin Trees	LS	C	Thin trees to allow visibility of the ground and room to flood fight.	38.759531 ° -121.594108 °	38.760358 ° -121.594164 °	11

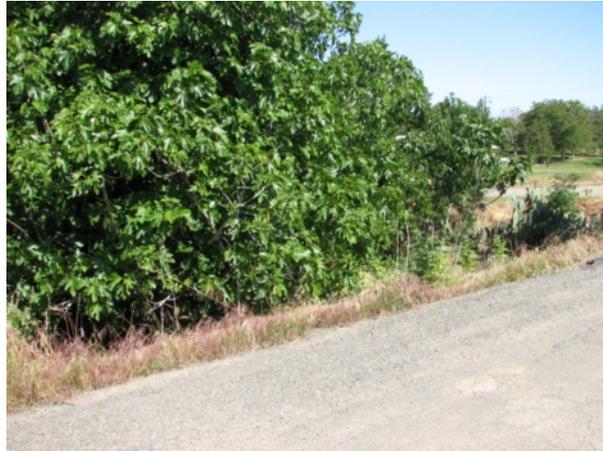
Levee Mile Report Line	17
Start Levee Mile	6.33
End Levee Mile	6.33
Location	Land Side
Category	Earthen Levee
Item	Trim / Thin Trees
fig tree on levee slope, cactus in back ground	
johngw_f_20101012_178.jpg

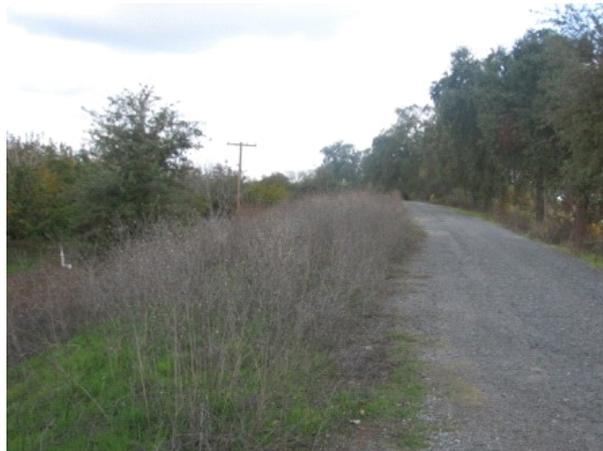
Levee Mile Report Line	18
Start Levee Mile	6.61
End Levee Mile	6.73
Location	Land Side
Category	Earthen Levee
Item	Vegetation
The vegetation is taller than 12".	
johngw_f_20101122_380.jpg

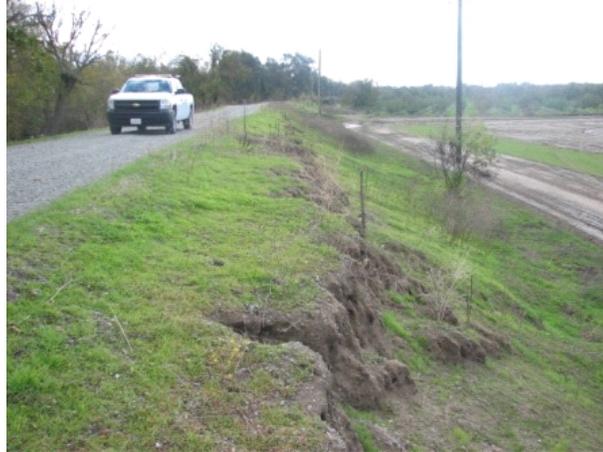
Levee Mile Report Line	21
Start Levee Mile	7.02
End Levee Mile	7.02
Location	Land Side
Category	Earthen Levee
Item	Erosion / Bank Caving
The erosion appears to be moving closer to the shoulder.	
johngw_f_20101122_381.jpg

20	7.00	7.00	Earthen Levee	Erosion / Bank Caving	WS	M	Note and monitor erosion site.	38.764940 ° -121.595348 °	38.764940 ° -121.595348 °	14
21	7.02	7.02	Earthen Levee	Erosion / Bank Caving	LS	M	Note and monitor erosion site.	38.764974 ° -121.595533 °	38.764974 ° -121.595533 °	27 Y
22	7.13	7.13	Earthen Levee	Erosion / Bank Caving	WS	M	Note and monitor erosion site.	38.766505 ° -121.596214 °	38.766505 ° -121.596214 °	20
23	7.27	7.27	Earthen Levee	Erosion / Bank Caving	WS	M	Note and monitor erosion site.	38.768409 ° -121.597213 °	38.768409 ° -121.597213 °	21
24	7.85	7.85	Earthen Levee	Encroachments	LS	M	Pipe	38.775499 ° -121.602735 °	38.775499 ° -121.602735 °	17 Y
25	9.71	10.42	Earthen Levee	Vegetation	WS	M	Remove the wild growth other than native grasses from the levee slopes.	38.775982 ° -121.630072 °	38.766575 ° -121.634065 °	28 Y
26	9.75	9.75	Earthen Levee	Animal Control	WS	W	Exterminate rodents and backfill and compact or grout burrows.	38.775523 ° -121.630720 °	38.775523 ° -121.630720 °	22

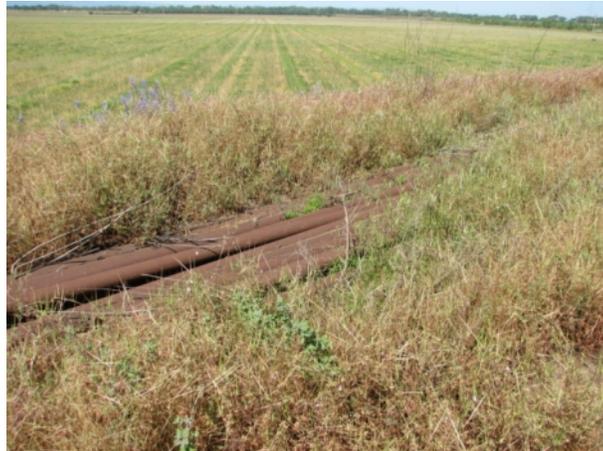
Levee Mile Report Line	24
Start Levee Mile	7.85
End Levee Mile	7.85
Location	Land Side
Category	Earthen Levee
Item	Encroachments
drilling pipe on levee crown landside	
johngw_f_20101012_179.jpg

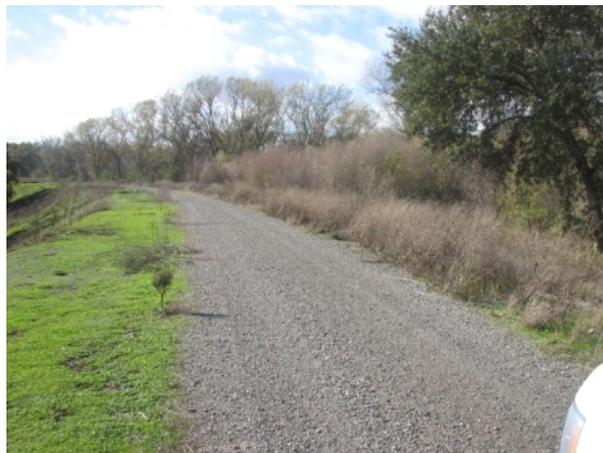
Levee Mile Report Line	25
Start Levee Mile	9.71
End Levee Mile	10.42
Location	Water Side
Category	Earthen Levee
Item	Vegetation
The vegetation is taller than 12" and the willows are creeping up the slope.	
johngw_f_20101122_382.jpg

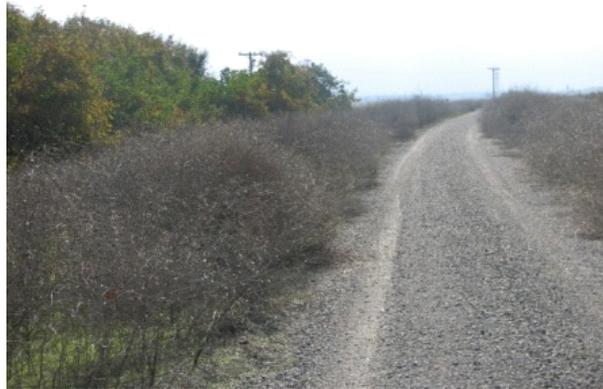
Levee Mile Report Line	27
Start Levee Mile	9.96
End Levee Mile	10.31
Location	Land Side
Category	Earthen Levee
Item	Vegetation
<p>The vegetation is taller that 12" and make viewing the slope hard.</p>	
<p>johngw_f_20101122_383.jpg</p>

27	9.96	10.31	Earthen Levee	Vegetation	LS	M	Remove the wild growth other than native grasses from the levee slopes.	38.772810 ° -121.631638 °	38.767757 ° -121.633117 °	29 Y
28	10.31	10.31	Earthen Levee	Encroachments	CR	M	Equipment Inspector Comments: electrical wire cross the levee crown. No damage to crown.	38.767757 ° -121.633117 °	38.767757 ° -121.633117 °	30 Y

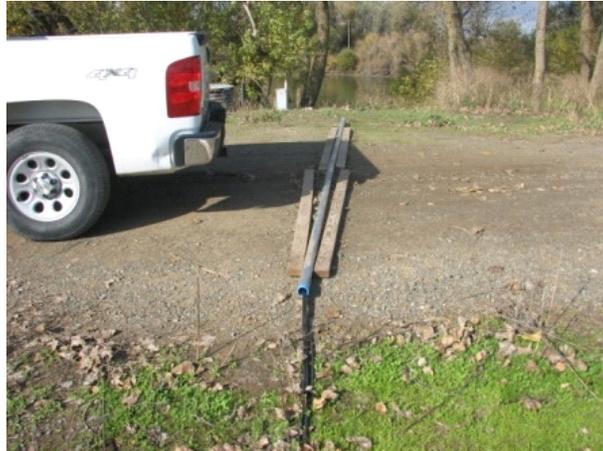
Levee Mile Report Line	28
Start Levee Mile	10.31
End Levee Mile	10.31
Location	Crown
Category	Earthen Levee
Item	Encroachments
<p>Electrical power is laying across the levee needs to get a permit.</p>	
<p>johngw_f_20101122_384.jpg</p>

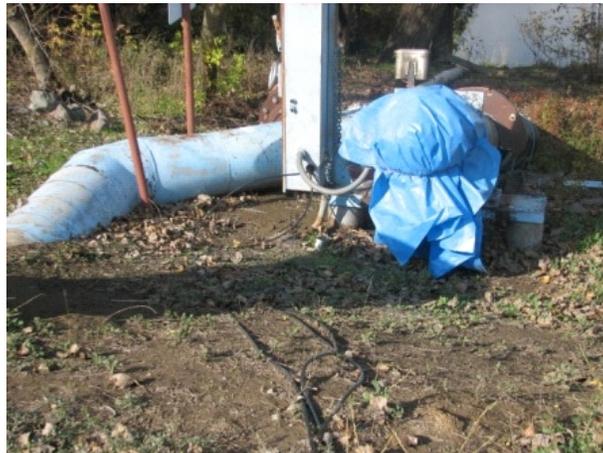
Levee Mile Report Line	28
Start Levee Mile	10.31
End Levee Mile	10.31
Location	Crown
Category	Earthen Levee
Item	Encroachments
<p>A photo of the wires on the ground and the tie in to the pump.</p>	
<p>johngw_f_20101122_385.jpg</p>

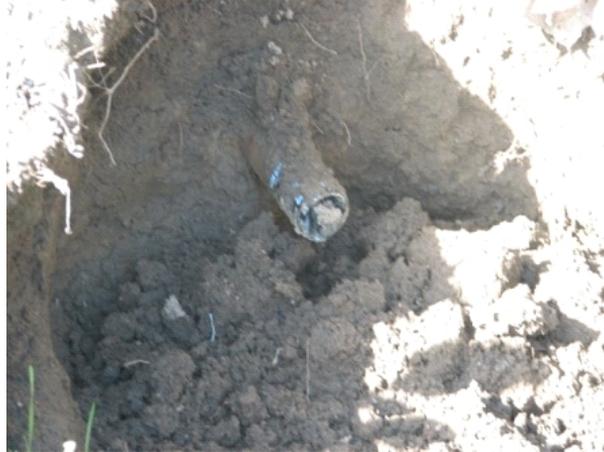
Levee Mile Report Line	28
Start Levee Mile	10.31
End Levee Mile	10.31
Location	Crown
Category	Earthen Levee
Item	Encroachments
The photo is the old conduit with the old wire cut off.	
johngw_f_20101122_386.jpg

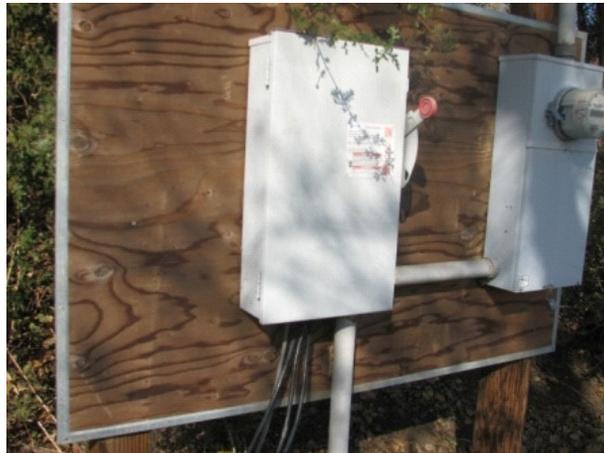
Levee Mile Report Line	28
Start Levee Mile	10.31
End Levee Mile	10.31
Location	Crown
Category	Earthen Levee
Item	Encroachments
The electrical box on the landside toe.	
johngw_f_20101122_387.jpg

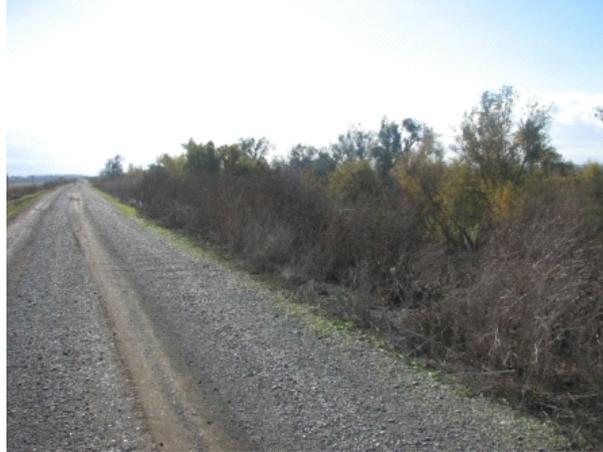
Levee Mile Report Line	1
Start Levee Mile	0.40
End Levee Mile	0.90
Location	Water Side
Category	Earthen Levee
Item	Vegetation
The waterside vegetation is taller than 12"	
johngw_f_20101122_388.jpg

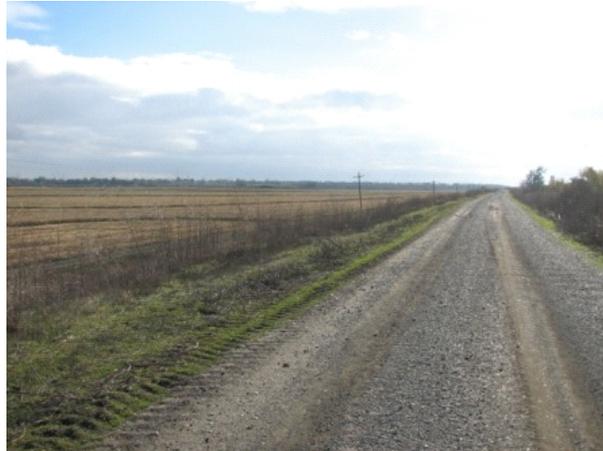
Levee Mile Report Line	2
Start Levee Mile	0.40
End Levee Mile	0.82
Location	Land Side
Category	Earthen Levee
Item	Vegetation
The landside vegetation is taller that 12" but not as thick as the waterside.	
johngw_f_20101122_389.jpg

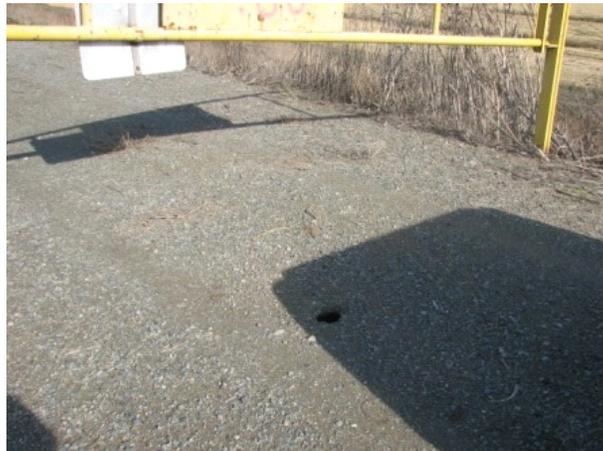
Levee Mile Report Line	5
Start Levee Mile	0.81
End Levee Mile	0.81
Location	Crown
Category	Earthen Levee
Item	Animal Control
A 4" diameter hole is in the levee crown caused by a rodent.	
johngw_f_20101122_390.jpg
