**Flood Control Project Maintenance
Levee Inspections**

Fall 2011 Levee Maintenance Deficiency Summary Report

Reclamation District No. 1600 Mull

Levee Inspection Report By Mile - Fall 2011

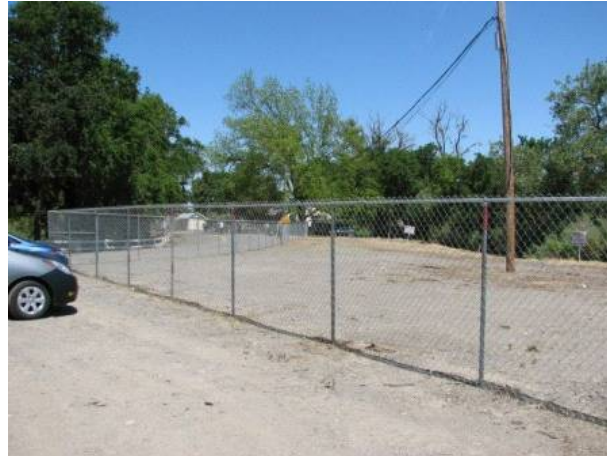
Levee Mile Report Line	1
Start Levee Mile	0.01
End Levee Mile	0.09
Location	Water Side
Category	Earthen Levee
Item	Encroachments
Chain link fence no permit. The building and pumping plant in background is an issue.	
johngw_f_20110923_604.jpg

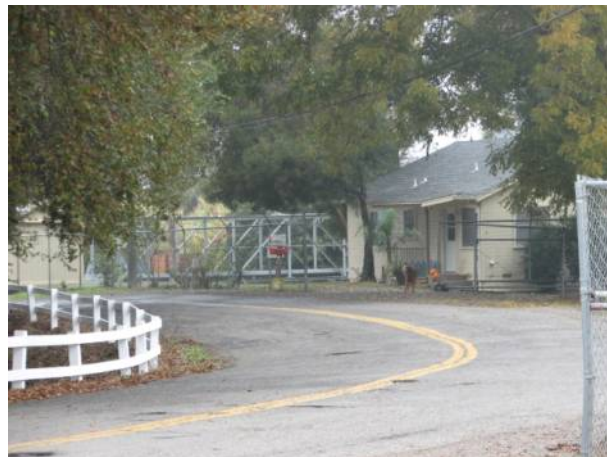
Levee Mile Report Line	2
Start Levee Mile	0.06
End Levee Mile	0.06
Location	Water Side
Category	Earthen Levee
Item	Encroachments
The house of the operator of the pumping plant for RD 2035.	
johngw_f_20111129_581.jpg

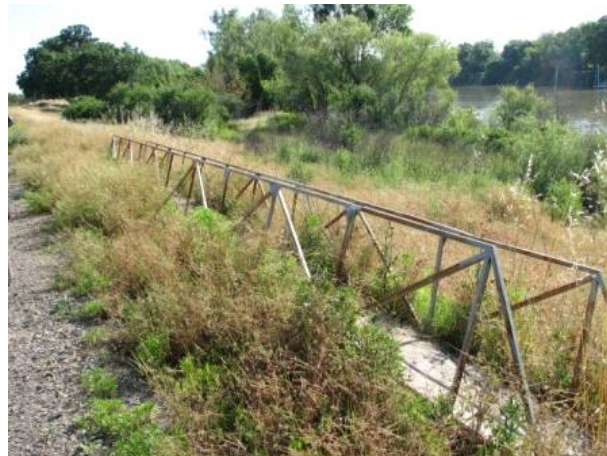
Levee Mile Report Line	8
Start Levee Mile	1.71
End Levee Mile	1.71
Location	Water Side
Category	Earthen Levee
Item	Encroachments

Ramp for dock not being used.

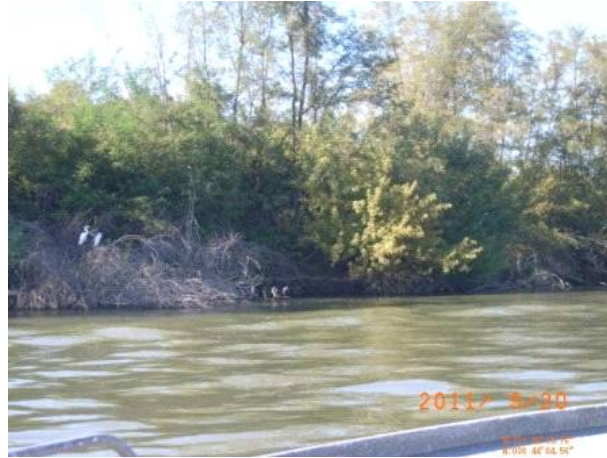
USACE 2011 Photo #1

10	4.21	4.21	Supplemental	USACE Erosion Survey	WS	M	Inspector Comments: 1997 - Very steep bank. 2005 - Lots of small trees down along the bank at the upstream end. 2006 - Minor new erosion, but slow. 2010 - Almost all of the roots are exposed on the trees, appears ready to fall. 2011: New erosion and tree popouts. [2011 Site ID: SAC_75-3_R]	38.728684 ° -121.605844 °	38.736110 ° -121.604153 °	10 Y
11	4.81	5.19	Earthen Levee	Vegetation	WS	M	Remove the wild growth other than native grasses from the levee slopes. Inspector Comments: Mares tail has taken over.	38.735065 ° -121.604953 °	38.740265 ° -121.603097 °	24 Y

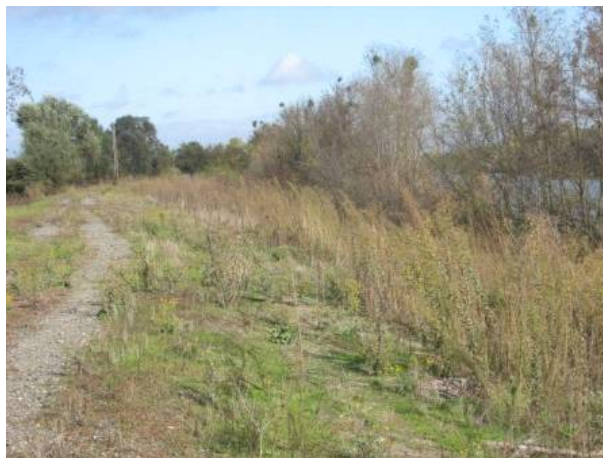
Levee Mile Report Line	11
Start Levee Mile	4.81
End Levee Mile	5.19
Location	Water Side
Category	Earthen Levee
Item	Vegetation

The vegetation is taller than 12" and a large quantity of Mares Tail.

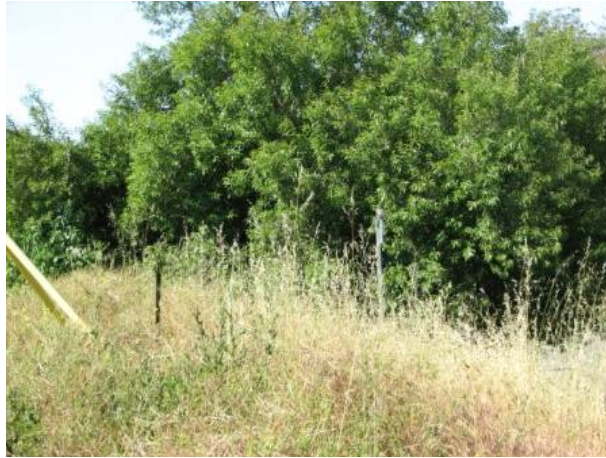
Levee Mile Report Line	14
Start Levee Mile	5.88
End Levee Mile	5.88
Location	Land Side
Category	Earthen Levee
Item	Trim / Thin Trees

Almond tree blocking levee slope view.

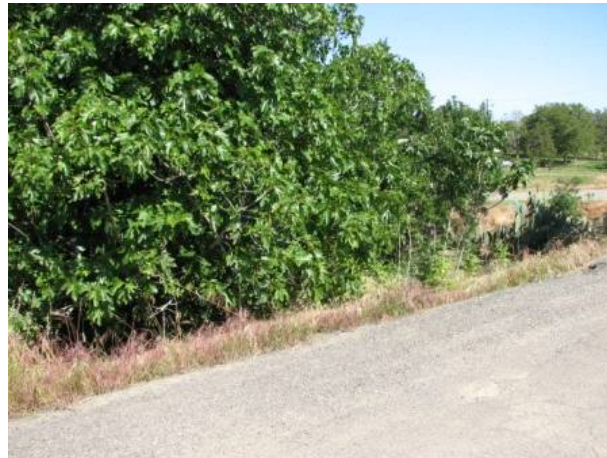
Levee Mile Report Line	16
Start Levee Mile	6.33
End Levee Mile	6.33
Location	Land Side
Category	Earthen Levee
Item	Trim / Thin Trees

16	6.33	6.33	Earthen Levee	Trim / Thin Trees	LS	M	Trim trees to at least five feet above ground level. Inspector Comments: Fig tree needs to be trimmed or removed cactus at levee toe.	38.755242 ° -121.594620 °	38.755242 ° -121.594620 °	15 Y
17	6.61	6.73	Earthen Levee	Vegetation	LS	M	Remove the wild growth other than native grasses from the levee slopes.	38.759289 ° -121.594104 °	38.761042 ° -121.594256 °	26 Y
18	6.97	6.98	Supplemental	USACE Erosion Survey	WS	M	Inspector Comments: 2006 - Eddy scour off end of rock causing erosion and scour hole near levee. Sandy silt bank with rock on upstream end. 2010 - Trees are leaning more, minor new erosion. 2011: Many of the tree roots have scoured out and trees look ready to fall. [2011 Site ID: SAC_77-7_R]	38.765219 ° -121.595049 °	38.764801 ° -121.594926 °	16 Y
19	7.00	7.00	Earthen Levee	Erosion / Bank Caving	WS	W	Note and monitor erosion site.	38.764940 ° -121.595348 °	38.764940 ° -121.595348 °	14 Y

Fig tree on levee slope, cactus in background.

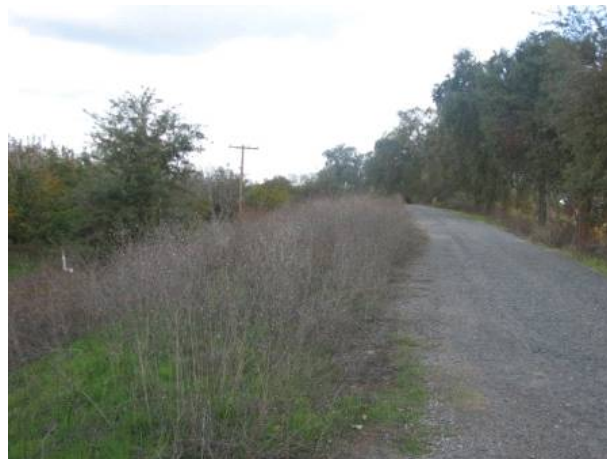
Levee Mile Report Line	17
Start Levee Mile	6.61
End Levee Mile	6.73
Location	Land Side
Category	Earthen Levee
Item	Vegetation

The vegetation is taller than 12".

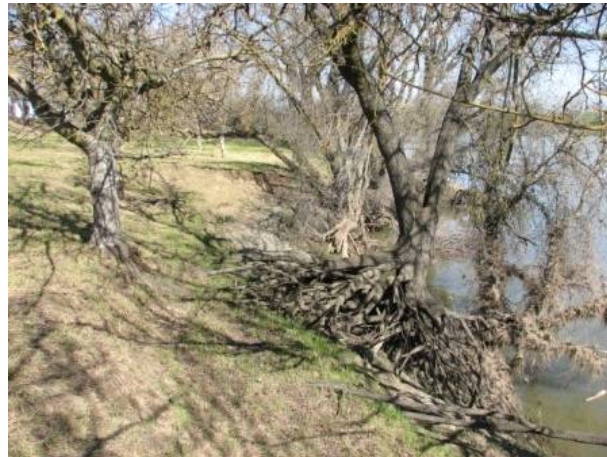
Levee Mile Report Line	19
Start Levee Mile	7.00
End Levee Mile	7.00
Location	Water Side
Category	Earthen Levee
Item	Erosion / Bank Caving

The erosion is continuing to erode the berm area.

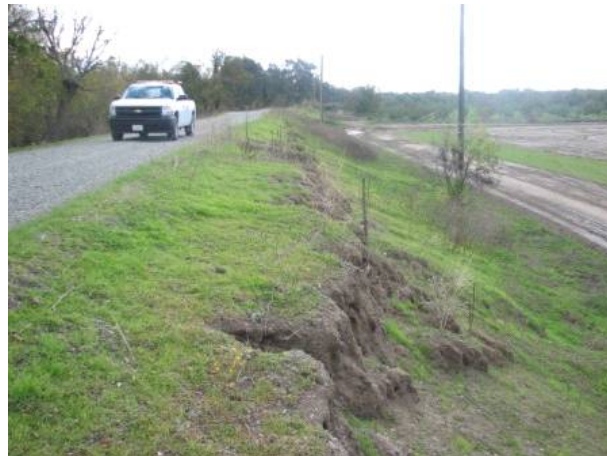
Levee Mile Report Line	20
Start Levee Mile	7.02
End Levee Mile	7.02
Location	Land Side
Category	Earthen Levee
Item	Erosion / Bank Caving

20	7.02	7.02	Earthen Levee	Erosion / Bank Caving	LS	M	Note and monitor erosion site.	38.764974 ° -121.595533 °	38.764974 ° -121.595533 °	27 Y
21	7.13	7.13	Earthen Levee	Erosion / Bank Caving	WS	W	Note and monitor erosion site.	38.766505 ° -121.596214 °	38.766505 ° -121.596214 °	20 Y
22	7.27	7.27	Earthen Levee	Erosion / Bank Caving	WS	M	Note and monitor erosion site.	38.768409 ° -121.597213 °	38.768409 ° -121.597213 °	21 Y
23	7.85	7.85	Earthen Levee	Encroachments	LS	C	Pipe	38.775499 ° -121.602735 °	38.775499 ° -121.602735 °	17
24	9.96	10.31	Earthen Levee	Vegetation	LS	M	Remove the wild growth other than native grasses from the levee slopes.	38.772810 ° -121.631638 °	38.767757 ° -121.633117 °	29 Y
25	10.42	10.42	Earthen Levee	Encroachments	CR	M	Equipment Inspector Comments: Electrical wire cross the levee crown. No damage to crown.	38.766549 ° -121.634084 °	38.766549 ° -121.634084 °	30 Y

The erosion appears to be moving closer to the shoulder.

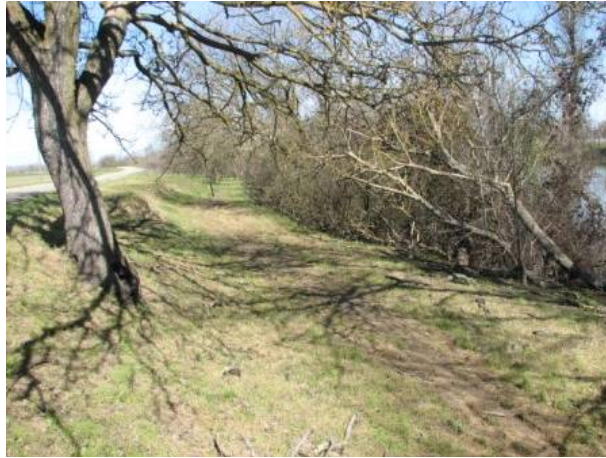
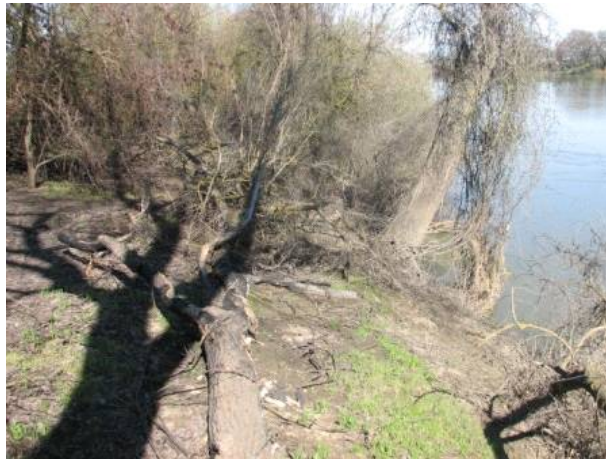
Levee Mile Report Line	21
Start Levee Mile	7.13
End Levee Mile	7.13
Location	Water Side
Category	Earthen Levee
Item	Erosion / Bank Caving

The erosion is eroding away at the berm area.

This another view of the site.

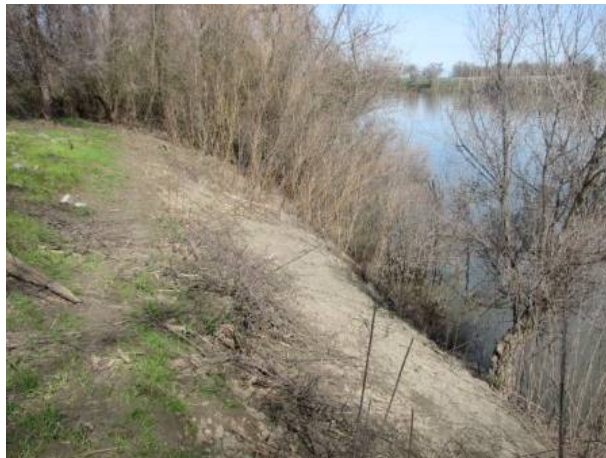
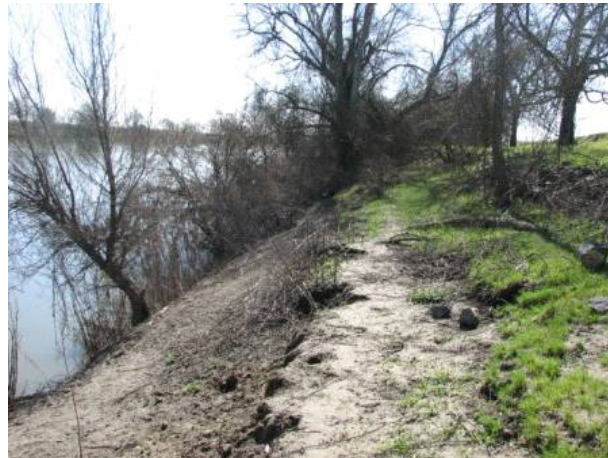
Levee Mile Report Line	22
Start Levee Mile	7.27
End Levee Mile	7.27
Location	Water Side
Category	Earthen Levee
Item	Erosion / Bank Caving

The bank is eroding away and has become very steep.

The erosion is eroding away the berm area.

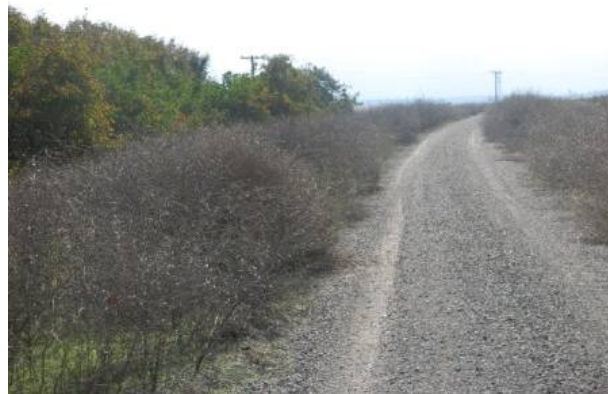
Levee Mile Report Line	24
Start Levee Mile	9.96
End Levee Mile	10.31
Location	Land Side
Category	Earthen Levee
Item	Vegetation

The vegetation is taller than 12" and makes viewing the slope hard.

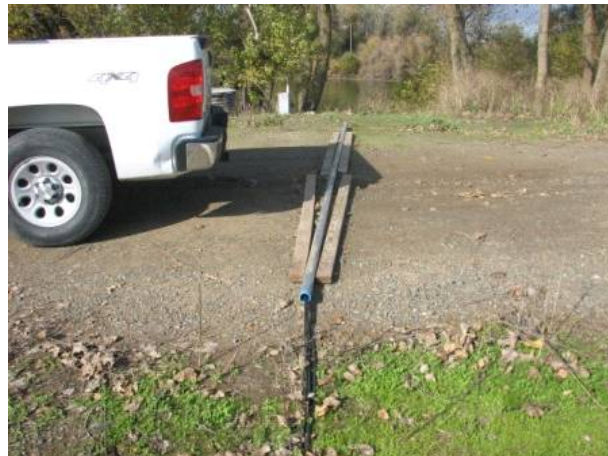
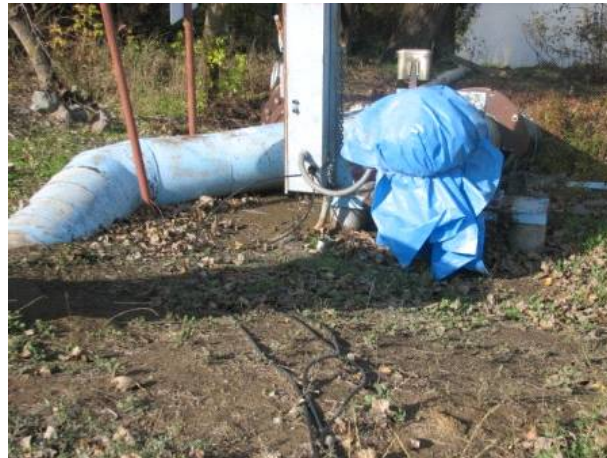
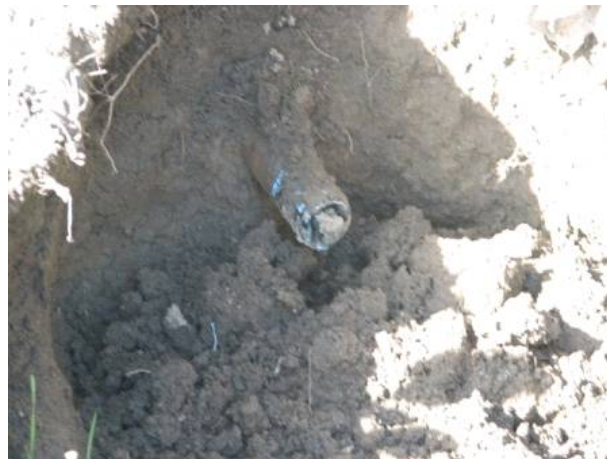
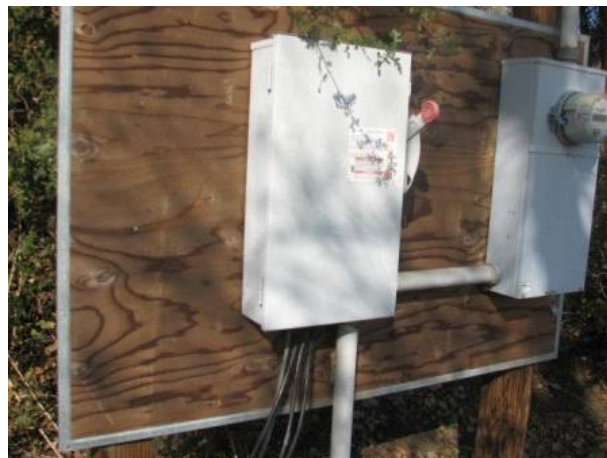
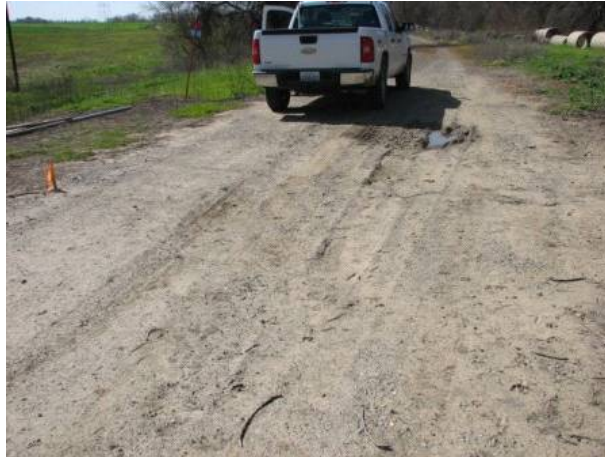
Levee Mile Report Line	25
Start Levee Mile	10.42
End Levee Mile	10.42
Location	Crown
Category	Earthen Levee
Item	Encroachments

Electrical power is laying across the levee needs to get a permit.

A photo of the wires on the ground and the tie in to the pump.

The photo is the old conduit with the old wire cut off.

The electrical box on the landside toe.

The temporary electrical wire has been removed at this time. The power has not been restored.

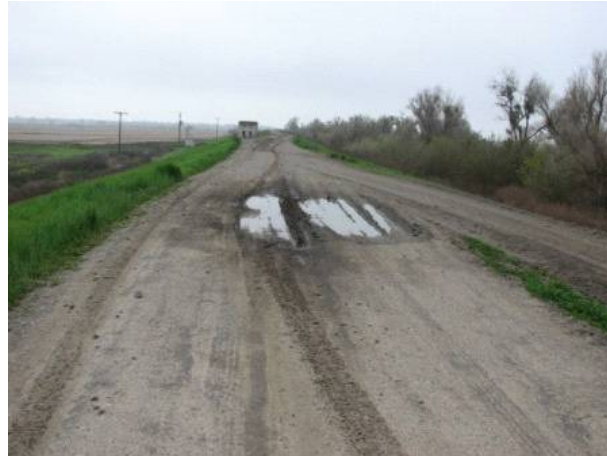
Levee Mile Report Line	2
Start Levee Mile	0.22
End Levee Mile	0.22
Location	Crown
Category	Earthen Levee
Item	Crown Surface / Depressions / Rutting
The crown needs to be graded and AB added to the crown.	
johngw_f_20110923_722.jpg

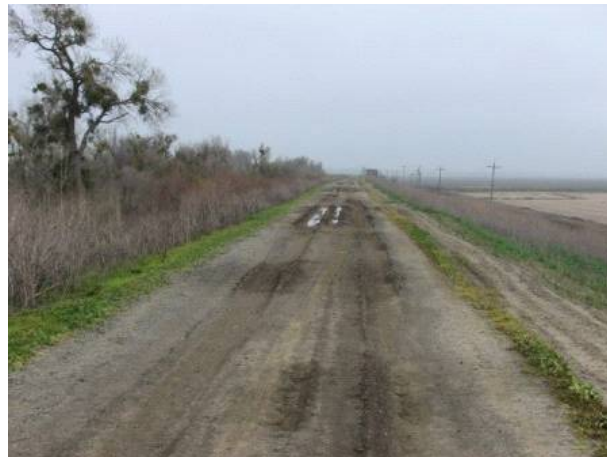
Levee Mile Report Line	3
Start Levee Mile	0.68
End Levee Mile	0.77
Location	Crown
Category	Earthen Levee
Item	Crown Surface / Depressions / Rutting
This area is soft and needs to have AB added to make an all weather surface.	
johngw_f_20110923_723.jpg

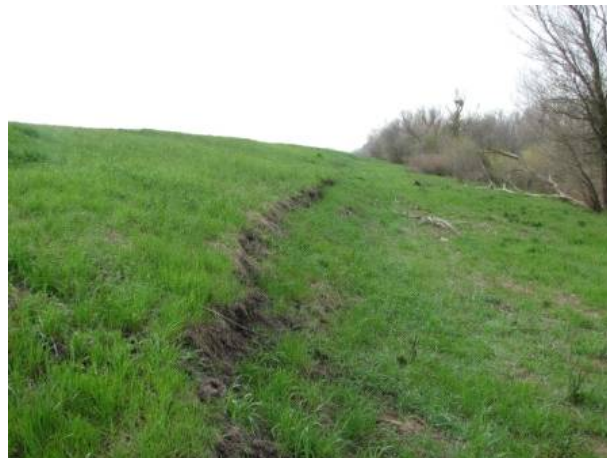
Levee Mile Report Line	5
Start Levee Mile	1.74
End Levee Mile	2.01
Location	Water Side
Category	Earthen Levee
Item	Erosion / Bank Caving
Wave wash damage along the slope the cut is 1'-2'.	
johngw_f_20110923_724.jpg

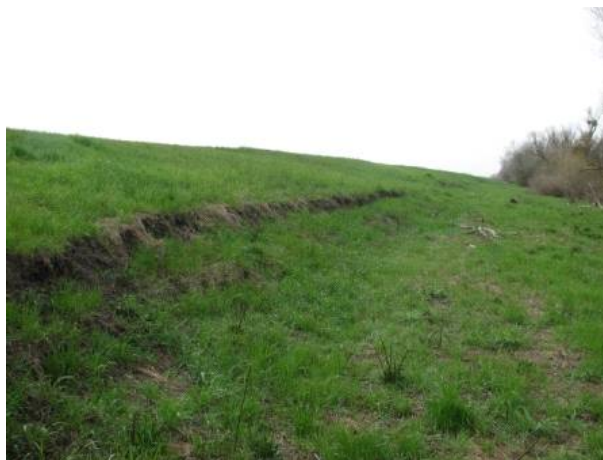
A closer view of the wave wash damage along the bypass.

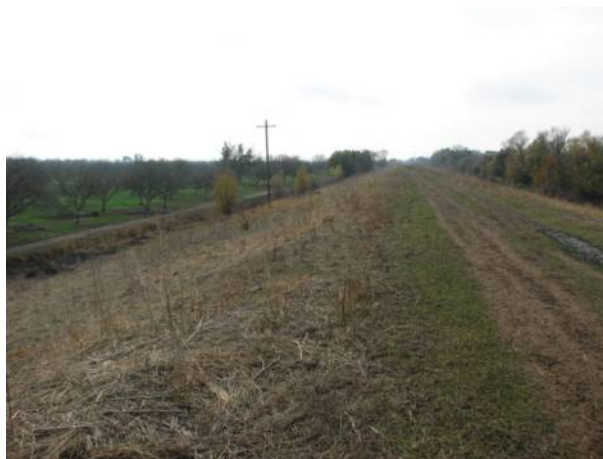
Levee Mile Report Line	6
Start Levee Mile	2.07
End Levee Mile	4.20
Location	Land Side
Category	Earthen Levee
Item	Vegetation

A view of the levee slope after the goats have been there.

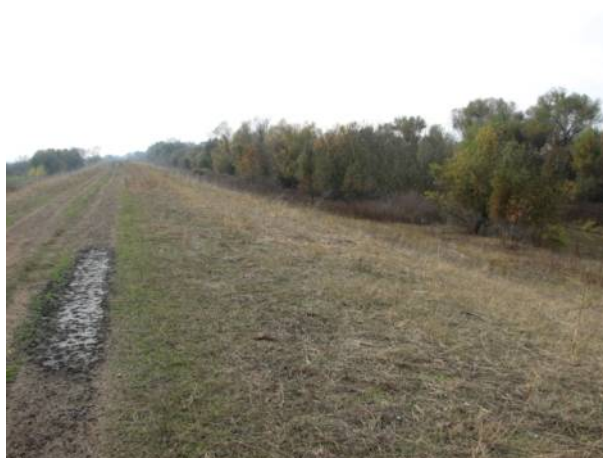
Levee Mile Report Line	7
Start Levee Mile	2.07
End Levee Mile	4.20
Location	Water Side
Category	Earthen Levee
Item	Vegetation

Waterside view after the goats have grazed.

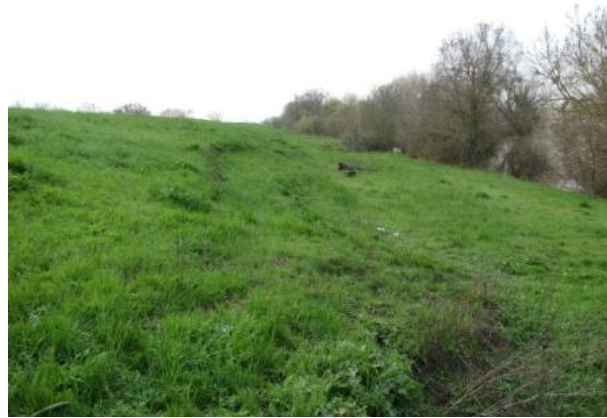
This is wave wash damage along the toe of the levee looking downstream.

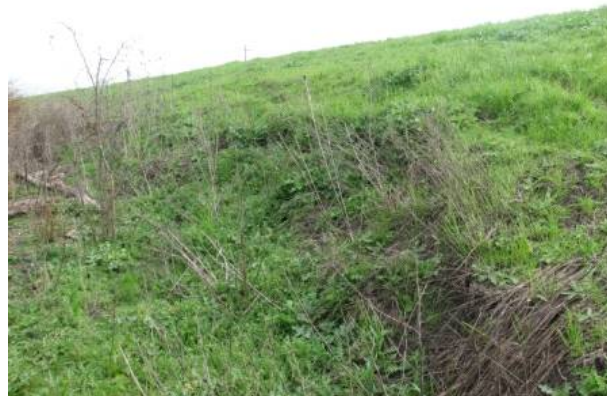
Levee Mile Report Line	8
Start Levee Mile	2.12
End Levee Mile	2.23
Location	Water Side
Category	Earthen Levee
Item	Erosion / Bank Caving

Looking upstream a deeper cut of 2'-3' damage.

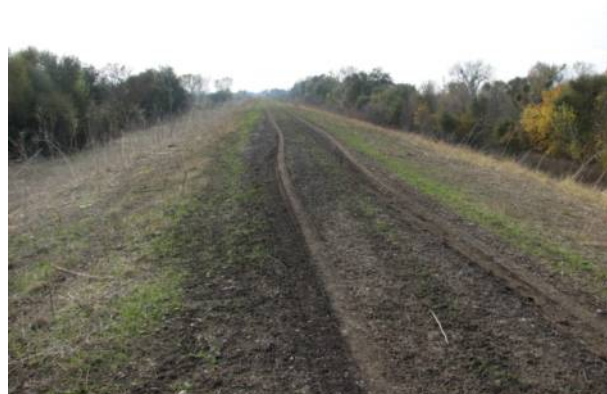
Levee Mile Report Line	9
Start Levee Mile	2.19
End Levee Mile	3.83
Location	Crown
Category	Earthen Levee
Item	Crown Surface / Depressions / Rutting

The crown of the levee needs to have AB added. Some rutting has occurred.
