**Flood Control Project Maintenance
Levee Inspections**

Fall 2012 Levee Maintenance Deficiency Summary Report

Reclamation District No. 1600 Mull

Levee Inspection Report By Mile - Fall 2012

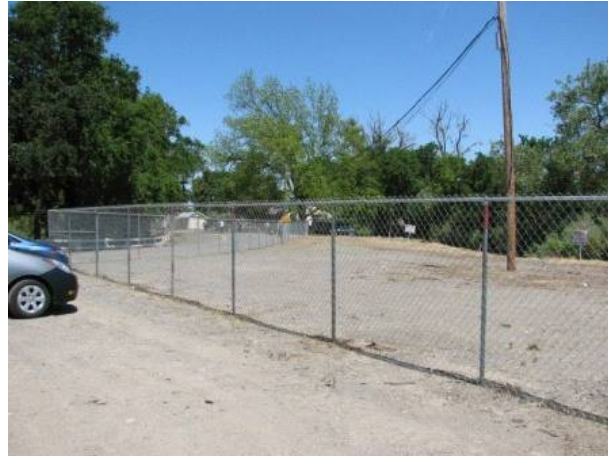
Levee Mile Report Line	4
Start Levee Mile	0.01
End Levee Mile	0.09
Location	Water Side
Category	Earthen Levee
Item	Encroachments
Chain link fence no permit. The building and pumping plant in background is an issue.	
johngw_f_20120911_556.jpg

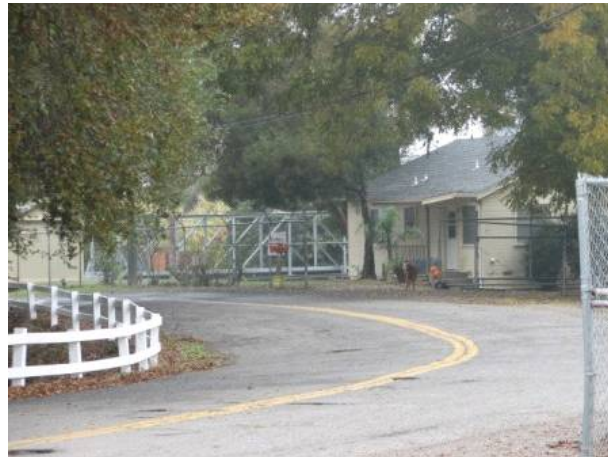
Levee Mile Report Line	5
Start Levee Mile	0.06
End Levee Mile	0.06
Location	Water Side
Category	Earthen Levee
Item	Encroachments
The house of the operator of the pumping plant for RD 2035.	
johngw_f_20120911_554.jpg

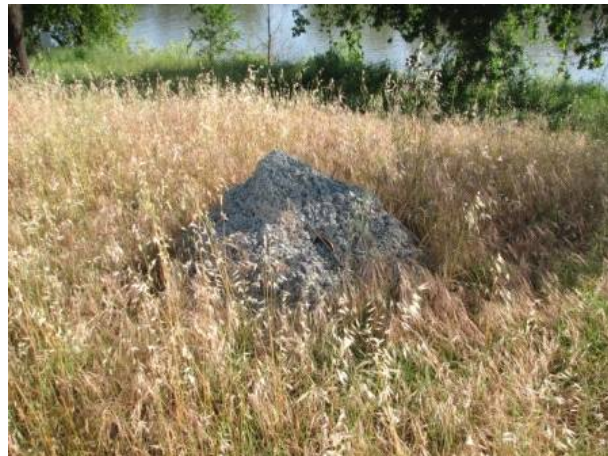
Levee Mile Report Line	6
Start Levee Mile	0.10
End Levee Mile	0.10
Location	Water Side
Category	Earthen Levee
Item	Encroachments
A pile of concrete left over from the drilling of the well. Photo taken spring 2012.	
johngw_f_20120911_582.jpg

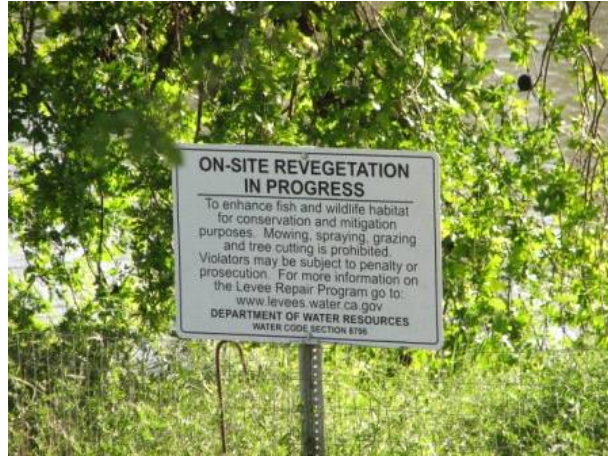
Levee Mile Report Line	7
Start Levee Mile	0.10
End Levee Mile	0.24
Location	Water Side
Category	Earthen Levee
Item	Vegetation

Revegetation site. Photo taken spring 2012.

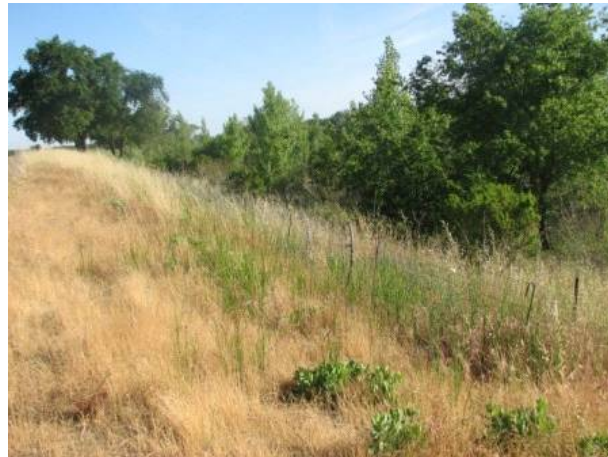
Levee Mile Report Line	7
Start Levee Mile	0.10
End Levee Mile	0.24
Location	Water Side
Category	Earthen Levee
Item	Vegetation

The revegetation site on the berm with the fence showing. Photo taken spring 2012.

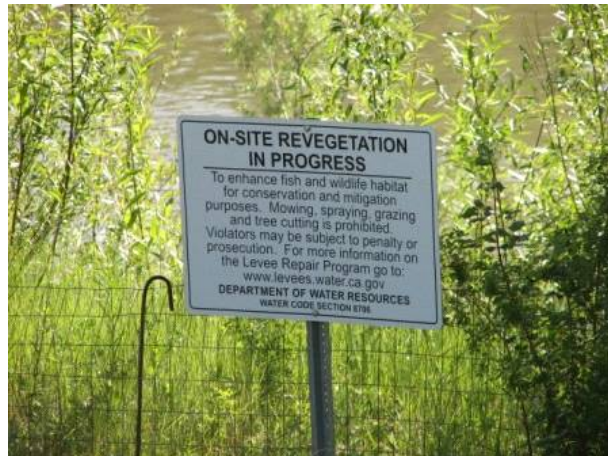
Levee Mile Report Line	10
Start Levee Mile	1.02
End Levee Mile	1.11
Location	Water Side
Category	Earthen Levee
Item	Vegetation

Revegetation site. Photo taken spring 2012.

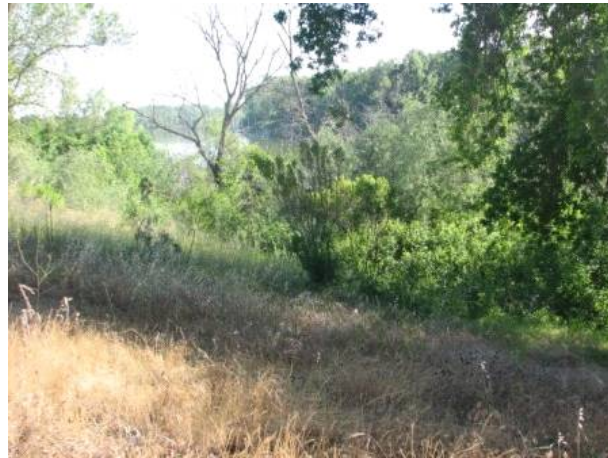
Levee Mile Report Line	10
Start Levee Mile	1.02
End Levee Mile	1.11
Location	Water Side
Category	Earthen Levee
Item	Vegetation

The revegetation site along the berm and shoulder of the river.

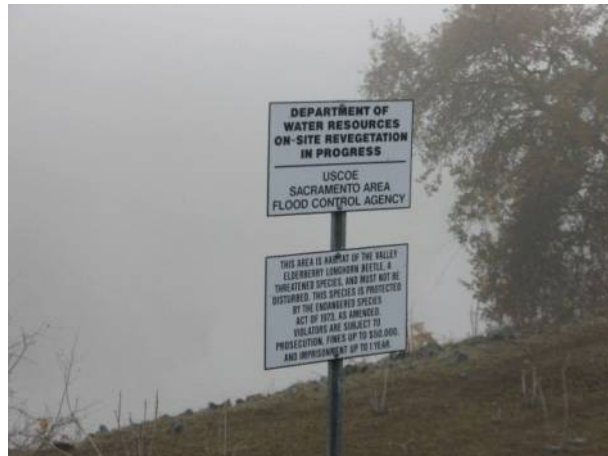
Levee Mile Report Line	12
Start Levee Mile	1.42
End Levee Mile	1.42
Location	Water Side
Category	Earthen Levee
Item	Vegetation

Revegetation site. Fall 2012.

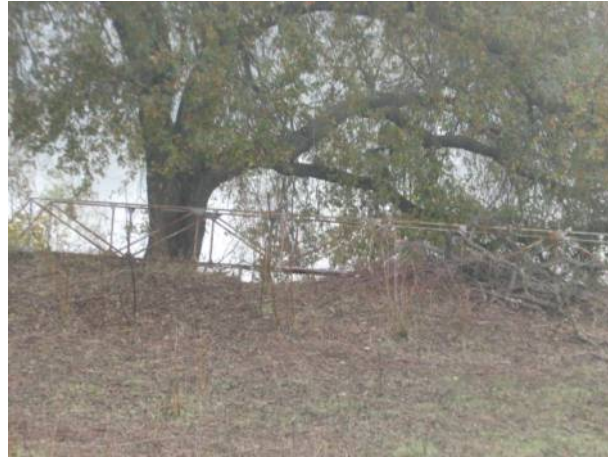
The ramp has been moved to the waterside edge. This ramp is next to repair and is scheduled to be put back in place. Fall 2012

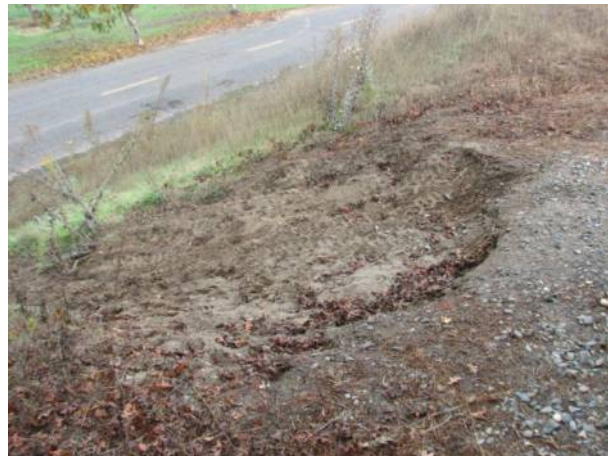
Levee Mile Report Line	18
Start Levee Mile	2.02
End Levee Mile	2.02
Location	Land Side
Category	Earthen Levee
Item	Erosion / Bank Caving

Vehicle and foot traffic has caused erosion. Fall 2012

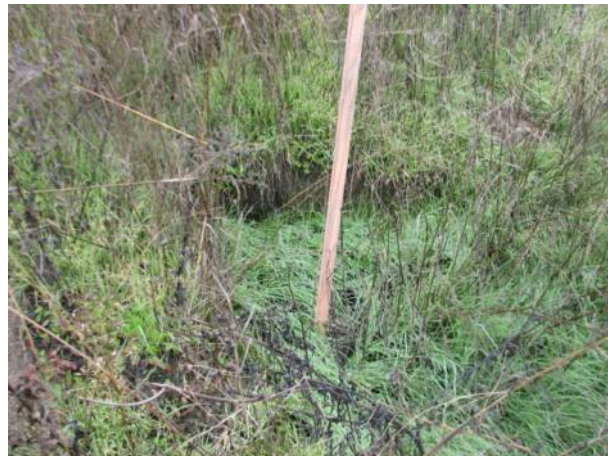
Levee Mile Report Line	25
Start Levee Mile	4.89
End Levee Mile	4.89
Location	Land Side
Category	Earthen Levee
Item	Erosion / Bank Caving

LMR No.	Levee Mile		Category	Item	Location	Rating	Action/Comment	GPS Latitude/Longitude		Issue No.
	Start	End						Start	End	
25	4.89	4.89	Earthen Levee	Erosion / Bank Caving	LS	U Ma	E2 : Schedule repair of erosion site prior to the next inspection. Inspector Comments: Hole in pipe causing erosion of levee slope. Replace pipe and repair damage.	38.736250 ° -121.604605 °	38.736250 ° -121.604605 °	25 Y
DWR ID: DWR_RD1600_01_f_2012_25										
26	5.26	5.26	Earthen Levee	Encroachments	WS	C En	DE : Debris	38.741197 ° -121.602645 °	38.741197 ° -121.602645 °	41 Y
DWR ID: DWR_RD1600_01_s_2012_41										
27	5.43	5.43	Earthen Levee	Vegetation	LS A/W	Ma	V4 : Elderberries are blocking visibility and flood fight capability.	38.743632 ° -121.601173 °	38.743632 ° -121.601173 °	13 Y
DWR ID: DWR_RD1600_01_s_2012_13										
28	5.48	5.81	Earthen Levee	Erosion / Bank Caving	WS	M Ma	E1 : Note and monitor erosion site. Inspector Comments: Levee district had us add this because of the loss of the berm over years of water flows. Erosion is at the waters edge. Walnut trees are close to edge now.	38.744118 ° -121.601104 °	38.748210 ° -121.598025 °	19 Y

The hole in the levee slope from the leaking pipe. Fall 2012

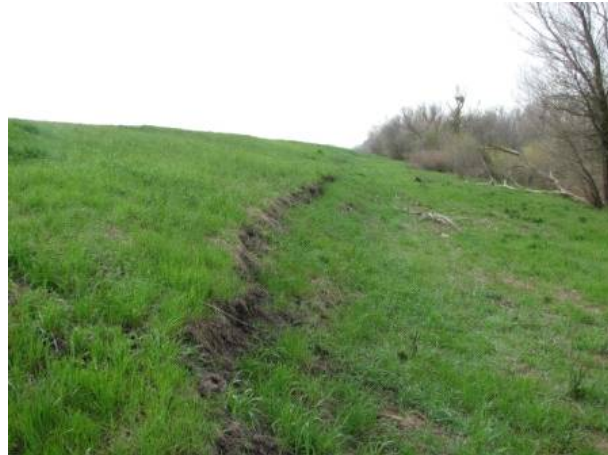
Levee Mile Report Line	13
Start Levee Mile	1.74
End Levee Mile	2.01
Location	Water Side
Category	Earthen Levee
Item	Erosion / Bank Caving

Wave wash damage along the slope the cut is 1'-2'.

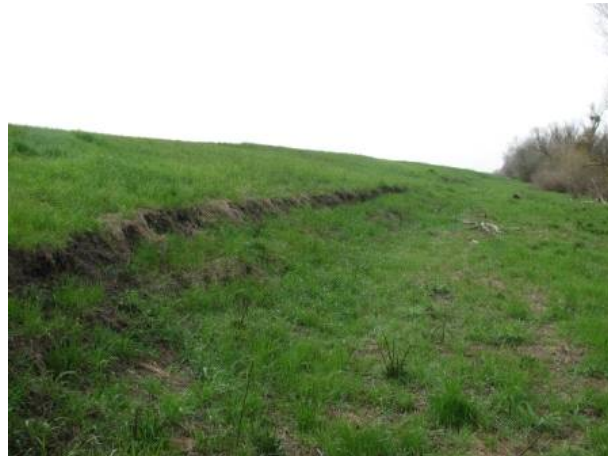
Levee Mile Report Line	13
Start Levee Mile	1.74
End Levee Mile	2.01
Location	Water Side
Category	Earthen Levee
Item	Erosion / Bank Caving

A closer view of the wave wash damage along the bypass.

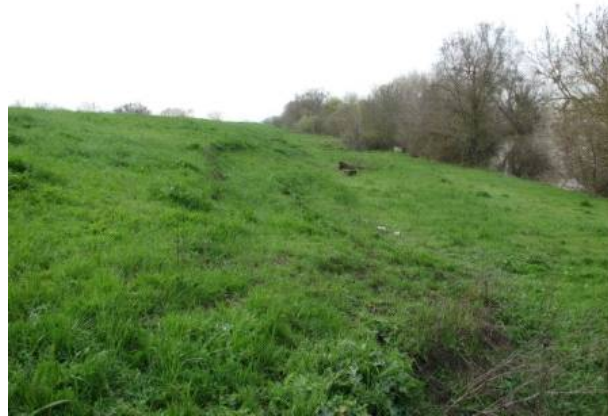
This is wave wash damage along the toe of the levee looking downstream.

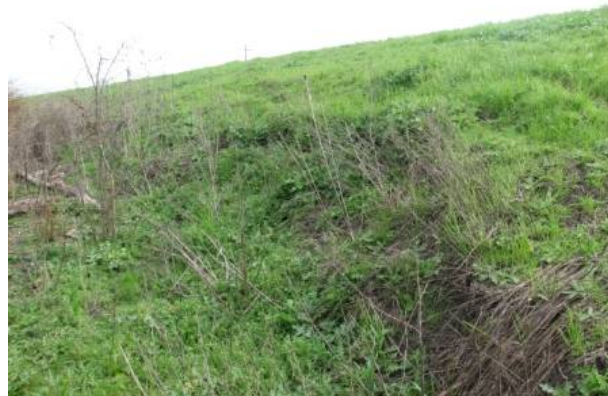
Levee Mile Report Line	14
Start Levee Mile	2.12
End Levee Mile	2.23
Location	Water Side
Category	Earthen Levee
Item	Erosion / Bank Caving

LMR No.	Levee Mile		Category	Item	Location *	Rating ** +	Action/Comment	GPS Latitude/Longitude		Issue No. Photo
	Start	End						Start	End	
14	2.12	2.23	Earthen Levee	Erosion / Bank Caving	WS	M Ma	E1 : Note and monitor erosion site. Inspector Comments: This is wave wash damage caused by last high water.	38.705614 ° -121.639357 °	38.704052 ° -121.640016 °	15 Y
DWR ID: DWR_RD1600_02_s_2012_15										
15	2.19	3.83	Earthen Levee	Crown Surface / Depressions / Rutting	CR A/W	M Ma	C3 : Add appropriate gravel or road base. Grade and compact. Inspector Comments: The areas on the crown. I have marked are the worst areas. The entire unit needs to have base added. This is to have all weather road for patrolling.	38.705027 ° -121.639568 °	38.682007 ° -121.644305 °	3 Y
DWR ID: DWR_RD1600_02_s_2012_3

Looking upstream a deeper cut of 2'-3' damage.
