**Flood Control Project Maintenance  
Levee Inspections**

**Fall 2013 Levee Maintenance Deficiency Summary Report**

**Sacramento River Basin**

**Reclamation District No. 1600 Mull**

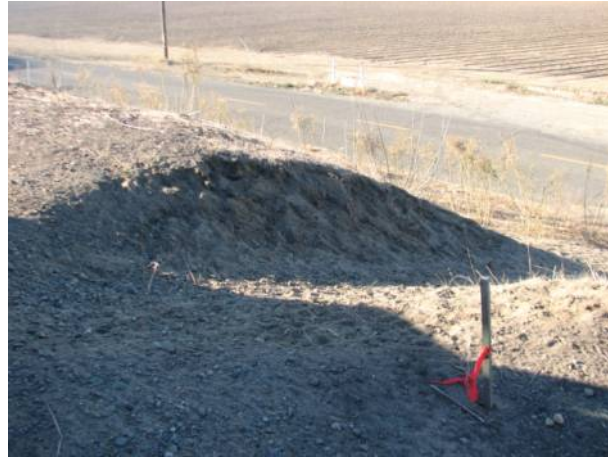
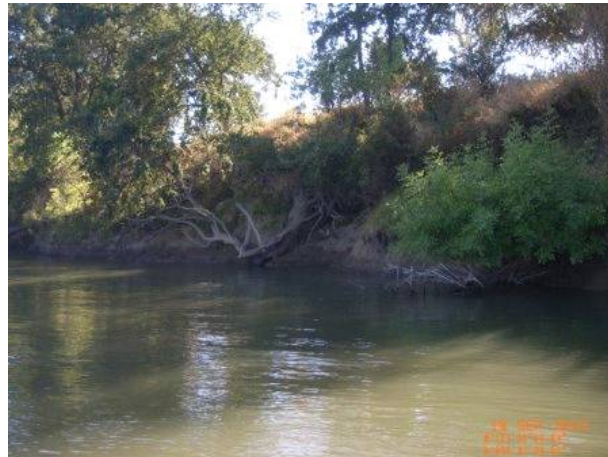
Levee Mile Report Line	15
Start Levee Mile	0.57
End Levee Mile	0.57
Location	Water Side
Category	Supplemental
Item	USACE Erosion Survey

DWR ID: DWR_RD1600_01_f_2013_133										
15	0.57	0.57	Supplemental	USACE Erosion Survey	WS	M Ma	Inspector Comments: 2000 - Very cohesive vertical bank. 2003 - Some minor new erosion. 2006 - Some minor erosion in old pockets. 2009 - Minimal new erosion. 2011 - Multiple new erosion pockets and a few new tree popouts. 2012: No observed change. [2012 Site ID: SAC_71-3_R]	38.684106 ° -121.634219 °	38.682707 ° -121.633830 °	6 Y
DWR ID:										
16	0.95	0.95	Supplemental	DWR UCIP Field Study	WS	M En	Inspector Comments: FS_ID:15085 EP_NO: 6100 Repair Type: Non-Urgent Crossing Status: Found UCIP Comments: Gate valve will not open or close. FIELD_STRUCT_DESC: 12-inch pipe through levee 3.4 feet below crown. Slant pump and gate valve on the waterward- slope. Siphon breaker in 12-inch steel riser on the landward shoulder. Filter, booster pump, and butterfly valve on LS toe. 2.25-inch galvanized iron electrical conduit at same location (Permit No. 6100, 1968). Replaced 8-inch pipe at same location. FS Date: 6/18/2013	38.688030 ° -121.635367 °	38.688030 ° -121.635367 °	115

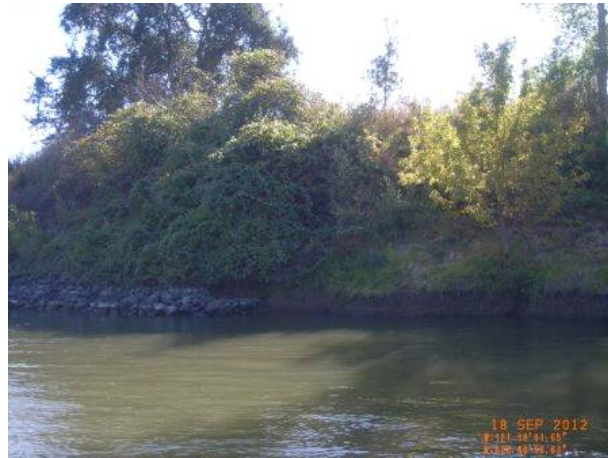
Levee Mile Report Line	17
Start Levee Mile	0.95
End Levee Mile	0.95
Location	Water Side
Category	Supplemental
Item	DWR UCIP Field Study

DWR ID: DWR_RD1600_01_f_2013_115										
17	0.95	0.95	Supplemental	DWR UCIP Field Study	WS	M En	Inspector Comments: FS_ID:15285 EP_NO: 6100 Repair Type: Non-Urgent Crossing Status: Found UCIP Comments: Gate valve will not open or close. FIELD_STRUCT_DESC: 12-inch pipe through levee 3.4 feet below crown. Slant pump and gate valve on the waterward- slope. Siphon breaker in 12-inch steel riser on the landward shoulder. Filter, booster pump, and butterfly valve on LS toe. 2.25-inch galvanized iron electrical conduit at same location (Permit No. 6100, 1968). Replaced 8-inch pipe at same location. FS Date: 6/18/2013	38.688030 ° -121.635367 °	38.688030 ° -121.635367 °	116 Y
DWR ID: DWR_RD1600_01_f_2013_116

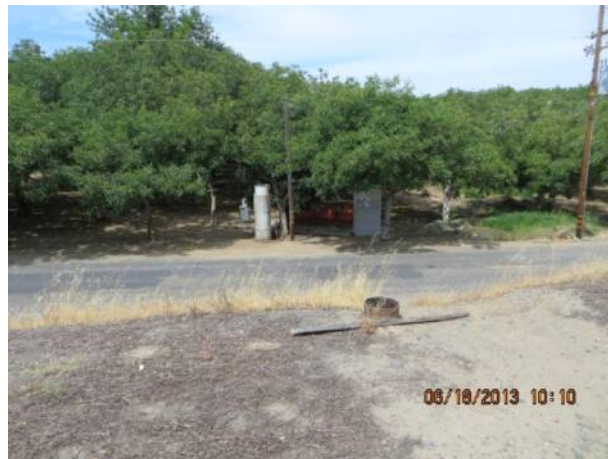
Levee Mile Report Line	18
Start Levee Mile	0.98
End Levee Mile	0.98
Location	Land Side
Category	Earthen Levee
Item	Slope Stability

The levee has a deep depression caused by slope stability. Fall 2013

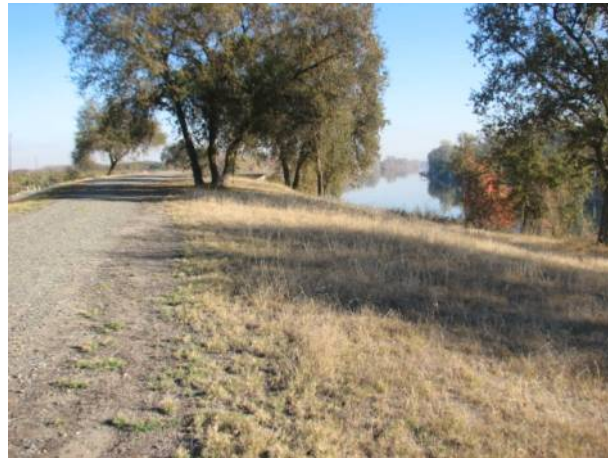
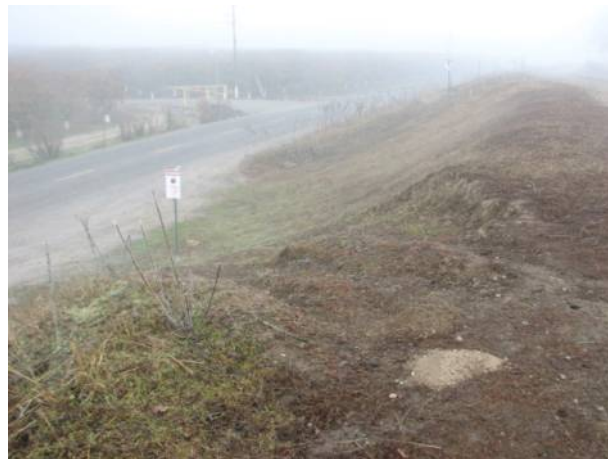
Levee Mile Report Line	22
Start Levee Mile	1.40
End Levee Mile	1.40
Location	Land Side
Category	Earthen Levee
Item	Erosion / Bank Caving

22	1.40	1.40	Earthen Levee	Erosion / Bank Caving	LS	M Ma	E2 : Schedule repair of erosion site prior to the next inspection. Inspector Comments: Damage looks like caused by vehicles.	38.694395 ° -121.634376 °	38.694395 ° -121.634376 °	4 Y
DWR ID: DWR_RD1600_01_f_2012_4										
23	1.42	1.42	Earthen Levee	Vegetation	WSA/W	V8 : Environmental Requirements.		38.694589 ° -121.634286 °	38.694589 ° -121.634286 °	5 Y
DWR ID: DWR_RD1600_01_f_2012_5										
24	1.58	1.58	Earthen Levee	Vegetation	WS	M Ma	V2 : Remove the wild growth other than native grasses from the levee slopes.	38.696748 ° -121.633201 °	38.696748 ° -121.633201 °	7 Y
DWR ID: DWR_RD1600_01_f_2012_7										
25	1.73	1.73	Earthen Levee	Vegetation	WSA/W	V8 : Environmental Requirements.		38.698613 ° -121.631710 °	38.698613 ° -121.631710 °	31 Y
DWR ID: DWR_RD1600_01_s_2012_31										
26	1.76	1.76	Earthen Levee	Crown Surface / Depressions / Rutting	WS	M Ma	C2 : Repair depressions or ruts in the crown or slope.	38.699130 ° -121.631300 °	38.699130 ° -121.631300 °	137 Y

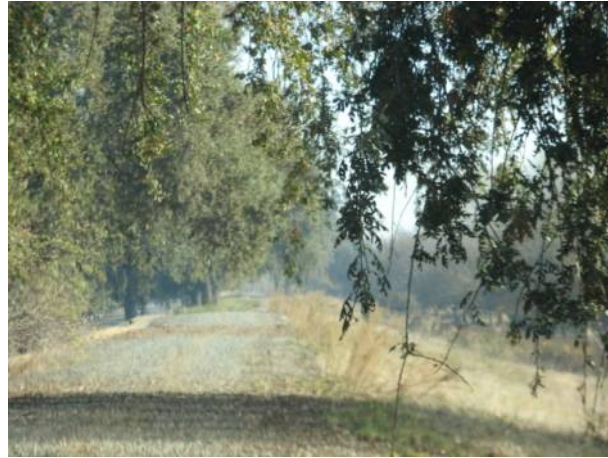
Levee Mile Report Line	28
Start Levee Mile	2.02
End Levee Mile	2.02
Location	Land Side
Category	Earthen Levee
Item	Erosion / Bank Caving

Vehicle and foot traffic has caused erosion. Fall 2012

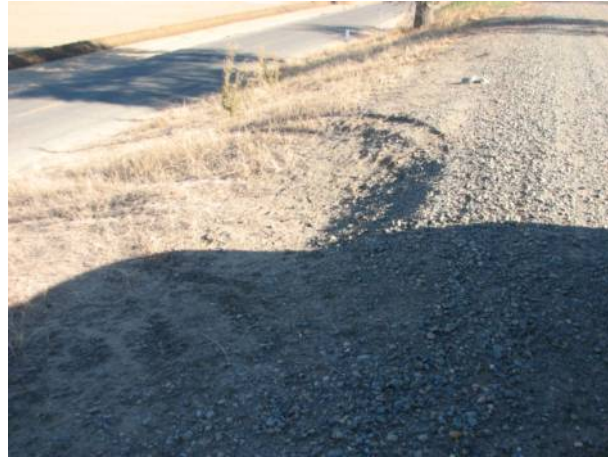
Levee Mile Report Line	32
Start Levee Mile	2.83
End Levee Mile	2.83
Location	Land Side
Category	Supplemental
Item	DWR UCIP Field Study

LMR No.	Levee Mile		Category	Item	Location	Rating	Action/Comment	GPS Latitude/Longitude		Issue No.
	Start	End						Start	End	
32	2.83	2.83	Supplemental	DWR UCIP Field Study	WS	M En	Inspector Comments: FS_ID:15108 EP_NO: N/A Repair Type: Non-Urgent Crossing Status: Found UCIP Comments: Appears abandoned and should be done so properly. Debris buildup on pier. Power cut to pump. FIELD_STRUCT_DESC: 16-inch pipe through levee 2-feet below crown. Walkway from berm to pump on pile structure in the stream. Siphon breaker on the landward slope. 12-inch PVC standpipe off LS toe. Originally included in 1955 O+M manual. FS Date: 6/18/2013	38.709350 ° -121.616913 °	38.709350 ° -121.616913 °	117 Y
DWR ID: DWR_RD1600_01_f_2013_117										
33	2.89	2.89	Earthen Levee	Trim / Thin Trees	CR	M Ma	T4 : Trim trees over roadway to at least 12 feet above ground level.	38.709898 ° -121.616180 °	38.709898 ° -121.616180 °	139 Y

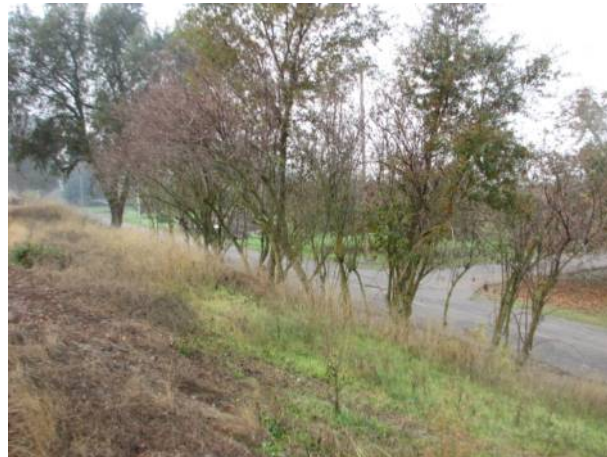
Levee Mile Report Line	36
Start Levee Mile	3.06
End Levee Mile	3.06
Location	Land Side
Category	Earthen Levee
Item	Erosion / Bank Caving

Erosion caused by vehicle traffic on the landside slope. Fall 2013

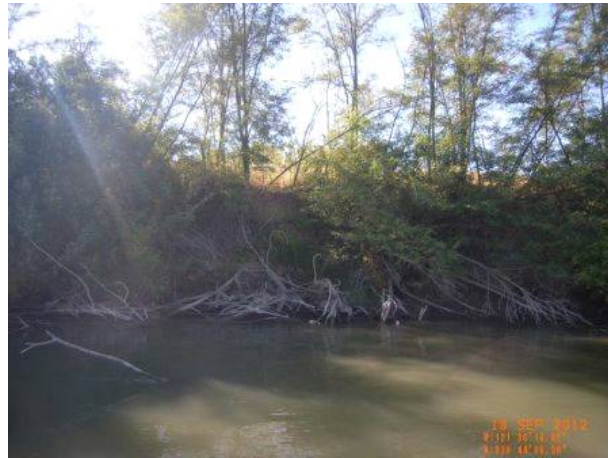
Levee Mile Report Line	40
Start Levee Mile	4.35
End Levee Mile	4.35
Location	Water Side
Category	Supplemental
Item	USACE Erosion Survey

40	4.35	4.35	Supplemental	USACE Erosion Survey	WS	M	Inspector Comments: 1997 - Very steep bank. 2005 - Lots of small trees down along the bank at the upstream end. 2006 - Minor new erosion, but slow. 2010 - Almost all of the roots are exposed on the trees, appears ready to fall. 2011 - New erosion and tree popouts. 2012: No observed change, however site is overgrown and hard to observe. [2012 Site ID: SAC_75-3_R]	38.736110 ° -121.604153 °	38.728684 ° -121.605844 °	10 Y
----	------	------	--------------	----------------------	----	---	--	------------------------------	------------------------------	---------

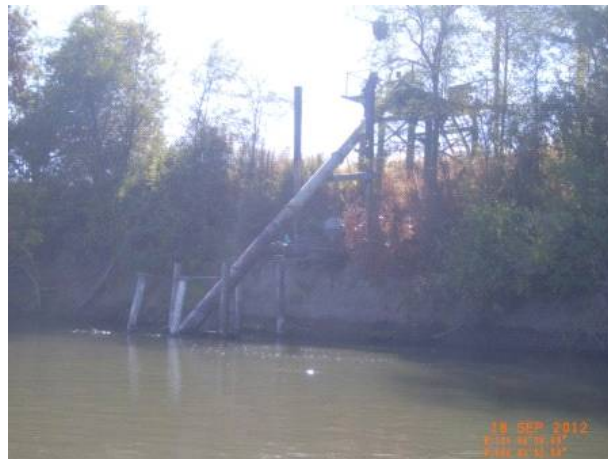
Levee Mile Report Line	41
Start Levee Mile	4.53
End Levee Mile	4.53
Location	Water Side
Category	Supplemental
Item	DWR UCIP Field Study

41	4.53	4.53	Supplemental	DWR UCIP Field Study	WS	M	Inspector Comments: FS_ID:15125 EP_NO: N/A Repair Type: Non-Urgent Crossing Status: Found UCIP Comments: Pumphouse abandoned with deep pit open. Safety issue. If plant is abandoned it should be done so properly. FIELD_STRUCT_DESC: 24-inch pipe through the levee 21.4 feet below the crown. 16-inch pipe ties into 24-inch at WS slope. Slant pump on metal platform and gate valve on water side berm. Gate valve in pump house off the landward side. Two power poles at the toe of the landward slope. FS Date: 6/18/2013 7:36:00 AM	38.731143 ° -121.605825 °	38.731143 ° -121.605825 °	119 Y
----	------	------	--------------	----------------------	----	---	--	------------------------------	------------------------------	----------

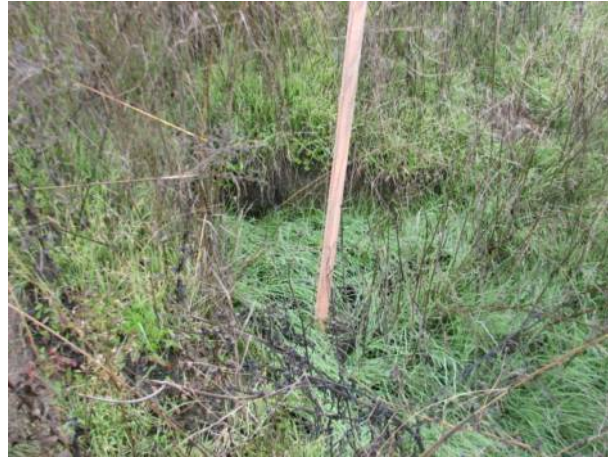
Levee Mile Report Line	45
Start Levee Mile	4.90
End Levee Mile	4.90
Location	Land Side
Category	Supplemental
Item	DWR UCIP Field Study

45	4.90	4.90	Supplemental	DWR UCIP Field Study	LS	U	Inspector Comments: FS_ID:15130 EP_NO: N/A Repair Type: Urgent Crossing Status: Found UCIP Comments: No pump on pier and pipe open on both ends without a closure device. FIELD_STRUCT_DESC: 18-inch steel pipe through levee 6.7-feet below crown. Pump on wooden pier off waterward side. Air vents on WS slope and meter at outlet on LS toe. 6'X14' concrete distribution box off LS toe. 2-inch galvanized iron electrical conduit through the levee at same location. Originally included in the 1955 O&M manual. FS Date: 6/18/2013	38.736299 ° -121.604582 °	38.736299 ° -121.604582 °	120 Y
----	------	------	--------------	----------------------	----	---	--	------------------------------	------------------------------	----------

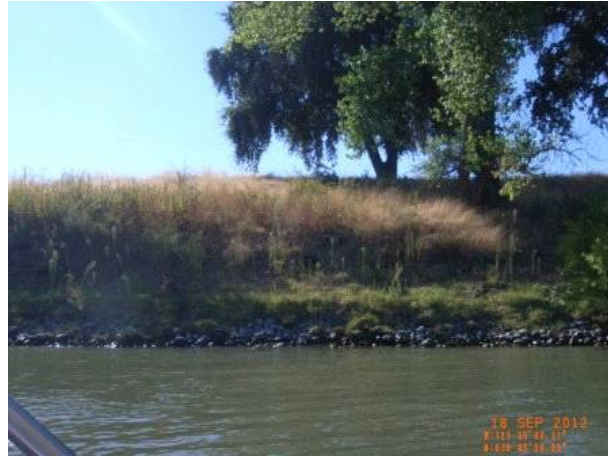
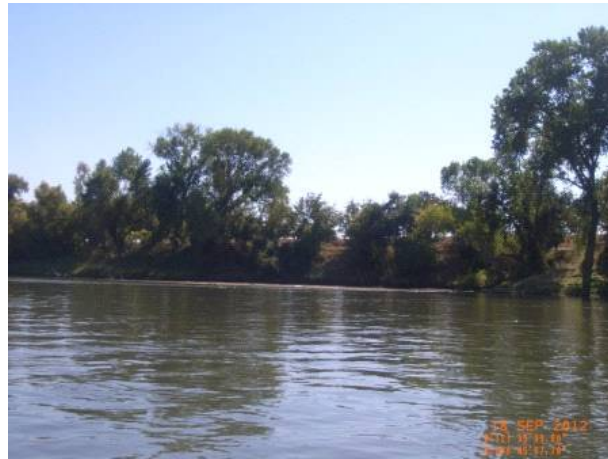
Levee Mile Report Line	52
Start Levee Mile	6.96
End Levee Mile	6.96
Location	Water Side
Category	Supplemental
Item	USACE Erosion Survey

LMR No.	Levee Mile		Category	Item	Location	Rating	Action/Comment	GPS Latitude/Longitude		Issue No.
	Start	End						Start	End	
52	6.96	6.96	Supplemental	USACE Erosion Survey	WS	M	Inspector Comments: 2006 - Eddy scour off end of rock causing erosion and scour hole near levee. Sandy silt bank with rock on upstream end. 2010 - Trees are leaning more, minor new erosion. 2011 - Many of the tree roots have scoured out and trees look ready to fall. 2012: No observed change. [2012 Site ID: SAC_77-7_R]	38.765219 ° -121.595049 °	38.764801 ° -121.594926 °	12 Y
DWR ID: _____										
53	7.01	7.01	Earthen Levee	Erosion / Bank Caving	WS	M	E1 : Note and monitor erosion site.	38.764943 ° -121.595504 °	38.764943 ° -121.595504 °	30 Y
DWR ID: DWR_RD1600_01_s_2013_30										
54	7.02	7.02	Earthen Levee	Erosion / Bank Caving	LS	M	E1 : Note and monitor erosion site.	38.764974 ° -121.595533 °	38.764974 ° -121.595533 °	27 Y

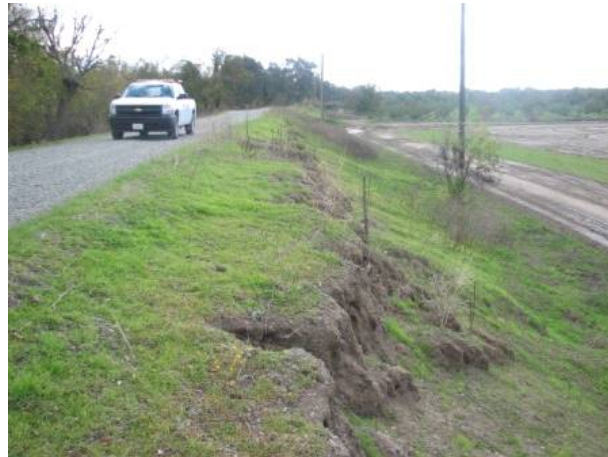
Levee Mile Report Line	55
Start Levee Mile	7.13
End Levee Mile	7.13
Location	Water Side
Category	Earthen Levee
Item	Erosion / Bank Caving
The erosion is eroding away at the berm area.	
johngw_f_20131021_627.jpg

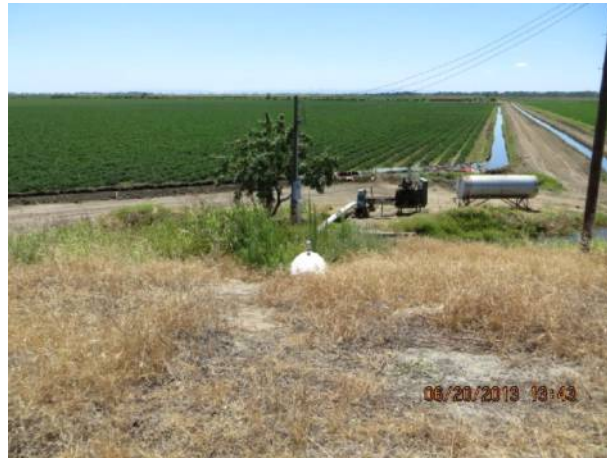
Levee Mile Report Line	62
Start Levee Mile	8.07
End Levee Mile	8.07
Location	Water Side
Category	Supplemental
Item	DWR UCIP Field Study

LMR No.	Levee Mile		Category	Item	Location *	Rating ** +	Action/Comment	GPS Latitude/Longitude		Issue No. Photo
	Start	End						Start	End	
62	8.07	8.07	Supplemental	DWR UCIP Field Study	WS	M En	Inspector Comments: FS_ID:15247 EP_NO: 7339 Repair Type: Non-Urgent Crossing Status: Indicator Found UCIP Comments: Need to determine disposition of pipe. If abandoned, it should be done so properly. FIELD_STRUCT_DESC: 24-inch steel pipe through levee 3.8 feet below crown. Steel plate welded on the waterward end. Pipe not visible on either slope. Pylons in river at WS toe and a 4-foot diameter steel standpipe on the LS toe (Permit No. 7339, 1977) Seepage area at toe of the landward slope. FS Date: 6/20/2013	38.777799 ° -121.609763 °	38.777799 ° -121.609763 °	128 Y
DWR ID: DWR_RD1600_01_f_2013_128										
63	9.41	9.52	Earthen Levee	Encroachments	WS	M En	PI : Pipe	38.779285 ° -121.626792 °	38.777562 ° -121.627669 °	142 Y

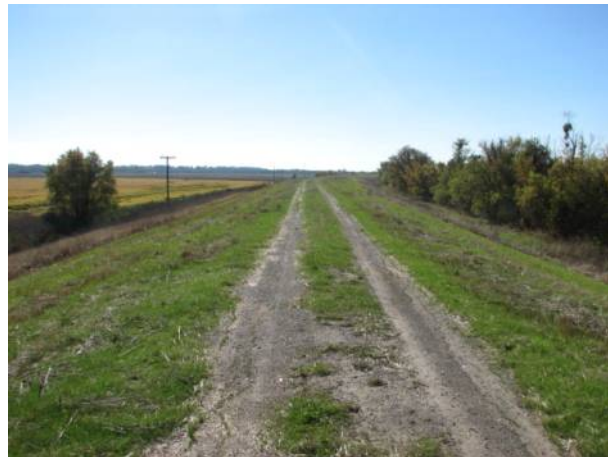
Levee Mile Report Line	7
Start Levee Mile	1.13
End Levee Mile	1.13
Location	Crown
Category	Earthen Levee
Item	Crown Surface / Depressions / Rutting
Ruts in the levee crown Spring 2013	
johngw_f_20131021_743.JPG

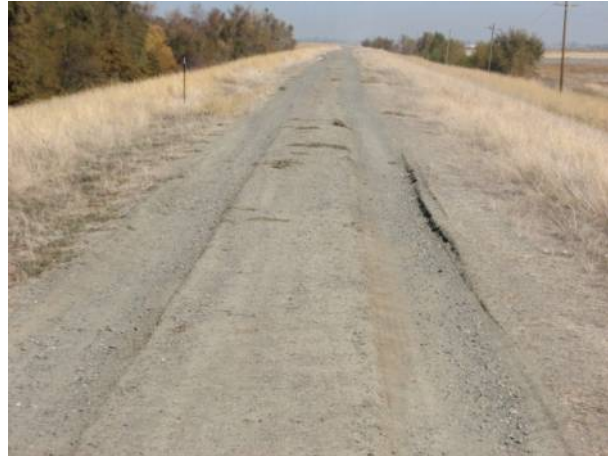
Levee Mile Report Line	12
Start Levee Mile	2.12
End Levee Mile	2.23
Location	Water Side
Category	Earthen Levee
Item	Erosion / Bank Caving
This is wave wash damage along the toe of the levee looking downstream.	
johngw_f_20131021_749.jpg

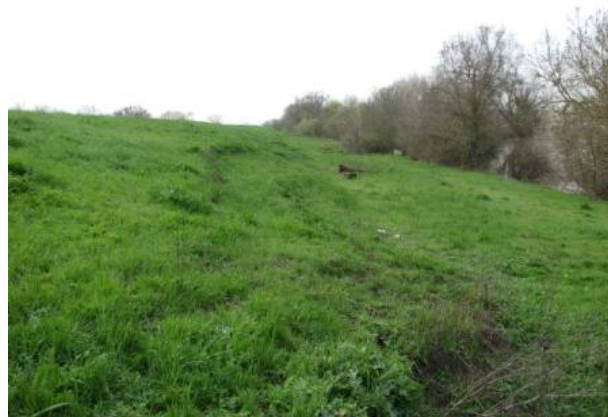
Levee Mile Report Line	12
Start Levee Mile	2.12
End Levee Mile	2.23
Location	Water Side
Category	Earthen Levee
Item	Erosion / Bank Caving
Looking upstream a deeper cut of 2'-3' damage.	
johngw_f_20131021_750.jpg

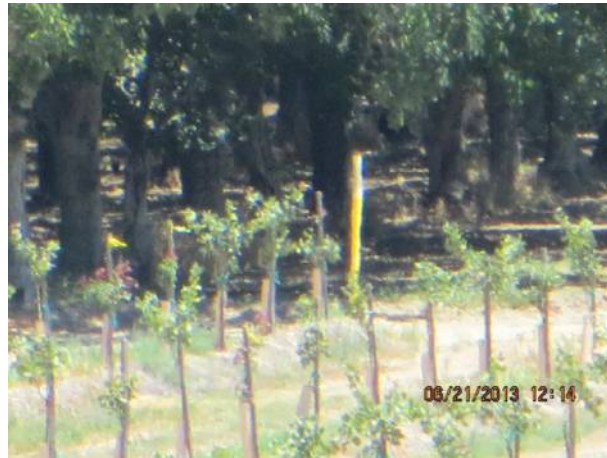
Levee Mile Report Line	15
Start Levee Mile	3.69
End Levee Mile	4.18
Location	Land Side
Category	Earthen Levee
Item	Vegetation
The goats have been through here. No unwanted vegetation on the levee. Fall 2013	
johngw_f_20131114_348.JPG
