**Flood Control Project Maintenance  
Levee Inspections**

**Fall 2014 Levee Maintenance Deficiency Summary Report**

**Sacramento River Basin**

**Reclamation District No. 1600 Mull**

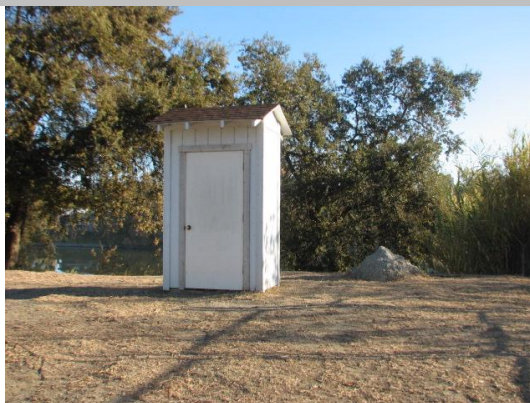
Photo 1 of 1 : FA\_2014\_RD1600\_191\_129\_20141014\_00037.jpg

LM Start	0.10	Rating **	M	Issue No.	129
LM End	0.10	Issue Type +	En	Location *	WS
Category	Earthen Levee			GPS Latitude/Longitude	
				Start	End
Item	Encroachments			38.676467 °	38.676467 °
				-121.631217 °	-121.631217 °
DWR ID	DWR_RD1600_01_f_2013_129				
Action/Comments					
Building					
Inspector Comments: This is a well pump house. It is potable water for the house and pumping plant.

The small building is a pump house for the well. It services the house with water. Fall 2013

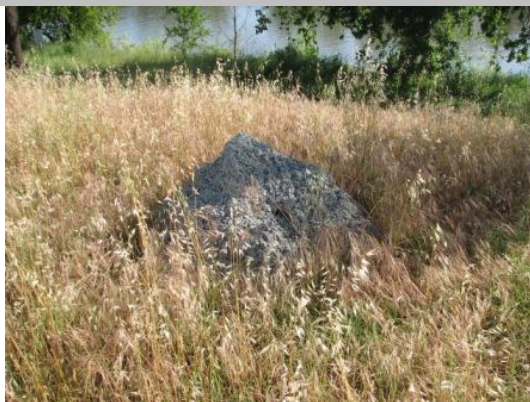
Photo 1 of 1 : FA\_2014\_RD1600\_191\_29\_20141014\_00028.jpg

LM Start	0.10	Rating **	M	Issue No.	29
LM End	0.10	Issue Type +	En	Location *	WS
Category	Earthen Levee			GPS Latitude/Longitude	
				Start	End
Item	Encroachments			38.676480 °	38.676480 °
				-121.631220 °	-121.631220 °
DWR ID	DWR_RD1600_01_s_2012_29				
Action/Comments					
Debris					
Inspector Comments: Pile of concrete.

A pile of concrete left over from the drilling of the well. Photo taken spring 2012.

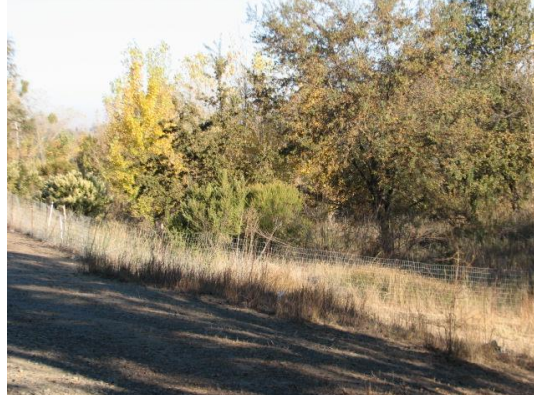
Photo 1 of 2 : FA\_2014\_RD1600\_191\_49\_20141014\_00035.jpg

The revegetation area is fenced off but nobody has been caring for it.  
Fall 2013

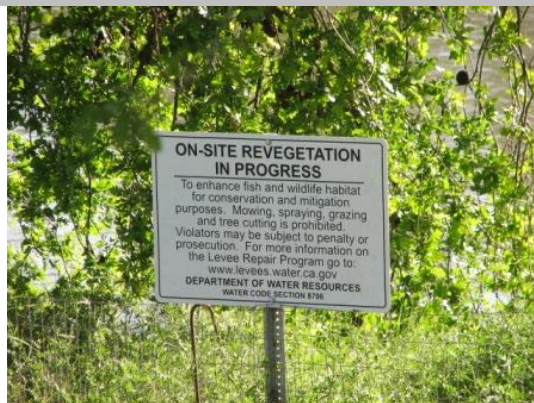
Photo 2 of 2 : FA\_2014\_RD1600\_191\_49\_20141014\_00036.jpg

Revegetation site. Photo taken spring 2012.

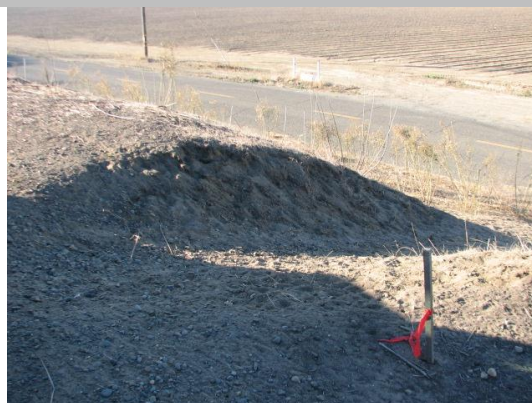
Photo 1 of 1 : FA\_2014\_RD1600\_191\_133\_20141014\_00040.jpg

LM Start	0.53	Rating **	M	Issue No.	133
LM End	0.53	Issue Type +	Ma	Location *	LS
Category	Earthen Levee			GPS Latitude/Longitude	
				Start	End
Item	Erosion / Bank Caving			38.682140 °	38.682140 °
				-121.634083 °	-121.634083 °
DWR ID	DWR_RD1600_01_f_2013_133				
Action/Comments					
Schedule repair of erosion site prior to the next inspection.

The erosion on the landside shoulder is caused by foot traffic. Fall 2013

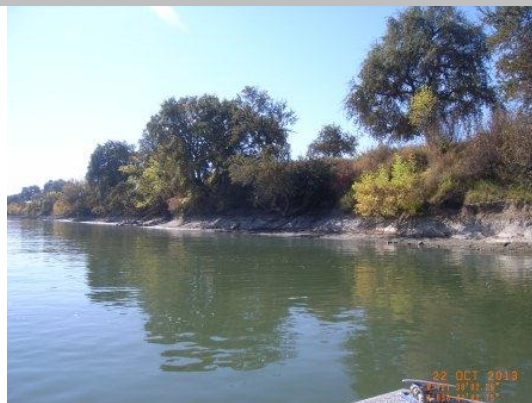
Photo 1 of 1 : FA\_2014\_RD1600\_191\_6\_20141014\_00007.jpg

LM Start	0.57	Rating **	M	Issue No.	6
LM End	0.57	Issue Type +	Ma	Location *	WS
Category	Supplemental			GPS Latitude/Longitude	
				Start	End
Item	USACE Erosion Survey			38.682707 °	38.684106 °
				-121.633830 °	-121.634219 °
DWR ID	DWR_RD1600_01_f_2014_6				
Action/Comments					
Inspector Comments: 2000 - Very cohesive vertical bank. 2003 - Some minor new erosion. 2006 - Some minor erosion in old pockets. 2009 - Minimal new erosion. 2011 - Multiple new erosion pockets and a few new tree popouts. 2013: No observed changes. [2013 Site ID: SAC_71-3_R]

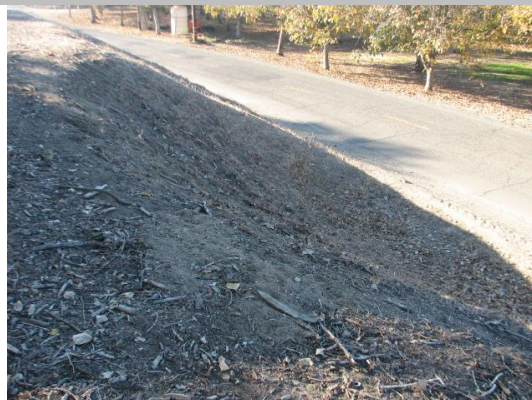
Photo 1 of 1 : FA\_2014\_RD1600\_191\_134\_20141014\_00041.jpg

LM Start	0.98	Rating **	M	Issue No.	134
LM End	0.98	Issue Type +	Ma	Location *	LS
Category	Earthen Levee			GPS Latitude/Longitude	
				Start	End
Item	Slope Stability			38.688454 °	38.688454 °
				-121.635528 °	-121.635528 °
DWR ID	DWR_RD1600_01_f _ 2013_134				
Action/Comments					
Repair slope instability.

The levee has a deep depression caused by slope stability. Fall 2013

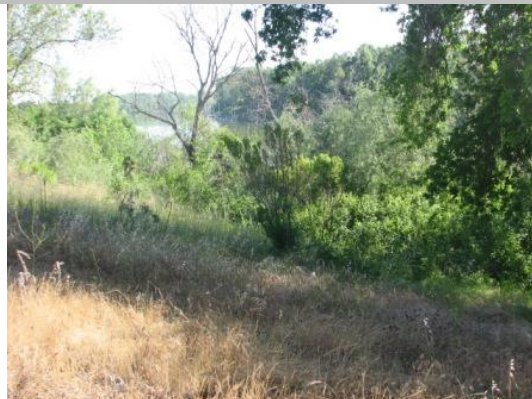
Photo 1 of 2 : FA\_2014\_RD1600\_191\_22\_20141014\_00022.jpg

The revegetation site along the berm and shoulder of the river.

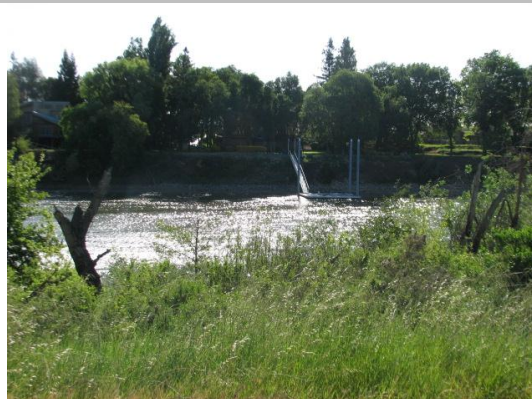
Photo 1 of 1 : FA\_2014\_RD1600\_191\_626\_20141014\_00051.jpg

LM Start	1.11	Rating **	A/W	Issue No.	626
LM End	1.11	Issue Type +	Ma	Location *	WS
Category	Earthen Levee			GPS Latitude/Longitude	
				Start	End
Item	Vegetation			38.690323 °	38.690323 °
				-121.635666 °	-121.635666 °
DWR ID	DWR_RD1600_01_s_2014_626				
Action/Comments					
Trees / Woody Vegetation

Two trees at the waterside berm that may pose a threat to the levee.  
Spring 2014

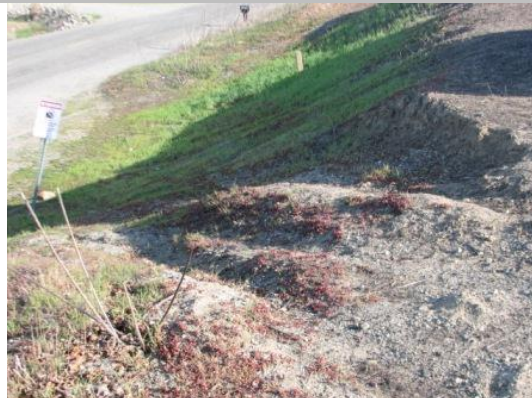
Photo 1 of 2 : FA\_2014\_RD1600\_191\_4\_20141014\_00003.jpg

LM Start	1.40	Rating **	M	Issue No.	4
LM End	1.40	Issue Type +	Ma	Location *	LS
Category	Earthen Levee			GPS Latitude/Longitude	
				Start	End
Item	Erosion / Bank Caving			38.694395 °	38.694395 °
				-121.634376 °	-121.634376 °
DWR ID	DWR_RD1600_01_f_2012_4				
Action/Comments					
Schedule repair of erosion site prior to the next inspection. Inspector Comments: Damage looks like caused by vehicles.

Erosion from vehicles on levee slope. Spring 2013

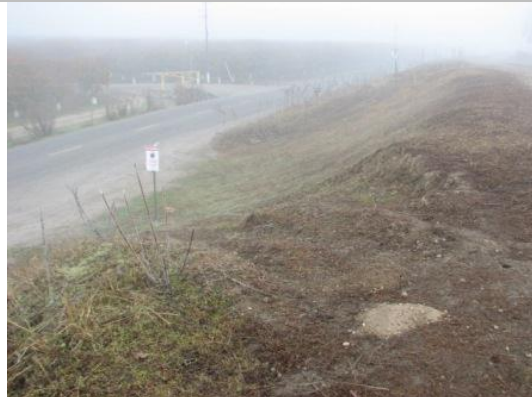
Photo 2 of 2 : FA\_2014\_RD1600\_191\_4\_20141014\_00004.jpg

LM Start	1.40	Rating **	M	Issue No.	4 (cont)	
LM End	1.40	Issue Type +	Ma	Location *	LS	
Category	Earthen Levee			GPS Latitude/Longitude		
				Start		End
Item	Erosion / Bank Caving			38.694395 °	38.694395 °	
				-121.634376 °	-121.634376 °	
DWR ID	DWR_RD1600_01_f_2012_4					
Action/Comments						
Schedule repair of erosion site prior to the next inspection. Inspector Comments: Damage looks like caused by vehicles.

Vehicles and people have created some erosion on the levee. Fall 2012

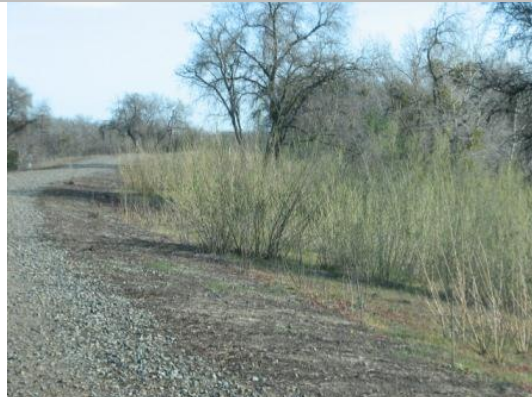
Photo 1 of 2 : FA\_2014\_RD1600\_191\_7\_20141014\_00008.jpg

Willows are starting to come back creeping up on to the shoulder.  
Spring 2013

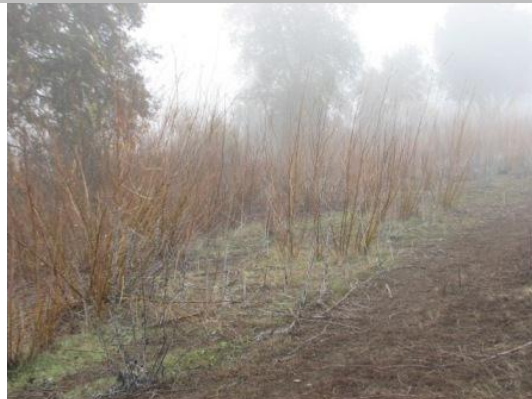
Photo 2 of 2 : FA\_2014\_RD1600\_191\_7\_20141014\_00009.jpg

Willows are growing on the waterside shoulder. They have been grazed by goats. Fall 2012

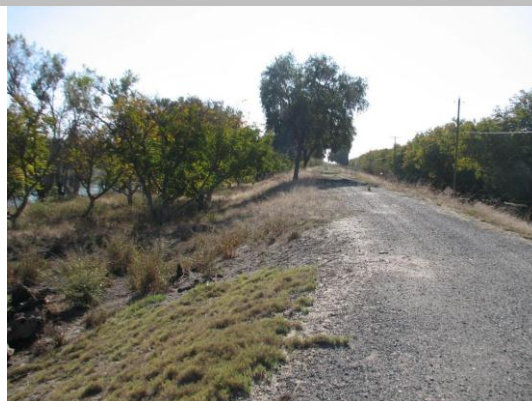
Photo 1 of 2 : FA\_2014\_RD1600\_191\_40\_20141114\_00067.jpg

LM Start	1.70	Rating **	M	Issue No.	40
LM End	10.51	Issue Type +	Ma	Location *	WS
Category	Earthen Levee			GPS Latitude/Longitude	
				Start	End
Item	Vegetation			38.749166 °	°
				-121.597261 °	°
DWR ID	DWR_RD1600_01_f_2014_40				
Action/Comments					
Control annual grass and weeds on the levee slopes and easements.

Levee mile 5.80, vegetation on the water side slope.

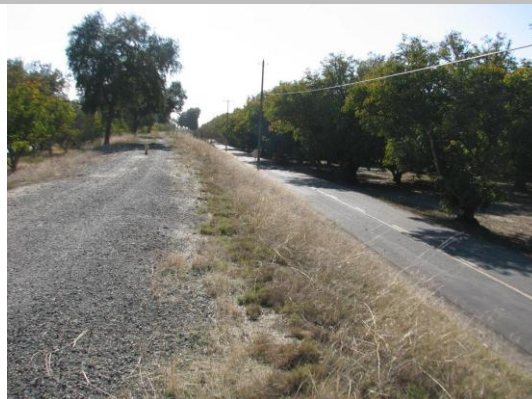
Photo 2 of 2 : FA\_2014\_RD1600\_191\_40\_20141114\_00068.jpg

Levee mile 5.80, vegetation on the land side slope.

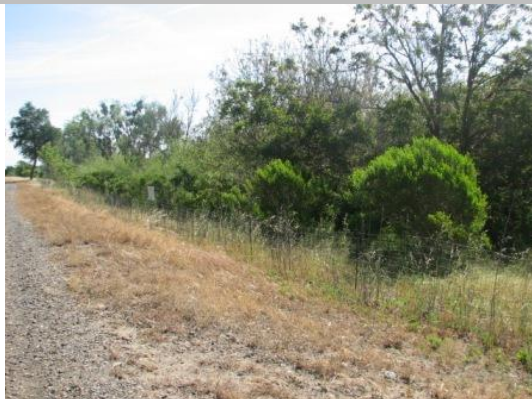
Photo 1 of 2 : FA\_2014\_RD1600\_191\_35\_20141014\_00032.jpg

The revegetation site extends almost to the hinge point.

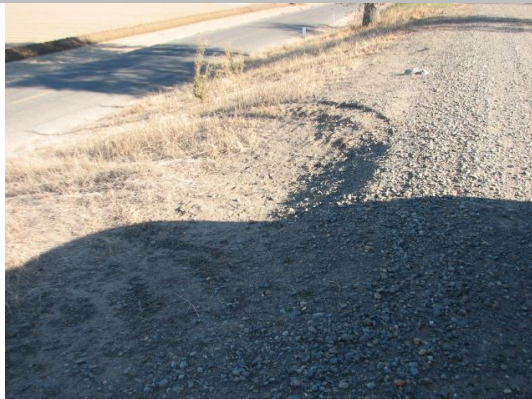
Photo 1 of 1 : FA\_2014\_RD1600\_191\_143\_20141014\_00048.jpg

LM Start	2.42	Rating **	M	Issue No.	143
LM End	2.42	Issue Type +	Ma	Location *	LS
Category	Earthen Levee			GPS Latitude/Longitude	
				Start	End
Item	Slope Stability			38.705152 °	38.705152 °
				-121.622190 °	-121.622190 °
DWR ID	DWR_RD1600_01_f_2013_143				
Action/Comments					
Repair slope instability.

The levee slope appears to have slipped at the shoulder. Fall 2013

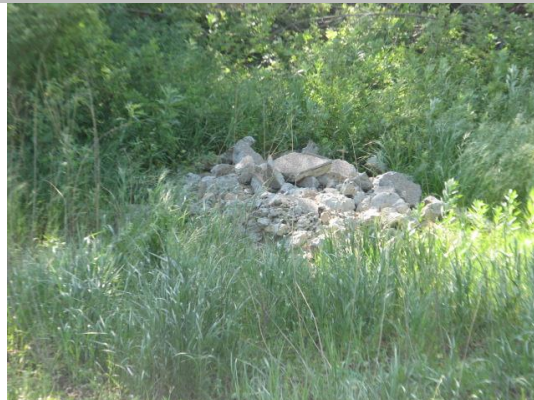
Photo 1 of 1 : FA\_2014\_RD1600\_191\_135\_20141014\_00042.jpg

Concrete debris is on the waterside berm. Spring 2014

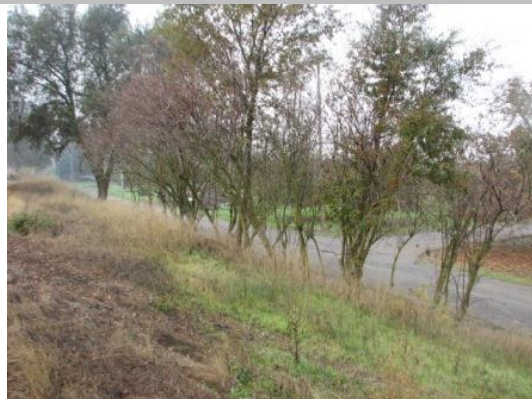
Photo 1 of 1 : FA\_2014\_RD1600\_191\_37\_20141014\_00034.jpg

A large stand of elderberries on the landside slope. Fall 2012

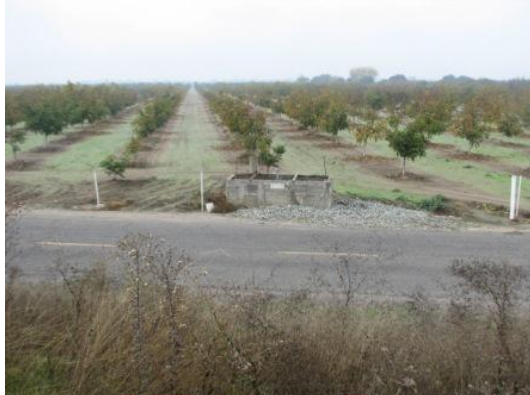
Photo 2 of 2 : FA\_2014\_RD1600\_191\_25\_20141014\_00025.jpg

LM Start	4.89	Rating **	U	Issue No.	25 (cont)
LM End	4.89	Issue Type +	Ma	Location *	LS
Category	Earthen Levee			GPS Latitude/Longitude	
				Start	End
Item	Erosion / Bank Caving			38.736250 °	38.736250 °
				-121.604605 °	-121.604605 °
DWR ID	DWR_RD1600_01_f_2012_25				
Action/Comments					
Schedule repair of erosion site prior to the next inspection. Inspector Comments: Hole in pipe causing erosion of levee slope. Replace pipe and repair damage.

The concrete collection box across the road. Fall 2012

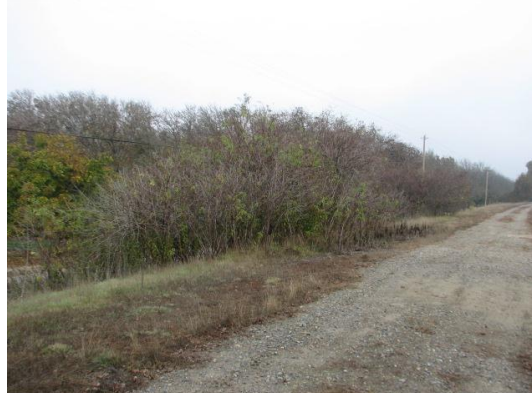
Photo 1 of 1 : FA\_2014\_RD1600\_191\_13\_20141014\_00014.jpg

A thick stand of elderberries on the landside. Fall 2012

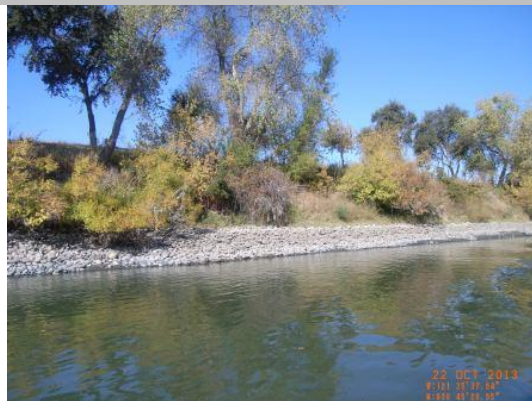
Photo 1 of 1 : FA\_2014\_RD1600\_191\_11\_20141014\_00012.jpg

LM Start	6.23	Rating **	M	Issue No.	11
LM End	6.23	Issue Type +	Ma	Location *	WS
Category	Supplemental			GPS Latitude/Longitude	
				Start	End
Item	USACE Erosion Survey			38.755246 °	38.756186 °
				-121.594206 °	-121.594024 °
DWR ID	DWR_RD1600_01_f_2014_11				
Action/Comments					
Inspector Comments: 2011 - Large vertical eroded face from a rotational failure just below pump. 2013: No observed changes. [2013 Site ID: SAC_77-0_R]

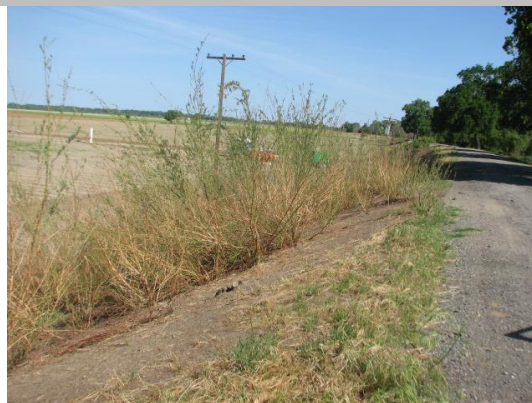
Photo 1 of 1 : FA\_2014\_RD1600\_191\_631\_20141014\_00056.jpg

LM Start	6.64	Rating **	M	Issue No.	631
LM End	6.64	Issue Type +	Ma	Location *	LS
Category	Earthen Levee			GPS Latitude/Longitude	
				Start	End
Item	Vegetation			38.759685 °	38.759685 °
				-121.594109 °	-121.594109 °
DWR ID	DWR_RD1600_01_s_2014_631				
Action/Comments					
Remove the wild growth other than native grasses from the levee slopes.

The tall brush and vegetation blocks visibility. Spring 2014

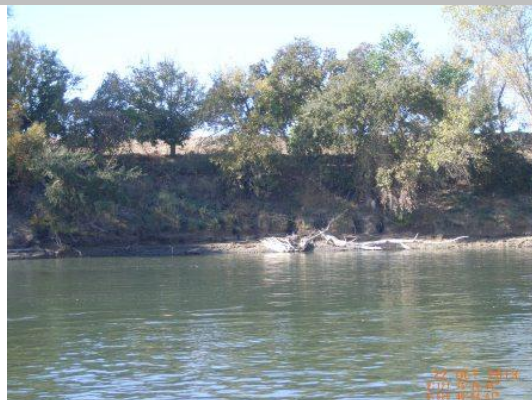
Photo 1 of 1 : FA\_2014\_RD1600\_191\_12\_20141014\_00013.jpg

LM Start	6.98	Rating **	M	Issue No.	12
LM End	6.98	Issue Type +	Ma	Location *	WS
Category	Supplemental			GPS Latitude/Longitude	
				Start	End
Item	USACE Erosion Survey			38.764801 °	38.765219 °
				-121.594926 °	-121.595049 °
DWR ID	DWR_RD1600_01_f_2014_12				
Action/Comments					
Inspector Comments: 2006 - Eddy scour off end of rock causing erosion and scour hole near levee. Sandy silt bank with rock on upstream end. 2010 - Trees are leaning more, minor new erosion. 2011 - Many of the tree roots have scoured out and trees look ready to fall. 2013: No observed changes. [2013 Site ID: SAC_77-7_R]

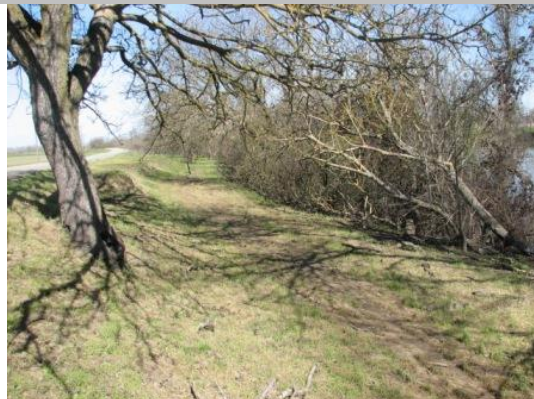
Photo 2 of 2 : FA\_2014\_RD1600\_191\_20\_20141014\_00019.jpg

The erosion is eroding away at the berm area.

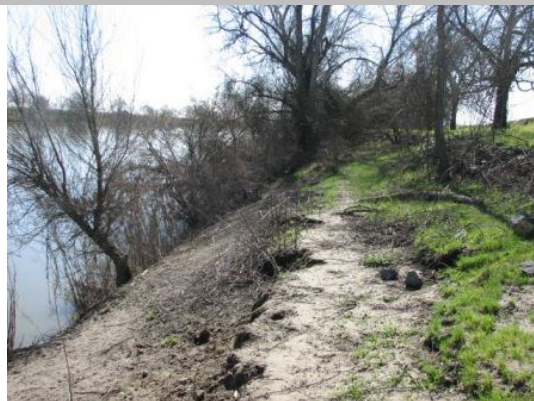
Photo 1 of 2 : FA\_2014\_RD1600\_191\_21\_20141014\_00020.jpg

LM Start	7.27	Rating **	M	Issue No.	21
LM End	7.27	Issue Type +	Ma	Location *	WS
Category	Earthen Levee			GPS Latitude/Longitude	
				Start	End
Item	Erosion / Bank Caving			38.768409 °	38.768409 °
				-121.597213 °	-121.597213 °
DWR ID	DWR_RD1600_01_s_2012_21				
Action/Comments					
Note and monitor erosion site.

The erosion is eroding away the berm area.

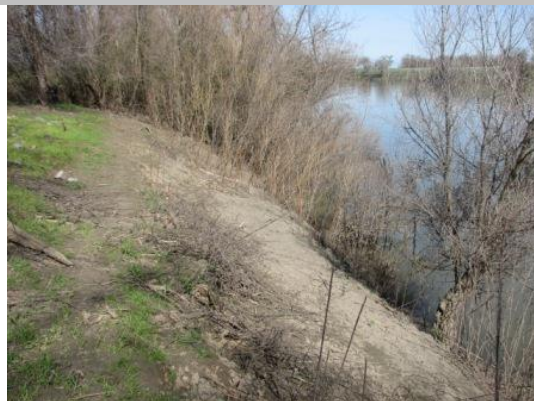
Photo 2 of 2 : FA\_2014\_RD1600\_191\_21\_20141014\_00021.jpg

The bank is eroding away and has become very steep.

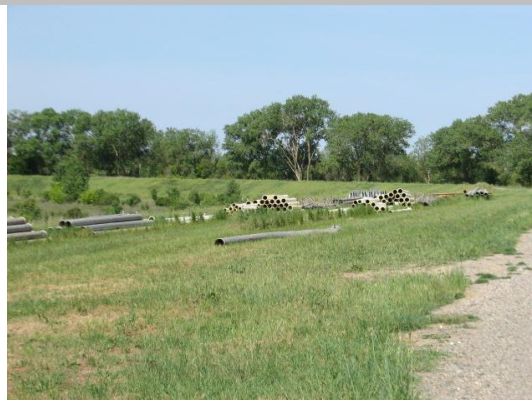
Photo 1 of 1 : FA\_2014\_RD1600\_191\_634\_20141014\_00057.jpg

Irrigation pipe is being stored on the landside. Spring 2014

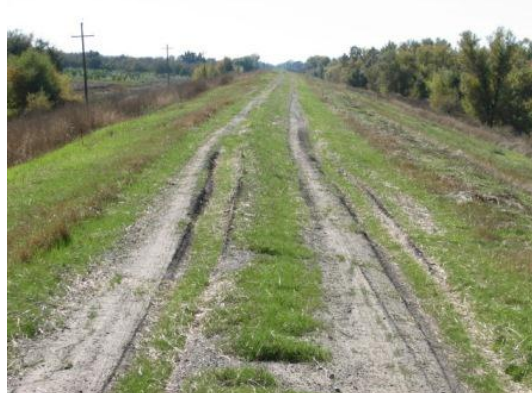
Photo 1 of 3 : FA\_2014\_RD1600\_192\_32\_20141014\_00014.jpg

LM Start	1.65	Rating **	M	Issue No.	32
LM End	1.65	Issue Type +	Ma	Location *	CR
Category	Earthen Levee			GPS Latitude/Longitude	
				Start	End
Item	Crown Surface / Depressions / Rutting			38.712382 °	38.712382 °
				-121.636417 °	-121.636417 °
DWR ID	DWR_RD1600_02_s_2012_32				
Action/Comments					
Repair depressions or ruts in the crown or slope.

The crown has ruts deeper then six inches. Fall 2012

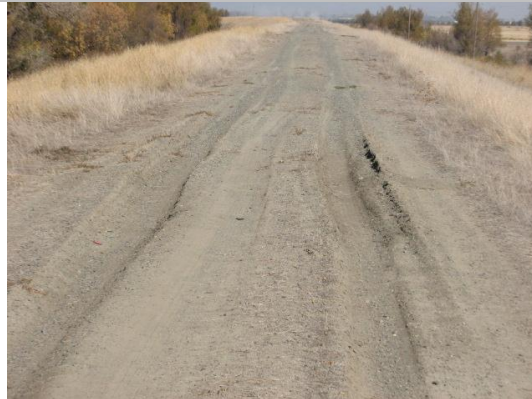
Photo 2 of 3 : FA\_2014\_RD1600\_192\_32\_20141014\_00015.jpg

Tire ruts are deeper than 6 inches on the crown. Fall 2013

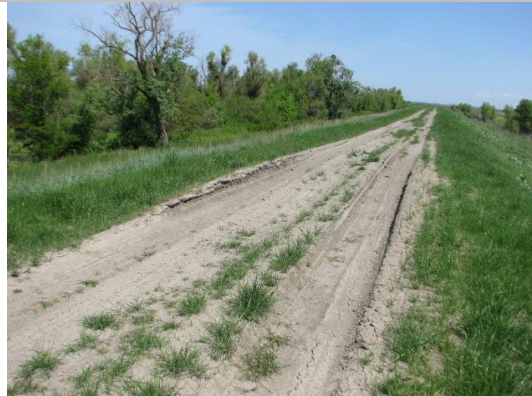
Photo 3 of 3 : FA\_2014\_RD1600\_192\_32\_20141014\_00016.jpg

Ruts in the all weather road needs to be repaired. Spring 2014

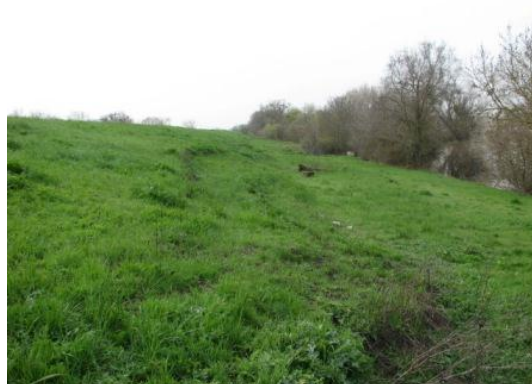
Photo 2 of 2 : FA\_2014\_RD1600\_192\_15\_20141014\_00011.jpg

This is wave wash damage along the toe of the levee looking downstream.
