**Flood Control Project Maintenance
Levee Inspections**

Fall 2015 Levee Maintenance Deficiency Summary Report

Sacramento River Basin

Reclamation District No. 1600 Mull

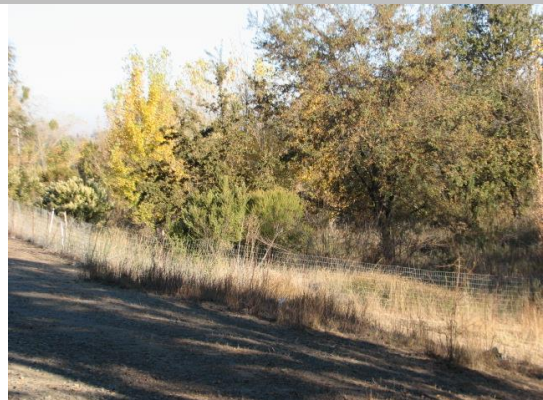
Photo 1 of 2 : FA_2015_RD1600_191_49_20150914_00030.jpg

The revegetation area is fenced off but nobody has been caring for it.
Fall 2013

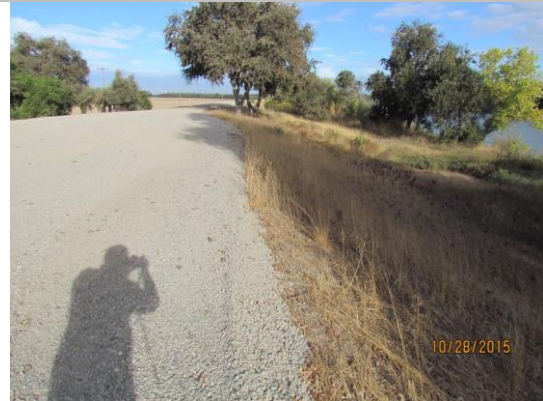
Photo 1 of 1 : FA_2015_RD1600_191_36_20151103_00060.jpg

View of the vegetation on the waterward side of the levee looking upstream. Fall 2015.

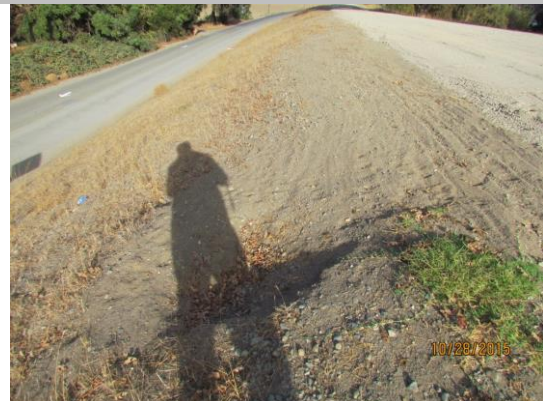
Photo 1 of 1 : FA_2015_RD1600_191_38_20151103_00061.jpg

LM Start	0.12	Rating **	M	Issue No.	38
LM End	0.12	Issue Type +	Ma	Location *	LS
Category	Earthen Levee			GPS Latitude/Longitude	
				Start	End
Item	Slope Stability			38.676654 °	38.676654 °
				-121.631348 °	-121.631348 °
DWR ID	DWR_RD1600_01_f_2015_38				
Action/Comments					
Repair the levee slope damaged by vehicle traffic and prevent access where possible.

View of a slope depression on the landward side of the levee looking downstream. Fall 2015.

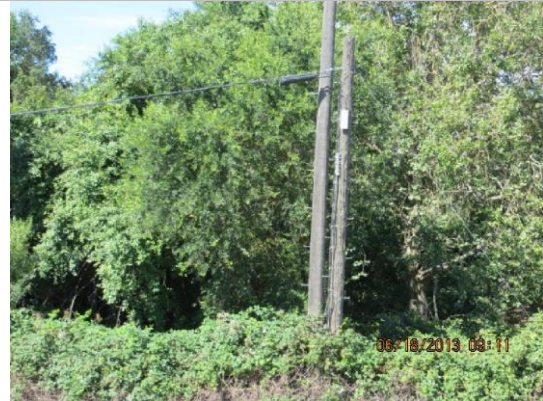
Photo 1 of 1 : UCIP_FA_2015_0825.jpg

LM Start	0.13	Rating **	M	Issue No.	1203
LM End	0.13	Issue Type +	En	Location *	LS
Category	Supplemental			GPS Latitude/Longitude	
				Start	End
Item	DWR UCIP Field Study			38.676802 °	38.676802 °
				-121.631442 °	-121.631442 °
DWR ID					
Action/Comments					
Inspector Comments: FS_ID:15087 DS_ID:21459 EP_NO: 1929 FS_HLM: 0.136 Repair Type: Non-Urgent Crossing Status: Indicator Found UCIP Comments: Line should be located with carsonite signs on both sides of levee. FIELD_STRUCT_DESC: Telephone cable through levee 3.0 feet below crown. Telephone line at JP off LS toe (Permit No. 1929, 1959). FS Date: 06/18/2013

Line visible on JP off LS toe. Likely this is the source of crossing.

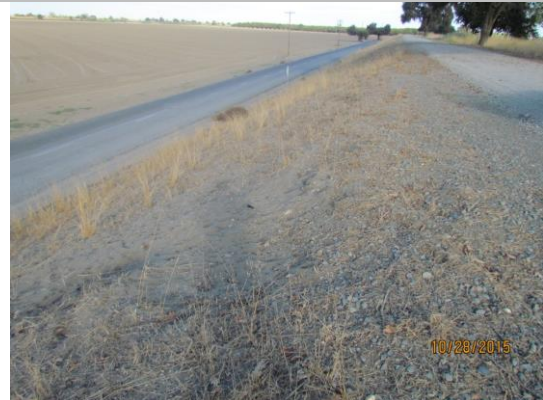
Photo 1 of 1 : FA_2015_RD1600_191_39_20151103_00063.jpg

LM Start	0.21	Rating **	M	Issue No.	39
LM End	0.21	Issue Type +	Ma	Location *	LS
Category	Earthen Levee			GPS Latitude/Longitude	
				Start	End
Item	Slope Stability			38.677766 °	38.677766 °
				-121.632123 °	-121.632123 °
DWR ID	DWR_RD1600_01_f_2015_39				
Action/Comments					
Repair the levee slope damaged by foot traffic and prevent access where possible.

View of the slope stability on the landward side of the levee looking upstream. Fall 2015.

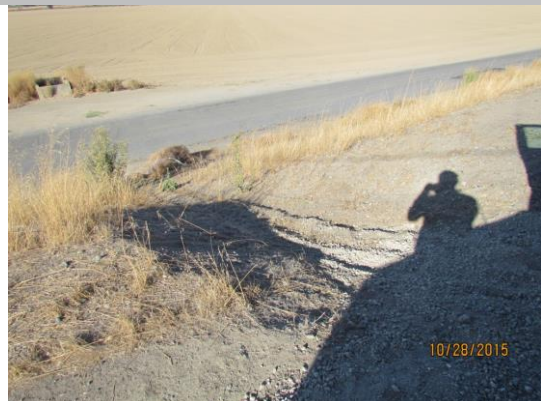
Photo 1 of 1 : FA_2015_RD1600_191_133_20151103_00065.jpg

LM Start	0.53	Rating **	M	Issue No.	133
LM End	0.53	Issue Type +	Ma	Location *	LS
Category	Earthen Levee			GPS Latitude/Longitude	
				Start	End
Item	Slope Stability			38.682140 °	38.682140 °
				-121.634083 °	-121.634083 °
DWR ID	DWR_RD1600_01_f _ 2013_133				
Action/Comments					
Repair the levee slope damaged by foot traffic and prevent access where possible.

View of the slope stability on the landward side of the levee. Fall 2015.

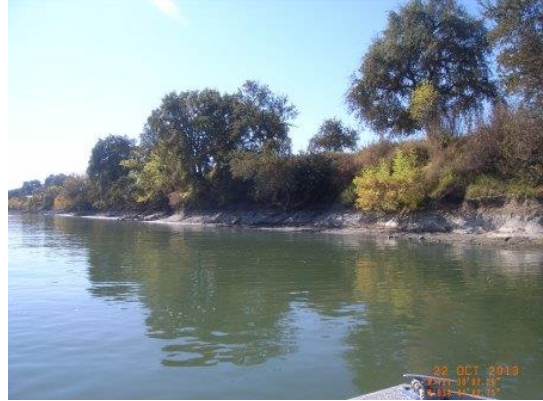
Photo 1 of 1 : USACE2013A_SAC_71-3_R_2.jpg

LM Start	0.56	Rating **	M	Issue No.	7
LM End	0.66	Issue Type +	Ma	Location *	WS
Category	Supplemental			GPS Latitude/Longitude	
				Start	End
Item	2015 USACE Erosion Survey, DRAFT			38.682707 °	38.684106 °
				-121.633830 °	-121.634219 °
DWR ID					
Action/Comments					
Inspector Comments: 2000 - Very cohesive vertical bank. 2003 - Some minor new erosion. 2006 - Some minor erosion in old pockets. 2009 - Minimal new erosion. 2011 - Multiple new erosion pockets and a few new tree popouts. 2015: No observed changes. [2015 Site ID: SAC_71-3_R]

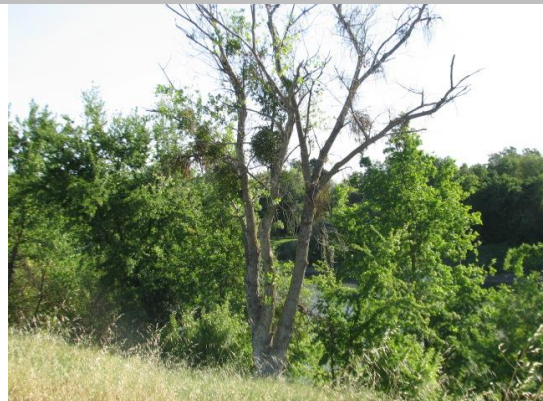
Photo 1 of 1 : FA_2015_RD1600_191_625_20150914_00041.jpg

The tree is dying and needs to be monitored so there is no threat to the levee. Spring 2014

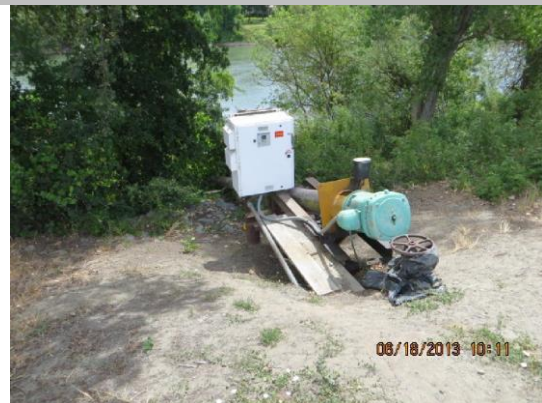
Photo 2 of 3 : UCIP_FA_2015_0795.jpg

Inspector Comments: FS_ID:15285
 DS_ID:21463
 EP_NO: 6100
 FS_HLM: 0.949
 Repair Type: Non-Urgent
 Crossing Status: Found
 UCIP Comments: Gate valve will not open or close.
 FIELD_STRUCT_DESC: 12-inch pipe through levee 3.4 feet below crown. Slant pump and gate valve on the waterward- slope. Siphon breaker in 12-inch steel riser on the landward shoulder. Filter, booster pump, and butterfly valve on LS toe. 2.25-inch galvanized iron electrical conduit at same location (Permit No. 6100, 1968). Replaced 8-inch pipe at same location.
 FS Date: 06/18/2013

Pump and gate valve on WS slope.

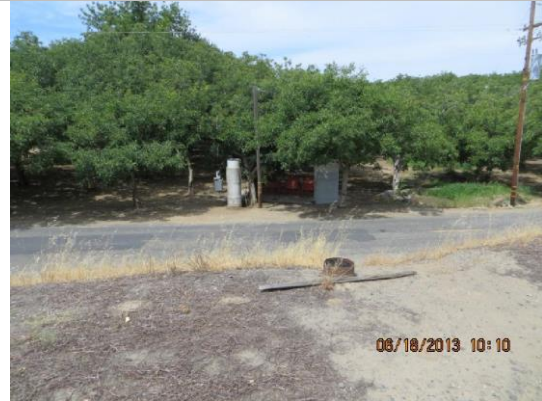
Photo 3 of 3 : UCIP_FA_2015_0796.jpg

LM Start	0.94	Rating **	M	Issue No.	1204 (cont)
LM End	0.94	Issue Type +	En	Location *	WS
Category	Supplemental			GPS Latitude/Longitude	
				Start	End
Item	DWR UCIP Field Study			38.688030 °	38.688030 °
				-121.635367 °	-121.635367 °
DWR ID					
Action/Comments					
Inspector Comments: FS_ID:15285					
DS_ID:21463					
EP_NO: 6100					
FS_HLM: 0.949					
Repair Type: Non-Urgent					
Crossing Status: Found

Siphon breaker in steel riser on LS shoulder and concrete standpipe off LS toe.

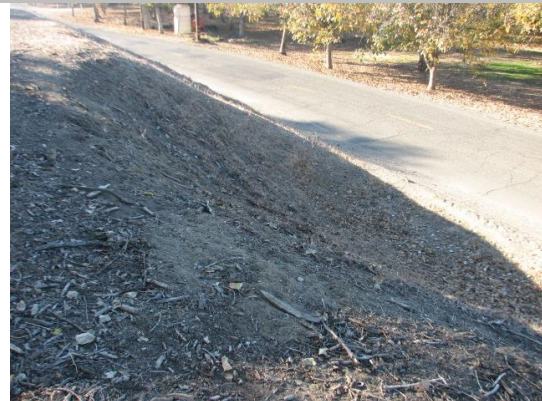
Photo 1 of 2 : FA_2015_RD1600_191_134_20150914_00034.jpg

LM Start	0.97	Rating **	M	Issue No.	134
LM End	0.97	Issue Type +	Ma	Location *	LS
Category	Earthen Levee			GPS Latitude/Longitude	
				Start	End
Item	Slope Stability			38.688454 °	38.688454 °
				-121.635528 °	-121.635528 °
DWR ID	DWR_RD1600_01_f_2013_134				
Action/Comments					
Repair slope instability.

The levee has a deep depression caused by slope stability. Fall 2013

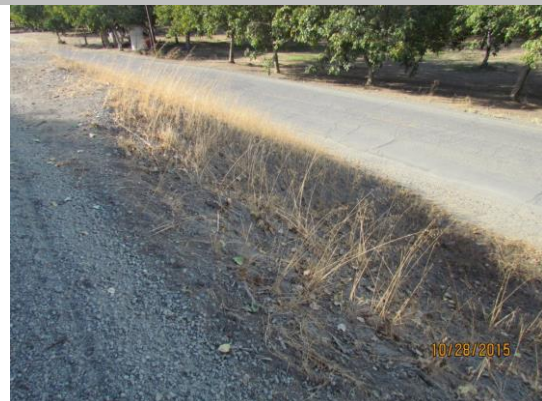
Photo 2 of 2 : FA_2015_RD1600_191_134_20151103_00067.jpg

View of the depression of the slope on the landward side of the levee looking downstream. Fall 2015.

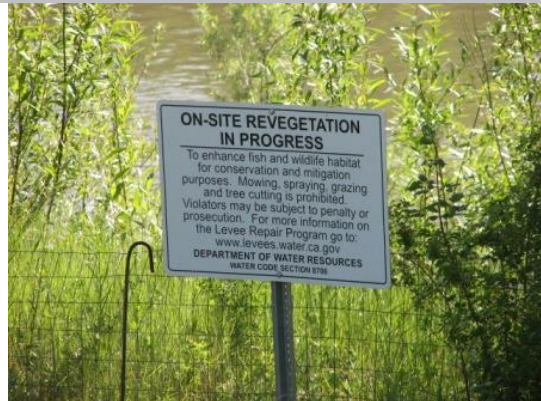
Photo 2 of 2 : FA_2015_RD1600_191_22_20150914_00021.jpg

Revegetation site. Photo taken spring 2012.

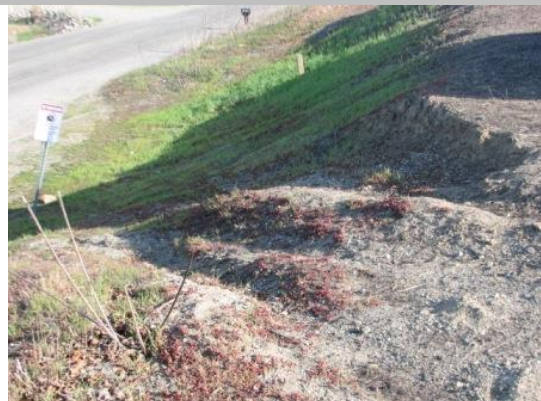
Photo 1 of 2 : FA_2015_RD1600_191_4_20150914_00003.jpg

LM Start	1.39	Rating **	M	Issue No.	4
LM End	1.39	Issue Type +	Ma	Location *	LS
Category	Earthen Levee			GPS Latitude/Longitude	
				Start	End
Item	Slope Stability			38.694395 °	38.694395 °
				-121.634376 °	-121.634376 °
DWR ID	DWR_RD1600_01_f _ 2012_4				
Action/Comments					
Repair the levee slope damaged by vehicle traffic and prevent access where possible.					
Inspector Comments: Damage looks like caused by vehicles.

Erosion from vehicles on levee slope. Spring 2013

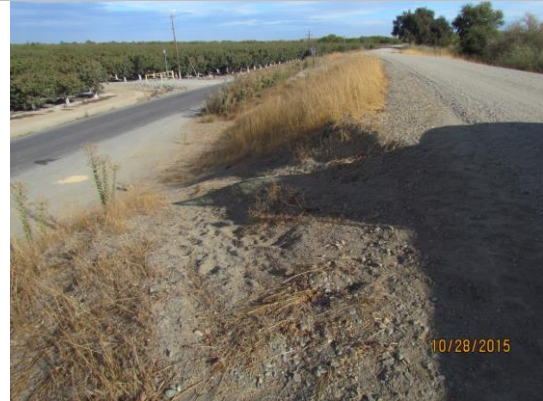
Photo 2 of 2 : FA_2015_RD1600_191_4_20151103_00068.jpg

LM Start	1.39	Rating **	M	Issue No.	4 (cont)	
LM End	1.39	Issue Type +	Ma	Location *	LS	
Category	Earthen Levee			GPS Latitude/Longitude		
				Start		End
Item	Slope Stability			38.694395 °		38.694395
				-121.634376 °		-121.634376
DWR ID	DWR_RD1600_01_f_2012_4					
Action/Comments						
Repair the levee slope damaged by vehicle traffic and prevent access where possible.						
Inspector Comments: Damage looks like caused by vehicles.

View of the slope stability caused by vehicles on the landward side of the levee looking upstream. Fall 2015.

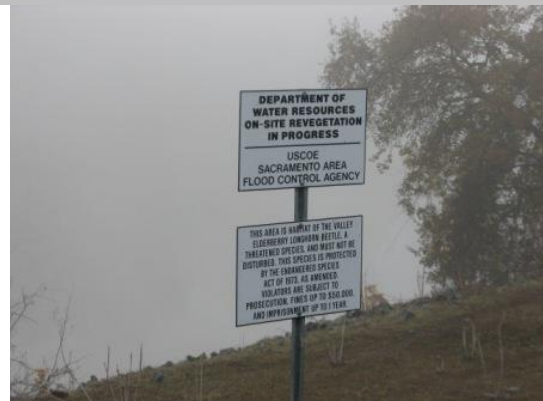
Photo 2 of 2 : FA_2015_RD1600_191_5_20150914_00006.jpg

Revegetation site. Fall 2012.

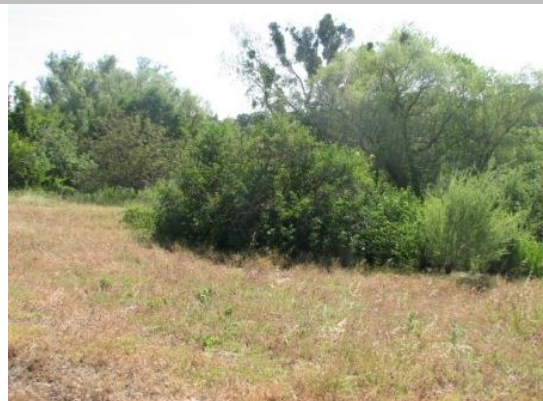
Photo 1 of 2 : FA_2015_RD1600_191_31_20150914_00025.jpg

A photo of a Elderberry bush in the area.

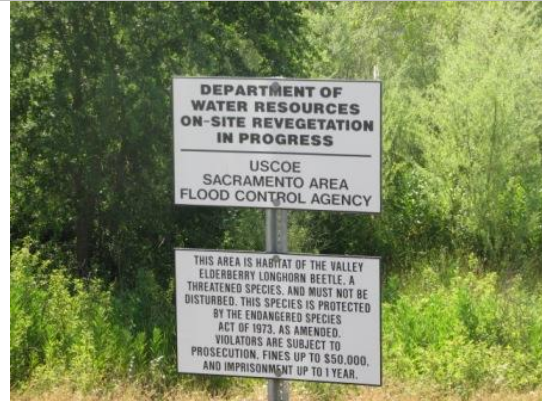
Photo 2 of 2 : FA_2015_RD1600_191_31_20150914_00026.jpg

Revegetation site with the Elderberry Beetle. Photo taken spring 2012.

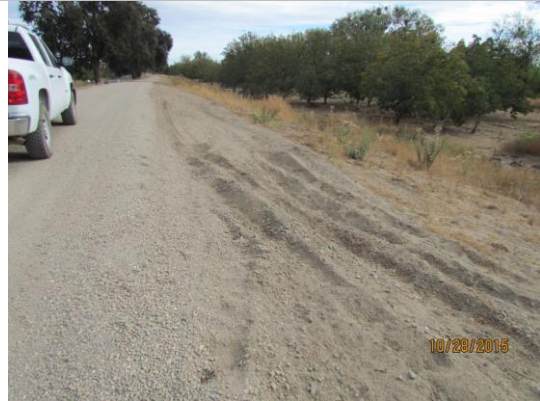
Photo 1 of 1 : FA_2015_RD1600_191_52_20151103_00070.jpg

LM Start	2.02	Rating **	M	Issue No.	52
LM End	2.02	Issue Type +	Ma	Location *	WS
Category	Earthen Levee			GPS Latitude/Longitude	
				Start	End
Item	Slope Stability			38.701753 °	38.701753
				-121.627734 °	-121.627734
DWR ID	DWR_RD1600_01_f_2015_52				
Action/Comments					
Repair the levee slope damaged by vehicle traffic and prevent access where possible.

View of the slope stability caused by vehicles on the waterward side of the levee looking upstream. Fall 2015.

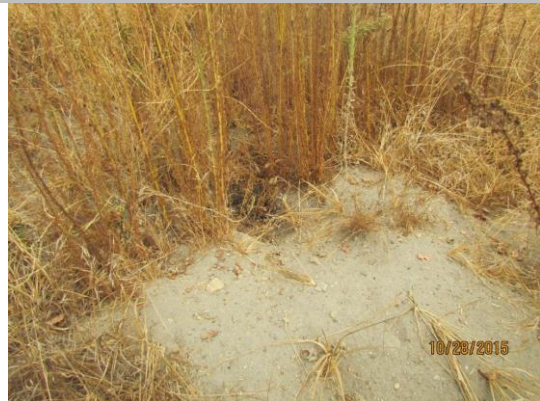
Photo 1 of 1 : FA_2015_RD1600_191_53_20151103_00071.jpg

View of the rodent hole on the waterward side of the levee. Fall 2015.

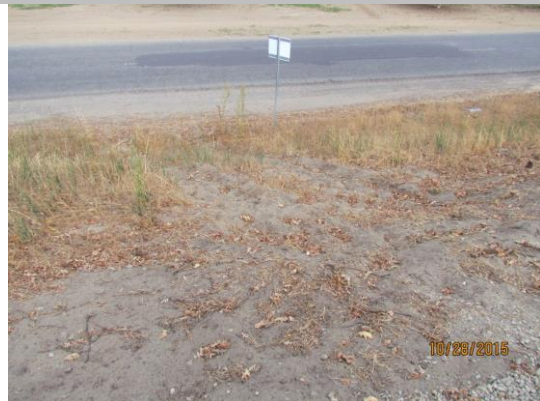
Photo 1 of 1 : FA_2015_RD1600_191_55_20151103_00072.jpg

LM Start	2.10	Rating **	M	Issue No.	55
LM End	2.10	Issue Type +	Ma	Location *	LS
Category	Earthen Levee			GPS Latitude/Longitude	
				Start	End
Item	Slope Stability			38.702416 °	38.702416 °
				-121.626593 °	-121.626593 °
DWR ID	DWR_RD1600_01_f_2015_55				
Action/Comments					
Repair the levee slope damaged by vehicle traffic and prevent access where possible.

View of the slope stability damaged by vehicles on the landward side of the levee. Fall 2015.

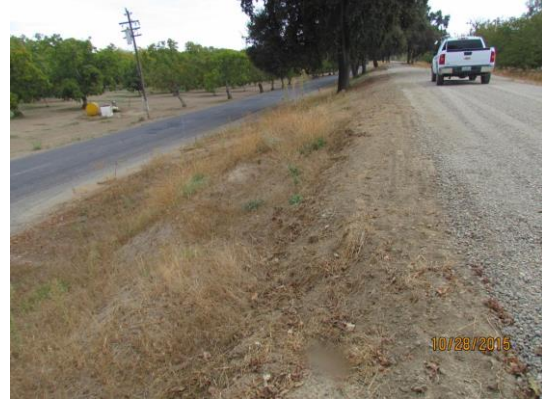
Photo 1 of 1 : FA_2015_RD1600_191_56_20151103_00073.jpg

LM Start	2.17	Rating **	M	Issue No.	56
LM End	2.17	Issue Type +	Ma	Location *	LS
Category	Earthen Levee			GPS Latitude/Longitude	
				Start	End
Item	Slope Stability			38.703025 °	38.703025 °
				-121.625605 °	-121.625605 °
DWR ID	DWR_RD1600_01_f_2015_56				
Action/Comments					
Repair slope instability.

View of the sloughing on the landward side of the levee looking upstream. Fall 2015.

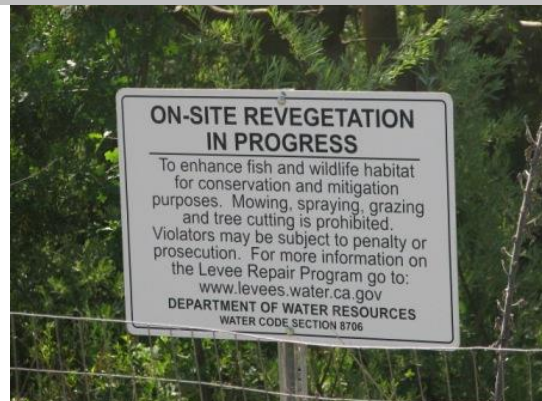
Photo 2 of 2 : FA_2015_RD1600_191_35_20150914_00028.jpg

Revegetation site, photo taken spring 2012.

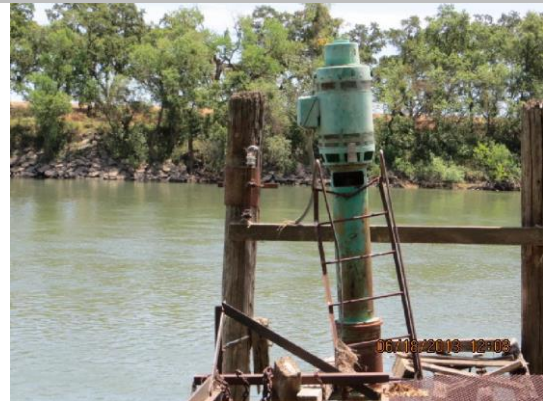
Photo 1 of 3 : UCIP_FA_2015_0826.jpg

LM Start	2.81	Rating **	M	Issue No.	1205
LM End	2.81	Issue Type +	En	Location *	LS
Category	Supplemental			GPS Latitude/Longitude	
				Start	End
Item	DWR UCIP Field Study			38.709350 °	38.709350 °
				-121.616913 °	-121.616913 °
DWR ID					
Action/Comments					
Inspector Comments: FS_ID:15108					
DS_ID:21467					
EP_NO: N/A					
FS_HLM: 2.827					
Repair Type: Non-Urgent					
Crossing Status: Found

Electrical cut to pump.

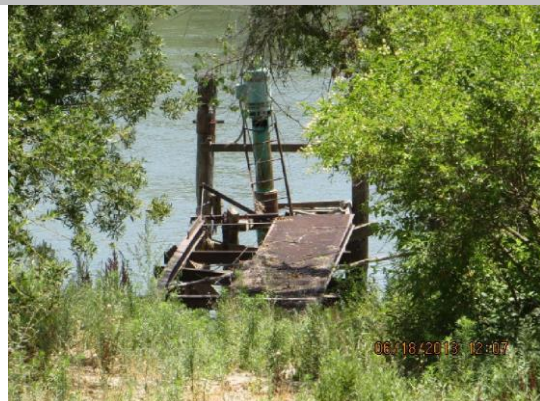
Photo 3 of 3 : UCIP_FA_2015_0828.jpg

Inspector Comments: FS_ID:15108
 DS_ID:21467
 EP_NO: N/A
 FS_HLM: 2.827
 Repair Type: Non-Urgent
 Crossing Status: Found
 UCIP Comments: Appears abandoned and should be done so properly. Debris buildup on pier. Power cut to pump.
 FIELD_STRUCT_DESC: 16-inch pipe through levee 2-feet below crown. Walkway from berm to pump on pile structure in the stream.
 Siphon breaker on the landward slope. 12-inch PVC standpipe off LS toe. Originally included in 1955 O+M manual.
 FS Date: 06/18/2013

Pump on metal platform off WS berm.

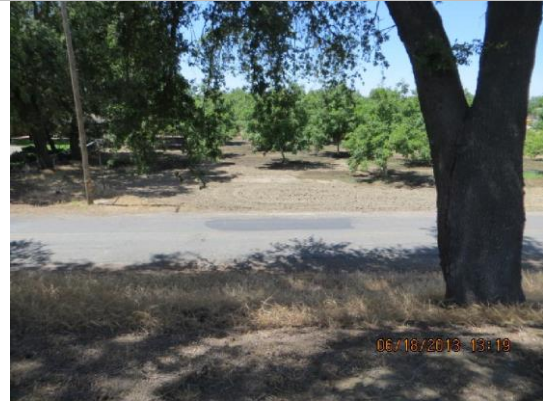
Photo 1 of 2 : UCIP_FA_2015_0829.jpg

LM Start	2.92	Rating **	M	Issue No.	1206
LM End	2.92	Issue Type +	En	Location *	LS
Category	Supplemental			GPS Latitude/Longitude	
				Start	End
Item	DWR UCIP Field Study			38.710497 °	38.710497 °
				-121.615381 °	-121.615381 °
DWR ID					
Action/Comments					
Inspector Comments: FS_ID:15110 DS_ID:21490 EP_NO: N/A FS_HLM: 2.943 Repair Type: Non-Urgent Crossing Status: Indicator Found

Pipe visible on LS slope.

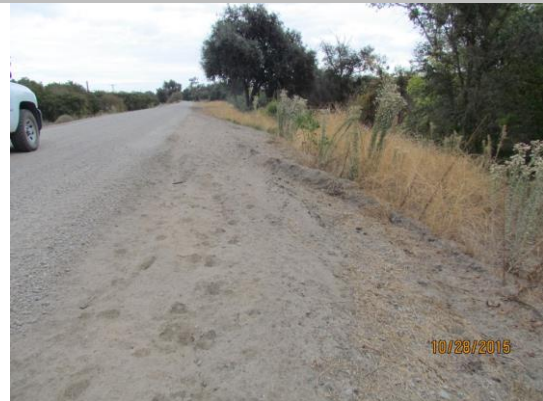
Photo 1 of 1 : FA_2015_RD1600_191_64_20151103_00077.jpg

View of the slope stability caused by vehicles on the waterward side of the levee looking upstream. Fall 2015.

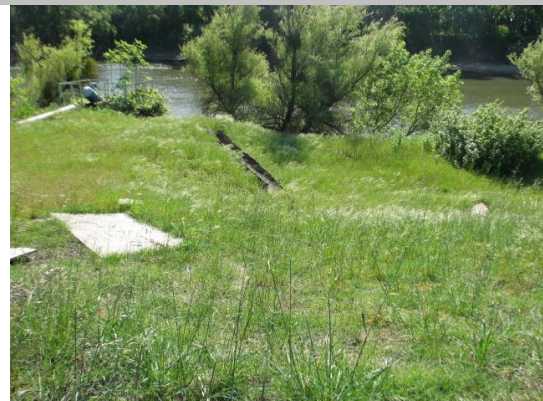
Photo 1 of 2 : FA_2015_RD1600_191_627_20150914_00043.jpg

Metal pipe and wood debris is on the waterside berm. Spring 2014

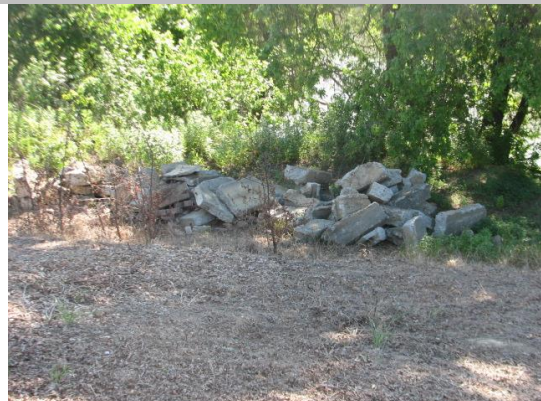
Photo 1 of 1 : FA_2015_RD1600_191_628_20150914_00044.jpg

Concrete debris is on the waterside berm. Spring 2014

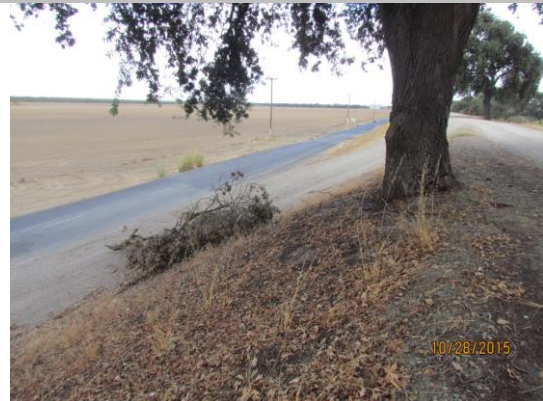
Photo 1 of 1 : FA_2015_RD1600_191_66_20151103_00079.jpg

View of a fallen tree branch on the landward side of the levee looking upstream. Fall 2015.

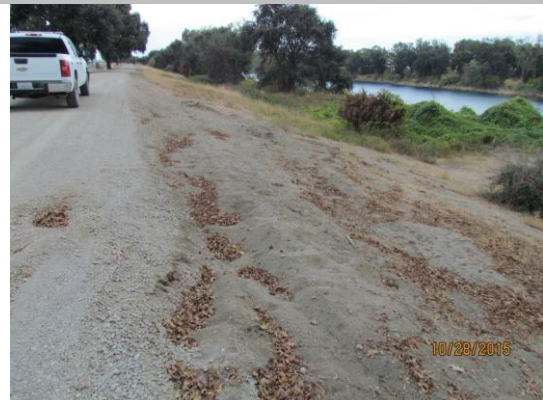
Photo 1 of 1 : FA_2015_RD1600_191_67_20151103_00080.jpg

View of the shoulder damaged by vehicles on the waterward side of the levee looking upstream. Fall 2015.

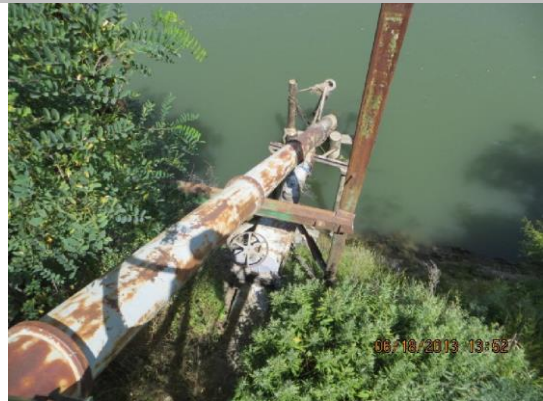
Photo 1 of 3 : UCIP_FA_2015_0831.jpg

16-inch pipe ties into 24-inch pipe under pump platform at slide gate.

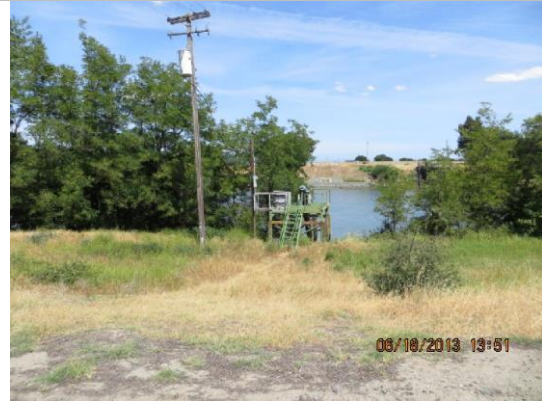
Photo 2 of 3 : UCIP_FA_2015_0832.jpg

Slant pump on metal pier on WS berm.

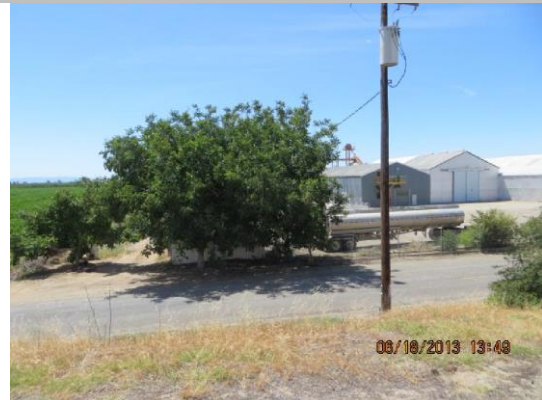
Photo 3 of 3 : UCIP_FA_2015_0835.jpg

Pumphouse/distribution box off LS toe.

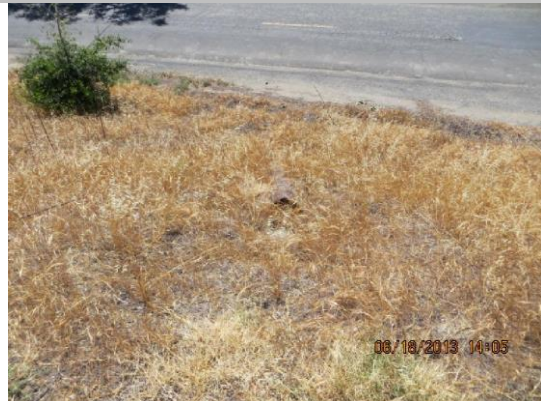
Photo 2 of 2 : UCIP_FA_2015_1459.jpg

Pipe and remnants of grouted pipe on LS slope.

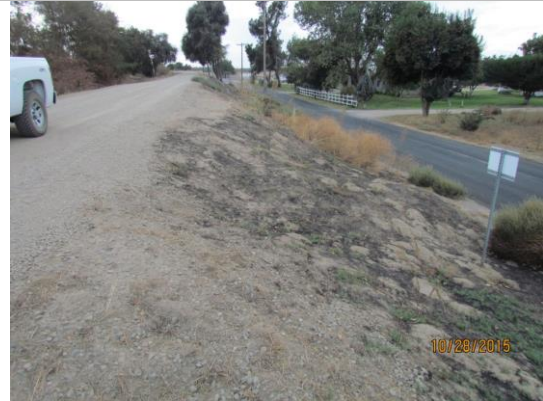
Photo 1 of 1 : FA_2015_RD1600_191_41_20151103_00081.jpg

LM Start	4.66	Rating **	M	Issue No.	41
LM End	4.66	Issue Type +	Ma	Location *	LS
Category	Earthen Levee			GPS Latitude/Longitude	
				Start	End
Item	Slope Stability			38.733294 °	38.733294 °
				-121.605484 °	-121.605484 °
DWR ID	DWR_RD1600_01_f_ 2015_41				
Action/Comments					
Repair slope instability.

View of the bulge at the toe of the levee on the landward side looking downstream. Fall 2015.

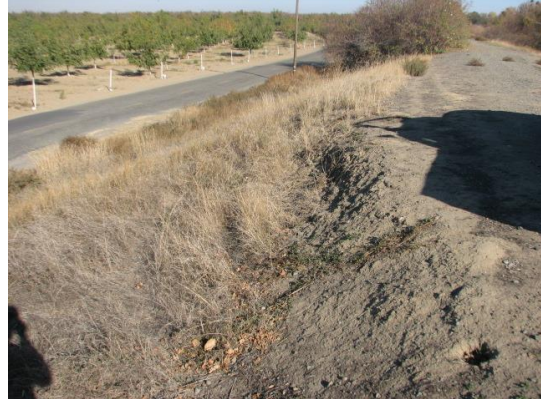
Photo 1 of 2 : FA_2015_RD1600_191_141_20150914_00038.jpg

The erosion at the shoulder of the levee could be slope instability. Fall 2013

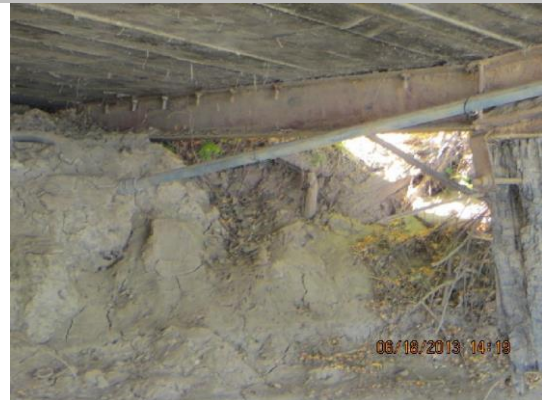
Photo 2 of 3 : UCIP_FA_2015_0652.jpg

2-inch galvanized iron electrical conduit at under pier.

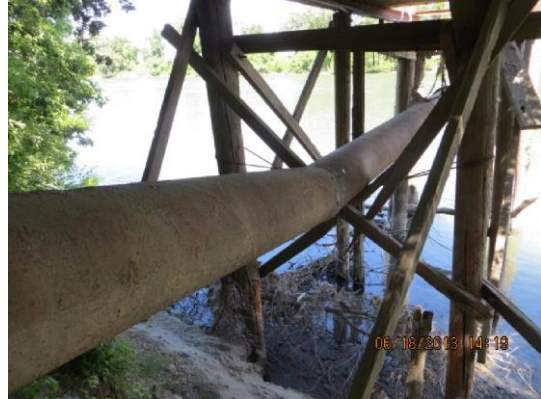
Photo 3 of 3 : UCIP_FA_2015_0653.jpg

Pipe under wooden pier on WS toe.

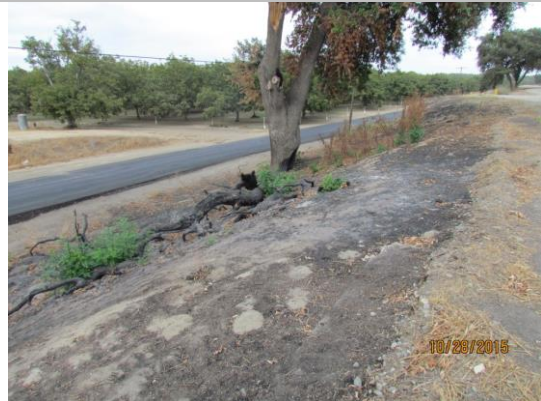
Photo 1 of 1 : FA_2015_RD1600_191_42_20151103_00083.jpg

View of the fallen tree branch on the landward side of the levee looking upstream. The branch was not completely burned. Fall 2015.

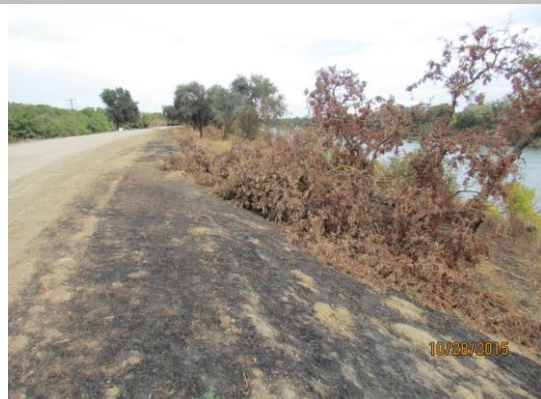
Photo 1 of 1 : FA_2015_RD1600_191_43_20151103_00084.jpg

View of a fallen tree branch on the waterward side of the levee looking upstream. Fall 2015.

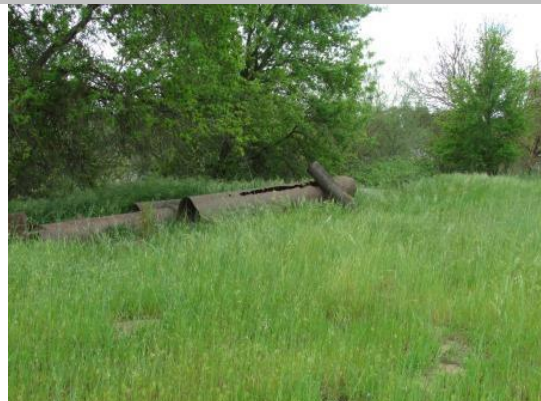
Photo 1 of 1 : FA_2015_RD1600_191_1198_20150914_00048.jpg

View of debris on the waterward side of the levee looking downstream. Spring 2015.

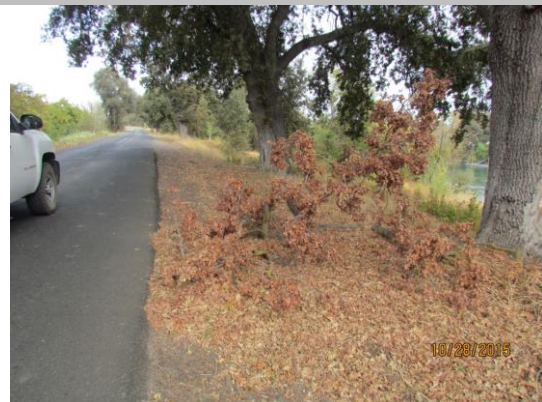
Photo 1 of 1 : FA_2015_RD1600_191_54_20151103_00087.jpg

View of the fallen tree branch on the waterward side of the levee looking upstream. Fall 2015.

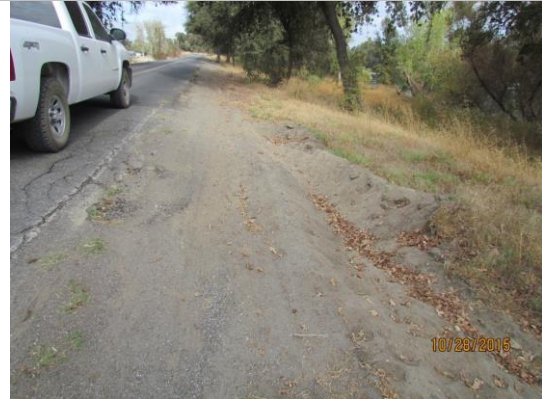
Photo 1 of 1 : FA_2015_RD1600_191_58_20151103_00088.jpg

View of the slope stability on the waterward side of the levee looking upstream. Fall 2015.

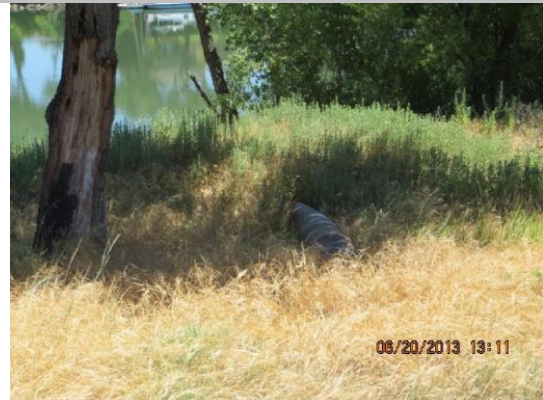
Photo 2 of 3 : UCIP_FA_2015_0742.jpg

Pipe on WS slope.

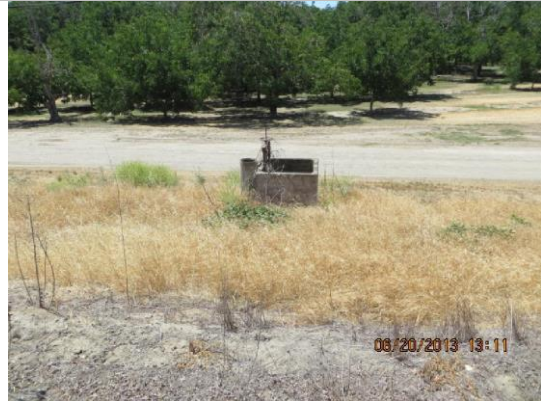
Photo 3 of 3 : UCIP_FA_2015_0743.jpg

6'X6' concrete distribution box on LS toe.

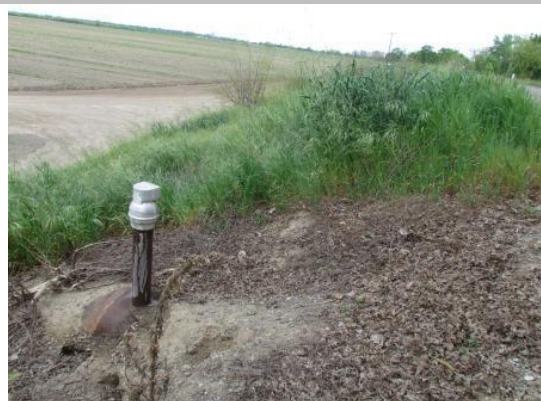
Photo 1 of 1 : FA_2015_RD1600_191_1199_20150914_00049.jpg

View of erosion and pipe on the landward side of the levee looking upstream. Spring 2015.

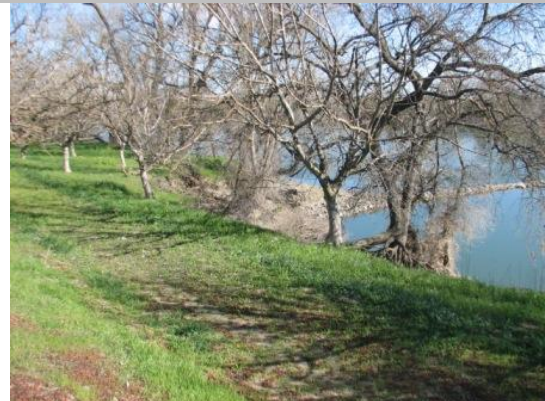
Photo 1 of 2 : FA_2015_RD1600_191_30_20150914_00024.jpg

Erosion is into the berm area and needs to be monitored. Spring 2013

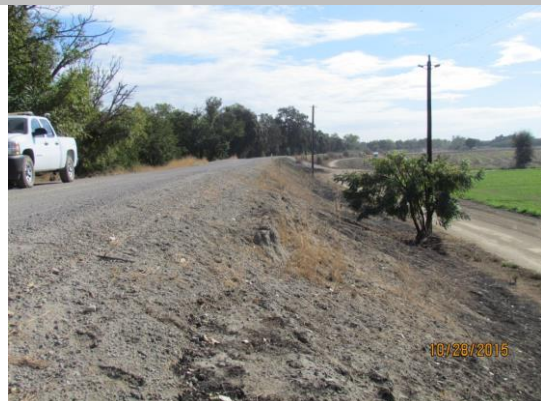
Photo 2 of 2 : FA_2015_RD1600_191_27_20151103_00092.jpg

The erosion seems to have been fixed. There still seems to be some erosion on the landward side of the levee looking downstream. Fall 2015.

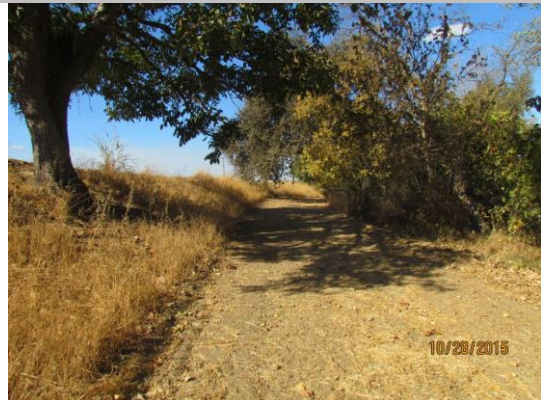
Photo 3 of 4 : FA_2015_RD1600_191_20_20151103_00094.jpg

View of the erosion in the berm area on the waterward side looking upstream. Fall 2015.

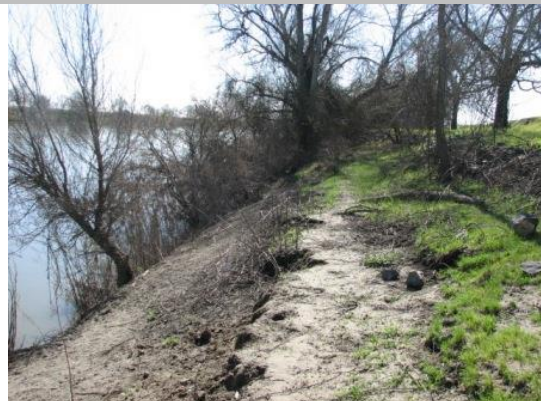
Photo 1 of 3 : FA_2015_RD1600_191_21_20150914_00018.jpg

The erosion is eroding away the berm area.

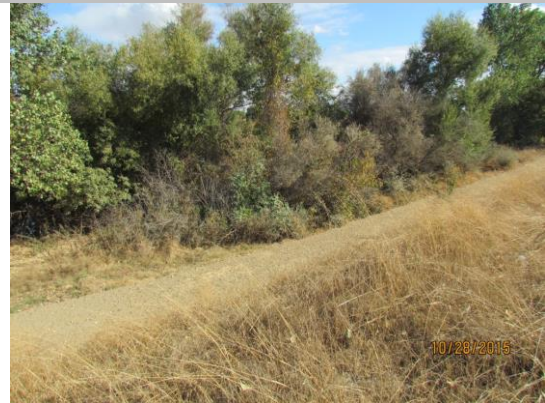
Photo 3 of 3 : FA_2015_RD1600_191_21_20151103_00096.jpg

View of the erosion along the waterward berm of the levee. Fall 2015.

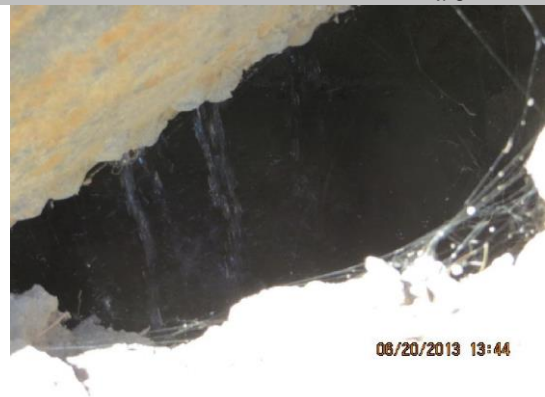
Photo 1 of 3 : UCIP_FA_2015_0791.jpg

Holes in pipe on LS slope.

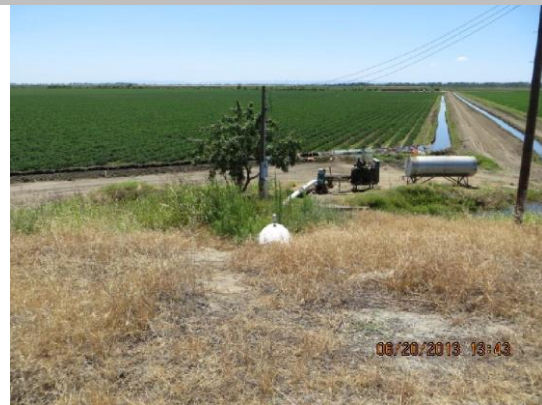
Photo 3 of 3 : UCIP_FA_2015_0793.jpg

Pipe on LS shoulder.

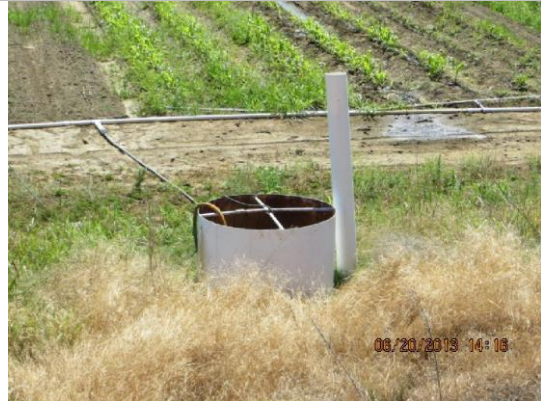
Photo 1 of 1 : UCIP_FA_2015_1479.jpg

4-foot diameter steel standpipe at LS toe, may be indicator of pipe location.

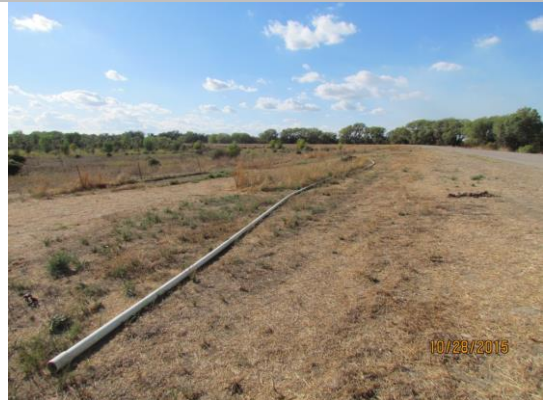
Photo 2 of 2 : FA_2015_RD1600_191_634_20151103_00097.jpg

View of the equipment on the landward side of the levee looking upstream. Fall 2015.

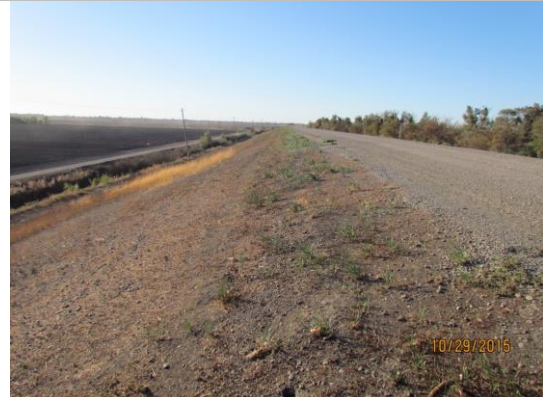
Photo 1 of 1 : FA_2015_RD1600_192_2_20151103_00019.jpg

View of the vegetation on the landward side of the levee looking downstream. Fall 2015.

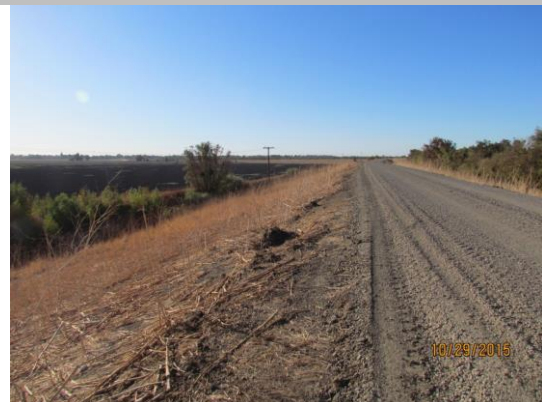
Photo 1 of 1 : FA_2015_RD1600_192_4_20151103_00021.jpg

View of the vegetation on the landward side of the levee looking downstream. Fall 2015.

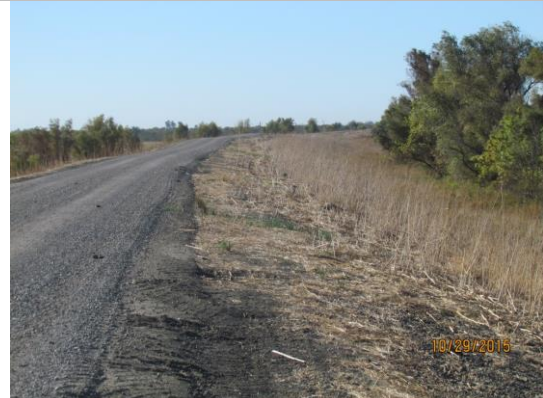
Photo 1 of 1 : FA_2015_RD1600_192_13_20151103_00025.jpg

View of the vegetation on the waterward side of the levee looking downstream. Fall 2015.

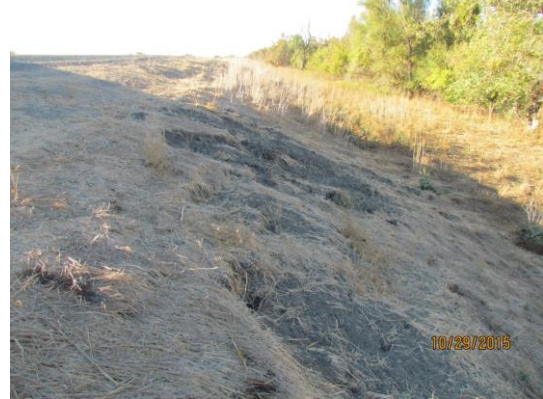
Photo 1 of 1 : FA_2015_RD1600_192_8_20151103_00023.jpg

View of the slope stability on the waterward side of the levee looking downstream. Fall 2015.

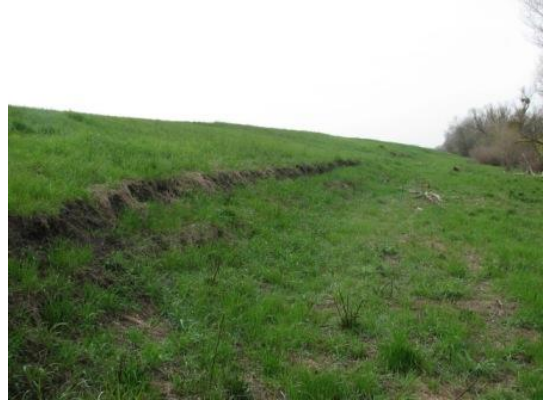
Photo 1 of 3 : FA_2015_RD1600_192_14_20150914_00007.jpg

A closer view of the wave wash damage along the bypass.

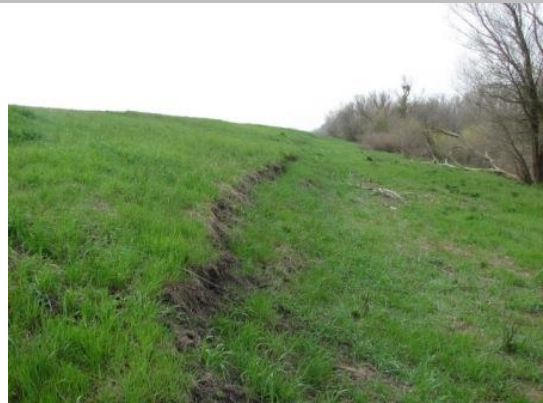
Photo 2 of 3 : FA_2015_RD1600_192_14_20150914_00008.jpg

Wave wash damage along the slope the cut is 1'-2'.

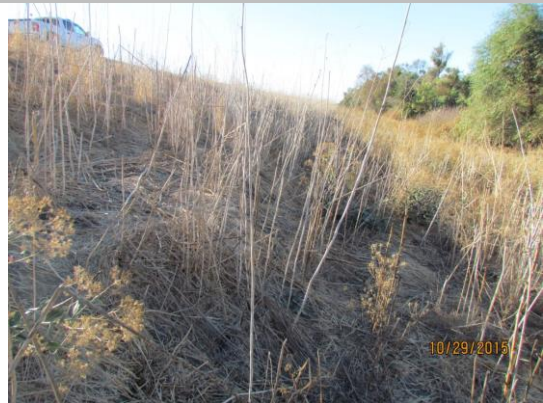
Photo 3 of 3 : FA_2015_RD1600_192_14_20151103_00024.jpg

View of the erosion on the waterward side of the levee looking downstream. Fall 2015.

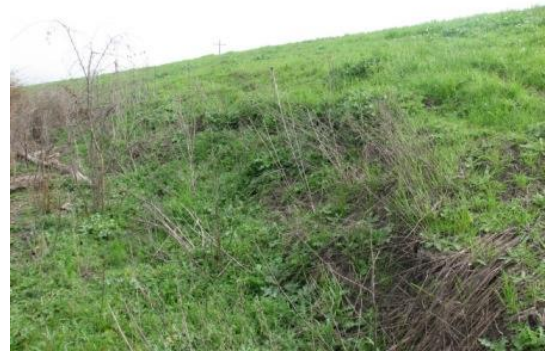
Photo 1 of 2 : FA_2015_RD1600_192_15_20150914_00009.jpg

Looking upstream a deeper cut of 2'-3' damage.

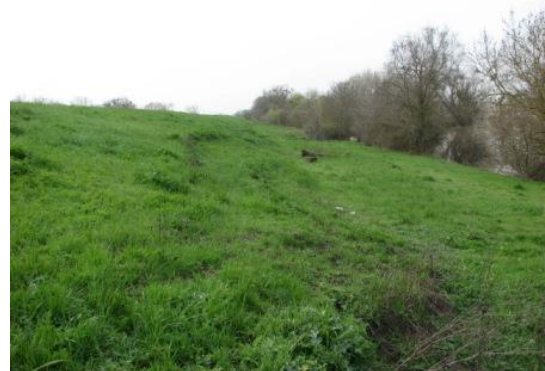
Photo 2 of 2 : FA_2015_RD1600_192_15_20150914_00010.jpg

This is wave wash damage along the toe of the levee looking downstream.

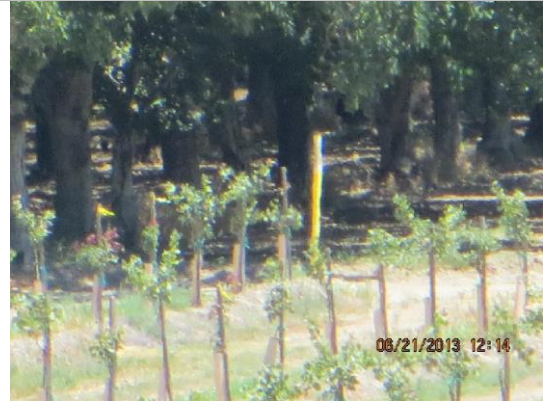
Photo 1 of 2 : UCIP_FA_2015_1477.jpg

Carsonite gasoline marker visible approximately 1,000-feet east of levee crown.

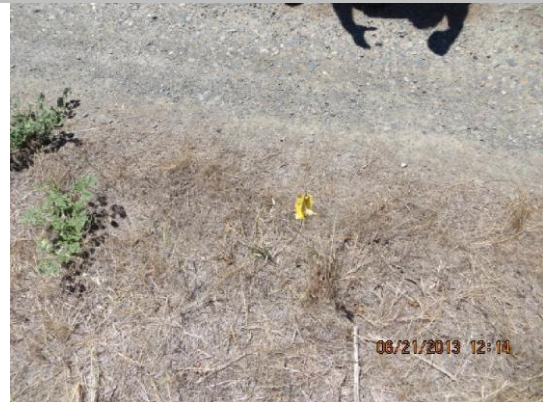
Photo 2 of 2 : UCIP_FA_2015_1478.jpg

PG&E marker flag on Crown.
