**Flood Control Project Maintenance
Levee Inspections**

Fall 2016 Levee Maintenance Deficiency Summary Report

Reclamation District No. 1600 Mull

Fall 2016 Levee Inspection Results

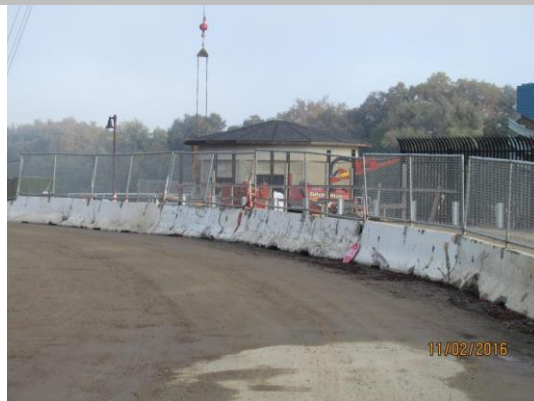
Photo 3 of 3 : FA_2016_RD1600_191_1_20161103_00095.jpg

View of a new pumping plant construction. Fall 2016.

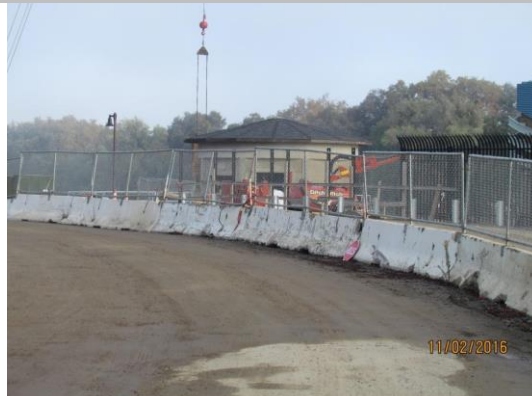
Photo 3 of 4 : FA_2016_RD1600_191_25_20161103_00099.jpg

View of construction site. Fall 2016.

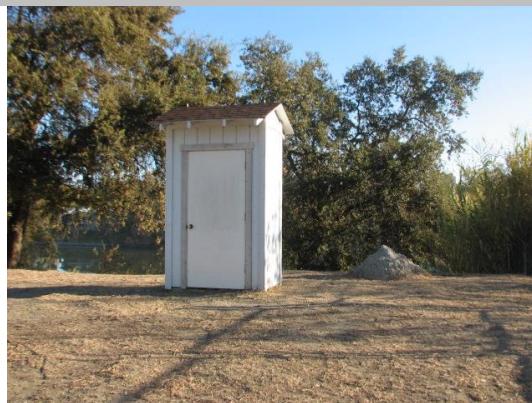
Photo 1 of 2 : FA_2016_RD1600_191_129_20160913_00055.jpg

The small building is a pump house for the well. It services the house with water. Fall 2013

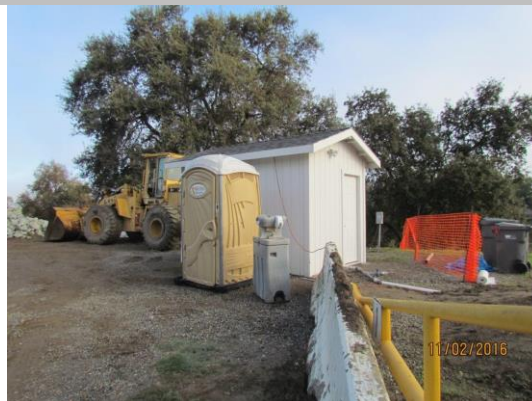
Photo 2 of 2 : FA_2016_RD1600_191_129_20161103_00101.jpg

Updated view of the building. Fall 2016.

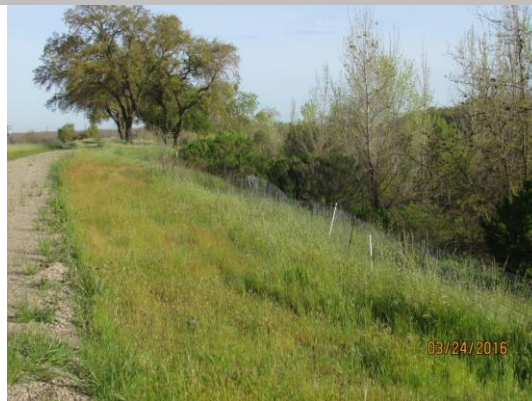
Photo 2 of 2 : FA_2016_RD1600_191_49_20160913_00042.jpg

View of the revegetation site and fence on the waterward side of the levee looking upstream. Spring 2016.

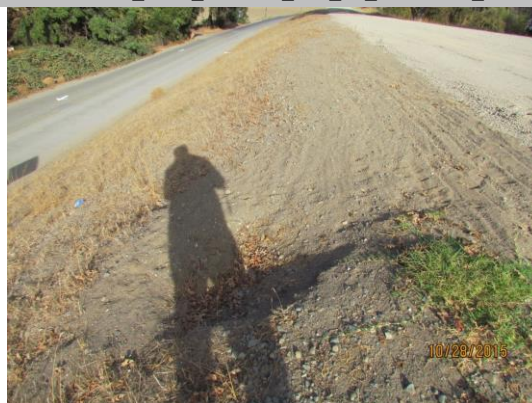
Photo 1 of 1 : FA_2016_RD1600_191_38_20160913_00035.jpg

LM Start	0.12	Rating **	M	Issue No.	38
LM End	0.12	Issue Type +	Ma	Location *	LS
Category	Earthen Levee			GPS Latitude/Longitude	
				Start	End
Item	Slope Stability			38.676654 °	38.676654 °
				-121.631348 °	-121.631348 °
DWR ID	DWR_RD1600_01_f_2015_38				
Comment Code					
S3 : Repair the levee slope damaged by vehicle traffic and prevent access where possible.					
Inspector Comment

View of a slope depression on the landward side of the levee looking downstream. Fall 2015.

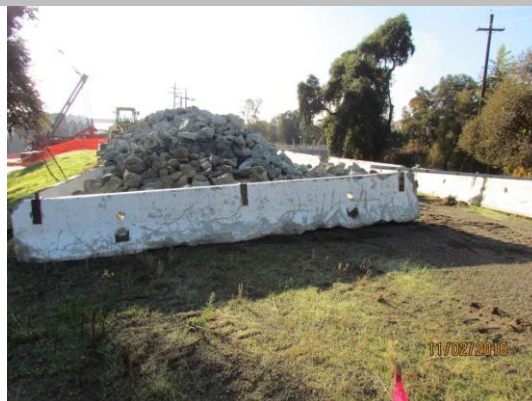
Photo 2 of 2 : FA_2016_RD1600_191_26_20161103_00103.jpg

Rockpile blocks access to the levee trough the gate. Looking downstream. Fall 2016.

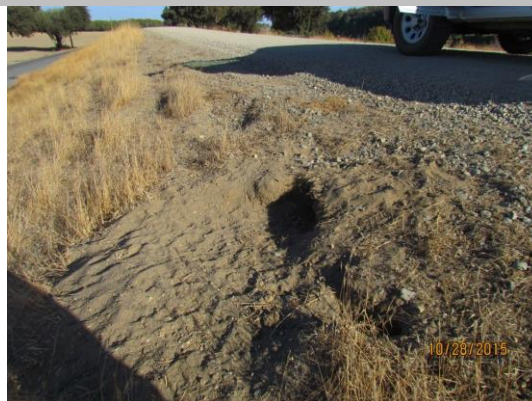
Photo 1 of 1 : FA_2016_RD1600_191_40_20160913_00037.jpg

View of the rodent hole on the landward side of the levee looking upstream. Fall 2015.

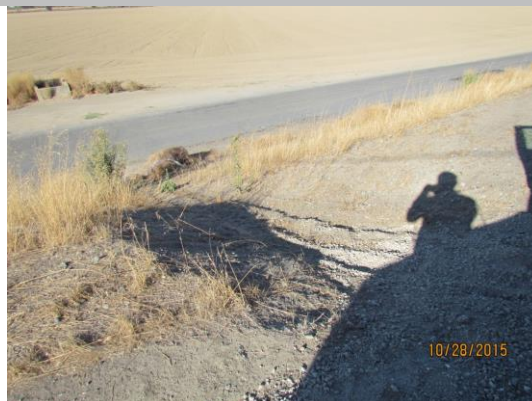
Photo 1 of 2 : FA_2016_RD1600_191_133_20160913_00056.jpg

LM Start	0.53	Rating **	M	Issue No.	133
LM End	0.53	Issue Type +	Ma	Location *	LS
Category	Earthen Levee			GPS Latitude/Longitude	
				Start	End
Item	Slope Stability			38.682140 °	38.682140 °
				-121.634083 °	-121.634083 °
DWR ID	DWR_RD1600_01_f_2013_133				
Comment Code					
S2 : Repair the levee slope damaged by foot traffic and prevent access where possible.					
Inspector Comment

View of the slope stability on the landward side of the levee. Fall 2015.

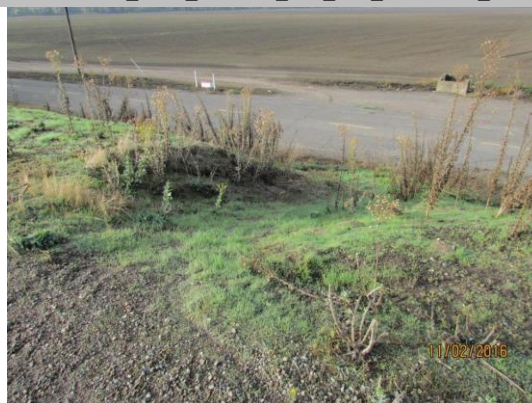
Photo 2 of 2 : FA_2016_RD1600_191_133_20161103_00106.jpg

Updated view of the slope stability site. Fall 2016.

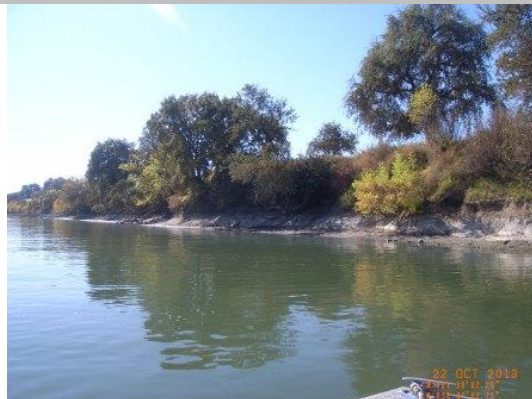
Photo 1 of 1 : FA_2016_RD1600_191_7_20160913_00010.jpg

LM Start	0.56	Rating **	M	Issue No.	7
LM End	0.66	Issue Type +	Ma	Location *	WS
Category	Supplemental			GPS Latitude/Longitude	
				Start	End
Item	2015 USACE Erosion Survey, DRAFT			38.682707 °	38.684106 °
				-121.633830 °	-121.634219 °
DWR ID	DWR_RD1600_01_s_2016_7				
Comment Code					
Inspector Comment					
2000 - Very cohesive vertical bank. 2003 - Some minor new erosion. 2006 - Some minor erosion in old pockets. 2009 - Minimal new erosion. 2011 - Multiple new erosion pockets and a few new tree popouts. 2015: No observed changes. [2015 Site ID: SAC_71-3_R]

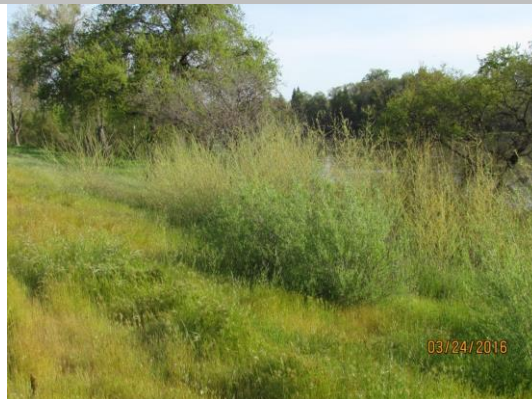
Photo 1 of 3 : FA_2016_RD1600_191_29_20160913_00027.jpg

Perspective view of the willows on the waterward side of the levee looking upstream. Spring 2016.

LM Start	0.60	Rating **	M	Issue No.	29
LM End	0.62	Issue Type +	Ma	Location *	WS
Category	Earthen Levee			GPS Latitude/Longitude	
				Start	End
Item	Vegetation			38.683238 °	38.683415 °
				-121.634388 °	-121.634448 °
DWR ID	DWR_RD1600_01_s_2016_29				
Comment Code					
V2 : Remove the wild growth other than native grasses from the levee slopes.					
Inspector Comment					
Recommend removal of willow trees.

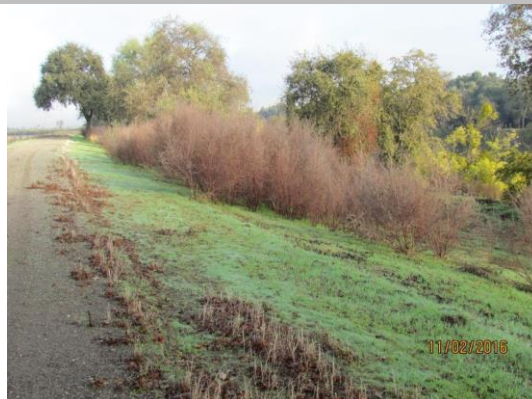
Photo 3 of 3 : FA_2016_RD1600_191_29_20161103_00105.jpg

Updated view of willows on waterward side. Fall 2016.

LM Start	0.60	Rating **	M	Issue No.	29 (cont)	
LM End	0.62	Issue Type +	Ma	Location *	WS	
Category	Earthen Levee			GPS Latitude/Longitude		
				Start		End
Item	Vegetation			38.683238 °		38.683415 °
				-121.634388 °		-121.634448 °
DWR ID	DWR_RD1600_01_s_2016_29					
Comment Code						
V2 : Remove the wild growth other than native grasses from the levee slopes.						
Inspector Comment						
Recommend removal of willow trees.

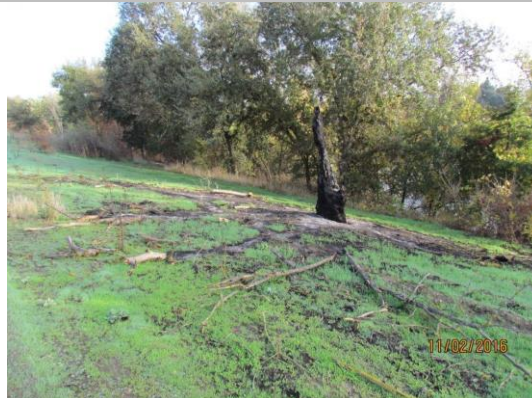
Photo 2 of 2 : FA_2016_RD1600_191_624_20161103_00104.jpg

Dying tree on waterward side was burnt. Fall 2016.

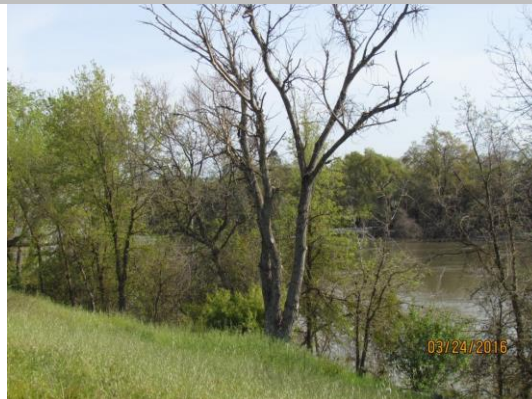
Photo 1 of 1 : FA_2016_RD1600_191_625_20160913_00062.jpg

View of the tree on the waterward side of the levee. Spring 2016.

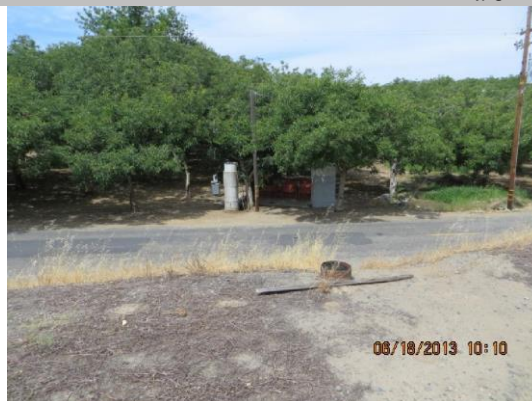
Photo 1 of 2 : UCIP_FA_2016_15285_25088.jpg

LM Start	0.94	Rating **	M	Issue No.	1208
LM End	0.94	Issue Type +	En	Location *	WS
Category	Supplemental			GPS Latitude/Longitude	
				Start	End
Item	DWR UCIP Field Study			38.688030 °	38.688030 °
				-121.635367 °	-121.635367 °
DWR ID					
Comment Code					
Inspector Comment					
FS_ID:15285 DS_ID:21463 EP_NO: 6100 Repair Type: Non-Urgent Crossing Status: Found UCIP Comments: Gate valve will not open or close. FIELD_STRUCT_DESC: 12-inch pipe through levee 3.4 feet below crown. Slant pump and gate valve on the waterward- slope. Siphon breaker in 12-inch steel riser on the landward shoulder. Filter, booster pump, and butterfly valve on LS toe. 2.25-inch galvanized iron electrical conduit at same location (Permit No. 6100, 1968). Replaced 8-inch pipe at same location. FS Date: 6/18/2013

Siphon breaker in steel riser on LS shoulder and concrete standpipe off LS toe.

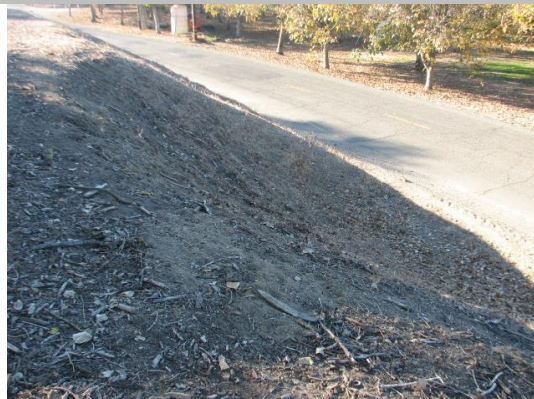
Photo 1 of 2 : FA_2016_RD1600_191_134_20160913_00057.jpg

The levee has a deep depression caused by slope stability. Fall 2013

LM Start	0.97	Rating **	M	Issue No.	134
LM End	0.97	Issue Type +	Ma	Location *	LS
Category	Earthen Levee			GPS Latitude/Longitude	
				Start	End
Item	Slope Stability			38.688454 °	38.688454 °
				-121.635528 °	-121.635528 °
DWR ID	DWR_RD1600_01_f_2013_134				
Comment Code					
S1 : Repair slope instability.					
Inspector Comment

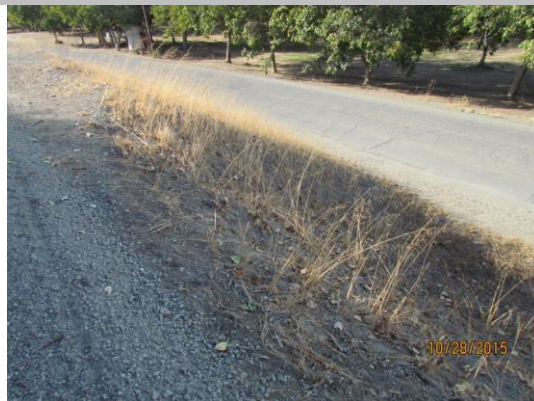
Photo 2 of 2 : FA_2016_RD1600_191_134_20160913_00058.jpg

View of the depression of the slope on the landward side of the levee looking downstream. Fall 2015.

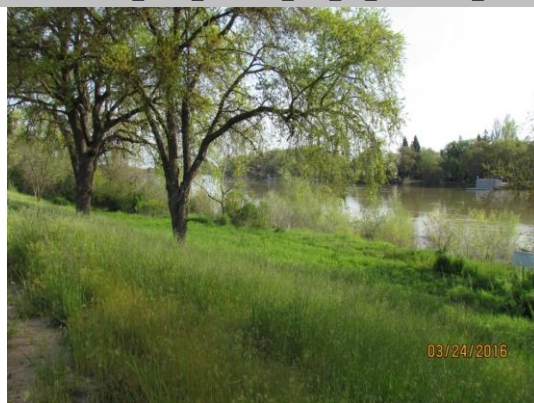
Photo 1 of 2 : FA_2016_RD1600_191_22_20160913_00021.jpg

View of the revegetation site at the berm edge on the waterward side of the levee looking upstream. Spring 2016.

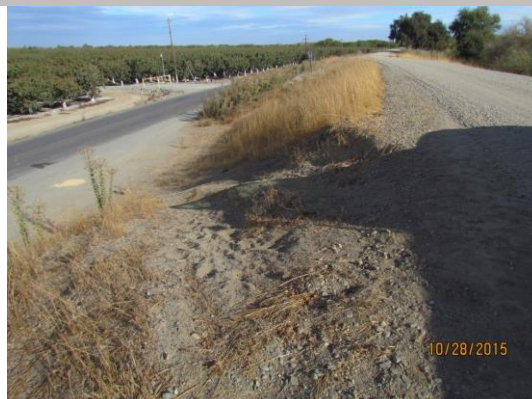
Photo 2 of 2 : FA_2016_RD1600_191_4_20160913_00006.jpg

LM Start	1.39	Rating **	M	Issue No.	4 (cont)	
LM End	1.39	Issue Type +	Ma	Location *	LS	
Category	Earthen Levee			GPS Latitude/Longitude		
				Start		End
Item	Slope Stability			38.694395 °		38.694395 °
				-121.634376 °		-121.634376 °
DWR ID	DWR_RD1600_01_f_2012_4					
Comment Code						
S3 : Repair the levee slope damaged by vehicle traffic and prevent access where possible.						
Inspector Comment						
Damage looks like caused by vehicles.

View of the slope stability caused by vehicles on the landward side of the levee looking upstream. Fall 2015.

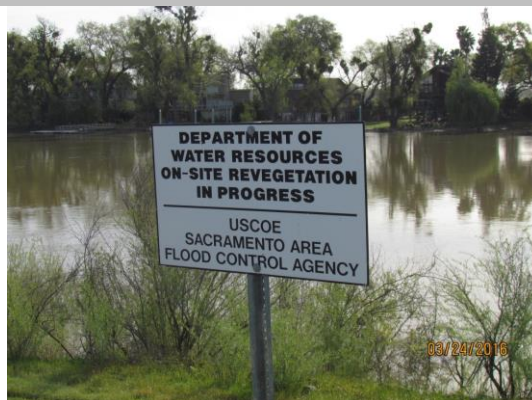
Photo 2 of 2 : FA_2016_RD1600_191_5_20160913_00008.jpg

DWR revegetation site. Spring 2016.

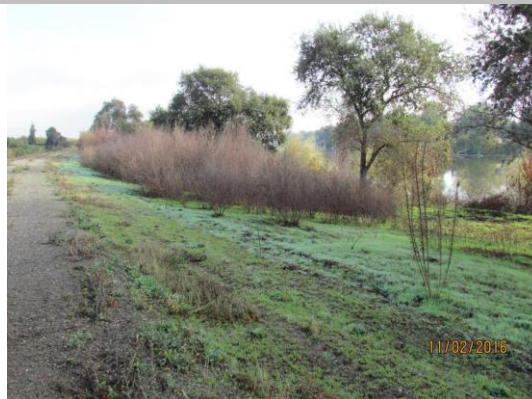
Photo 1 of 1 : FA_2016_RD1600_191_50_20161103_00109.jpg

View of willows on waterward side of the levee. Recommended removal. Fall 2016.

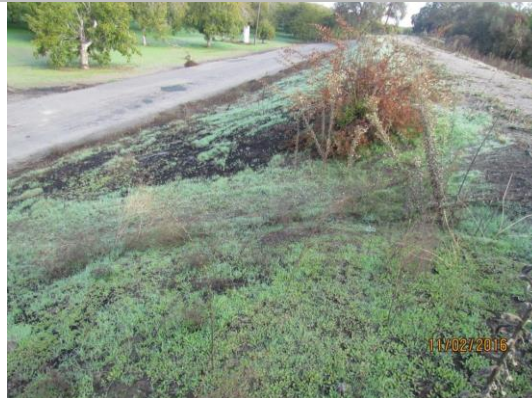
Photo 1 of 1 : FA_2016_RD1600_191_70_20161103_00110.jpg

View of slope instability due to vehicular activity. Fall 2016.

LM Start	1.70	Rating **	M	Issue No.	70
LM End	1.70	Issue Type +	Ma	Location *	LS
Category	Earthen Levee			GPS Latitude/Longitude	
				Start	End
Item	Slope Stability			38.698414 °	38.698414 °
				-121.631874 °	-121.631874 °
DWR ID	DWR_RD1600_01_s_2016_70				
Comment Code					
S3 : Repair the levee slope damaged by vehicle traffic and prevent access where possible.					
Inspector Comment

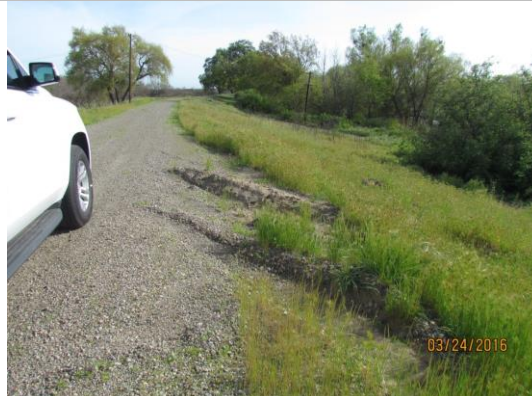
Photo 1 of 1 : FA_2016_RD1600_191_71_20160913_00050.jpg

View of the ruts on the shoulder of the levee on the waterward side. Spring 2016.

LM Start	1.72	Rating **	M	Issue No.	71
LM End	1.72	Issue Type +	Ma	Location *	WS
Category	Earthen Levee			GPS Latitude/Longitude	
				Start	End
Item	Slope Stability			38.698628 °	38.698628 °
				-121.631694 °	-121.631694 °
DWR ID	DWR_RD1600_01_s_2016_71				
Comment Code					
S3 : Repair the levee slope damaged by vehicle traffic and prevent access where possible.					
Inspector Comment

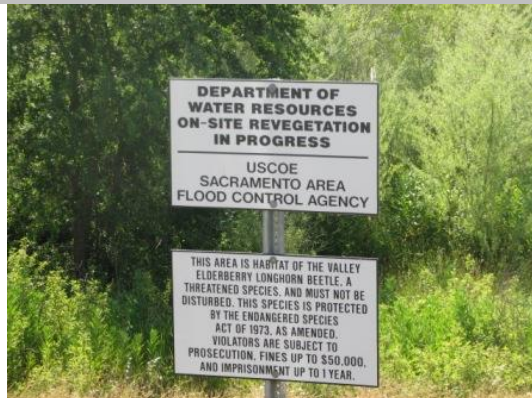
Photo 2 of 2 : FA_2016_RD1600_191_31_20160913_00032.jpg

Revegetation site with the Elderberry Beetle. Photo taken spring 2012.

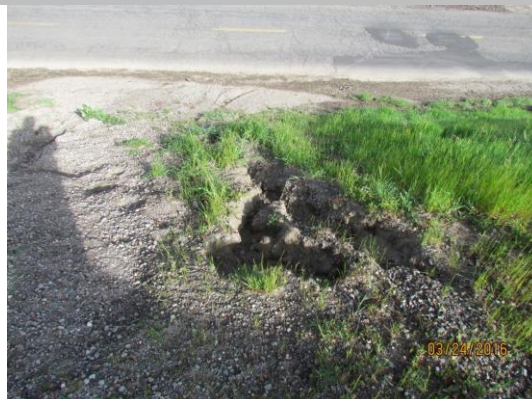
Photo 1 of 3 : FA_2016_RD1600_191_72_20160913_00051.jpg

LM Start	2.01	Rating **	U	Issue No.	72
LM End	2.01	Issue Type +	Ma	Location *	LS
Category	Earthen Levee			GPS Latitude/Longitude	
				Start	End
Item	Erosion / Bank Caving			38.701605 °	38.701605 °
				-121.627954 °	-121.627954 °
DWR ID	DWR_RD1600_01_s_2016_72				
Comment Code					
E2 : Schedule repair of erosion site prior to the next inspection.					
Inspector Comment					
Erosion seems to be caused by rain runoffs. Slope is graveled. Unsure if it is being used as a ramp.

Erosion is on the landward side of the levee about midway from the shoulder of the levee. Spring 2016.

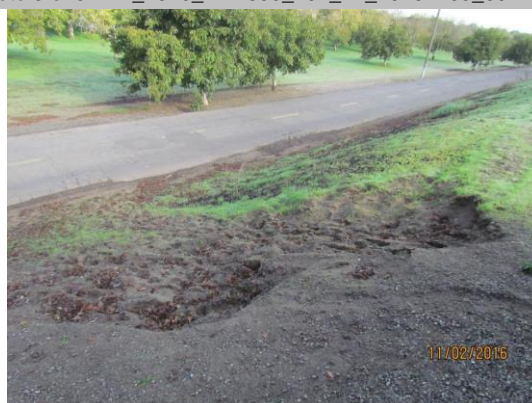
Photo 3 of 3 : FA_2016_RD1600_191_72_20161103_00111.jpg

Updated view of the erosion site. Fall 2016.

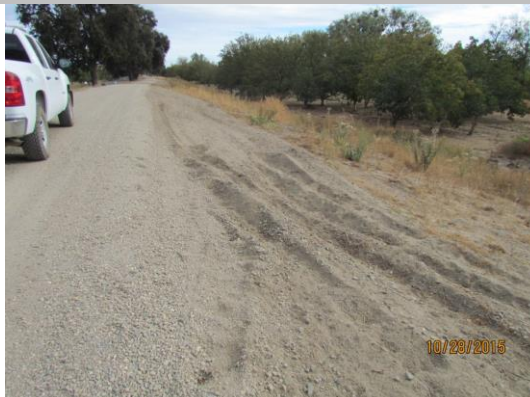
Photo 1 of 1 : FA_2016_RD1600_191_52_20160913_00043.jpg

View of the slope stability caused by vehicles on the waterward side of the levee looking upstream. Fall 2015.

LM Start	2.02	Rating **	M	Issue No.	52
LM End	2.02	Issue Type +	Ma	Location *	WS
Category	Earthen Levee			GPS Latitude/Longitude	
				Start	End
Item	Slope Stability			38.701753 °	38.701753 °
				-121.627734 °	-121.627734 °
DWR ID	DWR_RD1600_01_f_2015_52				
Comment Code					
S3 : Repair the levee slope damaged by vehicle traffic and prevent access where possible.					
Inspector Comment

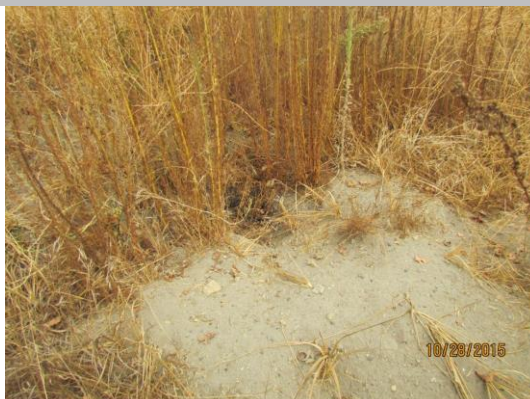
Photo 1 of 1 : FA_2016_RD1600_191_53_20160913_00044.jpg

View of the rodent hole on the waterward side of the levee. Fall 2015.

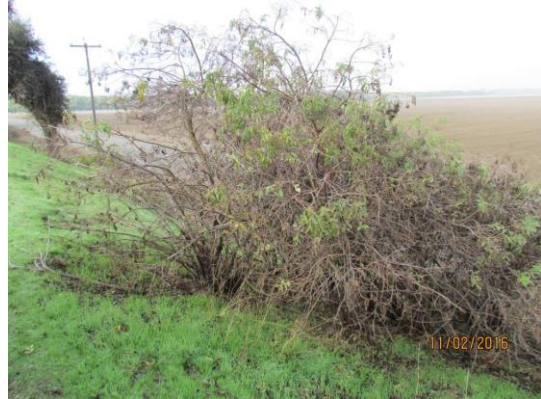
Photo 1 of 1 : FA_2016_RD1600_191_45_20161103_00114.jpg

Elderberry tree on landside slope. Fall 2016.

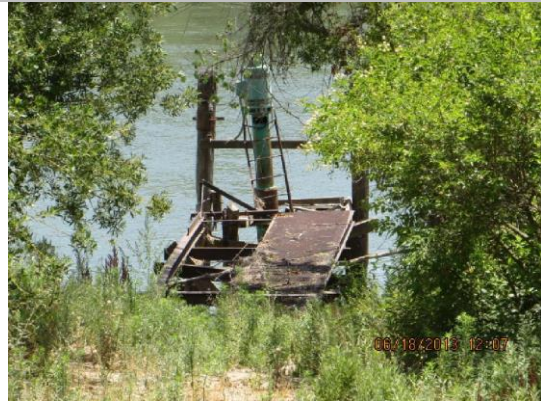
Photo 1 of 2 : UCIP_FA_2016_15108_24826.jpg

Pump on metal platform off WS berm.

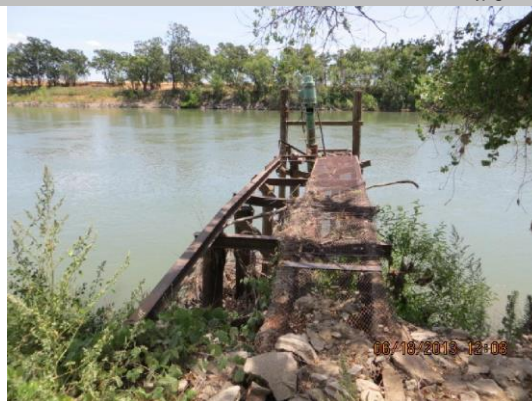
Photo 2 of 2 : UCIP_FA_2016_15108_24825.jpg

Debris buildup at metal platform waterline.

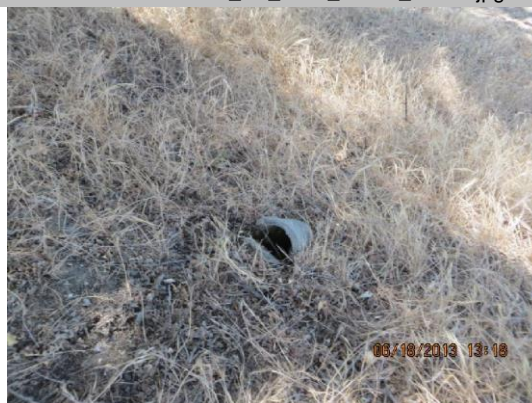
Photo 1 of 2 : UCIP_FA_2016_15110_24828.jpg

Pipe visible on LS slope.

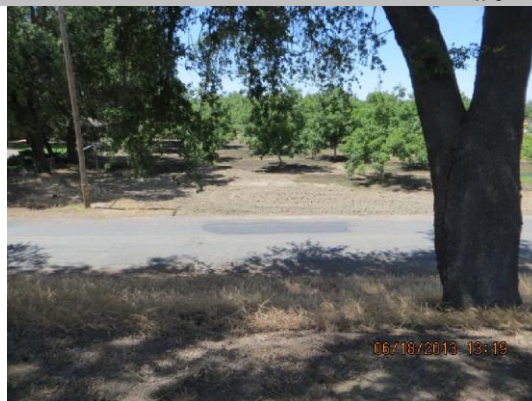
Photo 2 of 2 : UCIP_FA_2016_15110_24827.jpg

Pipe visible on LS slope.

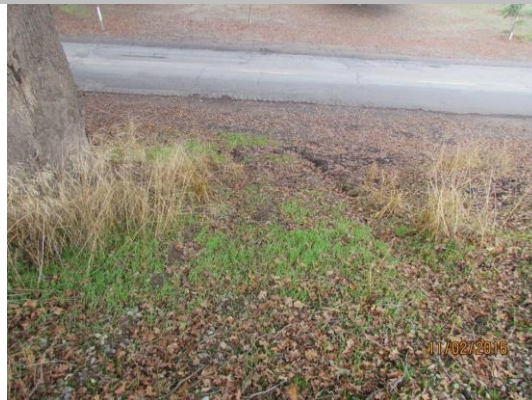
Photo 1 of 1 : FA_2016_RD1600_191_47_20161103_00115.jpg

LS levee slope damaged by a vehicle. Fall 2016.

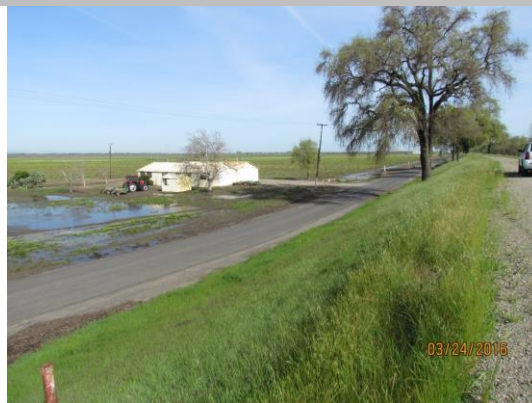
Photo 1 of 2 : FA_2016_RD1600_191_73_20160913_00053.jpg

View taken from the crown of the levee of the seepage. Spring 2016.

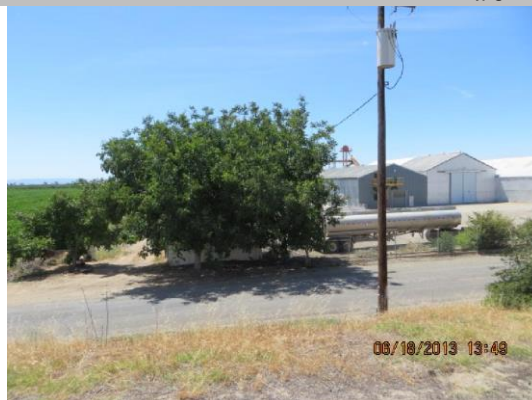
Photo 1 of 2 : UCIP_FA_2016_15125_24846.jpg

Pumphouse/distribution box off LS toe.

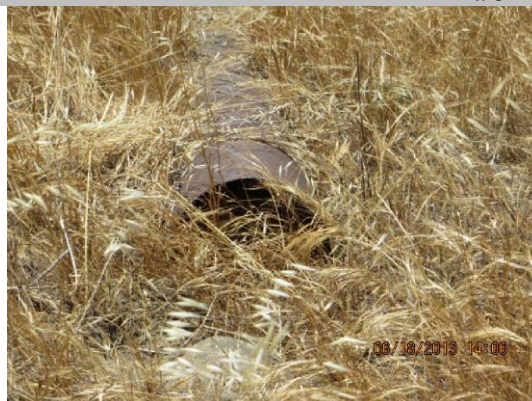
Photo 2 of 2 : UCIP_FA_2016_41563_27473.jpg

Pipe and remnants of grouted pipe on LS slope.

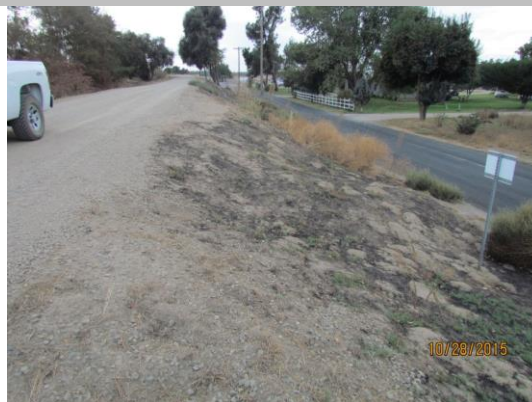
Photo 1 of 1 : FA_2016_RD1600_191_41_20160913_00038.jpg

View of the bulge at the toe of the levee on the landward side looking downstream. Fall 2015.

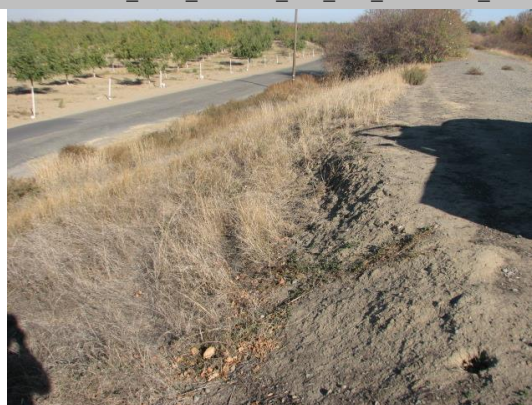
Photo 1 of 2 : FA_2016_RD1600_191_141_20160913_00059.jpg

The erosion at the shoulder of the levee could be slope instability. Fall 2013

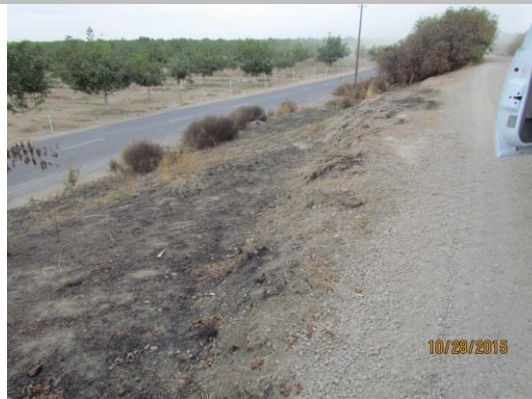
Photo 2 of 2 : FA_2016_RD1600_191_141_20160913_00060.jpg

View of the erosion on the landward side of the levee looking upstream.
Fall 2015.

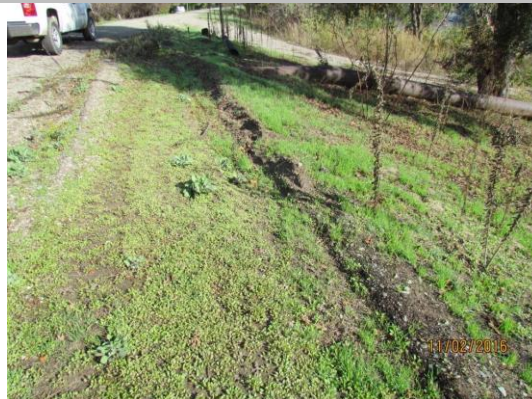
Photo 1 of 1 : FA_2016_RD1600_191_44_20161103_00119.jpg

View of WS slope depression. Fall 2016.

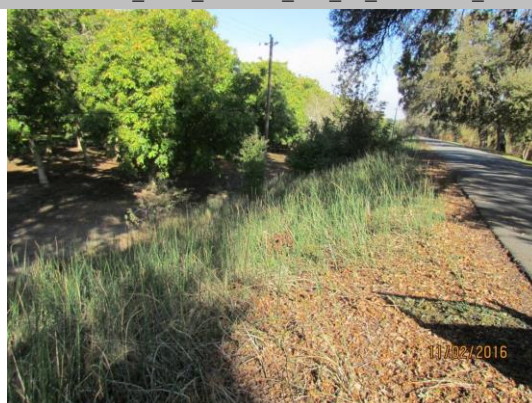
Photo 1 of 1 : FA_2016_RD1600_191_59_20161103_00121.jpg

Vegetation on LS slope partially blocks visibility. Fall 2016.

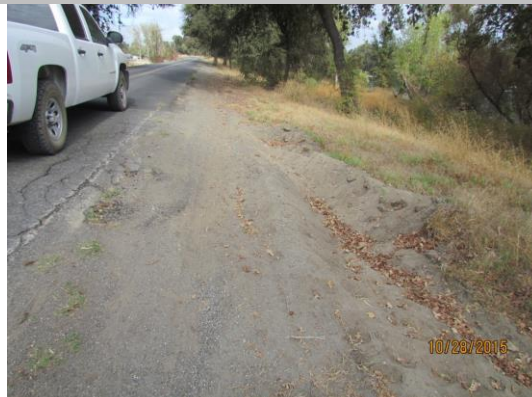
Photo 1 of 1 : FA_2016_RD1600_191_58_20160913_00047.jpg

View of the slope stability on the waterward side of the levee looking upstream. Fall 2015.

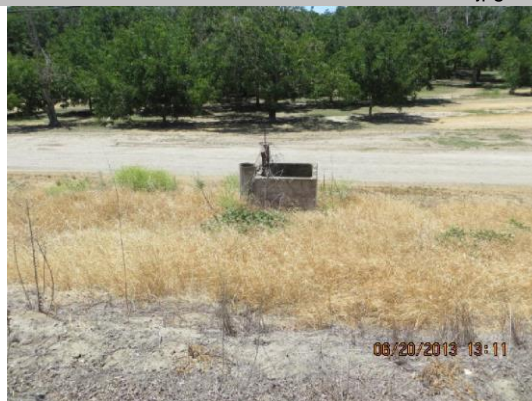
Photo 1 of 2 : UCIP_FA_2016_50101_25011.jpg

6'X6' concrete distribution box on LS toe.

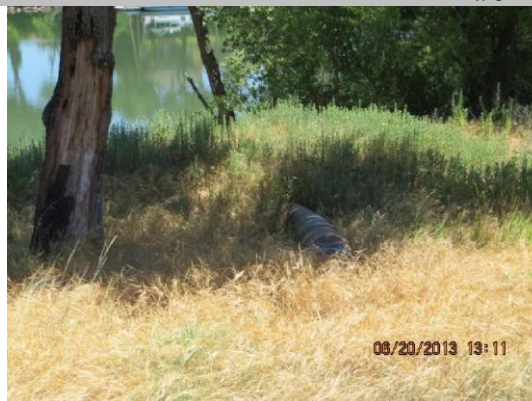
Photo 2 of 2 : UCIP_FA_2016_50101_25010.jpg

Pipe on WS slope.

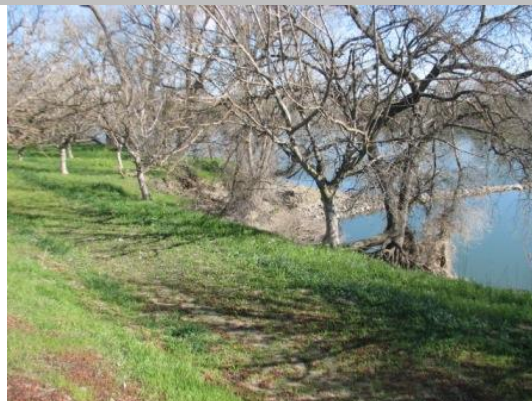
Photo 1 of 2 : FA_2016_RD1600_191_30_20160913_00029.jpg

Erosion is into the berm area and needs to be monitored. Spring 2013

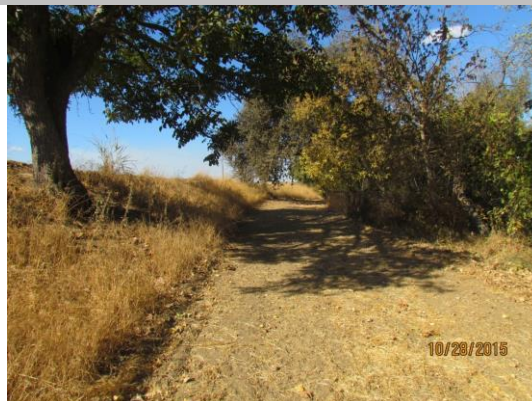
Photo 2 of 5 : FA_2016_RD1600_191_20_20160913_00015.jpg

View of the erosion in the berm area on the waterward side looking upstream. Fall 2015.

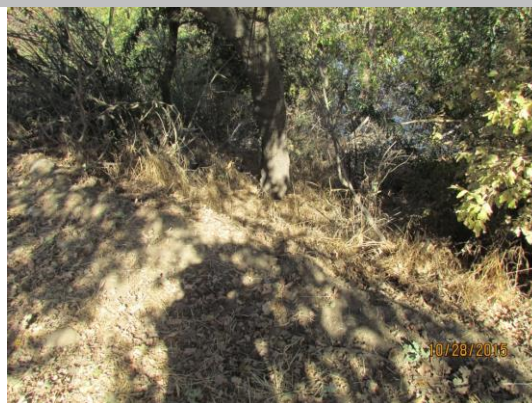
Photo 4 of 5 : FA_2016_RD1600_191_20_20160913_00017.jpg

Looking at the erosion site on the berm. Fall 2015.

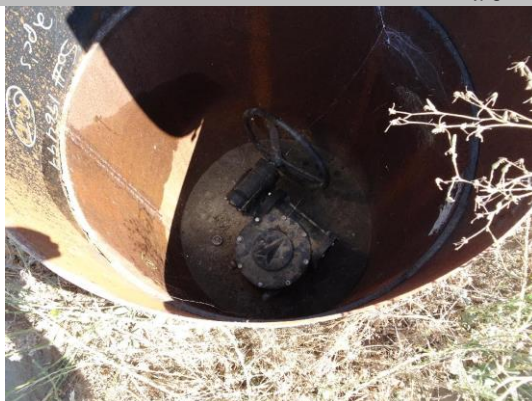
Photo 2 of 2 : UCIP_FA_2016_50169_75608.jpg

view of positive closure device in metal riser on WS shoulder of levee.

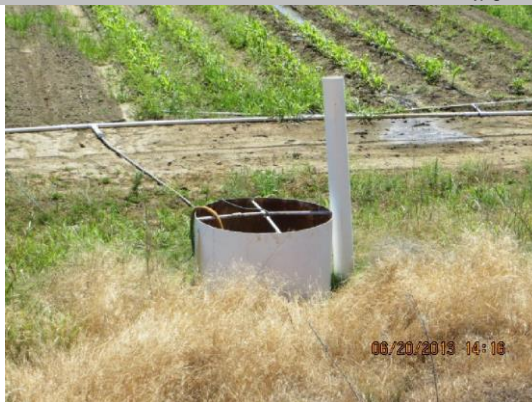
Photo 1 of 1 : UCIP_FA_2016_16310_27485.jpg

4-foot diameter steel standpipe at LS toe, may be indicator of pipe location.

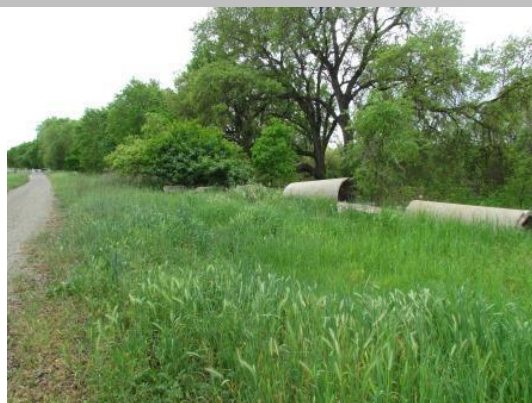
Photo 1 of 1 : FA_2016_RD1600_191_1202_20160913_00073.jpg

View of debris on the waterward side of the levee looking upstream. Spring 2015.

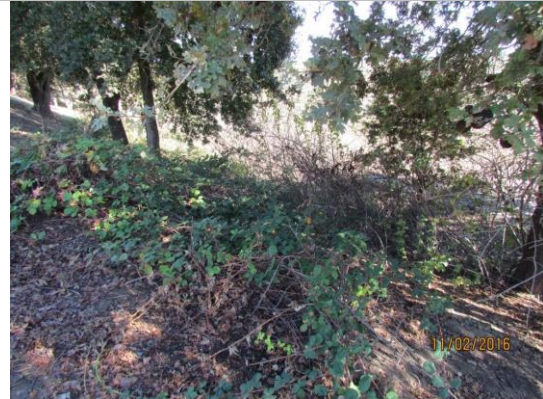
Photo 1 of 1 : FA_2016_RD1600_191_74_20161103_00132.jpg

Tree thinning on LS slope is needed. Fall 2016.

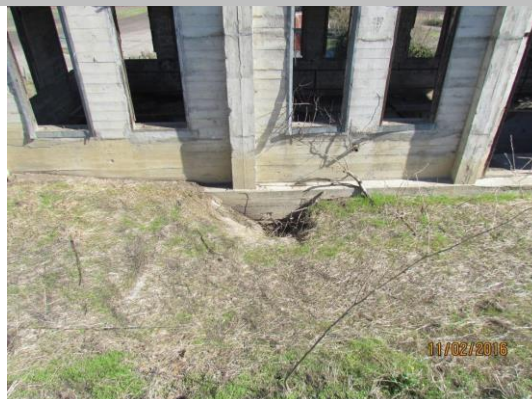
Photo 1 of 1 : FA_2016_RD1600_192_4_20161103_00012.jpg

Landside levee slope erosion at RD1600 pumping plant. Fall 2016.

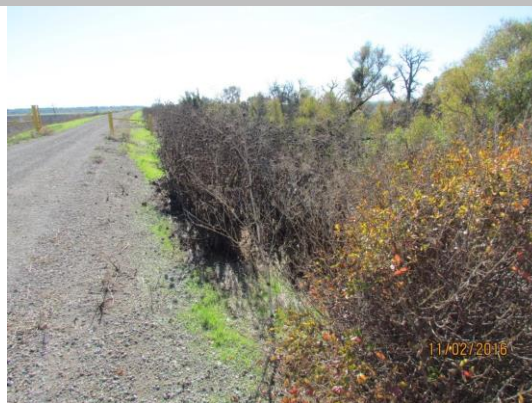
Photo 1 of 1 : FA_2016_RD1600_192_5_20161103_00013.jpg

View of vegetation on waterside slope. Fall 2016.

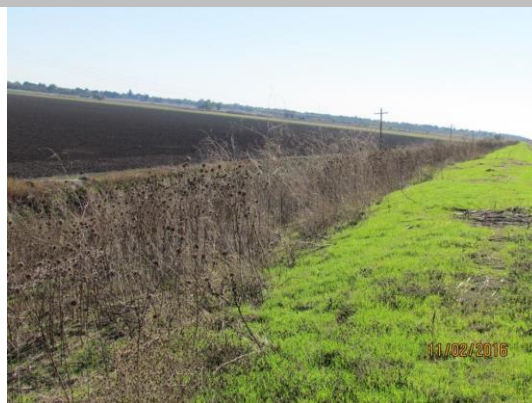
Photo 1 of 1 : FA_2016_RD1600_192_7_20161103_00014.jpg

View of vegetation on landside slope. Fall 2016.

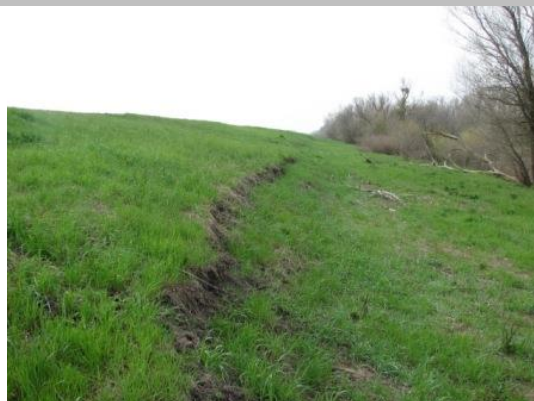
Photo 2 of 4 : FA_2016_RD1600_192_14_20160913_00006.jpg

Wave wash damage along the slope the cut is 1'-2'.

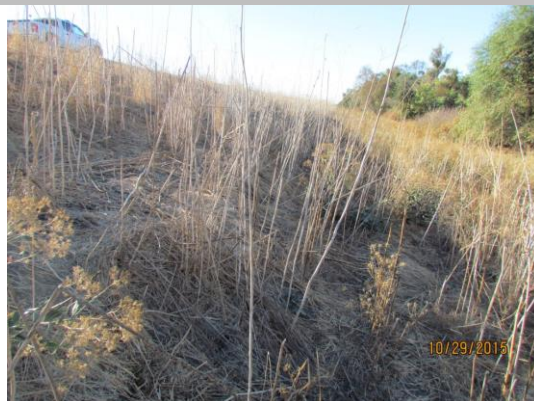
Photo 3 of 4 : FA_2016_RD1600_192_14_20160913_00007.jpg

View of the erosion on the waterward side of the levee looking downstream. Fall 2015.

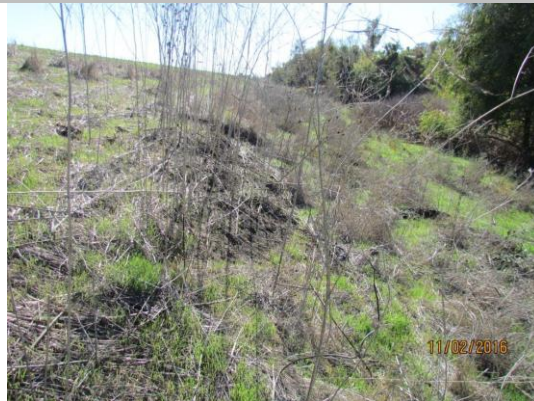
Photo 4 of 4 : FA_2016_RD1600_192_14_20161103_00015.jpg

Updated view of erosion site on WS slope. Fall 2016.

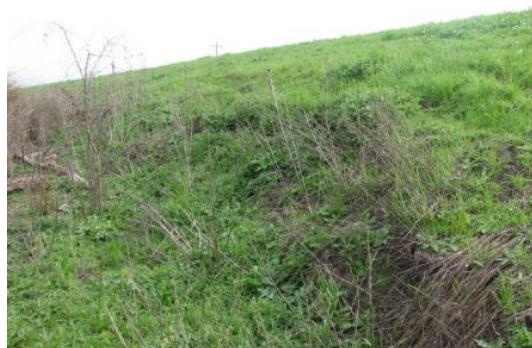
Photo 1 of 3 : FA_2016_RD1600_192_15_20160913_00008.jpg

Looking upstream a deeper cut of 2'-3' damage.

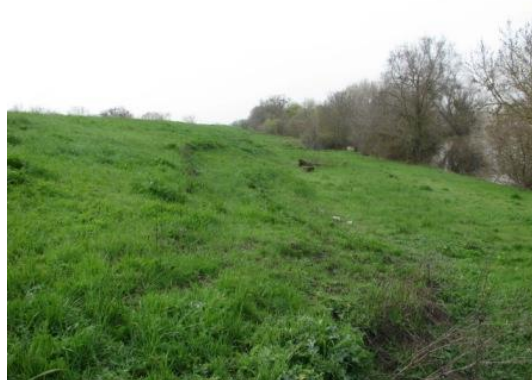
Photo 2 of 3 : FA_2016_RD1600_192_15_20160913_00009.jpg

This is wave wash damage along the toe of the levee looking downstream.

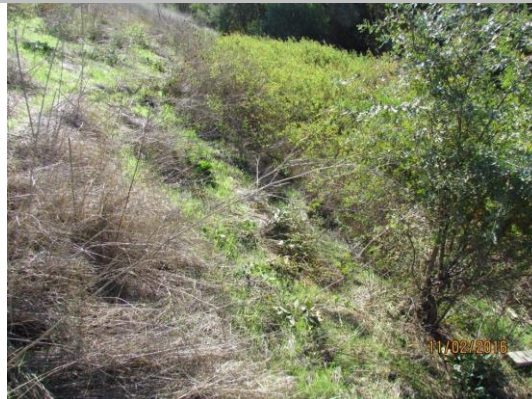
Photo 3 of 3 : FA_2016_RD1600_192_15_20161103_00016.jpg

Updated view of wave wash damage on WS slope. Fall 2016.

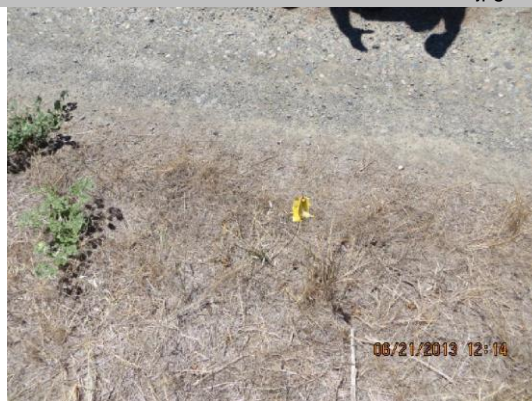
Photo 1 of 2 : UCIP_FA_2016_50099_27478.jpg

PG&E marker flag on Crown.

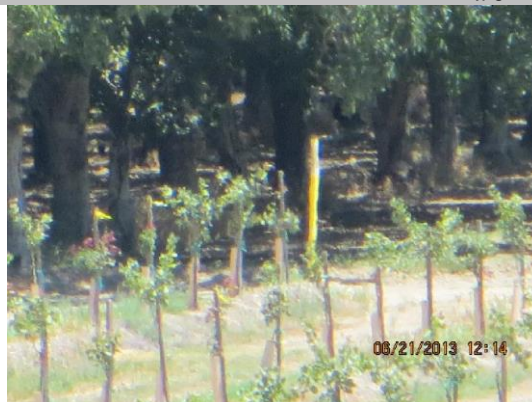
Photo 2 of 2 : UCIP_FA_2016_50099_27477.jpg

Carsonite gasline marker visible approximately 1,000-feet east of levee crown.

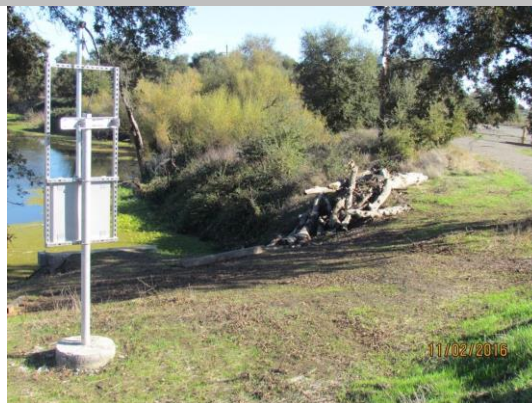
Photo 2 of 2 : FA_2016_RD1600_192_6_20161103_00021.jpg

View of debris on LS slope. Fall 2016.
