**Flood Control Project Maintenance
Levee Inspections**

Fall 2017 Levee Maintenance Deficiency Summary Report

Sacramento River Basin

Reclamation District No. 1600 Mull

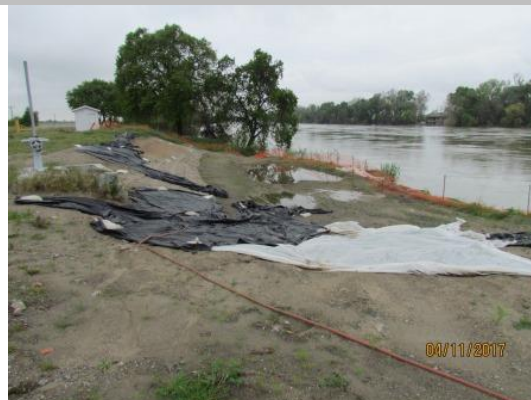
Photo 1 of 1 : FA_2017_RD1600_191_25_20170911_00024.jpg

LM Start	0.08	Rating **	M	Issue No.	25
LM End	0.08	Issue Type +	Ma	Location *	WS
Category	Earthen Levee			GPS Latitude/Longitude	
				Start	End
Item	Erosion / Bank Caving			38.676163 °	38.676163 °
				-121.631005 °	-121.631005 °
DWR ID	DWR_RD1600_01_s_2017_25				
Comment Code					
E2 : Schedule repair of erosion site prior to the next inspection.					
Inspector Comment					
Sloughing on waterside slope. RD has placed visqueen to protect the slope.

Runoff erosion on waterside levee slope. LMA placed visqueen to prevent further erosion. Spring 2017.

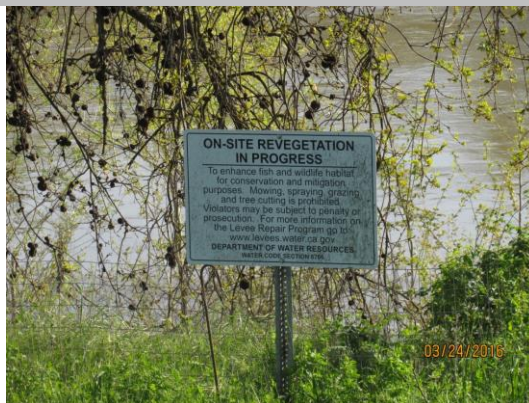
Photo 1 of 2 : FA_2017_RD1600_191_49_20170911_00047.jpg

Sign stating revegetation site. Spring 2016.

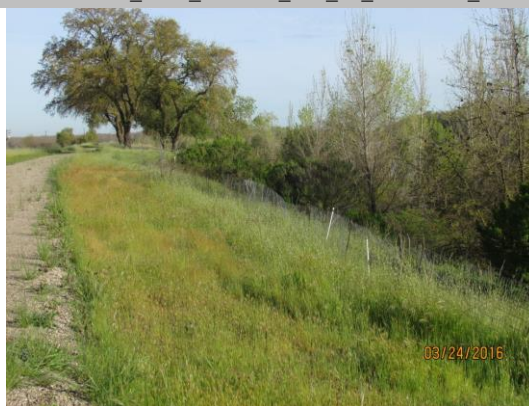
Photo 2 of 2 : FA_2017_RD1600_191_49_20170911_00048.jpg

View of the revegetation site and fence on the waterward side of the levee looking upstream. Spring 2016.

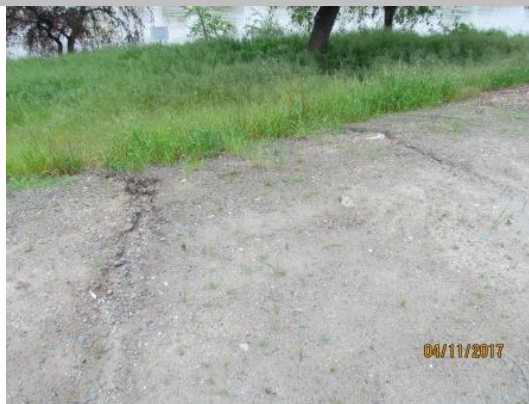
Photo 1 of 1 : FA_2017_RD1600_191_46_20170911_00044.jpg

Rills from runoff on waterside levee slope. Spring 2017.

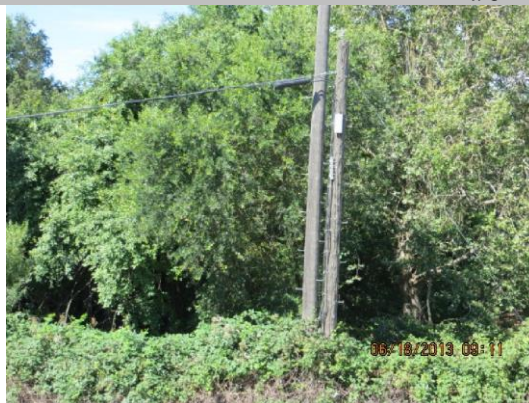
Photo 1 of 1 : UCIP_FA_2017_15087_24812.jpg

LM Start	0.13	Rating **	M	Issue No.	1203	
LM End	0.13	Issue Type +	En	Location *		
Category	Supplemental			GPS Latitude/Longitude		
				Start		End
Item	DWR UCIP Field Study			38.676802 °		38.676802 °
				-121.631442 °		-121.631442 °
DWR ID						
Comment Code						
Inspector Comment						
FS_ID:15087 DS_ID:21459 EP_NO: 1929 Repair Type: Non-Urgent Crossing Status: Indicator Found UCIP Comments: Line should be located with carsonite signs on both sides of levee. FIELD_STRUCT_DESC: Telephone conduit of an unknown size or material through the levee, 3 feet below the crown. Telephone line at joint pole (JP) off the landside (LS) toe. (Permit No. 1929, 1954 - Pacific Telephone and Telegraph Company [PT&T]). [Additional Reference(s): DWR Levee Log, 1988]. FS Date: 6/18/2013

Line visible on JP off LS toe. Likely this is the source of crossing.

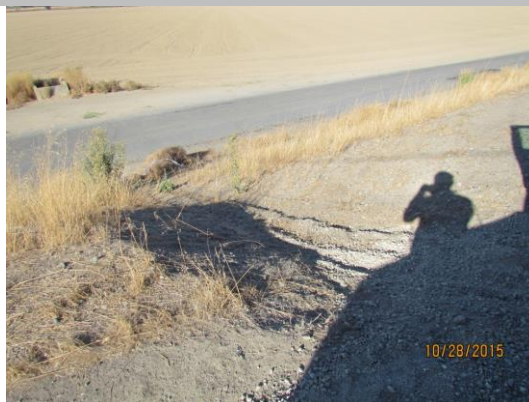
Photo 1 of 2 : FA_2017_RD1600_191_133_20170911_00077.jpg

LM Start	0.53	Rating **	M	Issue No.	133
LM End	0.53	Issue Type +	Ma	Location *	LS
Category	Earthen Levee			GPS Latitude/Longitude	
				Start	End
Item	Slope Stability			38.682140 °	38.682140 °
				-121.634083 °	-121.634083 °
DWR ID	DWR_RD1600_01_f_2013_133				
Comment Code					
S2 : Repair the levee slope damaged by foot traffic and prevent access where possible.					
Inspector Comment					
Footpath on landside slope over pipe crossing.

View of the slope stability on the landward side of the levee. Fall 2015.

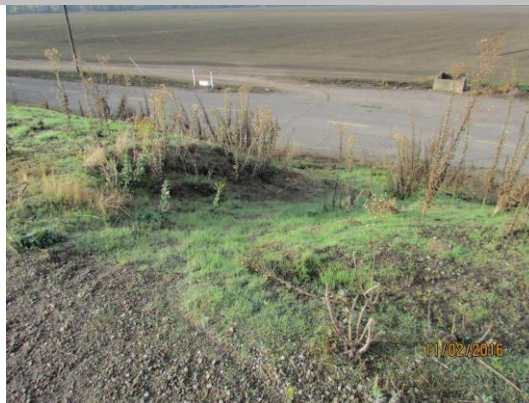
Photo 2 of 2 : FA_2017_RD1600_191_133_20170911_00078.jpg

LM Start	0.53	Rating **	M	Issue No.	133 (cont)	
LM End	0.53	Issue Type +	Ma	Location *	LS	
Category	Earthen Levee			GPS Latitude/Longitude		
				Start		End
Item	Slope Stability			38.682140 °		38.682140 °
				-121.634083 °		-121.634083 °
DWR ID	DWR_RD1600_01_f_2013_133					
Comment Code						
S2 : Repair the levee slope damaged by foot traffic and prevent access where possible.						
Inspector Comment						
Footpath on landside slope over pipe crossing.

Updated view of the slope stability site. Fall 2016.

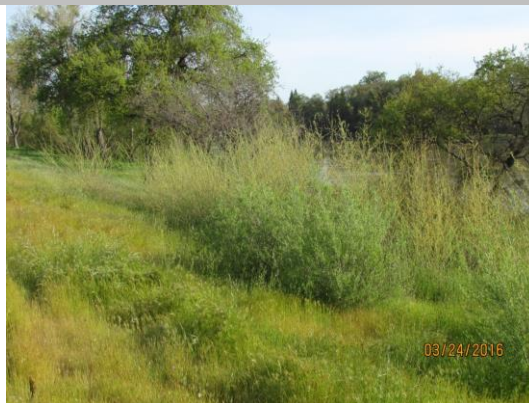
Photo 1 of 3 : FA_2017_RD1600_191_29_20170911_00030.jpg

LM Start	0.60	Rating **	M	Issue No.	29
LM End	0.62	Issue Type +	Ma	Location *	WS
Category	Earthen Levee			GPS Latitude/Longitude	
				Start	End
Item	Vegetation			38.683238 °	38.683415 °
				-121.634388 °	-121.634448 °
DWR ID	DWR_RD1600_01_s_2016_29				
Comment Code					
V2 : Remove the wild growth other than native grasses from the levee slopes.					
Inspector Comment					
Recommend removal of willow trees.

Perspective view of the willows on the waterward side of the levee looking upstream. Spring 2016.

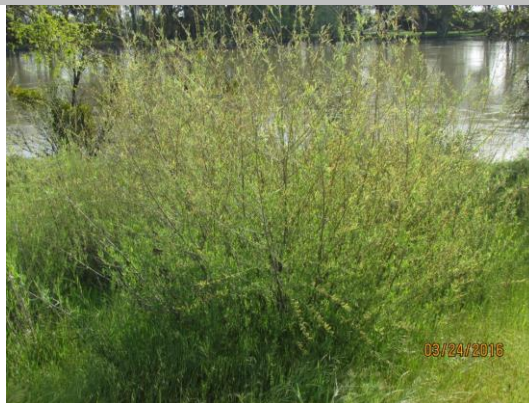
Photo 2 of 3 : FA_2017_RD1600_191_29_20170911_00031.jpg

LM Start	0.60	Rating **	M	Issue No.	29 (cont)	
LM End	0.62	Issue Type +	Ma	Location *	WS	
Category	Earthen Levee			GPS Latitude/Longitude		
				Start		End
Item	Vegetation			38.683238 °		38.683415 °
				-121.634388 °		-121.634448 °
DWR ID	DWR_RD1600_01_s_2016_29					
Comment Code						
V2 : Remove the wild growth other than native grasses from the levee slopes.						
Inspector Comment						
Recommend removal of willow trees.

Willows are growing on the waterward side of the levee. Spring 2016.

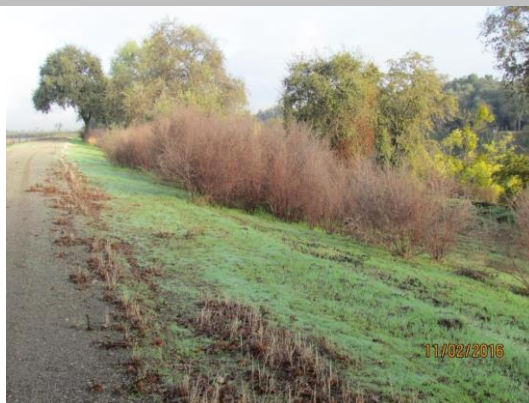
Photo 3 of 3 : FA_2017_RD1600_191_29_20170911_00032.jpg

Updated view of willows on waterward side. Fall 2016.

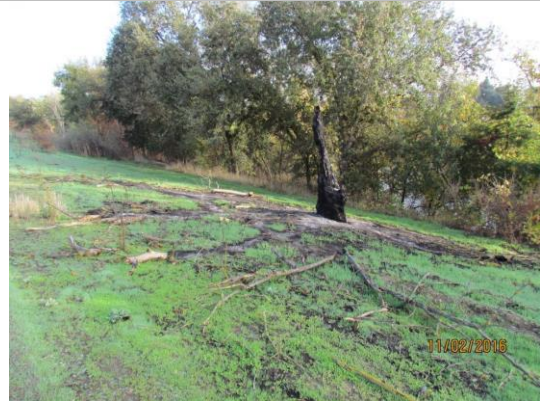
Photo 2 of 2 : FA_2017_RD1600_191_624_20170911_00084.jpg

LM Start	0.78	Rating **	U	Issue No.	624 (cont)	
LM End	0.78	Issue Type +	Ma	Location *	WS	
Category	Earthen Levee			GPS Latitude/Longitude		
				Start		End
Item	Trim / Thin Trees			38.685713 °		38.685713 °
				-121.634985 °		-121.634985 °
DWR ID	DWR_RD1600_01_s_2017_624					
Comment Code						
T5 : Tree stumps.						
Inspector Comment						
Burnt stump on waterside slope.

Dying tree on waterward side was burnt. Fall 2016.

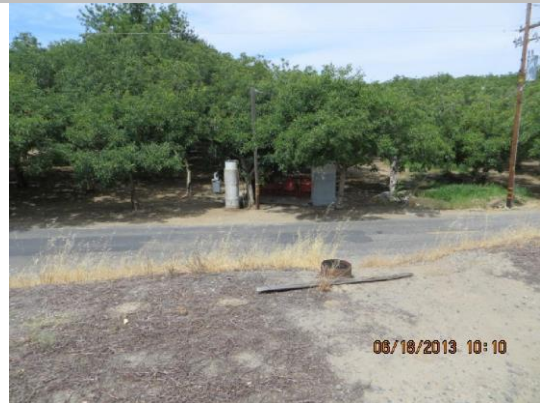
Photo 1 of 3 : UCIP_FA_2017_15285_25088.jpg

Comment Code						
Inspector Comment						
FS_ID:15285 DS_ID:21463 EP_NO: 6100 Repair Type: Non-Urgent Crossing Status: Found UCIP Comments: Gate valve will not open or close. FIELD_STRUCT_DESC: 12-inch steel irrigation pipe through the levee, 3.4 feet below the crown. Slant pump and gate valve on the waterside (WS) slope. Siphon breaker in a 12-inch steel riser on the landside (LS) shoulder. Filter, booster pump, and butterfly valve on the LS toe. 2.25-inch galvanized iron electrical conduit at the same location. (Permit No. 6100, 1968 - Charles Plumb Jr., replaced 8-inch pipe at same location). [Additional Reference(s): DWR Levee Log, 1988]. FS Date: 6/18/2013

Siphon breaker in steel riser on LS shoulder and concrete standpipe off LS toe.

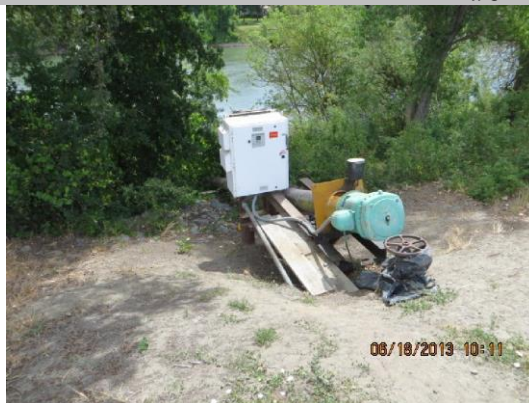
Photo 2 of 3 : UCIP_FA_2017_15285_25087.jpg

Comment Code						
Inspector Comment						
FS_ID:15285 DS_ID:21463 EP_NO: 6100 Repair Type: Non-Urgent Crossing Status: Found UCIP Comments: Gate valve will not open or close. FIELD_STRUCT_DESC: 12-inch steel irrigation pipe through the levee, 3.4 feet below the crown. Slant pump and gate valve on the waterside (WS) slope. Siphon breaker in a 12-inch steel riser on the landside (LS) shoulder. Filter, booster pump, and butterfly valve on the LS toe. 2.25-inch galvanized iron electrical conduit at the same location. (Permit No. 6100, 1968 - Charles Plumb Jr., replaced 8-inch pipe at same location). [Additional Reference(s): DWR Levee Log, 1988]. FS Date: 6/18/2013

Pump and gate valve on WS slope.

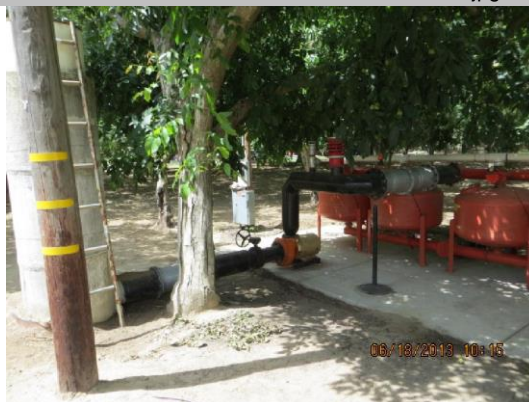
Photo 3 of 3 : UCIP_FA_2017_15285_25086.jpg

Filters, boost pump, and gate valve down stream from concrete standpipe off LS toe.

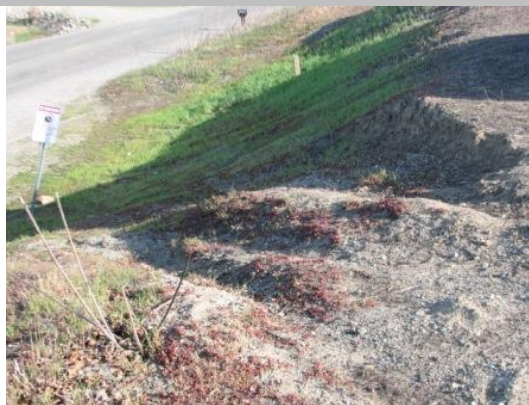
Photo 1 of 2 : FA_2017_RD1600_191_4_20170911_00005.jpg

LM Start	1.40	Rating **	A/W	Issue No.	4
LM End	1.40	Issue Type +	Ma	Location *	LS
Category	Earthen Levee			GPS Latitude/Longitude	
				Start	End
Item	Slope Stability			38.694452 °	38.694452 °
				-121.634292 °	-121.634292 °
DWR ID	DWR_RD1600_01_s_2017_4				
Comment Code					
S3 : Repair the levee slope damaged by vehicle traffic and prevent access where possible.					
Inspector Comment					
Vehicle access point. Recommend monitoring.

Erosion from vehicles on levee slope. Spring 2013

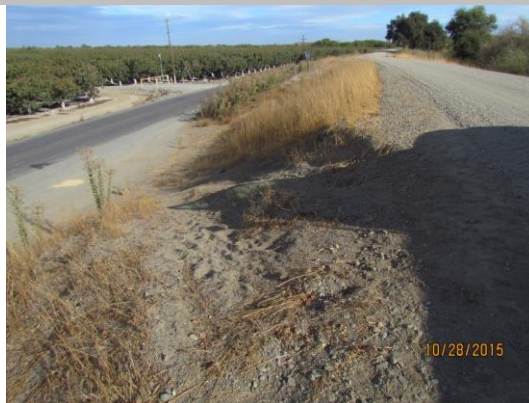
Photo 2 of 2 : FA_2017_RD1600_191_4_20170911_00006.jpg

LM Start	1.40	Rating **	A/W	Issue No.	4 (cont)	
LM End	1.40	Issue Type +	Ma	Location *	LS	
Category	Earthen Levee			GPS Latitude/Longitude		
				Start		End
Item	Slope Stability			38.694452 °		38.694452 °
				-121.634292 °		-121.634292 °
DWR ID	DWR_RD1600_01_s_2017_4					
Comment Code						
S3 : Repair the levee slope damaged by vehicle traffic and prevent access where possible.						
Inspector Comment						
Vehicle access point. Recommend monitoring.

View of the slope stability caused by vehicles on the landward side of the levee looking upstream. Fall 2015.

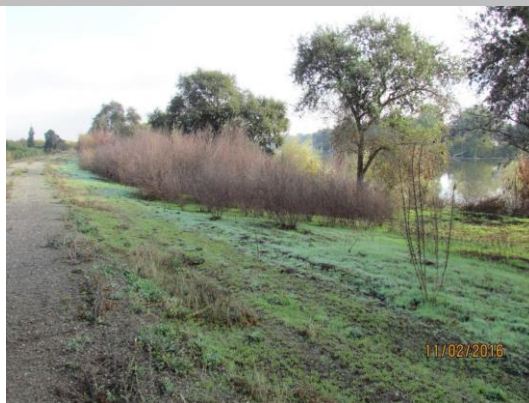
Photo 1 of 1 : FA_2017_RD1600_191_50_20170911_00049.jpg

LM Start	1.53	Rating **	M	Issue No.	50
LM End	1.58	Issue Type +	Ma	Location *	WS
Category	Earthen Levee			GPS Latitude/Longitude	
				Start	End
Item	Vegetation			38.696341 °	38.696918 °
				-121.633417 °	-121.633044 °
DWR ID	DWR_RD1600_01_s_2016_50				
Comment Code					
V2 : Remove the wild growth other than native grasses from the levee slopes.					
Inspector Comment					
Recommend removal of willows on waterward side of the levee.

View of willows on waterward side of the levee. Recommended removal. Fall 2016.

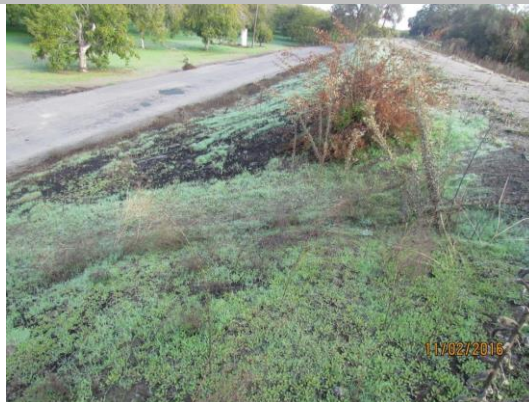
Photo 1 of 1 : FA_2017_RD1600_191_70_20170911_00063.jpg

LM Start	1.70	Rating **	A/W	Issue No.	70
LM End	1.70	Issue Type +	Ma	Location *	LS
Category	Earthen Levee			GPS Latitude/Longitude	
				Start	End
Item	Slope Stability			38.698414 °	38.698414 °
				-121.631874 °	-121.631874 °
DWR ID	DWR_RD1600_01_f_2017_70				
Comment Code					
S2 : Repair the levee slope damaged by foot traffic and prevent access where possible.					
Inspector Comment					
Footpath on landside slope.

View of slope instability due to vehicular activity. Fall 2016.

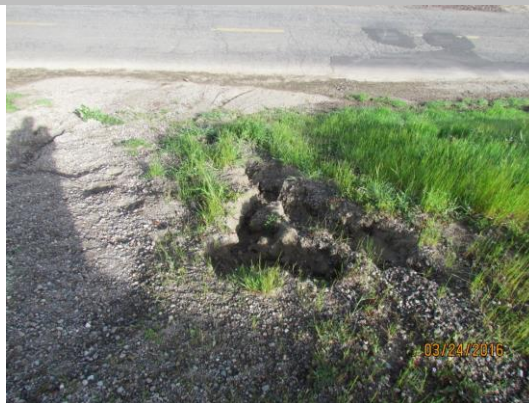
Photo 1 of 4 : FA_2017_RD1600_191_72_20170911_00065.jpg

LM Start	2.01	Rating **	M	Issue No.	72
LM End	2.01	Issue Type +	Ma	Location *	LS
Category	Earthen Levee			GPS Latitude/Longitude	
				Start	End
Item	Erosion / Bank Caving			38.701605 °	38.701605 °
				-121.627954 °	-121.627954 °
DWR ID	DWR_RD1600_01_s_2016_72				
Comment Code					
E2 : Schedule repair of erosion site prior to the next inspection.					
Inspector Comment					
Runoff on landside slope.

Erosion is on the landward side of the levee about midway from the shoulder of the levee. Spring 2016.

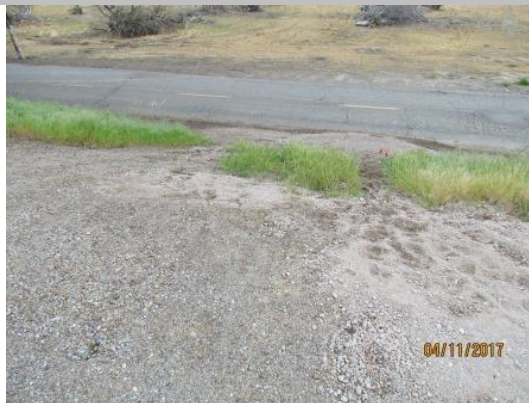
Photo 4 of 4 : FA_2017_RD1600_191_72_20170911_00068.jpg

LM Start	2.01	Rating **	M	Issue No.	72 (cont)	
LM End	2.01	Issue Type +	Ma	Location *	LS	
Category	Earthen Levee			GPS Latitude/Longitude		
				Start		End
Item	Erosion / Bank Caving			38.701605 °	38.701605 °	
				-121.627954 °	-121.627954 °	
DWR ID	DWR_RD1600_01_s_2016_72					
Comment Code						
E2 : Schedule repair of erosion site prior to the next inspection.						
Inspector Comment						
Runoff on landside slope.

Updated view of the erosion site. Spring 2017.

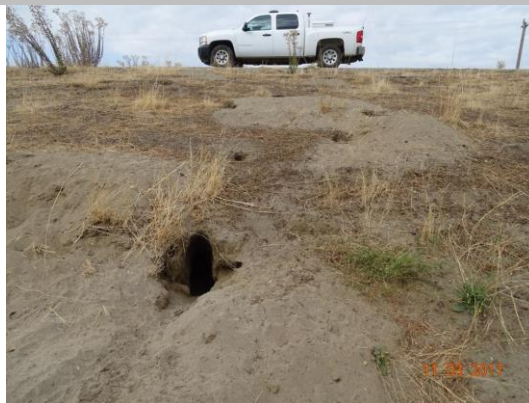
Photo 1 of 1 : FA_2017_RD1600_191_62_20171102_00118.jpg

View of rodent holes on waterside slope. Fall 2017.

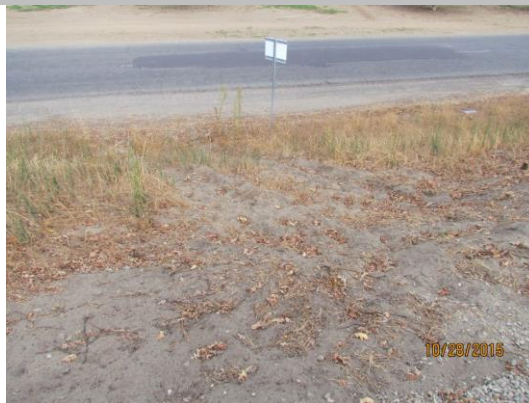
Photo 1 of 1 : FA_2017_RD1600_191_55_20170911_00052.jpg

View of the slope stability damaged by vehicles on the landward side of the levee. Fall 2015.

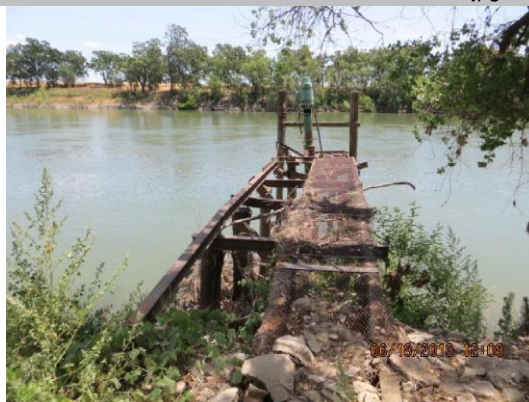
Photo 2 of 3 : UCIP_FA_2017_15108_24825.jpg

Debris buildup at metal platform waterline.

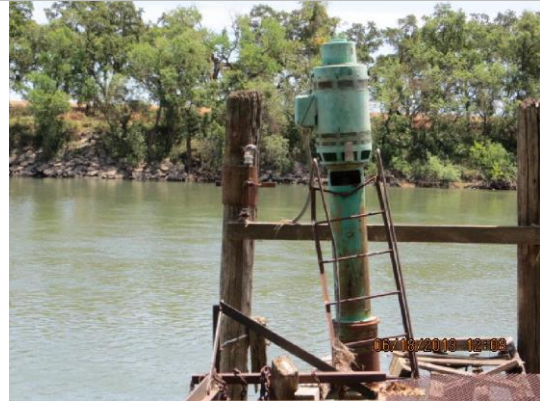
Photo 3 of 3 : UCIP_FA_2017_15108_24824.jpg

Electrical cut to pump.

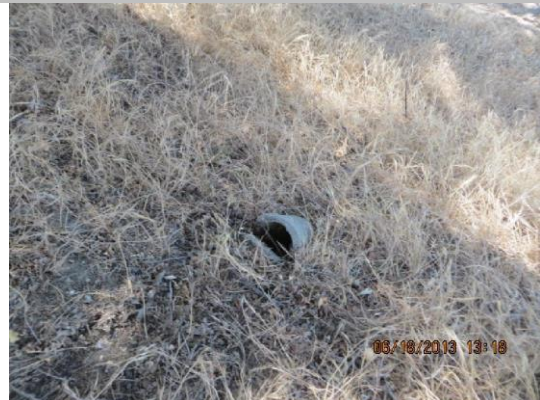
Photo 1 of 2 : UCIP_FA_2017_15110_24828.jpg

Pipe visible on LS slope.

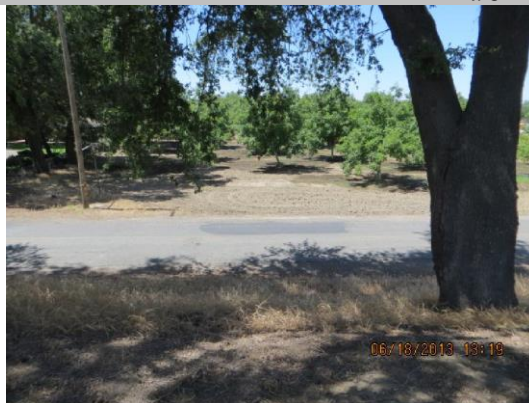
Photo 2 of 2 : UCIP_FA_2017_15110_24827.jpg

Pipe visible on LS slope.

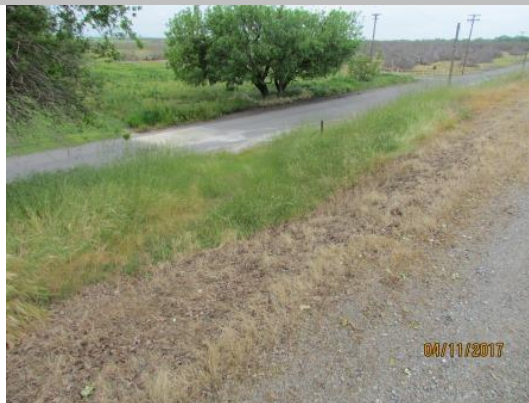
Photo 1 of 1 : FA_2017_RD1600_191_76_20170911_00073.jpg

Slope depression on landside levee slope from vehicle traffic. Spring 2017.

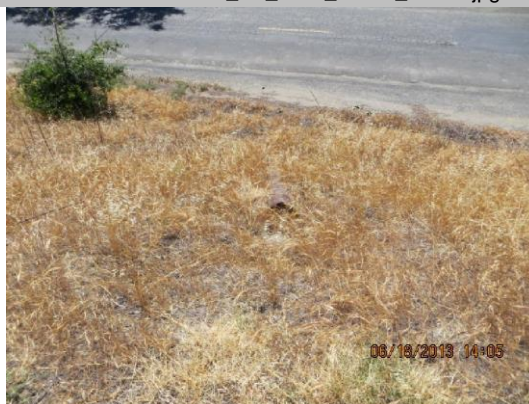
Photo 1 of 2 : UCIP_FA_2017_41563_27474.jpg

Pipe and remnants of grouted pipe on LS slope.

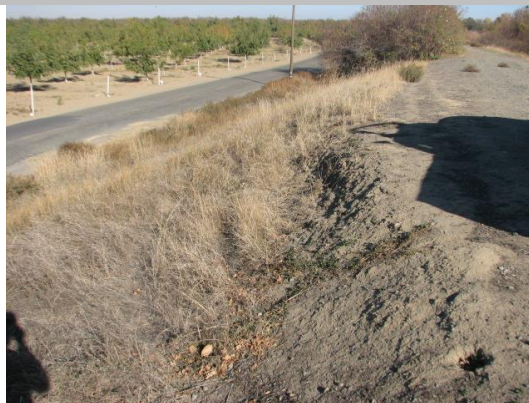
Photo 1 of 2 : FA_2017_RD1600_191_141_20170911_00081.jpg

The erosion at the shoulder of the levee could be slope instability. Fall 2013

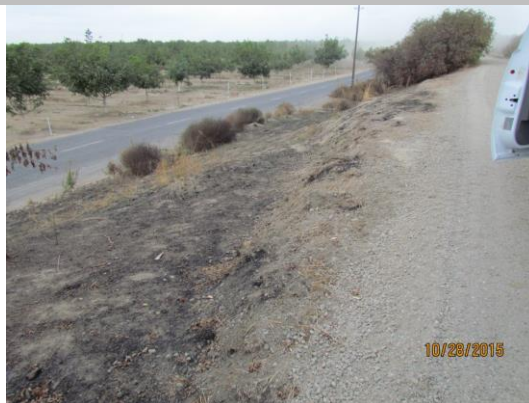
Photo 2 of 2 : FA_2017_RD1600_191_141_20170911_00082.jpg

View of the erosion on the landward side of the levee looking upstream.
Fall 2015.

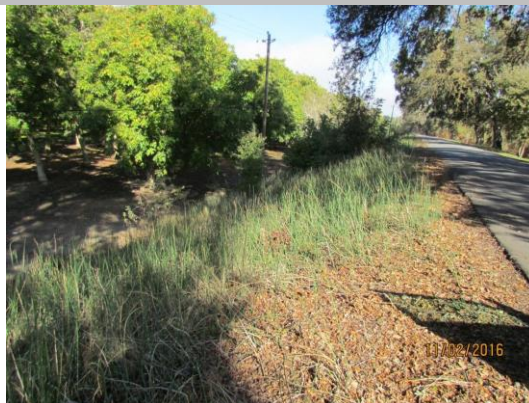
Photo 1 of 1 : FA_2017_RD1600_191_59_20170911_00057.jpg

Vegetation on LS slope partially blocks visibility. Fall 2016.

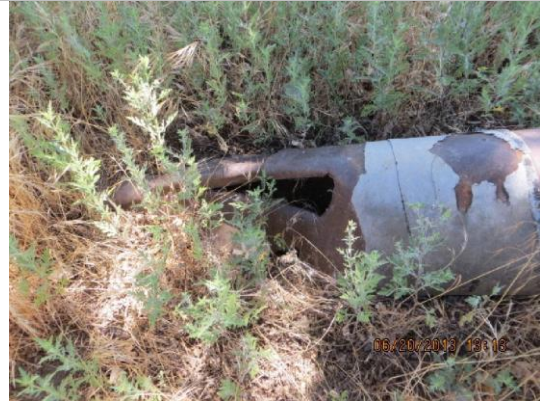
Photo 3 of 3 : UCIP_FA_2017_50101_25009.jpg

Hole in pipe at WS toe.

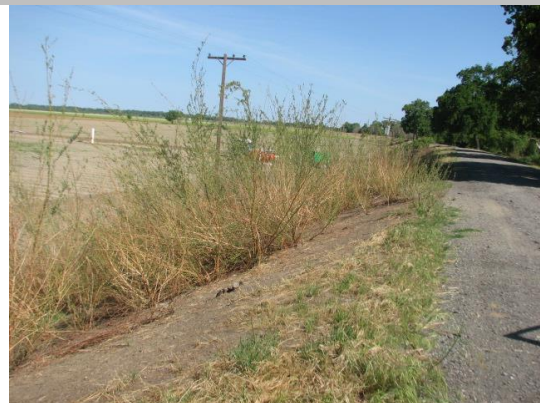
Photo 1 of 2 : FA_2017_RD1600_191_631_20170911_00089.jpg

The tall brush and vegetation blocks visibility. Spring 2014

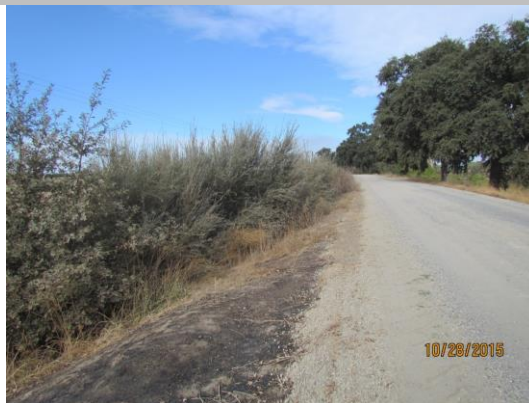
Photo 2 of 2 : FA_2017_RD1600_191_631_20170911_00090.jpg

View of the brush and vegetation on the landward side of the levee. Fall 2015.

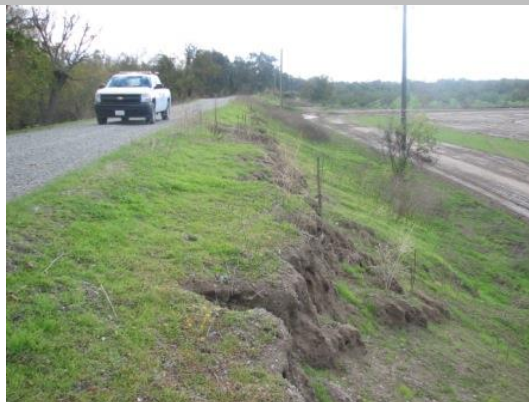
Photo 1 of 3 : FA_2017_RD1600_191_27_20170911_00025.jpg

The erosion appears to be moving closer to the shoulder.

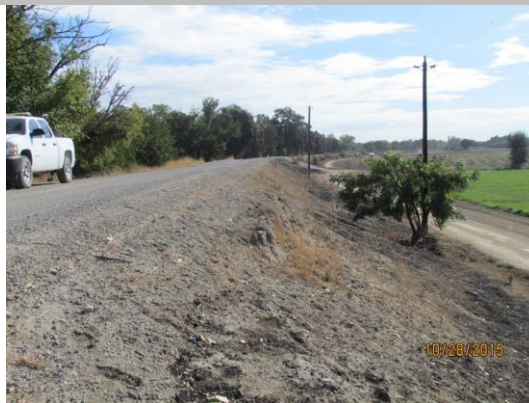
Photo 2 of 3 : FA_2017_RD1600_191_27_20170911_00026.jpg

The erosion seems to have been fixed. There still seems to be some erosion on the landward side of the levee looking downstream. Fall 2015.

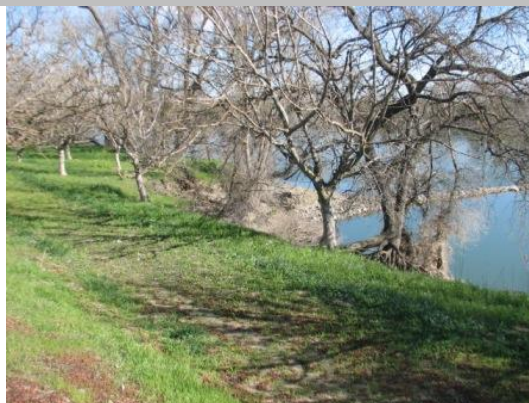
Photo 1 of 2 : FA_2017_RD1600_191_30_20170911_00033.jpg

Erosion is into the berm area and needs to be monitored. Spring 2013

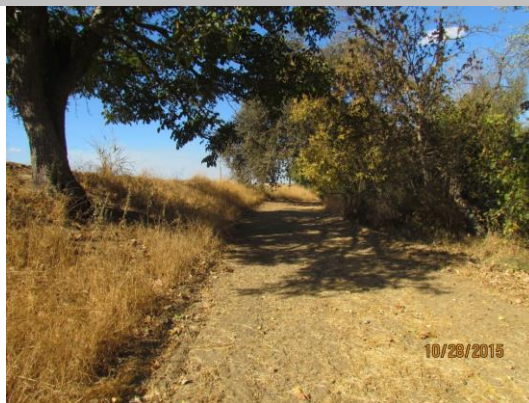
Photo 2 of 5 : FA_2017_RD1600_191_20_20170911_00015.jpg

View of the erosion in the berm area on the waterward side looking upstream. Fall 2015.

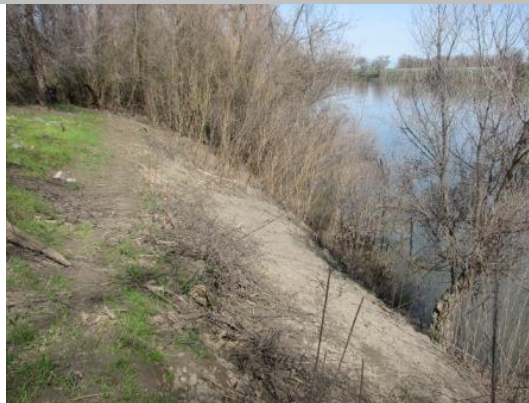
Photo 2 of 3 : FA_2017_RD1600_191_21_20170911_00020.jpg

The bank is eroding away and has become very steep.

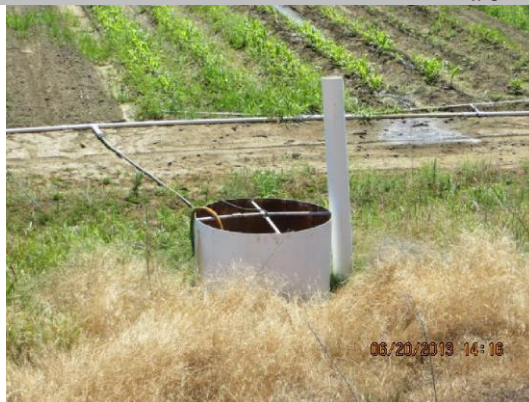
Photo 1 of 1 : UCIP_FA_2017_16310_27485.jpg

4-foot diameter steel standpipe at LS toe, may be indicator of pipe location.

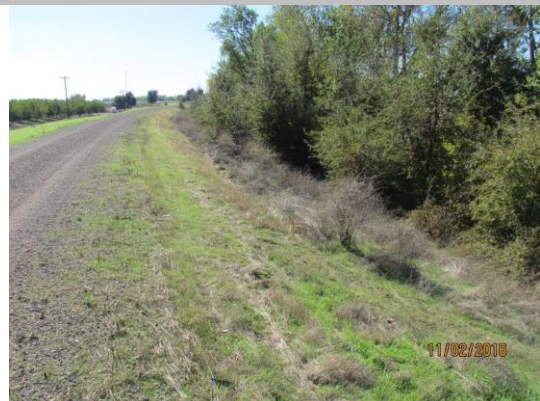
Photo 1 of 1 : FA_2017_RD1600_191_66_20170911_00061.jpg

Vegetation on WS slope has been cleared only about 10 ft. from the crown. Fall 2016.

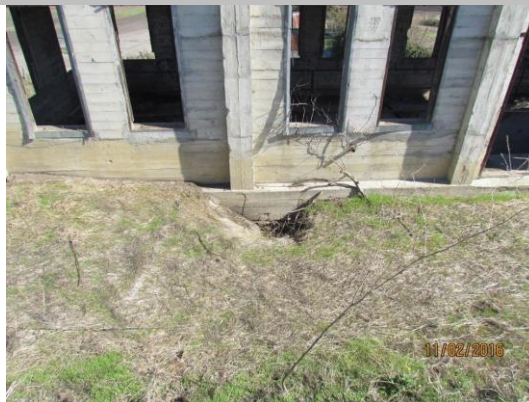
Photo 1 of 1 : FA_2017_RD1600_192_4_20170911_00003.jpg

LM Start	0.37	Rating **	M	Issue No.	4
LM End	0.37	Issue Type +	Ma	Location *	LS
Category	Earthen Levee			GPS Latitude/Longitude	
				Start	End
Item	Erosion / Bank Caving			38.730872 °	38.730872 °
				-121.633504 °	-121.633504 °
DWR ID	DWR_RD1600_02_f_2016_4				
Comment Code					
E2 : Schedule repair of erosion site prior to the next inspection.					
Inspector Comment

Landside levee slope erosion at RD1600 pumping plant. Fall 2016.

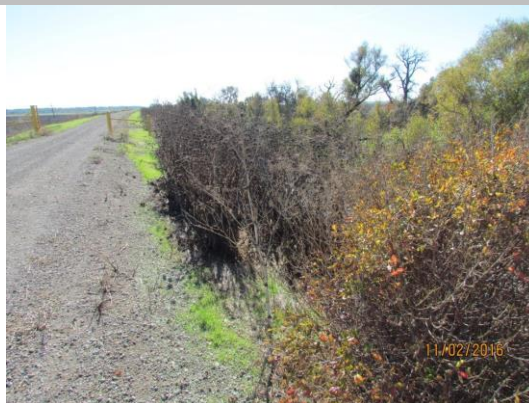
Photo 1 of 1 : FA_2017_RD1600_192_5_20170911_00004.jpg

Previous view of vegetation on waterside slope. Fall 2016.

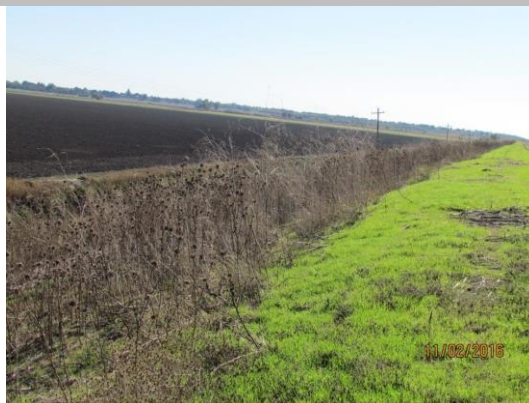
Photo 1 of 1 : FA_2017_RD1600_192_7_20170911_00007.jpg

Previous view of vegetation on landside slope. Fall 2016.

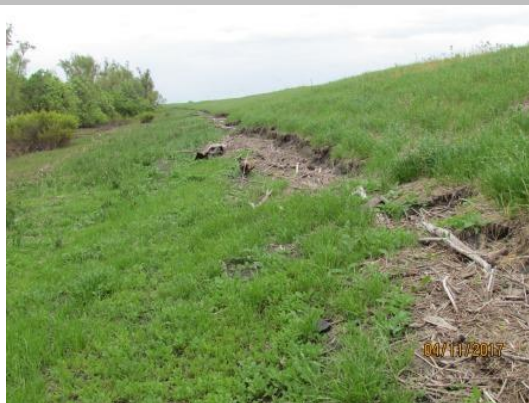
Photo 1 of 1 : FA_2017_RD1600_192_23_20170911_00024.jpg

View of wave wash damage on waterside levee slope. Spring 2017.

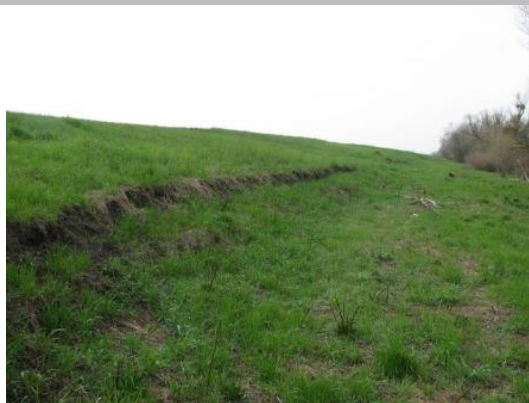
Photo 1 of 4 : FA_2017_RD1600_192_14_20170911_00012.jpg

A closer view of the wave wash damage along the bypass.

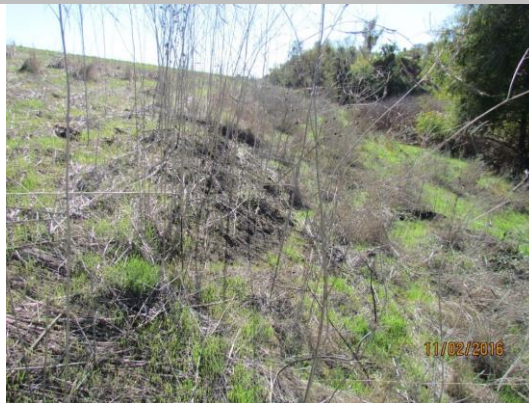
Photo 4 of 4 : FA_2017_RD1600_192_14_20170911_00015.jpg

Updated view of erosion site on WS slope. Fall 2016.

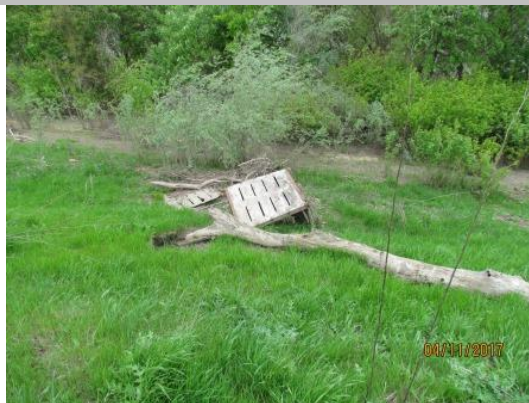
Photo 1 of 1 : FA_2017_RD1600_192_21_20170911_00022.jpg

Trash on waterside levee slope. Spring 2017.

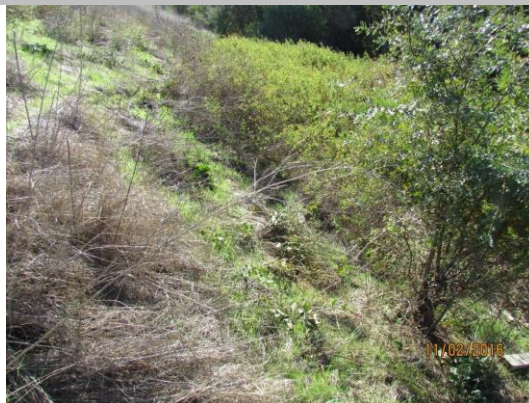
Photo 3 of 3 : FA_2017_RD1600_192_15_20170911_00018.jpg

Updated view of wave wash damage on WS slope. Fall 2016.

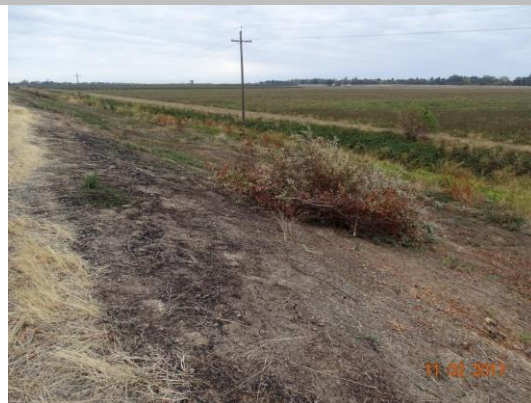
Photo 1 of 1 : FA_2017_RD1600_192_25_20171102_00037.jpg

View of pruning pile on landside slope. Fall 2017.

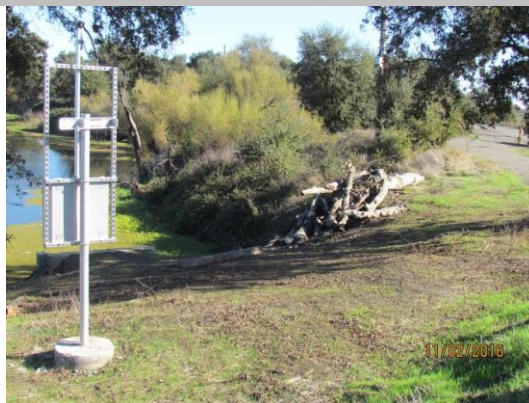
Photo 2 of 2 : FA_2017_RD1600_192_6_20170911_00006.jpg

View of debris on LS slope. Fall 2016.
