**Flood Control Project Maintenance
Levee Inspections**

Fall 2018 Levee Maintenance Deficiency Summary Report

Sacramento River Basin

Reclamation District No. 1600 Mull

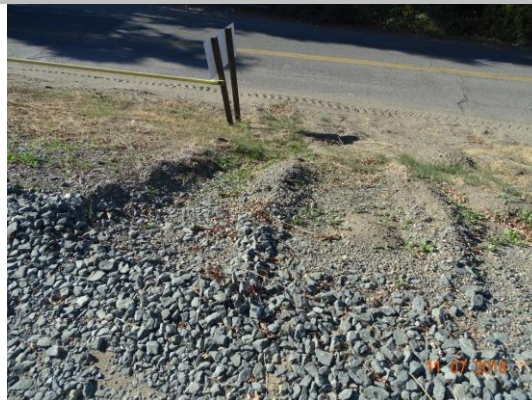
Photo 1 of 1 : FA_2018_RD1600_191_38_20181108_00078.jpg

LM Start	0.11	Rating **	M	Issue No.	38
LM End	0.11	Issue Type +	Ma	Location *	LS
Category	Earthen Levee			GPS Latitude/Longitude	
				Start	End
Item	Slope Stability			38.676524 °	38.676524 °
				-121.631245 °	-121.631245 °
DWR ID	DWR_RD1600_01_f_2018_38				
Comment Code					
S3 : Repair the levee slope damaged by vehicle traffic and prevent access where possible.					
Inspector Comment					
Vehicle ruts on the landside slope.

View of ruts on the landside slope. Fall 2018.

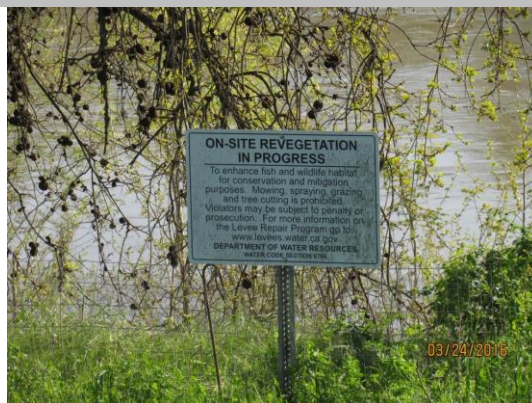
Photo 1 of 2 : FA_2018_RD1600_191_49_20180904_00030.jpg

LM Start	0.11	Rating **	A/W	Issue No.	49
LM End	0.23	Issue Type +	Ob	Location *	WS
Category	Earthen Levee			GPS Latitude/Longitude	
				Start	End
Item	Vegetation			38.676577 °	38.678131 °
				-121.631290 °	-121.632324 °
DWR ID	DWR_RD1600_01_s_2012_49				
Comment Code					
V8 : Environmental Requirements.					
Inspector Comment

Sign stating revegetation site. Spring 2016.

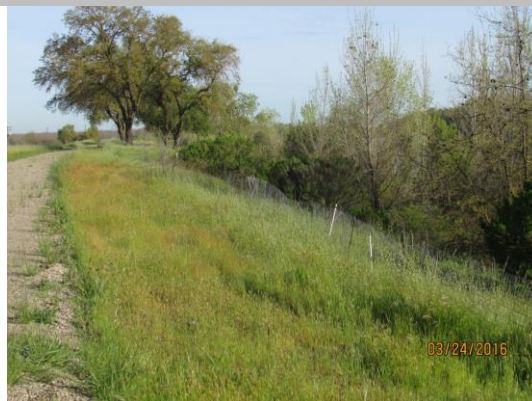
Photo 2 of 2 : FA_2018_RD1600_191_49_20180904_00031.jpg

LM Start	0.11	Rating **	A/W	Issue No.	49 (cont)
LM End	0.23	Issue Type +	Ob	Location *	WS

View of the revegetation site and fence on the waterward side of the levee looking upstream. Spring 2016.

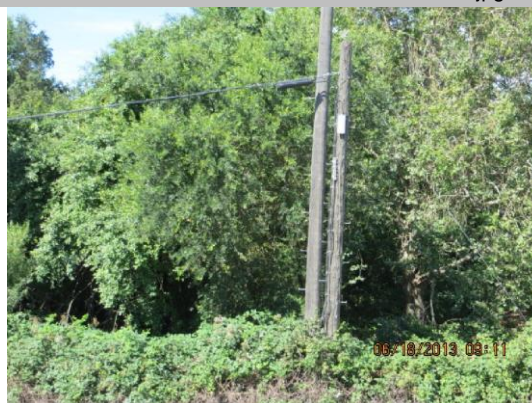
Photo 1 of 1 : UCIP_FA_2018_15087_24812.jpg

LM Start	0.13	Rating **	M	Issue No.	1203	
LM End	0.13	Issue Type +	En	Location *		
Category	Supplemental			GPS Latitude/Longitude		
				Start	End	
Item	DWR UCIP Field Study			38.676802 °	38.676802 °	
				-121.631442 °	-121.631442 °	
DWR ID	21459					
Comment Code						
Inspector Comment						
FS_ID:15087 DS_ID:21459 EP_NO: 1929 Repair Type: Non-Urgent Crossing Status: Indicator Found UCIP Comments: Line should be located with carsonite signs on both sides of levee. FIELD_STRUCT_DESC: Telephone conduit of an unknown size or material through the levee, 3 feet below the crown. Telephone line at joint pole (JP) off the landside (LS) toe. (Permit No. 1929, 1954 - Pacific Telephone and Telegraph Company [PT&T]). [Additional Reference(s): DWR Levee Log, 1988]. FS Date: 6/18/2013

Line visible on JP off LS toe. Likely this is the source of crossing.

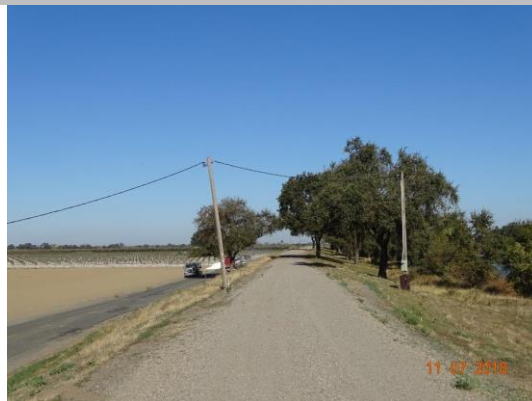
Photo 1 of 2 : FA_2018_RD1600_191_44_20181108_00079.jpg

View of telephone line over levee crown. Fall 2018.

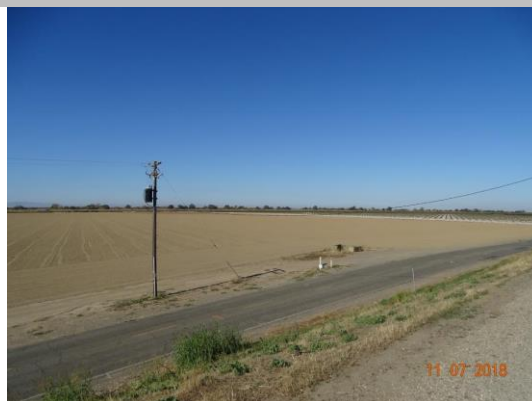
Photo 2 of 2 : FA_2018_RD1600_191_44_20181108_00080.jpg

View of line running to pole on the other side of County Road 117. Fall 2018.

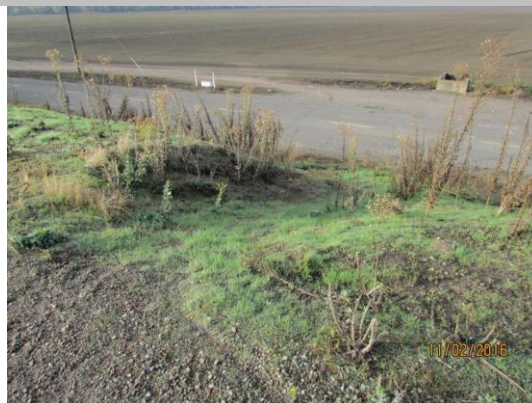
Photo 1 of 1 : FA_2018_RD1600_191_133_20180904_00047.jpg

LM Start	0.53	Rating **	M	Issue No.	133
LM End	0.53	Issue Type +	Ma	Location *	LS
Category	Earthen Levee			GPS Latitude/Longitude	
				Start	End
Item	Slope Stability			38.682140 °	38.682140 °
				-121.634083 °	-121.634083 °
DWR ID	DWR_RD1600_01_f_2013_133				
Comment Code					
S2 : Repair the levee slope damaged by foot traffic and prevent access where possible.					
Inspector Comment					
Footpath on landside slope over pipe crossing.

Updated view of the slope stability site. Fall 2016.

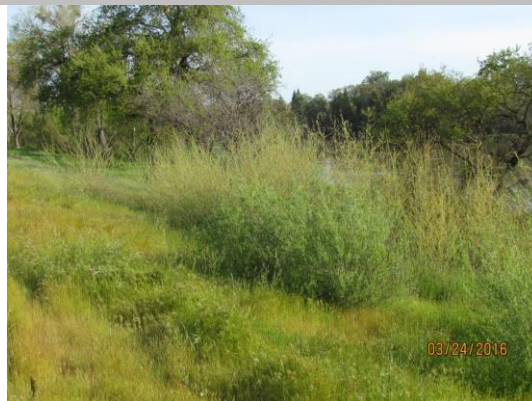
Photo 1 of 3 : FA_2018_RD1600_191_29_20180904_00018.jpg

LM Start	0.60	Rating **	M	Issue No.	29
LM End	0.62	Issue Type +	Ma	Location *	WS
Category	Earthen Levee		GPS Latitude/Longitude		
			Start	End	
Item	Vegetation		38.683238°	38.683415°	
			-121.634388°	-121.634448°	
DWR ID	DWR_RD1600_01_s_2016_29				
Comment Code					
V2 : Remove the wild growth other than native grasses from the levee slopes.					
Inspector Comment					
Recommend removal of willow trees.

Perspective view of the willows on the waterward side of the levee looking upstream. Spring 2016.

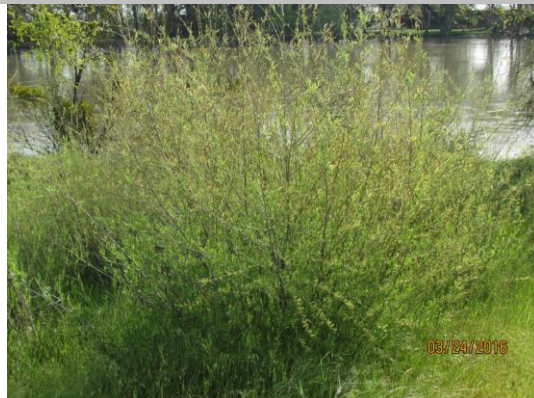
Photo 2 of 3 : FA_2018_RD1600_191_29_20180904_00019.jpg

LM Start	0.60	Rating **	M	Issue No.	29 (cont)	
LM End	0.62	Issue Type +	Ma	Location *	WS	
Category	Earthen Levee			GPS Latitude/Longitude		
				Start		End
Item	Vegetation			38.683238 °		38.683415 °
				-121.634388 °		-121.634448 °
DWR ID	DWR_RD1600_01_s_2016_29					
Comment Code						
V2 : Remove the wild growth other than native grasses from the levee slopes.						
Inspector Comment						
Recommend removal of willow trees.

Willows are growing on the waterward side of the levee. Spring 2016.

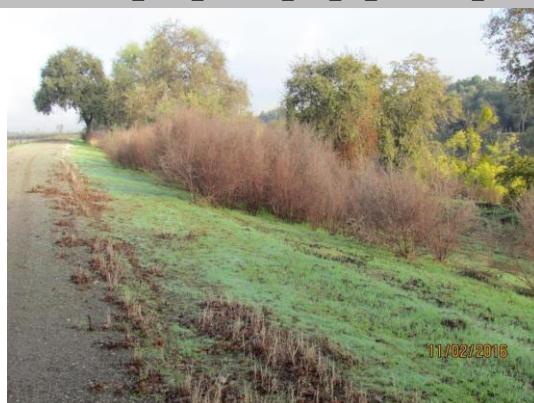
Photo 3 of 3 : FA_2018_RD1600_191_29_20180904_00020.jpg

Updated view of willows on waterward side. Fall 2016.

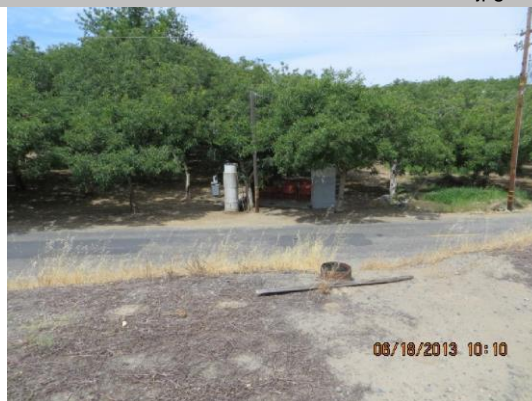
Photo 1 of 3 : UCIP_FA_2018_15285_25088.jpg

Comment Code						
Inspector Comment						
FS_ID:15285 DS_ID:21463 EP_NO: 6100 Repair Type: Non-Urgent Crossing Status: Found UCIP Comments: Gate valve will not open or close. FIELD_STRUCT_DESC: 12-inch steel irrigation pipe through the levee, 3.4 feet below the crown. Slant pump and gate valve on the waterside (WS) slope. Siphon breaker in a 12-inch steel riser on the landside (LS) shoulder. Filter, booster pump, and butterfly valve on the LS toe. 2.25-inch galvanized iron electrical conduit at the same location. (Permit No. 6100, 1968 - Charles Plumb Jr., replaced 8-inch pipe at same location). [Additional Reference(s): DWR Levee Log, 1988]. FS Date: 6/18/2013

Siphon breaker in steel riser on LS shoulder and concrete standpipe off LS toe.

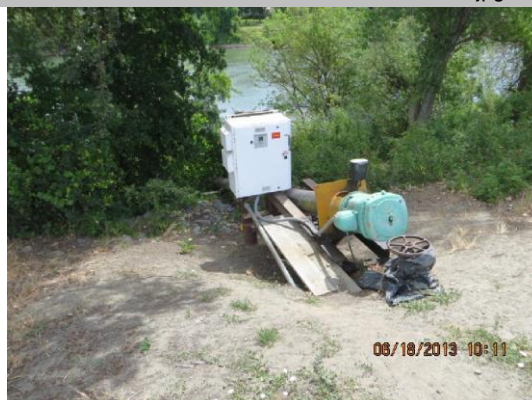
Photo 2 of 3 : UCIP_FA_2018_15285_25087.jpg

Pump and gate valve on WS slope.

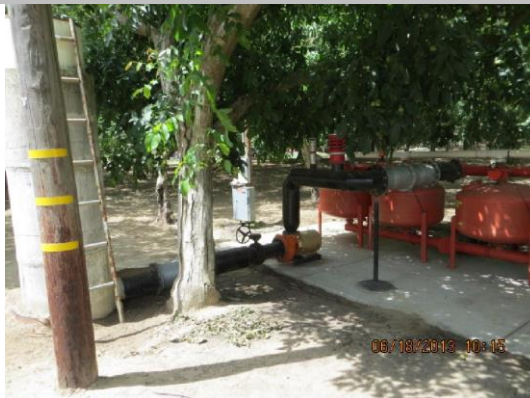
Photo 3 of 3 : UCIP_FA_2018_15285_25086.jpg

Comment Code						
Inspector Comment						
FS_ID:15285						
DS_ID:21463						
EP_NO: 6100						
Repair Type: Non-Urgent						
Crossing Status: Found						
UCIP Comments: Gate valve will not open or close.						
FIELD_STRUCT_DESC: 12-inch steel irrigation pipe through the levee, 3.4 feet below the crown. Slant pump and gate valve on the waterside (WS) slope. Siphon breaker in a 12-inch steel riser on the landside (LS) shoulder. Filter, booster pump, and butterfly valve on the LS toe. 2.25-inch galvanized iron electrical conduit at the same location. (Permit No. 6100, 1968 - Charles Plumb Jr., replaced 8-inch pipe at same location). [Additional Reference(s): DWR Levee Log, 1988].						
FS Date: 6/18/2013

Filters, boost pump, and gate valve down stream from concrete standpipe off LS toe.

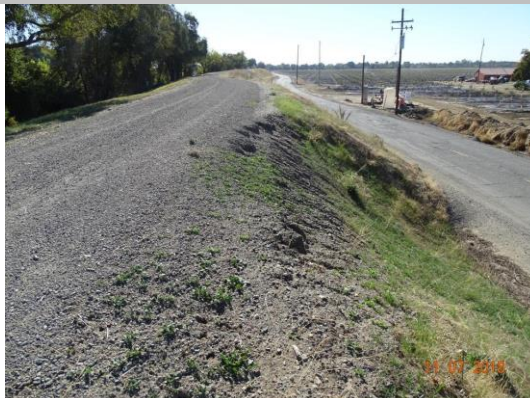
Photo 1 of 2 : FA_2018_RD1600_191_134_20181108_00081.jpg

LM Start	0.97	Rating **	M	Issue No.	134
LM End	0.97	Issue Type +	Ma	Location *	LS
Category	Earthen Levee			GPS Latitude/Longitude	
				Start	End
Item	Erosion / Bank Caving			38.688454 °	38.688454 °
				-121.635528 °	-121.635528 °
DWR ID	DWR_RD1600_01_f_2013_134				
Comment Code					
E2 : Schedule repair of erosion site prior to the next inspection.					
Inspector Comment

Updated view of slope depression and runoff erosion on landside slope. Fall 2018.

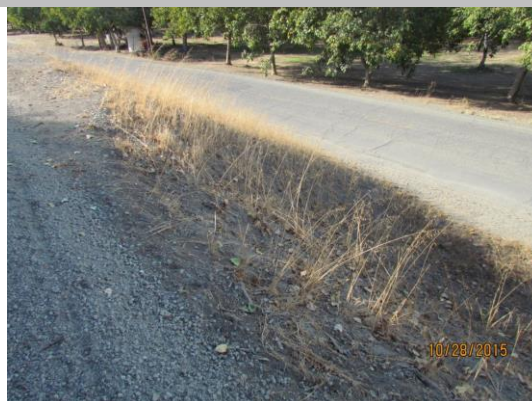
Photo 2 of 2 : FA_2018_RD1600_191_134_20180904_00049.jpg

LM Start	0.97	Rating **	M	Issue No.	134 (cont)	
LM End	0.97	Issue Type +	Ma	Location *	LS	
Category	Earthen Levee			GPS Latitude/Longitude		
				Start		End
Item	Erosion / Bank Caving			38.688454 °		38.688454 °
				-121.635528 °		-121.635528 °
DWR ID	DWR_RD1600_01_f_2013_134					
Comment Code						
E2 : Schedule repair of erosion site prior to the next inspection.						
Inspector Comment

View of the depression of the slope on the landward side of the levee looking downstream. Fall 2015.

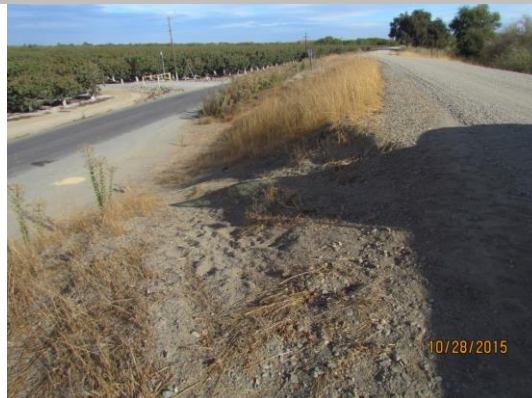
Photo 1 of 1 : FA_2018_RD1600_191_4_20180904_00003.jpg

LM Start	1.40	Rating **	M	Issue No.	4
LM End	1.40	Issue Type +	Ma	Location *	LS
Category	Earthen Levee			GPS Latitude/Longitude	
				Start	End
Item	Slope Stability			38.694452 °	38.694452 °
				-121.634292 °	-121.634292 °
DWR ID	DWR_RD1600_01_s_2017_4				
Comment Code					
S3 : Repair the levee slope damaged by vehicle traffic and prevent access where possible.					
Inspector Comment					
Ruts on the landside slope from vehicles.

View of the slope stability caused by vehicles on the landward side of the levee looking upstream. Fall 2015.

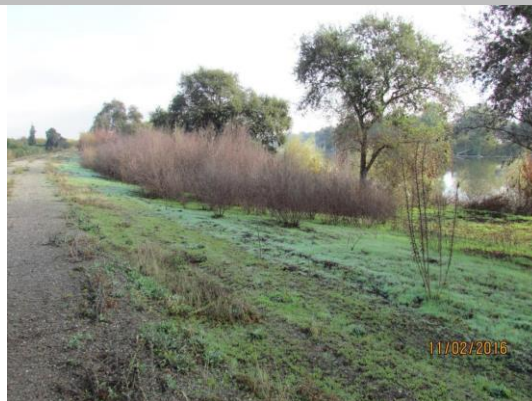
Photo 1 of 1 : FA_2018_RD1600_191_50_20180904_00032.jpg

LM Start	1.53	Rating **	M	Issue No.	50
LM End	1.58	Issue Type +	Ma	Location *	WS
Category	Earthen Levee			GPS Latitude/Longitude	
				Start	End
Item	Vegetation			38.696341 °	38.696918 °
				-121.633417 °	-121.633044 °
DWR ID	DWR_RD1600_01_s_2016_50				
Comment Code					
V2 : Remove the wild growth other than native grasses from the levee slopes.					
Inspector Comment					
Recommend removal of willows on waterward side of the levee.

View of willows on waterward side of the levee. Recommended removal. Fall 2016.

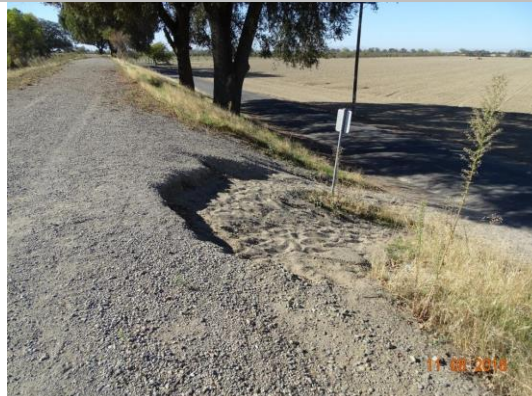
Photo 1 of 1 : FA_2018_RD1600_191_43_20181108_00082.jpg

LM Start	2.40	Rating **	M	Issue No.	43
LM End	2.40	Issue Type +	Ma	Location *	LS
Category	Earthen Levee			GPS Latitude/Longitude	
				Start	End
Item	Erosion / Bank Caving			38.705154 °	38.705154 °
				-121.622231 °	-121.622231 °
DWR ID	DWR_RD1600_01_f_2016_43				
Comment Code					
E2 : Schedule repair of erosion site prior to the next inspection.					
Inspector Comment					
Runoff on the landside slope.

View of runoff on the landside slope. Fall 2018.

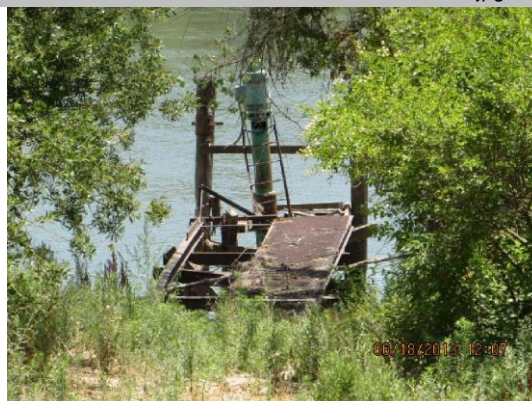
Photo 1 of 3 : UCIP_FA_2018_15108_24826.jpg

Comment Code						
Inspector Comment						
FS_ID:15108						
DS_ID:21467						
EP_NO: N/A						
Repair Type: Non-Urgent						
Crossing Status: Not Found						
UCIP Comments: Pipe removed and replaced with a pipe dsid 25565 - permit 18852.						
Appears abandoned and should be done so properly. Debris buildup on pier. Power cut to pump.						
FIELD_STRUCT_DESC: *REMOVED* 16-inch steel irrigation pipe through the levee, 2 feet below the crown. Walkway from berm to pump on pile structure in the stream. Siphon breaker on the landside (LS) slope. 12-inch polyvinyl chloride (PVC) standpipe off the LS toe.						
[Additional Reference(s): DWR Levee Log, 1988. USACE Sacramento O&M Manual 123, August 1955, (RM 73.4) (18-inch pipe listed)].						
FS Date: 6/18/2013

Pump on metal platform off WS berm.

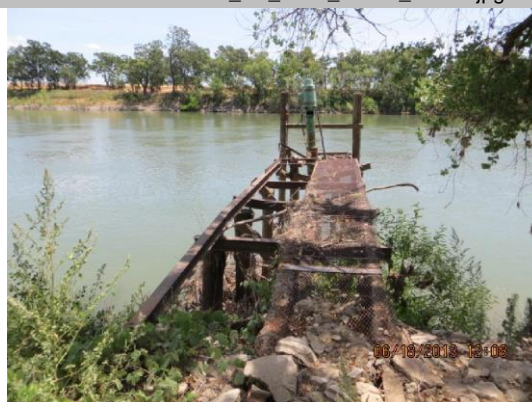
Photo 2 of 3 : UCIP_FA_2018_15108_24825.jpg

Debris buildup at metal platform waterline.

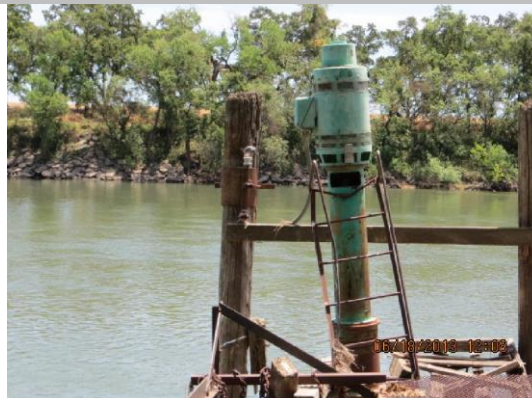
Photo 3 of 3 : UCIP_FA_2018_15108_24824.jpg

Electrical cut to pump.

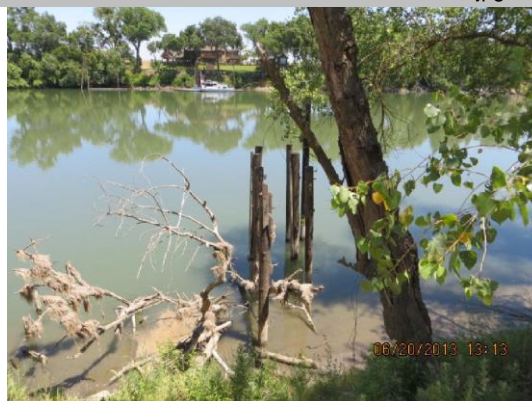
Photo 3 of 3 : UCIP_FA_2018_53410_25012.jpg

Pump missing from pier on WS toe.

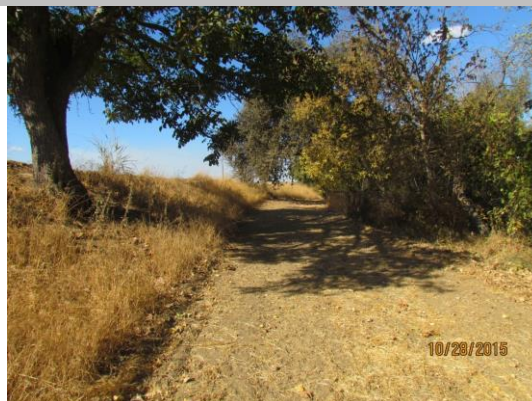
Photo 2 of 2 : FA_2018_RD1600_191_20_20180904_00007.jpg

View of the erosion in the berm area on the waterward side looking upstream. Fall 2015.

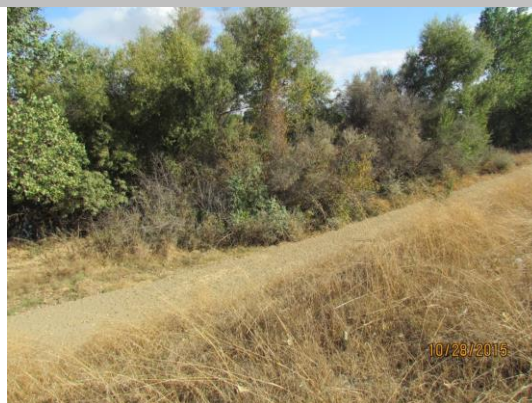
Photo 3 of 3 : FA_2018_RD1600_191_21_20180904_00013.jpg

View of the erosion along the waterward berm of the levee. Fall 2015.

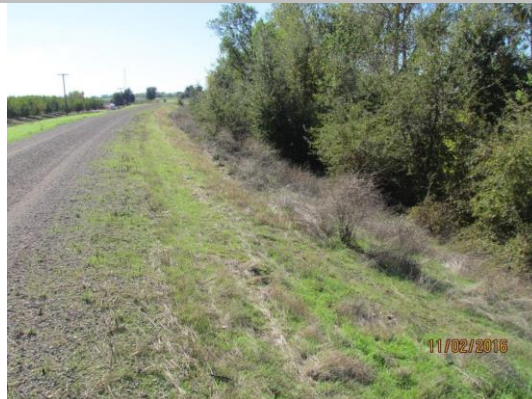
Photo 1 of 1 : FA_2018_RD1600_191_66_20180904_00036.jpg

Vegetation on WS slope has been cleared only about 10 ft. from the crown. Fall 2016.

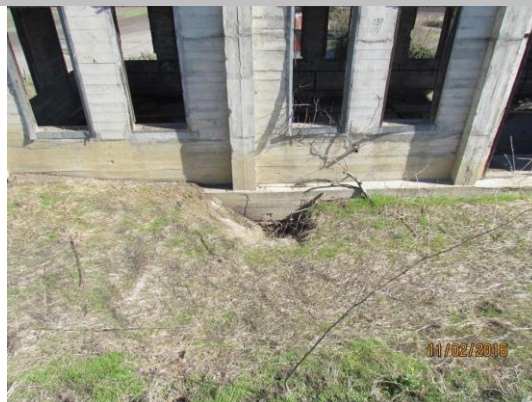
Photo 1 of 1 : FA_2018_RD1600_192_4_20180904_00001.jpg

LM Start	0.37	Rating **	M	Issue No.	4
LM End	0.37	Issue Type +	Ma	Location *	LS
Category	Earthen Levee			GPS Latitude/Longitude	
				Start	End
Item	Erosion / Bank Caving			38.730872°	38.730872°
				-121.633504°	-121.633504°
DWR ID	DWR_RD1600_02_f_2016_4				
Comment Code					
E2 : Schedule repair of erosion site prior to the next inspection.					
Inspector Comment

Landside levee slope erosion at RD1600 pumping plant. Fall 2016.

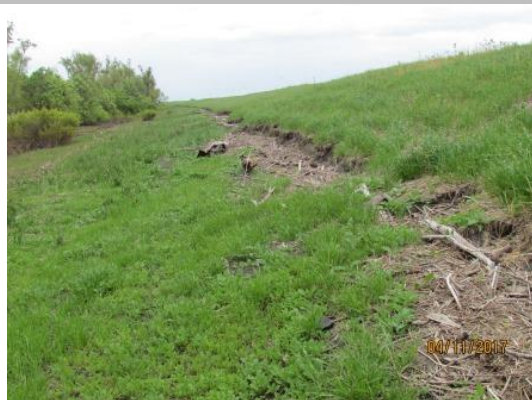
Photo 1 of 1 : FA_2018_RD1600_192_23_20180904_00016.jpg

View of wave wash damage on waterside levee slope. Spring 2017.

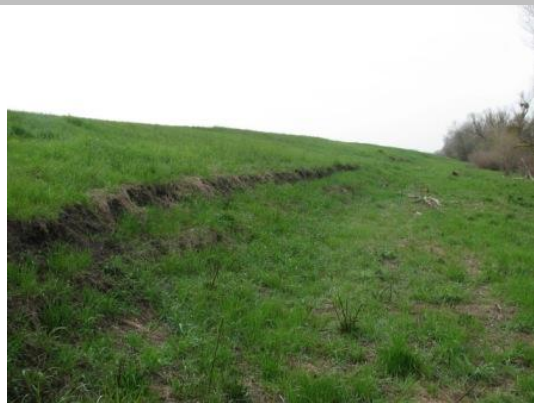
Photo 1 of 4 : FA_2018_RD1600_192_14_20180904_00005.jpg

A closer view of the wave wash damage along the bypass.

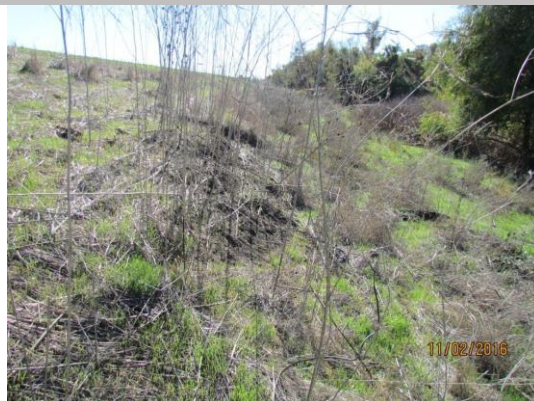
Photo 4 of 4 : FA_2018_RD1600_192_14_20180904_00008.jpg

Updated view of erosion site on WS slope. Fall 2016.

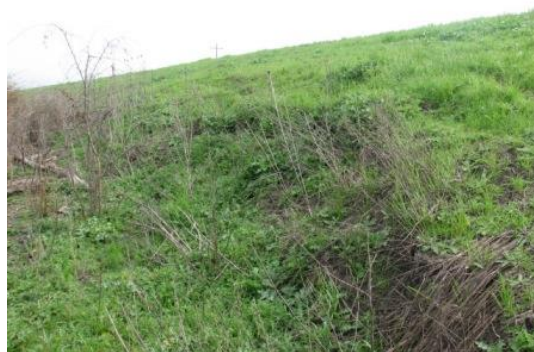
Photo 1 of 3 : FA_2018_RD1600_192_15_20180904_00009.jpg

Looking upstream a deeper cut of 2'-3' damage.

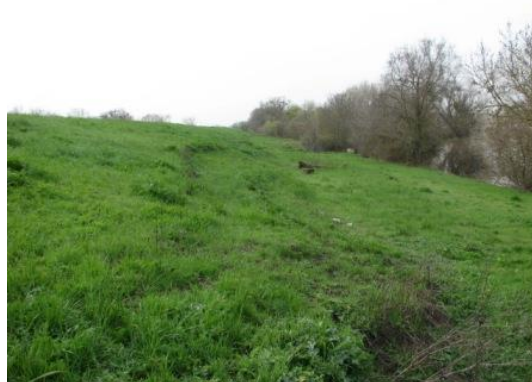
Photo 2 of 3 : FA_2018_RD1600_192_15_20180904_00010.jpg

This is wave wash damage along the toe of the levee looking downstream.

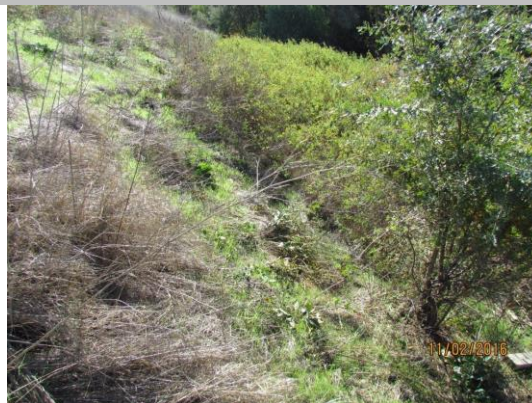
Photo 3 of 3 : FA_2018_RD1600_192_15_20180904_00011.jpg

Updated view of wave wash damage on WS slope. Fall 2016.

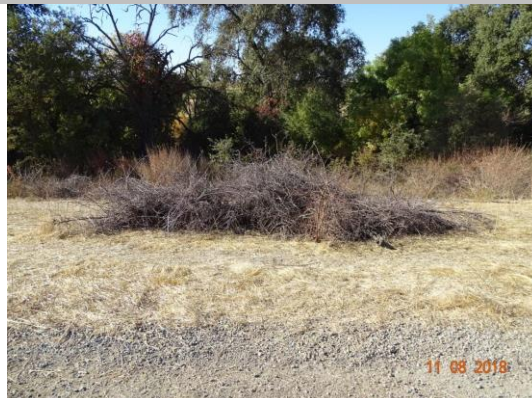
Photo 1 of 1 : FA_2018_RD1600_192_20_20181108_00024.jpg

View of pruning pile on the waterside slope. Fall 2018.

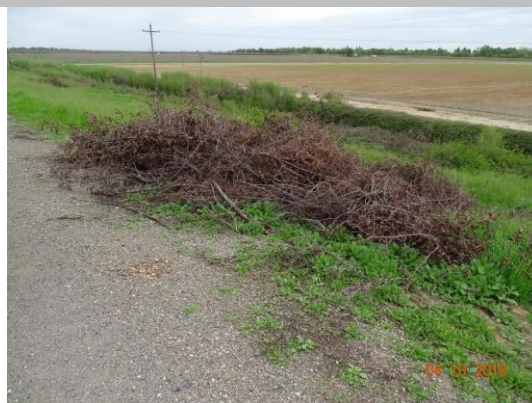
Photo 1 of 1 : FA_2018_RD1600_192_10_20180904_00004.jpg

View of pruning pile on the landside slope. Spring 2018.

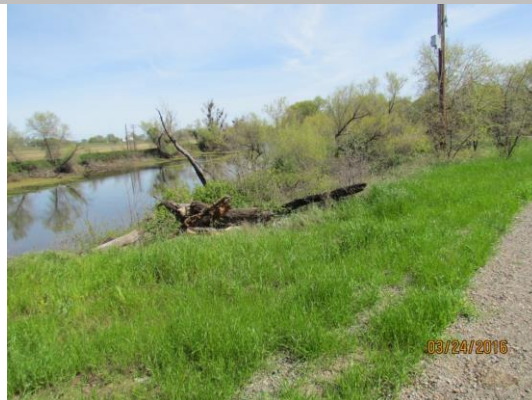
Photo 1 of 2 : FA_2018_RD1600_192_6_20180904_00002.jpg

View of the trees on the landward side of the levee looking downstream.
Spring 2016.

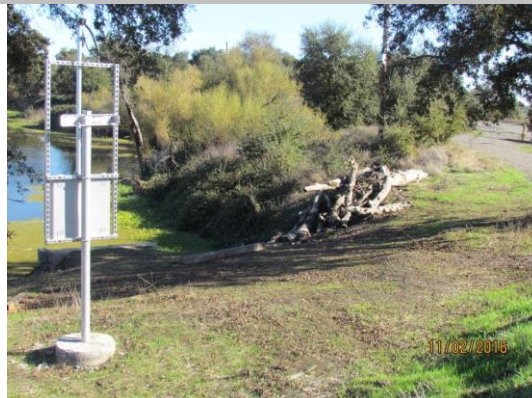
Photo 2 of 2 : FA_2018_RD1600_192_6_20180904_00003.jpg

View of debris on LS slope. Fall 2016.
