**Flood Control Project Maintenance  
Levee Inspections**

**Fall 2019 Levee Maintenance Deficiency Summary Report**

**Sacramento River Basin**

| <b>RD1600</b> | Overall LMA Rating | Total LMA Miles | | | | | | |
|---|---|---|---|---|---|---|---|---|
| <b>Reclamation District No. 1600 Mull</b> | <b>U</b> | <b>14.69</b> | | | | | | |

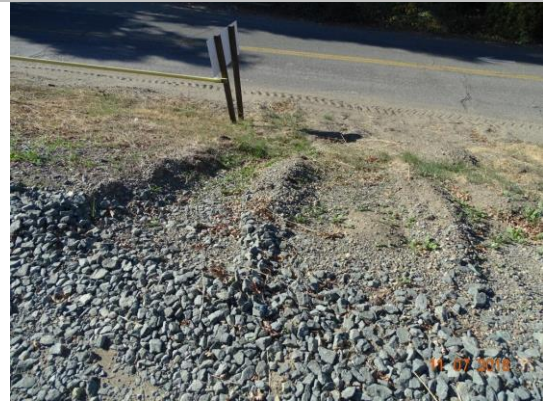
Photo 1 of 1 : FA\_2019\_RD1600\_191\_38\_20190829\_00016.jpg

View of ruts on the landside slope. Fall 2018.

| S3 : Repair the levee slope damaged by vehicle traffic and prevent access where possible. | | | | | |

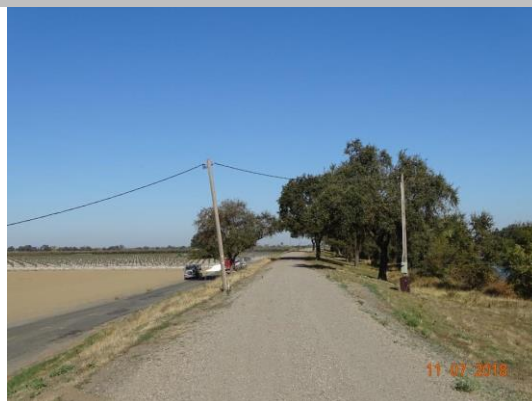
Photo 1 of 2 : FA\_2019\_RD1600\_191\_44\_20190829\_00018.jpg

View of telephone line over levee crown. Fall 2018.

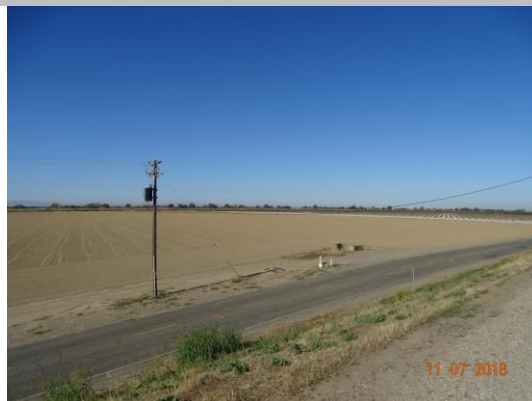
Photo 2 of 2 : FA\_2019\_RD1600\_191\_44\_20190829\_00019.jpg

View of line running to pole on the other side of County Road 117. Fall 2018.

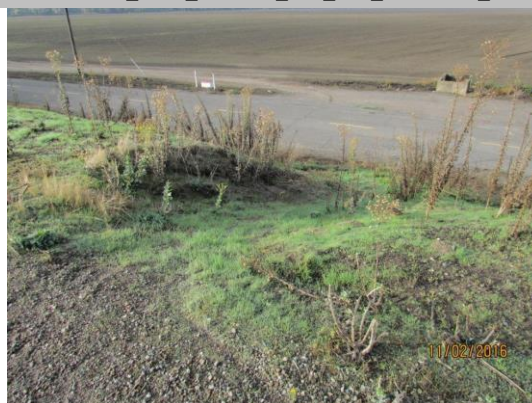
Photo 2 of 2 : FA\_2019\_RD1600\_191\_133\_20190829\_00029.jpg

View of the slope stability site. Fall 2016.

| S2 : Repair the levee slope damaged by foot traffic and prevent access where possible. | | | | | |

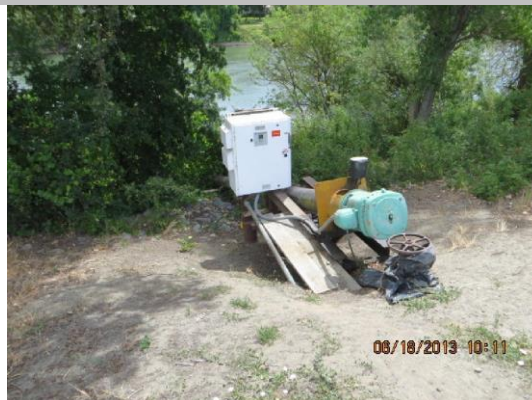
Photo 2 of 3 : UCIP\_FA\_2019\_15285\_25087.jpg

Pump and gate valve on WS slope.

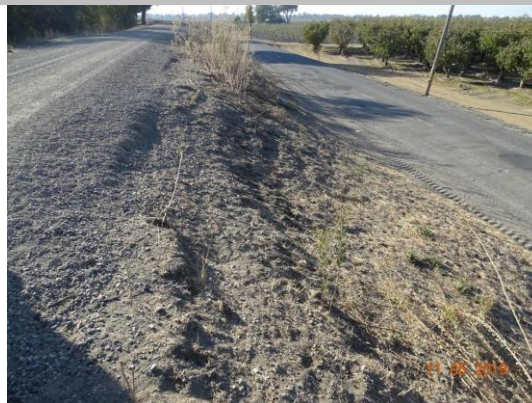
Photo 1 of 1 : FA\_2019\_RD1600\_191\_40\_20191112\_00056.jpg

| Bank caving on the landside slope caused by goats. | | | | | |

View of bank caving on the landside slope. Fall 2019.

| E2 : Schedule repair of erosion site prior to the next inspection. | | | | | |

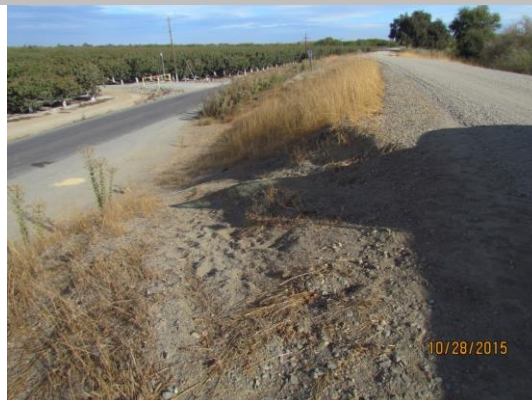
Photo 2 of 2 : FA\_2019\_RD1600\_191\_4\_20190829\_00001.jpg

View of the slope stability caused by vehicles on the landward side of the levee looking upstream. Fall 2015.

| E2 : Schedule repair of erosion site prior to the next inspection. | | | | | |

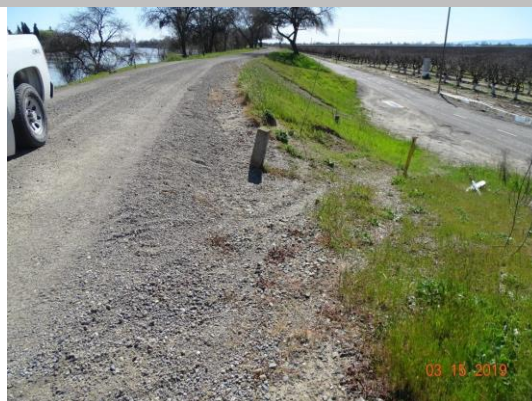
Photo 1 of 1 : FA\_2019\_RD1600\_191\_52\_20190829\_00022.jpg

| Ruts on the landside slope from vehicles. Recommend monitoring for future activity. | | | | | |

View of ruts on landside shoulder. Spring 2019.

| S3 : Repair the levee slope damaged by vehicle traffic and prevent access where possible. | | | | | |

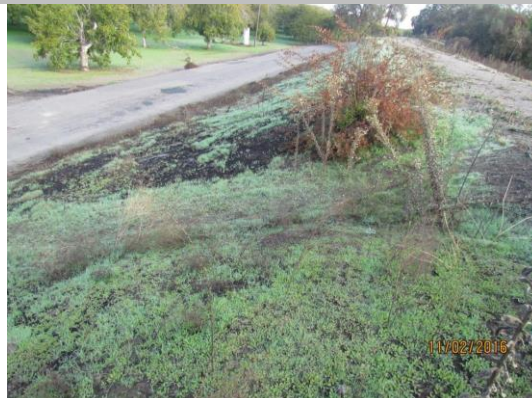
Photo 1 of 1 : FA\_2019\_RD1600\_191\_70\_20190829\_00025.jpg

| Footpath on landside slope. Recommend monitoring. | | | | | |

View of slope instability. Fall 2016.

| S2 : Repair the levee slope damaged by foot traffic and prevent access where possible. | | | | | |

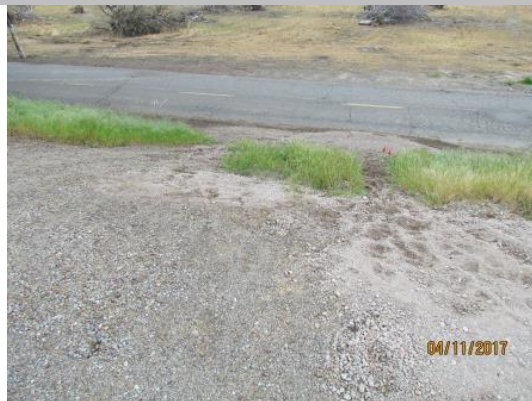
Photo 1 of 1 : FA\_2019\_RD1600\_191\_72\_20190829\_00026.jpg

View of the erosion site. Spring 2017.

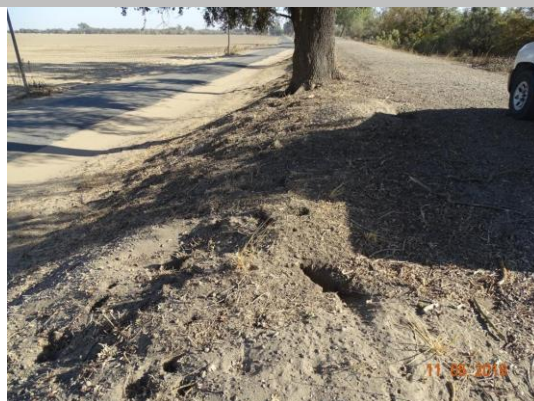
Photo 1 of 1 : FA\_2019\_RD1600\_191\_56\_20191112\_00058.jpg

View of the rodent holes on the landside shoulder. Fall 2019.

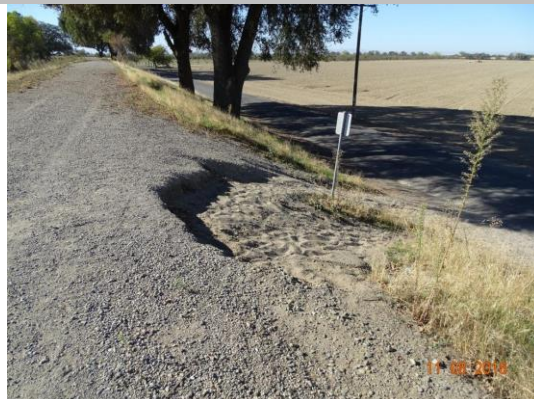
Photo 1 of 1 : FA\_2019\_RD1600\_191\_43\_20190829\_00017.jpg

View of erosion cutting into crown road on the landside soulder.

| E2 : Schedule repair of erosion site prior to the next inspection. | | | | | |

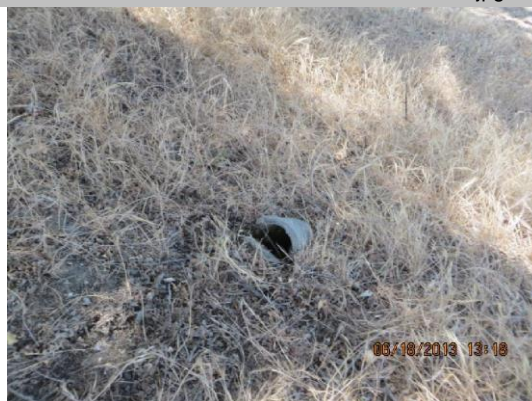
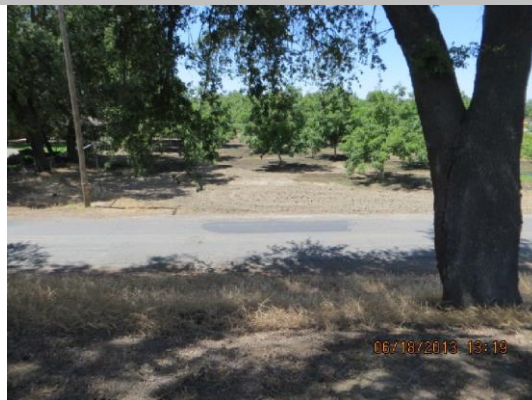
| DS_ID:21490<br>FS_ID:15110<br>EP_NO: N/A<br>Repair Type: Non-Urgent<br>Crossing Status: Indicator Found<br>UCIP Comments: Abandoned and should be removed from levee.<br>FIELD_STRUCT_DESC: *ABANDONED* 10-inch reinforced concrete pipe of an unknown purpose through the levee, 5 feet below the crown.<br>Pipe visible on the landside (LS) slope. [Additional Reference(s): USACE Sacramento O&M Manual 123, August 1955, (RM 73.5)].<br>FS Date: 6/18/2013 | | | | | |

Pipe visible on LS slope.

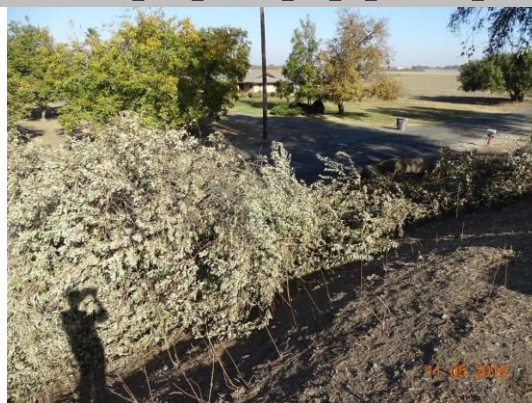
Photo 1 of 1 : FA\_2019\_RD1600\_191\_65\_20191112\_00059.jpg

| Tree popouts observed. | | | | | |

View of fallen tree on the landside slope. Fall 2019.

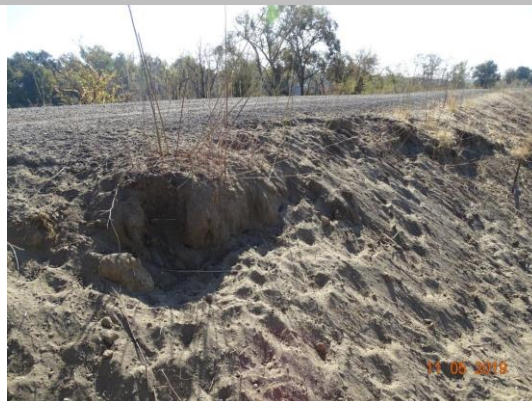
Photo 1 of 1 : FA\_2019\_RD1600\_191\_73\_20191112\_00060.jpg

| Bank caving on the landside slope caused by goats. | | | | | |

View of bank caving on the landside slope. Fall 2019.

| E2 : Schedule repair of erosion site prior to the next inspection. | | | | | |

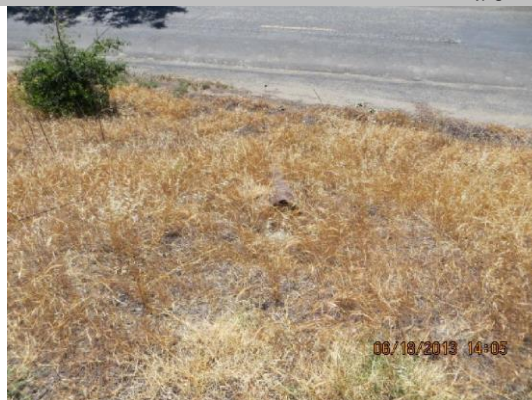
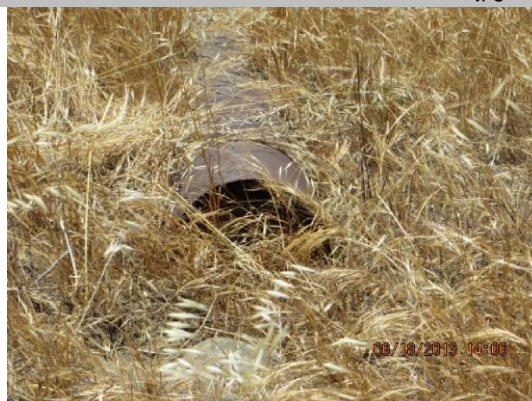
Pipe and remnants of grouted pipe on LS slope.

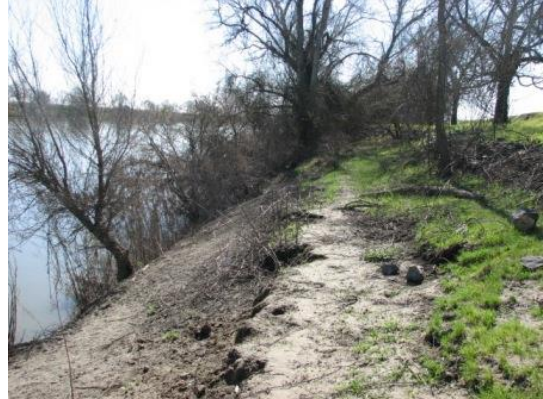
Photo 1 of 3 : FA\_2019\_RD1600\_191\_21\_20190829\_00008.jpg

The erosion is eroding away the berm area.

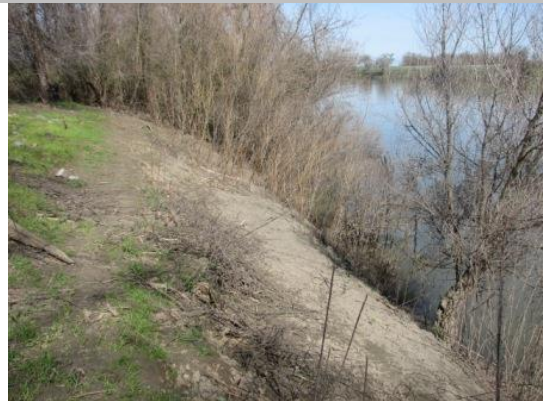
Photo 2 of 3 : FA\_2019\_RD1600\_191\_21\_20190829\_00009.jpg

The bank is eroding away and has become very steep.

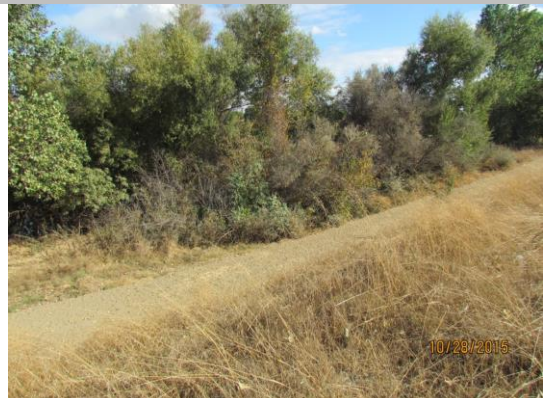
Photo 3 of 3 : FA\_2019\_RD1600\_191\_21\_20190829\_00010.jpg

View of the erosion along the waterward berm of the levee. Fall 2015.

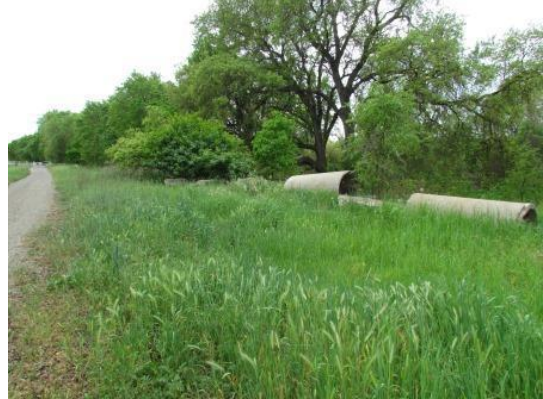
Photo 1 of 1 : FA\_2019\_RD1600\_191\_1202\_20190829\_00033.jpg

View of debris on the waterward side of the levee looking upstream.  
Spring 2015.

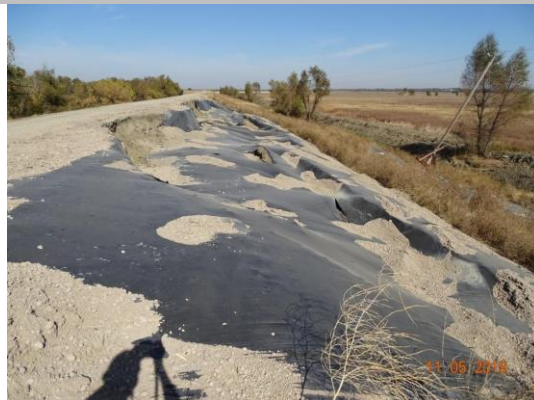
Photo 1 of 3 : FA\_2019\_RD1600\_192\_8\_20191112\_00024.jpg

View of sloughing on the landside slope. Fall 2019.

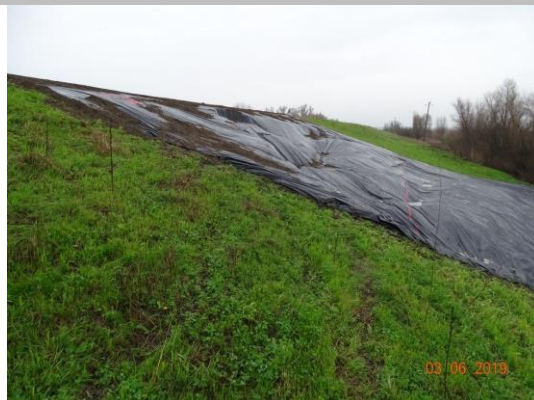
Photo 2 of 3 : FA\_2019\_RD1600\_192\_8\_20190829\_00003.jpg

View of sloughing on the landside slope. Spring 2019.

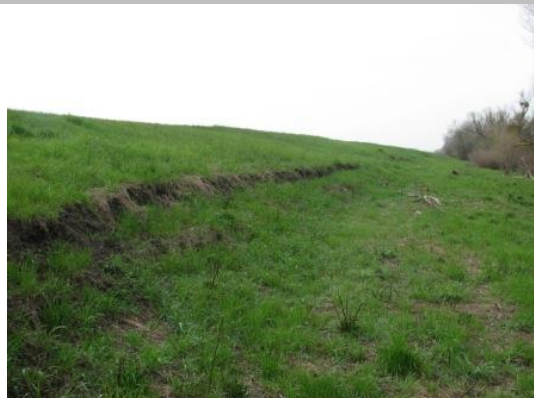
Photo 1 of 4 : FA\_2019\_RD1600\_192\_14\_20190829\_00006.jpg

A closer view of the wave wash damage along the bypass.

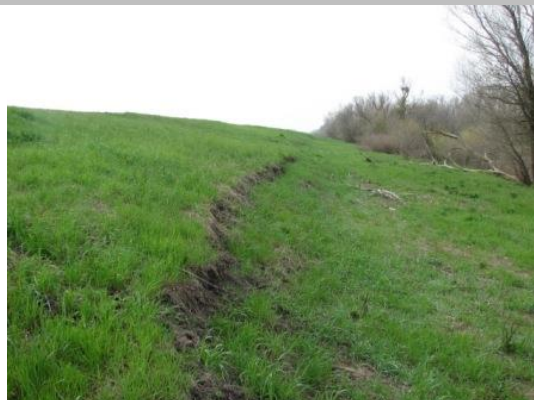
Photo 2 of 4 : FA\_2019\_RD1600\_192\_14\_20190829\_00007.jpg

Wave wash damage along the slope the cut is 1'-2'.

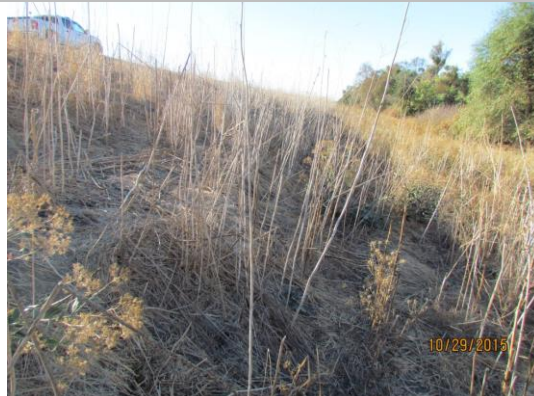
Photo 3 of 4 : FA\_2019\_RD1600\_192\_14\_20190829\_00008.jpg

View of the erosion on the waterward side of the levee looking downstream. Fall 2015.

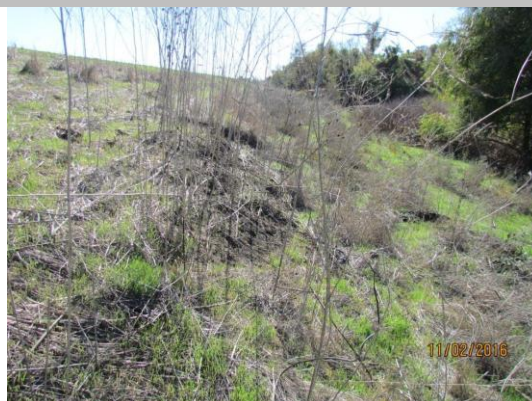
Photo 4 of 4 : FA\_2019\_RD1600\_192\_14\_20190829\_00009.jpg

View of erosion site on WS slope. Fall 2016.

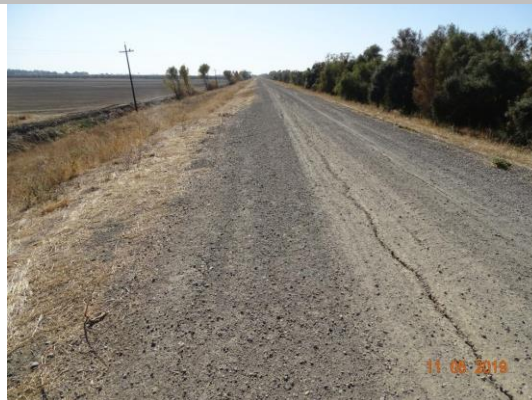
Photo 1 of 1 : FA\_2019\_RD1600\_192\_4\_20191112\_00025.jpg

View of cracking on the crown. Fall 2019.

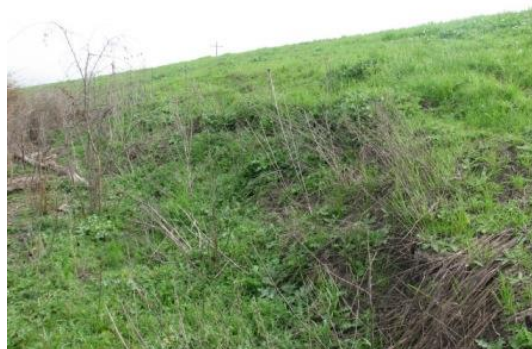
Photo 1 of 3 : FA\_2019\_RD1600\_192\_15\_20190829\_00010.jpg

Looking upstream a deeper cut of 2'-3' damage.

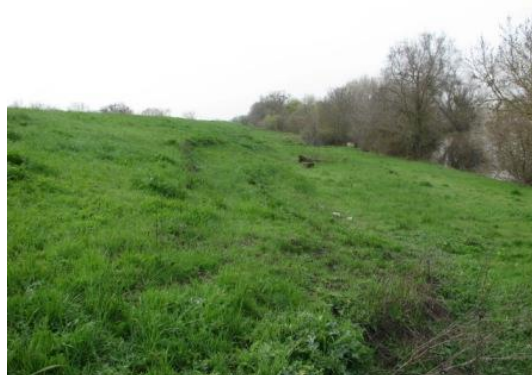
Photo 2 of 3 : FA\_2019\_RD1600\_192\_15\_20190829\_00011.jpg

This is wave wash damage along the toe of the levee looking downstream.

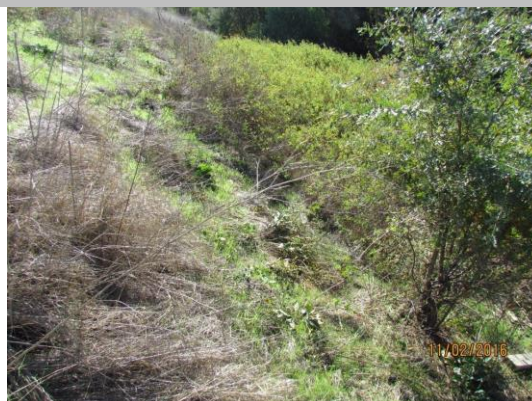
Photo 3 of 3 : FA\_2019\_RD1600\_192\_15\_20190829\_00012.jpg

View of wave wash damage on WS slope. Fall 2016.

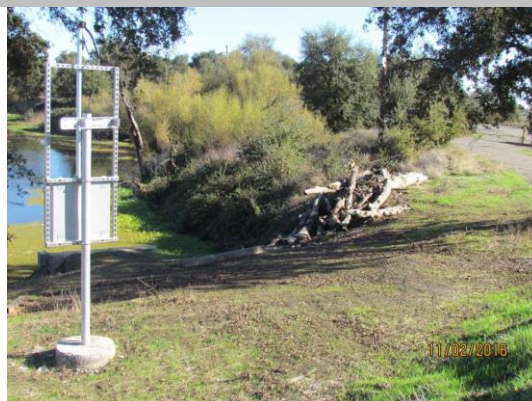
Photo 2 of 2 : FA\_2019\_RD1600\_192\_6\_20190829\_00002.jpg

View of debris on LS slope. Fall 2016.
