Flood Control Project Maintenance Levee Inspections

Fall 2020 Levee Maintenance Deficiency Summary Report

Sacramento River Basin

Reclamation District No. 1600 Mull

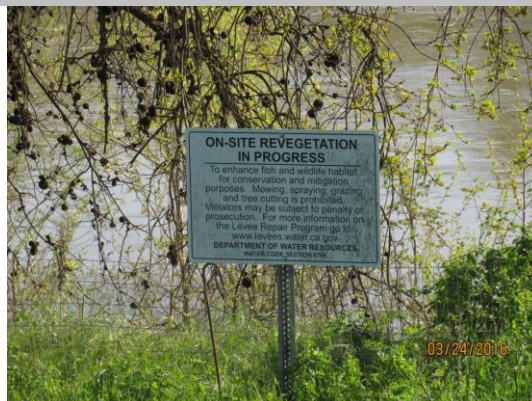
Photo 1 of 1 : FA_2020_RD1600_191_49_20200813_00019.jpg

Sign stating revegetation site. Spring 2016.

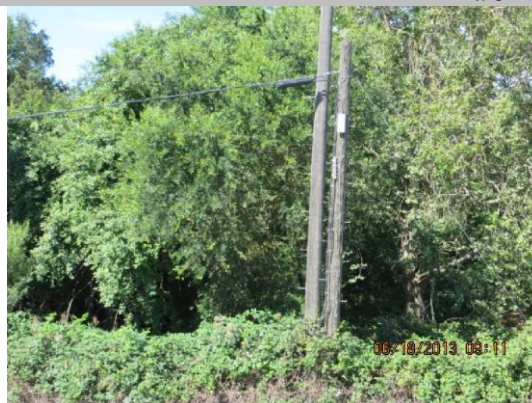
Photo 1 of 1 : UCIP_FA_2020_15087_24812.jpg

LM Start	0.13	Rating **	M	Issue No.	1203
LM End	0.13	Issue Type +	En	Location *	
Category	Supplemental			GPS Latitude/Longitude	
				Start	End
Item	DWR UCIP Field Study			38.676802 °	38.676802 °
				-121.631442 °	-121.631442 °
DWR ID	21459				
Comment Code					
Inspector Comment					
DS_ID:21459					
FS_ID:15087					
EP_NO: 1929					
Repair Type: Non-Urgent					
EVAL Issue:					
Crossing Status: Indicator Found					
UCIP Comments: Line should be located with carsonite signs on both sides of levee.					
FIELD_STRUCT_DESC: Telephone conduit of an unknown size or material through the levee, 3 feet below the crown. Telephone line at joint pole (JP) off the landside (LS) toe. (Permit No. 1929, 1954 - Pacific Telephone and Telegraph Company [PT&T]). [Additional Reference(s): DWR Levee Log, 1988].					
FS Date: 6/18/2013

Line visible on JP off LS toe. Likely this is the source of crossing.

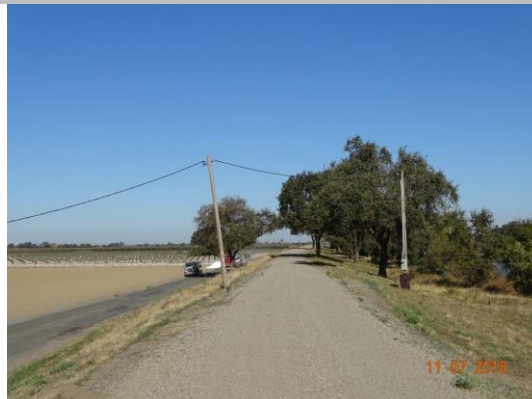
Photo 1 of 1 : FA_2020_RD1600_191_44_20200813_00018.jpg

View of telephone line over levee crown. Fall 2018.

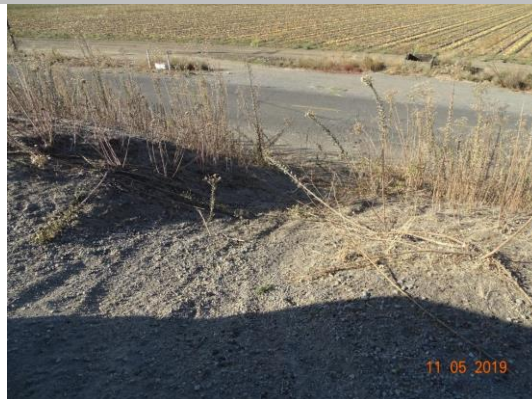
Photo 1 of 1 : FA_2020_RD1600_191_133_20200813_00027.jpg

LM Start	0.53	Rating **	M	Issue No.	133
LM End	0.53	Issue Type +	Ma	Location *	LS
Category	Earthen Levee			GPS Latitude/Longitude	
				Start	End
Item	Slope Stability			38.682140 °	38.682140 °
				-121.634083 °	-121.634083 °
DWR ID	DWR_RD1600_01_f_2013_133				
Comment Code					
S2 : Repair the levee slope damaged by foot traffic and prevent access where possible.					
Inspector Comment					
There appears to be a footpath and settlement on landside slope over pipe crossing.

View of settlement and footpath on landside slope. Fall 2019.

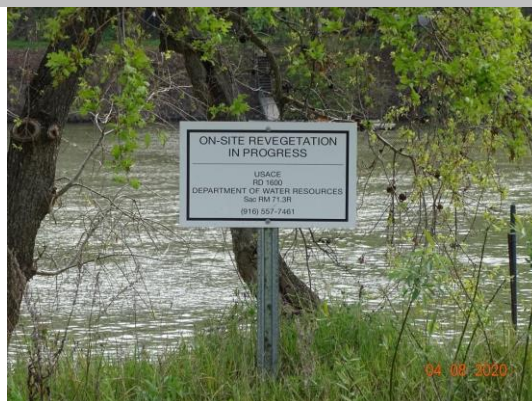
Photo 1 of 1 : FA_2020_RD1600_191_26_20200813_00013.jpg

LM Start	0.56	Rating **	A/W	Issue No.	26
LM End	0.66	Issue Type +	Ob	Location *	WS
Category	Earthen Levee			GPS Latitude/Longitude	
				Start	End
Item	Vegetation			38.682661 °	38.684099 °
				-121.634238 °	-121.634625 °
DWR ID	DWR_RD1600_01_s_2020_26				
Comment Code					
V8 : Environmental Requirements.					
Inspector Comment					
USACE, DWR, and RD 1600 revegetation site.

View of revegetation sign on the waterside berm. Spring 2020.

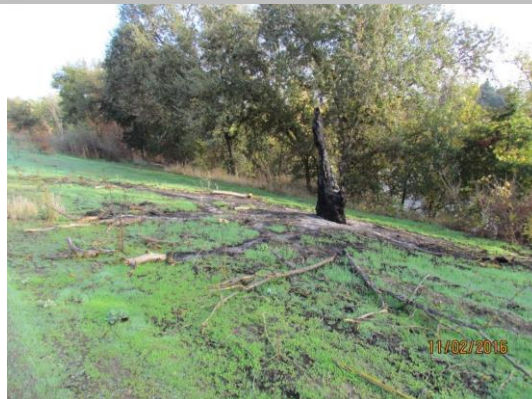
Photo 1 of 1 : FA_2020_RD1600_191_624_20200813_00029.jpg

LM Start	0.78	Rating **	N	Issue No.	624
LM End	0.78	Issue Type +	Ma	Location *	WS
Category	Earthen Levee			GPS Latitude/Longitude	
				Start	End
Item	Trim / Thin Trees			38.685713 °	38.685713 °
				-121.634985 °	-121.634985 °
DWR ID	DWR_RD1600_01_s_2017_624				
Comment Code					
T5 : Tree stumps.					
Inspector Comment					
Burnt stump on waterside slope.

View of burnt tree on waterside slope. Fall 2016.

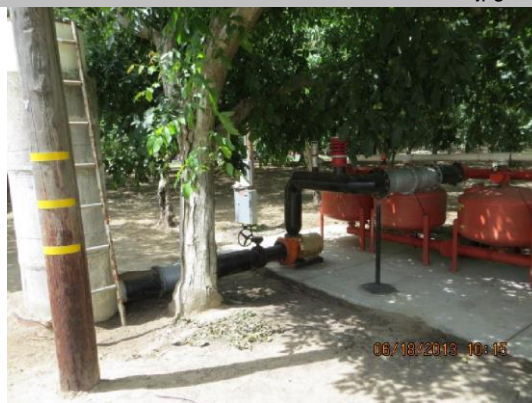
Photo 3 of 3 : UCIP_FA_2020_15285_25086.jpg

Filters, boost pump, and gate valve down stream from concrete standpipe off LS toe.

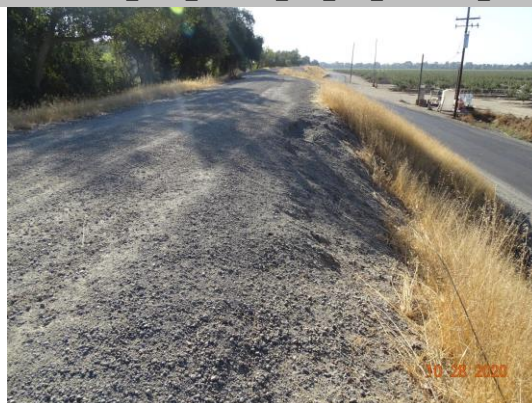
Photo 1 of 1 : FA_2020_RD1600_191_134_20201028_00052.jpg

LM Start	0.97	Rating **	M	Issue No.	134
LM End	0.97	Issue Type +	Ma	Location *	LS
Category	Earthen Levee			GPS Latitude/Longitude	
				Start	End
Item	Erosion / Bank Caving			38.688454 °	38.688454 °
				-121.635528 °	-121.635528 °
DWR ID	DWR_RD1600_01_f _ 2013_134				
Comment Code					
E2 : Schedule repair of erosion site prior to the next inspection.					
Inspector Comment					
Bank caving on the landside slope.

View of the erosion on the landside slope. Fall 2020.

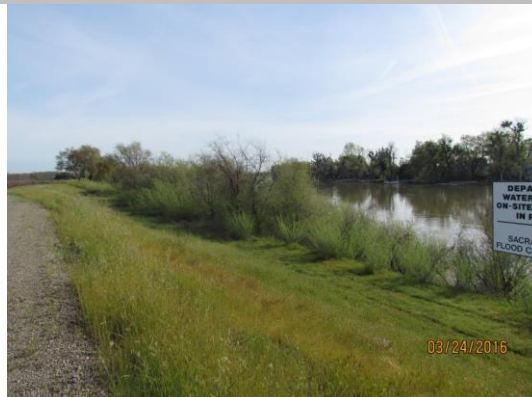
Photo 1 of 1 : FA_2020_RD1600_191_5_20200813_00002.jpg

View of the revegetation site on the berm of the waterward side of the levee looking upstream. Spring 2016.

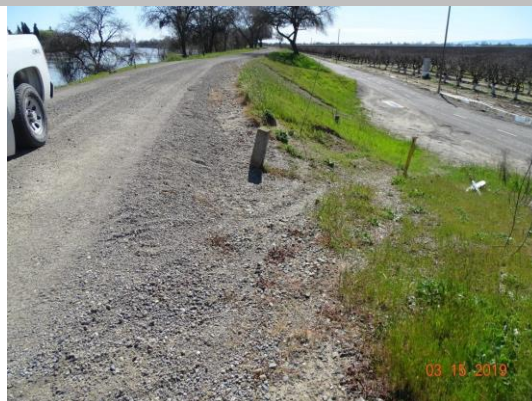
Photo 1 of 1 : FA_2020_RD1600_191_52_20200813_00021.jpg

LM Start	1.42	Rating **	A/W	Issue No.	52
LM End	1.42	Issue Type +	Ma	Location *	LS
Category	Earthen Levee			GPS Latitude/Longitude	
				Start	End
Item	Erosion / Bank Caving			38.694728 °	38.694728 °
				-121.634224 °	-121.634224 °
DWR ID	DWR_RD1600_01_f_2018_52				
Comment Code					
E1 : Note and monitor erosion site.					
Inspector Comment					
Previously a vehicle access ramp. The district has placed barriers to prevent access. Recommend monitoring for future erosion.

View of ruts on landside shoulder. Spring 2019.

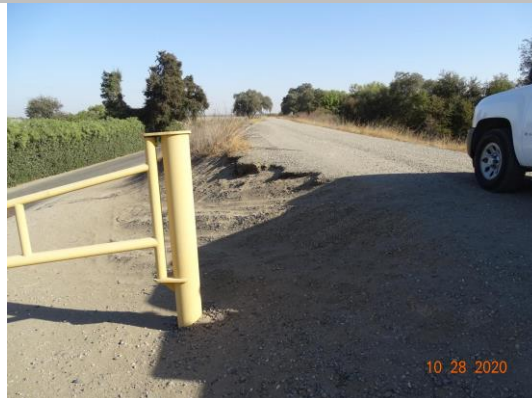
Photo 1 of 1 : FA_2020_RD1600_191_46_20201028_00054.jpg

LM Start	1.65	Rating **	M	Issue No.	46
LM End	1.65	Issue Type +	Ma	Location *	LS
Category	Earthen Levee			GPS Latitude/Longitude	
				Start	End
Item	Slope Stability			38.697799 °	38.697799 °
				-121.632396 °	-121.632396 °
DWR ID	DWR_RD1600_01_f_2019_46				
Comment Code					
S3 : Repair the levee slope damaged by vehicle traffic and prevent access where possible.					
Inspector Comment					
Erosion on landside slope near district gate.

View of erosion on the landside slope. Fall 2020.

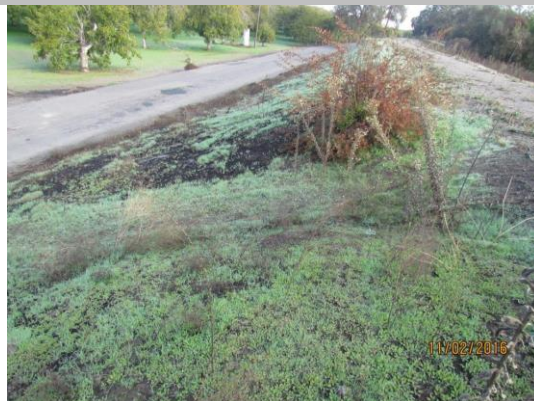
Photo 1 of 1 : FA_2020_RD1600_191_70_20200813_00024.jpg

View of slope instability. Fall 2016.

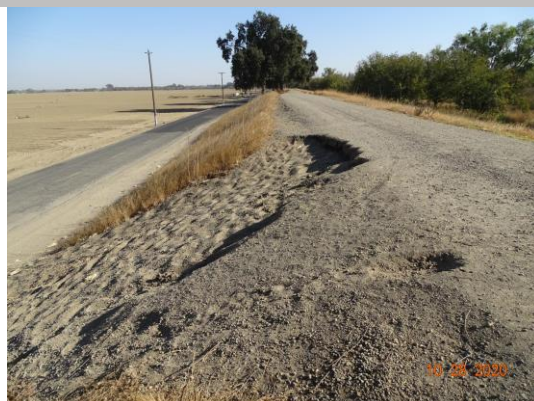
Photo 1 of 1 : FA_2020_RD1600_191_72_20201028_00055.jpg

View of bank caving on the landside slope. Fall 2020.

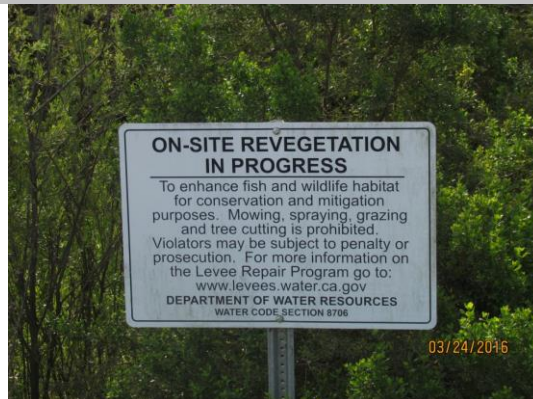
Photo 1 of 1 : FA_2020_RD1600_191_35_20200813_00014.jpg

Sign for revegetation site. Spring 2016.

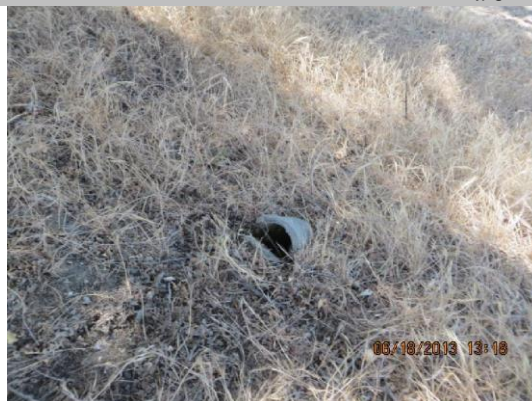
Photo 1 of 2 : UCIP_FA_2020_15110_24828.jpg

DS_ID:21490
 FS_ID:15110
 EP_NO: N/A
 Repair Type: Non-Urgent
 EVAL Issue:
 Crossing Status: Indicator Found
 UCIP Comments: Abandoned and should be removed from levee.
 FIELD_STRUCT_DESC: *ABANDONED* 10-inch reinforced concrete pipe of an unknown purpose through the levee, 5 feet below the crown.
 Pipe visible on the landside (LS) slope. [Additional Reference(s): USACE Sacramento O&M Manual 123, August 1955, (RM 73.5)].
 FS Date: 6/18/2013

Pipe visible on LS slope.

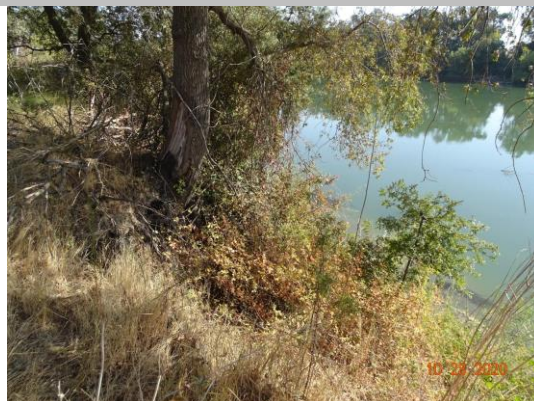
Photo 1 of 1 : FA_2020_RD1600_191_29_20201028_00056.jpg

LM Start	3.09	Rating **	M	Issue No.	29
LM End	3.09	Issue Type +	Ma	Location *	WS
Category	Earthen Levee			GPS Latitude/Longitude	
				Start	End
Item	Erosion / Bank Caving			38.712205 °	38.712205 °
				-121.613212 °	-121.613212 °
DWR ID	DWR_RD1600_01_f _ 2020_29				
Comment Code					
E2 : Schedule repair of erosion site prior to the next inspection.					
Inspector Comment					
Erosion pocket on the waterside slope. There is approximately 20' of berm before a vertical drop that cuts into the prism.

View of erosion location on the waterside berm. Fall 2020.

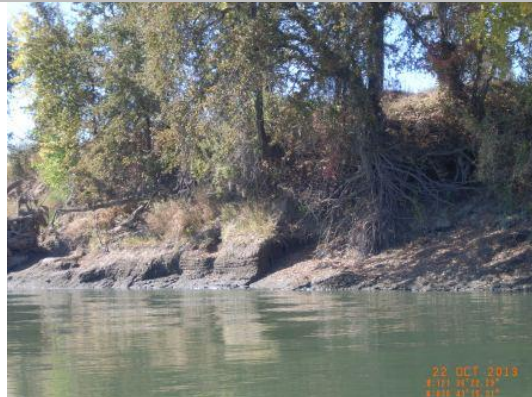
Photo 1 of 1 : FA_2020_RD1600_191_16_20200813_00004.jpg

USACE 2013 Photo #1

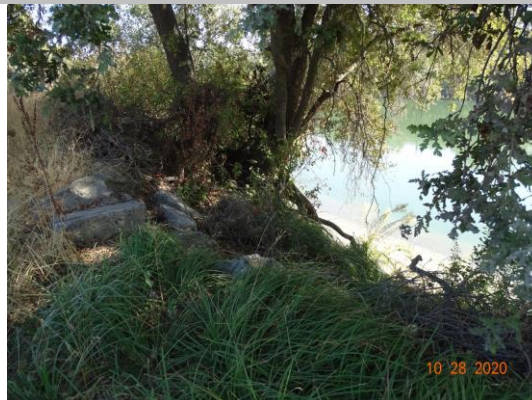
Photo 1 of 1 : FA_2020_RD1600_191_47_20201028_00057.jpg

LM Start	3.59	Rating **	M	Issue No.	47
LM End	3.59	Issue Type +	Ma	Location *	WS
Category	Earthen Levee			GPS Latitude/Longitude	
				Start	End
Item	Erosion / Bank Caving			38.718047 °	38.718047 °
				-121.607840 °	-121.607840 °
DWR ID	DWR_RD1600_01_f_2020_47				
Comment Code					
E2 : Schedule repair of erosion site prior to the next inspection.					
Inspector Comment					
Erosion pocket on waterside slope. Approximately 15 feet of berm until vertical drop into prism.

View of erosion location on waterside berm. Fall 2020.

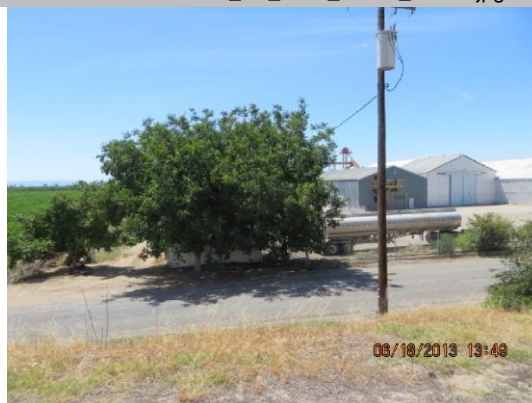
Photo 1 of 3 : UCIP_FA_2020_15125_24846.jpg

Comment Code					
Inspector Comment					
DS_ID:21470 FS_ID:15125 EP_NO: N/A Repair Type: Non-Urgent EVAL Issue: Crossing Status: Found UCIP Comments: Pumphouse abandoned with deep pit open. Safety issue. If plant is abandoned it should be done so properly. FIELD_STRUCT_DESC: 24-inch steel irrigation pipe through the levee, 21.4 feet below the crown. 16-inch pipe ties into 24-inch pipe at the waterside (WS) slope. Slant pump on metal platform and gate valve on the WS berm. Gate valve in pump house off the landside (LS). Two power poles at the LS toe. [Additional Reference(s): DWR Levee Log, 1988. USACE Sacramento O&M Manual 123, August 1955, (RM 75.2) (20-inch pipe listed)]. FS Date: 6/18/2013 7:36:00 AM

Pumphouse/distribution box off LS toe.

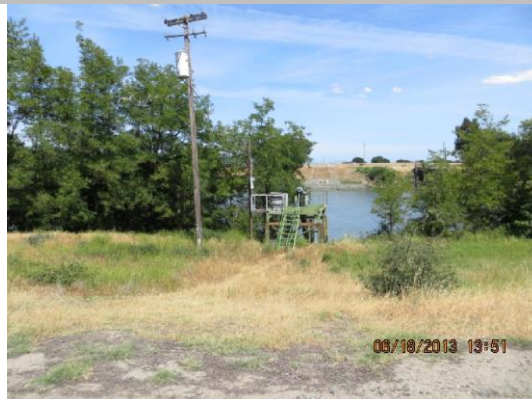
Photo 2 of 3 : UCIP_FA_2020_15125_24845.jpg

Slant pump on metal pier on WS berm.

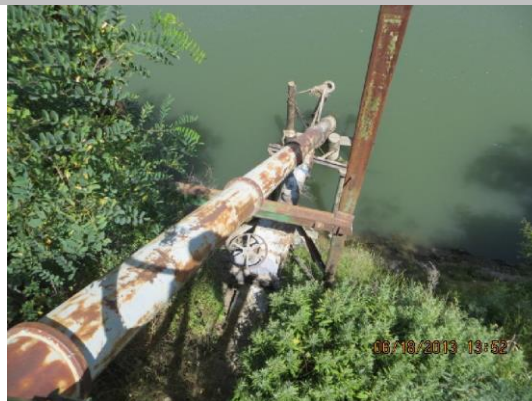
Photo 3 of 3 : UCIP_FA_2020_15125_24844.jpg

16-inch pipe ties into 24-inch pipe under pump platform at slide gate.

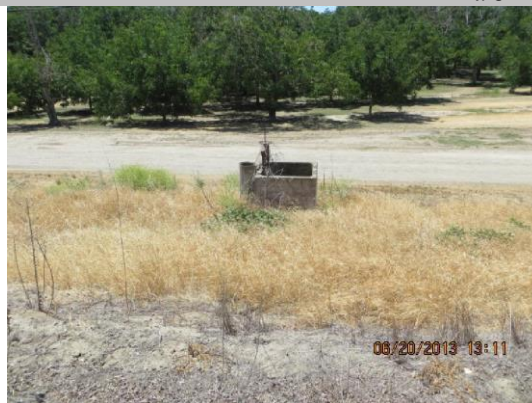
Photo 1 of 3 : UCIP_FA_2020_53410_25011.jpg

6'X6' concrete distribution box on LS toe.

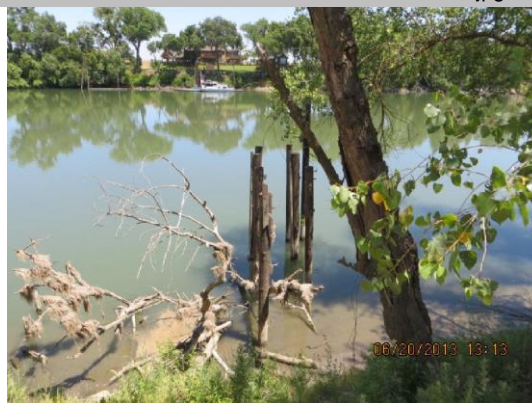
Photo 3 of 3 : UCIP_FA_2020_53410_25012.jpg

Pump missing from pier on WS toe.

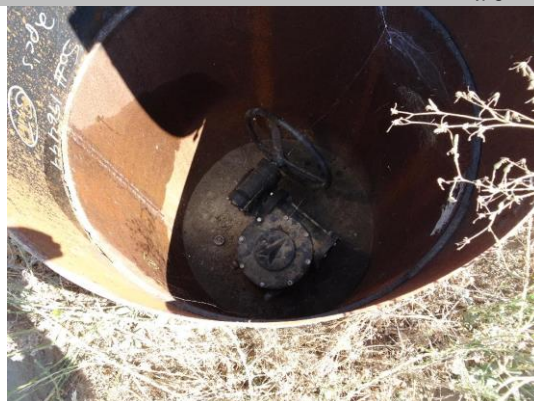
Photo 2 of 3 : UCIP_FA_2020_50169_75608.jpg

view of positive closure device in metal riser on WS shoulder of levee.

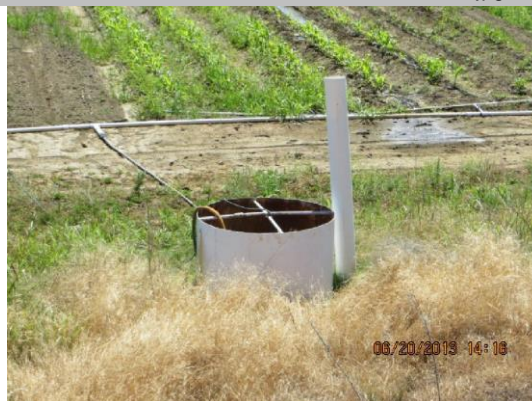
Photo 1 of 1 : UCIP_FA_2020_16310_27485.jpg

4-foot diameter steel standpipe at LS toe, may be indicator of pipe location.

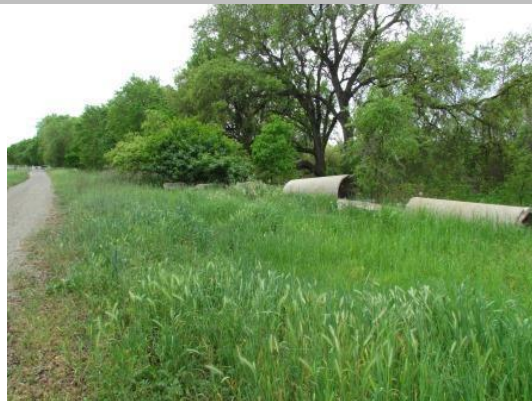
Photo 1 of 1 : FA_2020_RD1600_191_1202_20200813_00030.jpg

View of debris on the waterward side of the levee looking upstream.
Spring 2015.

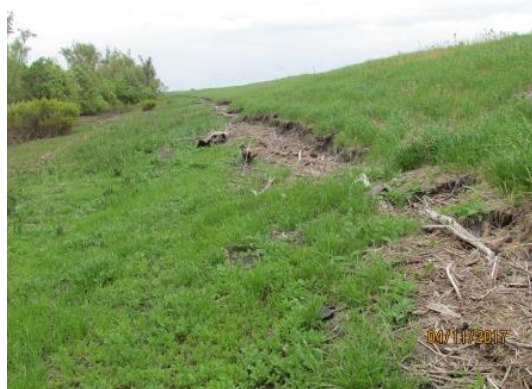
Photo 1 of 1 : FA_2020_RD1600_192_23_20200813_00005.jpg

View of wave wash damage on waterside levee slope. Spring 2017.

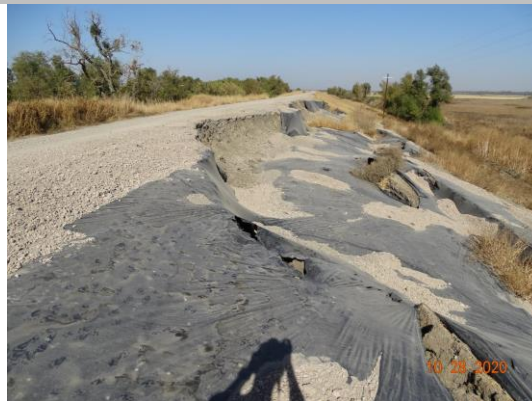
Photo 1 of 1 : FA_2020_RD1600_192_8_20201028_00012.jpg

View of sloughing on the landside slope. Fall 2020.

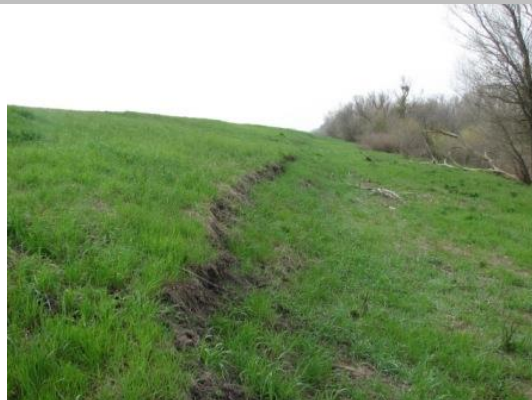
Photo 1 of 1 : FA_2020_RD1600_192_14_20200813_00004.jpg

Wave wash damage along the slope the cut is 1'-2'.
