Flood Control Project Maintenance Levee Inspections

Fall 2021 Levee Maintenance Deficiency Summary Report

Sacramento River Basin

Reclamation District No. 1600 Mull

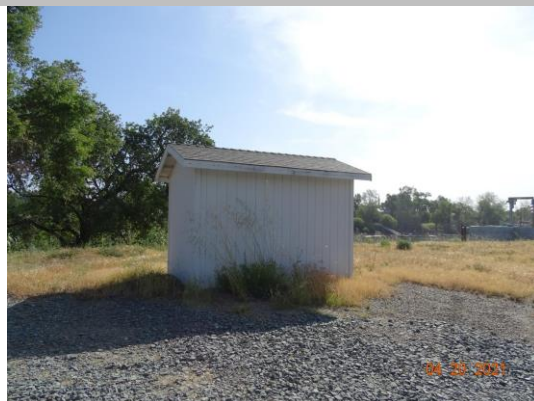
Photo 1 of 1 : FA_2021_RD1600_191_129_20210907_00025.jpg

View of pump house on the waterside shoulder. Spring 2021.

LM Start	0.11	Rating **	A/W	Issue No.	1
LM End	0.11	Issue Type +	Ma	Location *	WS
Category	Earthen Levee			GPS Latitude/Longitude	
				Start	End
Item	Erosion / Bank Caving			38.676524 °	38.676524 °
				-121.631243 °	-121.631243 °
DWR ID	DWR_RD1600_01_f_2018_1				
Comment Code					
E1 : Note and monitor erosion site.					
Inspector Comment					
Rills forming on overbuilt section of levee. Not within the prism. Recommend monitoring.

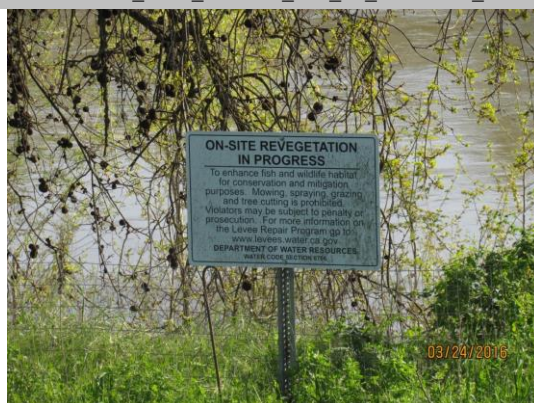
Photo 1 of 1 : FA_2021_RD1600_191_49_20210907_00018.jpg

Sign stating revegetation site. Spring 2016.

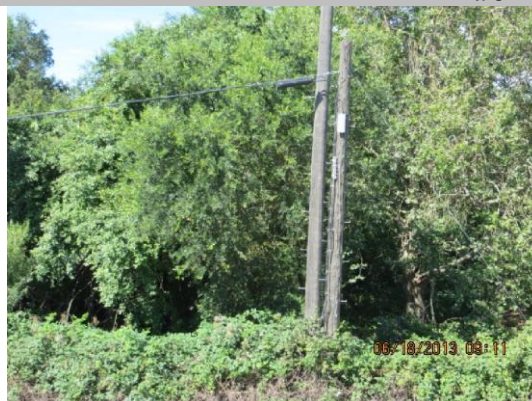
Photo 1 of 1 : UCIP_FA_2021_15087_24812.jpg

LM Start	0.13	Rating **	M	Issue No.	1203	
LM End	0.13	Issue Type +	En	Location *		
Category	Supplemental			GPS Latitude/Longitude		
				Start		End
Item	DWR UCIP Field Study			38.676802 °		38.676802 °
				-121.631442 °		-121.631442 °
DWR ID	21459					
Comment Code						
Inspector Comment						
DS_ID:21459 FS_ID:15087 EP_NO: 1929 Repair Type: Non-Urgent EVAL Issue: Crossing Status: Indicator Found UCIP Comments: Line should be located with carsonite signs on both sides of levee. FIELD_STRUCT_DESC: Telephone conduit of an unknown size or material through the levee, 3 feet below the crown. Telephone line at joint pole (JP) off the landside (LS) toe. (Permit No. 1929, 1954 - Pacific Telephone and Telegraph Company [PT&T]). [Additional Reference(s): DWR Levee Log, 1988]. FS Date: 6/18/2013

Line visible on JP off LS toe. Likely this is the source of crossing.

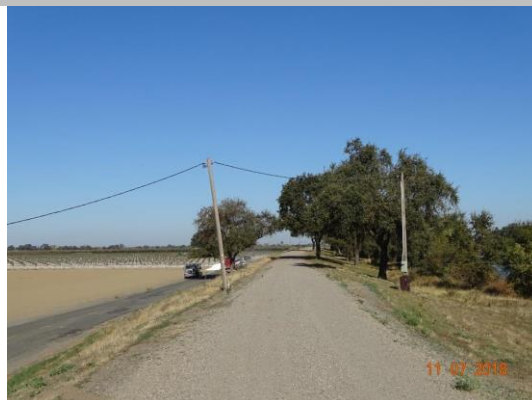
Photo 1 of 1 : FA_2021_RD1600_191_44_20210907_00014.jpg

LM Start	0.52	Rating **	M	Issue No.	44
LM End	0.52	Issue Type +	En	Location *	CR
Category	Earthen Levee			GPS Latitude/Longitude	
				Start	End
Item	Encroachments			38.682046 °	38.682046 °
				-121.634064 °	-121.634064 °
DWR ID	DWR_RD1600_01_s_2020_44				
Comment Code					
PO : Pole					
Inspector Comment					
Telephone pole over the levee crown.

View of telephone line over levee crown. Fall 2018.

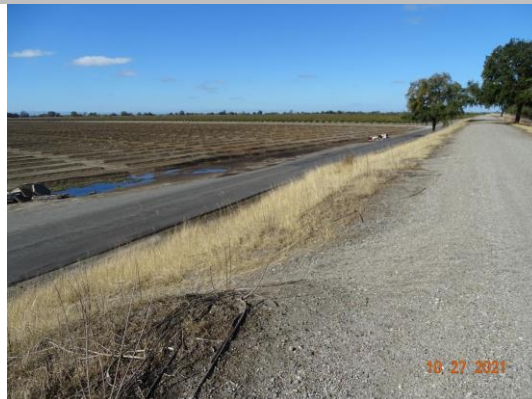
Photo 1 of 1 : FA_2021_RD1600_191_133_20211102_00053.jpg

LM Start	0.53	Rating **	M	Issue No.	133
LM End	0.53	Issue Type +	Ma	Location *	LS
Category	Earthen Levee			GPS Latitude/Longitude	
				Start	End
Item	Slope Stability			38.682140 °	38.682140 °
				-121.634083 °	-121.634083 °
DWR ID	DWR_RD1600_01_f_2013_133				
Comment Code					
S2 : Repair the levee slope damaged by foot traffic and prevent access where possible.					
Inspector Comment					
There appears to be a footpath and settlement on landside slope over pipe crossing.

View of settlement and footpath on landside slope. Fall 2021.

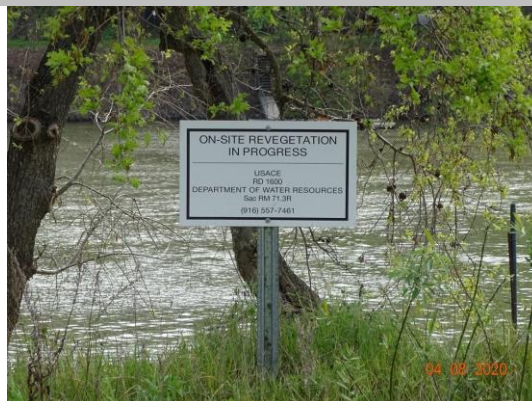
Photo 1 of 1 : FA_2021_RD1600_191_26_20210907_00010.jpg

LM Start	0.56	Rating **	A/W	Issue No.	26
LM End	0.66	Issue Type +	Ob	Location *	WS
Category	Earthen Levee			GPS Latitude/Longitude	
				Start	End
Item	Vegetation			38.682661 °	38.684099 °
				-121.634238 °	-121.634625 °
DWR ID	DWR_RD1600_01_s_2020_26				
Comment Code					
V8 : Environmental Requirements.					
Inspector Comment					
USACE, DWR, and RD 1600 revegetation site.

View of revegetation sign on the waterside berm. Spring 2020.

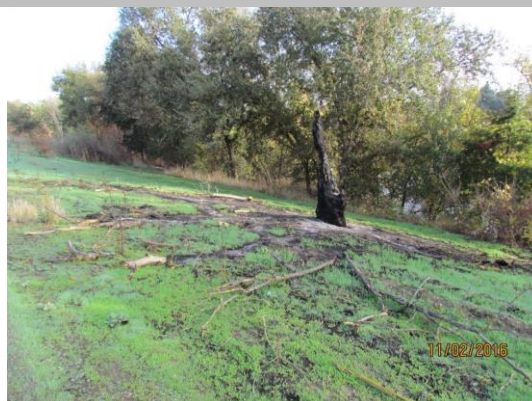
Photo 1 of 1 : FA_2021_RD1600_191_624_20210907_00028.jpg

LM Start	0.78	Rating **	N	Issue No.	624
LM End	0.78	Issue Type +	Ma	Location *	WS
Category	Earthen Levee			GPS Latitude/Longitude	
				Start	End
Item	Trim / Thin Trees			38.685713 °	38.685713 °
				-121.634985 °	-121.634985 °
DWR ID	DWR_RD1600_01_s_2017_624				
Comment Code					
T5 : Tree stumps.					
Inspector Comment					
Burnt stump on waterside slope.

View of burnt tree on waterside slope. Fall 2016.

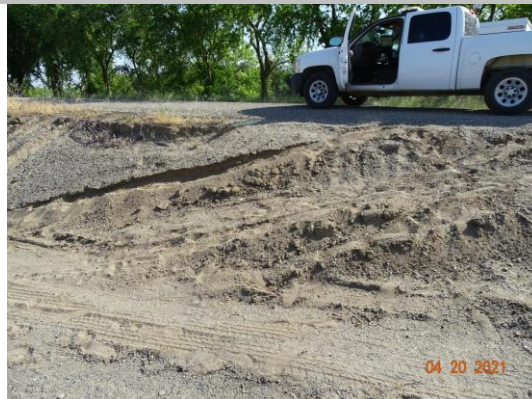
Photo 1 of 1 : FA_2021_RD1600_191_14_20210907_00003.jpg

LM Start	0.88	Rating **	M	Issue No.	14
LM End	0.88	Issue Type +	Ma	Location *	LS
Category	Earthen Levee			GPS Latitude/Longitude	
				Start	End
Item	Slope Stability			38.687192 °	38.687192 °
				-121.635169 °	-121.635169 °
DWR ID	DWR_RD1600_01_s_2021_14				
Comment Code					
S3 : Repair the levee slope damaged by vehicle traffic and prevent access where possible.					
Inspector Comment					
Ruts on the landside slope due to vehicles coming up on the levee.

View of ruts on the landside slope. Spring 2021.

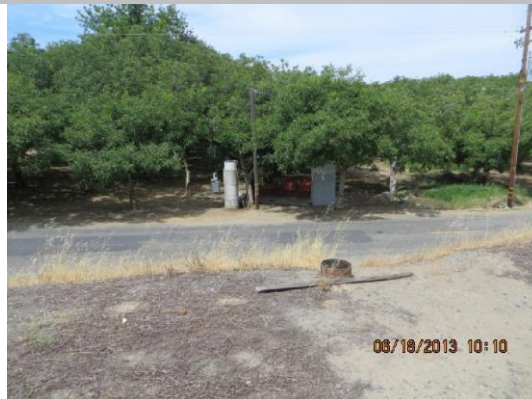
Photo 1 of 3 : UCIP_FA_2021_15285_25088.jpg

LM Start	0.94	Rating **	M	Issue No.	1204	
LM End	0.94	Issue Type +	En	Location *		
Category	Supplemental			GPS Latitude/Longitude		
				Start	End	
Item	DWR UCIP Field Study			38.688030 °	38.688030 °	
				-121.635367 °	-121.635367 °	
DWR ID	21463

Comment Code						
Inspector Comment						
DS_ID:21463 FS_ID:15285 EP_NO: 6100 Repair Type: Non-Urgent EVAL Issue: Crossing Status: Found UCIP Comments: Gate valve will not open or close. FIELD_STRUCT_DESC: 12-inch steel irrigation pipe through the levee, 3.4 feet below the crown. Slant pump and gate valve on the waterside (WS) slope. Siphon breaker in a 12-inch steel riser on the landside (LS) shoulder. Filter, booster pump, and butterfly valve on the LS toe. 2.25-inch galvanized iron electrical conduit at the same location. (Permit No. 6100, 1968 - Charles Plumb Jr., replaced 8-inch pipe at same location). [Additional Reference(s): DWR Levee Log, 1988]. FS Date: 6/18/2013

Siphon breaker in steel riser on LS shoulder and concrete standpipe off LS toe.

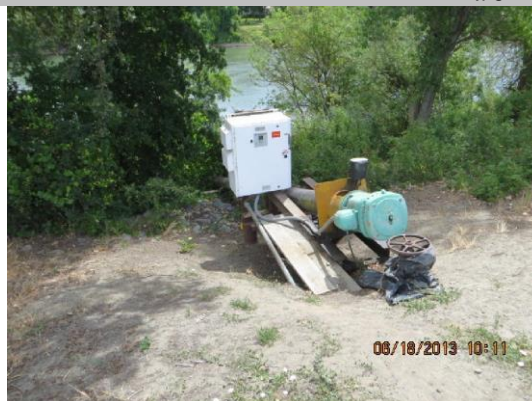
Photo 2 of 3 : UCIP_FA_2021_15285_25087.jpg

Pump and gate valve on WS slope.

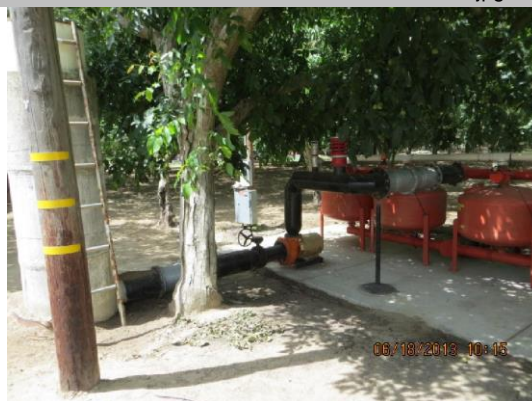
Photo 3 of 3 : UCIP_FA_2021_15285_25086.jpg

Filters, boost pump, and gate valve down stream from concrete standpipe off LS toe.

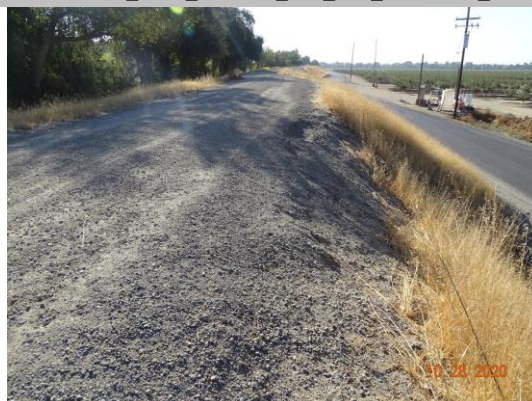
Photo 1 of 1 : FA_2021_RD1600_191_134_20210907_00027.jpg

LM Start	0.97	Rating **	M	Issue No.	134
LM End	0.97	Issue Type +	Ma	Location *	LS
Category	Earthen Levee			GPS Latitude/Longitude	
				Start	End
Item	Slope Stability			38.688454 °	38.688454 °
				-121.635528 °	-121.635528 °
DWR ID	DWR_RD1600_01_f_2021_134				
Comment Code					
S2 : Repair the levee slope damaged by foot traffic and prevent access where possible.					
Inspector Comment

View of the foot traffic on the landside slope. Fall 2020.

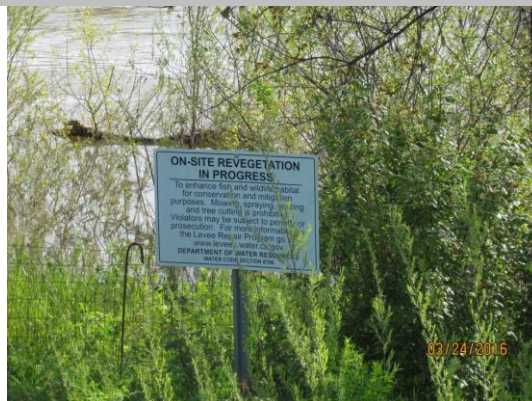
Photo 1 of 1 : FA_2021_RD1600_191_22_20210907_00008.jpg

Sign stating revegetation site. Spring 2016.

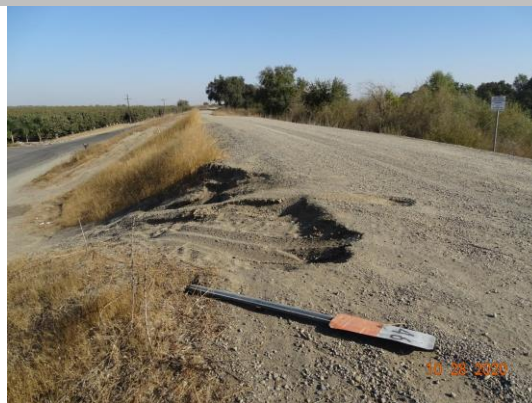
Photo 1 of 1 : FA_2021_RD1600_191_4_20210907_00001.jpg

LM Start	1.40	Rating **	M	Issue No.	4
LM End	1.40	Issue Type +	Ma	Location *	LS
Category	Earthen Levee			GPS Latitude/Longitude	
				Start	End
Item	Slope Stability			38.694452 °	38.694452 °
				-121.634292 °	-121.634292 °
DWR ID	DWR_RD1600_01_s_2017_4				
Comment Code					
S3 : Repair the levee slope damaged by vehicle traffic and prevent access where possible.					
Inspector Comment					
Tire ruts on the landside slope adjacent to ramp.

View of tire ruts on the landside slope. Fall 2020.

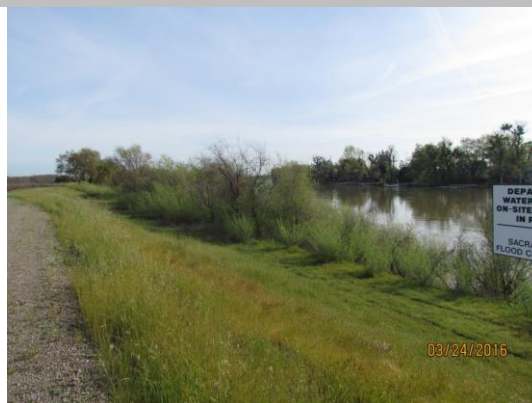
Photo 1 of 1 : FA_2021_RD1600_191_5_20210907_00002.jpg

LM Start	1.40	Rating **	A/W	Issue No.	5
LM End	1.40	Issue Type +	Ob	Location *	WS
Category	Earthen Levee			GPS Latitude/Longitude	
				Start	End
Item	Vegetation			38.694469 °	38.694469 °
				-121.634312 °	-121.634312 °
DWR ID	DWR_RD1600_01_f_2012_5				
Comment Code					
V8 : Environmental Requirements.					
Inspector Comment

View of the revegetation site on the berm of the waterward side of the levee looking upstream. Spring 2016.

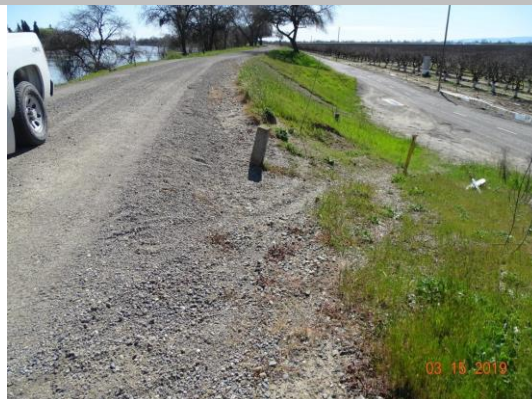
Photo 1 of 1 : FA_2021_RD1600_191_52_20210907_00020.jpg

LM Start	1.42	Rating **	A/W	Issue No.	52
LM End	1.42	Issue Type +	Ma	Location *	LS
Category	Earthen Levee			GPS Latitude/Longitude	
				Start	End
Item	Slope Stability			38.694728 °	38.694728 °
				-121.634224 °	-121.634224 °
DWR ID	DWR_RD1600_01_f_2018_52				
Comment Code					
S3 : Repair the levee slope damaged by vehicle traffic and prevent access where possible.					
Inspector Comment					
Previously a vehicle access ramp. The district has placed barriers to prevent access. Recommend monitoring for future erosion.

View of ruts on landside shoulder. Spring 2019.

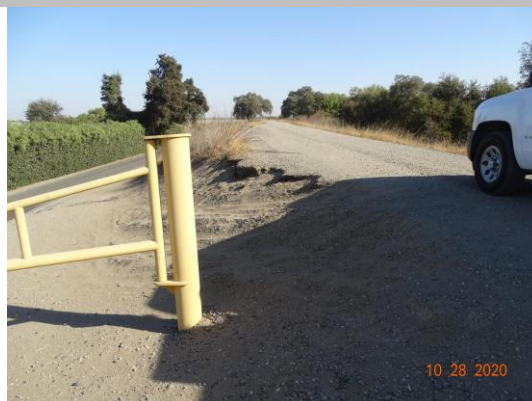
Photo 1 of 1 : FA_2021_RD1600_191_46_20210907_00015.jpg

LM Start	1.65	Rating **	M	Issue No.	46
LM End	1.65	Issue Type +	Ma	Location *	LS
Category	Earthen Levee			GPS Latitude/Longitude	
				Start	End
Item	Slope Stability			38.697799 °	38.697799 °
				-121.632396 °	-121.632396 °
DWR ID	DWR_RD1600_01_f_2019_46				
Comment Code					
S3 : Repair the levee slope damaged by vehicle traffic and prevent access where possible.					
Inspector Comment					
Erosion on landside slope near district gate.

View of erosion on the landside slope. Fall 2020.

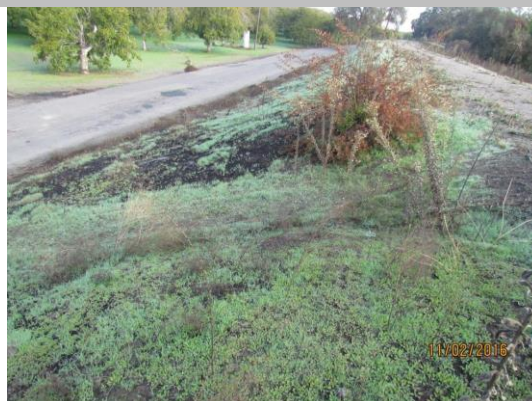
Photo 1 of 1 : FA_2021_RD1600_191_70_20210907_00023.jpg

LM Start	1.70	Rating **	A/W	Issue No.	70
LM End	1.70	Issue Type +	Ma	Location *	LS
Category	Earthen Levee			GPS Latitude/Longitude	
				Start	End
Item	Slope Stability			38.698414 °	38.698414 °
				-121.631874 °	-121.631874 °
DWR ID	DWR_RD1600_01_f_2017_70				
Comment Code					
S3 : Repair the levee slope damaged by vehicle traffic and prevent access where possible.					
Inspector Comment					
Footpath and vehicle access on landside slope. Recommend monitoring.

View of slope instability. Fall 2016.

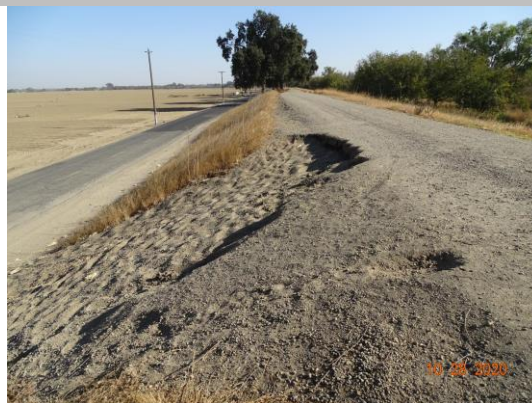
Photo 1 of 1 : FA_2021_RD1600_191_72_20210907_00024.jpg

LM Start	2.01	Rating **	M	Issue No.	72
LM End	2.01	Issue Type +	Ma	Location *	LS
Category	Earthen Levee			GPS Latitude/Longitude	
				Start	End
Item	Slope Stability			38.701605 °	38.701605 °
				-121.627954 °	-121.627954 °
DWR ID	DWR_RD1600_01_s_2018_72				
Comment Code					
S2 : Repair the levee slope damaged by foot traffic and prevent access where possible.					
Inspector Comment					
Foot traffic on the landside slope.

View of foot traffic on the landside slope. Fall 2020.

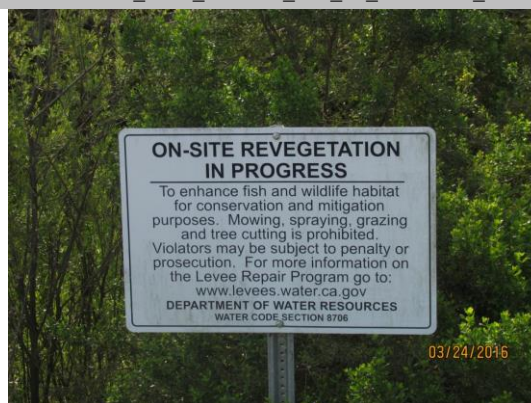
Photo 1 of 1 : FA_2021_RD1600_191_35_20210907_00012.jpg

Sign for revegetation site. Spring 2016.

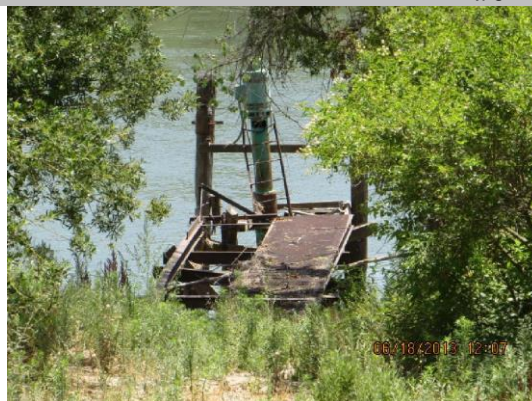
Photo 1 of 3 : UCIP_FA_2021_15108_24826.jpg

Comment Code						
Inspector Comment						
DS_ID:21467 FS_ID:15108 EP_NO: N/A Repair Type: Non-Urgent EVAL Issue: Crossing Status: Not Found UCIP Comments: Pipe removed and replaced with a pipe dsid 25565 - permit 18852. Appears abandoned and should be done so properly. Debris buildup on pier. Power cut to pump. FIELD_STRUCT_DESC: *REMOVED* 16-inch steel irrigation pipe through the levee, 2 feet below the crown. Walkway from berm to pump on pile structure in the stream. Siphon breaker on the landside (LS) slope. 12-inch polyvinyl chloride (PVC) standpipe off the LS toe. [Additional Reference(s): DWR Levee Log, 1988. USACE Sacramento O&M Manual 123, August 1955, (RM 73.4) (18-inch pipe listed)]. FS Date: 6/18/2013

Pump on metal platform off WS berm.

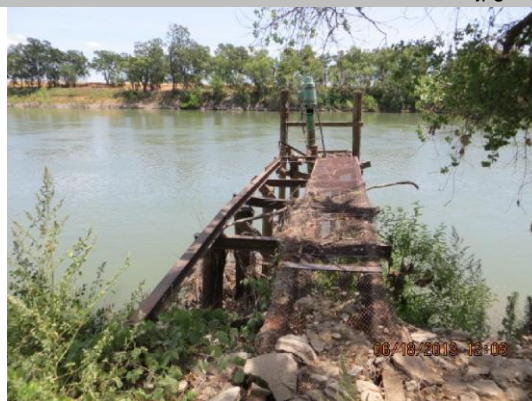
Photo 2 of 3 : UCIP_FA_2021_15108_24825.jpg

Debris buildup at metal platform waterline.

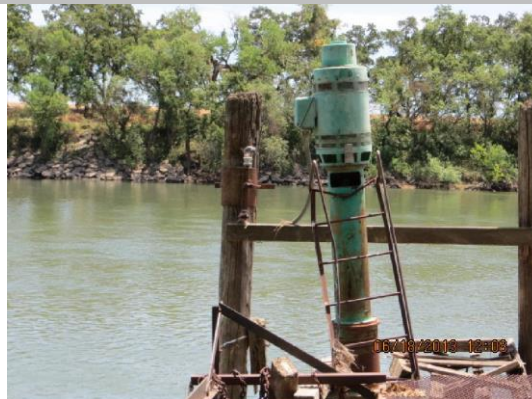
Photo 3 of 3 : UCIP_FA_2021_15108_24824.jpg

Electrical cut to pump.

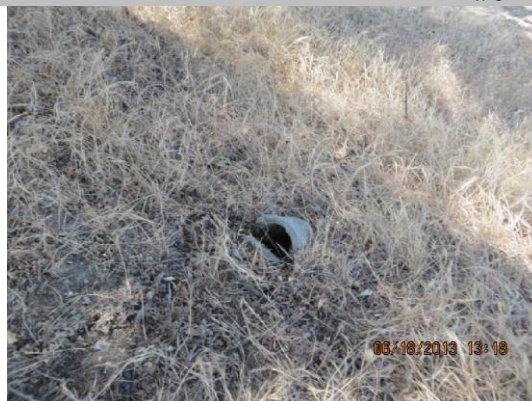
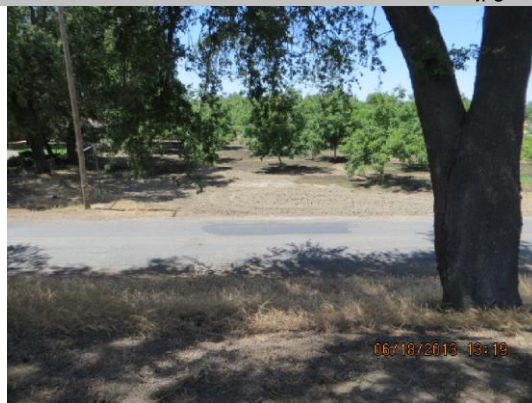
LM Start	2.93	Rating **	M	Issue No.	1206
LM End	2.93	Issue Type +	En	Location *	
Category	Supplemental			GPS Latitude/Longitude	
				Start	End
Item	DWR UCIP Field Study			38.710497 °	38.710497 °
				-121.615381 °	-121.615381 °
DWR ID	21490				
Comment Code					
Inspector Comment					
DS_ID:21490 FS_ID:15110 EP_NO: N/A Repair Type: Non-Urgent EVAL Issue: Crossing Status: Indicator Found UCIP Comments: Abandoned and should be removed from levee. FIELD_STRUCT_DESC: *ABANDONED* 10-inch reinforced concrete pipe of an unknown purpose through the levee, 5 feet below the crown. Pipe visible on the landside (LS) slope. [Additional Reference(s): USACE Sacramento O&M Manual 123, August 1955, (RM 73.5)]. FS Date: 6/18/2013

Pipe visible on LS slope.

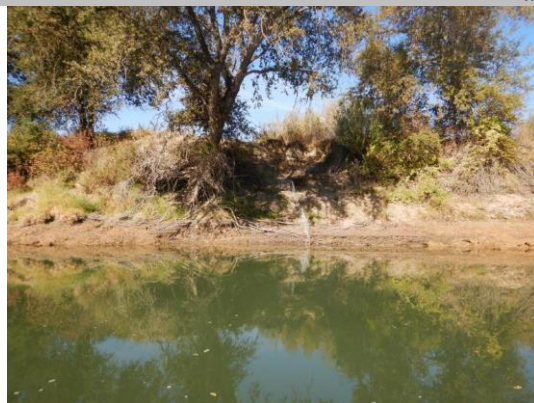
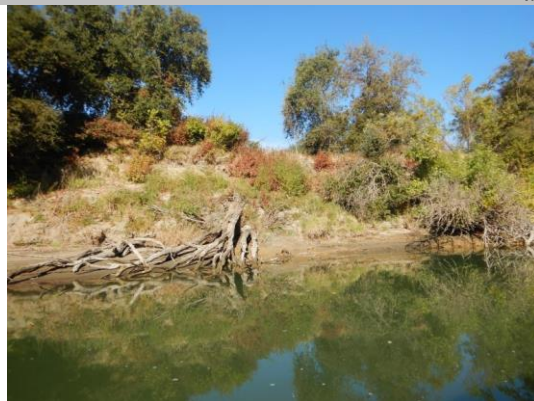
LM Start	2.99	Rating **	A/W	Issue No.	15
LM End	3.37	Issue Type +	Ma	Location *	WS
Category	Supplemental			GPS Latitude/Longitude	
				Start	End
Item	2018 USACE Erosion Survey			38.710874 °	38.715134 °
				-121.614239 °	-121.609566 °
DWR ID					
Comment Code					
Inspector Comment					
2018 Site ID: SAC 74.0 R					
Status: Eroding					
2018 Field Notes: Bank toe continues to erode.					
Site History: 2017 - Significant toe erosion. Erosion along entire bank.					
Tree popouts observed.

USACE 2018 Erosion Photo #1

USACE 2018 Erosion Photo #2

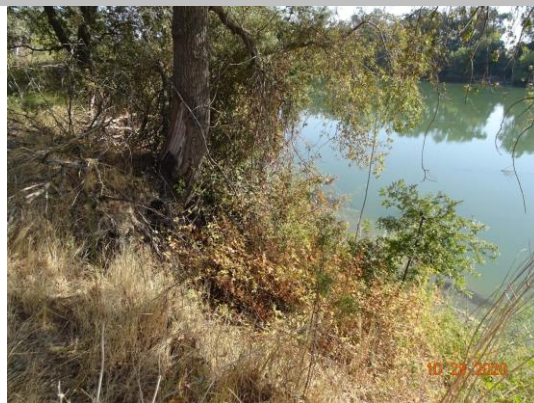
Photo 1 of 1 : FA_2021_RD1600_191_29_20210907_00011.jpg

LM Start	3.09	Rating **	M	Issue No.	29
LM End	3.09	Issue Type +	Ma	Location *	WS
Category	Earthen Levee			GPS Latitude/Longitude	
				Start	End
Item	Erosion / Bank Caving			38.712205 °	38.712205 °
				-121.613212 °	-121.613212 °
DWR ID	DWR_RD1600_01_f_2020_29				
Comment Code					
E2 : Schedule repair of erosion site prior to the next inspection.					
Inspector Comment					
Erosion pocket on the waterside slope. There is approximately 20' of berm before a vertical drop that cuts into the prism.

View of erosion location on the waterside berm. Fall 2020.

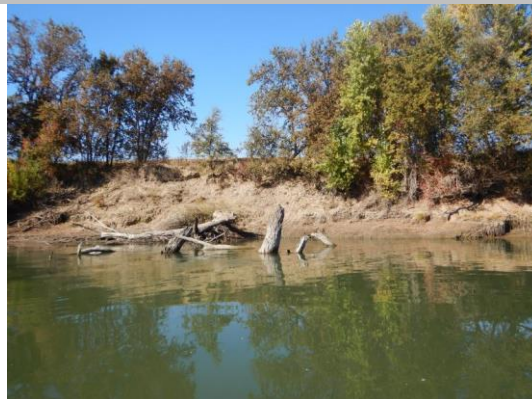
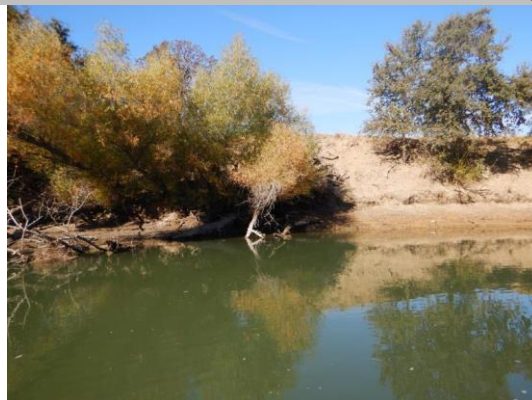
USACE 2018 Erosion Photo #1

USACE 2018 Erosion Photo #2

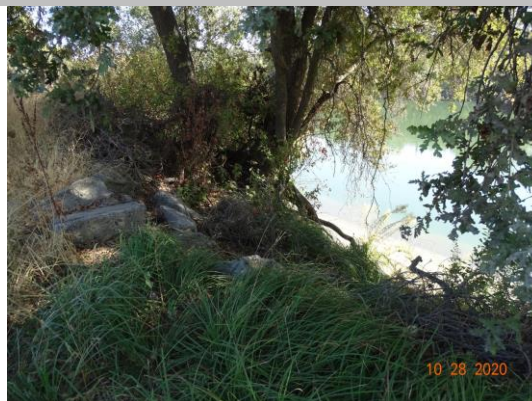
Photo 1 of 1 : FA_2021_RD1600_191_47_20210907_00016.jpg

LM Start	3.59	Rating **	M	Issue No.	47
LM End	3.59	Issue Type +	Ma	Location *	WS
Category	Earthen Levee			GPS Latitude/Longitude	
				Start	End
Item	Erosion / Bank Caving			38.718047 °	38.718047 °
				-121.607840 °	-121.607840 °
DWR ID	DWR_RD1600_01_f_2020_47				
Comment Code					
E2 : Schedule repair of erosion site prior to the next inspection.					
Inspector Comment					
Erosion pocket on waterside slope. Approximately 15 feet of berm until vertical drop into prism.

View of erosion location on waterside berm. Fall 2020.

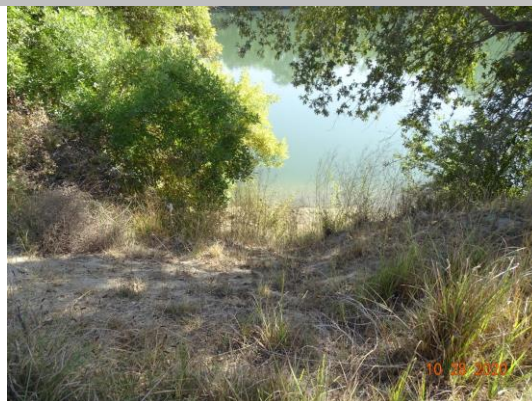
Photo 1 of 1 : FA_2021_RD1600_191_48_20210907_00017.jpg

LM Start	3.62	Rating **	M	Issue No.	48
LM End	3.62	Issue Type +	Ma	Location *	WS
Category	Earthen Levee			GPS Latitude/Longitude	
				Start	End
Item	Erosion / Bank Caving			38.718449 °	38.718449 °
				-121.607591 °	-121.607591 °
DWR ID	DWR_RD1600_01_f_2020_48				
Comment Code					
E2 : Schedule repair of erosion site prior to the next inspection.					
Inspector Comment					
Erosion pocket on waterside slope. Approximately 8 feet of berm until vertical drop into prism.

View of erosion location on waterside berm. Fall 2020.

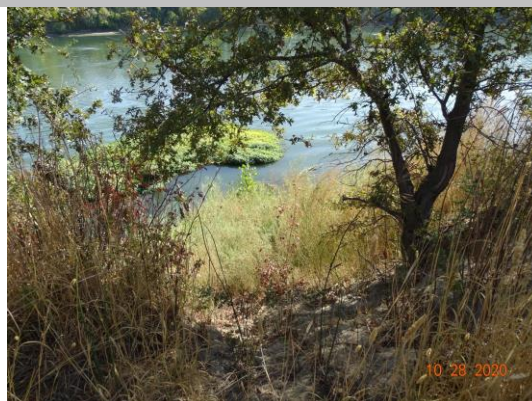
Photo 1 of 1 : FA_2021_RD1600_191_50_20210907_00019.jpg

LM Start	3.76	Rating **	M	Issue No.	50
LM End	3.76	Issue Type +	Ma	Location *	WS
Category	Earthen Levee			GPS Latitude/Longitude	
				Start	End
Item	Erosion / Bank Caving			38.720447 °	38.720447 °
				-121.606946 °	-121.606946 °
DWR ID	DWR_RD1600_01_f_2020_50				
Comment Code					
E2 : Schedule repair of erosion site prior to the next inspection.					
Inspector Comment					
Erosion pocket on waterside slope. Approximately 10 feet of berm until vertical drop into prism.

View of erosion on the waterside slope. Fall 2020.

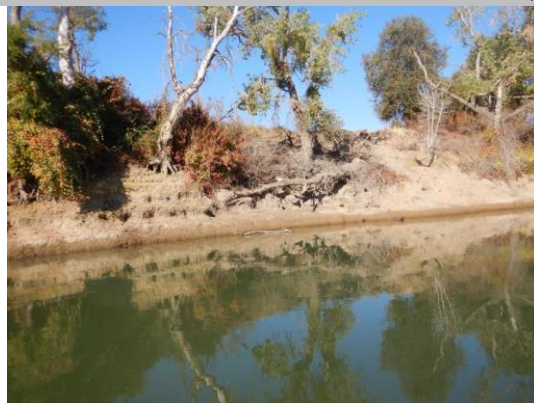
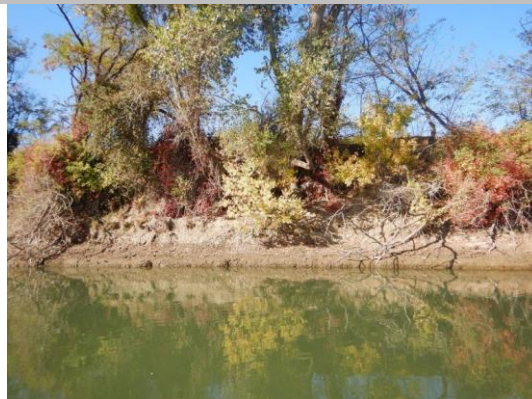
USACE 2018 Erosion Photo #1

USACE 2018 Erosion Photo #2

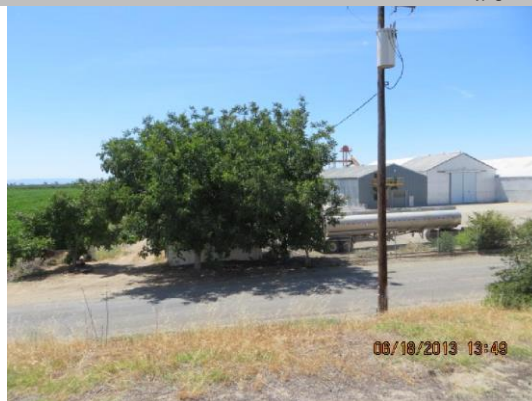
Photo 1 of 3 : UCIP_FA_2021_15125_24846.jpg

Pumphouse/distribution box off LS toe.

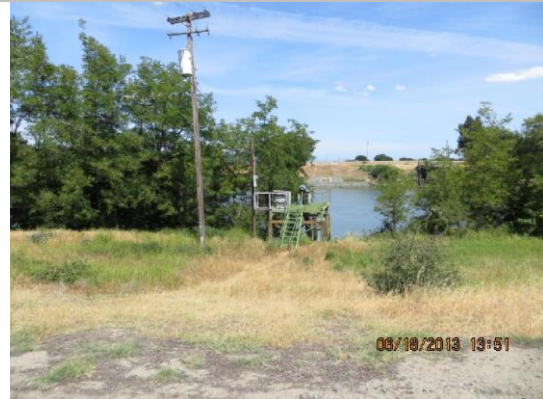
Photo 2 of 3 : UCIP_FA_2021_15125_24845.jpg

Slant pump on metal pier on WS berm.

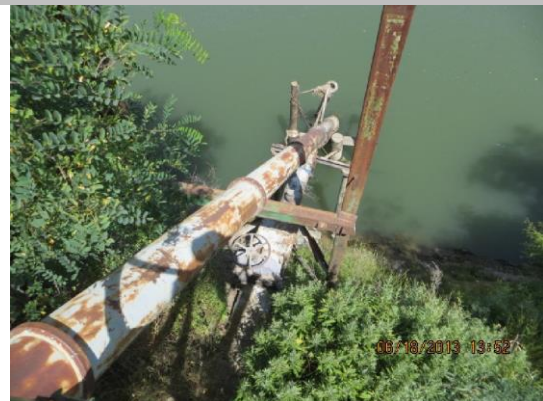
Photo 3 of 3 : UCIP_FA_2021_15125_24844.jpg

16-inch pipe ties into 24-inch pipe under pump platform at slide gate.

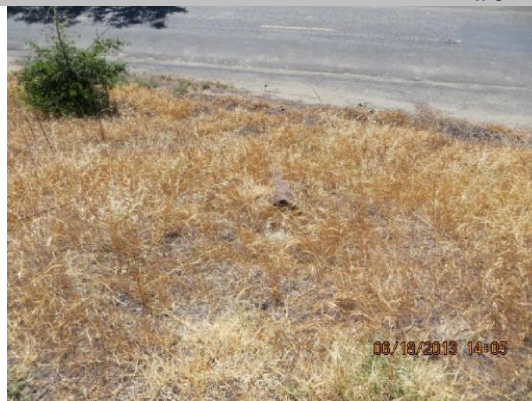
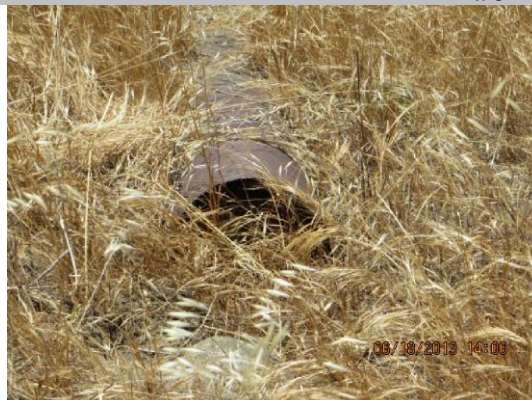
Pipe and remnants of grouted pipe on LS slope.

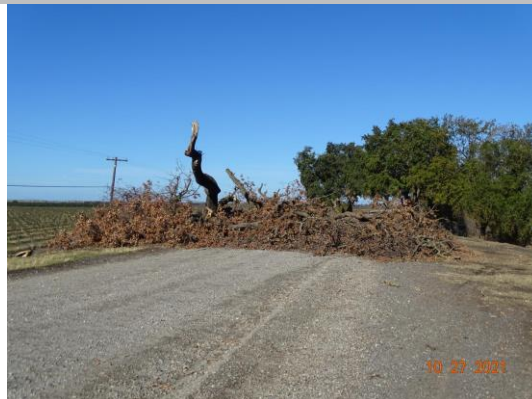
Photo 1 of 1 : FA_2021_RD1600_191_57_20211102_00054.jpg

View of fallen tree on the crown. Fall 2021.

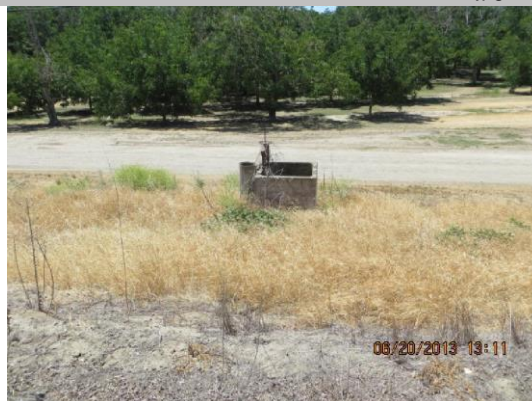
Photo 1 of 3 : UCIP_FA_2021_53410_25011.jpg

6'X6' concrete distribution box on LS toe.

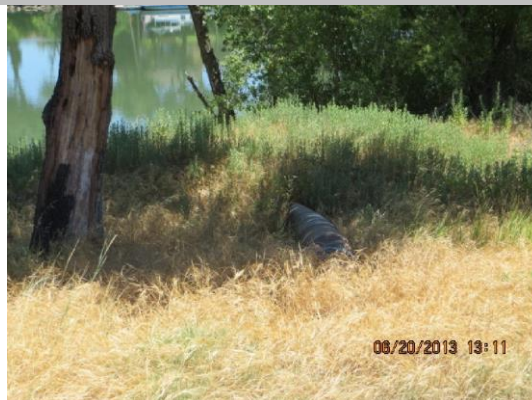
Photo 2 of 3 : UCIP_FA_2021_53410_25010.jpg

Pipe on WS slope.

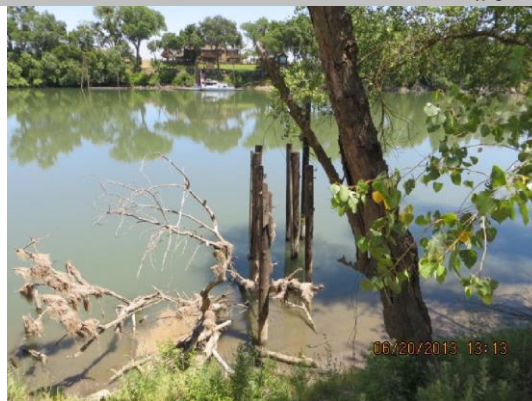
Photo 3 of 3 : UCIP_FA_2021_53410_25012.jpg

Pump missing from pier on WS toe.

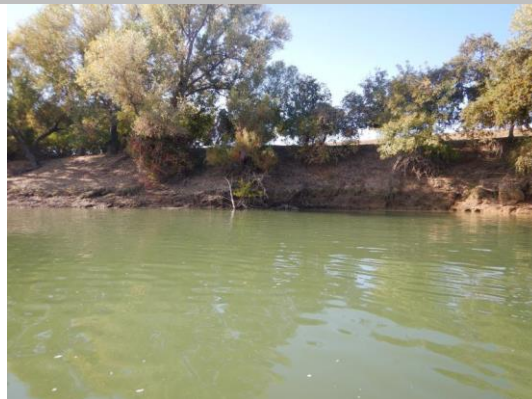
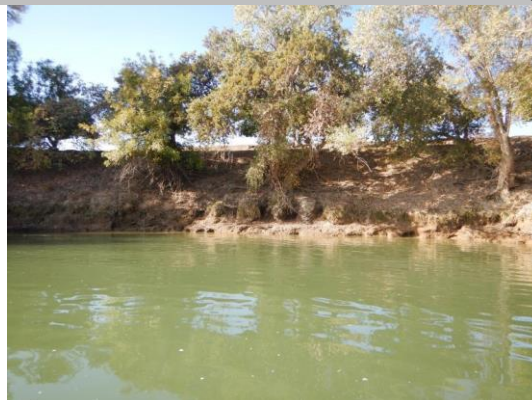
USACE 2018 Erosion Photo #1

USACE 2018 Erosion Photo #2

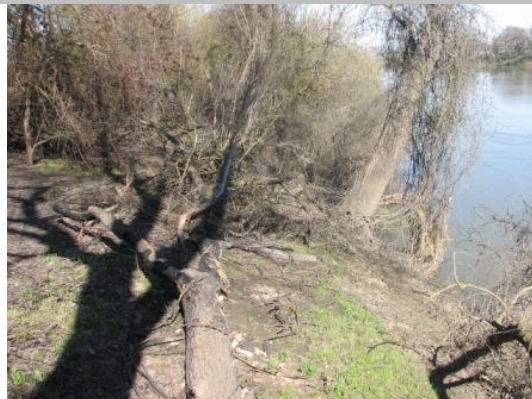
Photo 1 of 1 : FA_2021_RD1600_191_20_20210907_00006.jpg

View of erosion on the waterside berm.

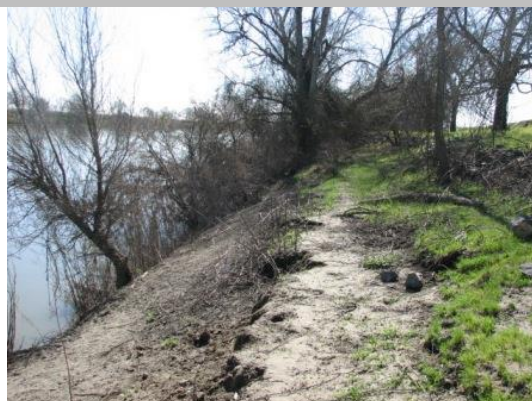
Photo 1 of 1 : FA_2021_RD1600_191_21_20210907_00007.jpg

The erosion is eroding away the berm area.

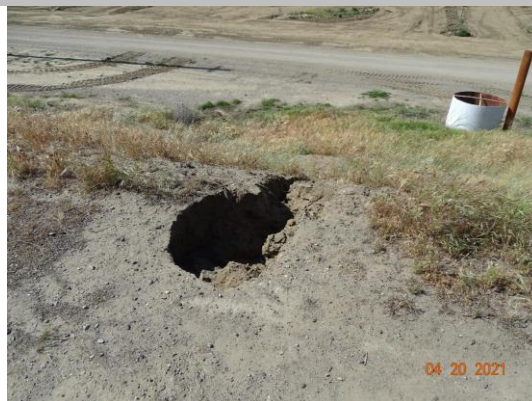
Photo 1 of 1 : FA_2021_RD1600_191_55_20210907_00021.jpg

View of rill on the landside slope. Spring 2021.

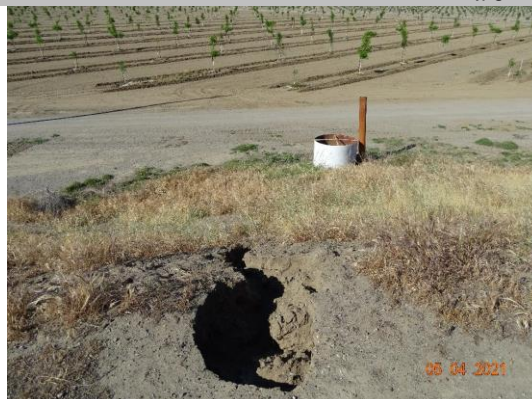
Photo 2 of 3 : UCIP_FA_2021_64693_97034.jpg

Land-Side: View of levee slope looking from crown. Steel riser and plastic standpipe at levee toe

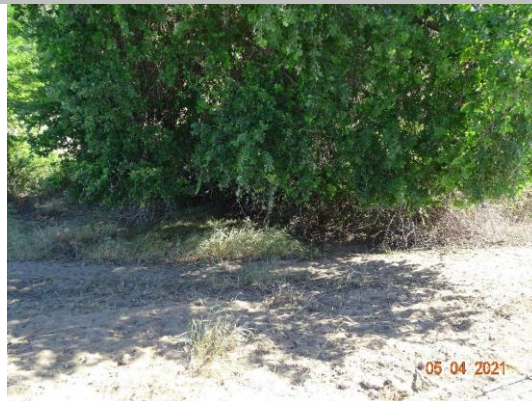
Photo 3 of 3 : UCIP_FA_2021_64693_97040.jpg

Water-Side: View of levee slope looking from crown. Pipe not found on waterside

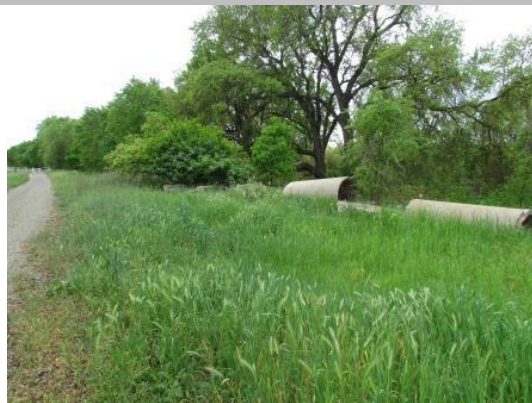
Photo 1 of 1 : FA_2021_RD1600_191_1202_20210907_00029.jpg

View of debris on the waterward side of the levee looking upstream.
Spring 2015.

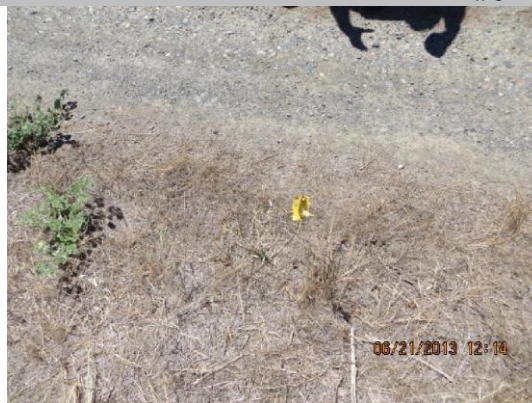
Photo 1 of 3 : UCIP_FA_2021_52738_27478.jpg

PG&E marker flag on Crown.

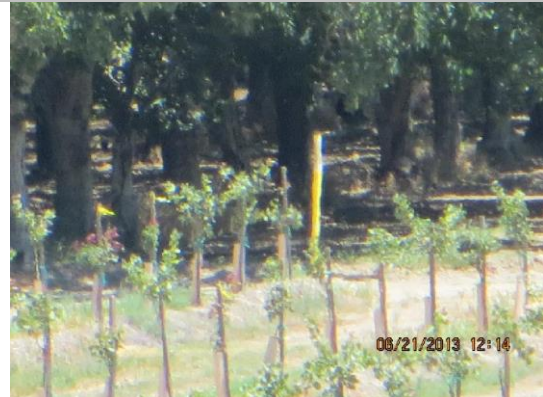
Photo 2 of 3 : UCIP_FA_2021_52738_27477.jpg

Carsonite gasline marker visible approximately 1,000-feet east of levee crown.

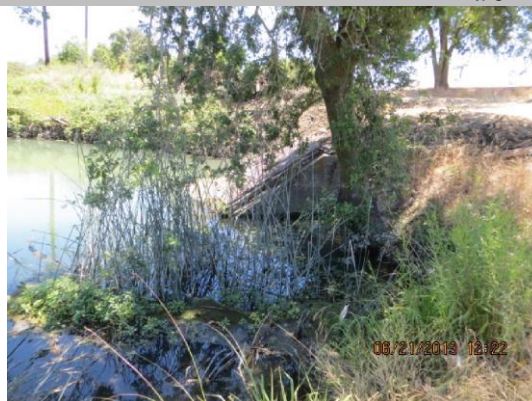
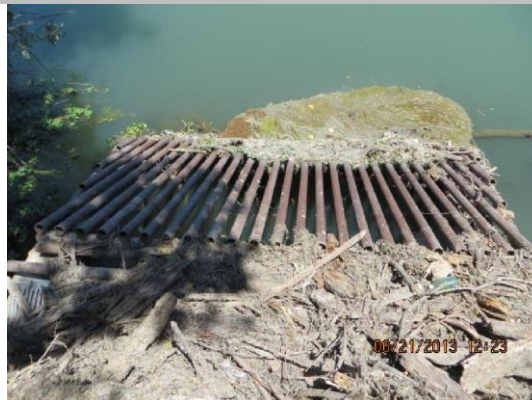
Concrete intake structure on LS.

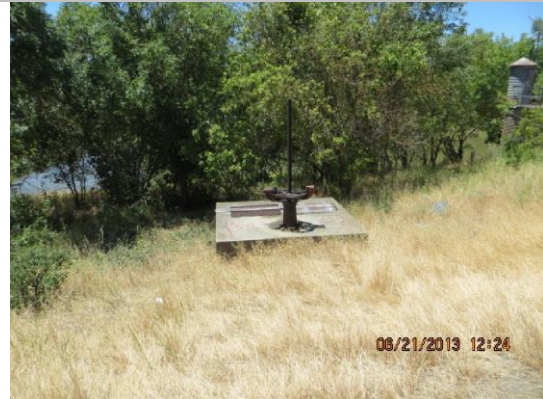
Photo 3 of 3 : UCIP_FA_2021_15303_25156.jpg

Slide gate in 9'X10' concrete box on WS slope.
