Flood Control Project Maintenance Levee Inspections

Fall 2022 Levee Maintenance Deficiency Summary Report

Sacramento River Basin

Reclamation District No. 1600 Mull

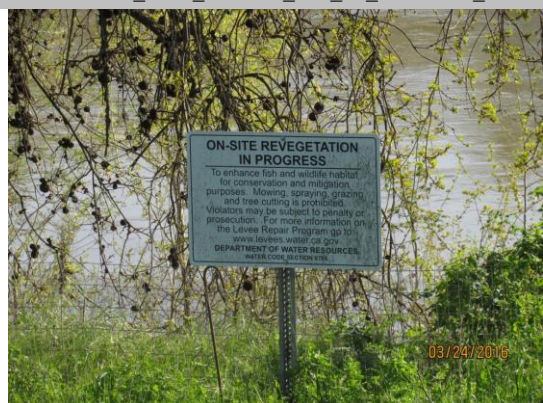
Photo 1 of 1 : FA_2022_RD1600_191_49_20220921_00023.jpg

Sign stating revegetation site. Spring 2016.

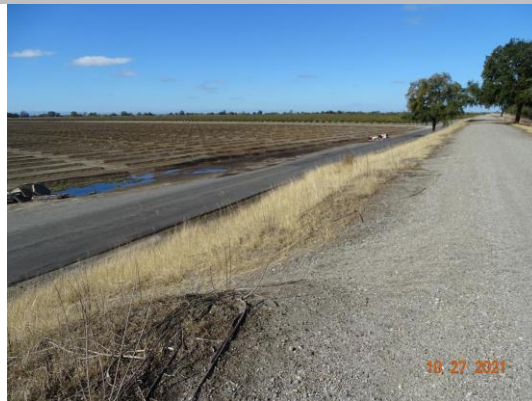
Photo 1 of 1 : FA_2022_RD1600_191_133_20220921_00031.jpg

LM Start	0.53	Rating **	M	Issue No.	133
LM End	0.53	Issue Type +	Ma	Location *	LS
Category	Earthen Levee			GPS Latitude/Longitude	
				Start	End
Item	Erosion / Foot Traffic			38.682140 °	38.682140 °
				-121.634083 °	-121.634083 °
DWR ID	DWR_RD1600_01_f_2013_133				
Comment Code					
E3 : Repair the levee slope damaged by foot traffic and prevent access where possible.					
Inspector Comment					
There appears to be a footpath and settlement on landside slope over pipe crossing.

View of settlement and footpath on landside slope. Fall 2021.

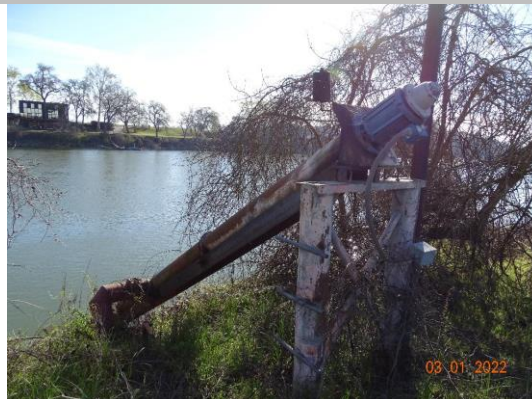
Photo 1 of 3 : UCIP_FA_2022_73418_109776.jpg

Comment Code						
Inspector Comment						
DS_ID:21460 FS_ID:73418 EP_NO: N/A Repair Type: Non-Urgent EVAL Issue: 6, Levee Damage or Threat for Levee Damage Crossing Status: Found UCIP Comments: 03/01/2022 Record updated from No Action Needed to Non-Urgent. Sinkhole measured 24-inch in diameter and 6-inch in depth located at the shoulder of CO RD 117. Depression on landside slope. New concrete distribution box constructed on landside. Vertical pump on the top of it, and sand filters in the field are installed. Old concrete distribution box debris found on road shoulder. No permit has been identified authorizing pipe. (O.Yakimov - DWR UCIP) FIELD_STRUCT_DESC: 14-inch steel irrigation pipe through the levee 15.2 feet below the crown. Slant pump and gate valve on the waterside (WS) slope. Service pole with electrical panel on WS shoulder, overhead power line. Concrete distribution box off the landside (LS) toe. Vertical pump over the concrete distribution box, sand filters on LS. [Additional Reference(s): DWR Levee Log, 1988. USACE Sacramento O&M Manual 123, August 1955, (RM 71.0) (14-inch pipe listed)]. FS Date: 3/1/2022

Water-Side: Slant pump at riverbank

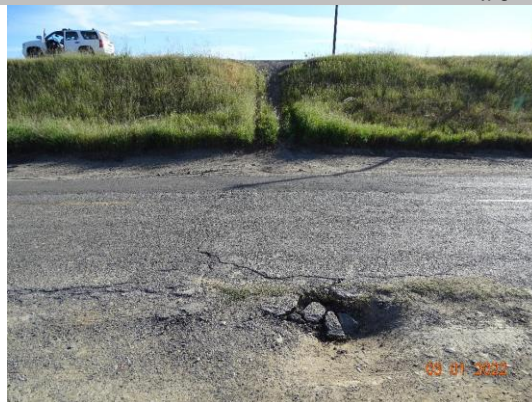
Photo 2 of 3 : UCIP_FA_2022_73418_109780.jpg

Land-Side: View of depression on levee slope and a sinkhole at road shoulder

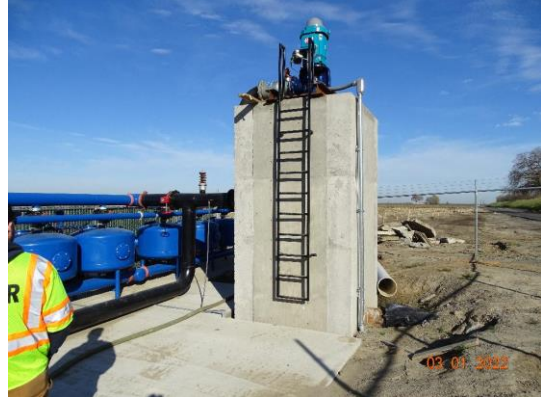
Photo 3 of 3 : UCIP_FA_2022_73418_109774.jpg

Land-Side: New concrete distribution box, pump on the top, and sand filters installed on landside

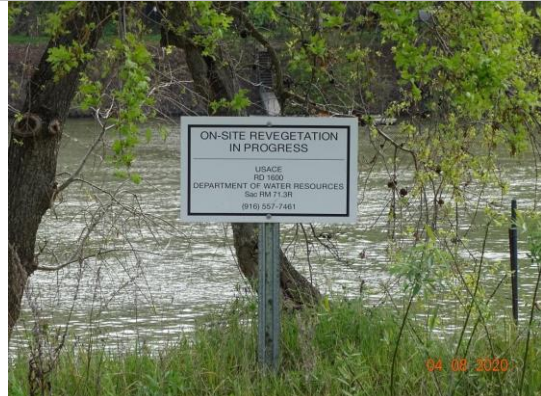
Photo 1 of 1 : FA_2022_RD1600_191_26_20220921_00014.jpg

LM Start	0.56	Rating **	A/W	Issue No.	26
LM End	0.66	Issue Type +	Ob	Location *	WS
Category	Earthen Levee			GPS Latitude/Longitude	
				Start	End
Item	Vegetation			38.682661 °	38.684099 °
				-121.634238 °	-121.634625 °
DWR ID	DWR_RD1600_01_s_2020_26				
Comment Code					
V5 : Environmental Requirements.					
Inspector Comment					
USACE, DWR, and RD 1600 revegetation site.

View of revegetation sign on the waterside berm. Spring 2020.

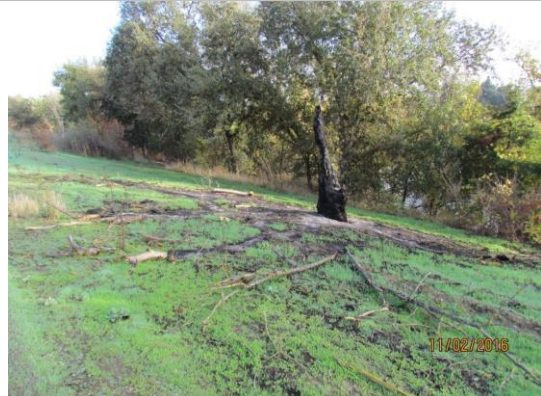
Photo 1 of 1 : FA_2022_RD1600_191_624_20220921_00033.jpg

LM Start	0.78	Rating **	N	Issue No.	624
LM End	0.78	Issue Type +	Ma	Location *	WS
Category	Earthen Levee			GPS Latitude/Longitude	
				Start	End
Item	Trim / Thin Trees			38.685713 °	38.685713 °
				-121.634985 °	-121.634985 °
DWR ID	DWR_RD1600_01_s_2017_624				
Comment Code					
T5 : Tree stumps.					
Inspector Comment					
Burnt stump on waterside slope.

View of burnt tree on waterside slope. Fall 2016.

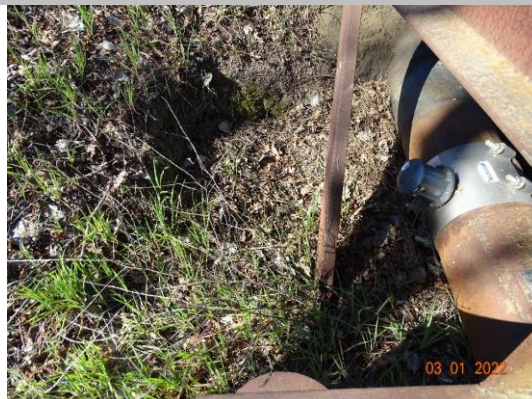
Photo 1 of 3 : UCIP_FA_2022_73427_109788.jpg

DS_ID:21463
FS_ID:73427
EP_NO: 6100
Repair Type: Urgent
EVAL Issue: 2a, Levee Integrity
Crossing Status: Found
UCIP Comments: 03/01/2022 Record updated from Non-Urgent to Urgent. Found unauthorized excavation under the pump on waterside to install flow meter. Excavation is 36 inches in diameter and 10 inches deep. Gate valve at the pump is in operable condition. (O.Yakimov - DWR UCIP)
06/18/2013 Gate valve will not open or close. (W.Wylie - DWR UCIP)
FIELD_STRUCT_DESC: 12-inch steel irrigation pipe through the levee, 3.4 feet below the crown. Slant pump and gate valve on the waterside (WS) slope. Siphon breaker in a 12-inch steel riser on the landside (LS) shoulder. Filter, booster pump, and butterfly valve on the LS toe. 2.25-inch galvanized iron electrical conduit at the same location. (Permit No. 6100, 1968 - Charles Plumb Jr., replaced 8-inch pipe at same location). [Additional Reference(s): DWR Levee Log, 1988].

Water-Side: Excavation made to install flow meter under the pump

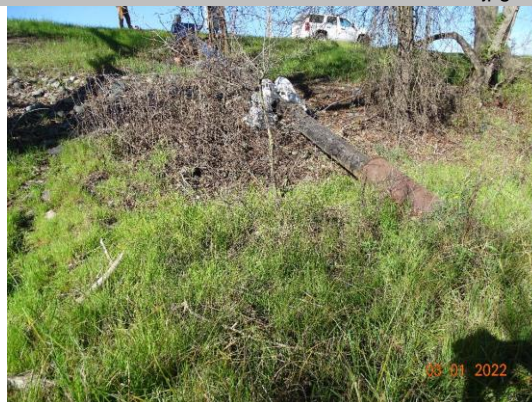
Photo 2 of 3 : UCIP_FA_2022_73427_109787.jpg

Water-Side: Overview of slant pipe on levee berm. Sand bags put on the top of pipe to lower vibration and keep pipe in place

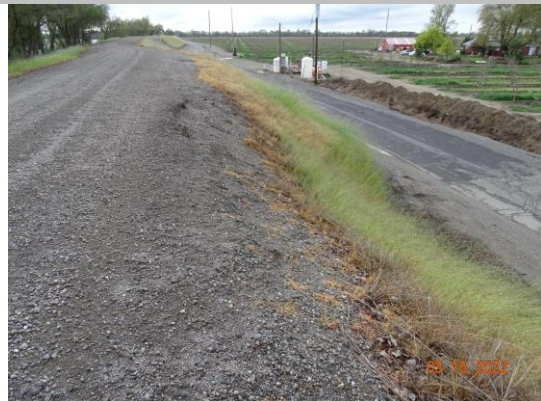
Photo 1 of 1 : FA_2022_RD1600_191_134_20220921_00032.jpg

LM Start	0.97	Rating **	M	Issue No.	134
LM End	0.97	Issue Type +	Ma	Location *	LS
Category	Earthen Levee			GPS Latitude/Longitude	
				Start	End
Item	Erosion / Rills			38.688454 °	38.688454 °
				-121.635528 °	-121.635528 °
DWR ID	DWR_RD1600_01_f _ 2021_134				
Comment Code					
E5 : Schedule repair of rills prior to the next inspection.					
Inspector Comment					
Rills forming on landside slope.

View of erosion on the landside shoulder. Spring 2022.

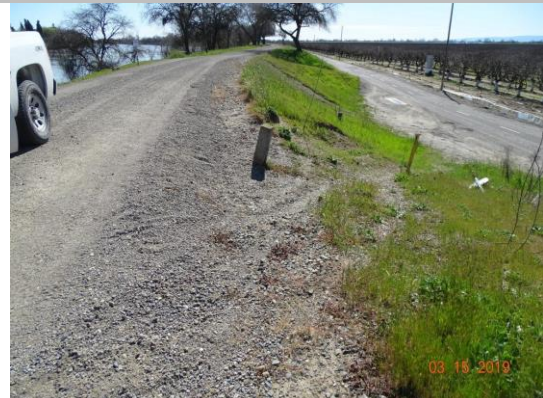
Photo 1 of 1 : FA_2022_RD1600_191_52_20220921_00025.jpg

LM Start	1.42	Rating **	A/W	Issue No.	52
LM End	1.42	Issue Type +	Ma	Location *	LS
Category	Earthen Levee			GPS Latitude/Longitude	
				Start	End
Item	Erosion / Vehicle Traffic			38.694728 °	38.694728 °
				-121.634224 °	-121.634224 °
DWR ID	DWR_RD1600_01_f_2018_52				
Comment Code					
E6 : Repair the levee slope damaged by vehicle traffic and prevent access where possible.					
Inspector Comment					
Previously a vehicle access ramp. The district has placed barriers to prevent access. Recommend monitoring for future erosion.

View of ruts on landside shoulder. Spring 2019.

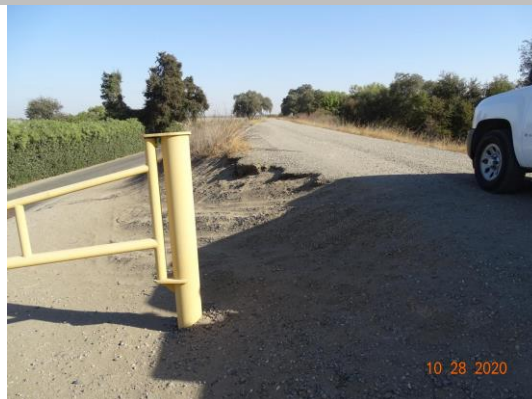
Photo 1 of 1 : FA_2022_RD1600_191_46_20220921_00020.jpg

LM Start	1.65	Rating **	M	Issue No.	46
LM End	1.65	Issue Type +	Ma	Location *	LS
Category	Earthen Levee			GPS Latitude/Longitude	
				Start	End
Item	Erosion / Rills			38.697799 °	38.697799 °
				-121.632396 °	-121.632396 °
DWR ID	DWR_RD1600_01_f_2019_46				
Comment Code					
E5 : Schedule repair of rills prior to the next inspection.					
Inspector Comment					
Erosion on landside slope near district gate.

View of erosion on the landside slope. Fall 2020.

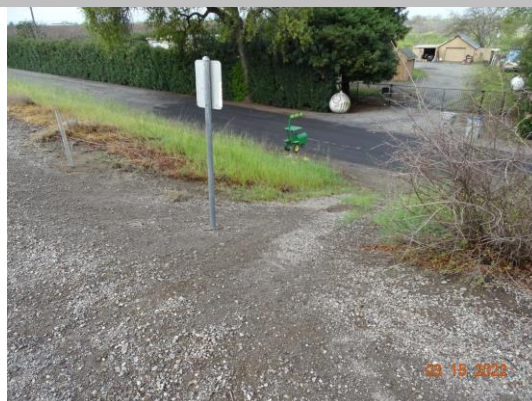
Photo 1 of 1 : FA_2022_RD1600_191_70_20220921_00028.jpg

LM Start	1.70	Rating **	A/W	Issue No.	70
LM End	1.70	Issue Type +	Ma	Location *	LS
Category	Earthen Levee			GPS Latitude/Longitude	
				Start	End
Item	Erosion / Vehicle Traffic			38.698414 °	38.698414 °
				-121.631874 °	-121.631874 °
DWR ID	DWR_RD1600_01_f_2017_70				
Comment Code					
E6 : Repair the levee slope damaged by vehicle traffic and prevent access where possible.					
Inspector Comment					
Footpath and vehicle access on landside slope. Recommend monitoring.

View of footpath on the landside slope. Spring 2022.

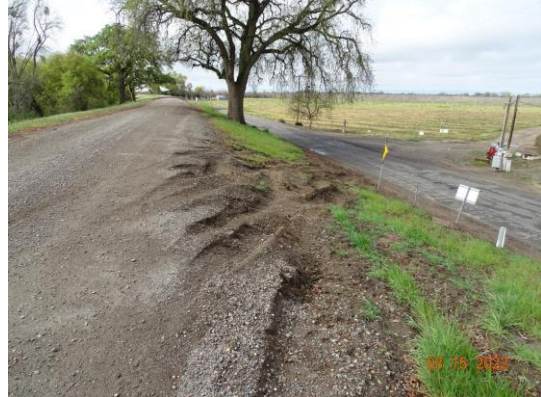
Photo 1 of 1 : FA_2022_RD1600_191_62_20220921_00026.jpg

LM Start	1.89	Rating **	M	Issue No.	62
LM End	1.89	Issue Type +	Ma	Location *	LS
Category	Earthen Levee			GPS Latitude/Longitude	
				Start	End
Item	Erosion / Vehicle Traffic			38.700579 °	38.700579 °
				-121.629585 °	-121.629585 °
DWR ID	DWR_RD1600_01_s _ 2022_62				
Comment Code					
E6 : Repair the levee slope damaged by vehicle traffic and prevent access where possible.					
Inspector Comment					
Significant vehicle traffic on the landside slope.

View of ruts on the landside slope. Spring 2022.

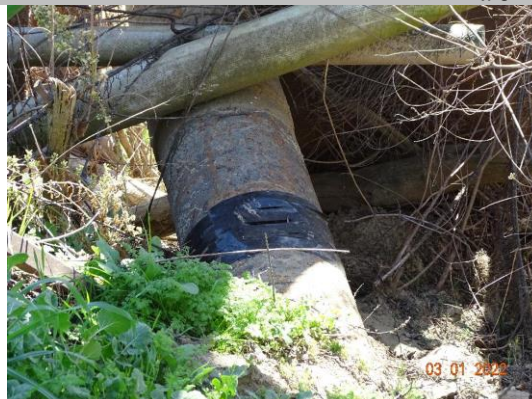
Photo 2 of 3 : UCIP_FA_2022_73455_109814.jpg

Comment Code					
Inspector Comment					
DS_ID:21466 FS_ID:73455 EP_NO: 14648 Repair Type: Non-Urgent EVAL Issue: 10, Unauthorized Modification or Non-Compliant Permit Crossing Status: Found UCIP Comments: 03/01/2022 Record updated from No Action Needed to Non-Urgent. Excavation was discovered to expose pipe section near steel standpipe on landside more that 15 feet from toe. Discharge pipe was cut open and its end was plugged with metal plate to re-route flow from steel standpipe to a booster pump and then to sand filters. Unable to find a permit for modification. Open hole on the top of pipe under the pump on waterside made for flow meter wrapped with tape. (O.Yakimov - DWR UCIP) FIELD_STRUCT_DESC: 24-inch steel irrigation pipe through the levee, 4 feet below the crown. Pump on metal platform on the waterside (WS). 8-foot-diameter steel distribution standpipe with gate valve, 45 feet from the landside (LS) toe. Diesel booster pump and sand filters on landside. (Permit No. 14648, 1987 - Layton Knaggs). [Additional Reference(s): DWR Levee Log, 1988]. FS Date: 3/1/2022 4:13:02 PM

Water-Side: Taped hole made for flow meter under the pump

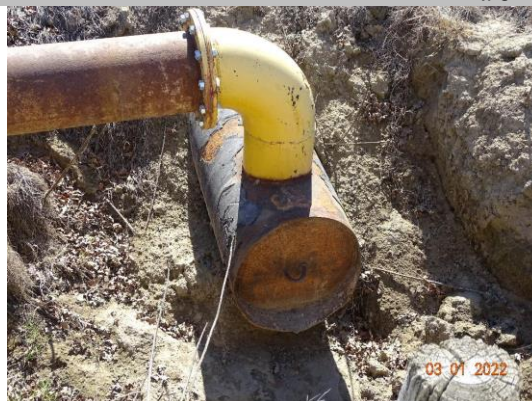
Photo 3 of 3 : UCIP_FA_2022_73455_109813.jpg

Land-Side: Excavation to expose pipe section and re-route water flow to booster pump and sand filters

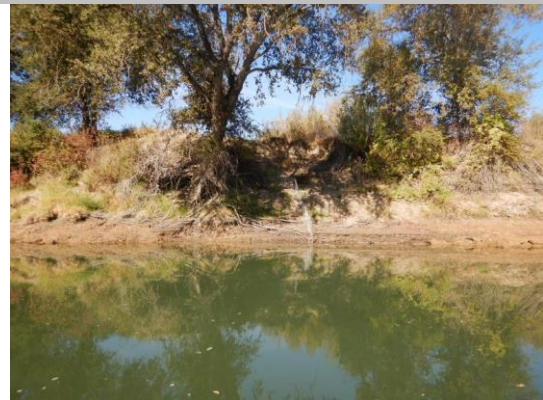
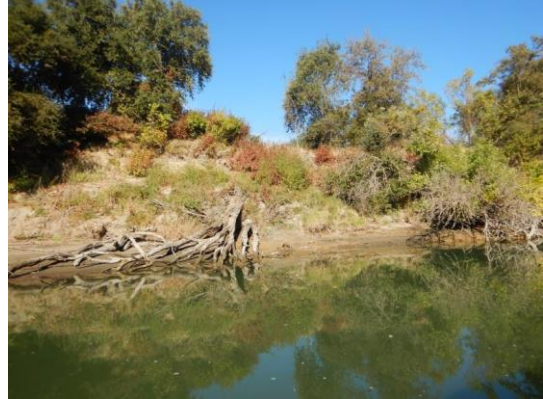
LM Start	2.99	Rating **	A/W	Issue No.	15
LM End	3.37	Issue Type +	Ma	Location *	WS
Category	Supplemental			GPS Latitude/Longitude	
				Start	End
Item	2018 USACE Erosion Survey			38.710874 °	38.715134 °
				-121.614239 °	-121.609566 °
DWR ID	DWR_RD1600_01_s_2022_15				
Comment Code					
Inspector Comment					
2018 Site ID: SAC 74.0 R					
Status: Eroding					
2018 Field Notes: Bank toe continues to erode.					
Site History: 2017 - Significant toe erosion. Erosion along entire bank.					
Tree popouts observed.

USACE 2018 Erosion Photo #1

USACE 2018 Erosion Photo #2

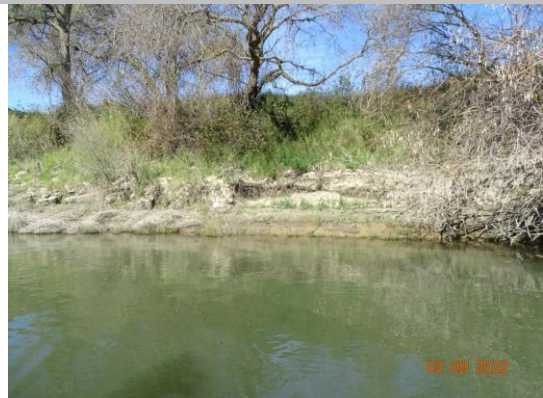
Photo 1 of 1 : FA_2022_RD1600_191_29_20220921_00015.jpg

LM Start	3.09	Rating **	M	Issue No.	29
LM End	3.09	Issue Type +	Ma	Location *	WS
Category	Earthen Levee			GPS Latitude/Longitude	
				Start	End
Item	Erosion / Bank Caving			38.712205 °	38.712205 °
				-121.613212 °	-121.613212 °
DWR ID	DWR_RD1600_01_f _ 2020_29				
Comment Code					
E2 : Schedule repair of erosion site prior to the next inspection.					
Inspector Comment					
Erosion pocket on the waterside slope. There is approximately 20' of berm before a vertical drop that cuts into the prism.

View of erosion from the water. Spring 2022.

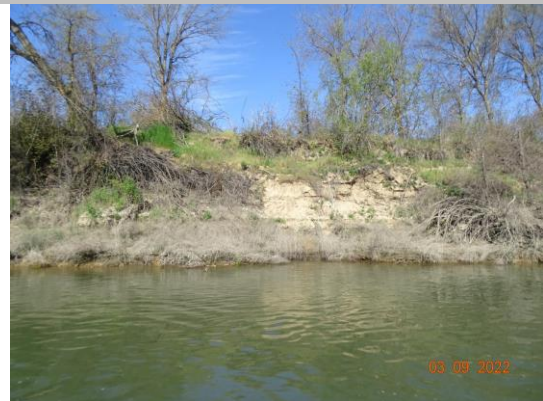
Photo 1 of 1 : FA_2022_RD1600_191_40_20220921_00017.jpg

LM Start	3.26	Rating **	M	Issue No.	40
LM End	3.26	Issue Type +	Ma	Location *	WS
Category	Earthen Levee			GPS Latitude/Longitude	
				Start	End
Item	Erosion / Bank Caving			38.713816 °	38.713816 °
				-121.610697 °	-121.610697 °
DWR ID	DWR_RD1600_01_s_2022_40				
Comment Code					
E2 : Schedule repair of erosion site prior to the next inspection.					
Inspector Comment					
Vertical erosion wall on the waterside slope.

View of erosion from the water. Spring 2022.

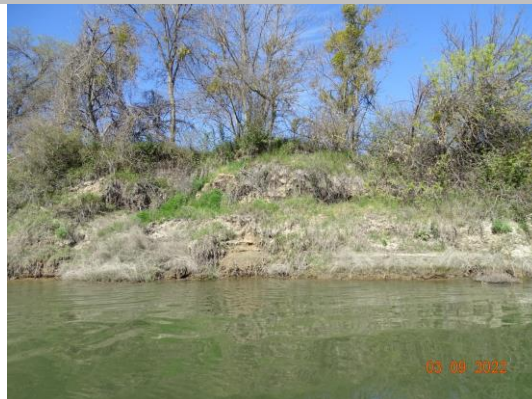
Photo 1 of 1 : FA_2022_RD1600_191_43_20220921_00018.jpg

LM Start	3.36	Rating **	M	Issue No.	43
LM End	3.36	Issue Type +	Ma	Location *	WS
Category	Earthen Levee			GPS Latitude/Longitude	
				Start	End
Item	Erosion / Bank Caving			38.714903 °	38.714903 °
				-121.609654 °	-121.609654 °
DWR ID	DWR_RD1600_01_s_2022_43				
Comment Code					
E2 : Schedule repair of erosion site prior to the next inspection.					
Inspector Comment					
Vertical erosion wall on the waterside slope.

View of erosion from the water. Spring 2022.

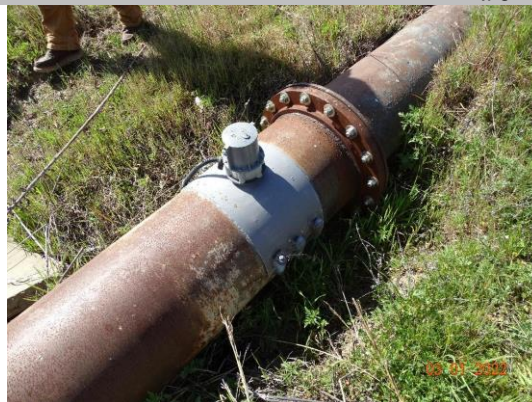
Photo 2 of 3 : UCIP_FA_2022_73513_109847.jpg

Comment Code					
Inspector Comment					
DS_ID:21468 FS_ID:73513 EP_NO: 6196 Repair Type: Urgent EVAL Issue: 2a, Levee Integrity Crossing Status: Found UCIP Comments: 03/01/2022 Record updated from No Action Needed to Urgent. Unauthorized excavation on waterside berm made to install flow meter and around pipe at the pumping platform. Electric motor removed from the pump. (O.Yakimov - DWR UCIP) FIELD_STRUCT_DESC: 18-inch steel irrigation pipe through the levee, 3 feet below the crown. Slant pump on the waterside (WS) berm. Siphon breaker in an 18-inch steel riser on the landside (LS) shoulder. 6-foot by 6-foot concrete distribution box off the LS toe. Water well on landside. [Additional Reference(s): DWR Levee Log, 1988]. FS Date: 3/1/2022 3:10:52 PM

Water-Side: Excavation around pipe on levee berm to install flow meter

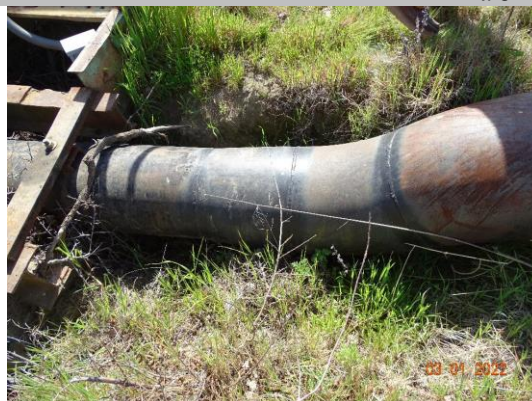
Photo 3 of 3 : UCIP_FA_2022_73513_109841.jpg

Water-Side: Excavation to install pipe at pumping platform

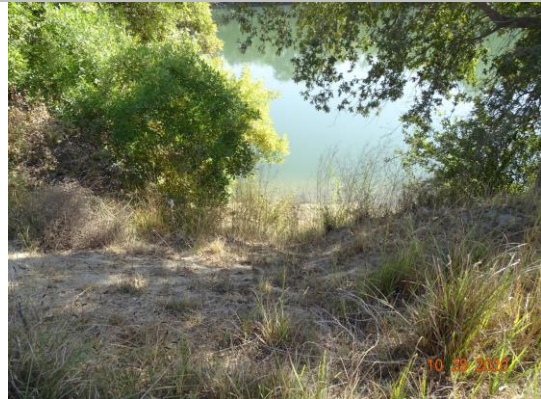
Photo 1 of 1 : FA_2022_RD1600_191_48_20220921_00022.jpg

View of erosion location on waterside berm. Fall 2020.

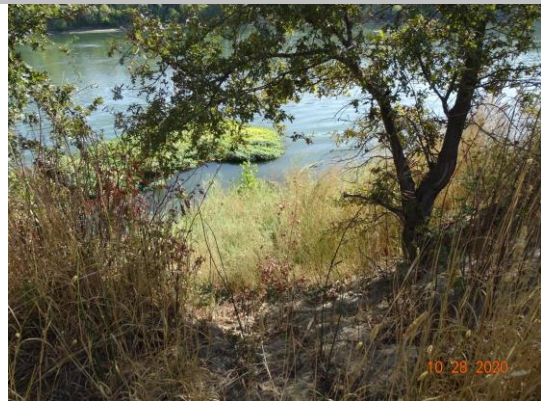
Photo 1 of 1 : FA_2022_RD1600_191_50_20220921_00024.jpg

View of erosion on the waterside slope. Fall 2020.

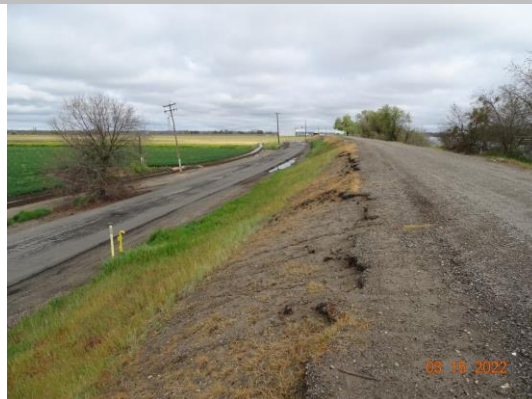
Photo 1 of 1 : FA_2022_RD1600_191_65_20220921_00027.jpg

View of erosion on the landside slope. Spring 2022.

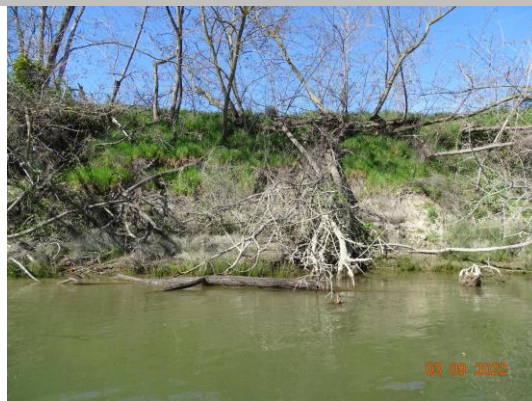
Photo 1 of 2 : FA_2022_RD1600_191_17_20220921_00008.jpg

View of erosion near downstream end. Spring 2022.

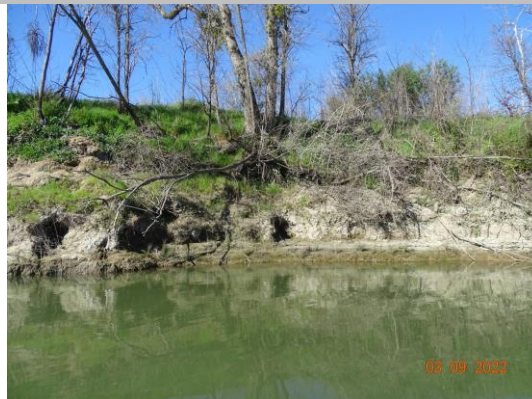
Photo 2 of 2 : FA_2022_RD1600_191_17_20220921_00009.jpg

View of erosion near upstream end. Spring 2022.

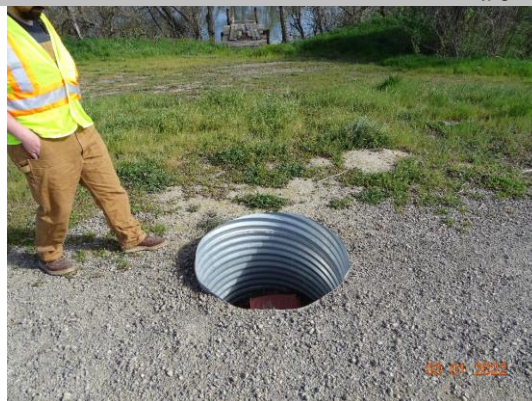
Photo 2 of 3 : UCIP_FA_2022_73530_109874.jpg

Water-Side: View of levee slope looking from crown. CMP riser missing top cover

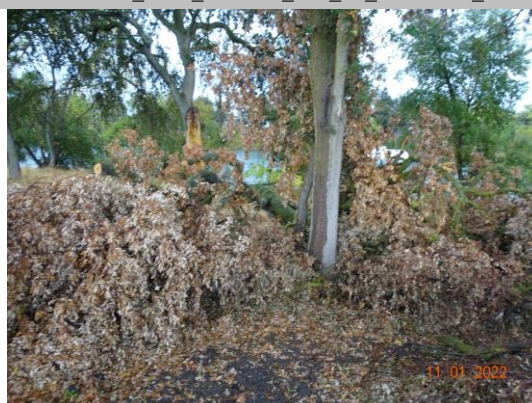
Photo 1 of 1 : FA_2022_RD1600_191_82_20221102_00040.jpg

Fallen tree limbs on the waterside slope. Fall 2022.

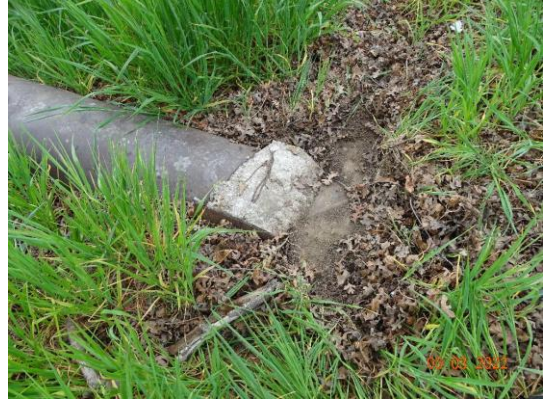
Photo 1 of 3 : UCIP_FA_2022_73560_109897.jpg

Water-Side: View of pipe at waterside shoulder. Pipe appears abandoned by concrete grouting

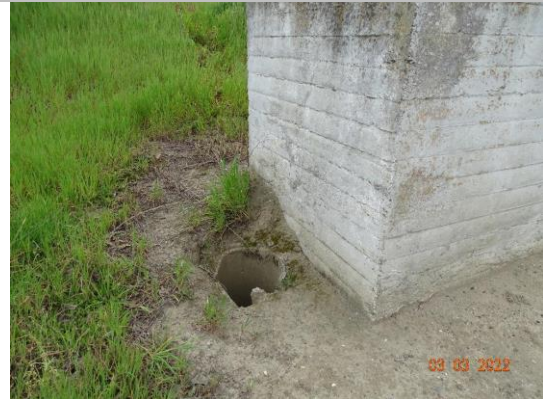
Photo 2 of 3 : UCIP_FA_2022_73560_109894.jpg

Land-Side: Broken at ground level one of two concrete standpipes at concrete distribution box

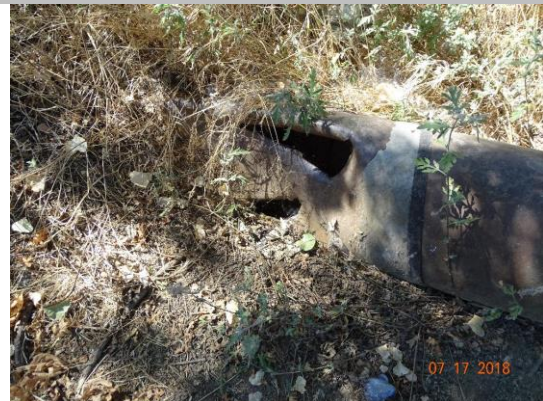
Photo 3 of 3 : UCIP_FA_2022_73560_77707.jpg

Holes in pipe on at WS toe.

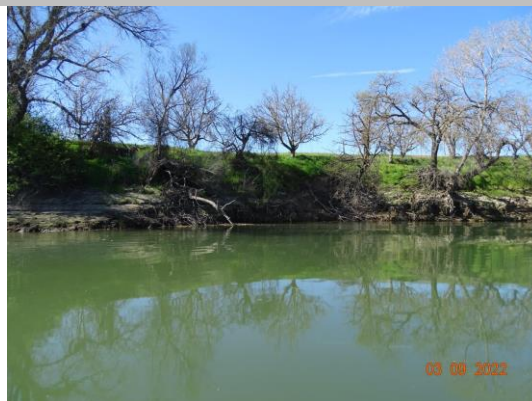
Photo 1 of 1 : FA_2022_RD1600_191_23_20220921_00013.jpg

View of erosion from the waterside. Spring 2022.

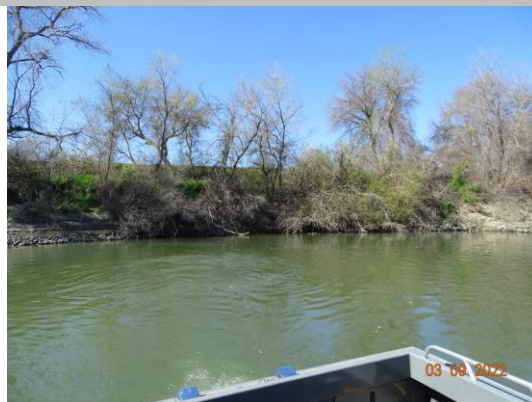
Photo 1 of 1 : FA_2022_RD1600_191_20_20220921_00010.jpg

View of erosion from the water. Spring 2022.

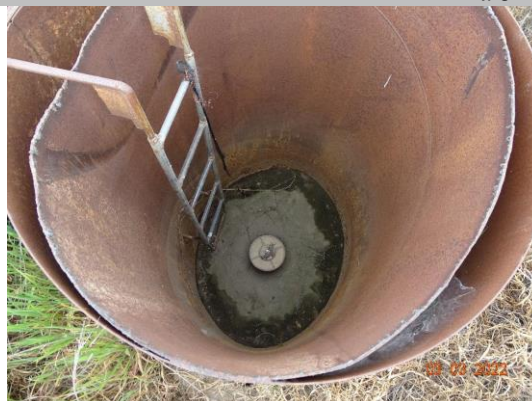
Photo 3 of 3 : UCIP_FA_2022_73694_110142.jpg

Land-Side: Siphon breaker inside steel riser. Was noted as leaking earlier

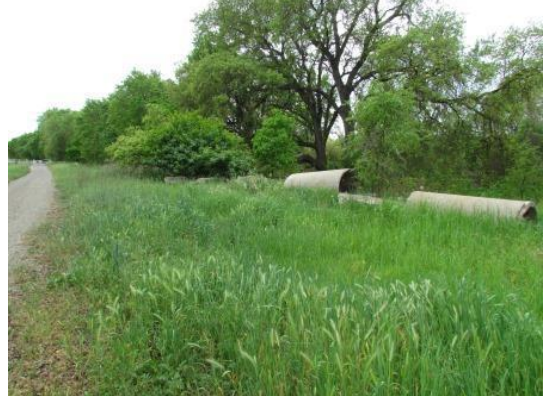
Photo 1 of 1 : FA_2022_RD1600_191_1202_20220921_00034.jpg

View of debris on the waterward side of the levee looking upstream.
Spring 2015.

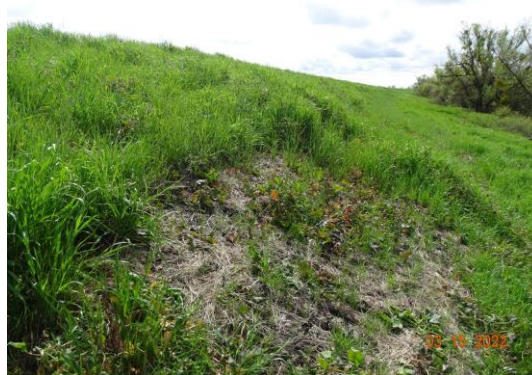
Photo 1 of 2 : FA_2022_RD1600_192_23_20220921_00002.jpg

View of wave wash damage on the waterside slope. Spring 2022.

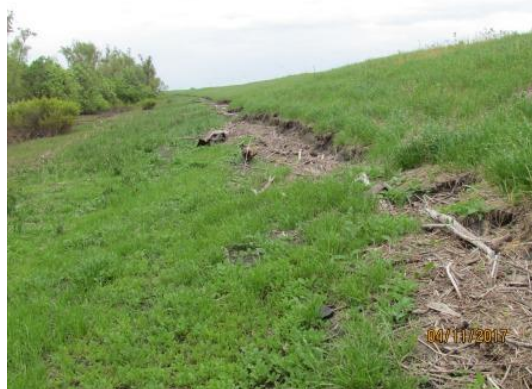
Photo 2 of 2 : FA_2022_RD1600_192_23_20220921_00003.jpg

View of wave wash damage on waterside levee slope. Spring 2017.

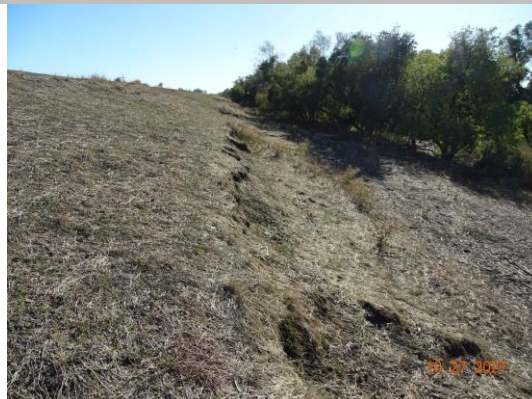
Photo 1 of 1 : FA_2022_RD1600_192_14_20220921_00001.jpg

View of wave wash on the waterside slope. Fall 2021.
