Flood Control Project Maintenance Levee Inspections

Fall 2023 Levee Maintenance Deficiency Summary Report

Reclamation District No. 1600 Mull

Levee Inspection Report By Mile - Fall 2023

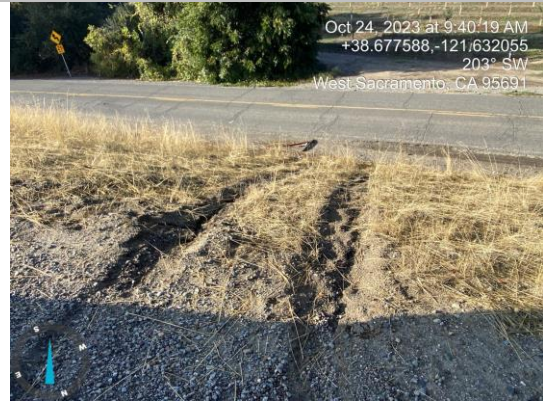
Photo 1 of 1 : FA_2023_RD1600_191_52_20231025_00067.jpg

LM Start	0.19	Rating **	M	Issue No.	52
LM End	0.19	Issue Type +	Ma	Location *	LS
Category	Earthen Levee			GPS Latitude/Longitude	
				Start	End
Item	Erosion / Vehicle Traffic			38.677589°	38.677589°
				-121.632022°	-121.632022°
DWR ID	DWR_RD1600_01_f_2023_52				
Comment Code					
E6 : Repair the levee slope damaged by vehicle traffic and prevent access where possible.					
Inspector Comment

View of tire ruts on the landside slope (Fall 2023).

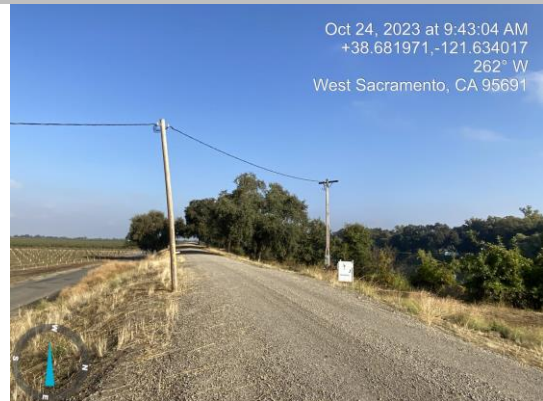
Photo 1 of 1 : FA_2023_RD1600_191_44_20231025_00068.jpg

LM Start	0.52	Rating **	M	Issue No.	44
LM End	0.52	Issue Type +	En	Location *	CR
Category	Earthen Levee			GPS Latitude/Longitude	
				Start	End
Item	Encroachments			38.682046°	38.682046°
				-121.634064°	-121.634064°
DWR ID	DWR_RD1600_01_s_2020_44				
Comment Code					
PO : Pole					
Inspector Comment					
There are telephone poles over the levee crown.

View of telephone line over levee crown (Fall 2023).

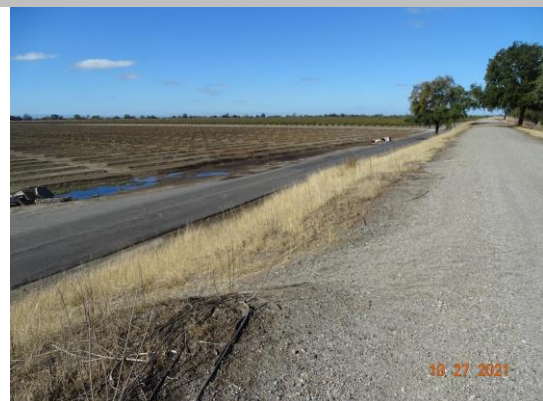
Photo 1 of 1 : FA_2023_RD1600_191_133_20231024_00041.jpg

LM Start	0.53	Rating **	M	Issue No.	133
LM End	0.53	Issue Type +	Ma	Location *	LS
Category	Earthen Levee			GPS Latitude/Longitude	
				Start	End
Item	Erosion / Foot Traffic			38.682140°	38.682140°
				-121.634083°	-121.634083°
DWR ID	DWR_RD1600_01_f_2013_133				
Comment Code					
E3 : Repair the levee slope damaged by foot traffic and prevent access where possible.					
Inspector Comment					
There appears to be a footpath and settlement on landside slope over pipe crossing.

View of settlement and footpath on landside slope. Fall 2021.

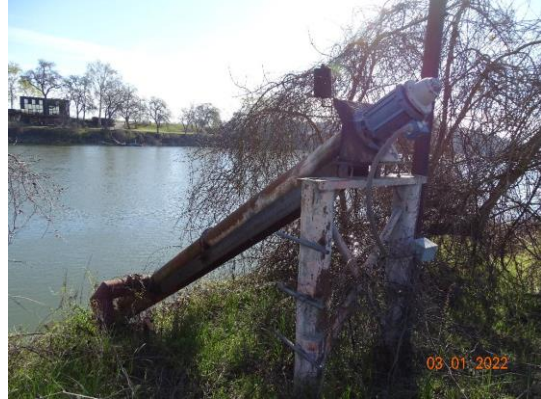
Photo 1 of 3 : UCIP_FA_2023_73418_109776.jpg

Comment Code					
Inspector Comment					
DS_ID:21460 FS_ID:73418 EP_NO: N/A Repair Type: Non-Urgent EVAL Issue: 6, Levee Damage or Threat for Levee Damage Crossing Status: Found UCIP Comments: 03/01/2022 Record updated from No Action Needed to Non-Urgent. Sinkhole measured 24-inch in diameter and 6-inch in depth located at the shoulder of CO RD 117. Depression on landside slope. New concrete distribution box constructed on landside. Vertical pump on the top of it, and sand filters in the field are installed. Old concrete distribution box debris found on road shoulder. No permit has been identified authorizing pipe. (O.Yakimov - DWR UCIP) FIELD_STRUCT_DESC: 14-inch steel irrigation pipe through the levee 15.2 feet below the crown. Slant pump and gate valve on the waterside (WS) slope. Service pole with electrical panel on WS shoulder, overhead power line. Concrete distribution box off the landside (LS) toe. Vertical pump over the concrete distribution box, sand filters on LS. [Additional Reference(s): DWR Levee Log, 1988. USACE Sacramento O&M Manual 123, August 1955, (RM 71.0) (14-inch pipe listed)]. FS Date: 3/1/2022

Water-Side: Slant pump at riverbank

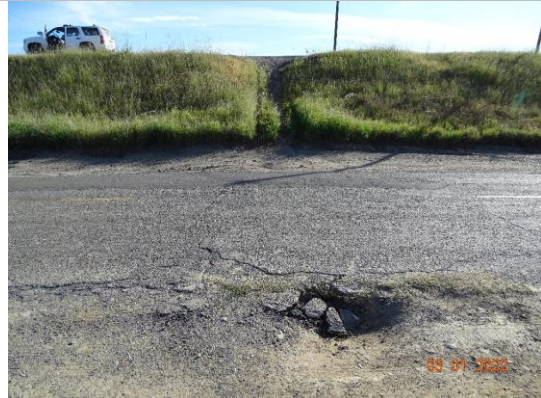
Photo 2 of 3 : UCIP_FA_2023_73418_109780.jpg

Land-Side: View of depression on levee slope and a sinkhole at road shoulder

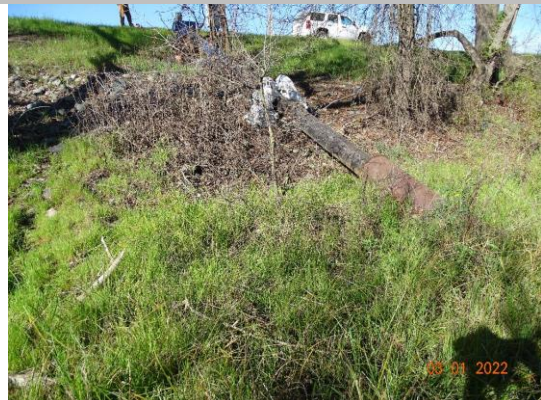
Photo 2 of 3 : UCIP_FA_2023_73427_109787.jpg

Comment Code						
Inspector Comment						
DS_ID:21463 FS_ID:73427 EP_NO: 6100 Repair Type: Urgent EVAL Issue: 2a, Levee Integrity Crossing Status: Found UCIP Comments: 03/01/2022 Record updated from Non-Urgent to Urgent. Found unauthorized excavation under the pump on waterside to install flow meter. Excavation is 36 inches in diameter and 10 inches deep. Gate valve at the pump is in operable condition. (O.Yakimov - DWR UCIP) 06/18/2013 Gate valve will not open or close. (W.Wylie - DWR UCIP) FIELD_STRUCT_DESC: 12-inch steel irrigation pipe through the levee, 3.4 feet below the crown. Slant pump and gate valve on the waterside (WS) slope. Siphon breaker in a 12-inch steel riser on the landside (LS) shoulder. Filter, booster pump, and butterfly valve on the LS toe. 2.25-inch galvanized iron electrical conduit at the same location. (Permit No. 6100, 1968 - Charles Plumb Jr., replaced 8-inch pipe at same location). [Additional Reference(s): DWR Levee Log, 1988]. FS Date: 3/1/2022 2:36:45 PM

Water-Side: Overview of slant pipe on levee berm. Sand bags put on the top of pipe to lower vibration and keep pipe in place

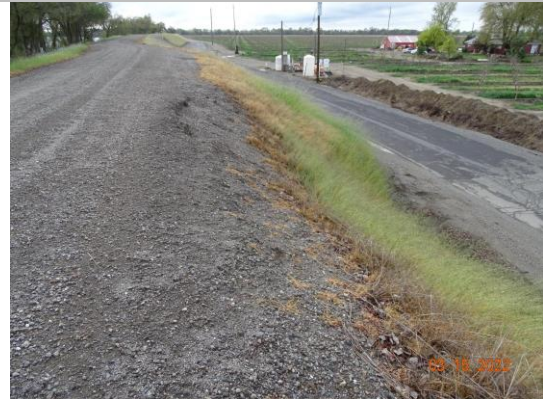
Photo 1 of 1 : FA_2023_RD1600_191_134_20231024_00042.jpg

LM Start	0.97	Rating **	M	Issue No.	134
LM End	0.97	Issue Type +	Ma	Location *	LS
Category	Earthen Levee			GPS Latitude/Longitude	
				Start	End
Item	Erosion / Rills			38.688454°	38.688454°
				-121.635528°	-121.635528°
DWR ID	DWR_RD1600_01_f_2021_134				
Comment Code					
E5 : Schedule repair of rills prior to the next inspection.					
Inspector Comment					
Rills are forming on the landside slope.

View of erosion on the landside shoulder. Spring 2022.

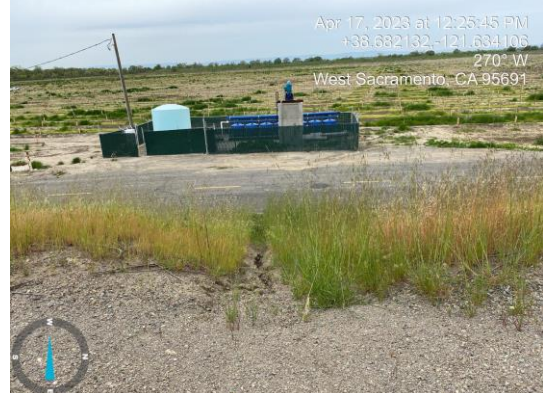
Photo 1 of 1 : FA_2023_RD1600_191_12_20231024_00002.jpg

LM Start	1.38	Rating **	M	Issue No.	12
LM End	1.42	Issue Type +	Ma	Location *	LS
Category	Earthen Levee			GPS Latitude/Longitude	
				Start	End
Item	Erosion / Rills			38.694317°	38.694741°
				-121.634404°	-121.634240°
DWR ID	DWR_RD1600_01_s_ 2023_12				
Comment Code					
E5 : Schedule repair of rills prior to the next inspection.					
Inspector Comment

View of rills along the landside levee slope (Spring 2023).

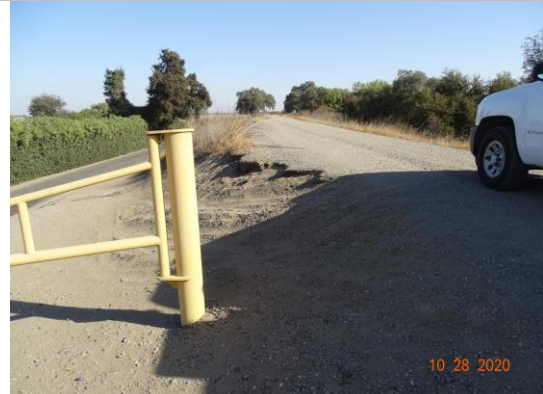
Photo 1 of 1 : FA_2023_RD1600_191_46_20231024_00025.jpg

LM Start	1.65	Rating **	M	Issue No.	46
LM End	1.65	Issue Type +	Ma	Location *	LS
Category	Earthen Levee			GPS Latitude/Longitude	
				Start	End
Item	Erosion / Rills			38.697799°	38.697799°
				-121.632396°	-121.632396°
DWR ID	DWR_RD1600_01_f_ 2019_46				
Comment Code					
E5 : Schedule repair of rills prior to the next inspection.					
Inspector Comment					
Erosion on landside slope near district gate.

View of erosion on the landside slope. Fall 2020.

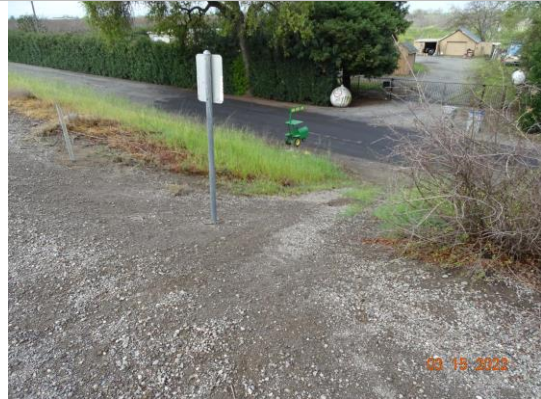
Photo 1 of 1 : FA_2023_RD1600_191_70_20231024_00039.jpg

LM Start	1.70	Rating **	A/W	Issue No.	70
LM End	1.70	Issue Type +	Ma	Location *	LS
Category	Earthen Levee			GPS Latitude/Longitude	
				Start	End
Item	Erosion / Vehicle Traffic			38.698414°	38.698414°
				-121.631874°	-121.631874°
DWR ID	DWR_RD1600_01_f_2017_70				
Comment Code					
E6 : Repair the levee slope damaged by vehicle traffic and prevent access where possible.					
Inspector Comment					
Footpath and vehicle access on landside slope. Recommend monitoring.

View of footpath on the landside slope. Spring 2022.

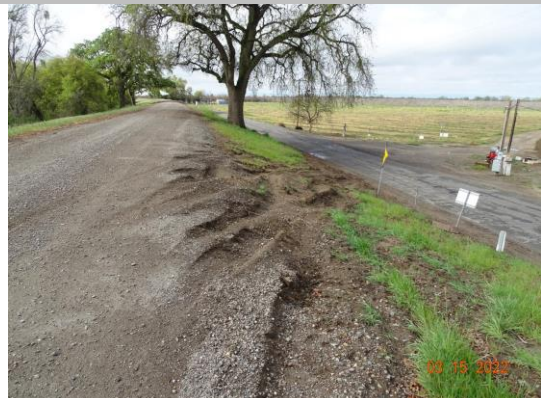
Photo 1 of 1 : FA_2023_RD1600_191_62_20231024_00037.jpg

LM Start	1.89	Rating **	M	Issue No.	62
LM End	1.89	Issue Type +	Ma	Location *	LS
Category	Earthen Levee			GPS Latitude/Longitude	
				Start	End
Item	Erosion / Vehicle Traffic			38.700579°	38.700579°
				-121.629585°	-121.629585°
DWR ID	DWR_RD1600_01_s_2022_62				
Comment Code					
E6 : Repair the levee slope damaged by vehicle traffic and prevent access where possible.					
Inspector Comment					
There is significant vehicle traffic on the landside slope.

View of ruts on the landside slope. Spring 2022.

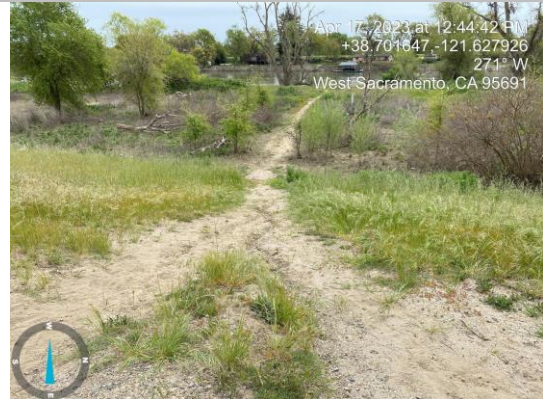
Photo 1 of 1 : FA_2023_RD1600_191_14_20231024_00003.jpg

LM Start	2.01	Rating **	A/W	Issue No.	14
LM End	2.01	Issue Type +	Ma	Location *	WS
Category	Earthen Levee			GPS Latitude/Longitude	
				Start	End
Item	Erosion / Foot Traffic			38.701633°	38.701633°
				-121.627945°	-121.627945°
DWR ID	DWR_RD1600_01_s_2023_14				
Comment Code					
E3 : Repair the levee slope damaged by foot traffic and prevent access where possible.					
Inspector Comment					
There is a foot path on the waterside slope. Recommend monitoring for now.

View of foot path that has eroded the waterside levee slope (Spring 2023).

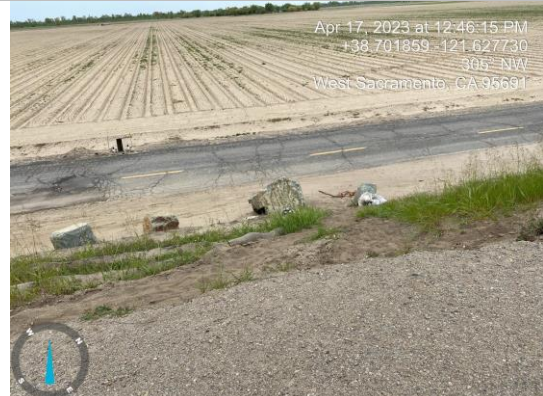
Photo 1 of 1 : FA_2023_RD1600_191_24_20231024_00015.jpg

LM Start	2.02	Rating **	M	Issue No.	24
LM End	2.02	Issue Type +	Ma	Location *	LS
Category	Earthen Levee			GPS Latitude/Longitude	
				Start	End
Item	Erosion / Foot Traffic			38.701724°	38.701724°
				-121.627778°	-121.627778°
DWR ID	DWR_RD1600_01_s_2023_24				
Comment Code					
E3 : Repair the levee slope damaged by foot traffic and prevent access where possible.					
Inspector Comment

View of foot path that has eroded the landside levee slope (Spring 2023).

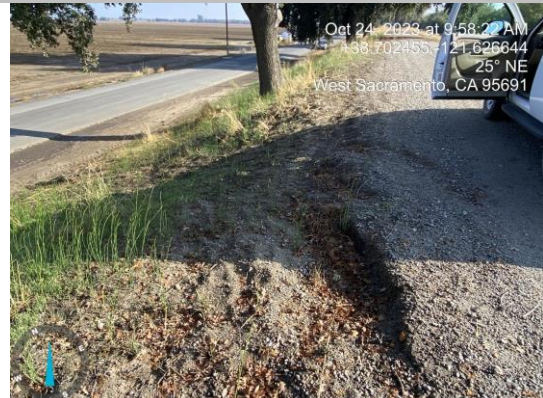
Photo 1 of 1 : FA_2023_RD1600_191_66_20231025_00069.jpg

LM Start	2.10	Rating **	M	Issue No.	66
LM End	2.10	Issue Type +	Ma	Location *	LS
Category	Earthen Levee			GPS Latitude/Longitude	
				Start	End
Item	Slope Stability			38.702417°	38.702417°
				-121.626588°	-121.626588°
DWR ID	DWR_RD1600_01_f_2023_66				
Comment Code					
S1 : Repair slope instability.					
Inspector Comment					
Slope instability may be caused by sheep grazing. Recommend caution with future use.

View of slope instability on the landside slope (Fall 2023).

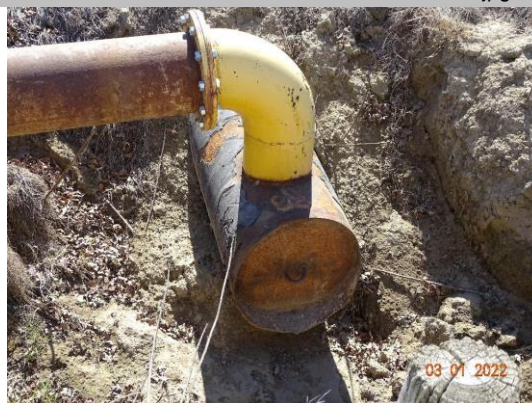
Photo 3 of 3 : UCIP_FA_2023_73455_109813.jpg

Comment Code					
Inspector Comment					
DS_ID:21466 FS_ID:73455 EP_NO: 14648 Repair Type: Non-Urgent EVAL Issue: 10, Unauthorized Modification or Non-Compliant Permit Crossing Status: Found UCIP Comments: 03/01/2022 Record updated from No Action Needed to Non-Urgent. Excavation was discovered to expose pipe section near steel standpipe on landside more that 15 feet from toe. Discharge pipe was cut open and its end was plugged with metal plate to re-route flow from steel standpipe to a booster pump and then to sand filters. Unable to find a permit for modification. Open hole on the top of pipe under the pump on waterside made for flow meter wrapped with tape. (O.Yakimov - DWR UCIP) FIELD_STRUCT_DESC: 24-inch steel irrigation pipe through the levee, 4 feet below the crown. Pump on metal platform on the waterside (WS). 8-foot-diameter steel distribution standpipe with gate valve, 45 feet from the landside (LS) toe. Diesel booster pump and sand filters on landside. (Permit No. 14648, 1987 - Layton Knaggs). [Additional Reference(s): DWR Levee Log, 1988]. FS Date: 3/1/2022 4:13:02 PM

Land-Side: Excavation to expose pipe section and re-route water flow to booster pump and sand filters

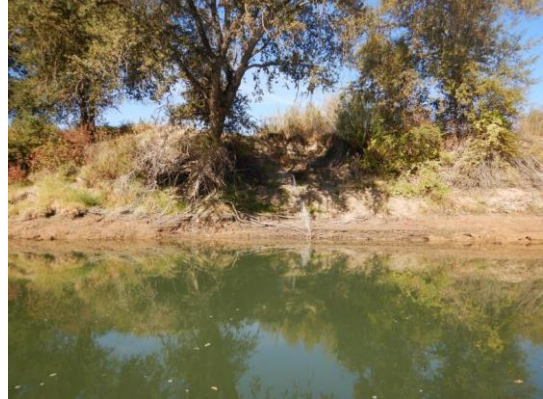
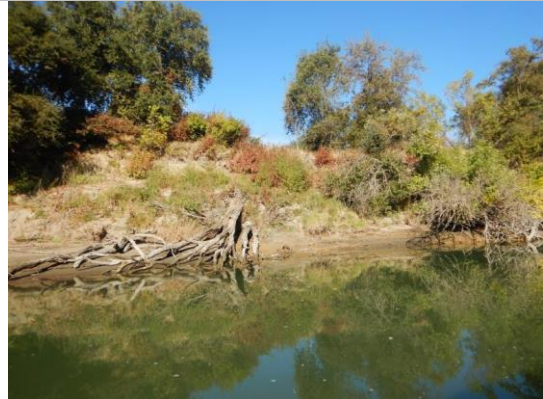
LM Start	2.99	Rating **	A/W	Issue No.	15
LM End	3.37	Issue Type +	Ma	Location *	WS
Category	Supplemental			GPS Latitude/Longitude	
				Start	End
Item	2018 USACE Erosion Survey			38.710874°	38.715134°
				-121.614239°	-121.609566°
DWR ID	DWR_RD1600_01_s_2022_15				
Comment Code					
Inspector Comment					
2018 Site ID: SAC 74.0 R					
Status: Eroding					
2018 Field Notes: Bank toe continues to erode.					
Site History: 2017 - Significant toe erosion. Erosion along entire bank.					
Tree popouts observed.

USACE 2018 Erosion Photo #1

USACE 2018 Erosion Photo #2

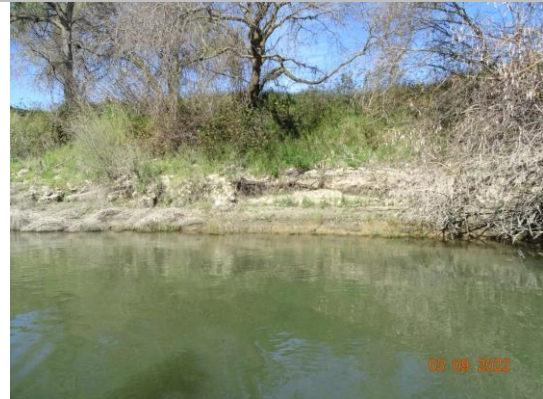
Photo 1 of 1 : FA_2023_RD1600_191_29_20231024_00020.jpg

LM Start	3.09	Rating **	M	Issue No.	29
LM End	3.09	Issue Type +	Ma	Location *	WS
Category	Earthen Levee			GPS Latitude/Longitude	
				Start	End
Item	Erosion / Bank Caving			38.712205°	38.712205°
				-121.613212°	-121.613212°
DWR ID	DWR_RD1600_01_f _ 2020_29				
Comment Code					
E2 : Schedule repair of erosion site prior to the next inspection.					
Inspector Comment					
There is an erosion pocket on the waterside slope. There is approximately 20' of berm before a vertical drop that cuts into the prism.

View of erosion from the water. Spring 2022.

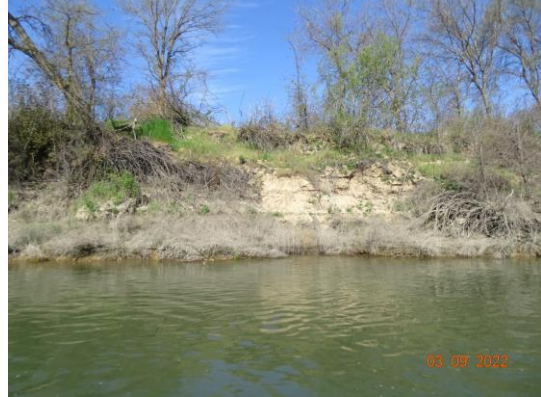
Photo 1 of 1 : FA_2023_RD1600_191_40_20231024_00022.jpg

LM Start	3.26	Rating **	M	Issue No.	40
LM End	3.26	Issue Type +	Ma	Location *	WS
Category	Earthen Levee			GPS Latitude/Longitude	
				Start	End
Item	Erosion / Bank Caving			38.713816°	38.713816°
				-121.610697°	-121.610697°
DWR ID	DWR_RD1600_01_s_2022_40				
Comment Code					
E2 : Schedule repair of erosion site prior to the next inspection.					
Inspector Comment					
Vertical erosion wall on the waterside slope.

View of erosion from the water. Spring 2022.

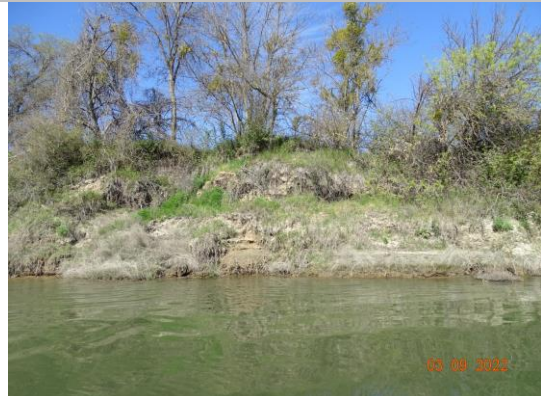
Photo 1 of 1 : FA_2023_RD1600_191_43_20231024_00023.jpg

View of erosion from the water. Spring 2022.

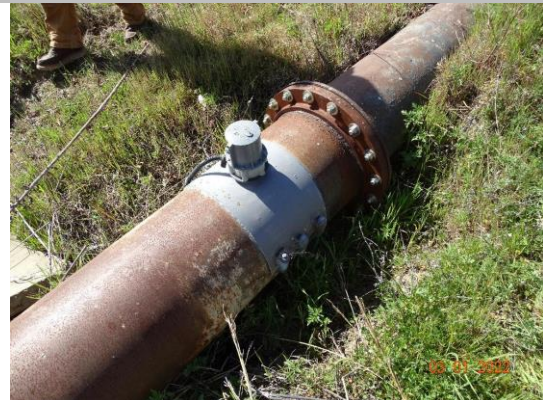
Photo 2 of 3 : UCIP_FA_2023_73513_109847.jpg

Water-Side: Excavation around pipe on levee berm to install flow meter

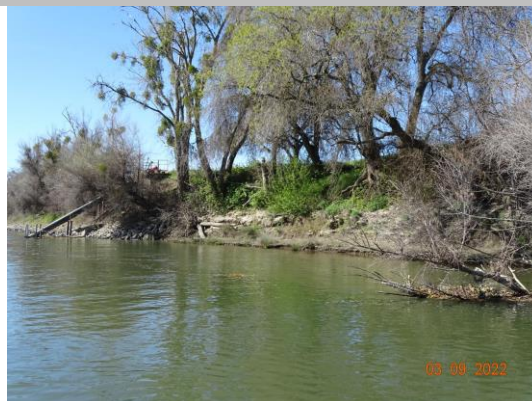
Photo 1 of 3 : FA_2023_RD1600_191_16_20231024_00006.jpg

View of beginning of erosion from downstream end. Spring 2022.

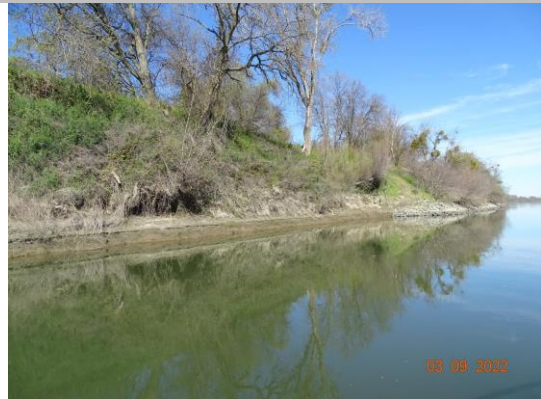
Photo 3 of 3 : FA_2023_RD1600_191_16_20231024_00008.jpg

View of end of erosion at the upstream end. Spring 2022.

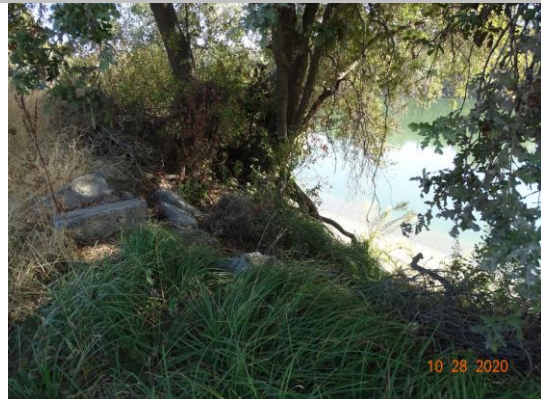
Photo 1 of 1 : FA_2023_RD1600_191_47_20231024_00026.jpg

View of erosion location on waterside berm. Fall 2020.

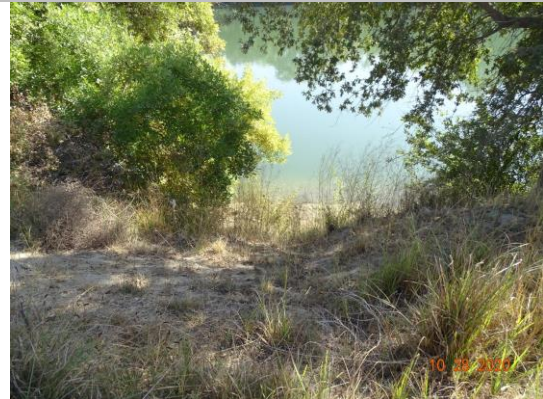
Photo 1 of 1 : FA_2023_RD1600_191_48_20231024_00027.jpg

View of erosion location on waterside berm. Fall 2020.

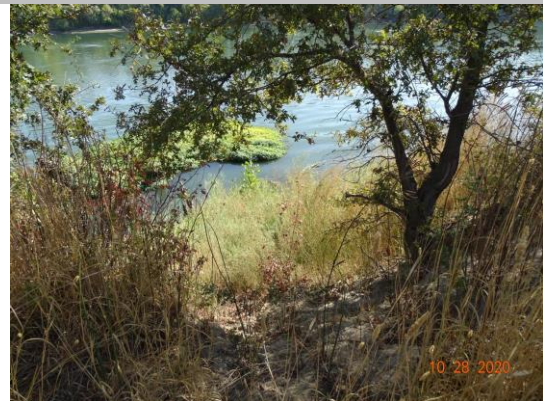
Photo 1 of 1 : FA_2023_RD1600_191_50_20231024_00029.jpg

View of erosion on the waterside slope. Fall 2020.

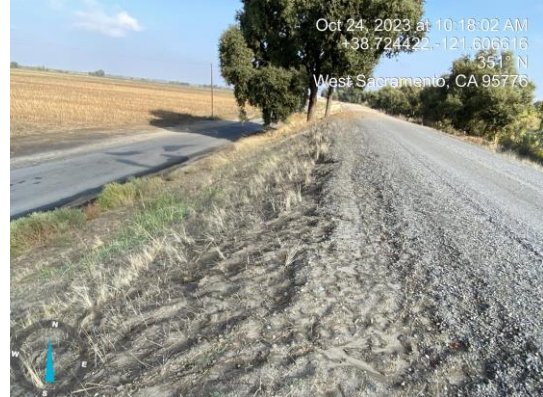
Photo 1 of 1 : FA_2023_RD1600_191_67_20231025_00070.jpg

View of erosion/rills on landside slope (Fall 2023).

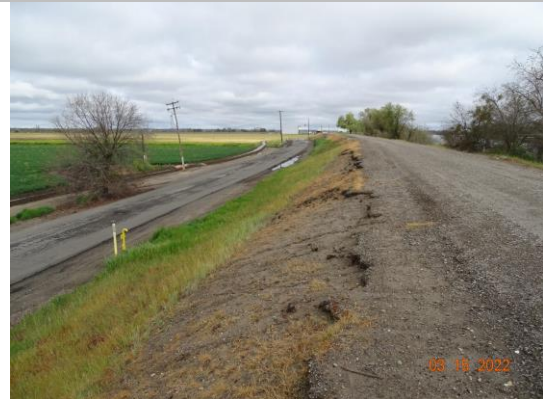
Photo 1 of 1 : FA_2023_RD1600_191_65_20231024_00038.jpg

View of erosion on the landside slope. Spring 2022.

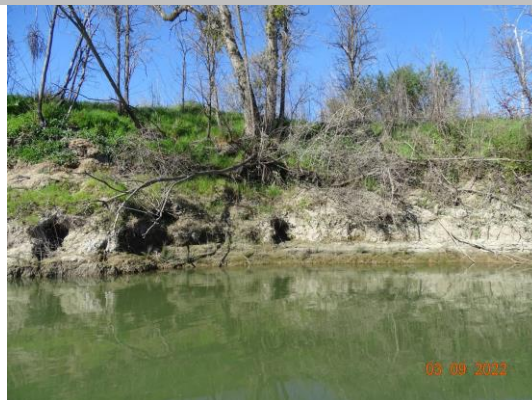
Photo 2 of 2 : FA_2023_RD1600_191_17_20231024_00010.jpg

View of erosion near upstream end. Spring 2022.

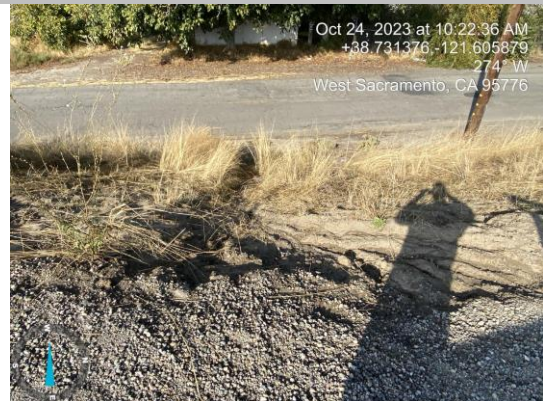
Photo 1 of 1 : FA_2023_RD1600_191_69_20231025_00071.jpg

View of erosion along a foot path on the landside slope (Fall 2023).

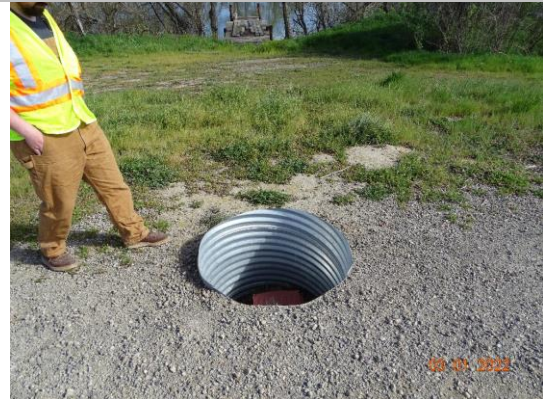
Photo 2 of 3 : UCIP_FA_2023_73530_109874.jpg

Water-Side: View of levee slope looking from crown. CMP riser missing top cover

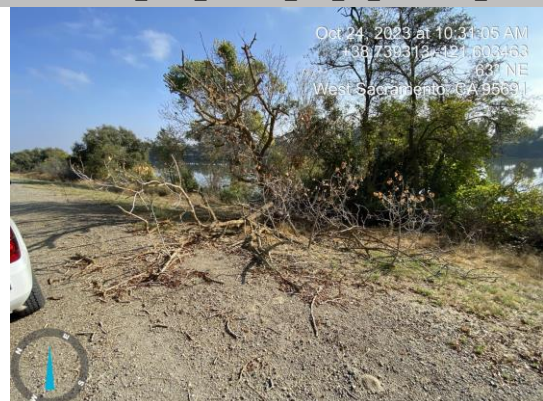
Photo 1 of 1 : FA_2023_RD1600_191_71_20231025_00072.jpg

View of fallen tree on the waterside slope (Fall 2023).

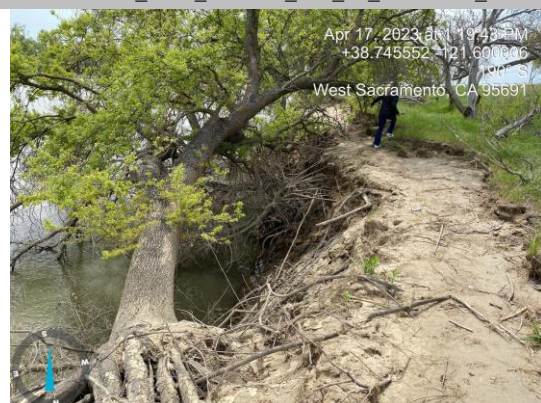
Photo 1 of 1 : FA_2023_RD1600_191_28_20231024_00019.jpg

View of erosion on waterside berm (Spring 2023).

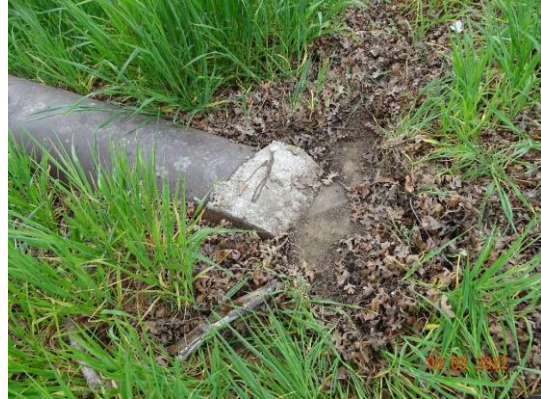
Photo 1 of 3 : UCIP_FA_2023_73560_109897.jpg

Water-Side: View of pipe at waterside shoulder. Pipe appears abandoned by concrete grouting

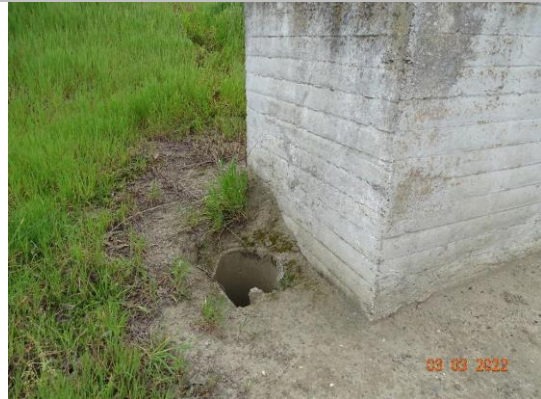
Photo 2 of 3 : UCIP_FA_2023_73560_109894.jpg

Land-Side: Broken at ground level one of two concrete standpipes at concrete distribution box

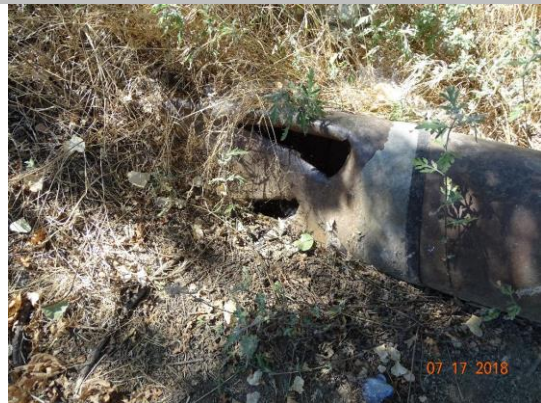
Photo 3 of 3 : UCIP_FA_2023_73560_77707.jpg

Holes in pipe on at WS toe.

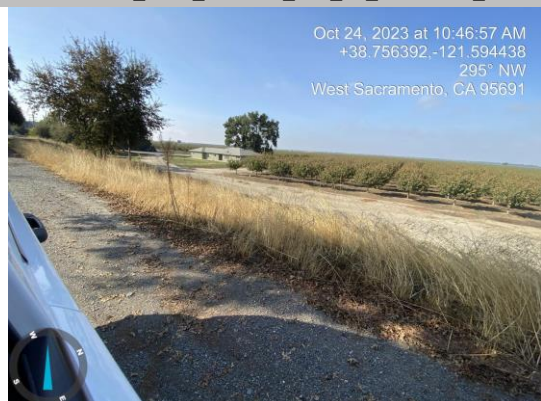
Photo 1 of 1 : FA_2023_RD1600_191_74_20231025_00074.jpg

View of vegetation on the landside slope (Fall 2023).

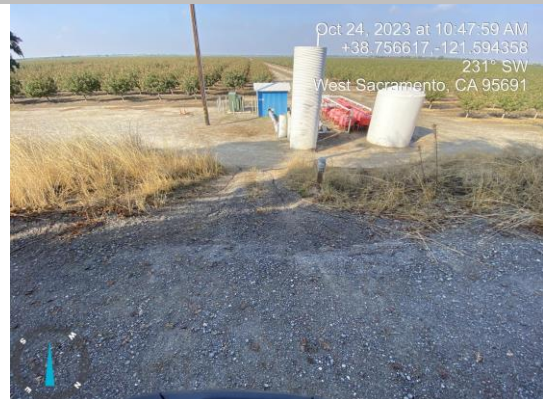
Photo 1 of 1 : FA_2023_RD1600_191_75_20231025_00075.jpg

View of vehicle ruts on the landside slope (Fall 2023).

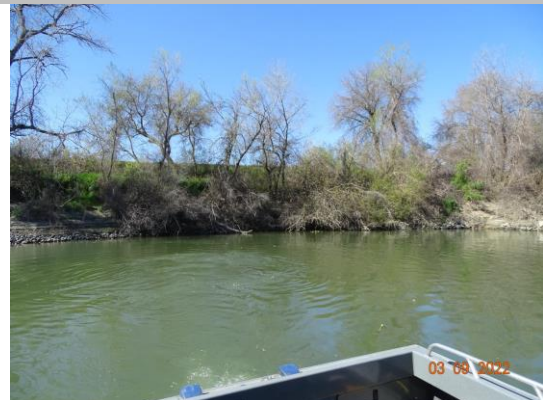
Photo 1 of 1 : FA_2023_RD1600_191_20_20231024_00011.jpg

View of erosion from the water. Spring 2022.

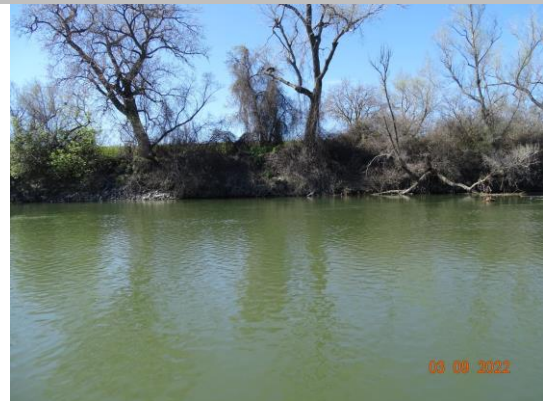
Photo 1 of 1 : FA_2023_RD1600_191_21_20231024_00012.jpg

View of erosion from the water. Spring 2022.

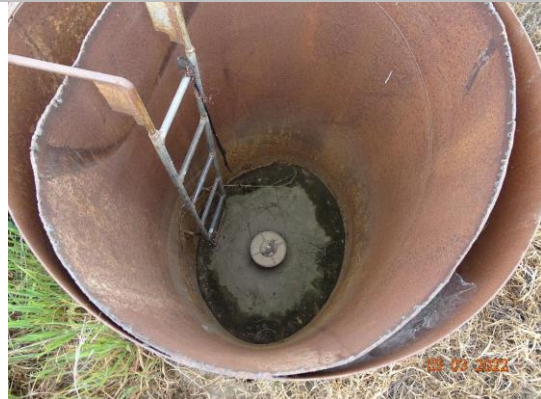
Photo 3 of 3 : UCIP_FA_2023_73694_110142.jpg

Land-Side: Siphon breaker inside steel riser. Was noted as leaking earlier

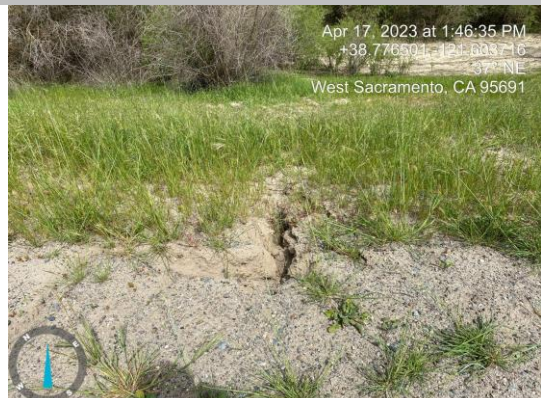
Photo 1 of 1 : FA_2023_RD1600_191_56_20231024_00032.jpg

View of rills on waterside levee slope near the shoulder (Spring 2023).

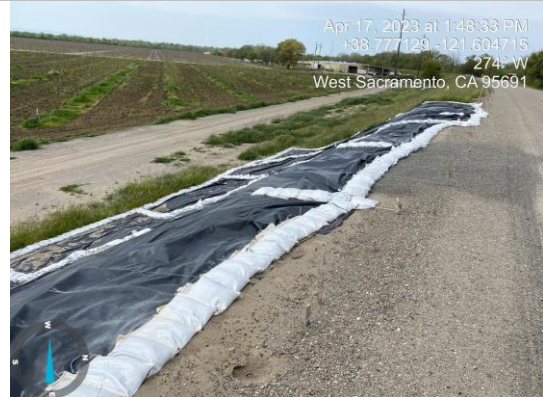
Photo 1 of 1 : FA_2023_RD1600_191_57_20231024_00033.jpg

View of landside erosion with raincoat placed over the site (Spring 2023).

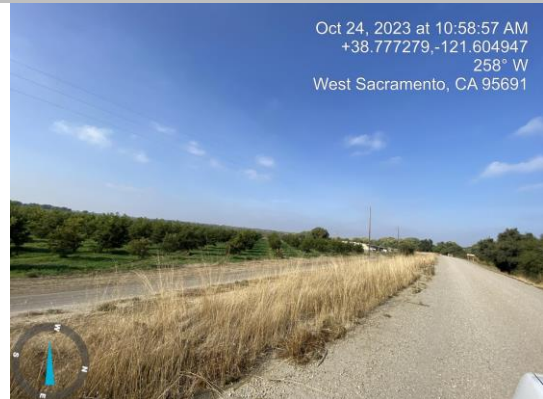
Photo 1 of 1 : FA_2023_RD1600_191_76_20231025_00076.jpg

View of vegetation on the landside slope (Fall 2023).

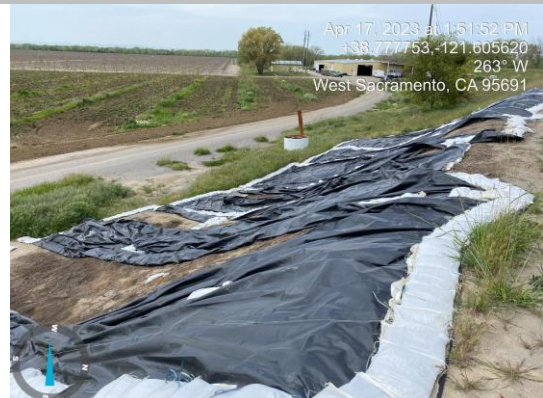
Photo 1 of 1 : FA_2023_RD1600_191_55_20231024_00031.jpg

View of landside erosion with raincoat placed over the site (Spring 2023).

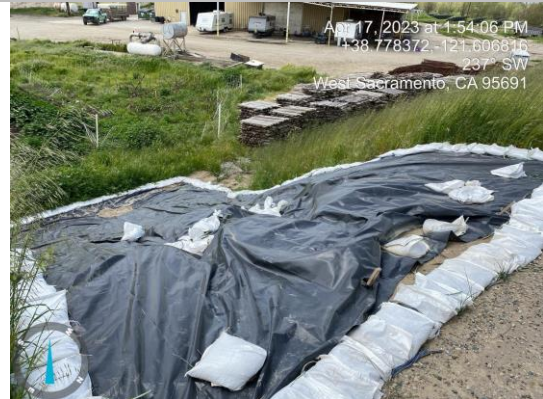
Photo 1 of 1 : FA_2023_RD1600_191_58_20231024_00034.jpg

View of landside erosion with raincoat placed over the site (Spring 2023).

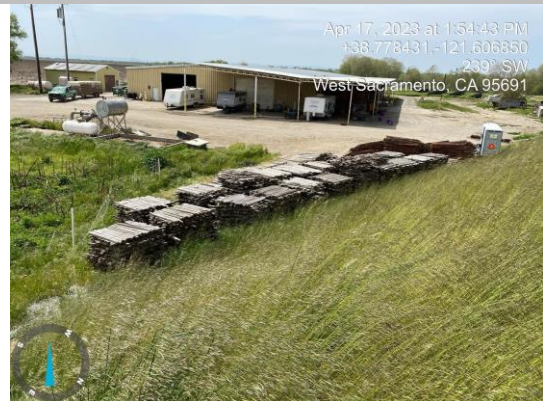
Photo 1 of 1 : FA_2023_RD1600_191_59_20231024_00035.jpg

View of wooden stakes within the levee easement (Spring 2023).

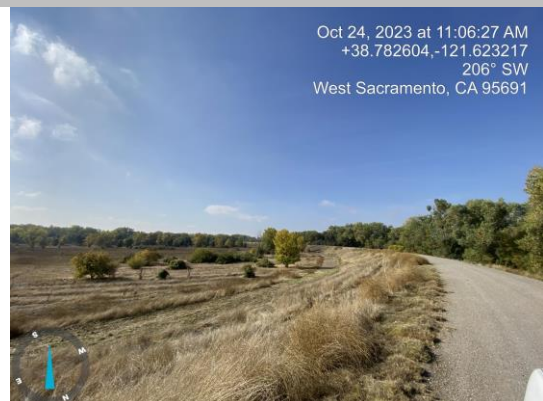
Photo 1 of 1 : FA_2023_RD1600_191_78_20231025_00077.jpg

View of vegetation on the landside slope (Fall 2023).

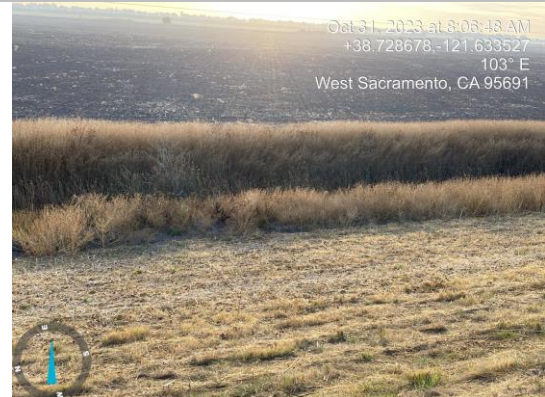
Photo 1 of 1 : FA_2023_RD1600_192_4_20231103_00011.jpg

View of vegetation on the landside toe up to the ditch (Fall 2023).

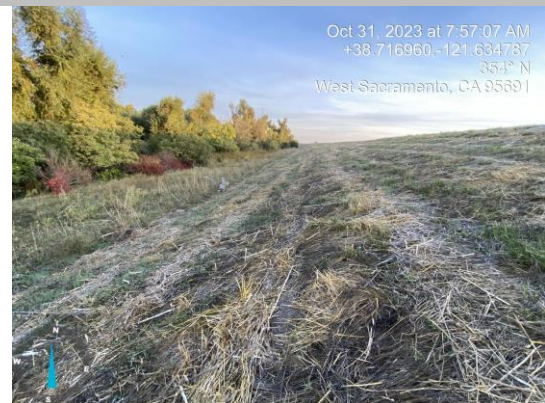
Photo 1 of 2 : FA_2023_RD1600_192_23_20231103_00012.jpg

View of wave wash damage on the waterside slope (Fall 2023).

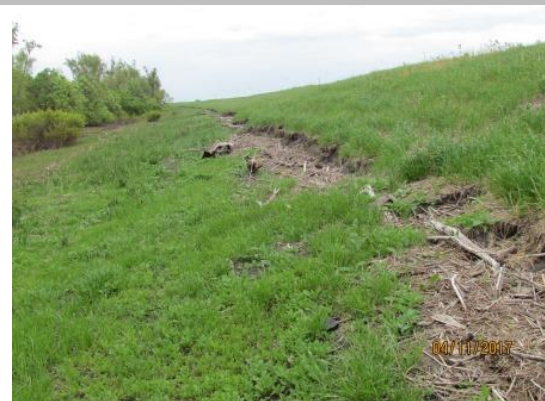
Photo 2 of 2 : FA_2023_RD1600_192_23_20231024_00003.jpg

View of wave wash damage on waterside levee slope. Spring 2017.

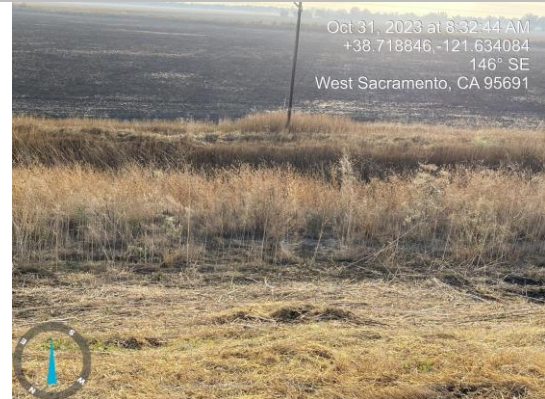
Photo 1 of 1 : FA_2023_RD1600_192_5_20231103_00013.jpg

View of vegetation on the landside toe up to the ditch (Fall 2023).

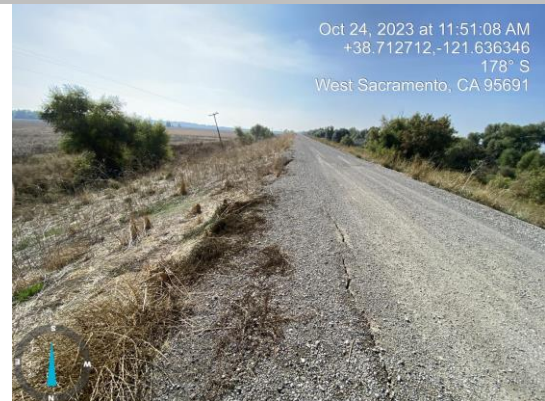
Photo 1 of 1 : FA_2023_RD1600_192_6_20231025_00010.jpg

View of landside cracking and sloughing (Fall 2023).

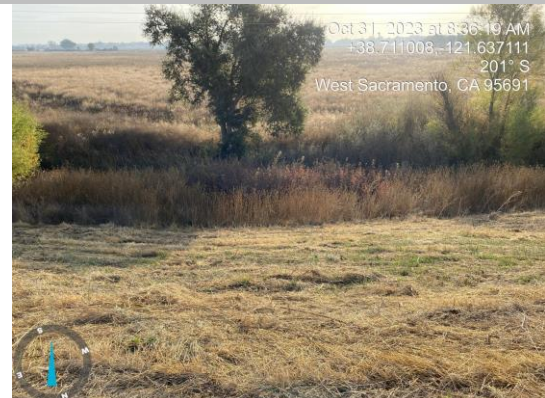
Photo 1 of 1 : FA_2023_RD1600_192_7_20231103_00014.jpg

View of vegetation on the landside toe up to the ditch (Fall 2023).

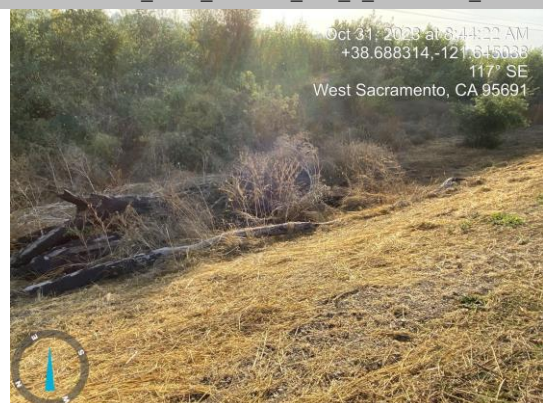
Photo 1 of 1 : FA_2023_RD1600_192_8_20231103_00016.jpg

View of discarded tree limbs on the landside slope (Fall 2023).
