Flood Control Project Maintenance Levee Inspections

Fall 2024 Levee Maintenance Deficiency Summary Report

Reclamation District No. 1600 Mull

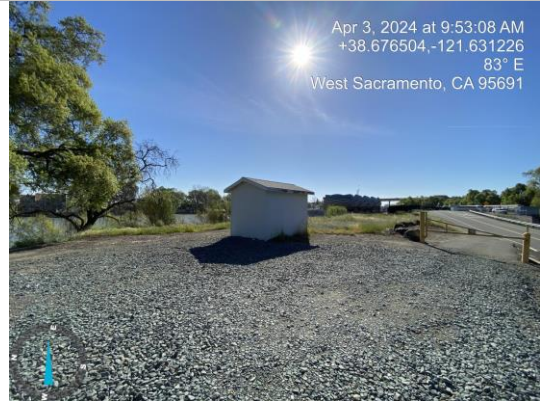
Photo 1 of 1 : FA_2024_RD1600_191_129_20241028_00042.jpg

View of pump house on the waterside shoulder (Spring 2024).

LM Start	0.11	Rating **	A/W	Issue No.	49
LM End	0.23	Issue Type +	Ob	Location *	WS
Category	Earthen Levee			GPS Latitude/Longitude	
				Start	End
Item	Vegetation			38.676577°	38.678131°
				-121.631290°	-121.632324°
DWR ID	DWR_RD1600_01_s _ 2012_49				
Comment Code					
V5 : Environmental Requirements.					
Inspector Comment

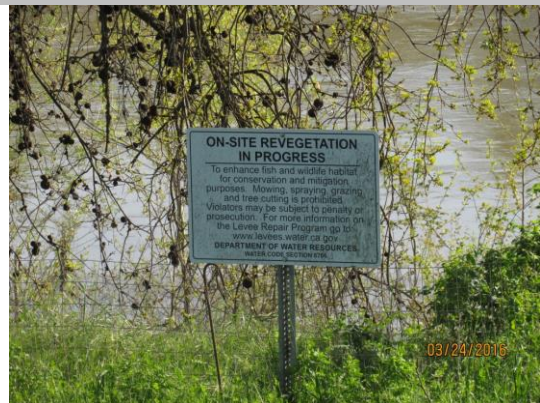
Photo 1 of 1 : FA_2024_RD1600_191_49_20241028_00028.jpg

Sign stating revegetation site. Spring 2016.

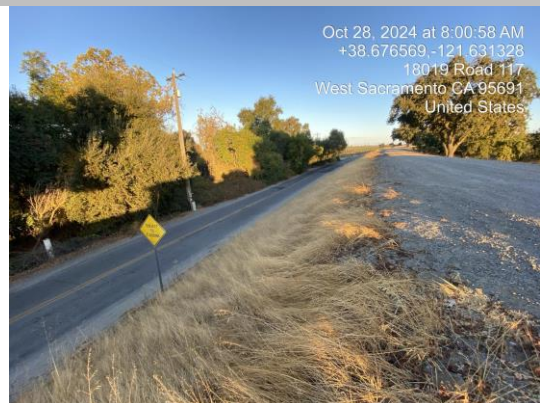
Photo 1 of 1 : FA_2024_RD1600_191_10_20241101_00069.jpg

LM Start	0.12	Rating **	M	Issue No.	10
LM End	3.42	Issue Type +	Ma	Location *	LS
Category	Earthen Levee			GPS Latitude/Longitude	
				Start	End
Item	Vegetation			38.676638°	38.715894°
				-121.631361°	-121.609373°
DWR ID	DWR_RD1600_01_f _ 2024_10				
Comment Code					
V1 : Control annual grass and weeds on the levee slopes and easements.					
Inspector Comment

View of vegetation on the landside slope (Fall 2024).

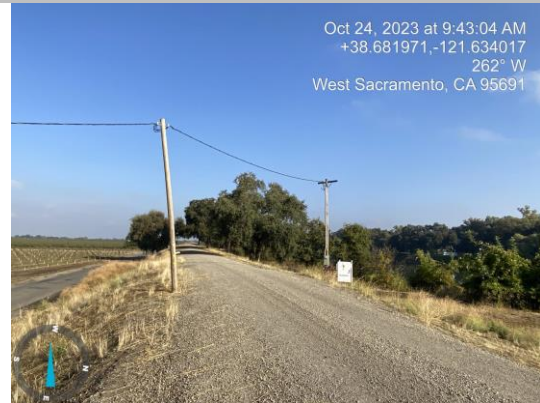
Photo 1 of 1 : FA_2024_RD1600_191_44_20241028_00024.jpg

View of telephone line over levee crown (Fall 2023).

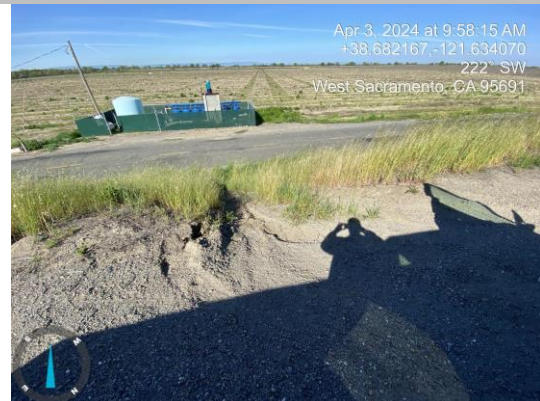
Photo 1 of 1 : FA_2024_RD1600_191_133_20241028_00043.jpg

LM Start	0.53	Rating **	M	Issue No.	133
LM End	0.53	Issue Type +	Ma	Location *	LS
Category	Earthen Levee			GPS Latitude/Longitude	
				Start	End
Item	Erosion / Foot Traffic			38.682140°	38.682140°
				-121.634083°	-121.634083°
DWR ID	DWR_RD1600_01_f_2013_133				
Comment Code					
E3 : Repair the levee slope damaged by foot traffic and prevent access where possible.					
Inspector Comment					
There appears to be a footpath and settlement on landside slope over pipe crossing.

View of settlement and footpath on landside slope (Spring 2024).

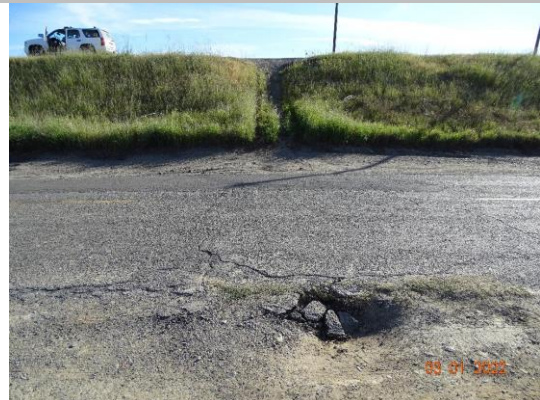
Photo 2 of 3 : UCIP_FA_2024_73418_109780.jpg

Comment Code						
Inspector Comment						
DS_ID:21460 FS_ID:73418 EP_NO: N/A Repair Type: Non-Urgent EVAL Issue: 6, Levee Damage or Threat for Levee Damage Crossing Status: Found UCIP Comments: 03/01/2022 Record updated from No Action Needed to Non-Urgent. Sinkhole measured 24-inch in diameter and 6-inch in depth located at the shoulder of CO RD 117. Depression on landside slope. New concrete distribution box constructed on landside. Vertical pump on the top of it, and sand filters in the field are installed. Old concrete distribution box debris found on road shoulder. No permit has been identified authorizing pipe. (O.Yakimov - DWR UCIP) FIELD_STRUCT_DESC: 14-inch steel irrigation pipe through the levee 15.2 feet below the crown. Slant pump and gate valve on the waterside (WS) slope. Service pole with electrical panel on WS shoulder, overhead power line. Concrete distribution box off the landside (LS) toe. Vertical pump over the concrete distribution box, sand filters on LS. [Additional Reference(s): DWR Levee Log, 1988 (HLM 0.53). USACE Sacramento O&M Manual, Unit 123, August 1955, Revised 17 December 2020, (RM 71.0), listed as 14-inch pipe]. FS Date: 3/1/2022

Land-Side: View of depression on levee slope and a sinkhole at road shoulder

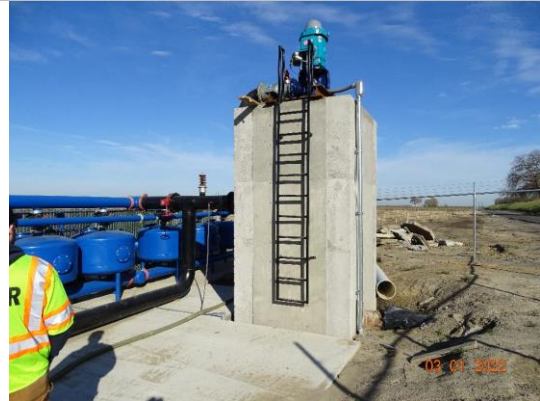
Photo 3 of 3 : UCIP_FA_2024_73418_109774.jpg

Land-Side: New concrete distribution box, pump on the top, and sand filters installed on landside

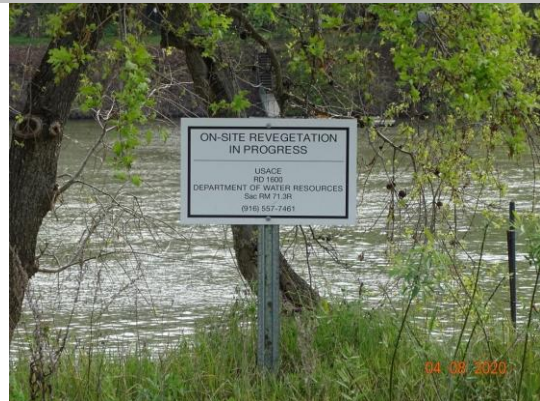
Photo 1 of 1 : FA_2024_RD1600_191_26_20241028_00018.jpg

LM Start	0.56	Rating **	A/W	Issue No.	26
LM End	0.66	Issue Type +	Ob	Location *	WS
Category	Earthen Levee			GPS Latitude/Longitude	
				Start	End
Item	Vegetation			38.682661°	38.684099°
				-121.634238°	-121.634625°
DWR ID	DWR_RD1600_01_s_2020_26				
Comment Code					
V5 : Environmental Requirements.					
Inspector Comment					
USACE, DWR, and RD 1600 revegetation site.

View of revegetation sign on the waterside berm. Spring 2020.

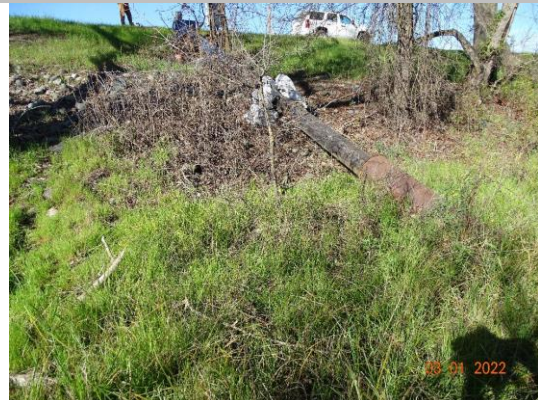
Photo 2 of 3 : UCIP_FA_2024_73427_109787.jpg

Comment Code						
Inspector Comment						
DS_ID:21463 FS_ID:73427 EP_NO: 6100 Repair Type: Urgent EVAL Issue: 2a, Levee Integrity Crossing Status: Found UCIP Comments: 03/01/2022 Record updated from Non-Urgent to Urgent. Found unauthorized excavation under the pump on waterside to install flow meter. Excavation is 36 inches in diameter and 10 inches deep. Gate valve at the pump is in operable condition. (O.Yakimov - DWR UCIP) 06/18/2013 Gate valve will not open or close. (W.Wylie - DWR UCIP) FIELD_STRUCT_DESC: 12-inch steel irrigation pipe through the levee, 3.4 feet below the crown. Slant pump and gate valve on the waterside (WS) slope. Siphon breaker in a 12-inch steel riser on the landside (LS) shoulder. Filter, booster pump, and butterfly valve on the LS toe. 2.25-inch galvanized iron electrical conduit at the same location. This crossing replaces 8-inch pipe (see DSID 21462). (12-inch pipe authorized under Permit No. 6100, 1968 - Charles Plumb Jr.). [Additional Reference(s): DWR Levee Log, 1988 (HLM 0.94)]. FS Date: 3/1/2022 2:36:45 PM

Water-Side: Overview of slant pipe on levee berm. Sand bags put on the top of pipe to lower vibration and keep pipe in place

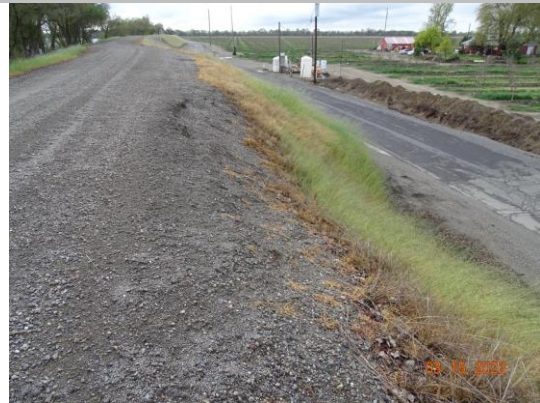
Photo 1 of 1 : FA_2024_RD1600_191_134_20241028_00044.jpg

LM Start	0.97	Rating **	M	Issue No.	134
LM End	0.97	Issue Type +	Ma	Location *	LS
Category	Earthen Levee			GPS Latitude/Longitude	
				Start	End
Item	Erosion / Rills			38.688454°	38.688454°
				-121.635528°	-121.635528°
DWR ID	DWR_RD1600_01_f_2021_134				
Comment Code					
E5 : Schedule repair of rills prior to the next inspection.					
Inspector Comment					
Rills are forming on the landside slope.

View of erosion on the landside shoulder. Spring 2022.

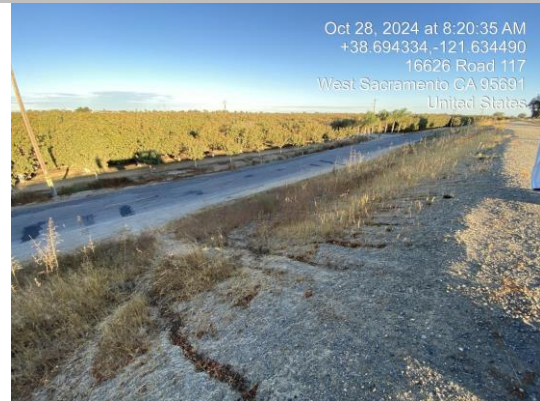
Photo 1 of 1 : FA_2024_RD1600_191_12_20241101_00070.jpg

LM Start	1.38	Rating **	A/W	Issue No.	12
LM End	1.42	Issue Type +	Ma	Location *	LS
Category	Earthen Levee			GPS Latitude/Longitude	
				Start	End
Item	Erosion / Rills			38.694317°	38.694741°
				-121.634404°	-121.634240°
DWR ID	DWR_RD1600_01_s_2023_12				
Comment Code					
E5 : Schedule repair of rills prior to the next inspection.					
Inspector Comment					
Rills are beginning to form on the landside slope. Recommend monitoring.

View of rills beginning to form on the landside slope (Fall 2024).

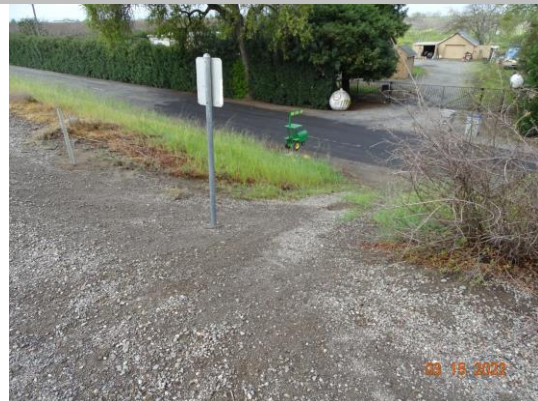
Photo 1 of 1 : FA_2024_RD1600_191_70_20241028_00039.jpg

LM Start	1.70	Rating **	A/W	Issue No.	70
LM End	1.70	Issue Type +	Ma	Location *	LS
Category	Earthen Levee			GPS Latitude/Longitude	
				Start	End
Item	Erosion / Vehicle Traffic			38.698414°	38.698414°
				-121.631874°	-121.631874°
DWR ID	DWR_RD1600_01_f_2017_70				
Comment Code					
E6 : Repair the levee slope damaged by vehicle traffic and prevent access where possible.					
Inspector Comment					
Footpath and vehicle access on landside slope. Recommend monitoring.

View of footpath on the landside slope. Spring 2022.

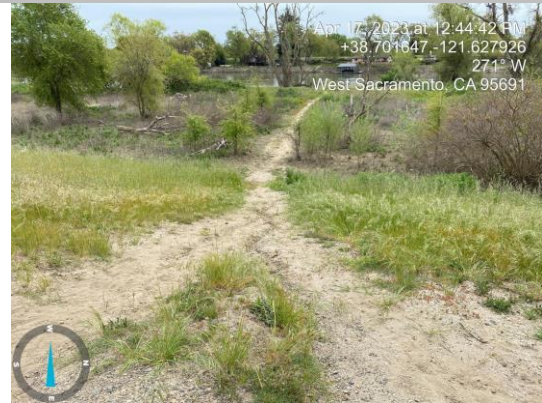
Photo 1 of 1 : FA_2024_RD1600_191_14_20241028_00004.jpg

LM Start	2.01	Rating **	A/W	Issue No.	14
LM End	2.01	Issue Type +	Ma	Location *	WS
Category	Earthen Levee			GPS Latitude/Longitude	
				Start	End
Item	Erosion / Foot Traffic			38.701633°	38.701633°
				-121.627945°	-121.627945°
DWR ID	DWR_RD1600_01_s _ 2023_14				
Comment Code					
E3 : Repair the levee slope damaged by foot traffic and prevent access where possible.					
Inspector Comment					
There is a footpath on the waterside slope. Recommend monitoring for now.

View of footpath that has eroded the waterside levee slope (Spring 2023).

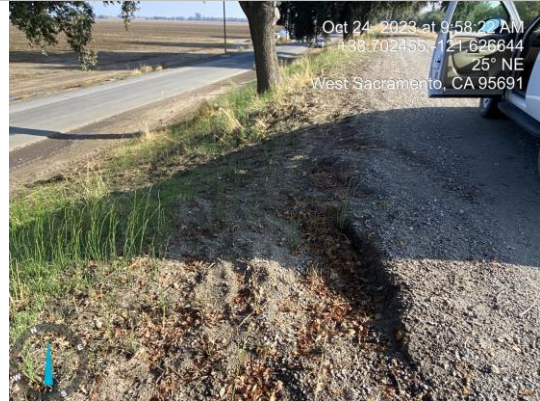
Photo 1 of 1 : FA_2024_RD1600_191_66_20241028_00036.jpg

LM Start	2.10	Rating **	M	Issue No.	66
LM End	2.10	Issue Type +	Ma	Location *	LS
Category	Earthen Levee			GPS Latitude/Longitude	
				Start	End
Item	Slope Stability			38.702417°	38.702417°
				-121.626588°	-121.626588°
DWR ID	DWR_RD1600_01_f_2023_66				
Comment Code					
S1 : Repair slope instability.					
Inspector Comment					
Slope instability may be caused by sheep grazing. Recommend caution with future use.

View of slope instability on the landside slope (Fall 2023).

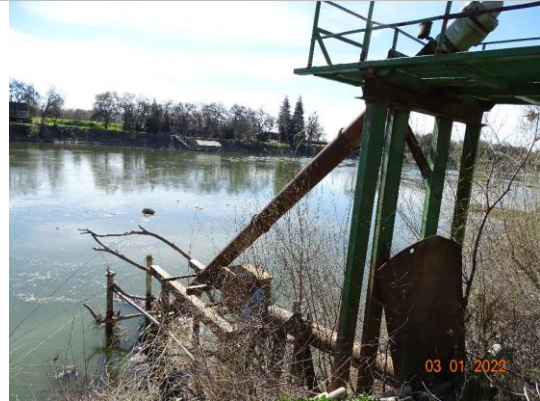
Photo 1 of 3 : UCIP_FA_2024_73455_109809.jpg

Comment Code					
Inspector Comment					
DS_ID:21466 FS_ID:73455 EP_NO: 14648 Repair Type: Non-Urgent EVAL Issue: 10, Unauthorized Modification or Non-Compliant Permit Crossing Status: Found UCIP Comments: 03/01/2022 Record updated from No Action Needed to Non-Urgent. Excavation was discovered to expose pipe section near steel standpipe on landside more that 15 feet from toe. Discharge pipe was cut open and its end was plugged with metal plate to re-route flow from steel standpipe to a booster pump and then to sand filters. Unable to find a permit for modification. Open hole on the top of pipe under the pump on waterside made for flow meter wrapped with tape. (O.Yakimov - DWR UCIP) FIELD_STRUCT_DESC: 24-inch steel irrigation pipe through the levee, 4 feet below the crown. Pump on metal platform on the waterside (WS). 8-foot-diameter steel distribution standpipe with gate valve, 45 feet from the landside (LS) toe. Diesel booster pump and sand filters on landside. (24-inch pipe authorized under Permit No. 14648, 1987 - Layton Knaggs). [Additional Reference(s): DWR Levee Log, 1988 (HLM 2.10)]. FS Date: 3/1/2022 4:13:02 PM

Water-Side: Slant pump at riverbank

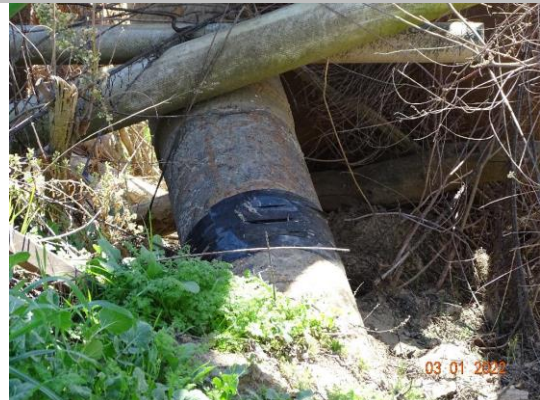
Photo 2 of 3 : UCIP_FA_2024_73455_109814.jpg

Water-Side: Taped hole made for flow meter under the pump

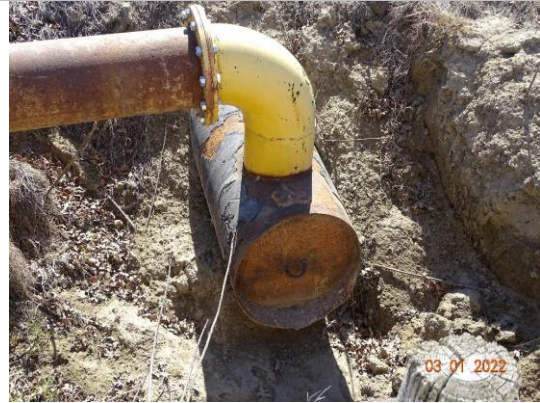
Photo 3 of 3 : UCIP_FA_2024_73455_109813.jpg

Land-Side: Excavation to expose pipe section and re-route water flow to booster pump and sand filters

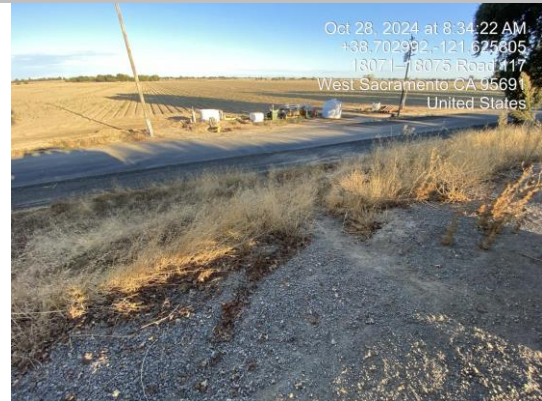
Photo 1 of 1 : FA_2024_RD1600_191_30_20241101_00071.jpg

LM Start	2.18	Rating **	M	Issue No.	30
LM End	2.18	Issue Type +	Ma	Location *	LS
Category	Earthen Levee			GPS Latitude/Longitude	
				Start	End
Item	Erosion / Vehicle Traffic			38.703143°	38.703143°
				-121.625415°	-121.625415°
DWR ID	DWR_RD1600_01_s_2021_30				
Comment Code					
E6 : Repair the levee slope damaged by vehicle traffic and prevent access where possible.					
Inspector Comment					
There is vehicle traffic on the landside slope causing erosion.

View of erosion caused by vehicle traffic on the landside slope (Fall 2024).

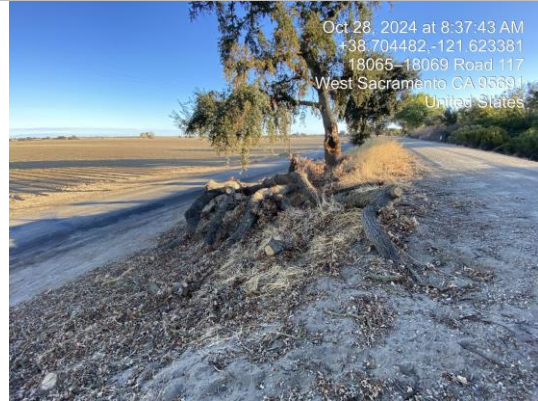
Photo 1 of 1 : FA_2024_RD1600_191_27_20241101_00072.jpg

View of fallen tree on the landside slope and easement (Fall 2024).

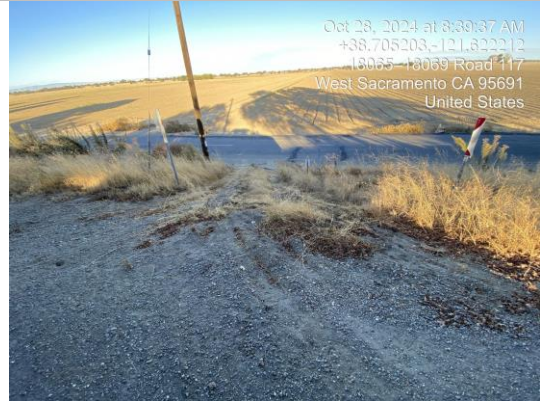
Photo 1 of 1 : FA_2024_RD1600_191_42_20241101_00073.jpg

LM Start	2.41	Rating **	A/W	Issue No.	42
LM End	2.41	Issue Type +	Ma	Location *	LS
Category	Earthen Levee			GPS Latitude/Longitude	
				Start	End
Item	Erosion / Vehicle Traffic			38.705187°	38.705187°
				-121.622177°	-121.622177°
DWR ID	DWR_RD1600_01_f _ 2024_42				
Comment Code					
E6 : Repair the levee slope damaged by vehicle traffic and prevent access where possible.					
Inspector Comment					
Erosion damage caused by vehicle traffic. Recommend monitoring.

View of erosion caused by vehicle traffic on the landside slope (Fall 2024).

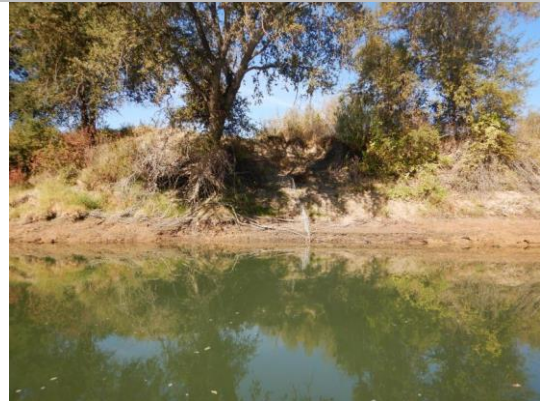
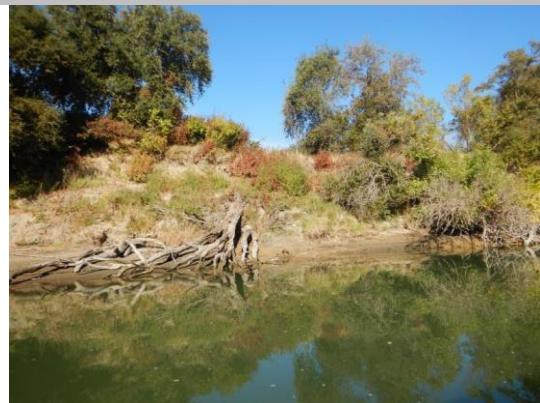
LM Start	2.99	Rating **	A/W	Issue No.	15
LM End	3.37	Issue Type +	Ma	Location *	WS
Category	Supplemental			GPS Latitude/Longitude	
				Start	End
Item	2018 USACE Erosion Survey			38.710874°	38.715134°
				-121.614239°	-121.609566°
DWR ID	DWR_RD1600_01_s_2022_15				
Comment Code					
Inspector Comment					
2018 Site ID: SAC 74.0 R					
Status: Eroding					
2018 Field Notes: Bank toe continues to erode.					
Site History: 2017 - Significant toe erosion. Erosion along entire bank.					
Tree popouts observed.

USACE 2018 Erosion Photo #1

USACE 2018 Erosion Photo #2

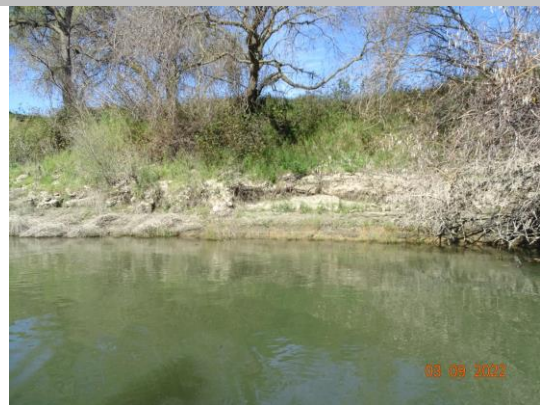
Photo 1 of 1 : FA_2024_RD1600_191_29_20241028_00020.jpg

View of erosion from the water. Spring 2022.

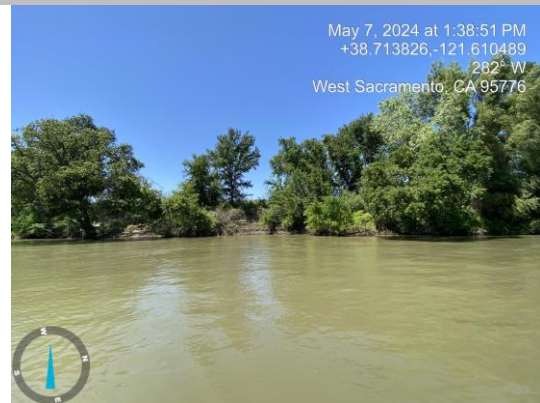
Photo 1 of 1 : FA_2024_RD1600_191_40_20241028_00022.jpg

View of erosion from the water (Spring 2024).

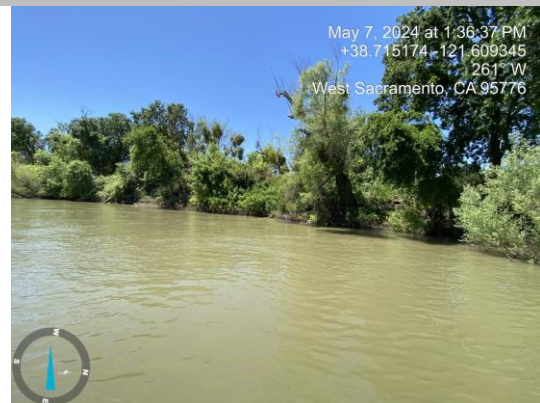
Photo 1 of 1 : FA_2024_RD1600_191_43_20241028_00023.jpg

View of erosion from the water (Spring 2024).

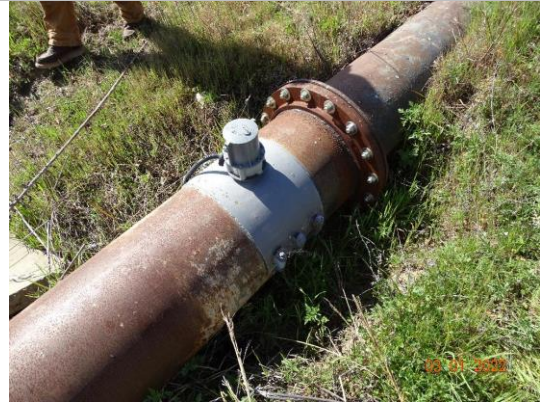
Photo 2 of 3 : UCIP_FA_2024_73513_109847.jpg

Water-Side: Excavation around pipe on levee berm to install flow meter

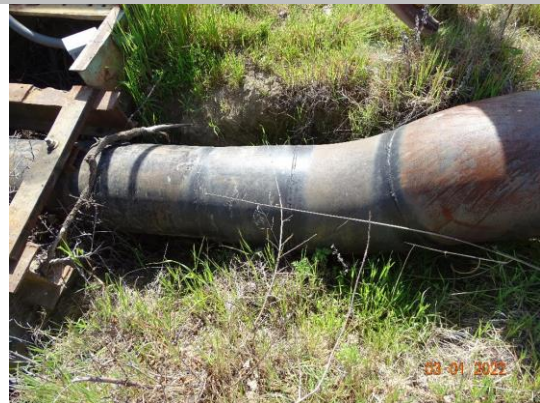
Photo 3 of 3 : UCIP_FA_2024_73513_109841.jpg

Water-Side: Excavation to install pipe at pumping platform

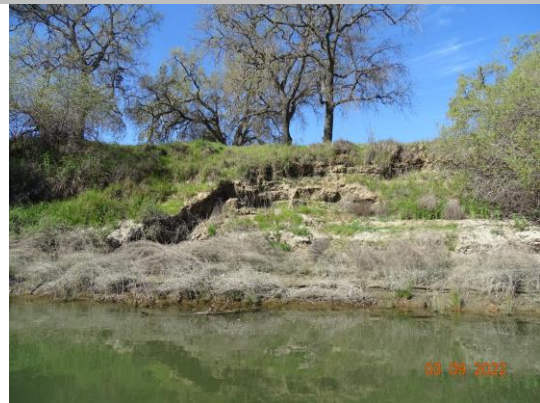
Photo 2 of 3 : FA_2024_RD1600_191_16_20241028_00008.jpg

View of erosion at the worst location. Spring 2022.

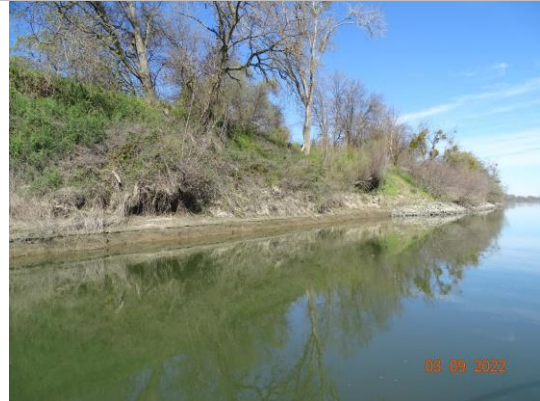
Photo 3 of 3 : FA_2024_RD1600_191_16_20241028_00009.jpg

View of end of erosion at the upstream end. Spring 2022.

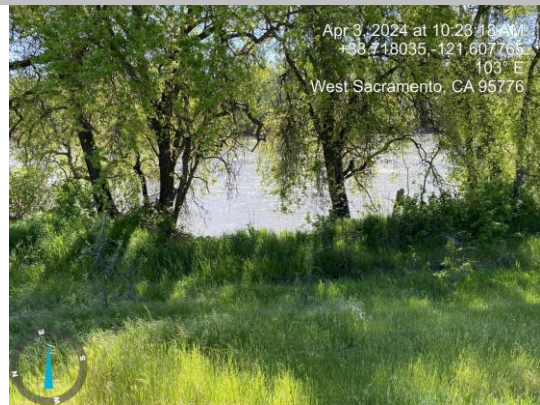
Photo 1 of 1 : FA_2024_RD1600_191_47_20241028_00026.jpg

View of erosion on waterside berm (Spring 2024).

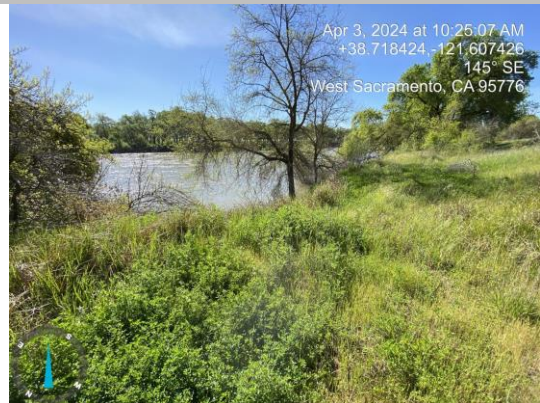
Photo 1 of 1 : FA_2024_RD1600_191_48_20241028_00027.jpg

View of erosion location on waterside berm (Spring 2024).

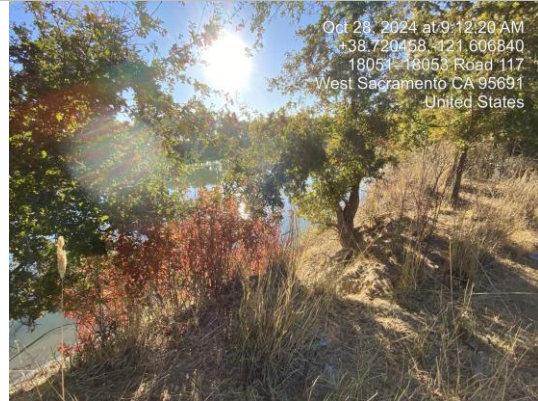
Photo 1 of 1 : FA_2024_RD1600_191_50_20241101_00074.jpg

View of erosion on the waterside bank that appears to be encroaching into the theoretical levee prism (Fall 2024).

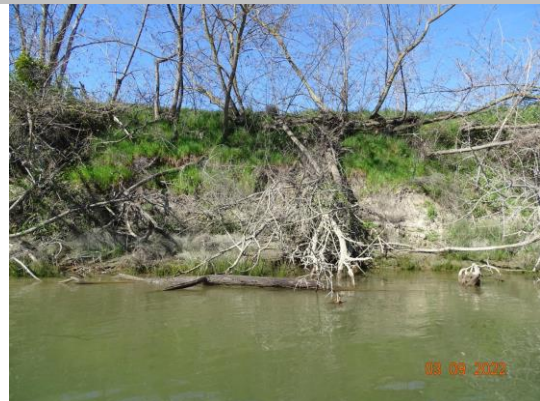
Photo 1 of 2 : FA_2024_RD1600_191_17_20241028_00010.jpg

View of erosion near downstream end. Spring 2022.

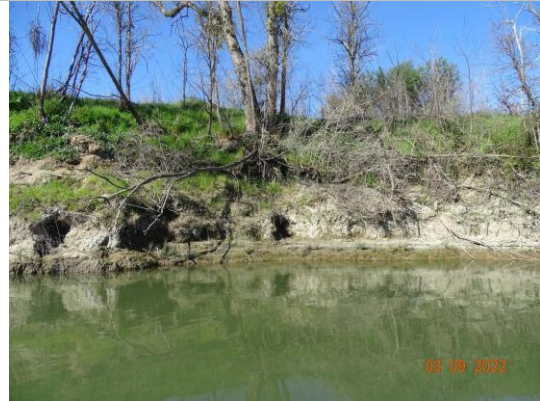
Photo 2 of 2 : FA_2024_RD1600_191_17_20241028_00011.jpg

View of erosion near upstream end. Spring 2022.

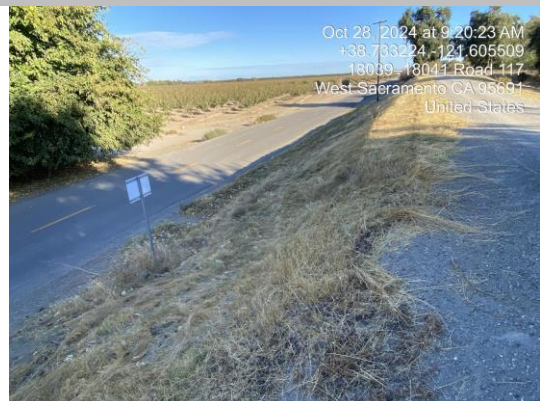
Photo 1 of 1 : FA_2024_RD1600_191_36_20241101_00075.jpg

View of bank caving on the landside slope (Fall 2024).

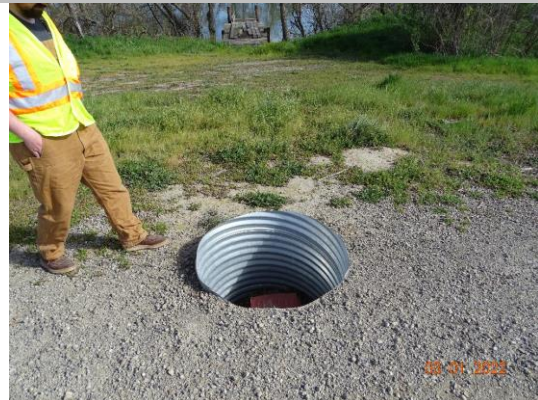
Photo 2 of 3 : UCIP_FA_2024_73530_109874.jpg

Water-Side: View of levee slope looking from crown. CMP riser missing top cover

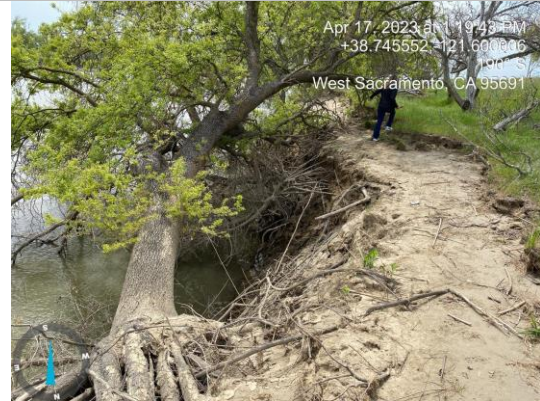
Photo 1 of 1 : FA_2024_RD1600_191_28_20241028_00019.jpg

View of erosion on waterside berm (Spring 2023).

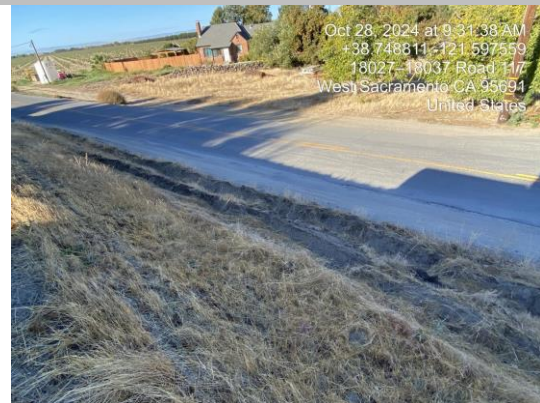
Photo 1 of 1 : FA_2024_RD1600_191_57_20241101_00076.jpg

View of slope damage caused by mowing activities (Fall 2024).

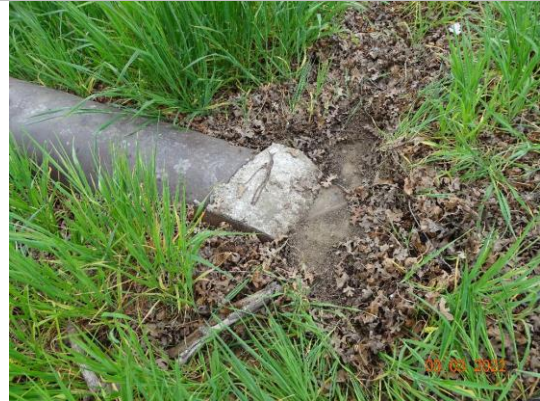
Photo 1 of 3 : UCIP_FA_2024_73560_109897.jpg

Water-Side: View of pipe at waterside shoulder. Pipe appears abandoned by concrete grouting

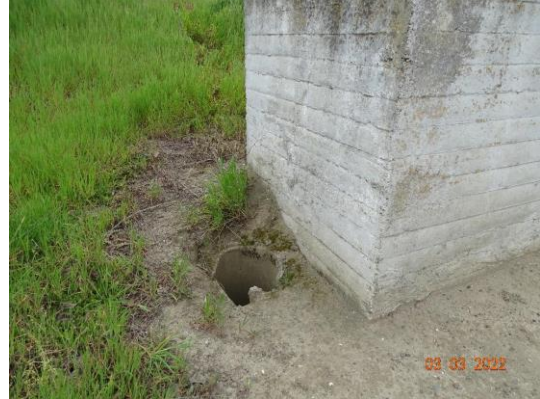
Photo 2 of 3 : UCIP_FA_2024_73560_109894.jpg

Land-Side: Broken at ground level one of two concrete standpipes at concrete distribution box

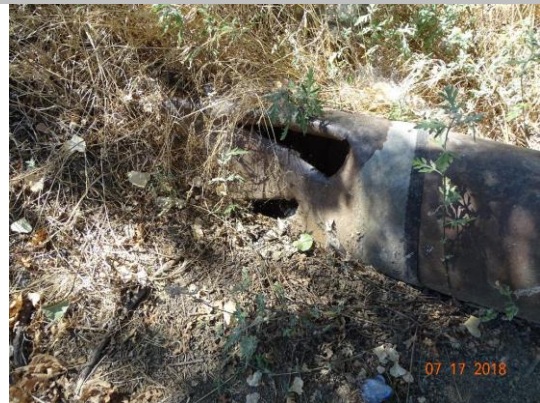
Photo 3 of 3 : UCIP_FA_2024_73560_77707.jpg

Holes in pipe on at WS toe.

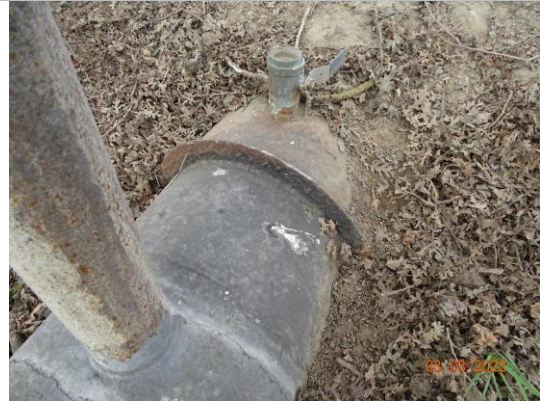
Photo 2 of 3 : UCIP_FA_2024_73691_110133.jpg

Water-Side: View of pipe sleeved through larger pipe on waterside shoulder

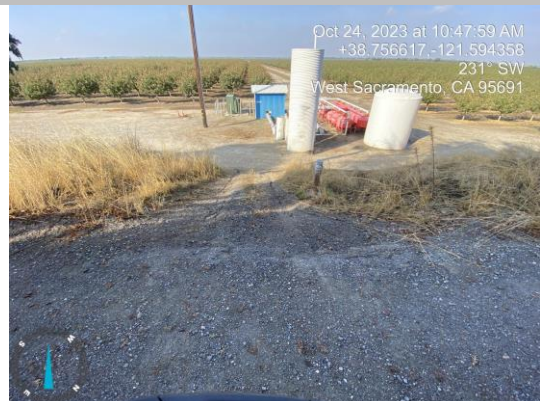
Photo 1 of 1 : FA_2024_RD1600_191_75_20241028_00041.jpg

View of vehicle ruts on the landside slope (Fall 2023).

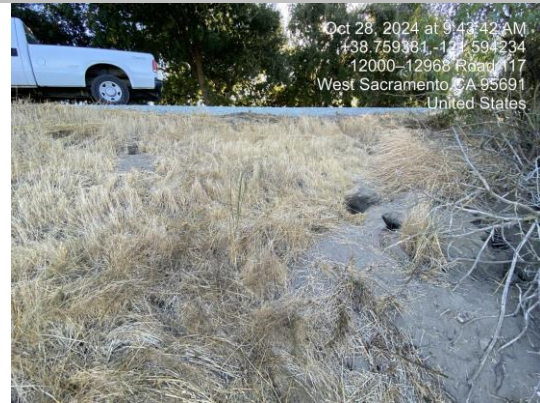
Photo 1 of 1 : FA_2024_RD1600_191_58_20241101_00077.jpg

View of animal burrows on the landside slope (Fall 2024).

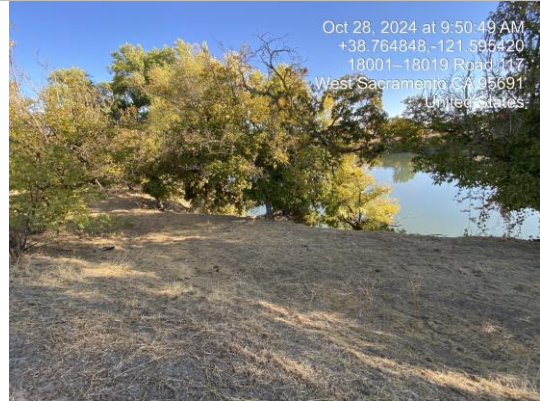
Photo 1 of 1 : FA_2024_RD1600_191_23_20241101_00078.jpg

View of erosion on the waterside bank (Fall 2024).

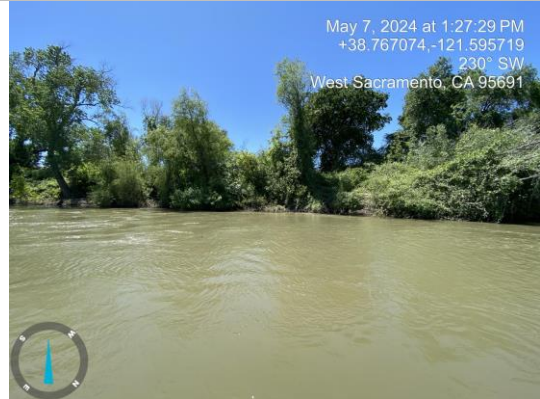
Photo 1 of 2 : FA_2024_RD1600_191_20_20241028_00012.jpg

View of erosion from the water (Spring 2024).

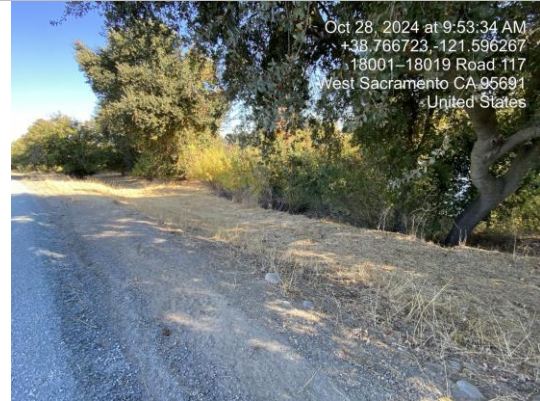
Photo 2 of 2 : FA_2024_RD1600_191_20_20241101_00079.jpg

View of erosion taken from the levee crown and looking upstream (Fall 2024).

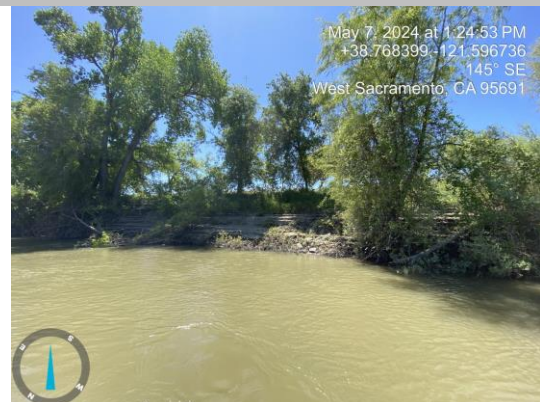
Photo 1 of 1 : FA_2024_RD1600_191_21_20241028_00013.jpg

View of erosion from the water (Spring 2024).

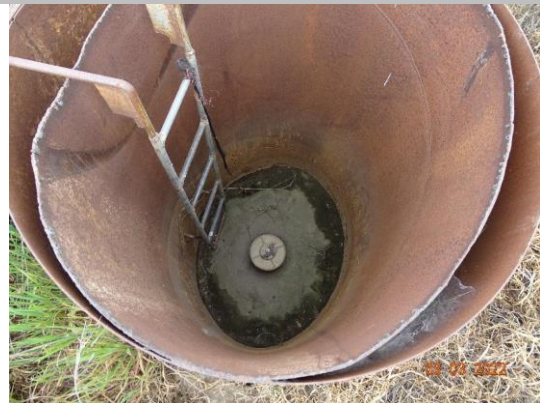
Photo 3 of 3 : UCIP_FA_2024_73694_110142.jpg

Land-Side: Siphon breaker inside steel riser. Was noted as leaking earlier

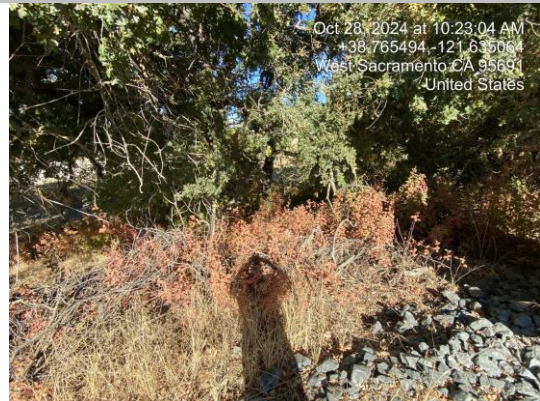
Photo 1 of 1 : FA_2024_RD1600_191_79_20241101_00080.jpg

View of woody growth on the waterside slope (Fall 2024).

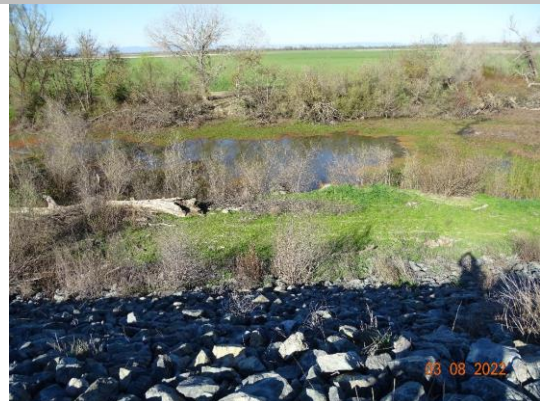
Photo 2 of 3 : UCIP_FA_2024_73777_110238.jpg

Water-Side: View of levee slope looking from crown. Flap gate underwater

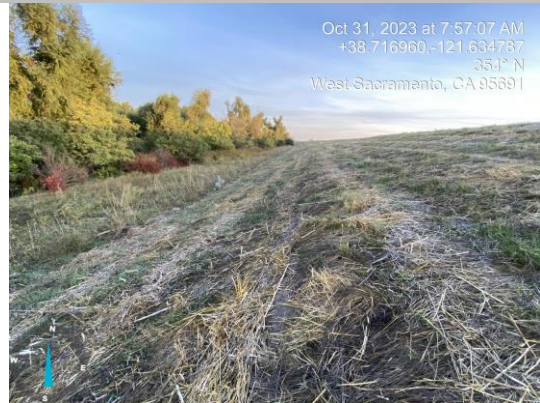
Photo 1 of 2 : FA_2024_RD1600_192_23_20241028_00004.jpg

View of wave wash damage on the waterside slope (Fall 2023).

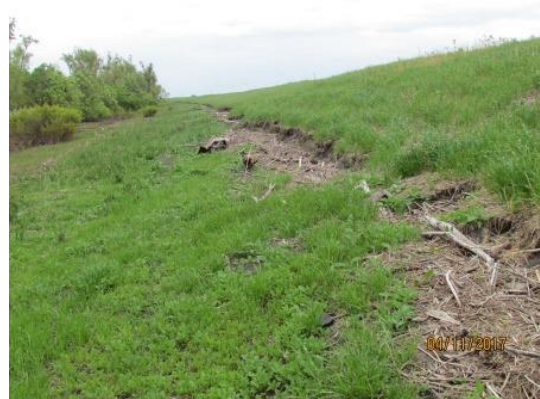
Photo 2 of 2 : FA_2024_RD1600_192_23_20241028_00005.jpg

View of wave wash damage on waterside levee slope. Spring 2017.

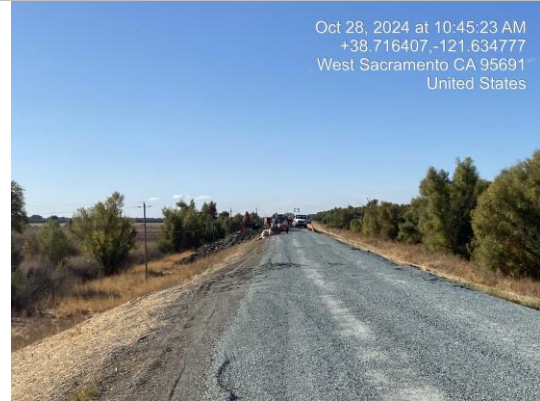
Photo 1 of 1 : FA_2024_RD1600_192_4_20241101_00012.jpg

View of USACE levee repair (Fall 2024).

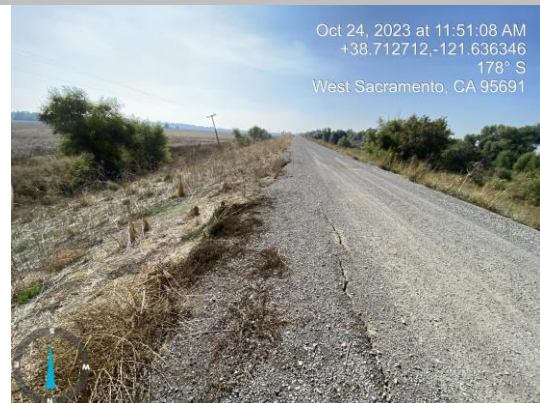
Photo 1 of 1 : FA_2024_RD1600_192_6_20241028_00001.jpg

View of landside cracking and sloughing (Fall 2023).

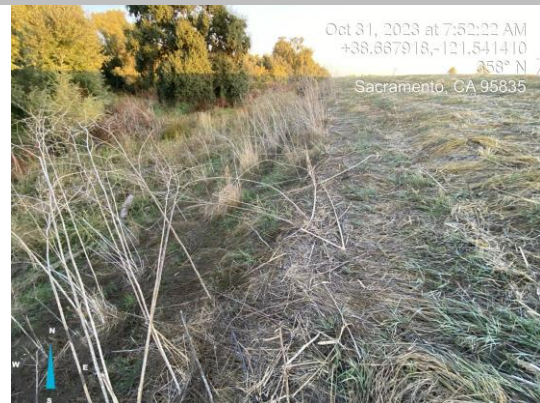
Photo 1 of 1 : FA_2024_RD1600_192_14_20241028_00003.jpg

View of wave wash on the waterside slope (Fall 2023).

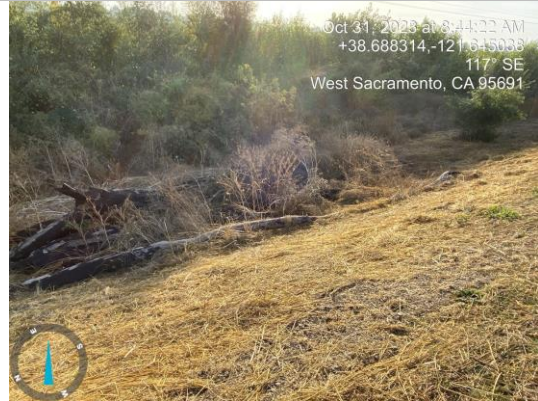
Photo 1 of 1 : FA_2024_RD1600_192_8_20241028_00002.jpg

View of discarded tree limbs on the landside slope (Fall 2023).

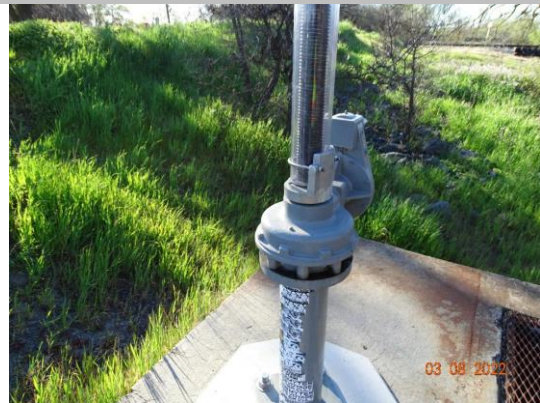
Photo 3 of 3 : UCIP_FA_2024_73790_110273.jpg

Water-Side: New slide gate actuator installed
