**Flood Control Project Maintenance
Levee Inspections**
LMA District Cover Sheet
Spring 2014 Levee Inspection Results

Reclamation District No. 1600 Mull

Spring 2014 Levee Inspection Results

Waterway	Bank	Unit Miles
Unit No. 01 Sacramento River	Right	10.51

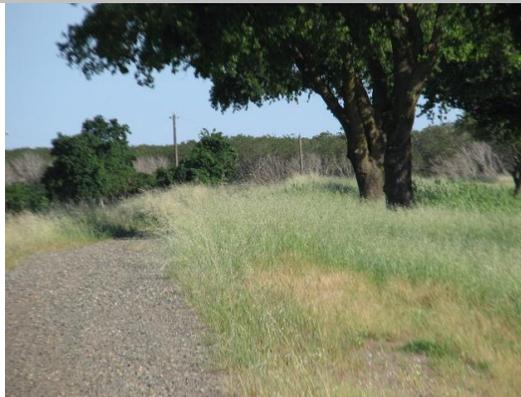
Photo 1 of 1 : johngw_s_20140421_813.jpg

Tall grasses partially blocks visibility. Spring 2014

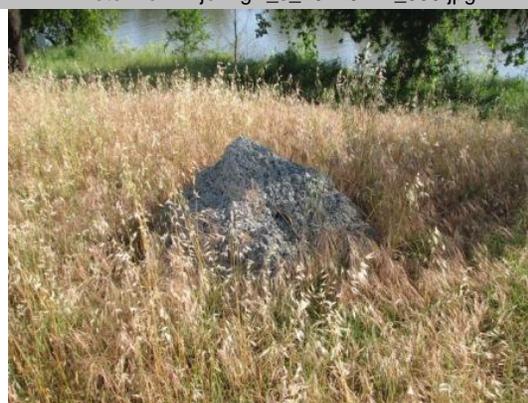
Photo 1 of 1 : johngw_s_20140414_559.jpg

A pile of concrete left over from the drilling of the well. Photo taken spring 2012.

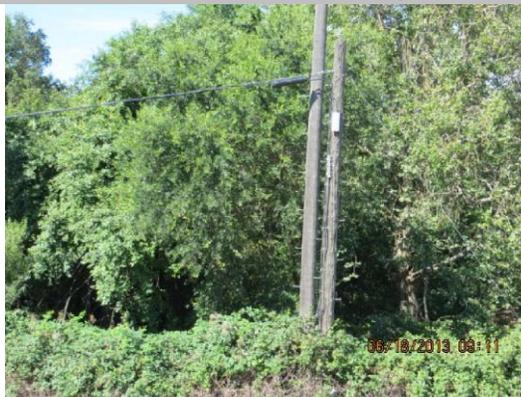
Photo 1 of 1 : UCIP_1209.jpg

Line visible on JP off LS toe. Likely this is the source of crossing.

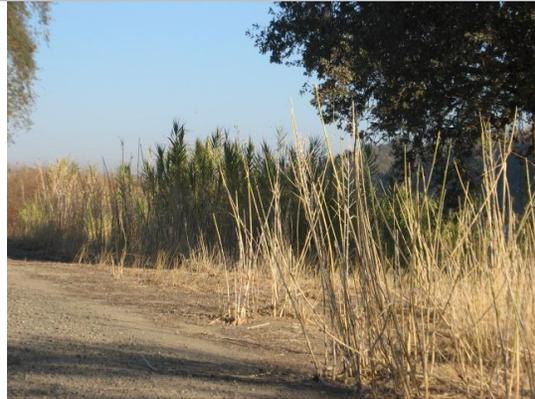
Photo 1 of 2 : johngw_s_20140414_569.jpg

The Arundo has increased in size and obstructs the view of the levee slope. Fall 2013

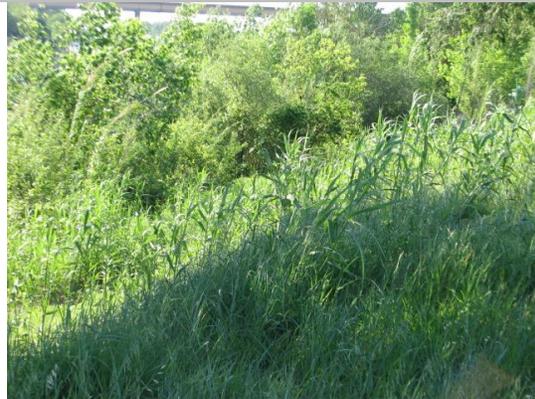
Photo 2 of 2 : johngw_s_20140421_815.jpg

The goats did a good job of knocking the Arundo down. The Arundo has begun to spread and may need chemical control. Spring 2014

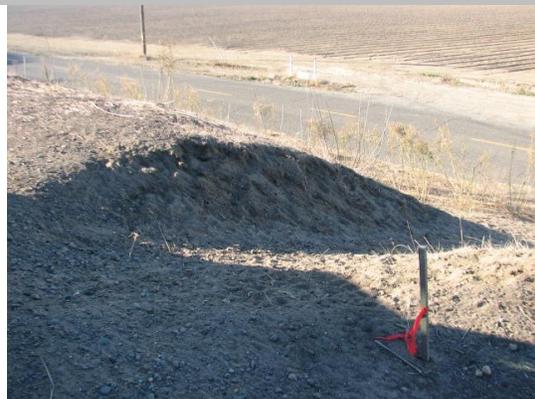
Photo 1 of 1 : johngw_s_20140414_570.jpg

LM Start	0.53	Rating **	M	Issue No.	133
LM End	0.53	Issue Type +	Ma	Location *	LS
Category	Earthen Levee		GPS Latitude/Longitude		
			Start	End	
Item	Erosion / Bank Caving		38.682140 °	38.682140 °	
			-121.634083 °	-121.634083 °	
DWR ID	DWR_RD1600_01_f_2013_133				
Action/Comments					
Schedule repair of erosion site prior to the next inspection.

The erosion on the landside shoulder is caused by foot traffic. Fall 2013

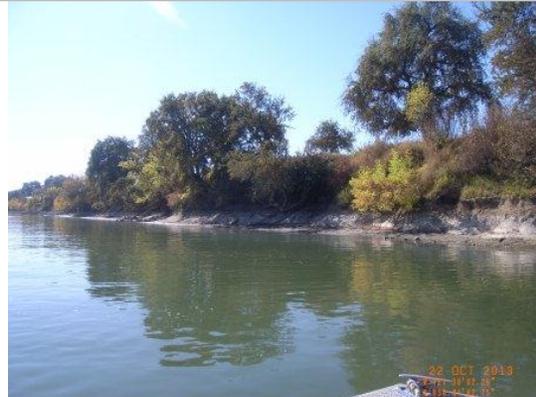
Photo 1 of 1 : USACE2013A_SAC_71-3_R_2.jpg

LM Start	0.57	Rating **	M	Issue No.	6
LM End	0.57	Issue Type +	Ma	Location *	WS
Category	Supplemental			GPS Latitude/Longitude	
				Start	End
Item	USACE Erosion Survey			38.682707 °	38.684106 °
				-121.633830 °	-121.634219 °
DWR ID					
Action/Comments					
Inspector Comments: 2000 - Very cohesive vertical bank. 2003 - Some minor new erosion. 2006 - Some minor erosion in old pockets. 2009 - Minimal new erosion. 2011 - Multiple new erosion pockets and a few new tree popouts. 2013: No observed changes. [2013 Site ID: SAC_71-3_R]

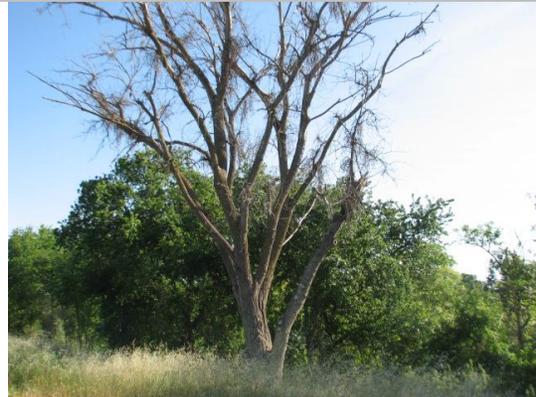
Photo 1 of 1 : johngw_s_20140421_816.jpg

LM Start	0.79	Rating **	A/W	Issue No.	624
LM End	0.79	Issue Type +	Ma	Location *	WS
Category	Earthen Levee			GPS Latitude/Longitude	
				Start	End
Item	Vegetation			38.685713 °	38.685713 °
				-121.634985 °	-121.634985 °
DWR ID	DWR_RD1600_01_s_2014_624				
Action/Comments					
Trees / Woody Vegetation

The tree is dying and needs to be monitored so there is no threat to the levee. Spring 2014

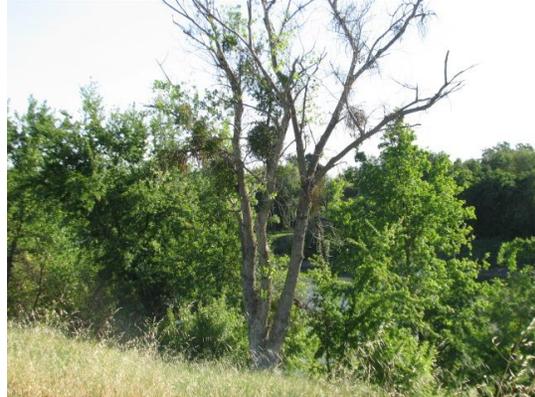
Photo 1 of 1 : johngw_s_20140421_817.jpg

The tree is dying and needs to be monitored so there is no threat to the levee. Spring 2014

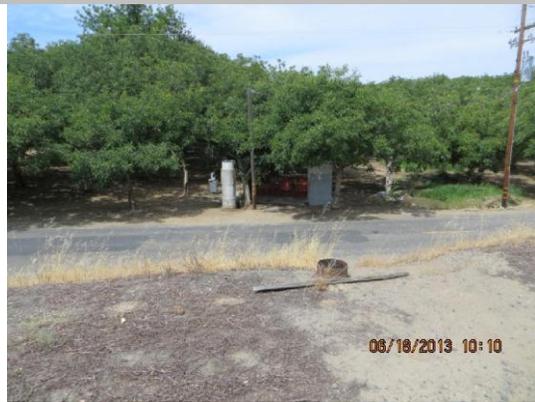
Photo 1 of 1 : UCIP_1256.jpg

LM Start	0.95	Rating **	M	Issue No.	614
LM End	0.95	Issue Type +	En	Location *	WS
Category	Supplemental			GPS Latitude/Longitude	
				Start	End
Item	DWR UCIP Field Study			38.688030 °	38.688030 °
				-121.635367 °	-121.635367 °
DWR ID	DWR_RD1600_01_s_2014_614				
Action/Comments					
Inspector Comments: FS_ID:15285 EP_NO: 6100 Repair Type: Crossing Status: UCIP Comments: Gate valve will not open or close. FIELD_STRUCT_DESC: 12-inch pipe through levee 3.4 feet below crown. Slant pump and gate valve on the waterward- slope. Siphon breaker in 12-inch steel riser on the landward shoulder. Filter, booster pump, and butterfly valve on LS toe. 2.25-inch galvanized iron electrical conduit at same location (Permit No. 6100, 1968). Replaced 8-inch pipe at same location. FS Date: 6/18/2013

Siphon breaker in steel riser on LS shoulder and concrete standpipe off LS toe.

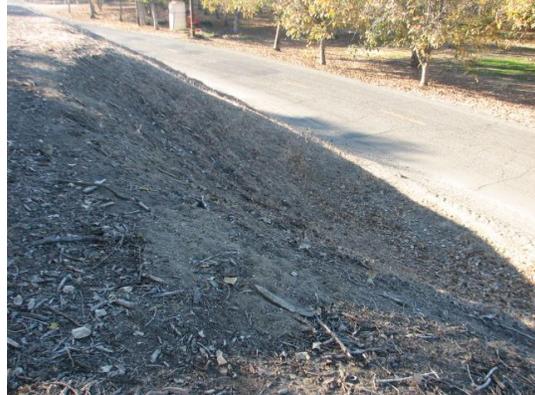
Photo 1 of 1 : johngw_s_20140414_571.jpg

LM Start	0.98	Rating **	M	Issue No.	134
LM End	0.98	Issue Type +	Ma	Location *	LS
Category	Earthen Levee		GPS Latitude/Longitude		
			Start	End	
Item	Slope Stability		38.688454 °	38.688454 °	
			-121.635528 °	-121.635528 °	
DWR ID	DWR_RD1600_01_f_2013_134				
Action/Comments					
Repair slope instability.

The levee has a deep depression caused by slope stability. Fall 2013

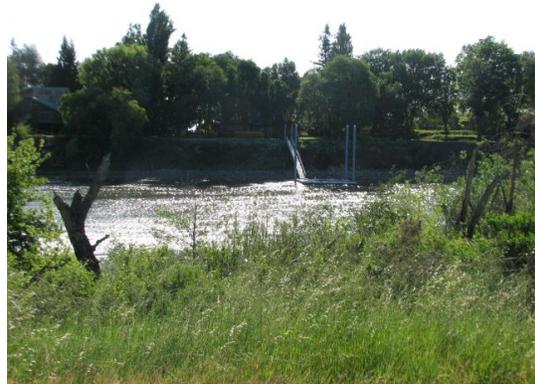
Photo 1 of 1 : johngw_s_20140421_818.jpg

Two trees at the waterside berm that may pose a threat to the levee. Spring 2014

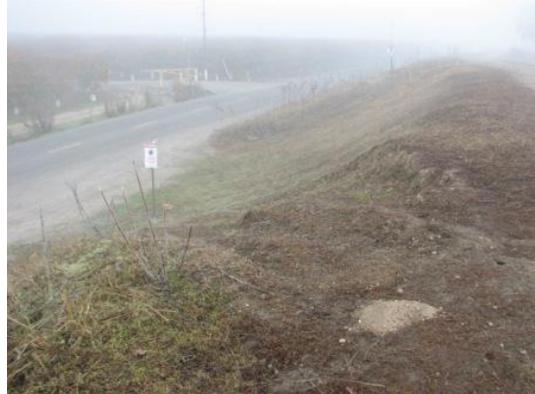
Photo 1 of 2 : johngw_s_20140414_522.jpg

LM Start	1.40	Rating **	M	Issue No.	4
LM End	1.40	Issue Type +	Ma	Location *	LS
Category	Earthen Levee			GPS Latitude/Longitude	
				Start	End
Item	Erosion / Bank Caving			38.694395 °	38.694395 °
				-121.634376 °	-121.634376 °
DWR ID	DWR_RD1600_01_f_2012_4				
Action/Comments					
Schedule repair of erosion site prior to the next inspection. Inspector Comments: Damage looks like caused by vehicles.

Vehicles and people have created some erosion on the levee. Fall 2012

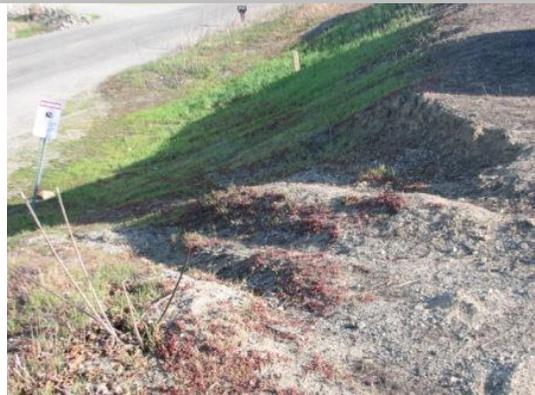
Photo 2 of 2 : johngw_s_20140414_523.jpg

Erosion from vehicles on levee slope. Spring 2013

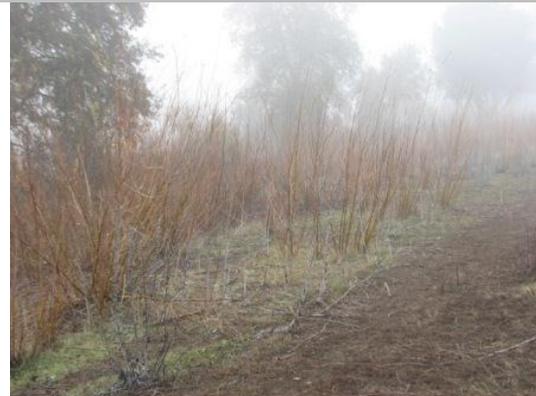
Photo 1 of 2 : johngw_s_20140414_529.jpg

Willows are growing on the waterside shoulder. They have been grazed by goats. Fall 2012

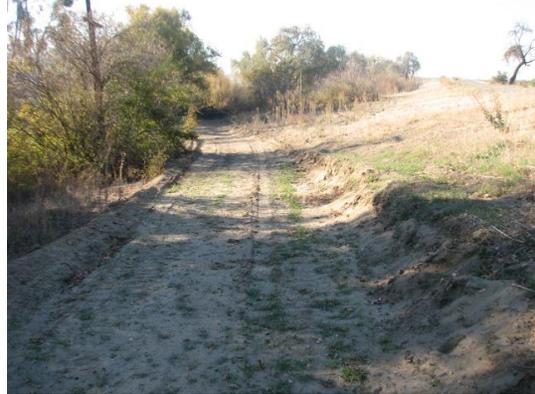
Photo 1 of 2 : johngw_s_20140414_574.jpg

LM Start	1.76	Rating **	M	Issue No.	137
LM End	1.76	Issue Type +	Ma	Location *	WS
Category	Earthen Levee		GPS Latitude/Longitude		
			Start	End	
Item	Crown Surface / Depressions / Rutting		38.699130 °	38.699130 °	
			-121.631300 °	-121.631300 °	
DWR ID	DWR_RD1600_01_f_2013_137				
Action/Comments					
Repair depressions or ruts in the crown or slope.

It appears that a dozer has pushed a pile of brush to the waters edge.
Fall 2013

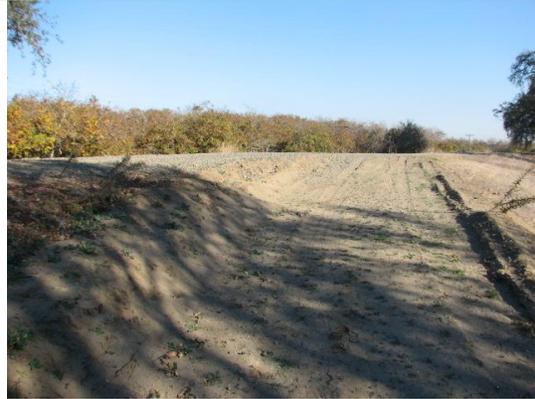
Photo 2 of 2 : johngw_s_20140414_575.jpg

A look at the cut done by the dozer. Fall 2013

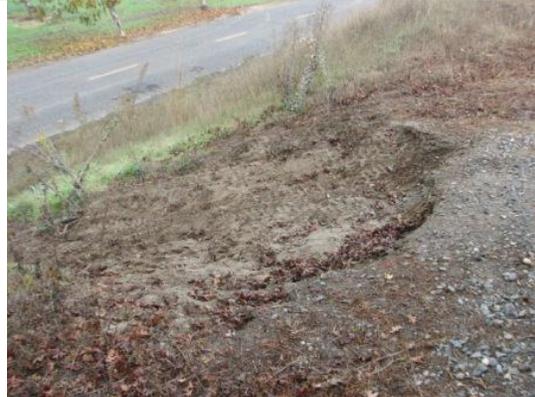
Photo 1 of 1 : johngw_s_20140414_545.jpg

LM Start	2.02	Rating **	M	Issue No.	17
LM End	2.02	Issue Type +	Ma	Location *	LS
Category	Earthen Levee			GPS Latitude/Longitude	
				Start	End
Item	Erosion / Bank Caving			38.701590 °	38.701590 °
				-121.627991 °	-121.627991 °
DWR ID	DWR_RD1600_01_f_2012_17				
Action/Comments					
Schedule repair of erosion site prior to the next inspection.

Vehicle and foot traffic has caused erosion. Fall 2012

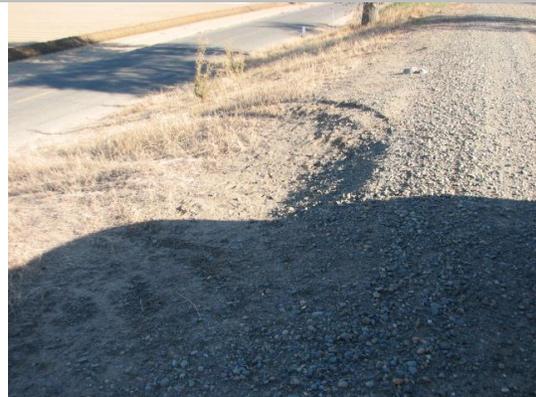
Photo 1 of 1 : johngw_s_20140414_583.jpg

LM Start	2.42	Rating **	M	Issue No.	143
LM End	2.42	Issue Type +	Ma	Location *	LS
Category	Earthen Levee		GPS Latitude/Longitude		
			Start	End	
Item	Slope Stability		38.705152 °	38.705152 °	
			-121.622190 °	-121.622190 °	
DWR ID	DWR_RD1600_01_f_2013_143				
Action/Comments					
Repair slope instability.

The levee slope appears to have slipped at the shoulder. Fall 2013

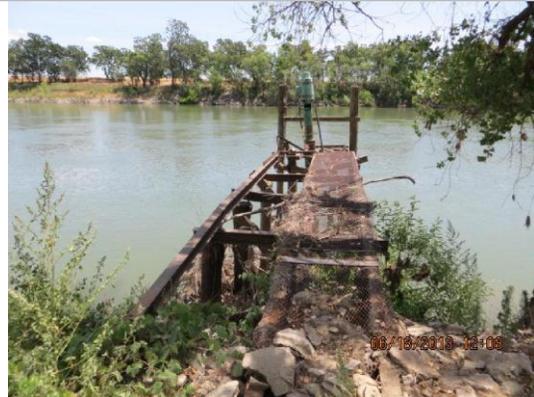
Photo 1 of 1 : UCIP_1212.jpg

LM Start	2.83	Rating **	M	Issue No.	615
LM End	2.83	Issue Type +	En	Location *	LS
Category	Supplemental			GPS Latitude/Longitude	
				Start	End
Item	DWR UCIP Field Study			38.709350 °	38.709350 °
				-121.616912 °	-121.616912 °
DWR ID	DWR_RD1600_01_s_2014_615				
Action/Comments					
Inspector Comments: FS_ID:15108 EP_NO: N/A Repair Type: Crossing Status: UCIP Comments: Appears abandoned and should be done so properly. Debris buildup on pier. Power cut to pump. FIELD_STRUCT_DESC: 16-inch pipe through levee 2-feet below crown. Walkway from berm to pump on pile structure in the stream. Siphon breaker on the landward slope. 12-inch PVC standpipe off LS toe. Originally included in 1955 O+M manual. FS Date: 6/18/2013

Debris buildup at metal platform waterline.

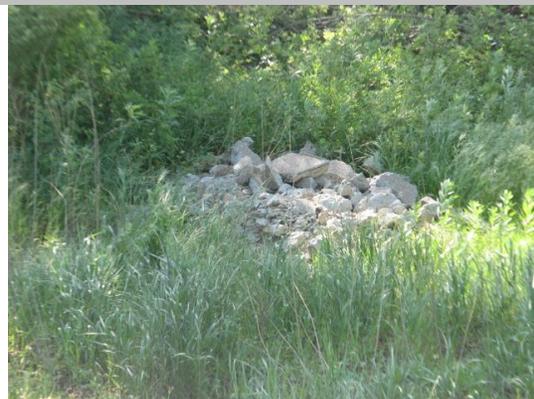
Photo 1 of 1 : johngw_s_20140421_819.jpg

Concrete debris is on the waterside berm. Spring 2014

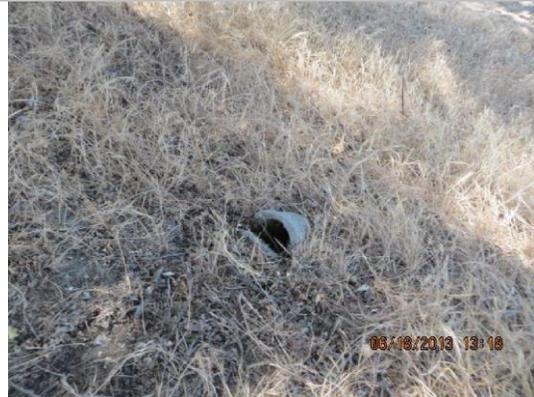
Photo 1 of 1 : UCIP_1215.jpg

LM Start	2.94	Rating **	M	Issue No.	616
LM End	2.94	Issue Type +	En	Location *	CR
Category	Supplemental		GPS Latitude/Longitude		
			Start	End	
Item	DWR UCIP Field Study		38.710497 °	38.710497 °	
			-121.615381 °	-121.615381 °	
DWR ID	DWR_RD1600_01_s_2014_616				
Action/Comments					
Inspector Comments: FS_ID:15110 EP_NO: N/A Repair Type: Crossing Status: UCIP Comments: Abandoned and should be removed from levee. FIELD_STRUCT_DESC: *Abandoned* 10-inch concrete pipe through levee 5.0 feet below crown. Pipe visible on LS slope. Originally included in the 1955 O&M manual. FS Date: 6/18/2013

Pipe visible on LS slope.

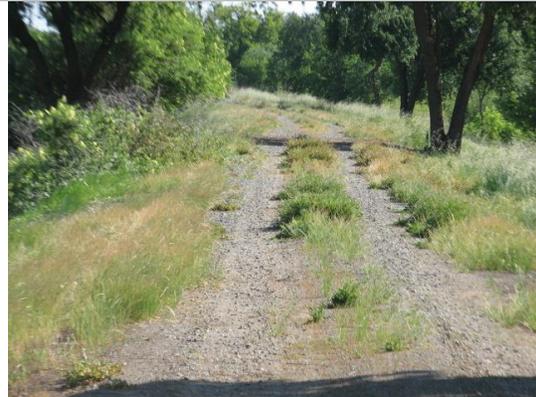
Photo 1 of 1 : johngw_s_20140421_820.jpg

The vegetation on the crown needs to be controlled. Spring 2014

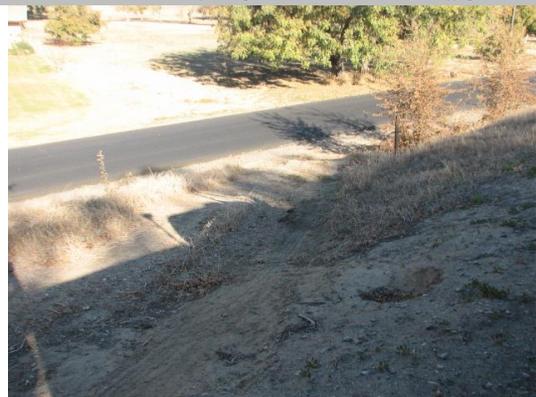
Photo 1 of 1 : johngw_s_20140414_579.jpg

LM Start	3.06	Rating **	M	Issue No.	140
LM End	3.06	Issue Type +	Ma	Location *	LS
Category	Earthen Levee		GPS Latitude/Longitude		
			Start	End	
Item	Erosion / Bank Caving		38.711655 °	38.711655 °	
			-121.613871 °	-121.613871 °	
DWR ID	DWR_RD1600_01_f_2013_140				
Action/Comments					
Schedule repair of erosion site prior to the next inspection.

Erosion caused by vehicle traffic on the landside slope. Fall 2013

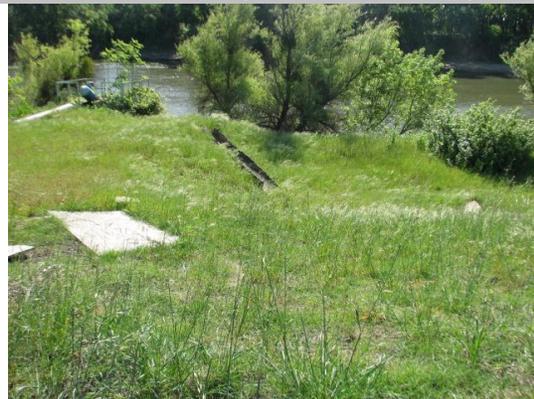
Photo 1 of 1 : johngw_s_20140421_821.jpg

Metal pipe and wood debris is on the waterside berm. Spring 2014

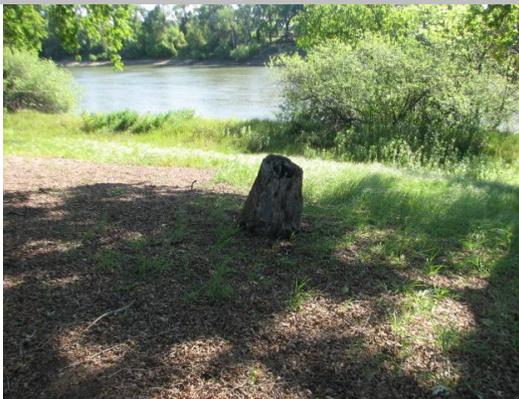
Photo 1 of 1 : johngw_s_20140421_823.jpg

A stump visibly decomposing and may cause a risk to the levee. Spring 2014

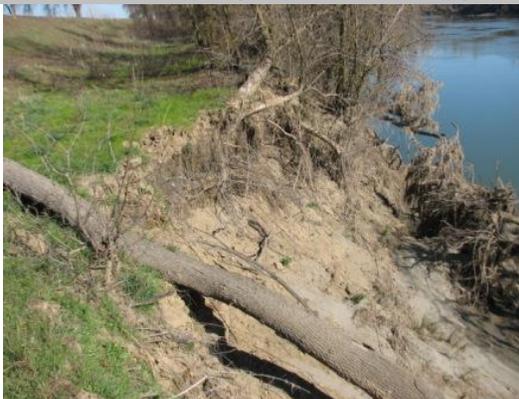
Photo 1 of 1 : johngw_s_20140414_520.jpg

Trees have fallen and the water has created the erosion into the berm. Spring 2013

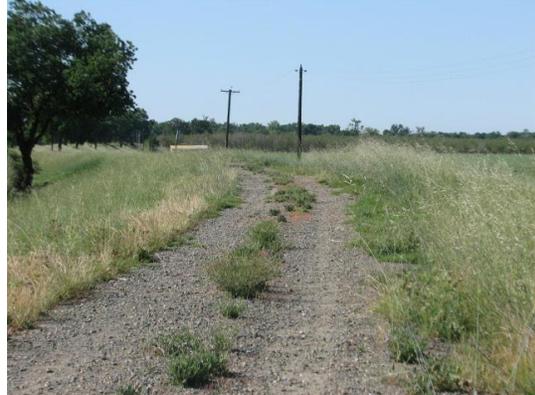
Photo 1 of 1 : johngw_s_20140421_824.jpg

The vegetation needs to be controlled on the crown. Spring 2014

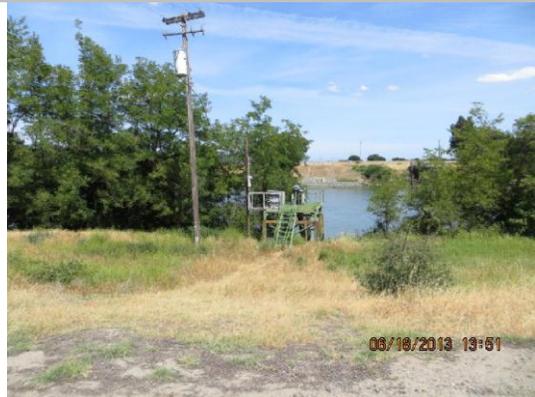
Photo 1 of 1 : UCIP_1217.jpg

LM Start	4.53	Rating **	M	Issue No.	617
LM End	4.53	Issue Type +	En	Location *	CR
Category	Supplemental		GPS Latitude/Longitude		
			Start	End	
Item	DWR UCIP Field Study		38.731143 °	38.731143 °	
			-121.605825 °	-121.605825 °	
DWR ID	DWR_RD1600_01_s_2014_617				
Action/Comments					
Inspector Comments: FS_ID:15125 EP_NO: N/A Repair Type: Crossing Status: UCIP Comments: Pumphouse abandoned with deep pit open. Safety issue. If plant is abandoned it should be done so properly. FIELD_STRUCT_DESC: 24-inch pipe through the levee 21.4 feet below the crown. 16-inch pipe ties into 24-inch at WS slope. Slant pump on metal platform and gate valve on water side berm. Gate valve in pump house off the landward side. Two power poles at the toe of the landward slope. FS Date: 6/18/2013 7:36:00 AM

Slant pump on metal pier on WS berm.

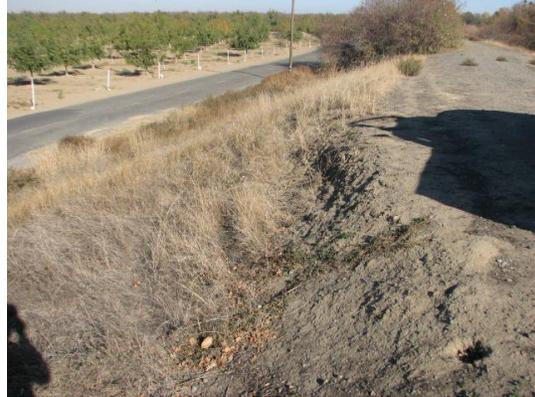
Photo 1 of 1 : johngw_s_20140414_580.jpg

LM Start	4.80	Rating **	M	Issue No.	141
LM End	4.80	Issue Type +	Ma	Location *	LS
Category	Earthen Levee		GPS Latitude/Longitude		
			Start	End	
Item	Slope Stability		38.734840 °	38.734840 °	
			-121.605026 °	-121.605026 °	
DWR ID	DWR_RD1600_01_f_2013_141				
Action/Comments					
Repair slope instability.

The erosion at the shoulder of the levee could be slope instability. Fall 2013

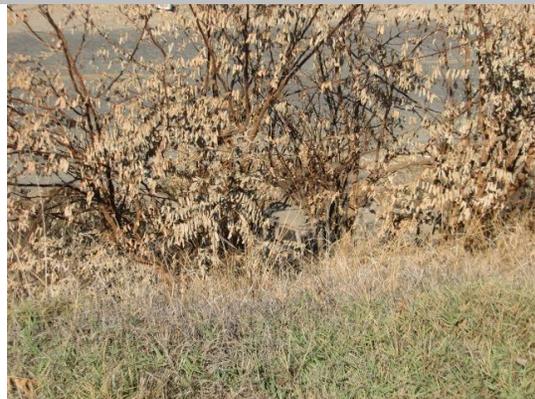
Photo 1 of 1 : johngw_s_20140414_544.jpg

Tree stumps on the levee slope has been sprayed. Fall 2013

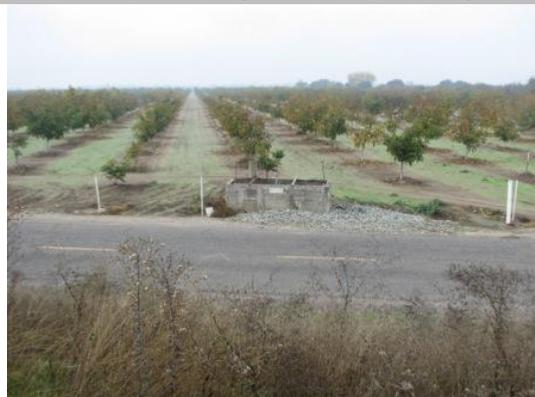
Photo 1 of 2 : johngw_s_20140414_555.jpg

LM Start	4.89	Rating **	U	Issue No.	25
LM End	4.89	Issue Type +	Ma	Location *	LS
Category	Earthen Levee		GPS Latitude/Longitude		
			Start	End	
Item	Erosion / Bank Caving		38.736250 °	38.736250 °	
			-121.604605 °	-121.604605 °	
DWR ID	DWR_RD1600_01_f_2012_25				
Action/Comments					
Schedule repair of erosion site prior to the next inspection. Inspector Comments: Hole in pipe causing erosion of levee slope. Replace pipe and repair damage.

The concrete collection box across the road. Fall 2012

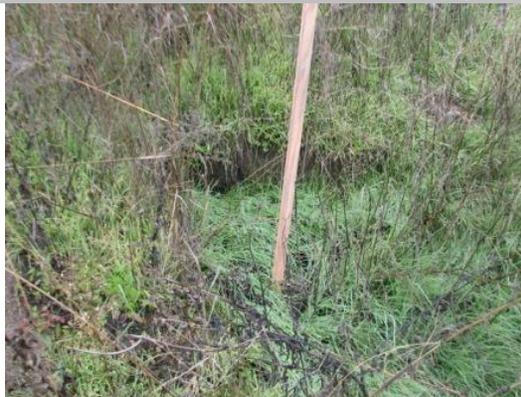
Photo 2 of 2 : johngw_s_20140414_556.jpg

LM Start	4.89	Rating **	U	Issue No.	25 (cont)
LM End	4.89	Issue Type +	Ma	Location *	LS
Category	Earthen Levee			GPS Latitude/Longitude	
				Start	End
Item	Erosion / Bank Caving			38.736250 °	38.736250 °
				-121.604605 °	-121.604605 °
DWR ID	DWR_RD1600_01_f_2012_25				
Action/Comments					
Schedule repair of erosion site prior to the next inspection. Inspector Comments: Hole in pipe causing erosion of levee slope. Replace pipe and repair damage.

The hole in the levee slope from the leaking pipe. Fall 2012

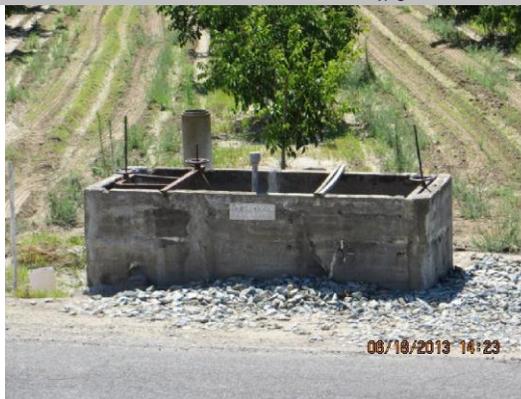
Photo 1 of 1 : UCIP_1224.jpg

LM Start	4.90	Rating **	M	Issue No.	618
LM End	4.90	Issue Type +	En	Location *	LS
Category	Supplemental			GPS Latitude/Longitude	
				Start	End
Item	DWR UCIP Field Study			38.736299 °	38.736299 °
				-121.604582 °	-121.604582 °
DWR ID	DWR_RD1600_01_s_2014_618				
Action/Comments					
Inspector Comments: FS_ID:15130 EP_NO: N/A Repair Type: Crossing Status: UCIP Comments: No pump on pier and pipe open on both ends without a closure device. FIELD_STRUCT_DESC: 18-inch steel pipe through levee 6.7-feet below crown. Pump on wooden pier off waterward side. Air vents on WS slope and meter at outlet on LS toe. 6'X14' concrete distribution box off LS toe. 2-inch galvanized iron electrical conduit through the levee at same location. Originally included in the 1955 O&M manual. FS Date: 6/18/2013

6'X14' concrete distribution box off LS toe.

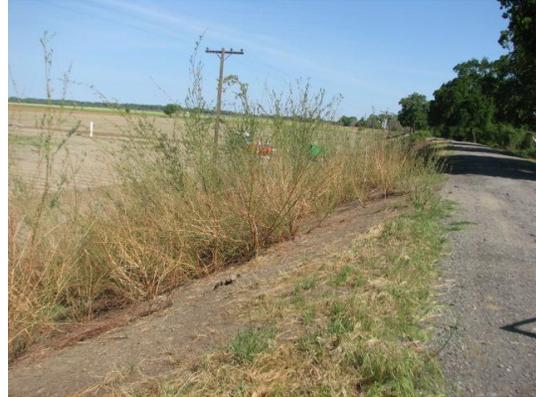
Photo 1 of 1 : johngw_s_20140421_825.jpg

The tall brush and vegetation blocks visibility. Spring 2014

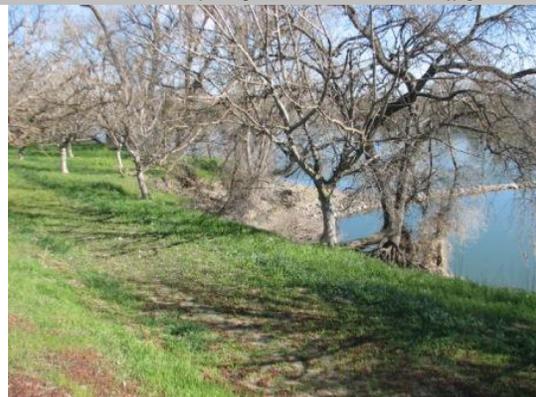
Photo 1 of 1 : johngw_s_20140414_560.jpg

Erosion is into the berm area and needs to be monitored. Spring 2013

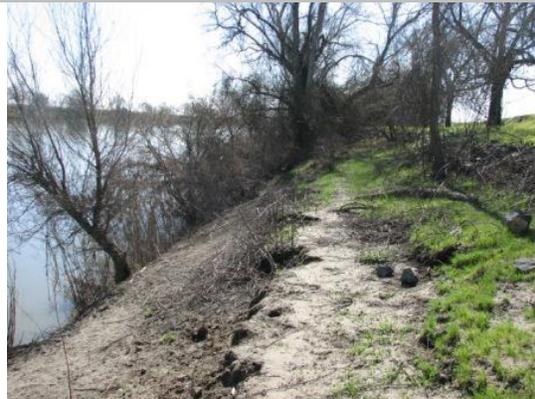
Photo 2 of 2 : johngw_s_20140414_550.jpg

The erosion is eroding away the berm area.

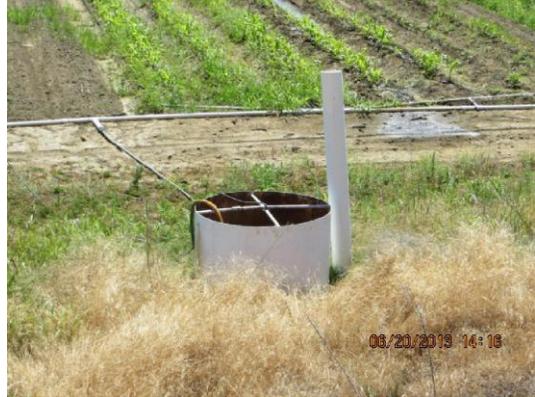
Photo 1 of 1 : UCIP_1452.jpg

4-foot diameter steel standpipe at LS toe, may be indicator of pipe location.

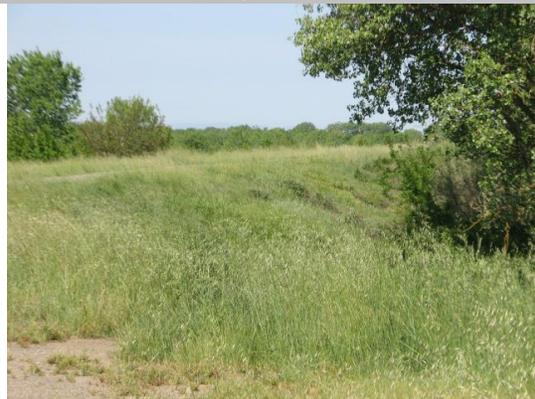
Photo 1 of 1 : johngw_s_20140421_826.jpg

Tall grasses partially blocks visibility. Spring 2014

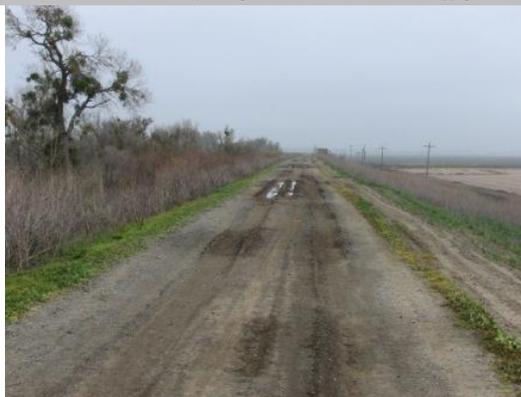
Photo 1 of 1 : johngw_s_20140414_693.jpg

This area is soft and needs to have AB added to make an all weather surface.

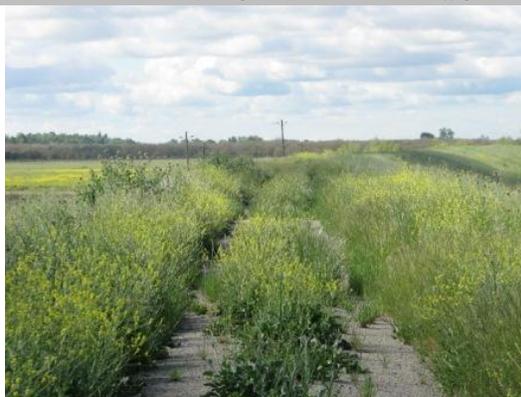
Photo 1 of 2 : johngw_s_20140414_698.jpg

The crown roadway needs to be free of weeds. Photo taken spring 2012.

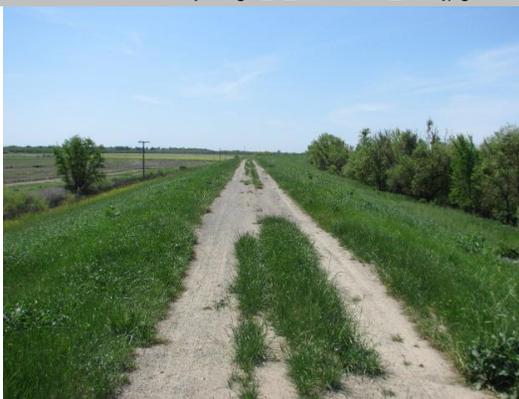
Photo 1 of 1 : johngw_s_20140421_833.jpg

The vegetation on the crown needs to be controlled. Spring 2014

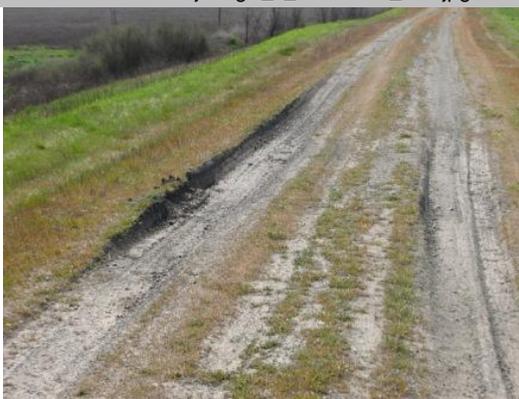
Photo 1 of 1 : johngw_s_20140414_687.jpg

Ruts in the levee crown Spring 2013

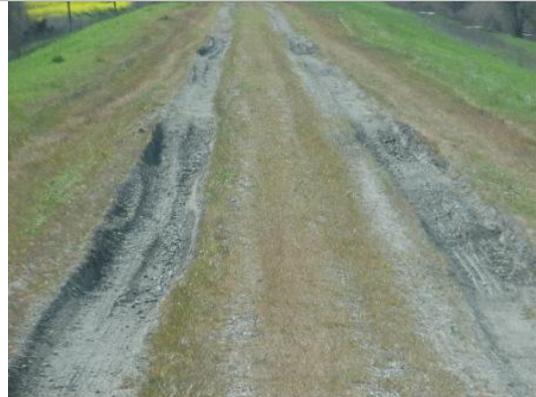
Photo 1 of 2 : johngw_s_20140414_689.jpg

Ruts in the levee crown. Spring 2013

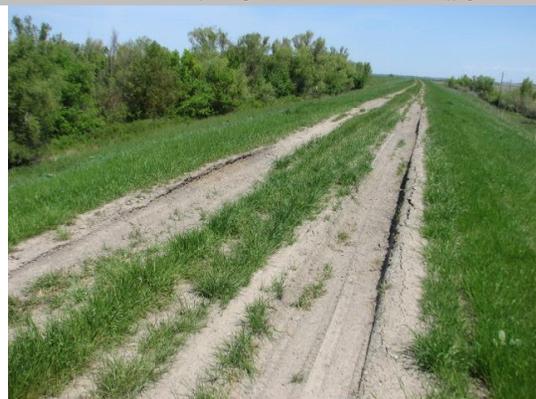
Photo 2 of 2 : johngw_s_20140421_834.jpg

Ruts in the all weather road need to be repaired. Spring 2014

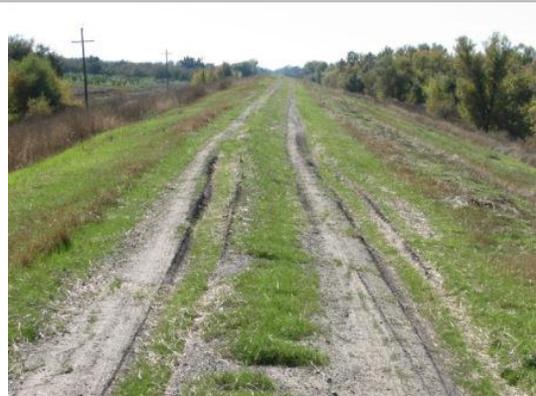
Photo 1 of 3 : johngw_s_20140414_700.jpg

The crown has ruts deeper then six inches. Fall 2012

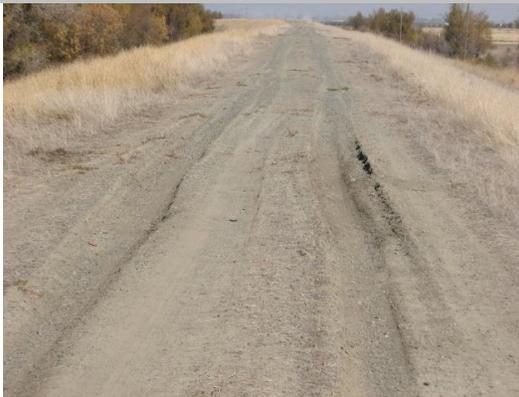
Photo 2 of 3 : johngw_s_20140414_701.jpg

Tire ruts are deeper than 6 inches on the crown. Fall 2013

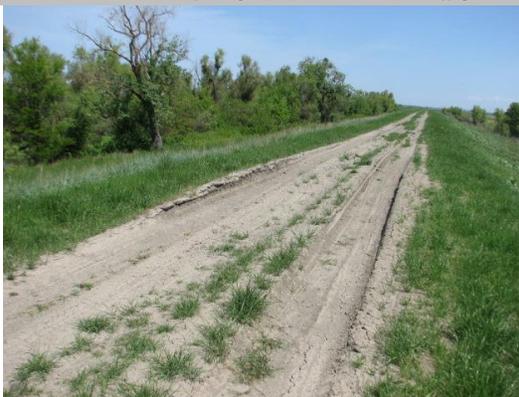
Photo 3 of 3 : johngw_s_20140421_835.jpg

Ruts in the all weather road needs to be repaired. Spring 2014

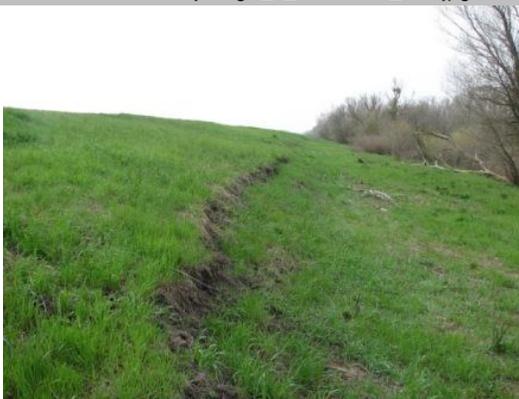
Photo 1 of 2 : johngw_s_20140414_694.jpg

Wave wash damage along the slope the cut is 1'-2'.

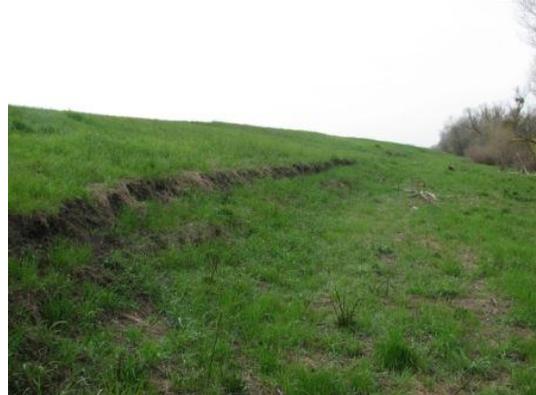
Photo 2 of 2 : johngw_s_20140414_695.jpg

A closer view of the wave wash damage along the bypass.

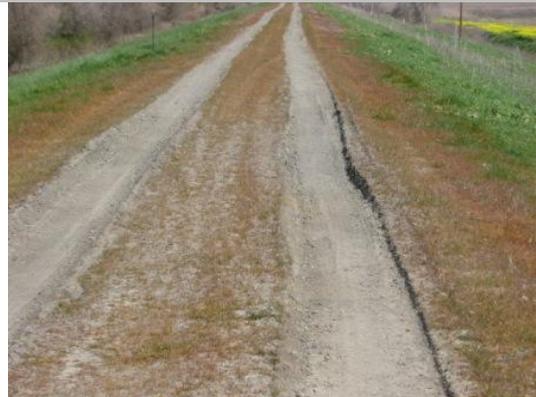
Photo 1 of 3 : johngw_s_20140414_690.jpg

Ruts in the levee crown. Spring 2013

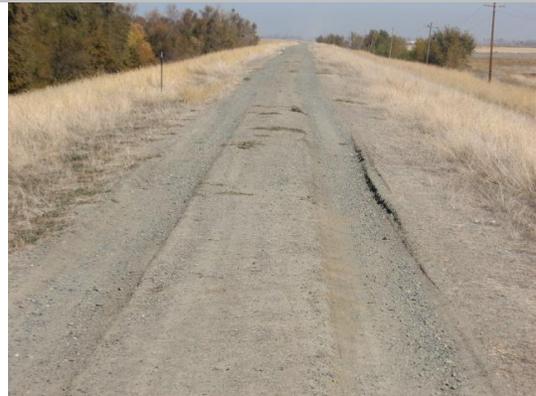
Photo 2 of 3 : johngw_s_20140414_691.jpg

Tire ruts are deeper than 6 inches on the crown. Fall 2013

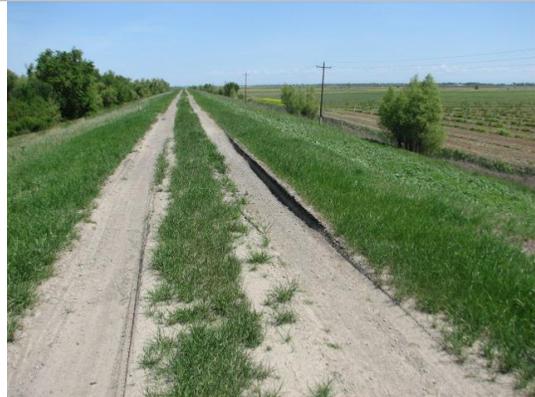
Photo 3 of 3 : johngw_s_20140421_836.jpg

Ruts in the all weather road needs to be repaired. Spring 2014

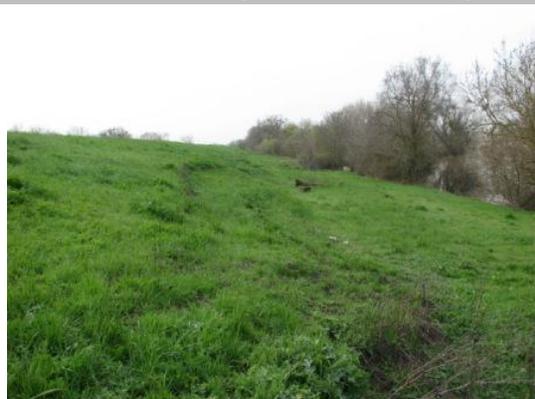
Photo 1 of 2 : johngw_s_20140414_696.jpg

This is wave wash damage along the toe of the levee looking downstream.

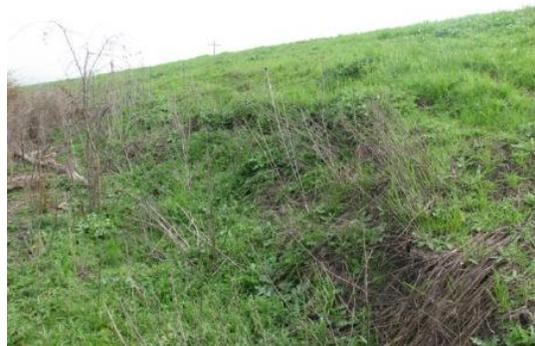
Photo 2 of 2 : johngw_s_20140414_697.jpg

Looking upstream a deeper cut of 2'-3' damage.
