**Flood Control Project Maintenance
Levee Inspections**
LMA District Cover Sheet
Spring 2016 Levee Inspection Results

Reclamation District No. 1600 Mull

Spring 2016 Levee Inspection Results

Waterway		Bank	Unit Miles	
Unit No. 01 Sacramento River		Right	10.46	
	Spring (March - May)	Summer (June - August)	(September - November) Fall	Winter (December - February)
Unit Maintenance Rating (Fall Only)				
Date of Inspection	3/24/2016 - 3/24/2016			
DWR Inspector	Jai Lor			
Accompanied By

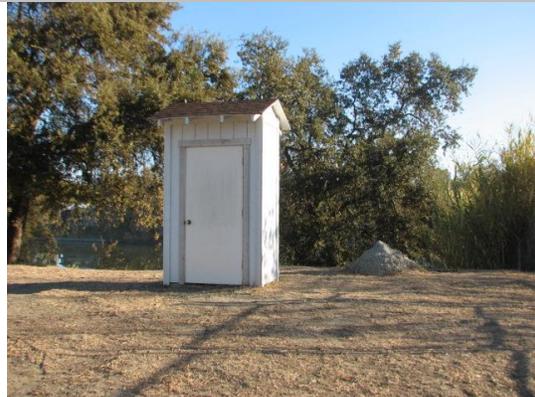
Photo 1 of 1 : SP_2016_RD1600_191_129_20160304_00054.jpg

The small building is a pump house for the well. It services the house with water. Fall 2013

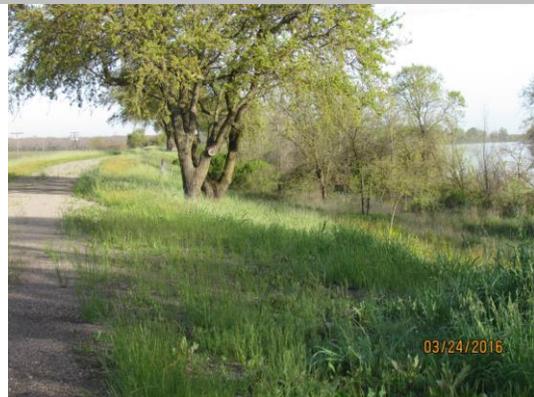
Photo 1 of 1 : SP_2016_RD1600_191_36_20160407_00098.jpg

View of the vegetation on the waterward side of the levee looking upstream. Spring 2016.

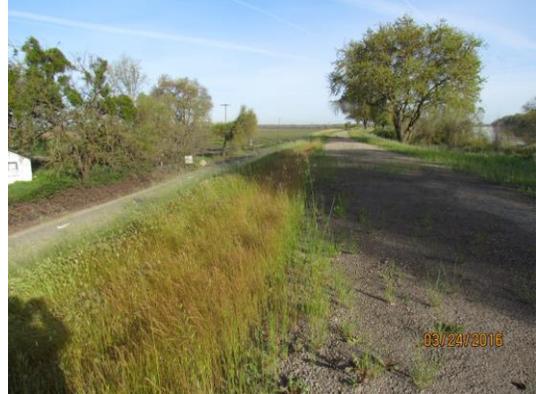
Photo 1 of 1 : SP_2016_RD1600_191_26_20160407_00097.jpg

View of the vegetation on the landward side of the levee looking upstream. Spring 2016.

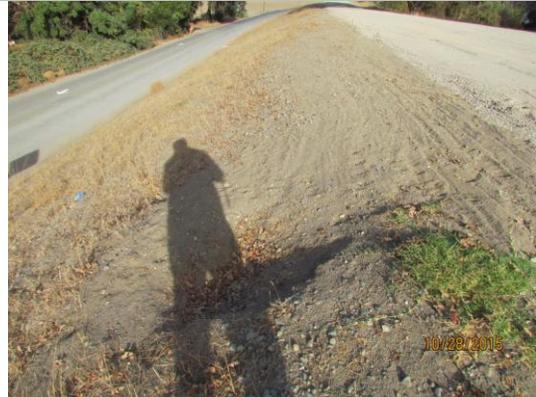
Photo 1 of 1 : SP_2016_RD1600_191_38_20160304_00033.jpg

LM Start	0.12	Rating **	M	Issue No.	38
LM End	0.12	Issue Type +	Ma	Location *	LS
Category	Earthen Levee		GPS Latitude/Longitude		
			Start	End	
Item	Slope Stability		38.676654 °	38.676654 °	
			-121.631348 °	-121.631348 °	
DWR ID	DWR_RD1600_01_f_2015_38				
Comment Code					
S3 : Repair the levee slope damaged by vehicle traffic and prevent access where possible.					
Inspector Comment

View of a slope depression on the landward side of the levee looking downstream. Fall 2015.

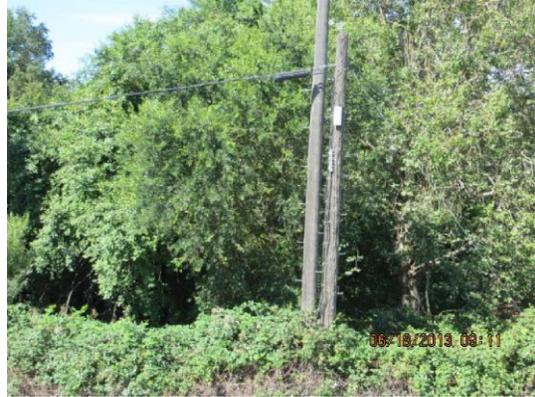
Photo 1 of 1 : UCIP_SP_2016_15087_24812.jpg

LM Start	0.13	Rating **	M	Issue No.	1203
LM End	0.13	Issue Type +	En	Location *	LS
Category	Supplemental			GPS Latitude/Longitude	
				Start	End
Item	DWR UCIP Field Study			38.676802 °	38.676802 °
				-121.631442 °	-121.631442 °
DWR ID					
Comment Code					
Inspector Comment					
FS_ID:15087 DS_ID:21459 EP_NO: 1929 Repair Type: Non-Urgent Crossing Status: Indicator Found UCIP Comments: Line should be located with carsonite signs on both sides of levee. FIELD_STRUCT_DESC: Telephone cable through levee 3.0 feet below crown. Telephone line at JP off LS toe (Permit No. 1929, 1959). FS Date: 6/18/2013

Line visible on JP off LS toe. Likely this is the source of crossing.

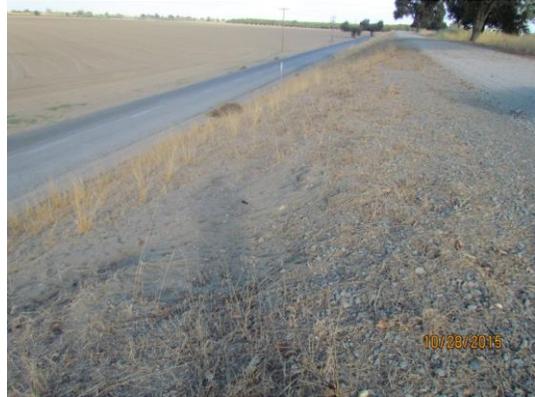
Photo 1 of 1 : SP_2016_RD1600_191_39_20160304_00034.jpg

LM Start	0.21	Rating **	M	Issue No.	39
LM End	0.21	Issue Type +	Ma	Location *	LS
Category	Earthen Levee			GPS Latitude/Longitude	
				Start	End
Item	Slope Stability			38.677766 °	38.677766 °
				-121.632123 °	-121.632123 °
DWR ID	DWR_RD1600_01_f_2015_39				
Comment Code					
S2 : Repair the levee slope damaged by foot traffic and prevent access where possible.					
Inspector Comment

View of the slope stability on the landward side of the levee looking upstream. Fall 2015.

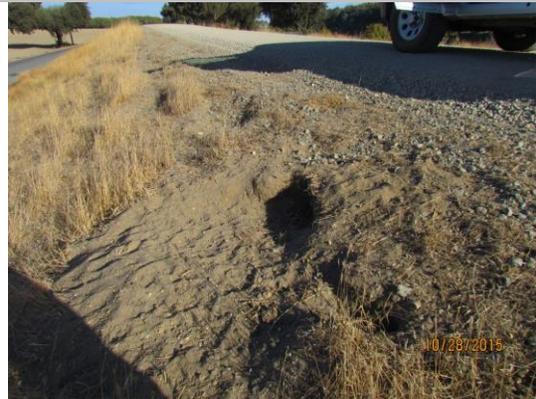
Photo 1 of 1 : SP_2016_RD1600_191_40_20160304_00035.jpg

View of the rodent hole on the landward side of the levee looking upstream. Fall 2015.

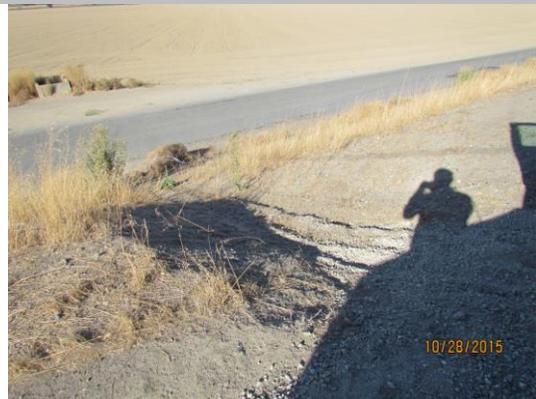
Photo 1 of 1 : SP_2016_RD1600_191_133_20160304_00055.jpg

LM Start	0.53	Rating **	M	Issue No.	133
LM End	0.53	Issue Type +	Ma	Location *	LS
Category	Earthen Levee			GPS Latitude/Longitude	
				Start	End
Item	Slope Stability			38.682140 °	38.682140 °
				-121.634083 °	-121.634083 °
DWR ID	DWR_RD1600_01_f_2013_133				
Comment Code					
S2 : Repair the levee slope damaged by foot traffic and prevent access where possible.					
Inspector Comment

View of the slope stability on the landward side of the levee. Fall 2015.

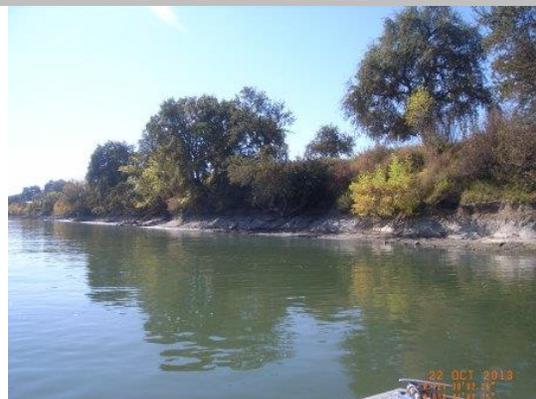
Photo 1 of 1 : SP_2016_RD1600_191_7_20160304_00009.jpg

LM Start	0.56	Rating **	M	Issue No.	7
LM End	0.66	Issue Type +	Ma	Location *	WS
Category	Supplemental			GPS Latitude/Longitude	
				Start	End
Item	2015 USACE Erosion Survey, DRAFT			38.682707 °	38.684106 °
				-121.633830 °	-121.634219 °
DWR ID	DWR_RD1600_01_s_2016_7				
Comment Code					
Inspector Comment					
2000 - Very cohesive vertical bank. 2003 - Some minor new erosion. 2006 - Some minor erosion in old pockets. 2009 - Minimal new erosion. 2011 - Multiple new erosion pockets and a few new tree popouts. 2015: No observed changes. [2015 Site ID: SAC_71-3_R]

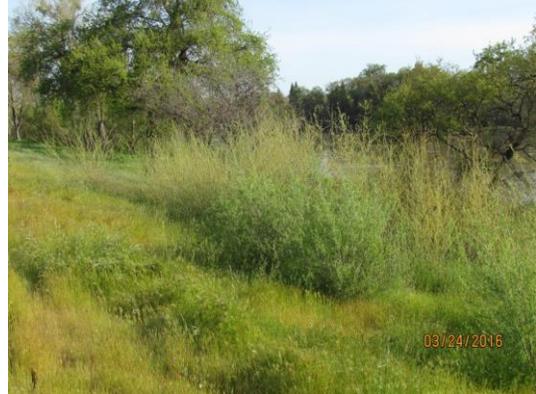
Photo 1 of 2 : SP_2016_RD1600_191_29_20160407_00101.jpg

LM Start	0.62	Rating **	M	Issue No.	29
LM End	0.62	Issue Type +	Ma	Location *	WS
Category	Earthen Levee		GPS Latitude/Longitude		
			Start	End	
Item	Vegetation		38.683415 °	38.683415 °	
			-121.634448 °	-121.634448 °	
DWR ID	DWR_RD1600_01_s_2016_29				
Comment Code					
V2 : Remove the wild growth other than native grasses from the levee slopes.					
Inspector Comment					
Recommend removal of willow trees.

Perspective view of the willows on the waterward side of the levee looking upstream. Spring 2016.

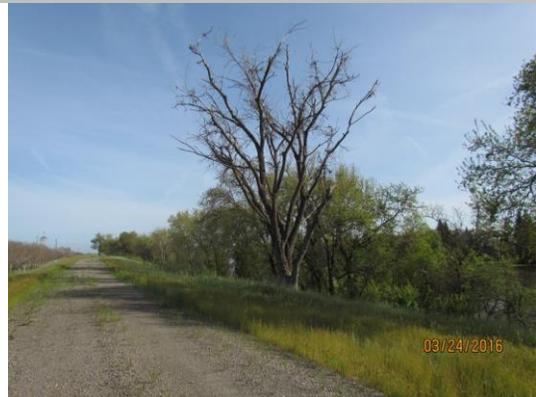
Photo 1 of 1 : SP_2016_RD1600_191_624_20160407_00104.jpg

View of the dying tree on the waterward side of the levee looking upstream. Spring 2016.

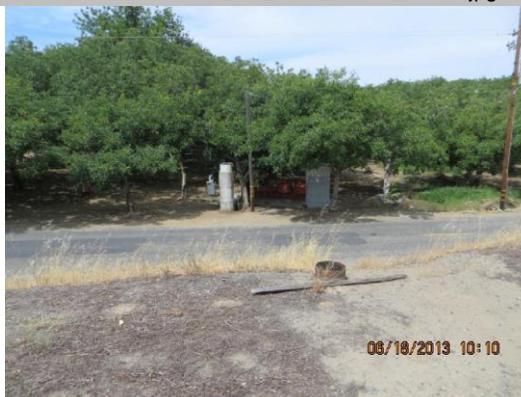
Photo 1 of 2 : UCIP_SP_2016_15285_25088.jpg

LM Start	0.94	Rating **	M	Issue No.	1211
LM End	0.94	Issue Type +	En	Location *	WS
Category	Supplemental			GPS Latitude/Longitude	
				Start	End
Item	DWR UCIP Field Study			38.688030 °	38.688030 °
				-121.635367 °	-121.635367 °
DWR ID					
Comment Code					
Inspector Comment					
FS_ID:15285 DS_ID:21463 EP_NO: 6100 Repair Type: Non-Urgent Crossing Status: Found UCIP Comments: Gate valve will not open or close. FIELD_STRUCT_DESC: 12-inch pipe through levee 3.4 feet below crown. Slant pump and gate valve on the waterward- slope. Siphon breaker in 12-inch steel riser on the landward shoulder. Filter, booster pump, and butterfly valve on LS toe. 2.25-inch galvanized iron electrical conduit at same location (Permit No. 6100, 1968). Replaced 8-inch pipe at same location. FS Date: 6/18/2013

Siphon breaker in steel riser on LS shoulder and concrete standpipe off LS toe.

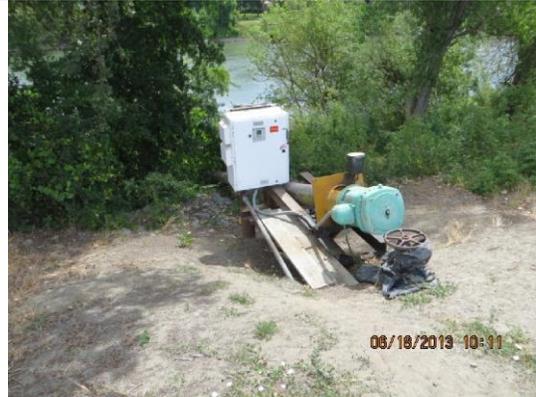
Photo 2 of 2 : UCIP_SP_2016_15285_25087.jpg

LM Start	0.94	Rating **	M	Issue No.	1211 (cont)
LM End	0.94	Issue Type +	En	Location *	WS
Category	Supplemental			GPS Latitude/Longitude	
				Start	End
Item	DWR UCIP Field Study			38.688030 °	38.688030 °
				-121.635367 °	-121.635367 °
DWR ID					
Comment Code					
Inspector Comment					
FS_ID:15285 DS_ID:21463 EP_NO: 6100 Repair Type: Non-Urgent Crossing Status: Found UCIP Comments: Gate valve will not open or close. FIELD_STRUCT_DESC: 12-inch pipe through levee 3.4 feet below crown. Slant pump and gate valve on the waterward- slope. Siphon breaker in 12-inch steel riser on the landward shoulder. Filter, booster pump, and butterfly valve on LS toe. 2.25-inch galvanized iron electrical conduit at same location (Permit No. 6100, 1968). Replaced 8-inch pipe at same location. FS Date: 6/18/2013

Pump and gate valve on WS slope.

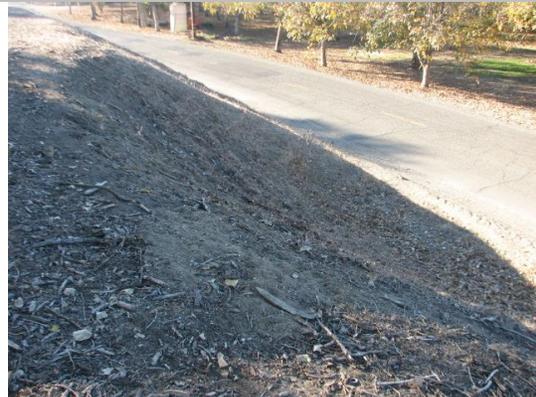
Photo 1 of 2 : SP_2016_RD1600_191_134_20160304_00056.jpg

LM Start	0.97	Rating **	M	Issue No.	134
LM End	0.97	Issue Type +	Ma	Location *	LS
Category	Earthen Levee			GPS Latitude/Longitude	
				Start	End
Item	Slope Stability			38.688454 °	38.688454 °
				-121.635528 °	-121.635528 °
DWR ID	DWR_RD1600_01_f_2013_134				
Comment Code					
S1 : Repair slope instability.					
Inspector Comment

The levee has a deep depression caused by slope stability. Fall 2013

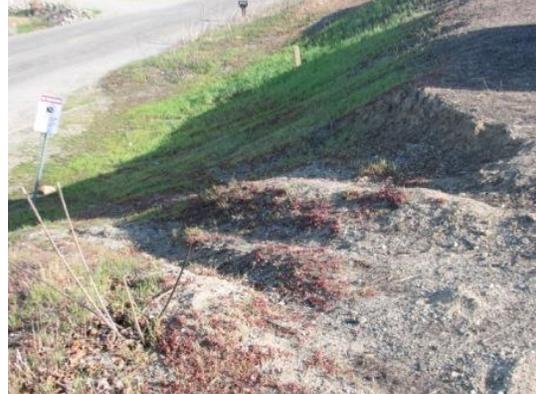
Photo 1 of 2 : SP_2016_RD1600_191_4_20160304_00004.jpg

LM Start	1.39	Rating **	M	Issue No.	4
LM End	1.39	Issue Type +	Ma	Location *	LS
Category	Earthen Levee		GPS Latitude/Longitude		
			Start	End	
Item	Slope Stability		38.694395°	38.694395°	
			-121.634376°	-121.634376°	
DWR ID	DWR_RD1600_01_f_2012_4				
Comment Code					
S3 : Repair the levee slope damaged by vehicle traffic and prevent access where possible.					
Inspector Comment					
Damage looks like caused by vehicles.

Erosion from vehicles on levee slope. Spring 2013

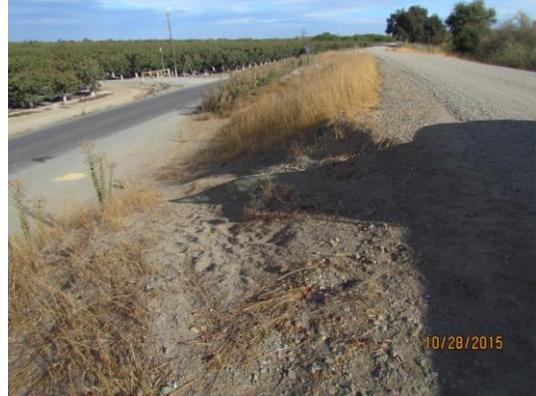
Photo 2 of 2 : SP_2016_RD1600_191_4_20160304_00005.jpg

View of the slope stability caused by vehicles on the landward side of the levee looking upstream. Fall 2015.

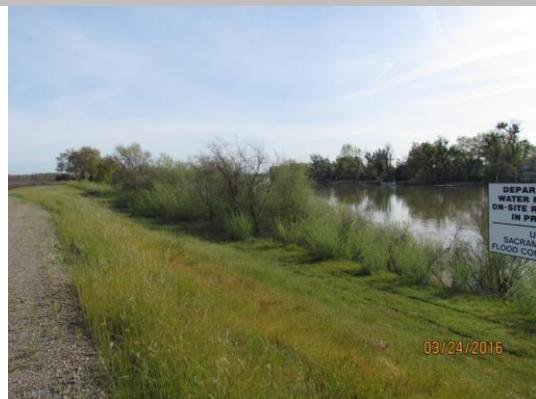
Photo 1 of 2 : SP_2016_RD1600_191_5_20160407_00110.jpg

View of the revegetation site on the berm of the waterward side of the levee looking upstream. Spring 2016.

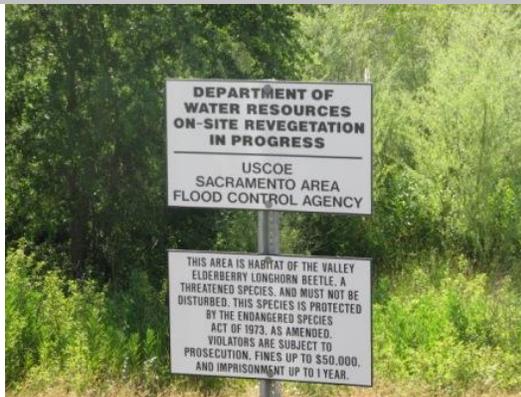
Photo 2 of 2 : SP_2016_RD1600_191_31_20160304_00029.jpg

Revegetation site with the Elderberry Beetle. Photo taken spring 2012.

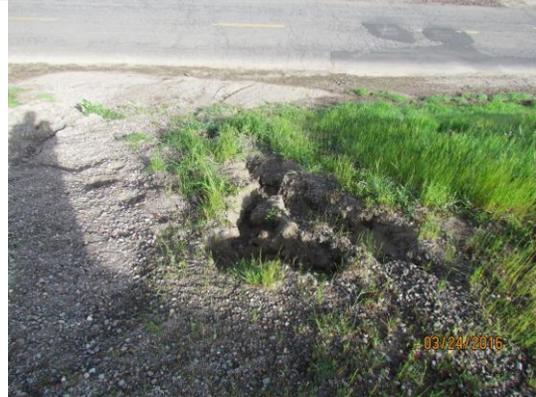
Photo 1 of 2 : SP_2016_RD1600_191_72_20160407_00113.jpg

LM Start	2.01	Rating **	U	Issue No.	72
LM End	2.01	Issue Type +	Ma	Location *	LS
Category	Earthen Levee			GPS Latitude/Longitude	
				Start	End
Item	Erosion / Bank Caving			38.701605 °	38.701605 °
				-121.627954 °	-121.627954 °
DWR ID	DWR_RD1600_01_s_2016_72				
Comment Code					
E2 : Schedule repair of erosion site prior to the next inspection.					
Inspector Comment					
Erosion seems to be caused by rain runoffs. Slope is graveled. Unsure if it is being used as a ramp.

Erosion is on the landward side of the levee about midway from the shoulder of the levee. Spring 2016.

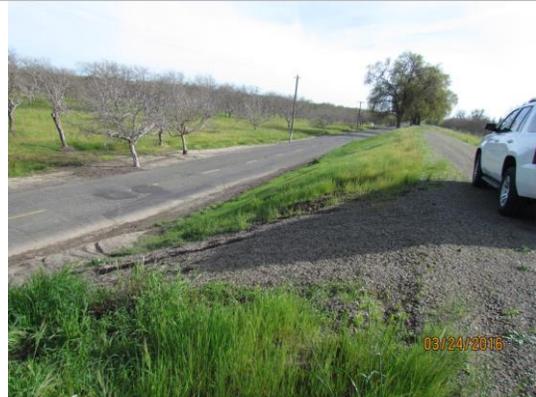
Photo 2 of 2 : SP_2016_RD1600_191_72_20160407_00114.jpg

Perspective view of the erosion on the landward side of the levee looking upstream. Spring 2016.

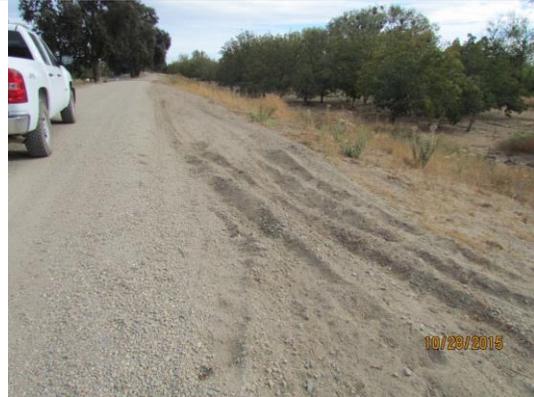
Photo 1 of 1 : SP_2016_RD1600_191_52_20160304_00044.jpg

LM Start	2.02	Rating **	M	Issue No.	52
LM End	2.02	Issue Type +	Ma	Location *	WS
Category	Earthen Levee			GPS Latitude/Longitude	
				Start	End
Item	Slope Stability			38.701753 °	38.701753 °
				-121.627734 °	-121.627734 °
DWR ID	DWR_RD1600_01_f_2015_52				
Comment Code					
S3 : Repair the levee slope damaged by vehicle traffic and prevent access where possible.					
Inspector Comment

View of the slope stability caused by vehicles on the waterward side of the levee looking upstream. Fall 2015.

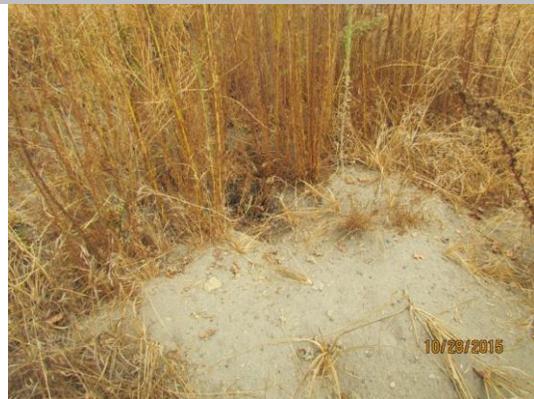
Photo 1 of 1 : SP_2016_RD1600_191_53_20160304_00045.jpg

View of the rodent hole on the waterward side of the levee. Fall 2015.

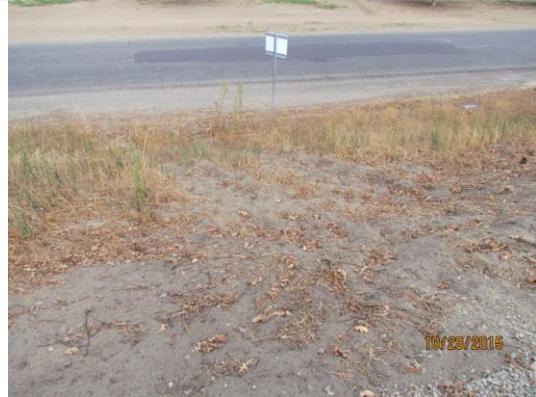
Photo 1 of 1 : SP_2016_RD1600_191_55_20160304_00047.jpg

LM Start	2.10	Rating **	M	Issue No.	55
LM End	2.10	Issue Type +	Ma	Location *	LS
Category	Earthen Levee			GPS Latitude/Longitude	
				Start	End
Item	Slope Stability			38.702416 °	38.702416 °
				-121.626593 °	-121.626593 °
DWR ID	DWR_RD1600_01_f_2015_55				
Comment Code					
S3 : Repair the levee slope damaged by vehicle traffic and prevent access where possible.					
Inspector Comment

View of the slope stability damaged by vehicles on the landward side of the levee. Fall 2015.

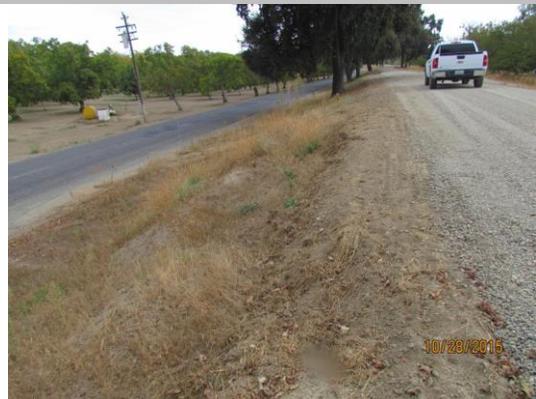
Photo 1 of 1 : SP_2016_RD1600_191_56_20160304_00048.jpg

LM Start	2.17	Rating **	M	Issue No.	56
LM End	2.17	Issue Type +	Ma	Location *	LS
Category	Earthen Levee			GPS Latitude/Longitude	
				Start	End
Item	Slope Stability			38.703025 °	38.703025 °
				-121.625605 °	-121.625605 °
DWR ID	DWR_RD1600_01_f_2015_56				
Comment Code					
S1 : Repair slope instability.					
Inspector Comment

View of the sloughing on the landward side of the levee looking upstream. Fall 2015.

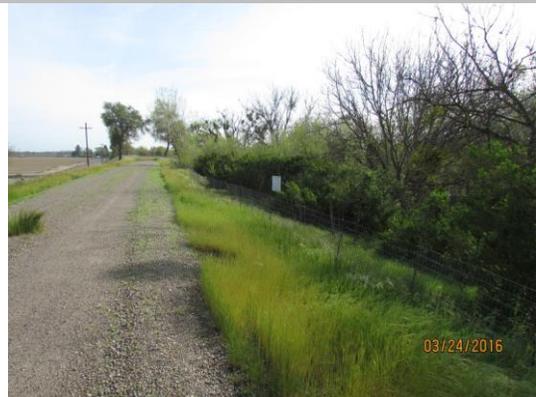
Photo 2 of 2 : SP_2016_RD1600_191_35_20160407_00115.jpg

View of the revegetation site on the waterward side of the levee looking upstream. Spring 2016.

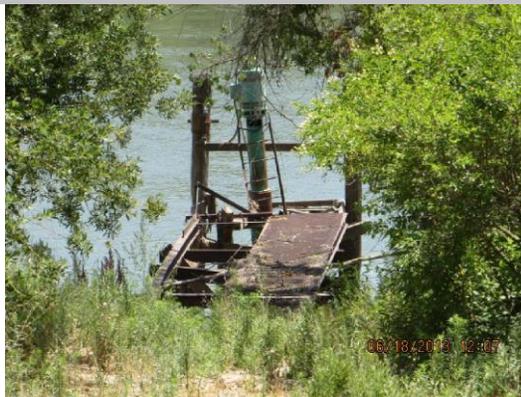
Photo 1 of 2 : UCIP_SP_2016_15108_24826.jpg

LM Start	2.81	Rating **	M	Issue No.	1204
LM End	2.81	Issue Type +	En	Location *	WS
Category	Supplemental			GPS Latitude/Longitude	
				Start	End
Item	DWR UCIP Field Study			38.709350 °	38.709350 °
				-121.616913 °	-121.616913 °
DWR ID					
Comment Code					
Inspector Comment					
FS_ID:15108 DS_ID:21467 EP_NO: N/A Repair Type: Non-Urgent Crossing Status: Found UCIP Comments: Appears abandoned and should be done so properly. Debris buildup on pier. Power cut to pump. FIELD_STRUCT_DESC: 16-inch pipe through levee 2-feet below crown. Walkway from berm to pump on pile structure in the stream. Siphon breaker on the landward slope. 12-inch PVC standpipe off LS toe. Originally included in 1955 O+M manual. FS Date: 6/18/2013

Pump on metal platform off WS berm.

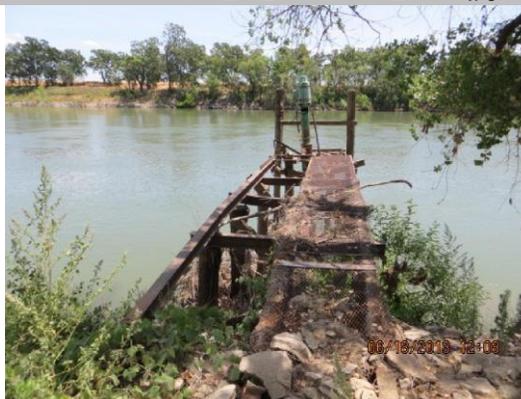
Photo 2 of 2 : UCIP_SP_2016_15108_24825.jpg

Debris buildup at metal platform waterline.

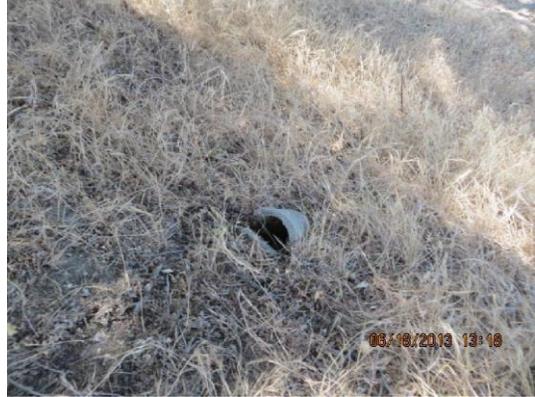
Photo 1 of 2 : UCIP_SP_2016_15110_24828.jpg

Pipe visible on LS slope.

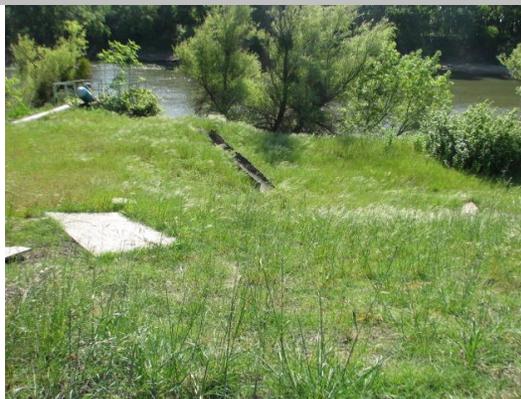
Photo 1 of 2 : SP_2016_RD1600_191_627_20160304_00063.jpg

Metal pipe and wood debris is on the waterside berm. Spring 2014

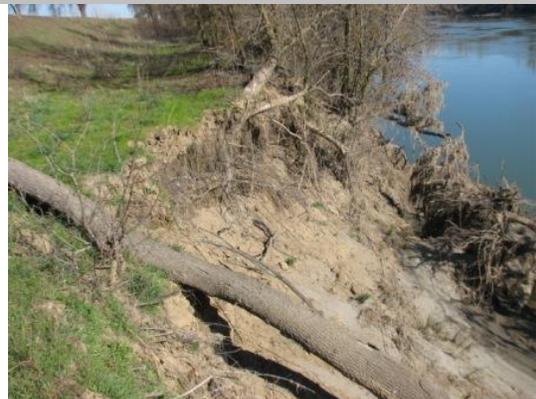
Photo 1 of 2 : SP_2016_RD1600_191_2_20160304_00002.jpg

Trees have fallen and the water has created the erosion into the berm. Spring 2013

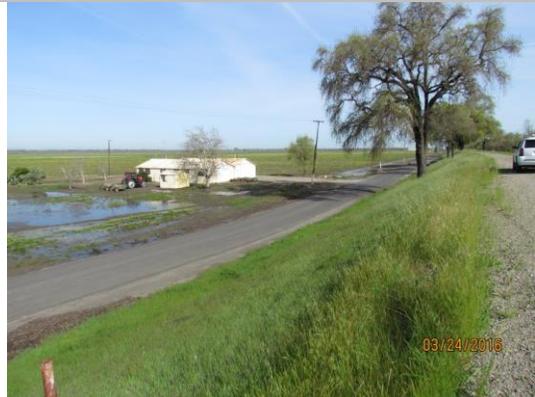
Photo 2 of 2 : SP_2016_RD1600_191_73_20160407_00121.jpg

View taken from the crown of the levee of the seepage. Spring 2016.

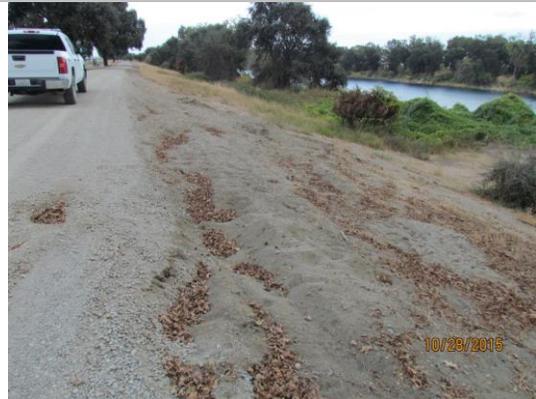
Photo 1 of 1 : SP_2016_RD1600_191_67_20160304_00053.jpg

View of the shoulder damaged by vehicles on the waterward side of the levee looking upstream. Fall 2015.

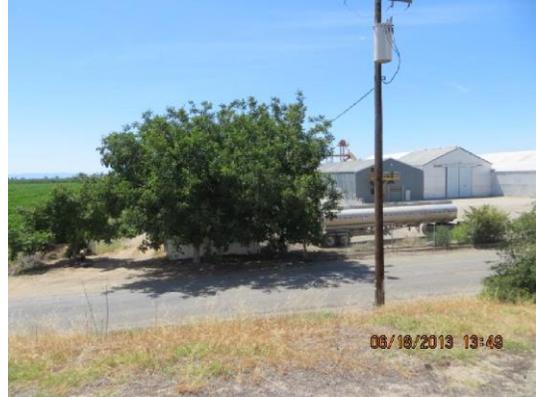
Photo 1 of 2 : UCIP_SP_2016_15125_24846.jpg

Pumphouse/distribution box off LS toe.

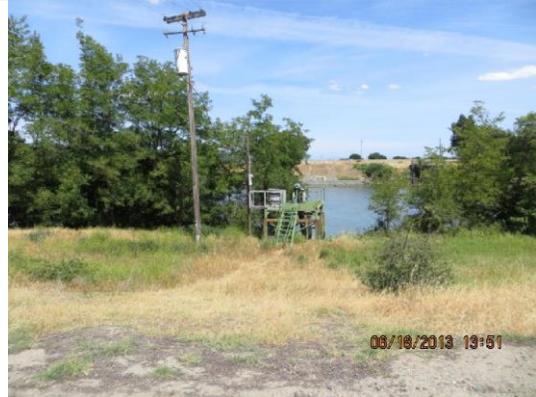
Photo 2 of 2 : UCIP_SP_2016_15125_24845.jpg

Slant pump on metal pier on WS berm.

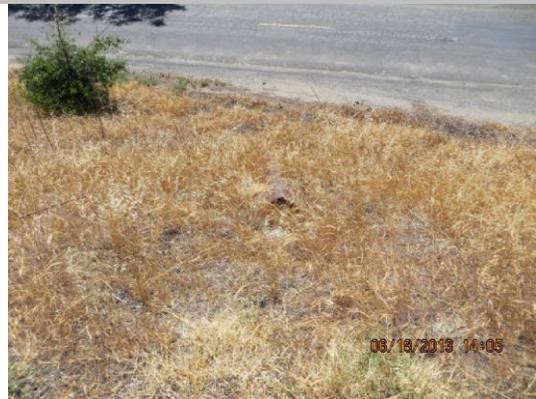
Photo 1 of 2 : UCIP_SP_2016_41563_27474.jpg

Pipe and remnants of grouted pipe on LS slope.

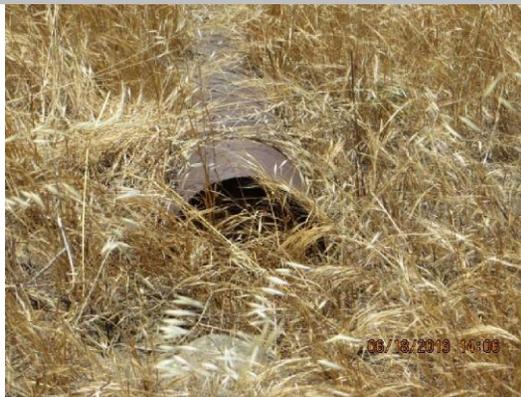
Photo 2 of 2 : UCIP_SP_2016_41563_27473.jpg

Pipe and remnants of grouted pipe on LS slope.

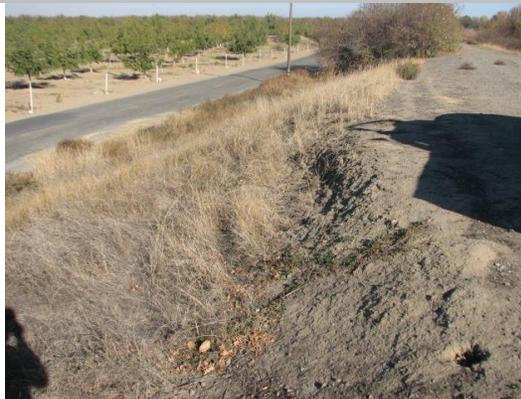
Photo 1 of 2 : SP_2016_RD1600_191_141_20160304_00058.jpg

The erosion at the shoulder of the levee could be slope instability. Fall 2013

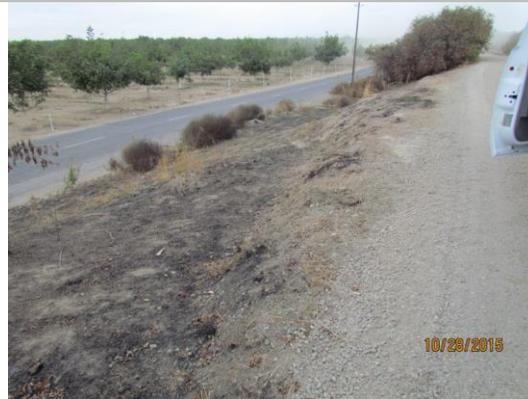
Photo 2 of 2 : SP_2016_RD1600_191_141_20160304_00059.jpg

View of the erosion on the landward side of the levee looking upstream. Fall 2015.

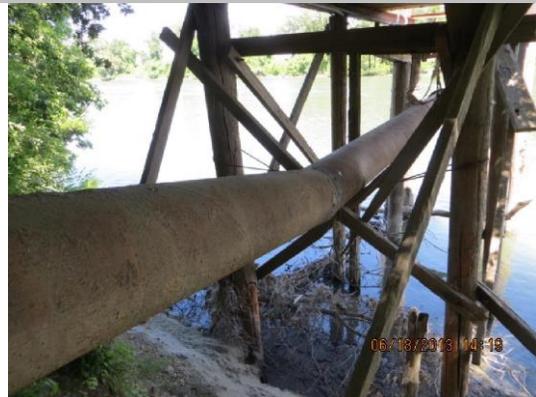
Photo 1 of 2 : UCIP_SP_2016_15130_24857.jpg

Pipe under wooden pier on WS toe.

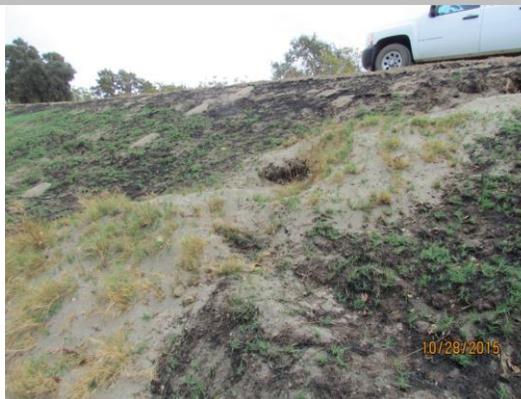
Photo 1 of 1 : SP_2016_RD1600_191_46_20160304_00040.jpg

View of the animal holes on the landward side of the levee. Fall 2015.

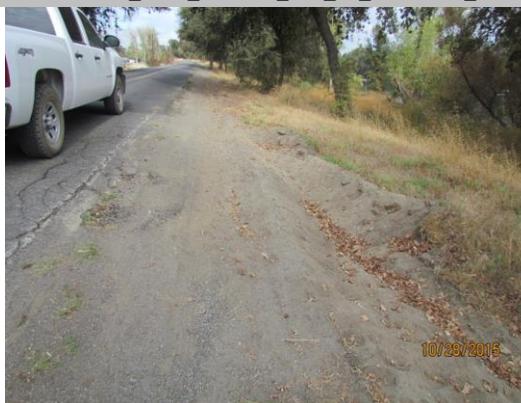
Photo 1 of 1 : SP_2016_RD1600_191_58_20160304_00049.jpg

View of the slope stability on the waterward side of the levee looking upstream. Fall 2015.

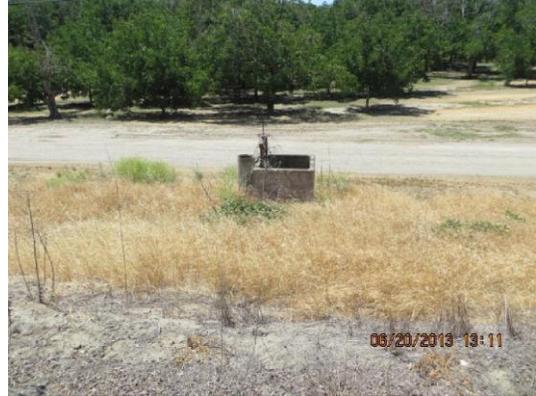
Photo 1 of 2 : UCIP_SP_2016_15207_25011.jpg

6'X6' concrete distribution box on LS toe.

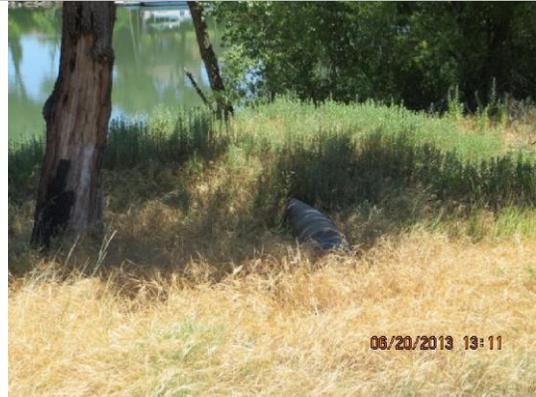
Photo 2 of 2 : UCIP_SP_2016_15207_25010.jpg

Pipe on WS slope.

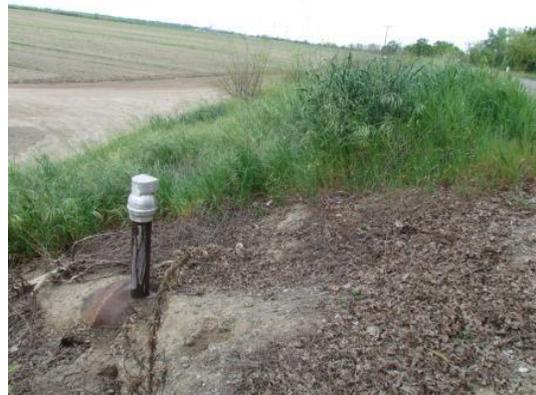
Photo 1 of 1 : SP_2016_RD1600_191_1199_20160304_00071.jpg

View of erosion and pipe on the landward side of the levee looking upstream. Spring 2015.

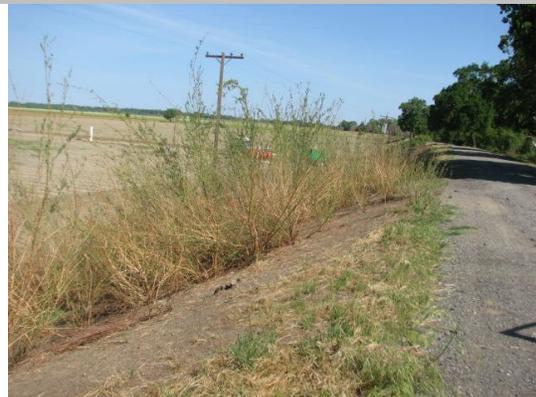
Photo 1 of 2 : SP_2016_RD1600_191_631_20160304_00066.jpg

The tall brush and vegetation blocks visibility. Spring 2014

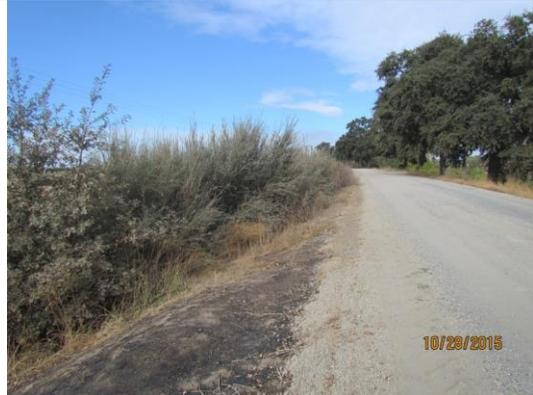
Photo 2 of 2 : SP_2016_RD1600_191_631_20160304_00067.jpg

View of the brush and vegetation on the landward side of the levee. Fall 2015.

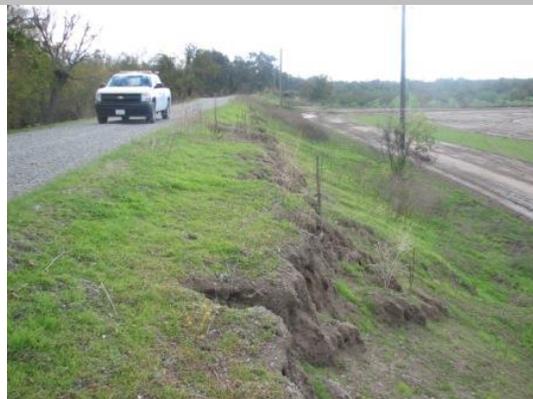
Photo 1 of 2 : SP_2016_RD1600_191_27_20160304_00022.jpg

The erosion appears to be moving closer to the shoulder.

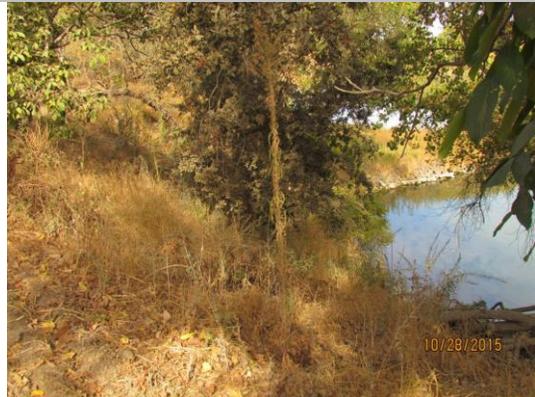
Photo 2 of 2 : SP_2016_RD1600_191_30_20160304_00027.jpg

View of the erosion into the berm area that needs to be monitored. Fall 2015.

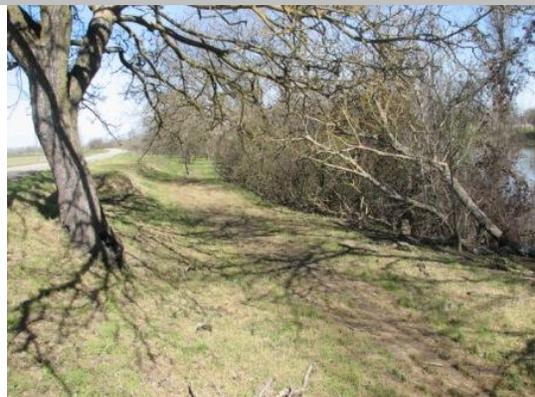
Photo 3 of 4 : SP_2016_RD1600_191_20_20160304_00015.jpg

The erosion is eroding away at the berm area.

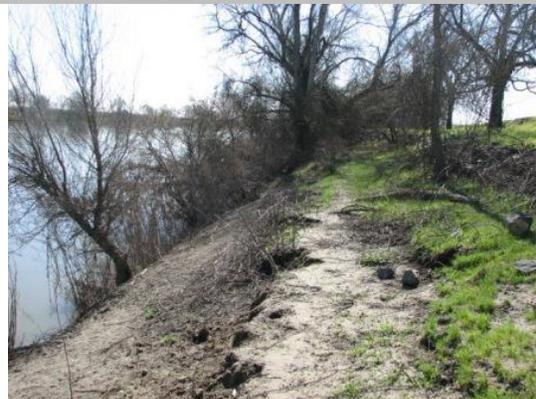
Photo 1 of 3 : SP_2016_RD1600_191_21_20160304_00017.jpg

The erosion is eroding away the berm area.

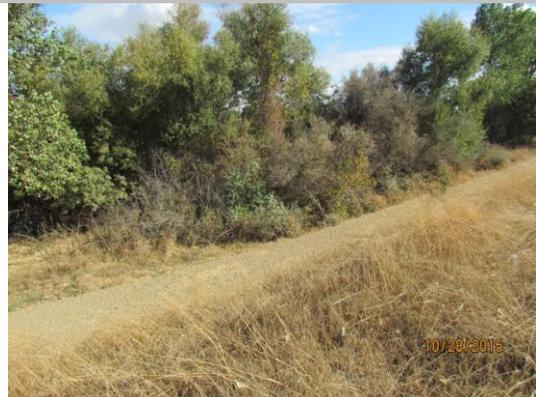
Photo 3 of 3 : SP_2016_RD1600_191_21_20160304_00019.jpg

View of the erosion along the waterward berm of the levee. Fall 2015.

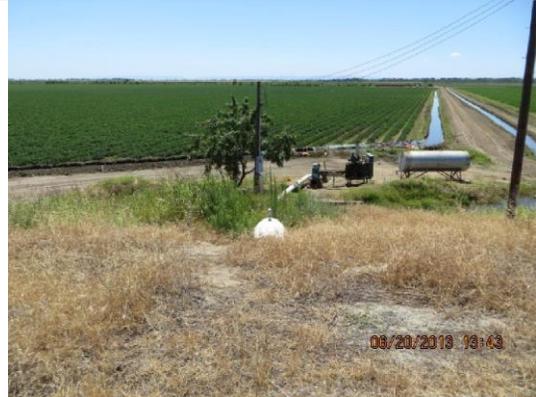
Photo 1 of 2 : UCIP_SP_2016_15264_25075.jpg

Pipe on LS shoulder.

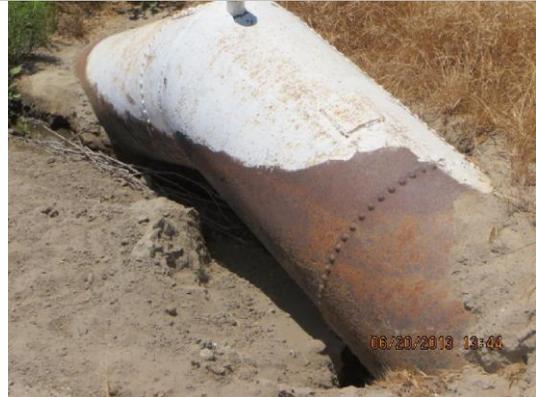
Photo 2 of 2 : UCIP_SP_2016_15264_25074.jpg

Pipe and vent on LS shoulder.

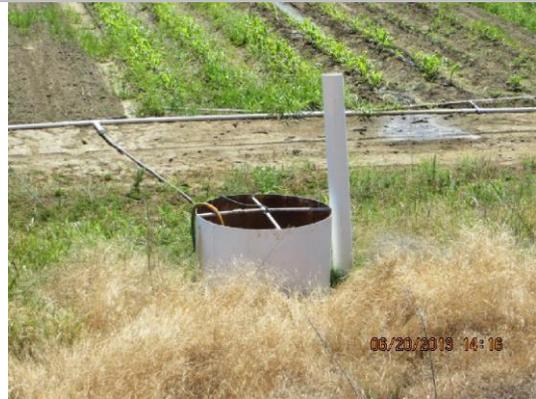
Photo 1 of 1 : UCIP_SP_2016_16310_27485.jpg

4-foot diameter steel standpipe at LS toe, may be indicator of pipe location.

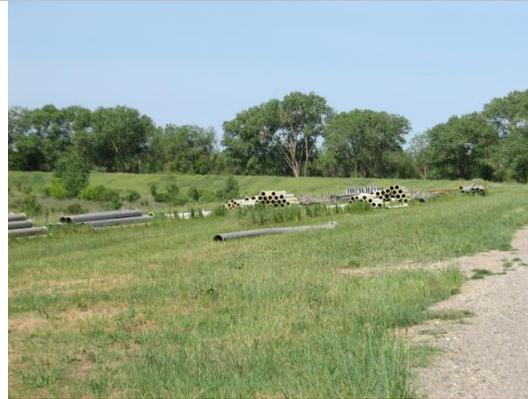
Photo 1 of 2 : SP_2016_RD1600_191_634_20160304_00068.jpg

Irrigation pipe is being stored on the landside. Spring 2014

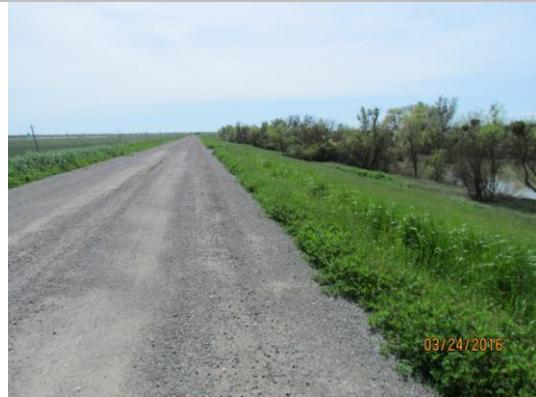
Photo 1 of 1 : SP_2016_RD1600_192_5_20160407_00013.jpg

View of the vegetation on the waterward side of the levee looking downstream. Spring 2016.

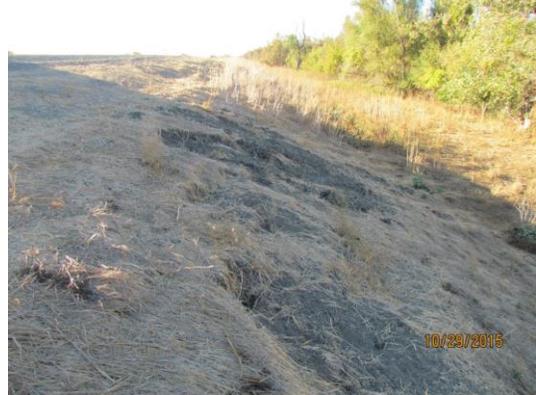
Photo 1 of 1 : SP_2016_RD1600_192_8_20160304_00003.jpg

View of the slope stability on the waterward side of the levee looking downstream. Fall 2015.

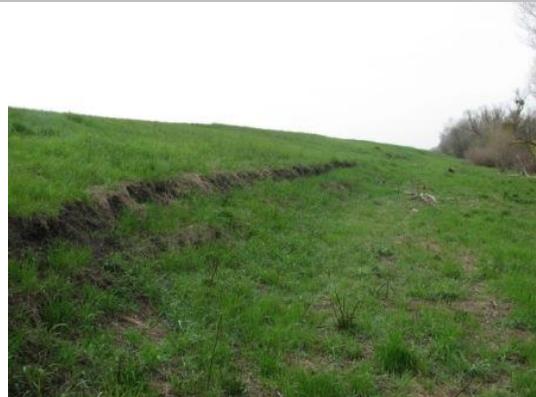
Photo 1 of 3 : SP_2016_RD1600_192_14_20160304_00005.jpg

A closer view of the wave wash damage along the bypass.

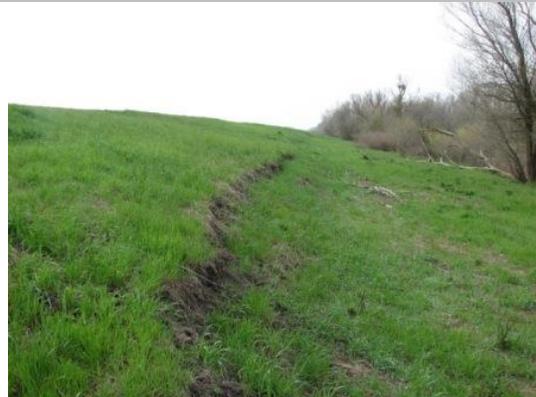
Photo 2 of 3 : SP_2016_RD1600_192_14_20160304_00006.jpg

Wave wash damage along the slope the cut is 1'-2'.

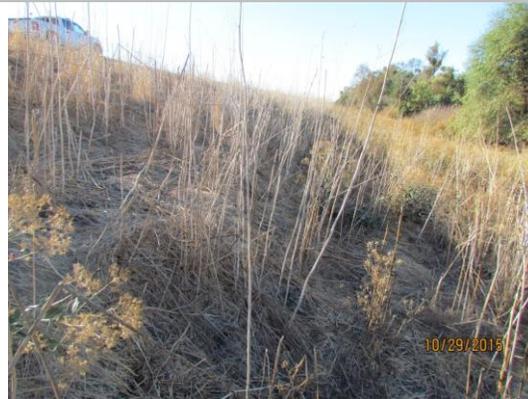
Photo 3 of 3 : SP_2016_RD1600_192_14_20160304_00007.jpg

View of the erosion on the waterward side of the levee looking downstream. Fall 2015.

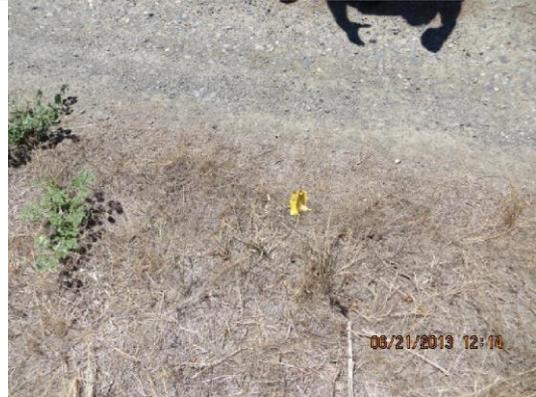
Photo 1 of 2 : UCIP_SP_2016_16308_27478.jpg

PG&E marker flag on Crown.

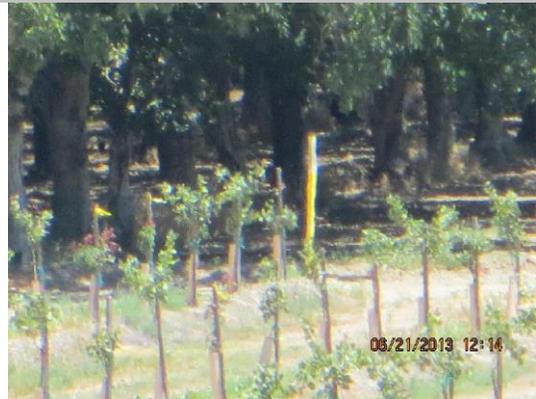
Photo 2 of 2 : UCIP_SP_2016_16308_27477.jpg

Carsonite gasline marker visible approximately 1,000-feet east of levee crown.
