**Flood Control Project Maintenance
Levee Inspections**

Fall 2015 Levee Maintenance Deficiency Summary Report

Levee Inspection Report By Mile - Fall 2015

Reclamation District No. 1601 Twitchell

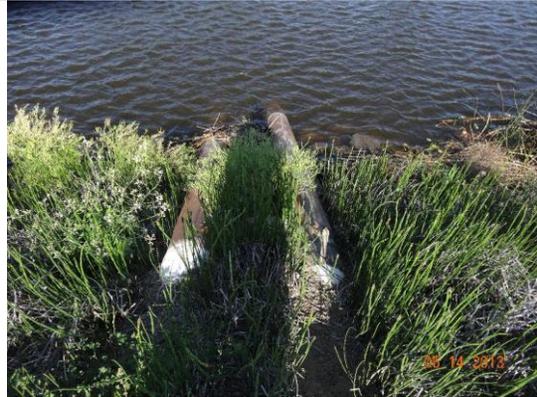
Photo 1 of 3 : UCIP_FA_2015_1935.jpg

LM Start	0.11	Rating **	M	Issue No.	16
LM End	0.11	Issue Type +	En	Location *	CR
Category	Supplemental			GPS Latitude/Longitude	
				Start	End
Item	DWR UCIP Field Study			38.120716 °	38.120716 °
				-121.682796 °	-121.682796 °
DWR ID					
Action/Comments					
Inspector Comments: FS_ID:22043 DS_ID:20950 EP_NO: 11227 FS_HLM: 0.11 Repair Type: Non-Urgent Crossing Status: Found UCIP Comments: Appears this crossing might be been recently modified--exposed section of pipe is protected with white paint. Need to contact owner to obtain records. Recommend clearing vegetation along the pipe alignment. FIELD_STRUCT_DESC: 14-inch pipe (not 12-inch pipe as original description noted) through the levee, 4.0 feet below the crown. Siphon primer on waterward shoulder. 36-inch steel (not concrete as original description noted) pipe with shut-off valve inside at landward toe ditch. (ABO No. 11227-1975) FS Date: 05/14/2013

View of waterward side. 12-inch pipe to the right and 14-inch pipe to the left.

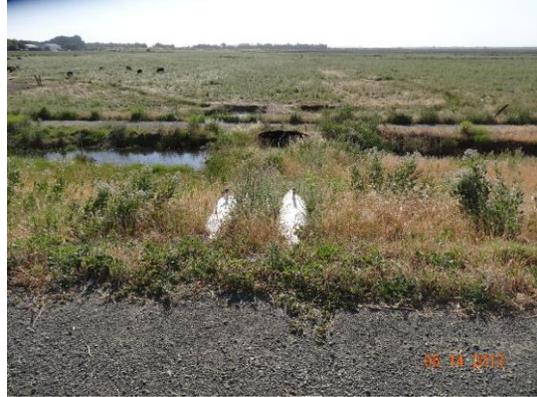
Photo 2 of 3 : UCIP_FA_2015_1936.jpg

LM Start	0.11	Rating **	M	Issue No.	16 (cont)
LM End	0.11	Issue Type +	En	Location *	CR
Category	Supplemental			GPS Latitude/Longitude	
				Start	End
Item	DWR UCIP Field Study			38.120716 °	38.120716 °
				-121.682796 °	-121.682796 °
DWR ID					
Action/Comments					
Inspector Comments: FS_ID:22043 DS_ID:20950 EP_NO: 11227 FS_HLM: 0.11 Repair Type: Non-Urgent Crossing Status: Found UCIP Comments: Appears this crossing might be been recently modified--exposed section of pipe is protected with white paint. Need to contact owner to obtain records. Recommend clearing vegetation along the pipe alignment. FIELD_STRUCT_DESC: 14-inch pipe (not 12-inch pipe as original description noted) through the levee, 4.0 feet below the crown. Siphon primer on waterward shoulder. 36-inch steel (not concrete as original description noted) pipe with shut-off valve inside at landward toe ditch. (ABO No. 11227-1975) FS Date: 05/14/2013

View of landward side with canal located at toe.

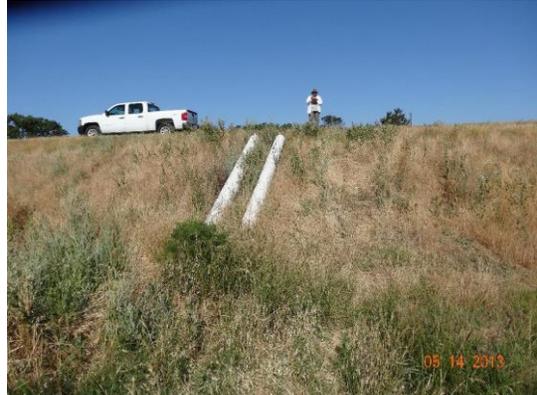
Photo 3 of 3 : UCIP_FA_2015_1937.jpg

View of pipes located on landward side-dense vegetation along slope.

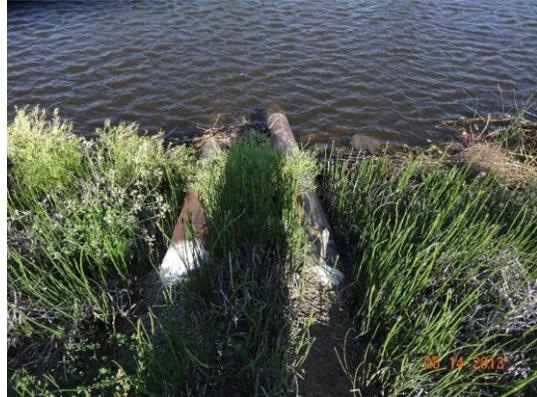
Photo 1 of 3 : UCIP_FA_2015_3665.jpg

LM Start	0.11	Rating **	M	Issue No.	17
LM End	0.11	Issue Type +	En	Location *	CR
Category	Supplemental			GPS Latitude/Longitude	
				Start	End
Item	DWR UCIP Field Study			38.120708 °	38.120708 °
				-121.682798 °	-121.682798 °
DWR ID					
Action/Comments					
Inspector Comments: FS_ID:42024 DS_ID:20953 EP_NO: N/A FS_HLM: 0.109 Repair Type: Non-Urgent Crossing Status: Found

View of waterward side. 12-inch pipe on the right (u/s) and 14-inch pipe on the left (d/s).

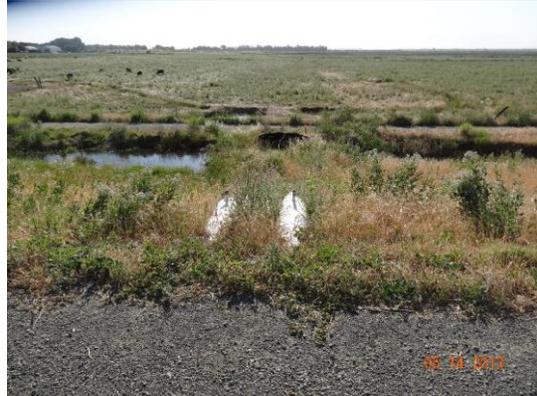
Photo 2 of 3 : UCIP_FA_2015_3666.jpg

View of pipes from landward shoulder. Levee is a gravel road.

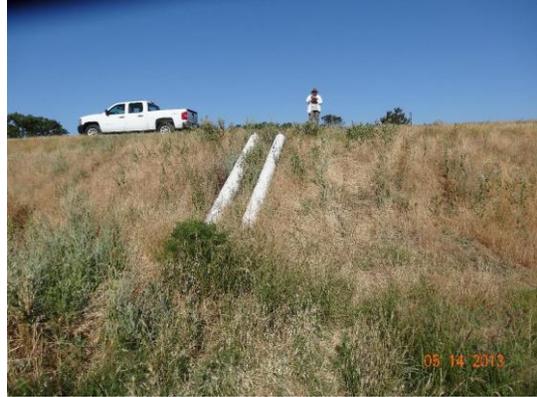
Photo 3 of 3 : UCIP_FA_2015_3667.jpg

LM Start	0.11	Rating **	M	Issue No.	17 (cont)
LM End	0.11	Issue Type +	En	Location *	CR
Category	Supplemental			GPS Latitude/Longitude	
				Start	End
Item	DWR UCIP Field Study			38.120708 °	38.120708 °
DWR ID				-121.682798 °	-121.682798 °
Action/Comments					
Inspector Comments: FS_ID:42024 DS_ID:20953 EP_NO: N/A FS_HLM: 0.109 Repair Type: Non-Urgent Crossing Status: Found

View of pipes on landward side-dense vegetation along slope.

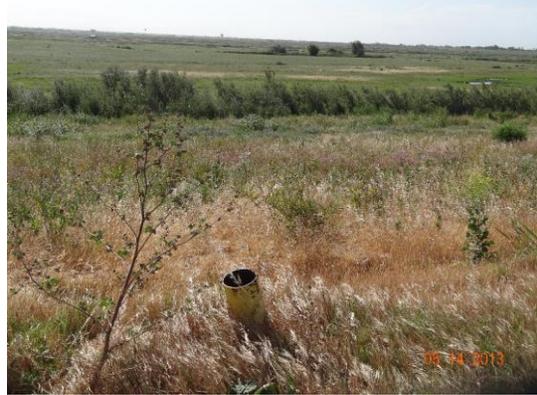
Photo 1 of 3 : UCIP_FA_2015_6669.jpg

Inspector Comments: FS_ID:39946
 DS_ID:24069
 EP_NO: N/A
 FS_HLM: 0.803
 Repair Type: Non-Urgent
 Crossing Status: Indicator Found
 UCIP Comments: Unable to determine if line crosses levee. Need to contact owner to determine if crossing goes through levee. Also need to determine permit authorizing work on landward side.
 FIELD_STRUCT_DESC: Steel stand pipe with PVC pipe inside located on landward shoulder. Rip rap located on waterward slope. Unable to determine if crossing goes through levee. Appears to be monitoring gas well.
 FS Date: 03/19/2009

View of landward side--dense vegetation along slope.

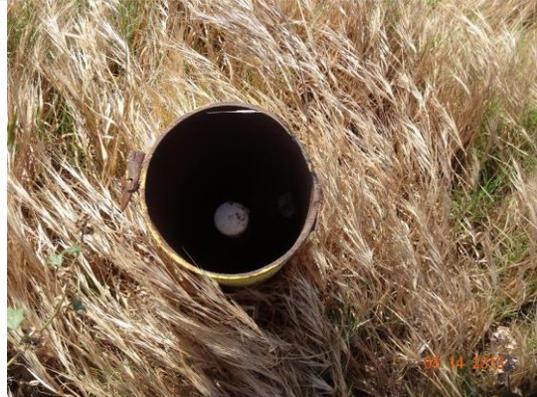
Photo 2 of 3 : UCIP_FA_2015_6670.jpg

PVC pipe inside standpipe located on landward side.

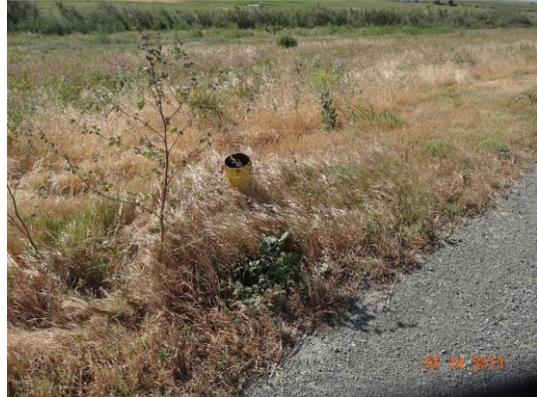
Photo 3 of 3 : UCIP_FA_2015_6671.jpg

LM Start	0.79	Rating **	M	Issue No.	18 (cont)
LM End	0.79	Issue Type +	En	Location *	CR
Category	Supplemental			GPS Latitude/Longitude	
				Start	End
Item	DWR UCIP Field Study			38.111078 °	38.111078 °
				-121.682011 °	-121.682011 °
DWR ID					
Action/Comments					
Inspector Comments: FS_ID:39946 DS_ID:24069 EP_NO: N/A FS_HLM: 0.803 Repair Type: Non-Urgent Crossing Status: Indicator Found

View of landward side--standpipe located on slope.

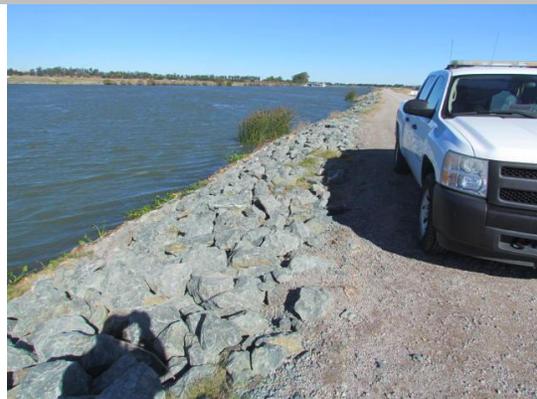
Photo 1 of 3 : FA_2015_RD1601_237_15_20151106_00008.jpg

LM Start	1.27	Rating **	A	Issue No.	15
LM End	1.28	Issue Type +	Ma	Location *	WS
Category	Earthen Levee		GPS Latitude/Longitude		
			Start	End	
Item	Slope Stability		38.104340 °	38.104114 °	
			-121.683890 °	-121.683933 °	
DWR ID	DWR_RD1601_01_s_2015_15				
Action/Comments					
Repair slope instability. Inspector Comments: Slight caving observed on waterward shoulder and slope.

Looking northwest at repaired depression/caving on waterward shoulder and slope.

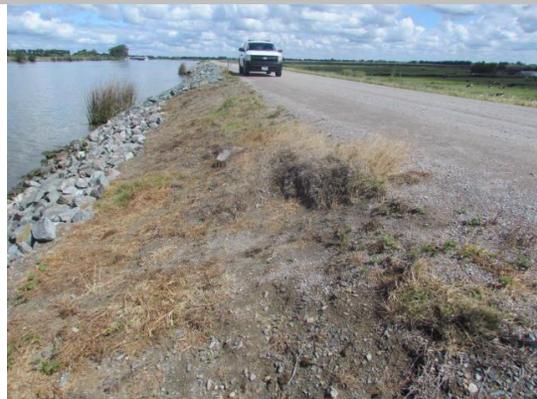
Photo 2 of 3 : FA_2015_RD1601_237_15_20150914_00004.jpg

Looking north at depression/caving on waterward shoulder and slope.

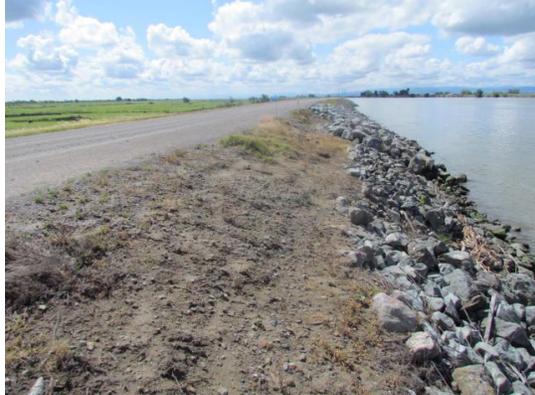
Photo 3 of 3 : FA_2015_RD1601_237_15_20150914_00003.jpg

LM Start	1.27	Rating **	A	Issue No.	15 (cont)
LM End	1.28	Issue Type +	Ma	Location *	WS
Category	Earthen Levee			GPS Latitude/Longitude	
				Start	End
Item	Slope Stability			38.104340 °	38.104114 °
				-121.683890 °	-121.683933 °
DWR ID	DWR_RD1601_01_s_2015_15				
Action/Comments					
Repair slope instability. Inspector Comments: Slight caving observed on waterward shoulder and slope.

Looking south at depression/caving on waterward shoulder and slope.

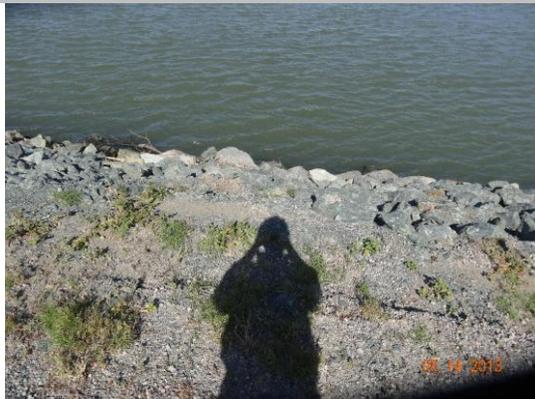
Photo 1 of 3 : UCIP_FA_2015_6672.jpg

LM Start	1.40	Rating **	M	Issue No.	20
LM End	1.40	Issue Type +	En	Location *	WS
Category	Supplemental			GPS Latitude/Longitude	
				Start	End
Item	DWR UCIP Field Study			38.102422 °	38.102422 °
				-121.684289 °	-121.684289 °
DWR ID					
Action/Comments					
Inspector Comments: FS_ID:39947 DS_ID:24068 EP_NO: N/A FS_HLM: 1.43 Repair Type: Non-Urgent Crossing Status: Indicator Found UCIP Comments: Unable to determine if line crosses levee. Need to contact owner to determine if crossing goes through levee. Also need to determine permit authorizing work on landward side. FIELD_STRUCT_DESC: Steel stand pipe with PVC pipe inside located on landward shoulder. Rip rap located on waterward slope. Unable to determine if crossing goes through levee. Appears to be monitoring gas well. FS Date: 03/19/2009

View of waterward side -- rip rap located along waterward toe.

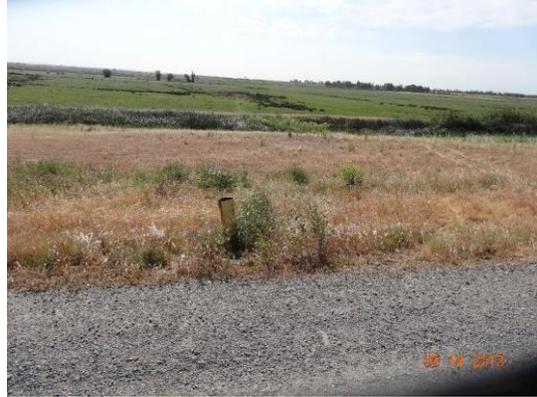
Photo 2 of 3 : UCIP_FA_2015_6673.jpg

Inspector Comments: FS_ID:39947
 DS_ID:24068
 EP_NO: N/A
 FS_HLM: 1.43
 Repair Type: Non-Urgent
 Crossing Status: Indicator Found
 UCIP Comments: Unable to determine if line crosses levee. Need to contact owner to determine if crossing goes through levee. Also need to determine permit authorizing work on landward side.
 FIELD_STRUCT_DESC: Steel stand pipe with PVC pipe inside located on landward shoulder. Rip rap located on waterward slope. Unable to determine if crossing goes through levee. Appears to be monitoring gas well.
 FS Date: 03/19/2009

View of landward side.

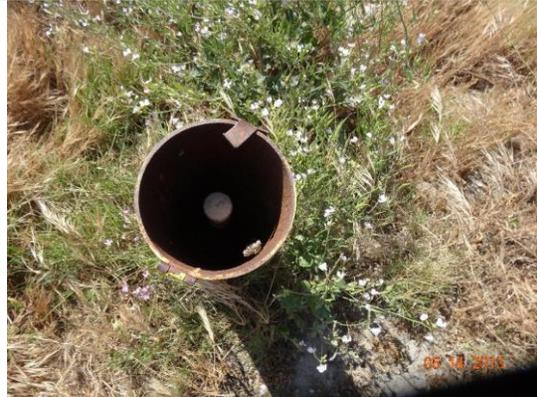
Photo 3 of 3 : UCIP_FA_2015_6674.jpg

PVC inside standpipe located on landward side.

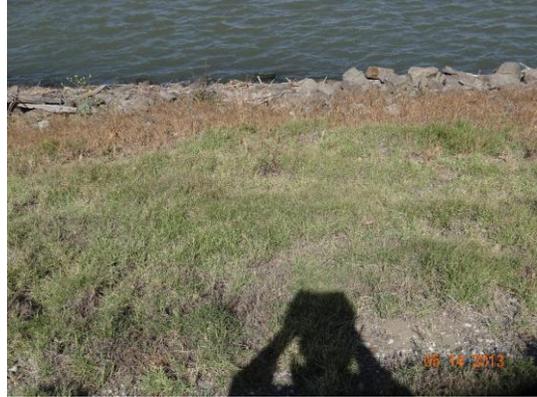
Photo 1 of 3 : UCIP_FA_2015_6675.jpg

LM Start	1.77	Rating **	M	Issue No.	21
LM End	1.77	Issue Type +	En	Location *	WS
Category	Supplemental			GPS Latitude/Longitude	
				Start	End
Item	DWR UCIP Field Study			38.097105 °	38.097105 °
				-121.684815 °	-121.684815 °
DWR ID					
Action/Comments					
Inspector Comments: FS_ID:39948 DS_ID:24071 EP_NO: N/A FS_HLM: 1.8 Repair Type: Non-Urgent Crossing Status: Indicator Found

View of waterward side.

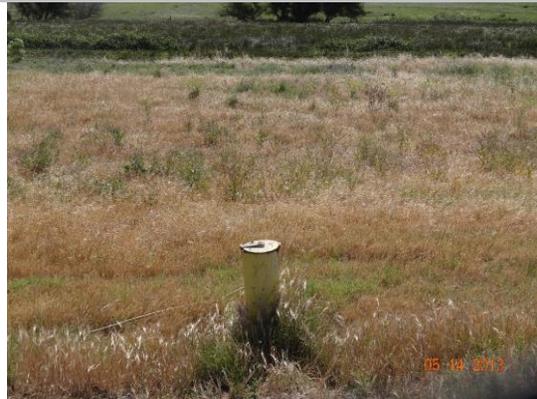
Photo 2 of 3 : UCIP_FA_2015_6676.jpg

View of landward side.

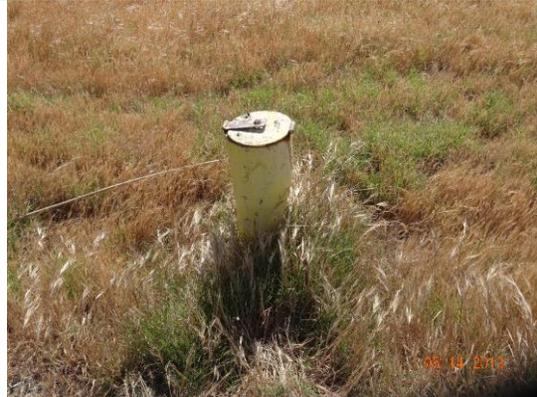
Photo 3 of 3 : UCIP_FA_2015_6677.jpg

LM Start	1.77	Rating **	M	Issue No.	21 (cont)
LM End	1.77	Issue Type +	En	Location *	WS
Category	Supplemental			GPS Latitude/Longitude	
				Start	End
Item	DWR UCIP Field Study			38.097105 °	38.097105 °
				-121.684815 °	-121.684815 °
DWR ID					
Action/Comments					
Inspector Comments: FS_ID:39948 DS_ID:24071 EP_NO: N/A FS_HLM: 1.8 Repair Type: Non-Urgent Crossing Status: Indicator Found

Standpipe located on landward side.

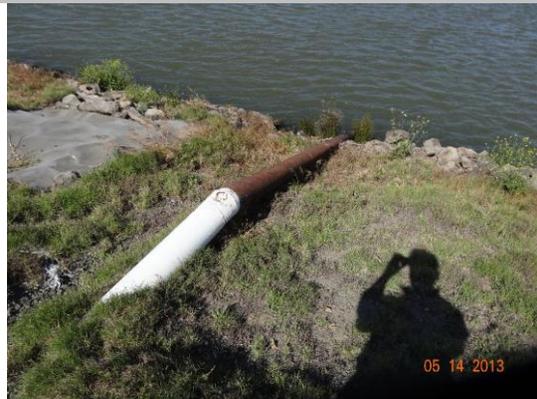
Photo 1 of 3 : UCIP_FA_2015_1699.jpg

LM Start	2.04	Rating **	M	Issue No.	22
LM End	2.04	Issue Type +	En	Location *	WS
Category	Supplemental			GPS Latitude/Longitude	
				Start	End
Item	DWR UCIP Field Study			38.093107 °	38.093107 °
				-121.684525 °	-121.684525 °
DWR ID					
Action/Comments					
Inspector Comments: FS_ID:19545 DS_ID:20951 EP_NO: 2909A FS_HLM: 2.083 Repair Type: Non-Urgent Crossing Status: Found UCIP Comments: Appears this crossing might be been recently modified--exposed section of pipe is protected with white paint. Need to contact owner to obtain records. Recommend clearing vegetation along the pipe alignment. Dense vegetation on landward slope limits the inspector's visibility to identify signs of leaks along levee slope. FIELD_STRUCT_DESC: 8-inch siphon pipe through levee, 2.4 feet below crown. Cutoff wall around pipe at center of levee. Siphon breaker on apex of pipe on landward shoulder. Hand primer pump on landward slope. (Permit No. 2909A-1960) FS Date: 05/14/2013

View of crossing on waterward slope. Rip rap present at waterward toe.

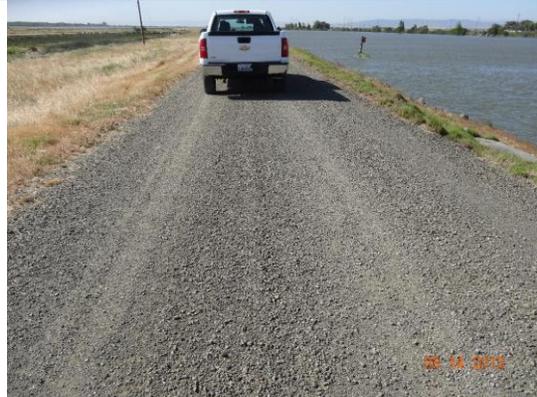
Photo 2 of 3 : UCIP_FA_2015_1700.jpg

LM Start	2.04	Rating **	M	Issue No.	22 (cont)
LM End	2.04	Issue Type +	En	Location *	WS
Category	Supplemental			GPS Latitude/Longitude	
				Start	End
Item	DWR UCIP Field Study			38.093107 °	38.093107 °
				-121.684525 °	-121.684525 °
DWR ID					
Action/Comments					
Inspector Comments: FS_ID:19545 DS_ID:20951 EP_NO: 2909A FS_HLM: 2.083 Repair Type: Non-Urgent Crossing Status: Found UCIP Comments: Appears this crossing might be been recently modified--exposed section of pipe is protected with white paint. Need to contact owner to obtain records. Recommend clearing vegetation along the pipe alignment. Dense vegetation on landward slope limits the inspector's visibility to identify signs of leaks along levee slope. FIELD_STRUCT_DESC: 8-inch siphon pipe through levee, 2.4 feet below crown. Cutoff wall around pipe at center of levee. Siphon breaker on apex of pipe on landward shoulder. Hand primer pump on landward slope. (Permit No. 2909A-1960) FS Date: 05/14/2013

View of levee crown looking downstream at crossing.

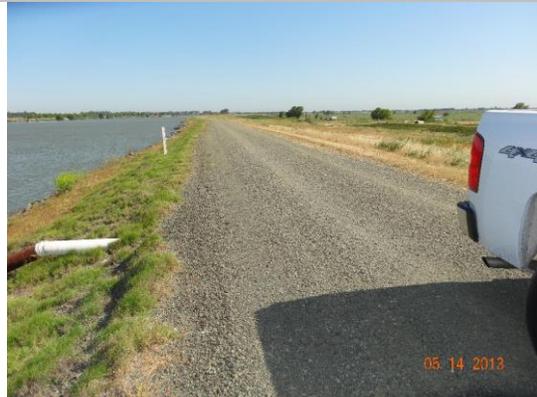
Photo 3 of 3 : UCIP_FA_2015_1701.jpg

View of levee crown looking upstream at crossing.
