**Flood Control Project Maintenance
Levee Inspections**
LMA District Cover Sheet
Spring 2014 Levee Inspection Results

Reclamation District No. 1601 Twitchell

Waterway	Bank	Unit Miles
Unit No. 01 Threemile Slough	Left	2.47

Levee Inspection Report By Mile - Spring 2014

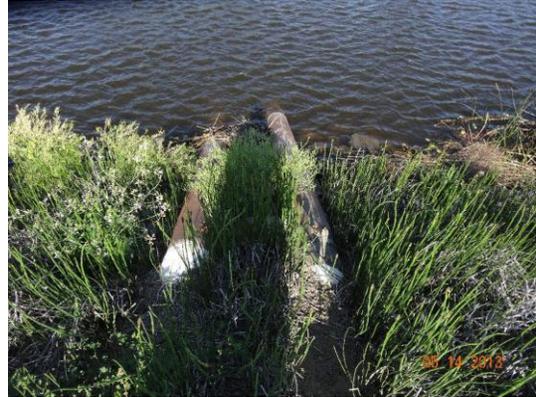
Photo 1 of 1 : UCIP_2791.jpg

LM Start	0.11	Rating **	M	Issue No.	1
LM End	0.11	Issue Type +	En	Location *	WS
Category	Supplemental			GPS Latitude/Longitude	
				Start	End
Item	DWR UCIP Field Study			38.120716 °	38.120716 °
				-121.682796 °	-121.682796 °
DWR ID	DWR_RD1601_01_s_2014_1				
Action/Comments					
Inspector Comments: FS_ID:22043 EP_NO: 11227 Repair Type: Crossing Status: UCIP Comments: Appears this crossing might be been recently modified--exposed section of pipe is protected with white paint. Need to contact owner to obtain records. Recommend clearing vegetation along the pipe alignment. FIELD_STRUCT_DESC: 14-inch pipe (not 12-inch pipe as original description noted) through the levee, 4.0 feet below the crown. Siphon primer on waterward shoulder. 36-inch steel (not concrete as original description noted) pipe with shut-off valve inside at landward toe ditch. (ABO No. 11227-1975) FS Date: 5/14/2013

View of waterward side. 12-inch pipe to the right and 14-inch pipe to the left.

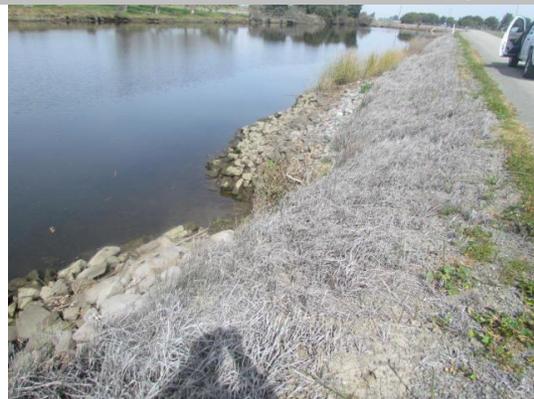
Photo 1 of 5 : richard_s_20140227_059.jpg

LM Start	0.18	Rating **	M	Issue No.	3
LM End	0.18	Issue Type +	Ma	Location *	WS
Category	Earthen Levee			GPS Latitude/Longitude	
				Start	End
Item	Erosion / Bank Caving			38.119698 °	38.119698 °
				-121.682760 °	-121.682760 °
DWR ID	DWR_RD1601_01_s_2013_3				
Action/Comments					
Note and monitor erosion site. Inspector Comments: District repaired site.

Looking northwest at erosion on waterside toe.

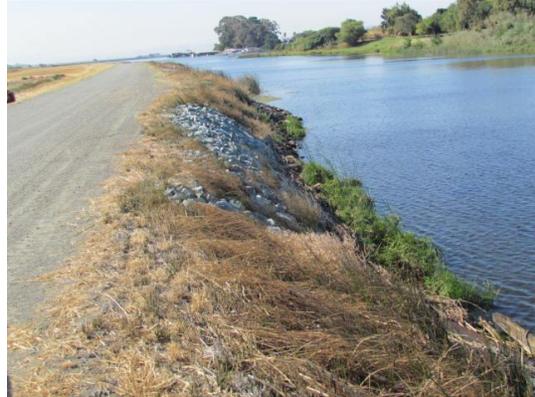
Photo 2 of 5 : richard_s_20140227_060.jpg

LM Start	0.18	Rating **	M	Issue No.	3 (cont)
LM End	0.18	Issue Type +	Ma	Location *	WS
Category	Earthen Levee			GPS Latitude/Longitude	
				Start	End
Item	Erosion / Bank Caving			38.119698 °	38.119698 °
				-121.682760 °	-121.682760 °
DWR ID	DWR_RD1601_01_s_2013_3				
Action/Comments					
Note and monitor erosion site.					
Inspector Comments: District repaired site.

Looking southwest at repaired site on waterward slope

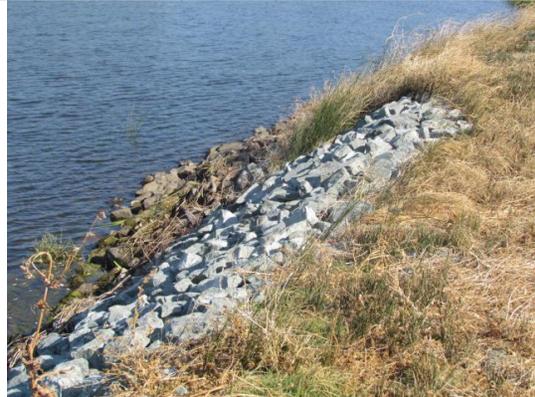
Photo 3 of 5 : richard_s_20140227_061.jpg

Looking northwest at repaired erosion site on waterward slope.

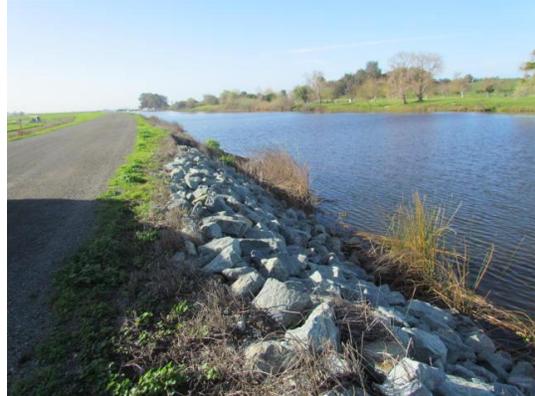
Photo 4 of 5 : richard_s_20140306_147.jpg

Looking southwest at repaired site on waterward slope.

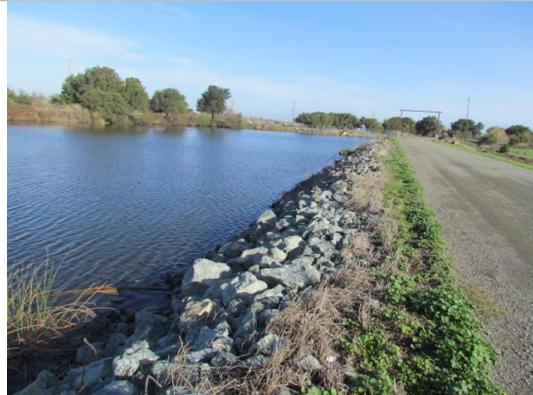
Photo 5 of 5 : richard_s_20140306_148.jpg

LM Start	0.18	Rating **	M	Issue No.	3 (cont)
LM End	0.18	Issue Type +	Ma	Location *	WS
Category	Earthen Levee			GPS Latitude/Longitude	
				Start	End
Item	Erosion / Bank Caving			38.119698 °	38.119698 °
				-121.682760 °	-121.682760 °
DWR ID	DWR_RD1601_01_s_2013_3				
Action/Comments					
Note and monitor erosion site.

Looking northwest at repaired site on waterward slope.

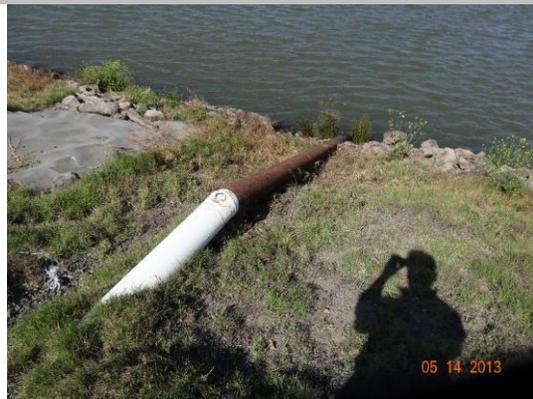
Photo 1 of 1 : UCIP_1841.jpg

LM Start	2.08	Rating **	M	Issue No.	4
LM End	2.08	Issue Type +	En	Location *	WS
Category	Supplemental			GPS Latitude/Longitude	
				Start	End
Item	DWR UCIP Field Study			38.093107 °	38.093107 °
				-121.684525 °	-121.684525 °
DWR ID	DWR_RD1601_01_s_2014_4				
Action/Comments					
Inspector Comments: FS_ID:19545 EP_NO: 2909A Repair Type: Crossing Status: UCIP Comments: Appears this crossing might be been recently modified--exposed section of pipe is protected with white paint. Need to contact owner to obtain records. Recommend clearing vegetation along the pipe alignment. Dense vegetation on landward slope limits the inspector's visibility to identify signs of leaks along levee slope. FIELD_STRUCT_DESC: 8-inch siphon pipe through levee, 2.4 feet below crown. Cutoff wall around pipe at center of levee. Siphon breaker on apex of pipe on landward shoulder. Hand primer pump on landward slope. (Permit No. 2909A-1960) FS Date: 5/14/2013

View of crossing on waterward slope. Rip rap present at waterward toe.
