**Flood Control Project Maintenance  
Levee Inspections**

## Maintenance Issue Types Only, Levee Inspection Report By Mile - Fall 2015

### Reclamation District No. 1601 Twitchell

Waterway	Bank	Unit Miles	Inspection Start/End	Inspector
Unit No. 01 Threemile Slough	Left	2.43	11/03/2015 11/03/2015	Richard Willoughby

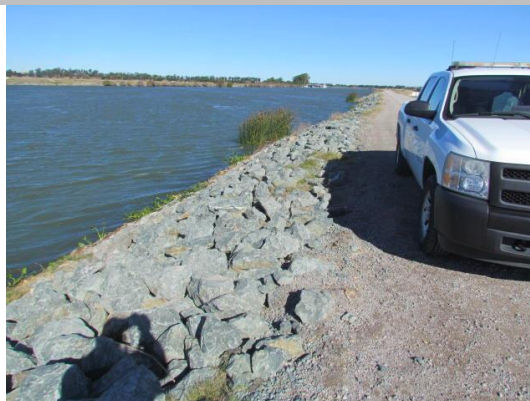
Photo 1 of 3 : FA\_2015\_RD1601\_237\_15\_20151106\_00008.jpg

LM Start	1.27	Rating **	A	Issue No.	15
LM End	1.28	Issue Type +	Ma	Location *	WS
Category	Earthen Levee			GPS Latitude/Longitude	
				Start	End
Item	Slope Stability			38.104340 °	38.104114 °
				-121.683890 °	-121.683933 °
DWR ID	DWR_RD1601_01_s_2015_15				
Action/Comments					
Repair slope instability. Inspector Comments: Slight caving observed on waterward shoulder and slope.

Looking northwest at repaired depression/caving on waterward shoulder and slope.

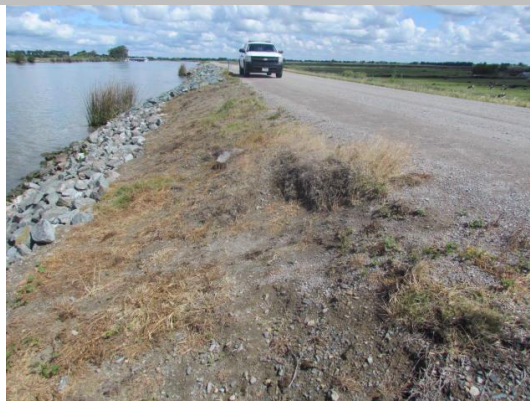
Photo 2 of 3 : FA\_2015\_RD1601\_237\_15\_20150914\_00004.jpg

Looking north at depression/caving on waterward shoulder and slope.

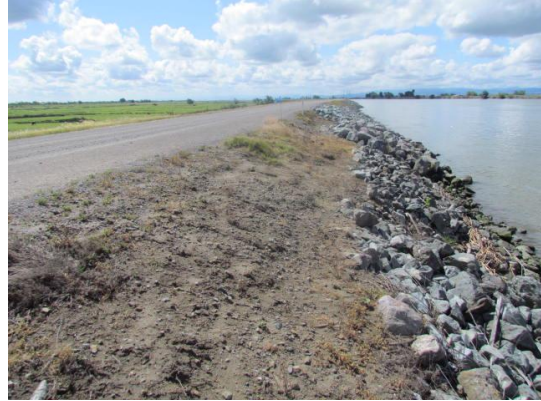
Photo 3 of 3 : FA\_2015\_RD1601\_237\_15\_20150914\_000003.jpg

LM Start	1.27	Rating **	A	Issue No.	15 (cont)
LM End	1.28	Issue Type +	Ma	Location *	WS
Category	Earthen Levee			GPS Latitude/Longitude	
				Start	End
Item	Slope Stability			38.104340 °	38.104114 °
				-121.683890 °	-121.683933 °
DWR ID	DWR_RD1601_01_s _ 2015_15				
Action/Comments					
Repair slope instability. Inspector Comments: Slight caving observed on waterward shoulder and slope.

Looking south at depression/caving on waterward shoulder and slope.
