**Flood Control Project Maintenance  
Levee Inspections**

## Maintenance Issue Types Only, Levee Inspection Report By Mile - Fall 2017

### Reclamation District No. 1601 Twitchell

Waterway	Bank	Unit Miles	Inspection Start/End	Inspector
Unit No. 01 Threemile Slough	Left	2.43	09/06/2017 09/06/2017	Dave Torres

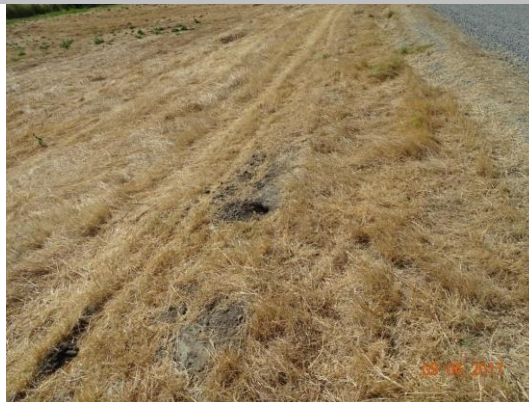
Photo 1 of 1 : FA\_2017\_RD1601\_237\_12\_20170906\_00022.jpg

LM Start	<b>0.56</b>	Rating **	A	Issue No.	<b>12</b>
LM End	<b>0.56</b>	Issue Type +	Ma	Location *	LS
Category	Earthen Levee		GPS Latitude/Longitude		
			Start	End	
Item	Animal Control		38.114409 °	38.114409 °	
			-121.681861 °	-121.681861 °	
DWR ID	DWR_RD1601_01_f_2017_12				
Comment Code					
A1 : Exterminate rodents and backfill and compact or grout burrows.					
Inspector Comment					
LMA has rodent control program in place. New rodent activity recently identified and is being addressed.

Looking south at rodent activity on the landside of the levee.

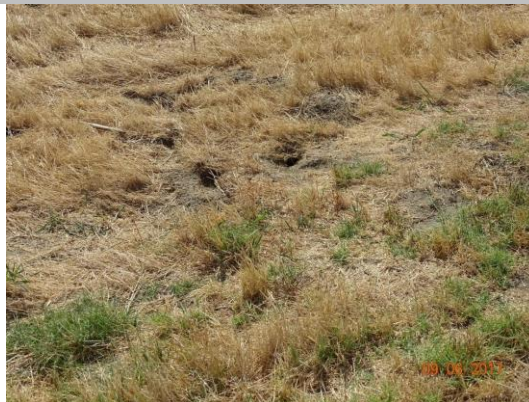
Photo 1 of 1 : FA\_2017\_RD1601\_237\_15\_20170907\_00023.jpg

LM Start	0.88	Rating **	M	Issue No.	15
LM End	0.88	Issue Type +	Ma	Location *	LS
Category	Earthen Levee			GPS Latitude/Longitude	
				Start	End
Item	Animal Control			38.109753 °	38.109753 °
				-121.682200 °	-121.682200 °
DWR ID	DWR_RD1601_01_f_2017_15				
Comment Code					
A1 : Exterminate rodents and backfill and compact or grout burrows.					
Inspector Comment					
LMA has rodent control program in place. New rodent activity recently identified and is being addressed.

View of landside rodent activity.
