**Flood Control Project Maintenance
Levee Inspections**

Maintenance Issue Types Only, Levee Inspection Report By Mile - Fall 2019

Reclamation District No. 1601 Twitchell

Waterway	Bank	Unit Miles	Inspection Start/End	Inspector
Unit No. 01 Threemile Slough	Left	2.43	10/24/2019 10/24/2019	David Julian

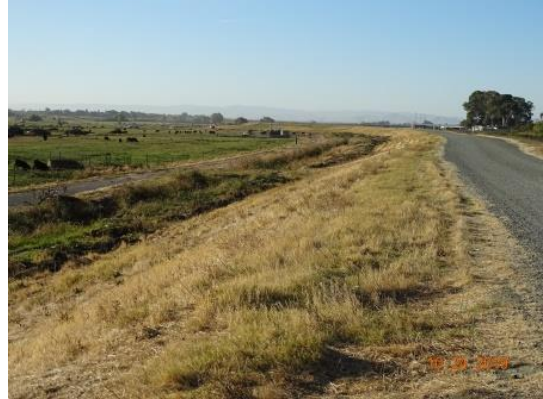
Photo 1 of 1 : FA_2019_RD1601_237_10_20191028_00013.jpg

LM Start	0.06	Rating **	A	Issue No.	10
LM End	2.43	Issue Type +	Ma	Location *	LS
Category	Earthen Levee			GPS Latitude/Longitude	
				Start	End
Item	Vegetation			38.121448°	38.087715°
				-121.682732°	-121.683800°
DWR ID	DWR_RD1601_01_f_2019_10				
Comment Code					
V1 : Control annual grass and weeds on the levee slopes and easements.					
Inspector Comment

View looking downstream at well maintained annual vegetation on the landside slope (Fall 2019).
