**Flood Control Project Maintenance
Levee Inspections**

Maintenance Issue Types Only, Levee Inspection Report By Mile - Fall 2021

Reclamation District No. 1601 Twitchell

Waterway	Bank	Unit Miles	Inspection Start/End	Inspector
Unit No. 01 Threemile Slough	Left	2.43	09/29/2021 09/29/2021	David Julian

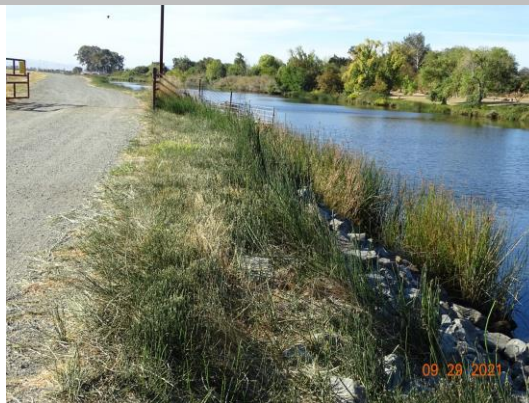
Photo 1 of 1 : FA_2021_RD1601_237_10_20210930_00014.jpg

LM Start	0.03	Rating **	M	Issue No.	10
LM End	1.26	Issue Type +	Ma	Location *	WS
Category	Earthen Levee			GPS Latitude/Longitude	
				Start	End
Item	Vegetation			38.121834 °	38.104413 °
				-121.682653 °	-121.683859 °
DWR ID	DWR_RD1601_01_f_2021_10				
Comment Code					
V1 : Control annual grass and weeds on the levee slopes and easements.					
Inspector Comment

View looking downstream at vegetation on the waterside slope (Fall 2021).
