**Flood Control Project Maintenance
Levee Inspections**

Maintenance Issue Types Only, Levee Inspection Report By Mile - Fall 2022

Reclamation District No. 1601 Twitchell

Waterway	Bank	Unit Miles	Inspection Start/End	Inspector
Unit No. 01 Threemile Slough	Left	2.43	10/13/2022 10/13/2022	Saskia Donovan

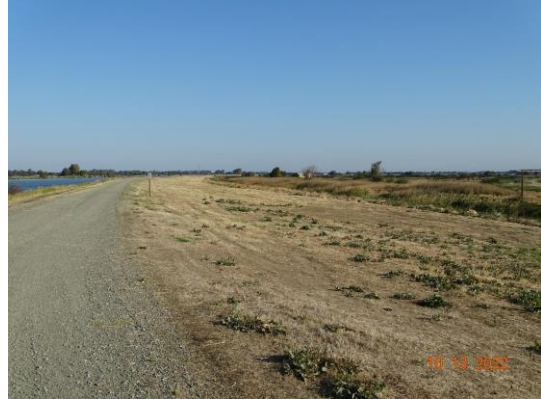
Photo 1 of 1 : FA_2022_RD1601_237_15_20221017_00001.jpg

LM Start	2.41	Rating **	A	Issue No.	15
LM End	2.41	Issue Type +	Ma	Location *	LS
Category	Earthen Levee			GPS Latitude/Longitude	
				Start	End
Item	Vegetation			38.087830 °	38.087830 °
				-121.683960 °	-121.683960 °
DWR ID	DWR_RD1601_01_f_2022_15				
Comment Code					
V1 : Control annual grass and weeds on the levee slopes and easements.					
Inspector Comment					
The district has been doing an excellent job maintaining the annual vegetation.

View of the well-maintained LS slope (Fall 2022).
